**Flood Control Project Maintenance
Levee Inspections**

Fall 2013 Levee Maintenance Deficiency Summary Report

San Joaquin River Basin

Reclamation District No. 0524 Middle Roberts Island

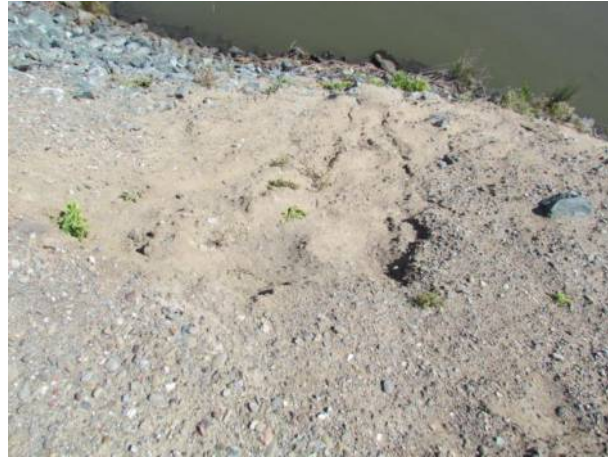
Levee Mile Report Line	10
Start Levee Mile	0.63
End Levee Mile	0.64
Location	Water Side
Category	Earthen Levee
Item	Vegetation

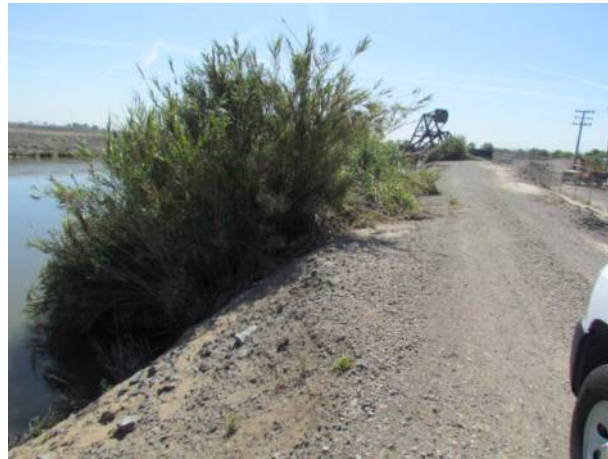
Levee Mile Report Line	10
Start Levee Mile	0.63
End Levee Mile	0.64
Location	Water Side
Category	Earthen Levee
Item	Vegetation

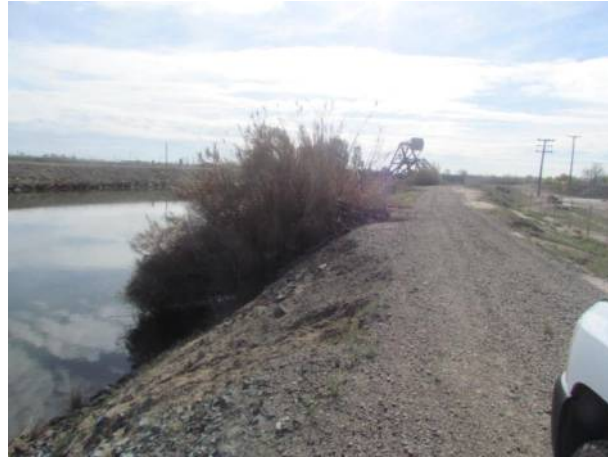
Levee Mile Report Line	11
Start Levee Mile	0.65
End Levee Mile	0.66
Location	Water Side
Category	Earthen Levee
Item	Slope Stability

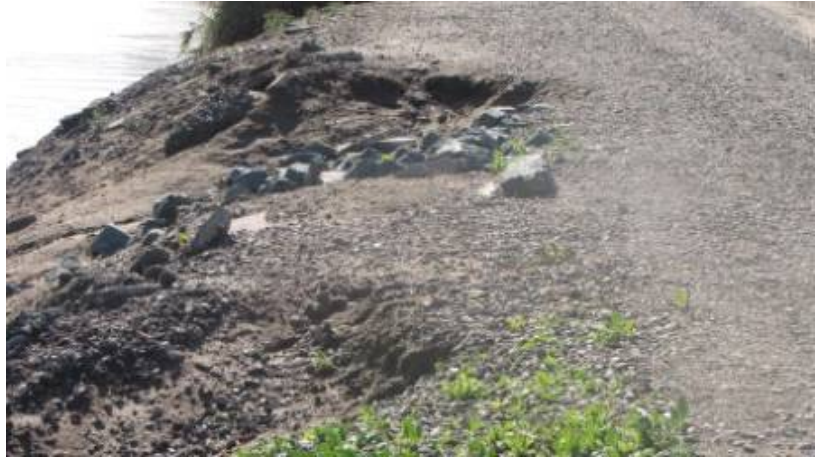
Levee Mile Report Line	12
Start Levee Mile	0.68
End Levee Mile	0.68
Location	Water Side
Category	Earthen Levee
Item	Vegetation

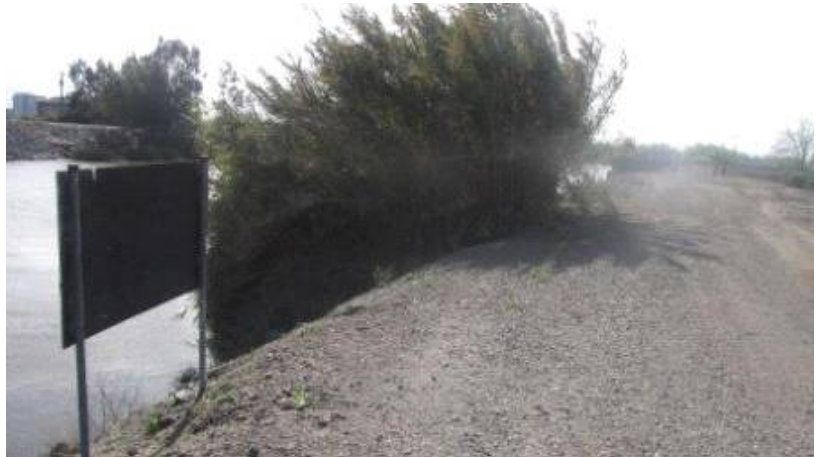
Levee Mile Report Line	12
Start Levee Mile	0.68
End Levee Mile	0.68
Location	Water Side
Category	Earthen Levee
Item	Vegetation

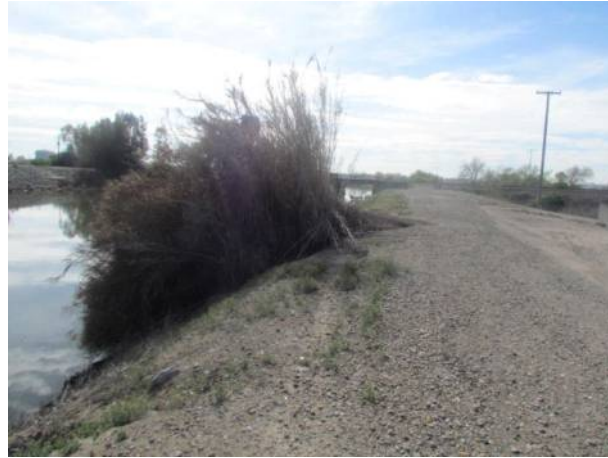
Levee Mile Report Line	12
Start Levee Mile	0.68
End Levee Mile	0.68
Location	Water Side
Category	Earthen Levee
Item	Vegetation
Looking south at dying bamboo on waterward slope. (Spring 2013)	
richard_f_20130930_799.JPG

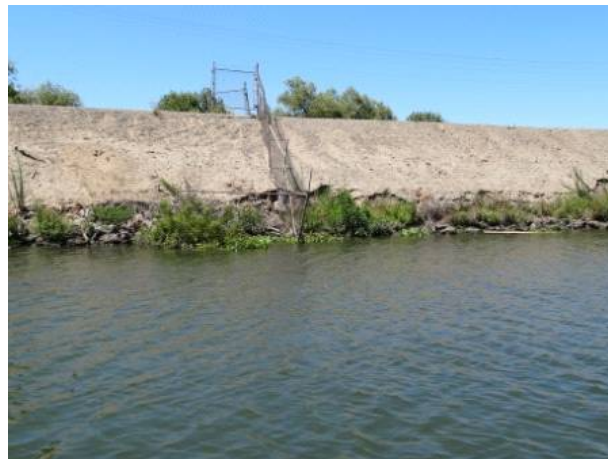
DWR ID: DWR_RD0524_01_s_2012_14										
13	0.77	0.78	Supplemental	DWR Erosion Survey	WS	U	Inspector Comments: 08/13/2013: No significant change at this site. 08/07/2012: The site has been visited by boat survey. No significant change observed 08/23/2011: The site is located immediately upstream of a Railroad bridge. Dense vegetation at the water line blocks the view of erosion. [2013 Site ID:RD0524U01RM41.39]	37.936821 ° -121.334582 °	37.936821 ° -121.334582 °	55 Y
DWR ID:										
14	0.78	0.78	Earthen Levee	Vegetation	LS	M	V2 : Remove the wild growth other than native grasses from the levee slopes. Inspector Comments: Dense vegetation at landside toe along fence line.	37.936555 ° -121.334847 °	37.936555 ° -121.334847 °	262 Y
DWR ID: DWR_RD0524_01_s_2012_262										
15	0.79	0.79	Earthen Levee	Trim / Thin Trees	LS	M	T1 : Trim trees to at least five feet above ground level.	37.936444 ° -121.334797 °	37.936444 ° -121.334797 °	76 Y

Levee Mile Report Line	13
Start Levee Mile	0.77
End Levee Mile	0.78
Location	Water Side
Category	Supplemental
Item	DWR Erosion Survey
Upstream view of the erosion site.	
SJR2013_RD0524U01RM41.39_1.jpg

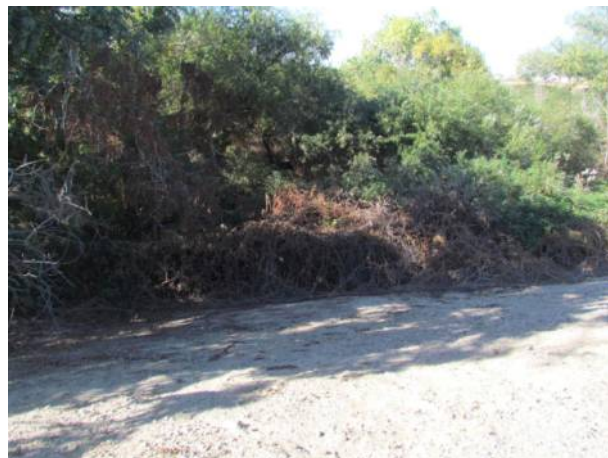
Levee Mile Report Line	14
Start Levee Mile	0.78
End Levee Mile	0.78
Location	Land Side
Category	Earthen Levee
Item	Vegetation
Looking west at dense vegetation on landside toe.	
richard_f_20130930_908.jpg

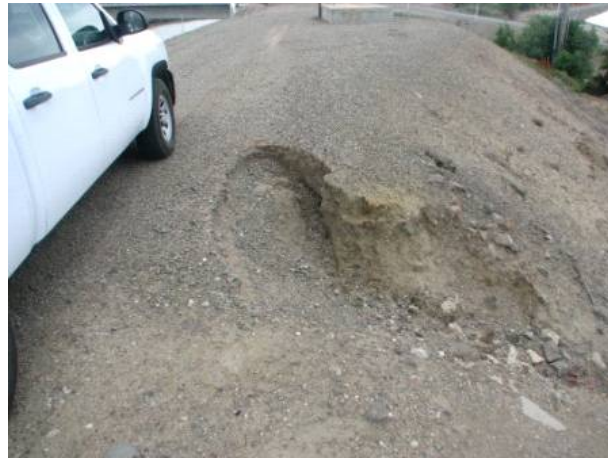
Landward slope damage at LM 1.09.

Levee Mile Report Line	25
Start Levee Mile	1.09
End Levee Mile	1.09
Location	Land Side
Category	Earthen Levee
Item	Slope Stability

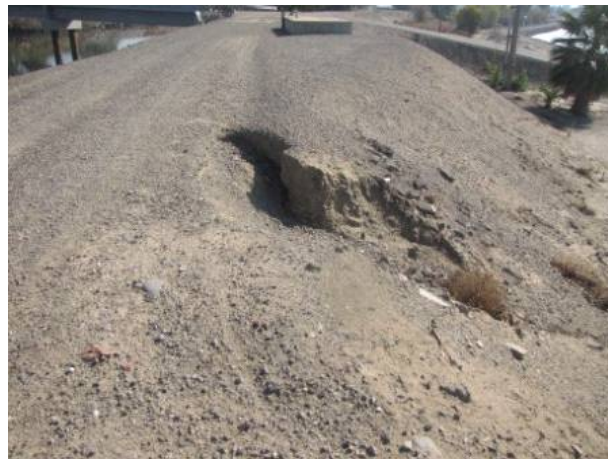
Levee Mile Report Line	25
Start Levee Mile	1.09
End Levee Mile	1.09
Location	Land Side
Category	Earthen Levee
Item	Slope Stability

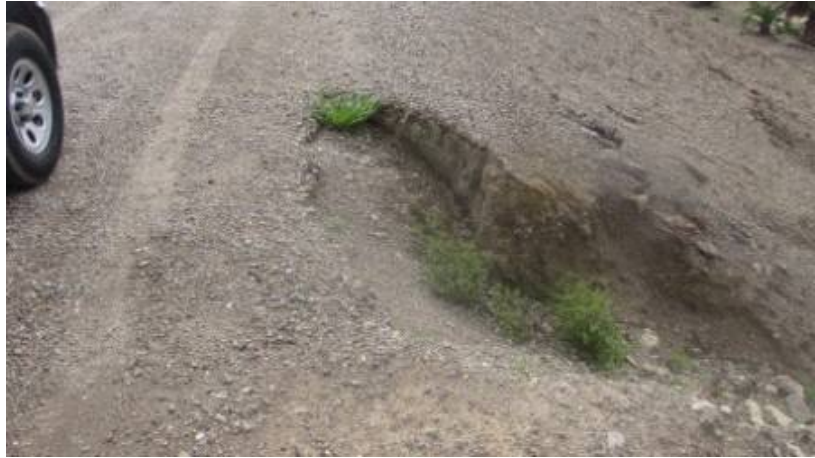
Levee Mile Report Line	25
Start Levee Mile	1.09
End Levee Mile	1.09
Location	Land Side
Category	Earthen Levee
Item	Slope Stability

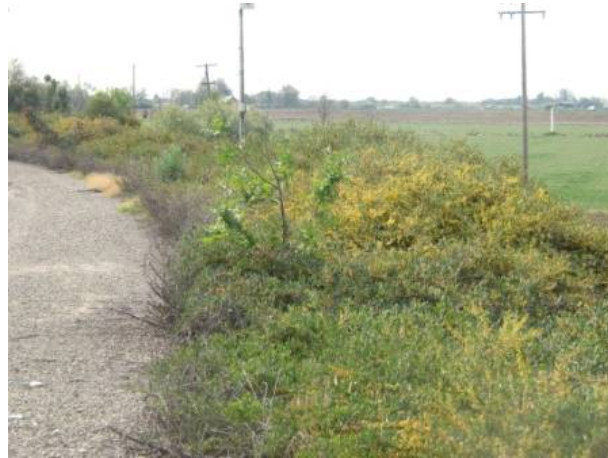
Levee Mile Report Line	36
Start Levee Mile	1.56
End Levee Mile	1.74
Location	Land Side
Category	Earthen Levee
Item	Vegetation
Overgrown landscaping on landward slope from LM 1.56 to 1.74	
richard_f_20130930_810.jpg

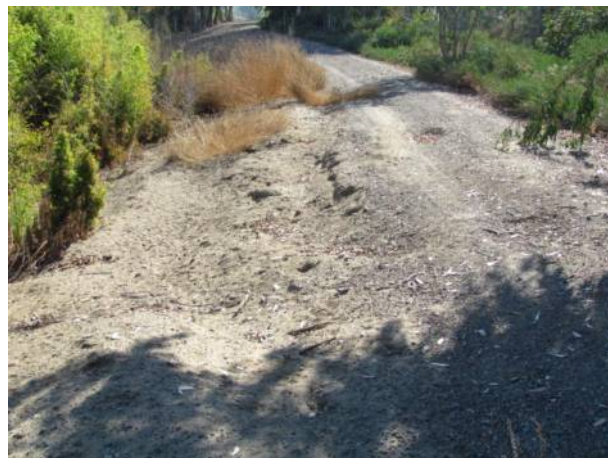
DWR ID: DWR_RD0524_01_s_2012_23									
38	1.60	1.60	Earthen Levee	Slope Stability	CR M Ma	S2 : Repair the levee slope damaged by foot traffic and prevent access where possible.	37.927775 ° -121.327860 °	37.927775 ° -121.327860 °	136 Y
DWR ID: DWR_RD0524_01_s_2013_136									
39	1.62	1.63	Earthen Levee	Vegetation	LS U Ma	V2 : Remove the wild growth other than native grasses from the levee slopes.	37.927635 ° -121.327812 °	37.927540 ° -121.327648 °	24 Y
DWR ID: DWR_RD0524_01_s_2012_24									
40	1.62	1.63	Earthen Levee	Vegetation	WS U Ma	V2 : Remove the wild growth other than native grasses from the levee slopes.	37.927635 ° -121.327812 °	37.927540 ° -121.327648 °	25 Y
DWR ID: DWR_RD0524_01_s_2012_25									
41	1.63	1.66	Earthen Levee	Erosion / Bank Caving	WS M Ma	E1 : Note and monitor erosion site.	37.927507 ° -121.327593 °	37.927295 ° -121.327298 °	26 Y
DWR ID: DWR_RD0524_01_s_2012_26

Levee Mile Report Line	38
Start Levee Mile	1.60
End Levee Mile	1.60
Location	Crown
Category	Earthen Levee
Item	Slope Stability
Looking south at depression on levee crown near waterward shoulder.	
richard_f_20131024_124.JPG

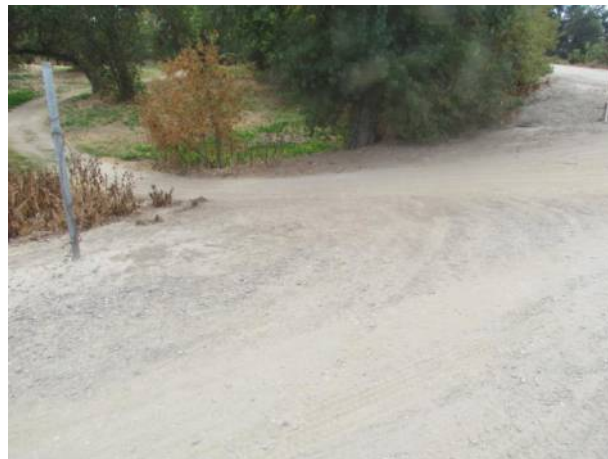
DWR ID: DWR_RD0524_01_f_2012_7		
74	2.60	2.60	Earthen Levee	Encroachments	LS	M En	PO : Pole Inspector Comments: Old fence poles on landside shoulder and slope should be removed.	37.917538 ° -121.322757 °	37.917538 ° -121.322757 °	12 Y
								DWR ID: DWR_RD0524_01_f_2012_12		
75	2.60	2.60	Earthen Levee	Animal Control	LS	M Ma	A2 : Repair the levee slope damaged by livestock and prevent large animal access.	37.917475 ° -121.322808 °	37.917475 ° -121.322808 °	917
								DWR ID: DWR_RD0524_01_s_2012_917		
76	2.61	2.61	Earthen Levee	Vegetation	LS	A/W Ma	V2 : Remove the wild growth other than native grasses from the levee slopes.	37.917228 ° -121.322730 °	37.917228 ° -121.322730 °	9
								DWR ID: DWR_RD0524_01_s_2012_9		
77	2.65	2.65	Supplemental	DWR Erosion Survey	WS	U Ma	Inspector Comments: 08/13/2013: No significant change observed. 08/07/2012: The site was first reported in 2012 spring levee inspection report. [2013 Site ID:RD0524U01RM43.23]	37.916650 ° -121.321980 °	37.916650 ° -121.321980 °	135 Y

Levee Mile Report Line	74
Start Levee Mile	2.60
End Levee Mile	2.60
Location	Land Side
Category	Earthen Levee
Item	Encroachments
