**Flood Control Project Maintenance  
Levee Inspections**

**Fall 2014 Levee Maintenance Deficiency Summary Report**

**Reclamation District No. 0524 Middle Roberts Island**

Waterway			Bank	Unit Miles
Unit No. 01 San Joaquin River			Left	6.20
	Spring (March - May)	Summer (June - August)	(September - November) Fall	Winter (December - February)
Unit Maintenance Rating (Fall Only)			<b>U</b>	
Date of Inspection	04/08/2014 - 04/08/2014		10/20/2014 - 10/20/2014	
DWR Inspector	Richard Willoughby		Richard Willoughby	
Accompanied By	Mario Jaques RD 524		Mario Jaques RD 524

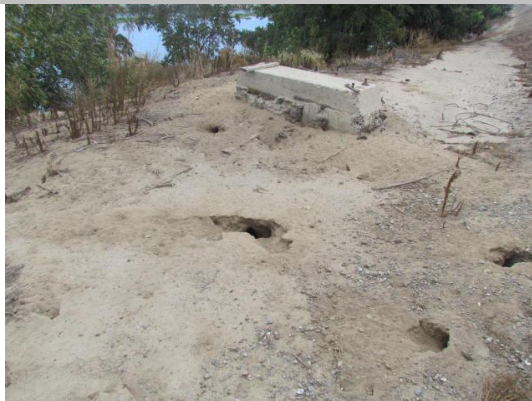
Photo 1 of 1 : FA\_2014\_RD0524\_107\_174\_20141023\_00191.jpg

Looking southeast at several rodent holes on waterward slope.

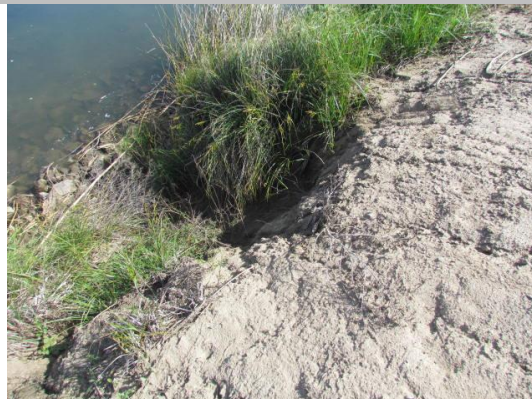
Photo 1 of 2 : FA\_2014\_RD0524\_107\_180\_20141020\_00135.jpg

LM Start	0.34	Rating **	M	Issue No.	180
LM End	0.34	Issue Type +	Ma	Location *	WS
Category	Earthen Levee			GPS Latitude/Longitude	
				Start	End
Item	Erosion / Bank Caving			37.938461 °	37.938461 °
				-121.341626 °	-121.341626 °
DWR ID	DWR_RD0524_01_s_2014_180				
Action/Comments					
Schedule repair of erosion site prior to the next inspection. Inspector Comments: Erosion is located along the lower level of waterward slope.

Looking southeast at erosion on waterward toe.

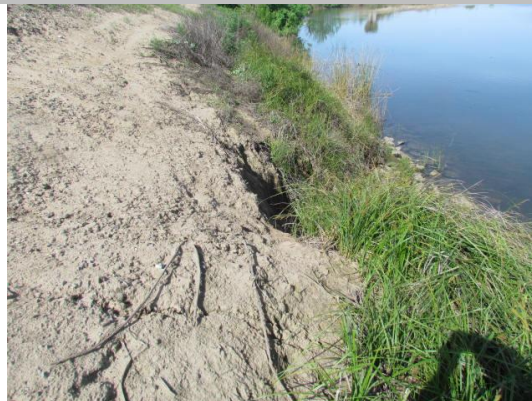
Photo 2 of 2 : FA\_2014\_RD0524\_107\_180\_20141020\_00136.jpg

Looking northeast at erosion on waterward toe.

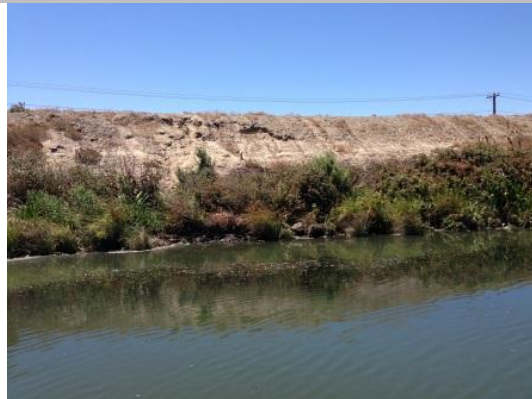
Photo 1 of 1 : SJR2014\_RD0524U01RM40.99\_1.jpg

LM Start	0.40	Rating **	U	Issue No.	131
LM End	0.40	Issue Type +	Ma	Location *	WS
Category	Supplemental			GPS Latitude/Longitude	
				Start	End
Item	DWR Erosion Survey			37.938870 °	37.938870 °
				-121.340460 °	-121.340460 °
DWR ID					
Action/Comments					
Inspector Comments: 6/19/2014: No significant change observed. 08/13/2013: No significant change at this site. 8/7/2012: The erosion is at the upper levee slope, and likely caused by slope slip. The lower levee slope is covered with dense vegetation. [2014 Site ID:RD0524U01RM40.99]

Front view of the erosion site. Note the vegetation at the levee toe and lower slope.

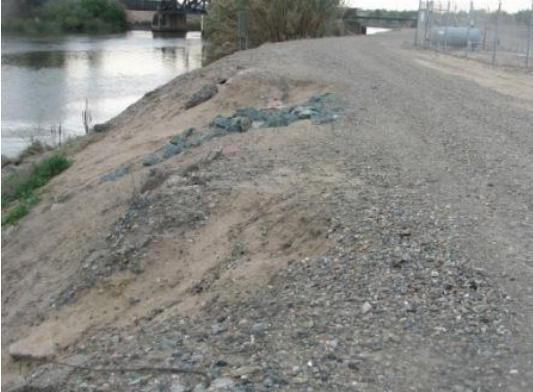
Photo 1 of 3 : FA\_2014\_RD0524\_107\_13\_20141020\_00018.jpg

Looking east at waterside erosion appears to be caused by runoff.

Erosion from LM 0.65 to 0.66

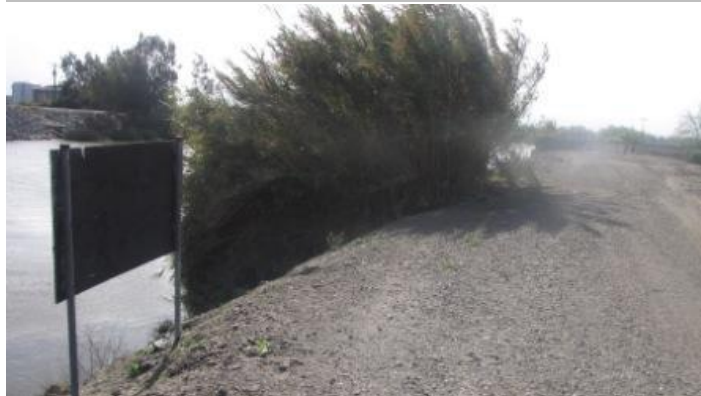
Photo 1 of 3 : FA\_2014\_RD0524\_107\_14\_20141020\_00021.jpg

Looking southeast at bamboo on waterside shoulder as of 4/2010.

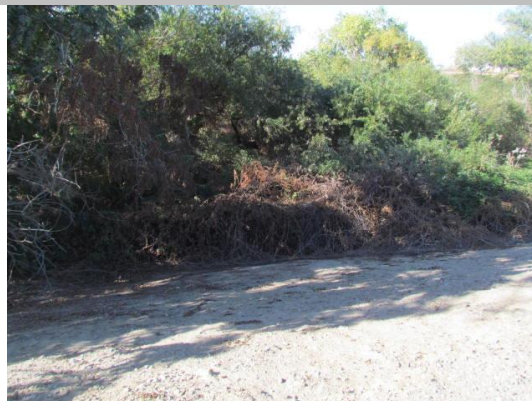
Photo 2 of 2 : FA\_2014\_RD0524\_107\_262\_20141020\_00143.jpg

Looking west at dense vegetation on landside toe.

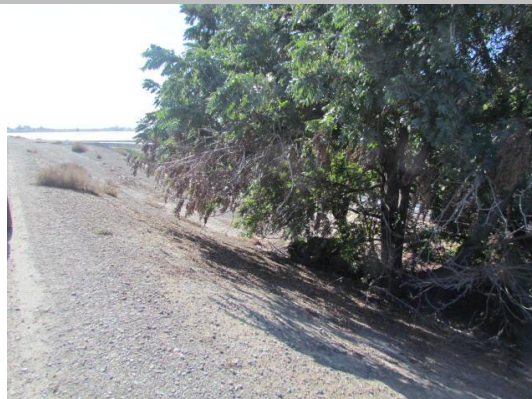
Photo 1 of 1 : FA\_2014\_RD0524\_107\_76\_20141020\_00078.jpg

Looking southwest at low hanging tree branches at landside toe.

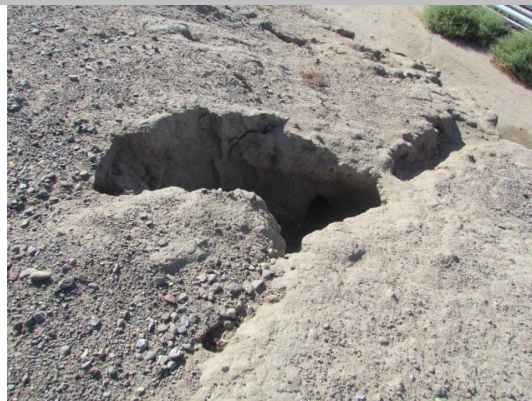
Photo 1 of 5 : FA\_2014\_RD0524\_107\_2\_20141020\_00002.jpg

LM Start	0.82	Rating **	U	Issue No.	2
LM End	0.82	Issue Type +	Ma	Location *	LS
Category	Earthen Levee			GPS Latitude/Longitude	
				Start	End
Item	Erosion / Bank Caving			37.936093 °	37.936004 °
				-121.334648 °	-121.334615 °
DWR ID	DWR_RD0524_01_f_2013_2				
Action/Comments					
Schedule repair of erosion site prior to the next inspection. Inspector Comments: Several holes and finger erosions on landward slope.

Looking southwest at hole on landward shoulder.

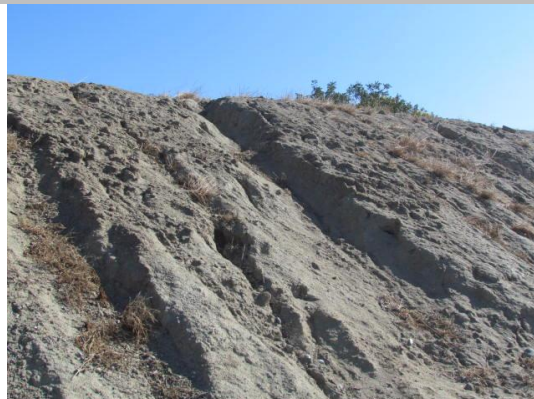
Photo 3 of 5 : FA\_2014\_RD0524\_107\_2\_20141020\_00004.jpg

LM Start	0.82	Rating **	U	Issue No.	2 (cont)	
LM End	0.82	Issue Type +	Ma	Location *	LS	
Category	Earthen Levee			GPS Latitude/Longitude		
				Start		End
Item	Erosion / Bank Caving			37.936093 °		37.936004 °
				-121.334648 °		-121.334615 °
DWR ID	DWR_RD0524_01_f_2013_2					
Action/Comments						
Schedule repair of erosion site prior to the next inspection. Inspector Comments: Several holes and finger erosions on landward slope.

Looking southeast at finger erosion on landward slope.

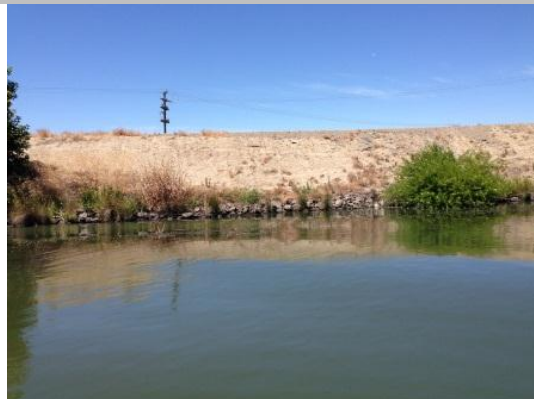
Photo 1 of 1 : SJR2014\_RD0524U01RM41.44\_1.jpg

LM Start	0.83	Rating **	U	Issue No.	133
LM End	0.84	Issue Type +	Ma	Location *	WS
Category	Supplemental			GPS Latitude/Longitude	
				Start	End
Item	DWR Erosion Survey			37.935930 °	37.935930 °
				-121.334133 °	-121.334133 °
DWR ID					
Action/Comments					
Inspector Comments: 06/19/2014: No significant change observed. 08/13/2013: Site was discovered during boat survey. The dense vegetation blocks a clear view of the erosion. Size of erosion site was very roughly estimated. [2014 Site ID:RD0524U01RM41.44]

Close view of the site. Dense vegetation covers the erosion.

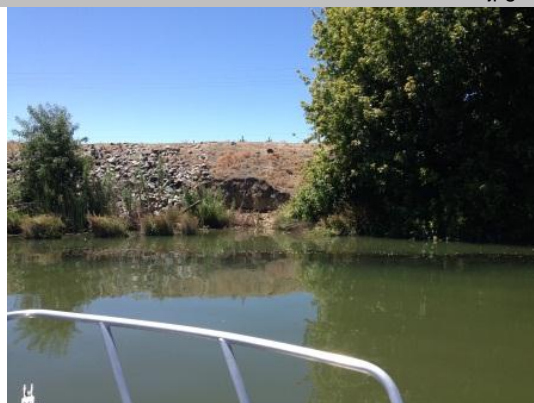
Photo 1 of 1 : SJR2014\_RD0524U01RM41.5\_1.jpg

LM Start	0.91	Rating **	U	Issue No.	134
LM End	0.91	Issue Type +	Ma	Location *	WS
Category	Supplemental			GPS Latitude/Longitude	
				Start	End
Item	DWR Erosion Survey			37.935576 °	37.935576 °
				-121.333202 °	-121.333202 °
DWR ID					
Action/Comments					
Inspector Comments: 6/19/2014: No significant change observed. 08/13/2013: No significant change at this site. 08/07/2012: The site has been visited by boat survey. No significant change observed 08/23/2011: The erosion site is immediately downstream of the riprap protection. [2014 Site ID:RD0524U01RM41.5]

Front view of the erosion. Note the riprap protection near the site.

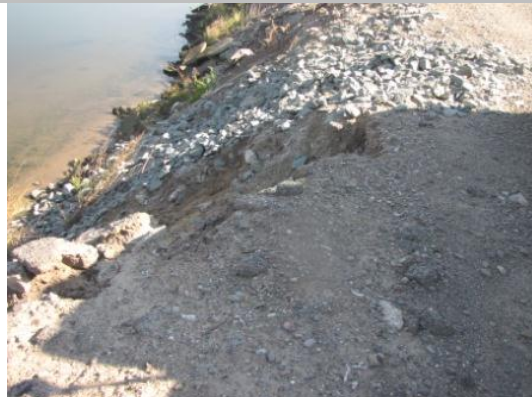
Photo 1 of 3 : FA\_2014\_RD0524\_107\_17\_20141020\_00024.jpg

Looking upstream (south) at erosion site.

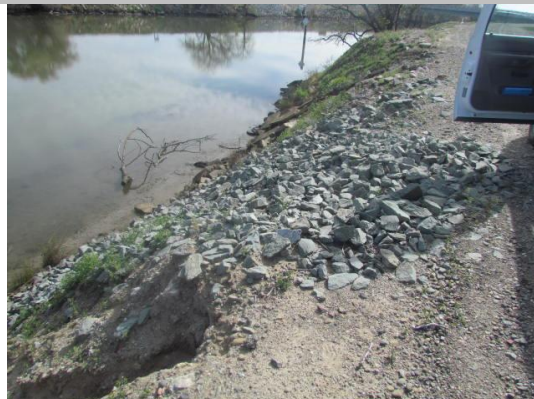
Photo 2 of 3 : FA\_2014\_RD0524\_107\_17\_20141020\_00025.jpg

LM Start	1.03	Rating **	M	Issue No.	17 (cont)
LM End	1.03	Issue Type +	Ma	Location *	WS
Category	Earthen Levee			GPS Latitude/Longitude	
				Start	End
Item	Erosion / Bank Caving			37.935018 °	37.935098 °
				-121.331248 °	-121.331645 °
DWR ID	DWR_RD0524_01_s_2012_17				
Action/Comments					
Schedule repair of erosion site prior to the next inspection.					
Inspector Comments: Minor erosion was noted next to repaired site.

Looking southeast at erosion next to repaired site on waterward slope (Spring 2013)

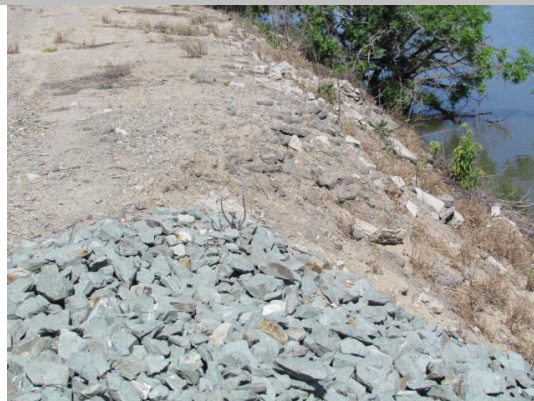
Photo 3 of 3 : FA\_2014\_RD0524\_107\_17\_20141020\_00026.jpg

Looking north at erosion site next to repaired site. (Spring 2012)

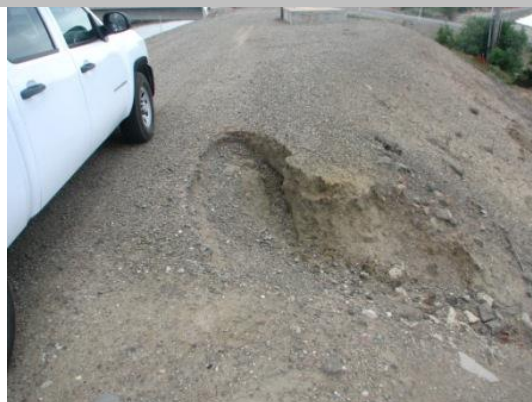
Photo 1 of 5 : FA\_2014\_RD0524\_107\_18\_20141020\_00027.jpg

Action/Comments					
Repair slope instability. Inspector Comments: Slope damage extend from shoulder to middle of slope.

Landward slope damage at LM 1.09.

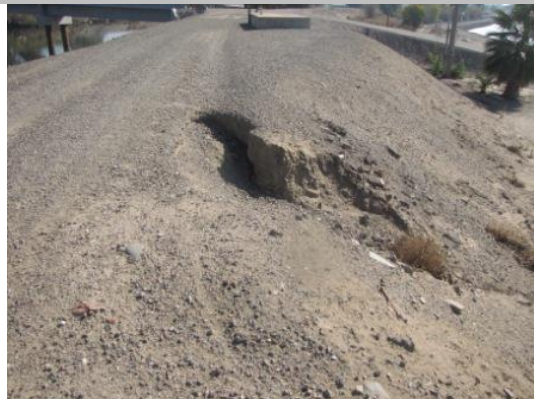
Photo 2 of 5 : FA\_2014\_RD0524\_107\_18\_20141020\_00028.jpg

LM Start	1.09	Rating **	M	Issue No.	18 (cont)	
LM End	1.09	Issue Type +	Ma	Location *	LS	
Category	Earthen Levee			GPS Latitude/Longitude		
				Start		End
Item	Slope Stability			37.934645 °		37.934645 °
				-121.330310 °		-121.330310 °
DWR ID	DWR_RD0524_01_s_2012_18					
Action/Comments						
Repair slope instability. Inspector Comments: Slope damage extend from shoulder to middle of slope.

Updated picture of the erosion site on the landside shoulder.

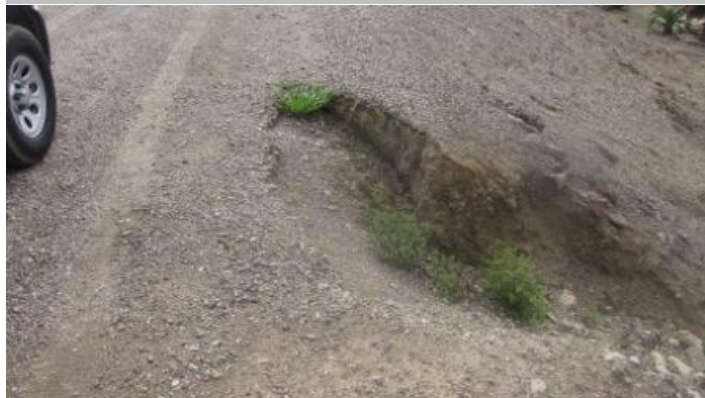
Photo 4 of 5 : FA\_2014\_RD0524\_107\_18\_20141020\_00030.jpg

Looking at updated slope stability as of 4/2010.

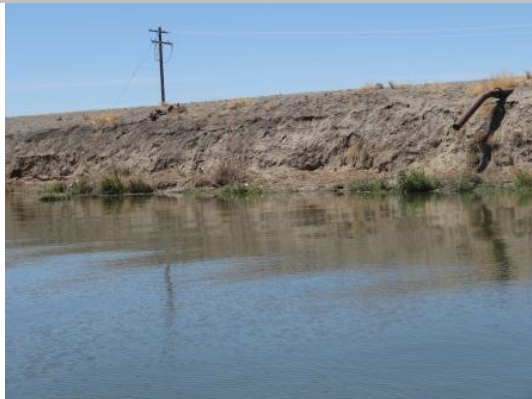
Photo 1 of 1 : SJR2014\_RD0524U01RM41.92\_1.jpg

Front view of the erosion. Note the drainage pipe on the site.

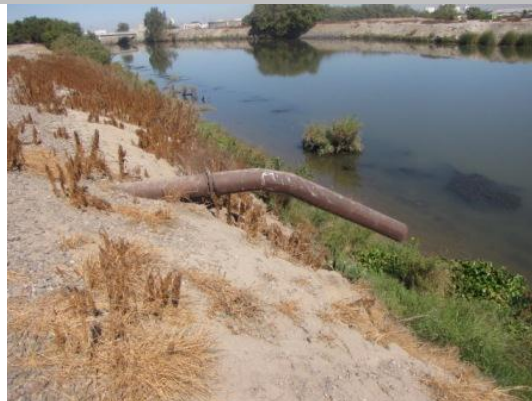
Photo 2 of 2 : FA\_2014\_RD0524\_107\_33\_20141020\_00042.jpg

Looking north at broken pipe.

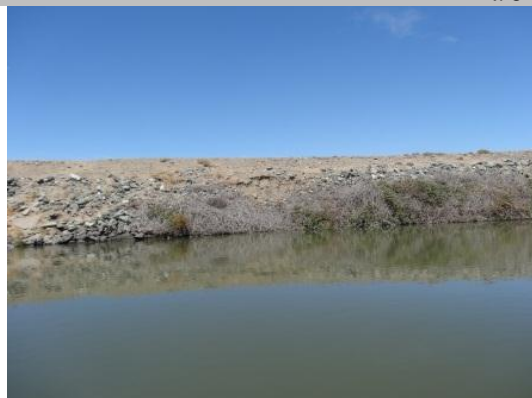
Photo 1 of 1 : SJR2014\_RD0524U01RM42.09\_1.jpg

Front view of the erosion site.

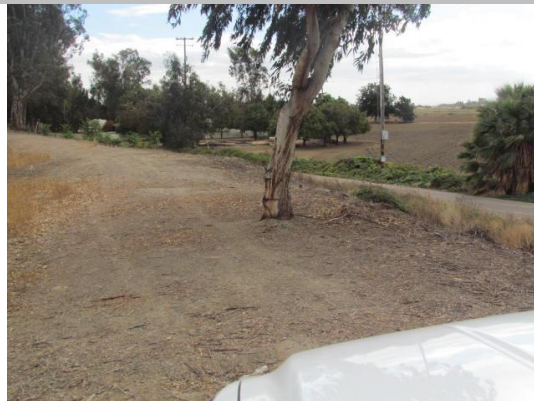
Photo 5 of 5 : FA\_2014\_RD0524\_107\_23\_20141023\_00198.jpg

Looking south from levee crown at upstream end of corrected site.

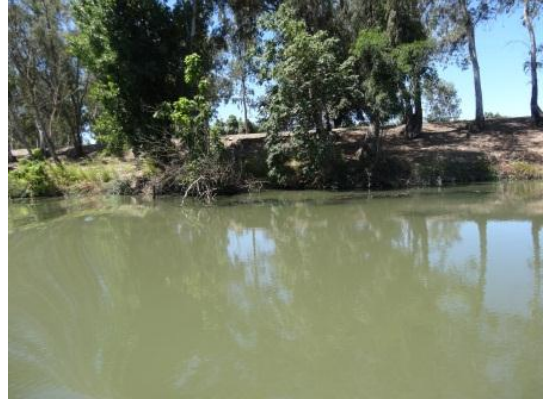
Photo 1 of 1 : SJR2014\_RD0524U01RM42.2\_1.jpg

Front view of the site where undermining has occurred.

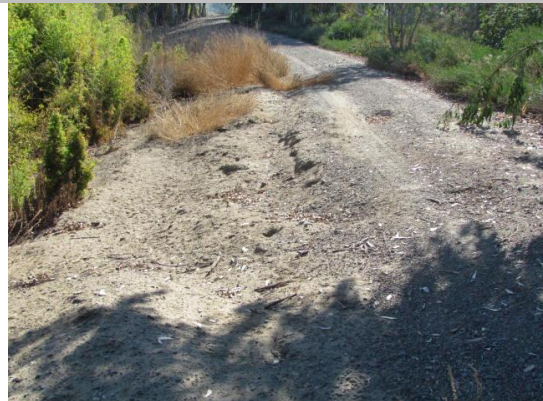
Photo 1 of 1 : FA\_2014\_RD0524\_107\_136\_20141020\_00125.jpg

Looking south at depression on levee crown near waterward shoulder.

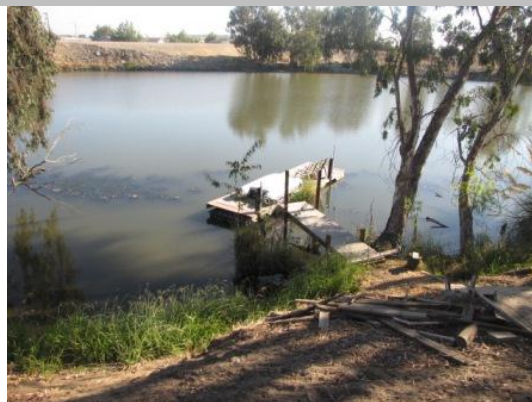
Photo 2 of 2 : FA\_2014\_RD0524\_107\_39\_20141020\_00053.jpg

Looking east at non-permitted boat dock.

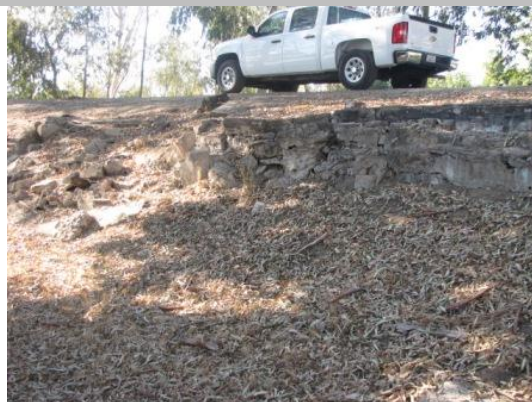
Photo 2 of 3 : FA 2014 RD0524 107 45 20141020 00058.jpg

Looking southwest at retaining wall connected to concrete stairs.

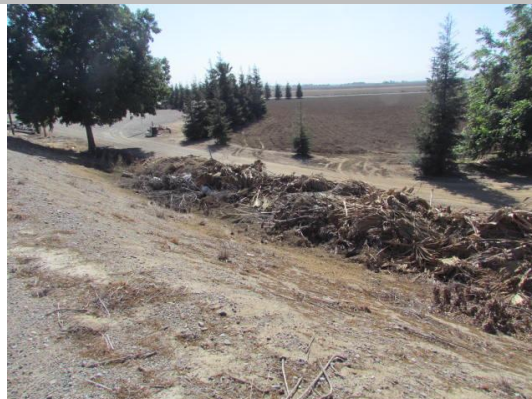
Photo 1 of 1 : FA\_2014\_RD0524\_107\_100\_20141020\_00093.jpg

Looking southwest at prunings on landside toe.

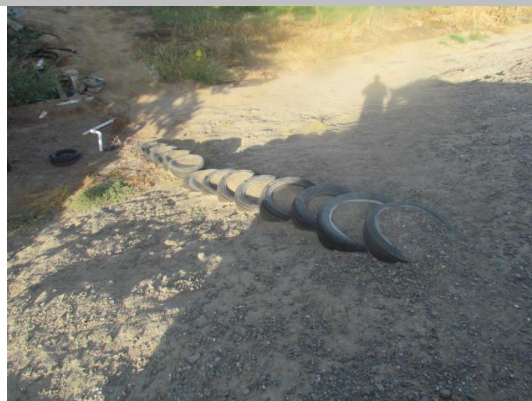
Photo 1 of 1 : FA\_2014\_RD0524\_107\_4\_20141020\_00010.jpg

Looking west at rubber tires being used as stairs on landside slope.

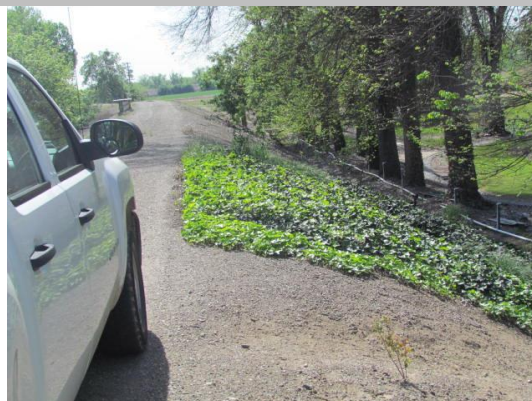
Photo 1 of 1 : FA\_2014\_RD0524\_107\_106\_20141020\_00098.jpg

Looking southwest at ground cover on landward slope.

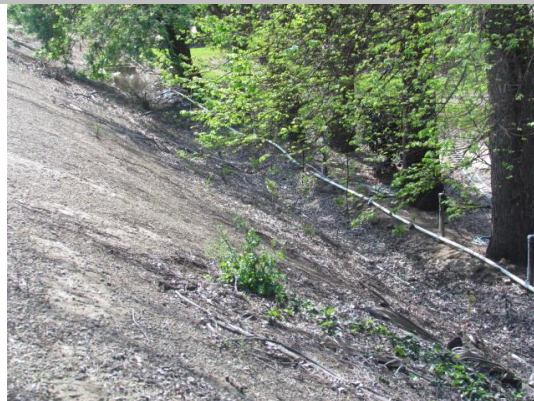
Photo 2 of 2 : FA\_2014\_RD0524\_107\_182\_20141020\_00139.jpg

Looking southwest at an old irrigation ditch at landward toe.

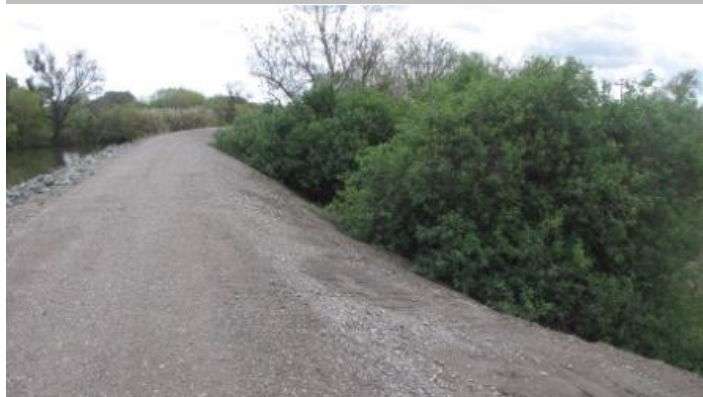
Photo 1 of 1 : FA\_2014\_RD0524\_107\_32\_20141020\_00040.jpg

Looking south at dense veg on landside slope and toe.

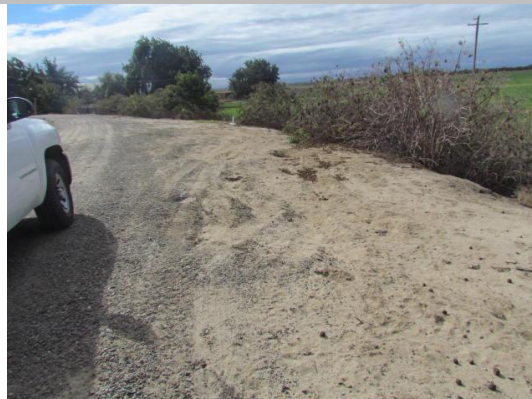
Photo 1 of 1 : FA\_2014\_RD0524\_107\_82\_20141023\_00206.jpg

Looking southwest at damaged landward slope.

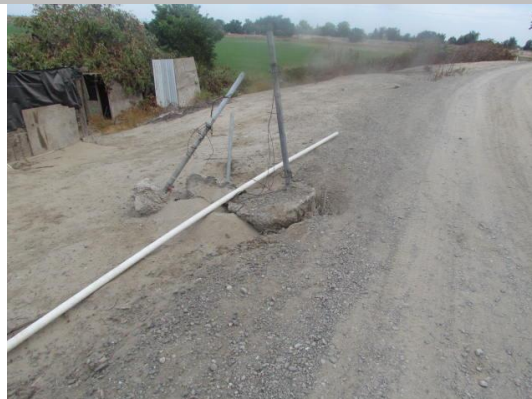
Photo 1 of 1 : FA\_2014\_RD0524\_107\_12\_20141020\_00017.jpg

Looking northwest at fence poles on landside shoulder.

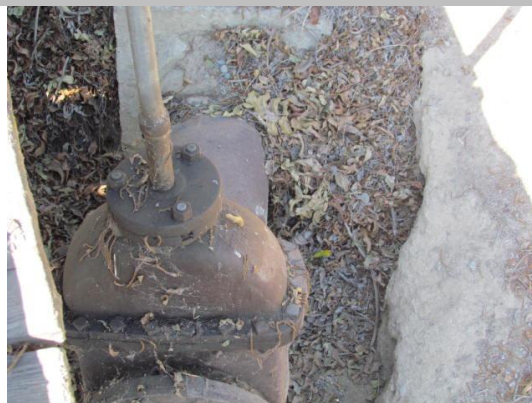
Photo 1 of 2 : FA\_2014\_RD0524\_107\_21\_20141020\_00033.jpg

Looking at erosion around irrigation pipe on waterward slope.

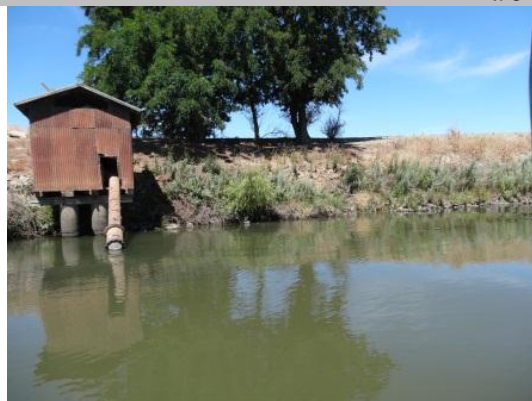
Photo 1 of 1 : SJR2014\_RD0524U01RM46.06\_1.jpg

Front view of the erosion.

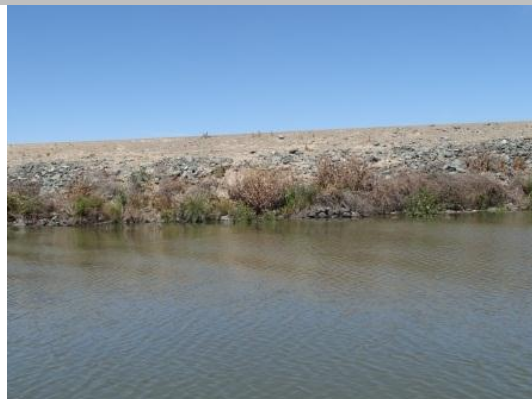
Photo 1 of 1 : SJR2014\_RD0524U01RM43.52\_1.jpg

Front view of the erosion.

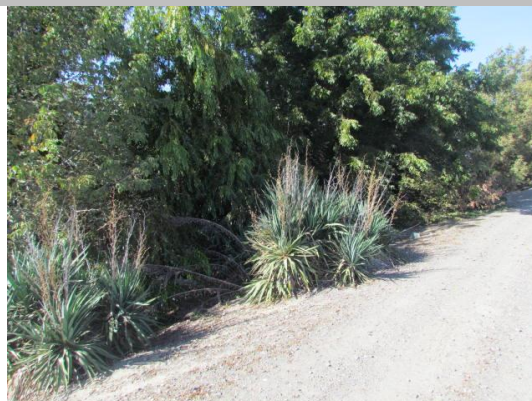
Photo 1 of 1 : FA\_2014\_RD0524\_107\_54\_20141020\_00065.jpg

Looking northwest at dense vegetation on landside slope.

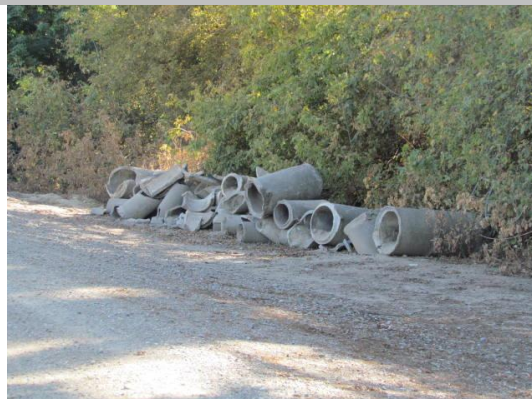
Photo 1 of 1 : FA\_2014\_RD0524\_107\_56\_20141020\_00067.jpg

Looking southwest at concrete pipes on landside toe.

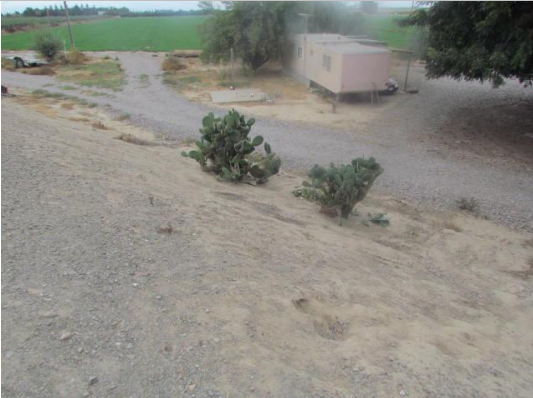
Photo 1 of 1 : FA\_2014\_RD0524\_107\_124\_20141020\_00114.jpg

Looking west at cactus on landside toe.

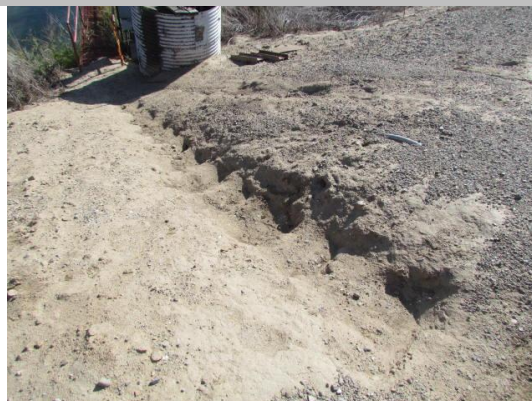
Photo 1 of 1 : FA\_2014\_RD0524\_107\_58\_20141020\_00069.jpg

Looking southeast steps cut into waterside slope.

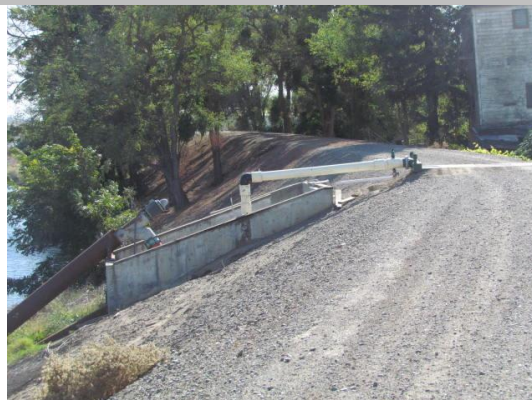
Photo 2 of 3 : FA\_2014\_RD0524\_107\_266\_20141020\_00148.jpg

Looking south unauthorized pvc irrigation pipe across the levee crown.

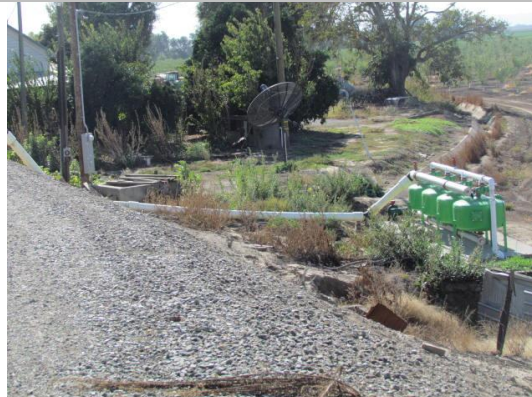
Photo 3 of 3 : FA\_2014\_RD0524\_107\_266\_20141020\_00149.jpg

Looking west at water filtration system on landside toe.

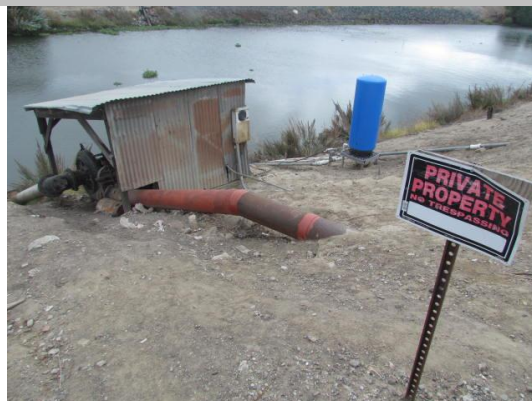
Photo 1 of 5 : FA\_2014\_RD0524\_107\_109\_20141023\_00211.jpg

Looking east at repaired pipe on waterward slope.

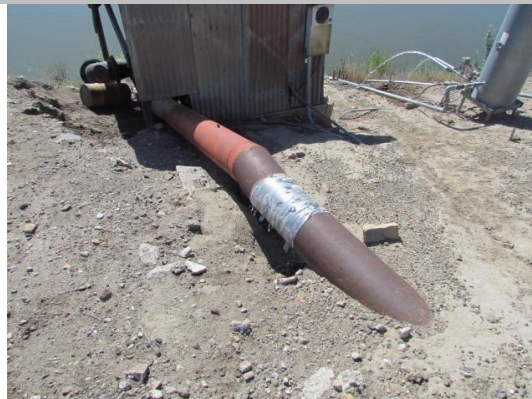
Photo 2 of 5 : FA\_2014\_RD0524\_107\_109\_20141020\_00100.jpg

Looking east at damaged pipe on waterside slope. (Spring 2012)

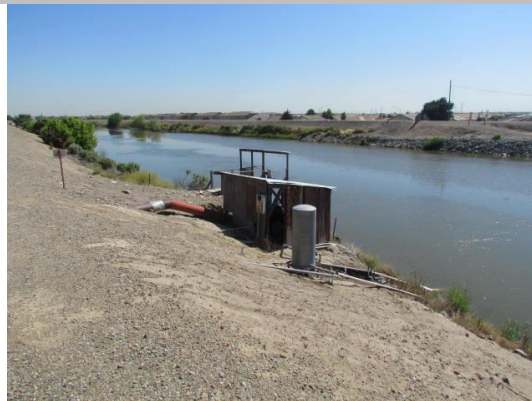
Photo 3 of 5 : FA\_2014\_RD0524\_107\_109\_20141020\_00101.jpg

Looking northeast at overview of irrigation system on waterside slope.

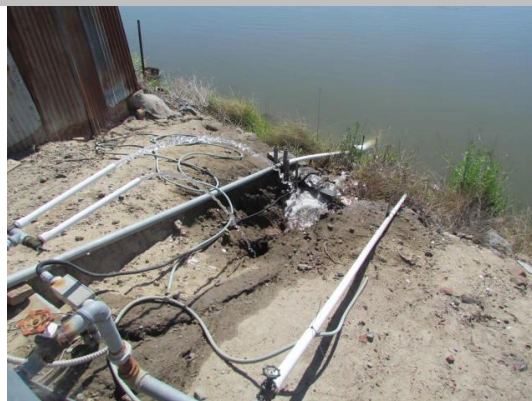
Photo 5 of 5 : FA\_2014\_RD0524\_107\_109\_20141020\_00103.jpg

Looking east at irrigation system damaging waterside toe.

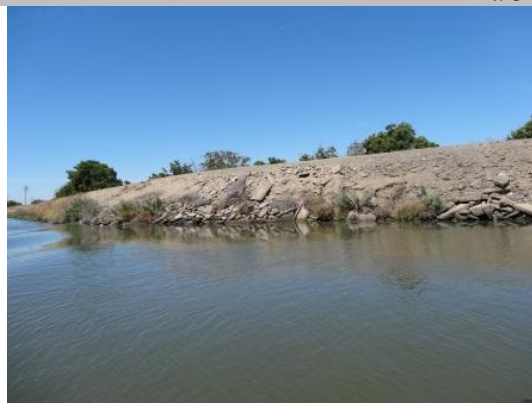
Photo 1 of 1 : SJR2014\_RD0524U01RM45.07\_1.jpg

Downstream view of the erosion site.

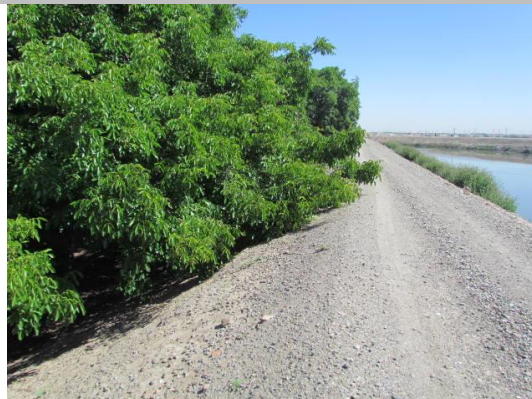
Photo 1 of 1 : FA\_2014\_RD0524\_107\_113\_20141020\_00106.jpg

Looking north at dense trees on landside slope.

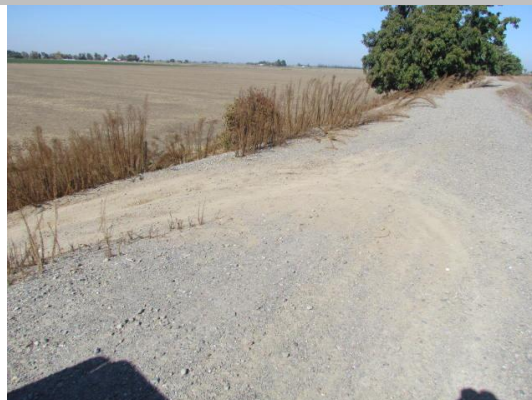
Photo 1 of 1 : FA\_2014\_RD0524\_107\_115\_20141020\_00107.jpg

Looking northwest at slope damage on landward slope.

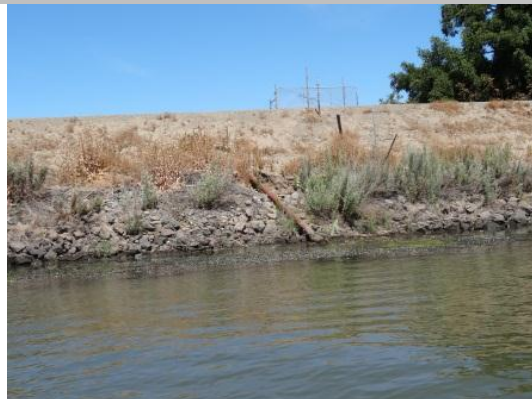
Photo 1 of 1 : SJR2014\_RD0524U01RM45.97\_1.jpg

Close view of the erosion and the pipe.

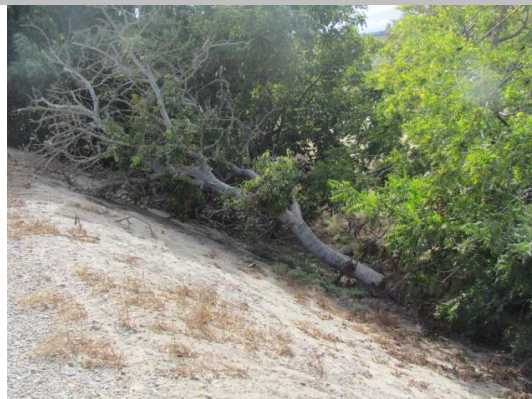
Photo 1 of 1 : FA\_2014\_RD0524\_107\_178\_20141023\_00212.jpg

Looking south at downed tree on landward slope.

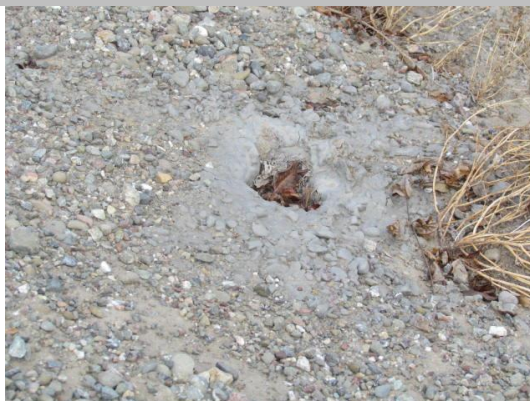
Photo 2 of 2 : FA\_2014\_RD0524\_107\_931\_20141023\_00214.jpg

Looking north at typical view of grouted rodent holes on waterward slope.

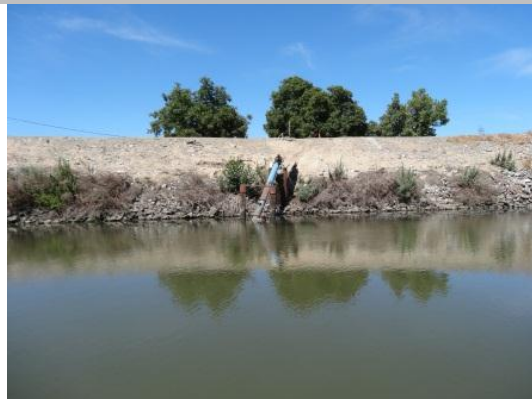
Photo 1 of 1 : SJR2014\_RD0524U01RM46.39\_1.jpg

Front view of the site.

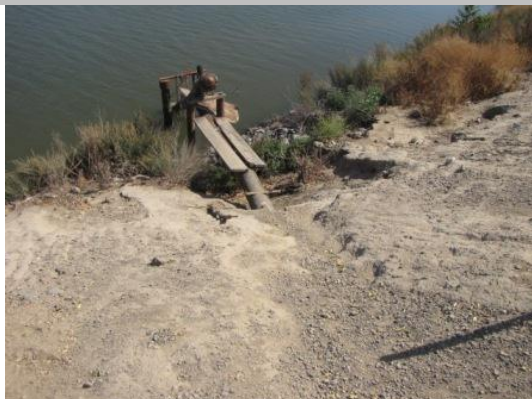
Photo 1 of 3 : FA\_2014\_RD0524\_107\_74\_20141020\_00075.jpg

Looking southeast at erosion around pipe.

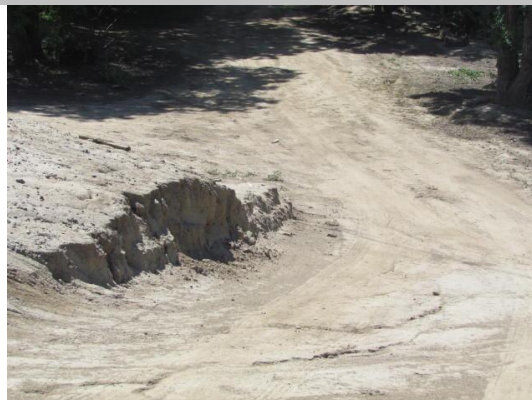
Photo 1 of 2 : FA\_2014\_RD0524\_107\_119\_20141020\_00111.jpg

Looking west at unauthorized ramp and landside slope damage.

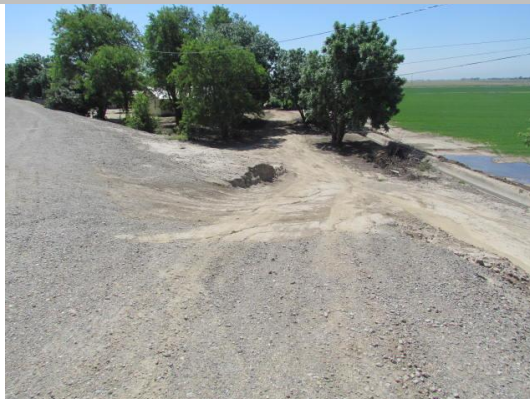
Photo 2 of 2 : FA\_2014\_RD0524\_107\_119\_20141020\_00112.jpg

Looking southwest at damaged slope and ramp on landside slope.

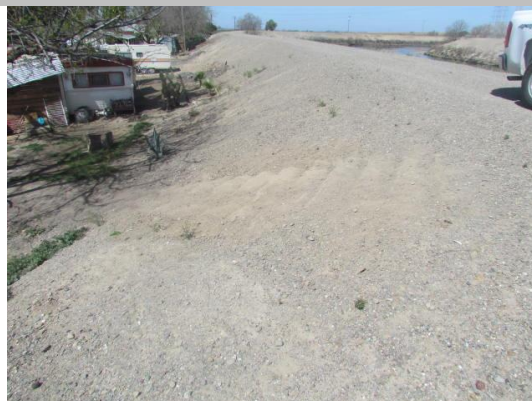
Photo 1 of 1 : FA\_2014\_RD0524\_107\_933\_20141020\_00156.jpg

Looking north at steps cut into landward slope.

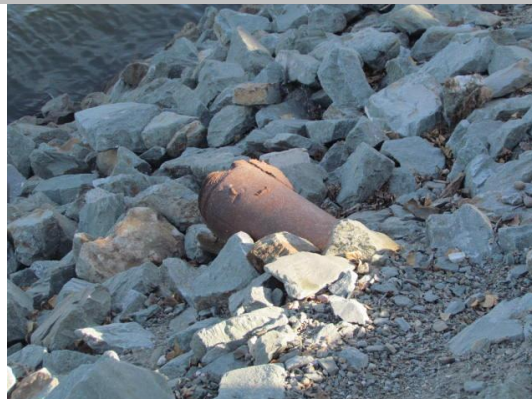
Photo 1 of 1 : FA\_2014\_RD0524\_107\_268\_20141020\_00150.jpg

Looking southeast at abandoned pipe on waterside slope.
