**Flood Control Project Maintenance
Levee Inspections**

Fall 2015 Levee Maintenance Deficiency Summary Report

San Joaquin River Basin

Reclamation District No. 0524 Middle Roberts Island

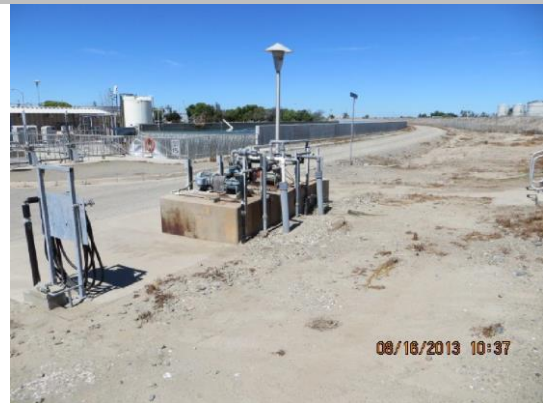
Photo 1 of 3 : UCIP_FA_2015_1532.jpg

LM Start	0.66	Rating **	M	Issue No.	934
LM End	0.66	Issue Type +	En	Location *	WS
Category	Supplemental			GPS Latitude/Longitude	
				Start	End
Item	DWR UCIP Field Study			37.937891 °	37.937891 °
				-121.335939 °	-121.335939 °
DWR ID					
Action/Comments					
Inspector Comments: FS_ID:17563					
DS_ID:20592					
EP_NO: 6035					
FS_HLM: 0.672					
Repair Type: Non-Urgent					
Crossing Status: Found					
UCIP Comments: Flows from primer tank causing erosion on LS slope.					
FIELD_STRUCT_DESC: 48-inch pipe through levee 7.3 feet below crown. Siphon pumps and primer tank enclosed by cyclone fence on the landward shoulder. Gate valve at inlet sump 100-feet off LS toe. One concrete cutoff wall. (Permit No. 6035, 1968).					
FS Date: 08/16/2013

Vacuum pumps off LS toe.

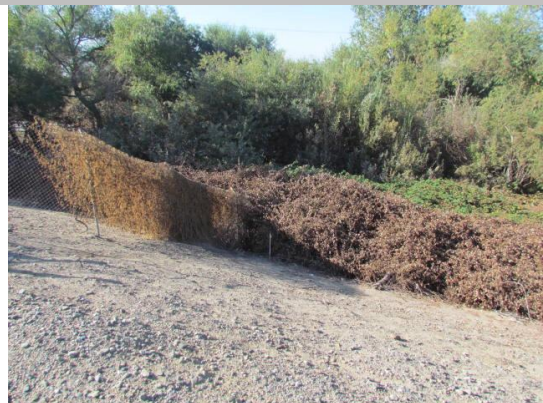
Photo 1 of 3 : FA_2015_RD0524_107_262_20151023_00245.jpg

Looking west at dense vegetation at landward slope and toe fall 2015.

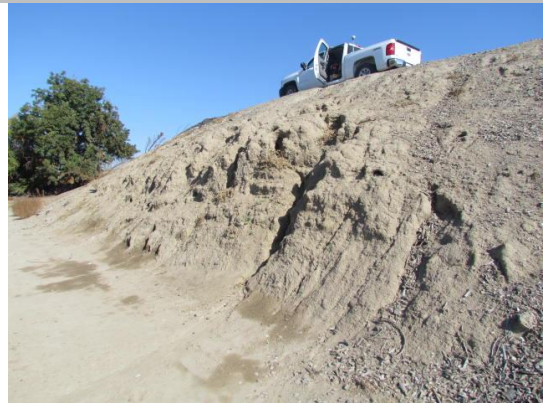
Photo 5 of 5 : FA_2015_RD0524_107_2_20150914_00005.jpg

Looking northeast at several finger erosion on landward slope.

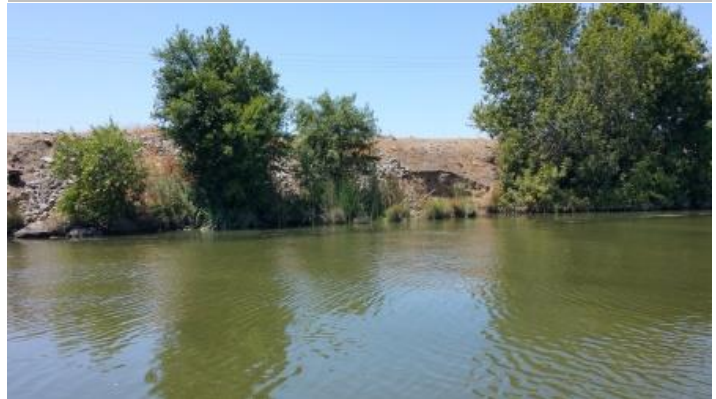
Photo 1 of 2 : SJR2015_RD0524U01RM41.50_4.jpg

Front view of the erosion. Note the riprap protection near the site.

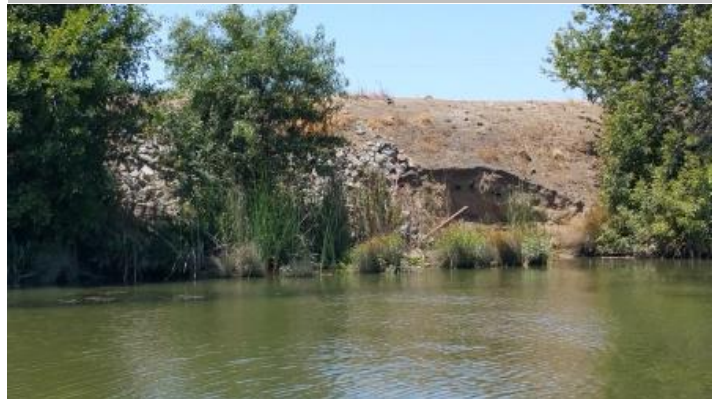
Photo 2 of 2 : SJR2015_RD0524U01RM41.50_5.jpg

A close view of the erosion.

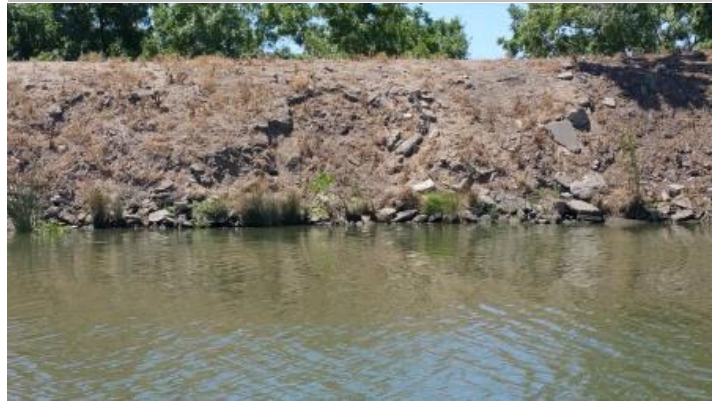
Photo 1 of 2 : SJR2015_RD0524U01RM41.58_2.jpg

Close view of the erosion.

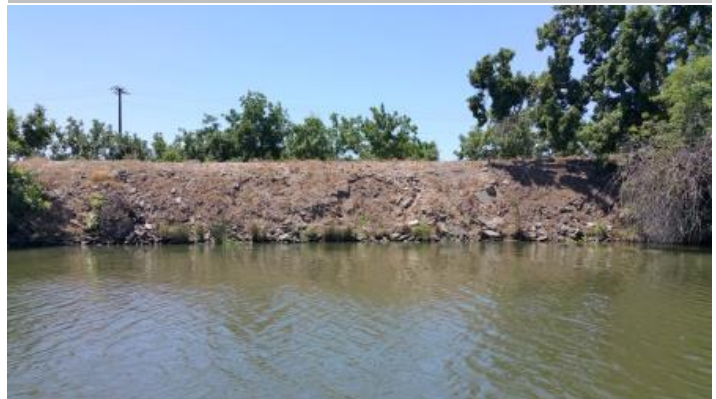
Photo 2 of 2 : SJR2015_RD0524U01RM41.58_3.jpg

Front view of the erosion.

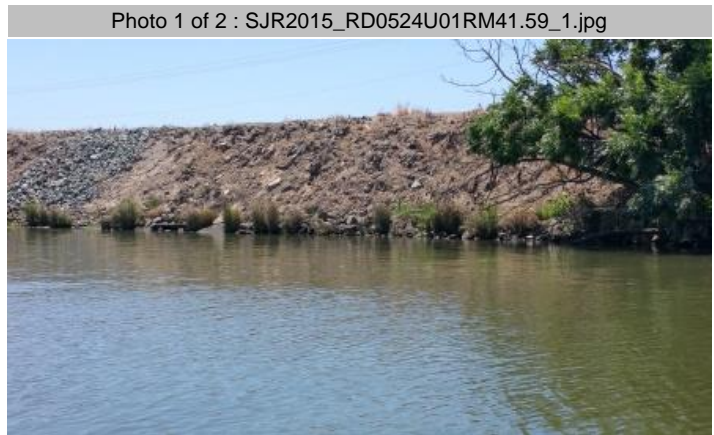
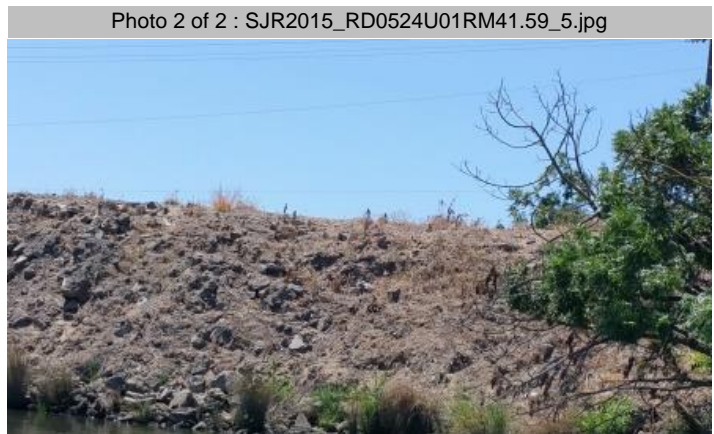
LM Start	1.02	Rating **	U	Issue No.	139
LM End	1.02	Issue Type +	Ma	Location *	WS
Category	Supplemental			GPS Latitude/Longitude	
				Start	End
Item	DWR Erosion Survey			37.935078 °	37.935078 °
				-121.331134 °	-121.331134 °
DWR ID					
Action/Comments					
Inspector Comments: 06/24/2015: No significant change observed. 6/19/2014: No significant change observed. 08/13/2013: No significant change at this site. 08/07/2012: The site has been visited by boat survey. Site has been repaired, but new erosion occurred at the levee slope and immediately upstream of the repaired site.

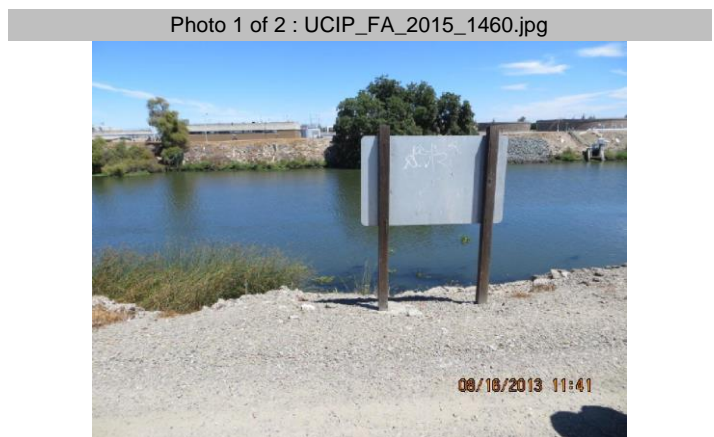
LM Start	1.06	Rating **	M	Issue No.	938
LM End	1.06	Issue Type +	En	Location *	WS
Category	Supplemental			GPS Latitude/Longitude	
				Start	End
Item	DWR UCIP Field Study			37.934778 °	37.934778 °
				-121.330460 °	-121.330460 °
DWR ID					
Action/Comments					
Inspector Comments: FS_ID:18703					
DS_ID:20600					
EP_NO: 2725B					
FS_HLM: 1.075					
Repair Type: Non-Urgent					
Crossing Status: Found

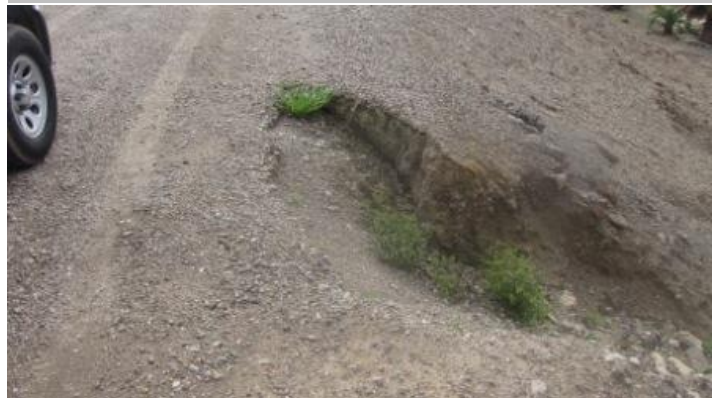
Photo 6 of 7 : FA_2015_RD0524_107_18_20150914_00030.jpg

Looking at updated slope stability as of Fall 2013.

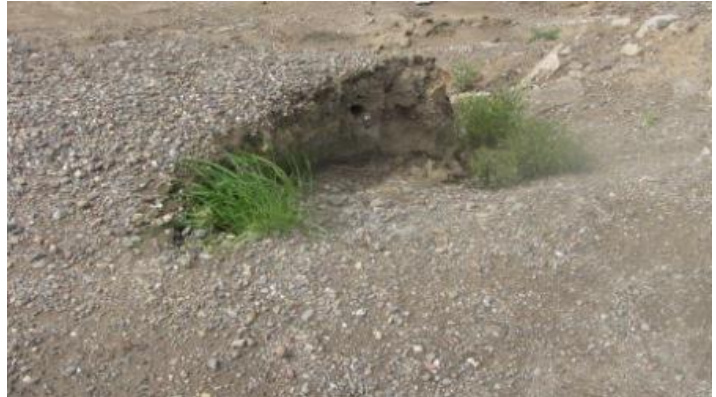
Photo 7 of 7 : FA_2015_RD0524_107_18_20150914_00031.jpg

Updated view from above the slope stability.

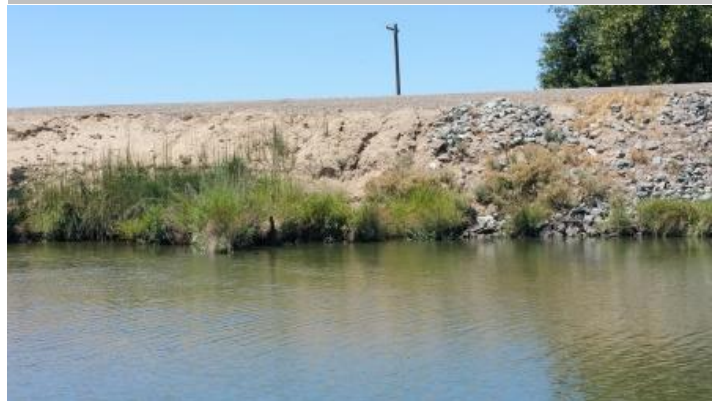
Photo 1 of 2 : SJR2015_RD0524U01RM41.79_3.jpg

Direct view of the site.

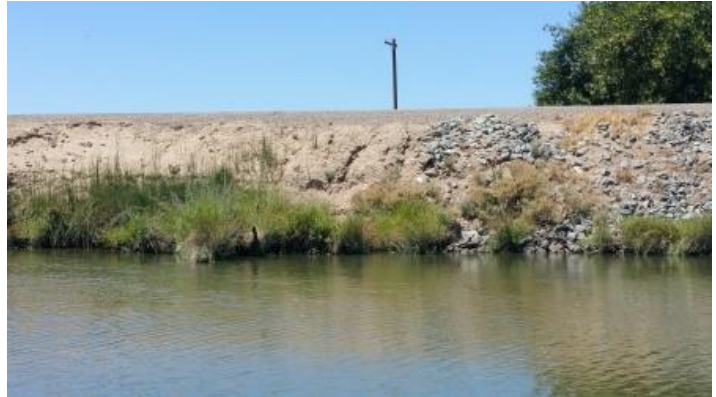
Photo 2 of 2 : SJR2015_RD0524U01RM41.79_5.jpg

Close view of the upstream side of the erosion.

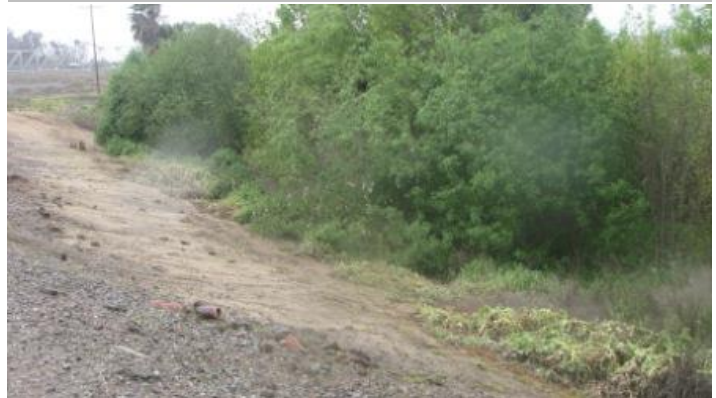
Photo 1 of 1 : FA_2015_RD0524_107_915_20150914_00197.jpg

Looking southwest at dense veg. on landside toe.

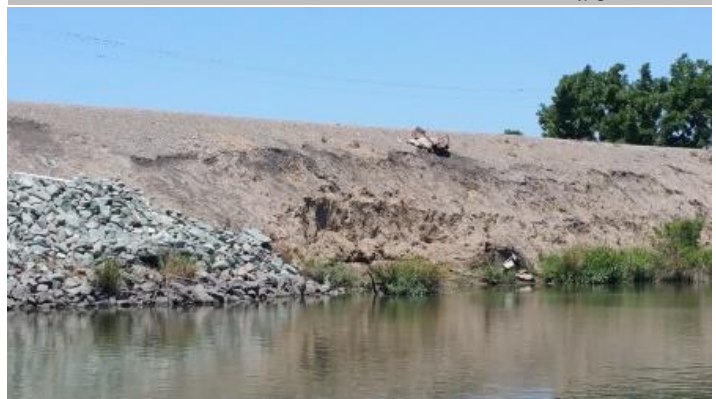
Photo 1 of 1 : SJR2015_RD0524U01RM41.92_2.jpg

Front view of the erosion.

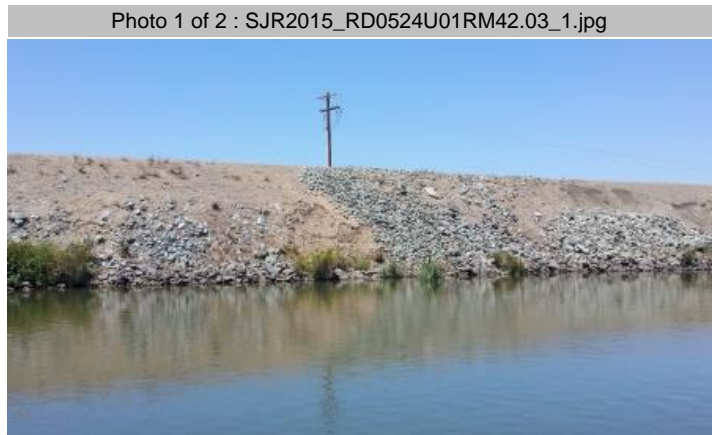
LM Start	1.39	Rating **	U	Issue No.	79
LM End	1.39	Issue Type +	Ma	Location *	WS
Category	Supplemental			GPS Latitude/Longitude	
				Start	End
Item	DWR Erosion Survey			37.930575 °	37.930575 °
				-121.328090 °	-121.328090 °
DWR ID					
Action/Comments					
Inspector Comments: 06/24/2015: No significant change observed. 6/19/2014: No significant change observed. 08/13/2013: No significant change observed. 08/07/2012: The site was first reported in 2012 spring levee inspection report. The site is located about 750 ft downstream of SR 4 Bridge. [2015 Site ID:RD0524U01RM42.03]

Front view of the erosion.

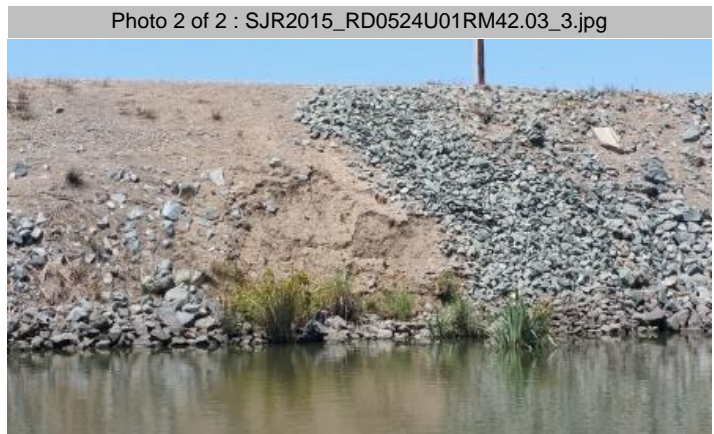
Close view of the erosion.

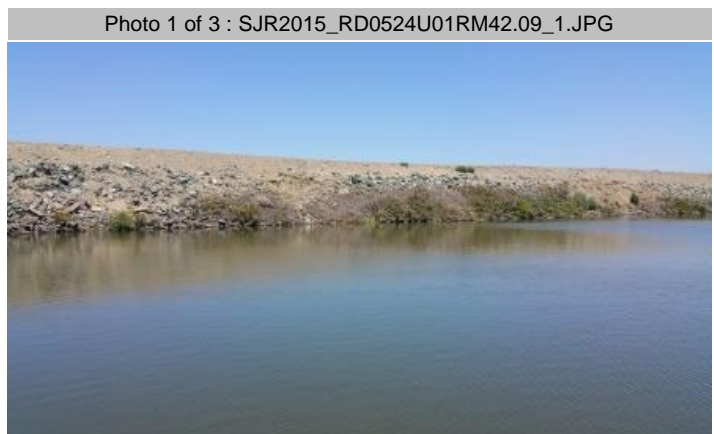
LM Start	1.45	Rating **	U	Issue No.	89
LM End	1.47	Issue Type +	Ma	Location *	WS
Category	Supplemental			GPS Latitude/Longitude	
				Start	End
Item	DWR Erosion Survey			37.929650 °	37.929650 °
				-121.328110 °	-121.328110 °
DWR ID					
Action/Comments					
Inspector Comments: 06/24/2015: No significant change observed. 6/19/2014: No significant change observed. 08/13/2013: The site is located approximately 400 ft. downstream SR 4 Bridge. Dense vegetation is visible at the toe. [2015 Site ID:RD0524U01RM42.09]

Front view of the erosion site.

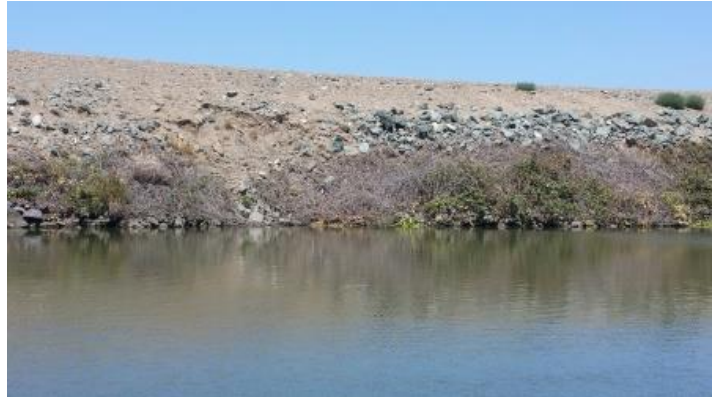
Photo 2 of 3 : SJR2015_RD0524U01RM42.09_2.JPG

Close view of the erosion.

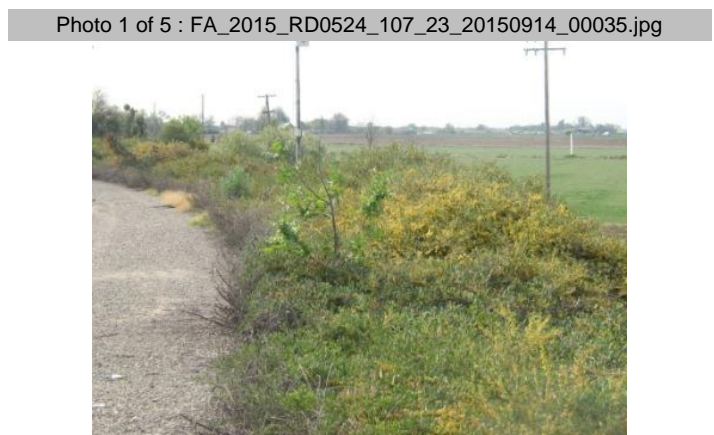
LM Start	1.55	Rating **	A/W	Issue No.	23
LM End	1.59	Issue Type +	Ma	Location *	LS
Category	Earthen Levee			GPS Latitude/Longitude	
				Start	End
Item	Vegetation			37.928388 °	37.927797 °
				-121.328280 °	-121.327854 °
DWR ID	DWR_RD0524_01_s_2012_23				
Action/Comments					
Remove the wild growth other than native grasses from the levee slopes.

Overgrown landscaping on landward slope from LM 1.56 to 1.74

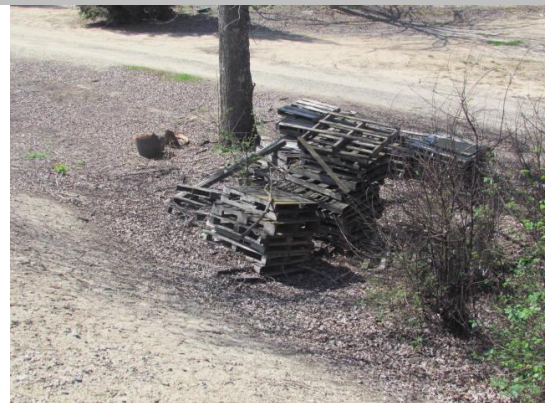
Photo 1 of 1 : FA_2015_RD0524_107_181_20150914_00173.jpg

Looking west at wooden pallets at landward toe.

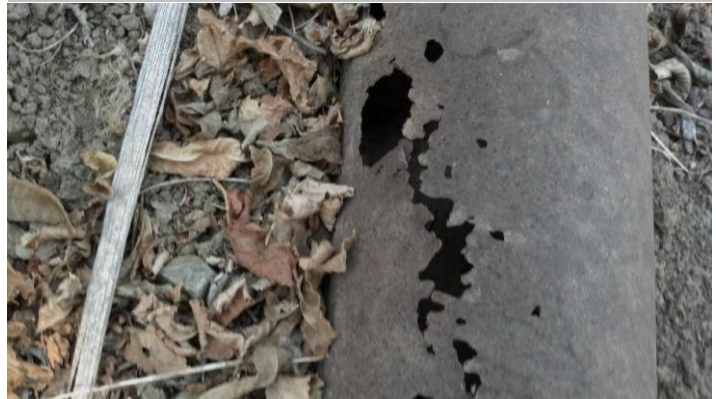
Photo 1 of 2 : UCIP_FA_2015_2014.jpg

Holes in pipe along exposed side of pipe at WS slope.

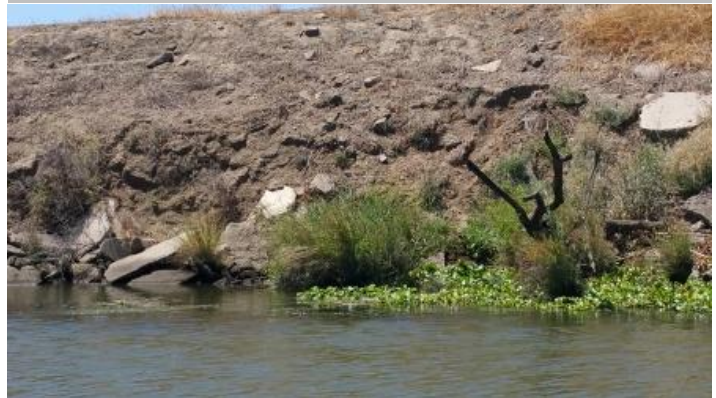
Photo 1 of 2 : SJR2015_RD0524U01RM42.79_1.jpg

Close view of the pocket erosion.

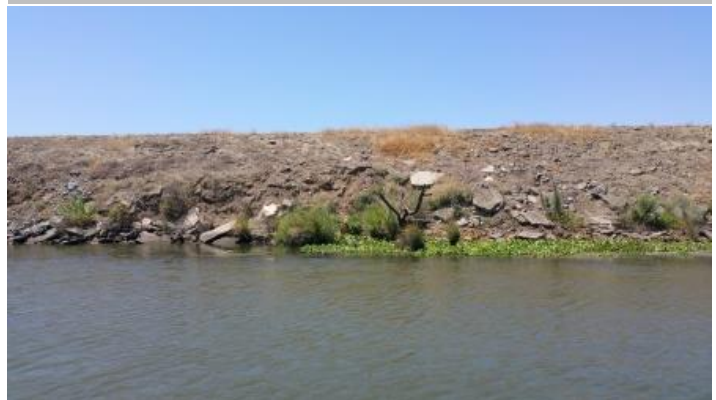
Photo 2 of 2 : SJR2015_RD0524U01RM42.79_4.jpg

Front view of the erosion.

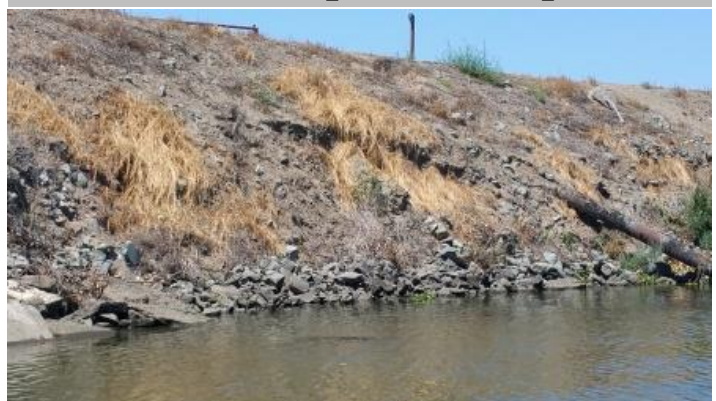
Photo 2 of 3 : SJR2015_RD0524U01RM42.84_4.JPG

Close view of the erosion. Note the irrigation pipe.

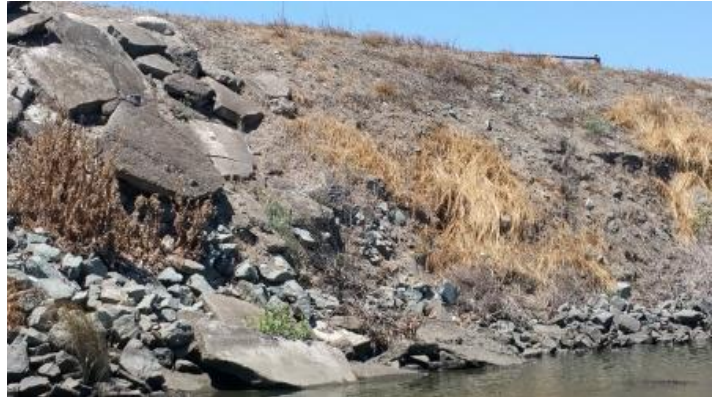
Photo 3 of 3 : SJR2015_RD0524U01RM42.84_5.JPG

Close view of the erosion.

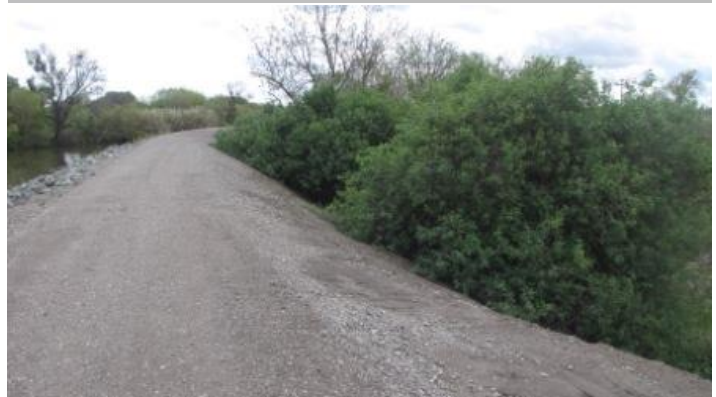
Photo 2 of 2 : FA_2015_RD0524_107_32_20150914_00050.jpg

Looking south at dense veg on landside slope and toe.

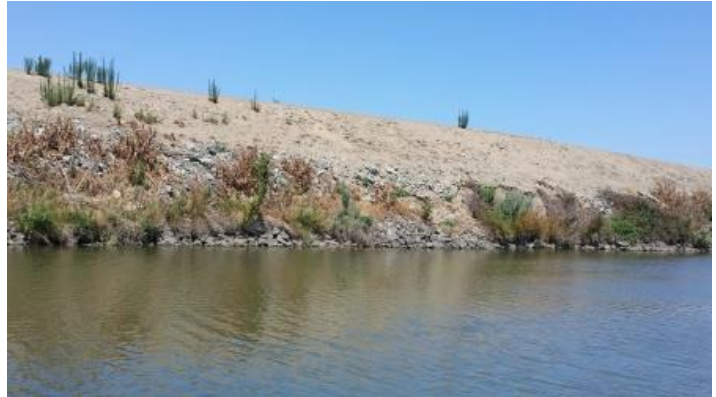
Photo 1 of 1 : SJR2015_RD0524U01RM43.52_2.jpg

Front view of the erosion.

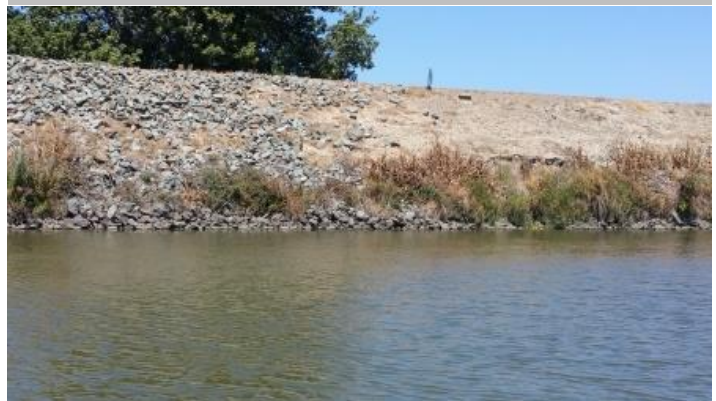
Photo 1 of 2 : SJR2015_RD0524U01RM43.86_2.JPG

Front view of the erosion.

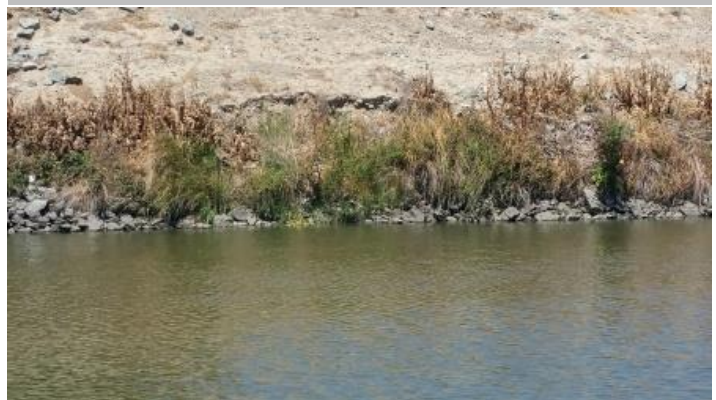
Photo 2 of 2 : SJR2015_RD0524U01RM43.86_5.JPG

Close view of the erosion.

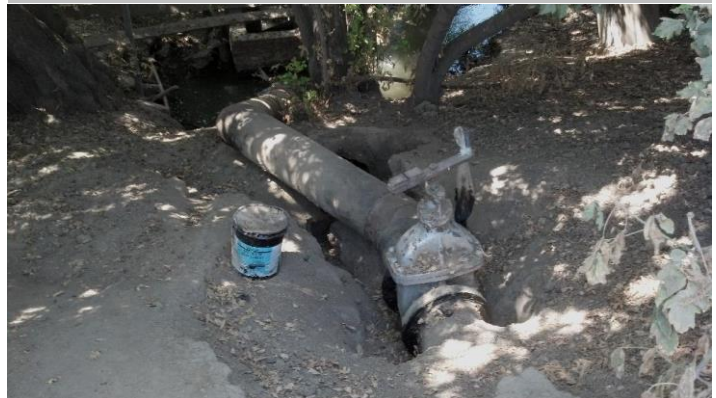
Photo 2 of 3 : UCIP_FA_2015_1525.jpg

Pipe, gatevalve, and erosion on LS slope.

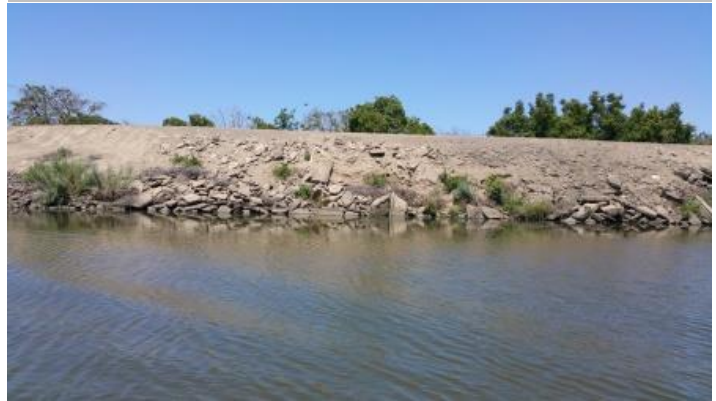
Photo 1 of 2 : SJR2015_RD0524U01RM45.07_1.jpg

Front view of the erosion site.

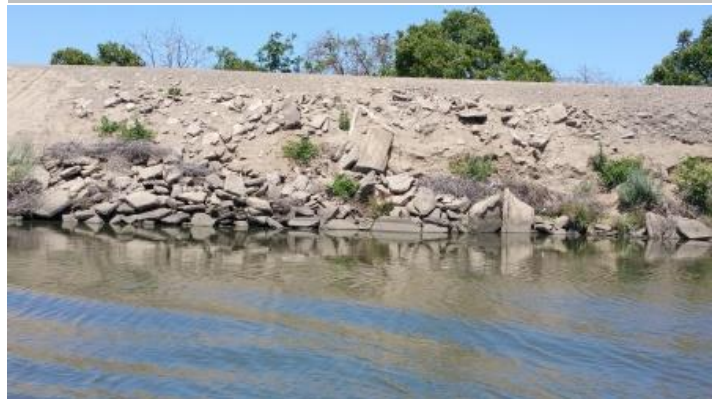
Photo 2 of 2 : SJR2015_RD0524U01RM45.07_2.jpg

Close view of the site.

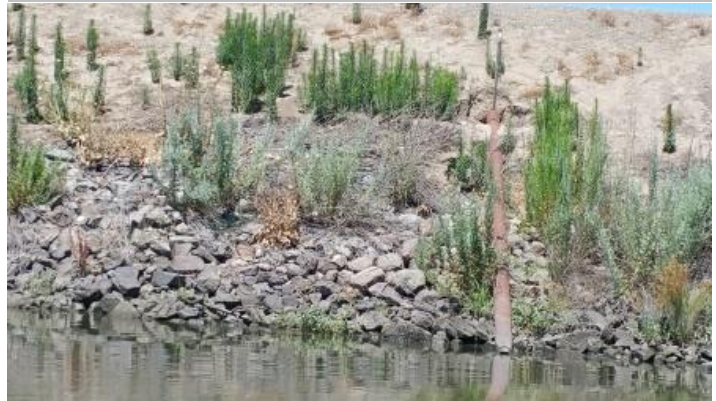
Photo 1 of 2 : SJR2015_RD0524U01RM45.97_2.jpg

Close view of the erosion and the pipe.

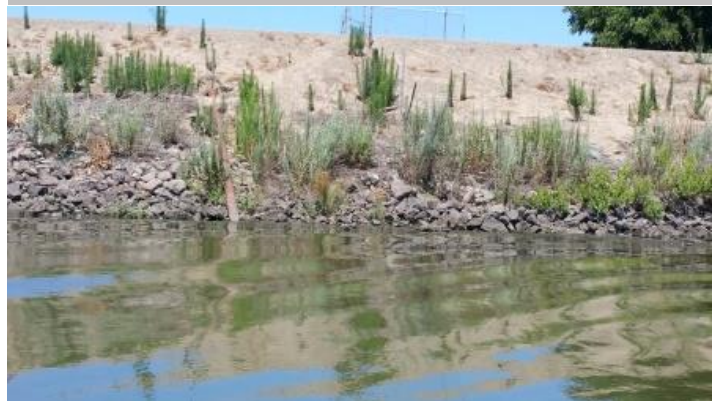
Photo 2 of 2 : SJR2015_RD0524U01RM45.97_4.jpg

Front view of the site.

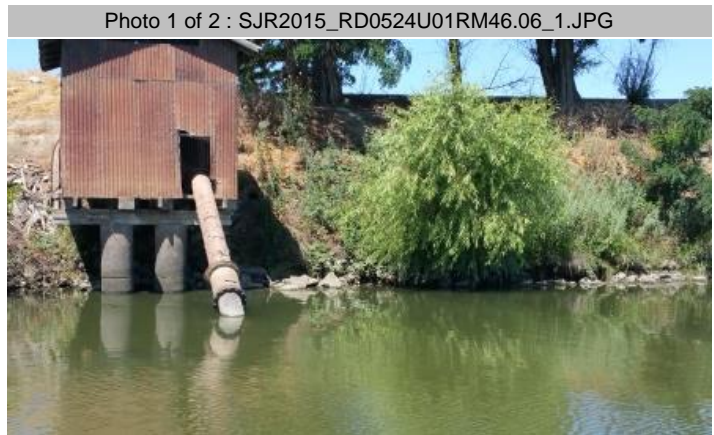
LM Start	5.53	Rating **	M	Issue No.	22
LM End	5.53	Issue Type +	Ma	Location *	WS
Category	Supplemental			GPS Latitude/Longitude	
				Start	End
Item	DWR Erosion Survey			37.878920 °	37.878920 °
				-121.332670 °	-121.332670 °
DWR ID					
Action/Comments					
Inspector Comments: 06/24/2015: No significant change observed. 6/19/2014: No significant change observed. 08/13/2013: Larger trees are at the levee shoulder, and an irrigation pump station is next to the erosion site. [2015 Site ID:RD0524U01RM46.06]

Front view of the erosion.

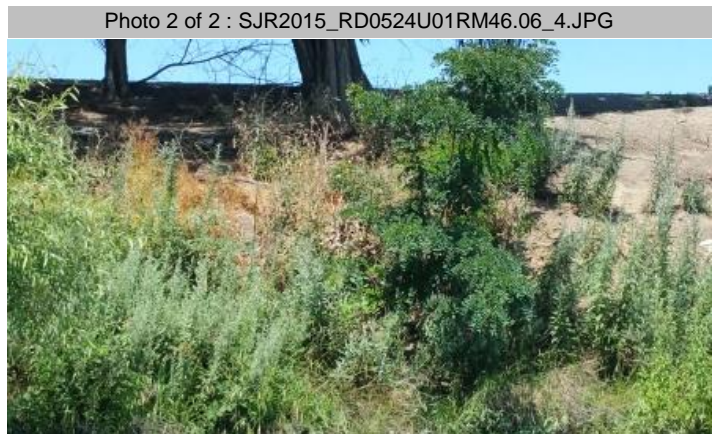
Close view of the site. Note large trees at the levee shoulder.

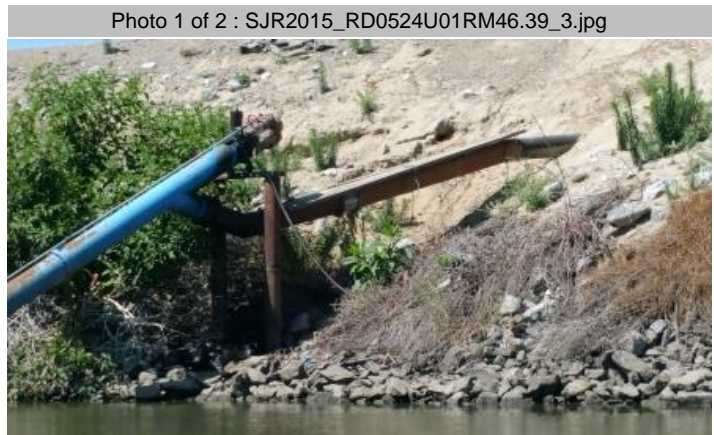
LM Start	5.86	Rating **	U	Issue No.	47
LM End	5.86	Issue Type +	Ma	Location *	WS
Category	Supplemental			GPS Latitude/Longitude	
				Start	End
Item	DWR Erosion Survey			37.874370 °	37.874370 °
				-121.332850 °	-121.332850 °
DWR ID					
Action/Comments					
Inspector Comments: 06/24/2015: No significant change observed. 06/19/2014: No significant change observed. 08/13/2013: No significant change observed. 08/07/2012: The erosion is near a water-intake structure. Pipe leakage likely caused the erosion. [2015 Site ID:RD0524U01RM46.39]

Close view of the erosion and the pipe.

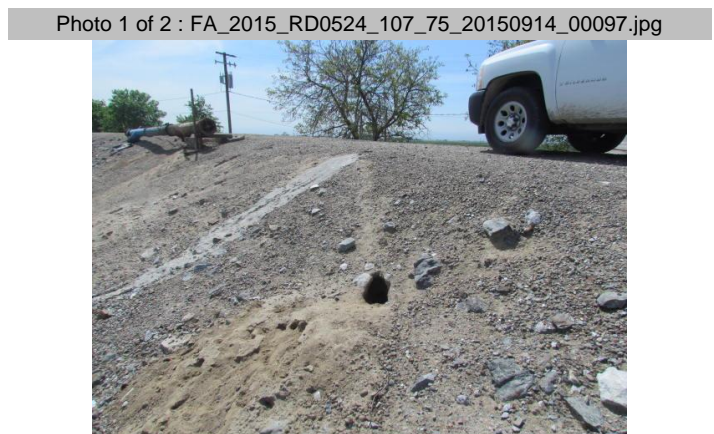
LM Start	5.86	Rating **	M	Issue No.	75
LM End	5.88	Issue Type +	Ma	Location *	WS
Category	Earthen Levee			GPS Latitude/Longitude	
				Start	End
Item	Animal Control			37.874240 °	37.874002 °
				-121.333187 °	-121.333027 °
DWR ID	DWR_RD0524_01_s_2012_75				
Action/Comments					
No rodents visible, but rodent burrows visible; need to backfill and compact or grout burrows. Inspector Comments: District has grouted rodent holes, but other rodent holes have appeared.

Looking southwest at typical rodent holes on waterward slope.
