**Flood Control Project Maintenance  
Levee Inspections**

**Fall 2016 Levee Maintenance Deficiency Summary Report**

**Reclamation District No. 0524 Middle Roberts Island**

Waterway			Bank	Unit Miles
Unit No. 01 San Joaquin River			Left	6.20
	Spring (March - May)	Summer (June - August)	(September - November) Fall	Winter (December - February)
Unit Maintenance Rating (Fall Only)			<b>U</b>	
Date of Inspection	4/12/2016 - 4/13/2016		10/10/2016 - 10/11/2016	
DWR Inspector	Richard Willoughby		Richard Willoughby	
Accompanied By	Mario Jaques RD 524		Mario Jaques RD 524

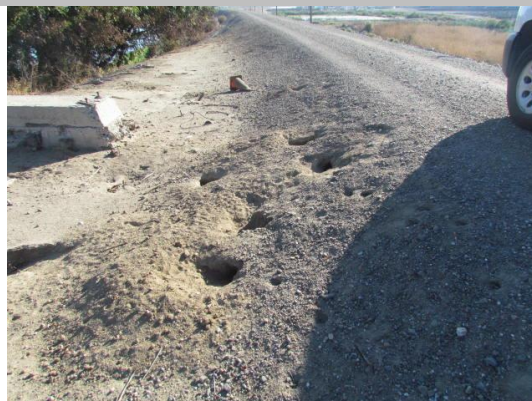
Photo 4 of 4 : FA\_2016\_RD0524\_107\_174\_20160929\_00217.jpg

Looking southeast at several rodent holes on waterward slope. (Fall 2015).

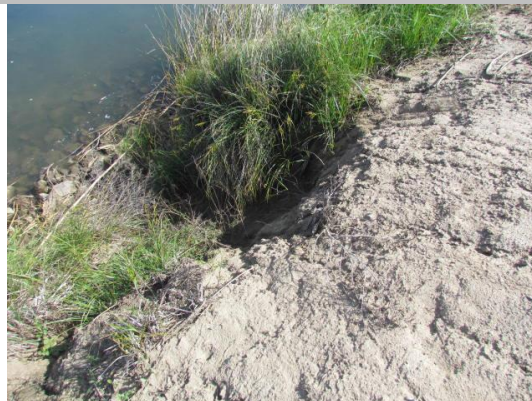
Photo 1 of 2 : FA\_2016\_RD0524\_107\_180\_20160929\_00227.jpg

LM Start	0.34	Rating **	M	Issue No.	180
LM End	0.34	Issue Type +	Ma	Location *	WS
Category	Earthen Levee			GPS Latitude/Longitude	
				Start	End
Item	Erosion / Bank Caving			37.938461°	37.938461°
				-121.341626°	-121.341626°
DWR ID	DWR_RD0524_01_s_2014_180				
Comment Code					
E2 : Schedule repair of erosion site prior to the next inspection.					
Inspector Comment					
Erosion is located along the lower level of waterward slope.

Looking southeast at erosion on waterward toe.

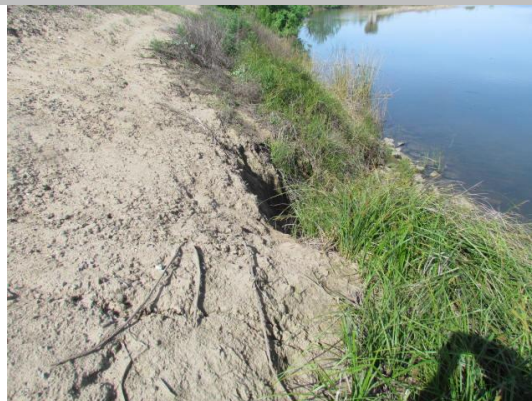
Photo 2 of 2 : FA\_2016\_RD0524\_107\_180\_20160929\_00228.jpg

Looking northeast at erosion on waterward toe.

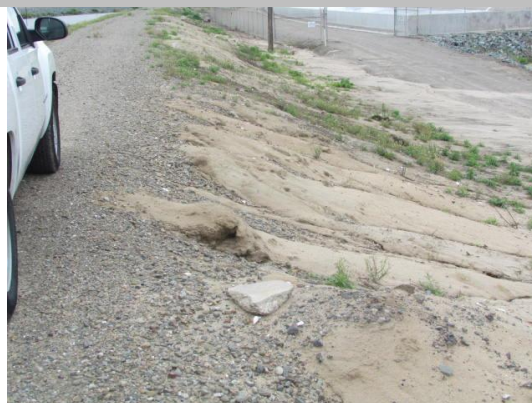
Photo 2 of 2 : FA\_2016\_RD0524\_107\_205\_20160929\_00247.jpg

LM Start	0.40	Rating **	U	Issue No.	205
LM End	0.46	Issue Type +	Ma	Location *	LS
Category	Earthen Levee			GPS Latitude/Longitude	
				Start	End
Item	Slope Stability			37.938625 °	37.938695 °
				-121.340479 °	-121.339420 °
DWR ID	DWR_RD0524_01_s_2016_205				
Comment Code					
S1 : Repair slope instability.					
Inspector Comment					
Several damage site within this reach.

Looking at slope damage on landward slope.

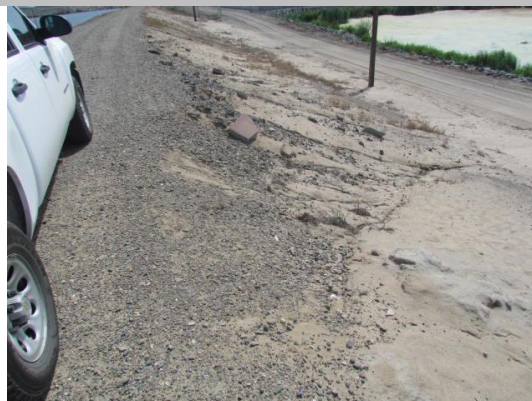
Photo 2 of 3 : FA\_2016\_RD0524\_107\_170\_20160929\_00211.jpg

LM Start	0.41	Rating **	U	Issue No.	170 (cont)	
LM End	0.45	Issue Type +	Ma	Location *	WS	
Category	Earthen Levee			GPS Latitude/Longitude		
				Start		End
Item	Slope Stability			37.938628 °		37.938688 °
				-121.340385 °		-121.339627 °
DWR ID	DWR_RD0524_01_s_2015_170					
Comment Code						
S1 : Repair slope instability.						
Inspector Comment						
Several slope instabilities within this reach.

Looking at slope damage on waterward shoulder.

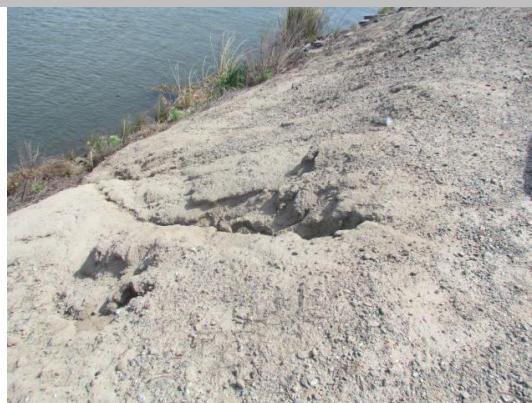
Photo 3 of 3 : FA\_2016\_RD0524\_107\_170\_20160929\_00212.jpg

Looking at waterward slope erosion.

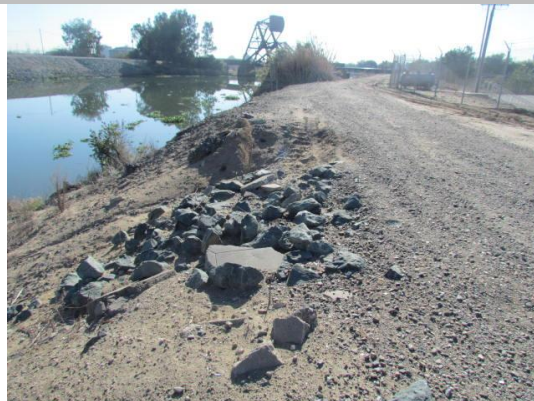
Photo 1 of 4 : FA\_2016\_RD0524\_107\_13\_20160929\_00024.jpg

LM Start	0.64	Rating **	M	Issue No.	13
LM End	0.65	Issue Type +	Ma	Location *	WS
Category	Earthen Levee			GPS Latitude/Longitude	
				Start	End
Item	Slope Stability			37.938105 °	37.938023 °
				-121.336288 °	-121.336173 °
DWR ID	DWR_RD0524_01_s_2012_13				
Comment Code					
S1 : Repair slope instability.					
Inspector Comment					
Depression extend from shoulder to mid levee slope two site with this section.

Looking southeast at depression on waterward shoulder fall 2015

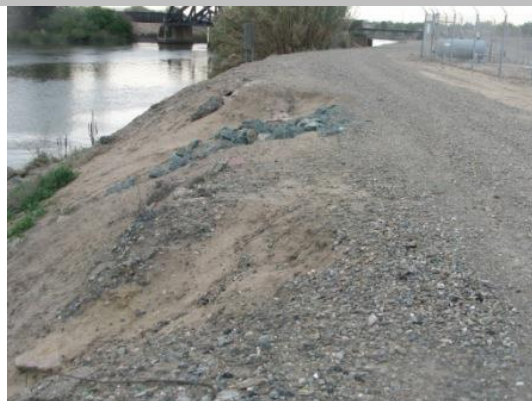
Photo 3 of 4 : FA\_2016\_RD0524\_107\_13\_20160929\_00026.jpg

View of the erosion.

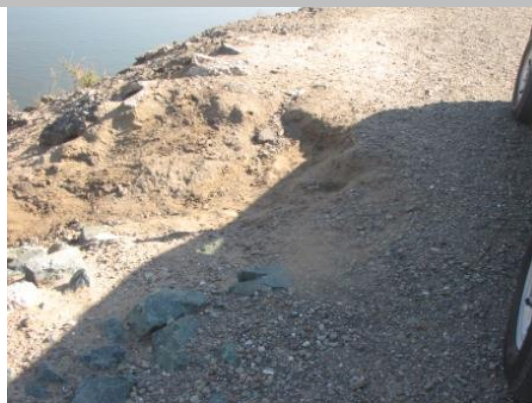
Photo 4 of 4 : FA\_2016\_RD0524\_107\_13\_20160929\_00027.jpg

Update view of the erosion site.

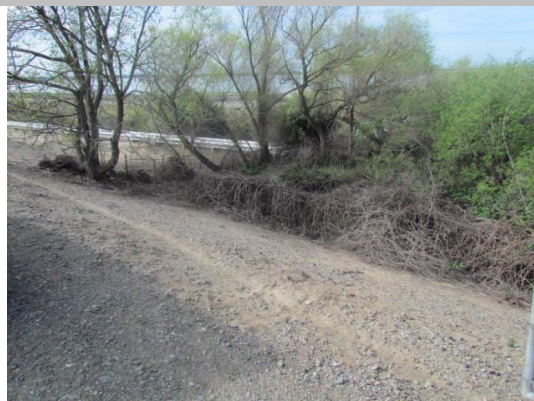
Photo 3 of 3 : FA\_2016\_RD0524\_107\_262\_20160929\_00266.jpg

Looking southwest at vegetation on landward slope and toe. (Spring 2013)

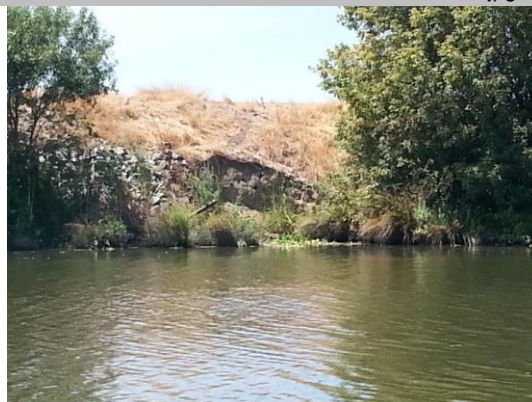
Photo 2 of 2 : SJR2016\_RD0524U01RM41.5\_2.jpg

Close view of the erosion.

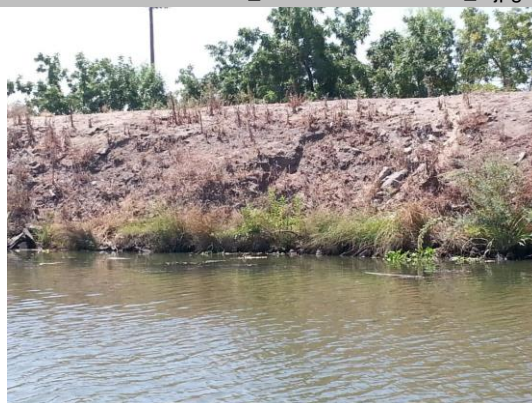
Photo 2 of 2 : SJR2016\_RD0524U01RM41.58\_2.jpg

Close view of the erosion.

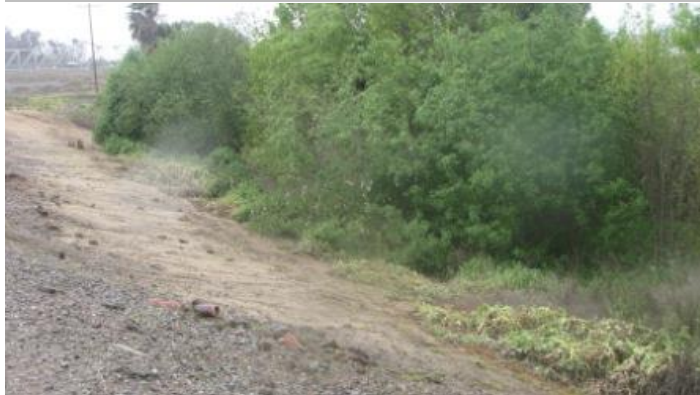
Looking southwest at dense veg. on landside toe. (Fall 2015)

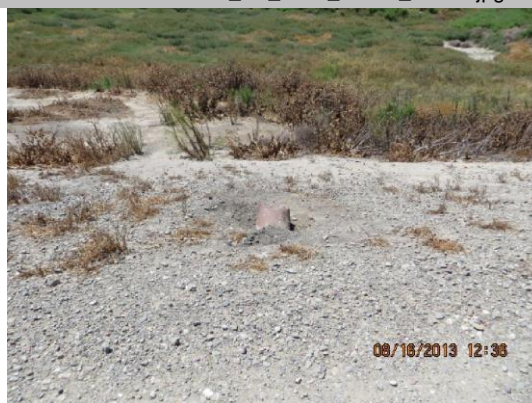
Photo 2 of 2 : UCIP\_FA\_2016\_50747\_29861.jpg

Pipe open and visible on LS slope.

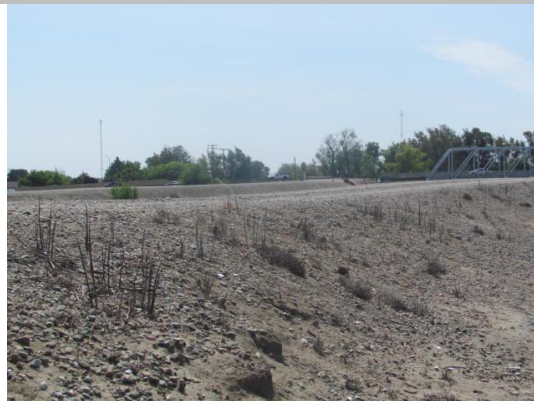
Photo 1 of 2 : FA\_2016\_RD0524\_107\_172\_20160929\_00214.jpg

Looking east at depression on levee crown.

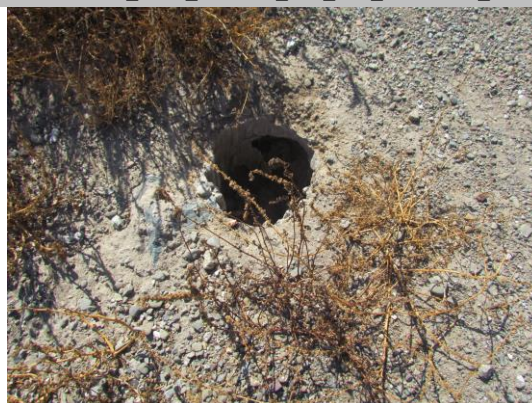
Photo 2 of 2 : FA\_2016\_RD0524\_107\_202\_20161013\_00390.jpg

Looking at hole on waterward shoulder.

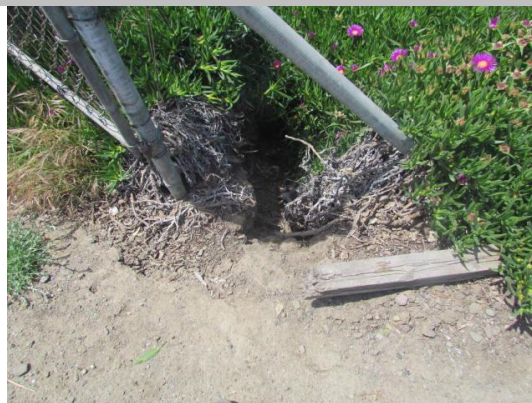
Photo 1 of 2 : FA\_2016\_RD0524\_107\_176\_20160929\_00220.jpg

Looking west at erosion within landscaping on landward shoulder and slope.

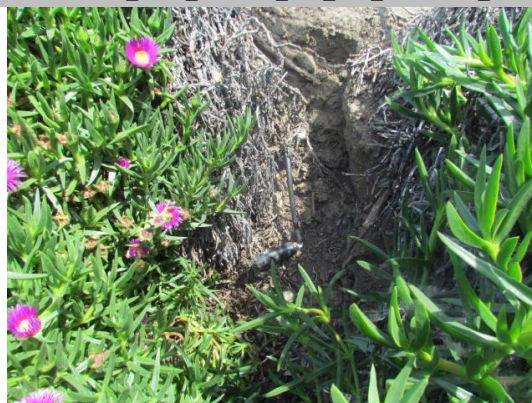
Photo 2 of 2 : FA\_2016\_RD0524\_107\_176\_20160929\_00221.jpg

Looking east at erosion within landscaping on landward slope and shoulder.

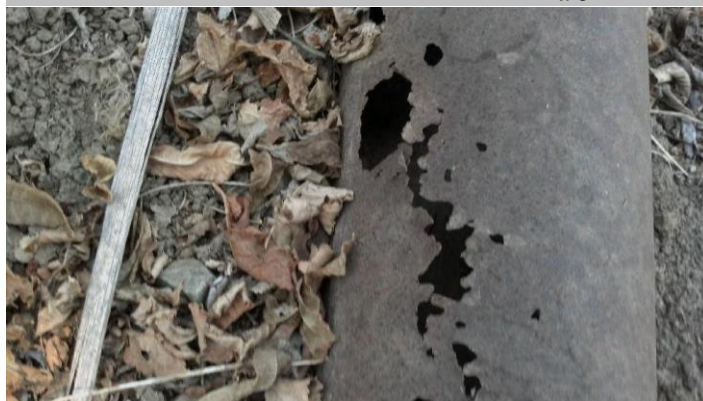
Photo 2 of 2 : UCIP\_FA\_2016\_21883\_37133.jpg

Holes in pipe along exposed side of pipe at WS slope.

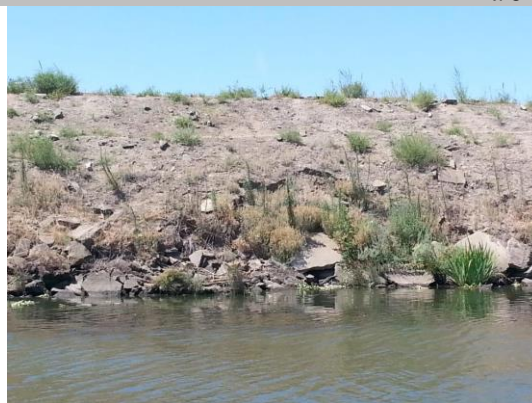
Photo 1 of 2 : SJR2016\_RD0524U01RM42.79\_2.jpg

Close view of the pocket erosion.

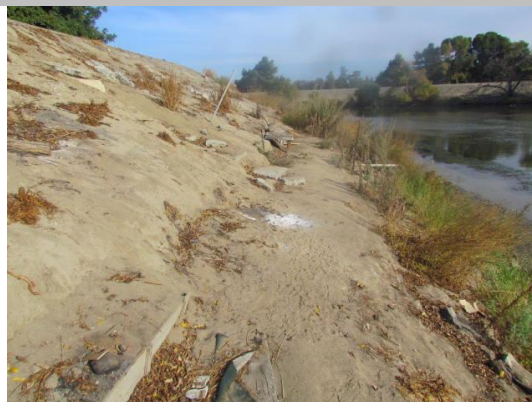
Photo 1 of 1 : FA\_2016\_RD0524\_107\_34\_20160929\_00072.jpg

Looking northeast at damage to the slope possibly caused by human activity.

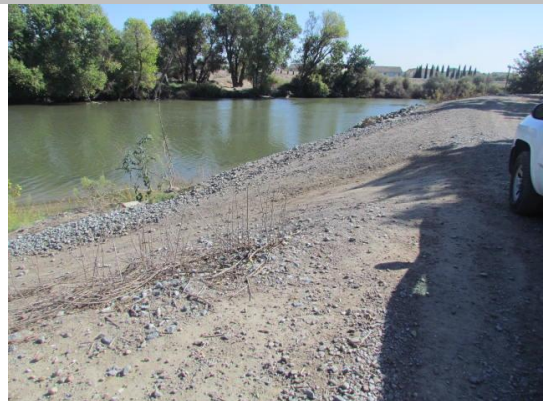
Photo 1 of 1 : FA\_2016\_RD0524\_107\_920\_20160929\_00281.jpg

Looking southeast at unauthorized ramp on waterside slope.

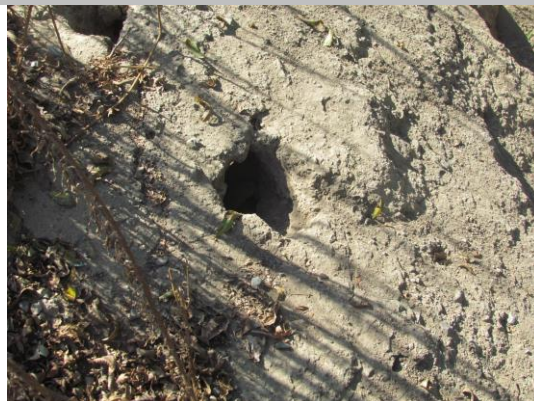
Photo 2 of 2 : FA\_2016\_RD0524\_107\_219\_20161013\_00407.jpg

Looking at typical rodent hole on waterward slope.

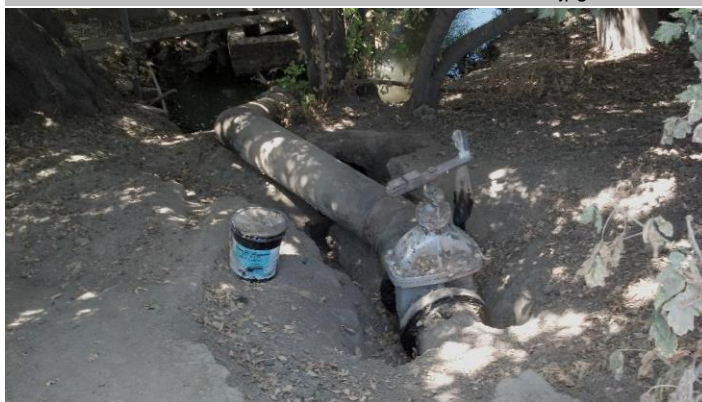
Photo 2 of 2 : UCIP\_FA\_2016\_50748\_30205.jpg

Pipe, gatevalve, and erosion on LS slope.

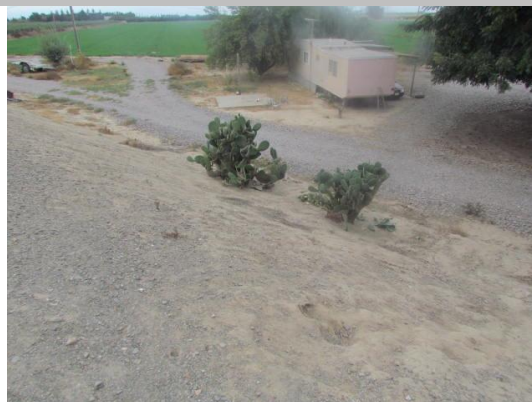
Photo 1 of 1 : FA\_2016\_RD0524\_107\_124\_20160929\_00187.jpg

Looking west at cactus on landside toe.

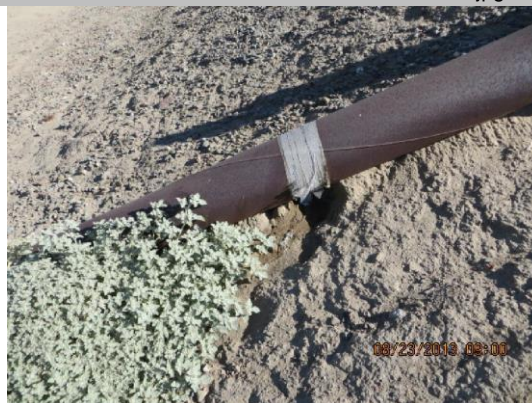
Photo 2 of 2 : UCIP\_FA\_2016\_18320\_30593.jpg

Small leak in pipe on LS slope.

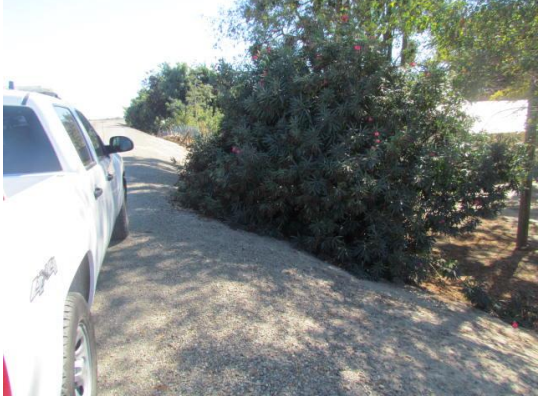
Photo 1 of 1 : FA\_2016\_RD0524\_107\_188\_20161013\_00413.jpg

Looking south at oleander on landward slope.

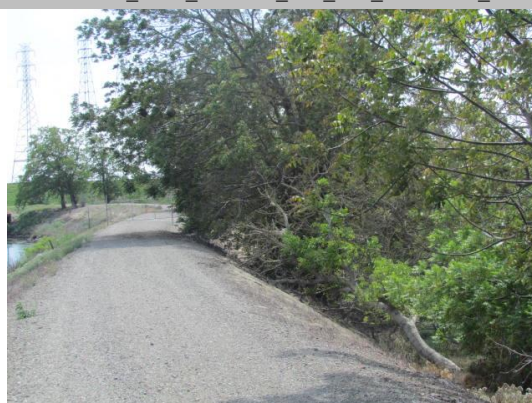
Photo 1 of 1 : FA\_2016\_RD0524\_107\_932\_20160929\_00290.jpg

Looking south at untrimmed trees on landward slope and toe.

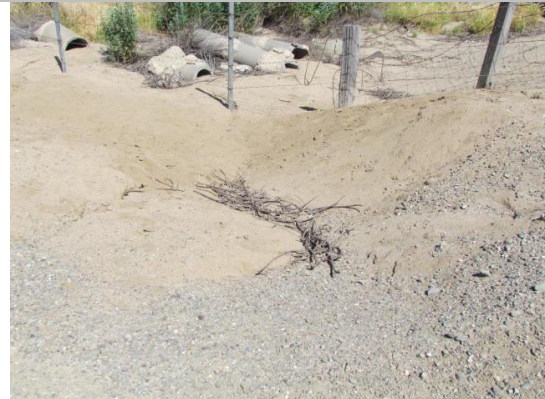
Photo 1 of 3 : FA\_2016\_RD0524\_107\_118\_20160929\_00180.jpg

Looking west at slope damage on landside slope.

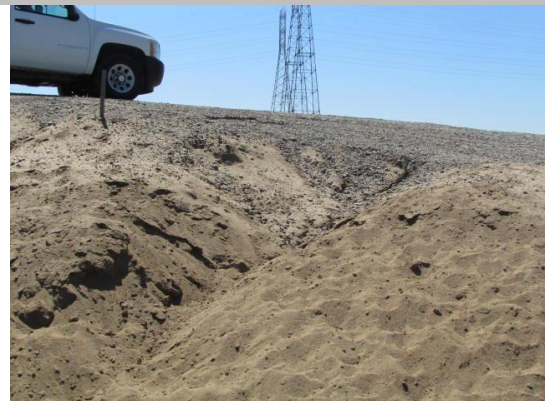
Photo 2 of 3 : FA\_2016\_RD0524\_107\_118\_20160929\_00181.jpg

Looking southeast at damaged slope.

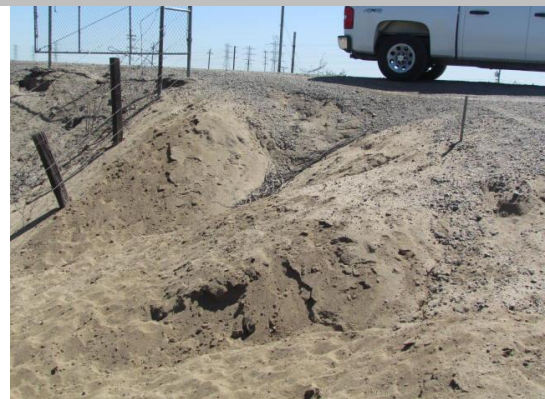
Photo 3 of 3 : FA\_2016\_RD0524\_107\_118\_20160929\_00182.jpg

Looking east at slope caving on landside slope.

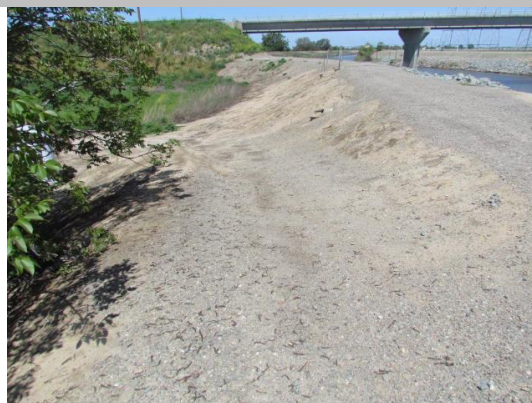
Photo 2 of 3 : FA\_2016\_RD0524\_107\_215\_20160929\_00261.jpg

Looking north at slope damage (ramp) on landward slope.

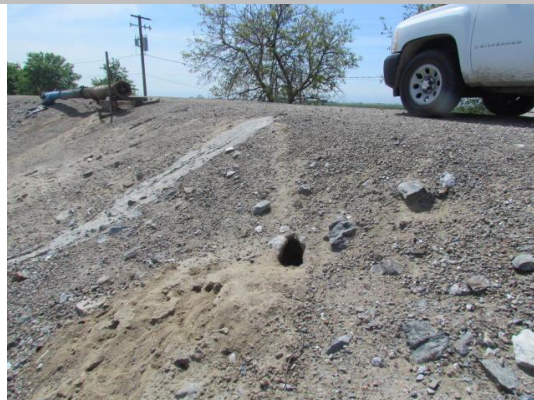
Photo 1 of 2 : FA\_2016\_RD0524\_107\_75\_20160929\_00124.jpg

Looking southwest at typical rodent holes on waterward slope.

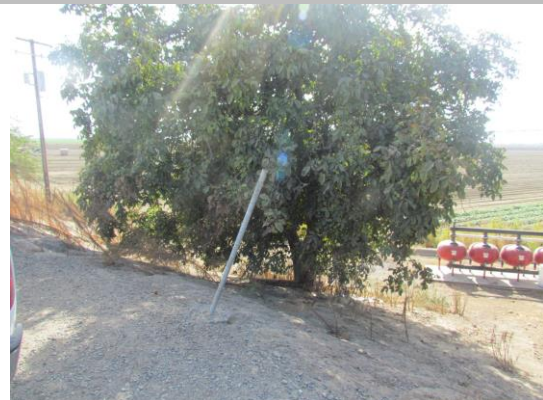
Photo 1 of 1 : FA\_2016\_RD0524\_107\_217\_20161013\_00418.jpg

Looking west at walnut tree on landward slope.

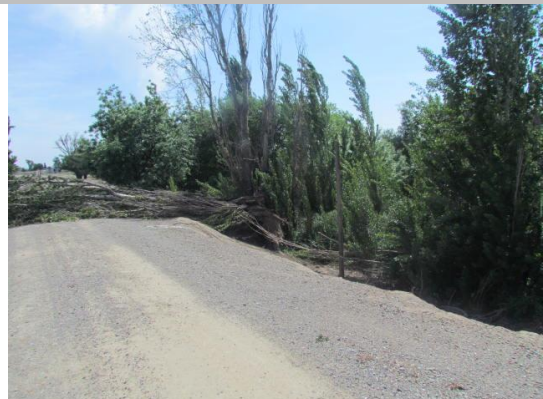
Photo 3 of 4 : FA\_2016\_RD0524\_107\_81\_20160929\_00134.jpg

Looking southwest at large tree across levee crown. (Fall 2015)
