**Flood Control Project Maintenance  
Levee Inspections**

**Fall 2017 Levee Maintenance Deficiency Summary Report**

***San Joaquin River Basin***

**Reclamation District No. 0524 Middle Roberts Island**

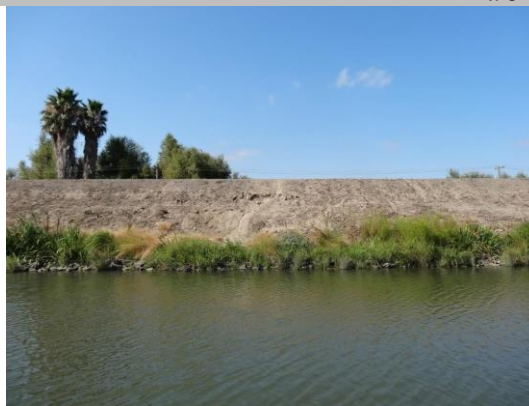
Photo 1 of 3 : SJR2017\_RD0524U01RM40.85\_1.jpg

LM Start	0.19	Rating **	U	Issue No.	1
LM End	0.19	Issue Type +	Ma	Location *	WS
Category	Supplemental			GPS Latitude/Longitude	
				Start	End
Item	DWR Erosion Survey			37.939085 °	37.939085 °
				-121.343917 °	-121.343917 °
DWR ID	RD0524U01RM40.85				
Comment Code					
Inspector Comment					
09/13/2017: No significant change observed.					
07/25/2016: No significant change observed.					
06/24/2015: No significant change observed.					
06/19/2014: No significant change observed.					
08/13/2013: The erosion was discovered during 2013 spring levee inspection. Inspector comment: Erosion is located along the lower level of water-ward slope. [2017 Site ID:RD0524U01RM40.85]

Close view of the erosion.

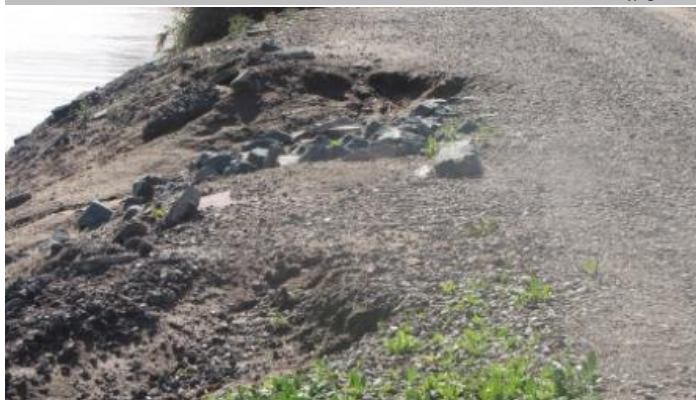
Photo 2 of 4 : FA\_2017\_RD0524\_107\_13\_20170919\_00021.jpg

LM Start	0.64	Rating **	M	Issue No.	13
LM End	0.65	Issue Type +	Ma	Location *	WS
Category	Earthen Levee			GPS Latitude/Longitude	
				Start	End
Item	Slope Stability			37.938105 °	37.938023 °
				-121.336288 °	-121.336173 °
DWR ID	DWR_RD0524_01_s_2012_13				
Comment Code					
S1 : Repair slope instability.					
Inspector Comment					
Depression extends from shoulder to mid levee slope two site with this section.

Looking south at erosion on waterside shoulder.

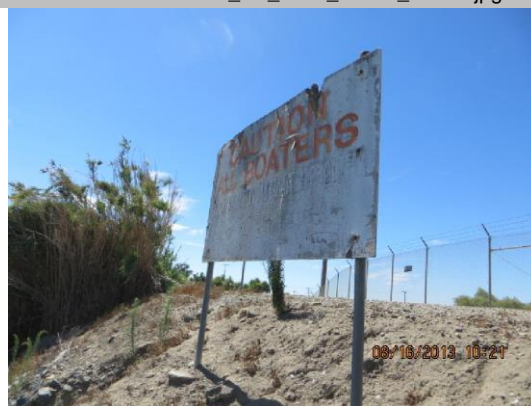
Photo 1 of 3 : UCIP\_FA\_2017\_17563\_29702.jpg

Signage for effluent pipe on WS shoulder.

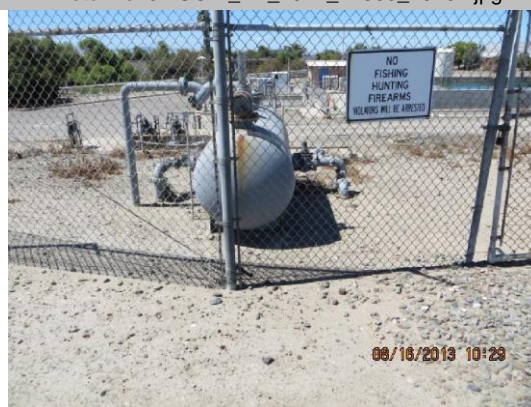
Photo 2 of 3 : UCIP\_FA\_2017\_17563\_29701.jpg

Siphon Priming tank and associated pipes on LS shoulder.

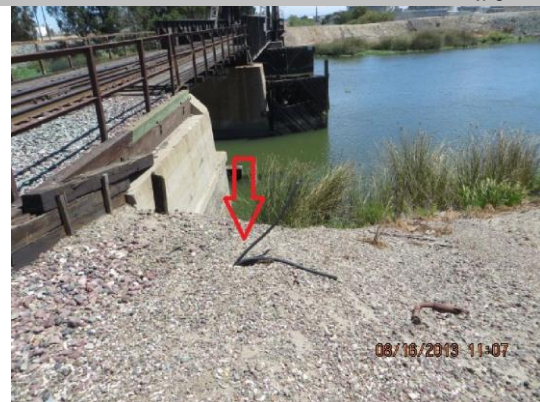
Photo 1 of 1 : UCIP\_FA\_2017\_41463\_29717.jpg

LM Start	0.74	Rating **	M	Issue No.	934	
LM End	0.74	Issue Type +	En	Location *		
Category	Supplemental			GPS Latitude/Longitude		
				Start	End	
Item	DWR UCIP Field Study			37.936951 °	37.936951 °	
				-121.335132 °	-121.335132 °	
DWR ID						
Comment Code						
Inspector Comment						
FS_ID:41463 DS_ID:20595 EP_NO: N/A Repair Type: Non-Urgent Crossing Status: Indicator Found UCIP Comments: Appears abandoned and should be done so properly. FIELD_STRUCT_DESC: 2.5-inch telephone conduit of an unknown material through the levee, 2 feet below the crown and under the channel. Conduit visible on the waterside (WS) shoulder. [Additional Reference(s): DWR Levee Log, 2004]. FS Date: 8/16/2013

Conduit visible on WS shoulder next to bridge abutment. Cable appears to be abandoned.

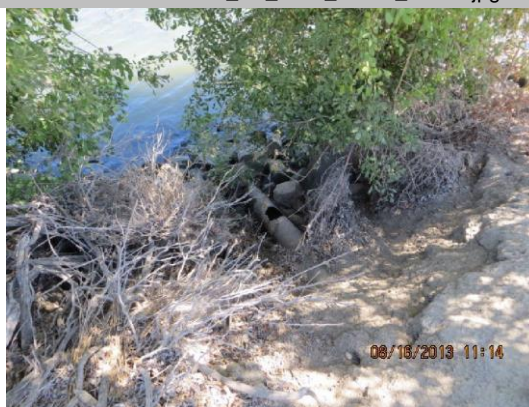
Photo 2 of 2 : UCIP\_FA\_2017\_17571\_29718.jpg

Large hole in pipe at WS toe.

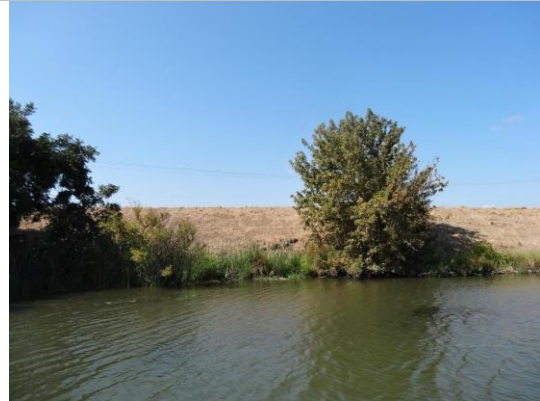
Photo 2 of 2 : SJR2017\_RD0524U01RM41.44\_2.jpg

Close view of the erosion site.

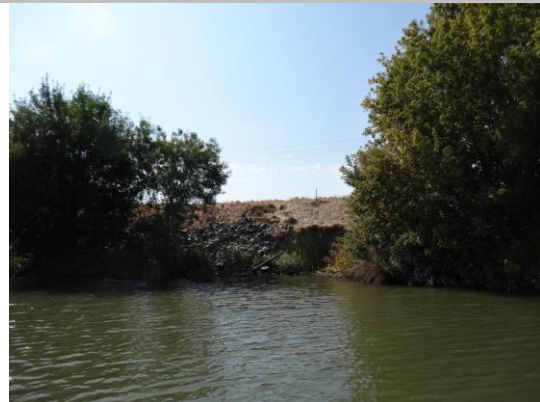
Photo 1 of 3 : SJR2017\_RD0524U01RM41.5\_1.jpg

LM Start	0.91	Rating **	U	Issue No.	29
LM End	0.91	Issue Type +	Ma	Location *	WS
Category	Supplemental			GPS Latitude/Longitude	
				Start	End
Item	DWR Erosion Survey			37.935576 °	37.935576 °
				-121.333202 °	-121.333202 °
DWR ID	RD0524U01RM41.5				
Comment Code					
Inspector Comment					
09/13/2017: No significant change observed.					
07/25/2016: No significant change observed.					
06/24/2015: No significant change observed.					
06/19/2014: No significant change observed.					
08/13/2013: No significant change at this site.					
08/07/2012: The site has been visited by boat survey. No significant change observed					
08/23/2011: The erosion site is immediately downstream of the riprap protection. [2017 Site ID:RD0524U01RM41.5]

Front view of the erosion. Note the riprap protection near the site.

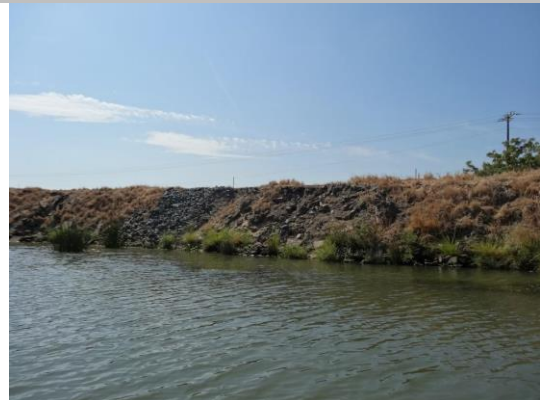
Photo 1 of 3 : SJR2017\_RD0524U01RM41.59\_1.jpg

LM Start	1.02	Rating **	U	Issue No.	33
LM End	1.02	Issue Type +	Ma	Location *	WS
Category	Supplemental			GPS Latitude/Longitude	
				Start	End
Item	DWR Erosion Survey			37.935078 °	37.935078 °
				-121.331134 °	-121.331134 °
DWR ID	RD0524U01RM41.59				
Comment Code					
Inspector Comment					
09/13/2017: No significant change observed.					
07/25/2016: No significant change observed.					
06/24/2015: No significant change observed.					
06/19/2014: No significant change observed.					
08/13/2013: No significant change at this site.					
08/07/2012: The site has been visited by boat survey. Site has been repaired, but new erosion occurred at the levee slope and immediately upstream of the repaired site.					
08/23/2011: The site is about 500 ft downstream of bridge. The levee toe seems to be protected, but the protection is being washed away.					
[2017 Site ID:RD0524U01RM41.59]

Upstream view of the site.

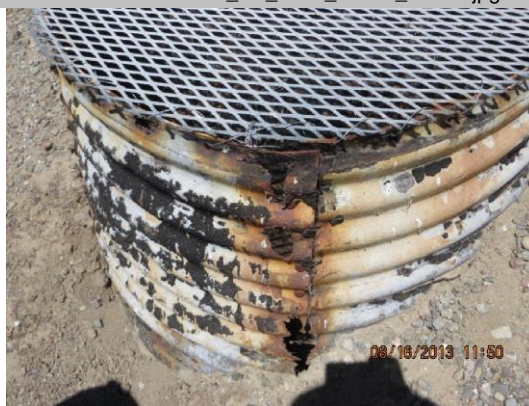
Photo 3 of 3 : UCIP\_FA\_2017\_17589\_29746.jpg

36-inch CMP riser on LS slope severely corroded with various holes along seams.

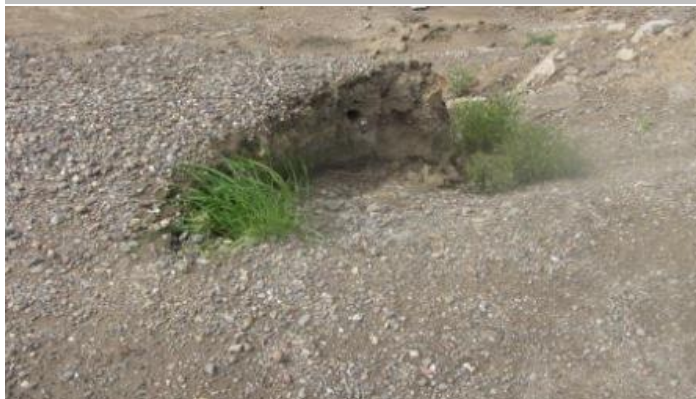
Photo 7 of 7 : FA\_2017\_RD0524\_107\_18\_20170919\_00037.jpg

Updated view from above the slope stability.

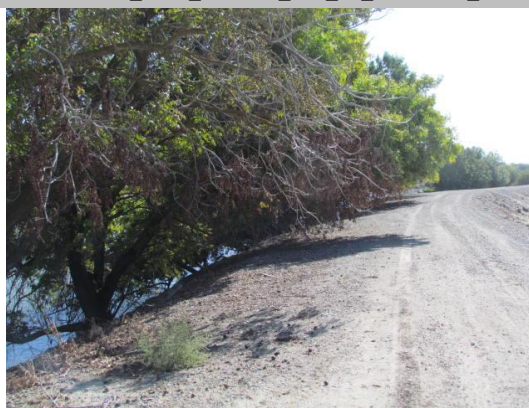
Photo 1 of 1 : FA\_2017\_RD0524\_107\_19\_20170919\_00038.jpg

Looking southeast at low hanging tree branches at waterside toe.

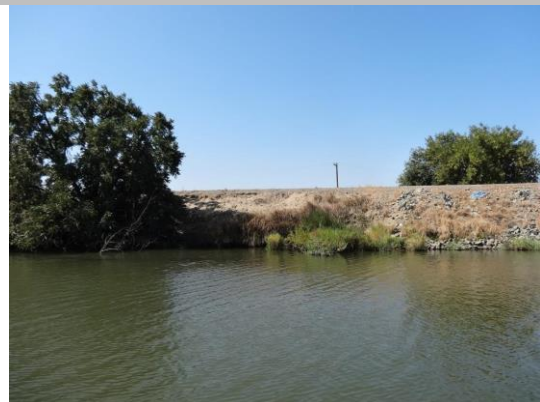
Photo 2 of 4 : SJR2017\_RD0524U01RM41.79\_2.jpg

Direct view of the site.

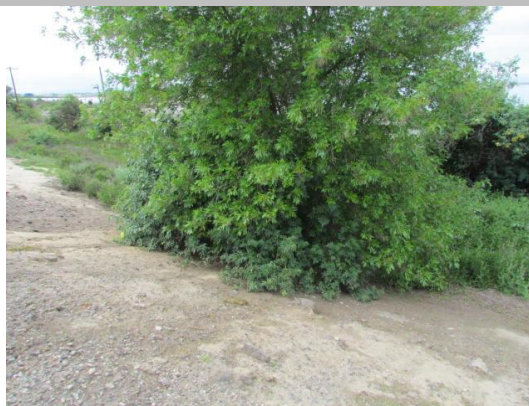
Photo 1 of 1 : FA\_2017\_RD0524\_107\_206\_20170919\_00248.jpg

Looking southwest a untrimmed tree at landward toe. (Spring 2016)

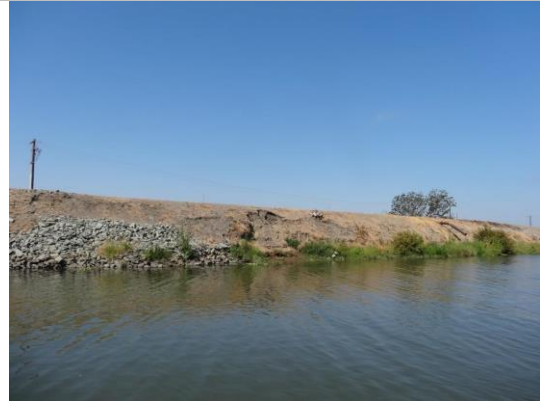
Photo 4 of 4 : SJR2017\_RD0524U01RM41.92\_4.jpg

Front view of the erosion. Note the worsened erosion next to the protected slope.

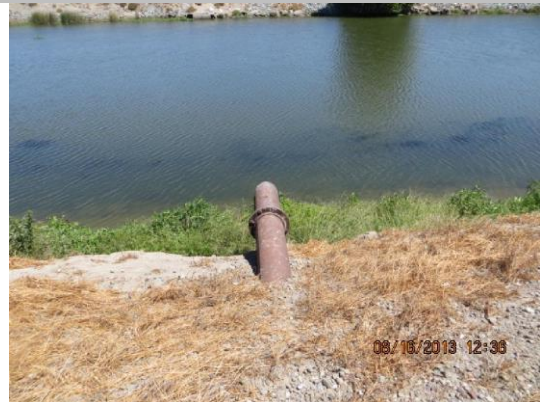
Photo 1 of 3 : UCIP\_FA\_2017\_51319\_29862.jpg

Pipe visible and open on WS slope.

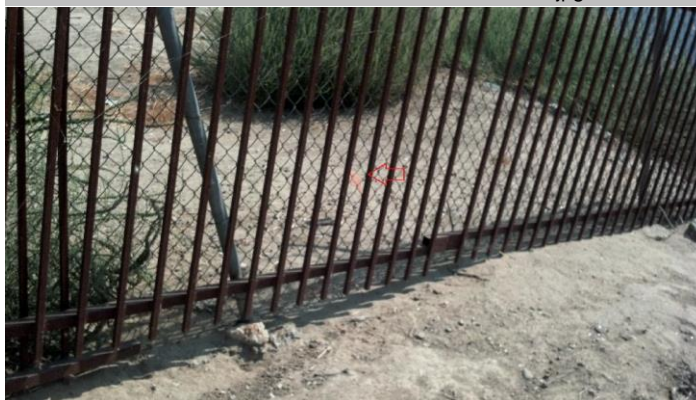
Photo 2 of 2 : UCIP\_FA\_2017\_17798\_29934.jpg

USAA markers along alignment at gate.

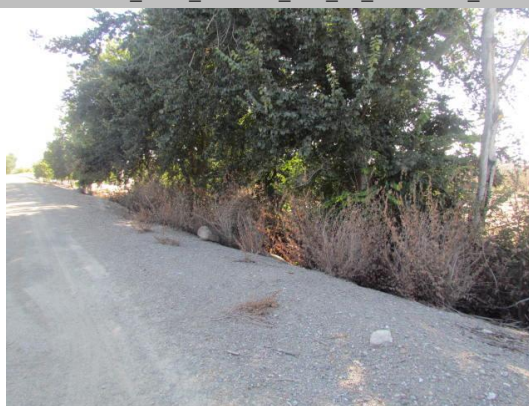
Photo 4 of 4 : FA\_2017\_RD0524\_107\_46\_20170919\_00083.jpg

Looking southwest at dense vegetation and low hanging tree branches on landside slope and toe.

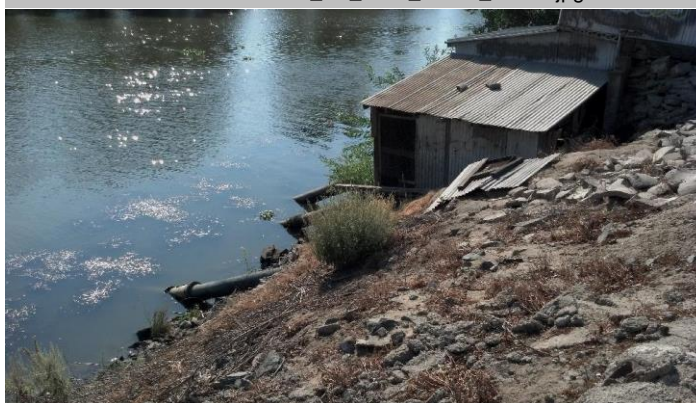
Photo 1 of 3 : UCIP\_FA\_2017\_21866\_37124.jpg

Pipe visible at lower left.

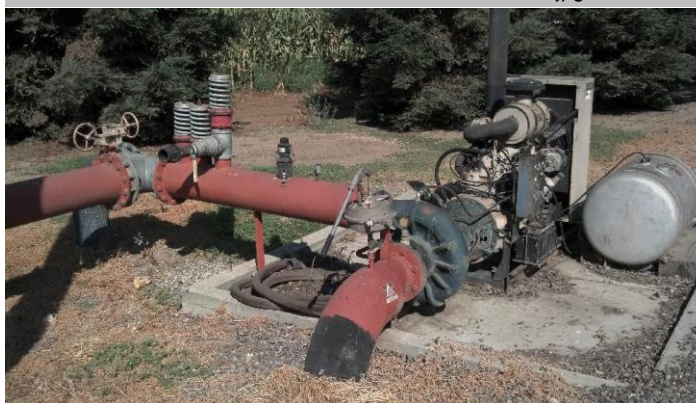
Photo 3 of 3 : UCIP\_FA\_2017\_21866\_37122.jpg

Pumping plant with siphon breaker, vents, and butterfly valves.

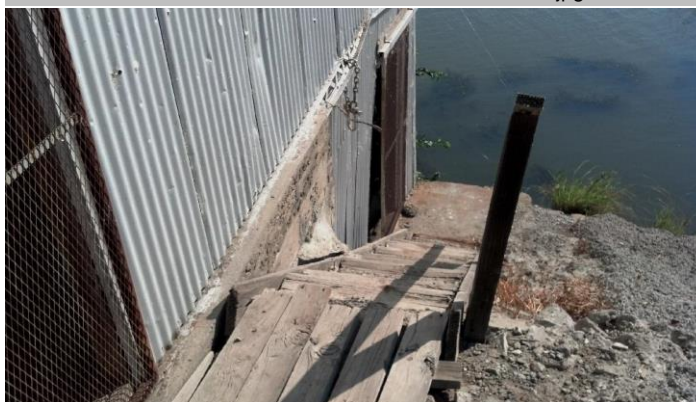
Photo 2 of 3 : UCIP\_FA\_2017\_17847\_29961.jpg

Steps to pump on WS slope.

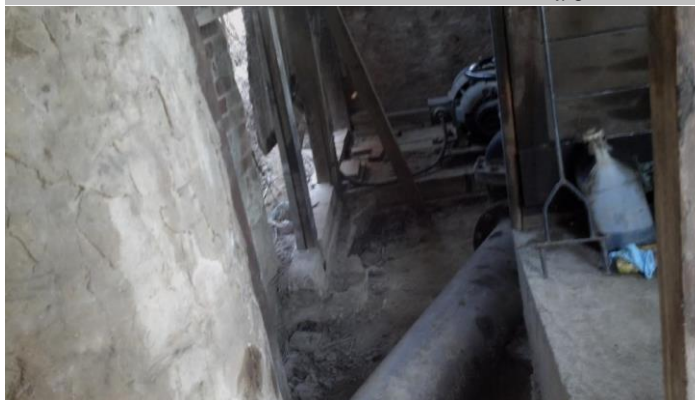
Photo 3 of 3 : UCIP\_FA\_2017\_17847\_29960.jpg

Pipes at connection to concrete surge box on WS inside pumphouse.

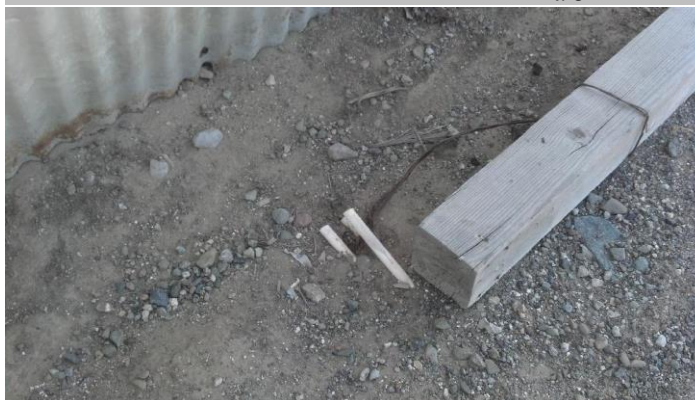
Photo 1 of 2 : UCIP\_FA\_2017\_21865\_37121.jpg

Pipes visible on WS shoulder directly in front of pumphouse.

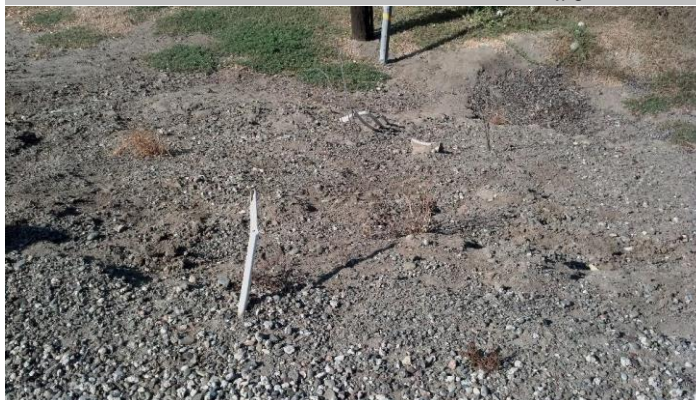
Photo 2 of 2 : UCIP\_FA\_2017\_21865\_37120.jpg

Pipes visible on LS slope.

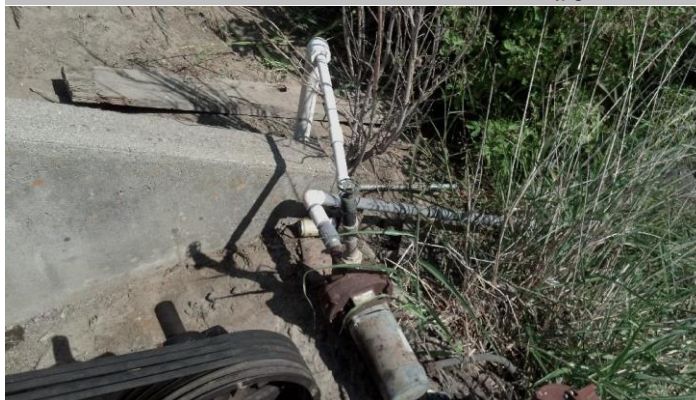
Photo 1 of 3 : UCIP\_FA\_2017\_21872\_37128.jpg

Pump on concrete pad at WS slope.

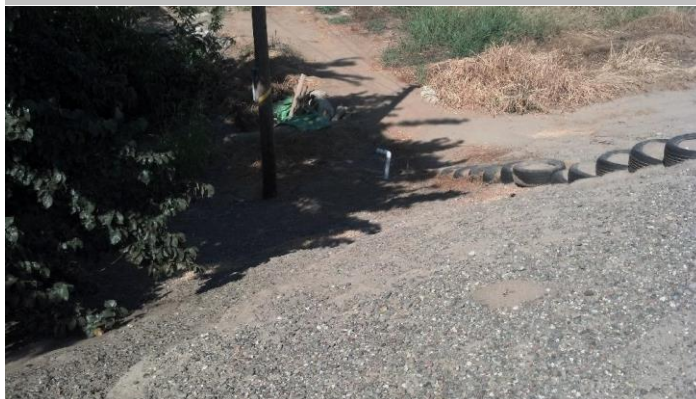
Photo 2 of 3 : UCIP\_FA\_2017\_21872\_37127.jpg

PVC pipe visible on LS toe.

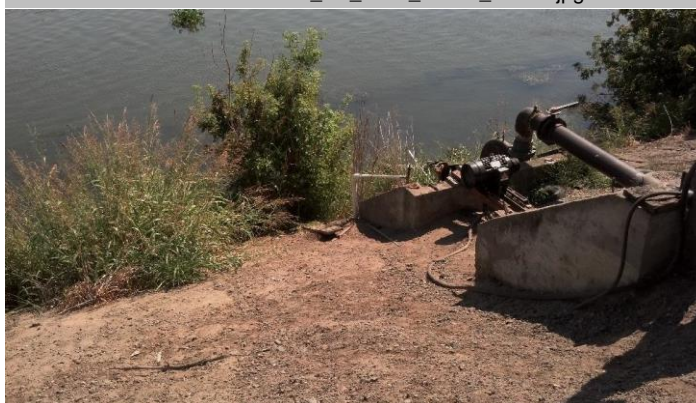
Photo 3 of 3 : UCIP\_FA\_2017\_21872\_37126.jpg

Pump and pipe visible on WS slope.

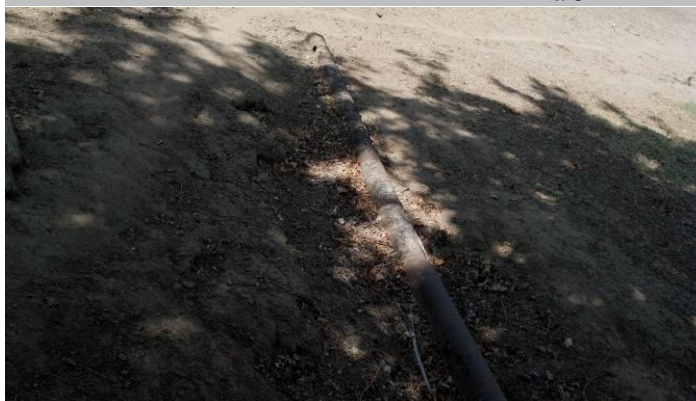
Photo 1 of 2 : UCIP\_FA\_2017\_21883\_37134.jpg

Pipe visible on WS slope.

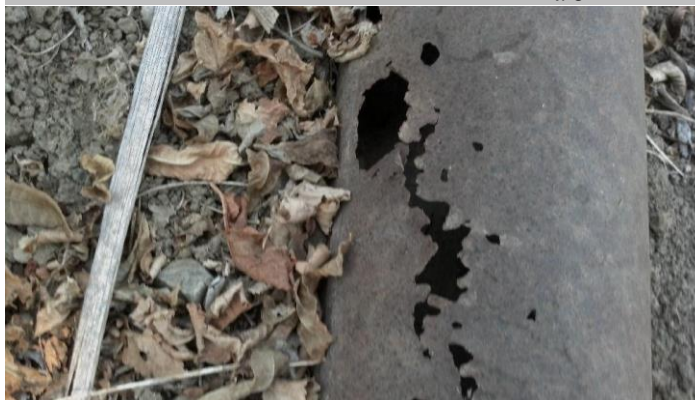
Photo 2 of 2 : UCIP\_FA\_2017\_21883\_37133.jpg

Holes in pipe along exposed side of pipe at WS slope.

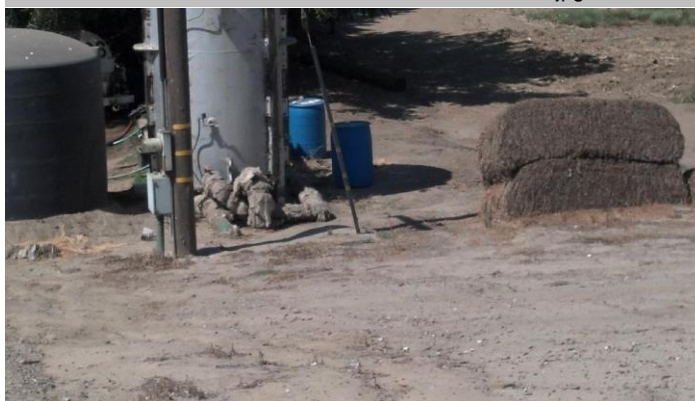
Photo 1 of 3 : UCIP\_FA\_2017\_21895\_37142.jpg

Steel irrigation line visible in front of tank to right of powerpole off LS toe.

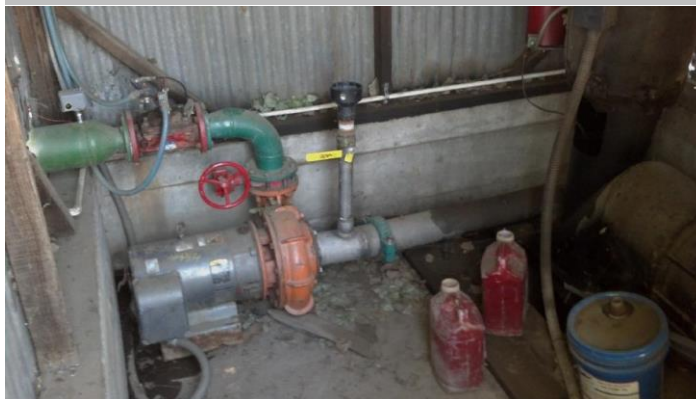
Photo 3 of 3 : UCIP\_FA\_2017\_21895\_37140.jpg

Pump and butterfly valve inside pumphouse on WS berm.

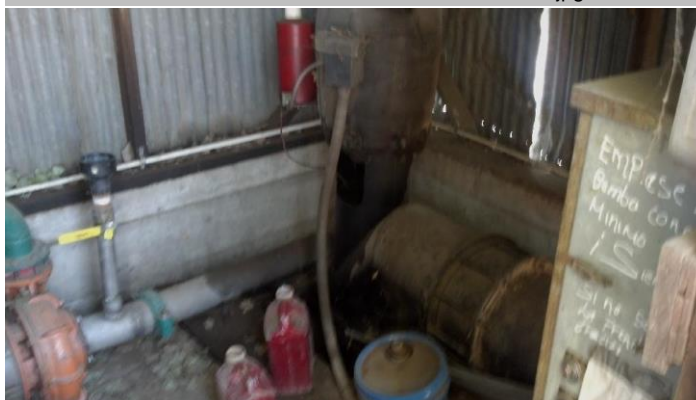
Photo 2 of 3 : UCIP\_FA\_2017\_17944\_30044.jpg

Pump and pipe inside pumphouse.

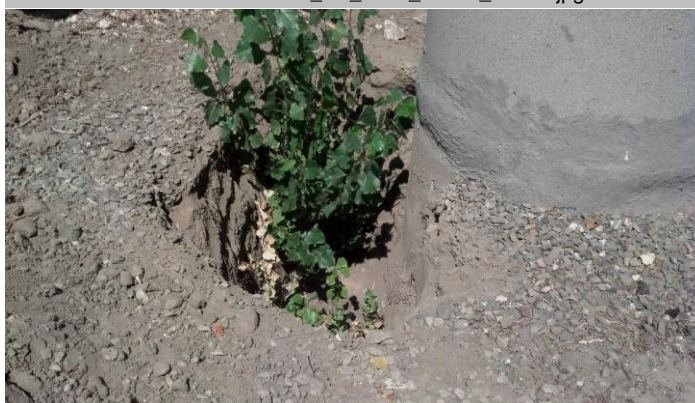
Photo 3 of 3 : UCIP\_FA\_2017\_17944\_30043.jpg

Hole over pipe next to 4-foot diameter concrete standpipe on WS slope.

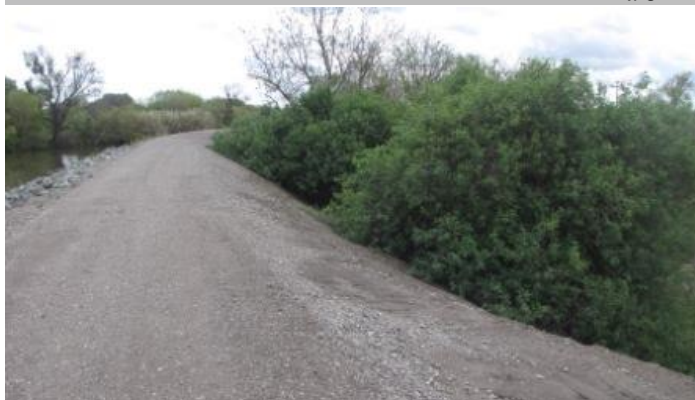
Photo 2 of 2 : FA\_2017\_RD0524\_107\_32\_20170919\_00057.jpg

Looking south at dense veg on landside slope and toe.

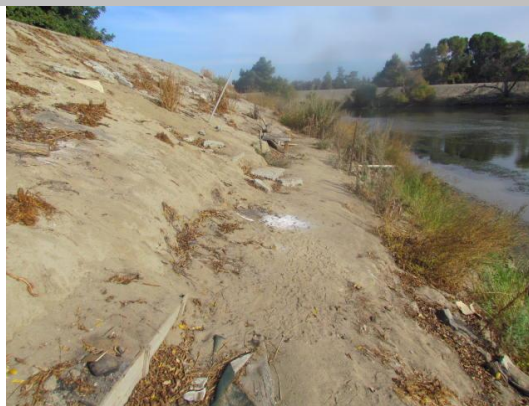
Photo 1 of 1 : FA\_2017\_RD0524\_107\_34\_20170919\_00060.jpg

Looking northeast at damage to the slope possibly caused by human activity.

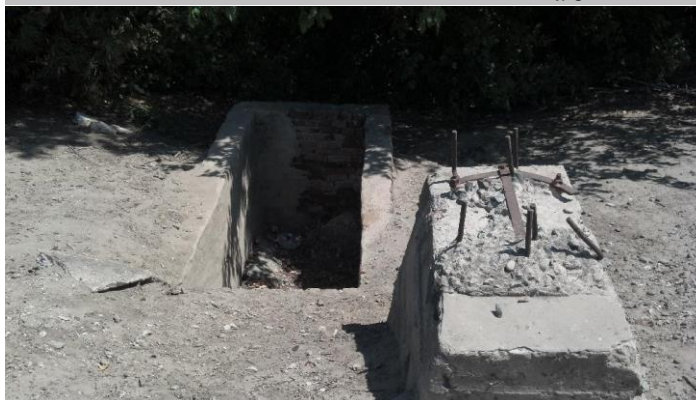
Photo 1 of 3 : UCIP\_FA\_2017\_21935\_37162.jpg

Foundation for pump with distribution box on WS shoulder.

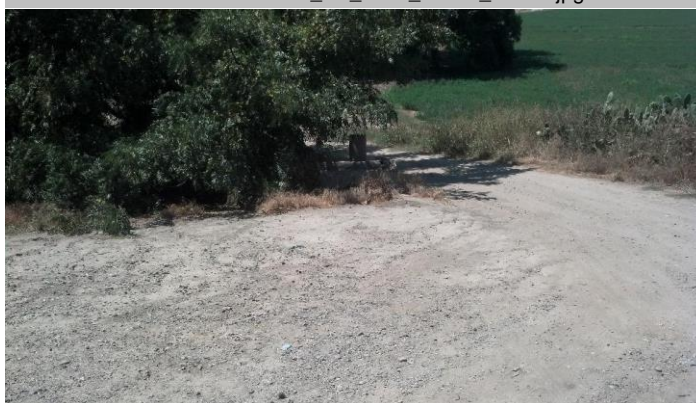
Photo 2 of 3 : UCIP\_FA\_2017\_21935\_37161.jpg

Distribution box on LS toe.

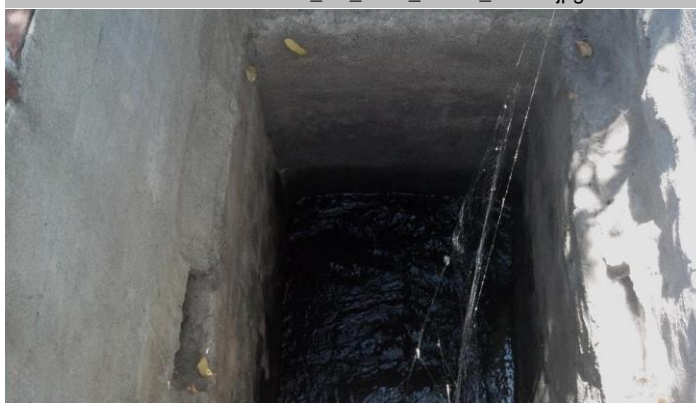
Photo 3 of 3 : UCIP\_FA\_2017\_21935\_37160.jpg

Distribution box on LS toe.

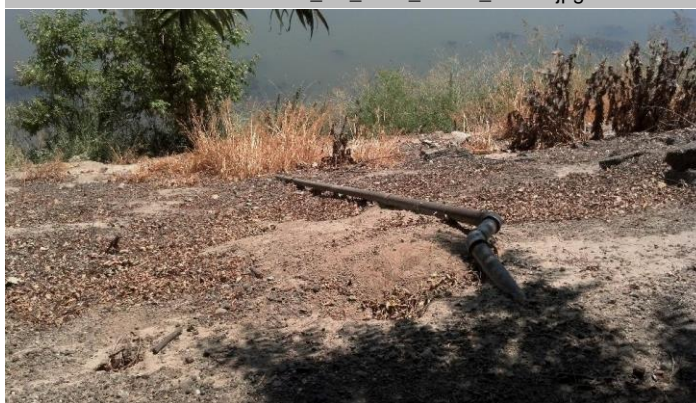
Photo 2 of 2 : UCIP\_FA\_2017\_18085\_30190.jpg

Pipe visible on WS slope.

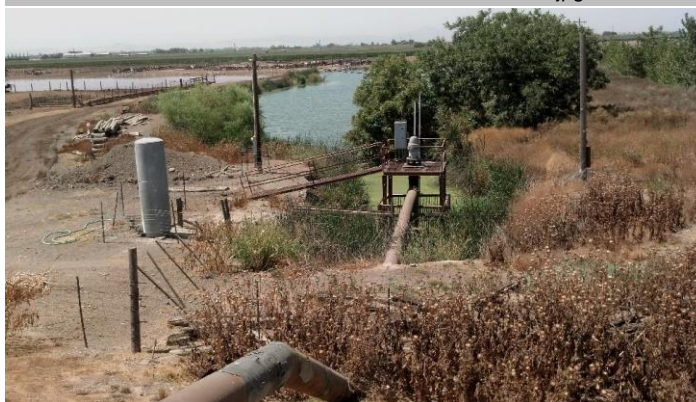
Photo 2 of 2 : UCIP\_FA\_2017\_18089\_30197.jpg

Pipe, pump, power pole, and meter visible off LS toe.

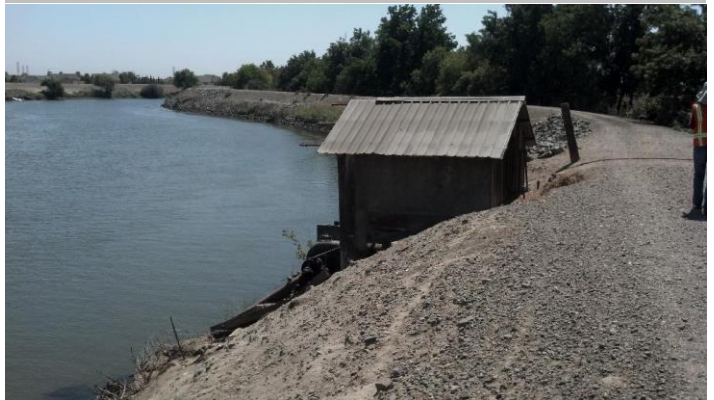
Photo 1 of 3 : UCIP\_FA\_2017\_51320\_30206.jpg

Pipe and pumphouse on WS slope.

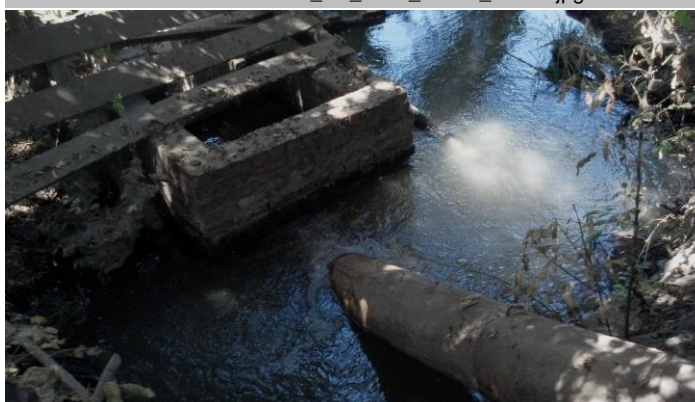
Photo 3 of 3 : UCIP\_FA\_2017\_51320\_30204.jpg

Extensive erosion around distribution box at LS toe.

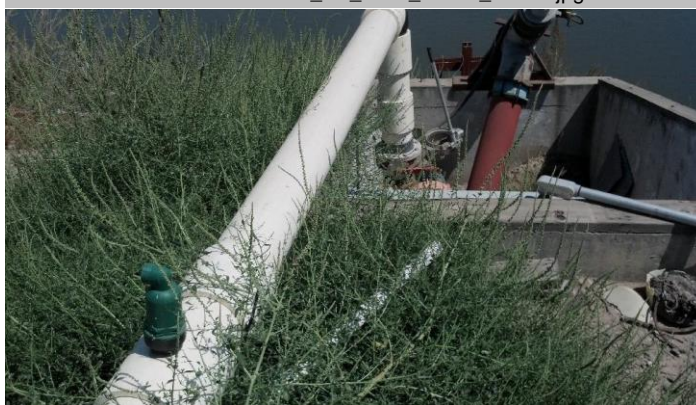
Photo 2 of 3 : UCIP\_FA\_2017\_22725\_38444.jpg

Vent on PVC pipe at WS shoulder.

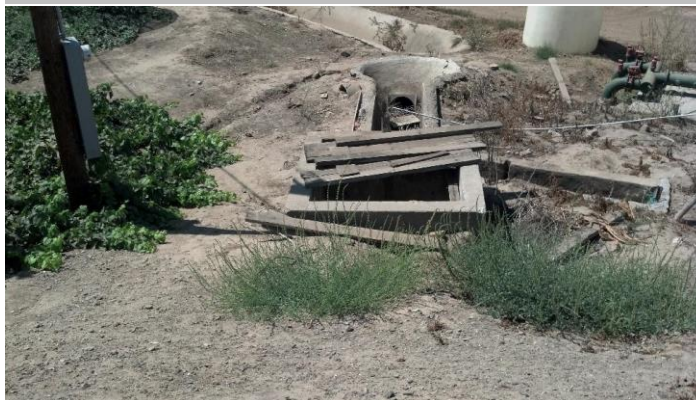
Photo 3 of 3 : UCIP\_FA\_2017\_18307\_30526.jpg

6'X6' concrete distribution box and power pole on LS toe.

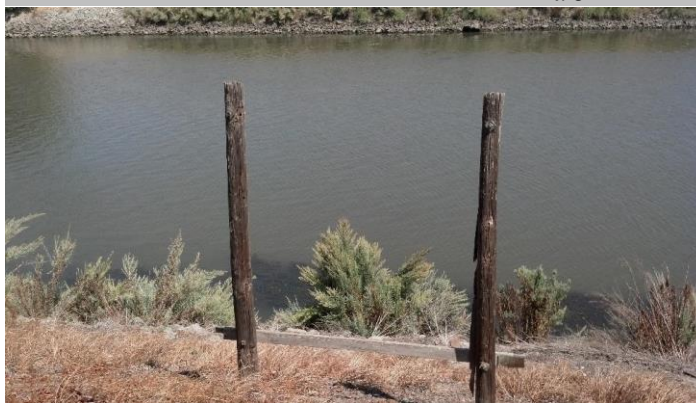
Photo 1 of 2 : UCIP\_FA\_2017\_41464\_30543.jpg

Sign posts with sign removed on WS slope.

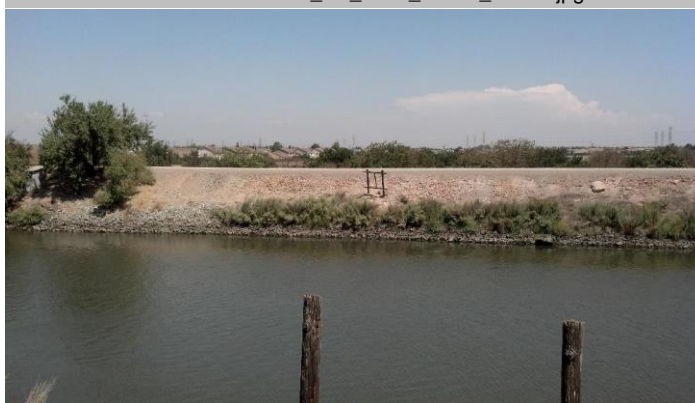
Photo 2 of 2 : UCIP\_FA\_2017\_41464\_30542.jpg

Sign posts visible on opposite river bank in same condition.

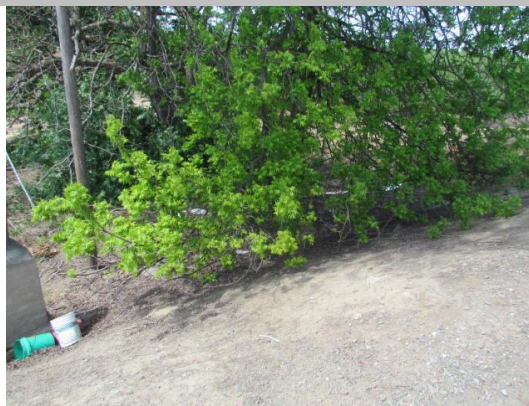
Photo 1 of 1 : FA\_2017\_RD0524\_107\_61\_20170919\_00104.jpg

Looking east at untrimmed tree at landward toe.

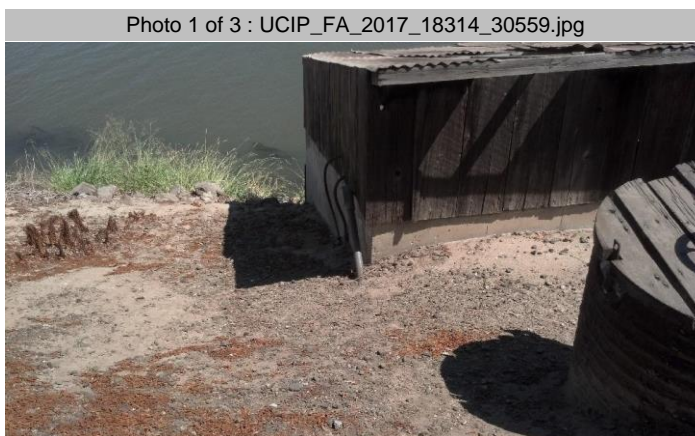
Comment Code					
Inspector Comment					
FS_ID:18314					
DS_ID:20623					
EP_NO: N/A					
Repair Type: Non-Urgent					
Crossing Status: Found					
UCIP Comments: Appears abandoned and if so should be done so properly.					
FIELD_STRUCT_DESC: 8-inch concrete encased steel irrigation pipe through the levee, 9.5 feet below the crown. Pump and gate valve in pump house on the waterside (WS) slope. Slide gate in 42-inch corrugated metal pipe riser unit on the WS slope. Brick standpipe at the toe of the landside (LS) slope. 1.5-inch galvanized iron electrical conduit through the levee, 3 feet below the crown at the same location.					
[Additional Reference(s): DWR Levee Log, 2004. USACE San Joaquin O&M Manual 7, April 1964, (HLM 4.08)].					
FS Date: 8/20/2013

Electrical conduit visible on WS slope at pumphouse.

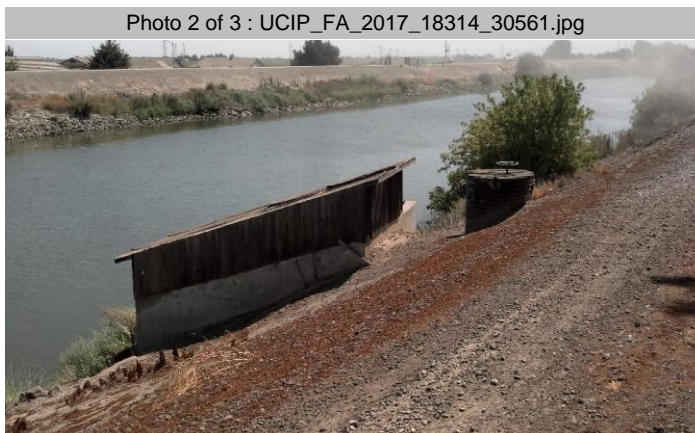
Pumphouse and gate valve in CMP riser on WS slope.

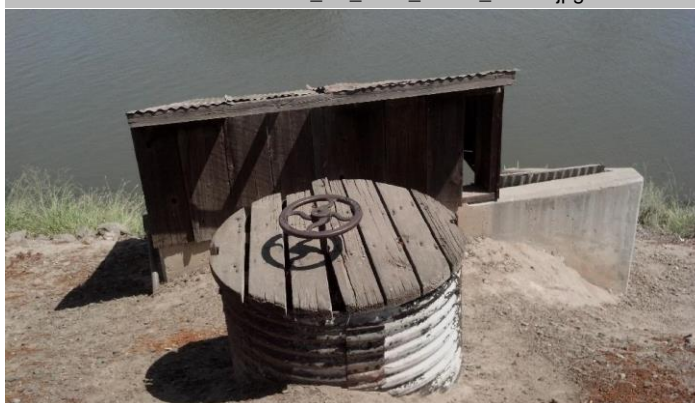
Photo 3 of 3 : UCIP\_FA\_2017\_18314\_30560.jpg

Pumphouse and gate valve in CMP riser on WS slope.

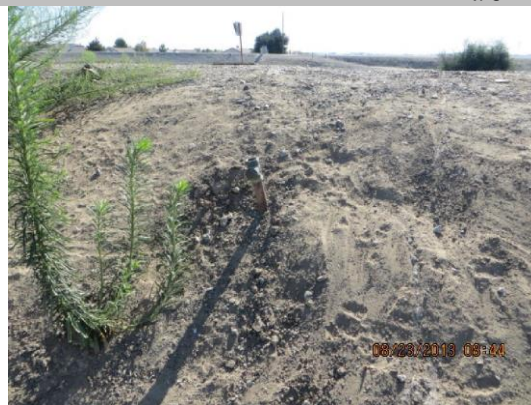
Photo 2 of 3 : UCIP\_FA\_2017\_18318\_30588.jpg

Vent or siphon breaker just off LS shoulder.

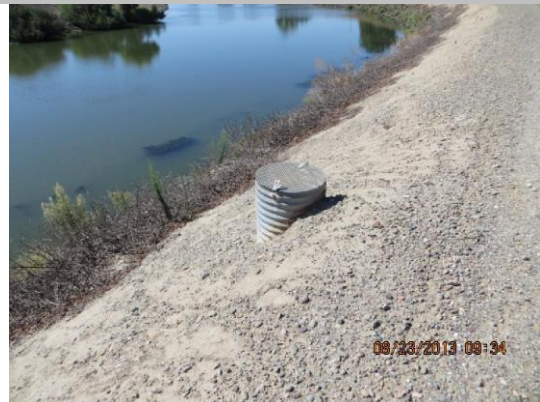
Photo 1 of 3 : UCIP\_FA\_2017\_22728\_38453.jpg

LM Start	4.89	Rating **	M	Issue No.	961
LM End	4.89	Issue Type +	En	Location *	
Category	Supplemental			GPS Latitude/Longitude	
				Start	End
Item	DWR UCIP Field Study			37.887694 °	37.887694 °
				-121.331019 °	-121.331019 °
DWR ID					
Comment Code					
Inspector Comment					
FS_ID:22728 DS_ID:20628 EP_NO: 3817 Repair Type: Non-Urgent Crossing Status: Found UCIP Comments: Appears abandoned and if so should be done so properly. FIELD_STRUCT_DESC: *ABANDONED* 6-inch steel drainage pipe through the levee, 3 feet below the crown. Pump 120 feet off the landside (LS) toe. Siphon breaker in 24-inch corrugated metal riser unit on the waterside (WS) shoulder. (Permit No. 3817, 1961 - Ohm and Saunders). [Additional Reference(s): DWR Levee Log, 2004. USACE San Joaquin O&M Manual 7, April 1964, (HLM 4.95)]. FS Date: 8/23/2013

Siphon breaker in 24-inch CMP riser on WS shoulder.

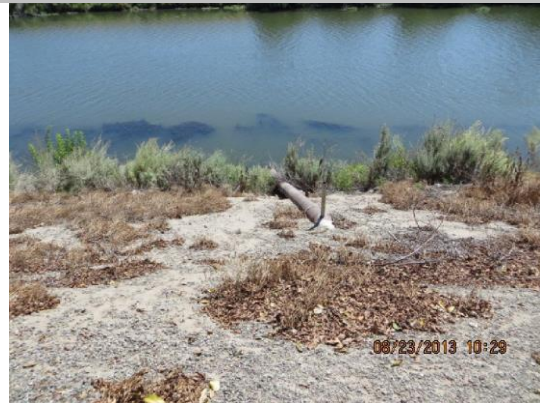
Photo 1 of 3 : UCIP\_FA\_2017\_51633\_30689.jpg

Pipe visible on WS slope.

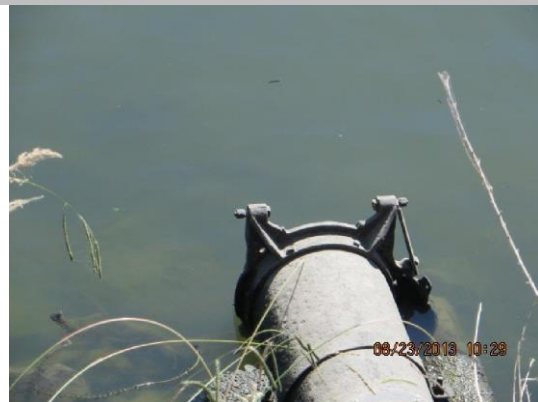
Photo 3 of 3 : UCIP\_FA\_2017\_51633\_30687.jpg

Broken flap gate at WS toe.

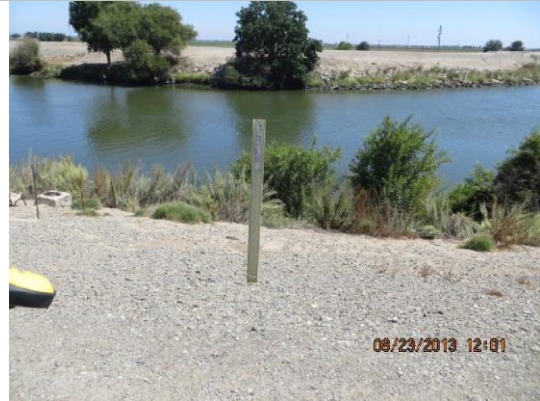
Photo 1 of 1 : UCIP\_FA\_2017\_18705\_31249.jpg

Gasline marker on WS shoulder.

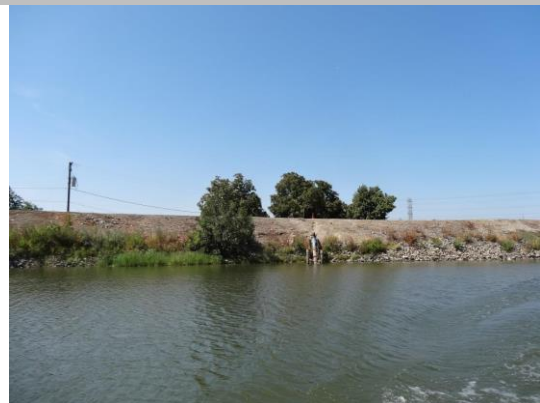
Photo 1 of 2 : SJR2017\_RD0524U01RM46.39\_1.jpg

Front view of the site.

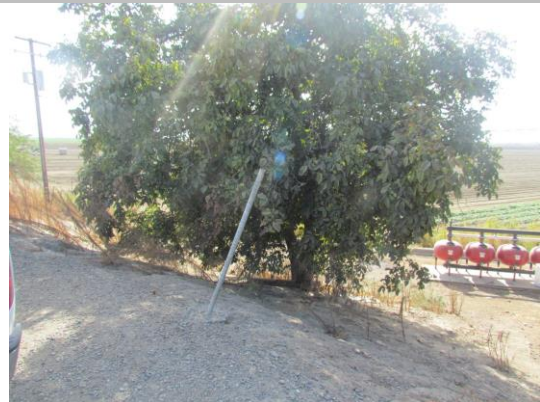
Photo 1 of 1 : FA\_2017\_RD0524\_107\_98\_20171120\_00493.jpg

Looking west at walnut tree on landward slope.
