**Flood Control Project Maintenance  
Levee Inspections**

**Fall 2019 Levee Maintenance Deficiency Summary Report**

**Flood Control Project Maintenance  
Levee Inspections****LMA District Cover Sheet****Fall 2019 Levee Inspection Results****Reclamation District No. 0524 Middle Roberts Island**

**Reclamation District No. 0524 Middle Roberts Island**

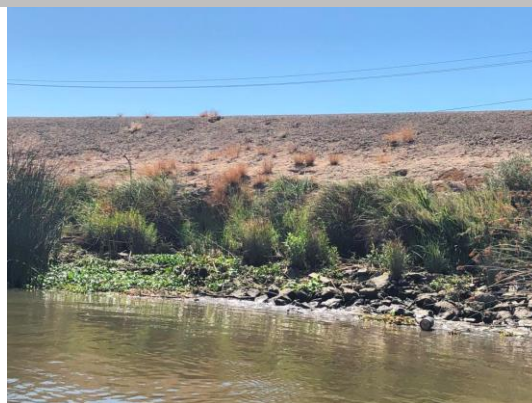
Photo 1 of 3 : SJR2019\_RD0524U01RM40.93\_2.JPG

LM Start	0.34	Rating **	M	Issue No.	2	
LM End	0.34	Issue Type +	Ma	Location *		
Category	Supplemental			GPS Latitude/Longitude		
				Start	End	
Item	DWR Erosion Survey			37.938461 °	37.938461 °	
				-121.341526 °	-121.341526 °	
DWR ID	RD0524U01RM40.93					
Comment Code						
Inspector Comment						
Site ID: RD0524U01RM40.93						
08/13/2019: No significant change observed.						
09/13/2017: There are two pocket erosions at the site; both erosions are around 10 ft long and 6 ft high.

Front view of the erosion site.

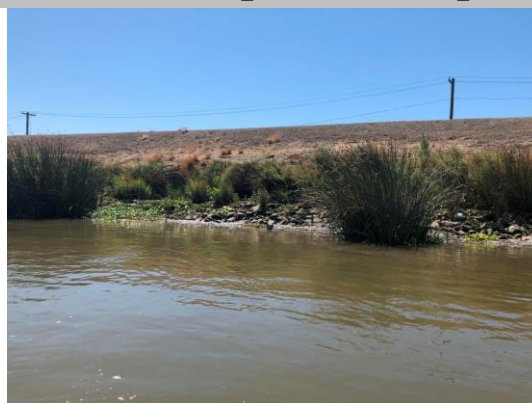
Photo 2 of 3 : SJR2019\_RD0524U01RM40.93\_1.JPG

Looking downstream of the erosion.

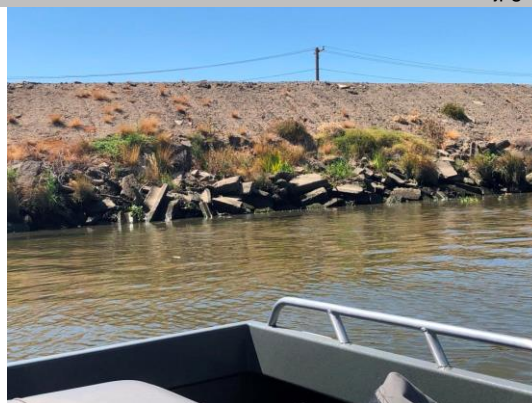
Photo 1 of 3 : SJR2019\_RD0524U01RM40.99\_1.jpg

LM Start	0.40	Rating **	U	Issue No.	5	
LM End	0.40	Issue Type +	Ma	Location *		
Category	Supplemental			GPS Latitude/Longitude		
				Start		End
Item	DWR Erosion Survey			37.938870 °		37.938870 °
				-121.340460 °		-121.340460 °
DWR ID	RD0524U01RM40.99					
Comment Code						
Inspector Comment						
Site ID: RD0524U01RM40.99						
08/13/2019: No significant change observed.						
09/13/2017: No significant change observed.						
07/25/2016: More vegetation observed at the site.						
06/24/2015: No significant change observed.						
06/19/2014: No significant change observed.						
08/13/2013: No significant change at this site.						
08/07/2012: The erosion is at the upper levee slope, and likely caused by slope slip. The lower levee slope is covered with dense vegetation.

Front view of the erosion site.

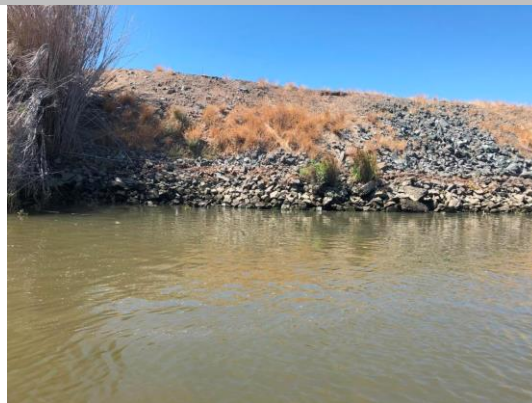
Photo 2 of 3 : SJR2019\_RD0524U01RM41.26\_2.JPG

LM Start	0.63	Rating **	U	Issue No.	15	
LM End	0.63	Issue Type +	Ma	Location *		
Category	Supplemental			GPS Latitude/Longitude		
				Start	End	
Item	DWR Erosion Survey			37.938247 °	37.938247 °	
				-121.336503 °	-121.336503 °	
DWR ID	RD0524U01RM41.26					
Comment Code						
Inspector Comment						
Site ID: RD0524U01RM41.26						
08/13/2019: No significant change observed.						
09/13/2017: The erosion was discovered by levee inspection. The erosion site is immediately downstream of tall vegetation.

Front view of the erosion.

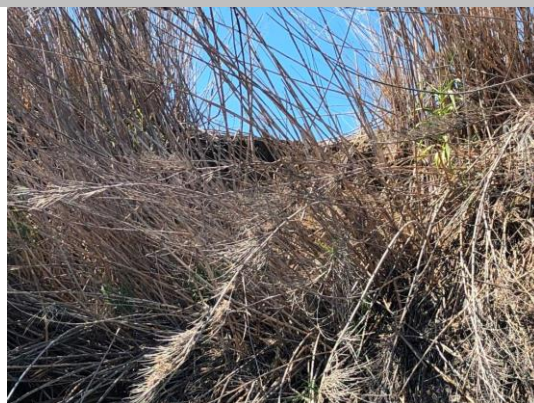
Photo 3 of 3 : SJR2019\_RD0524U01RM41.26\_5.JPG

LM Start	0.63	Rating **	U	Issue No.	15 (cont)	
LM End	0.63	Issue Type +	Ma	Location *		
Category	Supplemental			GPS Latitude/Longitude		
				Start	End	
Item	DWR Erosion Survey			37.938247 °	37.938247 °	
				-121.336503 °	-121.336503 °	
DWR ID	RD0524U01RM41.26					
Comment Code						
Inspector Comment						
Site ID: RD0524U01RM41.26						
08/13/2019: No significant change observed.						
09/13/2017: The erosion was discovered by levee inspection. The erosion site is immediately downstream of tall vegetation.

Close-up view of the erosion between the high bushes.

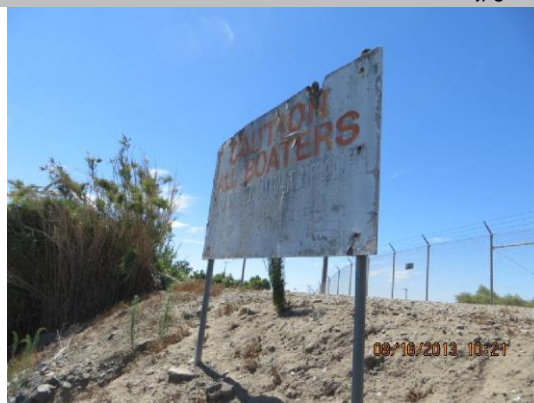
Photo 1 of 3 : UCIP\_FA\_2019\_17563\_29702.jpg

LM Start	0.67	Rating **	M	Issue No.	933
LM End	0.67	Issue Type +	En	Location *	
Category	Supplemental			GPS Latitude/Longitude	
				Start	End
Item	DRAFT DWR UCIP Field Study			37.937891°	37.937891°
				-121.335939°	-121.335939°
DWR ID	20592				
Comment Code					
Inspector Comment					
DS_ID:20592					
FS_ID:17563					
EP_NO: 6035					
Repair Type: Non-Urgent					
Crossing Status: Found					
UCIP Comments: Flows from primer tank causing erosion on LS slope.					
FIELD_STRUCT_DESC: 48-inch coated steel sewer pipe through the					
levee, 7.3 feet below the crown. Siphon pumps and primer tank					
enclosed by cyclone fence on the landside (LS) shoulder. Gate valve at					
inlet sump 100 feet off the LS toe. One concrete cutoff wall. (Permit No.					
6035, 1968 - City of Stockton). [Additional Reference(s): DWR Levee					
Log, 2004].					
FS Date: 8/16/2013

Signage for effluent pipe on WS shoulder.

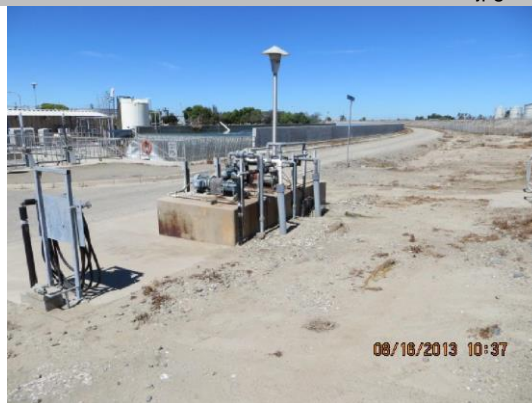
Photo 3 of 3 : UCIP\_FA\_2019\_17563\_29700.jpg

LM Start	0.67	Rating **	M	Issue No.	933 (cont)	
LM End	0.67	Issue Type +	En	Location *		
Category	Supplemental			GPS Latitude/Longitude		
				Start		End
Item	DRAFT DWR UCIP Field Study			37.937891 °		37.937891 °
				-121.335939 °		-121.335939 °
DWR ID	20592					
Comment Code						
Inspector Comment						
DS_ID:20592 FS_ID:17563 EP_NO: 6035 Repair Type: Non-Urgent Crossing Status: Found UCIP Comments: Flows from primer tank causing erosion on LS slope. FIELD_STRUCT_DESC: 48-inch coated steel sewer pipe through the levee, 7.3 feet below the crown. Siphon pumps and primer tank enclosed by cyclone fence on the landside (LS) shoulder. Gate valve at inlet sump 100 feet off the LS toe. One concrete cutoff wall. (Permit No. 6035, 1968 - City of Stockton). [Additional Reference(s): DWR Levee Log, 2004]. FS Date: 8/16/2013

Vacuum pumps off LS toe.

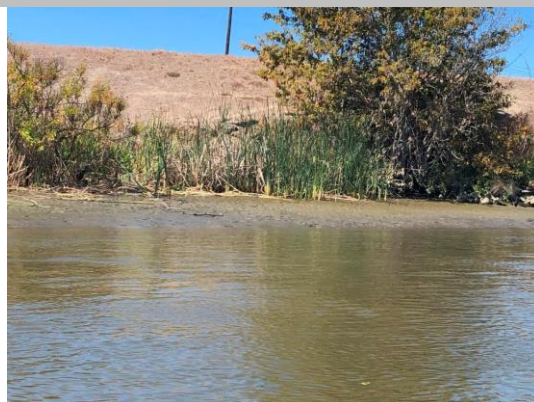
Photo 2 of 3 : SJR2019\_RD0524U01RM41.44\_2.JPG

Close-up view of the erosion site.

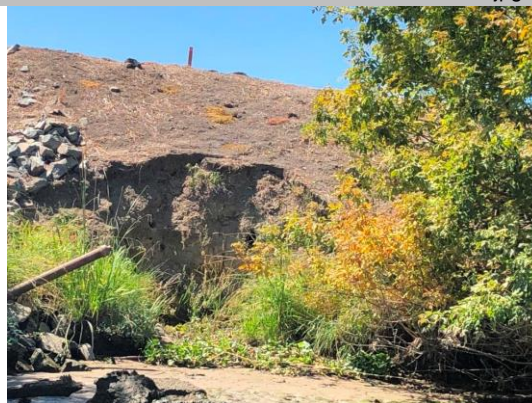
Photo 2 of 3 : SJR2019\_RD0524U01RM41.50\_1.jpg

Close-up view of the erosion.

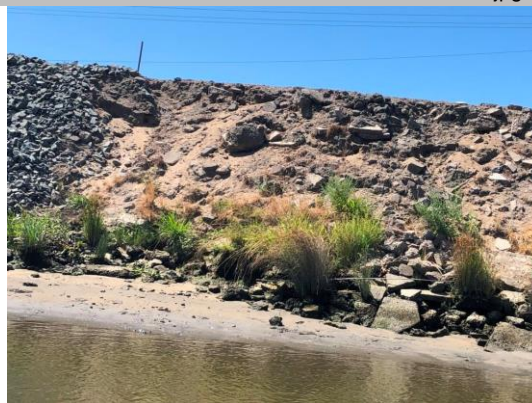
Photo 2 of 3 : SJR2019\_RD0524U01RM41.59\_3.jpg

Close-up view of the erosion.

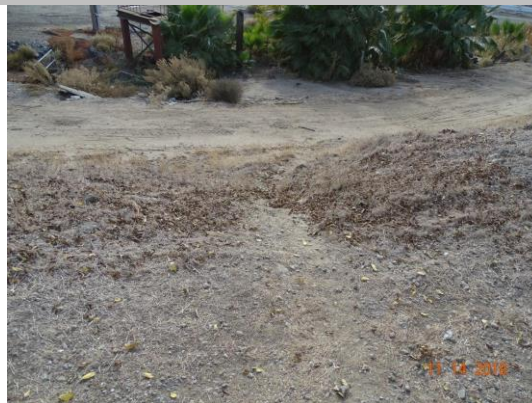
Photo 1 of 1 : FA\_2019\_RD0524\_107\_143\_20191117\_00365.jpg

View of landside ramp caused by foot traffic. Fall 2019

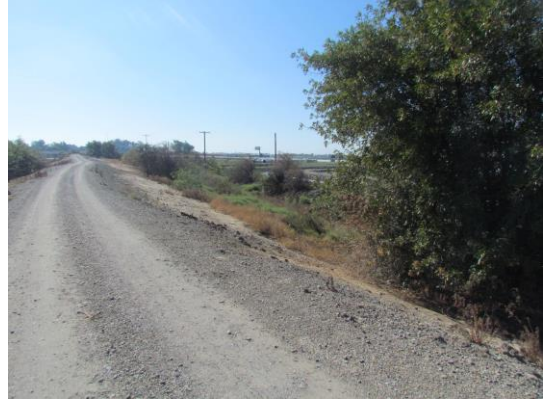
Photo 1 of 1 : FA\_2019\_RD0524\_107\_915\_20190830\_00254.jpg

Looking southwest at dense veg at landward toe and berm. (Fall 2016)

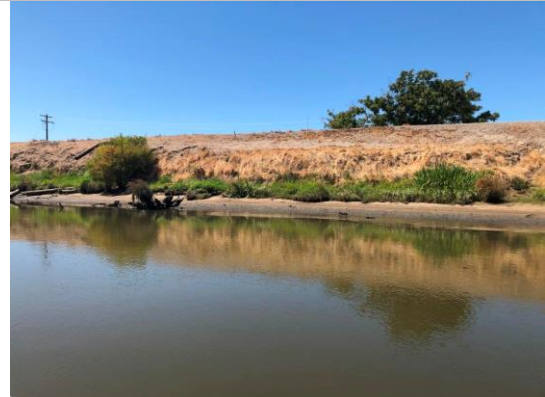
Photo 2 of 3 : SJR2019\_RD0524U01RM41.92\_1.jpg

Front view of the erosion.

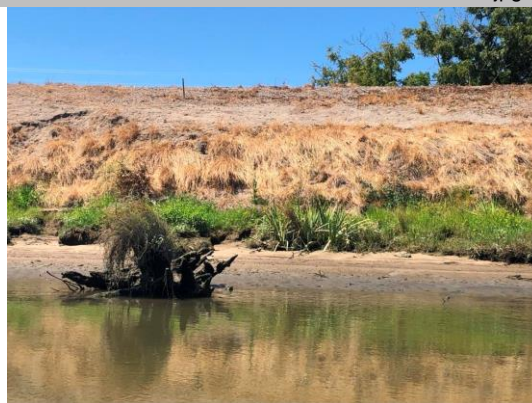
Photo 3 of 3 : SJR2019\_RD0524U01RM41.92\_5.jpg

Close-up view of the erosion.

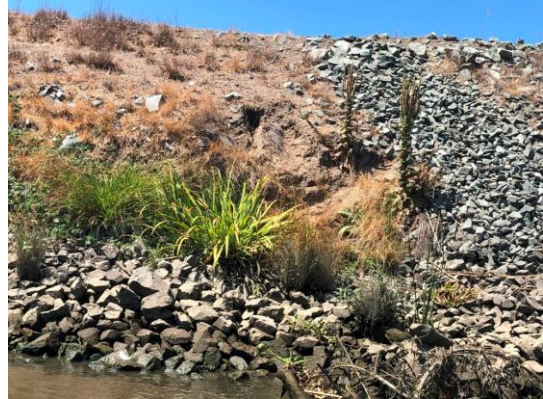
Photo 2 of 2 : SJR2019\_RD0524U01RM41.95\_5.JPG

Close-up view of the erosion.

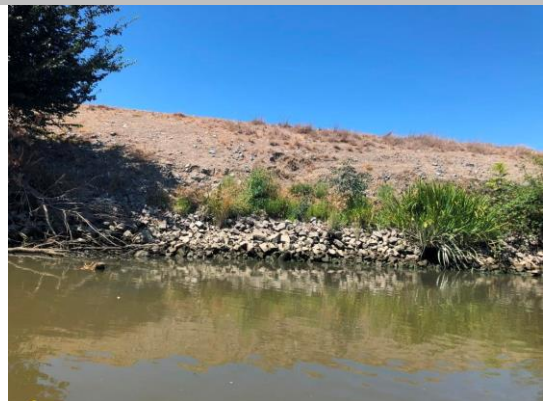
Photo 1 of 3 : SJR2019\_RD0524U01RM42.03\_1.jpg

Front view of the erosion.

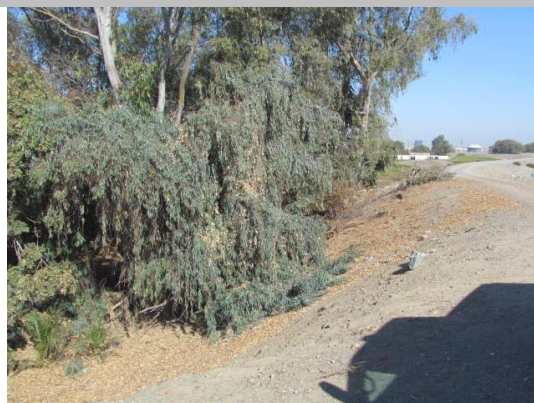
Photo 1 of 1 : FA\_2019\_RD0524\_107\_916\_20190830\_00255.jpg

Looking at dense trees on landward slope and toe fall 2015

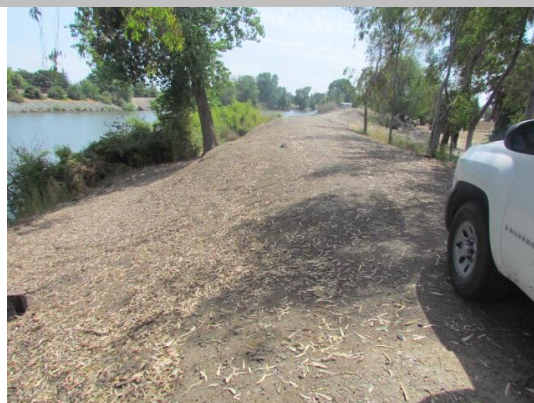
Photo 1 of 1 : FA\_2019\_RD0524\_107\_27\_20190830\_00038.jpg

Looking south at landward slope depression.

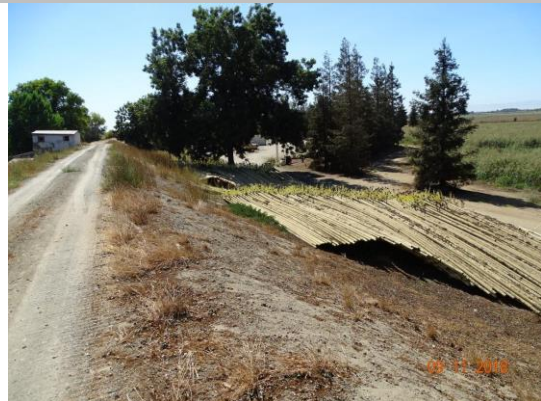
Photo 2 of 2 : FA\_2019\_RD0524\_107\_46\_20190830\_00061.jpg

Looking southwest at irrigation pipes stored at landward slope and toe.  
(Fall 2018)

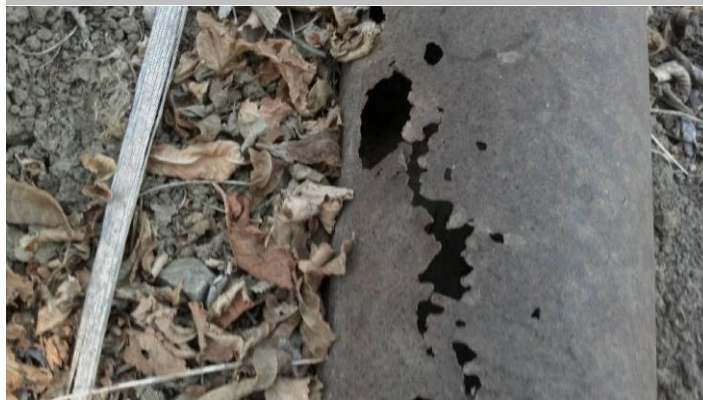
Photo 2 of 2 : UCIP\_FA\_2019\_21883\_37133.jpg

Holes in pipe along exposed side of pipe at WS slope.

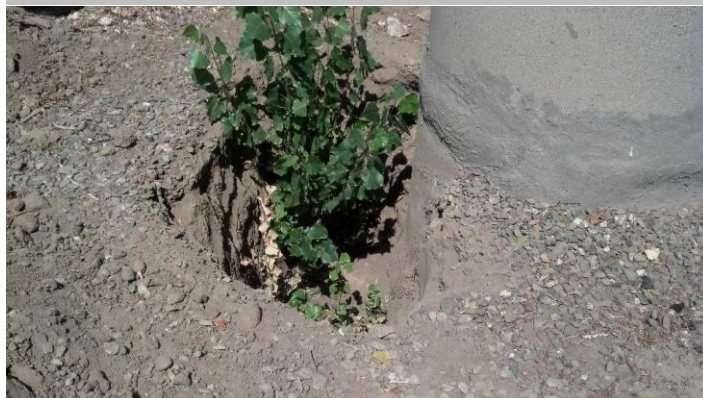
Photo 3 of 3 : UCIP\_FA\_2019\_17944\_30043.jpg

Hole over pipe next to 4-foot diameter concrete standpipe on WS slope.

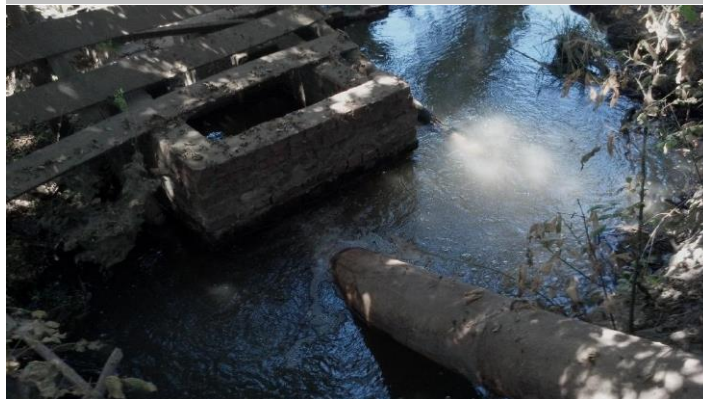
Photo 3 of 3 : UCIP\_FA\_2019\_53357\_30204.jpg

Extensive erosion around distribution box at LS toe.

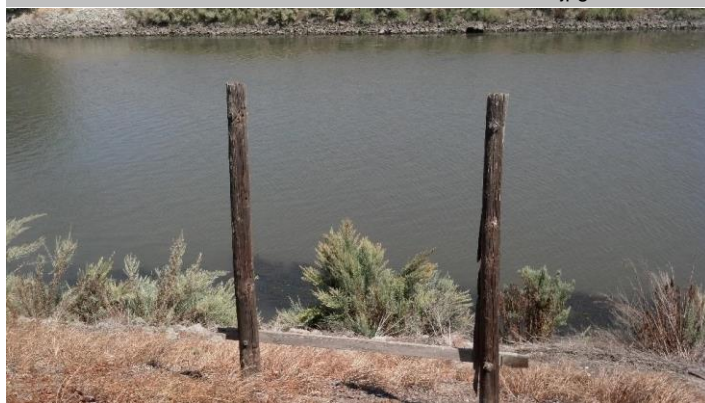
Photo 1 of 2 : UCIP\_FA\_2019\_41464\_30543.jpg

Sign posts with sign removed on WS slope.

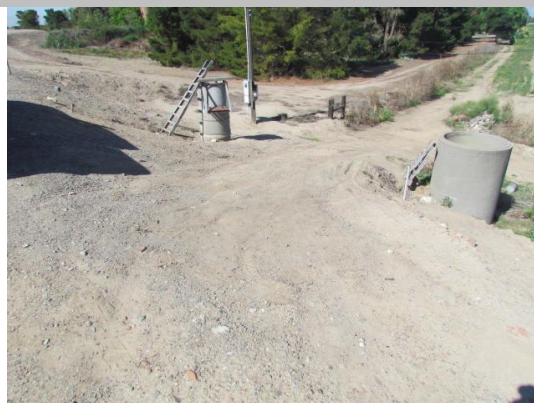
Photo 1 of 1 : FA\_2019\_RD0524\_107\_110\_20190830\_00127.jpg

Looking southwest at an unauthorized ramp on landside slope.

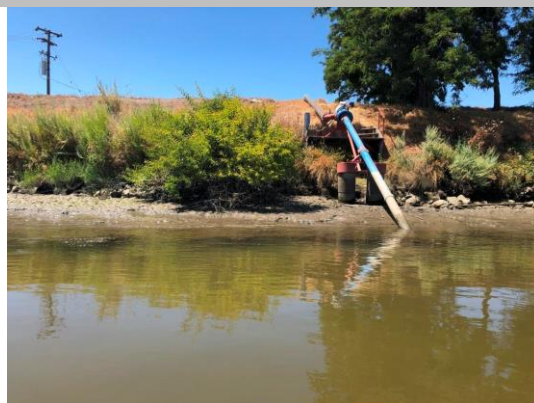
Photo 1 of 2 : SJR2019\_RD0524U01RM46.06\_1.JPG

Front view of the erosion.

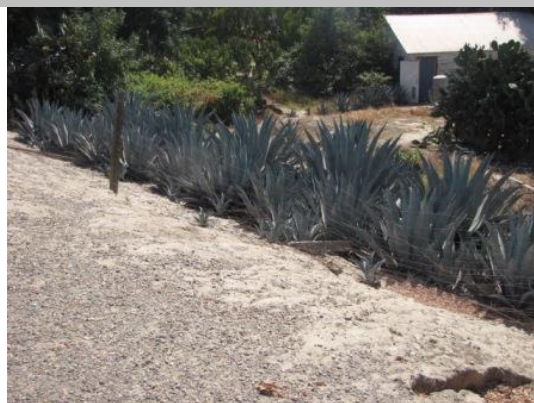
Photo 1 of 1 : FA\_2019\_RD0524\_107\_88\_20190830\_00109.jpg

Looking southeast at fence and cactus on landside slope and toe.
