## Flood Control Project Maintenance Levee Inspections

### Fall 2020 Levee Maintenance Deficiency Summary Report

#### San Joaquin River Basin

**Reclamation District No. 0524 Middle Roberts Island**

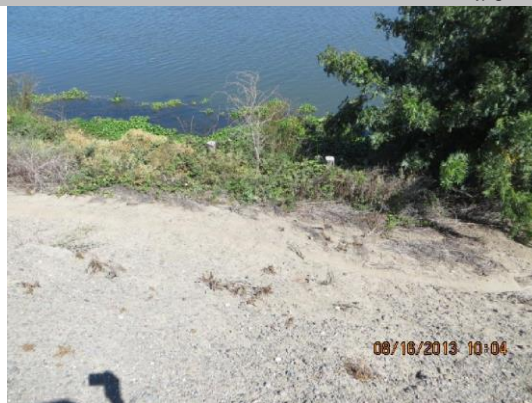
Photo 1 of 3 : UCIP\_FA\_2020\_61803\_29694.jpg

Comment Code						
Inspector Comment						
DS_ID:20591 FS_ID:61803 EP_NO: N/A Repair Type: Non-Urgent EVAL Issue: Pipe Not Found Crossing Status: Indicator Found UCIP Comments: 06/23/2020 Record updated from No Action Needed to Non-Urgent. Crossing not found. Crossing appears abandoned. (D.Sanoski - DWR UCIP)						
FIELD_STRUCT_DESC: *ABANDONED* 8-inch irrigation pipe of an unknown material through the levee, 5 feet below the crown. Plugged with concrete. Abandoned pump house and pump on the waterside (WS) slope. (Abandoned under Permit No. 6035, 1968 - City of Stockton). [Additional Reference(s): DWR Levee Log, 2004. USACE San Joaquin O&M Manual 7, April 1964, (HLM 0.33)]. FS Date: 6/23/2020 2:30:00 PM

Pilons filled with concrete on WS slope at possible location of crossing.

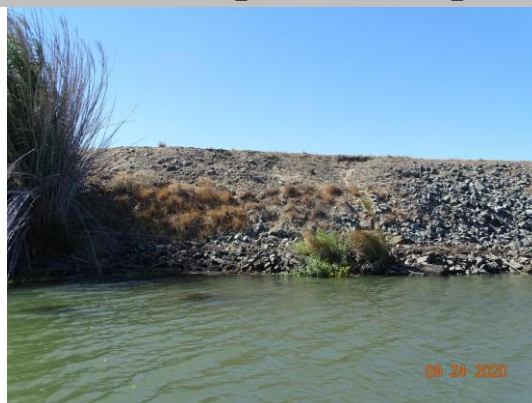
Photo 1 of 2 : SJR2019\_RD0524U01RM41.26\_01.JPG

LM Start	0.63	Rating **	M	Issue No.	25
LM End	0.63	Issue Type +	Ma	Location *	WS
Category	Supplemental			GPS Latitude/Longitude	
				Start	End
Item	DWR Erosion Survey			37.938247 °	37.938247 °
				-121.336503 °	-121.336503 °
DWR ID	RD0524U01RM41.26				
Comment Code					
Inspector Comment					
Site ID: RD0524U01RM41.26					
09/24/2020: From 2018 to present, no significant changes were observed during the annual survey.					
09/13/2017: The erosion was discovered by levee inspection. The erosion site is immediately downstream of tall vegetation.

9/24/2020: Front view of the erosion.

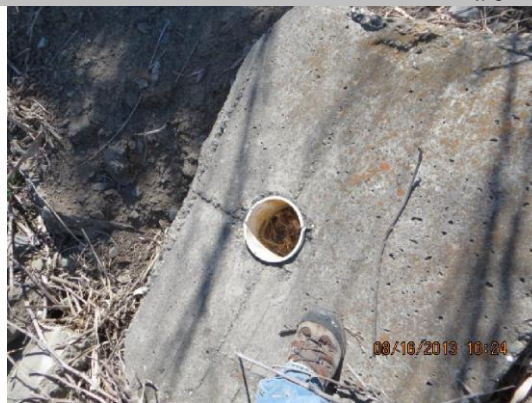
Photo 1 of 3 : UCIP\_FA\_2020\_61809\_29710.jpg

LM Start	0.67	Rating **	M	Issue No.	935	
LM End	0.67	Issue Type +	En	Location *		
Category	Supplemental			GPS Latitude/Longitude		
				Start		End
Item	DWR UCIP Field Study			37.937813 °		37.937813 °
				-121.335817 °		-121.335817 °
DWR ID	20653					
Comment Code						
Inspector Comment						
DS_ID:20653 FS_ID:61809 EP_NO: 9127A Repair Type: Non-Urgent EVAL Issue: Abandoned encroachment Crossing Status: Indicator Found UCIP Comments: 06/23/2020 Record updated from No Action Needed to Non-Urgent. Crossing appears abandoned. (D.Sanoski - DWR UCIP)						
FIELD_STRUCT_DESC: *REMOVED* 3 of 4: 6-inch polyvinyl chloride sewer pipe through the levee, 1 foot below the crown. Evidence of crossing remains in concrete debris on the waterside (WS) slope. (Permit No. 9127-A, 1975 - City of Stockton). FS Date: 6/23/2020 2:31:00 PM

6-inch PVC pipe visible in concrete debris on WS slope.

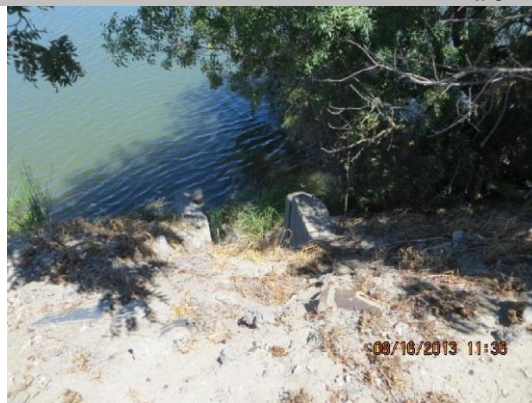
Photo 1 of 3 : UCIP\_FA\_2020\_61920\_29736.jpg

Concrete headwall visible on WS slope.

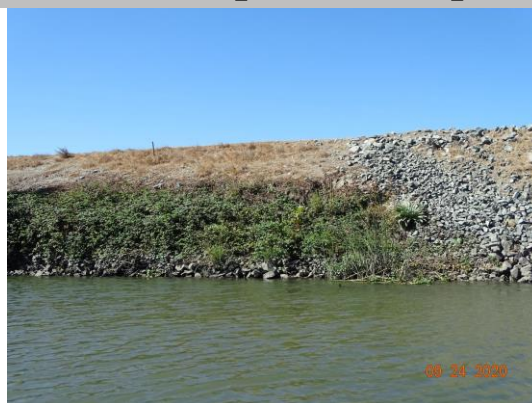
Photo 1 of 2 : SJR2019\_RD0524U01RM41.95\_01.JPG

9/24/2020: Front view of the erosion.

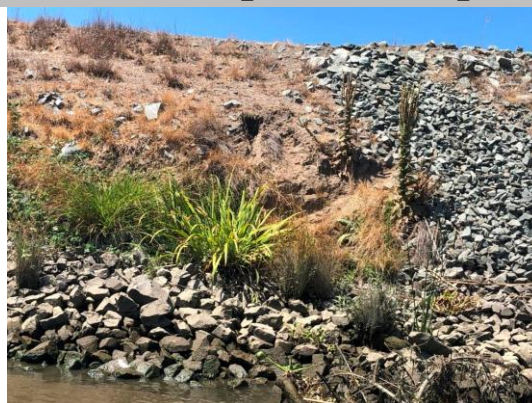
Photo 2 of 2 : SJR2019\_RD0524U01RM41.95\_5.JPG

8/13/2019: Close-up view of the erosion.

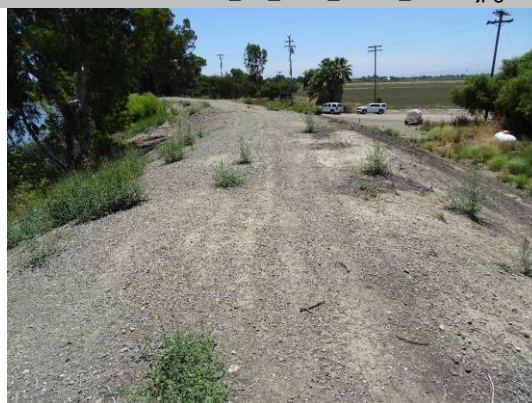
Photo 1 of 3 : UCIP\_FA\_2020\_61935\_89335.jpg

Top of Levee: view of crown and pvc pipe cap exposed.

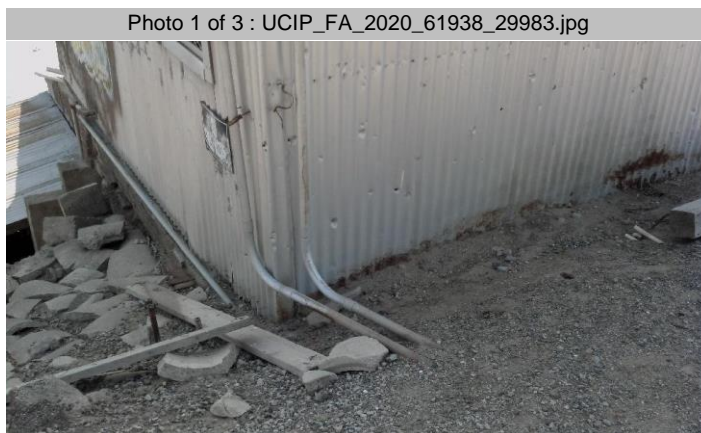
Comment Code						
Inspector Comment						
DS_ID:20662 FS_ID:61938 EP_NO: N/A Repair Type: Non-Urgent EVAL Issue: Unauthorized Encroachment, installed decades prior Crossing Status: Found UCIP Comments: 06/23/2020 Record updated from No Action Needed to Non-Urgent. Unauthorized encroachment recorded in Levee Log prior to 2011. No permit has been identified authorizing pipe. (D.Sanoski - DWR UCIP)  FIELD_STRUCT_DESC: 1.25-inch electrical conduit of an unknown material through the levee, 6 inches below the crown. Conduit visible at power pole on the landside (LS) toe and at corner of pump house on the waterside (WS) shoulder. [Additional Reference(s): DWR Levee Log, 2004. USACE San Joaquin O&M Manual 7, April 1964, (HLM 1.83), listed as a 14-inch pipe, 20 feet below the crown]. FS Date: 6/23/2020 2:39:00 PM

Conduit visible at corner of pumphouse on WS shoulder.

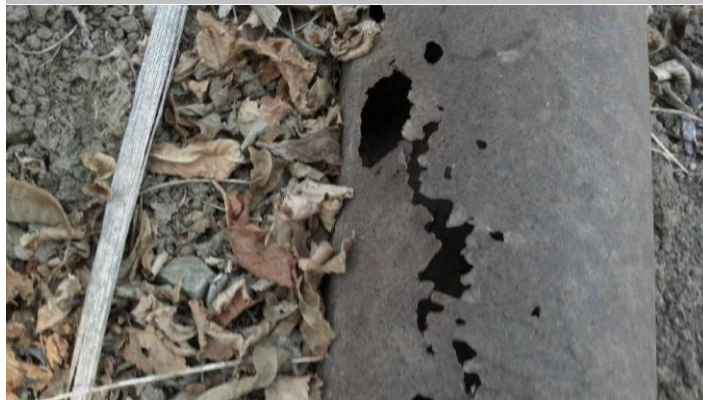
Photo 2 of 3 : UCIP\_FA\_2020\_61945\_37133.jpg

Holes in pipe along exposed side of pipe at WS slope.

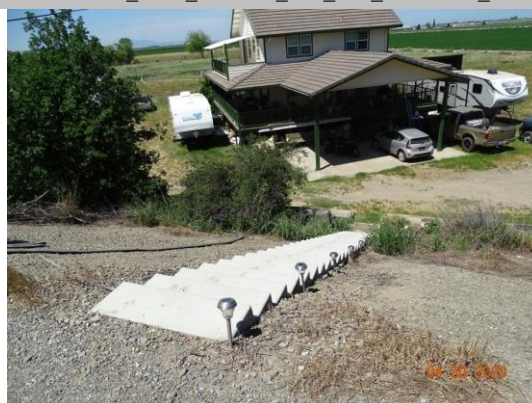
Photo 1 of 1 : FA\_2020\_RD0524\_107\_135\_20200901\_00057.jpg

View of stirrings made of concrete on landside slope. Spring 2020

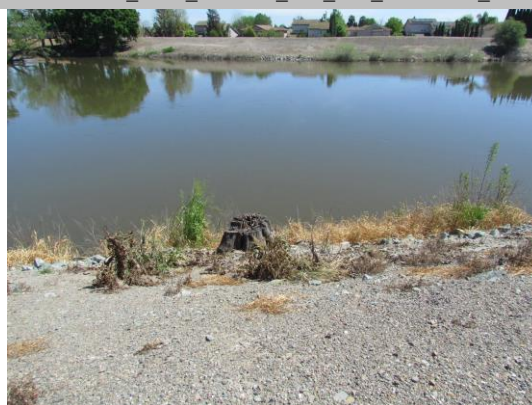
Photo 1 of 1 : FA\_2020\_RD0524\_107\_161\_20200901\_00065.jpg

Looking east at large tree stump on waterward shoulder.

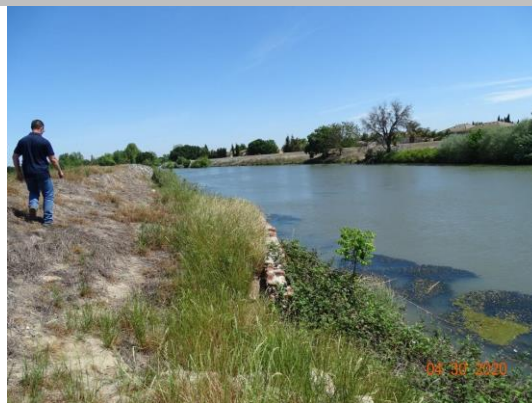
Photo 1 of 1 : FA\_2020\_RD0524\_107\_220\_20200901\_00092.jpg

View of damaged retaining wall on waterside slope. Approximately 30 ft. long, 8 ft. high and 20 ft. from waterside hinge. Spring 2020

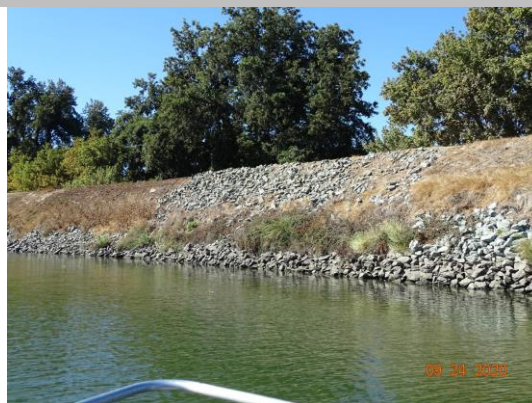
Photo 1 of 2 : SJR2019\_RD0524U01RM43.86\_01.JPG

9/24/2020: View of the erosion with repaired section.

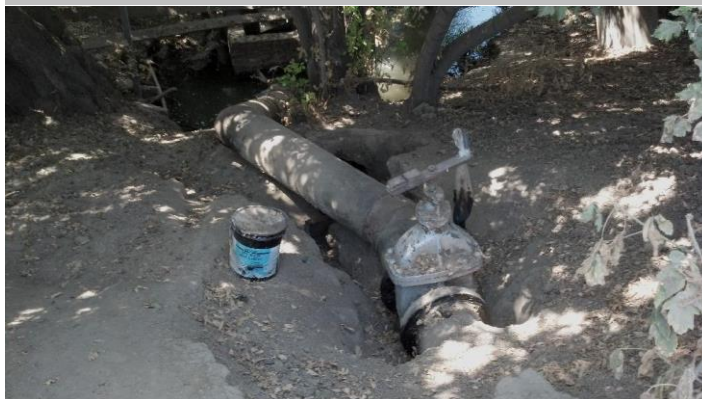
Photo 2 of 3 : UCIP\_FA\_2020\_61960\_30205.jpg

Pipe, gatevalve, and erosion on LS slope.

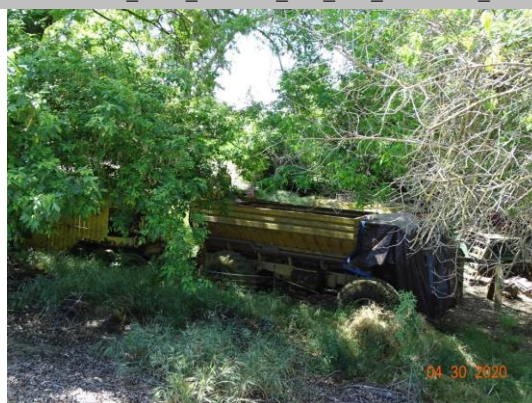
Photo 1 of 1 : FA\_2020\_RD0524\_107\_213\_20200901\_00089.jpg

View of stored farming equipment within the landside easement. Spring 2020

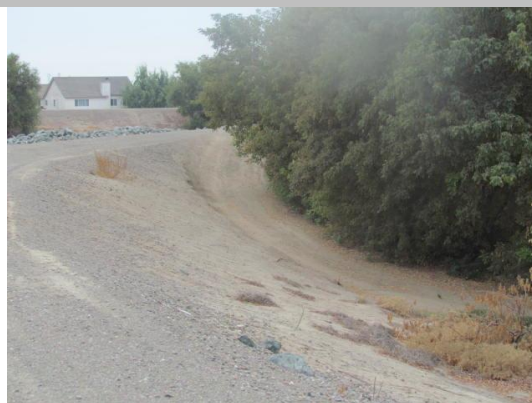
Photo 1 of 1 : FA\_2020\_RD0524\_107\_265\_20200901\_00114.jpg

Looking southeast at unauthorized ramp on landside slope and toe.

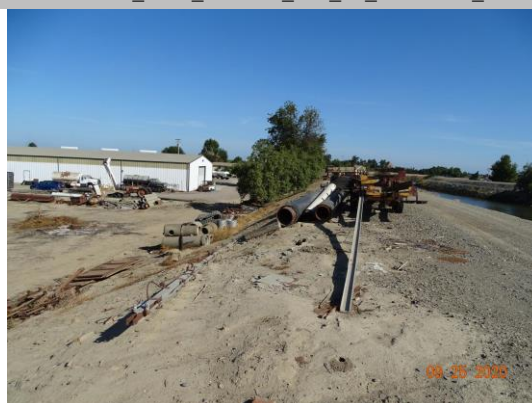
Photo 1 of 1 : FA\_2020\_RD0524\_107\_95\_20201005\_00223.jpg

View of farm equipment stored on landside shoulder. Fall 2020

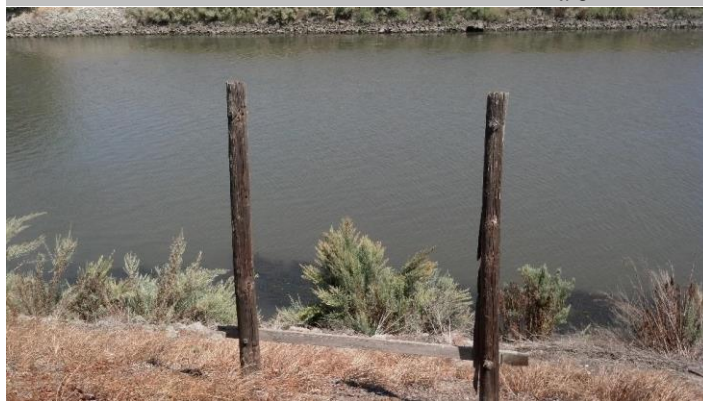
Photo 1 of 3 : UCIP\_FA\_2020\_61968\_30543.jpg

Sign posts with sign removed on WS slope.

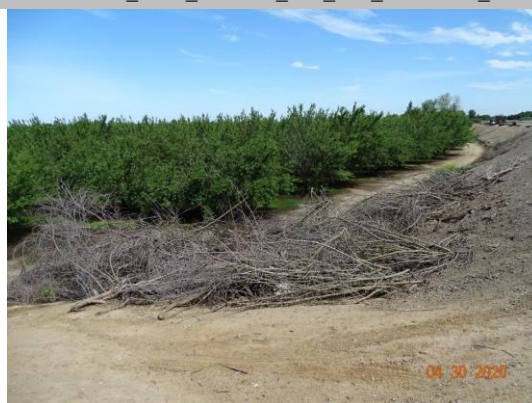
Photo 1 of 1 : FA\_2020\_RD0524\_107\_195\_20200901\_00078.jpg

View of a large pruning pile on landside slope. Spring 2020

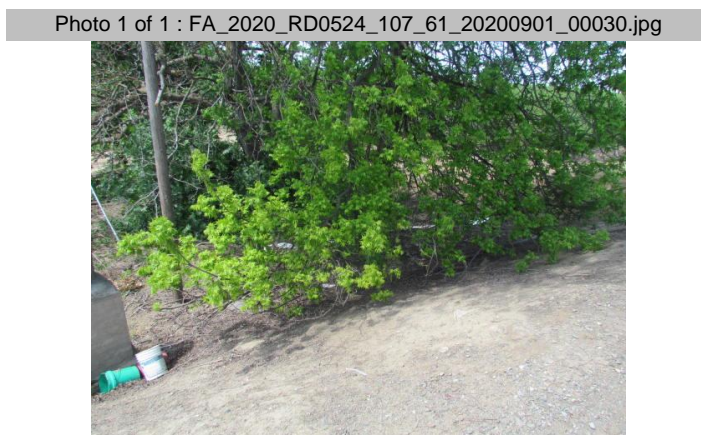
LM Start	4.04	Rating **	M	Issue No.	61
LM End	4.04	Issue Type +	Ma	Location *	LS
Category	Earthen Levee			GPS Latitude/Longitude	
				Start	End
Item	Trim / Thin Trees			37.898861 °	37.898861 °
				-121.327071 °	-121.327071 °
DWR ID	DWR_RD0524_01_s_2012_61				
Comment Code					
T1 : Trim trees to at least five feet above ground level.					
Inspector Comment

Looking east at untrimmed tree at landward toe.

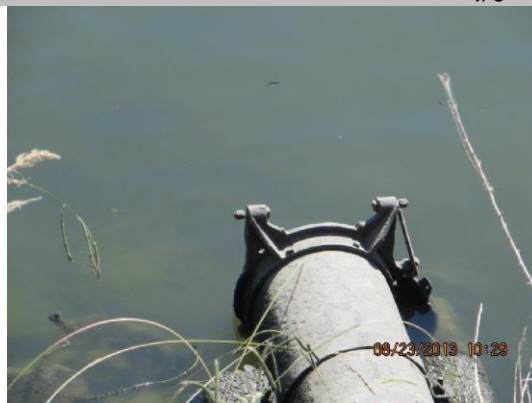
Photo 3 of 3 : UCIP\_FA\_2020\_62007\_30687.jpg

Broken flap gate at WS toe.

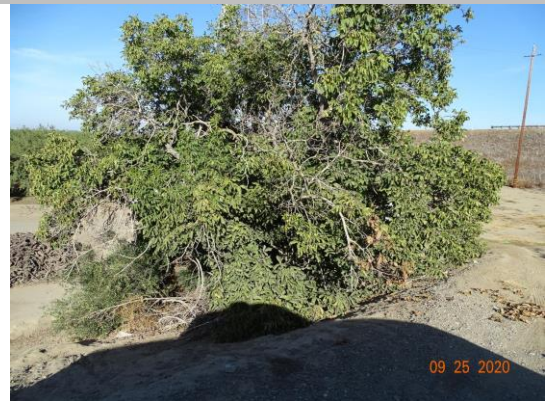
Photo 1 of 1 : FA\_2020\_RD0524\_107\_117\_20201005\_00218.jpg

View of large untrimmed walnut tree on landside slope. Fall 2020
