Flood Control Project Maintenance Levee Inspections

Fall 2021 Levee Maintenance Deficiency Summary Report

San Joaquin River Basin

Reclamation District No. 0524 Middle Roberts Island

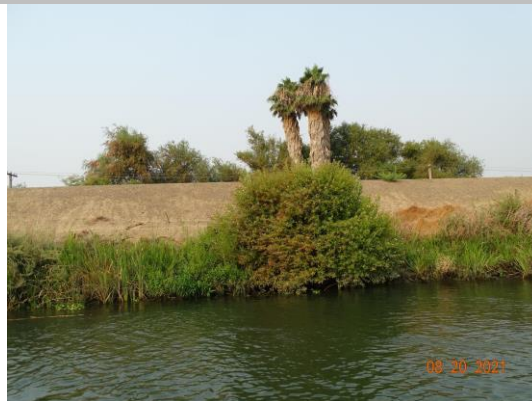
Photo 1 of 2 : SJR2021_RD0524U01RM40.85_2.JPG

LM Start	0.18	Rating **	U	Issue No.	9	
LM End	0.19	Issue Type +	Ma	Location *		
Category	Supplemental			GPS Latitude/Longitude		
				Start		End
Item	DWR Erosion Survey			37.939085 °	37.939085 °	
				-121.343917 °	-121.343917 °	
DWR ID	RD0524U01RM40.85					
Comment Code						
Inspector Comment						
Site ID: RD0524U01RM40.85						
08/20/2021: From 2014 to present, no significant changes were observed during the annual survey.						
08/13/2013: The erosion was discovered during 2013 spring levee inspection. Inspector comment: Erosion is located along the lower level of water-ward slope.

8/20/2021: Front view of the erosion.

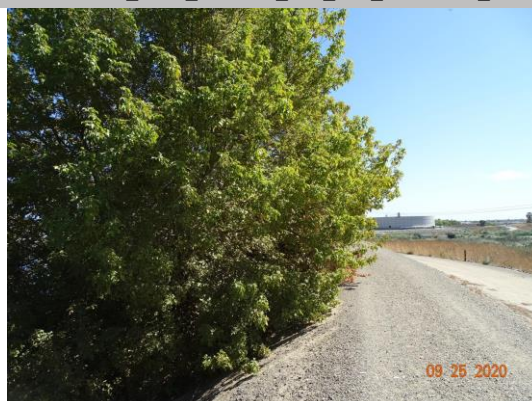
Photo 1 of 1 : FA_2021_RD0524_107_179_20210913_00069.jpg

View of large untrimmed walnut tree on landside slope. Fall 2020

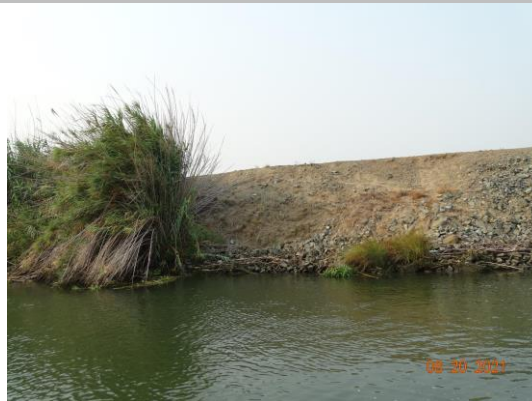
Photo 1 of 2 : SJR2021_RD0524U01RM41.26_01.JPG

LM Start	0.63	Rating **	M	Issue No.	2	
LM End	0.64	Issue Type +	Ma	Location *		
Category	Supplemental			GPS Latitude/Longitude		
				Start		End
Item	DWR Erosion Survey			37.938247 °		37.938247 °
				-121.336503 °		-121.336503 °
DWR ID	RD0524U01RM41.26					
Comment Code						
Inspector Comment						
Site ID: RD0524U01RM41.26						
08/20/2021: From 2018 to present, no significant changes were observed during the annual survey.						
09/13/2017: The erosion was discovered by levee inspection. The erosion site is immediately downstream of tall vegetation.

08/20/2021: Front view of the erosion.

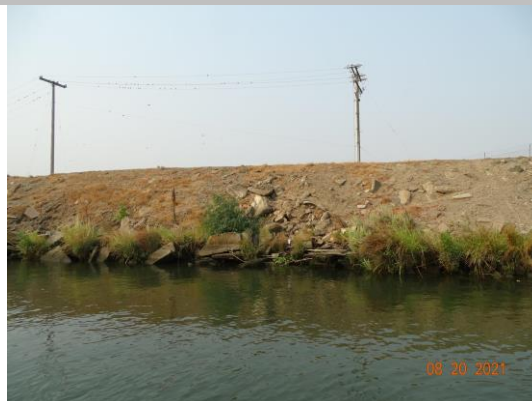
Photo 2 of 2 : SJR2021_RD0524U01RM41.34_02.JPG

LM Start	0.70	Rating **	M	Issue No.	3	
LM End	0.71	Issue Type +	Ma	Location *		
Category	Supplemental			GPS Latitude/Longitude		
				Start	End	
Item	DWR Erosion Survey			37.937577 °	37.937577 °	
				-121.335491 °	-121.335491 °	
DWR ID	RD0524U01RM41.34					
Comment Code						
Inspector Comment						
Site ID: RD0524U01RM41.34						
08/20/2021: During the annual erosion survey the erosion length was extended by 35 feet to 50 feet.						
09/24/2020: From 2018 to present, no significant changes were observed during the annual survey.						
09/13/2017: Pocket erosion above the protected levee toe.

8/20/2021: Close-up view of the erosion.

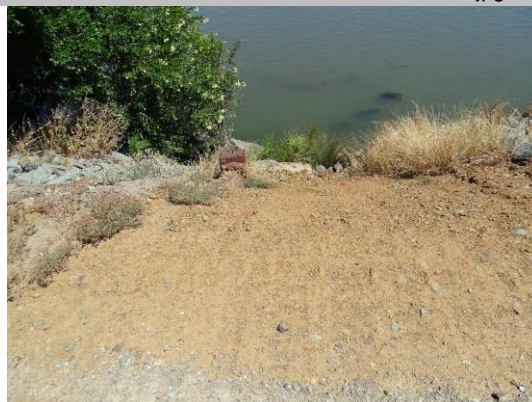
Photo 2 of 3 : UCIP_FA_2021_70214_89285.jpg

DS_ID:20597
FS_ID:70214
EP_NO: N/A
Repair Type: Non-Urgent
EVAL Issue: Unauthorized Encroachment, installed decades prior
Crossing Status: Found
UCIP Comments: 06/23/2020 Record remains Non-Urgent. No permit has been identified authorizing pipe. Crossing appears abandoned. Location updated to be at LM 0.92. (D.Sanoski - DWR UCIP)
11/16/2016 - Location may be at LM 0.92 (37.935267, -121.332985) rather than LM 0.974. Need to field verify (DWR UCIP - thatch)
8/16/2013 - Pipe abandoned and should be done so properly. (DWR UCIP -wwylie)
FIELD_STRUCT_DESC: *ABANDONED* 14-inch irrigation pipe of an unknown material through the levee, 6 feet below the crown. Concrete pad for pump on the waterside (WS) shoulder. No pump or other appurtenances remain. [Additional Reference(s): DWR Levee Log, 2004 (HLM 0.93). USACE San Joaquin O&M Manual, Unit 7, April 1964, Revised 29 December 2016, (0.93), listed as 14-inch pipe].

Water-Side: view of repaired WS slope with no concrete pads.

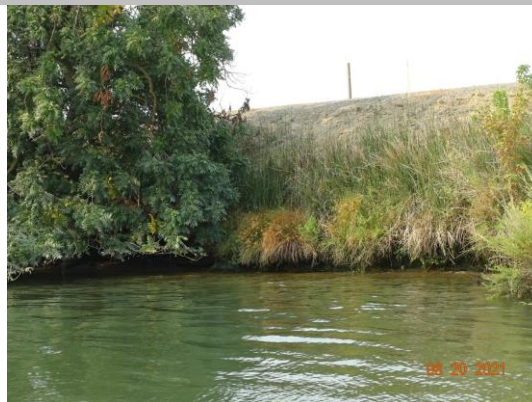
Photo 2 of 2 : SJR2021_RD0524U01RM41.79_02.JPG

8/20/2021: Front view of the erosion with riprap on the levee slope.

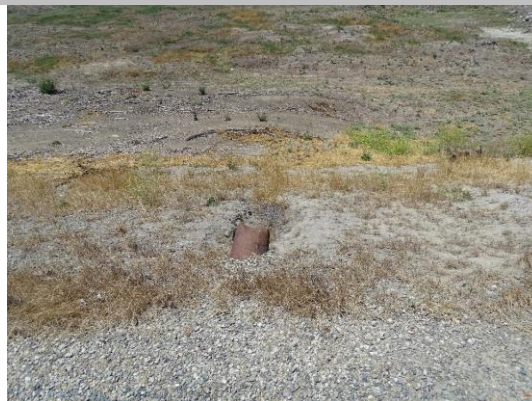
Photo 3 of 3 : UCIP_FA_2021_70217_89311.jpg

Land-Side: view of LS slope and abandoned pipe.

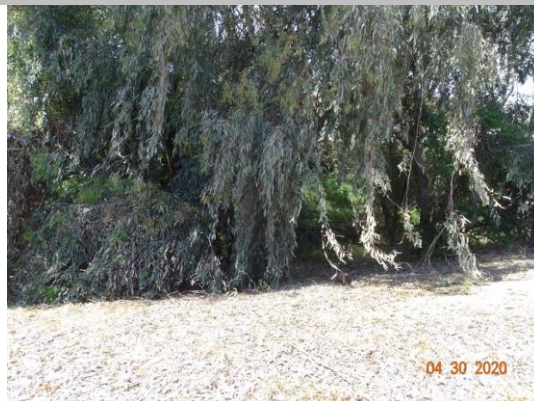
Photo 1 of 1 : FA_2021_RD0524_107_916_20210913_00107.jpg

View of tree that need to be trimmed and thinned on landside slope.
Spring 2020

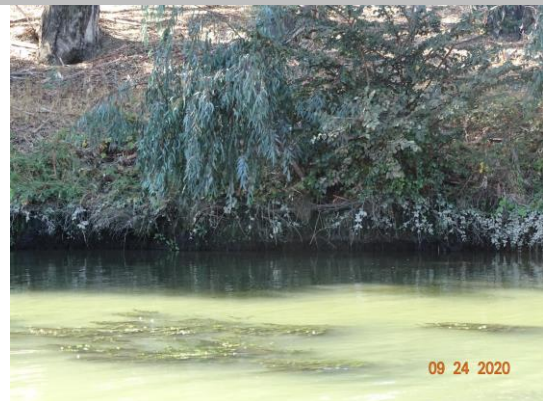
Photo 3 of 3 : SJR2021_RD0524U01RM42.2_06.JPG

9/24/2020: Close-up view of the erosion.

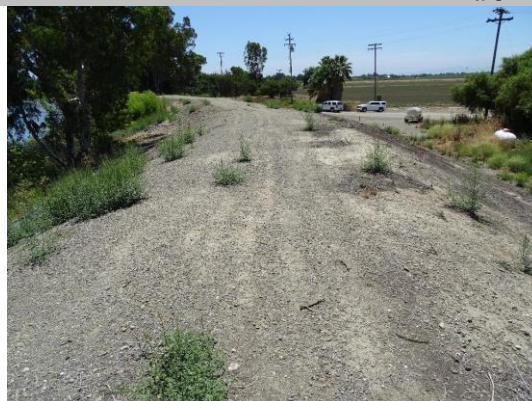
Photo 1 of 3 : UCIP_FA_2021_61935_89335.jpg

Top of Levee: view of crown and pvc pipe cap exposed.

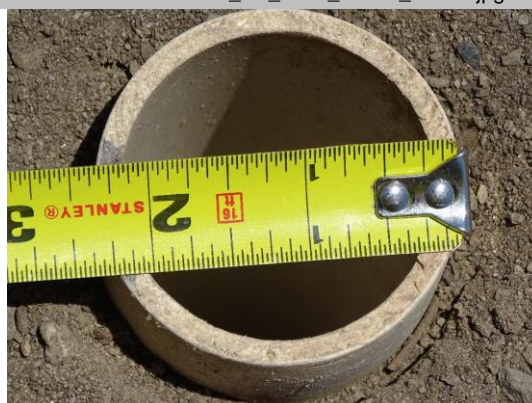
Photo 3 of 3 : UCIP_FA_2021_61935_89339.jpg

Top of Levee: view of 2-inch pvc pipe in crown.

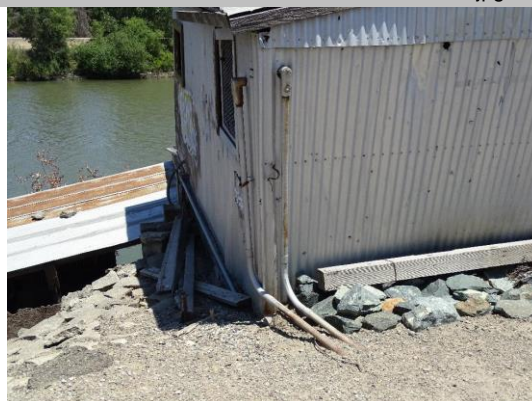
Photo 2 of 3 : UCIP_FA_2021_70223_89348.jpg

Water-Side: view of electrical conduit through the levee.

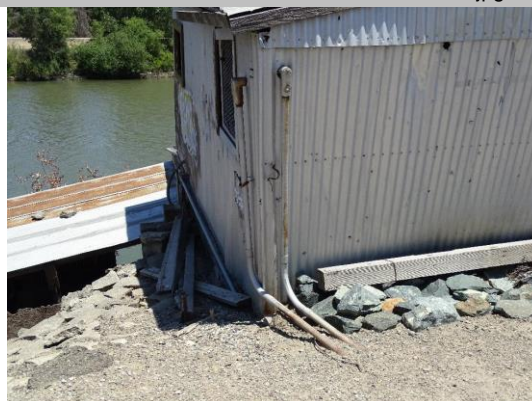
Photo 2 of 3 : UCIP_FA_2021_70224_89351.jpg

Water-Side: view of electrical conduit through the levee.

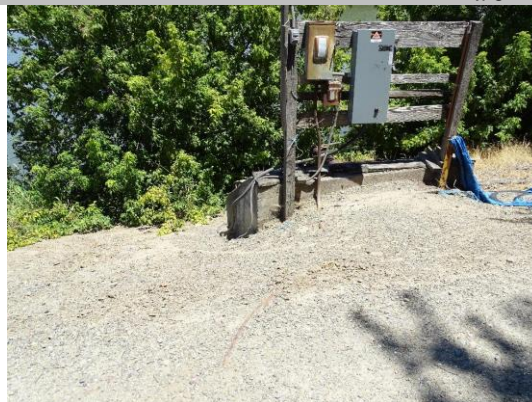
Photo 2 of 3 : UCIP_FA_2021_70227_89368.jpg

Water-Side: view of electrical panel with conduit going through levee.

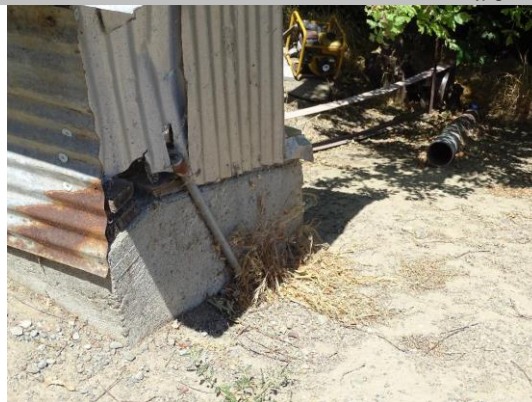
Photo 2 of 3 : UCIP_FA_2021_70229_89378.jpg

Water-Side: view of Ws slope and conduit out of pumphouse and through levee.

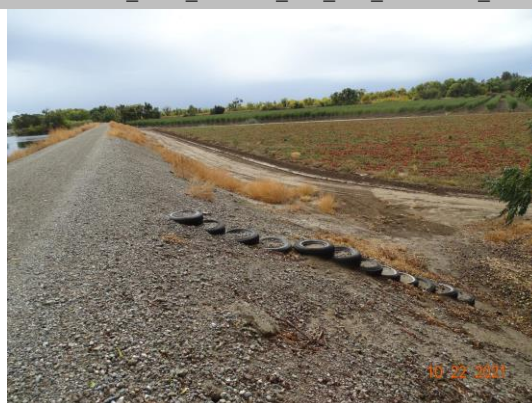
Photo 1 of 1 : FA_2021_RD0524_107_247_20211025_00338.jpg

View of rubber tires being used as stairs on landside slope. Fall 2021

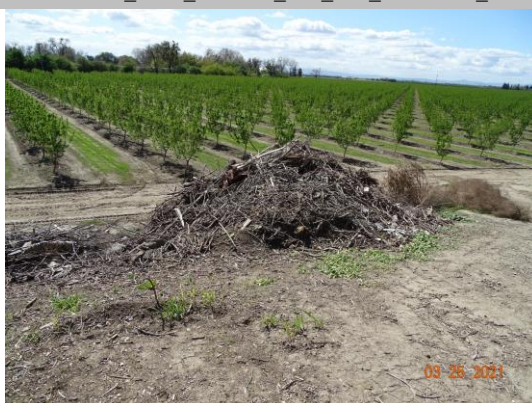
Photo 1 of 1 : FA_2021_RD0524_107_152_20210913_00066.jpg

View of prunings on the landside slope. Spring 2021

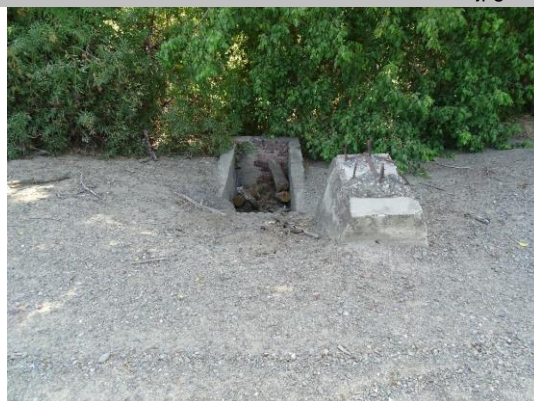
Photo 2 of 3 : UCIP_FA_2021_61955_89399.jpg

Water-Side: view of abandoned pump pad.

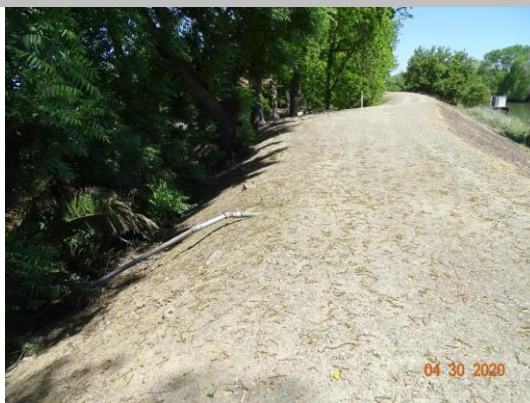
Photo 1 of 1 : FA_2021_RD0524_107_240_20210913_00088.jpg

View of 4 inch pipe going through levee from landside to waterside.
Spring 2020

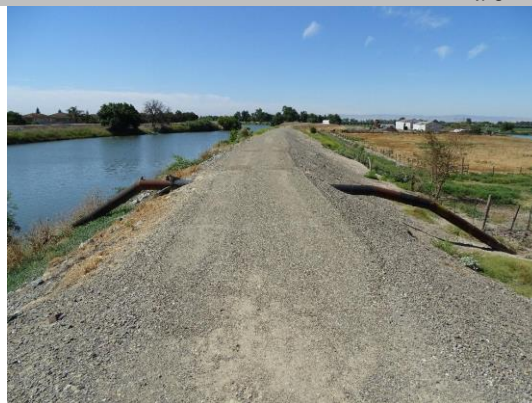
Photo 1 of 3 : UCIP_FA_2021_61959_89412.jpg

Overview of Levee: view of crown with pipe through crown.

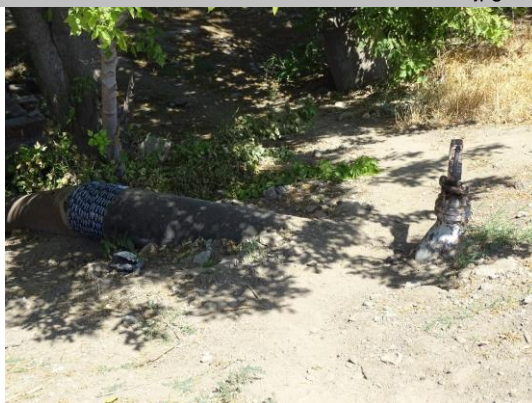
Photo 3 of 3 : UCIP_FA_2021_70236_89418.jpg

Land-Side: view of LS slope and repaired levee around pipe.

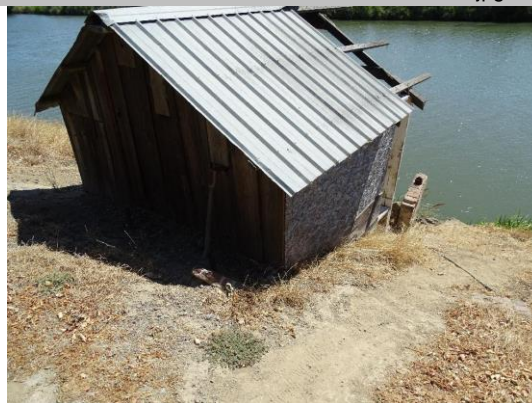
Photo 2 of 3 : UCIP_FA_2021_70237_89420.jpg

Water-Side: view of WS slope and electrical conduit out of pumphouse.

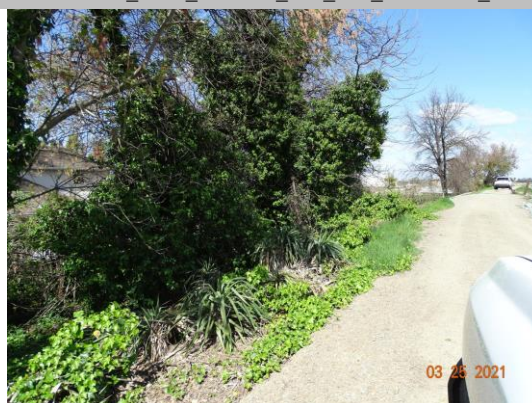
Photo 1 of 1 : FA_2021_RD0524_107_307_20210913_00101.jpg

View of heavy landscape vegetation along the landside slope. Spring 2021

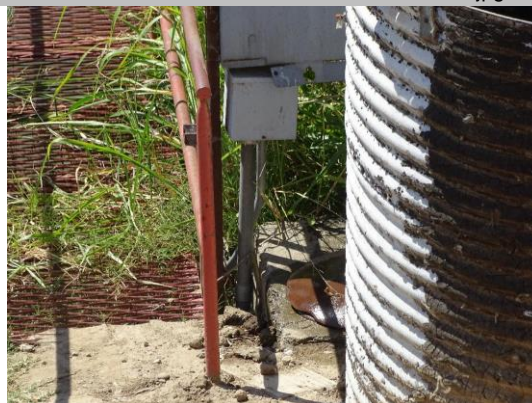
Photo 2 of 3 : UCIP_FA_2021_70239_89428.jpg

Water-Side: view of electrical conduit through the levee.

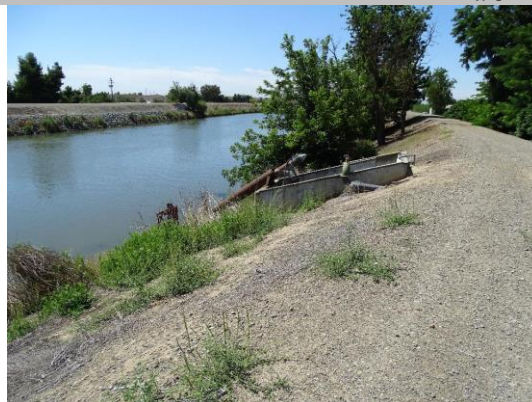
Photo 2 of 3 : UCIP_FA_2021_70240_89432.jpg

Water-Side: view of WS slope and new alignment of steel pipe out of pump; cattle guard removed.

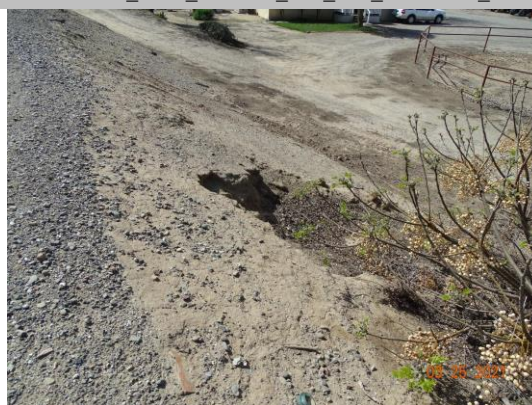
Photo 1 of 1 : FA_2021_RD0524_107_297_20210913_00098.jpg

View of erosion on the landside slope, approximately 5 ft wide, 10 ft long, 2 ft deep. Spring 2021

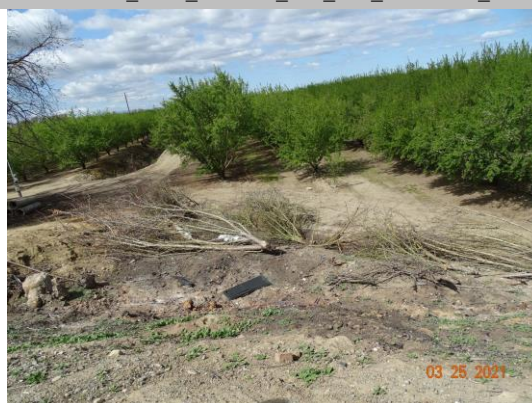
Photo 1 of 1 : FA_2021_RD0524_107_195_20210913_00073.jpg

View of pruning pile within the landside easement. Spring 2021

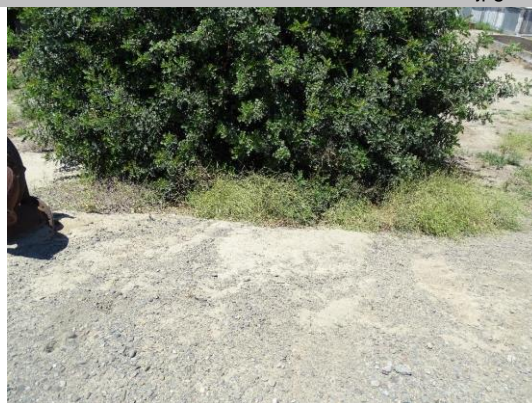
Photo 3 of 3 : UCIP_FA_2021_61991_89472.jpg

Land-Side: view of LS slope with channel on toe beneath tree.

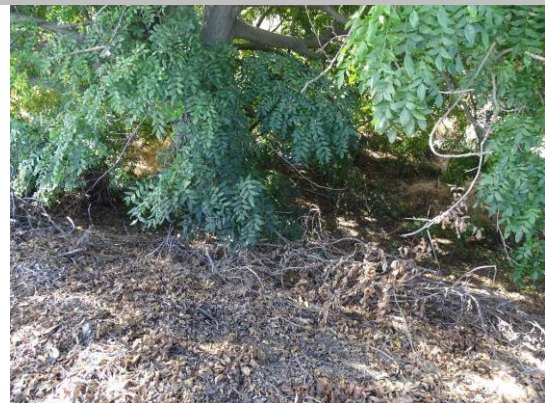
Photo 3 of 3 : UCIP_FA_2021_70252_78506.jpg

LS view - could not find pipe outlet.

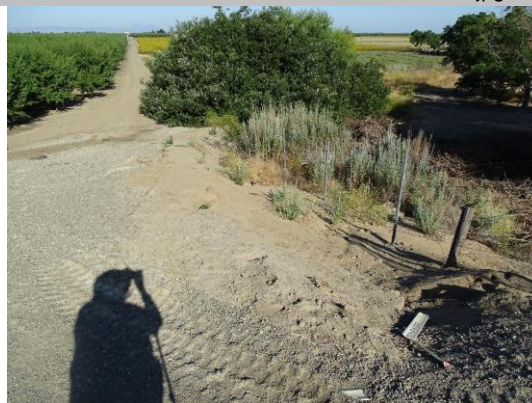
Photo 3 of 3 : UCIP_FA_2021_70253_89489.jpg

Land-Side: view of LS slope with no sign of inlet pipe due to overgrown vegetation limiting inspection.

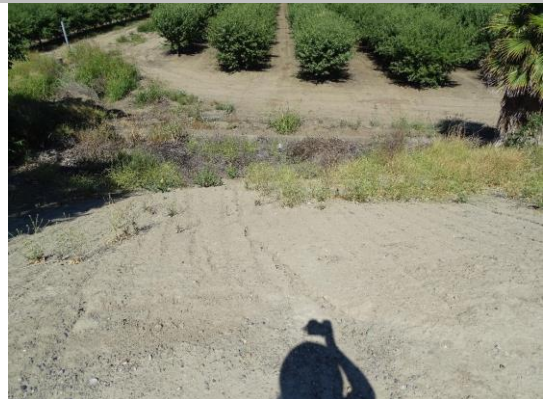
Photo 3 of 3 : UCIP_FA_2021_70265_89620.jpg

Land-Side: view of LS slope with no sign of pipe.

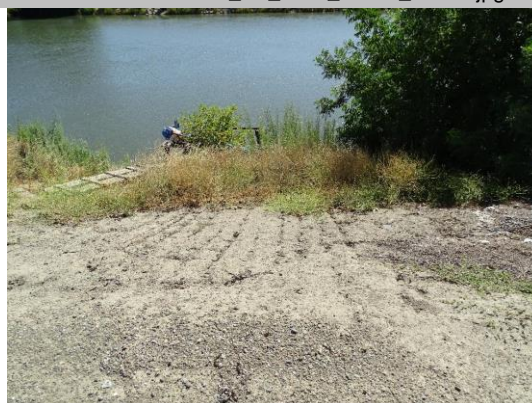
Photo 2 of 3 : UCIP_FA_2021_70267_89625.jpg

Water-Side: view of WS slope with no sign of crossing.

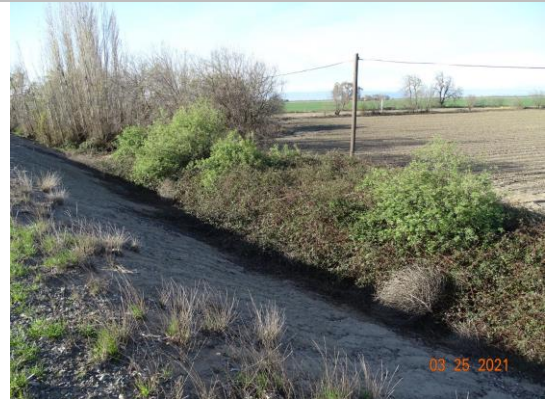
Photo 1 of 1 : FA_2021_RD0524_107_283_20210913_00094.jpg

View of dense berry bushes along landside easement. Spring 2021
