Flood Control Project Maintenance Levee Inspections

Fall 2022 Levee Maintenance Deficiency Summary Report

San Joaquin River Basin

Reclamation District No. 0524 Middle Roberts Island

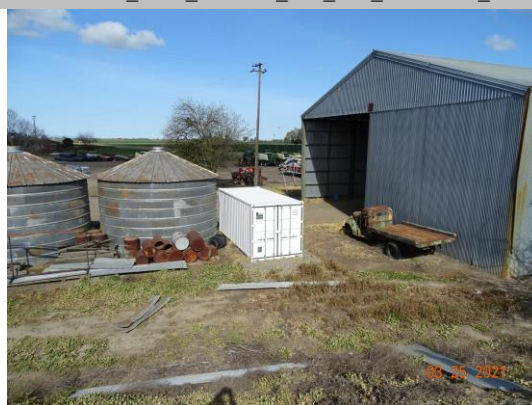
Photo 1 of 1 : FA_2022_RD0524_107_138_20220919_00038.jpg

View of container with Districts Flood Fight Materials. Spring 2021

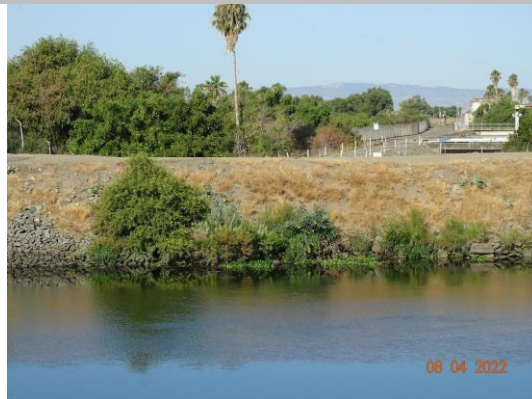
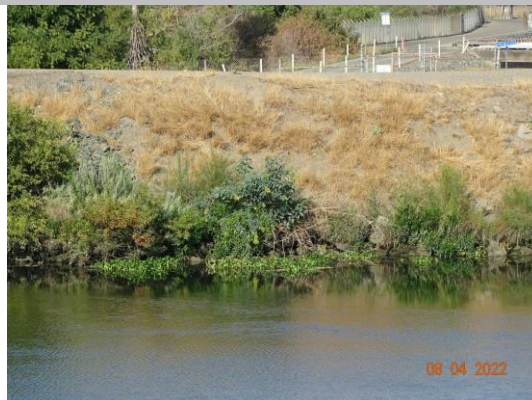
LM Start	0.70	Rating **	M	Issue No.	3	
LM End	0.71	Issue Type +	Ma	Location *		
Category	Supplemental			GPS Latitude/Longitude		
				Start	End	
Item	DWR Erosion Survey			37.937577 °	37.937577 °	
				-121.335491 °	-121.335491 °	
DWR ID	RD0524U01RM41.34					
Comment Code						
Inspector Comment						
Site ID: RD0524U01RM41.34						
08/04/2022: No significant changes were observed since the previous inspection.						
08/20/2021: During the annual erosion survey the erosion length was extended by 35 feet to 50 feet.						
09/24/2020: From 2018 to present, no significant changes were observed during the annual survey.						
09/13/2017: Pocket erosion above the protected levee toe.

8/4/2022: Front view of the erosion.

8/4/2022: Close-up view of the erosion.

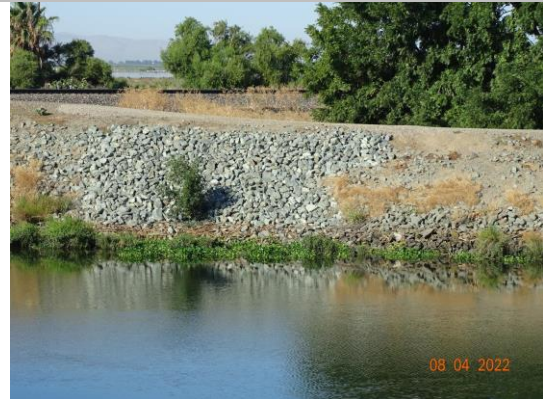
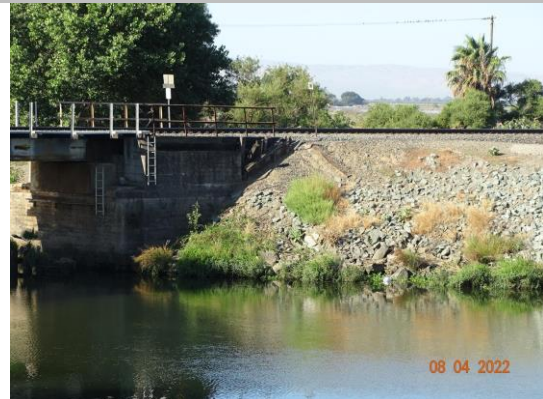
LM Start	0.71	Rating **	M	Issue No.	13
LM End	0.73	Issue Type +	Ma	Location *	
Category	Supplemental			GPS Latitude/Longitude	
				Start	End
Item	DWR Erosion Survey			37.937222 °	37.937222 °
				-121.335277 °	-121.335277 °
DWR ID	RD0524U01RM41.36				
Comment Code					
Inspector Comment					
Site ID: RD0524U01RM41.36					
08/04/2022: From 2016 to present, no significant changes were observed during the annual survey. Some of the old riprap has been displaced and doesn't provide adequate protection.					
06/24/2015: The erosion site is immediately downstream of the RR bridge.

8/4/2022: Close-up view of the erosion.

8/4/2022: Another view of the erosion.

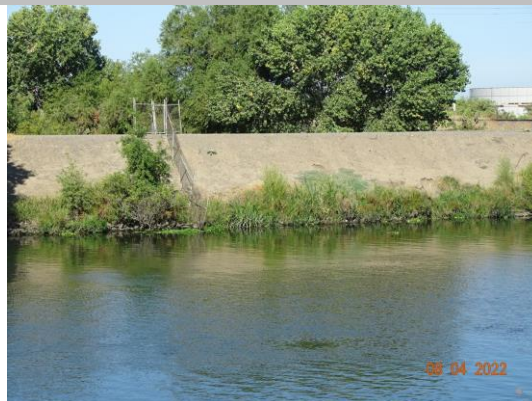
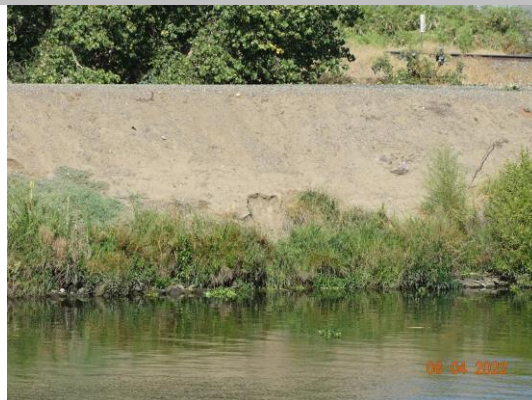
LM Start	0.76	Rating **	U	Issue No.	8	
LM End	0.77	Issue Type +	Ma	Location *		
Category	Supplemental			GPS Latitude/Longitude		
				Start	End	
Item	DWR Erosion Survey			37.936749 °	37.936749 °	
				-121.334971 °	-121.334971 °	
DWR ID	RD0524U01RM41.39					
Comment Code						
Inspector Comment						
Site ID: RD0524U01RM41.39						
08/04/2022: From 2013 to present, no significant changes were observed during the annual survey.						
08/07/2012: The site has been visited by boat survey. No significant change observed.						
08/23/2011: The site is located immediately upstream of a Railroad bridge. Dense vegetation at the water line blocks the view of erosion.

8/4/2022: View of the erosion from the opposite bank.

8/4/2022: Close-up view of the erosion.

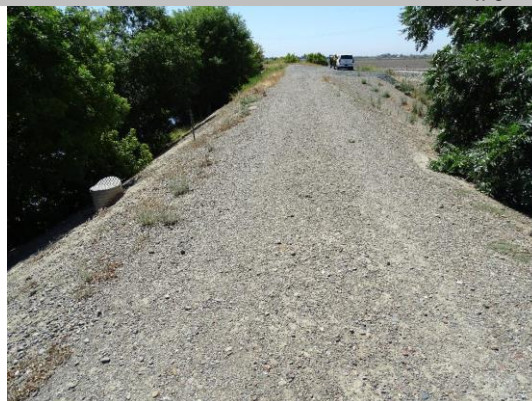
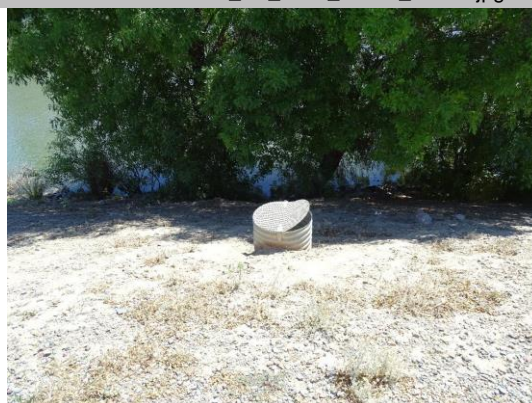
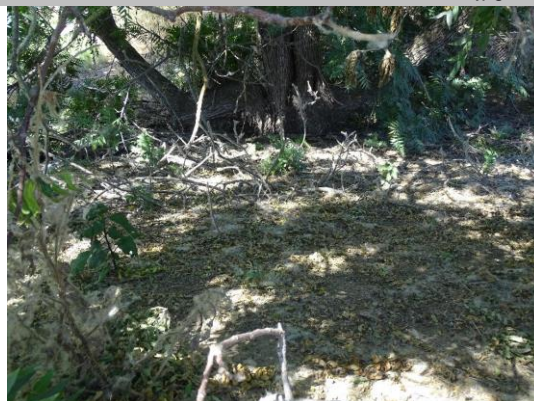
Comment Code					
Inspector Comment					
DS_ID:20596 FS_ID:70215 EP_NO: N/A Repair Type: Non-Urgent EVAL Issue: 5, Pipe Damage Crossing Status: Found UCIP Comments: 06/23/2020 Record remains Non-Urgent. Pipe damage at WS toe could be indication of internal pipe damage through levee. Recommend internal pipe inspection or owner to contact CVFPB to abandon or remove pipe from levee. Crossing appears abandoned. No permit has been identified authorizing pipe. (D.Sanoski - DWR UCIP) 08/16/2013 Large hole in pipe at WS toe. Appears abandoned and should be done so properly. (W.Wylie - DWR UCIP) FIELD_STRUCT_DESC: 8-inch steel pipe of unknown purpose through the levee, 4 feet below the crown. Siphon breaker in 24-inch corrugated metal riser unit on the waterside (WS) slope. [Additional Reference(s): USACE San Joaquin O&M Manual, Unit 7, April 1964, Revised 29 December 2016, (0.79), listed as 8-inch pipe]. FS Date: 6/23/2020 2:32:00 PM

Top of Levee: view of crown.

Water-Side: view of WS slope and standpipe.

Land-Side: view of LS with no sign of pipe.

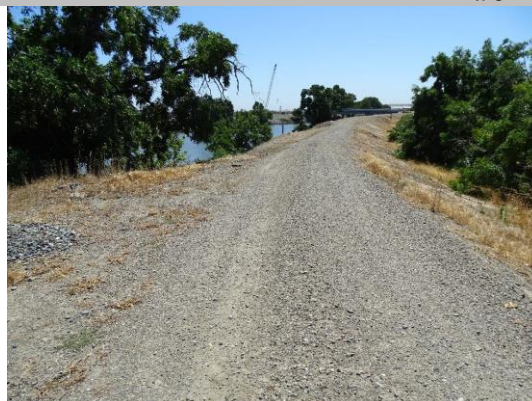
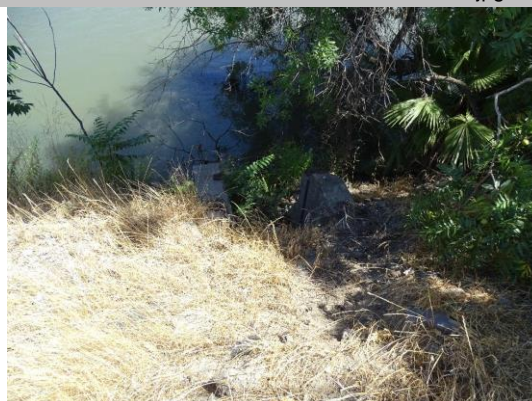
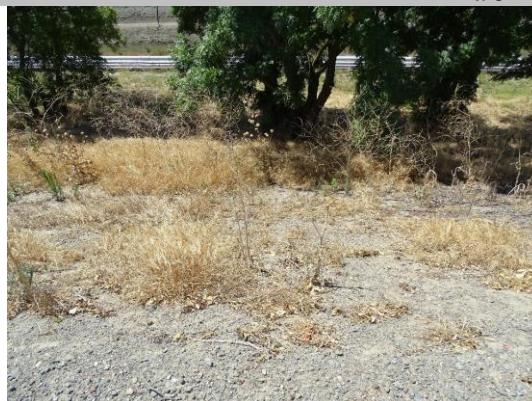
Comment Code						
Inspector Comment						
DS_ID:20598						
FS_ID:73982						
EP_NO: N/A						
Repair Type: Non-Urgent						
EVAL Issue:						
Crossing Status: Found						
UCIP Comments: 06/23/2020 Record updated from No Action Needed to Non-Urgent. System Feature. Crossing appears abandoned.						
(D.Sanoski - DWR UCIP)						
FIELD_STRUCT_DESC: *ABANDONED* 36-inch drainage pipe of an unknown material through the levee, 15 feet below the crown. Landside (LS) end is not visible. Concrete headwall at outlet on the waterside (WS) slope is visible. Pipe appears to be abandoned in place. Slide gate on the WS removed. [Additional Reference(s): DWR Levee Log, 2004 (HLM 0.99). USACE San Joaquin O&M Manual, Unit 7, April 1964, Revised 29 December 2016, (0.99), listed as 36-inch pipe].						
FS Date: 6/23/2020 2:32:00 PM

Top of Levee: view of crown.

Water-Side: view of WS slope.

Land-Side: view of LS slope.

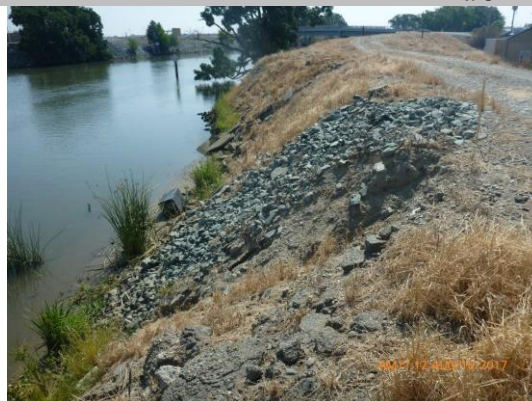
Photo 1 of 1 : LEVAL_FA_2022_536_4109.jpg

LM Start	1.00	Rating **	A/W	Issue No.	198
LM End	1.01	Issue Type +	Ma	Location *	WS
Category	Earthen Levee		GPS Latitude/Longitude		
			Start	End	
Item	Erosion / Bank Caving		37.935100 °	37.935100 °	
			-121.331500 °	-121.331300 °	
DWR ID	LMA-442

Fall Inspection 2021: Revetment is present on the waterside toe and there is no active erosion. This was a 2017 Storm Damage Site. Slope protection repairs are needed along the waterside slope due to riprap displacement from high water. Based upon levee inspections, it was determined the waterside levee slope is eroding, deteriorating, and degrading.

There appears to be previous repair site adjacent to LMA-442.

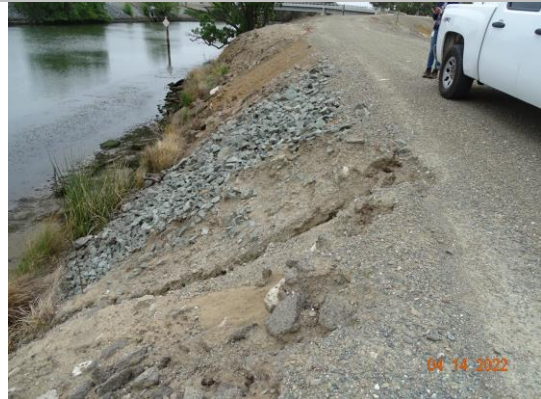
Photo 1 of 1 : FA_2022_RD0524_107_132_20220919_00036.jpg

LM Start	1.02	Rating **	U	Issue No.	132
LM End	1.02	Issue Type +	Ma	Location *	WS
Category	Earthen Levee			GPS Latitude/Longitude	
				Start	End
Item	Erosion / Rills			37.935032 °	37.935032 °
				-121.331210 °	-121.331210 °
DWR ID	DWR_RD0524_01_s_2022_132				
Comment Code					
E5 : Schedule repair of rills prior to the next inspection.					
Inspector Comment

View of rills along the waterside slope caused by surface runoff. Spring 2022

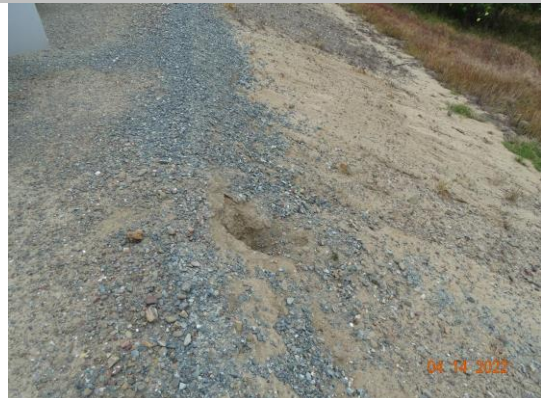
Photo 1 of 1 : FA_2022_RD0524_107_134_20220919_00037.jpg

LM Start	1.02	Rating **	M	Issue No.	134
LM End	1.02	Issue Type +	Ma	Location *	LS
Category	Earthen Levee			GPS Latitude/Longitude	
				Start	End
Item	Animal Control			37.935032 °	37.935032 °
				-121.331210 °	-121.331210 °
DWR ID	DWR_RD0524_01_s_2022_134				
Comment Code					
A3 : No rodents visible, but rodent burrows visible; need to backfill and compact or grout burrows.					
Inspector Comment

View of animal burrow along the landside slope. Spring 2022

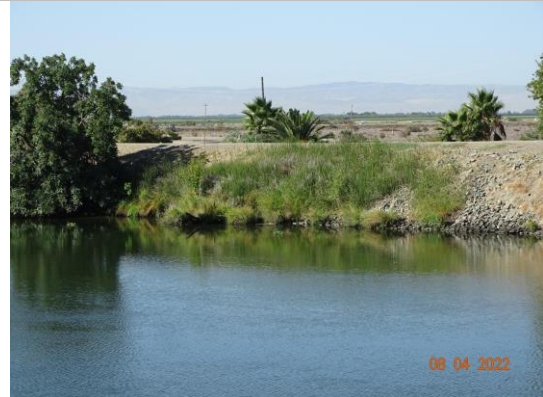
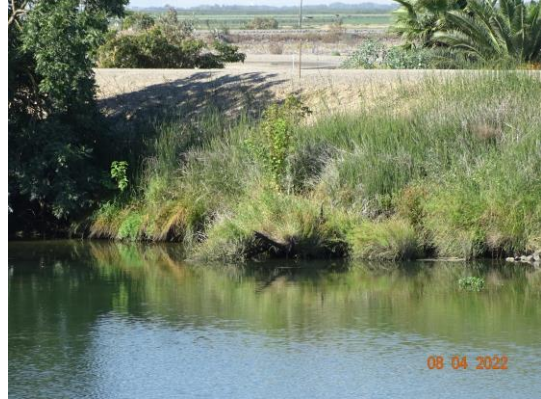
Comment Code						
Inspector Comment						
Site ID: RD0524U01RM41.79						
08/04/2022: From 2011 to present, no significant changes were observed during the annual survey. Minimal vegetation covers the upper levee slope. The lower slope is covered with medium dense vegetation. Riprap is visible in some areas.						
09/07/2010: Vegetation is visible at the water line. There is an exposed pipe discharge partially hanging at the mid-slope, possibly still used for discharging irrigation/runoff water. There is minimal rip rap protection along the bank, and what's left of it is no longer adequately protecting the bank.						
9/29/2009: Site consists of a 400-foot long eroding bank with minimal vegetation and protection; the existing rip rap has sloughed, rendering it useless; note that there is an exposed section of a pipe.						
10/18/2006: There is extensive loss of rip rap on some sections; sewage disposal pond is on the landside of the levee; there is an exposed pipe outlet "hanging" from the upper slope.

8/4/2022: View of the erosion from the oppoite bank.

8/4/2022: Close-up view of the erosion.

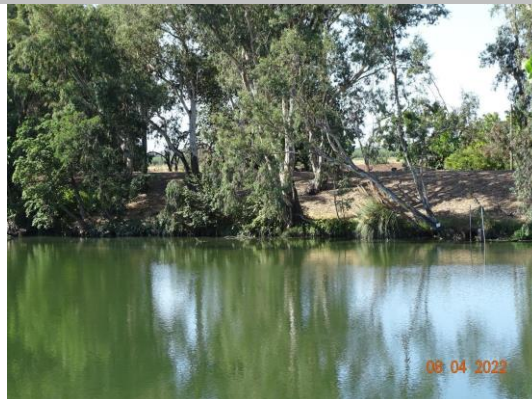
Photo 3 of 3 : SJR2022_RD0524U01RM42.4_6.JPG

8/4/2022: Visible undermining of the levee toe.

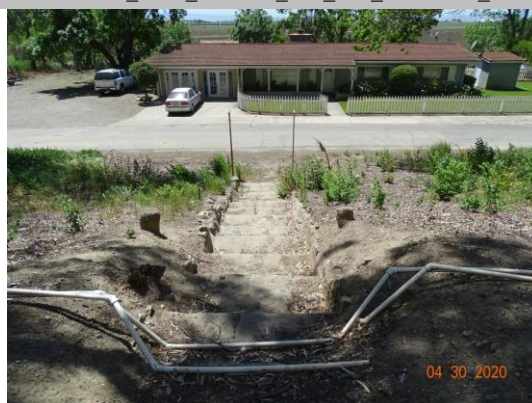
Photo 1 of 1 : FA_2022_RD0524_107_267_20220919_00055.jpg

View of concrete stairs on landside slope. Spring 2020

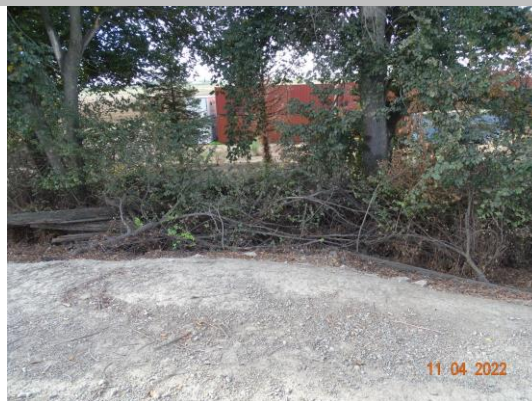
Photo 1 of 1 : FA_2022_RD0524_107_154_20221104_00280.jpg

View of tree prunings along the landside slope and easement. Fall 2022

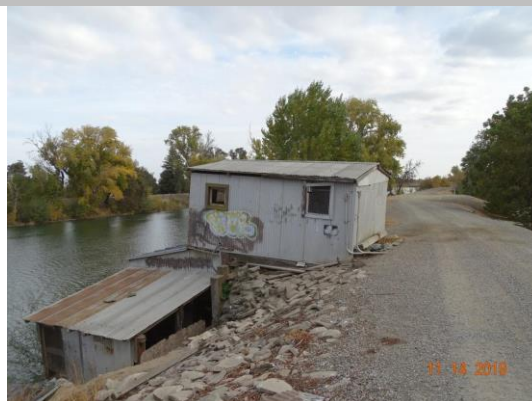
Photo 1 of 1 : FA_2022_RD0524_107_148_20220919_00039.jpg

View of pump house on waterside shoulder. Fall 2019

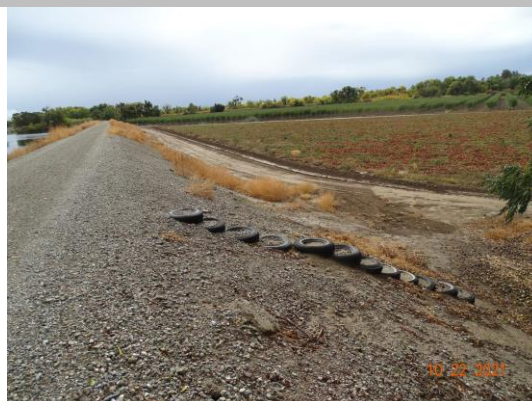
Photo 1 of 1 : FA_2022_RD0524_107_247_20220919_00053.jpg

View of rubber tires being used as stairs on landside slope. Fall 2021

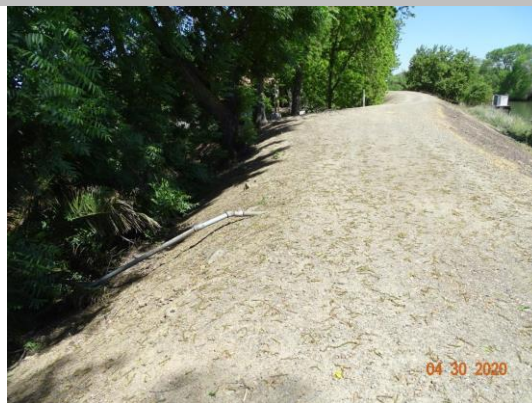
Photo 1 of 1 : FA_2022_RD0524_107_240_20220919_00052.jpg

View of 4 inch pipe going through levee from landside to waterside.
Spring 2020

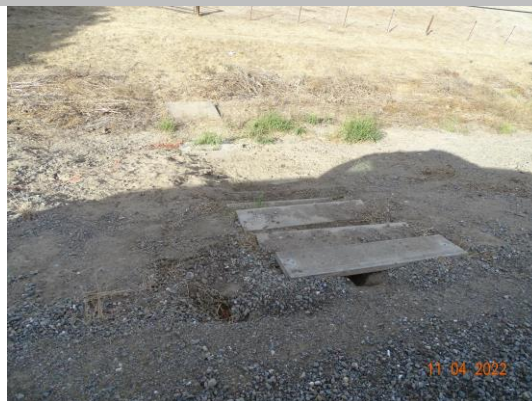
Photo 1 of 1 : FA_2022_RD0524_107_223_20221104_00279.jpg

View of stairs cut into levee landside slope. Fall 2022

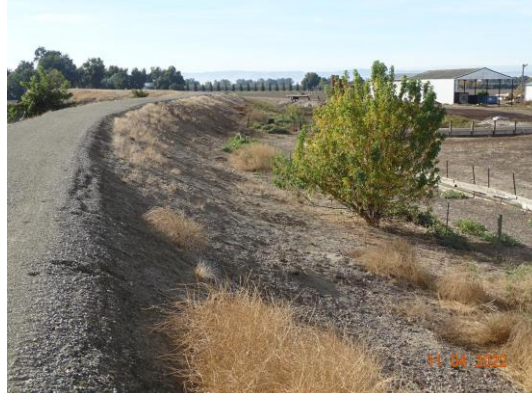
Photo 1 of 1 : FA_2022_RD0524_107_925_20221104_00278.jpg

View of landside slope with multiple animal burrows. Fall 2022

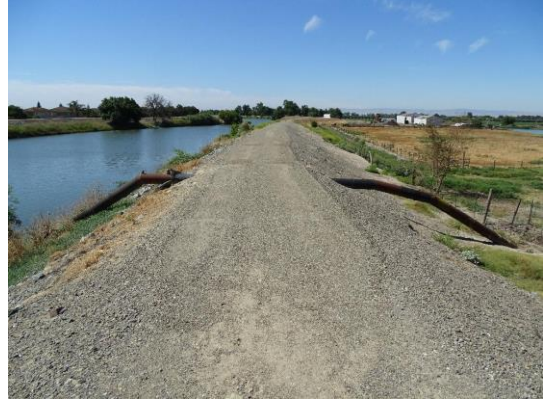
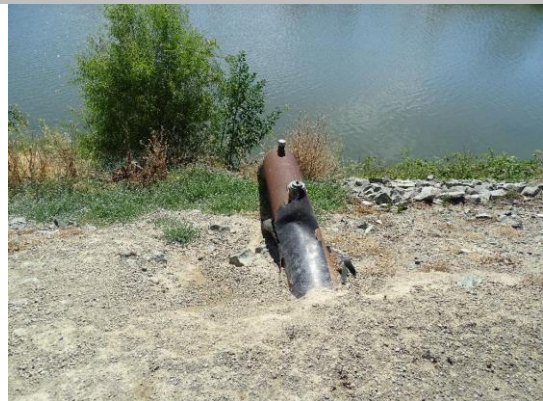
Overview of Levee: view of crown with pipe through crown.

Water-Side: view of WS slope with pipe out of slope.

Land-Side: view of LS slope and pipe out of slope.

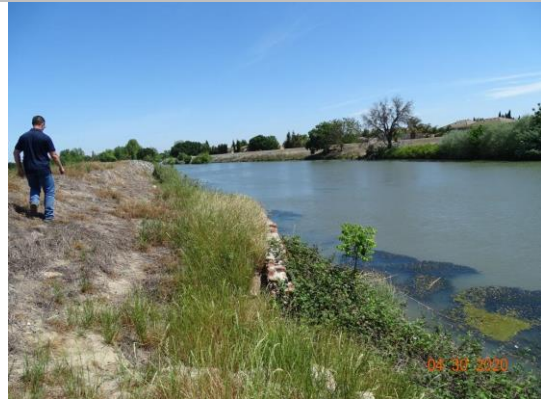
Photo 1 of 1 : FA_2022_RD0524_107_220_20220919_00049.jpg

View of damaged retaining wall on waterside slope. Approximately 30 ft. long, 8 ft. high and 20 ft. from waterside hinge. Spring 2020

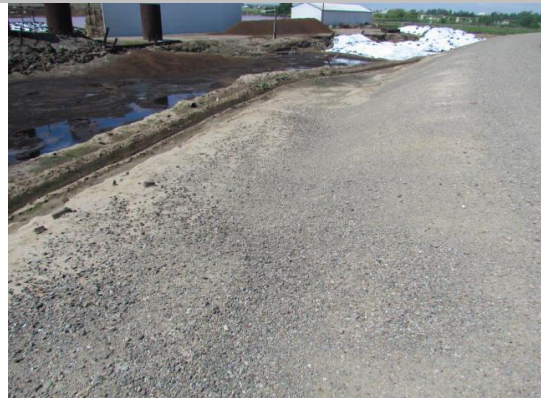
Photo 1 of 1 : FA_2022_RD0524_107_211_20220919_00047.jpg

Looking northwest at unauthorized ramp on landward slope.

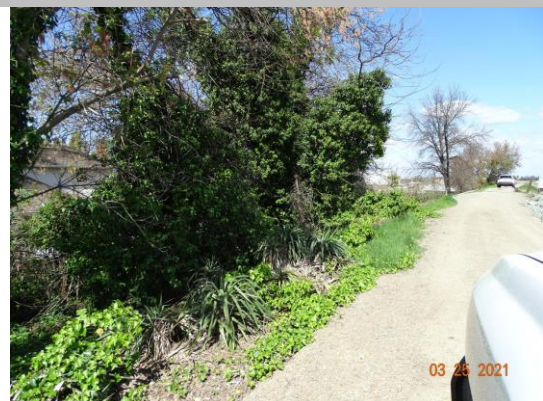
Photo 1 of 1 : FA_2022_RD0524_107_307_20220919_00061.jpg

View of heavy landscape vegetation along the landside slope. Spring 2021

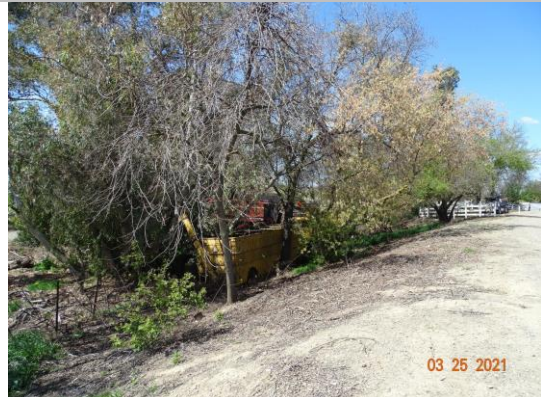
Photo 1 of 1 : FA_2022_RD0524_107_213_20220919_00048.jpg

View of abandoned farm equipment within the landside easement. Spring 2021

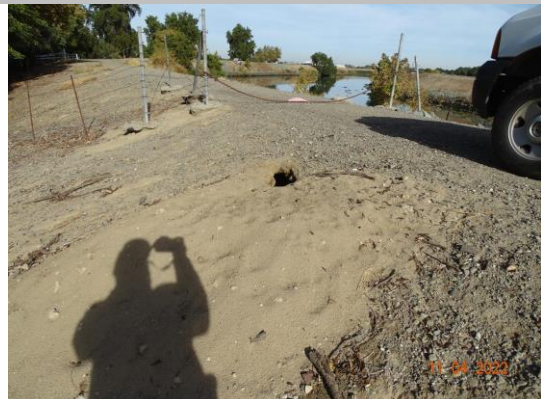
Photo 1 of 1 : FA_2022_RD0524_107_304_20221104_00277.jpg

View of large animal burrow on the landside slope. Fall 2022

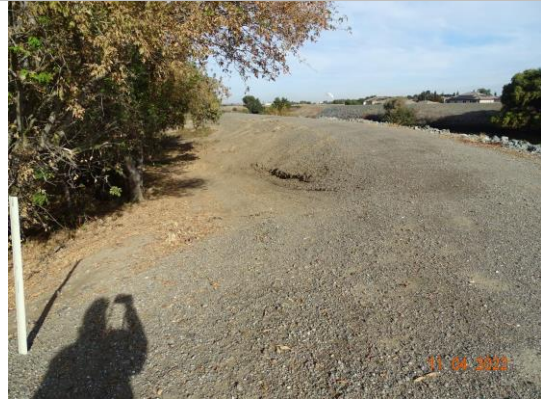
Photo 1 of 1 : FA_2022_RD0524_107_265_20221104_00276.jpg

View of unauthorized ramp along the landside slope. Fall 2022

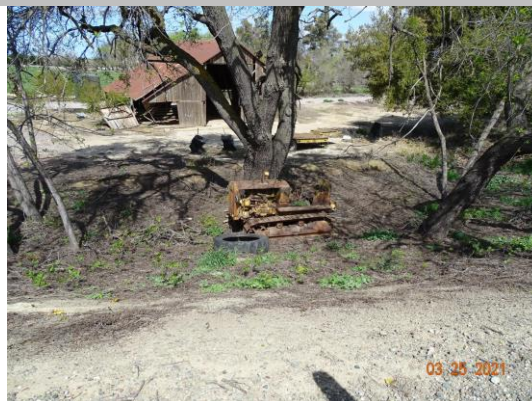
Photo 1 of 1 : FA_2022_RD0524_107_301_20220919_00060.jpg

View of an abandoned piece of farm equipment within the landside easement. Spring 2021

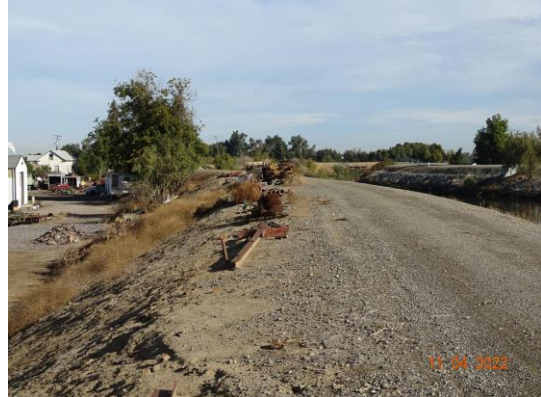
Photo 1 of 1 : FA_2022_RD0524_107_95_20221104_00275.jpg

View of farm equipment being stored along the landside shoulder. Fall 2022

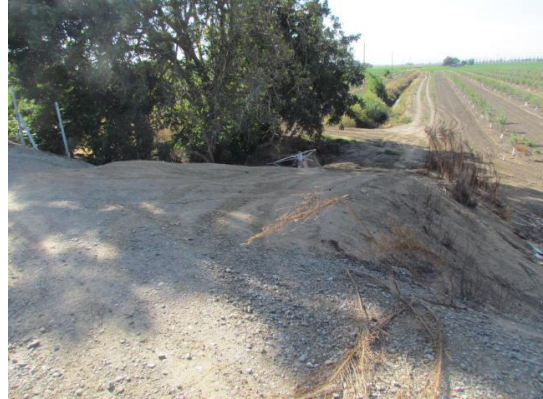
Photo 1 of 1 : FA_2022_RD0524_107_101_20220919_00026.jpg

Looking west at unauthorized ramp on landside slope.

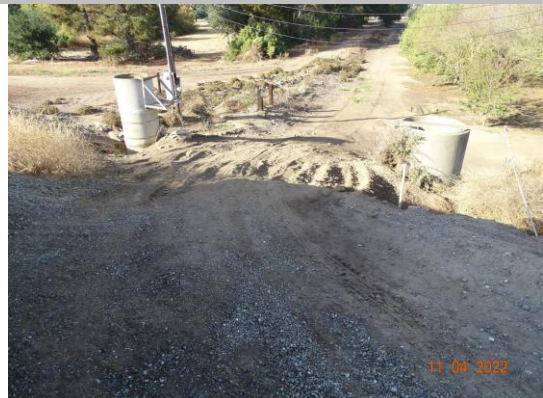
Photo 1 of 1 : FA_2022_RD0524_107_110_20221104_00274.jpg

View of rills along the landside ramp. Fall 2022

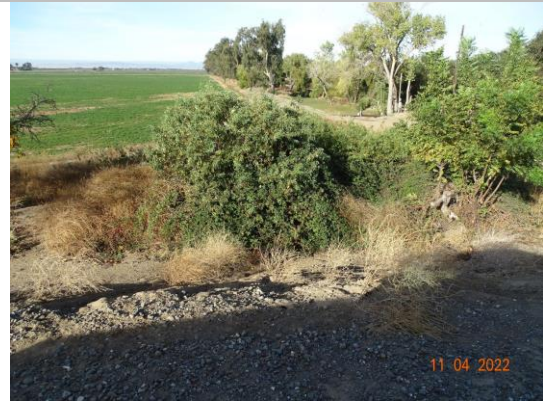
Photo 1 of 1 : FA_2022_RD0524_107_150_20221104_00273.jpg

View of wild vegetation along the landside slope and easement. Fall 2022

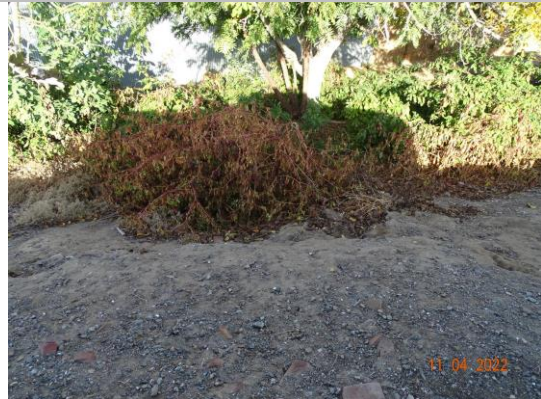
Photo 1 of 1 : FA_2022_RD0524_107_147_20221104_00272.jpg

View of prunings along the landside slope and easement. Fall 2022

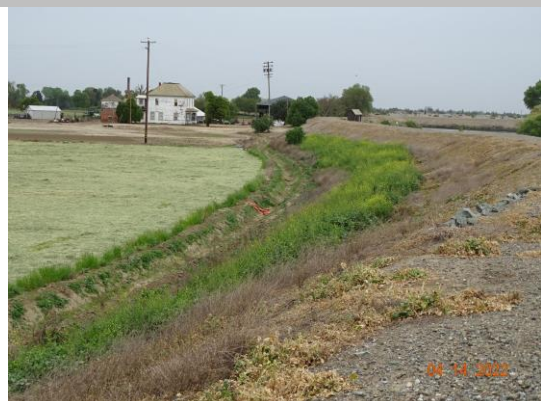
Photo 1 of 1 : FA_2022_RD0524_107_116_20220919_00032.jpg

View of an irrigation ditch along the landside easement. Spring 2022

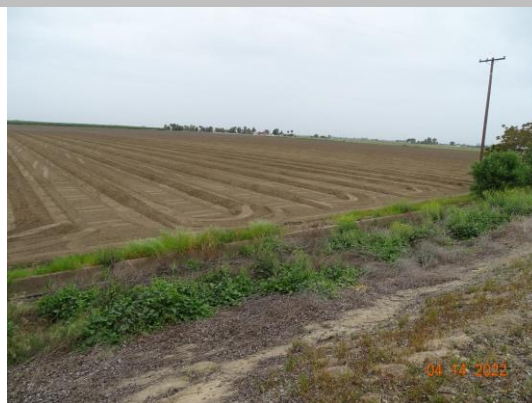
Photo 1 of 1 : FA_2022_RD0524_107_111_20220919_00030.jpg

View of concrete lined irrigation ditch along the landside easement.
Spring 2022

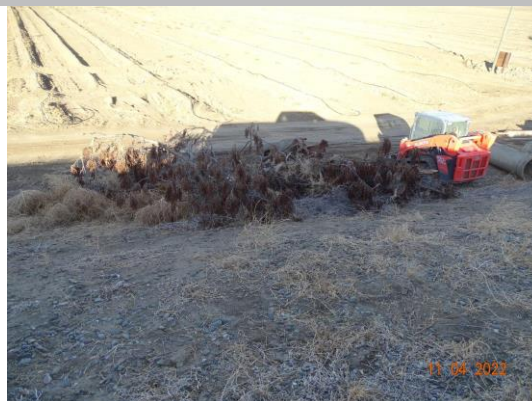
Photo 1 of 1 : FA_2022_RD0524_107_139_20221104_00271.jpg

View of prunings along the landside slope and easement. Fall 2022

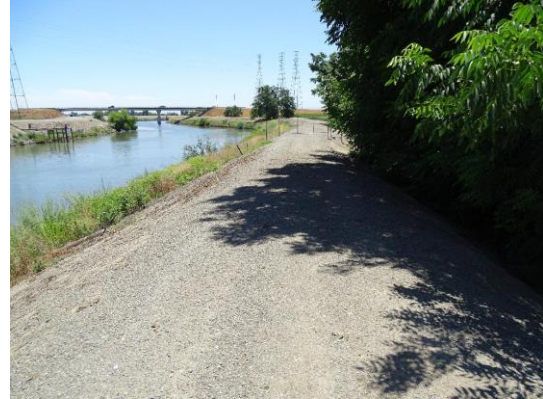
Top of Levee: view of crown.

Water-Side: view of WS slope and pipe.

LS view - could not find pipe outlet.

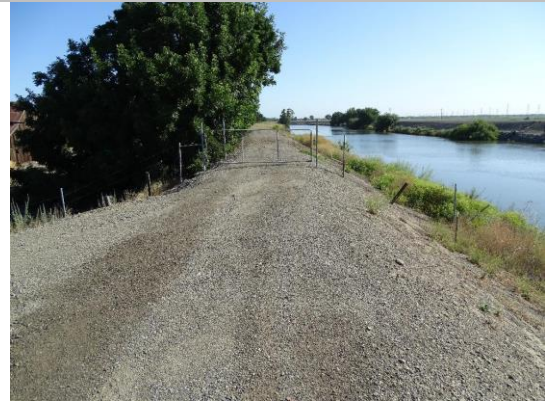
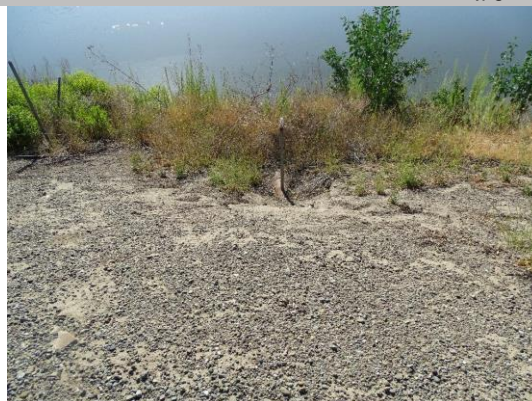
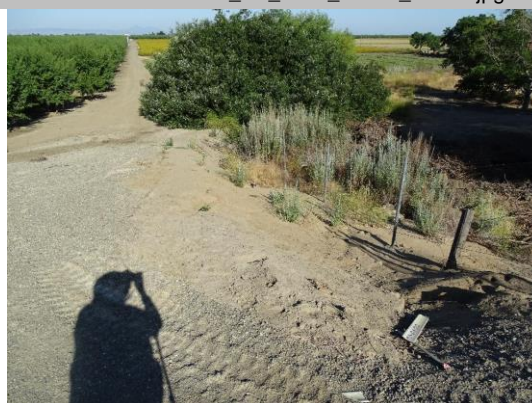
Water-Side: view of WS slope and pipe.

Land-Side: view of LS slope with no sign of inlet pipe due to overgrown vegetation limiting inspection.

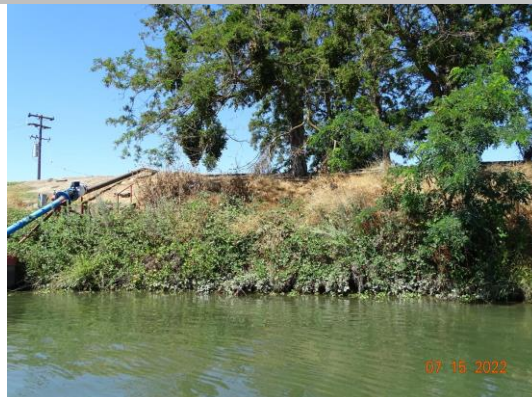
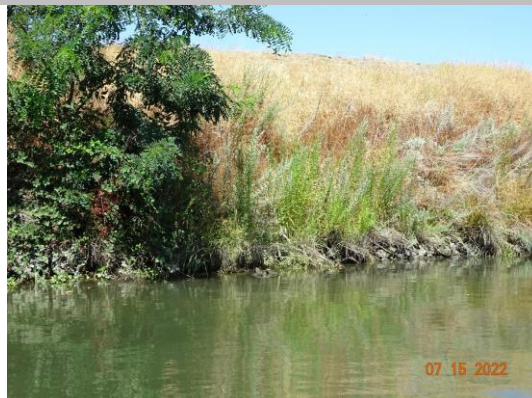
7/15/2022: View of the erosion immediately downstream of an irrigation pipe.

7/15/2022: Close-up view of the erosion.

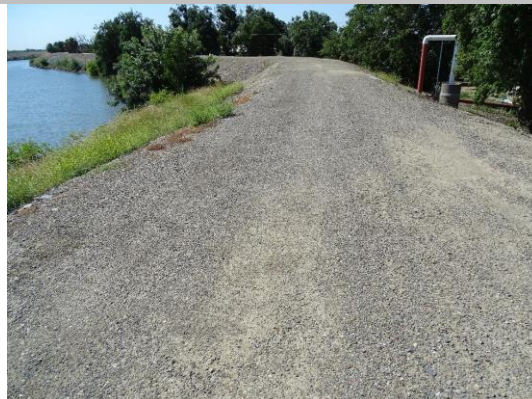
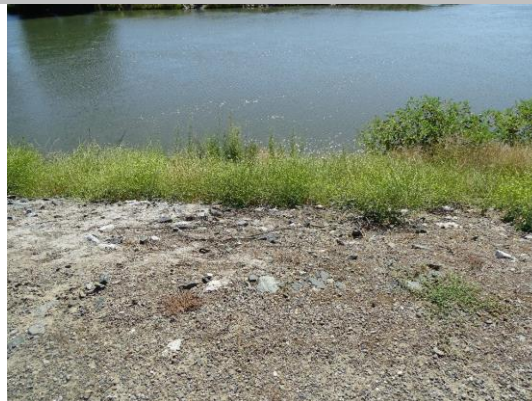
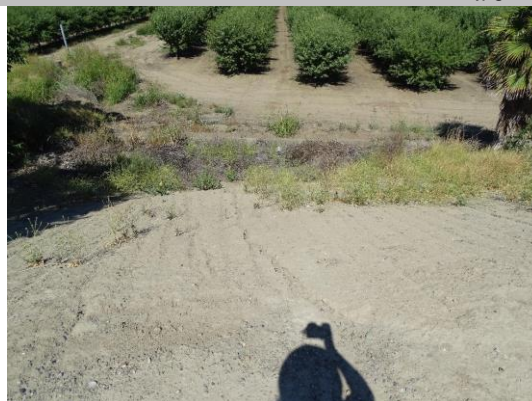
Water-Side: view of WS slope with no sign of pipe or concrete structure.

Land-Side: view of LS slope with no sign of pipe.

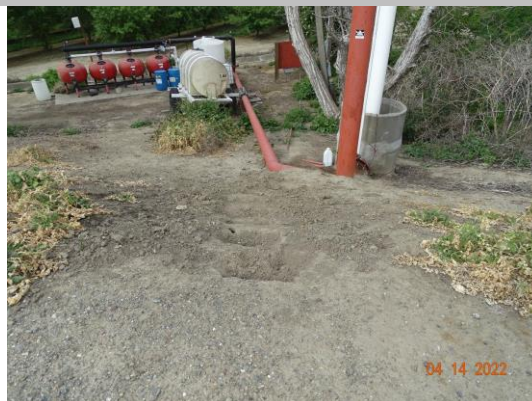
Photo 1 of 1 : FA_2022_RD0524_107_103_20220919_00027.jpg

View of stairs cutting into the landside slope. Spring 2022

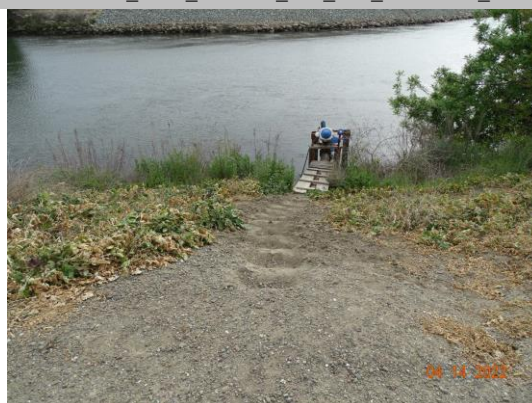
Photo 1 of 1 : FA_2022_RD0524_107_104_20220919_00028.jpg

View of stairs cutting into the waterside slope. Spring 2022

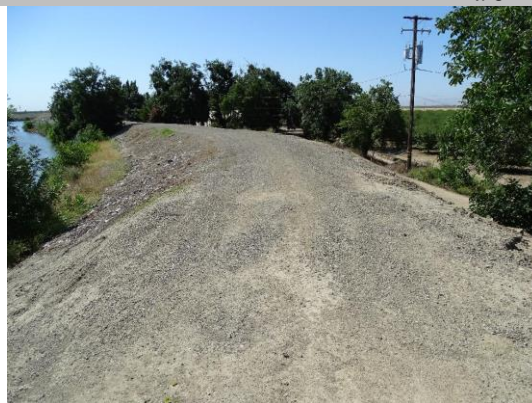
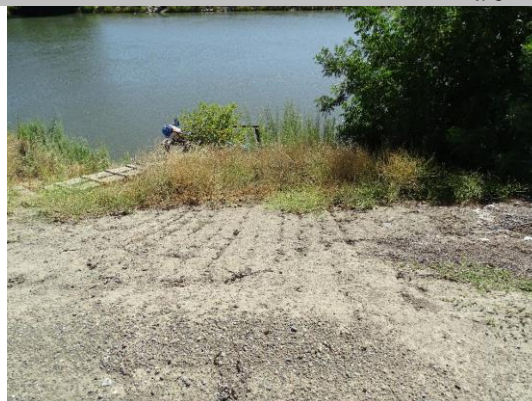
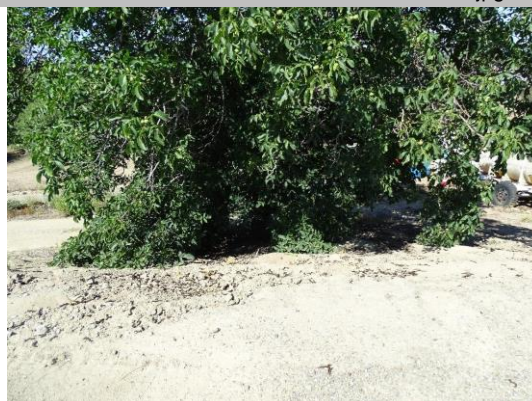
Water-Side: view of WS slope with no sign of crossing.

Land-Side: view of LS slope with no sign of crossing.

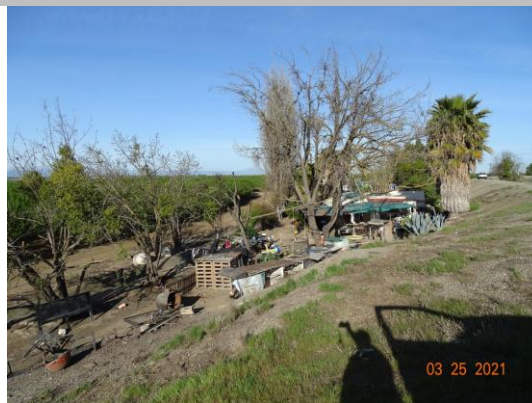
Photo 1 of 1 : FA_2022_RD0524_107_274_20220919_00056.jpg

View of chicken coop buildings along landside easement. Spring 2021

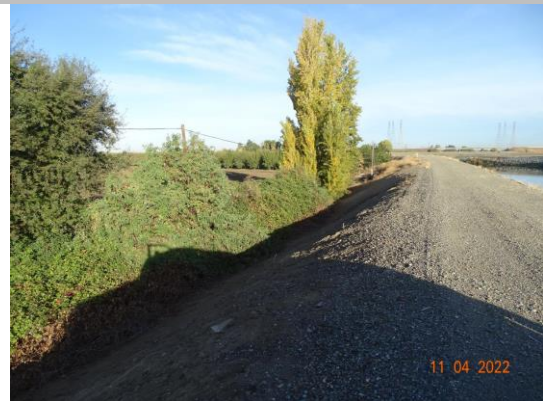
Photo 1 of 1 : FA_2022_RD0524_107_98_20221104_00270.jpg

View of berry bushes and ivy along the landside slope and easement.
Fall 2022

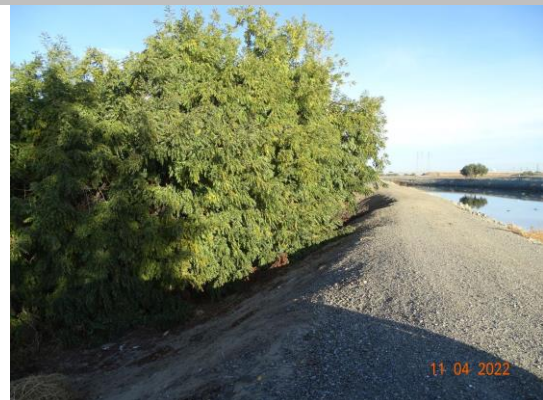
Photo 1 of 1 : FA_2022_RD0524_107_188_20221104_00269.jpg

View of untrimmed trees along the landside slope. Fall 2022
