**Flood Control Project Maintenance
Levee Inspections
Fall 2023 Levee Maintenance Deficiency Summary Report**

San Joaquin River Basin

Reclamation District No. 0524 Middle Roberts Island

**Flood Control Project Maintenance
Levee Inspections
Unit Cover Sheet**

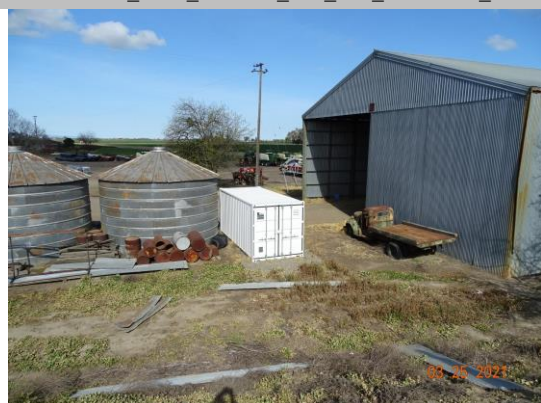
Photo 1 of 1 : FA_2023_RD0524_107_138_20230905_00022.jpg

View of container with Districts Flood Fight Materials. Spring 2021

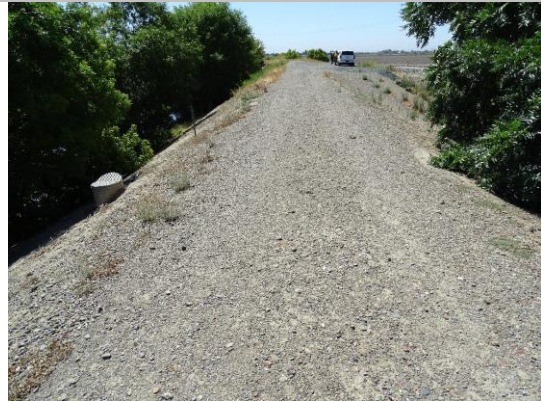
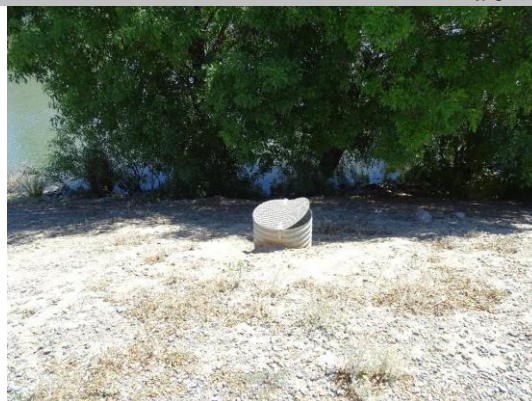
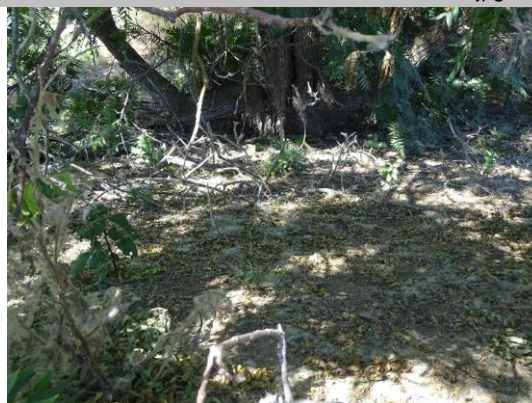
Comment Code					
Inspector Comment					
DS_ID:20596 FS_ID:70215 EP_NO: N/A Repair Type: Non-Urgent EVAL Issue: 5, Pipe Damage Crossing Status: Found UCIP Comments: 06/23/2020 Record remains Non-Urgent. Pipe damage at WS toe could be indication of internal pipe damage through levee. Recommend internal pipe inspection or owner to contact CVFPB to abandon or remove pipe from levee. Crossing appears abandoned. No permit has been identified authorizing pipe. (D.Sanoski - DWR UCIP) 08/16/2013 Large hole in pipe at WS toe. Appears abandoned and should be done so properly. (W.Wylie - DWR UCIP) FIELD_STRUCT_DESC: 8-inch steel pipe of unknown purpose through the levee, 4 feet below the crown. Siphon breaker in 24-inch corrugated metal riser unit on the waterside (WS) slope. [Additional Reference(s): USACE San Joaquin O&M Manual, Unit 7, April 1964, Revised 29 December 2016, (0.79), listed as 8-inch pipe]. FS Date: 6/23/2020 2:32:00 PM

Top of Levee: view of crown.

Water-Side: view of WS slope and standpipe.

Land-Side: view of LS with no sign of pipe.

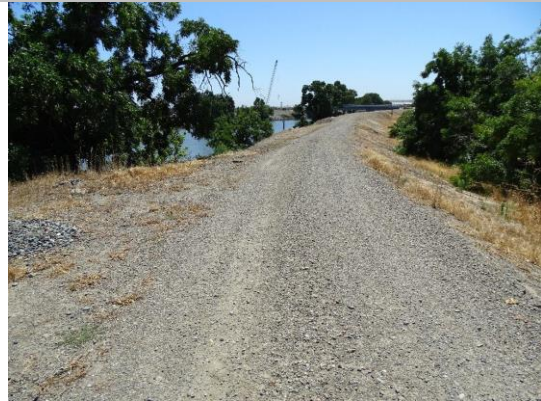
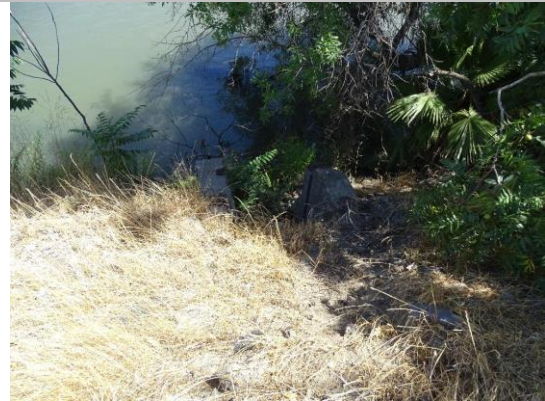
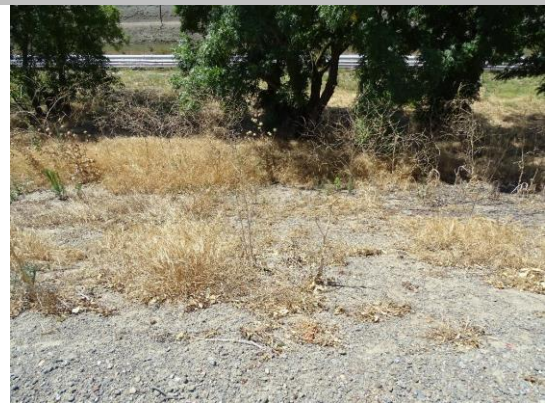
Comment Code						
Inspector Comment						
DS_ID:20598						
FS_ID:73982						
EP_NO: N/A						
Repair Type: Non-Urgent						
EVAL Issue:						
Crossing Status: Found						
UCIP Comments: 06/23/2020 Record updated from No Action Needed to Non-Urgent. System Feature. Crossing appears abandoned.						
(D.Sanoski - DWR UCIP)						
FIELD_STRUCT_DESC: *ABANDONED* 36-inch drainage pipe of an unknown material through the levee, 15 feet below the crown. Landside (LS) end is not visible. Concrete headwall at outlet on the waterside (WS) slope is visible. Pipe appears to be abandoned in place. Slide gate on the WS removed. [Additional Reference(s): DWR Levee Log, 2004 (HLM 0.99). USACE San Joaquin O&M Manual, Unit 7, April 1964, Revised 29 December 2016, (0.99), listed as 36-inch pipe].						
FS Date: 6/23/2020 2:32:00 PM

Top of Levee: view of crown.

Water-Side: view of WS slope.

Land-Side: view of LS slope.

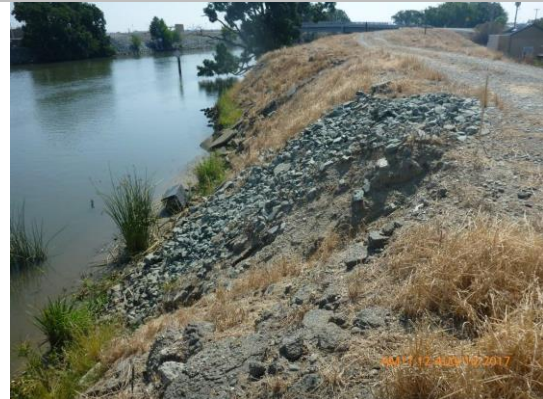
Photo 1 of 1 : LEVAL_FA_2023_536_4109.jpg

LM Start	1.00	Rating **	A/W	Issue No.	198
LM End	1.01	Issue Type +	Ma	Location *	WS
Category	Earthen Levee			GPS Latitude/Longitude	
				Start	End
Item	Erosion / Bank Caving			37.935100°	37.935100°
				-121.331500°	-121.331300°
DWR ID	LMA-442				
Comment Code					
E1 : Note and monitor erosion site.					
Inspector Comment					
Fall Inspection 2021: Revetment is present on the waterside toe and there is no active erosion. This was a 2017 Storm Damage Site. Slope protection repairs are needed along the waterside slope due to riprap displacement from high water. Based upon levee inspections, it was determined the waterside levee slope is eroding, deteriorating, and degrading.					
Site ID No:536					
Site Designation:LMA-442					
There appears to be previous repair site adjacent to LMA-442.

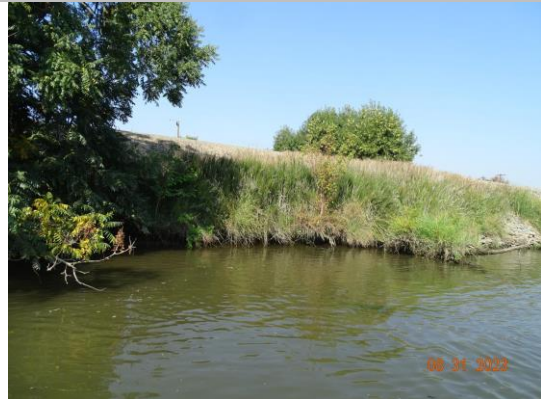
Photo 1 of 2 : SJR2023_RD524U01RM41.79_5.JPG

8/31/2023: From 2010 to present, no significant changes were observed during the annual survey. Minimal vegetation covers the upper levee slope. The lower slope is covered with medium dense vegetation.

8/31/2023: View of the erosion from the opposite bank.

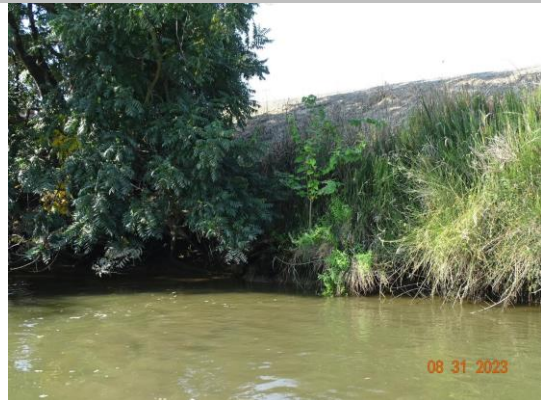
Photo 2 of 2 : SJR2023_RD524U01RM41.79_1.JPG

8/31/2023: Close-up view of the erosion.

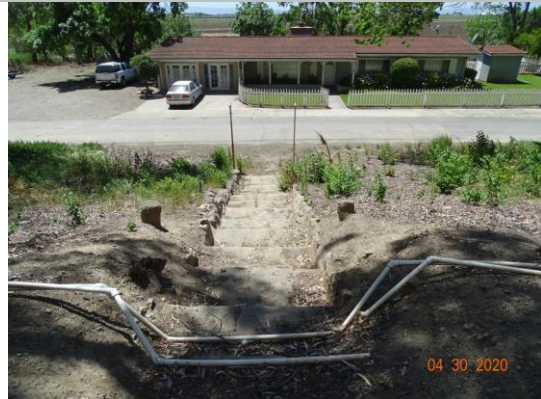
Photo 1 of 1 : FA_2023_RD0524_107_267_20230905_00036.jpg

View of concrete stairs on landside slope. Spring 2020

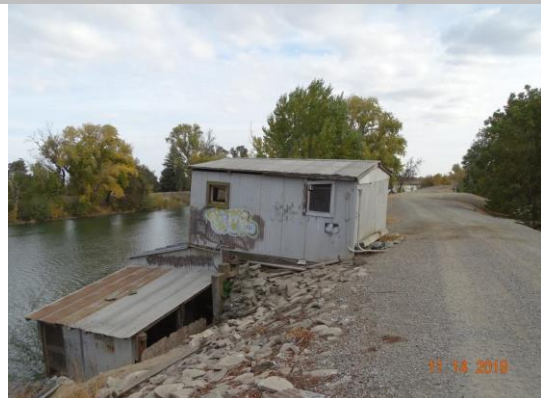
Photo 1 of 1 : FA_2023_RD0524_107_148_20230905_00024.jpg

View of pump house on waterside shoulder. Fall 2019

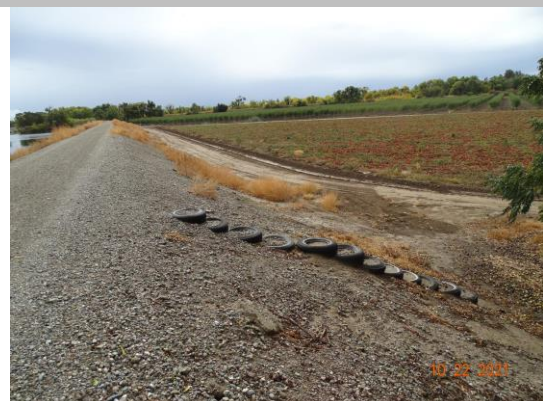
Photo 1 of 1 : FA_2023_RD0524_107_247_20230905_00035.jpg

View of rubber tires being used as stairs on landside slope. Fall 2021

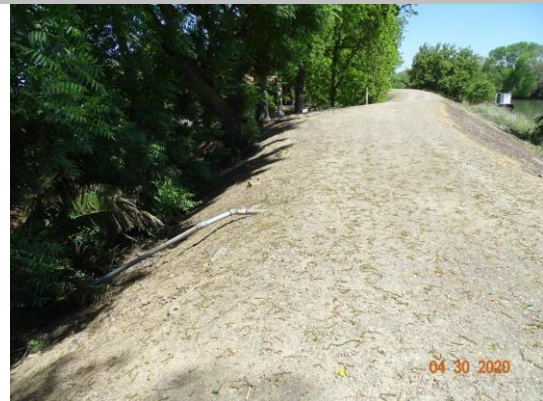
Photo 1 of 1 : FA_2023_RD0524_107_240_20230905_00034.jpg

View of 4 inch pipe going through levee from landside to waterside.
Spring 2020

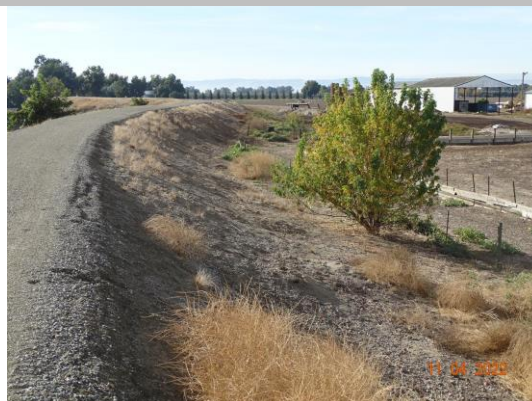
Photo 1 of 1 : FA_2023_RD0524_107_925_20230905_00040.jpg

LM Start	2.94	Rating **	M	Issue No.	925
LM End	3.28	Issue Type +	Ma	Location *	LS
Category	Earthen Levee			GPS Latitude/Longitude	
				Start	End
Item	Animal Control			37.913206°	37.908410°
				-121.324533°	-121.325438°
DWR ID	DWR_RD0524_01_s_2012_925				
Comment Code					
A1 : Exterminate rodents and backfill and compact or grout burrows.					
Inspector Comment					
There are several rodent holes on the levee slope.

View of landside slope with multiple animal burrows. Fall 2022

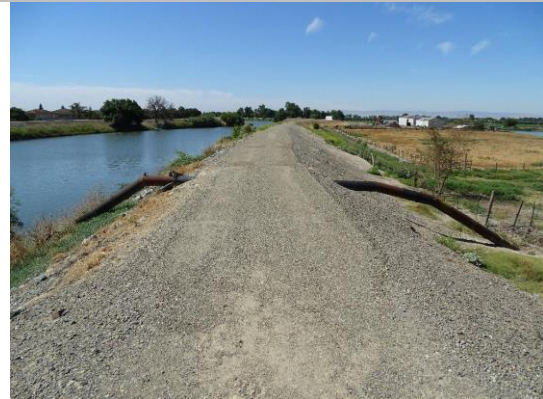
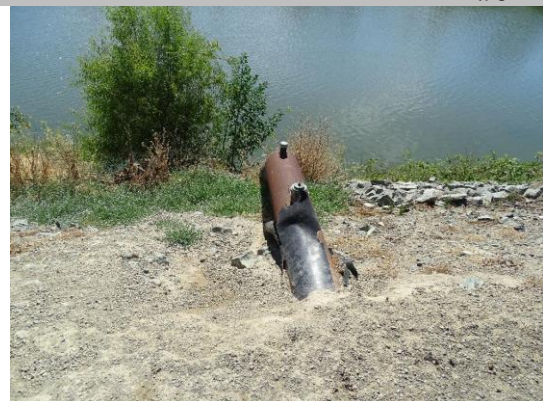
Comment Code					
Inspector Comment					
DS_ID:20617 FS_ID:73984 EP_NO: N/A Repair Type: No Action Needed EVAL Issue: Crossing Status: Indicator Found UCIP Comments: 06/24/2020 Record remains No Action Needed. No issues observed during inspection. System Feature. (D.Sanoski - DWR UCIP) 08/20/2013 Review crossing with inspector as records indicate that this should be an 8-inch pipe through levee 3.0 feet below crown, pump on landward side. Siphon breaker on the waterward slope. Originally included in the 1964 O&M manual. (W.Wylie - DWR UCIP) FIELD_STRUCT_DESC: 16-inch wrapped steel storm discharge pipe through the levee, 1.5 feet below the crown. Pump on steel pile structure at drainage canal off landside (LS) toe. [Additional Reference(s): DWR Levee Log, 2004 (HLM 2.99, listed as 8-inch pipe). USACE San Joaquin O&M Manual, Unit 7, April 1964, Revised 29 December 2016, (2.99), listed as 9-inch pipe]. FS Date: 6/24/2020 2:44:00 PM

Overview of Levee: view of crown with pipe through crown.

Water-Side: view of WS slope with pipe out of slope.

Land-Side: view of LS slope and pipe out of slope.

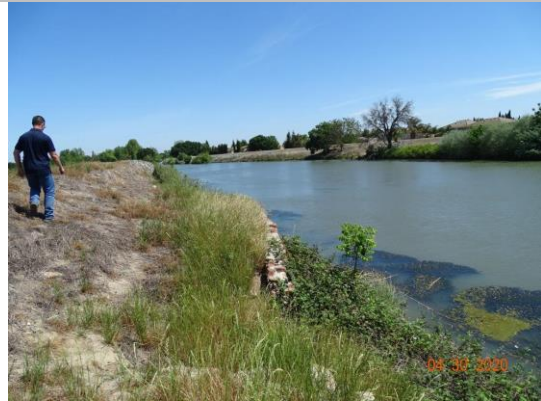
Photo 1 of 1 : FA_2023_RD0524_107_220_20230905_00031.jpg

LM Start	3.12	Rating **	M	Issue No.	220
LM End	3.12	Issue Type +	En	Location *	WS
Category	Earthen Levee			GPS Latitude/Longitude	
				Start	End
Item	Encroachments			37.910786°	37.910786°
				-121.325243°	-121.325243°
DWR ID	DWR_RD0524_01_s_2020_220				
Comment Code					
RW : Retaining Wall					
Inspector Comment					
An old retaining wall made of bricks on the waterside slope is in poor condition.

View of damaged retaining wall on waterside slope. Approximately 30 ft. long, 8 ft. high and 20 ft. from waterside hinge. Spring 2020

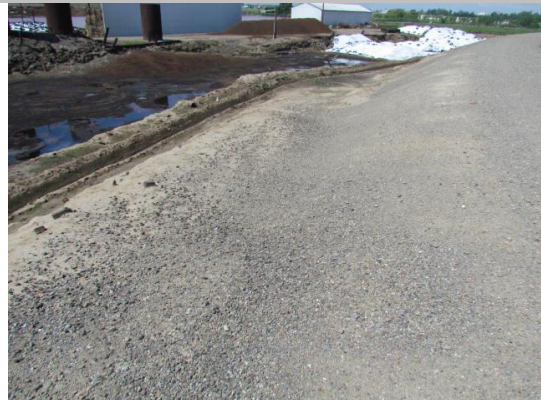
Photo 1 of 1 : FA_2023_RD0524_107_211_20230905_00029.jpg

LM Start	3.18	Rating **	M	Issue No.	211
LM End	3.18	Issue Type +	En	Location *	LS
Category	Earthen Levee			GPS Latitude/Longitude	
				Start	End
Item	Encroachments			37.909945°	37.909945°
				-121.325543°	-121.325543°
DWR ID	DWR_RD0524_01_f_2020_211				
Comment Code					
RA : Ramp					
Inspector Comment					
There is an unauthorized ramp on the landside slope.

Looking northwest at unauthorized ramp on landward slope.

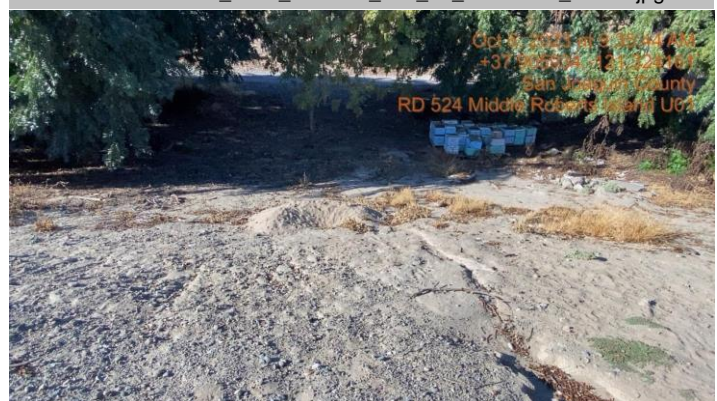
Photo 1 of 1 : FA_2023_RD0524_107_24_20231101_00071.jpg

View of large animal burrow on the landside slope. Fall 2023

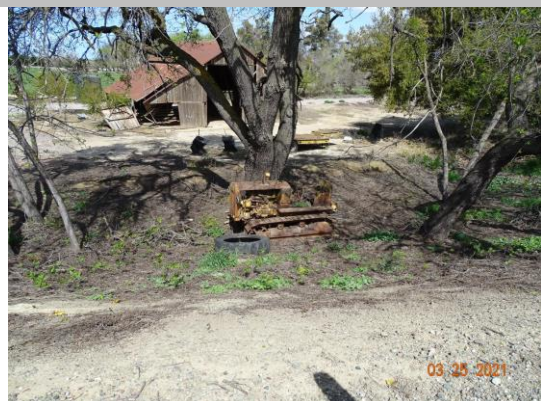
Photo 1 of 1 : FA_2023_RD0524_107_301_20230905_00038.jpg

View of an abandoned piece of farm equipment within the landside easement. Spring 2021

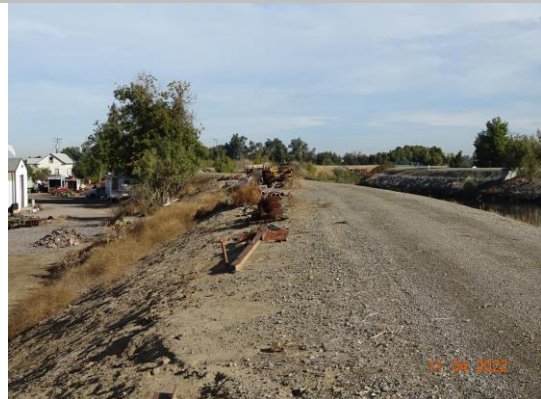
Photo 1 of 1 : FA_2023_RD0524_107_95_20230905_00015.jpg

View of farm equipment being stored along the landside shoulder. Fall 2022

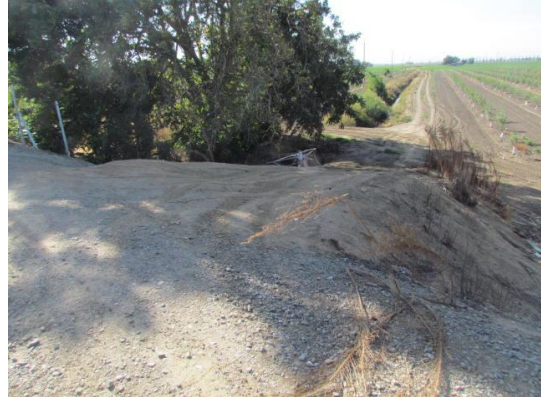
Photo 1 of 1 : FA_2023_RD0524_107_101_20230905_00017.jpg

Looking west at unauthorized ramp on landside slope.

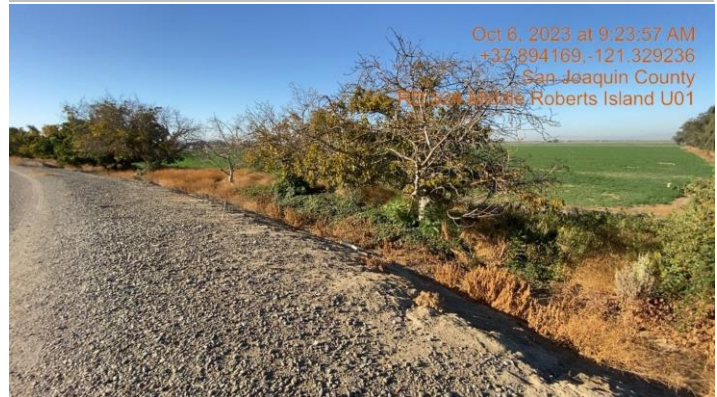
Photo 1 of 1 : FA_2023_RD0524_107_150_20231101_00070.jpg

View of wild vegetation growth along the landside slope and easement.
Fall 2023

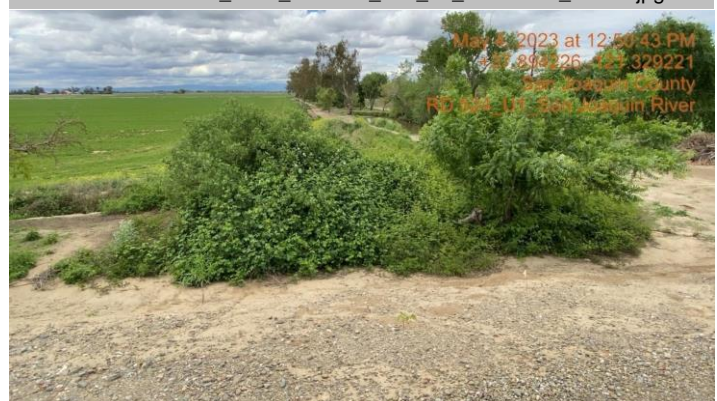
Photo 1 of 1 : FA_2023_RD0524_107_16_20230905_00014.jpg

View of fallen tree along the landside slope and easement. Spring 2023

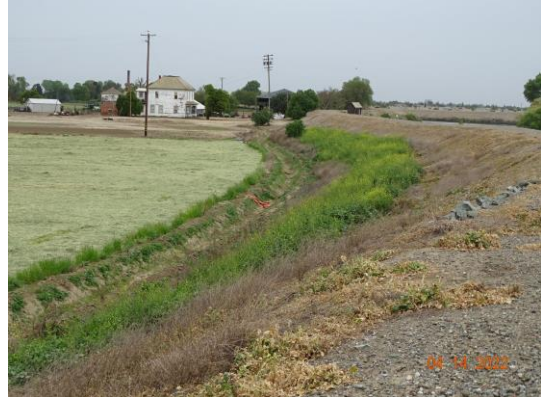
Photo 1 of 1 : FA_2023_RD0524_107_116_20230905_00019.jpg

View of an irrigation ditch along the landside easement. Spring 2022

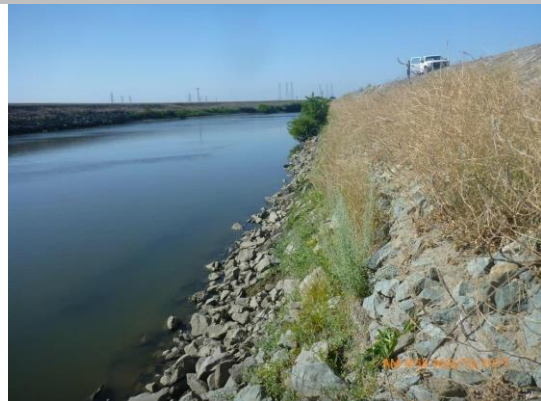
Photo 1 of 1 : LEVAL_FA_2023_523_4217.jpg

LM Start	4.76	Rating **	A/W	Issue No.	236
LM End	4.76	Issue Type +	Ma	Location *	WS
Category	Earthen Levee			GPS Latitude/Longitude	
				Start	End
Item	Erosion / Bank Caving			37.889300°	37.889300°
				-121.329800°	-121.329800°
DWR ID	DWR_RD0524_01_s_2020_236				
Comment Code					
E1 : Note and monitor erosion site.					
Inspector Comment					
This is a 2017 Strom Damage Site, ID No. 523, LMA-429.

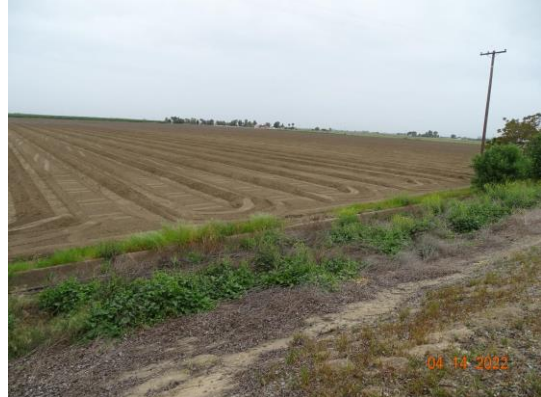
Photo 1 of 1 : FA_2023_RD0524_107_111_20230905_00018.jpg

View of concrete lined irrigation ditch along the landside easement.
Spring 2022

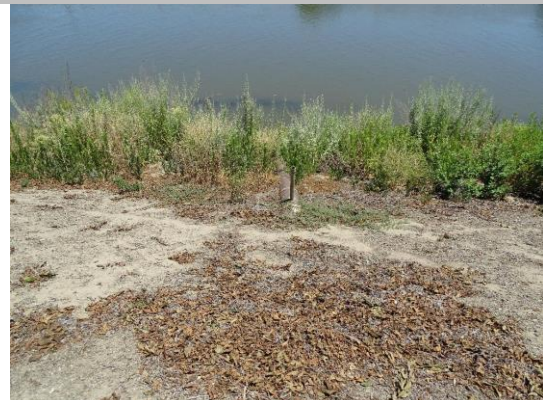
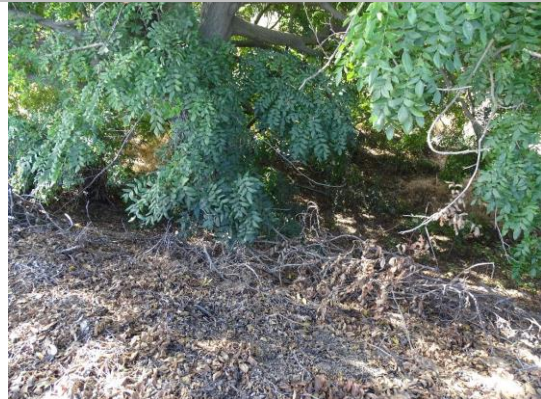
Comment Code						
Inspector Comment						
DS_ID:20630 FS_ID:73985 EP_NO: N/A Repair Type: Non-Urgent EVAL Issue: 5, Pipe Damage Crossing Status: Found UCIP Comments: 06/24/2020 Record updated from Urgent to Non-Urgent. Pipe damage visible on WS. Crossing appears abandoned. Limited inspection on LS due to overgrown vegetation. System Feature. (D.Sanoski - DWR UCIP) 10/2/2018 Same as last inspection. Holes present in pipe pose a potential threat to levee's internal integrity. Recommend video inspection (D. Sanoski - DWR UCIP).11/16/2016 same as previous inspection hole in pipe is still present on WS near toe. This pipe does not appear to be in use. Need to contact owner to determine status of crossing. If the crossing is abandoned or still in use, owner will need to coordinate with the CVFPB to comply with Title 23 requirements. (O. Magana - DWR UCIP)08/23/2013 flap gate damage and does not work at WS toe. Large hole in pipe at WS toe. Pipe appears abandoned and should be done so properly. (W. Wylie - DWR UCIP) FIELD_STRUCT_DESC: 12-inch steel pipe through the levee, 6 feet below the crown. Flap gate located on the WS end. LS end not found. FS Date: 6/24/2020 2:53:00 PM

Top of Levee: view of crown.

Water-Side: view of WS slope and pipe.

LS view - could not find pipe outlet.

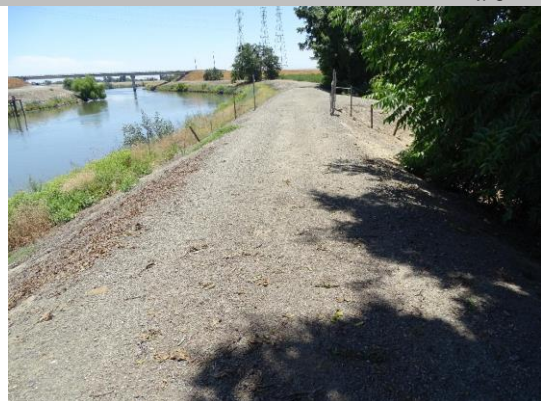
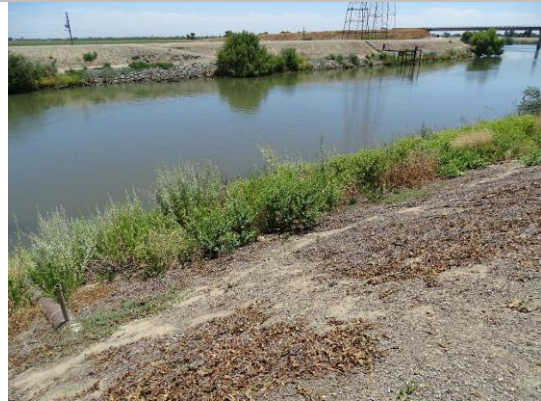
Top of Levee: view of crown.

Water-Side: view of WS slope.

Land-Side: view of LS slope.

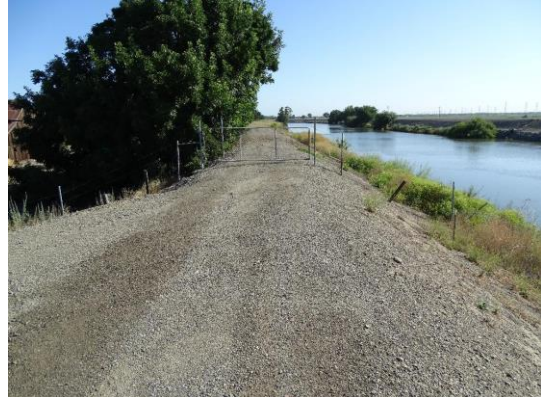
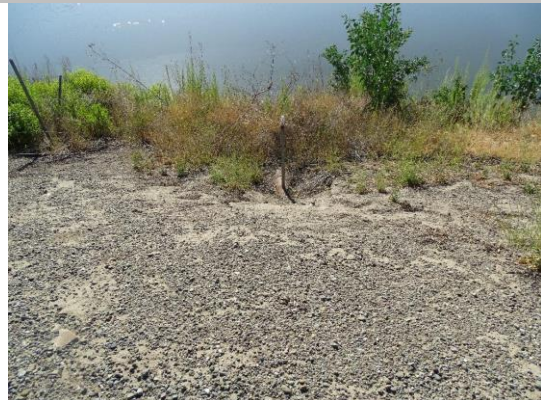
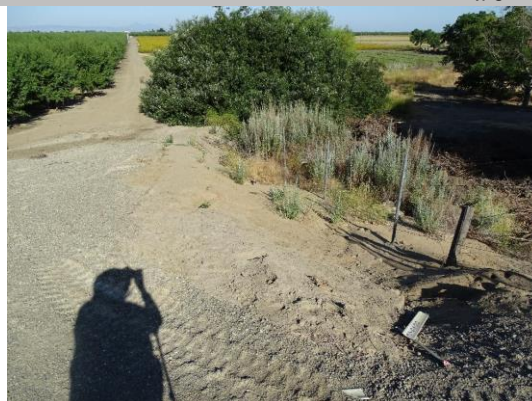
Top of Levee: view of crown.

Water-Side: view of WS slope and pipe.

Land-Side: view of LS slope with no sign of inlet pipe due to overgrown vegetation limiting inspection.

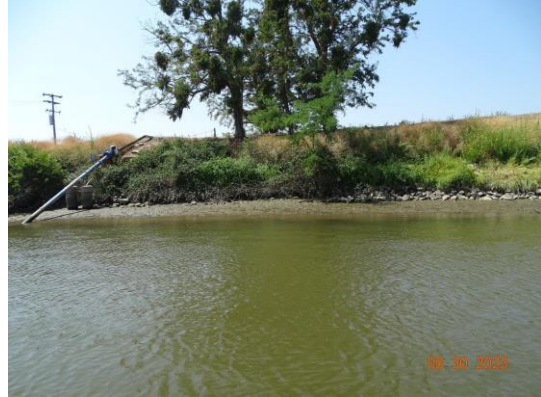
Photo 1 of 2 : SJR2023_RD524U01RM46.06_1.JPG

8/31/2023: View of the erosion immediately downstream of an irrigation pipe.

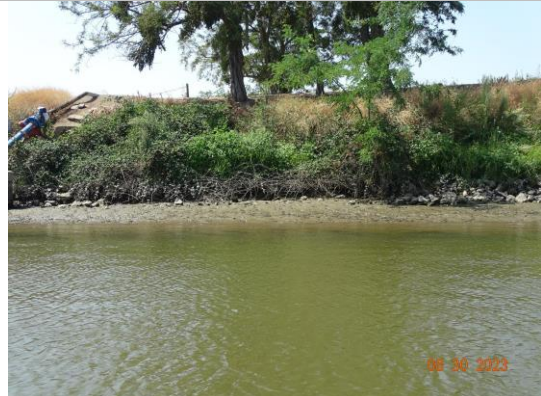
Photo 2 of 2 : SJR2023_RD524U01RM46.06_2.JPG

8/31/2023: Close-up view of the erosion.

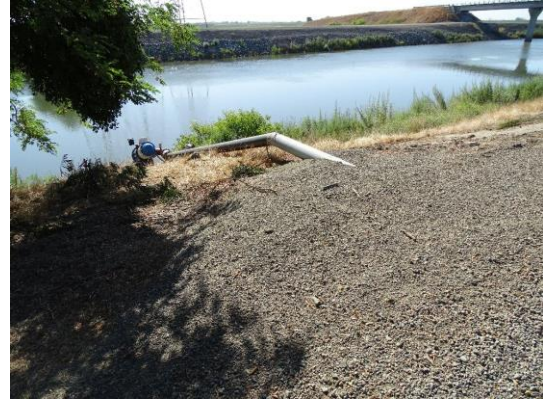
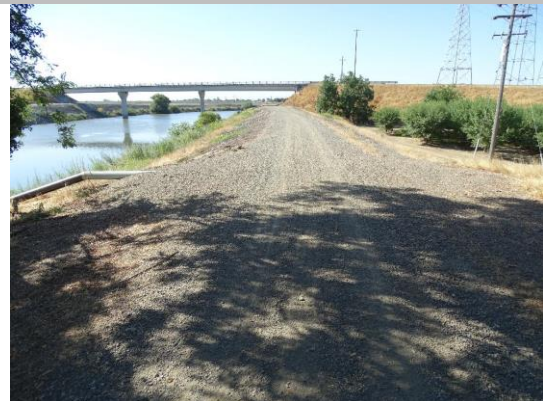
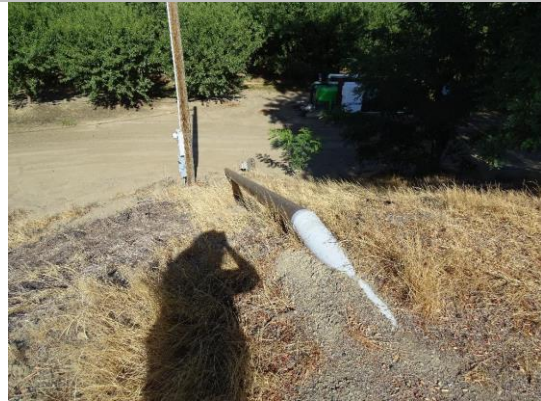
View of WS slope.

View of levee crown.

View of LS slope.

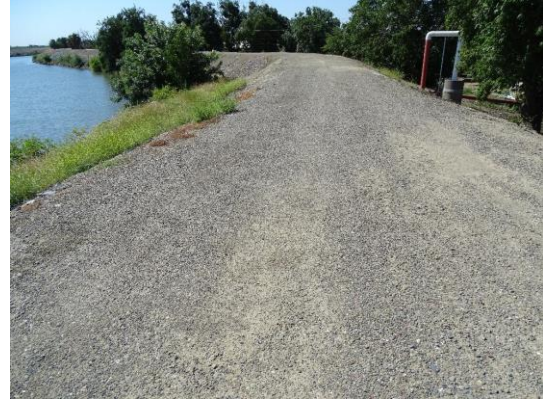
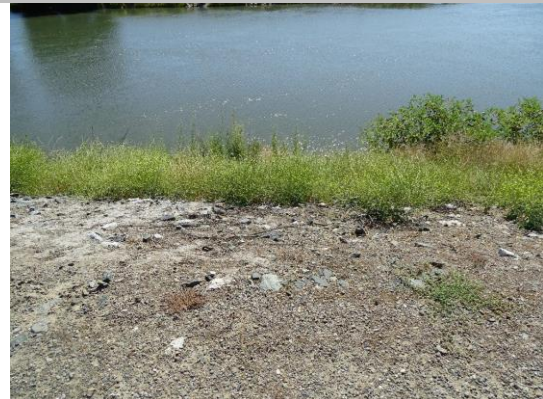
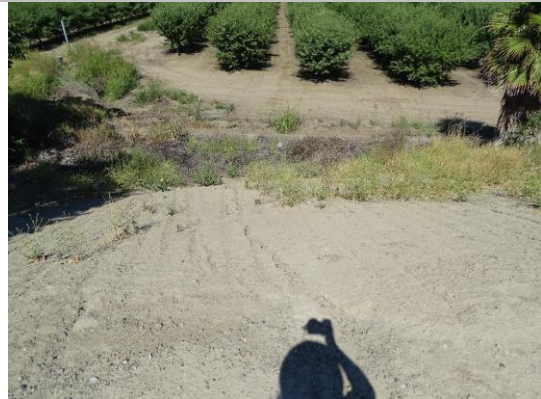
Top of Levee: view of crown.

Water-Side: view of WS slope with no sign of pipe or concrete structure.

Land-Side: view of LS slope with no sign of pipe.

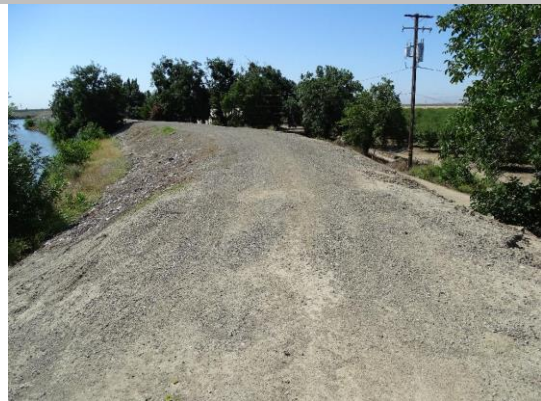
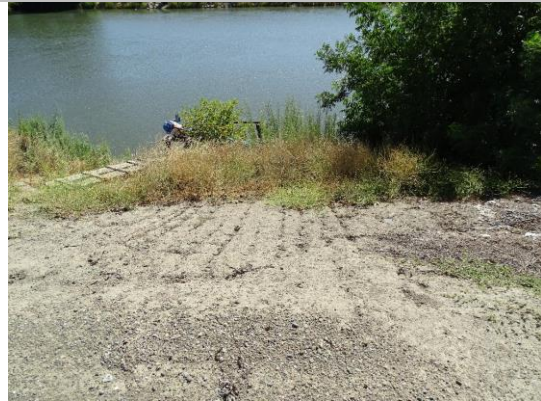
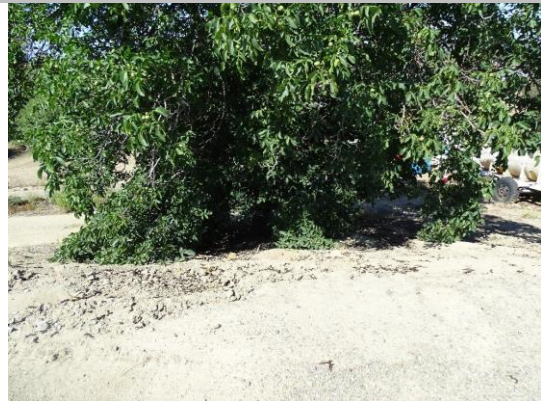
Top of Levee: view of crown.

Water-Side: view of WS slope with no sign of crossing.

Land-Side: view of LS slope with no sign of crossing.

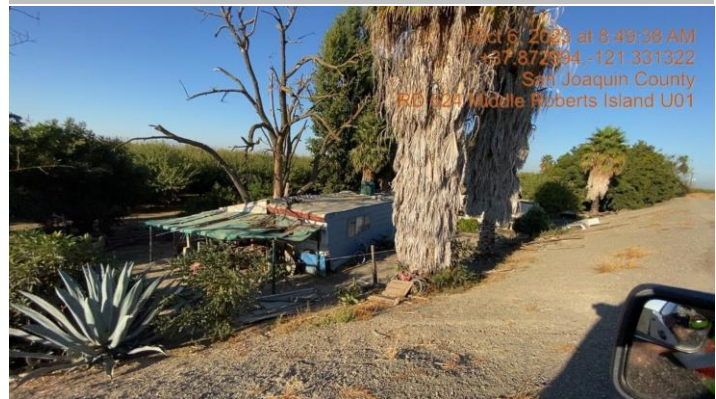
Photo 1 of 1 : FA_2023_RD0524_107_274_20231101_00069.jpg

View of dwellings and animal pens along the landside easement. Fall 2023

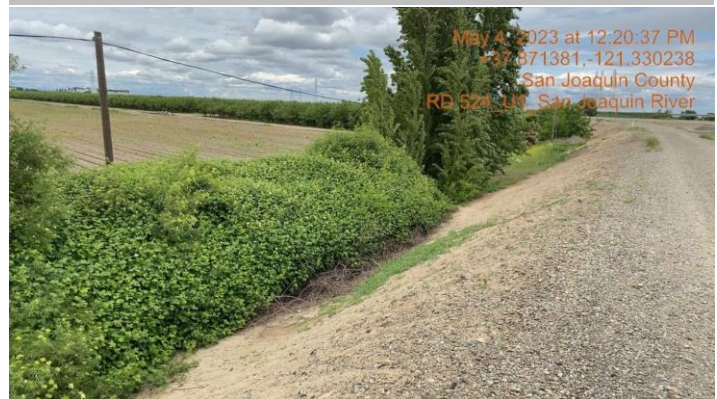
Photo 1 of 1 : FA_2023_RD0524_107_98_20230905_00016.jpg

View of berry bushes and ivy along the landside slope and easement.
Spring 2023

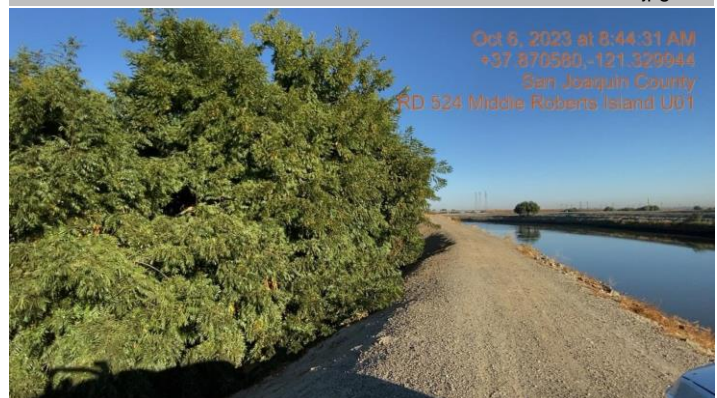
Photo 1 of 1 : FA_2023_RD0524_107_188_20231101_00068.jpg

View of untrimmed trees along the landside slope. Fall 2023
