Flood Control Project Maintenance Levee Inspections

Fall 2024 Levee Maintenance Deficiency Summary Report

San Joaquin River Basin

Reclamation District No. 0524 Middle Roberts Island

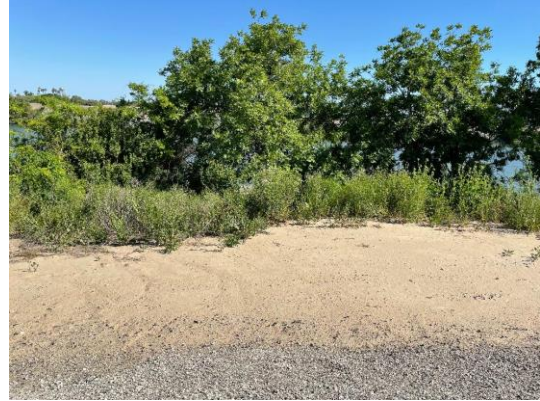
Photo 2 of 3 : UCIP_FA_2024_83419_121987.jpg

WS view: overview of WS shoulder. abandoned concrete pad removed.

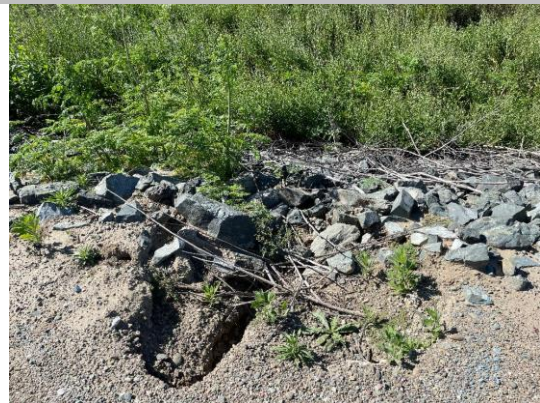
Photo 3 of 3 : UCIP_FA_2024_83419_121985.jpg

LS view: minor sloughing about 15 feet off LS toe.

LM Start	0.32	Rating **	M	Issue No.	113
LM End	0.37	Issue Type +	Ma	Location *	WS
Category	Earthen Levee			GPS Latitude/Longitude	
				Start	End
Item	Animal Control			37.938434 °	37.938535 °
				-121.341967 °	-121.341037 °
DWR ID	DWR_RD0524_01_f_2019_113				
Comment Code					
A3 : No rodents visible, but rodent burrows visible; need to backfill and compact or grout burrows.					
Inspector Comment

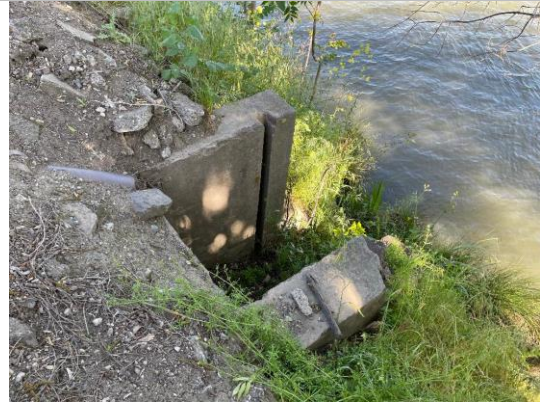
Photo 3 of 3 : UCIP_FA_2024_83469_122090.jpg

Comment Code					
Inspector Comment					
DS_ID:20598 FS_ID:83469 EP_NO: N/A Repair Type: Non-Urgent EVAL Issue: Crossing Status: Found UCIP Comments: 04/29/2024 Record remains Non-Urgent. Pipe is a good candidate for internal pipe inspection. (J. Taylor - DWR UCIP) 06/23/2020 Record updated from No Action Needed to Non-Urgent. System Feature. Crossing appears abandoned. (D.Sanoski - DWR UCIP) FIELD_STRUCT_DESC: 36-inch drainage pipe of an unknown material through the levee, 15 feet below the crown. Landside (LS) end is not visible. Concrete headwall at outlet on the waterside (WS) slope is visible. Pipe appears to be abandoned in place. Slide gate on the WS removed. [Additional Reference(s): DWR Levee Log, 2004 (HLM 0.99). USACE San Joaquin O&M Manual, Unit 7, April 1964, Revised 29 December 2016, (0.99), listed as 36-inch pipe]. FS Date: 4/29/2024 12:26:34 PM

WS view: view of concrete headwall. Pipe not safely accessible.

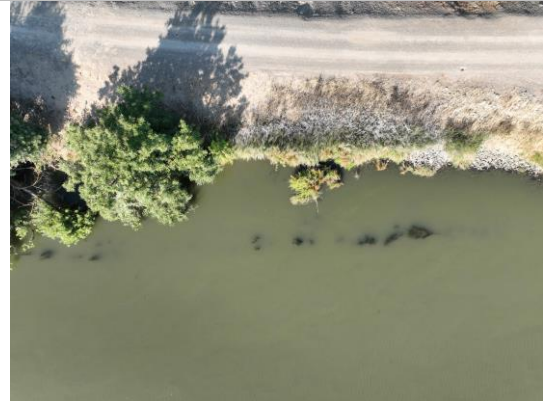
Photo 1 of 1 : SJR2024_RD0524U01RM41.79_1.JPG

Comment Code					
Inspector Comment					
Site ID: RD0524U01RM41.79 8/9/2024: From 2010 to present, no significant changes were observed during the annual survey. Minimal vegetation covers the upper levee slope. The lower slope is covered with medium dense vegetation. Riprap is visible in some areas. 09/07/2010: Vegetation is visible at the water line. There is an exposed pipe discharge partially hanging at the mid-slope, possibly still used for discharging irrigation/runoff water. There is minimal rip rap protection along the bank, and what's left of it is no longer adequately protecting the bank. 9/29/2009: Site consists of a 400-foot long eroding bank with minimal vegetation and protection; the existing rip rap has sloughed, rendering it useless; note that there is an exposed section of a pipe. 10/18/2006: There is extensive loss of rip rap on some sections; sewage disposal pond is on the landside of the levee; there is an exposed pipe outlet "hanging" from the upper slope.

8/9/2024: Aerial view of the erosion.

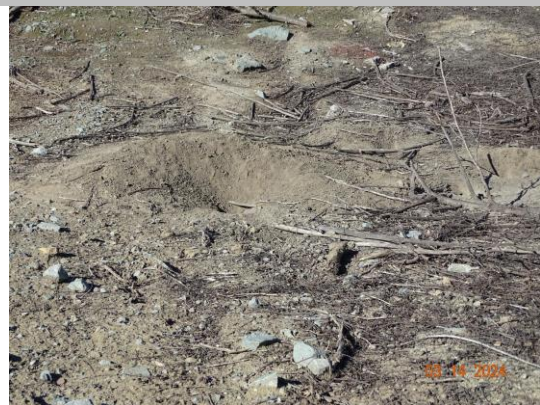
Photo 1 of 1 : FA_2024_RD0524_107_50_20240910_00017.jpg

View of large animal burrow along the landside slope. Spring 2024

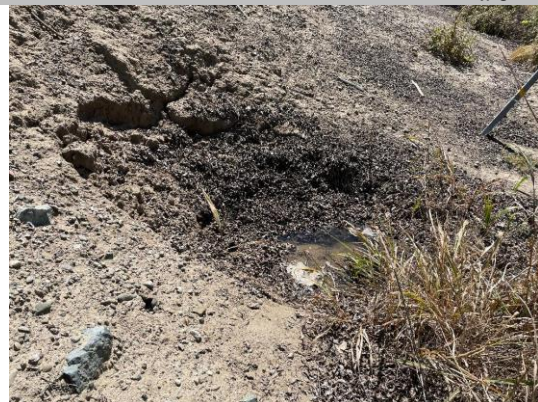
Photo 2 of 3 : UCIP_FA_2024_83639_122618.jpg

Comment Code					
Inspector Comment					
DS_ID:20609 FS_ID:83639 EP_NO: N/A Repair Type: Urgent EVAL Issue: 1, Pipe Integrity Crossing Status: Found UCIP Comments: 04/29/2024 Record updated from Non-Urgent to Urgent. Leaking pipe on both WS and LS. On LS water is coming out of the LS toe and causing significant erosion on LS slope. Leaking on WS is coming from the wrap on the pipe but does not appear to be causing erosion on the levee slope. (J. Taylor - DWR UCIP) 6/23/2020 Record remains Non-Urgent. Unauthorized encroachment recorded in Levee Log prior to 2011. No permit has been identified authorizing pipe. (D.Sanoski - DWR UCIP) FIELD_STRUCT_DESC: 14-inch irrigation pipe of an unknown material through the levee, 20 feet below the crown. 2 pumps and gate valves discharge into surge tank in pump house on the waterside (WS) slope. Concrete distribution box removed from the WS slope. Abandoned 36-inch diameter concrete standpipe on the landside (LS) toe next to service pole. [Additional Reference(s): DWR Levee Log, 2004. USACE San Joaquin O&M Manual 7, April 1964, (HLM 1.83)]. FS Date: 4/29/2024 7:59:42 AM

LS view: view of erosion caused by pipe on LS slope and toe.

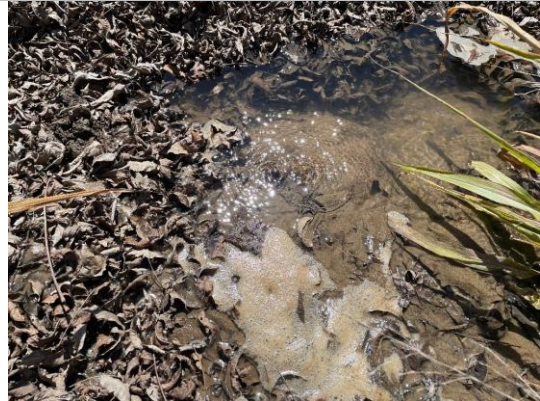
Photo 3 of 3 : UCIP_FA_2024_83639_122619.jpg

LS view: pipe leaking up through the levee slope like a boil.

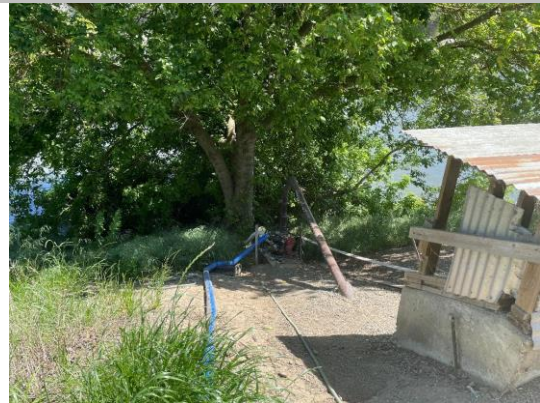
Photo 1 of 3 : UCIP_FA_2024_83659_122685.jpg

WS view: overview of WS slope with sleeved pipe and pump visible on slope.

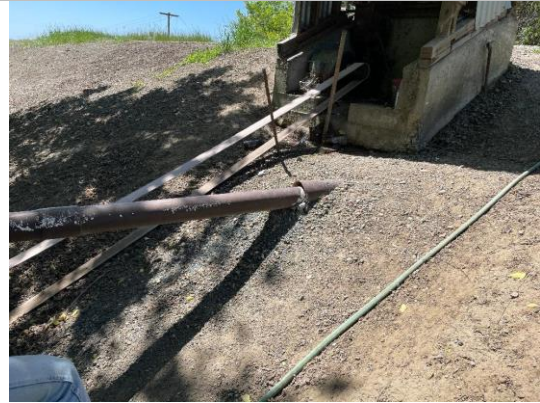
Photo 2 of 3 : UCIP_FA_2024_83659_122683.jpg

Comment Code					
Inspector Comment					
DS_ID:20611 FS_ID:83659 EP_NO: N/A Repair Type: Urgent EVAL Issue: 3b, Flood Risk Crossing Status: Found UCIP Comments: 04/29/2024 Record updated from Non-Urgent to Urgent. Pipe is open on the WS slope where pipe is sleeved approximately 5 feet below levee crown, also open on LS. Because the opening is above the 200-year WSE it received code 3b and is a flood risk during high water events. (J. Taylor - DWR UCIP) 06/23/2020 Record updated from No Action Needed to Non-Urgent. No permit has been identified authorizing pipe. (D.Sanoski - DWR UCIP) FIELD_STRUCT_DESC: 6-inch irrigation pipe of an unknown material through the levee, 3.5 feet below the crown. 4.5-inch irrigation pipe of unknown material sleeved through 6-inch pipe. Pump on concrete slab on the waterside (WS) slope. 6-foot by 6-foot brick distribution box and power pole at the landside (LS) toe. [Additional Reference(s): DWR Levee Log, 2004 (HLM 2.06). USACE San Joaquin O&M Manual, Unit 7, April 1964, Revised 29 December 2016, (2.06), listed as 6-inch pipe]. FS Date: 4/29/2024 12:06:37 PM

WS view: view of loosely sleeved pipe which is a flood threat during high water. Approximately 5 feet below levee crown.

LM Start	2.04	Rating **	U	Issue No.	929 (cont)
LM End	2.04	Issue Type +	En	Location *

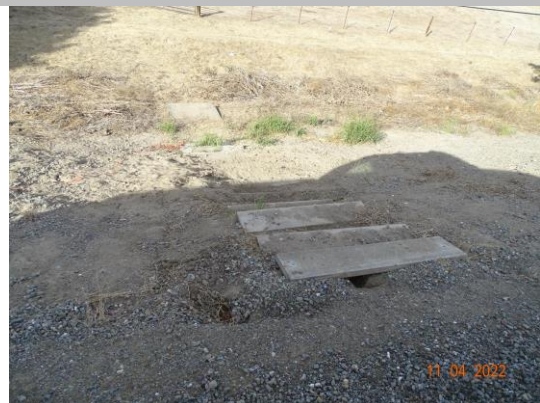
Photo 1 of 1 : FA_2024_RD0524_107_223_20240910_00028.jpg

View of stairs cut into levee landside slope. Fall 2022

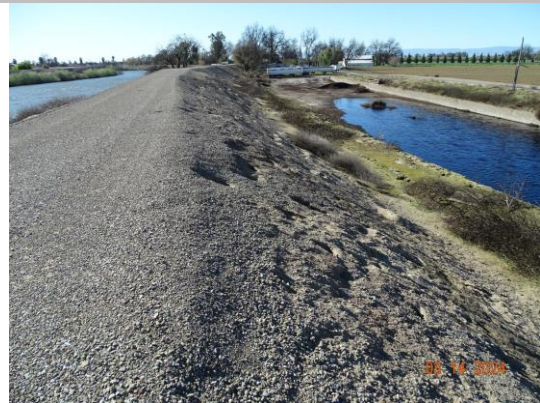
Photo 1 of 1 : FA_2024_RD0524_107_925_20240910_00035.jpg

View of multiple animal burrows along the landside slope. Spring 2024

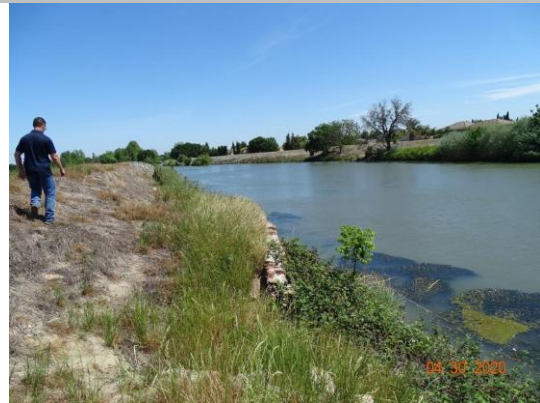
Photo 1 of 1 : FA_2024_RD0524_107_220_20240910_00027.jpg

View of damaged retaining wall on waterside slope. Approximately 30 ft. long, 8 ft. high and 20 ft. from waterside hinge. Spring 2020

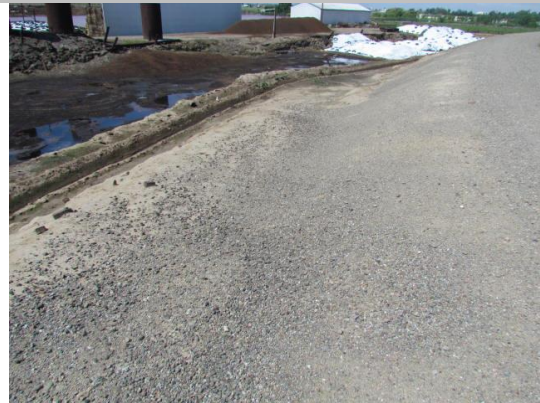
Photo 1 of 1 : FA_2024_RD0524_107_211_20240910_00026.jpg

Looking northwest at unauthorized ramp on landward slope.

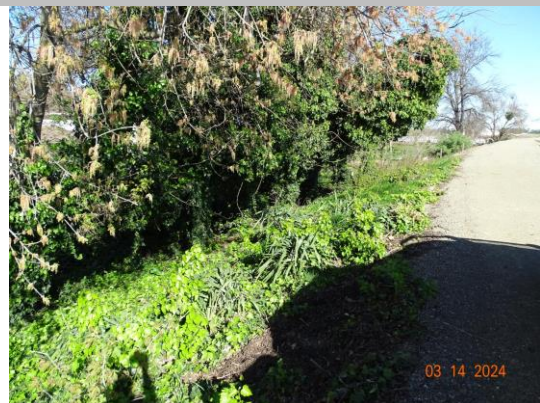
Photo 1 of 1 : FA_2024_RD0524_107_42_20240910_00015.jpg

View of ivy covering the landside slope and easement. Spring 2024

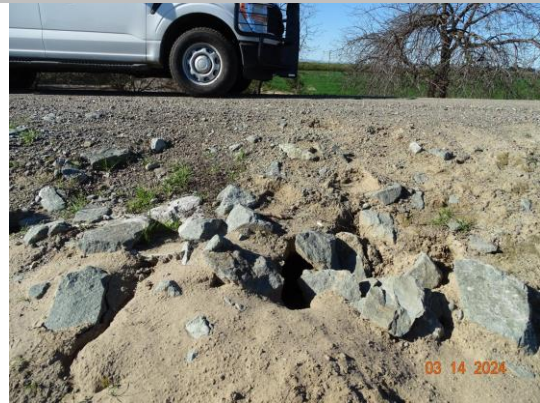
Photo 1 of 1 : FA_2024_RD0524_107_41_20240910_00014.jpg

View of large animal burrow along the waterside slope. Spring 2024

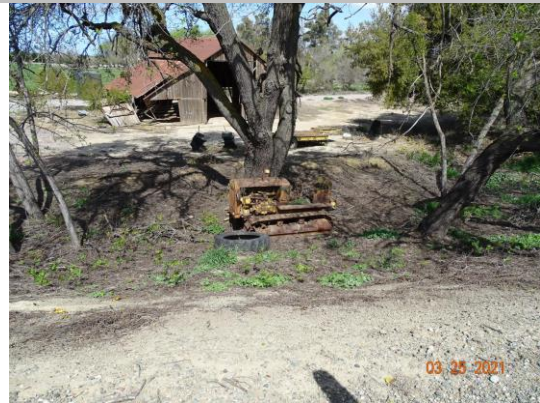
Photo 1 of 1 : FA_2024_RD0524_107_301_20240910_00034.jpg

View of an abandoned piece of farm equipment within the landside easement. Spring 2021

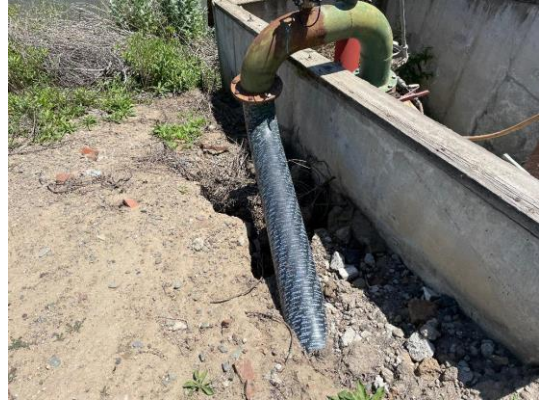
Photo 3 of 3 : UCIP_FA_2024_83717_122857.jpg

WS view: minor erosion under pipe on the left side of the concrete foundation when looking towards the WS.

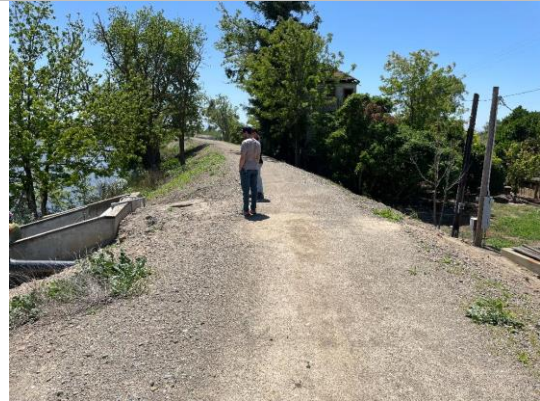
Photo 1 of 3 : UCIP_FA_2024_83720_122871.jpg

Overview of levee crown. Sink hole visible on WS shoulder.

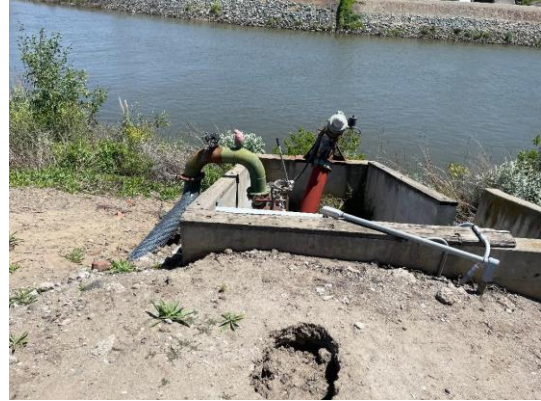
Photo 2 of 3 : UCIP_FA_2024_83720_122872.jpg

WS view: view of sink hole on WS shoulder in alignment with 12-inch pipe.

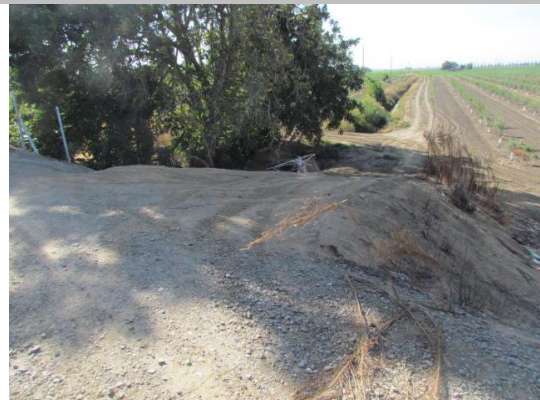
Photo 1 of 1 : FA_2024_RD0524_107_101_20240910_00020.jpg

Looking west at unauthorized ramp on landside slope.

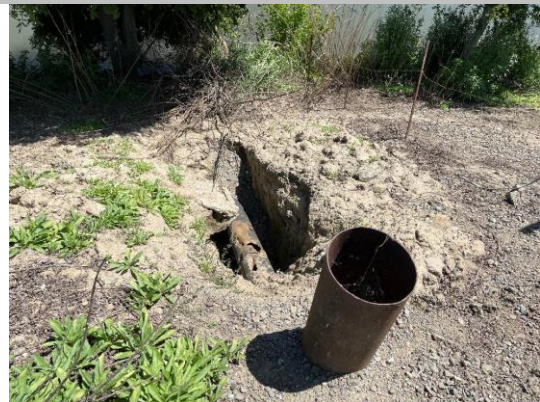
Photo 2 of 3 : UCIP_FA_2024_83727_122888.jpg

WS view: severe erosion on WS slope caused by pipe with severe holes.

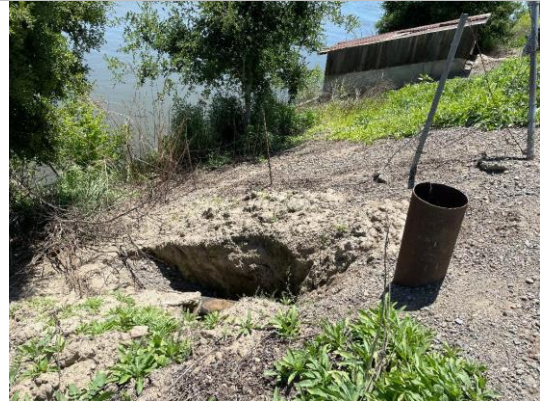
Photo 3 of 3 : UCIP_FA_2024_83727_122889.jpg

WS view: severe erosion on WS slope caused by pipe.

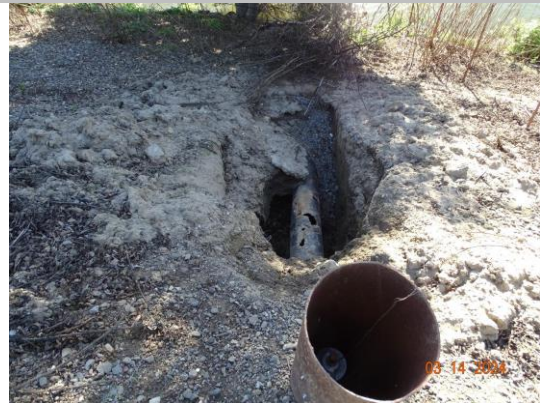
Photo 1 of 1 : FA_2024_RD0524_107_34_20240910_00012.jpg

View of an exposed pipe with holes along the waterside slope. Spring 2024

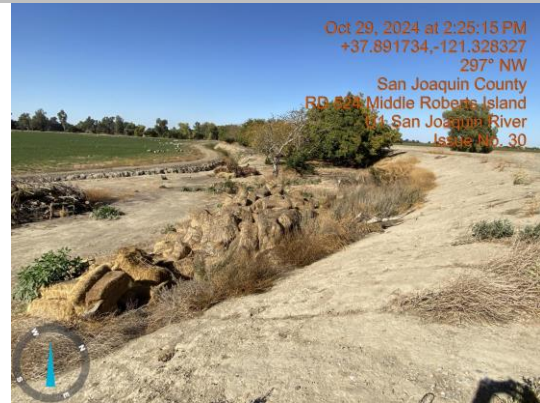
Photo 1 of 1 : FA_2024_RD0524_107_30_20241029_00090.jpg

View of hay stacks being stored along the landside easement. Fall 2024

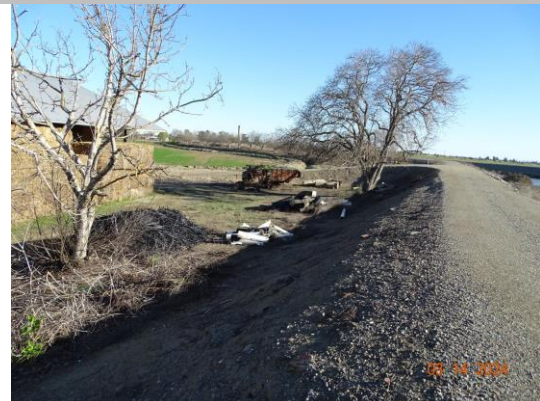
Photo 1 of 1 : FA_2024_RD0524_107_29_20240910_00010.jpg

View of farm equipment being stored along the landside easement.
Spring 2024

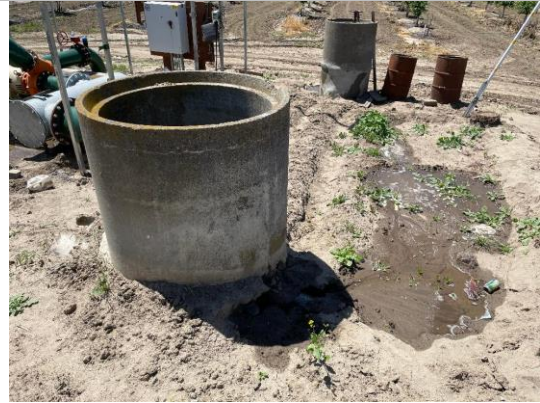
Photo 2 of 2 : UCIP_FA_2024_83779_122988.jpg

LS view: maintenance issue of concrete riser on LS leaking.

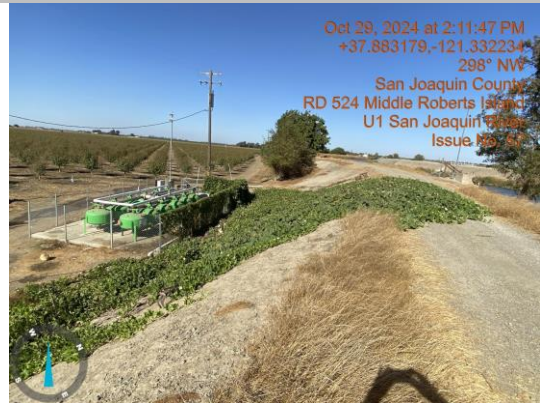
Photo 1 of 1 : FA_2024_RD0524_107_57_20241029_00089.jpg

View of vegetation on the landside slope and easement. Fall 2024

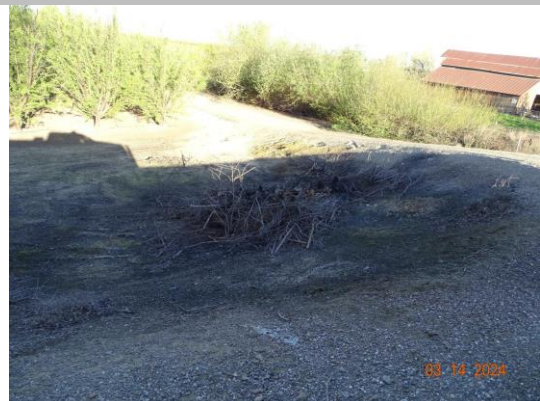
Photo 1 of 1 : FA_2024_RD0524_107_12_20240910_00005.jpg

View of prunings along the landside easement. Spring 2024

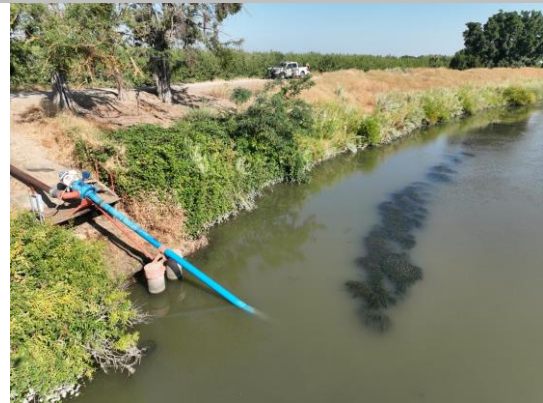
Photo 1 of 2 : SJR2024_RD0524U01RM46.06_4.JPG

8/9/2024: Aerial view of the erosion.

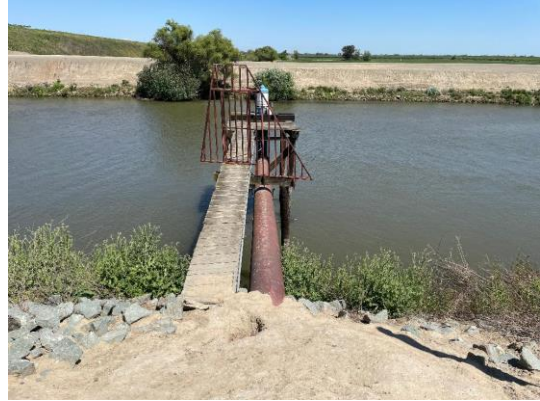
Photo 2 of 3 : UCIP_FA_2024_83790_123009.jpg

WS view: pump on pile structure with wooden walkway. Pipe visible entering the levee. Minor erosion around pipe on WS shoulder.

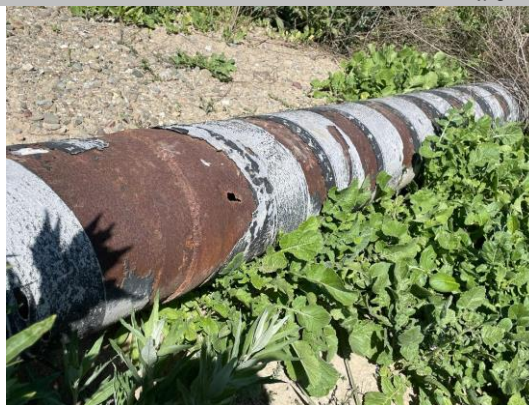
Photo 3 of 3 : UCIP_FA_2024_84032_123048.jpg

WS view: hole in pipe on WS slope.

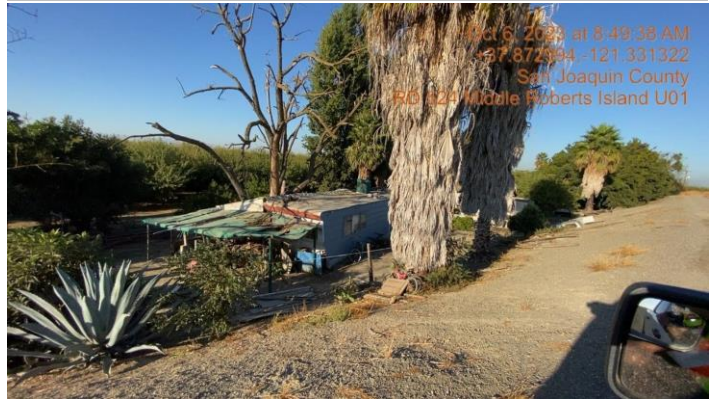
Photo 1 of 1 : FA_2024_RD0524_107_274_20240910_00033.jpg

View of dwellings and animal pens along the landside easement. Fall 2023

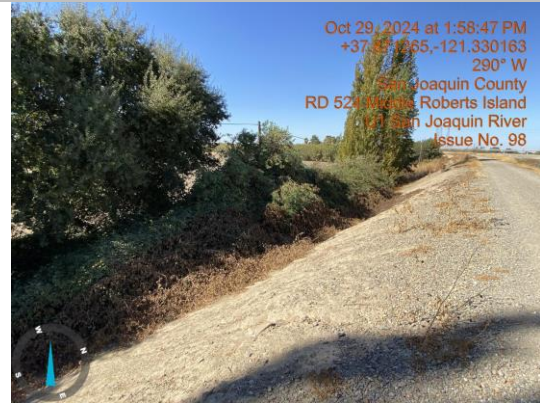
Photo 1 of 1 : FA_2024_RD0524_107_98_20241029_00088.jpg

View of berry bushes and ivy along the landside slope and easement.
Fall 2024

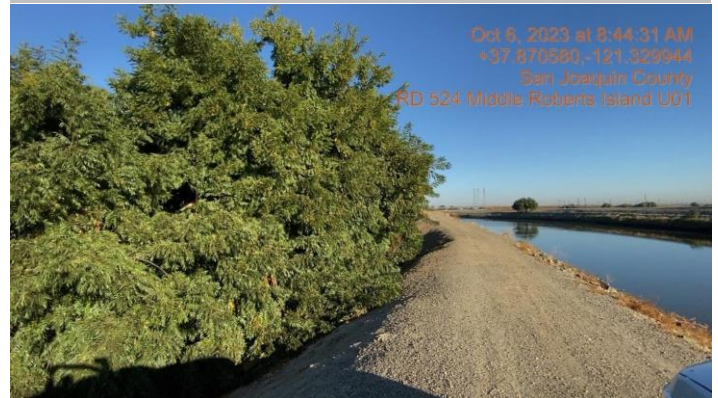
Photo 1 of 1 : FA_2024_RD0524_107_188_20240910_00025.jpg

View of untrimmed trees along the landside slope. Fall 2023
