**Flood Control Project Maintenance
Levee Inspections**
LMA District Cover Sheet
Spring 2009 Levee Inspection Results

Reclamation District No. 0524

**Flood Control Project Maintenance
Levee Inspections
Unit Cover Sheet
Spring 2009 Levee Inspection Results
Reclamation District No. 0524**

Levee Inspection Report By Mile - Spring 2009

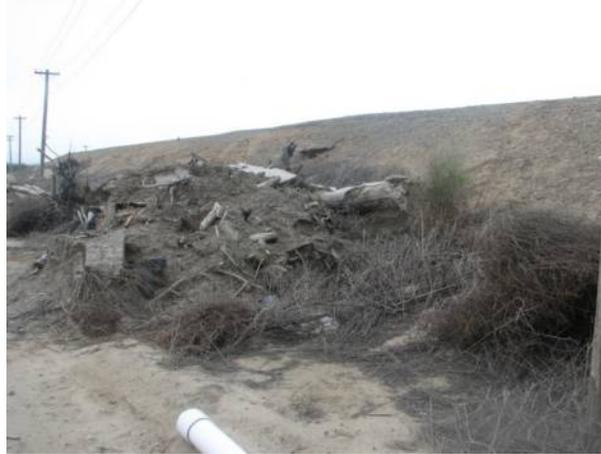
Levee Mile Report Line	4
Start Levee Mile	0.36
End Levee Mile	0.36
Location	Land Side
Category	Earthen Levee
Item	Encroachments
Garbage pile at landward toe at LM 0.36

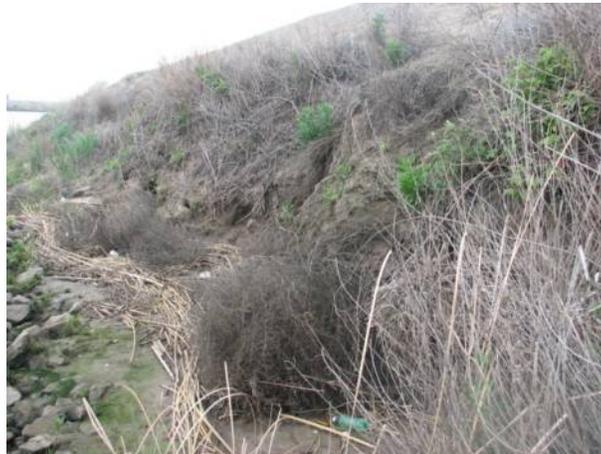
Levee Mile Report Line	5
Start Levee Mile	0.38
End Levee Mile	0.39
Location	Water Side
Category	Earthen Levee
Item	Erosion / Bank Caving
Minor erosion from LM 0.38 to 0.39

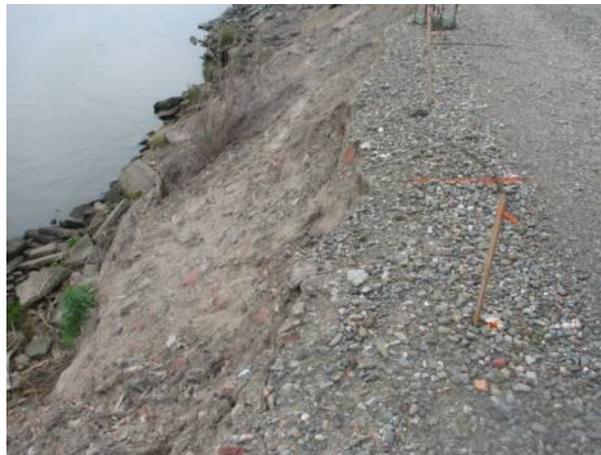
Levee Mile Report Line	7
Start Levee Mile	0.48
End Levee Mile	0.49
Location	Water Side
Category	Earthen Levee
Item	Erosion / Bank Caving
Major erosion from LM 0.48 to 0.49

7	0.48	0.49	Earthen Levee	Erosion / Bank Caving	WS	U	Schedule repair of erosion site prior to the next inspection.	37.938693 ° -121.339063 °	37.938693 ° -121.338993 °	Y	6
8	0.51	0.52	Earthen Levee	Erosion / Bank Caving	WS	M	Note and monitor erosion site.	37.938682 ° -121.338518 °	37.938657 ° -121.338425 °	Y	7
9	0.53	0.54	Earthen Levee	Erosion / Bank Caving	WS	M	Note and monitor erosion site.	37.938623 ° -121.338182 °	37.938617 ° -121.338045 °		8
10	0.58	0.59	Earthen Levee	Erosion / Bank Caving	WS	M	Note and monitor erosion site.	37.938512 ° -121.337335 °	37.938495 ° -121.337212 °		9
11	0.63	0.63	Earthen Levee	Slope Stability	WS	M	Repair the levee slope damaged by foot traffic and prevent access where possible.	37.938247 ° -121.336503 °	37.938247 ° -121.336503 °		10
12	0.63	0.64	Earthen Levee	Vegetation	WS	U	Remove the wild growth other than native grasses from the levee slopes.	37.938247 ° -121.336503 °	37.938197 ° -121.336405 °		11

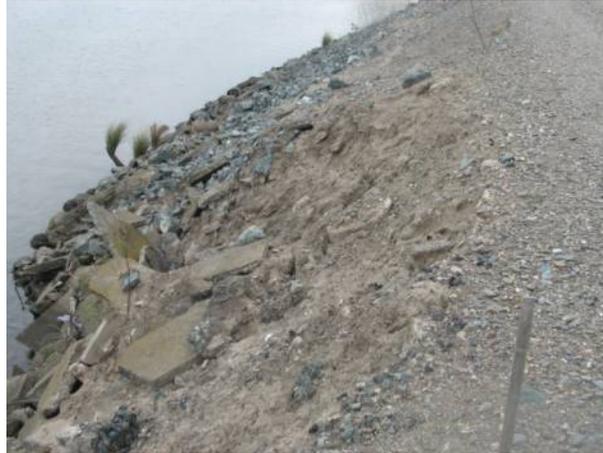
Levee Mile Report Line	8
Start Levee Mile	0.51
End Levee Mile	0.52
Location	Water Side
Category	Earthen Levee
Item	Erosion / Bank Caving
Erosion from LM 0.51 to 0.52

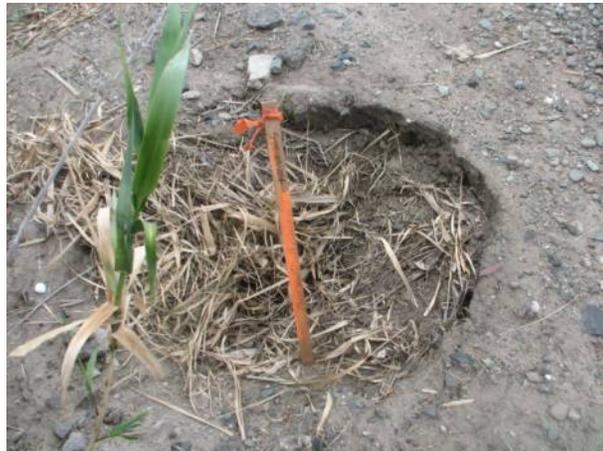
Levee Mile Report Line	13
Start Levee Mile	0.64
End Levee Mile	0.64
Location	Crown
Category	Earthen Levee
Item	Crown Surface / Depressions / Rutting
Large hole 3 x 3 on levee crown near waterside shoulder at LM 0.64

13	0.64	0.64	Earthen Levee	Crown Surface / Depressions / Rutting	CR	M	Regrade the crown roadway for proper drainage.	37.938198 ° -121.336407 °	37.938198 ° -121.336407 °	Y	12
14	0.65	0.66	Earthen Levee	Slope Stability	WS	M	Repair slope instability.	37.938105 ° -121.336288 °	37.938023 ° -121.336173 °	Y	13
15	0.68	0.68	Earthen Levee	Vegetation	WS	U	Remove the wild growth other than native grasses from the levee slopes.	37.937808 ° -121.335913 °	37.937808 ° -121.335913 °	Y	14
16	0.79	0.79	Boat Survey	Boat Survey Erosion	WS	M	Inspector Comments: Another site near Site 9.5 about 50 ft. upstream of fence; exposed pipe	37.936540 ° -121.334810 °	° °		913

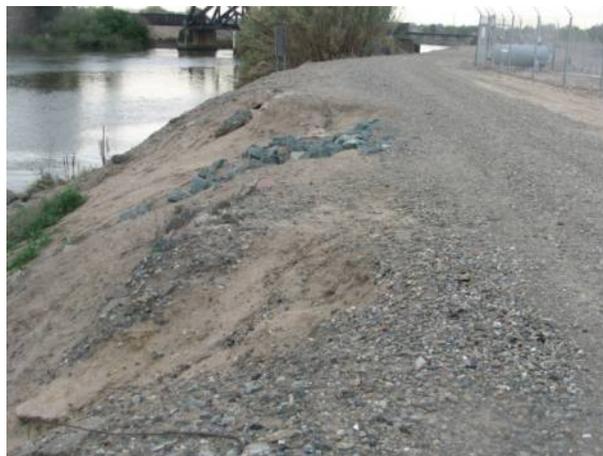
Levee Mile Report Line	14
Start Levee Mile	0.65
End Levee Mile	0.66
Location	Water Side
Category	Earthen Levee
Item	Slope Stability
Erosion from LM 0.65 to 0.66

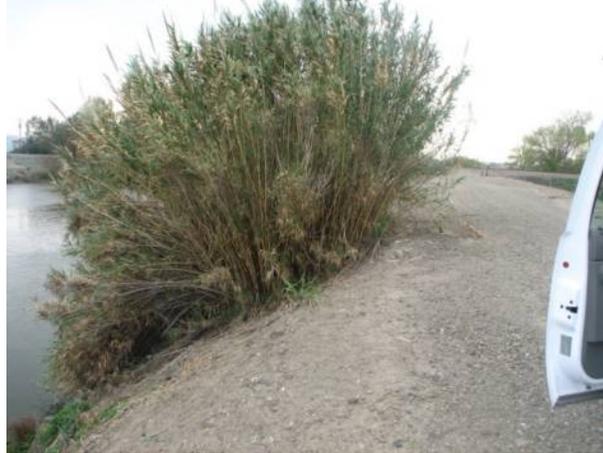
Levee Mile Report Line	15
Start Levee Mile	0.68
End Levee Mile	0.68
Location	Water Side
Category	Earthen Levee
Item	Vegetation
Bamboo on waterward slope at LM 0.68

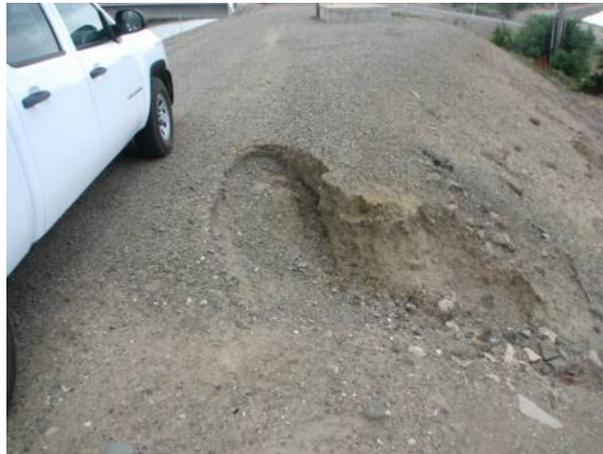
Levee Mile Report Line	21
Start Levee Mile	1.09
End Levee Mile	1.09
Location	Land Side
Category	Earthen Levee
Item	Slope Stability
Landward slope damage at LM 1.09

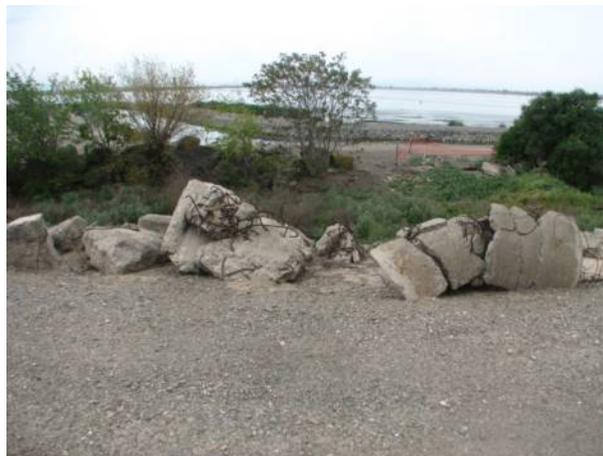
Levee Mile Report Line	24
Start Levee Mile	1.25
End Levee Mile	1.25
Location	Land Side
Category	Earthen Levee
Item	Encroachments
Concrete rubble with rebar on landward shoulder at LM 1.25

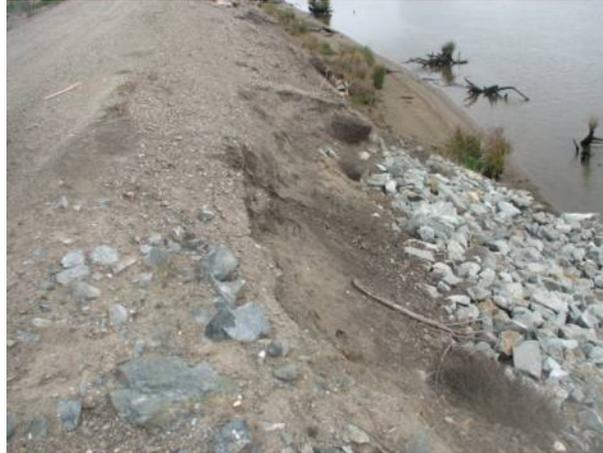
Levee Mile Report Line	25
Start Levee Mile	1.32
End Levee Mile	1.33
Location	Water Side
Category	Earthen Levee
Item	Erosion / Bank Caving
Erosion from LM 1.32 to 1.33

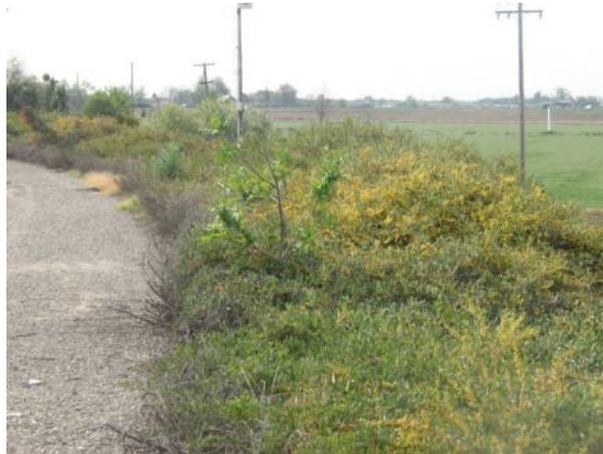
Levee Mile Report Line	28
Start Levee Mile	1.56
End Levee Mile	1.74
Location	Land Side
Category	Earthen Levee
Item	Encroachments
Overgrown landscaping on landward slope from LM 1.56 to 1.74

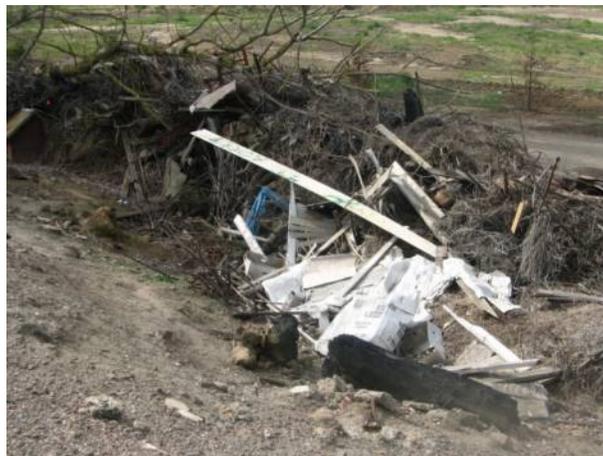
Levee Mile Report Line	33
Start Levee Mile	1.75
End Levee Mile	1.76
Location	Land Side
Category	Earthen Levee
Item	Encroachments
Garbage on landward toe from LM 1.75 to 1.76

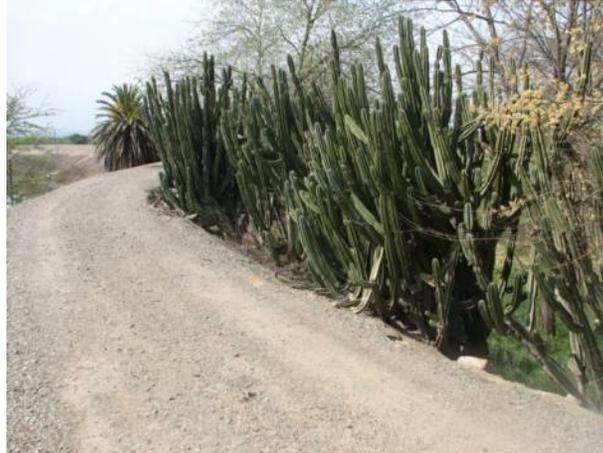
Levee Mile Report Line	60
Start Levee Mile	2.78
End Levee Mile	2.79
Location	Land Side
Category	Earthen Levee
Item	Encroachments
Landscaping (Cactus) on landward slope from LM 2.78 to 2.79

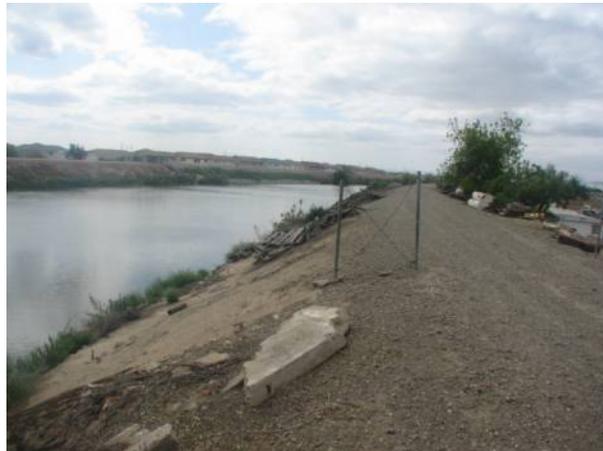
Levee Mile Report Line	82
Start Levee Mile	3.88
End Levee Mile	4.02
Location	Water Side
Category	Earthen Levee
Item	Encroachments
Looking upstream at prunings on waterside slope

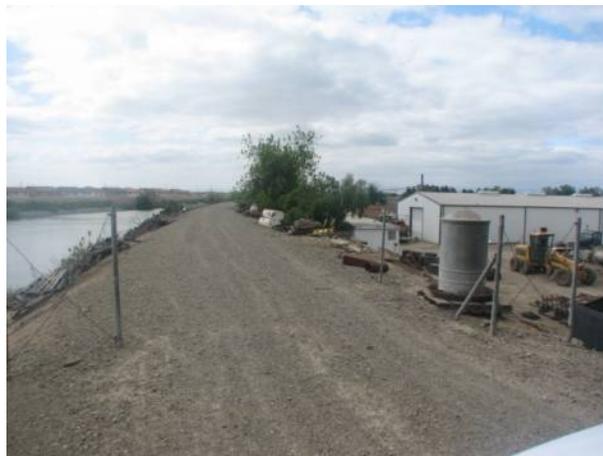
Levee Mile Report Line	84
Start Levee Mile	3.89
End Levee Mile	4.01
Location	Land Side
Category	Earthen Levee
Item	Encroachments
Looking upstream at equipment on landside shoulder

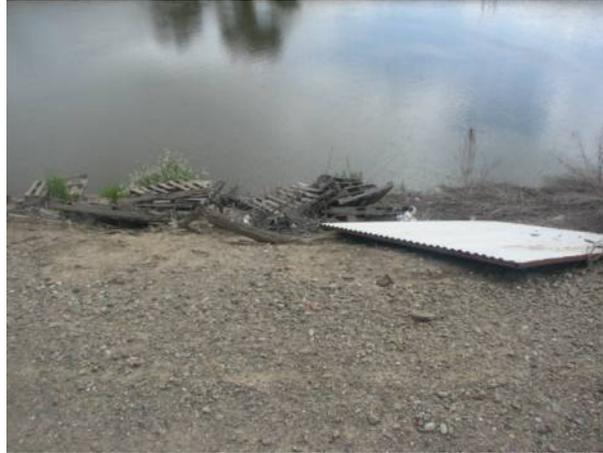
Levee Mile Report Line	85
Start Levee Mile	3.91
End Levee Mile	3.91
Location	Water Side
Category	Earthen Levee
Item	Encroachments
Looking at garbage (pallets) on waterside slope.

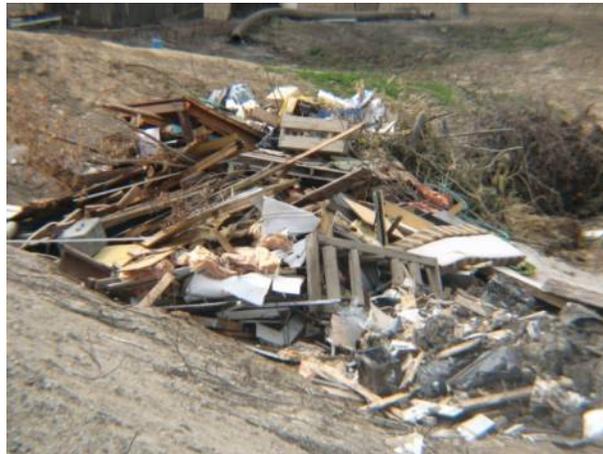
Levee Mile Report Line	87
Start Levee Mile	4.05
End Levee Mile	4.05
Location	Land Side
Category	Earthen Levee
Item	Encroachments
Garbage at landward toe at LM 4.05

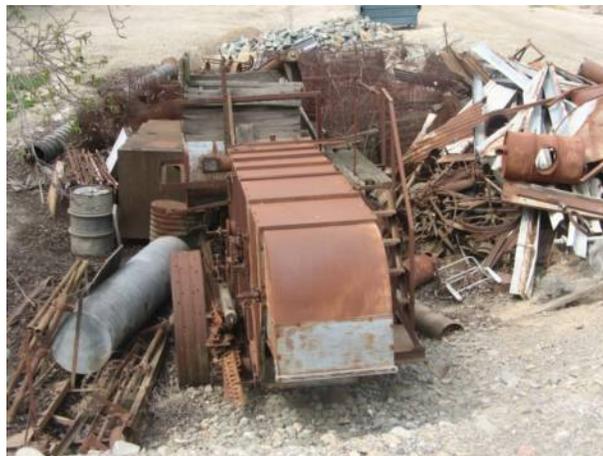
Levee Mile Report Line	91
Start Levee Mile	4.64
End Levee Mile	4.64
Location	Land Side
Category	Earthen Levee
Item	Encroachments
Garbage at landward toe next to ramp at LM 4.64

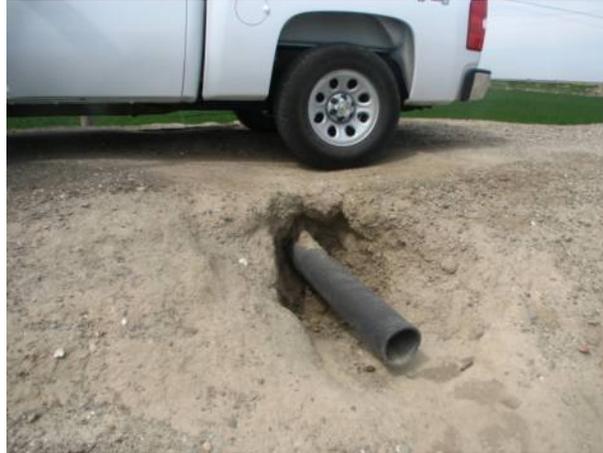
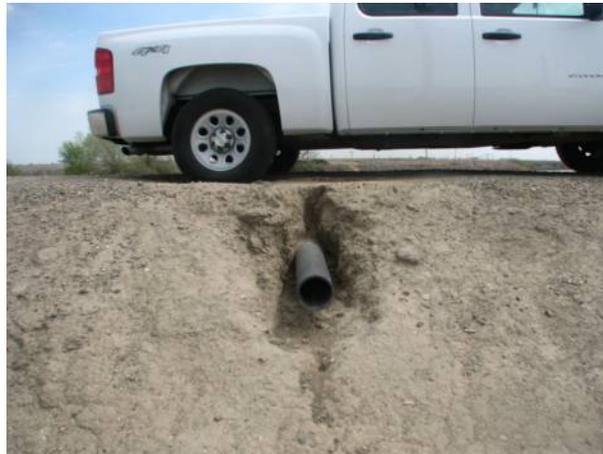
Levee Mile Report Line	101
Start Levee Mile	5.87
End Levee Mile	5.87
Location	Crown
Category	Earthen Levee
Item	Encroachments
Abandoned pipe at LM 5.87 wateside view

Levee Mile Report Line	101
Start Levee Mile	5.87
End Levee Mile	5.87
Location	Crown
Category	Earthen Levee
Item	Encroachments
Abandoned pipe at LM 5.87 landside view

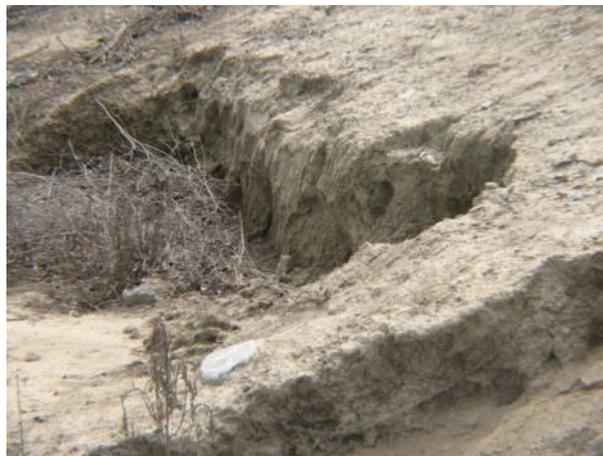
Levee Mile Report Line	104
Start Levee Mile	5.92
End Levee Mile	5.92
Location	Water Side
Category	Earthen Levee
Item	Erosion / Bank Caving
Erosion at waterward toe at LM 5.92

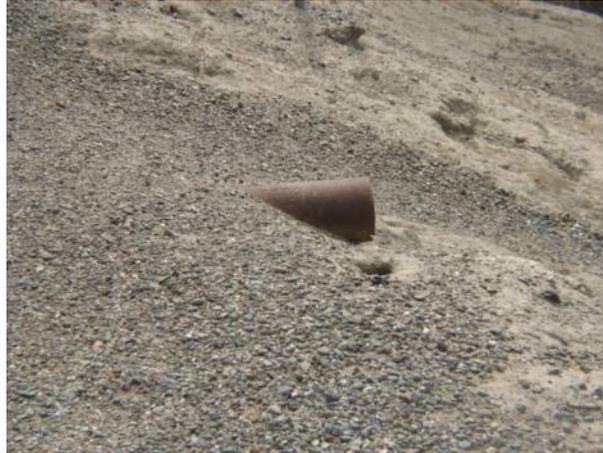
Levee Mile Report Line	105
Start Levee Mile	5.92
End Levee Mile	5.92
Location	Crown
Category	Earthen Levee
Item	Encroachments
Abandoned pipe at LM 5.92 waterside view

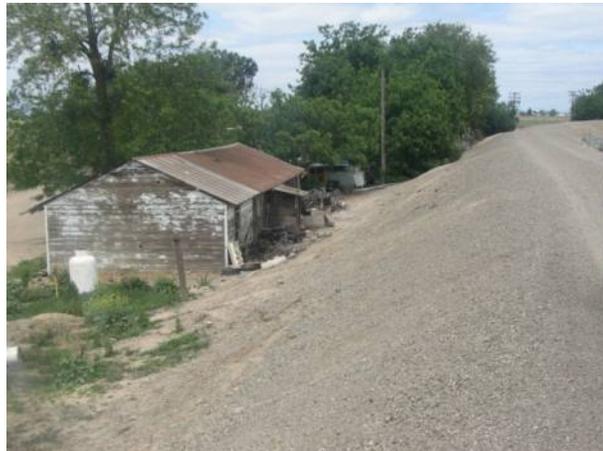
Levee Mile Report Line	109
Start Levee Mile	6.01
End Levee Mile	6.05
Location	Land Side
Category	Earthen Levee
Item	Encroachments
Looking downstream at building on landside toe.
