**Flood Control Project Maintenance
Levee Inspections**

Maintenance Issue Types Only, Levee Inspection Report By Mile - Fall 2014

Reclamation District No. 0524 Middle Roberts Island

Waterway	Bank	Unit Miles	Inspection Start/End	Inspector
Unit No. 01 San Joaquin River	Left	6.20	10/20/2014 10/20/2014	Richard Willoughby

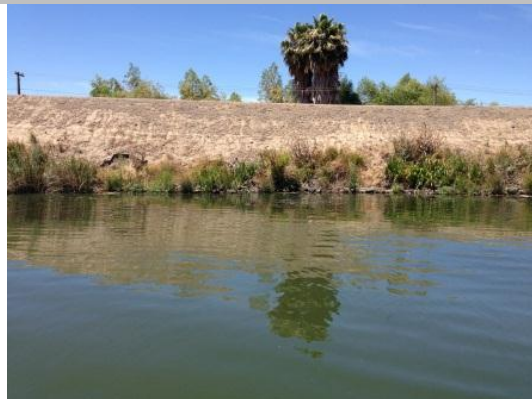
Photo 1 of 1 : SJR2014_RD0524U01RM40.85_1.jpg

LM Start	0.18	Rating **	U	Issue No.	129
LM End	0.18	Issue Type +	Ma	Location *	WS
Category	Supplemental			GPS Latitude/Longitude	
				Start	End
Item	DWR Erosion Survey			37.939085 °	37.939085 °
				-121.343917 °	-121.343917 °
DWR ID					
Action/Comments					
Inspector Comments: 6/19/2014: No significant change observed. 08/13/2013: The erosion was discovered during 2013 spring levee inspection. Inspector comment: Erosion is located along the lower level of water-ward slope. [2014 Site ID:RD0524U01RM40.85]

Close view of the erosion.

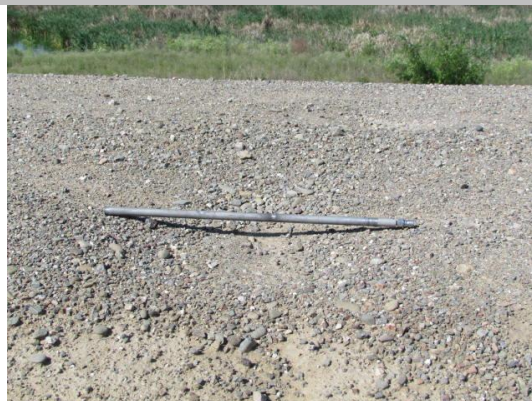
Photo 1 of 3 : FA_2014_RD0524_107_3_20141020_00007.jpg

LM Start	0.22	Rating **	M	Issue No.	3
LM End	0.22	Issue Type +	Ma	Location *	CR
Category	Earthen Levee			GPS Latitude/Longitude	
				Start	End
Item	Crown Surface / Depressions / Rutting			37.938890 °	37.938890 °
				-121.343657 °	-121.343657 °
DWR ID	DWR_RD0524_01_s_2012_3				
Action/Comments					
Repair depressions or ruts in the crown or slope.					
Inspector Comments: No change in status.

Looking west at 3" depression on levee crown. (Spring 2012)

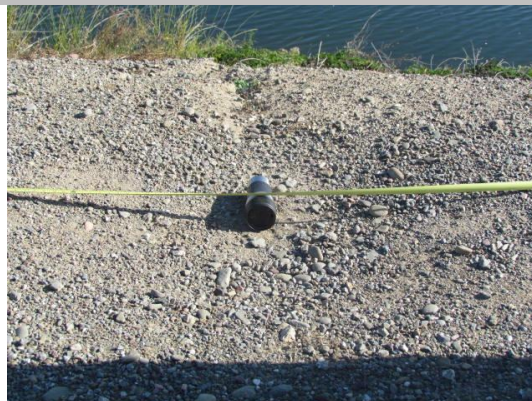
Photo 2 of 3 : FA_2014_RD0524_107_3_20141020_00008.jpg

Looking west at depression on levee crown near waterward shoulder.

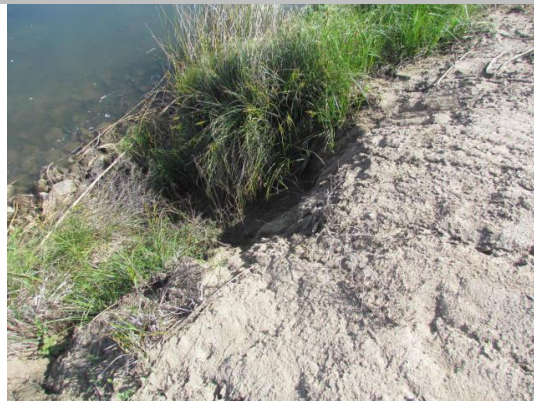
Photo 1 of 2 : FA_2014_RD0524_107_180_20141020_00135.jpg

LM Start	0.34	Rating **	M	Issue No.	180
LM End	0.34	Issue Type +	Ma	Location *	WS
Category	Earthen Levee			GPS Latitude/Longitude	
				Start	End
Item	Erosion / Bank Caving			37.938461 °	37.938461 °
				-121.341626 °	-121.341626 °
DWR ID	DWR_RD0524_01_s_2014_180				
Action/Comments					
Schedule repair of erosion site prior to the next inspection. Inspector Comments: Erosion is located along the lower level of waterward slope.

Looking southeast at erosion on waterward toe.

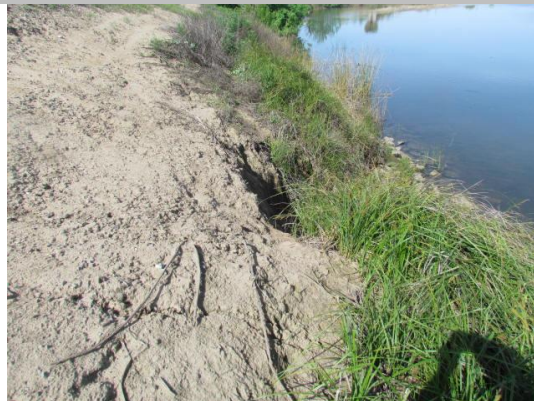
Photo 2 of 2 : FA_2014_RD0524_107_180_20141020_00136.jpg

Looking northeast at erosion on waterward toe.

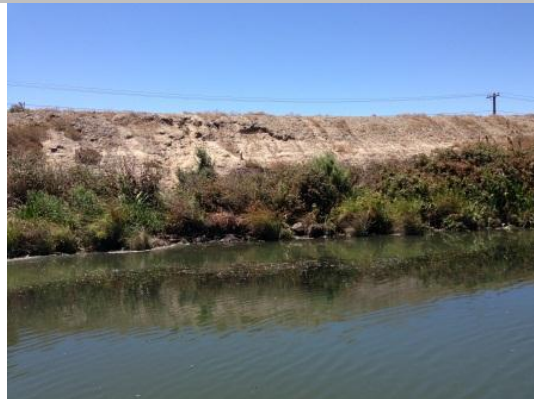
Photo 1 of 1 : SJR2014_RD0524U01RM40.99_1.jpg

LM Start	0.40	Rating **	U	Issue No.	131
LM End	0.40	Issue Type +	Ma	Location *	WS
Category	Supplemental			GPS Latitude/Longitude	
				Start	End
Item	DWR Erosion Survey			37.938870 °	37.938870 °
				-121.340460 °	-121.340460 °
DWR ID					
Action/Comments					
Inspector Comments: 6/19/2014: No significant change observed. 08/13/2013: No significant change at this site. 8/7/2012: The erosion is at the upper levee slope, and likely caused by slope slip. The lower levee slope is covered with dense vegetation. [2014 Site ID:RD0524U01RM40.99]

Front view of the erosion site. Note the vegetation at the levee toe and lower slope.

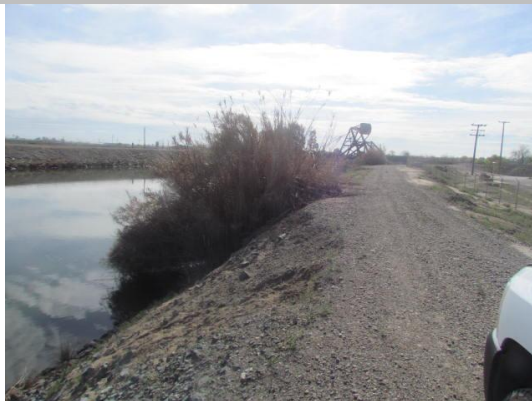
Photo 2 of 3 : FA_2014_RD0524_107_11_20141020_00015.jpg

Looking south at dying bamboo on waterward slope. (Spring 2013)

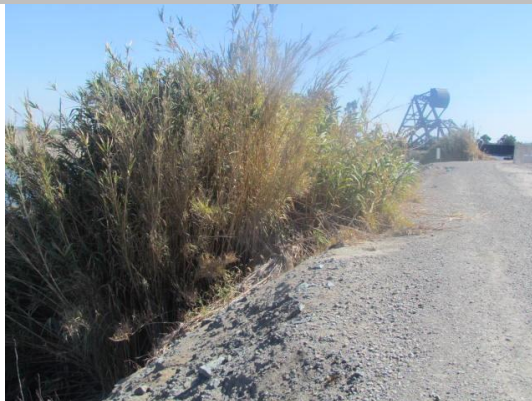
Photo 3 of 3 : FA_2014_RD0524_107_11_20141020_00016.jpg

Looking south at bamboo on waterside slope. (Fall Inspection 2012)

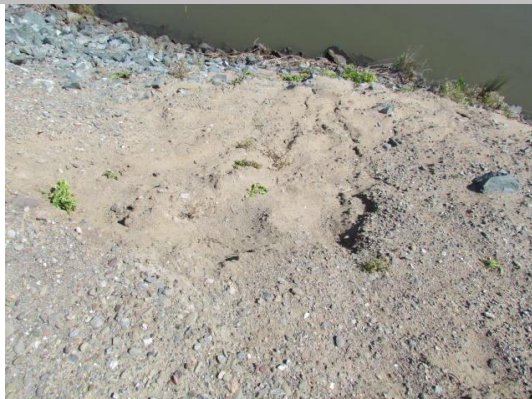
Photo 1 of 1 : FA_2014_RD0524_107_10_20141020_00013.jpg

Looking east at waterside erosion appears to be caused by runoff.

LM Start	0.63	Rating **	M	Issue No.	10
LM End	0.63	Issue Type +	Ma	Location *	WS
Category	Earthen Levee			GPS Latitude/Longitude	
				Start	End
Item	Slope Stability			37.938247 °	37.938247 °
				-121.336503 °	-121.336503 °
DWR ID	DWR_RD0524_01_s_2012_10				
Action/Comments					
Repair the levee slope damaged by foot traffic and prevent access where possible.

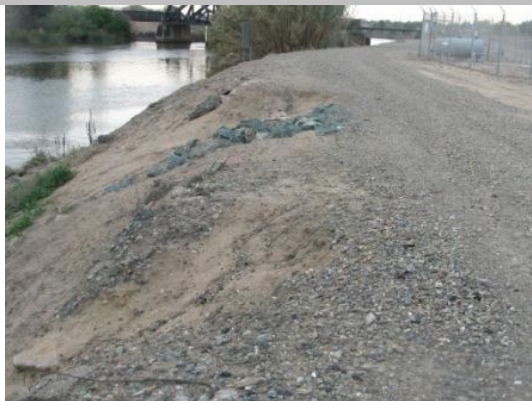
Photo 1 of 3 : FA_2014_RD0524_107_13_20141020_00018.jpg

LM Start	0.65	Rating **	M	Issue No.	13
LM End	0.66	Issue Type +	Ma	Location *	WS
Category	Earthen Levee			GPS Latitude/Longitude	
				Start	End
Item	Slope Stability			37.938105 °	37.938023 °
				-121.336288 °	-121.336173 °
DWR ID	DWR_RD0524_01_s_2012_13				
Action/Comments					
Repair slope instability.					
Inspector Comments: Erosion extends from mid levee slope to shoulder.

Erosion from LM 0.65 to 0.66

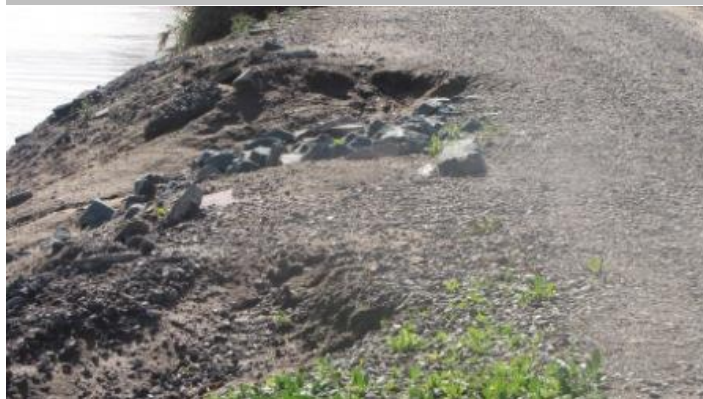
Photo 2 of 3 : FA_2014_RD0524_107_13_20141020_00019.jpg

Looking south at erosion on waterside shoulder.

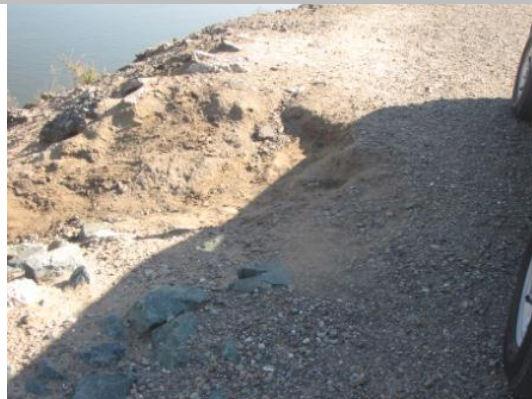
Photo 3 of 3 : FA_2014_RD0524_107_13_20141020_00020.jpg

LM Start	0.65	Rating **	M	Issue No.	13 (cont)
LM End	0.66	Issue Type +	Ma	Location *	WS
Category	Earthen Levee			GPS Latitude/Longitude	
				Start	End
Item	Slope Stability			37.938105 °	37.938023 °
				-121.336288 °	-121.336173 °
DWR ID	DWR_RD0524_01_s_2012_13				
Action/Comments					
Repair slope instability.					
Inspector Comments: Erosion extends from mid levee slope to shoulder.

Update of erosion site at LM 0.65 to 0.66

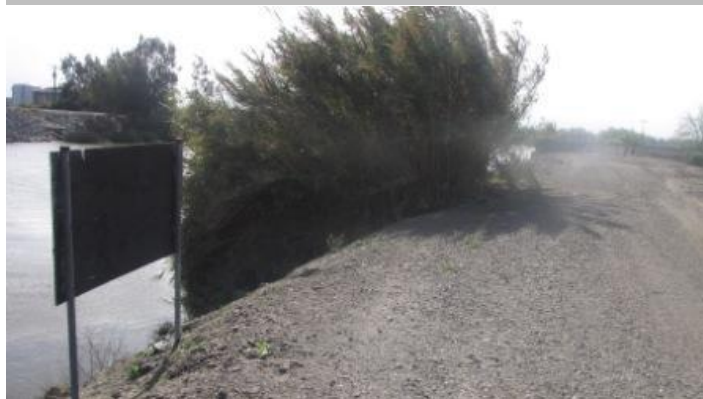
Photo 1 of 3 : FA_2014_RD0524_107_14_20141020_00021.jpg

LM Start	0.68	Rating **	M	Issue No.	14
LM End	0.68	Issue Type +	Ma	Location *	WS
Category	Earthen Levee			GPS Latitude/Longitude	
				Start	End
Item	Vegetation			37.937808 °	37.937808 °
				-121.335913 °	-121.335913 °
DWR ID	DWR_RD0524_01_s_2012_14				
Action/Comments					
Remove the wild growth other than native grasses from the levee slopes.					
Inspector Comments: Bamboo on waterward slope.

Looking southeast at bamboo on waterside shoulder as of 4/2010.

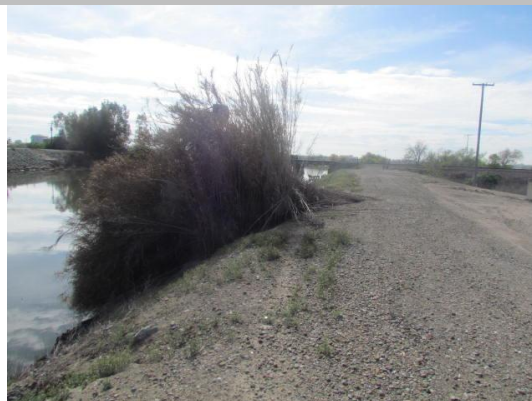
Photo 2 of 3 : FA_2014_RD0524_107_14_20141020_00022.jpg

Looking south at dying bamboo on waterward slope. (Spring 2013)

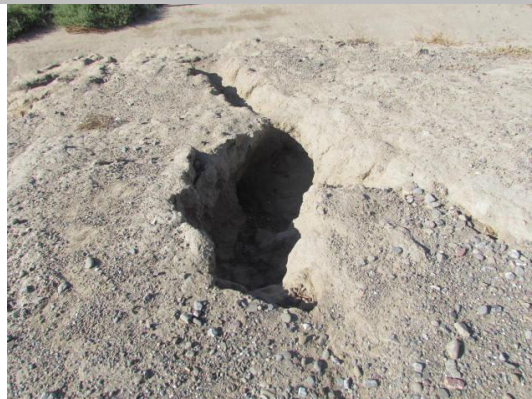
Photo 2 of 5 : FA_2014_RD0524_107_2_20141020_00003.jpg

LM Start	0.82	Rating **	U	Issue No.	2 (cont)	
LM End	0.82	Issue Type +	Ma	Location *	LS	
Category	Earthen Levee			GPS Latitude/Longitude		
				Start		End
Item	Erosion / Bank Caving			37.936093 °	37.936004 °	
				-121.334648 °	-121.334615 °	
DWR ID	DWR_RD0524_01_f_2013_2					
Action/Comments						
Schedule repair of erosion site prior to the next inspection. Inspector Comments: Several holes and finger erosions on landward slope.

Looking west at hole on landward shoulder.

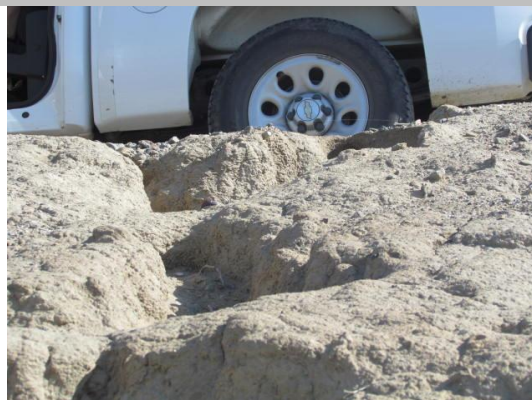
Photo 4 of 5 : FA_2014_RD0524_107_2_20141020_00005.jpg

Looking east at erosion on landward slope.

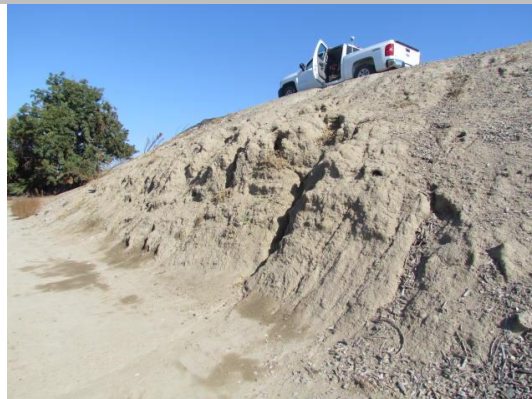
Photo 5 of 5 : FA_2014_RD0524_107_2_20141020_00006.jpg

LM Start	0.82	Rating **	U	Issue No.	2 (cont)	
LM End	0.82	Issue Type +	Ma	Location *	LS	
Category	Earthen Levee			GPS Latitude/Longitude		
				Start		End
Item	Erosion / Bank Caving			37.936093 °	37.936004 °	
				-121.334648 °	-121.334615 °	
DWR ID	DWR_RD0524_01_f_2013_2					
Action/Comments						
Schedule repair of erosion site prior to the next inspection. Inspector Comments: Several holes and finger erosions on landward slope.

Looking northeast at several finger erosion on landward slope.

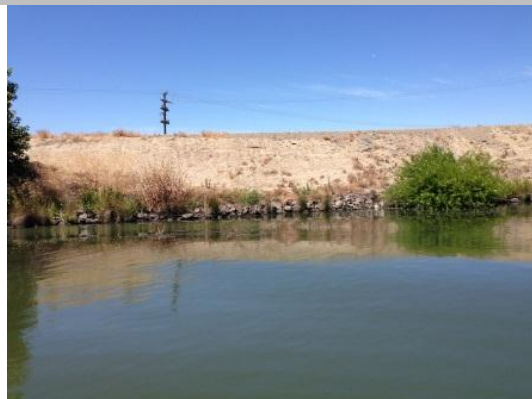
Photo 1 of 1 : SJR2014_RD0524U01RM41.44_1.jpg

LM Start	0.83	Rating **	U	Issue No.	133
LM End	0.84	Issue Type +	Ma	Location *	WS
Category	Supplemental			GPS Latitude/Longitude	
				Start	End
Item	DWR Erosion Survey			37.935930 °	37.935930 °
				-121.334133 °	-121.334133 °
DWR ID					
Action/Comments					
Inspector Comments: 06/19/2014: No significant change observed. 08/13/2013: Site was discovered during boat survey. The dense vegetation blocks a clear view of the erosion. Size of erosion site was very roughly estimated. [2014 Site ID:RD0524U01RM41.44]

Close view of the site. Dense vegetation covers the erosion.

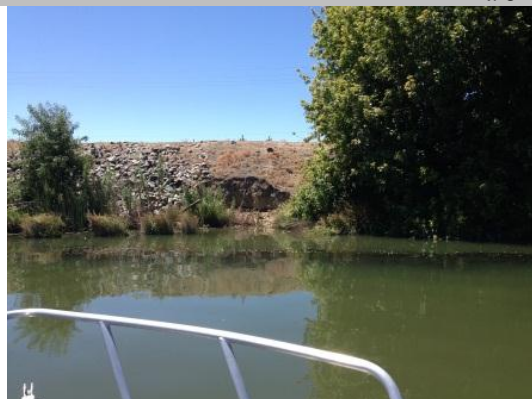
Photo 1 of 1 : SJR2014_RD0524U01RM41.5_1.jpg

LM Start	0.91	Rating **	U	Issue No.	134
LM End	0.91	Issue Type +	Ma	Location *	WS
Category	Supplemental			GPS Latitude/Longitude	
				Start	End
Item	DWR Erosion Survey			37.935576 °	37.935576 °
				-121.333202 °	-121.333202 °
DWR ID					
Action/Comments					
Inspector Comments: 6/19/2014: No significant change observed. 08/13/2013: No significant change at this site. 08/07/2012: The site has been visited by boat survey. No significant change observed 08/23/2011: The erosion site is immediately downstream of the riprap protection. [2014 Site ID:RD0524U01RM41.5]

Front view of the erosion. Note the riprap protection near the site.

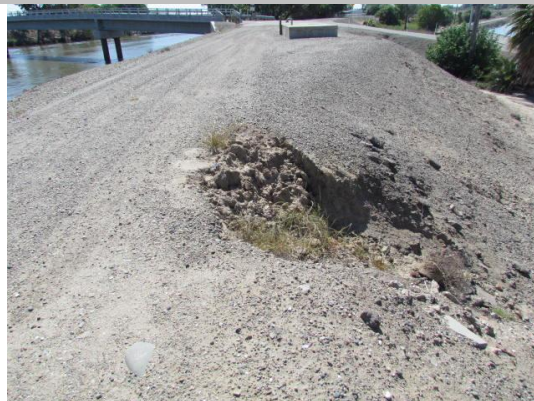
Photo 3 of 5 : FA_2014_RD0524_107_18_20141020_00029.jpg

Looking south at caving on landside shoulder. (Sping 2012)

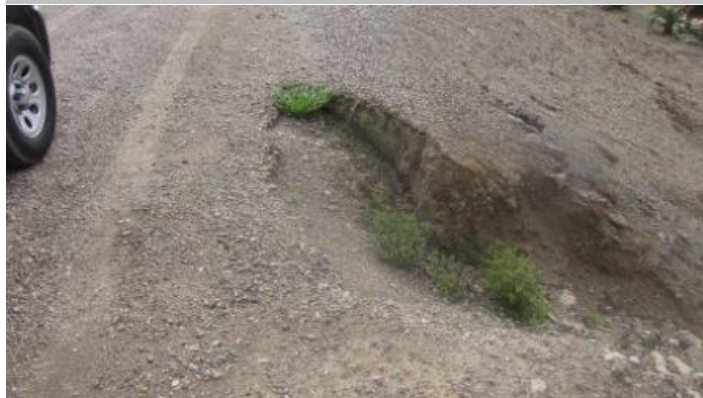
Photo 4 of 5 : FA_2014_RD0524_107_18_20141020_00030.jpg

Looking at updated slope stability as of 4/2010.

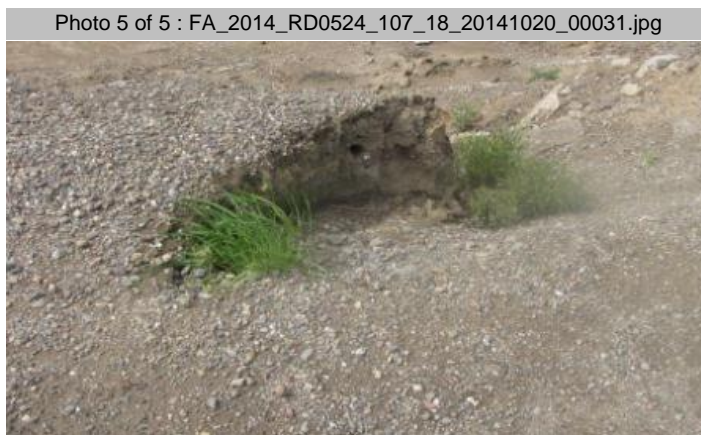
LM Start	1.09	Rating **	M	Issue No.	18 (cont)	
LM End	1.09	Issue Type +	Ma	Location *	LS	
Category	Earthen Levee			GPS Latitude/Longitude		
				Start	End	
Item	Slope Stability			37.934645 °	37.934645 °	
				-121.330310 °	-121.330310 °	
DWR ID	DWR_RD0524_01_s_2012_18					
Action/Comments						
Repair slope instability. Inspector Comments: Slope damage extend from shoulder to middle of slope.

Updated view from above the slope stability.

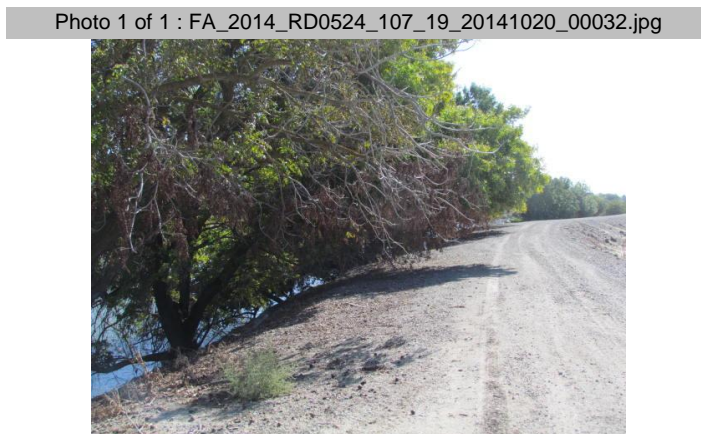
Looking northwest at low hanging tree branches at waterside toe.

LM Start	1.14	Rating **	M	Issue No.	19
LM End	1.17	Issue Type +	Ma	Location *	WS
Category	Earthen Levee			GPS Latitude/Longitude	
				Start	End
Item	Trim / Thin Trees			37.934118 °	37.933775 °
				-121.329657 °	-121.329305 °
DWR ID	DWR_RD0524_01_s_2012_19				
Action/Comments					
Trim trees to at least five feet above ground level.

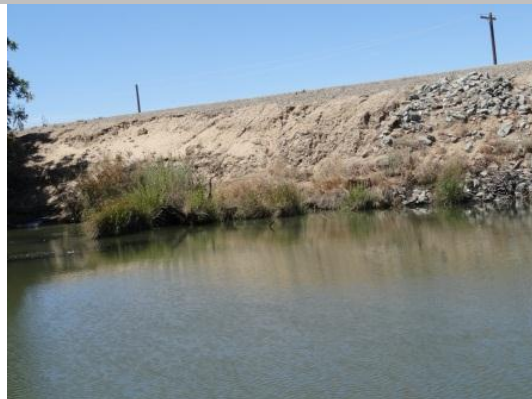
Photo 1 of 1 : SJR2014_RD0524U01RM41.79_1.jpg

Inspector Comments: 6/19/2014: No significant change observed.
08/13/2013: No significant change at this site.
08/07/2012: The site has been visited by boat survey. No significant change observed
08/23/2011: No significant change observed on site.
9/07/2010: No significant change observed on site. Vegetation is visible at the water line. There is an exposed pipe discharge partially hanging at the mid-slope, possibly still used for discharging irrigation/runoff water. There is minimal rip rap protection along the bank, and what's left of it is no longer adequately protecting the bank.
9/29/2009: Site consists of a 400-foot long eroding bank with minimal vegetation and protection; the existing rip rap has sloughed, rendering it useless; note that there is an exposed section of a pipe.
10/18/2006: There is extensive loss of rip rap on some sections; sewage disposal pond is on the landside of the levee; there is an exposed pipe outlet "hanging" from the upper slope. [2014 Site ID:RD0524U01RM41.79]

Direct view of the site.

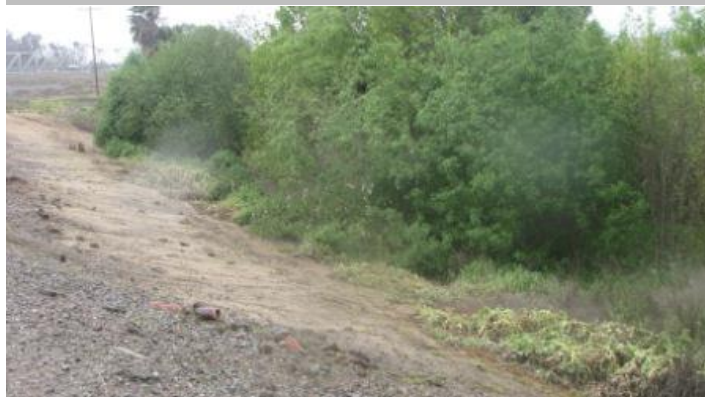
Photo 1 of 1 : FA_2014_RD0524_107_915_20141020_00151.jpg

Looking southwest at dense veg. on landside toe.

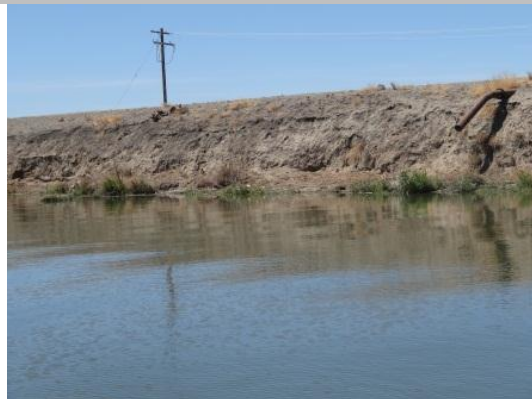
Photo 1 of 1 : SJR2014_RD0524U01RM41.92_1.jpg

LM Start	1.29	Rating **	U	Issue No.	142
LM End	1.32	Issue Type +	Ma	Location *	WS
Category	Supplemental			GPS Latitude/Longitude	
				Start	End
Item	DWR Erosion Survey			37.931858 °	37.931858 °
				-121.328300 °	-121.328300 °
DWR ID					
Action/Comments					
Inspector Comments: 6/19/2014: No significant change observed. 08/13/2013: New signs of animal activity were found. 08/07/2012: The site was first reported in 2012 spring levee inspection report. [2014 Site ID:RD0524U01RM41.92]

Front view of the erosion. Note the drainage pipe on the site.

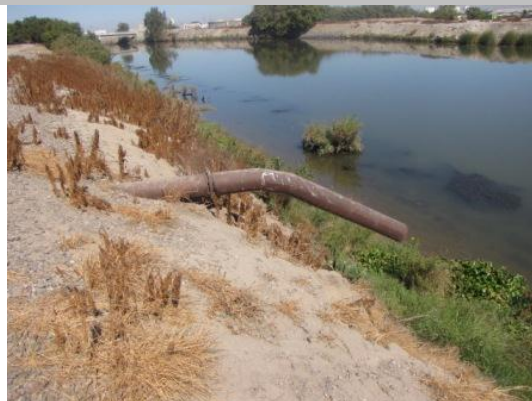
Photo 2 of 2 : FA_2014_RD0524_107_33_20141020_00042.jpg

Looking north at broken pipe.

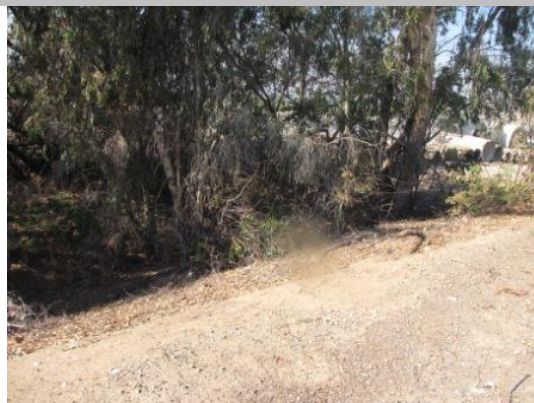
Photo 1 of 3 : FA_2014_RD0524_107_916_20141020_00152.jpg

Dense vegetation on landside toe.

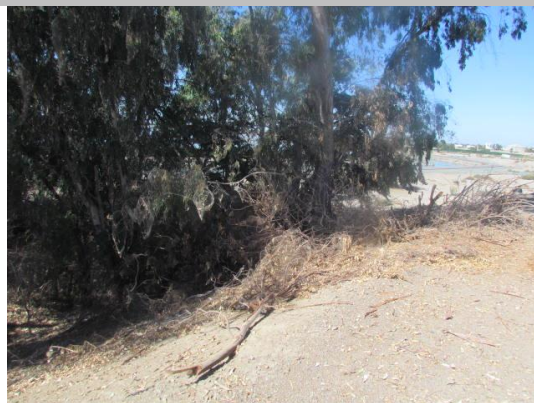
Photo 2 of 3 : FA_2014_RD0524_107_916_20141020_00153.jpg

Looking south at trees on landside slope. (Fall 2012)

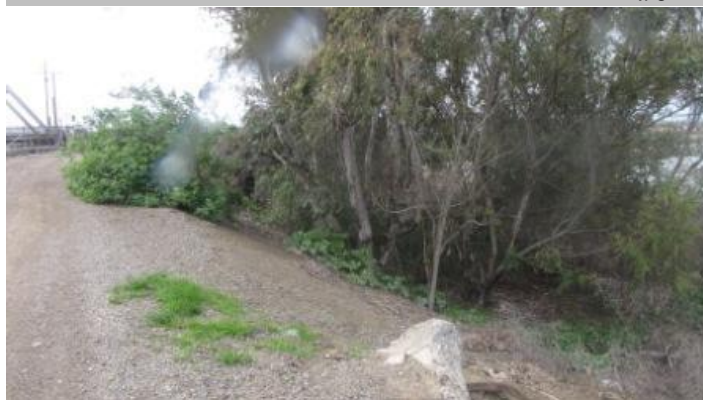
Photo 3 of 3 : FA_2014_RD0524_107_916_20141020_00154.jpg

Looking south at dense veg. on landside slope and toe.

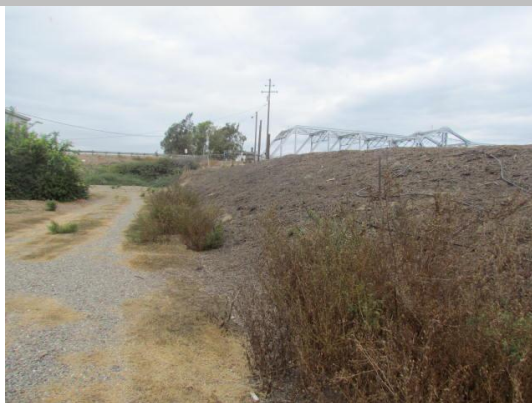
Photo 2 of 5 : FA_2014_RD0524_107_23_20141023_00195.jpg

Looking north from landward berm at corrected site.

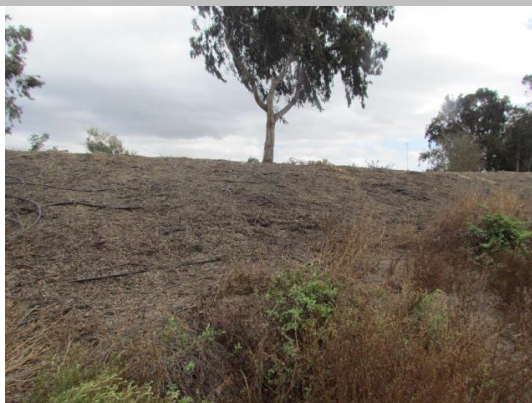
Photo 3 of 5 : FA_2014_RD0524_107_23_20141023_00196.jpg

Looking east from landward berm at corrected site.

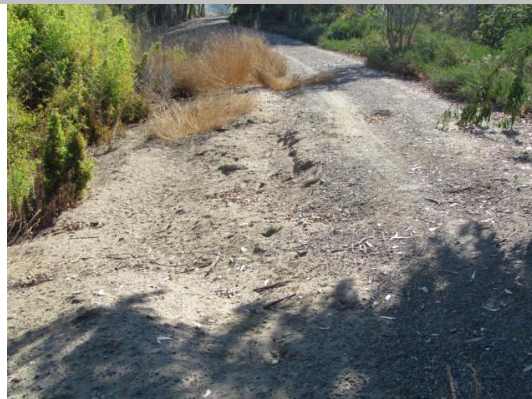
Photo 1 of 1 : FA_2014_RD0524_107_136_20141020_00125.jpg

Looking south at depression on levee crown near waterward shoulder.

LM Start	1.60	Rating **	M	Issue No.	136
LM End	1.60	Issue Type +	Ma	Location *	CR
Category	Earthen Levee			GPS Latitude/Longitude	
				Start	End
Item	Slope Stability			37.927775 °	37.927775 °
				-121.327860 °	-121.327860 °
DWR ID	DWR_RD0524_01_s_2013_136				
Action/Comments					
Repair the levee slope damaged by foot traffic and prevent access where possible.

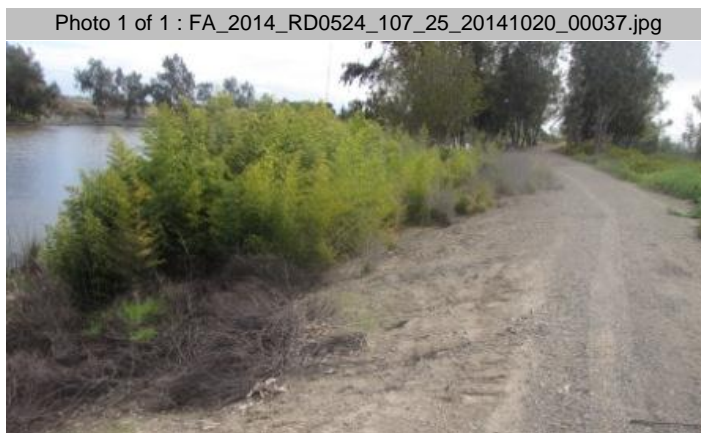
Looking southeast at dense vegetation on the waterside slope.

LM Start	1.62	Rating **	A/W	Issue No.	25
LM End	1.63	Issue Type +	Ma	Location *	WS
Category	Earthen Levee			GPS Latitude/Longitude	
				Start	End
Item	Vegetation			37.927635 °	37.927540 °
				-121.327812 °	-121.327648 °
DWR ID	DWR_RD0524_01_s _ 2012_25				
Action/Comments					
Remove the wild growth other than native grasses from the levee slopes.

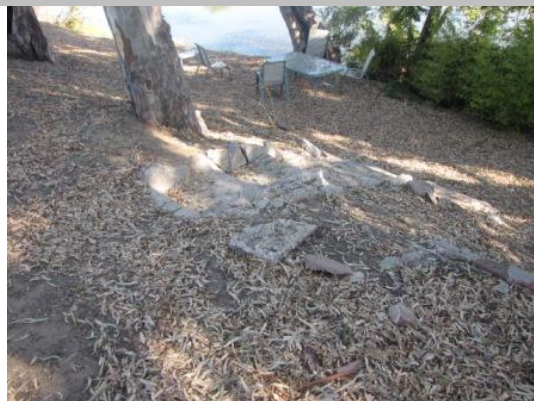
Photo 1 of 3 : FA_2014_RD0524_107_45_20141020_00057.jpg

Looking northeast at non-permitted concrete stairs on waterside slope.

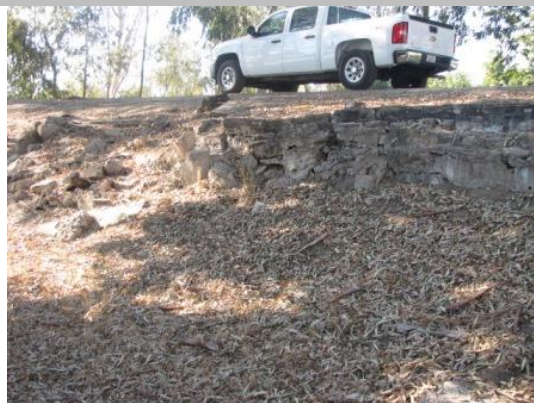
Photo 2 of 3 : FA_2014_RD0524_107_45_20141020_00058.jpg

Looking southwest at retaining wall connected to concrete stairs.

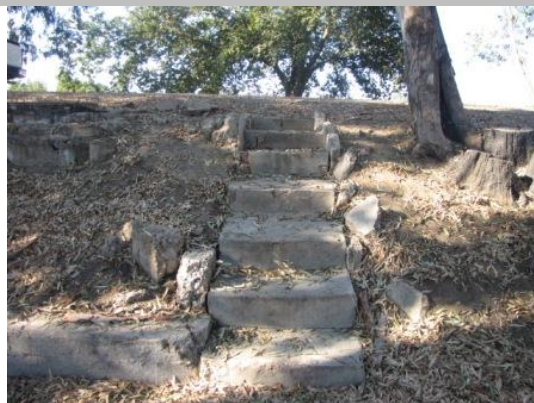
Photo 3 of 3 : FA_2014_RD0524_107_45_20141020_00059.jpg

Looking west at concrete stairs on waterside slope.

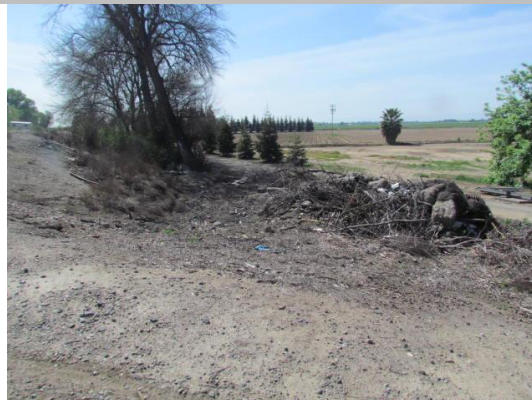
Photo 2 of 2 : FA_2014_RD0524_107_28_20141020_00038.jpg

Looking at southwest at a pruning pile at landward berm.

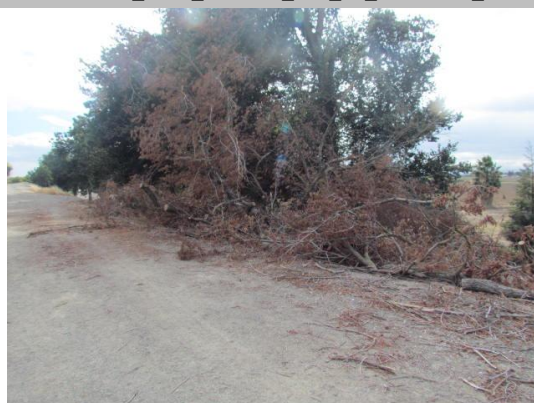
Photo 3 of 4 : FA_2014_RD0524_107_46_20141023_00203.jpg

Looking south at tree limbs on landward slope.

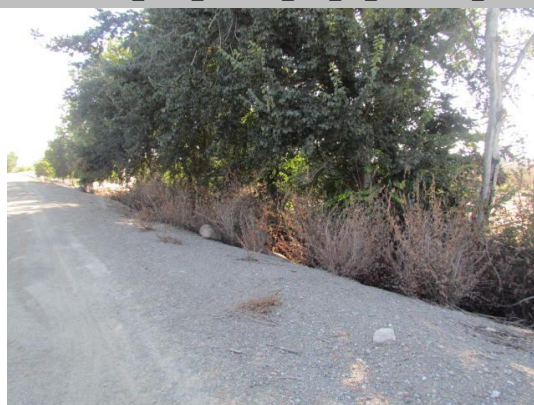
Photo 4 of 4 : FA_2014_RD0524_107_46_20141020_00060.jpg

Looking southwest at dense vegetation and low hanging tree branches on landside slope and toe.

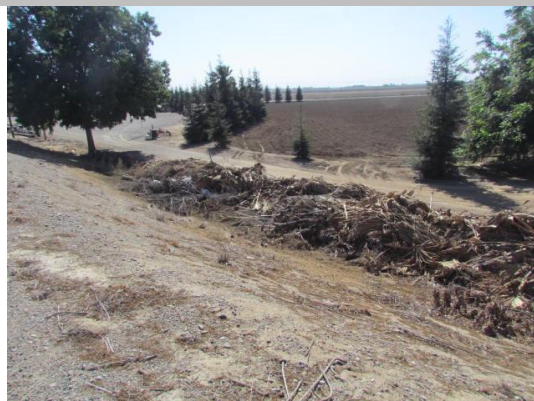
Photo 1 of 1 : FA_2014_RD0524_107_100_20141020_00093.jpg

Looking southwest at prunings on landside toe.

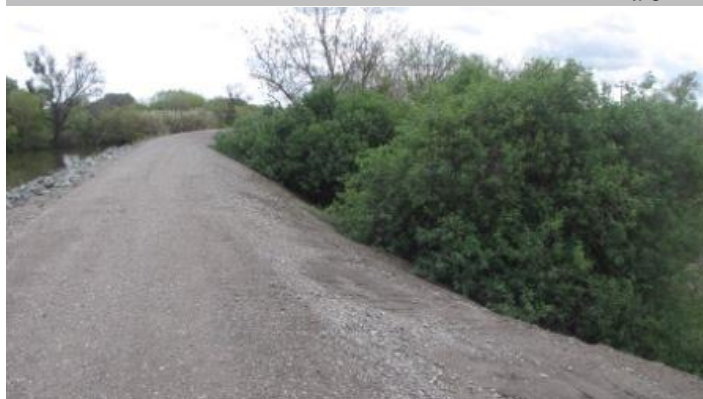
Photo 1 of 1 : FA_2014_RD0524_107_32_20141020_00040.jpg

Looking south at dense veg on landside slope and toe.

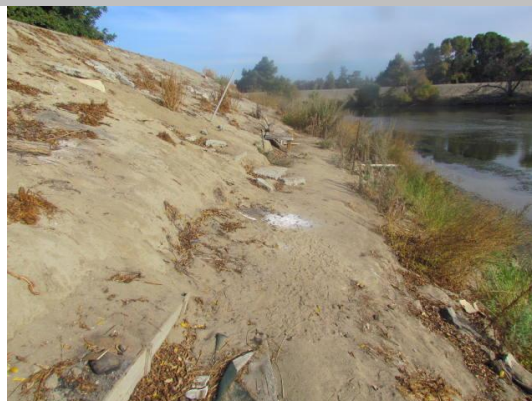
Photo 1 of 1 : FA_2014_RD0524_107_34_20141020_00043.jpg

LM Start	2.34	Rating **	M	Issue No.	34
LM End	2.35	Issue Type +	Ma	Location *	WS
Category	Earthen Levee			GPS Latitude/Longitude	
				Start	End
Item	Slope Stability			37.919885 °	37.919703 °
				-121.319713 °	-121.319702 °
DWR ID	DWR_RD0524_01_s_2012_34				
Action/Comments					
Repair the levee slope damaged by foot traffic and prevent access where possible.					
Inspector Comments: Slope damage caused by walking traffic and using bank as a fishing platform.

Looking northeast at damage to the slope possibly caused by human activity.

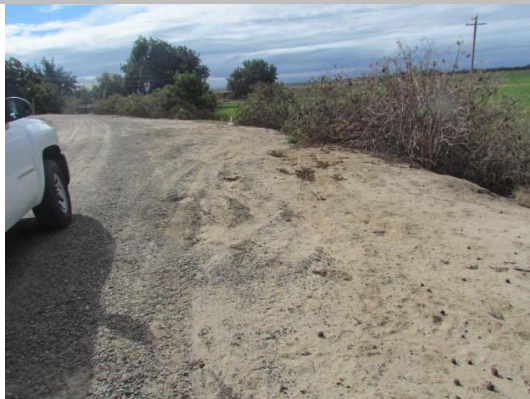
Photo 1 of 1 : FA_2014_RD0524_107_82_20141023_00206.jpg

Looking southwest at damaged landward slope.

LM Start	2.55	Rating **	M	Issue No.	82
LM End	2.59	Issue Type +	Ma	Location *	LS
Category	Earthen Levee			GPS Latitude/Longitude	
				Start	End
Item	Slope Stability			37.918060 °	37.917667 °
				-121.322384 °	-121.322713 °
DWR ID	DWR_RD0524_01_s _ 2012_82				
Action/Comments					
Repair slope instability.

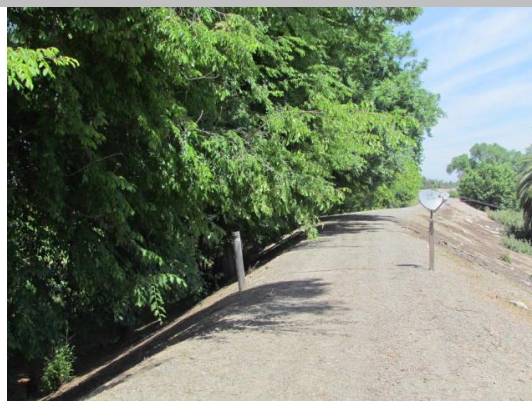
Photo 1 of 1 : FA_2014_RD0524_107_44_20141020_00056.jpg

Looking north at dense trees overhanging levee crown.

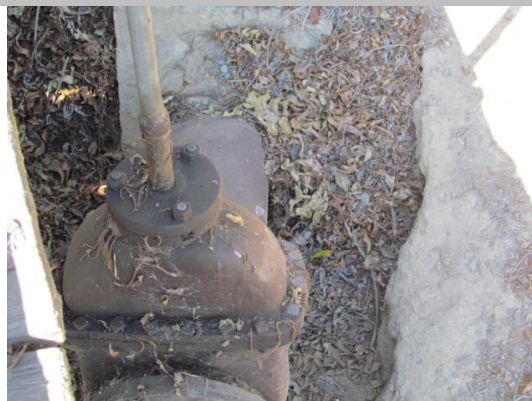
Photo 1 of 2 : FA_2014_RD0524_107_21_20141020_00033.jpg

Looking at erosion around irrigation pipe on waterward slope.

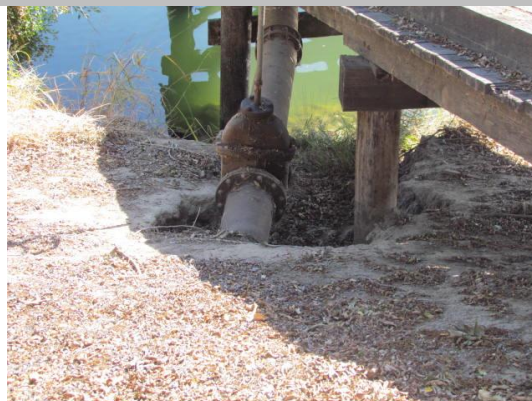
Photo 2 of 2 : FA_2014_RD0524_107_21_20141020_00034.jpg

Looking east at erosion around irrigation pipe on waterward slope.

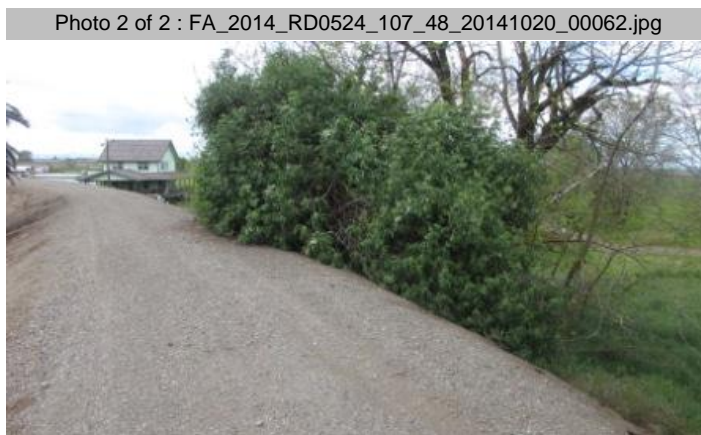
LM Start	2.82	Rating **	U	Issue No.	48 (cont)	
LM End	2.82	Issue Type +	Ma	Location *	LS	
Category	Earthen Levee			GPS Latitude/Longitude		
				Start		End
Item	Vegetation			37.915022 °		37.915022 °
				-121.323443 °		-121.323443 °
DWR ID	DWR_RD0524_01_s _ 2012_48					
Action/Comments						
Elderberries are blocking visibility and flood fight capability.

Looking south at elderberry on landside slope.(Spring 2011)

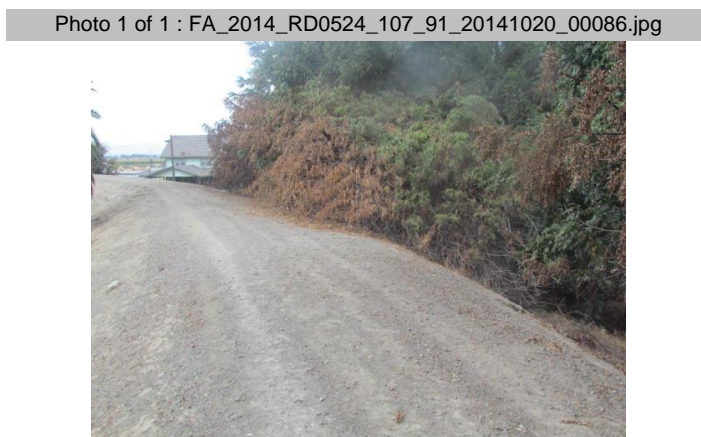
Looking southwest at dense vegetation on landside slope.

LM Start	2.83	Rating **	U	Issue No.	91
LM End	2.83	Issue Type +	Ma	Location *	LS
Category	Earthen Levee			GPS Latitude/Longitude	
				Start	End
Item	Trim / Thin Trees			37.915063 °	37.915063 °
				-121.323585 °	-121.323585 °
DWR ID	DWR_RD0524_01_s _ 2012_91				
Action/Comments					
Thin trees to allow visibility of the ground and room to flood fight.

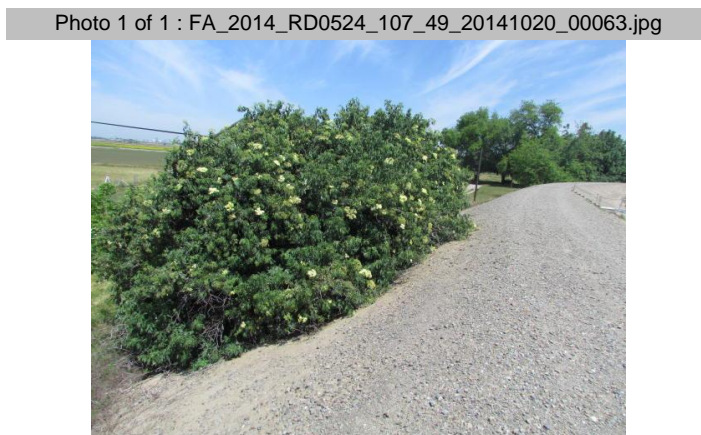
LM Start	2.88	Rating **	U	Issue No.	49
LM End	2.88	Issue Type +	Ma	Location *	LS
Category	Earthen Levee			GPS Latitude/Longitude	
				Start	End
Item	Vegetation			37.914427 °	37.914427 °
				-121.324198 °	-121.324198 °
DWR ID	DWR_RD0524_01_s _ 2012_49				
Action/Comments					
Elderberries are blocking visibility and flood fight capability.

Looking northwest at elderberry on landside slope.

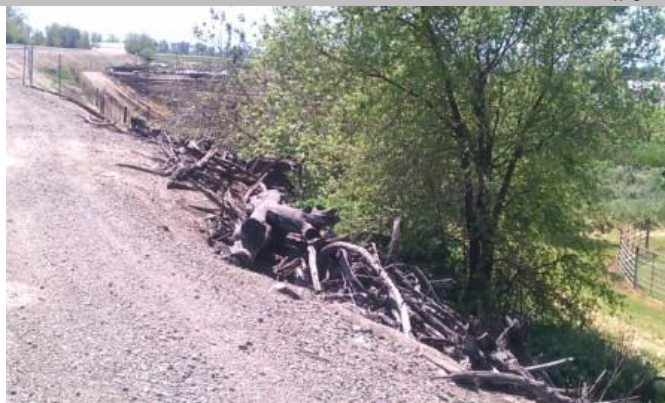
Photo 1 of 1 : FA_2014_RD0524_107_50_20141020_00064.jpg

Looking southwest at prunings on landside slope.

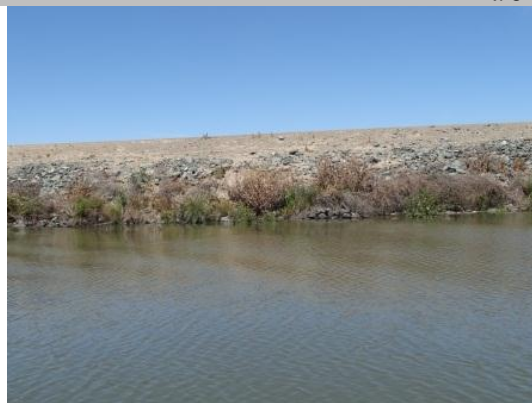
Photo 1 of 1 : SJR2014_RD0524U01RM43.52_1.jpg

Front view of the erosion.

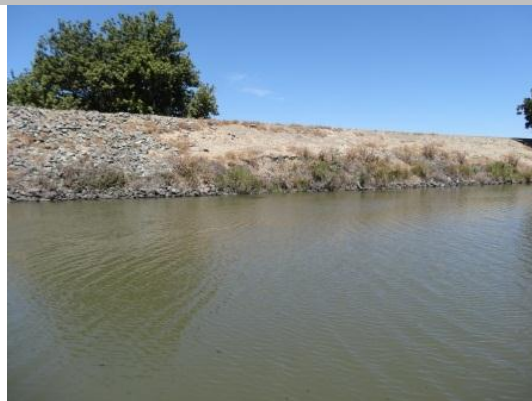
Photo 1 of 1 : SJR2014_RD0524U01RM43.86_1.jpg

View from upstream of the erosion.

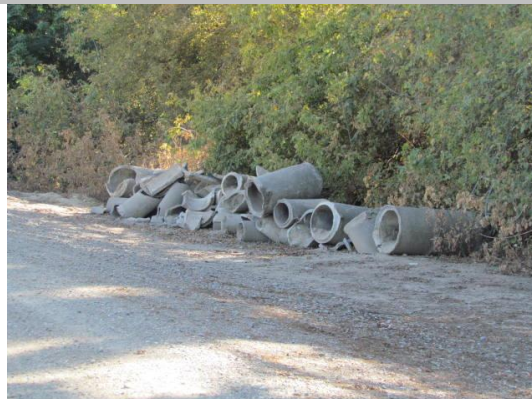
Photo 1 of 1 : FA_2014_RD0524_107_56_20141020_00067.jpg

Looking southwest at concrete pipes on landside toe.

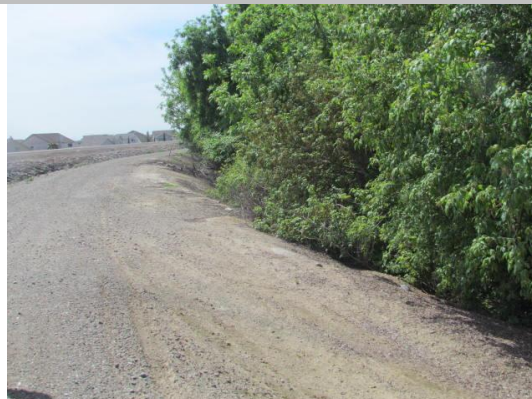
Photo 1 of 1 : FA_2014_RD0524_107_57_20141020_00068.jpg

Looking south at dense trees on landward slope.

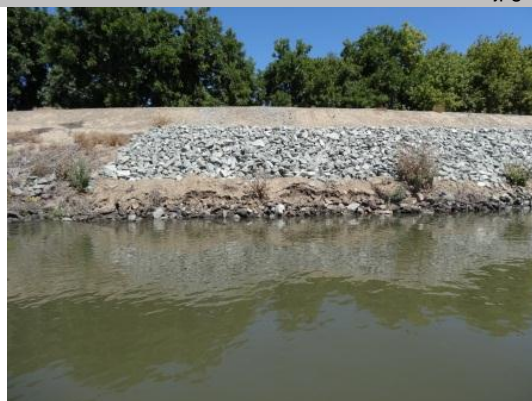
Photo 1 of 1 : SJR2014_RD0524U01RM44.13_1.jpg

View of the repaired site.

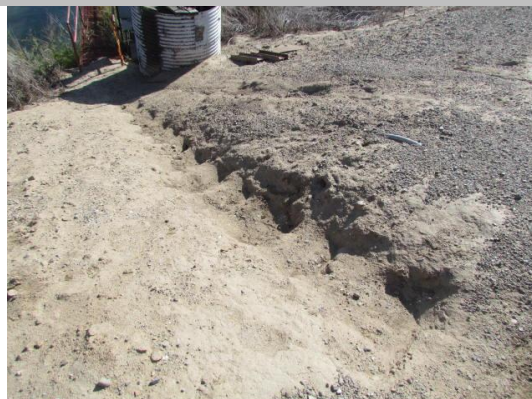
Photo 1 of 1 : FA_2014_RD0524_107_58_20141020_00069.jpg

Looking southeast steps cut into waterside slope.

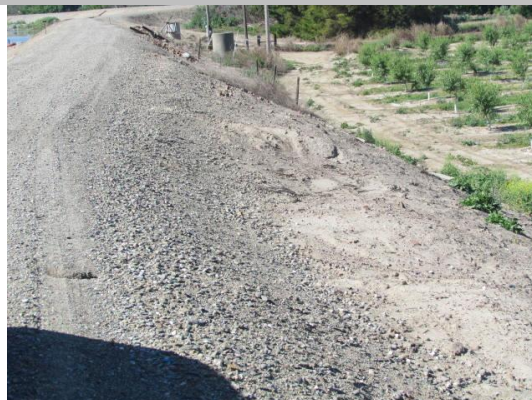
Photo 1 of 1 : FA_2014_RD0524_107_108_20141020_00099.jpg

Looking southwest at caving slope on landside of levee.

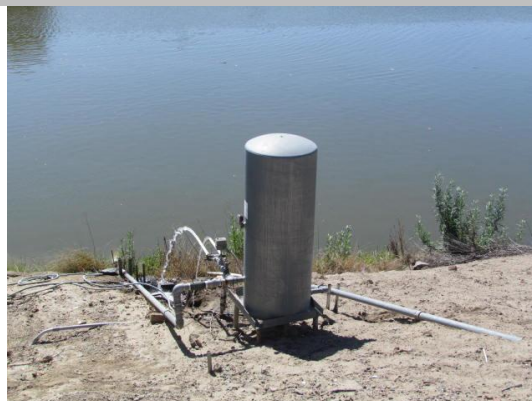
Photo 4 of 5 : FA_2014_RD0524_107_109_20141020_00102.jpg

Looking east at irrigation system on waterside slope.

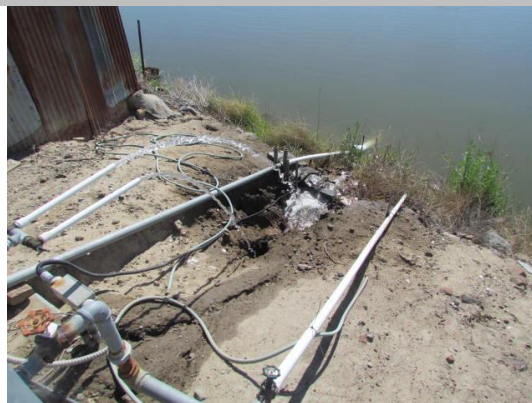
Photo 5 of 5 : FA_2014_RD0524_107_109_20141020_00103.jpg

Looking east at irrigation system damaging waterside toe.

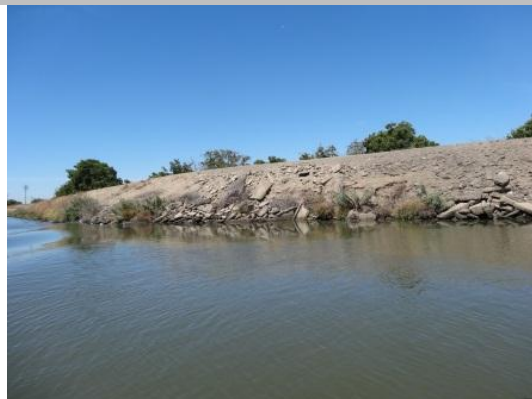
Photo 1 of 1 : SJR2014_RD0524U01RM45.07_1.jpg

Downstream view of the erosion site.

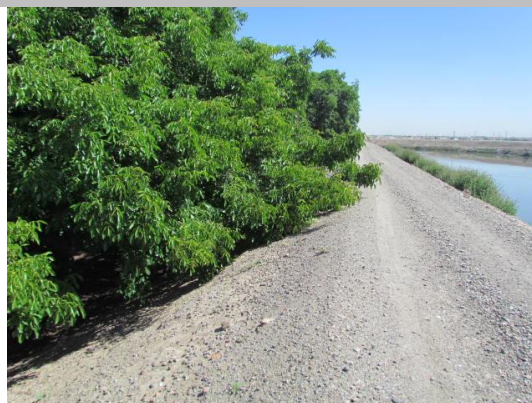
Photo 1 of 1 : FA_2014_RD0524_107_113_20141020_00106.jpg

Looking north at dense trees on landside slope.

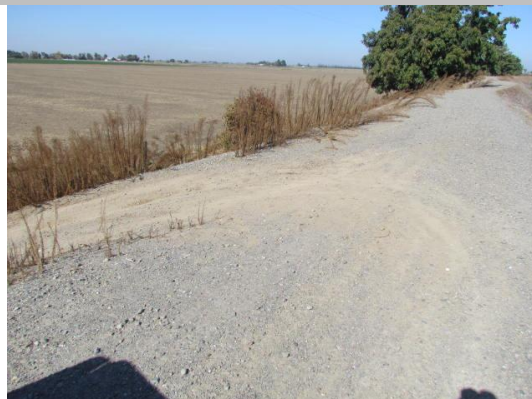
Photo 1 of 1 : FA_2014_RD0524_107_115_20141020_00107.jpg

Looking northwest at slope damage on landward slope.

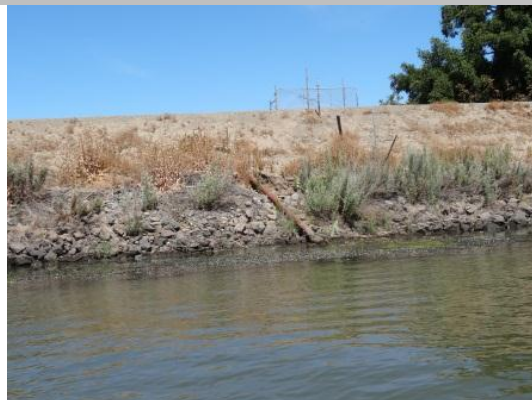
Photo 1 of 1 : SJR2014_RD0524U01RM45.97_1.jpg

Close view of the erosion and the pipe.

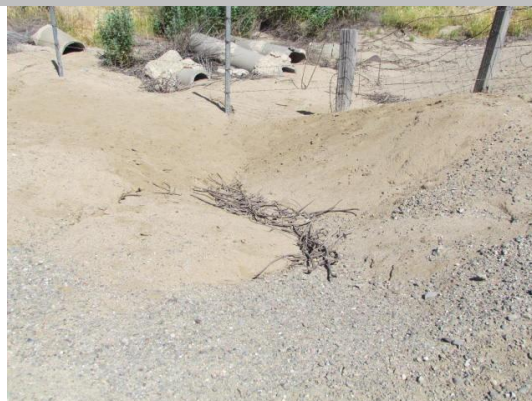
Photo 1 of 3 : FA_2014_RD0524_107_118_20141020_00108.jpg

Looking west at slope damage on landside slope.

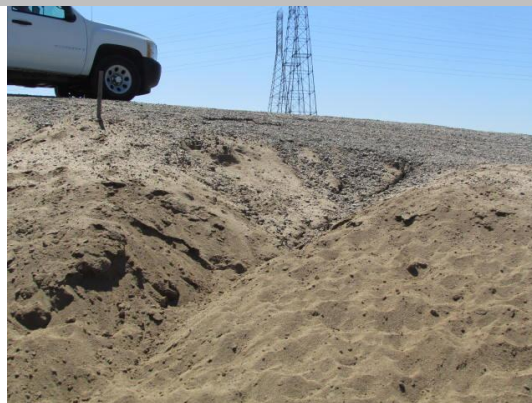
Photo 2 of 3 : FA_2014_RD0524_107_118_20141020_00109.jpg

Looking southeast at damaged slope.

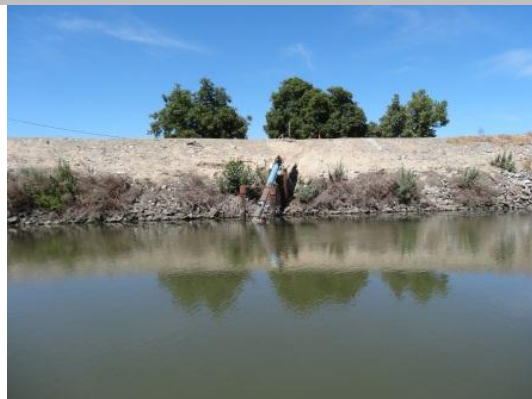
Photo 1 of 1 : SJR2014_RD0524U01RM46.39_1.jpg

Front view of the site.

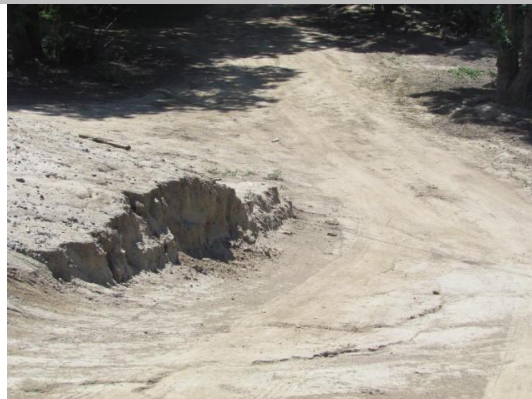
Photo 1 of 2 : FA_2014_RD0524_107_119_20141020_00111.jpg

Looking west at unauthorized ramp and landside slope damage.

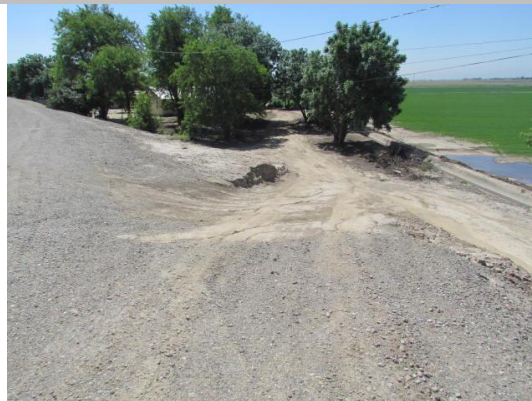
Photo 2 of 2 : FA_2014_RD0524_107_119_20141020_00112.jpg

Looking southwest at damaged slope and ramp on landside slope.

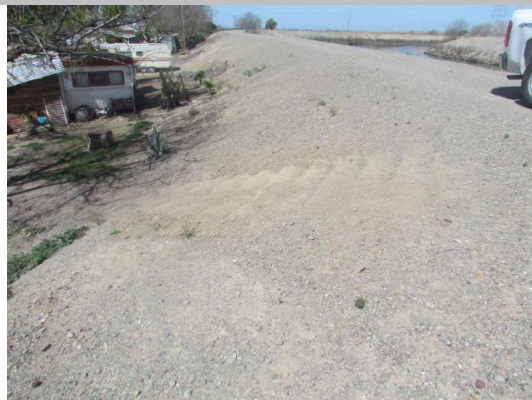
Photo 1 of 1 : FA_2014_RD0524_107_933_20141020_00156.jpg

Looking north at steps cut into landward slope.
