**Flood Control Project Maintenance
Levee Inspections**

Maintenance Issue Types Only, Levee Inspection Report By Mile - Fall 2015

Reclamation District No. 0524 Middle Roberts Island

Waterway	Bank	Unit Miles	Inspection Start/End	Inspector
Unit No. 01 San Joaquin River	Left	6.20	10/21/2015 10/21/2015	Richard Willoughby

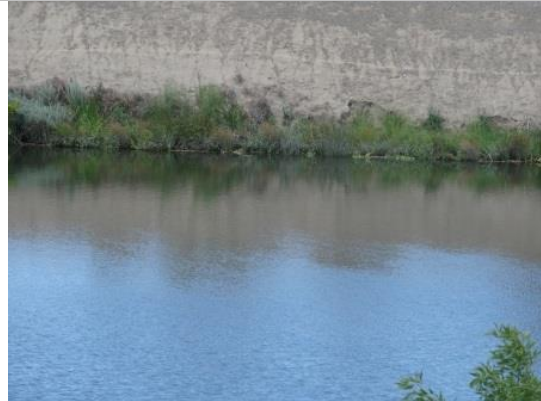
Photo 1 of 2 : SJR2015_RD0524U01RM40.85_2.JPG

LM Start	0.19	Rating **	U	Issue No.	129
LM End	0.19	Issue Type +	Ma	Location *	WS
Category	Supplemental			GPS Latitude/Longitude	
				Start	End
Item	DWR Erosion Survey			37.939085 °	37.939085 °
				-121.343917 °	-121.343917 °
DWR ID					
Action/Comments					
Inspector Comments: 06/24/2015: No significant change observed. 6/19/2014: No significant change observed. 08/13/2013: The erosion was discovered during 2013 spring levee inspection. Inspector comment: Erosion is located along the lower level of water-ward slope. [2015 Site ID:RD0524U01RM40.85]

Front view of the erosion.

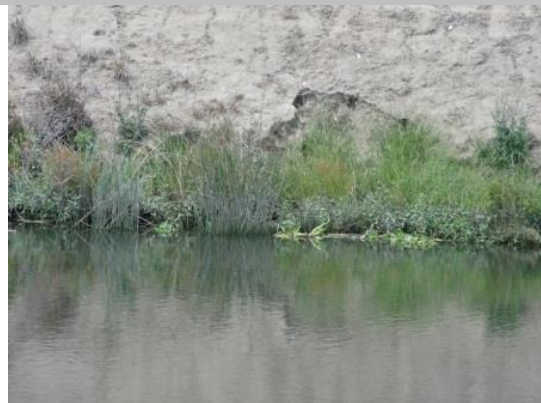
Photo 2 of 2 : SJR2015_RD0524U01RM40.85_5.JPG

Close view of the erosion.

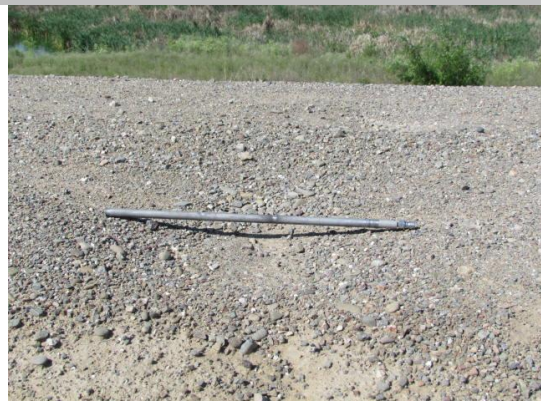
Photo 1 of 3 : FA_2015_RD0524_107_3_20150914_00006.jpg

LM Start	0.21	Rating **	M	Issue No.	3
LM End	0.21	Issue Type +	Ma	Location *	CR
Category	Earthen Levee			GPS Latitude/Longitude	
				Start	End
Item	Crown Surface / Depressions / Rutting			37.938890 °	37.938890 °
				-121.343657 °	-121.343657 °
DWR ID	DWR_RD0524_01_s_2012_3				
Action/Comments					
Repair depressions or ruts in the crown or slope. Inspector Comments: No change in status.

Looking west at 3" depression on levee crown. (Spring 2012)

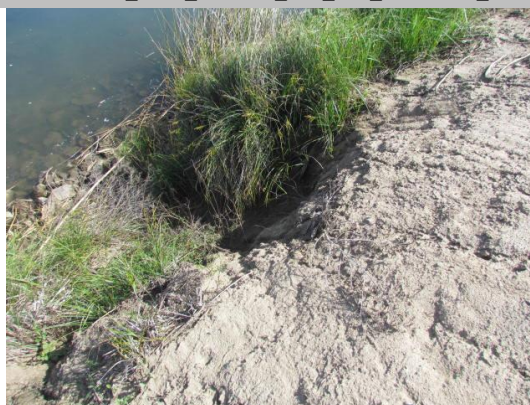
Photo 1 of 2 : FA_2015_RD0524_107_180_20150914_00171.jpg

LM Start	0.34	Rating **	M	Issue No.	180
LM End	0.34	Issue Type +	Ma	Location *	WS
Category	Earthen Levee			GPS Latitude/Longitude	
				Start	End
Item	Erosion / Bank Caving			37.938461 °	37.938461 °
				-121.341626 °	-121.341626 °
DWR ID	DWR_RD0524_01_s_2014_180				
Action/Comments					
Schedule repair of erosion site prior to the next inspection. Inspector Comments: Erosion is located along the lower level of waterward slope.

Looking southeast at erosion on waterward toe.

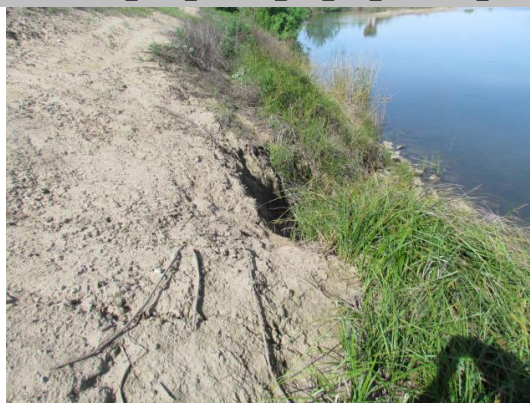
Photo 2 of 2 : FA_2015_RD0524_107_180_20150914_00172.jpg

Looking northeast at erosion on waterward toe.

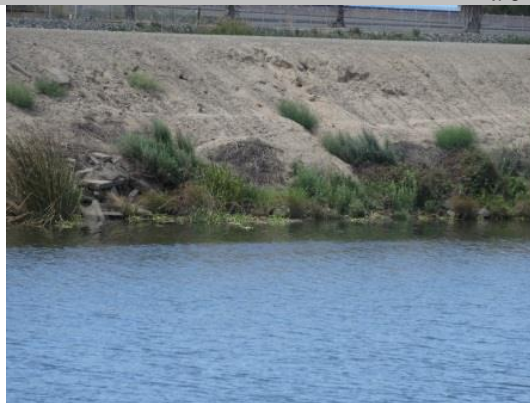
Photo 1 of 2 : SJR2015_RD0524U01RM40.99_1.jpg

LM Start	0.40	Rating **	U	Issue No.	131
LM End	0.40	Issue Type +	Ma	Location *	WS
Category	Supplemental			GPS Latitude/Longitude	
				Start	End
Item	DWR Erosion Survey			37.938870 °	37.938870 °
				-121.340460 °	-121.340460 °
DWR ID					
Action/Comments					
Inspector Comments: 06/24/2015: No significant change observed. 6/19/2014: No significant change observed. 08/13/2013: No significant change at this site. 8/7/2012: The erosion is at the upper levee slope, and likely caused by slope slip. The lower levee slope is covered with dense vegetation. [2015 Site ID:RD0524U01RM40.99]

Front view of the erosion site. Note the vegetation at the levee toe and on the lower slope.

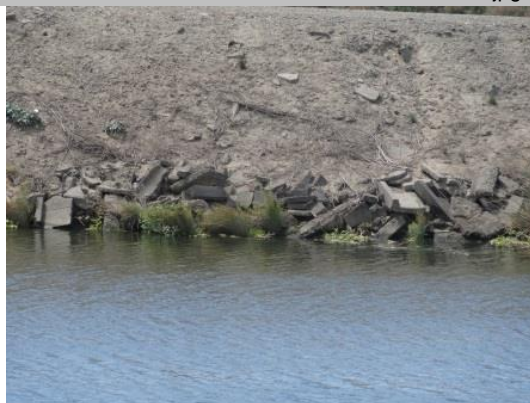
Photo 2 of 2 : SJR2015_RD0524U01RM40.99_5.jpg

Close view of the erosion.

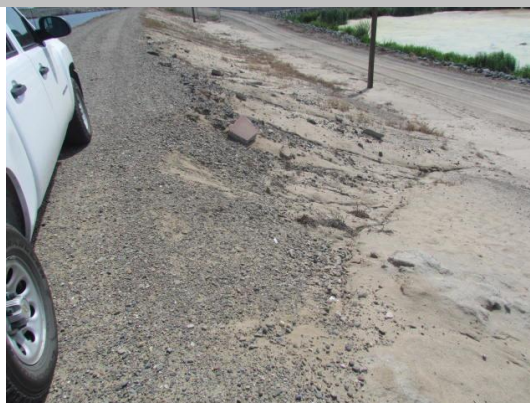
Photo 1 of 2 : FA_2015_RD0524_107_170_20150914_00158.jpg

LM Start	0.41	Rating **	M	Issue No.	170
LM End	0.45	Issue Type +	Ma	Location *	WS
Category	Earthen Levee			GPS Latitude/Longitude	
				Start	End
Item	Slope Stability			37.938628 °	37.938688 °
				-121.340385 °	-121.339627 °
DWR ID	DWR_RD0524_01_s_2015_170				
Action/Comments					
Repair slope instability.					
Inspector Comments: Several slope instabilites within this reach.

Looking south at slope damage on waterward shoulder.

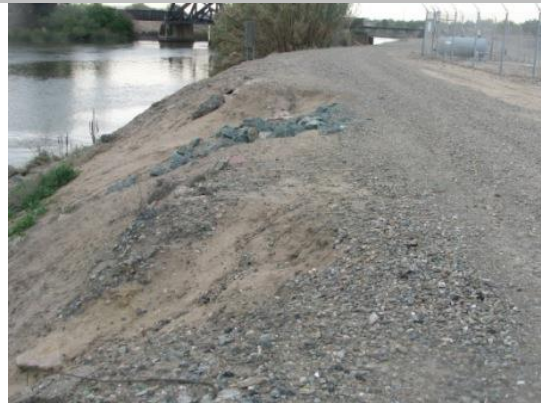
Photo 3 of 4 : FA_2015_RD0524_107_13_20150914_00017.jpg

View of the erosion.

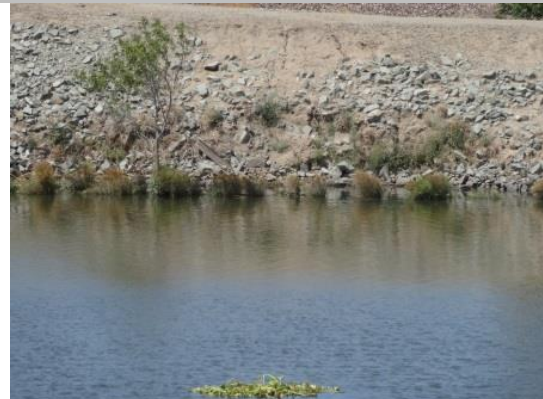
Photo 2 of 2 : SJR2015_RD0524U01RM41.36_7.JPG

Front view of the erosion.

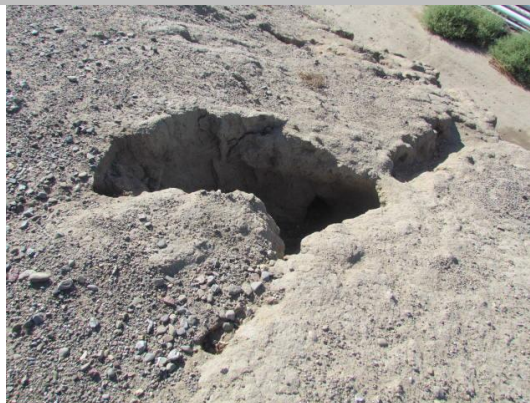
Photo 1 of 5 : FA_2015_RD0524_107_2_20150914_00001.jpg

LM Start	0.81	Rating **	U	Issue No.	2
LM End	0.81	Issue Type +	Ma	Location *	LS
Category	Earthen Levee			GPS Latitude/Longitude	
				Start	End
Item	Erosion / Bank Caving			37.936093 °	37.936004 °
				-121.334648 °	-121.334615 °
DWR ID	DWR_RD0524_01_f _ 2013_2				
Action/Comments					
Schedule repair of erosion site prior to the next inspection. Inspector Comments: One large hole. Hole is over 12" deep and 12" wide and several holes and finger erosions on landward slope.

Looking southwest at hole on landward shoulder.

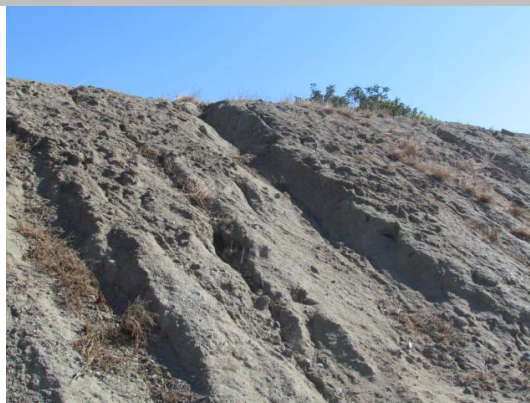
Photo 3 of 5 : FA_2015_RD0524_107_2_20150914_00003.jpg

Looking southeast at finger erosion on landward slope.

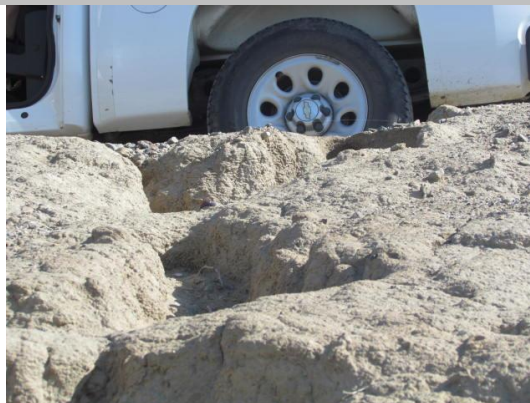
Photo 4 of 5 : FA_2015_RD0524_107_2_20150914_00004.jpg

Looking east at erosion on landward slope.

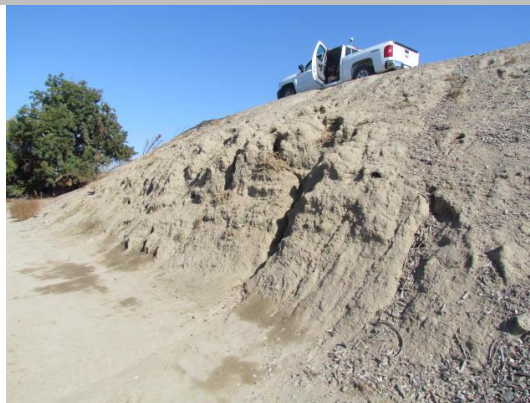
Photo 5 of 5 : FA_2015_RD0524_107_2_20150914_00005.jpg

Looking northeast at several finger erosion on landward slope.

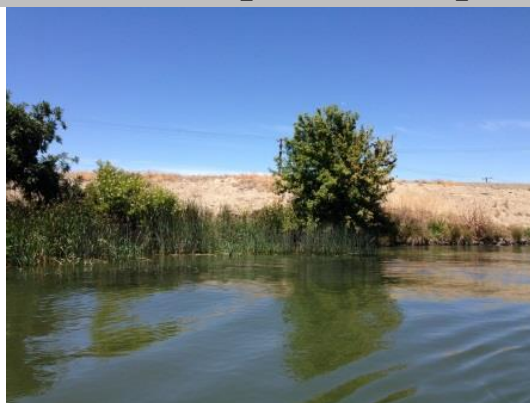
Photo 1 of 2 : SJR2015_RD0524U01RM41.44_1.JPG

LM Start	0.83	Rating **	U	Issue No.	134
LM End	0.84	Issue Type +	Ma	Location *	WS
Category	Supplemental			GPS Latitude/Longitude	
				Start	End
Item	DWR Erosion Survey			37.935930 °	37.935930 °
				-121.334133 °	-121.334133 °
DWR ID					
Action/Comments					
Inspector Comments: 06/24/2015: No significant change observed. 06/19/2014: No significant change observed. 08/13/2013: Site was discovered during boat survey. The dense vegetation blocks a clear view of the erosion. Size of erosion site was very roughly estimated. [2015 Site ID:RD0524U01RM41.44]

Front view of the erosion. The tree and vegetation block the view of the site.

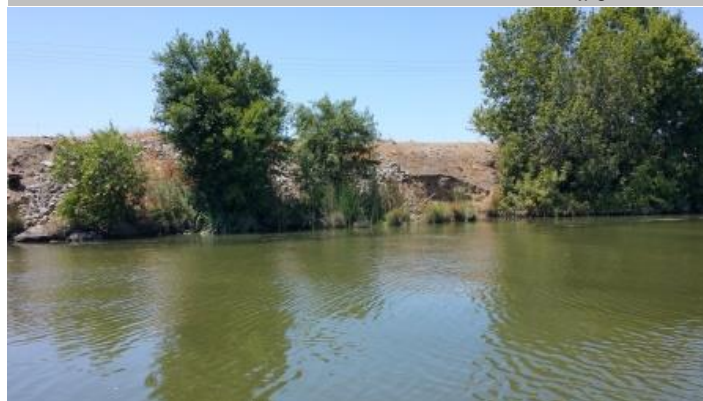
Photo 1 of 2 : SJR2015_RD0524U01RM41.50_4.jpg

LM Start	0.91	Rating **	U	Issue No.	135
LM End	0.91	Issue Type +	Ma	Location *	WS
Category	Supplemental			GPS Latitude/Longitude	
				Start	End
Item	DWR Erosion Survey			37.935576 °	37.935576 °
				-121.333202 °	-121.333202 °
DWR ID					
Action/Comments					
Inspector Comments: 06/24/2015: No significant change observed. 6/19/2014: No significant change observed. 08/13/2013: No significant change at this site. 08/07/2012: The site has been visited by boat survey. No significant change observed 08/23/2011: The erosion site is immediately downstream of the riprap protection. [2015 Site ID:RD0524U01RM41.5]

Front view of the erosion. Note the riprap protection near the site.

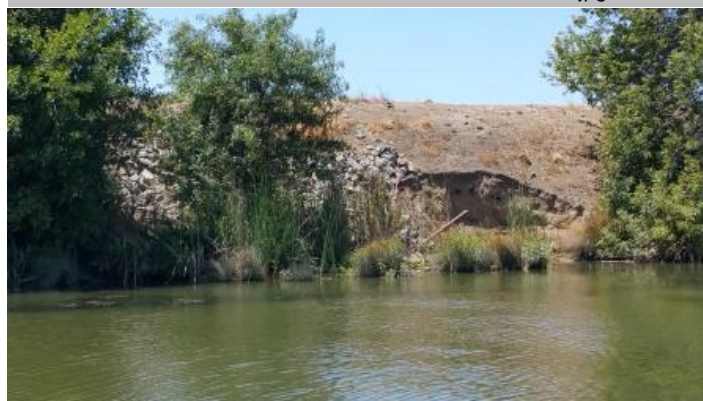
Photo 2 of 2 : SJR2015_RD0524U01RM41.50_5.jpg

A close view of the erosion.

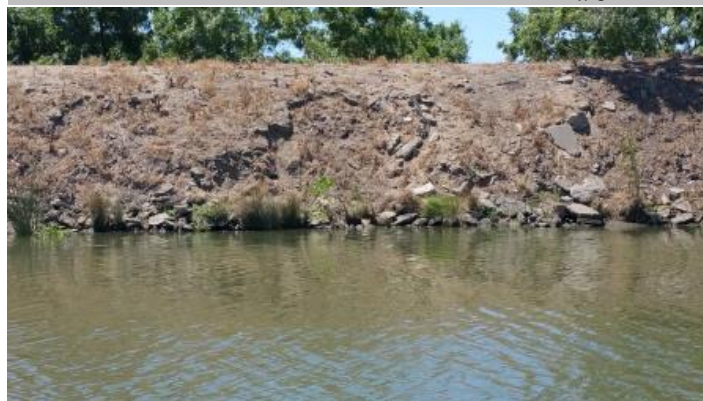
Photo 1 of 2 : SJR2015_RD0524U01RM41.58_2.jpg

LM Start	1.00	Rating **	U	Issue No.	137
LM End	1.00	Issue Type +	Ma	Location *	WS
Category	Supplemental			GPS Latitude/Longitude	
				Start	End
Item	DWR Erosion Survey			37.935410 °	37.935410 °
				-121.331560 °	-121.331560 °
DWR ID					
Action/Comments					
Inspector Comments: 06/24/2015: No significant change observed. 6/19/2014: No significant change observed. 08/13/2013: No significant change at this site. 08/07/2012: The erosion was discovered during the boat survey. [2015 Site ID:RD0524U01RM41.58]

Close view of the erosion.

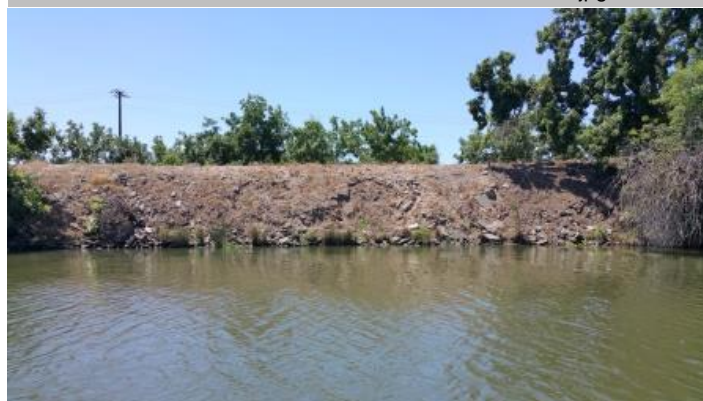
Photo 2 of 2 : SJR2015_RD0524U01RM41.58_3.jpg

Front view of the erosion.

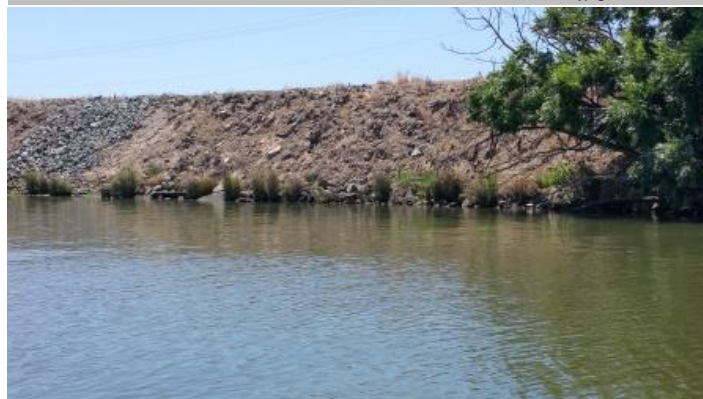
Photo 1 of 2 : SJR2015_RD0524U01RM41.59_1.jpg

LM Start	1.02	Rating **	U	Issue No.	139
LM End	1.02	Issue Type +	Ma	Location *	WS
Category	Supplemental			GPS Latitude/Longitude	
				Start	End
Item	DWR Erosion Survey			37.935078 °	37.935078 °
				-121.331134 °	-121.331134 °
DWR ID					
Action/Comments					
Inspector Comments: 06/24/2015: No significant change observed. 6/19/2014: No significant change observed. 08/13/2013: No significant change at this site. 08/07/2012: The site has been visited by boat survey. Site has been repaired, but new erosion occurred at the levee slope and immediately upstream of the repaired site.

Front view of the site.

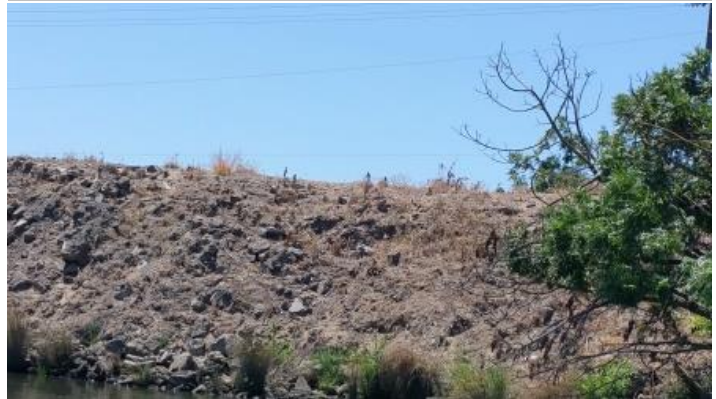
Photo 2 of 2 : SJR2015_RD0524U01RM41.59_5.jpg

Close view of the erosion.

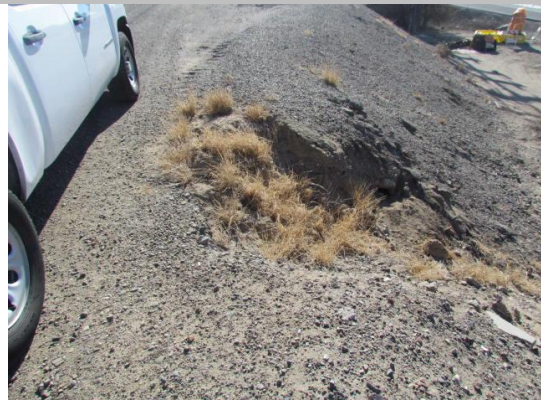
Photo 1 of 7 : FA_2015_RD0524_107_18_20151023_00246.jpg

Looking south at caving on landward shoulder. (Fall 2015)

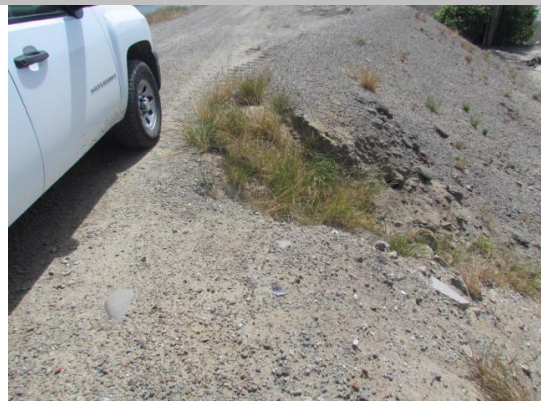
Photo 2 of 7 : FA_2015_RD0524_107_18_20150914_00026.jpg

Looking south at caving on landward shoulder. (Spring 2015)

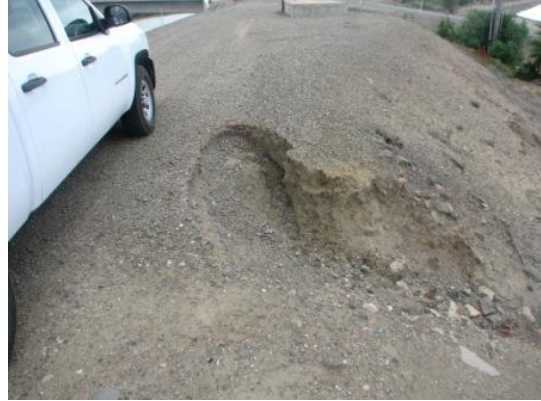
Photo 3 of 7 : FA_2015_RD0524_107_18_20150914_00027.jpg

Landward slope damage. Spring 2014

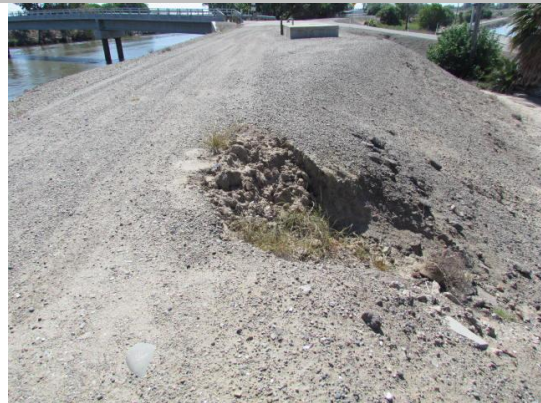
Photo 5 of 7 : FA_2015_RD0524_107_18_20150914_00029.jpg

Looking south at caving on landside shoulder. (Spring 2013)

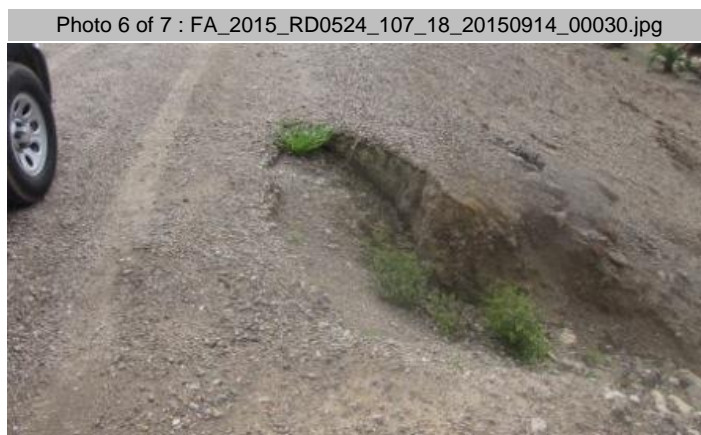
LM Start	1.08	Rating **	U	Issue No.	18 (cont)
LM End	1.08	Issue Type +	Ma	Location *	LS
Category	Earthen Levee			GPS Latitude/Longitude	
				Start	End
Item	Slope Stability			37.934645 °	37.934645 °
				-121.330310 °	-121.330310 °
DWR ID	DWR_RD0524_01_s _ 2012_18				
Action/Comments					
Repair slope instability. Inspector Comments: Slope damage extend from shoulder to middle of slope.

Looking at updated slope stability as of Fall 2013.

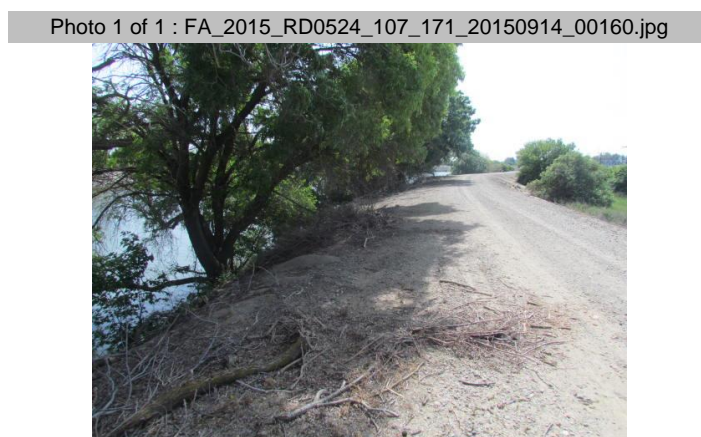
LM Start	1.12	Rating **	M	Issue No.	171
LM End	1.16	Issue Type +	Ma	Location *	WS
Category	Earthen Levee			GPS Latitude/Longitude	
				Start	End
Item	Encroachments			37.934225 °	37.933815 °
				-121.329693 °	-121.329242 °
DWR ID	DWR_RD0524_01_s _ 2015_171				
Action/Comments					
Prunings					
Inspector Comments: Prunings left on waterward shoulder and slope.

Looking south at prunings on waterward shoulders.

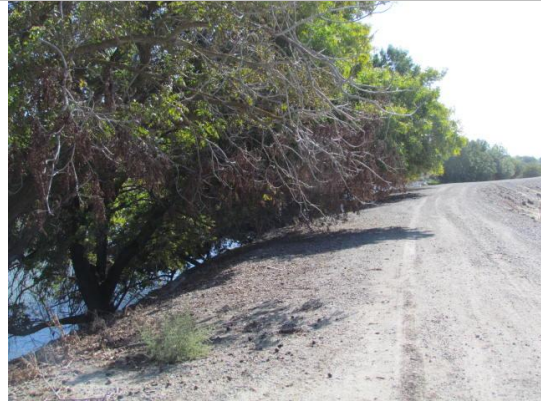
Photo 1 of 1 : FA_2015_RD0524_107_19_20150914_00032.jpg

Looking northwest at low hanging tree branches at waterside toe.

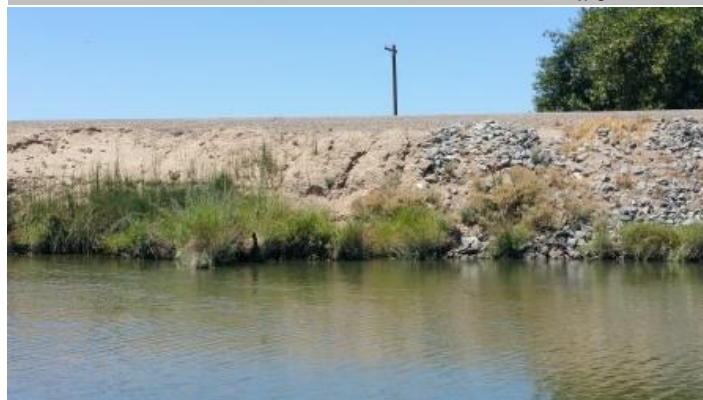
Photo 2 of 2 : SJR2015_RD0524U01RM41.79_5.jpg

Close view of the upstream side of the erosion.

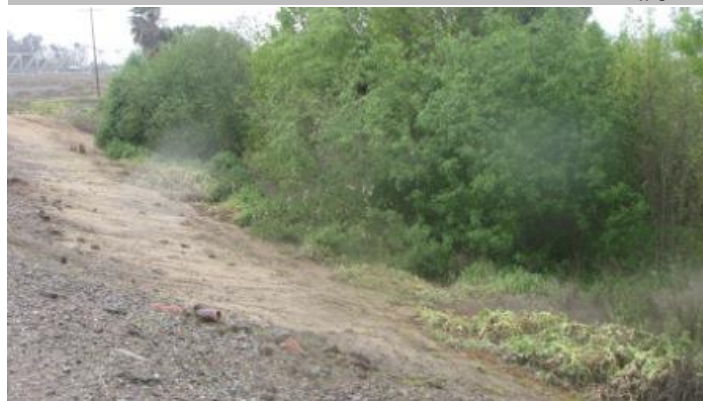
Photo 1 of 1 : FA_2015_RD0524_107_915_20150914_00197.jpg

Looking southwest at dense veg. on landside toe.

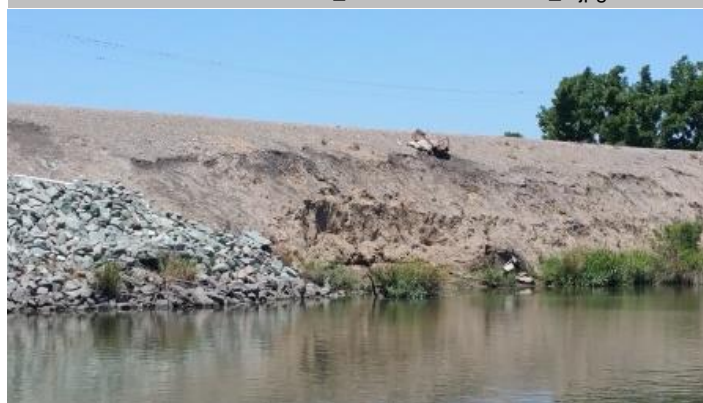
Photo 1 of 1 : SJR2015_RD0524U01RM41.92_2.jpg

Front view of the erosion.

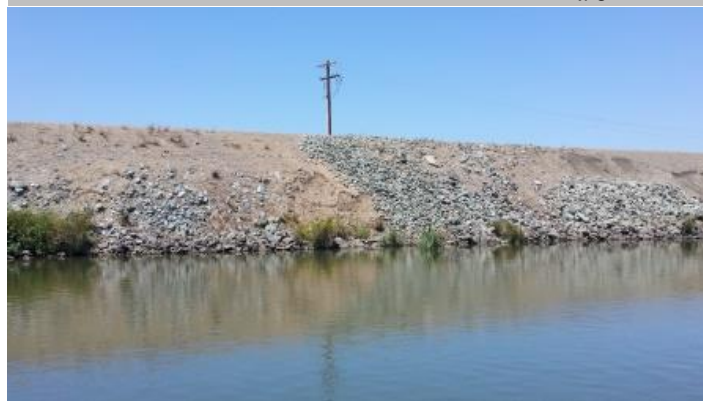
Photo 1 of 2 : SJR2015_RD0524U01RM42.03_1.jpg

Front view of the erosion.

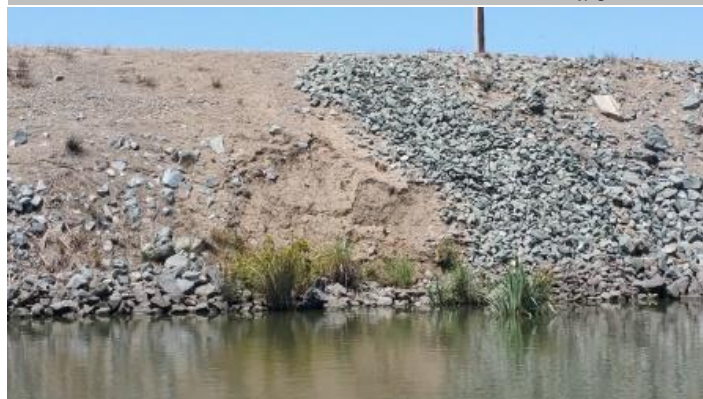
Photo 2 of 2 : SJR2015_RD0524U01RM42.03_3.jpg

Close view of the erosion.

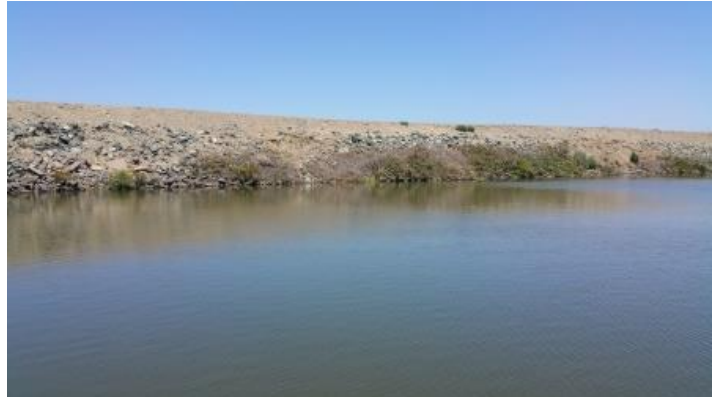
Photo 1 of 3 : SJR2015_RD0524U01RM42.09_1.JPG

Front view of the erosion site.

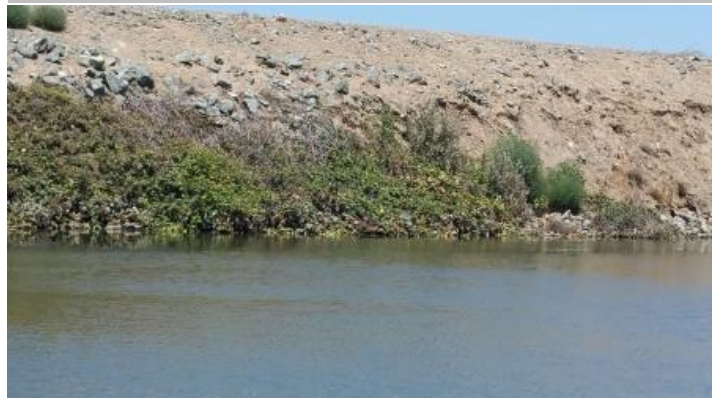
Photo 3 of 3 : SJR2015_RD0524U01RM42.09_4.JPG

Close view of the erosion. Note the vegetation at the site.

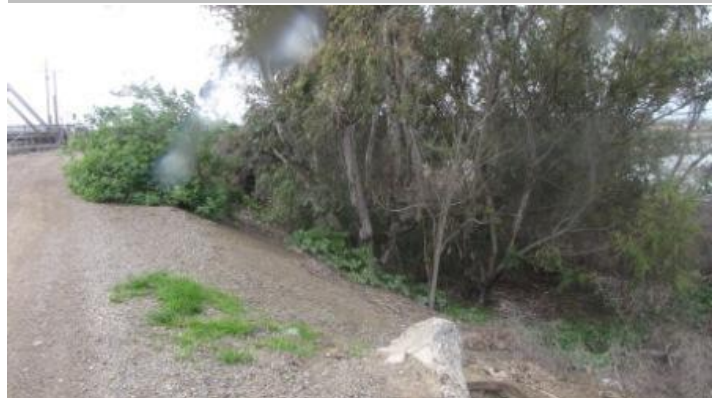
Photo 3 of 4 : FA_2015_RD0524_107_916_20150914_00200.jpg

Looking south at dense veg. on landside slope and toe.

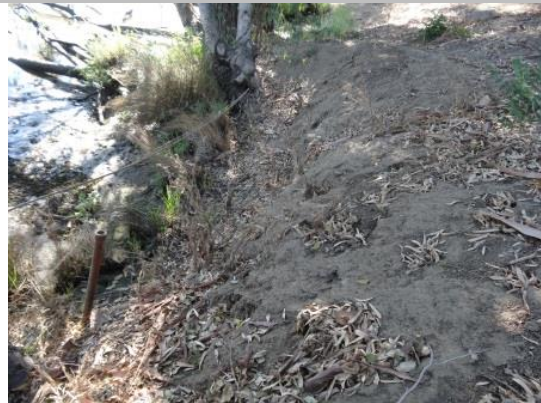
Photo 2 of 2 : SJR2015_RD0524U01RM42.20_5.jpg

Close view of the erosion at the levee toe.

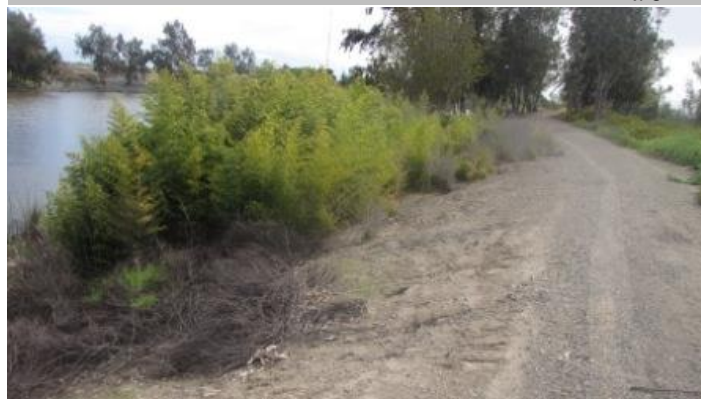
Photo 1 of 1 : FA_2015_RD0524_107_25_20150914_00042.jpg

Looking southeast at dense vegetation on the waterside slope.

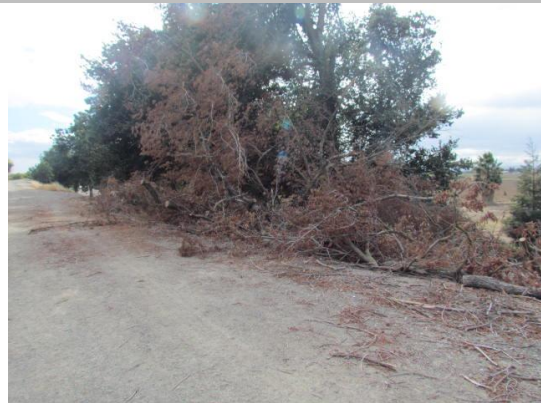
Photo 3 of 4 : FA_2015_RD0524_107_46_20150914_00072.jpg

Looking south at tree limbs on landward slope.

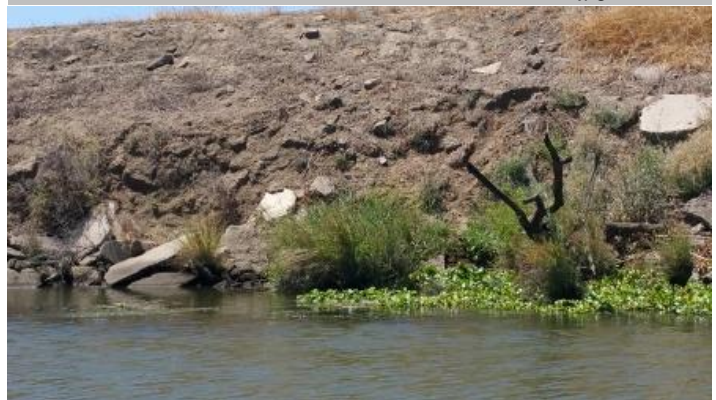
Photo 1 of 2 : SJR2015_RD0524U01RM42.79_1.jpg

Close view of the pocket erosion.

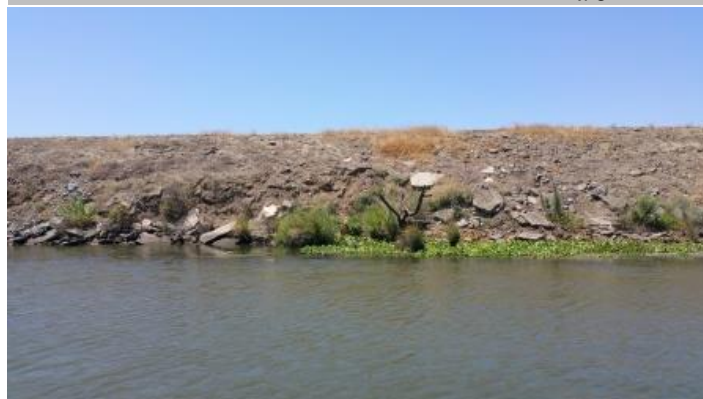
Photo 2 of 2 : SJR2015_RD0524U01RM42.79_4.jpg

Front view of the erosion.

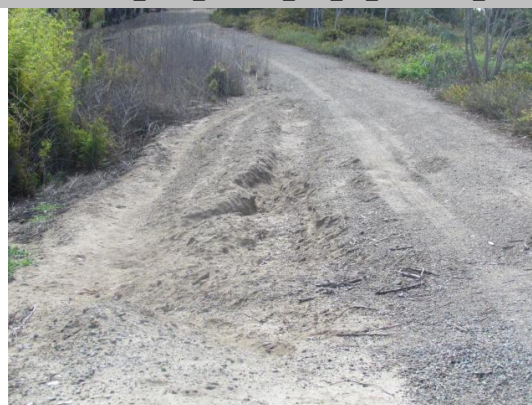
Photo 1 of 1 : FA_2015_RD0524_107_31_20150914_00049.jpg

Looking south slope damage on waterward shoulder and slope.

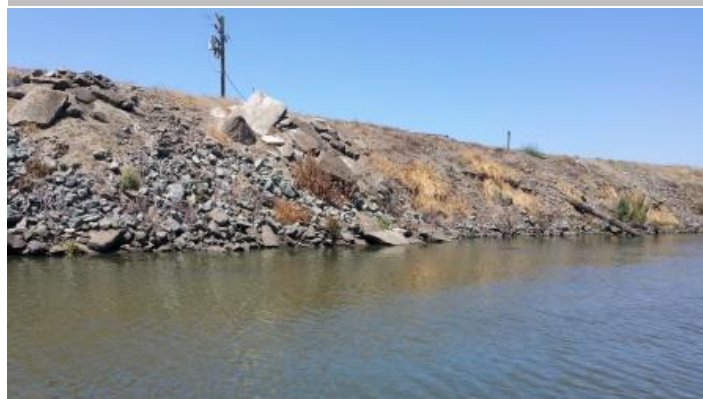
Photo 1 of 3 : SJR2015_RD0524U01RM42.84_1.JPG

View from upstream.

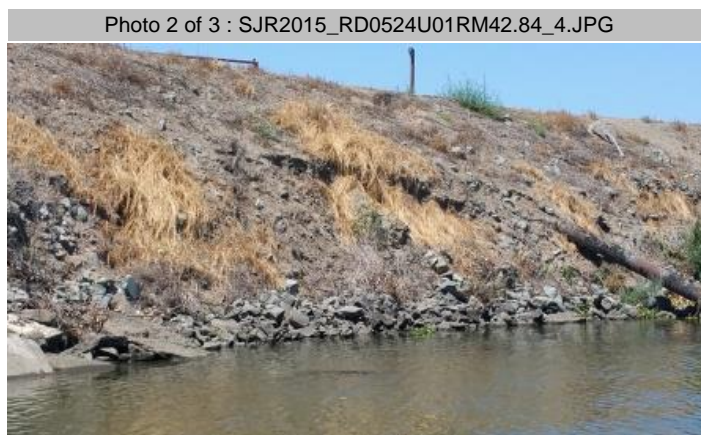
LM Start	2.24	Rating **	U	Issue No.	103 (cont)
LM End	2.27	Issue Type +	Ma	Location *	WS
Category	Supplemental			GPS Latitude/Longitude	
				Start	End
Item	DWR Erosion Survey			37.920650 °	37.920650 °
				-121.320370 °	-121.320370 °
DWR ID					
Action/Comments					
Inspector Comments: 06/24/2015: No significant change observed. 6/19/2014: No significant change observed. 08/13/2013: An irrigation pipe is on site. [2015 Site ID:RD0524U01RM42.84]

Close view of the erosion. Note the irrigation pipe.

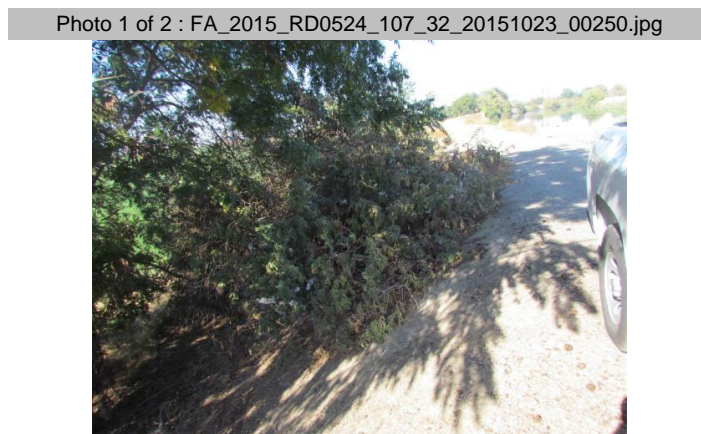
LM Start	2.27	Rating **	U	Issue No.	32
LM End	2.29	Issue Type +	Ma	Location *	LS
Category	Earthen Levee			GPS Latitude/Longitude	
				Start	End
Item	Vegetation			37.920372 °	37.920167 °
				-121.320230 °	-121.319890 °
DWR ID	DWR_RD0524_01_s_2012_32				
Action/Comments					
Elderberries are blocking visibility and flood fight capability. Inspector Comments: Dense elderberry bushes on landward slope and toe.

Looking northwest at dense veg on landward slope and toe fall 2015.

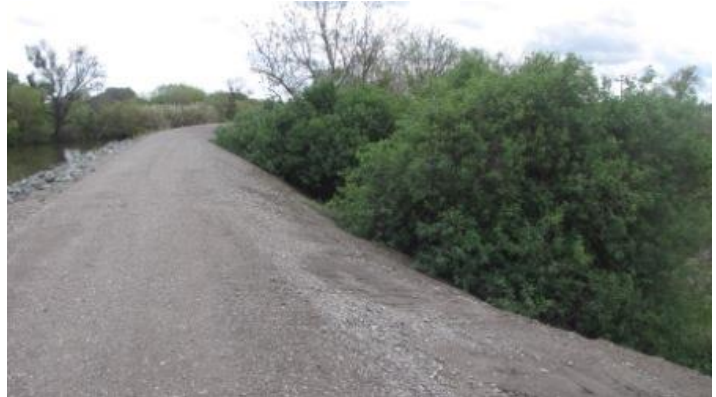
Photo 2 of 2 : FA_2015_RD0524_107_32_20150914_00050.jpg

Looking south at dense veg on landside slope and toe.

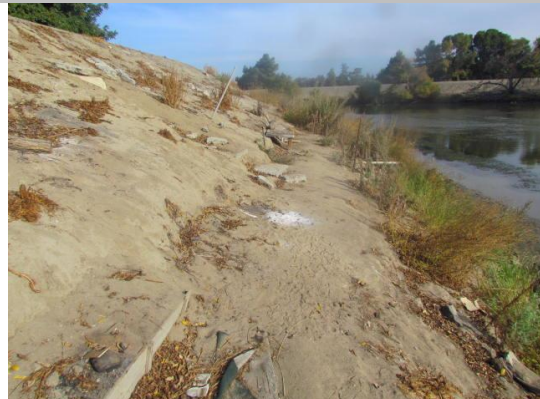
Photo 1 of 1 : FA_2015_RD0524_107_34_20150914_00053.jpg

Looking northeast at damage to the slope possibly caused by human activity.

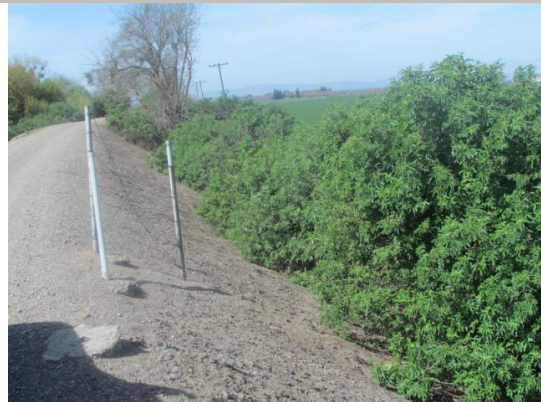
Photo 1 of 1 : FA_2015_RD0524_107_35_20150914_00054.jpg

Looking southwest at dense vegetation on landward toe.

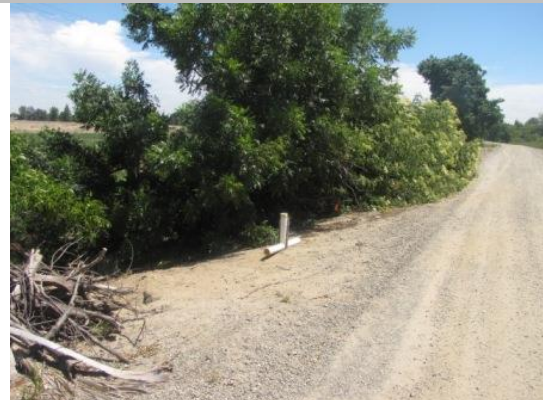
Photo 3 of 4 : FA_2015_RD0524_107_37_20150914_00058.jpg

Looking north at elderberry and trees on landside slope.

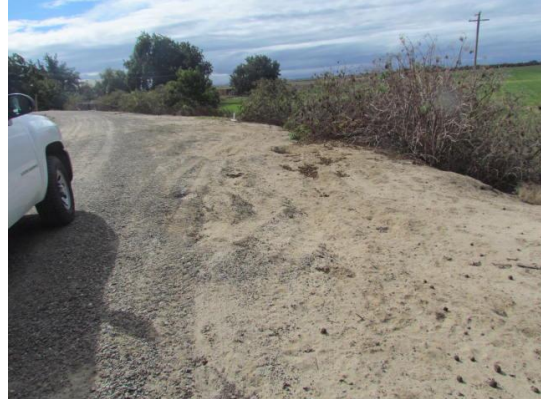
Photo 1 of 1 : FA_2015_RD0524_107_82_20150914_00107.jpg

Looking southwest at damaged landward slope.

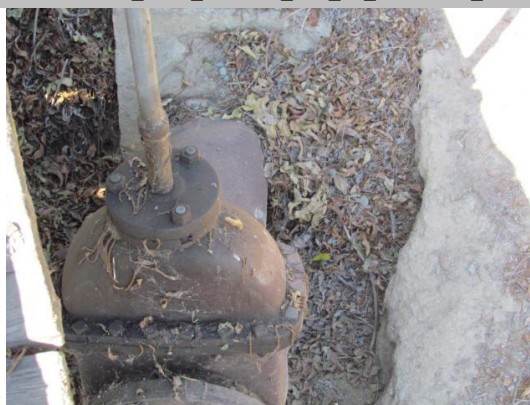
Photo 1 of 2 : FA_2015_RD0524_107_21_20150914_00033.jpg

Looking at erosion around irrigation pipe on waterward slope.

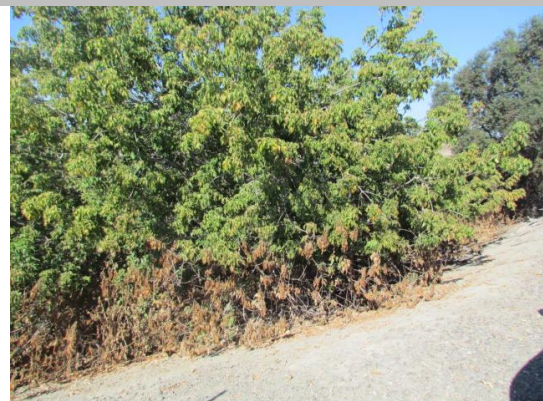
Photo 1 of 2 : FA_2015_RD0524_107_51_20151023_00253.jpg

Looking south at dense trees on landward slope fall 2015

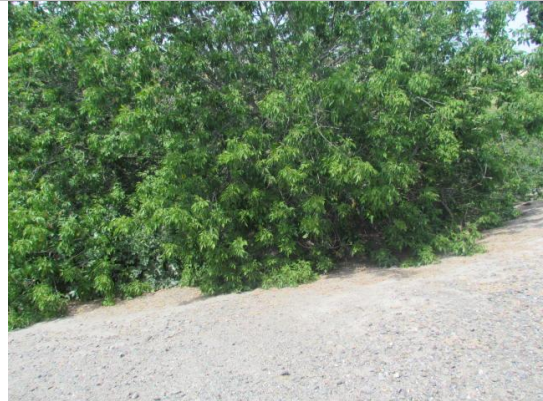
Photo 2 of 2 : FA_2015_RD0524_107_51_20150914_00078.jpg

Looking south at dense trees on landward slope spring 2015

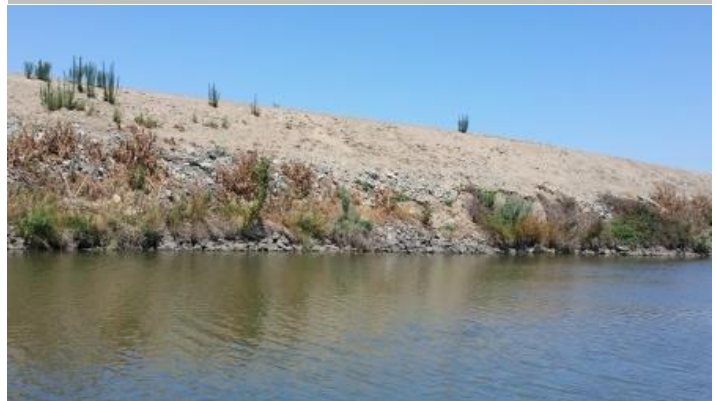
Photo 1 of 1 : SJR2015_RD0524U01RM43.52_2.jpg

Front view of the erosion.

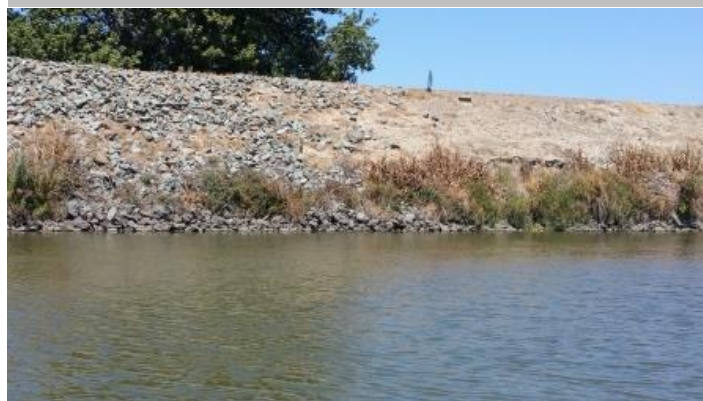
Photo 1 of 2 : SJR2015_RD0524U01RM43.86_2.JPG

Front view of the erosion.

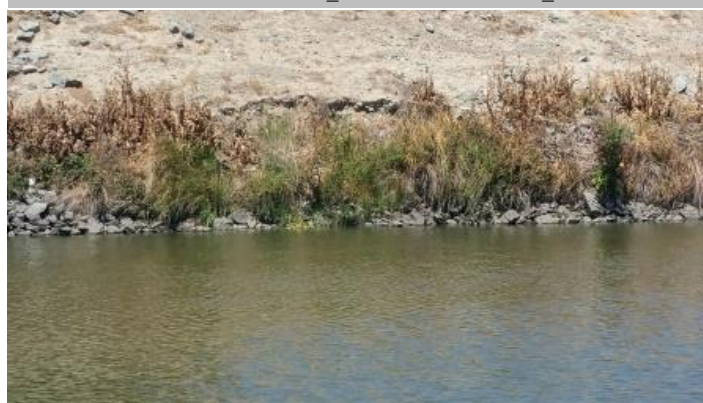
Photo 2 of 2 : SJR2015_RD0524U01RM43.86_5.JPG

Close view of the erosion.

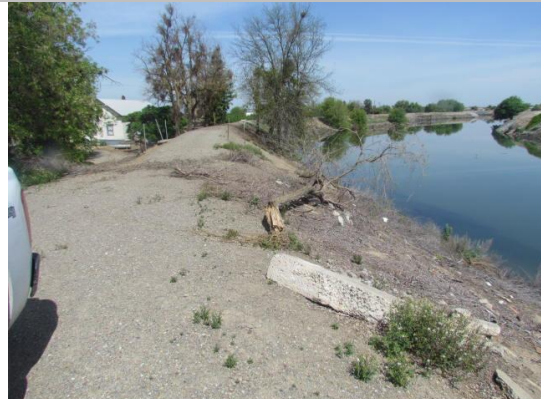
Photo 1 of 1 : FA_2015_RD0524_107_187_20150914_00176.jpg

Looking northeast at tree limb on waterward slope.

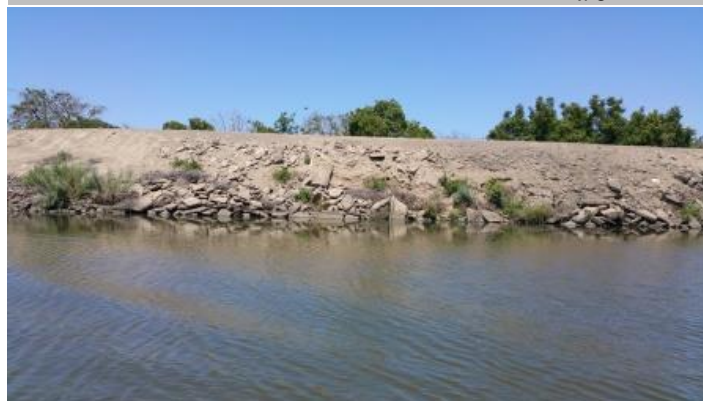
Photo 1 of 2 : SJR2015_RD0524U01RM45.07_1.jpg

Front view of the erosion site.

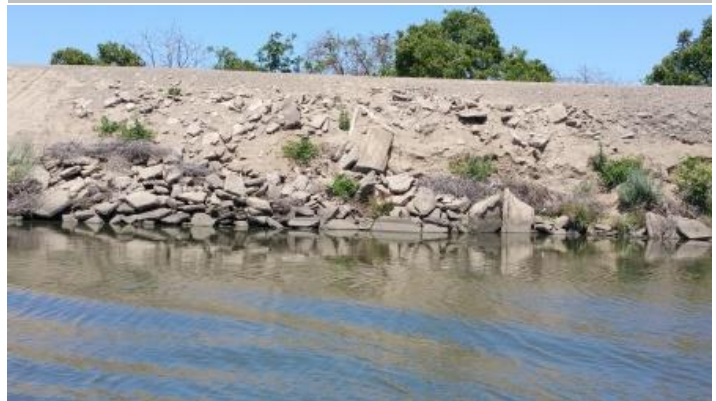
Photo 2 of 2 : SJR2015_RD0524U01RM45.07_2.jpg

Close view of the site.

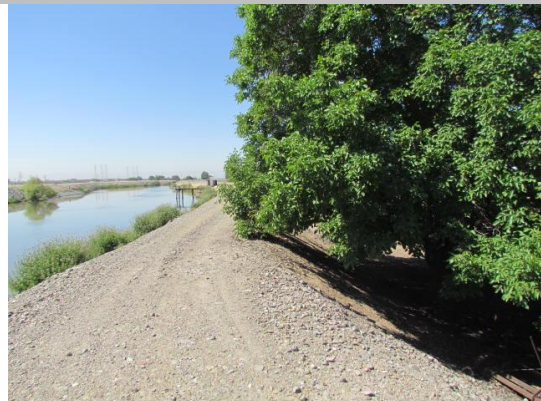
Photo 1 of 1 : FA_2015_RD0524_107_63_20150914_00088.jpg

Looking south at dense trees on landside slope.

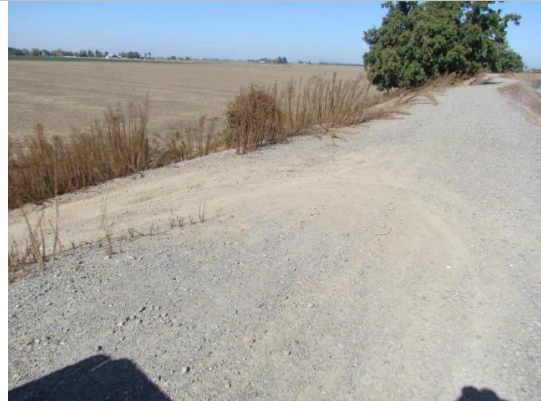
Photo 1 of 1 : FA_2015_RD0524_107_115_20150914_00130.jpg

Looking northwest at slope damage on landward slope.

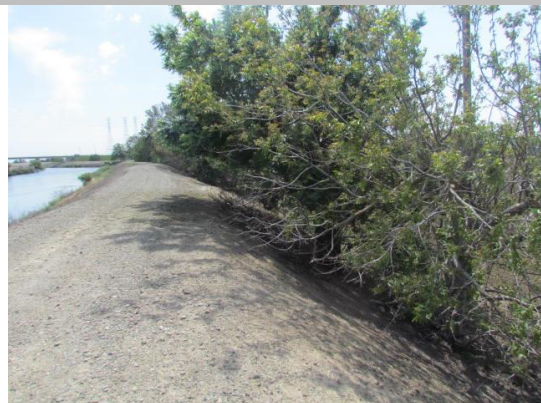
Photo 1 of 1 : FA_2015_RD0524_107_85_20150914_00109.jpg

Looking south at untrimmed trees on landward slope.

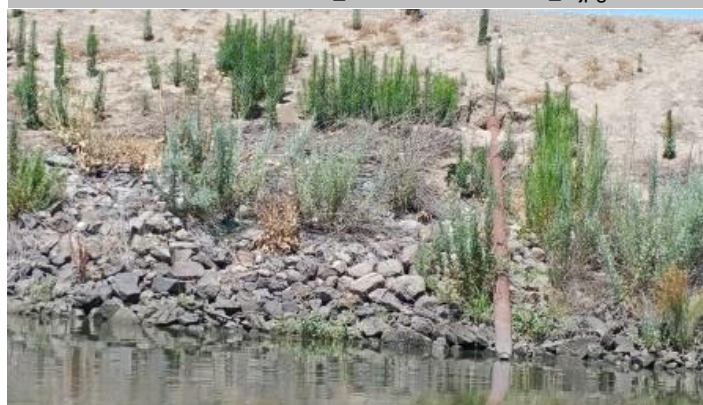
Photo 1 of 2 : SJR2015_RD0524U01RM45.97_2.jpg

Close view of the erosion and the pipe.

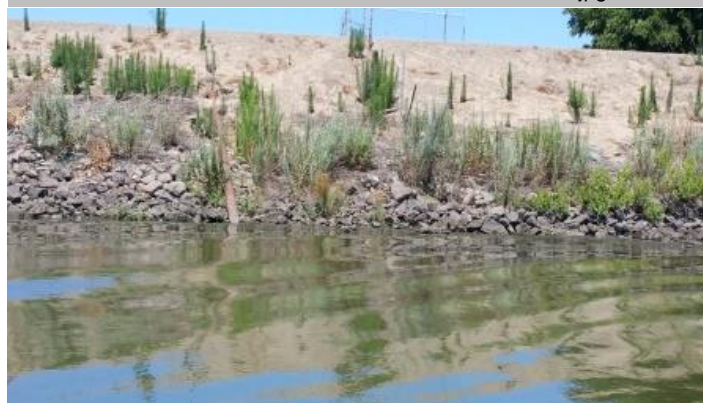
Photo 2 of 2 : SJR2015_RD0524U01RM45.97_4.jpg

Front view of the site.

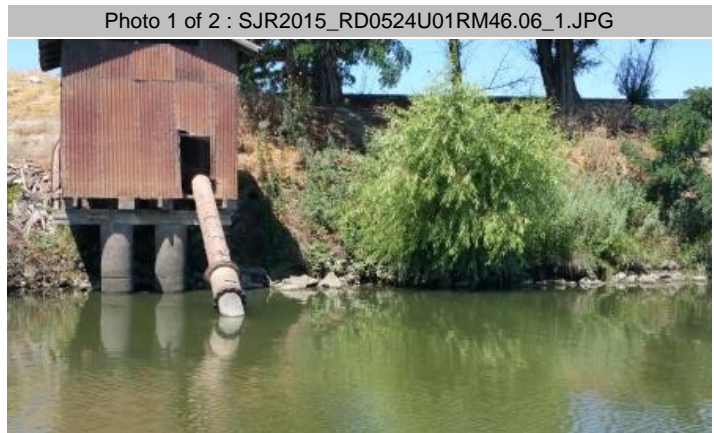
LM Start	5.53	Rating **	M	Issue No.	22
LM End	5.53	Issue Type +	Ma	Location *	WS
Category	Supplemental			GPS Latitude/Longitude	
				Start	End
Item	DWR Erosion Survey			37.878920 °	37.878920 °
				-121.332670 °	-121.332670 °
DWR ID					
Action/Comments					
Inspector Comments: 06/24/2015: No significant change observed. 6/19/2014: No significant change observed. 08/13/2013: Larger trees are at the levee shoulder, and an irrigation pump station is next to the erosion site. [2015 Site ID:RD0524U01RM46.06]

Front view of the erosion.

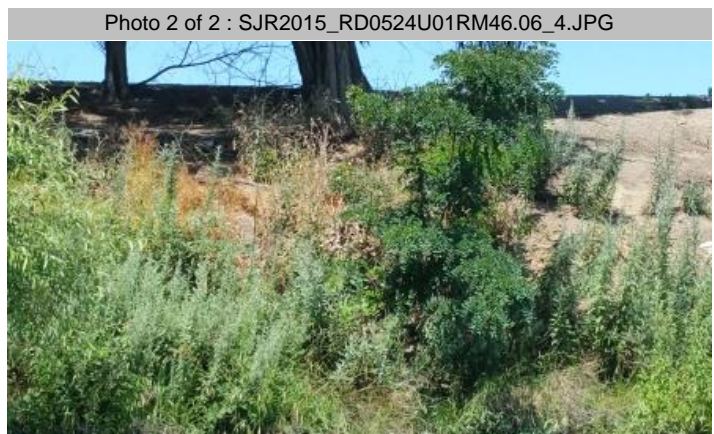
Close view of the site. Note large trees at the levee shoulder.

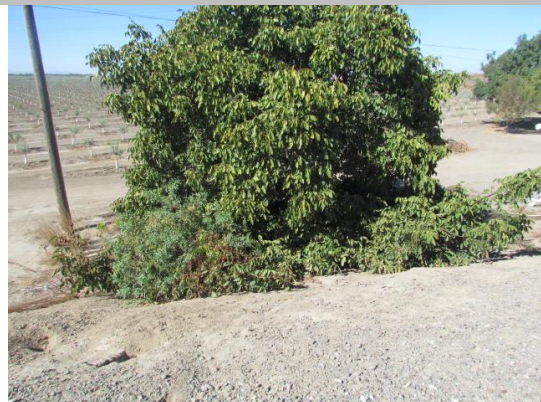
Photo 1 of 1 : FA_2015_RD0524_107_196_20151023_00265.jpg

Looking west at untrimmed tree at landward toe fall 2015.

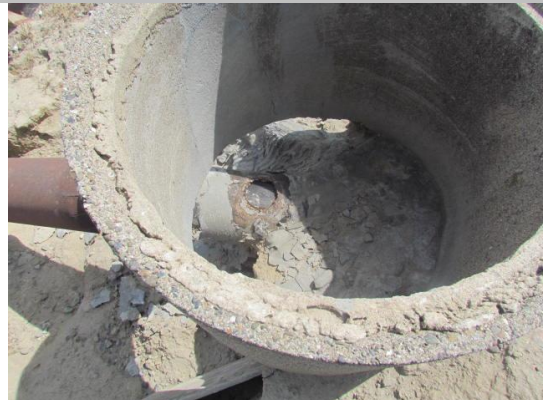
Photo 3 of 3 : FA_2015_RD0524_107_198_20150914_00186.jpg

Looking at erosion around pipe inside concrete collar.

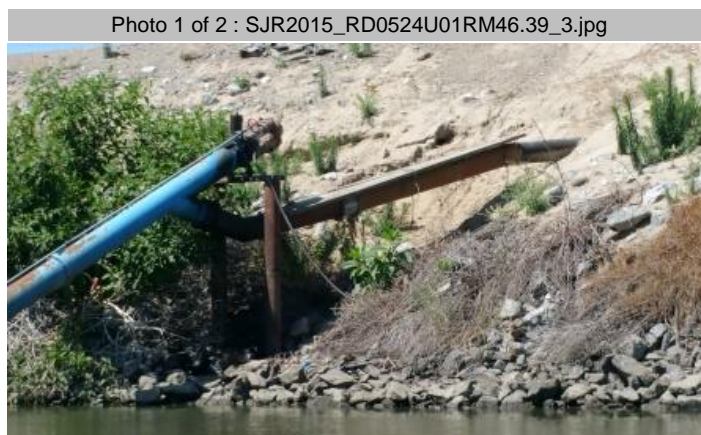
LM Start	5.86	Rating **	U	Issue No.	47
LM End	5.86	Issue Type +	Ma	Location *	WS
Category	Supplemental			GPS Latitude/Longitude	
				Start	End
Item	DWR Erosion Survey			37.874370 °	37.874370 °
				-121.332850 °	-121.332850 °
DWR ID					
Action/Comments					
Inspector Comments: 06/24/2015: No significant change observed. 06/19/2014: No significant change observed. 08/13/2013: No significant change observed. 08/07/2012: The erosion is near a water-intake structure. Pipe leakage likely caused the erosion. [2015 Site ID:RD0524U01RM46.39]

Close view of the erosion and the pipe.

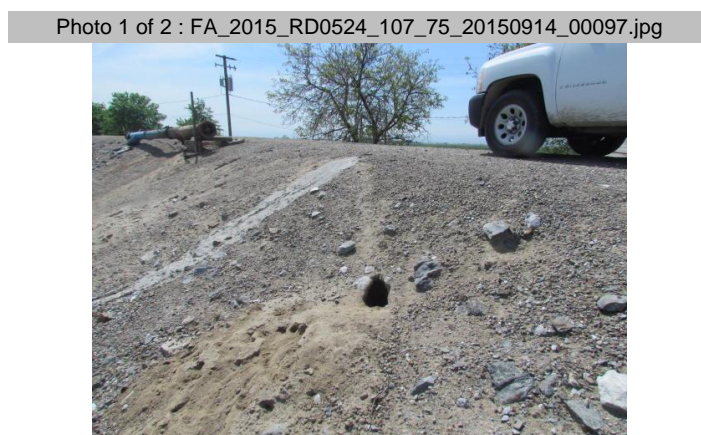
LM Start	5.86	Rating **	M	Issue No.	75
LM End	5.88	Issue Type +	Ma	Location *	WS
Category	Earthen Levee			GPS Latitude/Longitude	
				Start	End
Item	Animal Control			37.874240 °	37.874002 °
				-121.333187 °	-121.333027 °
DWR ID	DWR_RD0524_01_s_2012_75				
Action/Comments					
No rodents visible, but rodent burrows visible; need to backfill and compact or grout burrows. Inspector Comments: District has grouted rodent holes, but other rodent holes have appeared.

Looking southwest at typical rodent holes on waterward slope.
