**Flood Control Project Maintenance
Levee Inspections**

Maintenance Issue Types Only, Levee Inspection Report By Mile - Fall 2016

Reclamation District No. 0524 Middle Roberts Island

Waterway	Bank	Unit Miles	Inspection Start/End	Inspector
Unit No. 01 San Joaquin River	Left	6.20	10/10/2016 10/11/2016	Richard Willoughby

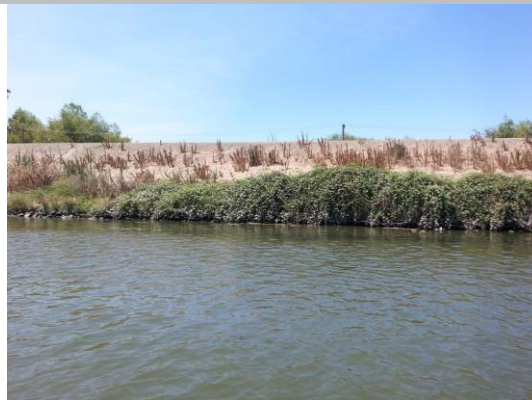
Photo 1 of 3 : SJR2016_RD0524U01RM40.85_1.jpg

LM Start	0.19	Rating **	U	Issue No.	5
LM End	0.19	Issue Type +	Ma	Location *	WS
Category	Supplemental			GPS Latitude/Longitude	
				Start	End
Item	DWR Erosion Survey			37.939085 °	37.939085 °
				-121.343917 °	-121.343917 °
DWR ID					
Comment Code					
Inspector Comment					
07/25/2016: No significant change observed.					
06/24/2015: No significant change observed.					
06/19/2014: No significant change observed.					
08/13/2013: The erosion was discovered during 2013 spring levee inspection. Inspector comment: Erosion is located along the lower level of water-ward slope. [2016 Site ID:RD0524U01RM40.85]

Close view of the erosion.

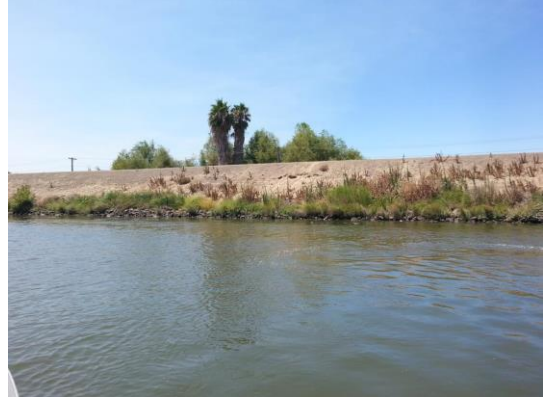
Photo 2 of 3 : SJR2016_RD0524U01RM40.85_3.jpg

LM Start	0.19	Rating **	U	Issue No.	5 (cont)	
LM End	0.19	Issue Type +	Ma	Location *	WS	
Category	Supplemental			GPS Latitude/Longitude		
				Start	End	
Item	DWR Erosion Survey			37.939085 °	37.939085 °	
				-121.343917 °	-121.343917 °	
DWR ID						
Comment Code						
Inspector Comment						
07/25/2016: No significant change observed.						
06/24/2015: No significant change observed.						
06/19/2014: No significant change observed.						
08/13/2013: The erosion was discovered during 2013 spring levee inspection. Inspector comment: Erosion is located along the lower level of water-ward slope. [2016 Site ID:RD0524U01RM40.85]

Close view of the erosion.

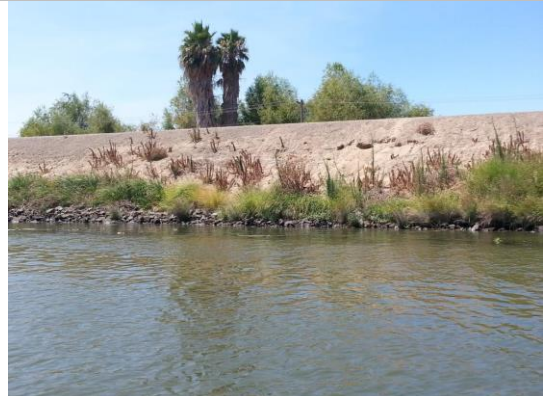
Photo 3 of 3 : SJR2016_RD0524U01RM40.85_4.jpg

Close view of the erosion.

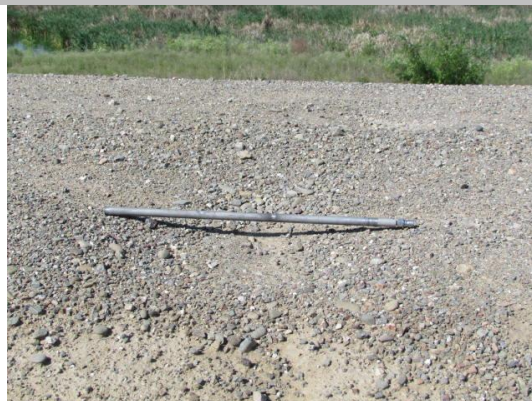
Photo 1 of 3 : FA_2016_RD0524_107_3_20160929_00007.jpg

LM Start	0.21	Rating **	M	Issue No.	3
LM End	0.21	Issue Type +	Ma	Location *	CR
Category	Earthen Levee			GPS Latitude/Longitude	
				Start	End
Item	Crown Surface / Depressions / Rutting			37.938890 °	37.938890 °
				-121.343657 °	-121.343657 °
DWR ID	DWR_RD0524_01_s_2016_3				
Comment Code					
C2 : Repair depressions or ruts in the crown or slope.					
Inspector Comment					
No change in status.

Looking west at 3" depression on levee crown. (Spring 2012)

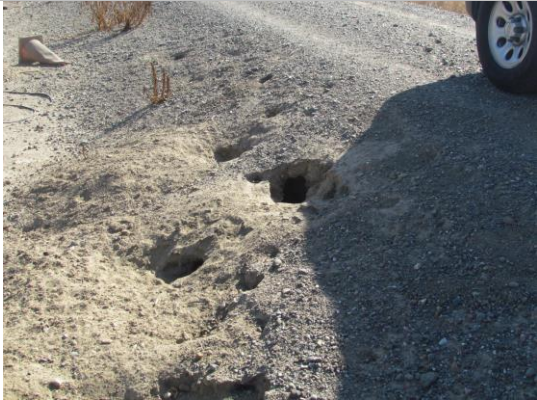
Photo 1 of 4 : FA_2016_RD0524_107_174_20161013_00386.jpg

Looking southwest at several rodent holes on waterward slope. (Fall 2016)

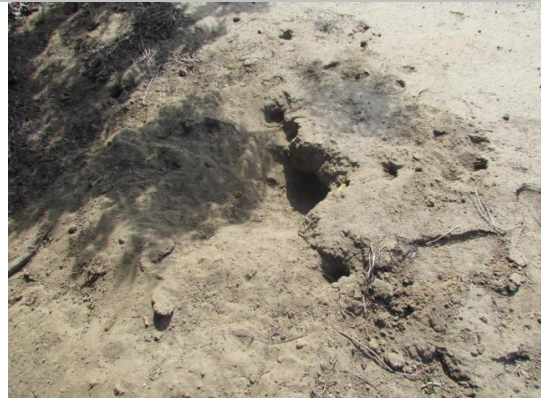
Photo 3 of 4 : FA_2016_RD0524_107_174_20160929_00218.jpg

Looking west at several rodent holes on waterward shoulder. (Spring 2015)

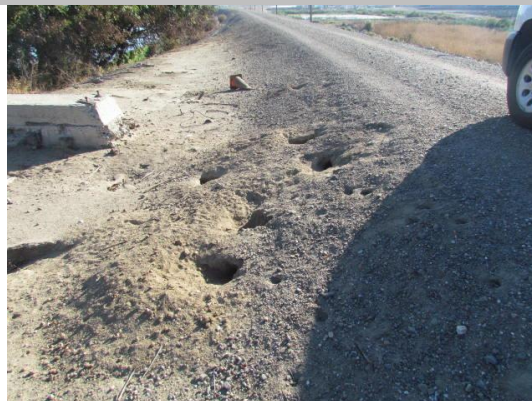
Photo 4 of 4 : FA_2016_RD0524_107_174_20160929_00217.jpg

Looking southeast at several rodent holes on waterward slope. (Fall 2015).

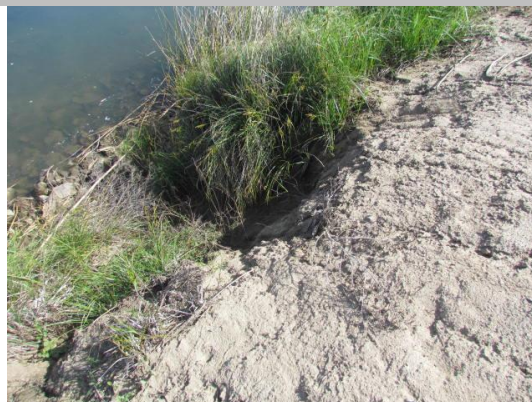
Photo 1 of 2 : FA_2016_RD0524_107_180_20160929_00227.jpg

LM Start	0.34	Rating **	M	Issue No.	180
LM End	0.34	Issue Type +	Ma	Location *	WS
Category	Earthen Levee			GPS Latitude/Longitude	
				Start	End
Item	Erosion / Bank Caving			37.938461°	37.938461°
				-121.341626°	-121.341626°
DWR ID	DWR_RD0524_01_s_2014_180				
Comment Code					
E2 : Schedule repair of erosion site prior to the next inspection.					
Inspector Comment					
Erosion is located along the lower level of waterward slope.

Looking southeast at erosion on waterward toe.

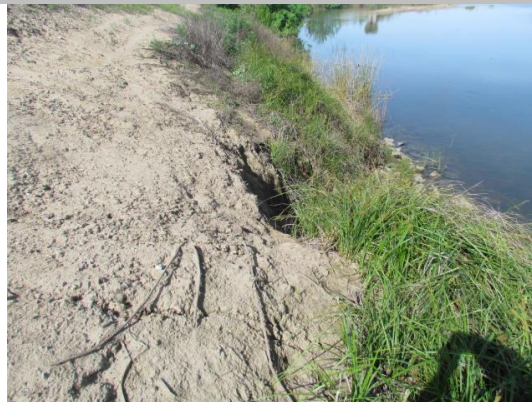
Photo 2 of 2 : FA_2016_RD0524_107_180_20160929_00228.jpg

Looking northeast at erosion on waterward toe.

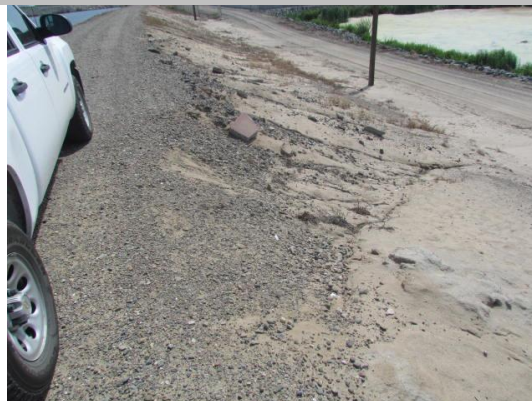
Photo 2 of 3 : FA_2016_RD0524_107_170_20160929_00211.jpg

LM Start	0.41	Rating **	U	Issue No.	170 (cont)	
LM End	0.45	Issue Type +	Ma	Location *	WS	
Category	Earthen Levee			GPS Latitude/Longitude		
				Start		End
Item	Slope Stability			37.938628 °	37.938688 °	
				-121.340385 °	-121.339627 °	
DWR ID	DWR_RD0524_01_s_2015_170					
Comment Code						
S1 : Repair slope instability.						
Inspector Comment						
Several slope instabilities within this reach.

Looking at slope damage on waterward shoulder.

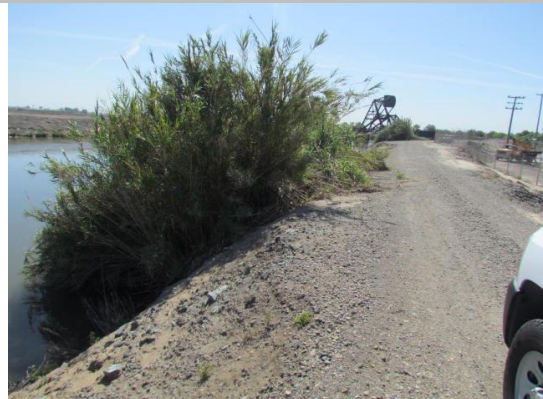
Photo 4 of 5 : FA_2016_RD0524_107_11_20160929_00021.jpg

Looking at bamboo on waterside slope. (Spring 2012)

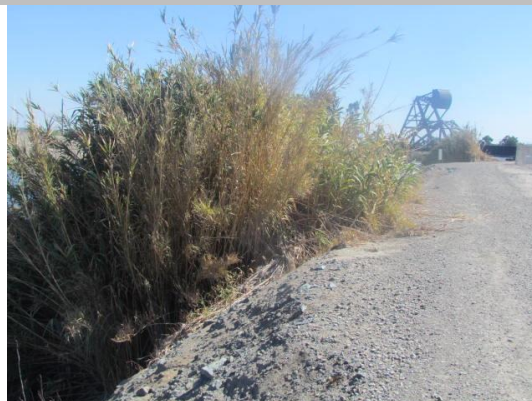
Photo 5 of 5 : FA_2016_RD0524_107_11_20160929_00022.jpg

Looking at bamboo on waterside slope. (Fall Inspection 2012)

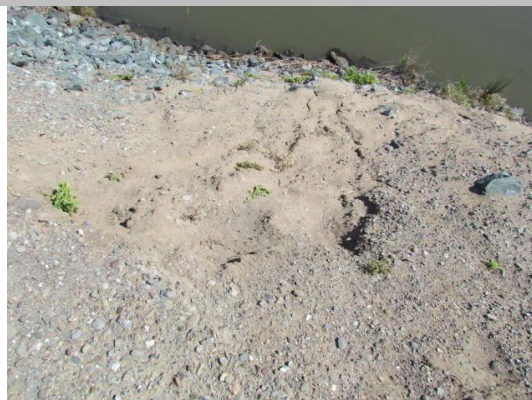
Photo 1 of 3 : FA_2016_RD0524_107_10_20160929_00015.jpg

LM Start	0.63	Rating **	U	Issue No.	10
LM End	0.63	Issue Type +	Ma	Location *	WS
Category	Earthen Levee			GPS Latitude/Longitude	
				Start	End
Item	Erosion / Bank Caving			37.938247 °	37.938247 °
				-121.336503 °	-121.336503 °
DWR ID	DWR_RD0524_01_f_2015_10				
Comment Code					
E2 : Schedule repair of erosion site prior to the next inspection.					
Inspector Comment					
Erosion located next to and under bamboo.

Looking east at waterside erosion appears to be caused by runoff.

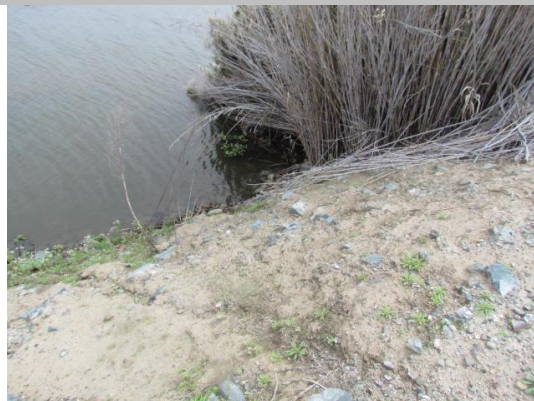
Photo 3 of 3 : FA_2016_RD0524_107_10_20160929_00017.jpg

LM Start	0.63	Rating **	U	Issue No.	10 (cont)	
LM End	0.63	Issue Type +	Ma	Location *	WS	
Category	Earthen Levee			GPS Latitude/Longitude		
				Start		End
Item	Erosion / Bank Caving			37.938247 °		37.938247 °
				-121.336503 °		-121.336503 °
DWR ID	DWR_RD0524_01_f_2015_10					
Comment Code						
E2 : Schedule repair of erosion site prior to the next inspection.						
Inspector Comment						
Erosion located next to and under bamboo.

Looking east at erosion under bamboo on waterward slope.

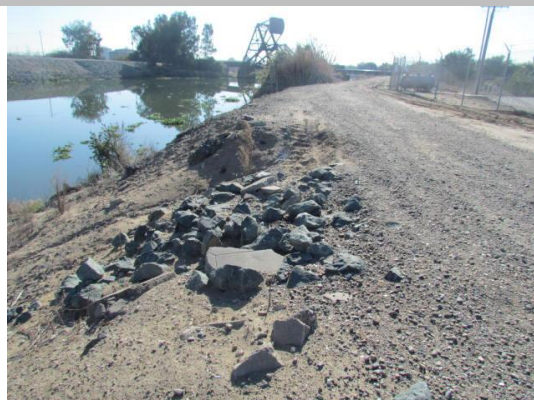
Photo 1 of 4 : FA_2016_RD0524_107_13_20160929_00024.jpg

LM Start	0.64	Rating **	M	Issue No.	13
LM End	0.65	Issue Type +	Ma	Location *	WS
Category	Earthen Levee			GPS Latitude/Longitude	
				Start	End
Item	Slope Stability			37.938105 °	37.938023 °
				-121.336288 °	-121.336173 °
DWR ID	DWR_RD0524_01_s_2012_13				
Comment Code					
S1 : Repair slope instability.					
Inspector Comment					
Depression extend from shoulder to mid levee slope two site with this section.

Looking southeast at depression on waterward shoulder fall 2015

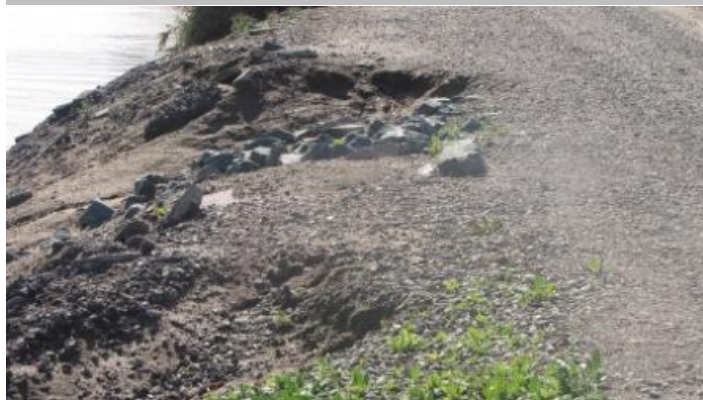
Photo 2 of 4 : FA_2016_RD0524_107_13_20160929_00025.jpg

Looking south at erosion on waterside shoulder.

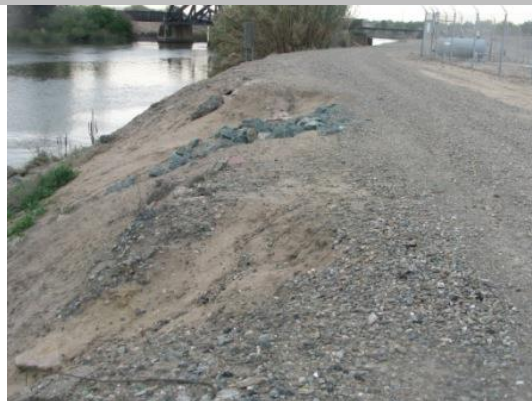
Photo 3 of 4 : FA_2016_RD0524_107_13_20160929_00026.jpg

LM Start	0.64	Rating **	M	Issue No.	13 (cont)	
LM End	0.65	Issue Type +	Ma	Location *	WS	
Category	Earthen Levee			GPS Latitude/Longitude		
				Start		End
Item	Slope Stability			37.938105 °		37.938023 °
				-121.336288 °		-121.336173 °
DWR ID	DWR_RD0524_01_s_2012_13					
Comment Code						
S1 : Repair slope instability.						
Inspector Comment						
Depression extend from shoulder to mid levee slope two site with this section.

View of the erosion.

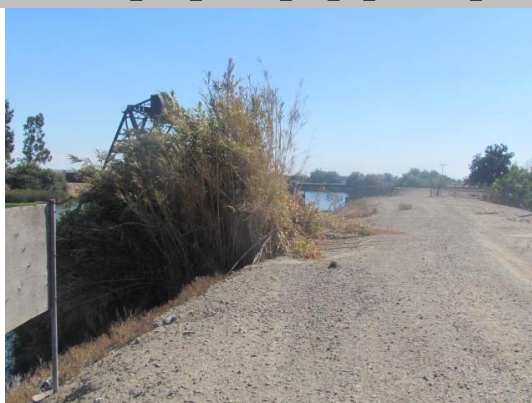
Photo 3 of 3 : FA_2016_RD0524_107_14_20160929_00030.jpg

Looking south at bamboo on waterside slope. (Fall 2012)

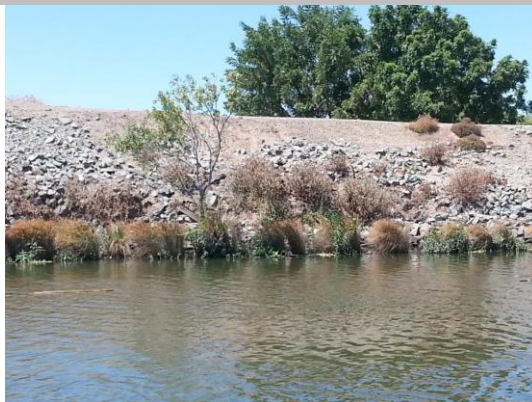
Photo 1 of 1 : SJR2016_RD0524U01RM41.36_3.jpg

LM Start	0.71	Rating **	M	Issue No.	17
LM End	0.73	Issue Type +	Ma	Location *	WS
Category	Supplemental			GPS Latitude/Longitude	
				Start	End
Item	DWR Erosion Survey			37.937222°	37.937222°
				-121.335277°	-121.335277°
DWR ID					
Comment Code					
Inspector Comment					
07/25/2016: No significant change observed.					
06/24/2015: The erosion site is immediately downstream of the RR bridge. [2016 Site ID:RD0524U01RM41.36]

Close view of the erosion.

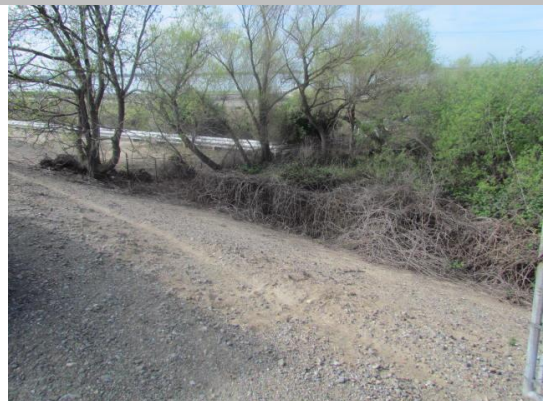
Photo 3 of 3 : FA_2016_RD0524_107_262_20160929_00266.jpg

Looking southwest at vegetation on landward slope and toe. (Spring 2013)

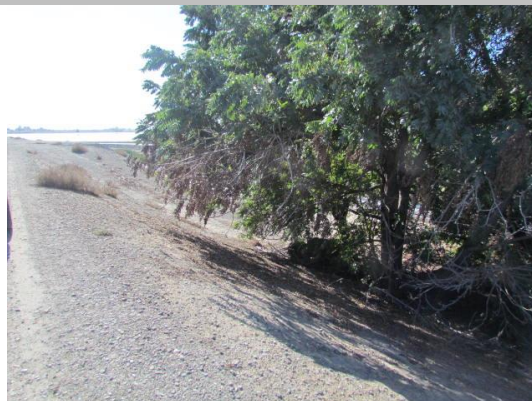
Photo 1 of 1 : FA_2016_RD0524_107_76_20160929_00126.jpg

Looking southwest at low hanging tree branches at landside toe.

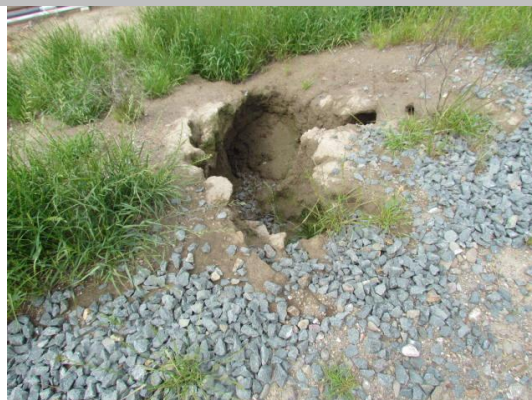
Photo 1 of 6 : FA_2016_RD0524_107_2_20160929_00001.jpg

LM Start	0.81	Rating **	U	Issue No.	2
LM End	0.81	Issue Type +	Ma	Location *	LS
Category	Earthen Levee			GPS Latitude/Longitude	
				Start	End
Item	Erosion / Bank Caving			37.936093 °	37.936004 °
				-121.334648 °	-121.334615 °
DWR ID	DWR_RD0524_01_f_2013_2				
Comment Code					
E2 : Schedule repair of erosion site prior to the next inspection.					
Inspector Comment					
One large hole. Hole is over 12" deep and 12" wide and several holes and finger erosions on landward slope.

Looking west at large hole on landward shoulder (Spring 2016)

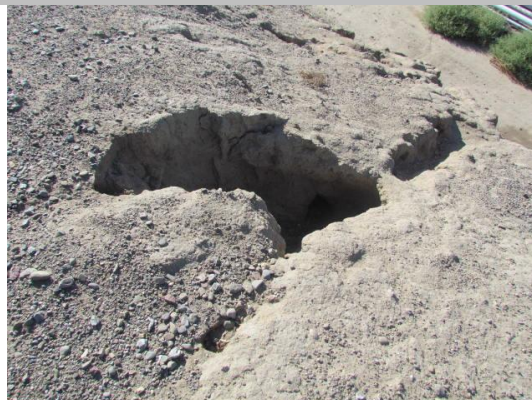
Photo 2 of 6 : FA_2016_RD0524_107_2_20160929_00002.jpg

Looking southwest at hole on landward shoulder.

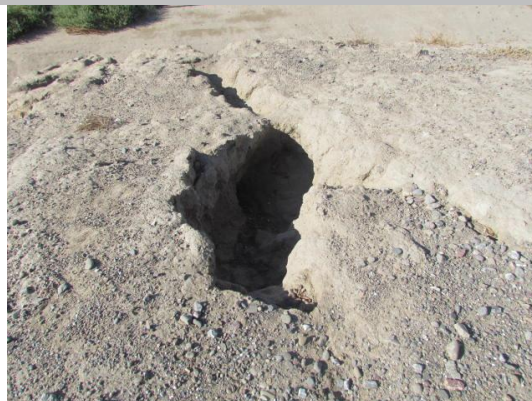
Photo 3 of 6 : FA_2016_RD0524_107_2_20160929_00003.jpg

LM Start	0.81	Rating **	U	Issue No.	2 (cont)	
LM End	0.81	Issue Type +	Ma	Location *	LS	
Category	Earthen Levee			GPS Latitude/Longitude		
				Start		End
Item	Erosion / Bank Caving			37.936093°	37.936004°	
				-121.334648°	-121.334615°	
DWR ID	DWR_RD0524_01_f_2013_2					
Comment Code						
E2 : Schedule repair of erosion site prior to the next inspection.						
Inspector Comment						
One large hole. Hole is over 12" deep and 12" wide and several holes and finger erosions on landward slope.

Looking west at hole on landward shoulder.

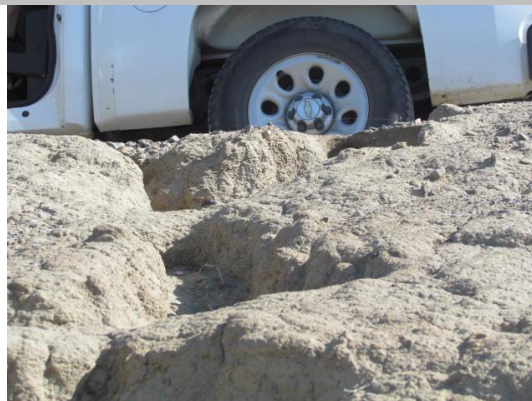
Photo 5 of 6 : FA_2016_RD0524_107_2_20160929_00005.jpg

Looking east at erosion on landward slope.

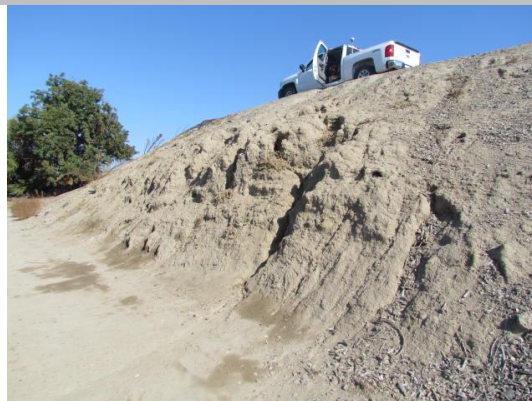
Photo 6 of 6 : FA_2016_RD0524_107_2_20160929_00006.jpg

LM Start	0.81	Rating **	U	Issue No.	2 (cont)	
LM End	0.81	Issue Type +	Ma	Location *	LS	
Category	Earthen Levee			GPS Latitude/Longitude		
				Start		End
Item	Erosion / Bank Caving			37.936093°	37.936004°	
				-121.334648°	-121.334615°	
DWR ID	DWR_RD0524_01_f_2013_2					
Comment Code						
E2 : Schedule repair of erosion site prior to the next inspection.						
Inspector Comment						
One large hole. Hole is over 12" deep and 12" wide and several holes and finger erosions on landward slope.

Looking northeast at several finger erosion on landward slope.

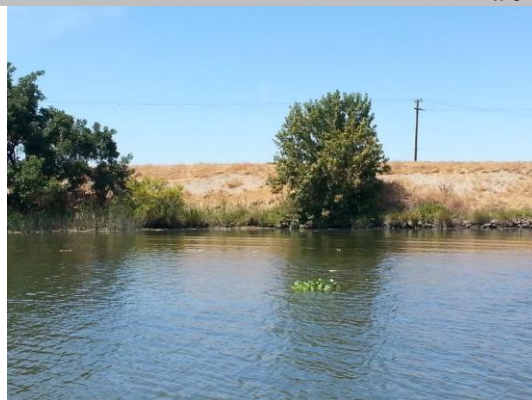
Photo 1 of 2 : SJR2016_RD0524U01RM41.44_2.jpg

LM Start	0.83	Rating **	U	Issue No.	22
LM End	0.84	Issue Type +	Ma	Location *	WS
Category	Supplemental			GPS Latitude/Longitude	
				Start	End
Item	DWR Erosion Survey			37.935930 °	37.935930 °
				-121.334133 °	-121.334133 °
DWR ID					
Comment Code					
Inspector Comment					
07/25/2016: No significant change observed.					
06/24/2015: No significant change observed.					
06/19/2014: No significant change observed.					
08/13/2013: Site was discovered during boat survey. The dense vegetation blocks a clear view of the erosion. Size of erosion site was very roughly estimated. [2016 Site ID:RD0524U01RM41.44]

Close view of the erosion site.

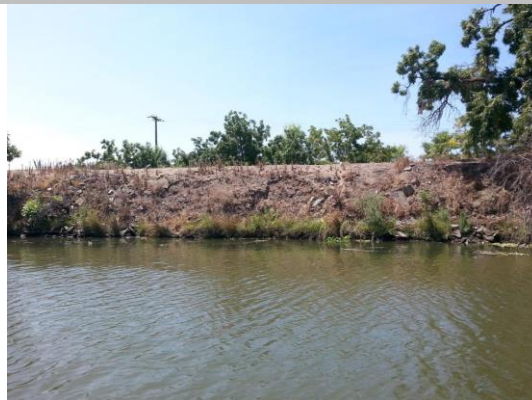
Photo 1 of 2 : SJR2016_RD0524U01RM41.58_1.jpg

LM Start	1.00	Rating **	U	Issue No.	47
LM End	1.00	Issue Type +	Ma	Location *	WS
Category	Supplemental			GPS Latitude/Longitude	
				Start	End
Item	DWR Erosion Survey			37.935410 °	37.935410 °
				-121.331560 °	-121.331560 °
DWR ID					
Comment Code					
Inspector Comment					
07/25/2016: No significant change observed.					
06/24/2015: No significant change observed.					
06/19/2014: No significant change observed.					
08/13/2013: No significant change at this site.					
08/07/2012: The erosion was discovered during the boat survey. [2016					
Site ID:RD0524U01RM41.58]

Front view of the erosion.

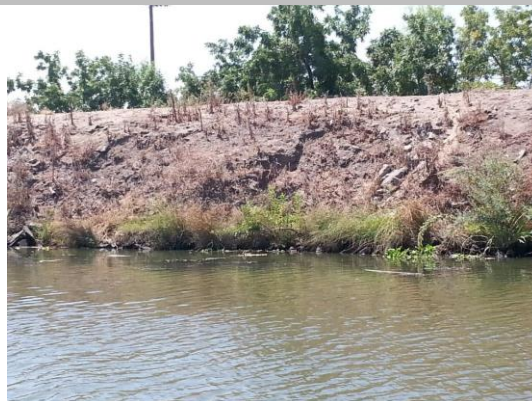
Photo 2 of 2 : SJR2016_RD0524U01RM41.58_2.jpg

LM Start	1.00	Rating **	U	Issue No.	47 (cont)
LM End	1.00	Issue Type +	Ma	Location *	WS
Category	Supplemental			GPS Latitude/Longitude	
				Start	End
Item	DWR Erosion Survey			37.935410 °	37.935410 °
				-121.331560 °	-121.331560 °
DWR ID					
Comment Code					
Inspector Comment					
07/25/2016: No significant change observed.					
06/24/2015: No significant change observed.					
06/19/2014: No significant change observed.					
08/13/2013: No significant change at this site.					
08/07/2012: The erosion was discovered during the boat survey. [2016					
Site ID:RD0524U01RM41.58]

Close view of the erosion.

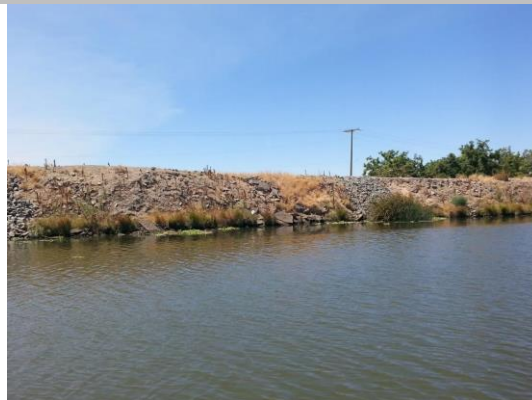
Photo 1 of 3 : SJR2016_RD0524U01RM41.59_1.jpg

LM Start	1.02	Rating **	U	Issue No.	55
LM End	1.02	Issue Type +	Ma	Location *	WS
Category	Supplemental			GPS Latitude/Longitude	
				Start	End
Item	DWR Erosion Survey			37.935078 °	37.935078 °
				-121.331134 °	-121.331134 °
DWR ID					
Comment Code					
Inspector Comment					
07/25/2016: No significant change observed. 06/24/2015: No significant change observed. 06/19/2014: No significant change observed. 08/13/2013: No significant change at this site. 08/07/2012: The site has been visited by boat survey. Site has been repaired, but new erosion occurred at the levee slope and immediately upstream of the repaired site. 08/23/2011: The site is about 500 ft downstream of bridge. The levee toe seems to be protected, but the protection is being washed away. [2016 Site ID:RD0524U01RM41.59]

Upstream view of the site.

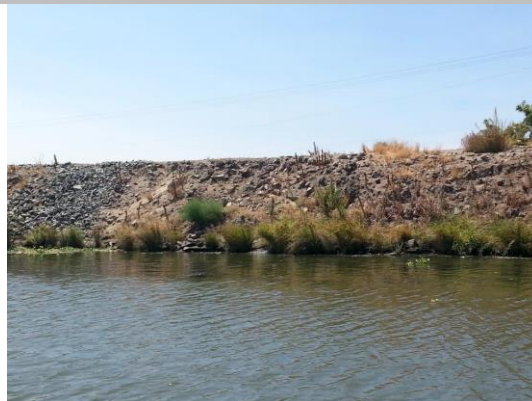
Photo 3 of 3 : SJR2016_RD0524U01RM41.59_4.jpg

Front view of the erosion.

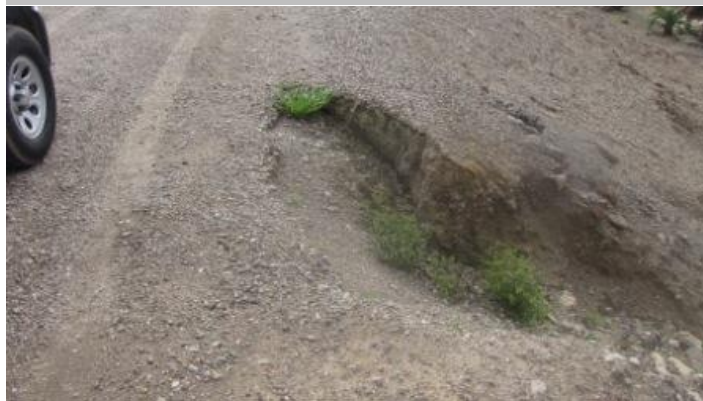
Photo 6 of 7 : FA_2016_RD0524_107_18_20160929_00042.jpg

Looking at updated slope stability as of Fall 2013.

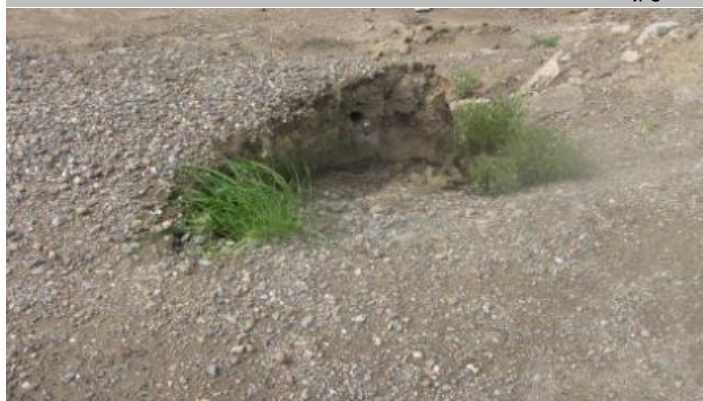
Photo 7 of 7 : FA_2016_RD0524_107_18_20160929_00043.jpg

Updated view from above the slope stability.

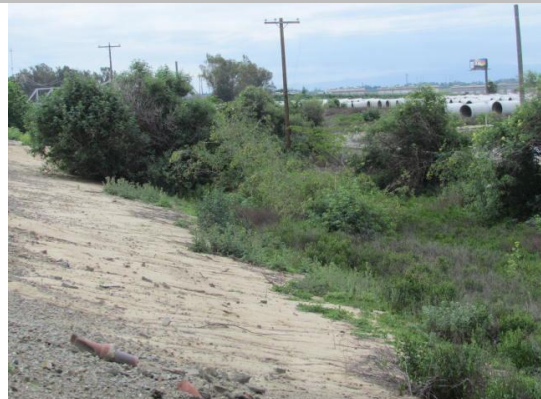
Photo 3 of 4 : FA_2016_RD0524_107_915_20160929_00275.jpg

Looking southwest at dense veg at landward toe and berm. (Spring 2015)

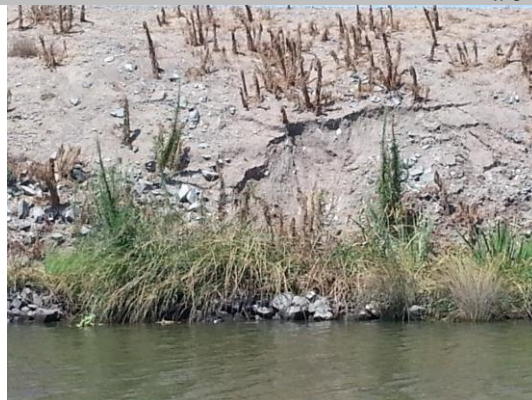
Photo 2 of 3 : SJR2016_RD0524U01RM42.03_3.jpg

Close view of the erosion.

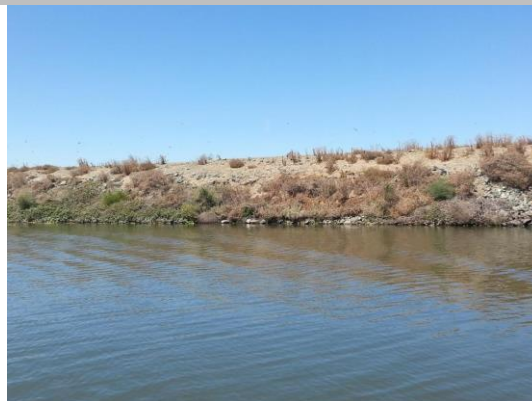
Photo 2 of 2 : SJR2016_RD0524U01RM42.09_4.jpg

Close view of the erosion.

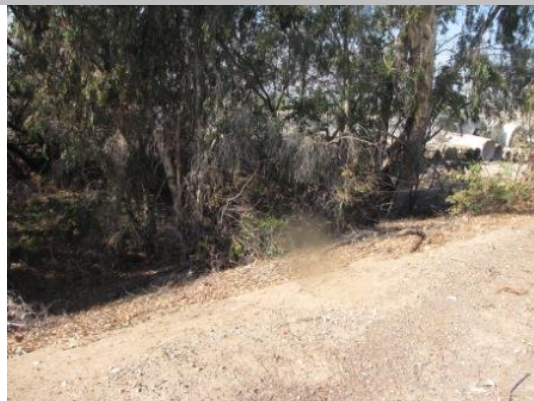
Photo 4 of 4 : FA_2016_RD0524_107_916_20160929_00280.jpg

Dense vegetation on landside toe.

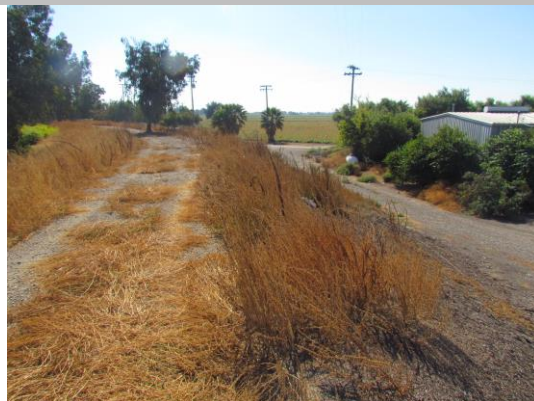
Photo 1 of 1 : FA_2016_RD0524_107_23_20161013_00388.jpg

Looking southwest at dense veg on landward slope. (Fall 2016)

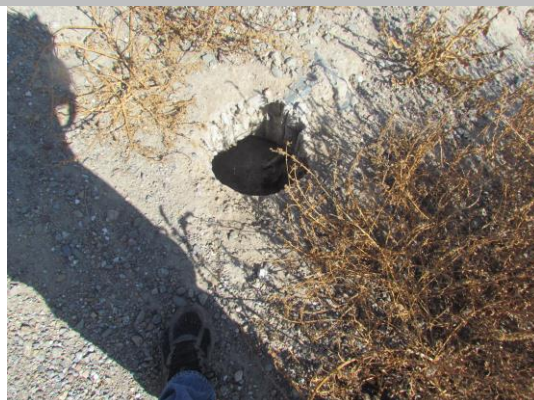
Photo 1 of 2 : FA_2016_RD0524_107_202_20161013_00389.jpg

Looking at large hole (Fence/telephone post hole) on waterward shoulder.

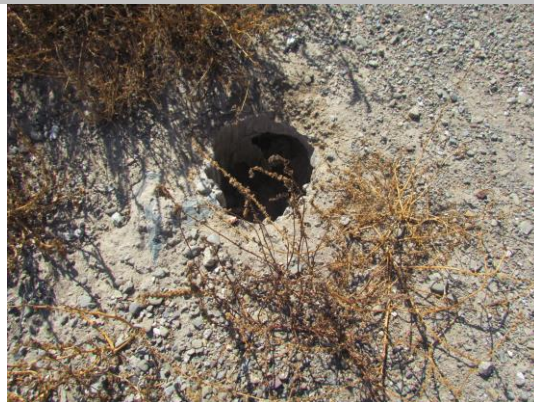
Photo 2 of 2 : FA_2016_RD0524_107_202_20161013_00390.jpg

Looking at hole on waterward shoulder.

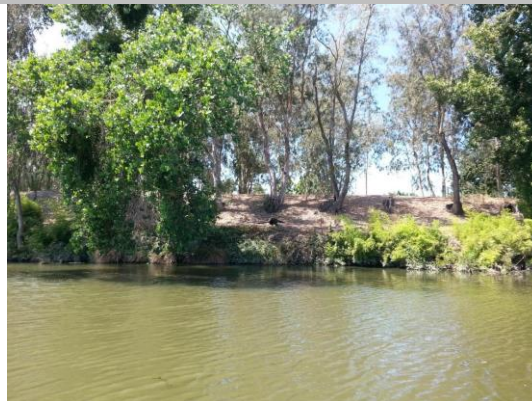
Photo 2 of 3 : SJR2016_RD0524U01RM42.2_2.jpg

Close view of the erosion.

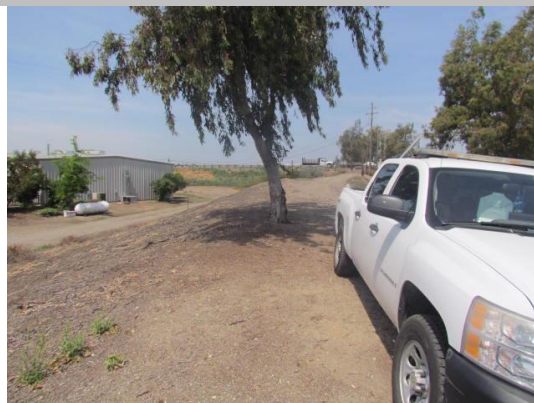
Photo 1 of 1 : FA_2016_RD0524_107_173_20160929_00216.jpg

Looking northwest at tree on within levee crown.

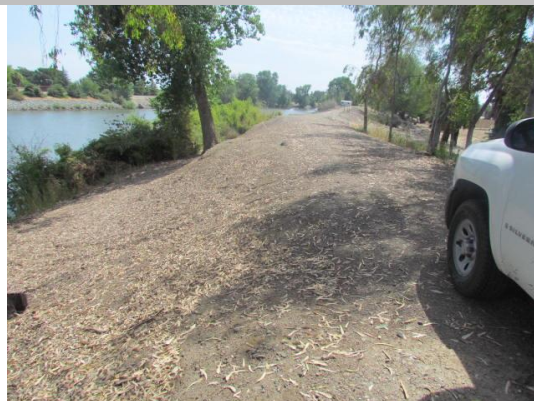
Photo 1 of 1 : FA_2016_RD0524_107_27_20160929_00062.jpg

Looking south at landward slope depression.

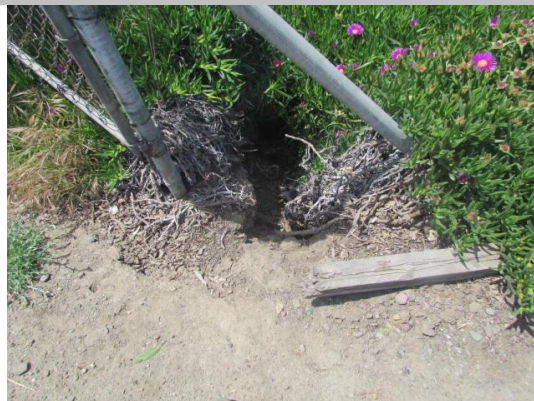
Photo 1 of 2 : FA_2016_RD0524_107_176_20160929_00220.jpg

Looking west at erosion within landscaping on landward shoulder and slope.

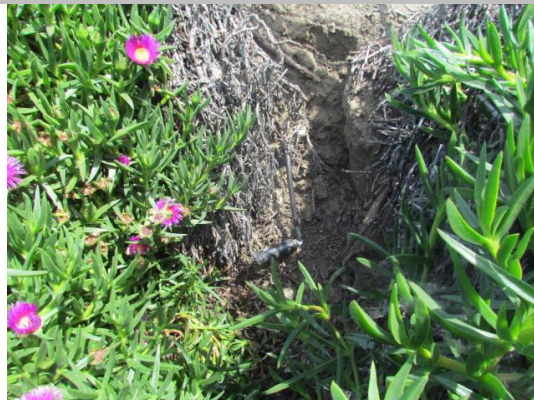
Photo 2 of 2 : FA_2016_RD0524_107_176_20160929_00221.jpg

Looking east at erosion within landscaping on landward slope and shoulder.

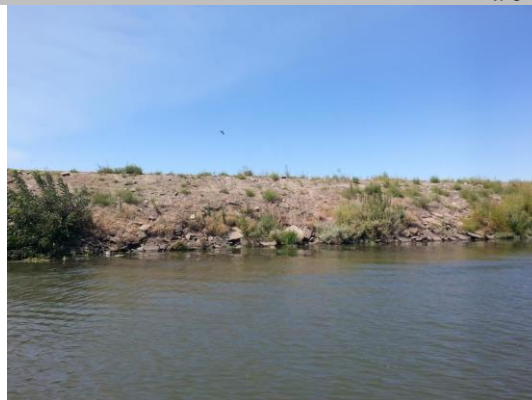
Photo 2 of 2 : SJR2016_RD0524U01RM42.79_4.jpg

Front view of the erosion.

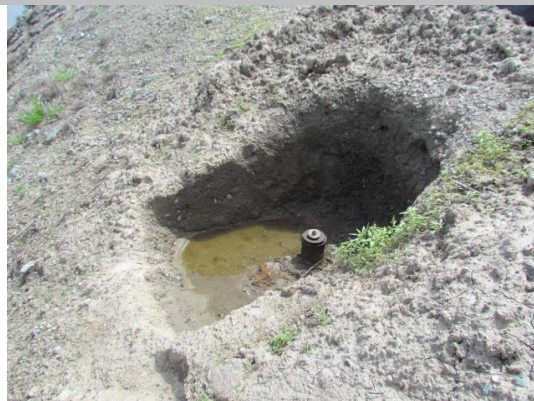
Photo 1 of 3 : FA_2016_RD0524_107_31_20160929_00065.jpg

Looking south at siphon on waterward slope.

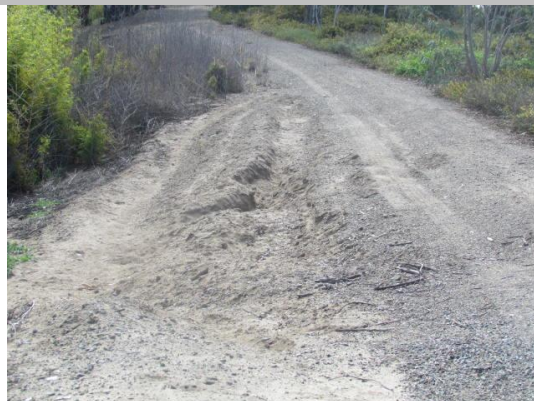
Photo 3 of 3 : FA_2016_RD0524_107_31_20160929_00067.jpg

Looking south slope damage on waterward shoulder and slope.

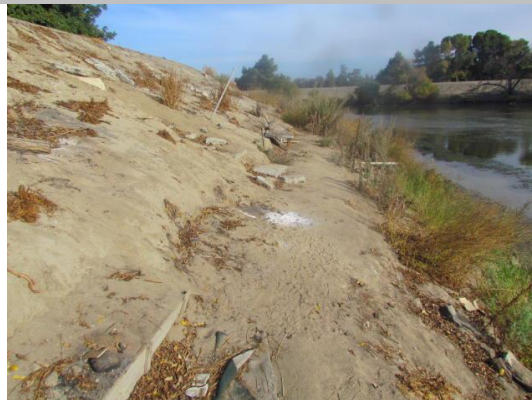
Photo 1 of 1 : FA_2016_RD0524_107_34_20160929_00072.jpg

Looking northeast at damage to the slope possibly caused by human activity.

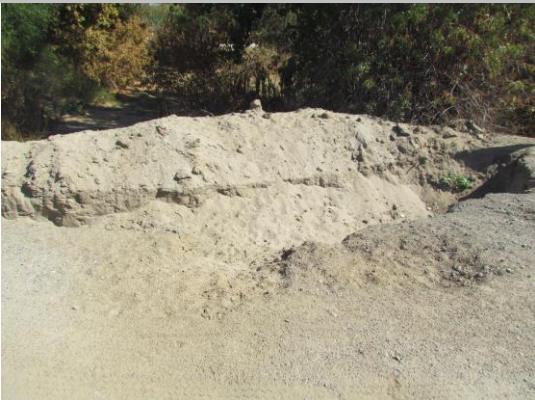
Photo 1 of 3 : FA_2016_RD0524_107_218_20161013_00402.jpg

Looking east at trench on waterward shoulder.

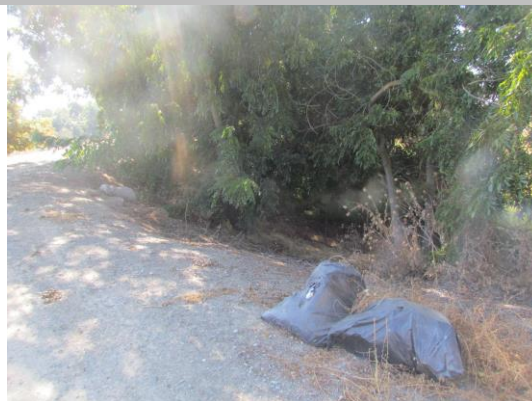
Photo 1 of 1 : FA_2016_RD0524_107_918_20161013_00404.jpg

Looking south at untrimmed trees on landward slope.

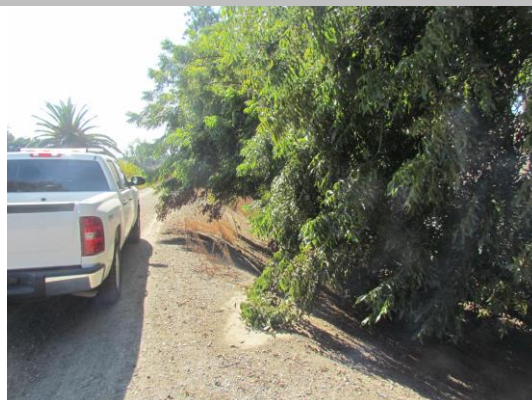
Photo 1 of 1 : FA_2016_RD0524_107_264_20161013_00405.jpg

Looking south at untrimmed trees on landward slope.

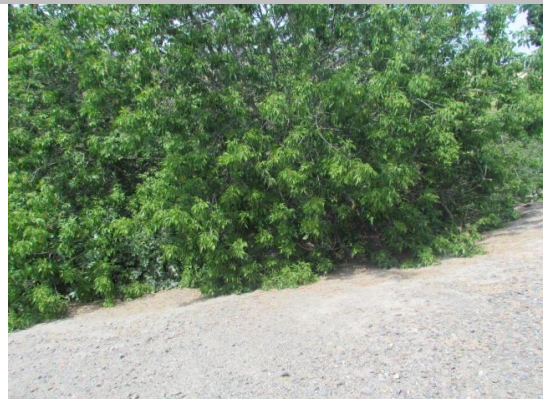
Photo 2 of 2 : FA_2016_RD0524_107_51_20160929_00103.jpg

Looking south at dense trees on landward slope spring 2015

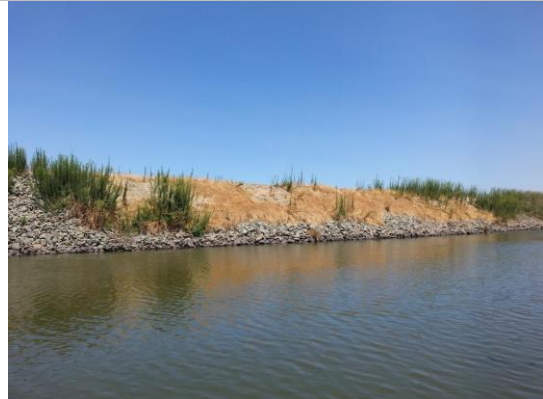
Photo 1 of 2 : SJR2016_RD0524U01RM43.52_1.jpg

Upstream view of the erosion.

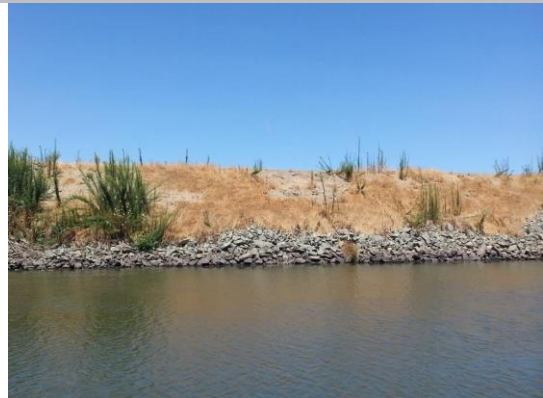
Photo 2 of 2 : SJR2016_RD0524U01RM43.52_4.jpg

Close view of the erosion. Note the vegetation at the site.

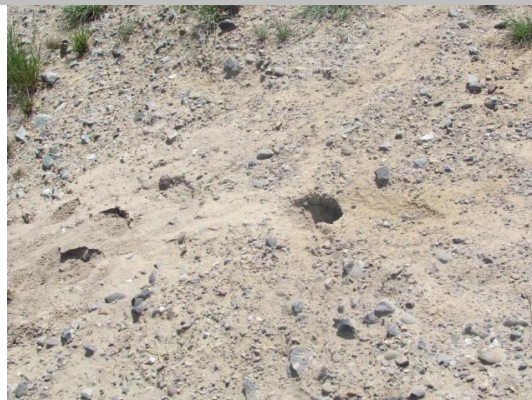
Photo 2 of 2 : FA_2016_RD0524_107_925_20160929_00283.jpg

Looking at typical rodent holes on landward slope along this reach.

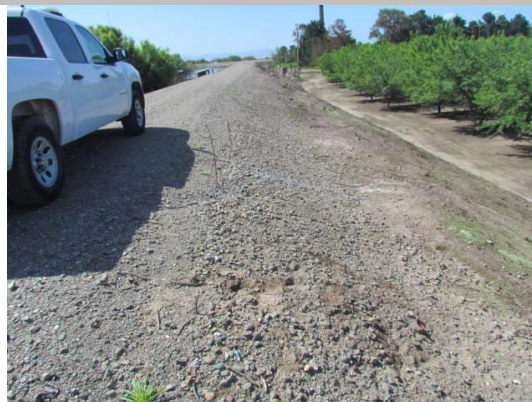
Photo 2 of 3 : FA_2016_RD0524_107_108_20160929_00170.jpg

Looking south at damage slope on landside of levee.

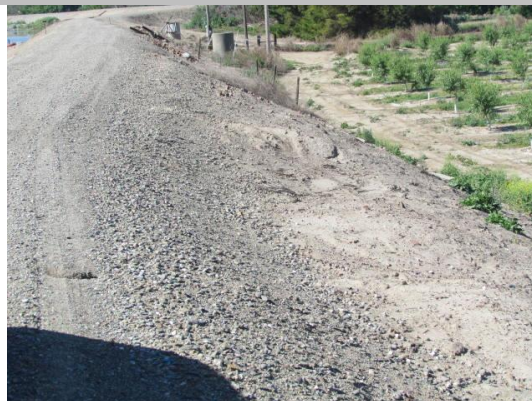
Photo 3 of 3 : FA_2016_RD0524_107_108_20160929_00171.jpg

Looking southwest at caving slope on landside of levee. (Spring 2014)

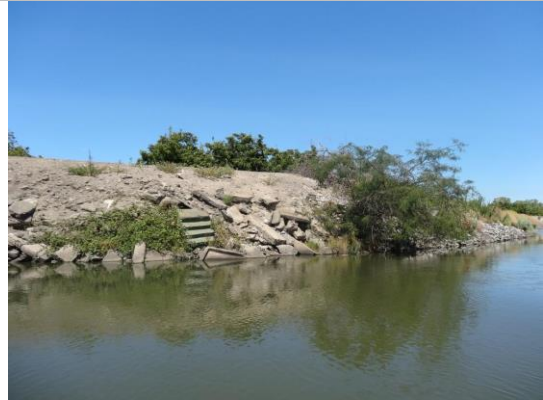
Photo 1 of 2 : SJR2016_RD0524U01RM45.07_3.jpg

Front view of the site. Note the loosely placed concrete blocks at the site.

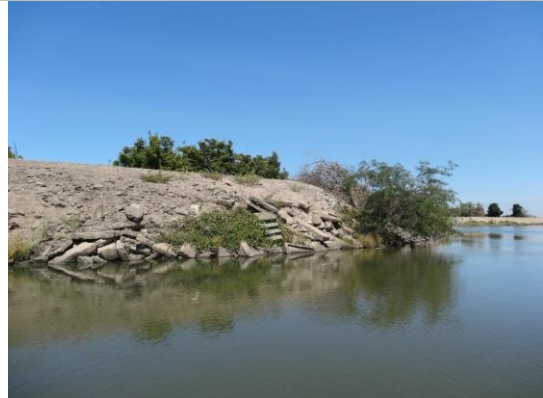
Photo 2 of 2 : SJR2016_RD0524U01RM45.07_4.jpg

Upstream view of the erosion.

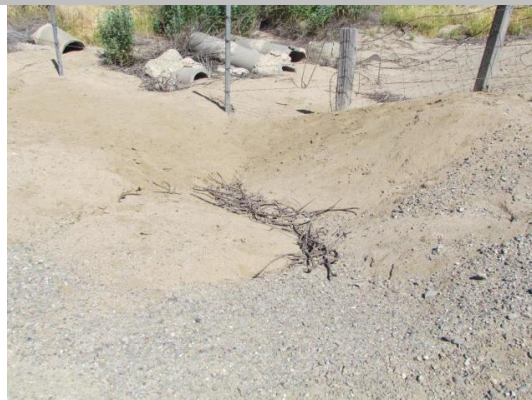
Photo 1 of 3 : FA_2016_RD0524_107_118_20160929_00180.jpg

Looking west at slope damage on landside slope.

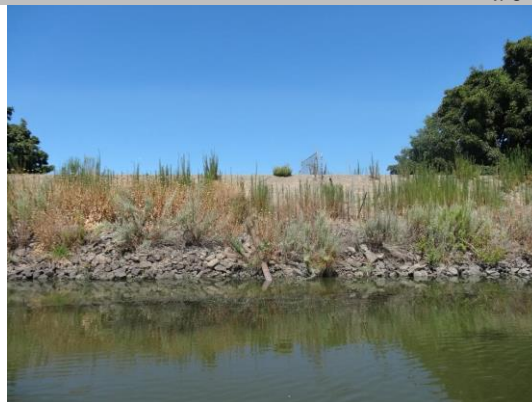
Photo 2 of 2 : SJR2016_RD0524U01RM45.97_4.jpg

Front view of the site.

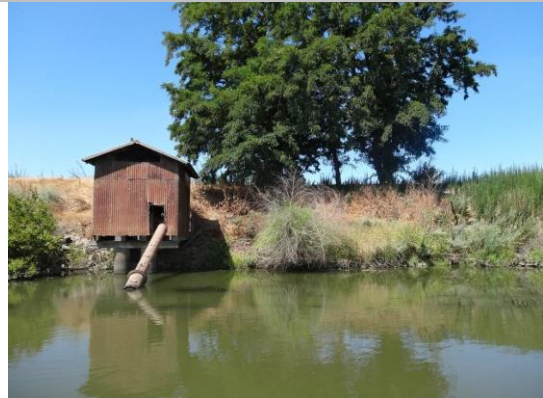
Photo 2 of 2 : SJR2016_RD0524U01RM46.06_4.jpg

Close view of the erosion.

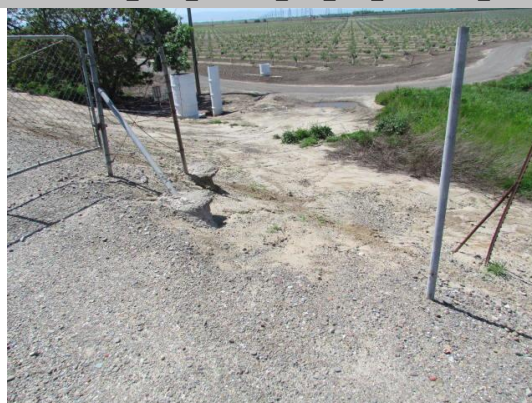
Photo 3 of 3 : FA_2016_RD0524_107_215_20160929_00262.jpg

Looking west at damage slope on landward slope.

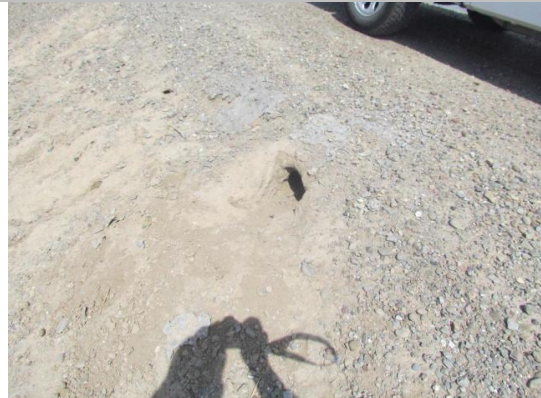
Photo 2 of 2 : FA_2016_RD0524_107_197_20160929_00240.jpg

Looking southwest at typical view of rodent hole at landward shoulder.

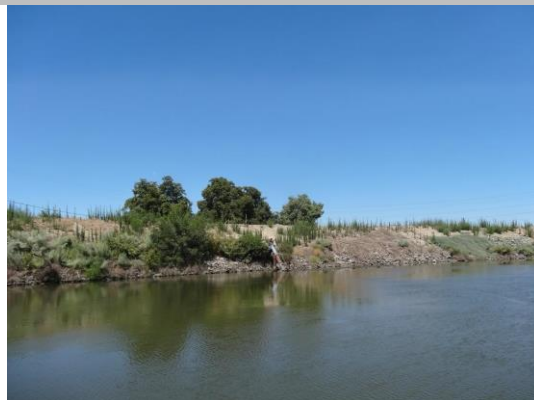
Photo 2 of 2 : SJR2016_RD0524U01RM46.39_4.jpg

Upstream view of the erosion and vegetation at the site.

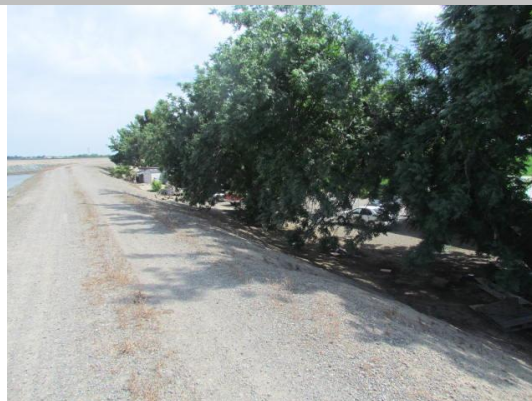
Photo 1 of 1 : FA_2016_RD0524_107_120_20160929_00185.jpg

Looking south at untrimmed trees on landward slope and toe.

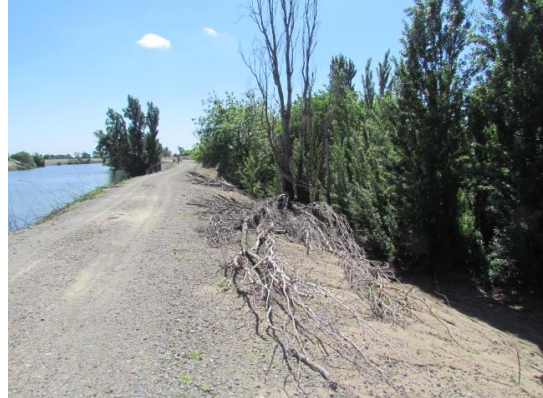
Photo 2 of 4 : FA_2016_RD0524_107_81_20160929_00133.jpg

Looking south at tree branches and limbs left on landward shoulder and slope. (Spring 2016)
