**Flood Control Project Maintenance
Levee Inspections**

Maintenance Issue Types Only, Levee Inspection Report By Mile - Fall 2017

Reclamation District No. 0524 Middle Roberts Island

Waterway	Bank	Unit Miles	Inspection Start/End	Inspector
Unit No. 01 San Joaquin River	Left	6.20	11/08/2017 11/08/2017	Dave Torres

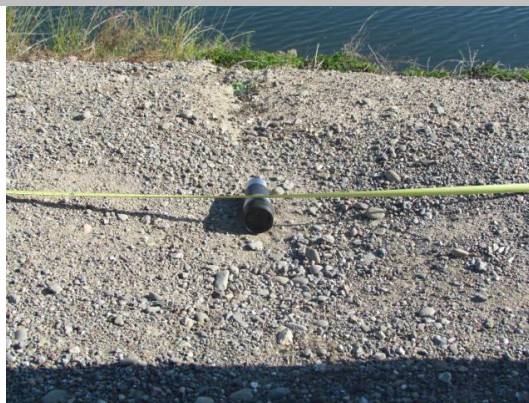
Photo 2 of 3 : FA_2017_RD0524_107_3_20170919_00002.jpg

LM Start	0.21	Rating **	M	Issue No.	3 (cont)	
LM End	0.21	Issue Type +	Ma	Location *	CR	
Category	Earthen Levee			GPS Latitude/Longitude		
				Start		End
Item	Crown Surface / Depressions / Rutting			37.938890 °		37.938890 °
				-121.343657 °		-121.343657 °
DWR ID	DWR_RD0524_01_s_2016_3					
Comment Code						
C2 : Repair depressions or ruts in the crown or slope.						
Inspector Comment						
No change in status.

Looking west at depression on levee crown near waterward shoulder.

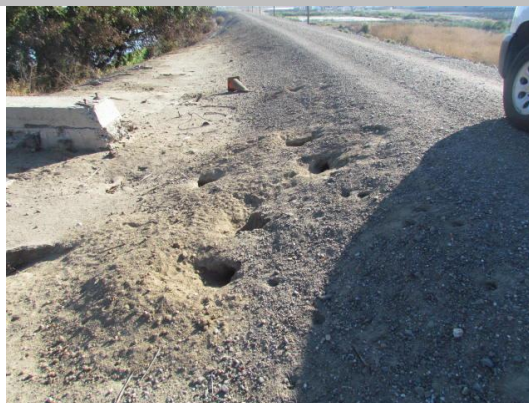
Photo 4 of 4 : FA_2017_RD0524_107_174_20170919_00211.jpg

Looking southeast at several rodent holes on waterward slope. (Fall 2015).

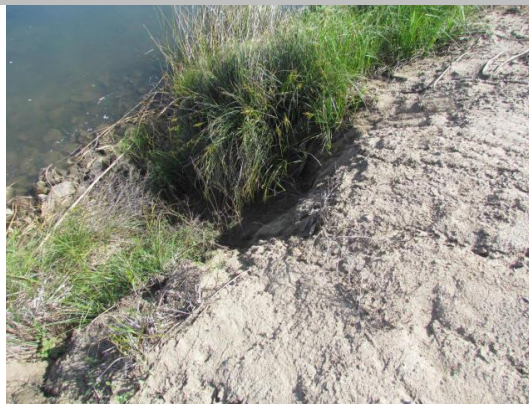
Photo 1 of 2 : FA_2017_RD0524_107_180_20170919_00221.jpg

LM Start	0.34	Rating **	M	Issue No.	180
LM End	0.34	Issue Type +	Ma	Location *	WS
Category	Earthen Levee			GPS Latitude/Longitude	
				Start	End
Item	Erosion / Bank Caving			37.938461 °	37.938461 °
				-121.341626 °	-121.341626 °
DWR ID	DWR_RD0524_01_s_2014_180				
Comment Code					
E2 : Schedule repair of erosion site prior to the next inspection.					
Inspector Comment					
Erosion is located along the lower level of waterside slope.

Looking southeast at erosion on waterward toe.

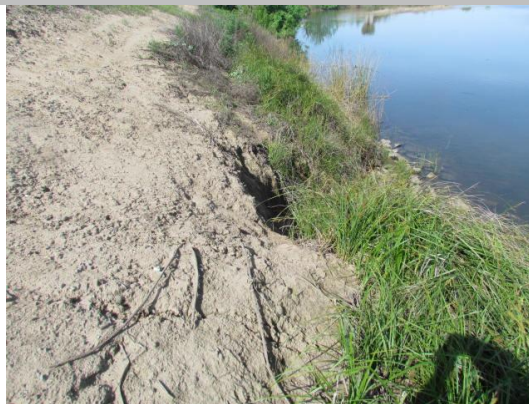
Photo 2 of 2 : FA_2017_RD0524_107_180_20170919_00222.jpg

Looking northeast at erosion on waterward toe.

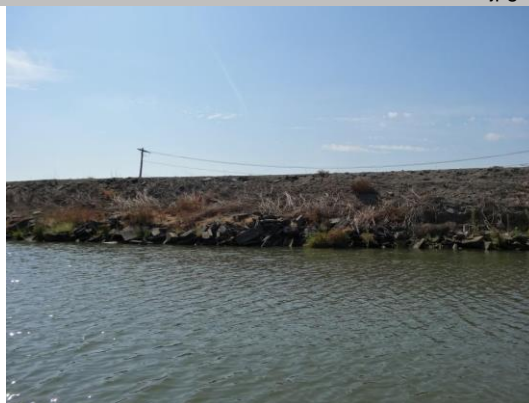
Photo 4 of 4 : SJR2017_RD0524U01RM40.99_4.jpg

LM Start	0.40	Rating **	A/W	Issue No.	5 (cont)	
LM End	0.40	Issue Type +	Ma	Location *	WS	
Category	Supplemental			GPS Latitude/Longitude		
				Start	End	
Item	DWR Erosion Survey			37.938870 °	37.938870 °	
				-121.340460 °	-121.340460 °	
DWR ID	RD0524U01RM40.99					
Comment Code						
Inspector Comment						
09/13/2017: No significant change observed.						
07/25/2016: More vegetation observed at the site.						
06/24/2015: No significant change observed.						
06/19/2014: No significant change observed.						
08/13/2013: No significant change at this site.						
08/07/2012: The erosion is at the upper levee slope, and likely caused by slope slip. The lower levee slope is covered with dense vegetation.						
[2017 Site ID:RD0524U01RM40.99]

Close view of the erosion.

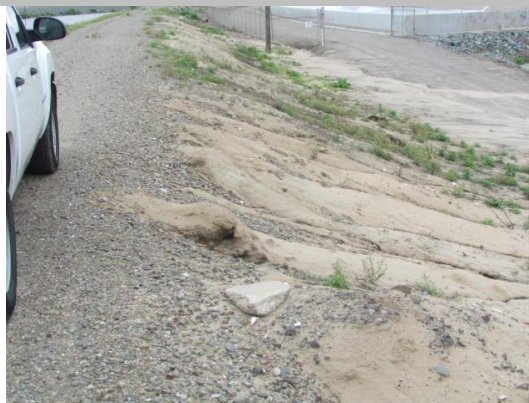
Photo 2 of 2 : FA_2017_RD0524_107_205_20170919_00247.jpg

LM Start	0.40	Rating **	U	Issue No.	205 (cont)	
LM End	0.46	Issue Type +	Ma	Location *	LS	
Category	Earthen Levee			GPS Latitude/Longitude		
				Start		End
Item	Erosion / Bank Caving			37.938625 °	37.938695 °	
				-121.340479 °	-121.339420 °	
DWR ID	DWR_RD0524_01_s_2016_205					
Comment Code						
E2 : Schedule repair of erosion site prior to the next inspection.						
Inspector Comment						
Several damaged sites within this reach.

Looking at slope damage on landward slope.

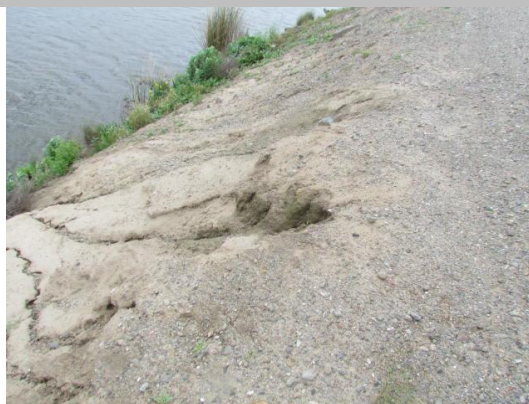
Photo 1 of 3 : FA_2017_RD0524_107_170_20170919_00201.jpg

LM Start	0.41	Rating **	U	Issue No.	170
LM End	0.45	Issue Type +	Ma	Location *	WS
Category	Earthen Levee			GPS Latitude/Longitude	
				Start	End
Item	Erosion / Bank Caving			37.938628 °	37.938688 °
				-121.340385 °	-121.339627 °
DWR ID	DWR_RD0524_01_s_2015_170				
Comment Code					
E2 : Schedule repair of erosion site prior to the next inspection.					
Inspector Comment					
Several slope instabilities within this reach.

Looking at slope damage on waterward shoulder (Spring 2016)

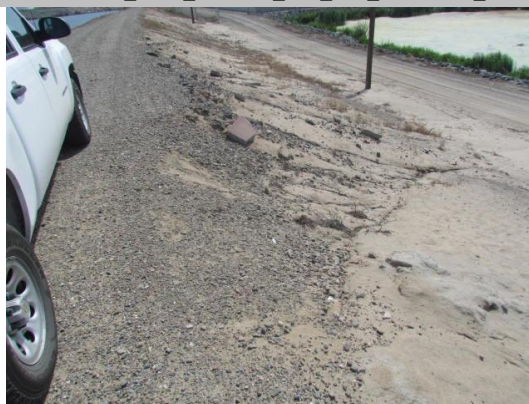
Photo 2 of 3 : FA_2017_RD0524_107_170_20170919_00202.jpg

Looking at slope damage on waterward shoulder.

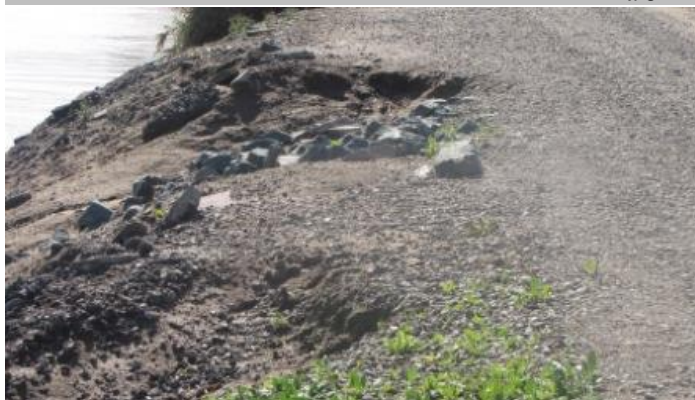
Photo 2 of 4 : FA_2017_RD0524_107_13_20170919_00021.jpg

LM Start	0.64	Rating **	M	Issue No.	13
LM End	0.65	Issue Type +	Ma	Location *	WS
Category	Earthen Levee			GPS Latitude/Longitude	
				Start	End
Item	Slope Stability			37.938105 °	37.938023 °
				-121.336288 °	-121.336173 °
DWR ID	DWR_RD0524_01_s_2012_13				
Comment Code					
S1 : Repair slope instability.					
Inspector Comment					
Depression extends from shoulder to mid levee slope two site with this section.

Looking south at erosion on waterside shoulder.

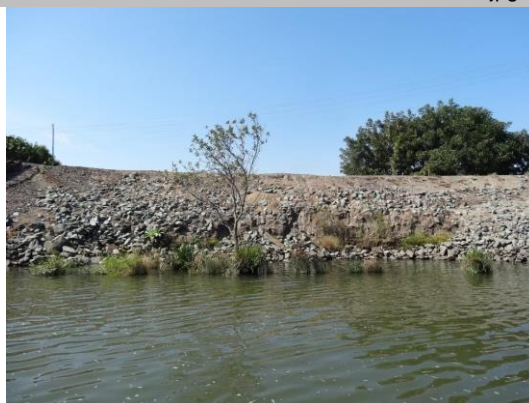
Photo 3 of 3 : SJR2017_RD0524U01RM41.36_3.jpg

LM Start	0.71	Rating **	M	Issue No.	17 (cont)	
LM End	0.73	Issue Type +	Ma	Location *	WS	
Category	Supplemental			GPS Latitude/Longitude		
				Start	End	
Item	DWR Erosion Survey			37.937222 °	37.937222 °	
				-121.335277 °	-121.335277 °	
DWR ID	RD0524U01RM41.36					
Comment Code						
Inspector Comment						
09/13/2017: No significant change observed.						
07/25/2016: No significant change observed.						
06/24/2015: The erosion site is immediately downstream of the RR bridge. [2017 Site ID:RD0524U01RM41.36]

Close view of the erosion.

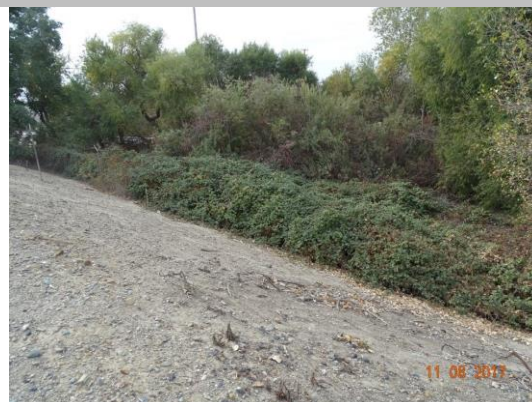
Photo 1 of 3 : FA_2017_RD0524_107_262_20171116_00470.jpg

LM Start	0.75	Rating **	U	Issue No.	262
LM End	0.78	Issue Type +	Ma	Location *	LS
Category	Earthen Levee		GPS Latitude/Longitude		
			Start	End	
Item	Vegetation		37.936813°	37.936539°	
			-121.335019°	-121.334863°	
DWR ID	DWR_RD0524_01_s_2012_262				
Comment Code					
V2 : Remove the wild growth other than native grasses from the levee slopes.					
Inspector Comment					
Dense vegetation at landside toe along fence line.

Looking northeast at the landside slope.

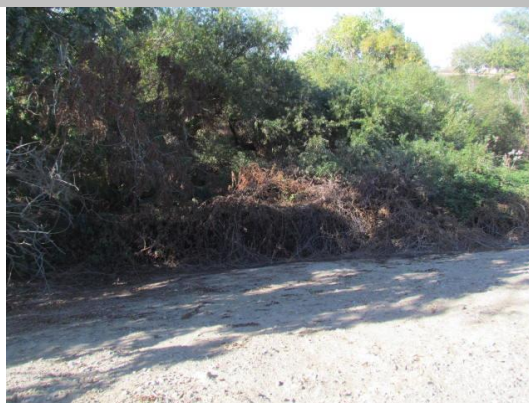
Photo 3 of 3 : FA_2017_RD0524_107_262_20170919_00270.jpg

Looking west at dense vegetation on landside toe. Spring 2014

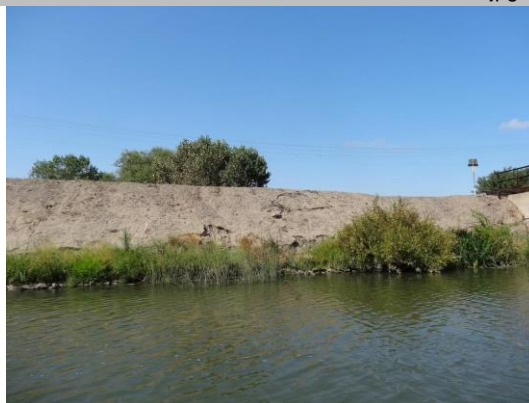
Photo 3 of 4 : SJR2017_RD0524U01RM41.39_3.jpg

Front view of the erosion.

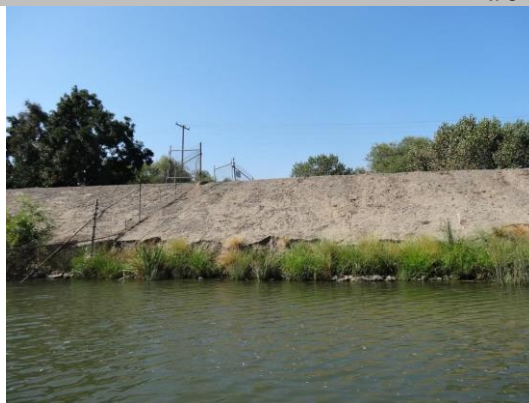
Photo 4 of 4 : SJR2017_RD0524U01RM41.39_4.jpg

Front view of the erosion.

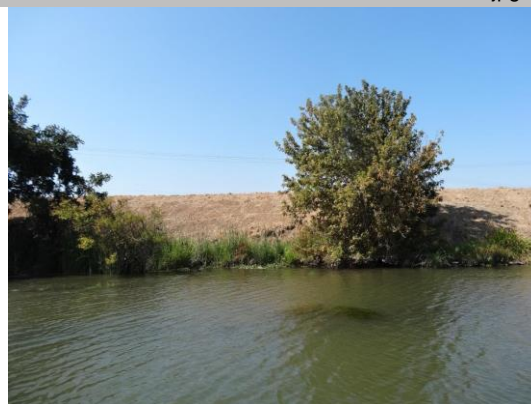
Photo 1 of 2 : SJR2017_RD0524U01RM41.44_1.jpg

LM Start	0.83	Rating **	U	Issue No.	22							
LM End	0.84	Issue Type +	Ma	Location *	WS							
Category	Supplemental		GPS Latitude/Longitude									
			Start	End								
Item	DWR Erosion Survey		37.935930 °	37.935930 °								
			-121.334133 °	-121.334133 °								
DWR ID	RD0524U01RM41.44											
Comment Code												
Inspector Comment												
09/13/2017: No significant change observed. 07/25/2016: No significant change observed. 06/24/2015: No significant change observed. 06/19/2014: No significant change observed. 08/13/2013: Site was discovered during boat survey. The dense vegetation blocks a clear view of the erosion. Size of erosion site was very roughly estimated. [2017 Site ID: RD0524U01RM41.44]

Front view of the erosion. The tree and vegetation block the view of the site.

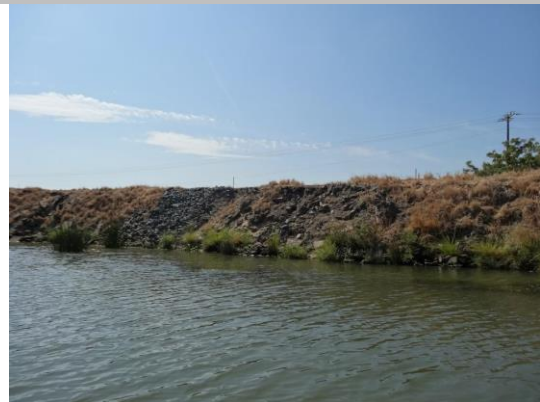
Photo 1 of 3 : SJR2017_RD0524U01RM41.59_1.jpg

LM Start	1.02	Rating **	U	Issue No.	33
LM End	1.02	Issue Type +	Ma	Location *	WS
Category	Supplemental			GPS Latitude/Longitude	
				Start	End
Item	DWR Erosion Survey			37.935078 °	37.935078 °
				-121.331134 °	-121.331134 °
DWR ID	RD0524U01RM41.59				
Comment Code					
Inspector Comment					
09/13/2017: No significant change observed.					
07/25/2016: No significant change observed.					
06/24/2015: No significant change observed.					
06/19/2014: No significant change observed.					
08/13/2013: No significant change at this site.					
08/07/2012: The site has been visited by boat survey. Site has been repaired, but new erosion occurred at the levee slope and immediately upstream of the repaired site.					
08/23/2011: The site is about 500 ft downstream of bridge. The levee toe seems to be protected, but the protection is being washed away.					
[2017 Site ID: RD0524U01RM41.59]

Upstream view of the site.

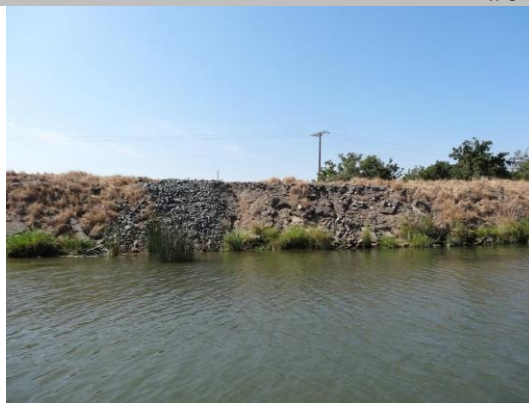
Photo 3 of 3 : SJR2017_RD0524U01RM41.59_3.jpg

Front view of the site.

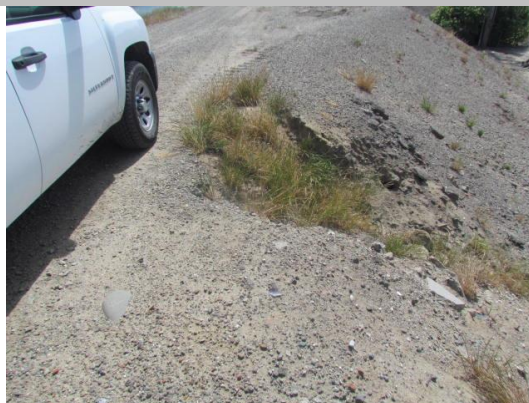
Photo 3 of 7 : FA_2017_RD0524_107_18_20170919_00033.jpg

Looking south at caving on landward shoulder. (Spring 2015)

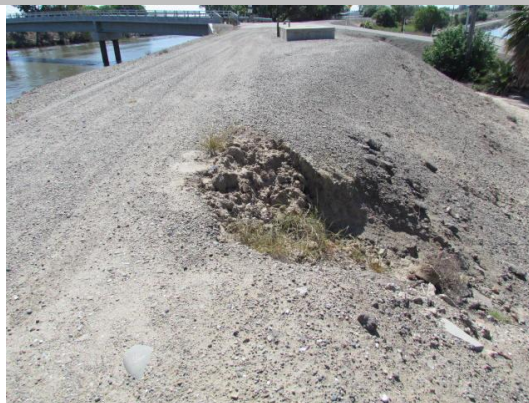
Photo 5 of 7 : FA_2017_RD0524_107_18_20170919_00035.jpg

Looking south at caving on landside shoulder. (Spring 2013)

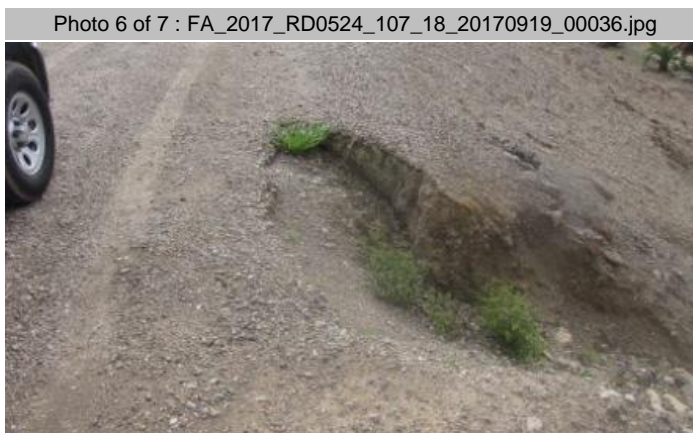
LM Start	1.07	Rating **	U	Issue No.	18 (cont)	
LM End	1.07	Issue Type +	Ma	Location *	LS	
Category	Earthen Levee			GPS Latitude/Longitude		
				Start		End
Item	Slope Stability			37.934715 °		37.934715 °
				-121.330343 °		-121.330343 °
DWR ID	DWR_RD0524_01_s_2012_18					
Comment Code						
S1 : Repair slope instability.						
Inspector Comment						
Slope damage extends from shoulder to middle of slope.

Looking at updated slope stability as of Fall 2013.

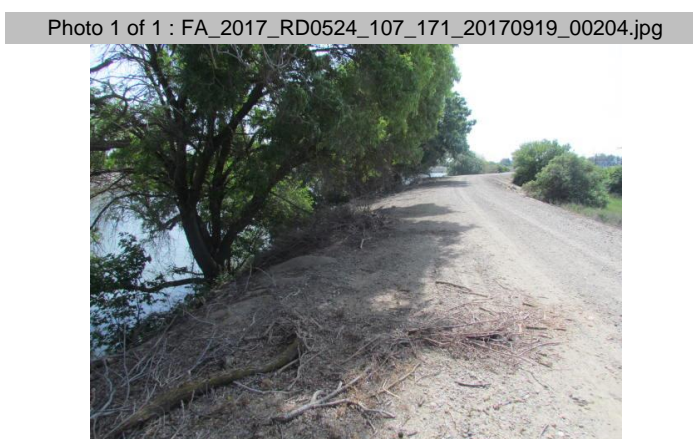
LM Start	1.12	Rating **	M	Issue No.	171
LM End	1.16	Issue Type +	Ma	Location *	WS
Category	Earthen Levee			GPS Latitude/Longitude	
				Start	End
Item	Encroachments			37.934225 °	37.933815 °
				-121.329693 °	-121.329242 °
DWR ID	DWR_RD0524_01_s_2015_171				
Comment Code					
PR : Prunings					
Inspector Comment					
Prunings left on waterside shoulder and slope.

Looking south at prunings on waterward shoulders.

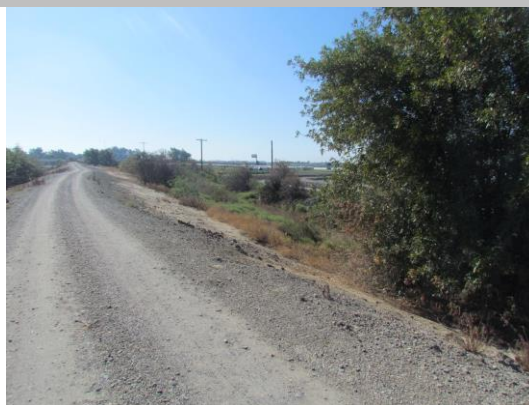
Photo 1 of 4 : FA_2017_RD0524_107_915_20170919_00277.jpg

Looking southwest at dense veg at landward toe and berm. (Fall 2016)

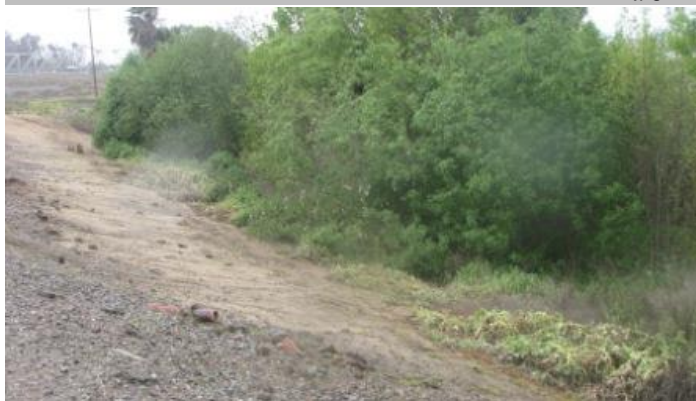
Photo 4 of 4 : FA_2017_RD0524_107_915_20170919_00280.jpg

Looking southwest at dense veg. on landside toe. (Fall 2015)

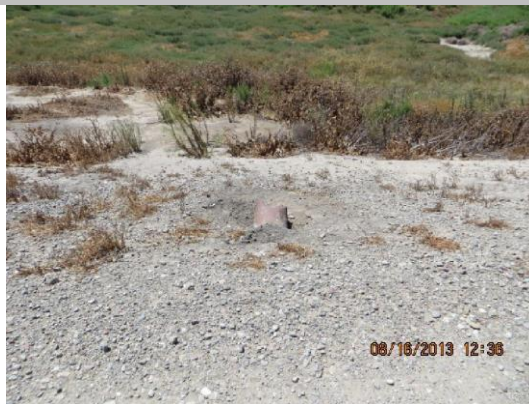
Photo 2 of 3 : UCIP_FA_2017_51319_29861.jpg

Pipe open and visible on LS slope.

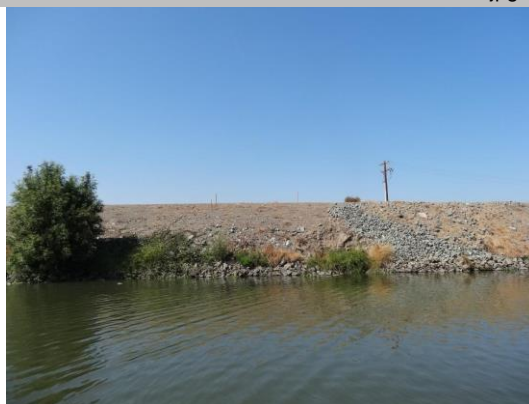
Photo 1 of 2 : SJR2017_RD0524U01RM41.95_1.jpg

LM Start	1.33	Rating **	M	Issue No.	55
LM End	1.33	Issue Type +	Ma	Location *	WS
Category	Supplemental			GPS Latitude/Longitude	
				Start	End
Item	DWR Erosion Survey			37.931510 °	37.931510 °
				-121.328120 °	-121.328120 °
DWR ID	RD0524U01RM41.95				
Comment Code					
Inspector Comment					
09/13/2017: The erosion is located immediately upstream of a protected levee section. [2017 Site ID:RD0524U01RM41.95]

Front view of the erosion.

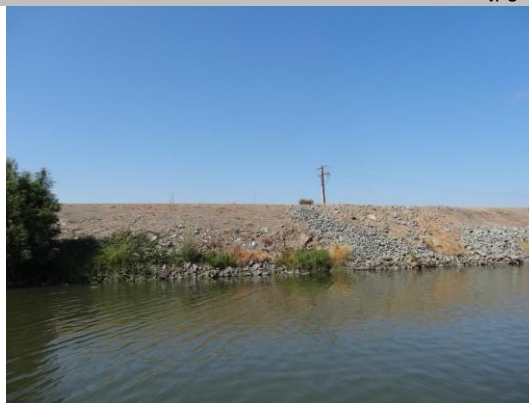
Photo 2 of 2 : SJR2017_RD0524U01RM41.95_2.jpg

Front view of the erosion.

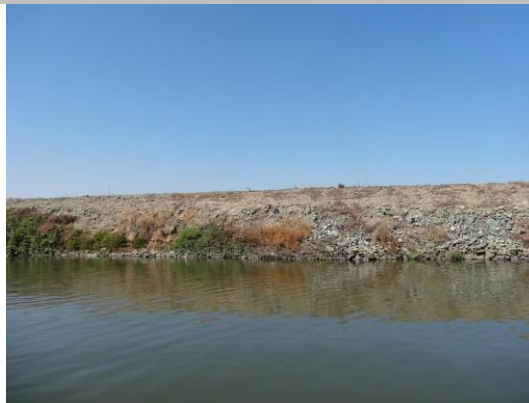
Photo 1 of 4 : SJR2017_RD0524U01RM42.09_1.jpg

Front view of the erosion site.

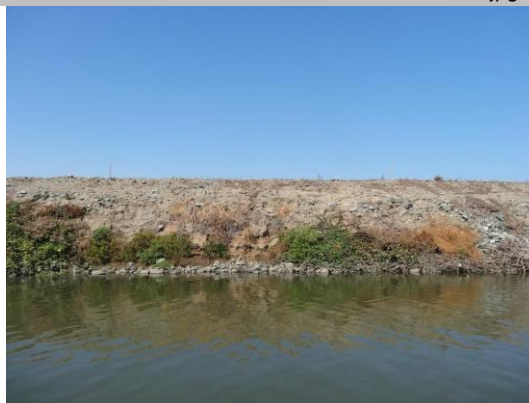
Photo 3 of 4 : SJR2017_RD0524U01RM42.09_3.jpg

Close view of the erosion. Note the vegetation at the site.

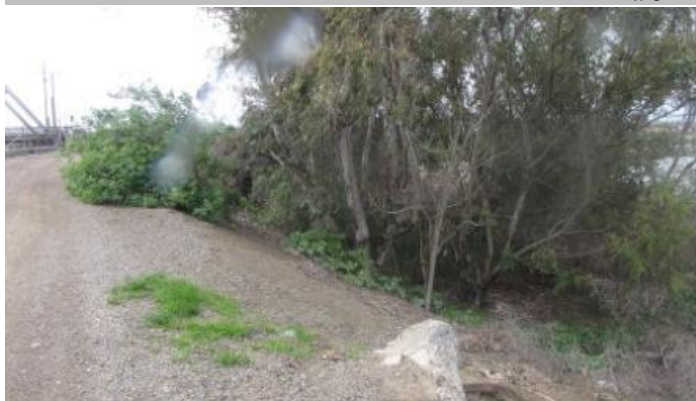
Photo 3 of 4 : FA_2017_RD0524_107_916_20170919_00283.jpg

Looking at dense veg. on landside slope and toe.

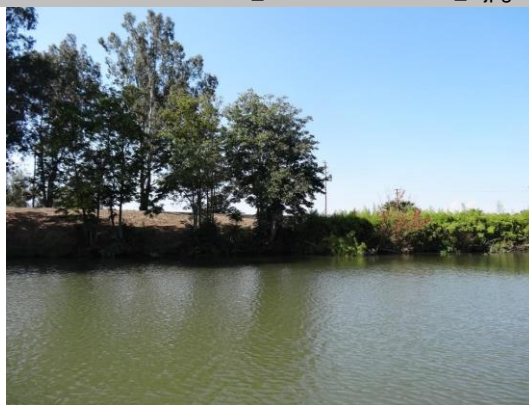
Photo 3 of 3 : SJR2017_RD0524U01RM42.2_3.jpg

Front view of the erosion. Dense vegetation is visible.

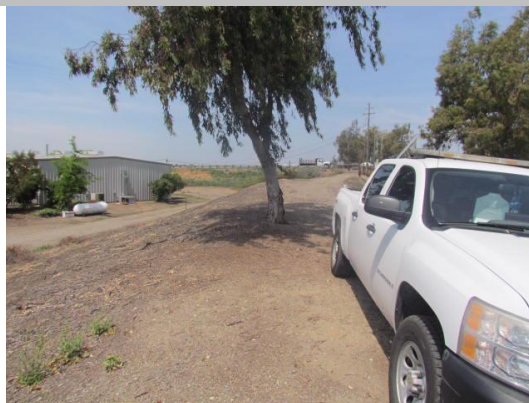
Photo 1 of 1 : FA_2017_RD0524_107_173_20170919_00207.jpg

Looking northwest at tree on within levee crown.

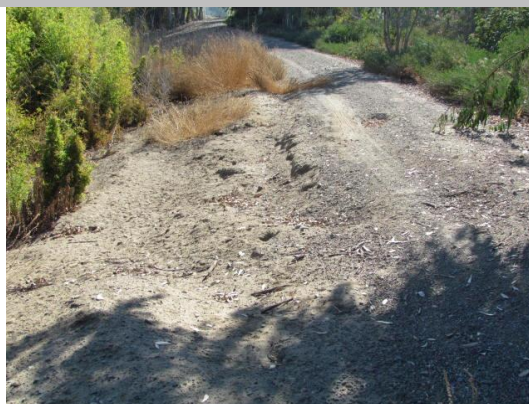
Photo 1 of 1 : FA_2017_RD0524_107_136_20170919_00186.jpg

Looking south at depression on levee crown near waterward shoulder.

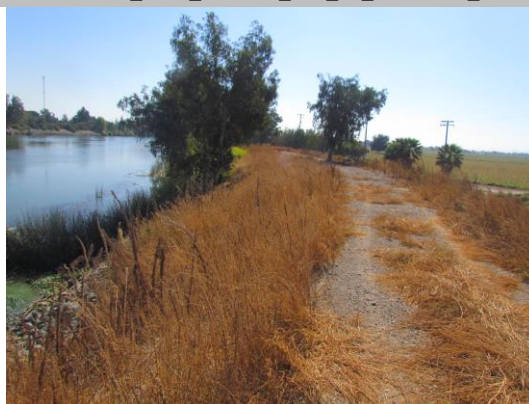
Photo 3 of 3 : FA_2017_RD0524_107_25_20170919_00047.jpg

Looking southwest at dense veg on waterward slope.

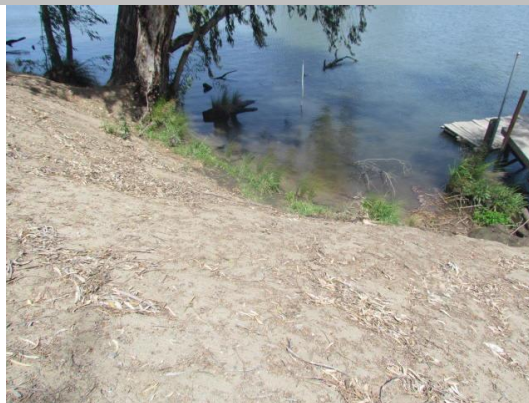
Photo 3 of 3 : FA_2017_RD0524_107_26_20170919_00050.jpg

Looking east at waterward erosion and depression.

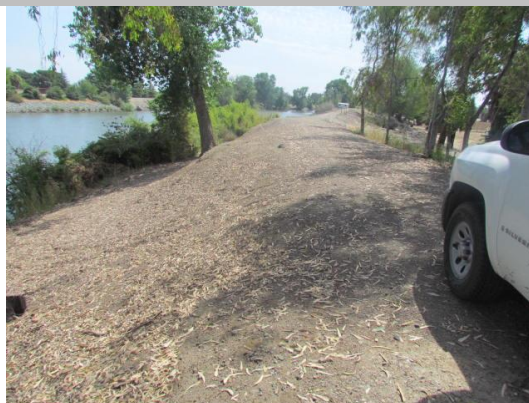
Photo 1 of 1 : FA_2017_RD0524_107_27_20170919_00051.jpg

Looking south at landward slope depression.

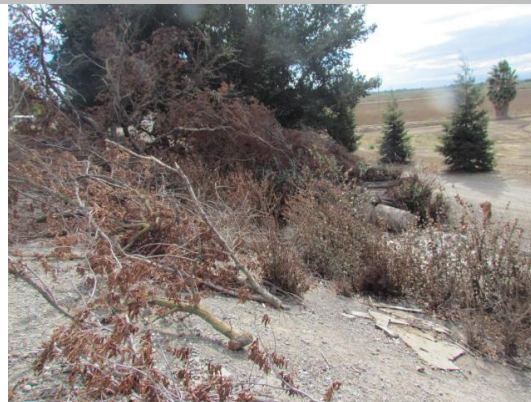
Photo 2 of 4 : FA_2017_RD0524_107_46_20170919_00081.jpg

Looking southwest at tree limbs on landward slope.

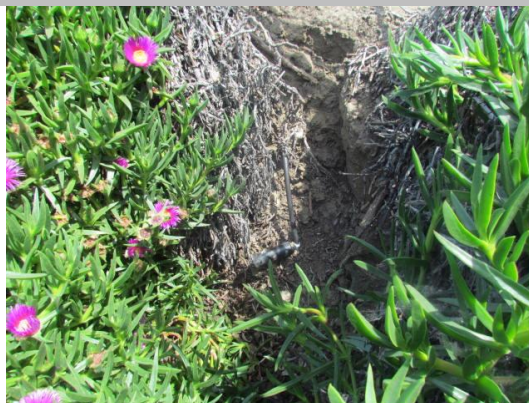
Photo 2 of 2 : FA_2017_RD0524_107_176_20170919_00214.jpg

Looking east at erosion within landscaping on landward slope and shoulder.

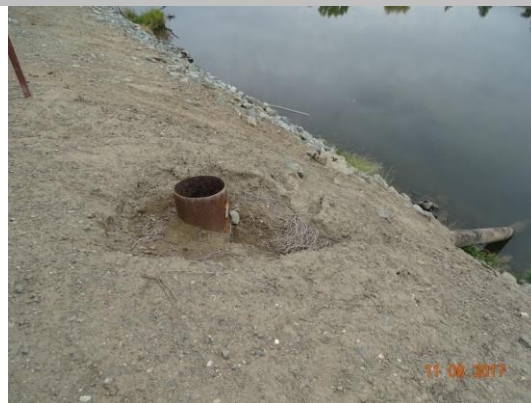
Photo 1 of 4 : FA_2017_RD0524_107_31_20171116_00478.jpg

Looking northwest at waterside slope.

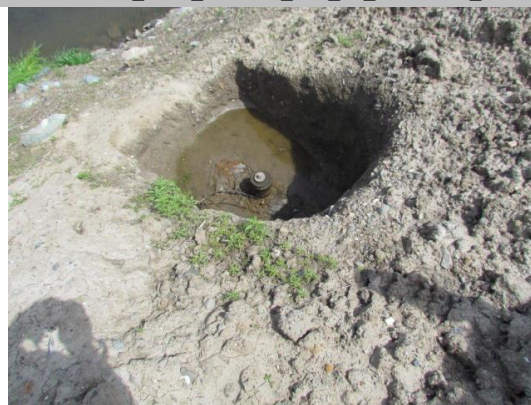
Photo 3 of 4 : FA_2017_RD0524_107_31_20170919_00054.jpg

Looking east at siphon on waterward slope.

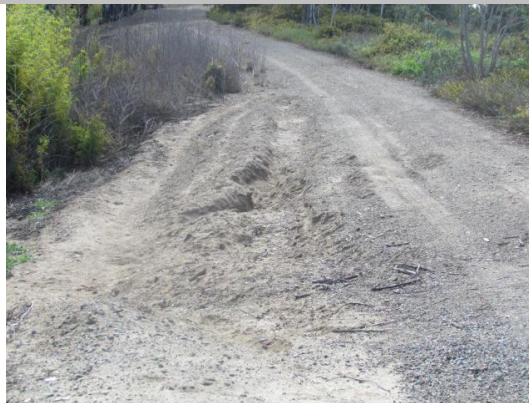
Photo 4 of 4 : FA_2017_RD0524_107_31_20170919_00055.jpg

Looking south slope damage on waterward shoulder and slope.

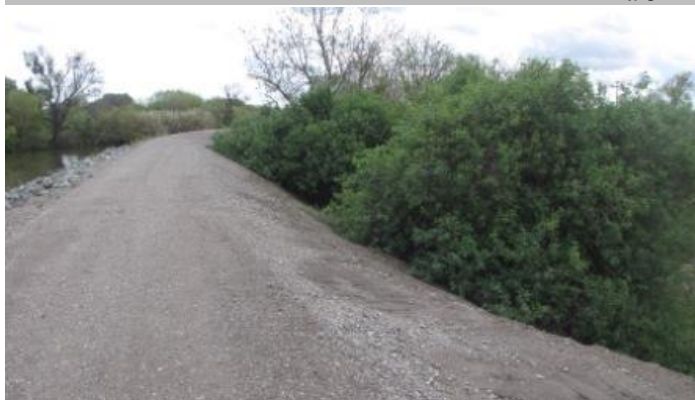
Photo 2 of 2 : FA_2017_RD0524_107_32_20170919_00057.jpg

Looking south at dense veg on landside slope and toe.

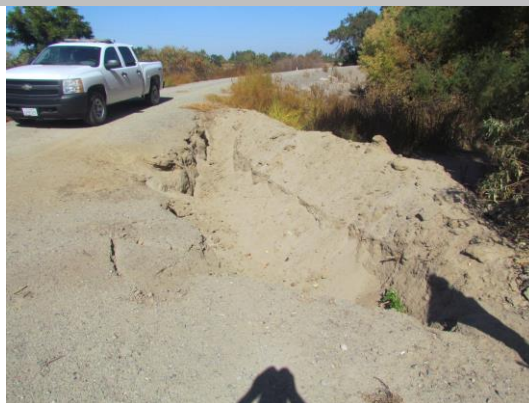
Photo 3 of 3 : FA_2017_RD0524_107_218_20170919_00266.jpg

Looking northwest at trench on waterward shoulder.

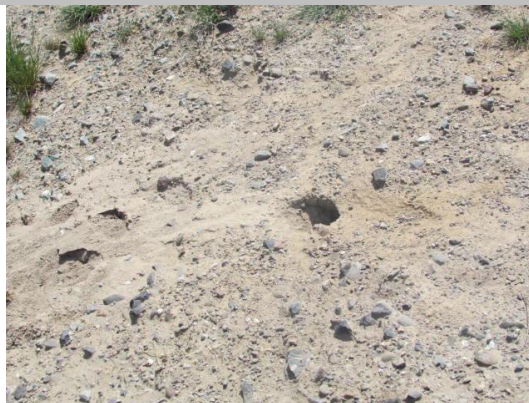
Photo 3 of 3 : FA_2017_RD0524_107_925_20170919_00289.jpg

Looking at typical rodent holes on landward slope along this reach.

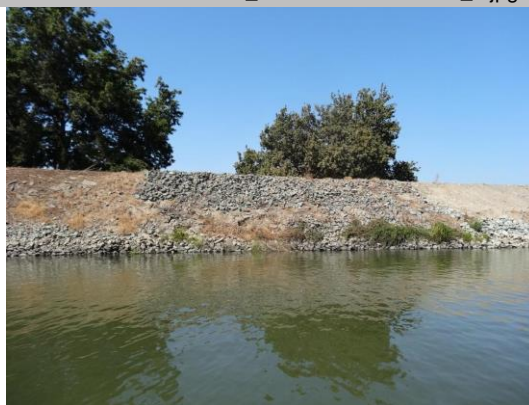
Photo 1 of 4 : SJR2017_RD0524U01RM43.86_1.jpg

LM Start	3.30	Rating **	U	Issue No.	79
LM End	3.32	Issue Type +	Ma	Location *	WS
Category	Supplemental			GPS Latitude/Longitude	
				Start	End
Item	DWR Erosion Survey			37.908090 °	37.908090 °
				-121.325090 °	-121.325090 °
DWR ID	RD0524U01RM43.86				
Comment Code					
Inspector Comment					
<p>09/13/2017: No significant change observed.</p> <p>07/25/2016: No significant change observed.</p> <p>06/24/2015: No significant change observed.</p> <p>06/19/2014: No significant change observed.</p> <p>08/13/2013: The levee toe seems to have been protected by river rocks and vegetation on site. [2017 Site ID: RD0524U01RM43.86]</p>

Front View of the erosion.

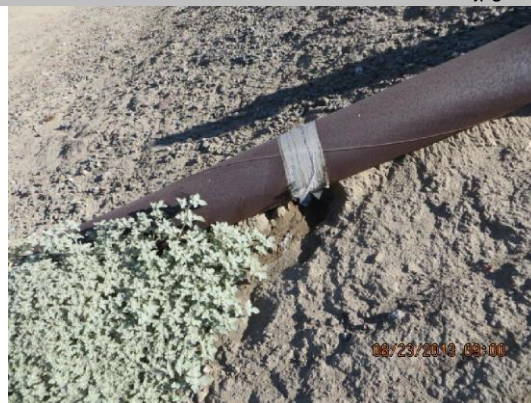
Photo 2 of 3 : UCIP_FA_2017_18320_30593.jpg

Small leak in pipe on LS slope.

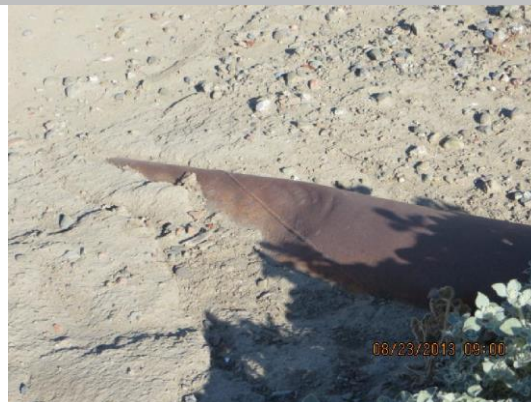
Photo 3 of 3 : UCIP_FA_2017_18320_30592.jpg

Pipe partially crushed at LS toe.

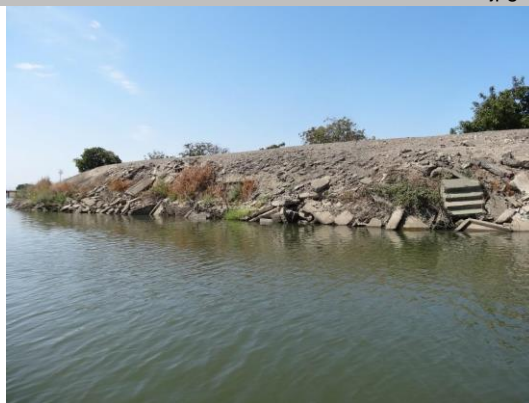
Photo 1 of 3 : SJR2017_RD0524U01RM45.07_1.jpg

Front view of the erosion site.

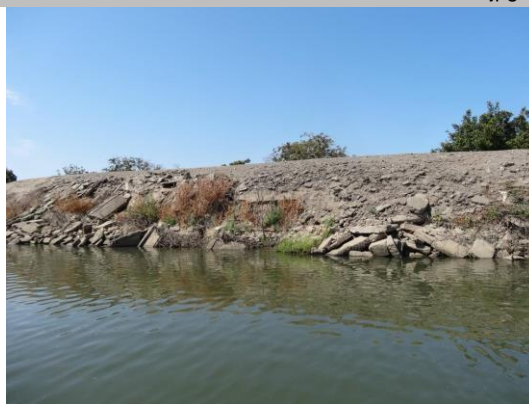
Photo 2 of 3 : SJR2017_RD0524U01RM45.07_2.jpg

Close view of the site.

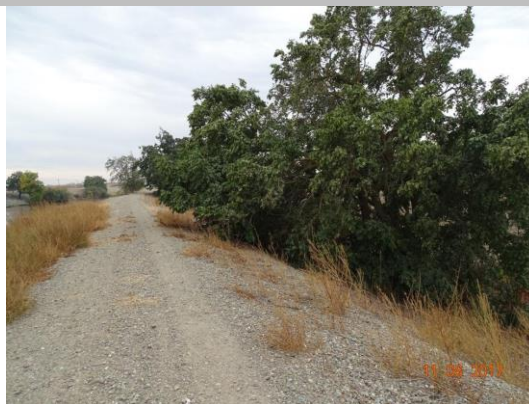
Photo 1 of 1 : FA_2017_RD0524_107_266_20171116_00489.jpg

Looking south at the landside slope.

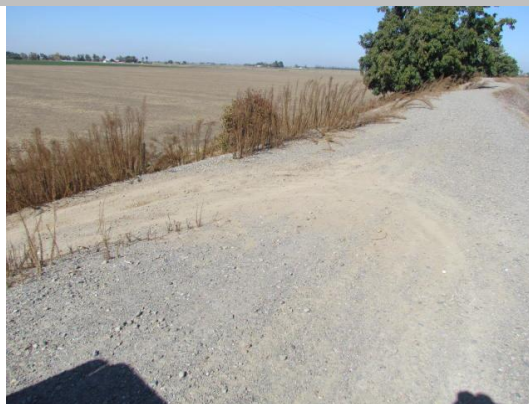
Photo 1 of 1 : FA_2017_RD0524_107_115_20170919_00168.jpg

Looking northwest at slope damage on landward slope.

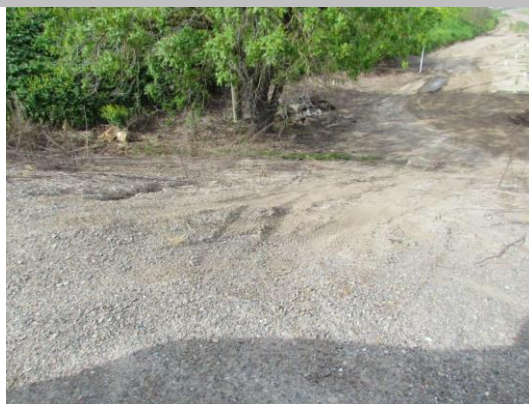
Photo 1 of 1 : FA_2017_RD0524_107_167_20170919_00198.jpg

Looking west at slope damage caused by vehicle traffic on landward slope.

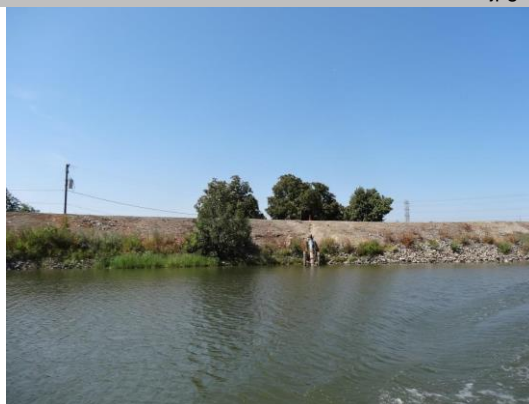
Photo 1 of 2 : SJR2017_RD0524U01RM46.39_1.jpg

Front view of the site.

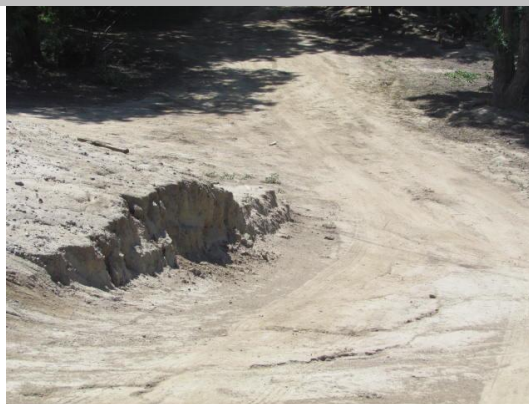
Photo 1 of 2 : FA_2017_RD0524_107_119_20170919_00173.jpg

Looking west at unauthorized ramp and landside slope damage.

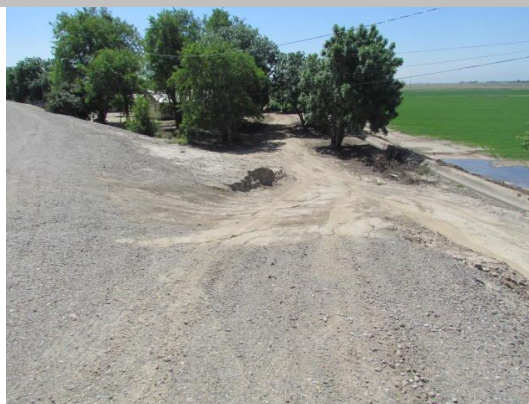
Photo 2 of 2 : FA_2017_RD0524_107_119_20170919_00174.jpg

Looking southwest at damaged slope and ramp on landside slope.
