**Flood Control Project Maintenance
Levee Inspections**

Maintenance Issue Types Only, Levee Inspection Report By Mile - Fall 2018

Reclamation District No. 0524 Middle Roberts Island

Waterway	Bank	Unit Miles	Inspection Start/End	Inspector
Unit No. 01 San Joaquin River	Left	6.20	09/11/2018 09/11/2018	Richard Willoughby

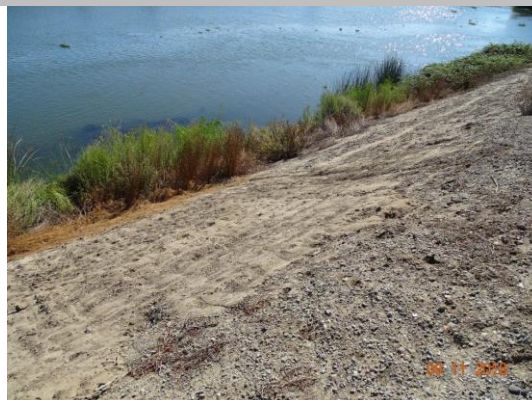
Photo 3 of 4 : FA_2018_RD0524_107_237_20180919_00465.jpg

LM Start	0.14	Rating **	A	Issue No.	237
LM End	0.14	Issue Type +	Ma	Location *	WS
Category	Earthen Levee			GPS Latitude/Longitude	
				Start	End
Item	Animal Control			37.939774 °	37.939774 °
				-121.344490 °	-121.344490 °
DWR ID	DWR_RD0524_01_f_2017_237				
Comment Code					
A3 : No rodents visible, but rodent burrows visible; need to backfill and compact or grout burrows.					
Inspector Comment					
LMA backfilled rodent hole, but no rodent program visible.

Looking southeast at backfill of rodent holes on waterward slope. (Fall 2018)

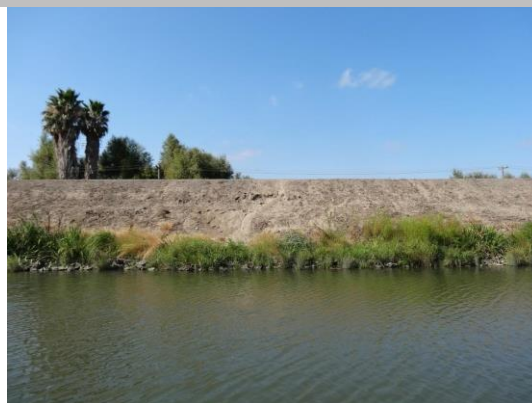
Photo 1 of 3 : FA_2018_RD0524_107_1_20180906_00001.jpg

LM Start	0.19	Rating **	U	Issue No.	1
LM End	0.19	Issue Type +	Ma	Location *	WS
Category	Supplemental			GPS Latitude/Longitude	
				Start	End
Item	DWR Erosion Survey			37.939085 °	37.939085 °
				-121.343917 °	-121.343917 °
DWR ID	RD0524U01RM40.85				
Comment Code					
Inspector Comment					
09/13/2017: No significant change observed.					
07/25/2016: No significant change observed.					
06/24/2015: No significant change observed.					
06/19/2014: No significant change observed.					
08/13/2013: The erosion was discovered during 2013 spring levee inspection. Inspector comment: Erosion is located along the lower level of water-ward slope. [2017 Site ID:RD0524U01RM40.85]

Close view of the erosion.

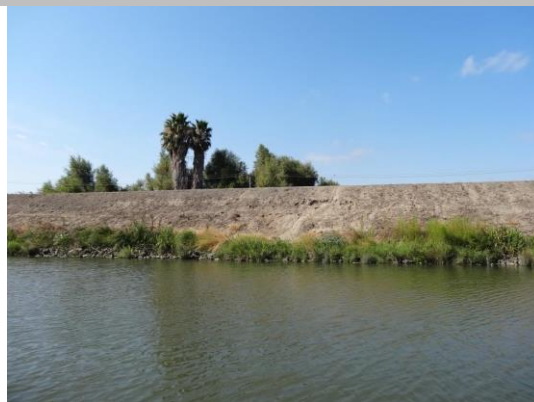
Photo 3 of 3 : FA_2018_RD0524_107_1_20180906_00003.jpg

LM Start	0.19	Rating **	U	Issue No.	1 (cont)	
LM End	0.19	Issue Type +	Ma	Location *	WS	
Category	Supplemental			GPS Latitude/Longitude		
				Start		End
Item	DWR Erosion Survey			37.939085 °		37.939085 °
				-121.343917 °		-121.343917 °
DWR ID	RD0524U01RM40.85					
Comment Code						
Inspector Comment						
09/13/2017: No significant change observed.						
07/25/2016: No significant change observed.						
06/24/2015: No significant change observed.						
06/19/2014: No significant change observed.						
08/13/2013: The erosion was discovered during 2013 spring levee inspection. Inspector comment: Erosion is located along the lower level of water-ward slope. [2017 Site ID:RD0524U01RM40.85]

Front view of the erosion.

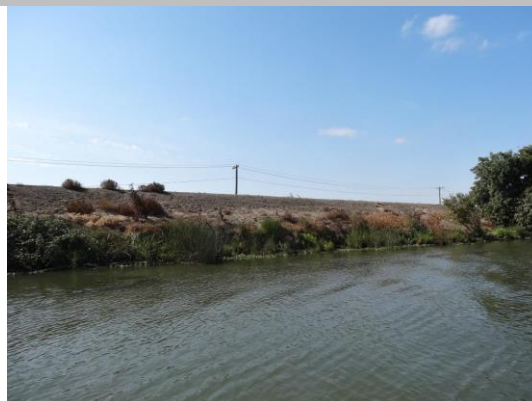
Photo 2 of 4 : FA_2018_RD0524_107_2_20180906_00005.jpg

Looking downstream of the erosion.

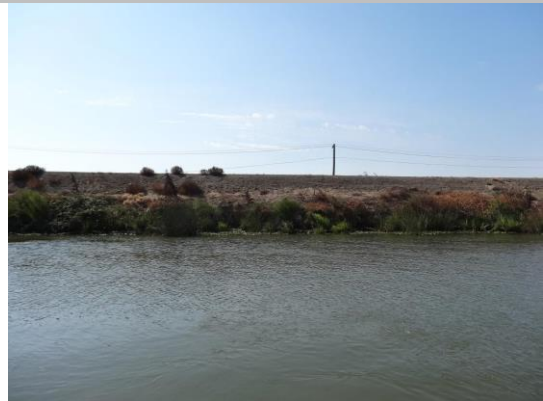
Photo 4 of 4 : FA_2018_RD0524_107_2_20180906_00007.jpg

Front view of the erosion.

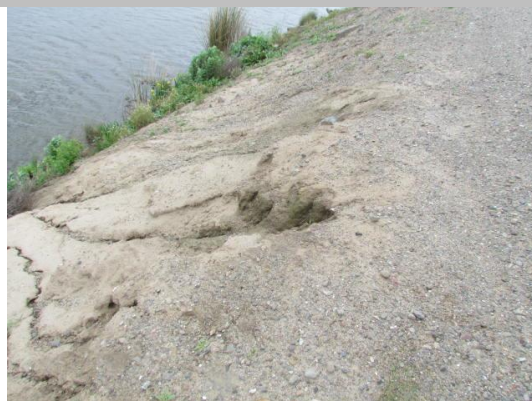
Photo 1 of 2 : FA_2018_RD0524_107_170_20180906_00221.jpg

LM Start	0.41	Rating **	U	Issue No.	170
LM End	0.45	Issue Type +	Ma	Location *	WS
Category	Earthen Levee			GPS Latitude/Longitude	
				Start	End
Item	Erosion / Bank Caving			37.938628 °	37.938688 °
				-121.340385 °	-121.339627 °
DWR ID	DWR_RD0524_01_s _ 2015_170				
Comment Code					
E2 : Schedule repair of erosion site prior to the next inspection.					
Inspector Comment					
Several slope instabilities within this reach.

Looking at slope damage on waterward shoulder (Spring 2016)

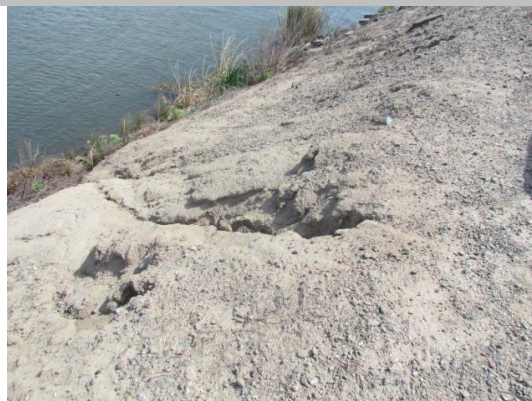
Photo 2 of 2 : FA_2018_RD0524_107_170_20180906_00222.jpg

Looking at waterward slope erosion.

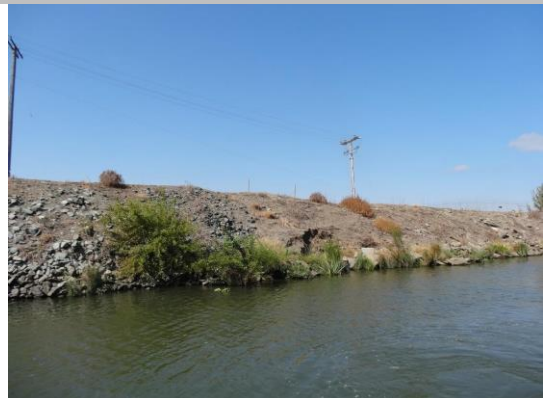
Photo 3 of 4 : FA_2018_RD0524_107_16_20180906_00028.jpg

Looking downstream of the erosion site.

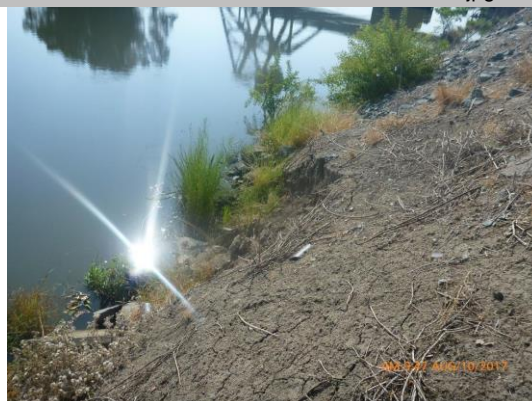
Photo 2 of 3 : LEVAL_FA_2018_541_4080.jpg

LM Start	0.70	Rating **	A/W	Issue No.	153 (cont)							
LM End	0.70	Issue Type +	Ma	Location *								
Category	Supplemental		GPS Latitude/Longitude									
			Start	End								
Item	2017 Storm Damage		37.937500°	37.937500°								
			-121.335500°	-121.335500°								
DWR ID	DWR_RD0524_01_f_2017_153											
Comment Code												
Inspector Comment												
Levee Evaluation Comments Description: Slope protection repairs are needed along the waterside slope due to erosion and riprap displacement from high water. Based upon levee inspections, it was determined the waterside levee slope is eroding, deteriorating, and degrading. The eroded levee sections need to be restored back to design standards to prevent further deterioration and damage. Site ID No: 541 Site Designation: LMA-447 Repair Type: Erosion Rating: Area of Concern Field Date: 8/10/2017 Notes:

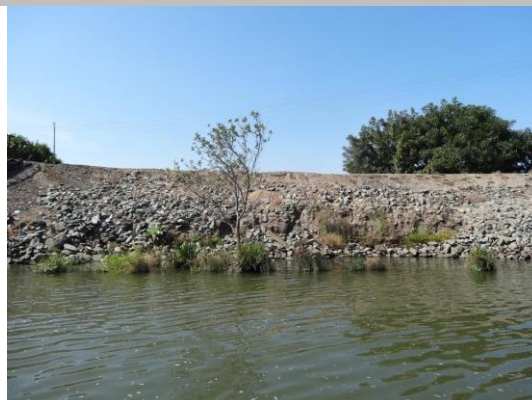
Photo 3 of 3 : FA_2018_RD0524_107_17_20180906_00032.jpg

LM Start	0.71	Rating **	M	Issue No.	17
LM End	0.73	Issue Type +	Ma	Location *	WS
Category	Supplemental			GPS Latitude/Longitude	
				Start	End
Item	DWR Erosion Survey			37.937222 °	37.937222 °
				-121.335277 °	-121.335277 °
DWR ID	RD0524U01RM41.36				
Comment Code					
Inspector Comment					
09/13/2017: No significant change observed.					
07/25/2016: No significant change observed.					
06/24/2015: The erosion site is immediately downstream of the RR bridge. [2017 Site ID:RD0524U01RM41.36]

Close view of the erosion.

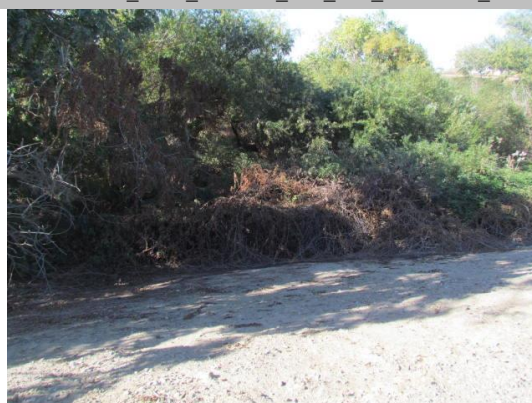
Photo 3 of 3 : FA_2018_RD0524_107_262_20180906_00349.jpg

Looking west at dense vegetation on landside toe. Spring 2014

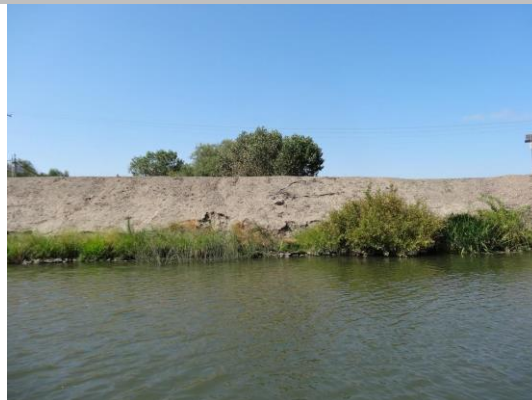
Photo 2 of 4 : FA_2018_RD0524_107_21_20180906_00037.jpg

LM Start	0.76	Rating **	U	Issue No.	21
LM End	0.77	Issue Type +	Ma	Location *	WS
Category	Supplemental			GPS Latitude/Longitude	
				Start	End
Item	DWR Erosion Survey			37.936821 °	37.936821 °
				-121.334582 °	-121.334582 °
DWR ID	RD0524U01RM41.39				
Comment Code					
Inspector Comment					
09/13/2017: No significant change observed.					
07/25/2016: No significant change observed.					
06/24/2015: No significant change observed.					
06/19/2014: No significant change observed.					
08/13/2013: No significant change at this site.					
08/07/2012: The site has been visited by boat survey. No significant change observed.					
08/23/2011: The site is located immediately upstream of a Railroad bridge. Dense vegetation at the water line blocks the view of erosion.					
[2017 Site ID:RD0524U01RM41.39]

Front view of the erosion site. Vegetation is visible.

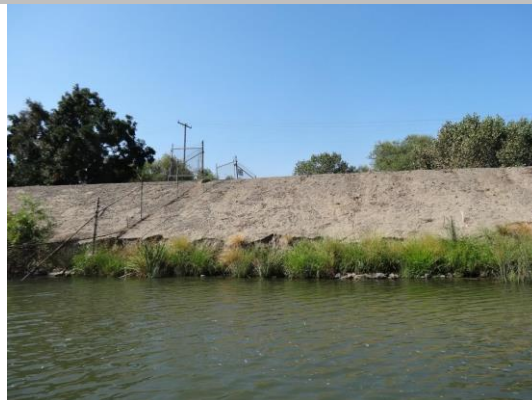
Photo 4 of 4 : FA_2018_RD0524_107_21_20180906_00039.jpg

LM Start	0.76	Rating **	U	Issue No.	21 (cont)
LM End	0.77	Issue Type +	Ma	Location *	WS
Category	Supplemental			GPS Latitude/Longitude	
				Start	End
Item	DWR Erosion Survey			37.936821 °	37.936821 °
				-121.334582 °	-121.334582 °
DWR ID	RD0524U01RM41.39				
Comment Code					
Inspector Comment					
09/13/2017: No significant change observed.					
07/25/2016: No significant change observed.					
06/24/2015: No significant change observed.					
06/19/2014: No significant change observed.					
08/13/2013: No significant change at this site.					
08/07/2012: The site has been visited by boat survey. No significant change observed.					
08/23/2011: The site is located immediately upstream of a Railroad bridge. Dense vegetation at the water line blocks the view of erosion.					
[2017 Site ID:RD0524U01RM41.39]

Front view of the erosion.

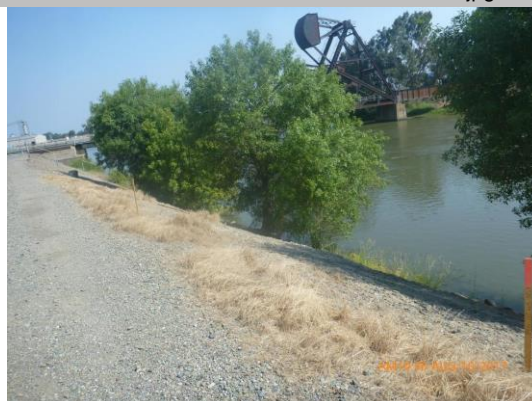
Photo 1 of 3 : LEVAL_FA_2018_538_4097.jpg

LM Start	0.79	Rating **	M	Issue No.	155
LM End	0.80	Issue Type +	Ma	Location *	
Category	Supplemental			GPS Latitude/Longitude	
				Start	End
Item	2017 Storm Damage			37.936300 °	37.936200 °
				-121.334700 °	-121.334600 °
DWR ID	DWR_RD0524_01_f_2017_155				
Comment Code					
Inspector Comment					
Levee Evaluation Comments					
Description:Slope protection repairs are needed along the waterside slope due to erosion and riprap displacement from high water. Based upon levee inspections, it was determined the waterside levee slope is eroding, deteriorating, and degrading. The eroded levee sections need to be restored back to design standards to prevent further deterioration and damage.					
Site ID No:538					
Site Designation:LMA-444					
Repair Type: Erosion					
Rating:Area of Concern					
Field Date:8/10/2017					
Notes:

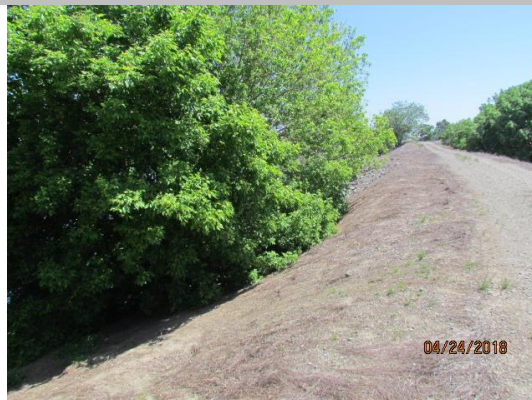
Photo 1 of 1 : FA_2018_RD0524_107_149_20180906_00190.jpg

Looking southeast at untrimmed trees on waterward slope. (Spring 2018)

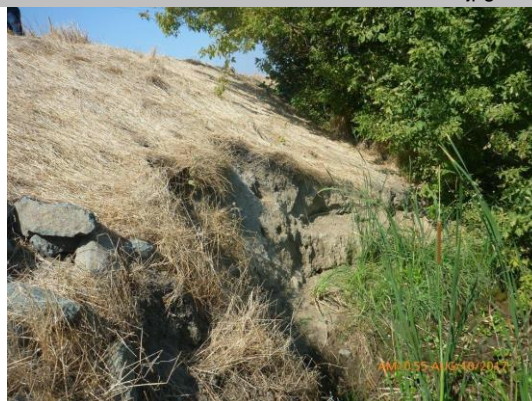
Photo 1 of 3 : LEVAL_FA_2018_537_4102.jpg

LM Start	0.90	Rating **	A/W	Issue No.	193
LM End	0.91	Issue Type +	Ma	Location *	
Category	Supplemental			GPS Latitude/Longitude	
				Start	End
Item	2017 Storm Damage			37.935400 °	37.935300 °
				-121.333300 °	-121.333200 °
DWR ID	DWR_RD0524_01_f_2017_193				
Comment Code					
Inspector Comment					
Levee Evaluation Comments					
Description:Slope protection repairs are needed along the waterside slope due to erosion and riprap displacement from high water. Based upon levee inspections, it was determined the waterside levee slope is eroding, deteriorating, and degrading. The eroded levee sections need to be restored back to design standards to prevent further deterioration and damage.					
Site ID No:537					
Site Designation:LMA-443					
Repair Type: Erosion					
Rating:Serious					
Field Date:8/10/2017					
Notes:

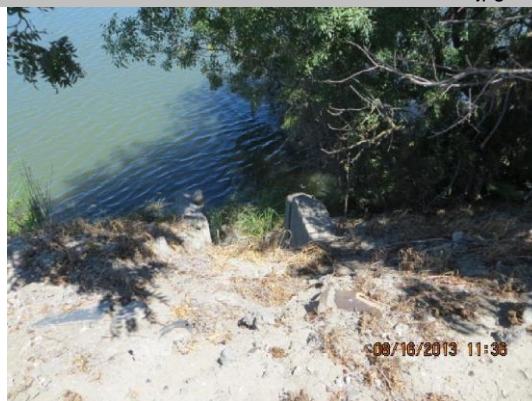
Photo 1 of 2 : UCIP_FA_2018_17575_29736.jpg

Concrete headwall visible on WS slope.

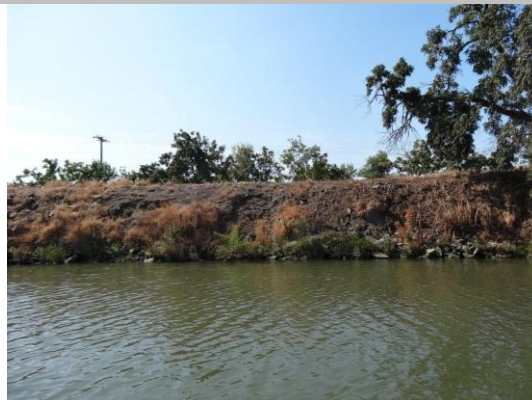
Photo 3 of 4 : FA_2018_RD0524_107_30_20180906_00055.jpg

Front view of the erosion.

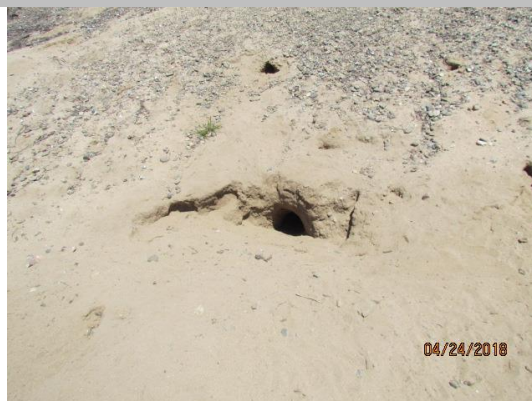
Photo 2 of 2 : FA_2018_RD0524_107_238_20180906_00332.jpg

Looking northeast at rodent hole on landward slope. (Spring 2018)

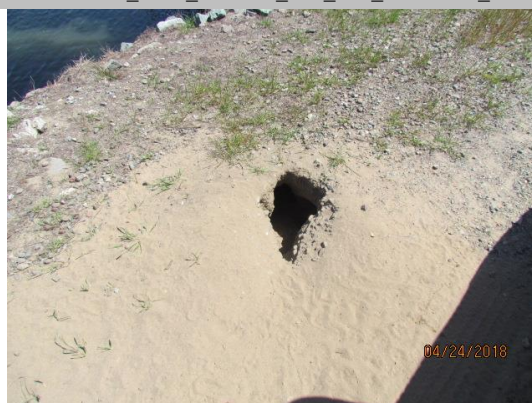
Photo 1 of 3 : FA_2018_RD0524_107_150_20180906_00191.jpg

Looking at close-up view of rodent hole on waterward shoulder. (Spring 2018)

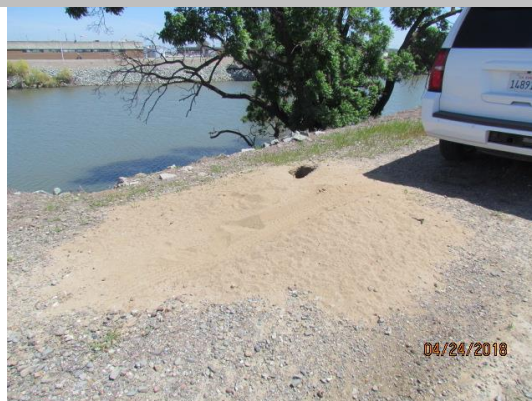
Photo 3 of 3 : FA_2018_RD0524_107_150_20180906_00193.jpg

Looking southeast at large rodent hole on waterward shoulder. (Spring 2018)

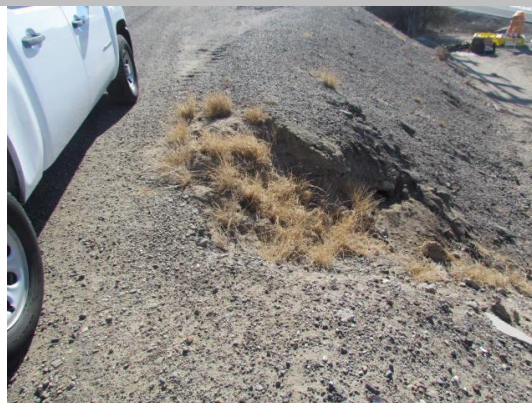
Photo 1 of 2 : FA_2018_RD0524_107_18_20180906_00033.jpg

Looking south at caving on landward shoulder. (Fall 2015)

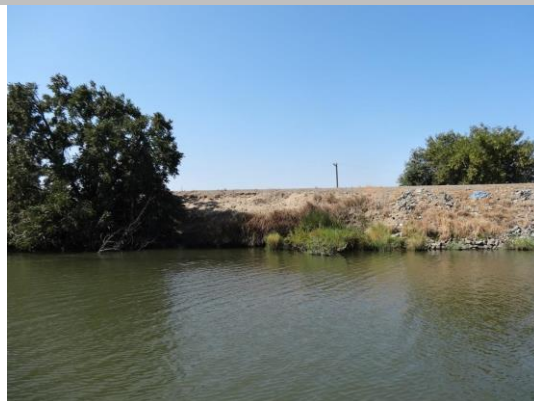
Photo 2 of 4 : FA_2018_RD0524_107_44_20180906_00074.jpg

Direct view of the site.

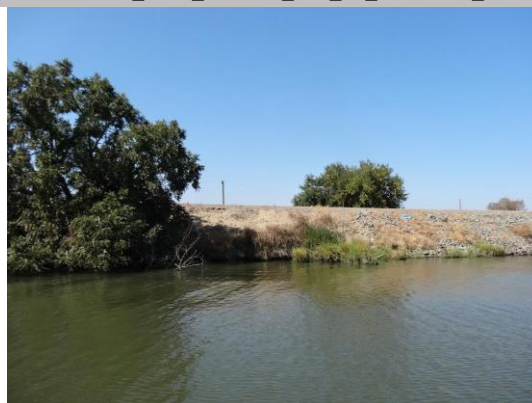
Photo 4 of 4 : FA_2018_RD0524_107_44_20180906_00076.jpg

View of the site. Note the tree near the erosion site.

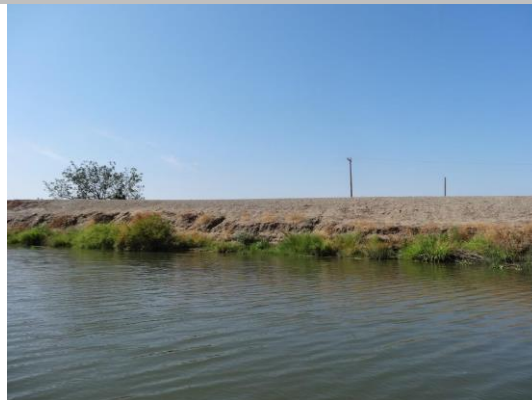
Photo 1 of 4 : FA_2018_RD0524_107_47_20180906_00084.jpg

Front view of the erosion.

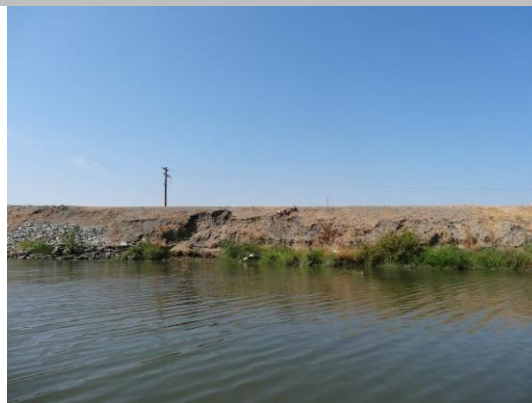
Photo 3 of 4 : FA_2018_RD0524_107_47_20180906_00086.jpg

Close view of the erosion.

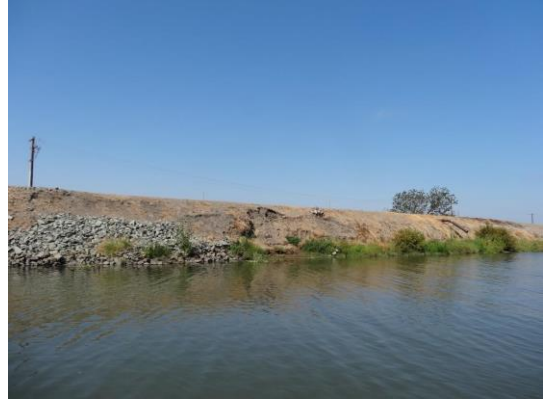
Photo 4 of 4 : FA_2018_RD0524_107_47_20180906_00087.jpg

Front view of the erosion. Note the worsen erosion next to the protected slope.

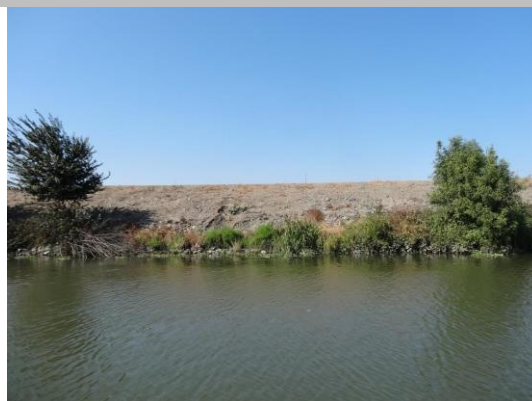
Photo 1 of 3 : FA_2018_RD0524_107_56_20180906_00098.jpg

Front view of the erosion.

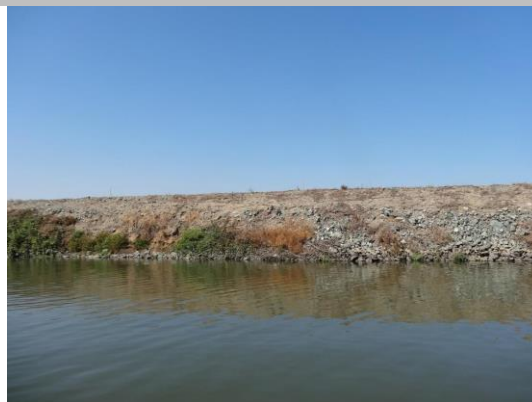
Photo 1 of 4 : FA_2018_RD0524_107_60_20180906_00106.jpg

LM Start	1.45	Rating **	U	Issue No.	60
LM End	1.47	Issue Type +	Ma	Location *	WS
Category	Supplemental			GPS Latitude/Longitude	
				Start	End
Item	DWR Erosion Survey			37.929650 °	37.929650 °
				-121.328110 °	-121.328110 °
DWR ID	RD0524U01RM42.09				
Comment Code					
Inspector Comment					
09/13/2017: No significant change observed.					
07/25/2016: No significant change observed.					
06/24/2015: No significant change observed.					
06/19/2014: No significant change observed.					
08/13/2013: The site is located approximately 400 ft. downstream SR 4					
Bridge. Dense vegetation is visible at the toe. [2017 Site					
ID:RD0524U01RM42.09]

Front view of the erosion site.

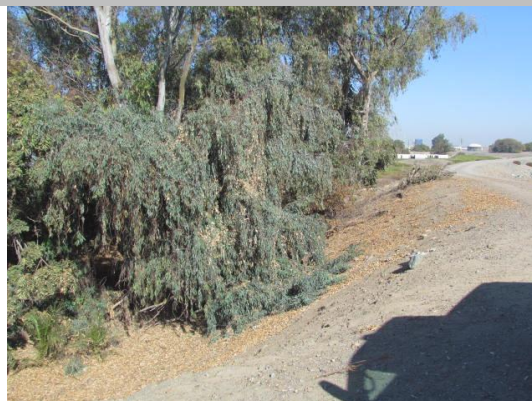
Photo 1 of 1 : FA_2018_RD0524_107_916_20180906_00360.jpg

Looking at dense trees on landward slope and toe fall 2015

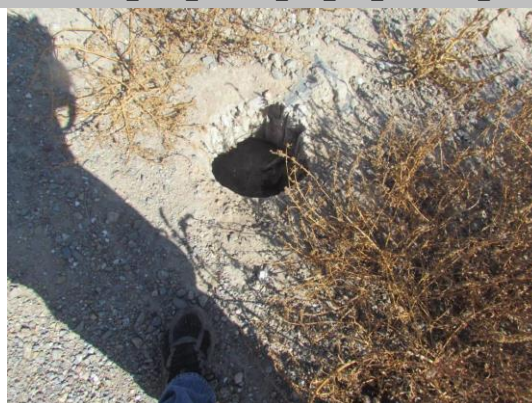
Photo 1 of 2 : FA_2018_RD0524_107_202_20180906_00267.jpg

Looking at large hole (Fence/telephone post hole) on waterward shoulder.

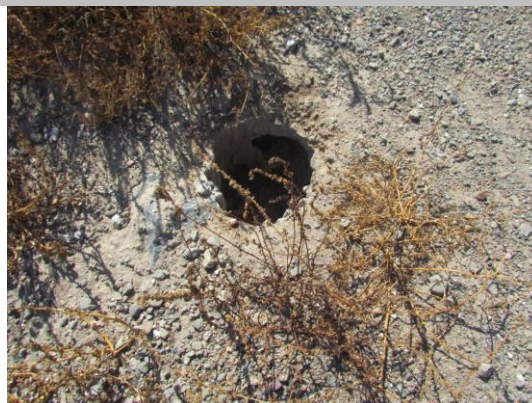
Photo 2 of 2 : FA_2018_RD0524_107_202_20180906_00268.jpg

Looking at hole on waterward shoulder.

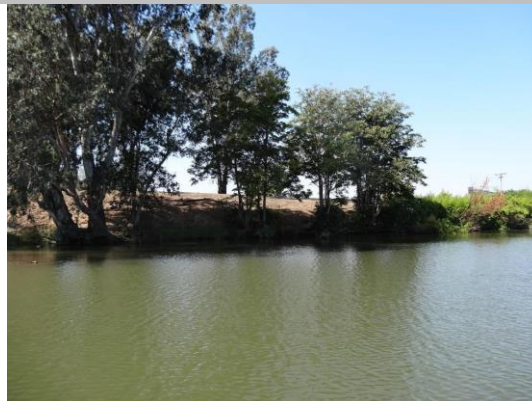
Photo 2 of 3 : FA_2018_RD0524_107_62_20180906_00112.jpg

Close view of the erosion.

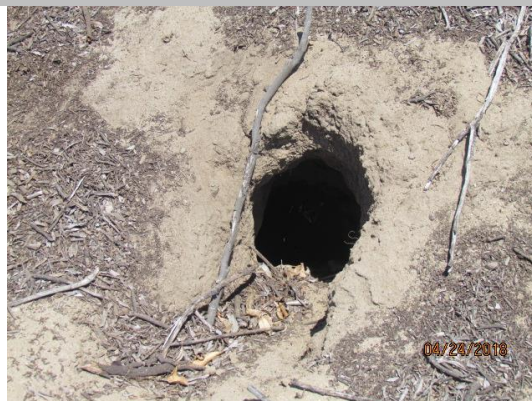
Photo 1 of 2 : FA_2018_RD0524_107_151_20180906_00194.jpg

Looking at close-up view of large rodent hole on landward slope. (Spring 2018)

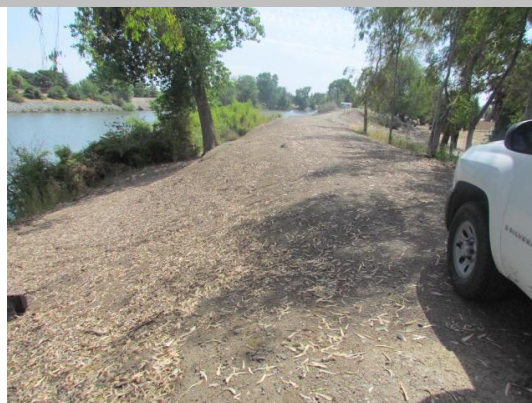
Photo 1 of 1 : FA_2018_RD0524_107_27_20180906_00048.jpg

Looking south at landward slope depression.

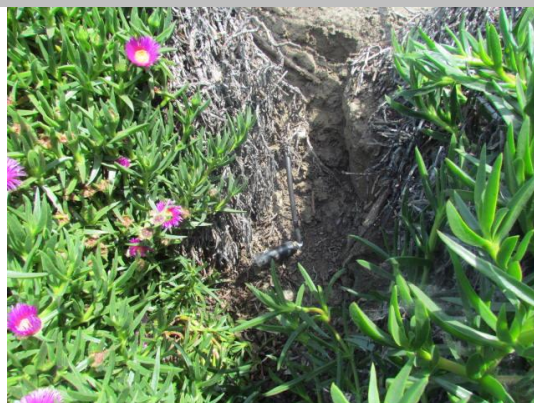
Photo 2 of 2 : FA_2018_RD0524_107_176_20180906_00232.jpg

Looking east at erosion within landscaping on landward slope and shoulder.

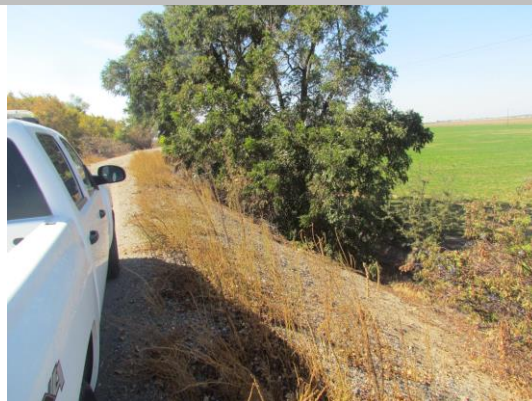
Photo 1 of 1 : FA_2018_RD0524_107_80_20180906_00140.jpg

Looking south at untrimmed tree on landward slope.

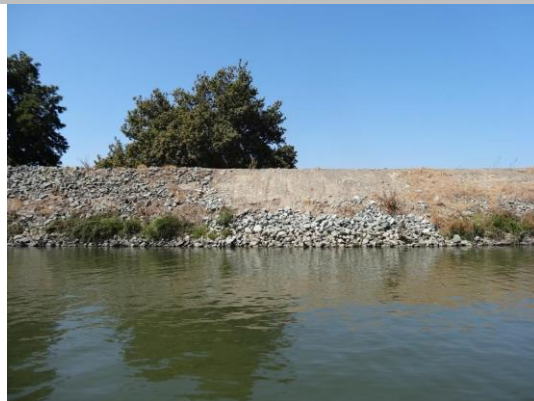
Photo 3 of 4 : FA_2018_RD0524_107_79_20180906_00138.jpg

Close view of the erosion. Note the river rocks and vegetation at the levee toe.

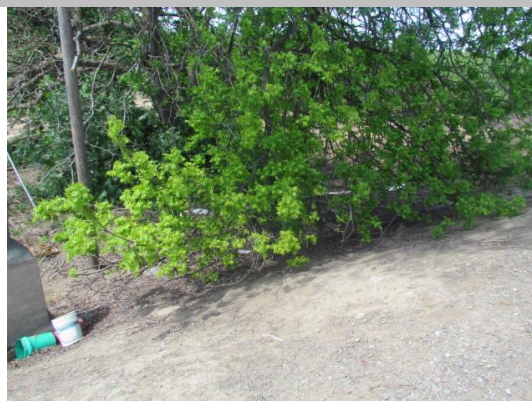
Photo 1 of 1 : FA_2018_RD0524_107_61_20180906_00110.jpg

Looking east at untrimmed tree at landward toe.

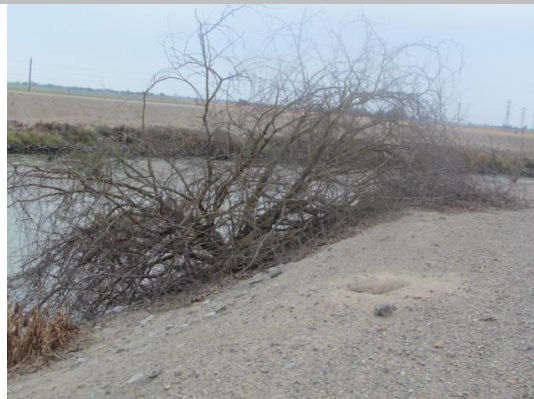
Photo 2 of 2 : FA_2018_RD0524_107_102_20180906_00167.jpg

Looking southeast at dead tree on waterside slope.

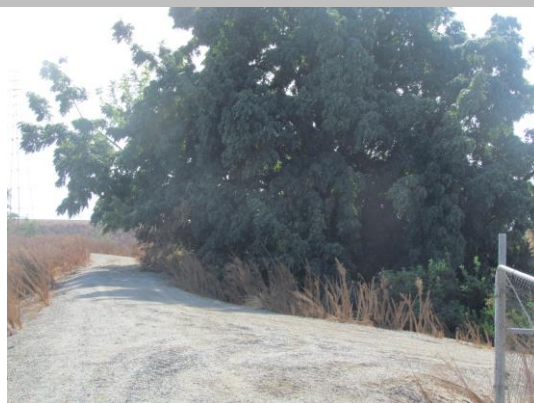
Photo 1 of 1 : FA_2018_RD0524_107_73_20180906_00127.jpg

Looking southwest at large untrimmed tree on landward slope.

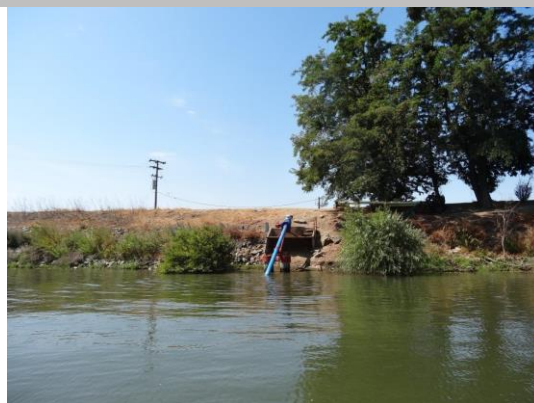
Photo 1 of 2 : FA_2018_RD0524_107_92_20180906_00155.jpg

Front view of the erosion.

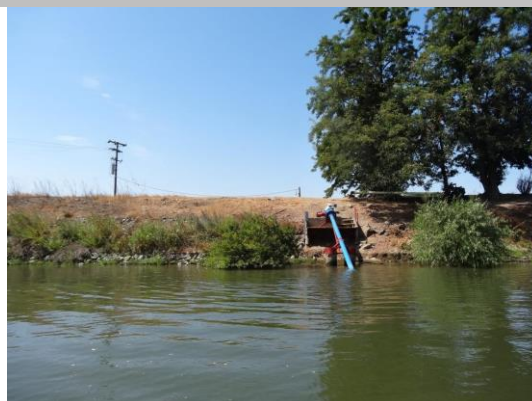
Photo 2 of 2 : FA_2018_RD0524_107_92_20180906_00156.jpg

Close view of the site.

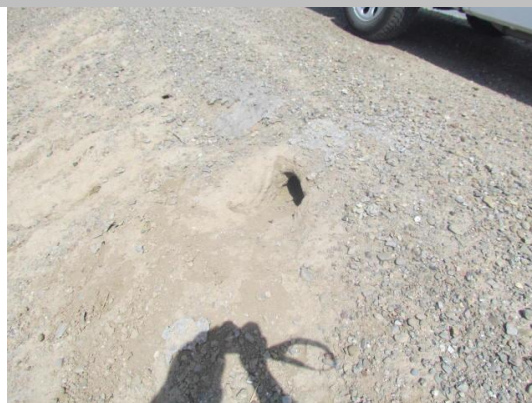
Photo 2 of 2 : FA_2018_RD0524_107_197_20180906_00260.jpg

Looking southwest at typical view of rodent hole at landward shoulder.

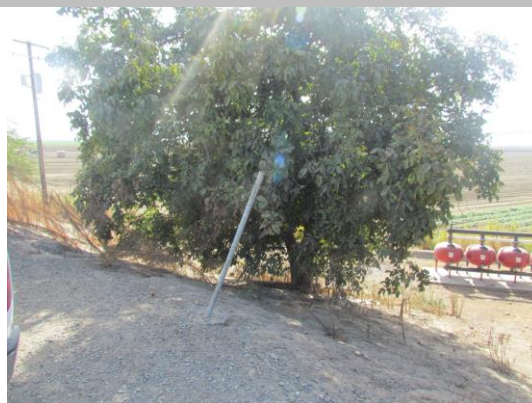
Photo 1 of 1 : FA_2018_RD0524_107_98_20180906_00164.jpg

Looking west at walnut tree on landward slope.

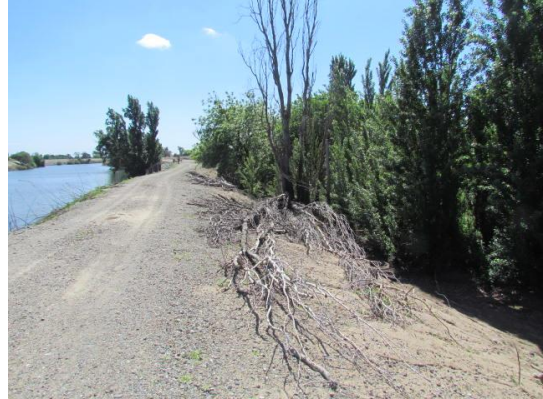
Photo 2 of 2 : FA_2018_RD0524_107_81_20180906_00142.jpg

Looking south at tree branches and limbs left on landward shoulder and slope. (Spring 2016)
