**Flood Control Project Maintenance
Levee Inspections**

Maintenance Issue Types Only, Levee Inspection Report By Mile - Fall 2019

Reclamation District No. 0524 Middle Roberts Island

Waterway	Bank	Unit Miles	Inspection Start/End	Inspector
Unit No. 01 San Joaquin River	Left	6.20	10/02/2019 11/14/2019	Alberto De Leon

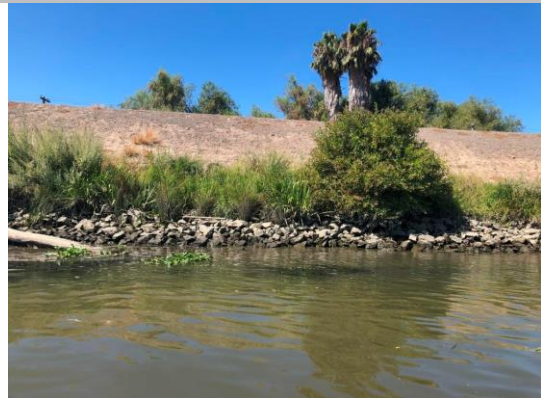
Photo 2 of 3 : SJR2019_RD0524U01RM40.85_1.JPG

LM Start	0.18	Rating **	U	Issue No.	1
LM End	0.18	Issue Type +	Ma	Location *	
Category	Supplemental			GPS Latitude/Longitude	
				Start	End
Item	DWR Erosion Survey			37.939085 °	37.939085 °
				-121.343917 °	-121.343917 °
DWR ID	RD0524U01RM40.85				
Comment Code					
Inspector Comment					
Site ID: RD0524U01RM40.85 08/13/2019: No significant change observed. 09/13/2017: No significant change observed. 07/25/2016: No significant change observed. 06/24/2015: No significant change observed. 06/19/2014: No significant change observed. 08/13/2013: The erosion was discovered during 2013 spring levee inspection. Inspector comment: Erosion is located along the lower level of water-ward slope.

Front view of the erosion.

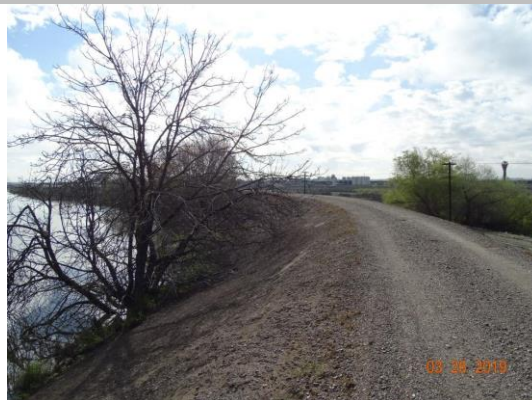
Photo 1 of 2 : FA_2019_RD0524_107_201_20190830_00184.jpg

View of tree on waterside slope looking upstream. Spring 2019.

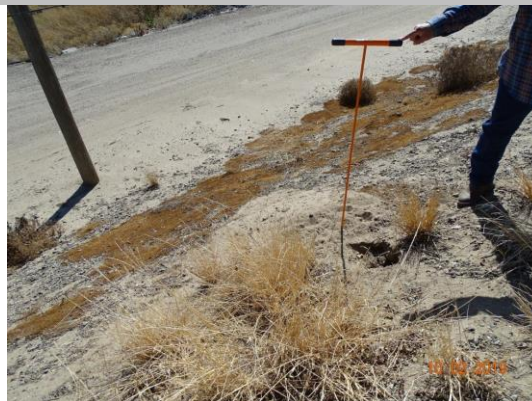
Photo 1 of 2 : FA_2019_RD0524_107_125_20191117_00359.jpg

View of large rodent hole on landside slope. Fall 2019

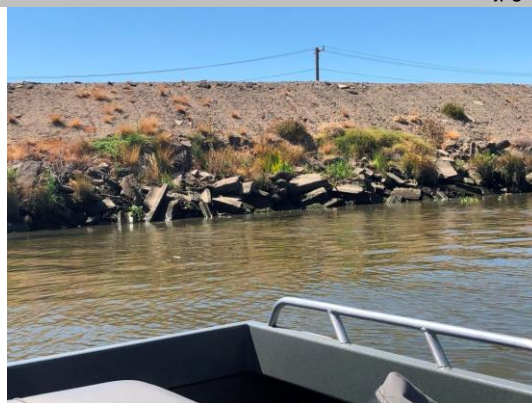
Photo 1 of 3 : SJR2019_RD0524U01RM40.99_1.jpg

LM Start	0.40	Rating **	U	Issue No.	5	
LM End	0.40	Issue Type +	Ma	Location *		
Category	Supplemental			GPS Latitude/Longitude		
				Start		End
Item	DWR Erosion Survey			37.938870 °		37.938870 °
				-121.340460 °		-121.340460 °
DWR ID	RD0524U01RM40.99					
Comment Code						
Inspector Comment						
Site ID: RD0524U01RM40.99						
08/13/2019: No significant change observed.						
09/13/2017: No significant change observed.						
07/25/2016: More vegetation observed at the site.						
06/24/2015: No significant change observed.						
06/19/2014: No significant change observed.						
08/13/2013: No significant change at this site.						
08/07/2012: The erosion is at the upper levee slope, and likely caused by slope slip. The lower levee slope is covered with dense vegetation.

Front view of the erosion site.

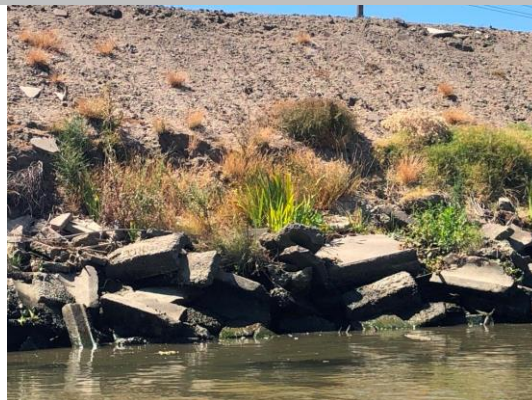
Photo 3 of 3 : SJR2019_RD0524U01RM40.99_3.jpg

LM Start	0.40	Rating **	U	Issue No.	5 (cont)	
LM End	0.40	Issue Type +	Ma	Location *		
Category	Supplemental			GPS Latitude/Longitude		
				Start		End
Item	DWR Erosion Survey			37.938870 °		37.938870 °
				-121.340460 °		-121.340460 °
DWR ID	RD0524U01RM40.99					
Comment Code						
Inspector Comment						
Site ID: RD0524U01RM40.99						
08/13/2019: No significant change observed.						
09/13/2017: No significant change observed.						
07/25/2016: More vegetation observed at the site.						
06/24/2015: No significant change observed.						
06/19/2014: No significant change observed.						
08/13/2013: No significant change at this site.						
08/07/2012: The erosion is at the upper levee slope, and likely caused by slope slip. The lower levee slope is covered with dense vegetation.

Close-up view of the erosion.

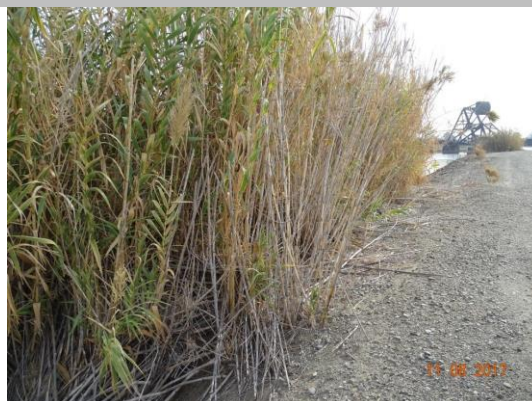
Photo 2 of 2 : FA_2019_RD0524_107_11_20190830_00014.jpg

Looking southeast at the waterside slope.

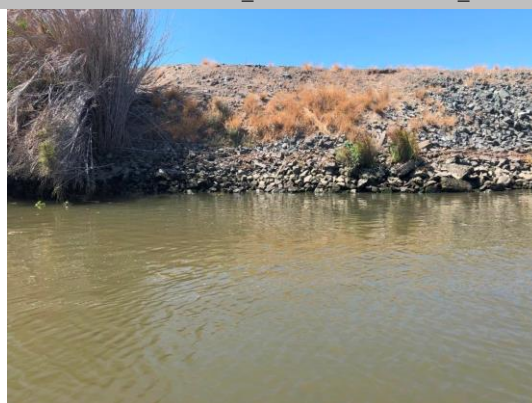
Photo 1 of 3 : SJR2019_RD0524U01RM41.26_1.JPG

LM Start	0.63	Rating **	U	Issue No.	15
LM End	0.63	Issue Type +	Ma	Location *	
Category	Supplemental			GPS Latitude/Longitude	
				Start	End
Item	DWR Erosion Survey			37.938247 °	37.938247 °
				-121.336503 °	-121.336503 °
DWR ID	RD0524U01RM41.26				
Comment Code					
Inspector Comment					
Site ID: RD0524U01RM41.26					
08/13/2019: No significant change observed.					
09/13/2017: The erosion was discovered by levee inspection. The erosion site is immediately downstream of tall vegetation.

Front view of the erosion. The erosion is located at the shadow of the vegetation.

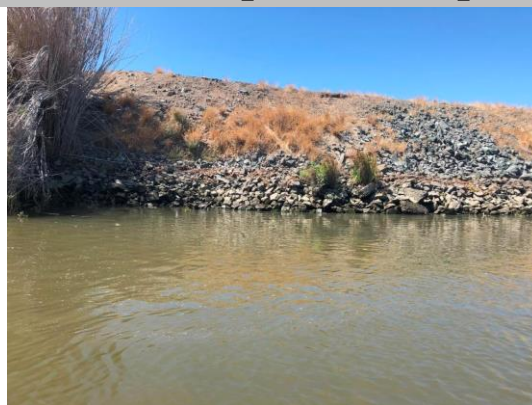
Photo 2 of 3 : SJR2019_RD0524U01RM41.26_2.JPG

Front view of the erosion.

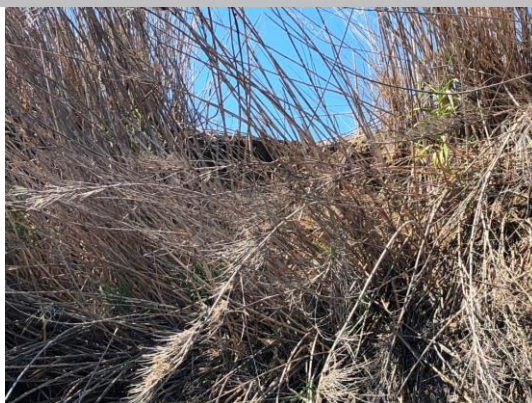
Photo 3 of 3 : SJR2019_RD0524U01RM41.26_5.JPG

LM Start	0.63	Rating **	U	Issue No.	15 (cont)	
LM End	0.63	Issue Type +	Ma	Location *		
Category	Supplemental			GPS Latitude/Longitude		
				Start	End	
Item	DWR Erosion Survey			37.938247 °	37.938247 °	
				-121.336503 °	-121.336503 °	
DWR ID	RD0524U01RM41.26					
Comment Code						
Inspector Comment						
Site ID: RD0524U01RM41.26						
08/13/2019: No significant change observed.						
09/13/2017: The erosion was discovered by levee inspection. The erosion site is immediately downstream of tall vegetation.

Close-up view of the erosion between the high bushes.

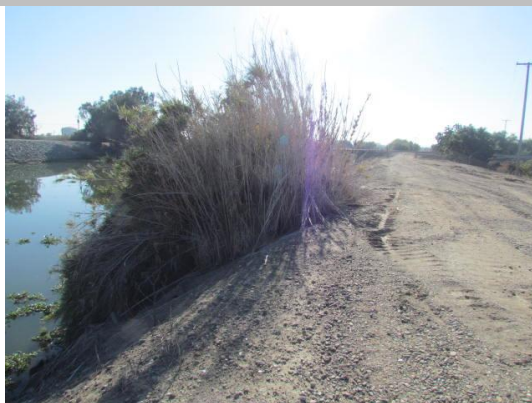
Photo 2 of 2 : FA_2019_RD0524_107_14_20190830_00015.jpg

Looking south at dying bamboo on waterward slope. Fall 2015

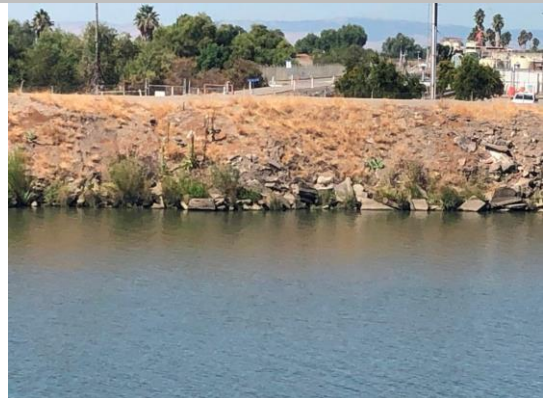
Photo 2 of 2 : SJR2019_RD0524U01RM41.34_2.JPG

LM Start	0.70	Rating **	M	Issue No.	16	
LM End	0.70	Issue Type +	Ma	Location *		
Category	Supplemental			GPS Latitude/Longitude		
				Start	End	
Item	DWR Erosion Survey			37.937577 °	37.937577 °	
				-121.335491 °	-121.335491 °	
DWR ID	RD0524U01RM41.34					
Comment Code						
Inspector Comment						
Site ID: RD0524U01RM41.34						
08/22/2019: No significant change observed.						
09/13/2017: Pocket erosion above the protected levee toe.

Close-up view of the erosion.

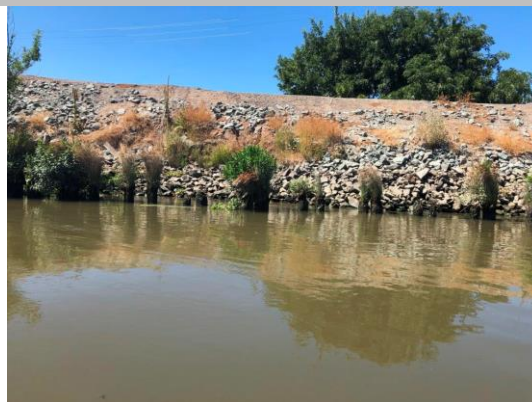
Photo 1 of 3 : SJR2019_RD0524U01RM41.36_1.JPG

LM Start	0.71	Rating **	M	Issue No.	17
LM End	0.73	Issue Type +	Ma	Location *	
Category	Supplemental			GPS Latitude/Longitude	
				Start	End
Item	DWR Erosion Survey			37.937222°	37.937222°
				-121.335277°	-121.335277°
DWR ID	RD0524U01RM41.36				
Comment Code					
Inspector Comment					
<p>Site ID: RD0524U01RM41.36</p> <p>08/13/2019: No significant change observed.</p> <p>09/13/2017: No significant change observed.</p> <p>07/25/2016: No significant change observed.</p> <p>06/24/2015: The erosion site is immediately downstream of the RR bridge.</p>

Front view of the erosion.

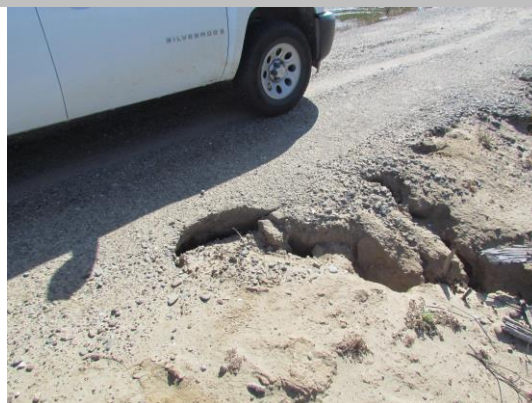
Photo 2 of 2 : FA_2019_RD0524_107_157_20190830_00148.jpg

LM Start	0.72	Rating **	M	Issue No.	157 (cont)	
LM End	0.72	Issue Type +	Ma	Location *	LS	
Category	Earthen Levee			GPS Latitude/Longitude		
				Start		End
Item	Erosion / Bank Caving			37.937290 °	37.937290 °	
				-121.335417 °	-121.335417 °	
DWR ID	DWR_RD0524_01_s_2017_157					
Comment Code						
E2 : Schedule repair of erosion site prior to the next inspection.						
Inspector Comment						
Slope damage caused by rain runoff on landside slope.

Looking west at slope damage caused by rain runoff on landward slope.

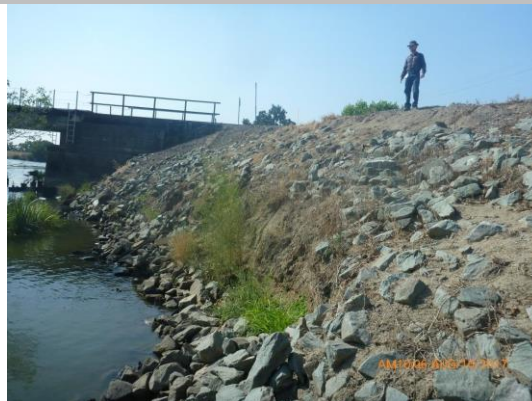
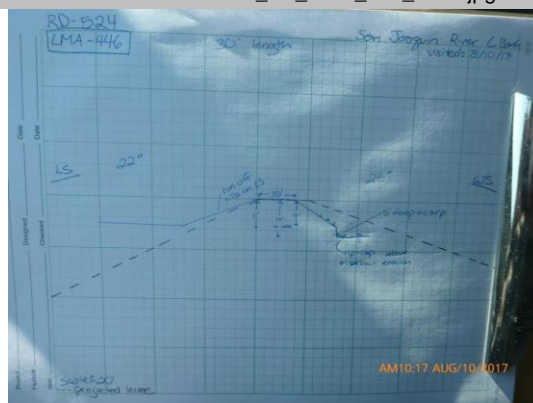
Description: Slope protection repairs are needed along the waterside slope due to erosion and riprap displacement from high water. Based upon levee inspections, it was determined the waterside levee slope is eroding, deteriorating, and degrading. The eroded levee sections need to be restored back to design standards to prevent further deterioration and damage.

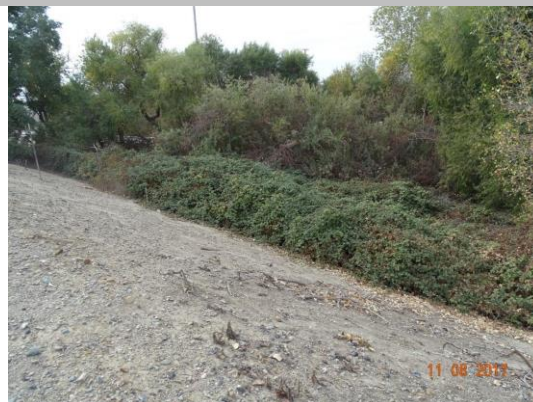
Photo 1 of 3 : FA_2019_RD0524_107_262_20190830_00244.jpg

LM Start	0.75	Rating **	U	Issue No.	262
LM End	0.78	Issue Type +	Ma	Location *	LS
Category	Earthen Levee			GPS Latitude/Longitude	
				Start	End
Item	Vegetation			37.936813 °	37.936539 °
				-121.335019 °	-121.334863 °
DWR ID	DWR_RD0524_01_s_2012_262				
Comment Code					
V2 : Remove the wild growth other than native grasses from the levee slopes.					
Inspector Comment					
Dense vegetation at landside toe along fence line.

Looking northeast at the landside slope.

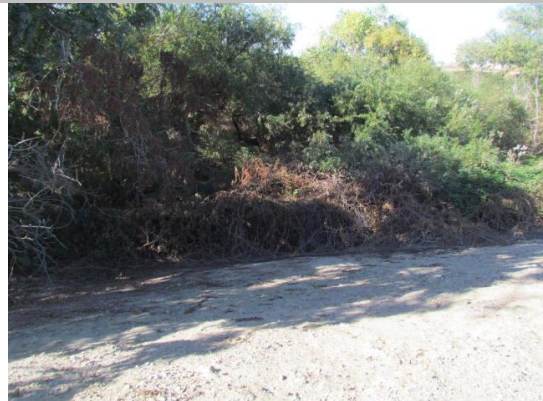
Photo 3 of 3 : FA_2019_RD0524_107_262_20190830_00246.jpg

Looking west at dense vegetation on landside toe. Spring 2014

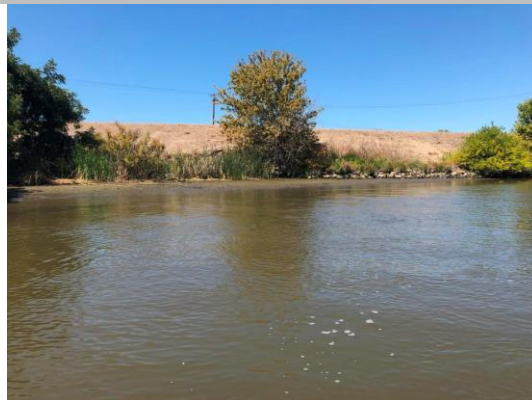
Photo 1 of 3 : SJR2019_RD0524U01RM41.44_1.JPG

Front view of the erosion. The tree and vegetation block the view of the site.

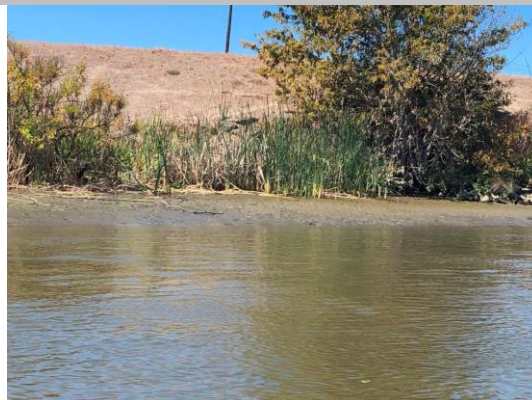
Photo 2 of 3 : SJR2019_RD0524U01RM41.44_2.JPG

Close-up view of the erosion site.

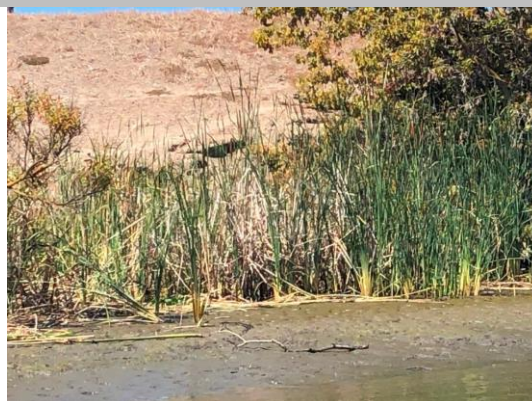
Photo 3 of 3 : SJR2019_RD0524U01RM41.44_3.JPG

Close-up view of the site.

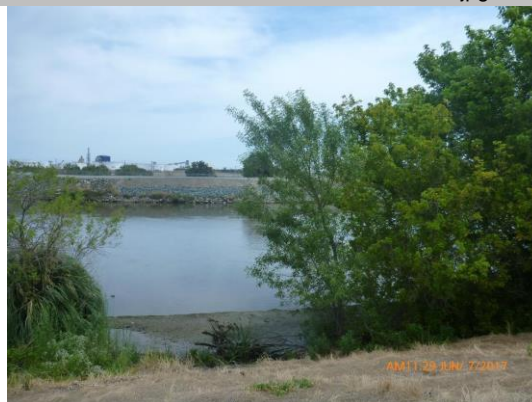
Photo 1 of 3 : LEVAL_FA_2019_87_1285.jpg

LM Start	0.91	Rating **	A/W	Issue No.	187
LM End		Issue Type +	Ma	Location *	
Category	Supplemental			GPS Latitude/Longitude	
				Start	End
Item	2017 Storm Damage			37.935580°	°
				-121.333200°	°
DWR ID	DWR_RD0524_01_s_2012_99				
Comment Code					
Inspector Comment					
Levee Evaluation Comments					
Description:					
Site ID No:87					
Site Designation:DWR_RD0524_01_s_2012_99					
Repair Type: Erosion					
Rating:Area of Concern					
Field Date:6/7/2017					
Notes: no observable defects to levee, vegetation blocks ws toe

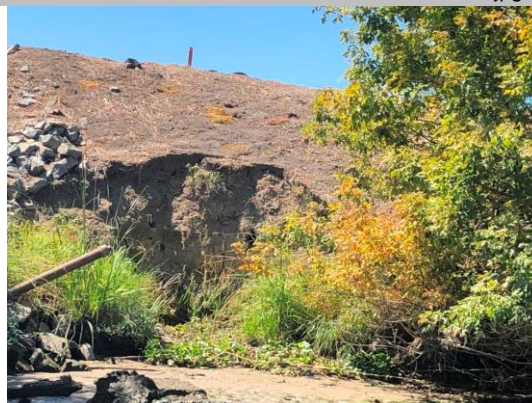
Photo 2 of 3 : SJR2019_RD0524U01RM41.50_1.jpg

Close-up view of the erosion.

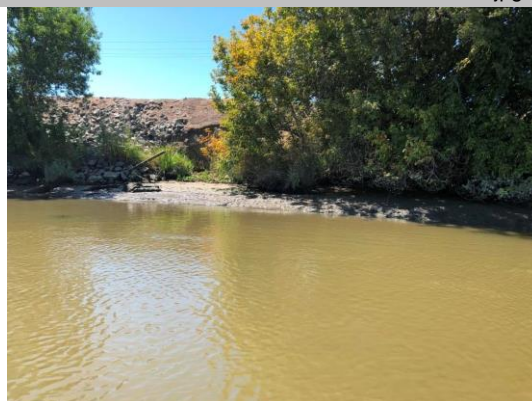
Photo 3 of 3 : SJR2019_RD0524U01RM41.50_3.jpg

Close-up view of the erosion.

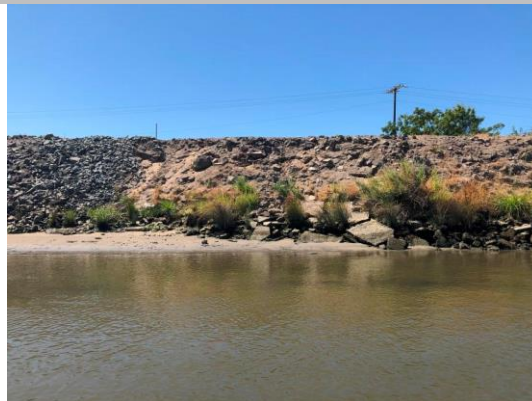
Photo 3 of 3 : SJR2019_RD0524U01RM41.59_2.jpg

Front view of the site.

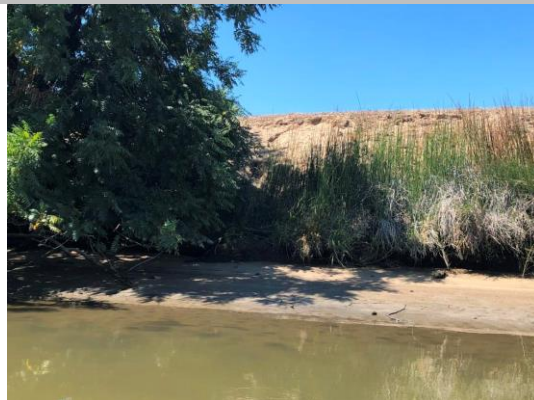
Photo 2 of 3 : SJR2019_RD0524U01RM41.79_2.jpg

Direct view of the site.

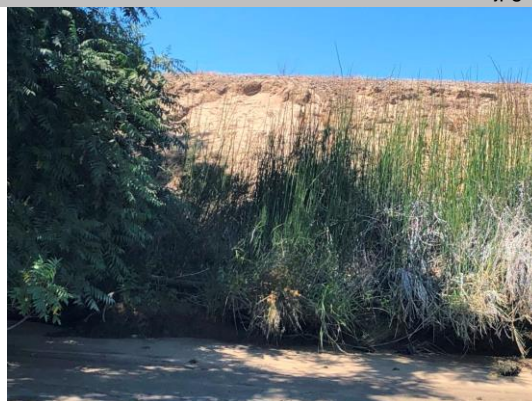
Photo 3 of 3 : SJR2019_RD0524U01RM41.79_4.jpg

Close-up view of the erosion.

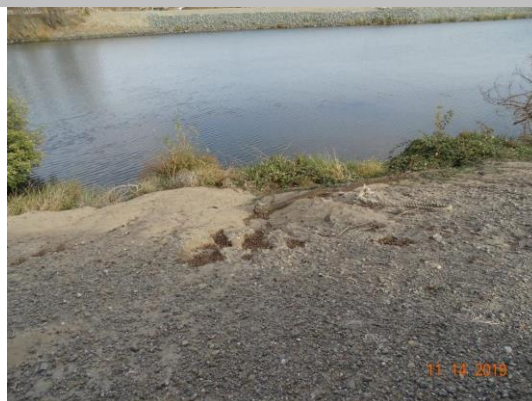
Photo 1 of 1 : FA_2019_RD0524_107_144_20191117_00367.jpg

View of erosion on waterside slope caused by surface runoff. Fall 2019

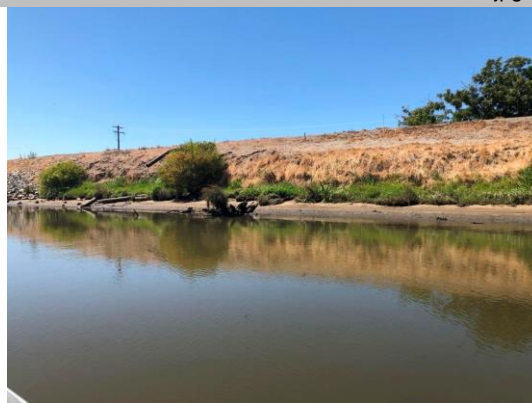
Photo 1 of 3 : SJR2019_RD0524U01RM41.92_2.jpg

Downstream view of the erosion.

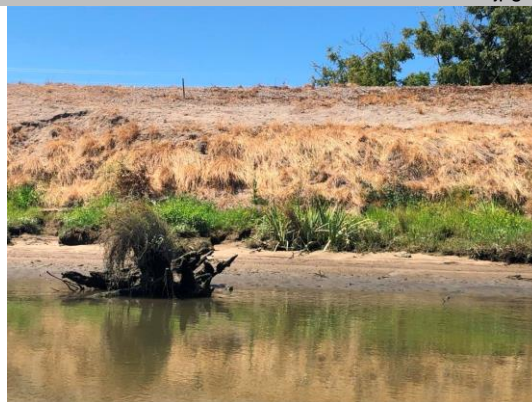
Photo 3 of 3 : SJR2019_RD0524U01RM41.92_5.jpg

Close-up view of the erosion.

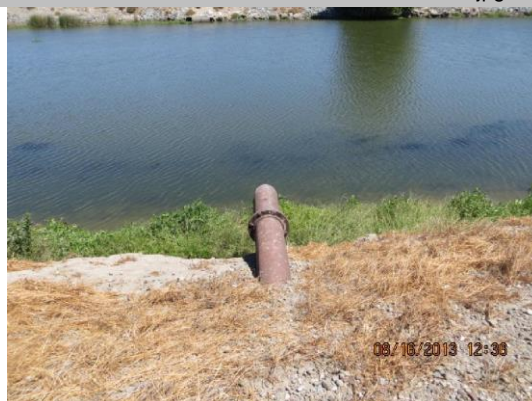
Photo 1 of 3 : UCIP_FA_2019_53162_29862.jpg

Pipe visible and open on WS slope.

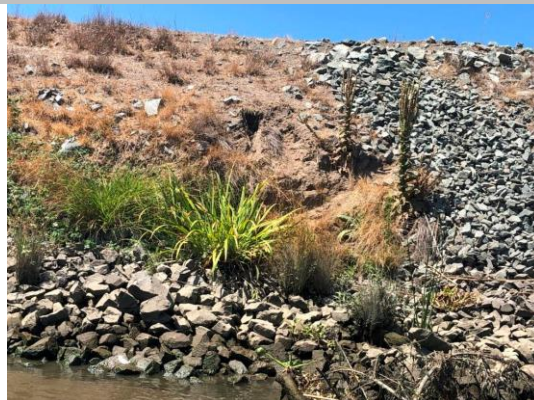
Photo 2 of 2 : SJR2019_RD0524U01RM41.95_5.JPG

Close-up view of the erosion.

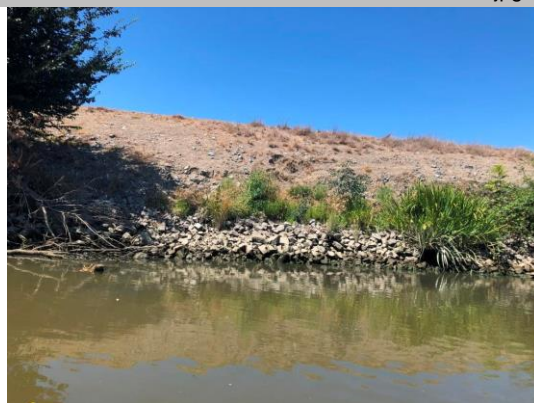
Photo 1 of 3 : SJR2019_RD0524U01RM42.03_1.jpg

Front view of the erosion.

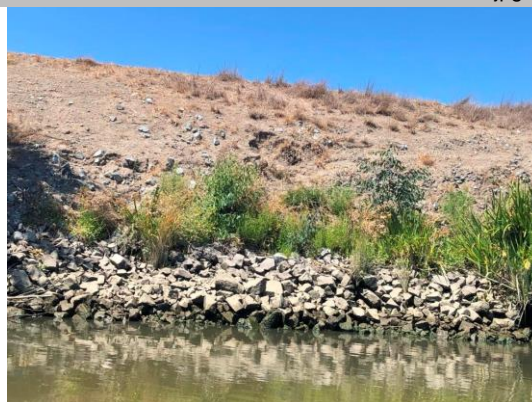
Photo 3 of 3 : SJR2019_RD0524U01RM42.03_2.jpg

Close-up view of the erosion.

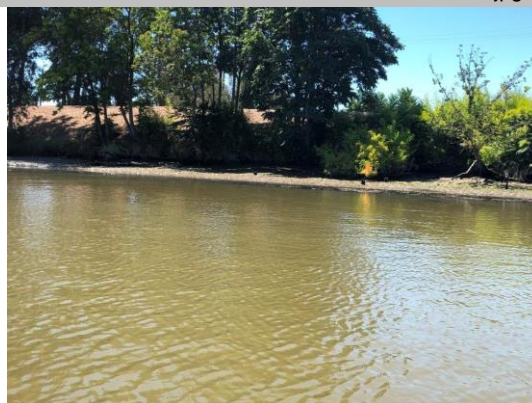
Photo 1 of 3 : SJR2019_RD0524U01RM42.20_2.jpg

Front view of the site where undermining has occurred.

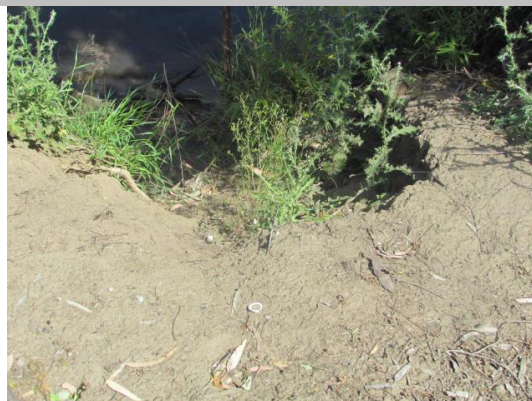
Photo 2 of 3 : FA_2019_RD0524_107_26_20190830_00036.jpg

Looking east at waterward erosion.

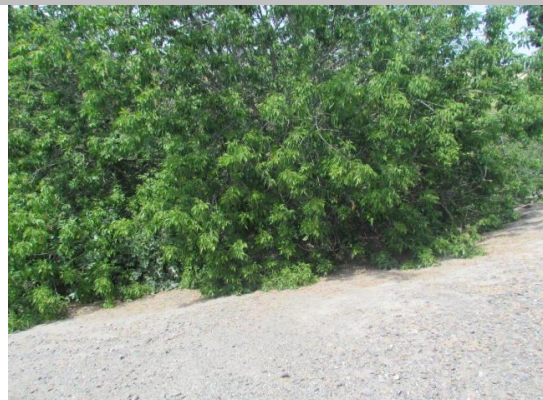
Photo 2 of 2 : FA_2019_RD0524_107_51_20190830_00068.jpg

Looking south at dense trees on landward slope spring 2015

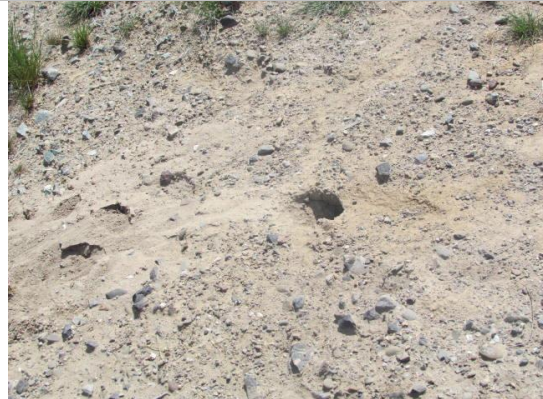
Photo 3 of 3 : FA_2019_RD0524_107_925_20190830_00258.jpg

Looking at typical rodent holes on landward slope along this reach.

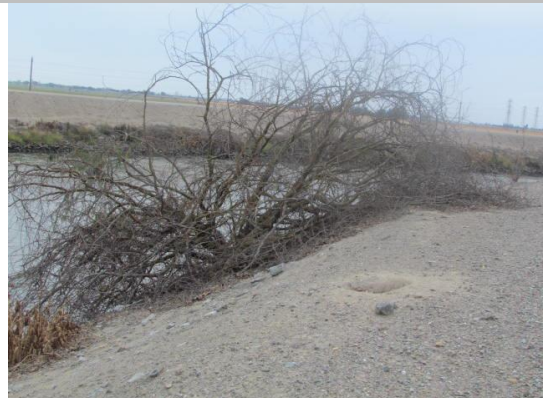
Photo 2 of 2 : FA_2019_RD0524_107_102_20190830_00125.jpg

Looking southeast at dead tree on waterside slope.

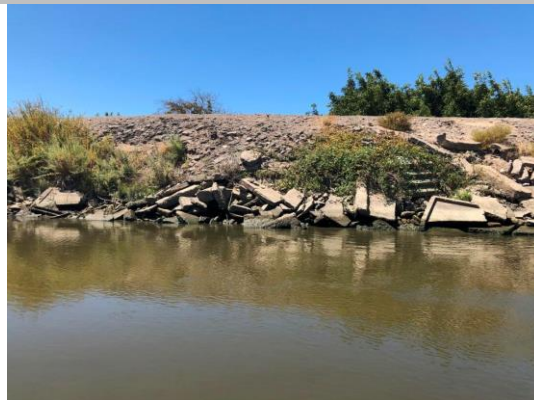
Photo 3 of 3 : SJR2019_RD0524U01RM45.07_2.jpg

Front view of the site. Note the loosely placed concrete blocks at the site.

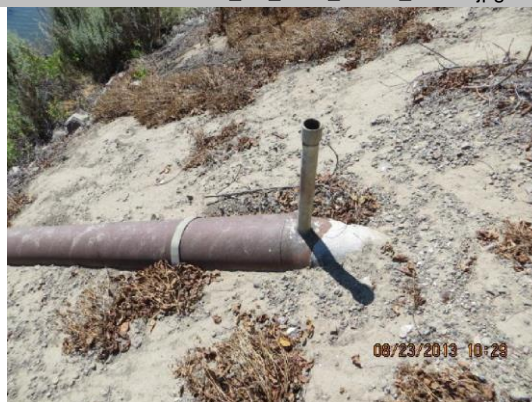
Photo 2 of 3 : UCIP_FA_2019_53358_30688.jpg

Vent on pipe on WS slope. Possible slurry standpipe that has not yet been used.

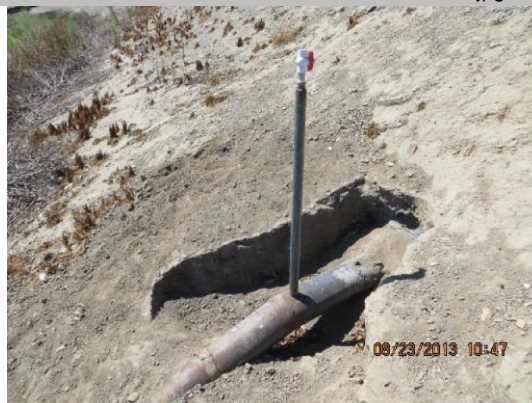
Photo 2 of 3 : UCIP_FA_2019_18348_30705.jpg

8-inch pipe sleeved through 10-inch pipe with vent on WS slope.

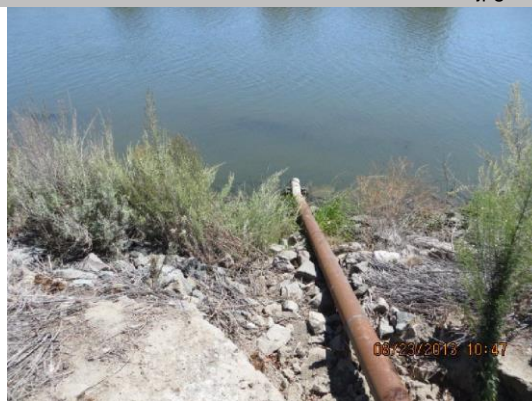
Photo 3 of 3 : UCIP_FA_2019_18348_30704.jpg

No flap gate on end of pipe at WS toe.

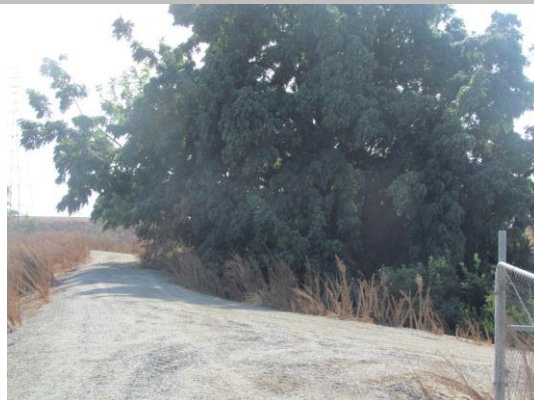
Photo 1 of 1 : FA_2019_RD0524_107_73_20190830_00095.jpg

Looking southwest at large untrimmed tree on landward slope.

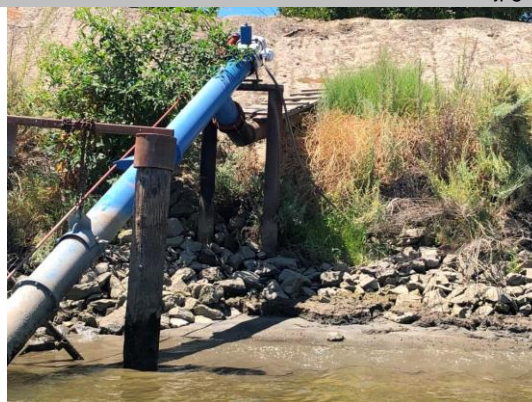
Photo 2 of 2 : SJR2019_RD0524U01RM46.39_3.jpg

Close-up view of the erosion.
