**Flood Control Project Maintenance  
Levee Inspections**

**Maintenance Issue Types Only, Levee Inspection Report By Mile - Fall 2020**

**Reclamation District No. 0524 Middle Roberts Island**

Waterway	Bank	Unit Miles	Inspection Start/End	Inspector
Unit No. 01 San Joaquin River	Left	6.20	09/25/2020 09/25/2020	Alberto De Leon

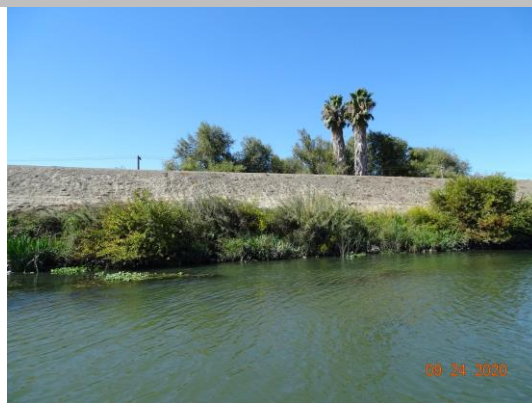
Photo 1 of 2 : SJR2019\_RD0524U01RM40.85\_02.JPG

LM Start	0.18	Rating **	U	Issue No.	5
LM End	0.18	Issue Type +	Ma	Location *	WS
Category	Supplemental			GPS Latitude/Longitude	
				Start	End
Item	DWR Erosion Survey			37.939085 °	37.939085 °
				-121.343917 °	-121.343917 °
DWR ID	RD0524U01RM40.85				
Comment Code					
Inspector Comment					
Site ID: RD0524U01RM40.85					
09/24/2020: From 2014 to present, no significant changes were observed during the annual survey.					
08/13/2013: The erosion was discovered during 2013 spring levee inspection. Inspector comment: Erosion is located along the lower level of water-ward slope.

9/24/2020: Front view of the erosion.

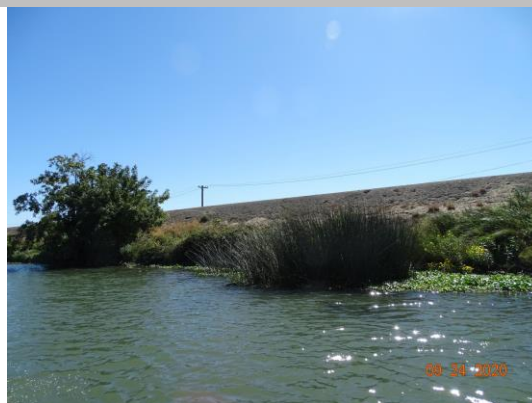
Photo 1 of 2 : SJR2019\_RD0524U01RM40.93\_02.JPG

LM Start	0.34	Rating **	M	Issue No.	24
LM End	0.34	Issue Type +	Ma	Location *	WS
Category	Supplemental			GPS Latitude/Longitude	
				Start	End
Item	DWR Erosion Survey			37.938461 °	37.938461 °
				-121.341526 °	-121.341526 °
DWR ID	RD0524U01RM40.93				
Comment Code					
Inspector Comment					
Site ID: RD0524U01RM40.93					
09/24/2020: From 2018 to present, no significant changes were observed during the annual survey.					
09/13/2017: There are two pocket erosions at the site; both erosions are around 10 ft long and 6 ft high.

9/24/2020: View of the erosion looking upstream.

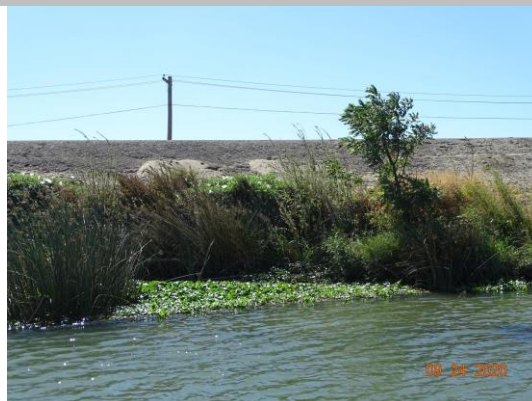
Photo 2 of 2 : SJR2019\_RD0524U01RM40.93\_03.JPG

9/24/2020: Front view of the one of the erosion pockets.

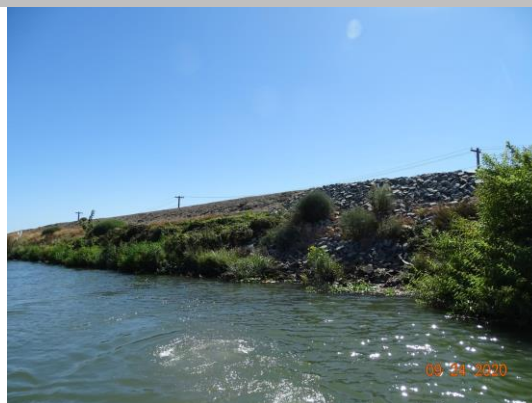
Photo 1 of 2 : SJR2019\_RD0524U01RM40.99\_01.JPG

LM Start	0.40	Rating **	U	Issue No.	16
LM End	0.40	Issue Type +	Ma	Location *	WS
Category	Supplemental			GPS Latitude/Longitude	
				Start	End
Item	DWR Erosion Survey			37.938608 °	37.938608 °
				-121.340498 °	-121.340498 °
DWR ID	RD0524U01RM40.99				
Comment Code					
Inspector Comment					
Site ID: RD0524U01RM40.99					
09/24/2020: From 2013 to present, no significant changes were observed during the annual survey. A small erosion repair site is located immediately downstream.					
08/07/2012: The erosion is at the upper levee slope, and likely caused by slope slip. The lower levee slope is covered with dense vegetation.

9/24/2020: Overview of the erosion which is just upstream of a small erosion repair.

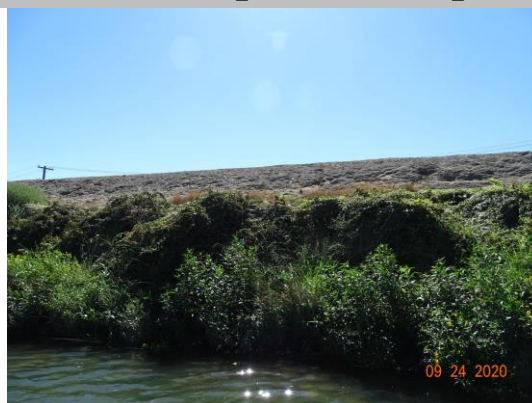
Photo 2 of 2 : SJR2019\_RD0524U01RM40.99\_03.JPG

9/24/2020: Close-up view of the erosion on the upper levee slope.

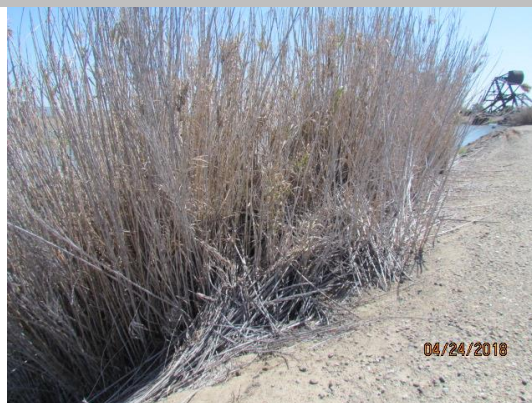
Photo 1 of 1 : FA\_2020\_RD0524\_107\_11\_20200901\_00005.jpg

Looking at bamboo on waterward slope. (Spring 2018)

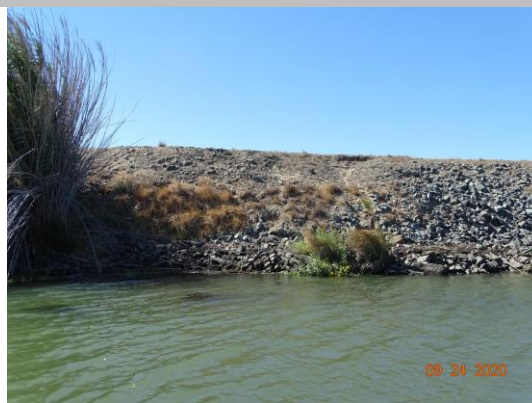
Photo 1 of 2 : SJR2019\_RD0524U01RM41.26\_01.JPG

LM Start	0.63	Rating **	M	Issue No.	25
LM End	0.63	Issue Type +	Ma	Location *	WS
Category	Supplemental			GPS Latitude/Longitude	
				Start	End
Item	DWR Erosion Survey			37.938247 °	37.938247 °
				-121.336503 °	-121.336503 °
DWR ID	RD0524U01RM41.26				
Comment Code					
Inspector Comment					
Site ID: RD0524U01RM41.26					
09/24/2020: From 2018 to present, no significant changes were observed during the annual survey.					
09/13/2017: The erosion was discovered by levee inspection. The erosion site is immediately downstream of tall vegetation.

9/24/2020: Front view of the erosion.

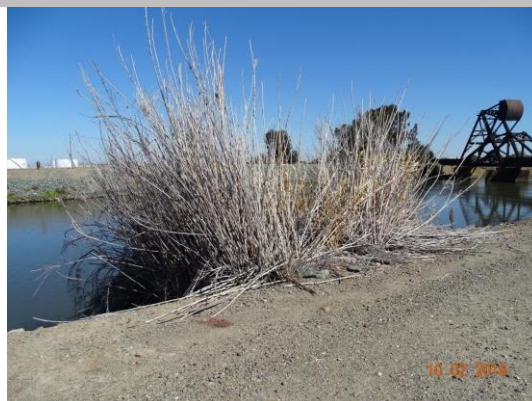
Photo 1 of 1 : FA\_2020\_RD0524\_107\_14\_20200901\_00006.jpg

View of bamboo on waterside slope. Fall 2019

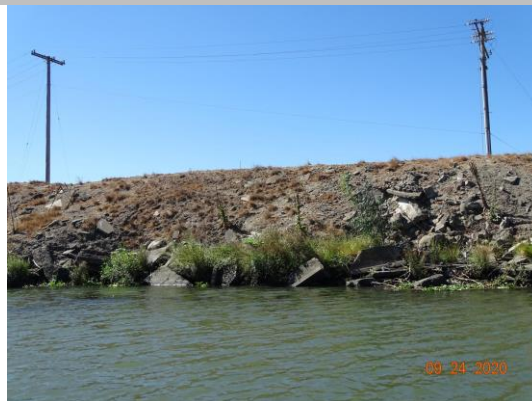
Photo 1 of 2 : SJR2019\_RD0524U01RM41.34\_03.JPG

LM Start	0.70	Rating **	M	Issue No.	26
LM End	0.70	Issue Type +	Ma	Location *	WS
Category	Supplemental			GPS Latitude/Longitude	
				Start	End
Item	DWR Erosion Survey			37.937577 °	37.937577 °
				-121.335491 °	-121.335491 °
DWR ID	RD0524U01RM41.34				
Comment Code					
Inspector Comment					
Site ID: RD0524U01RM41.34					
09/24/2020: From 2018 to present, no significant changes were observed during the annual survey.					
09/13/2017: Pocket erosion above the protected levee toe.

9/24/2020: Front view of the erosion.

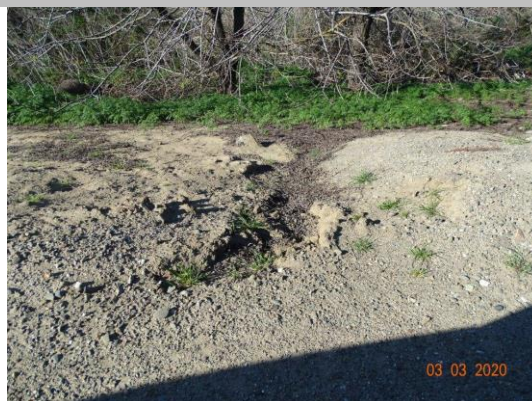
Photo 1 of 1 : FA\_2020\_RD0524\_107\_157\_20200901\_00064.jpg

LM Start	0.72	Rating **	M	Issue No.	157
LM End	0.72	Issue Type +	Ma	Location *	LS
Category	Earthen Levee			GPS Latitude/Longitude	
				Start	End
Item	Erosion / Bank Caving			37.937290 °	37.937290 °
				-121.335417 °	-121.335417 °
DWR ID	DWR_RD0524_01_s_2017_157				
Comment Code					
E2 : Schedule repair of erosion site prior to the next inspection.					
Inspector Comment					
Rills on landside slope appear to be caused by surface runoff.

View of erosion caused by surface runoff on landside slope. Spring 2020

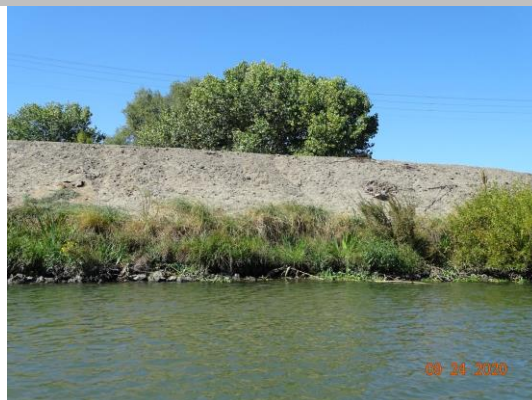
Photo 2 of 2 : SJR2019\_RD0524U01RM41.39\_02.JPG

LM Start	0.76	Rating **	U	Issue No.	4
LM End	0.77	Issue Type +	Ma	Location *	WS
Category	Supplemental			GPS Latitude/Longitude	
				Start	End
Item	DWR Erosion Survey			37.936749 °	37.936749 °
				-121.334971 °	-121.334971 °
DWR ID	RD0524U01RM41.39				
Comment Code					
Inspector Comment					
Site ID: RD0524U01RM41.39					
09/24/2020: From 2013 to present, no significant changes were observed during the annual survey.					
08/07/2012: The site has been visited by boat survey. No significant change observed.					
08/23/2011: The site is located immediately upstream of a Railroad bridge. Dense vegetation at the water line blocks the view of erosion.

9/24/2020: Close-up view of the erosion.

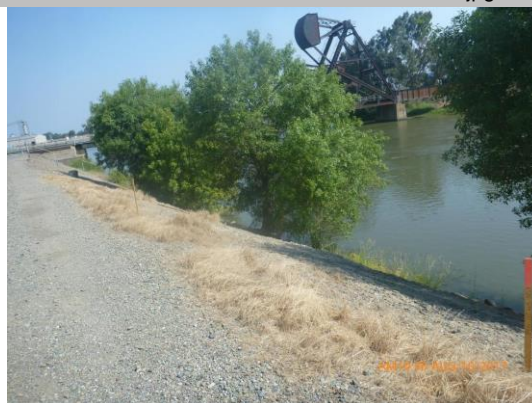
Photo 1 of 1 : LEVAL\_FA\_2020\_538\_4097.jpg

LM Start	0.79	Rating **	M	Issue No.	155
LM End	0.80	Issue Type +	Ma	Location *	WS
Category	Earthen Levee			GPS Latitude/Longitude	
				Start	End
Item	Erosion / Bank Caving			37.936300 °	37.936200 °
				-121.334700 °	-121.334600 °
DWR ID	LMA-444				
Comment Code					
E2 : Schedule repair of erosion site prior to the next inspection.					
Inspector Comment					
This was a 2017 Storm Damage Site. Slope protection repairs are needed along the waterside slope due to erosion and riprap displacement from high water. Based upon levee inspections, it was determined the waterside levee slope is eroding, deteriorating, and degrading. The eroded levee sections need to be restored back to design standards to prevent further deterioration and damage. Site ID No:538 Site Designation:LMA-444

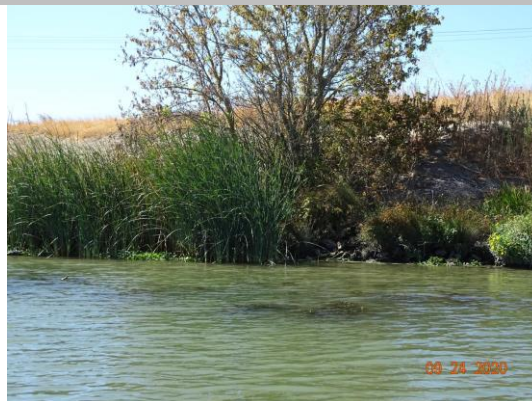
Photo 1 of 2 : SJR2019\_RD0524U01RM41.44\_02.JPG

LM Start	0.83	Rating **	U	Issue No.	10
LM End	0.84	Issue Type +	Ma	Location *	WS
Category	Supplemental			GPS Latitude/Longitude	
				Start	End
Item	DWR Erosion Survey			37.935838 °	37.935838 °
				-121.334408 °	-121.334408 °
DWR ID	RD0524U01RM41.44				
Comment Code					
Inspector Comment					
Site ID: RD0524U01RM41.44 09/24/2020: From 2014 to present, no significant changes were observed during the annual survey. The vegetation is tall and limiting the view of the erosion. 08/13/2013: Site was discovered during boat survey. The dense vegetation blocks a clear view of the erosion. Size of erosion site was very roughly estimated.

9/24/2020: Tall vegetation is blocking the view of the erosion.

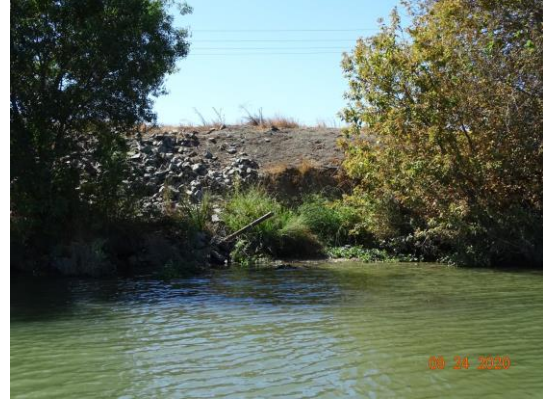
Photo 1 of 2 : SJR2019\_RD0524U01RM41.5\_01.JPG

LM Start	0.91	Rating **	U	Issue No.	3
LM End	0.91	Issue Type +	Ma	Location *	WS
Category	Supplemental			GPS Latitude/Longitude	
				Start	End
Item	DWR Erosion Survey			37.935297 °	37.935297 °
				-121.333182 °	-121.333182 °
DWR ID	RD0524U01RM41.5				
Comment Code					
Inspector Comment					
Site ID: RD0524U01RM41.5 09/24/2020: From 2013 to present, no significant changes were observed during the annual survey. Signs of animal activities were noticed. 08/07/2012: The site has been visited by boat survey. No significant change observed 08/23/2011: The erosion site is immediately downstream of the riprap protection.

9/24/2020: Front view of the erosion.

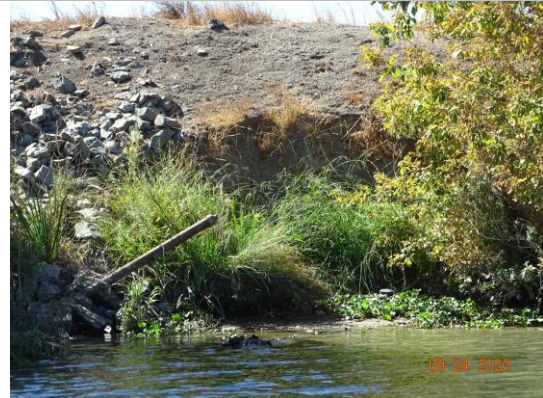
Photo 2 of 2 : SJR2019\_RD0524U01RM41.5\_02.JPG

9/24/2020: Close-up view of the erosion.

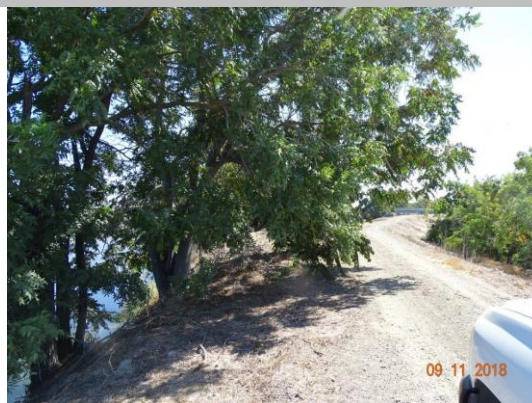
Photo 1 of 1 : FA\_2020\_RD0524\_107\_20\_20200901\_00013.jpg

Looking southeast at untrimmed tree on waterward slope.(Fall 2018)

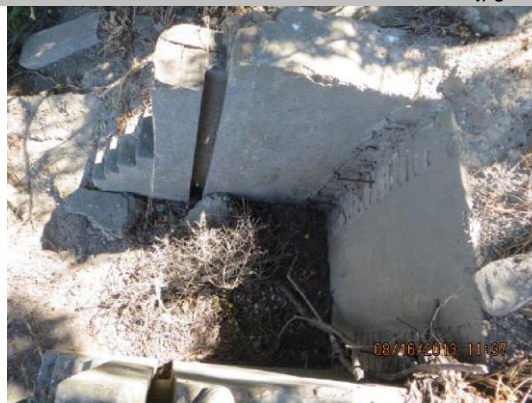
Photo 2 of 3 : UCIP\_FA\_2020\_61920\_29735.jpg

DS\_ID:20598  
FS\_ID:61920  
EP\_NO: N/A  
Repair Type: Non-Urgent  
EVAL Issue: Unauthorized Encroachment, installed decades prior  
Crossing Status: Found  
UCIP Comments: 06/23/2020 Record updated from No Action Needed to Non-Urgent. Unauthorized encroachment recorded in Levee Log prior to 2011. No permit has been identified authorizing pipe. Crossing appears abandoned. (D.Sanoski - DWR UCIP)

Slide gate removed from headwall on WS slope.

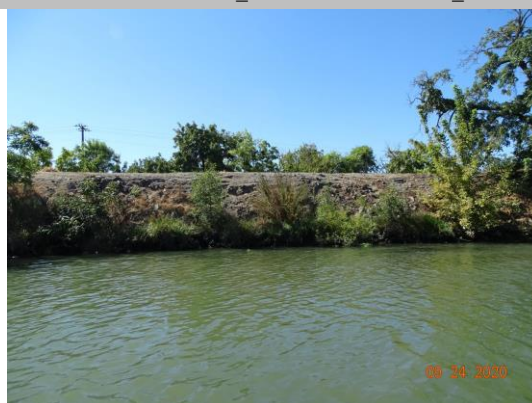
Photo 1 of 2 : SJR2019\_RD0524U01RM41.58\_03.JPG

LM Start	1.00	Rating **	U	Issue No.	15
LM End	1.01	Issue Type +	Ma	Location *	WS
Category	Supplemental			GPS Latitude/Longitude	
				Start	End
Item	DWR Erosion Survey			37.935106 °	37.935106 °
				-121.331554 °	-121.331554 °
DWR ID	RD0524U01RM41.58				
Comment Code					
Inspector Comment					
Site ID: RD0524U01RM41.58					
09/24/2020: From 2013 to present, no significant changes were observed during the annual survey.					
08/07/2012: The erosion was discovered during the boat survey.

9/24/2020: Front view of the erosion.

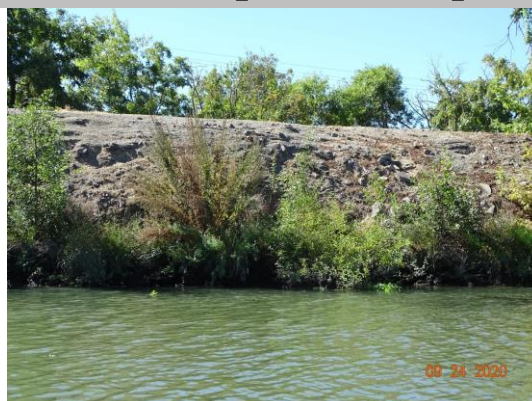
Photo 2 of 2 : SJR2019\_RD0524U01RM41.58\_02.JPG

9/24/2020: Close-up view of the erosion.

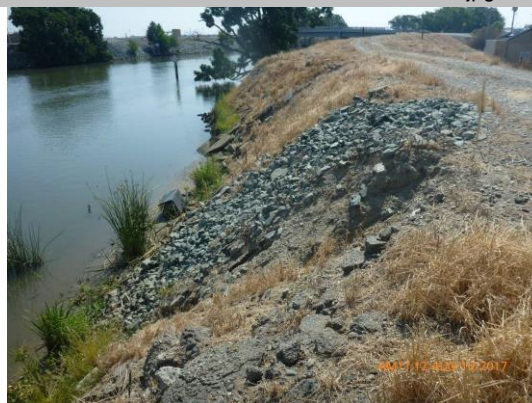
Photo 1 of 1 : LEVAL\_FA\_2020\_536\_4109.jpg

LM Start	1.00	Rating **	M	Issue No.	198
LM End	1.01	Issue Type +	Ma	Location *	WS
Category	Earthen Levee			GPS Latitude/Longitude	
				Start	End
Item	Erosion / Bank Caving			37.935100 °	37.935100 °
				-121.331500 °	-121.331300 °
DWR ID	LMA-442				
Comment Code					
E2 : Schedule repair of erosion site prior to the next inspection.					
Inspector Comment					
This was a 2017 Storm Damage Site. Slope protection repairs are needed along the waterside slope due to erosion and riprap displacement from high water. Based upon levee inspections, it was determined the waterside levee slope is eroding, deteriorating, and degrading. The eroded levee sections need to be restored back to design standards to prevent further deterioration and damage. Site ID No:536 Site Designation:LMA-442 There appears to be previous repair site adjacent to LMA-442. Large fox den on landside.

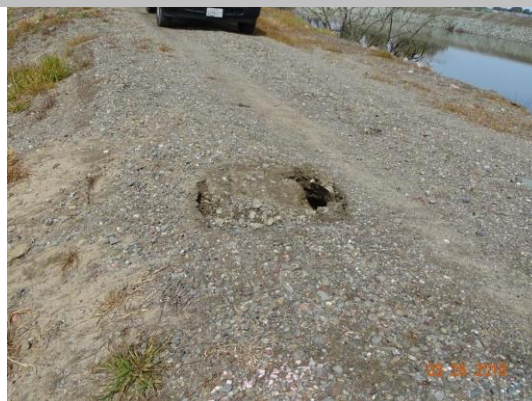
Photo 1 of 1 : FA\_2020\_RD0524\_107\_238\_20200901\_00106.jpg

Large rodent hole landside shoulder looking downstream. Spring 2019.

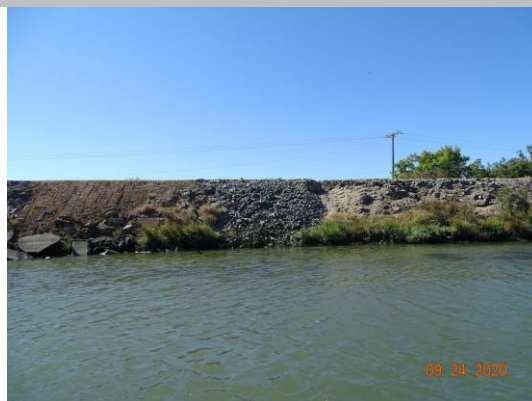
Photo 1 of 2 : SJR2019\_RD0524U01RM41.59\_04.JPG

LM Start	1.02	Rating **	U	Issue No.	2
LM End	1.02	Issue Type +	Ma	Location *	WS
Category	Supplemental			GPS Latitude/Longitude	
				Start	End
Item	DWR Erosion Survey			37.935078 °	37.935078 °
				-121.331134 °	-121.331134 °
DWR ID	RD0524U01RM41.59				
Comment Code					
Inspector Comment					
Site ID: RD0524U01RM41.59					
09/24/2020: From 2013 to present, no significant changes were observed during the annual survey. The erosion is occurring immediately downstream of a repaired site.					
08/07/2012: The site has been visited by boat survey. Site has been repaired, but new erosion occurred at the levee slope and immediately upstream of the repaired site.					
08/23/2011: The site is about 500 ft downstream of bridge. The levee toe seems to be protected, but the protection is being washed away.

9/24/2020: The erosion is occurring immediately downstream of a repaired site.

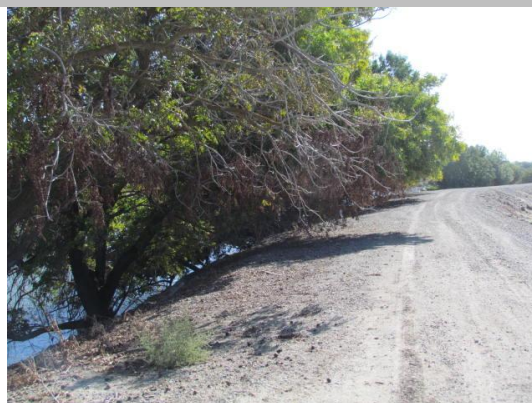
Photo 1 of 1 : FA\_2020\_RD0524\_107\_19\_20200901\_00012.jpg

Looking southeast at low hanging tree branches at waterside toe.

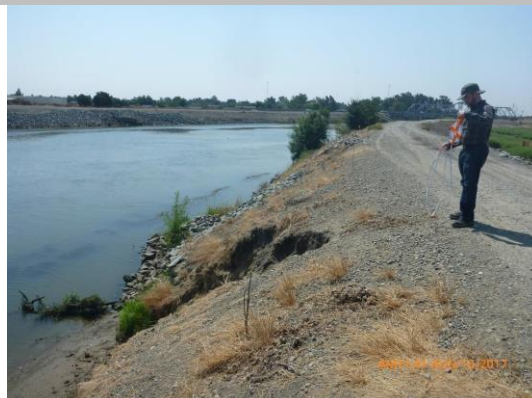
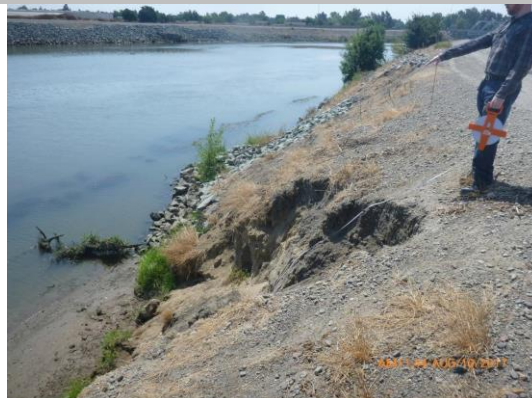
Planned For Repair.  
Levee Evaluation Comments  
Description: Slope protection repairs are needed along the waterside slope due to erosion and riprap displacement from high water. Based upon levee inspections, it was determined the waterside levee slope is eroding, deteriorating, and degrading. The eroded levee sections need to be restored back to design standards to prevent further deterioration and damage.  
Site ID No: 534  
Site Designation: LMA-440  
Repair Type: Erosion  
Rating: Serious  
Field Date: 8/10/2017  
Notes: site is related to, but not combined with, LMA-439 a portion of this site has been repaired.

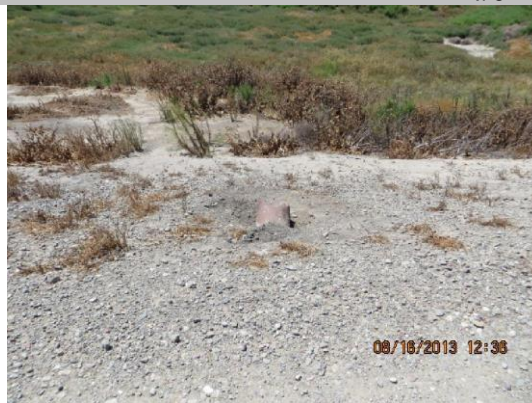
Photo 2 of 3 : UCIP\_FA\_2020\_61927\_29861.jpg

Pipe open and visible on LS slope.

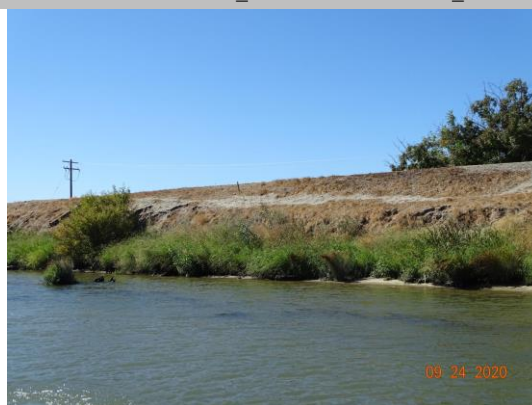
Photo 1 of 3 : SJR2019\_RD0524U01RM41.92\_04.JPG

9/24/2020: Overview of the erosion.

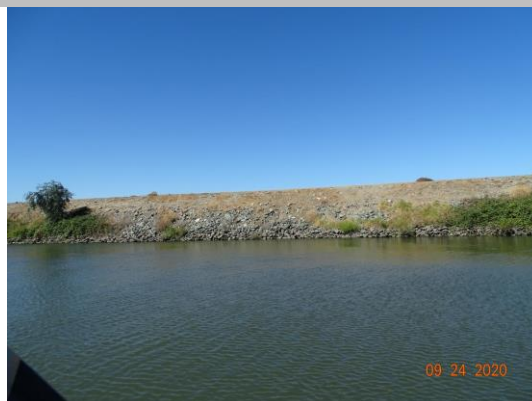
Photo 1 of 2 : SJR2019\_RD0524U01RM42.09\_03.JPG

9/24/2020: Overview of the erosion.

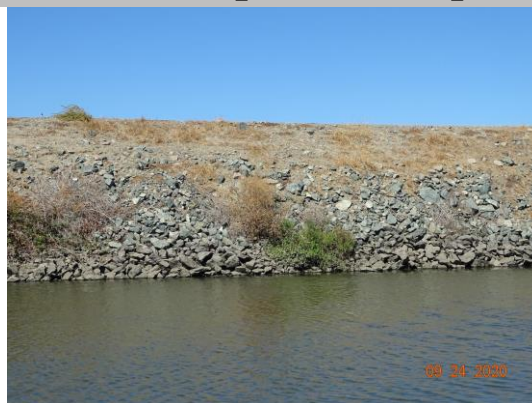
Photo 2 of 2 : SJR2019\_RD0524U01RM42.09\_02.JPG

9/24/2020: Close-up view of the erosion.

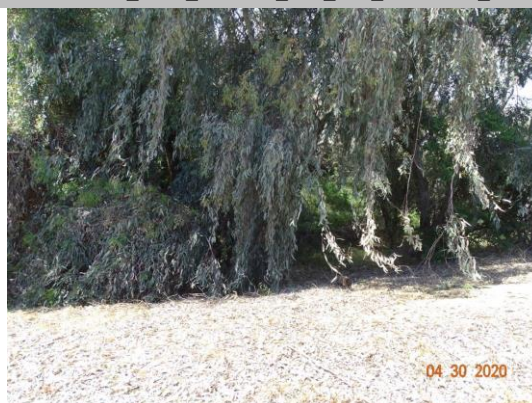
Photo 1 of 1 : FA\_2020\_RD0524\_107\_916\_20200901\_00118.jpg

View of tree that need to be trimmed and thinned on landside slope.  
Spring 2020

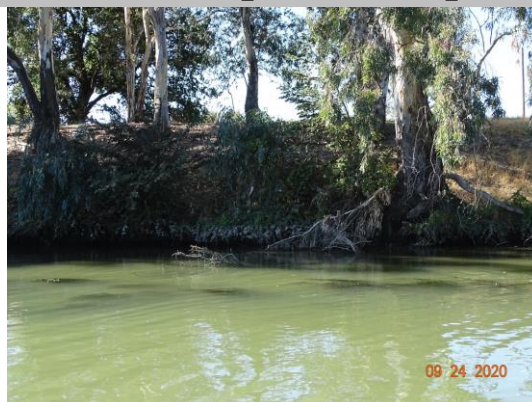
Photo 2 of 3 : SJR2019\_RD0524U01RM42.2\_05.JPG

9/24/2020: Visible undermining of the levee toe.

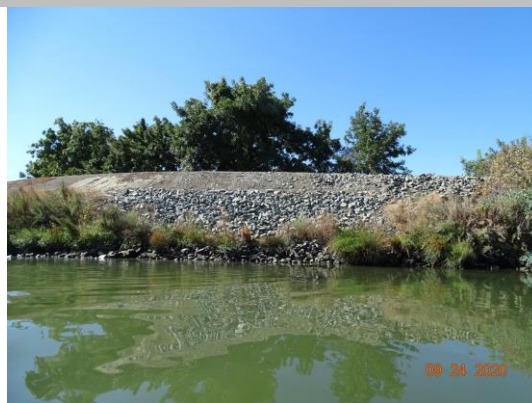
Photo 1 of 1 : SJR2019\_RD0524U01RM42.9\_02.JPG

9/24/2020: View of the repaired erosion site.

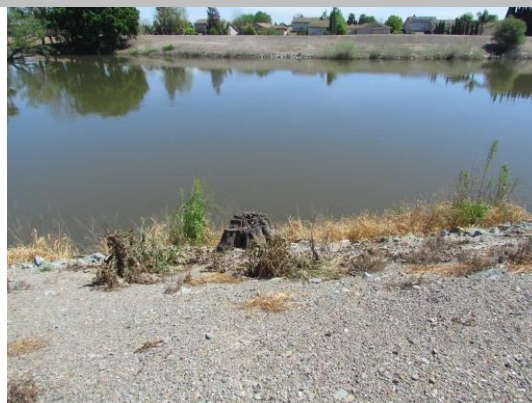
Photo 1 of 1 : FA\_2020\_RD0524\_107\_161\_20200901\_00065.jpg

Looking east at large tree stump on waterward shoulder.

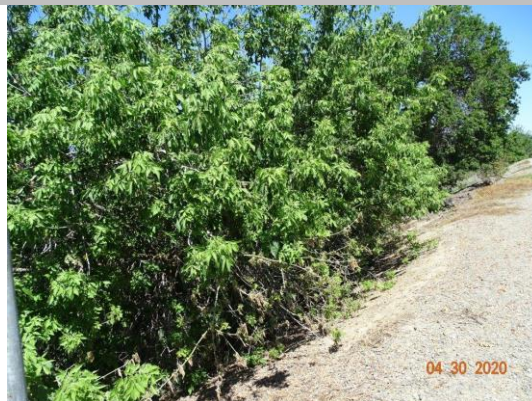
Photo 1 of 1 : FA\_2020\_RD0524\_107\_51\_20200901\_00025.jpg

View of trees that need to be trimmed and thinned on landside slope. Spring 2020

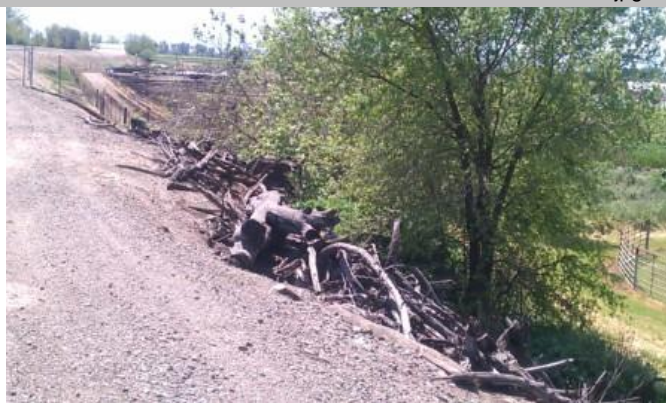
Photo 1 of 1 : FA\_2020\_RD0524\_107\_50\_20200901\_00024.jpg

Looking southwest at prunings on landside slope.

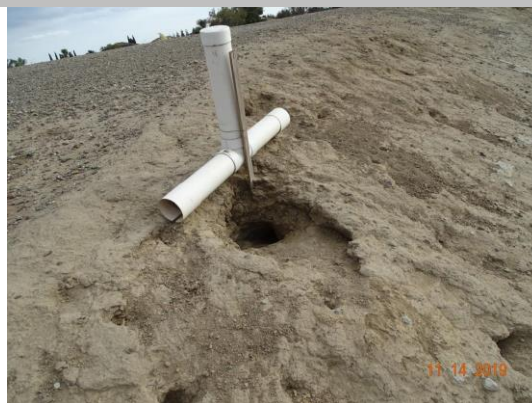
Photo 1 of 1 : FA\_2020\_RD0524\_107\_924\_20200901\_00119.jpg

View of large rodent holes on landside slope. Fall 2019

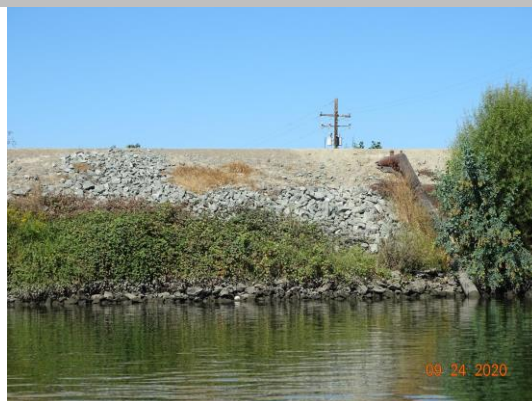
Photo 1 of 1 : SJR2019\_RD0524U01RM43.52\_02.JPG

9/24/2020: View of the repaired erosion site.

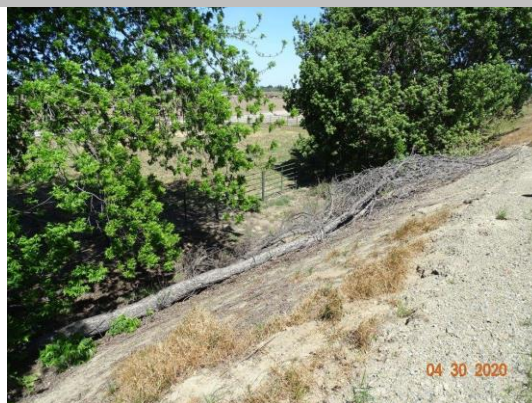
Photo 1 of 1 : FA\_2020\_RD0524\_107\_217\_20200901\_00090.jpg

View of downed tree on landside slope. Spring 2020

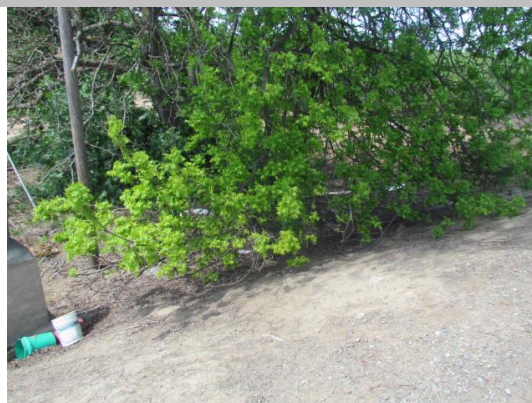
Photo 1 of 1 : FA\_2020\_RD0524\_107\_61\_20200901\_00030.jpg

Looking east at untrimmed tree at landward toe.

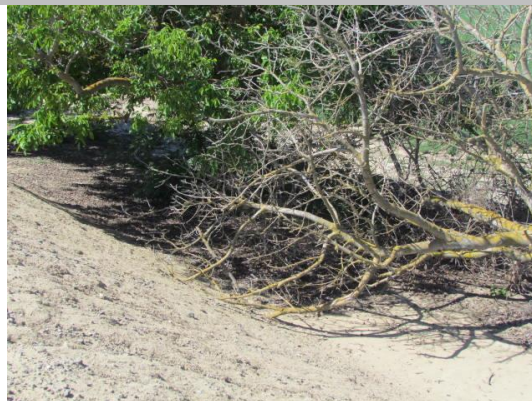
Photo 1 of 1 : FA\_2020\_RD0524\_107\_111\_20200901\_00052.jpg

Looking west at dead tree at landside toe.

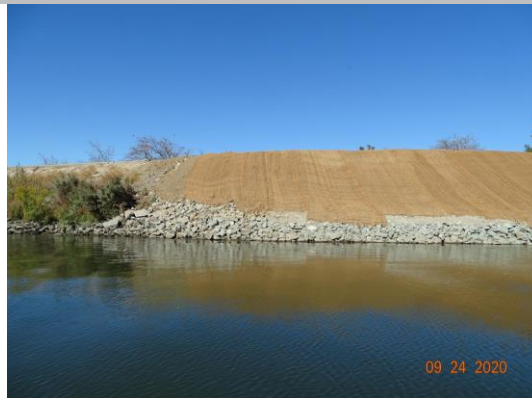
Photo 1 of 3 : SJR2019\_RD0524U01RM45.07\_01.JPG

9/24/2020: Upstream end of the erosion repair.

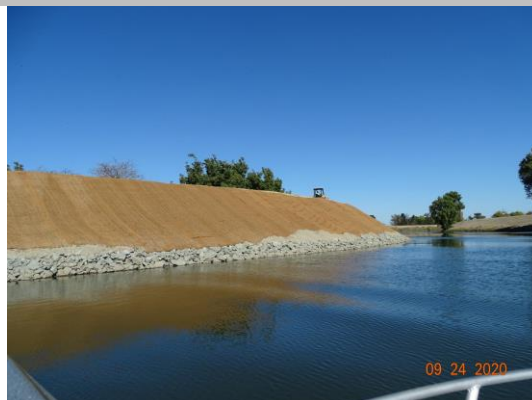
Photo 2 of 3 : SJR2019\_RD0524U01RM45.07\_02.JPG

9/24/2020: View of the ongoing erosion repair with fill, fabric, and riprap visible.

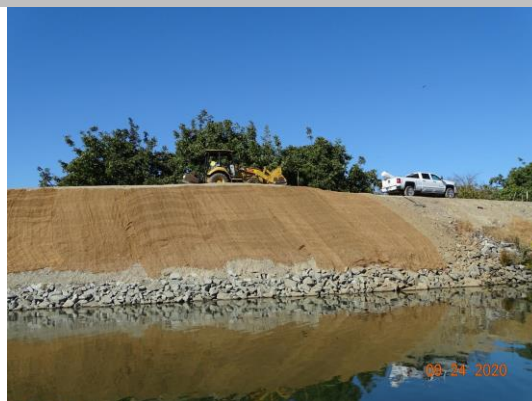
Photo 3 of 3 : SJR2019\_RD0524U01RM45.07\_04.JPG

9/24/2020: Downstream end of the erosion repair.

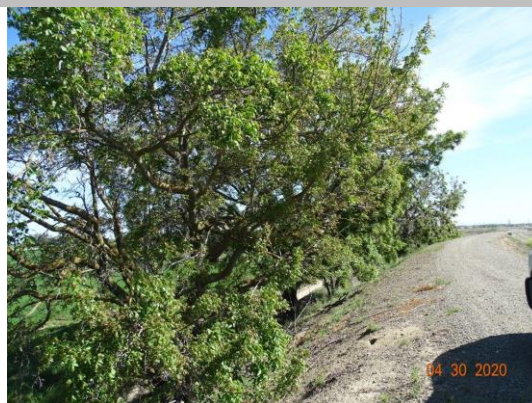
Photo 1 of 1 : FA\_2020\_RD0524\_107\_84\_20200901\_00040.jpg

View of trees that need to be trimmed on landside slope. Spring 2020

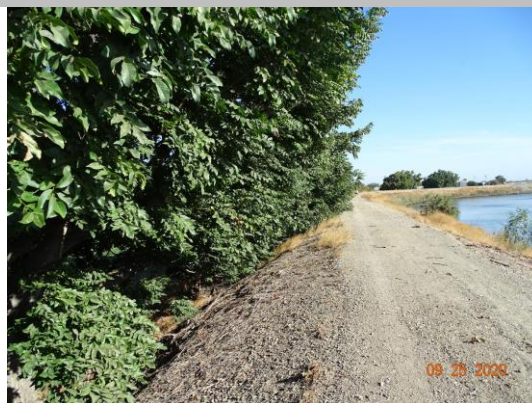
Photo 1 of 1 : FA\_2020\_RD0524\_107\_188\_20201005\_00221.jpg

View of large untrimmed walnut trees on landside slope. Fall 2020

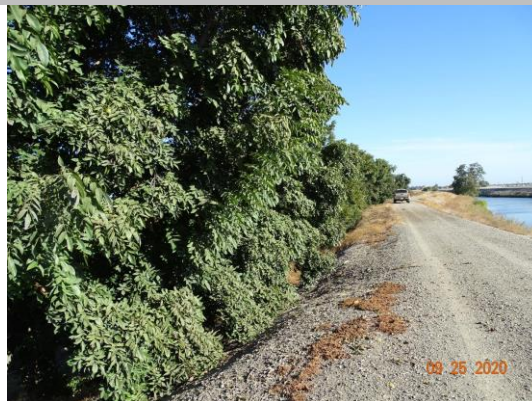
Photo 1 of 1 : FA\_2020\_RD0524\_107\_91\_20201005\_00220.jpg

View of large untrimmed walnut trees on landside slope. Fall 2020

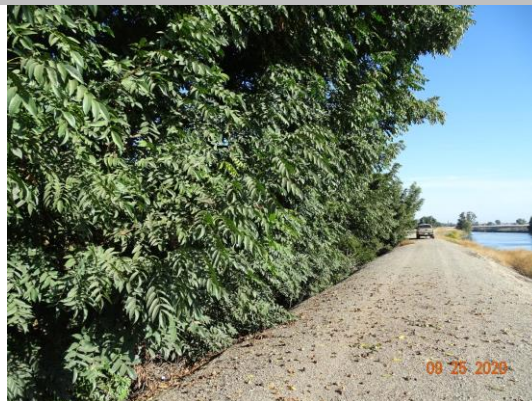
Photo 1 of 1 : FA\_2020\_RD0524\_107\_932\_20201005\_00219.jpg

View of large untrimmed walnut trees on landside slope. Fall 2020

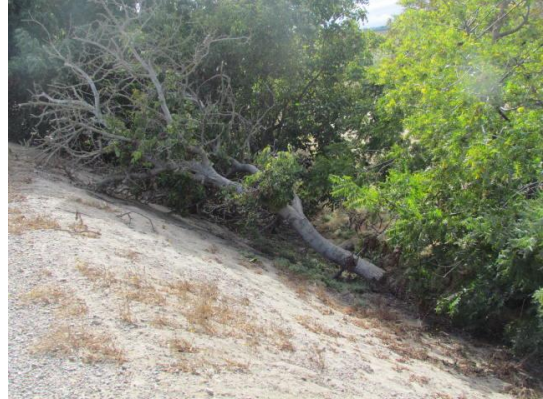
Photo 1 of 1 : FA\_2020\_RD0524\_107\_178\_20200901\_00069.jpg

Looking south at downed tree on landward slope.

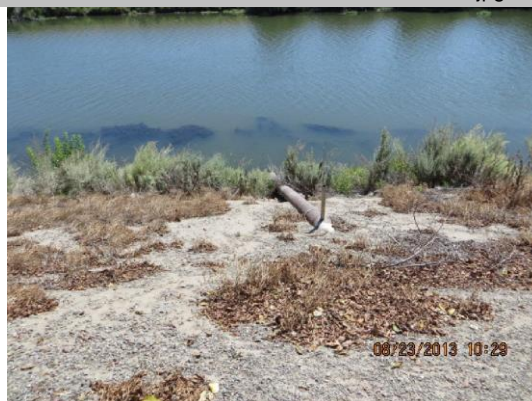
Photo 1 of 3 : UCIP\_FA\_2020\_62007\_30689.jpg

Pipe visible on WS slope.

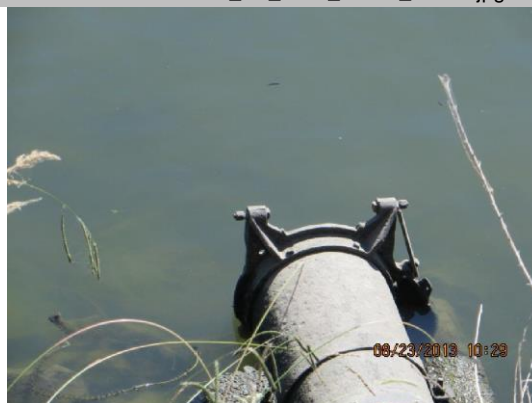
Photo 3 of 3 : UCIP\_FA\_2020\_62007\_30687.jpg

Broken flap gate at WS toe.

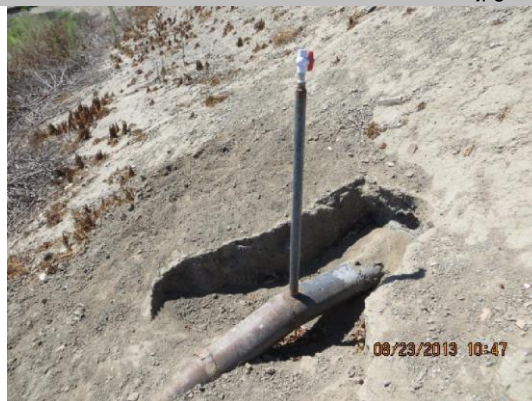
Photo 2 of 3 : UCIP\_FA\_2020\_62014\_30705.jpg

8-inch pipe sleeved through 10-inch pipe with vent on WS slope.

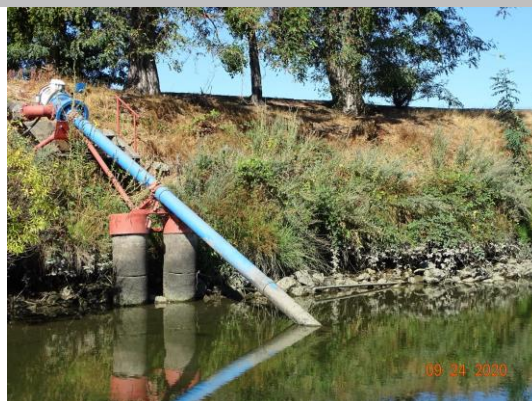
Photo 1 of 2 : SJR2019\_RD0524U01RM46.06\_01.JPG

9/24/2020: View of the erosion immediately downstream of irrigation pipe.

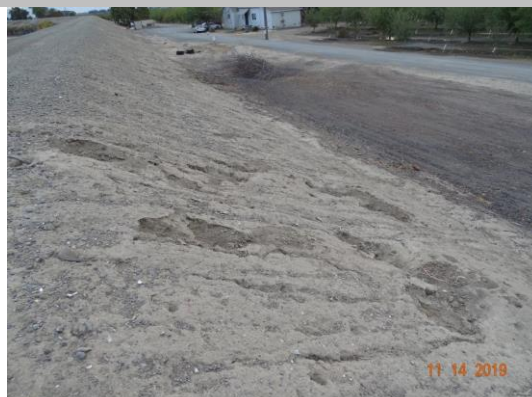
Photo 1 of 1 : FA\_2020\_RD0524\_107\_141\_20200901\_00059.jpg

View of multiple rodent holes on landside slope. Fall 2019

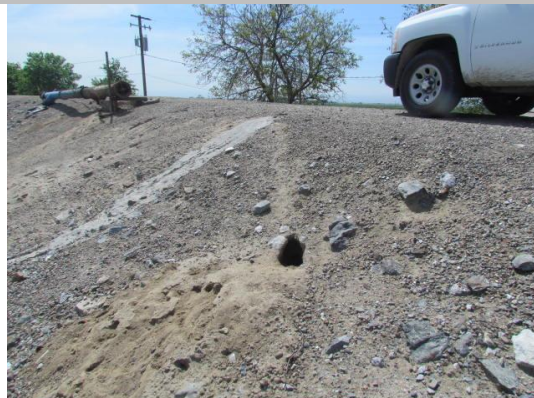
Photo 1 of 1 : FA\_2020\_RD0524\_107\_75\_20200901\_00036.jpg

View of rodent holes on waterside slope.

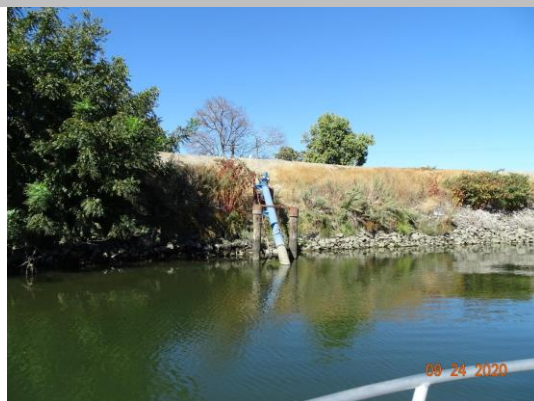
Photo 1 of 2 : SJR2019\_RD0524U01RM46.39\_01.JPG

9/24/2020: Overview of the pipe crossing at the erosion site.

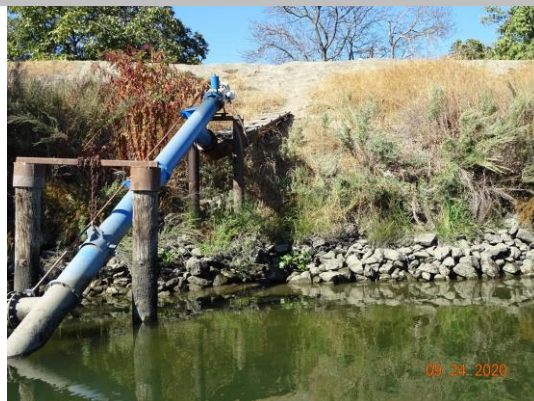
Photo 2 of 2 : SJR2019\_RD0524U01RM46.39\_02.JPG

9/24/2020: Close-up view of the erosion.

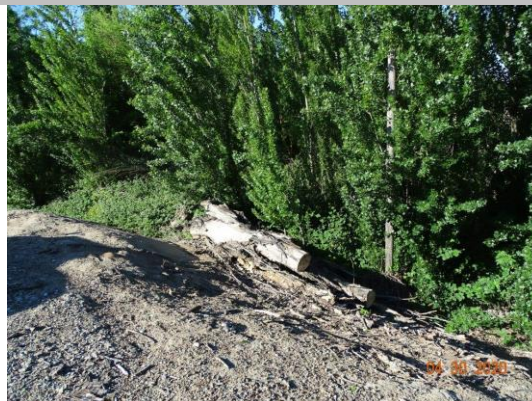
Photo 1 of 1 : FA\_2020\_RD0524\_107\_81\_20200901\_00039.jpg

View of tree branches on landside slope. Spring 2020

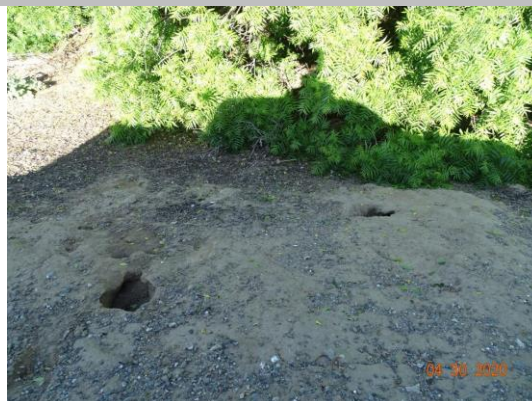
Photo 1 of 1 : FA\_2020\_RD0524\_107\_104\_20200901\_00048.jpg

View of large animal burrow on landside slope. Spring 2020
