**Flood Control Project Maintenance  
Levee Inspections**

**Maintenance Issue Types Only, Levee Inspection Report By Mile - Fall 2021**

**Reclamation District No. 0524 Middle Roberts Island**

Waterway	Bank	Unit Miles	Inspection Start/End	Inspector
Unit No. 01 San Joaquin River	Left	6.20	10/22/2021 10/22/2021	Alberto De Leon

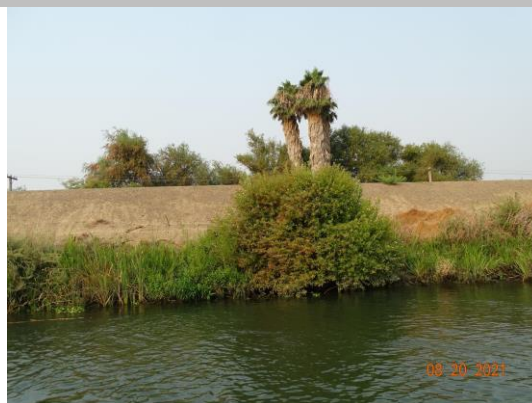
Photo 1 of 2 : SJR2021\_RD0524U01RM40.85\_2.JPG

LM Start	0.18	Rating **	U	Issue No.	9
LM End	0.19	Issue Type +	Ma	Location *	
Category	Supplemental			GPS Latitude/Longitude	
				Start	End
Item	DWR Erosion Survey			37.939085 °	37.939085 °
				-121.343917 °	-121.343917 °
DWR ID	RD0524U01RM40.85				
Comment Code					
Inspector Comment					
Site ID: RD0524U01RM40.85 08/20/2021: From 2014 to present, no significant changes were observed during the annual survey. 08/13/2013: The erosion was discovered during 2013 spring levee inspection. Inspector comment: Erosion is located along the lower level of water-ward slope.

8/20/2021: Front view of the erosion.

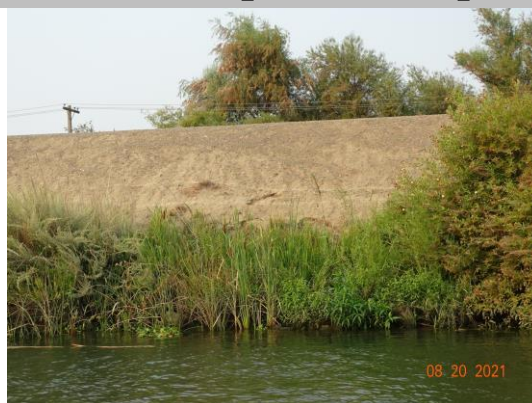
Photo 2 of 2 : SJR2021\_RD0524U01RM40.85\_1.JPG

8/20/2021: Close-up view of the erosion.

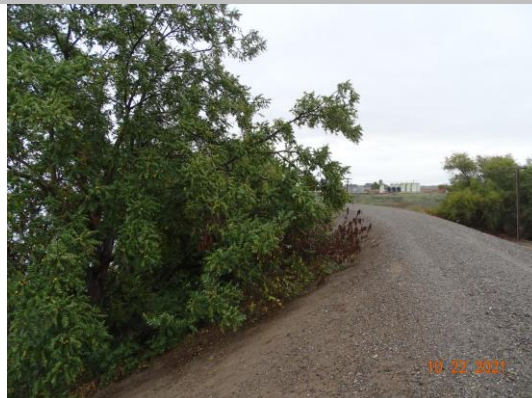
Photo 1 of 1 : FA\_2021\_RD0524\_107\_201\_20211025\_00337.jpg

View of tree on waterside slope looking upstream. Fall 2021

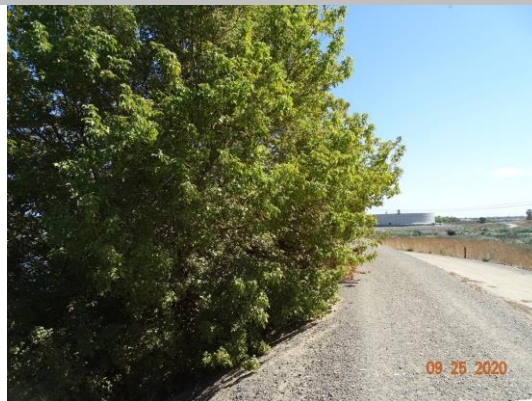
Photo 1 of 1 : FA\_2021\_RD0524\_107\_179\_20210913\_00069.jpg

View of large untrimmed walnut tree on landside slope. Fall 2020

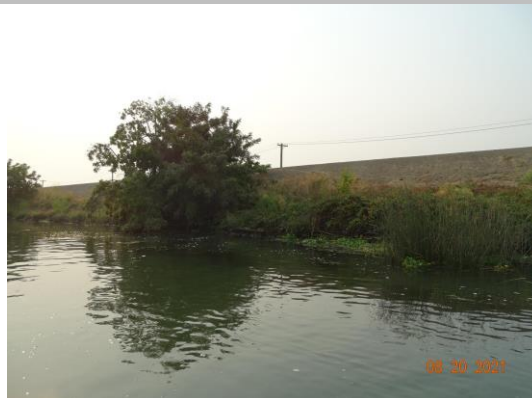
Photo 1 of 2 : SJR2021\_RD0524U01RM40.93\_02.JPG

LM Start	0.34	Rating **	M	Issue No.	1
LM End	0.35	Issue Type +	Ma	Location *	
Category	Supplemental			GPS Latitude/Longitude	
				Start	End
Item	DWR Erosion Survey			37.938461 °	37.938461 °
				-121.341526 °	-121.341526 °
DWR ID	RD0524U01RM40.93				
Comment Code					
Inspector Comment					
Site ID: RD0524U01RM40.93					
08/20/2021: From 2018 to present, no significant changes were observed during the annual survey.					
09/13/2017: There are two pocket erosions at the site; both erosions are around 10 ft long and 6 ft high.

08/20/2021: View of the erosion looking upstream.

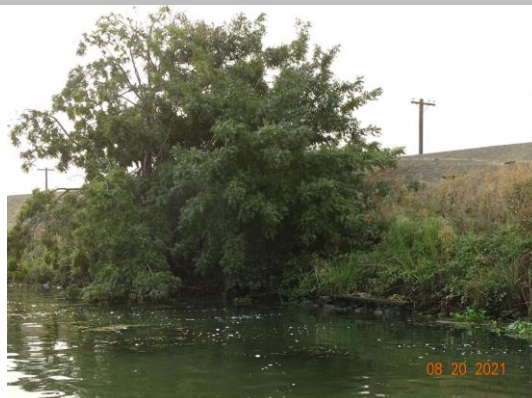
Photo 2 of 2 : SJR2021\_RD0524U01RM40.93\_01.JPG

08/20/2021: Front view of the one of the erosion pockets.

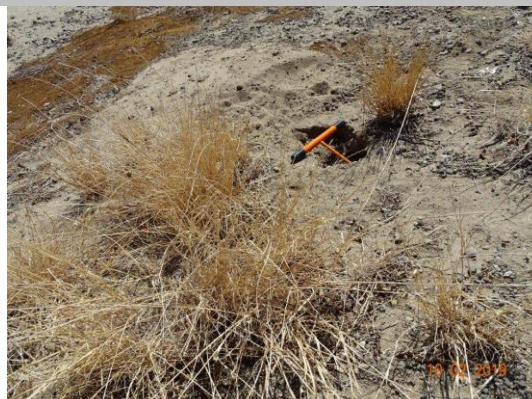
Photo 1 of 1 : FA\_2021\_RD0524\_107\_125\_20210913\_00063.jpg

LM Start	0.35	Rating **	U	Issue No.	125
LM End	0.35	Issue Type +	Ma	Location *	LS
Category	Earthen Levee			GPS Latitude/Longitude	
				Start	End
Item	Animal Control			37.938470 °	37.938470 °
				-121.341390 °	-121.341390 °
DWR ID	DWR_RD0524_01_f_2019_125				
Comment Code					
A3 : No rodents visible, but rodent burrows visible; need to backfill and compact or grout burrows.					
Inspector Comment

View of large rodent hole on landside slope. Fall 2019

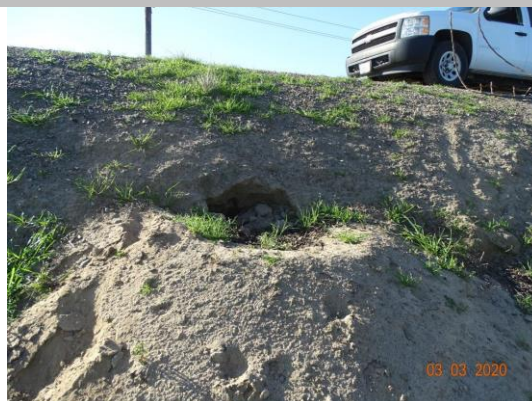
Photo 1 of 1 : FA\_2021\_RD0524\_107\_122\_20210913\_00062.jpg

View of large animal burrow on waterside slope. Spring 2020

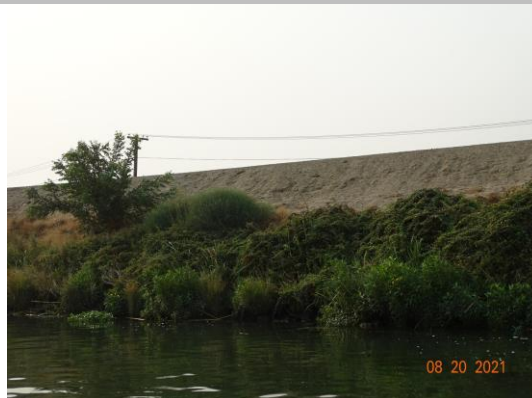
Photo 1 of 2 : SJR2021\_RD0524U01RM40.99\_01.JPG

LM Start	0.40	Rating **	U	Issue No.	4
LM End	0.41	Issue Type +	Ma	Location *	
Category	Supplemental			GPS Latitude/Longitude	
				Start	End
Item	DWR Erosion Survey			37.938608 °	37.938608 °
				-121.340498 °	-121.340498 °
DWR ID	RD0524U01RM40.99				
Comment Code					
Inspector Comment					
Site ID: RD0524U01RM40.99					
08/20/2021: From 2013 to present, no significant changes were observed during the annual survey. A small erosion repair site is located immediately downstream.					
08/07/2012: The erosion is at the upper levee slope, and likely caused by slope slip. The lower levee slope is covered with dense vegetation.					
LM Start	0.40	Rating **	U	Issue No.	4 (cont)
LM End	0.41	Issue Type +	Ma	Location *

08/20/2021: Overview of the erosion which is just upstream of a small erosion repair.

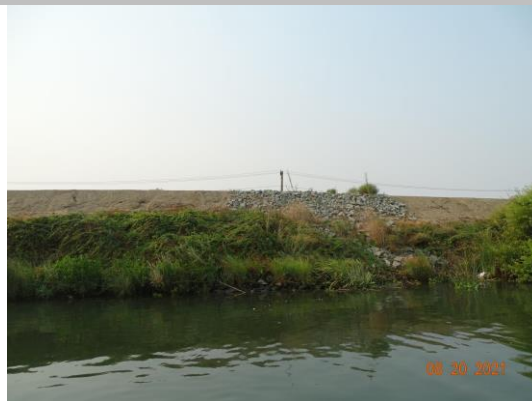
Photo 2 of 2 : SJR2021\_RD0524U01RM40.99\_02.JPG

08/20/2021: Close-up view of the erosion on the upper levee slope.

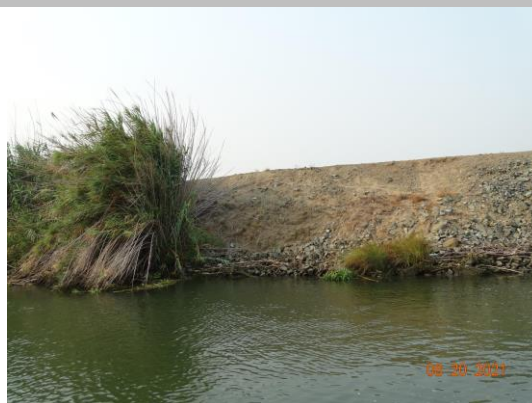
Photo 1 of 2 : SJR2021\_RD0524U01RM41.26\_01.JPG

LM Start	0.63	Rating **	M	Issue No.	2
LM End	0.64	Issue Type +	Ma	Location *	
Category	Supplemental			GPS Latitude/Longitude	
				Start	End
Item	DWR Erosion Survey			37.938247 °	37.938247 °
				-121.336503 °	-121.336503 °
DWR ID	RD0524U01RM41.26				
Comment Code					
Inspector Comment					
Site ID: RD0524U01RM41.26					
08/20/2021: From 2018 to present, no significant changes were observed during the annual survey.					
09/13/2017: The erosion was discovered by levee inspection. The erosion site is immediately downstream of tall vegetation.

08/20/2021: Front view of the erosion.

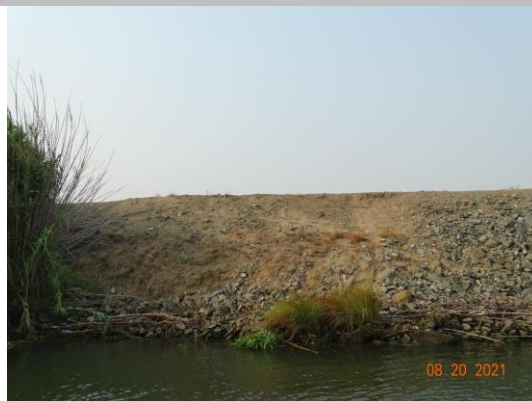
Photo 2 of 2 : SJR2021\_RD0524U01RM41.26\_02.JPG

08/20/2021: Close-up view of the erosion.

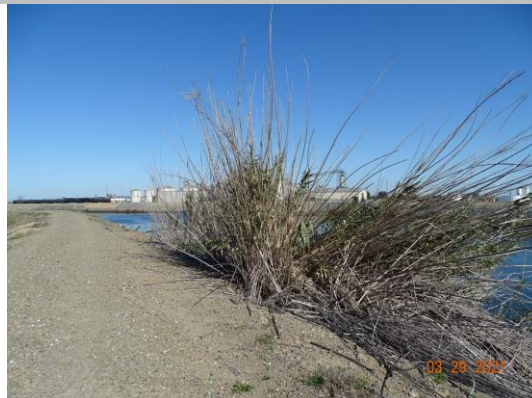
Photo 1 of 1 : FA\_2021\_RD0524\_107\_11\_20210913\_00021.jpg

View of Arundo on waterside slope. Spring 2021

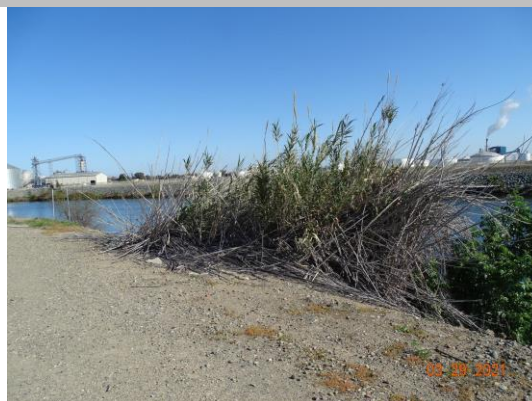
Photo 1 of 1 : FA\_2021\_RD0524\_107\_14\_20210913\_00027.jpg

LM Start	0.68	Rating **	U	Issue No.	14
LM End	0.68	Issue Type +	Ma	Location *	WS
Category	Earthen Levee			GPS Latitude/Longitude	
				Start	End
Item	Vegetation			37.937739 °	37.937739 °
				-121.335762 °	-121.335762 °
DWR ID	DWR_RD0524_01_s_2012_14				
Comment Code					
V2 : Remove the wild growth other than native grasses from the levee slopes.					
Inspector Comment					
Arundo on waterside slope.

View of Arundo along the waterside shoulder. Spring 2021

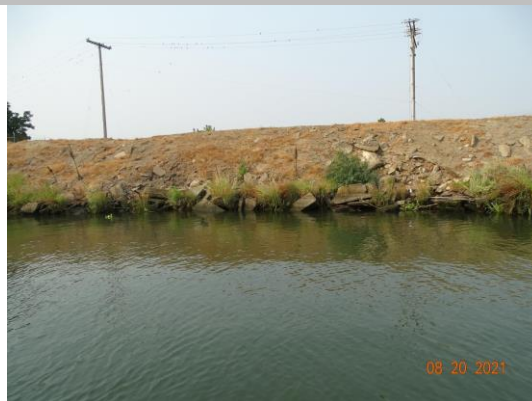
Photo 1 of 2 : SJR2021\_RD0524U01RM41.34\_01.JPG

LM Start	0.70	Rating **	M	Issue No.	3	
LM End	0.71	Issue Type +	Ma	Location *		
Category	Supplemental			GPS Latitude/Longitude		
				Start		End
Item	DWR Erosion Survey			37.937577 °		37.937577 °
				-121.335491 °		-121.335491 °
DWR ID	RD0524U01RM41.34					
Comment Code						
Inspector Comment						
Site ID: RD0524U01RM41.34						
08/20/2021: During the annual erosion survey the erosion length was extended by 35 feet to 50 feet.						
09/24/2020: From 2018 to present, no significant changes were observed during the annual survey.						
09/13/2017: Pocket erosion above the protected levee toe.

8/20/2021: Front view of the erosion.

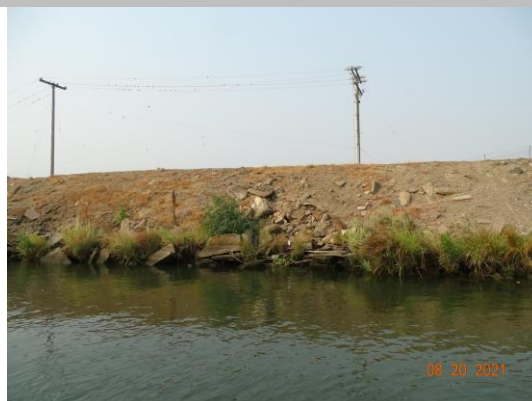
Photo 2 of 2 : SJR2021\_RD0524U01RM41.34\_02.JPG

8/20/2021: Close-up view of the erosion.

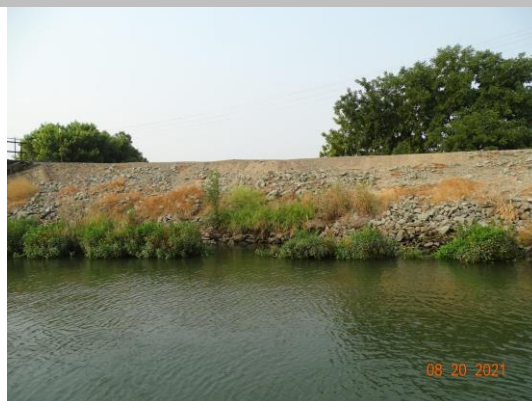
Photo 1 of 1 : SJR2021\_RD0524U01RM41.36\_01.JPG

Site ID: RD0524U01RM41.36  
 08/20/2021: From 2016 to present, no significant changes were observed during the annual survey. Some of the old riprap has been displaced and doesn't provide adequate protection.  
 06/24/2015: The erosion site is immediately downstream of the RR bridge.

08/20/2021: Overview of the erosion.

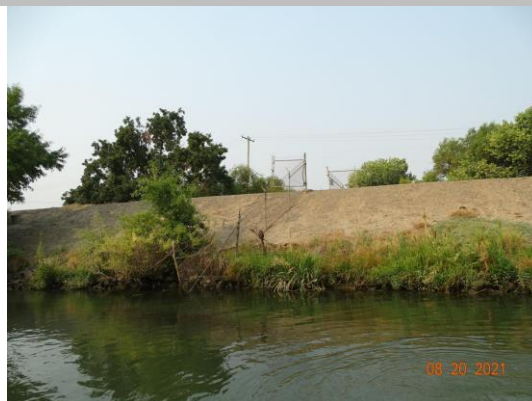
Photo 1 of 2 : SJR2021\_RD0524U01RM41.39\_01.JPG

LM Start	0.76	Rating **	U	Issue No.	8
LM End	0.77	Issue Type +	Ma	Location *	
Category	Supplemental			GPS Latitude/Longitude	
				Start	End
Item	DWR Erosion Survey			37.936749 °	37.936749 °
				-121.334971 °	-121.334971 °
DWR ID	RD0524U01RM41.39				
Comment Code					
Inspector Comment					
Site ID: RD0524U01RM41.39					
08/20/2021: From 2013 to present, no significant changes were observed during the annual survey.					
08/07/2012: The site has been visited by boat survey. No significant change observed.					
08/23/2011: The site is located immediately upstream of a Railroad bridge. Dense vegetation at the water line blocks the view of erosion.

08/20/2021: Front view of the erosion.

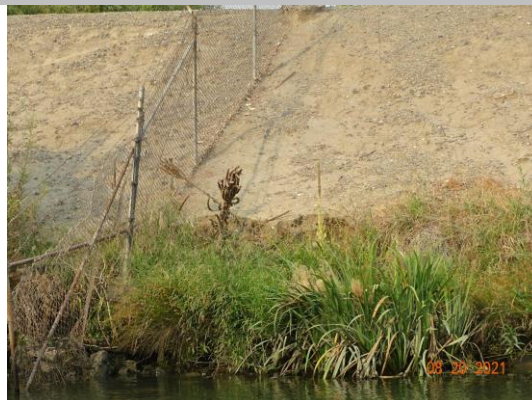
Photo 2 of 2 : SJR2021\_RD0524U01RM41.39\_02.JPG

08/20/2021: Close-up view of the erosion.

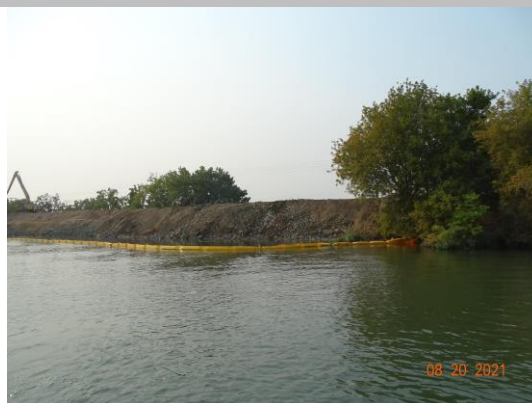
Photo 1 of 2 : SJR2021\_RD0524U01RM41.44\_01.JPG

LM Start	0.83	Rating **	U	Issue No.	12	
LM End	0.84	Issue Type +	Ma	Location *		
Category	Supplemental			GPS Latitude/Longitude		
				Start	End	
Item	DWR Erosion Survey			37.935838 °	37.935838 °	
				-121.334408 °	-121.334408 °	
DWR ID	RD0524U01RM41.44					
Comment Code						
Inspector Comment						
Site ID: RD0524U01RM41.44						
08/20/2021: Erosion site is planned for repair						
09/24/2020: From 2014 to present, no significant changes were observed during the annual survey. The vegetation is tall and limiting the view of the erosion.						
08/13/2013: Site was discovered during boat survey. The dense vegetation blocks a clear view of the erosion. Size of erosion site was very roughly estimated.

08/20/2021: View of erosion repair.

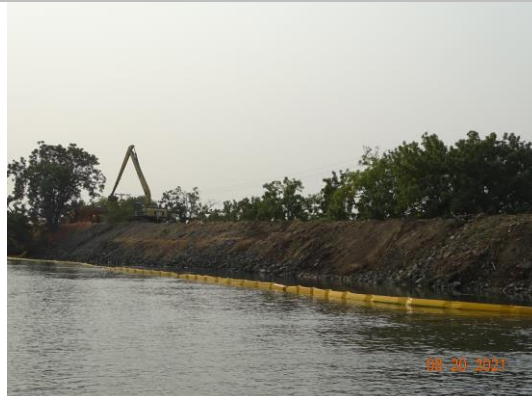
Photo 2 of 2 : SJR2021\_RD0524U01RM41.44\_02.JPG

08/20/2021: View of erosion repair.

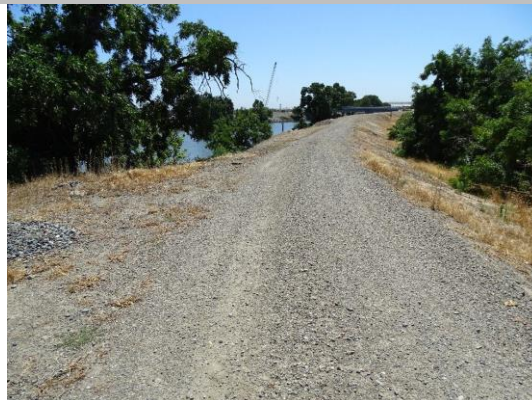
Photo 1 of 3 : UCIP\_FA\_2021\_70216\_89287.jpg

Comment Code					
Inspector Comment					
DS_ID:20598 FS_ID:70216 EP_NO: N/A Repair Type: Non-Urgent EVAL Issue: Unauthorized Encroachment, installed decades prior Crossing Status: Found UCIP Comments: 06/23/2020 Record updated from No Action Needed to Non-Urgent. No permit has been identified authorizing pipe. Crossing appears abandoned. Recommend owner to contact CVFPB to abandon or remove pipe from levee. (D.Sanoski - DWR UCIP) FIELD_STRUCT_DESC: *ABANDONED* 36-inch drainage pipe of an unknown material through the levee, 15 feet below the crown. Landside (LS) end is not visible. Concrete headwall at outlet on the waterside (WS) slope is visible. Pipe appears to be abandoned in place. Slide gate on the WS removed. [Additional Reference(s): DWR Levee Log, 2004 (HLM 0.99). USACE San Joaquin O&M Manual, Unit 7, April 1964, Revised 29 December 2016, (0.99), listed as 36-inch pipe]. FS Date: 6/23/2020 2:32:00 PM

Top of Levee: view of crown.

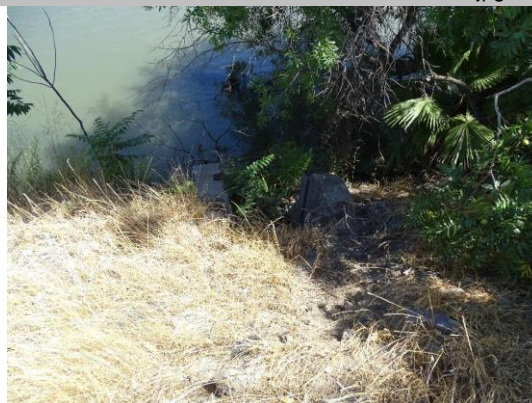
Photo 2 of 3 : UCIP\_FA\_2021\_70216\_89288.jpg

Water-Side: view of WS slope.

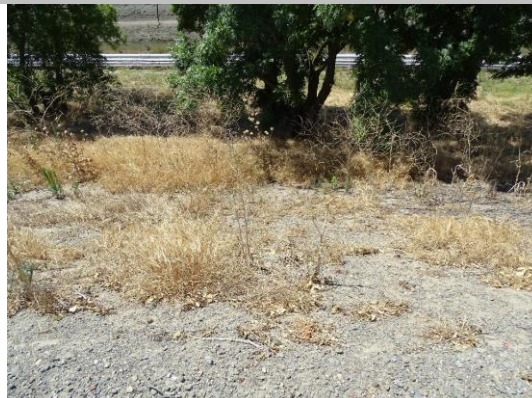
Photo 3 of 3 : UCIP\_FA\_2021\_70216\_89289.jpg

Land-Side: view of LS slope.

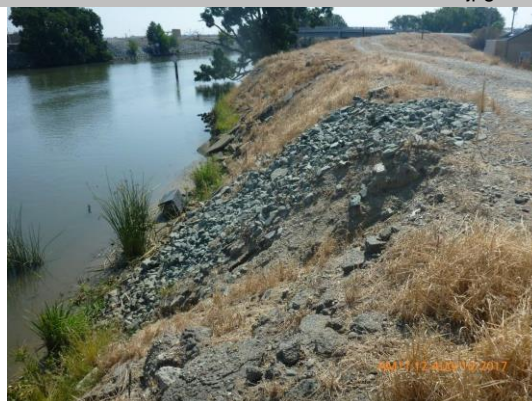
Photo 1 of 1 : LEVAL\_FA\_2021\_536\_4109.jpg

LM Start	1.00	Rating **	A/W	Issue No.	198
LM End	1.01	Issue Type +	Ma	Location *	WS
Category	Earthen Levee			GPS Latitude/Longitude	
				Start	End
Item	Slope Stability			37.935100 °	37.935100 °
				-121.331500 °	-121.331300 °
DWR ID	LMA-442				
Comment Code					
S1 : Repair slope instability.					
Inspector Comment					
Fall Inspection 2021: Revetment is present on the waterside toe and there is no active erosion. This was a 2017 Storm Damage Site. Slope protection repairs are needed along the waterside slope due to riprap displacement from high water. Based upon levee inspections, it was determined the waterside levee slope is eroding, deteriorating, and degrading. Site ID No:536 Site Designation:LMA-442 There appears to be previous repair site adjacent to LMA-442.

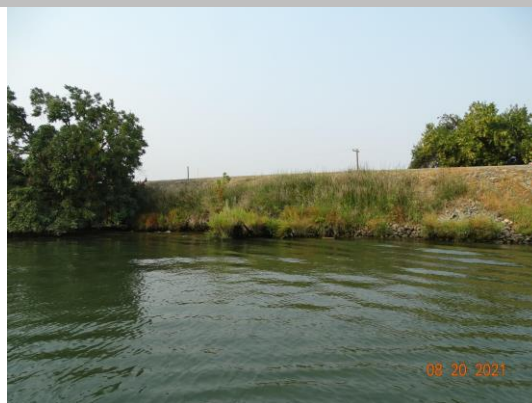
Photo 1 of 2 : SJR2021\_RD0524U01RM41.79\_01.JPG

Comment Code						
Inspector Comment						
Site ID: RD0524U01RM41.79 08/20/2021: From 2011 to present, no significant changes were observed during the annual survey. Minimal vegetation covers the upper levee slope. The lower slope is covered with medium dense vegetation. Riprap is visible in some areas. 09/07/2010: Vegetation is visible at the water line. There is an exposed pipe discharge partially hanging at the mid-slope, possibly still used for discharging irrigation/runoff water. There is minimal rip rap protection along the bank, and what's left of it is no longer adequately protecting the bank. 9/29/2009: Site consists of a 400-foot long eroding bank with minimal vegetation and protection; the existing rip rap has sloughed, rendering it useless; note that there is an exposed section of a pipe. 10/18/2006: There is extensive loss of rip rap on some sections; sewage disposal pond is on the landside of the levee; there is an exposed pipe outlet "hanging" from the upper slope.

8/20/2021: Erosion visible on the upper levee slope.

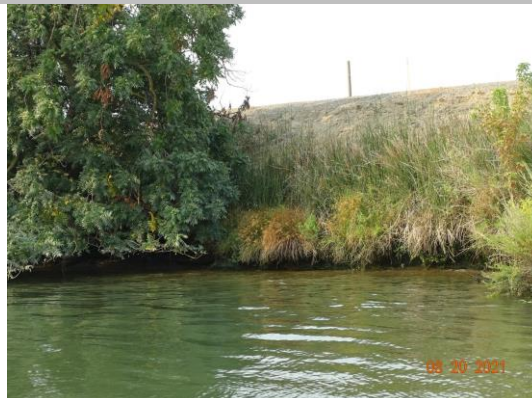
Photo 2 of 2 : SJR2021\_RD0524U01RM41.79\_02.JPG

8/20/2021: Front view of the erosion with riprap on the levee slope.

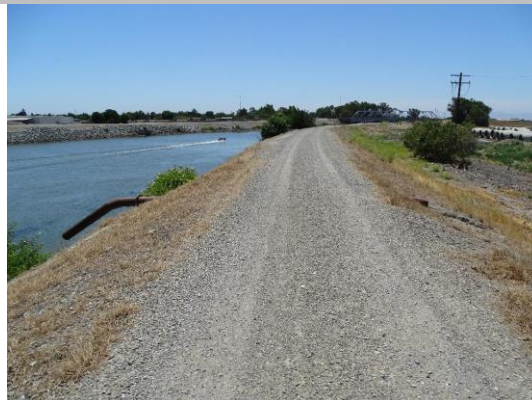
Photo 1 of 3 : UCIP\_FA\_2021\_70217\_89309.jpg

Comment Code						
Inspector Comment						
DS_ID:20602 FS_ID:70217 EP_NO: N/A Repair Type: Non-Urgent EVAL Issue: Unauthorized Encroachment, installed decades prior Crossing Status: Found UCIP Comments: 06/23/2020 Record remains Non-Urgent. No permit has been identified authorizing pipe. Crossing appears abandoned. (D.Sanoski - DWR UCIP) 10/2/2018 Pipe appears abandoned, but both the pipe and levee appear in good condition; downgrading to Non-Urgent (D. Sanoski - DWR UCIP).11/16/2016 same as previous inspection both ends are open. This pipe does not appear in use. Need to contact owner to determine status of crossing. If the crossing is abandoned or in use, owner will need to coordinate with the CVFPB to comply with Title 23 requirements. (O. Magana - DWR UCIP)08/16/2013 Pipe appears to be open on both ends. Abandoned and should be done so properly. (W. Wylie - DWR UCIP) FIELD_STRUCT_DESC: *ABANDONED* 12-inch steel drainage pipe through the levee, 3.5 feet below the crown. Pipe is opened on the waterside (WS) and landside (LS) ends. The pump house referenced in O&M manual is missing from the LS (2013). [Additional Reference(s): DWR Levee Log, 2004 (HLM 1.31). USACE San Joaquin O&M Manual, Unit 7, April 1964, Revised 29 December 2016, (1.31), listed as 12-inch pipe]. FS Date: 6/23/2020 2:35:00 PM

Top of Levee: view of crown.

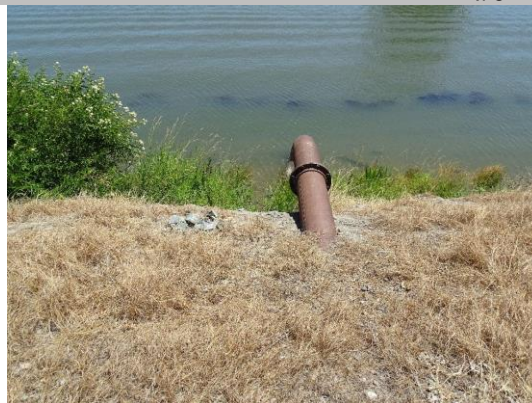
Photo 2 of 3 : UCIP\_FA\_2021\_70217\_89310.jpg

Water-Side: view of WS slope and abandoned pipe.

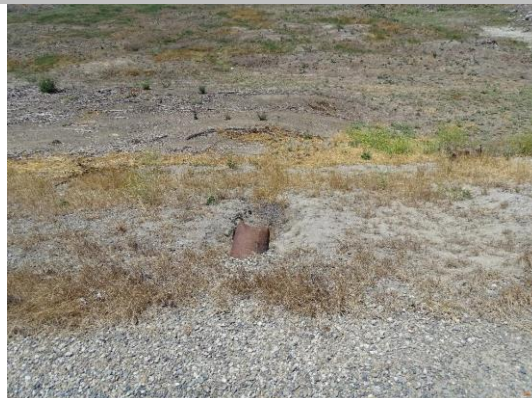
Photo 3 of 3 : UCIP\_FA\_2021\_70217\_89311.jpg

Land-Side: view of LS slope and abandoned pipe.

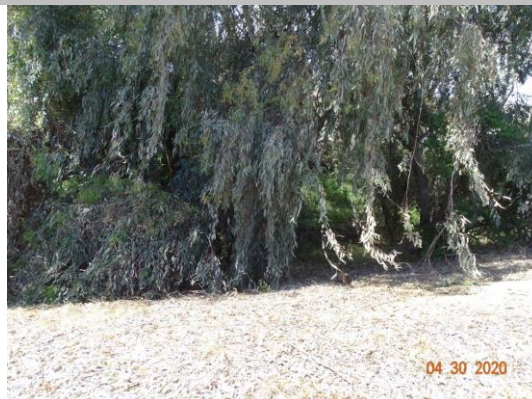
Photo 1 of 1 : FA\_2021\_RD0524\_107\_916\_20210913\_00107.jpg

LM Start	1.49	Rating **	M	Issue No.	916
LM End	1.50	Issue Type +	Ma	Location *	LS
Category	Earthen Levee			GPS Latitude/Longitude	
				Start	End
Item	Trim / Thin Trees			37.929118 °	37.929017 °
				-121.328368 °	-121.328367 °
DWR ID	DWR_RD0524_01_s_2012_916				
Comment Code					
T3 : Trim and thin trees to allow visibility of the ground and room to flood fight.					
Inspector Comment					
Untrimmed trees and dense vegetation on landside toe.

View of tree that need to be trimmed and thinned on landside slope.  
Spring 2020

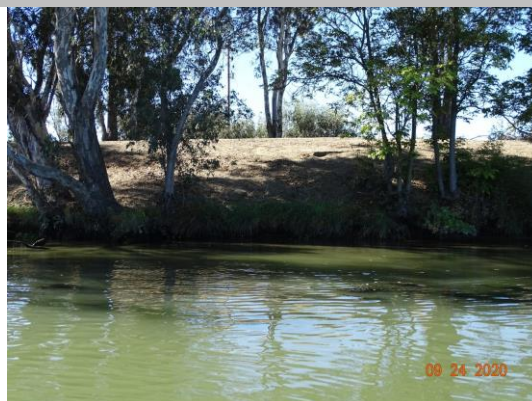
Photo 1 of 3 : SJR2021\_RD0524U01RM42.2\_02.JPG

09/24/2020: From 2013 to present, no significant changes were observed during the annual survey. Several erosion pockets and undermining of the levee toe visible.

9/24/2020: View of an erosion pocket between trees.

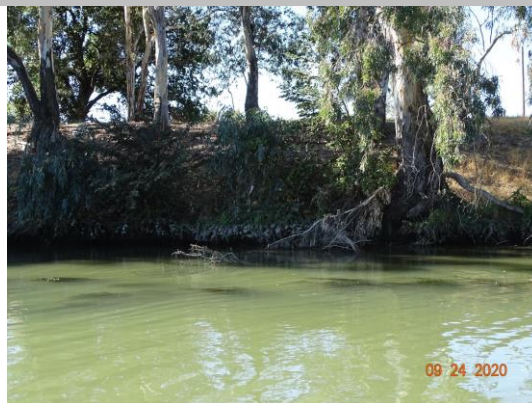
Photo 2 of 3 : SJR2021\_RD0524U01RM42.2\_05.JPG

9/24/2020: Visible undermining of the levee toe.

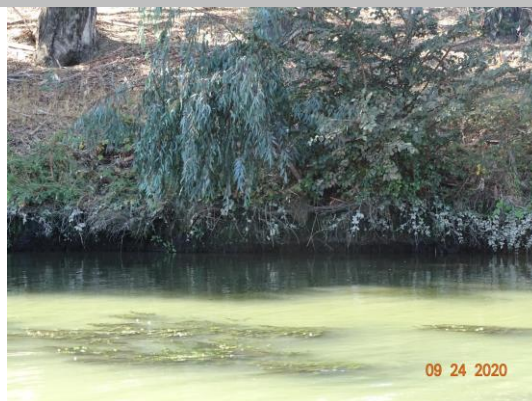
Photo 3 of 3 : SJR2021\_RD0524U01RM42.2\_06.JPG

9/24/2020: Close-up view of the erosion.

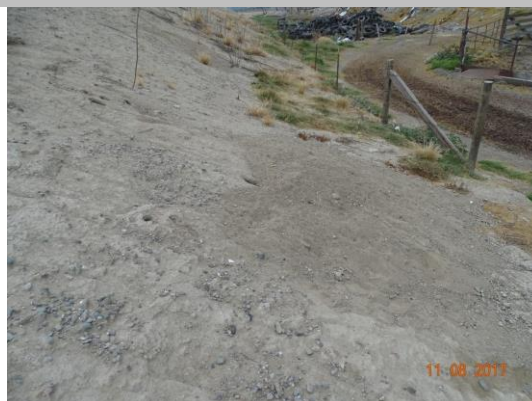
Photo 1 of 1 : FA\_2021\_RD0524\_107\_925\_20210913\_00108.jpg

Looking southwest at the landside slope.

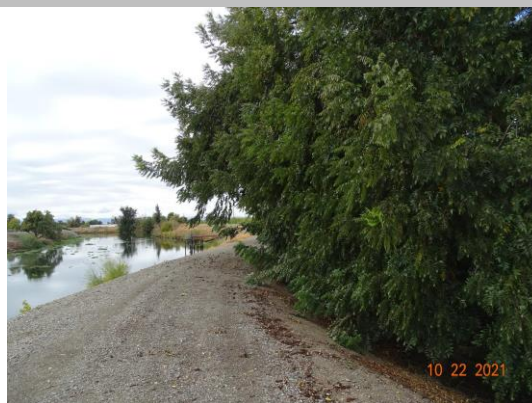
Photo 1 of 1 : FA\_2021\_RD0524\_107\_174\_20211025\_00339.jpg

View of untrimmed trees along the landside slope. Fall 2021

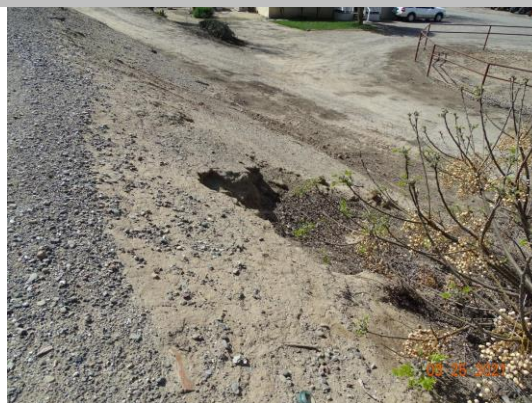
Photo 1 of 1 : FA\_2021\_RD0524\_107\_297\_20210913\_00098.jpg

View of erosion on the landside slope, approximately 5 ft wide, 10 ft long, 2 ft deep. Spring 2021

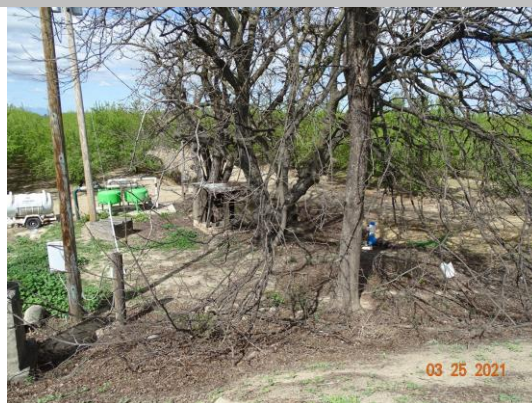
Photo 1 of 1 : FA\_2021\_RD0524\_107\_61\_20210913\_00055.jpg

View of untrimmed tree along the landside easement. Spring 2021

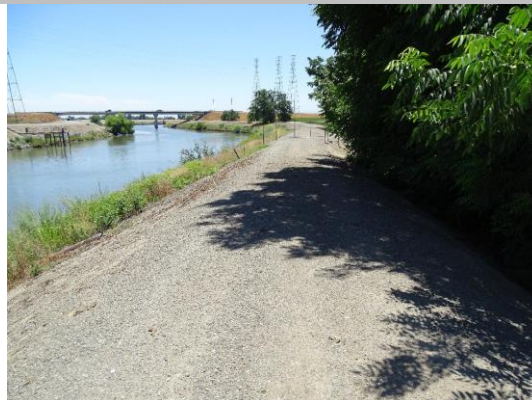
Photo 1 of 3 : UCIP\_FA\_2021\_70252\_89482.jpg

Top of Levee: view of crown.

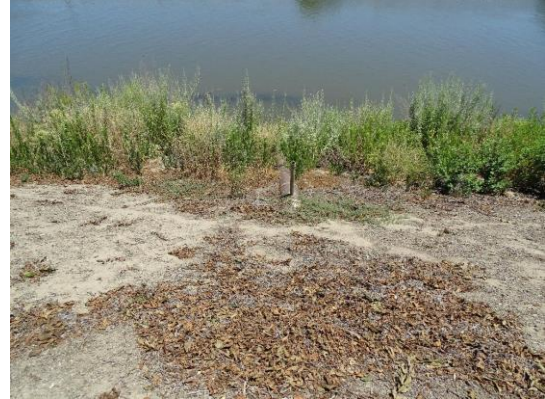
Photo 2 of 3 : UCIP\_FA\_2021\_70252\_89483.jpg

Water-Side: view of WS slope and pipe.

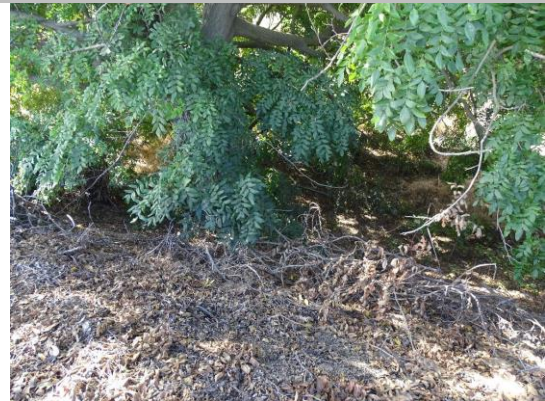
Photo 3 of 3 : UCIP\_FA\_2021\_70252\_78506.jpg

LS view - could not find pipe outlet.

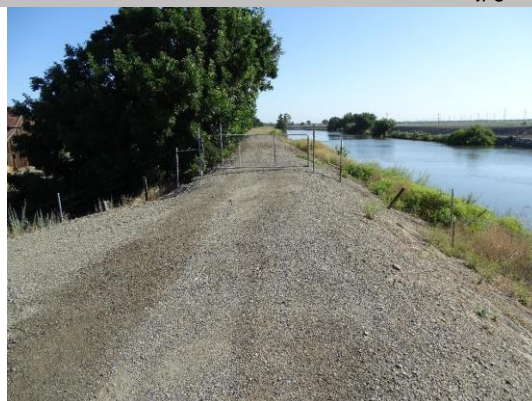
Photo 1 of 3 : UCIP\_FA\_2021\_70254\_89490.jpg

Top of Levee: view of crown.

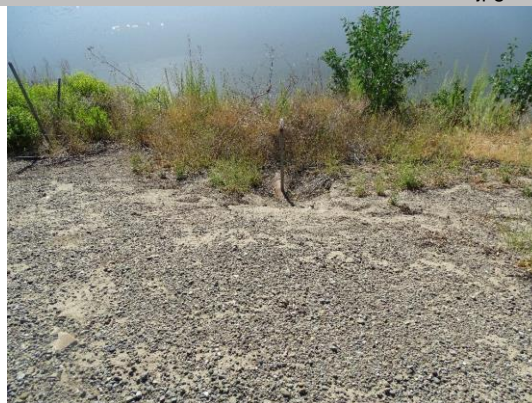
Photo 2 of 3 : UCIP\_FA\_2021\_70254\_89491.jpg

Water-Side: view of WS slope and pipe.

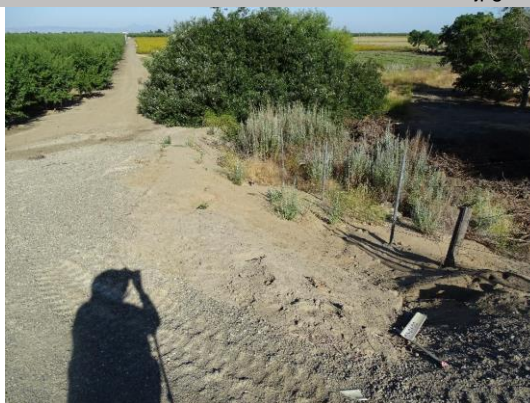
Photo 3 of 3 : UCIP\_FA\_2021\_70254\_89492.jpg

Land-Side: view of LS slope with no sign of inlet pipe due to overgrown vegetation limiting inspection.

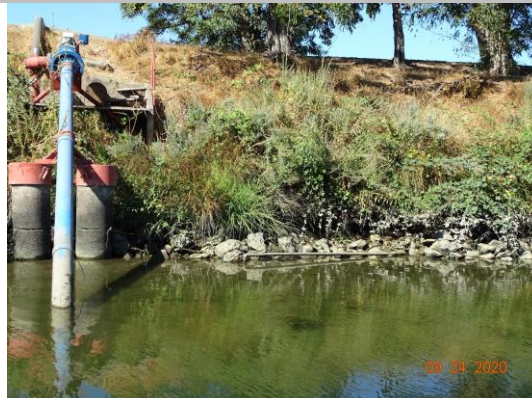
Photo 2 of 2 : SJR2021\_RD0524U01RM46.06\_03.JPG

9/24/2020: Close-up view of the undercutting.

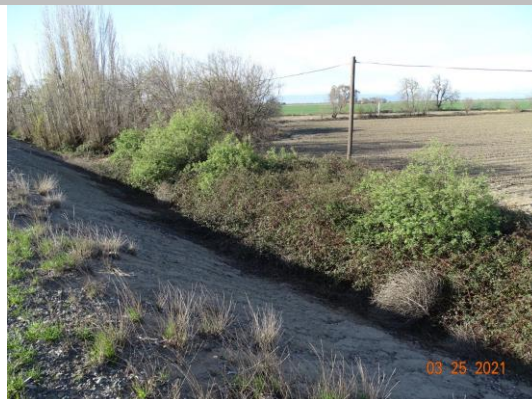
Photo 1 of 1 : FA\_2021\_RD0524\_107\_283\_20210913\_00094.jpg

View of dense berry bushes along landside easement. Spring 2021
