**Flood Control Project Maintenance
Levee Inspections**

Maintenance Issue Types Only, Levee Inspection Report By Mile - Fall 2022

Reclamation District No. 0524 Middle Roberts Island

Waterway	Bank	Unit Miles	Inspection Start/End	Inspector
Unit No. 01 San Joaquin River	Left	6.20	11/04/2022 11/04/2022	Alberto De Leon

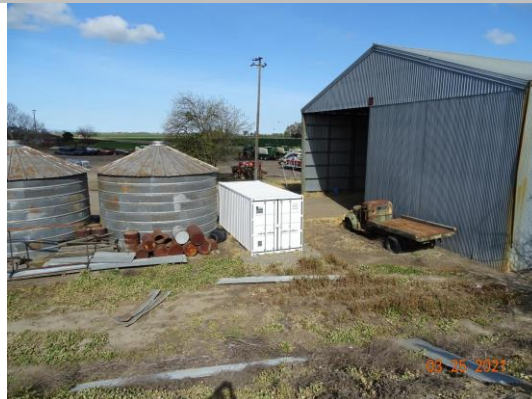
Photo 1 of 1 : FA_2022_RD0524_107_138_20220919_00038.jpg

LM Start	0.00	Rating **	A	Issue No.	138
LM End	0.00	Issue Type +	Ma	Location *	N/A
Category	Earthen Levee		GPS Latitude/Longitude		
			Start	End	
Item	Emergency Supplies & Equipment			°	°
DWR ID	DWR_RD0524_01_s_2013_138				
Comment Code					
ES : Emergency Supplies & Equipment					
Inspector Comment					
The LMA has emergency supplies or equipment stored in shipping container on at LM 4.65, (37.890799, -121.32913). Spring 2021

View of container with Districts Flood Fight Materials. Spring 2021

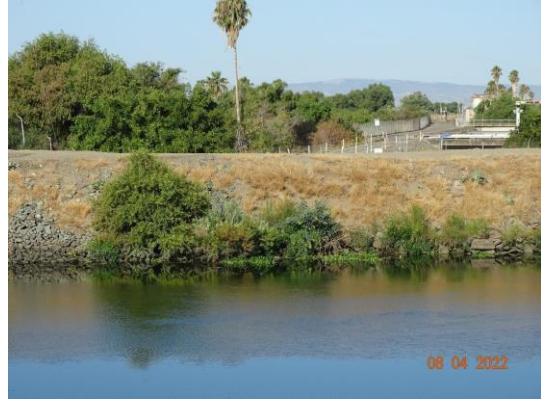
Photo 1 of 2 : SJR2022_RD0524U01RM41.34_3.JPG

LM Start	0.70	Rating **	M	Issue No.	3
LM End	0.71	Issue Type +	Ma	Location *	
Category	Supplemental			GPS Latitude/Longitude	
				Start	End
Item	DWR Erosion Survey			37.937577 °	37.937577 °
				-121.335491 °	-121.335491 °
DWR ID	RD0524U01RM41.34				
Comment Code					
Inspector Comment					
Site ID: RD0524U01RM41.34					
08/04/2022: No significant changes were observed since the previous inspection.					
08/20/2021: During the annual erosion survey the erosion length was extended by 35 feet to 50 feet.					
09/24/2020: From 2018 to present, no significant changes were observed during the annual survey.					
09/13/2017: Pocket erosion above the protected levee toe.

8/4/2022: Front view of the erosion.

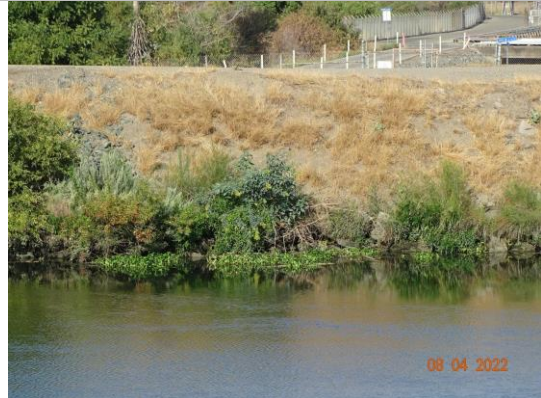
Photo 2 of 2 : SJR2022_RD0524U01RM41.34_2.JPG

8/4/2022: Close-up view of the erosion.

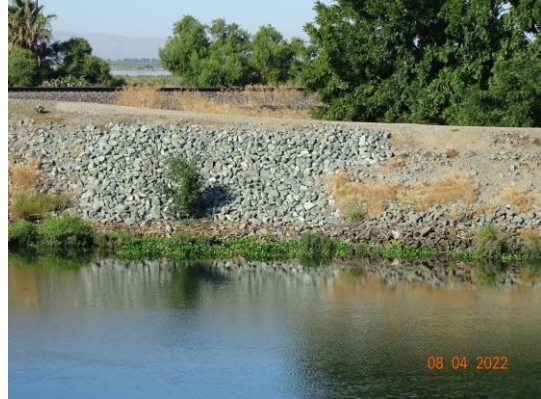
Photo 1 of 2 : SJR2022_RD0524U01RM41.36_2.JPG

LM Start	0.71	Rating **	M	Issue No.	13
LM End	0.73	Issue Type +	Ma	Location *	
Category	Supplemental			GPS Latitude/Longitude	
				Start	End
Item	DWR Erosion Survey			37.937222 °	37.937222 °
				-121.335277 °	-121.335277 °
DWR ID	RD0524U01RM41.36				
Comment Code					
Inspector Comment					
Site ID: RD0524U01RM41.36					
08/04/2022: From 2016 to present, no significant changes were observed during the annual survey. Some of the old riprap has been displaced and doesn't provide adequate protection.					
06/24/2015: The erosion site is immediately downstream of the RR bridge.

8/4/2022: Close-up view of the erosion.

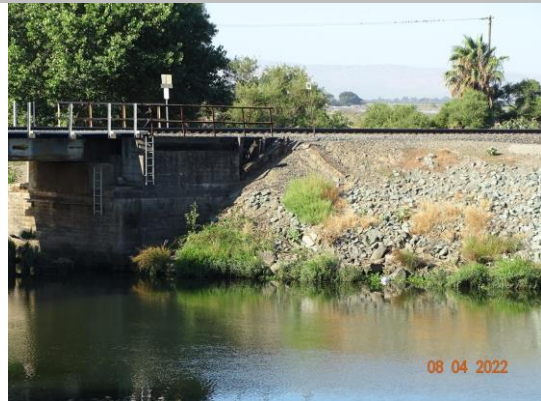
Photo 2 of 2 : SJR2022_RD0524U01RM41.36_4.JPG

8/4/2022: Another view of the erosion.

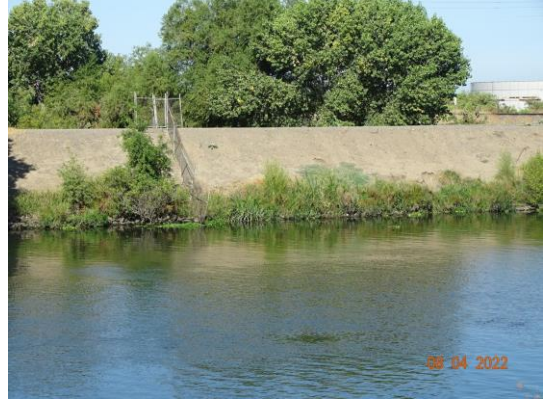
Photo 1 of 2 : SJR2022_RD0524U01RM41.39_5.JPG

LM Start	0.76	Rating **	U	Issue No.	8
LM End	0.77	Issue Type +	Ma	Location *	
Category	Supplemental			GPS Latitude/Longitude	
				Start	End
Item	DWR Erosion Survey			37.936749 °	37.936749 °
				-121.334971 °	-121.334971 °
DWR ID	RD0524U01RM41.39				
Comment Code					
Inspector Comment					
Site ID: RD0524U01RM41.39					
08/04/2022: From 2013 to present, no significant changes were observed during the annual survey.					
08/07/2012: The site has been visited by boat survey. No significant change observed.					
08/23/2011: The site is located immediately upstream of a Railroad bridge. Dense vegetation at the water line blocks the view of erosion.

8/4/2022: View of the erosion from the opposite bank.

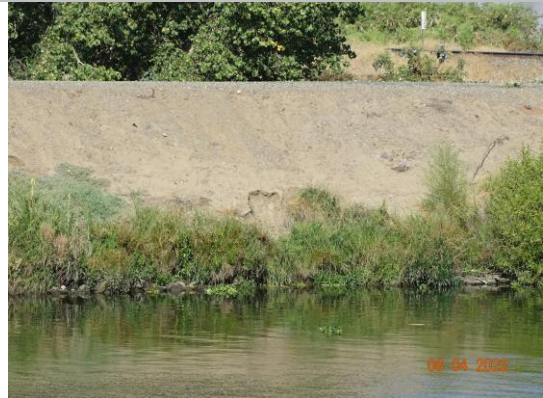
Photo 2 of 2 : SJR2022_RD0524U01RM41.39_2.JPG

8/4/2022: Close-up view of the erosion.

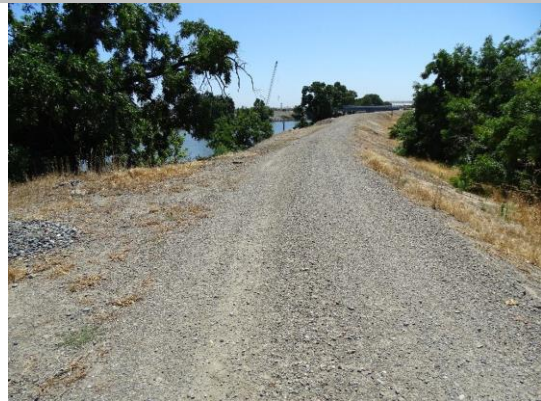
Photo 1 of 3 : UCIP_FA_2022_73982_89287.jpg

Comment Code						
Inspector Comment						
DS_ID:20598 FS_ID:73982 EP_NO: N/A Repair Type: Non-Urgent EVAL Issue: Crossing Status: Found UCIP Comments: 06/23/2020 Record updated from No Action Needed to Non-Urgent. System Feature. Crossing appears abandoned. (D.Sanoski - DWR UCIP) FIELD_STRUCT_DESC: *ABANDONED* 36-inch drainage pipe of an unknown material through the levee, 15 feet below the crown. Landside (LS) end is not visible. Concrete headwall at outlet on the waterside (WS) slope is visible. Pipe appears to be abandoned in place. Slide gate on the WS removed. [Additional Reference(s): DWR Levee Log, 2004 (HLM 0.99). USACE San Joaquin O&M Manual, Unit 7, April 1964, Revised 29 December 2016, (0.99), listed as 36-inch pipe]. FS Date: 6/23/2020 2:32:00 PM

Top of Levee: view of crown.

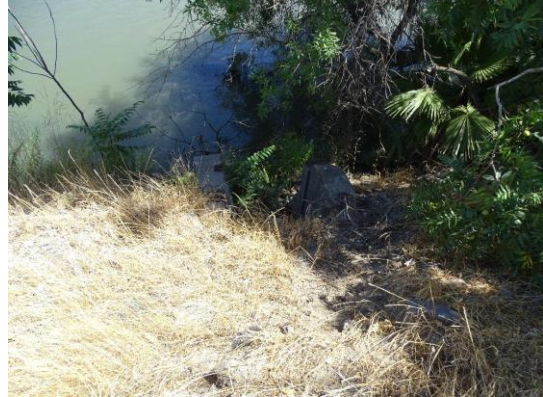
Photo 2 of 3 : UCIP_FA_2022_73982_89288.jpg

Water-Side: view of WS slope.

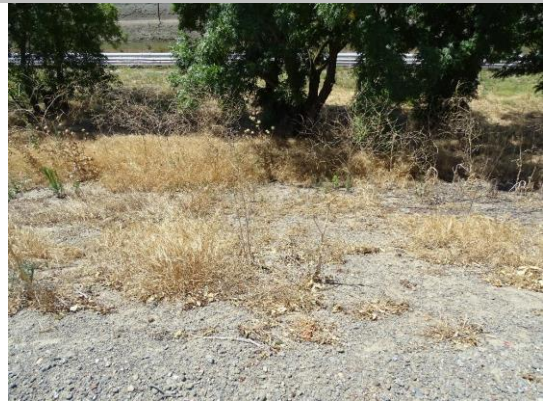
Photo 3 of 3 : UCIP_FA_2022_73982_89289.jpg

Land-Side: view of LS slope.

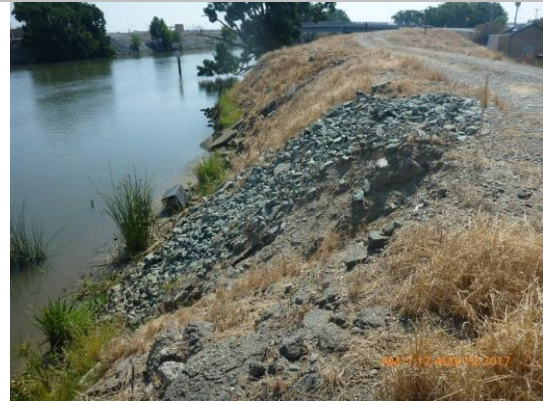
Photo 1 of 1 : LEVAL_FA_2022_536_4109.jpg

LM Start	1.00	Rating **	A/W	Issue No.	198
LM End	1.01	Issue Type +	Ma	Location *	WS
Category	Earthen Levee			GPS Latitude/Longitude	
				Start	End
Item	Erosion / Bank Caving			37.935100 °	37.935100 °
				-121.331500 °	-121.331300 °
DWR ID	LMA-442				
Comment Code					
E1 : Note and monitor erosion site.					
Inspector Comment					
Fall Inspection 2021: Revetment is present on the waterside toe and there is no active erosion. This was a 2017 Storm Damage Site. Slope protection repairs are needed along the waterside slope due to riprap displacement from high water. Based upon levee inspections, it was determined the waterside levee slope is eroding, deteriorating, and degrading.					
Site ID No:536					
Site Designation:LMA-442					
There appears to be previous repair site adjacent to LMA-442.

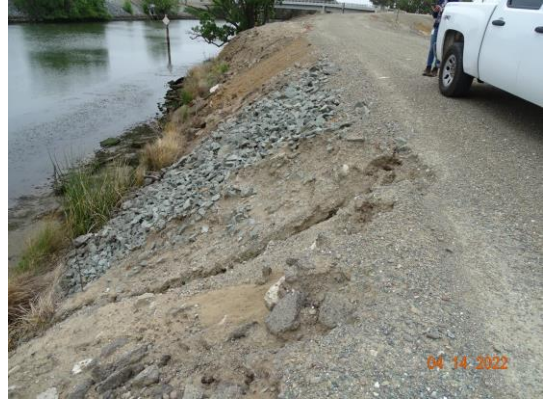
Photo 1 of 1 : FA_2022_RD0524_107_132_20220919_00036.jpg

LM Start	1.02	Rating **	U	Issue No.	132
LM End	1.02	Issue Type +	Ma	Location *	WS
Category	Earthen Levee			GPS Latitude/Longitude	
				Start	End
Item	Erosion / Rills			37.935032 °	37.935032 °
				-121.331210 °	-121.331210 °
DWR ID	DWR_RD0524_01_s_2022_132				
Comment Code					
E5 : Schedule repair of rills prior to the next inspection.					
Inspector Comment

View of rills along the waterside slope caused by surface runoff. Spring 2022

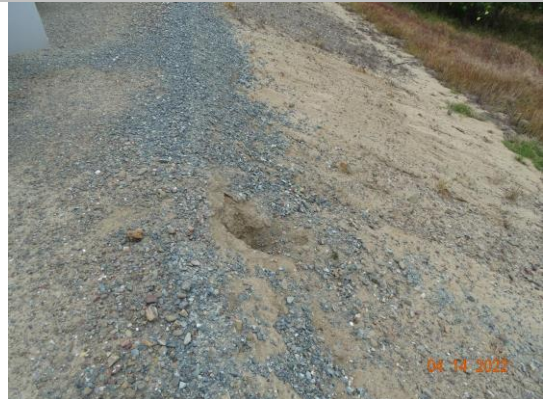
Photo 1 of 1 : FA_2022_RD0524_107_134_20220919_00037.jpg

LM Start	1.02	Rating **	M	Issue No.	134
LM End	1.02	Issue Type +	Ma	Location *	LS
Category	Earthen Levee			GPS Latitude/Longitude	
				Start	End
Item	Animal Control			37.935032 °	37.935032 °
				-121.331210 °	-121.331210 °
DWR ID	DWR_RD0524_01_s_2022_134				
Comment Code					
A3 : No rodents visible, but rodent burrows visible; need to backfill and compact or grout burrows.					
Inspector Comment

View of animal burrow along the landside slope. Spring 2022

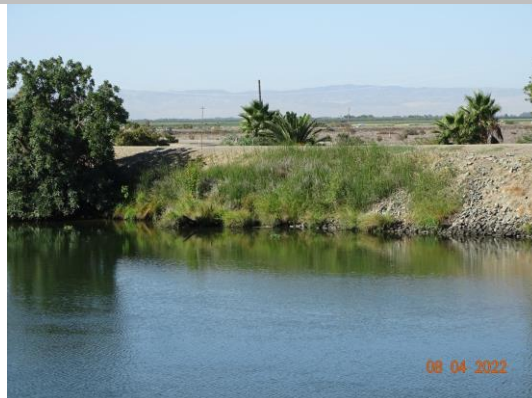
Photo 1 of 2 : SJR2022_RD0524U01RM41.79_4.JPG

Comment Code					
Inspector Comment					
Site ID: RD0524U01RM41.79					
08/04/2022: From 2011 to present, no significant changes were observed during the annual survey. Minimal vegetation covers the upper levee slope. The lower slope is covered with medium dense vegetation. Riprap is visible in some areas.					
09/07/2010: Vegetation is visible at the water line. There is an exposed pipe discharge partially hanging at the mid-slope, possibly still used for discharging irrigation/runoff water. There is minimal rip rap protection along the bank, and what's left of it is no longer adequately protecting the bank.					
9/29/2009: Site consists of a 400-foot long eroding bank with minimal vegetation and protection; the existing rip rap has sloughed, rendering it useless; note that there is an exposed section of a pipe.					
10/18/2006: There is extensive loss of rip rap on some sections; sewage disposal pond is on the landside of the levee; there is an exposed pipe outlet "hanging" from the upper slope.

8/4/2022: View of the erosion from the opposite bank.

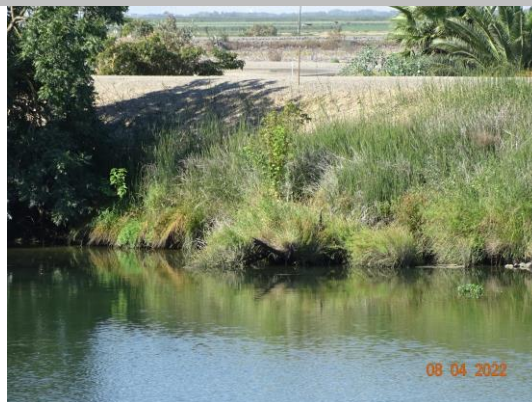
Photo 2 of 2 : SJR2022_RD0524U01RM41.79_5.JPG

8/4/2022: Close-up view of the erosion.

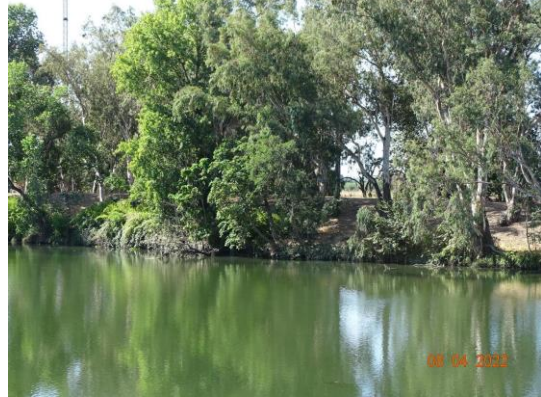
Photo 1 of 3 : SJR2022_RD0524U01RM42.4_2.JPG

08/04/2022: From 2013 to present, no significant changes were observed during the annual survey. Several erosion pockets and undermining of the levee toe are visible. The length has been increased to 500 ft.

09/07/2010: No significant change observed on site. The concern here is the undermining of the levee toe where most of trees are. There are erosion pockets lined along the lower slope and at the base of the trees, exposing tree roots. There is minimal slope protection.

8/4/2022: View of the erosion from the opposite bank.

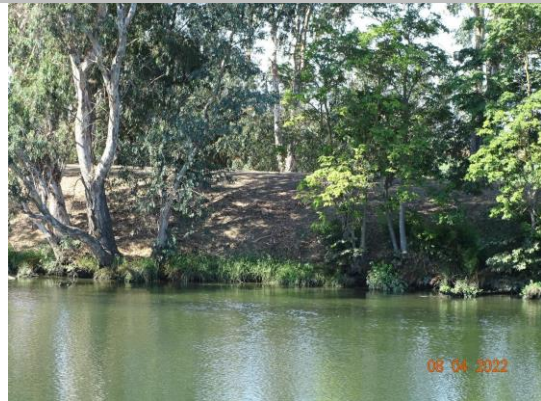
Photo 2 of 3 : SJR2022_RD0524U01RM42.4_4.JPG

8/4/2022: Another view of the erosion.

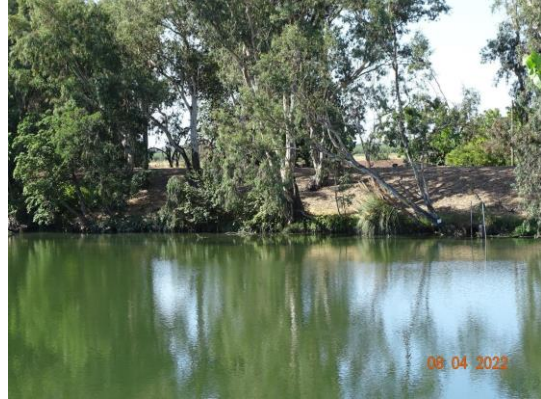
Photo 3 of 3 : SJR2022_RD0524U01RM42.4_6.JPG

8/4/2022: Visible undermining of the levee toe.

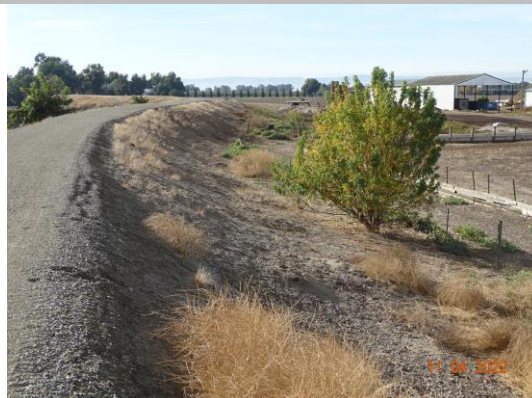
Photo 1 of 1 : FA_2022_RD0524_107_925_20221104_00278.jpg

View of landside slope with multiple animal burrows. Fall 2022

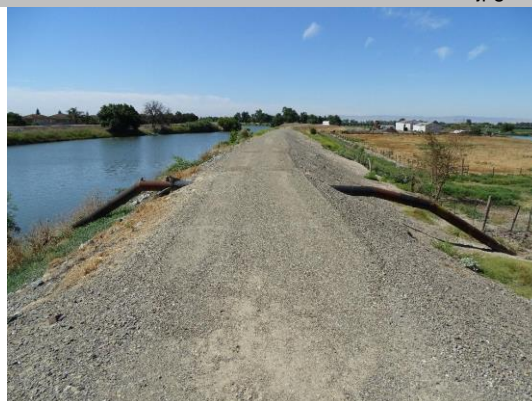
Photo 1 of 3 : UCIP_FA_2022_73984_89412.jpg

Overview of Levee: view of crown with pipe through crown.

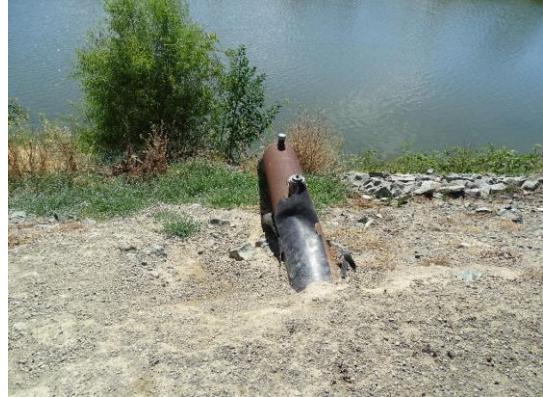
Photo 2 of 3 : UCIP_FA_2022_73984_89413.jpg

Water-Side: view of WS slope with pipe out of slope.

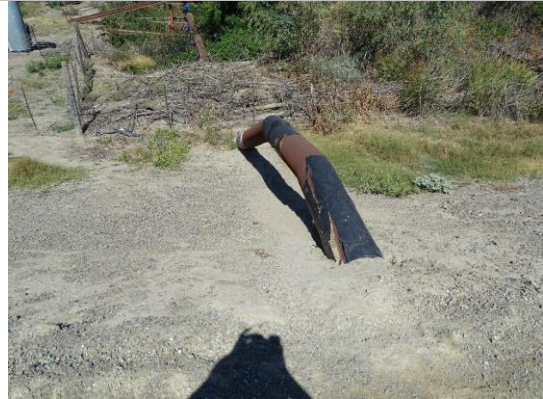
Photo 3 of 3 : UCIP_FA_2022_73984_89414.jpg

Land-Side: view of LS slope and pipe out of slope.

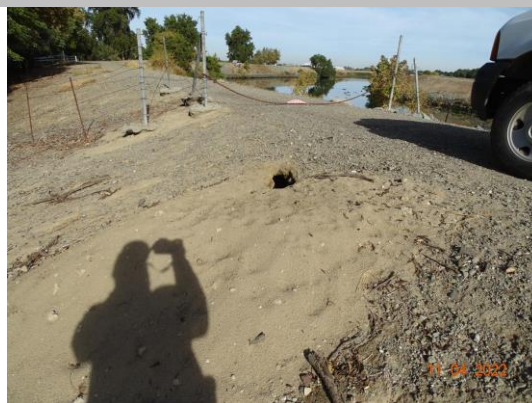
Photo 1 of 1 : FA_2022_RD0524_107_304_20221104_00277.jpg

View of large animal burrow on the landside slope. Fall 2022

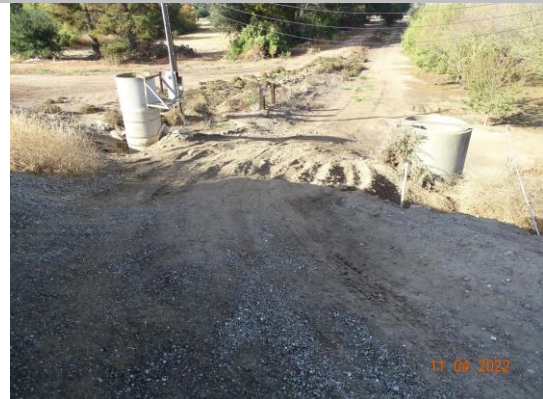
Photo 1 of 1 : FA_2022_RD0524_107_110_20221104_00274.jpg

View of rills along the landside ramp. Fall 2022

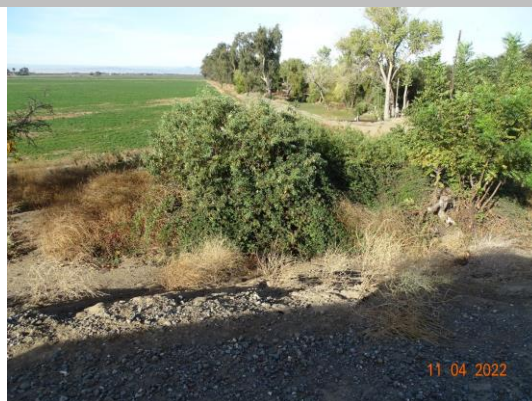
Photo 1 of 1 : FA_2022_RD0524_107_150_20221104_00273.jpg

View of wild vegetation along the landside slope and easement. Fall 2022

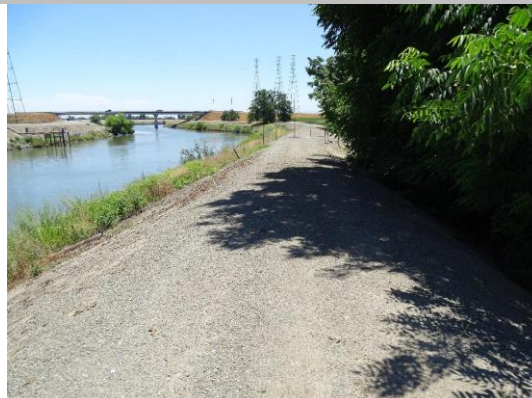
Photo 1 of 3 : UCIP_FA_2022_73985_89482.jpg

Top of Levee: view of crown.

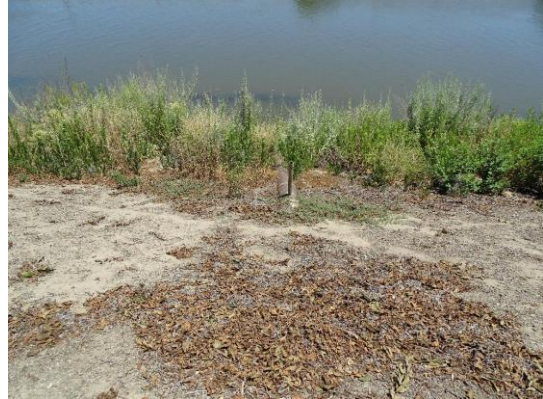
Photo 2 of 3 : UCIP_FA_2022_73985_89483.jpg

Water-Side: view of WS slope and pipe.

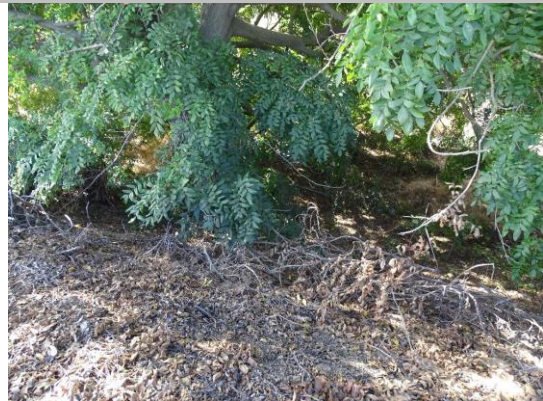
Photo 3 of 3 : UCIP_FA_2022_73985_78506.jpg

LS view - could not find pipe outlet.

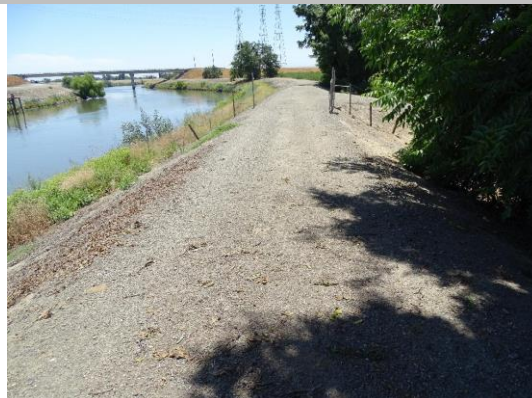
Photo 1 of 3 : UCIP_FA_2022_73986_89484.jpg

Top of Levee: view of crown.

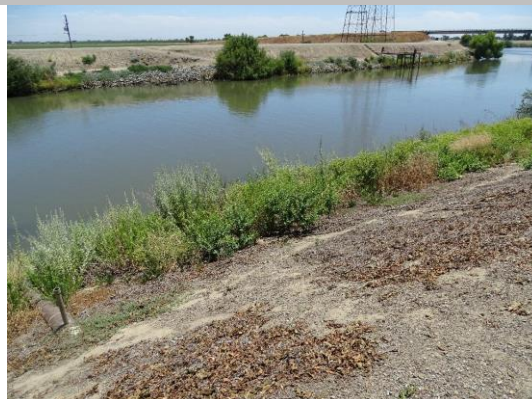
Photo 2 of 3 : UCIP_FA_2022_73986_89485.jpg

Water-Side: view of WS slope.

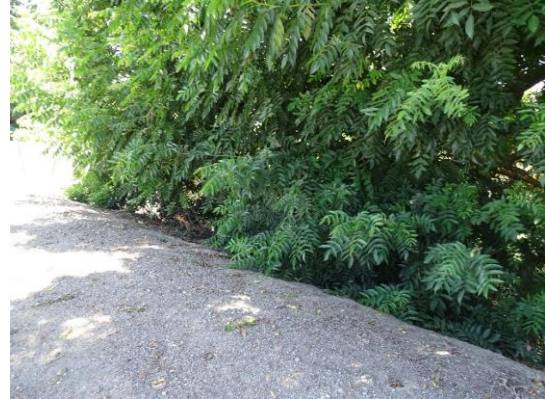
Photo 3 of 3 : UCIP_FA_2022_73986_89486.jpg

Land-Side: view of LS slope.

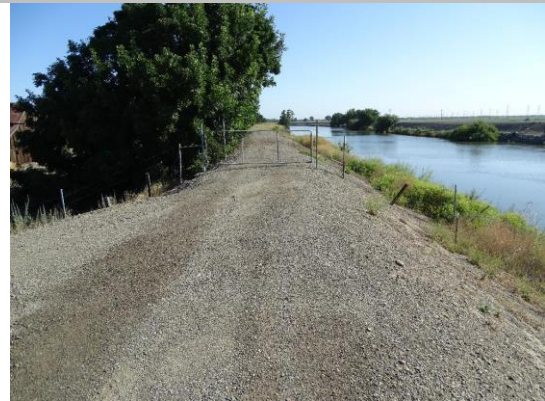
Photo 1 of 3 : UCIP_FA_2022_73987_89490.jpg

Top of Levee: view of crown.

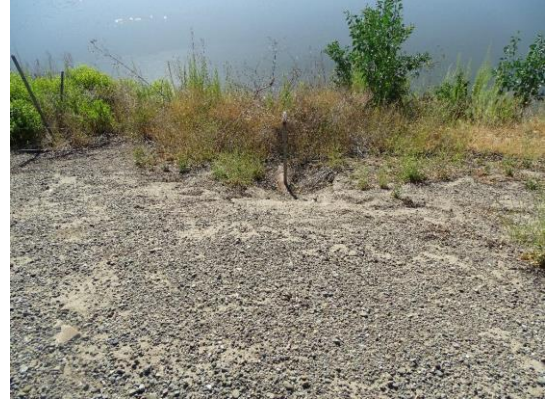
Photo 2 of 3 : UCIP_FA_2022_73987_89491.jpg

Water-Side: view of WS slope and pipe.

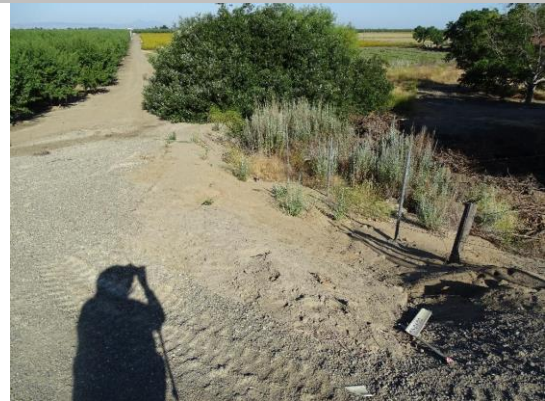
Photo 3 of 3 : UCIP_FA_2022_73987_89492.jpg

Land-Side: view of LS slope with no sign of inlet pipe due to overgrown vegetation limiting inspection.

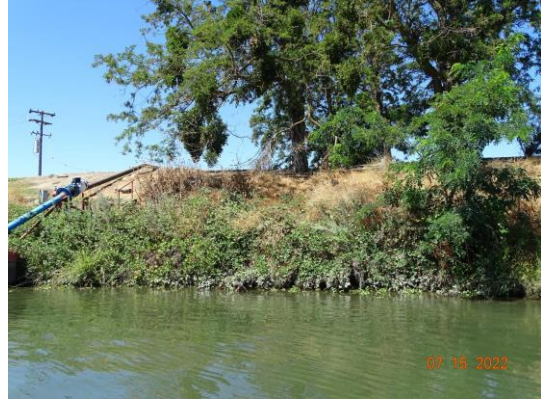
Photo 1 of 2 : SJR2022_RD0524U01RM46.06_4.JPG

7/15/2022: View of the erosion immediately downstream of an irrigation pipe.

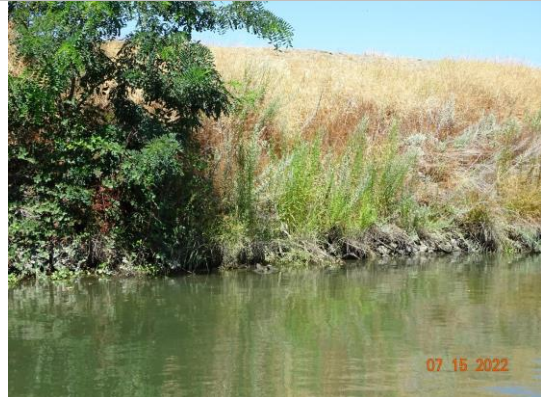
Photo 2 of 2 : SJR2022_RD0524U01RM46.06_3.JPG

7/15/2022: Close-up view of the erosion.

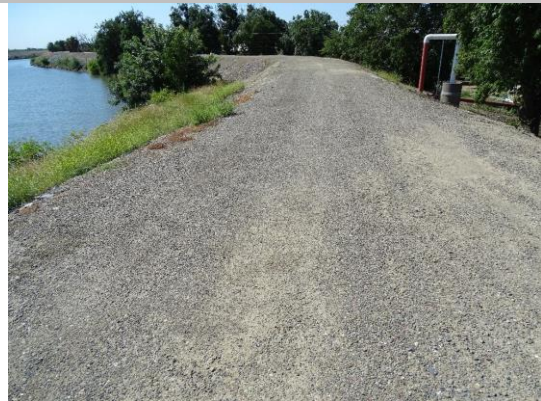
Photo 1 of 3 : UCIP_FA_2022_73988_89618.jpg

Top of Levee: view of crown.

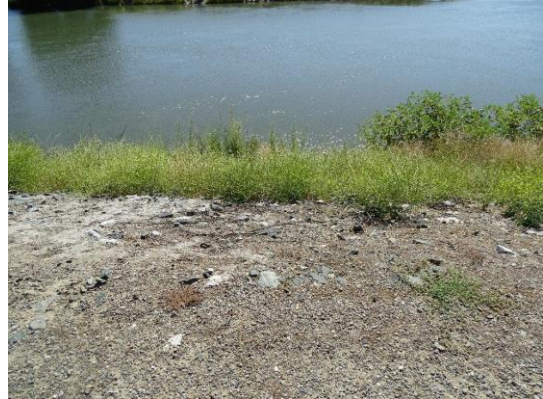
Photo 2 of 3 : UCIP_FA_2022_73988_89619.jpg

Water-Side: view of WS slope with no sign of pipe or concrete structure.

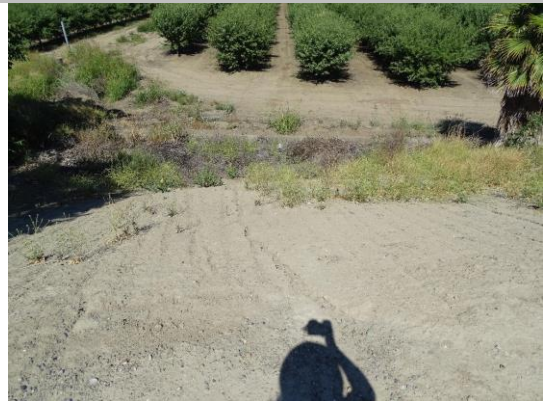
Photo 3 of 3 : UCIP_FA_2022_73988_89620.jpg

Land-Side: view of LS slope with no sign of pipe.

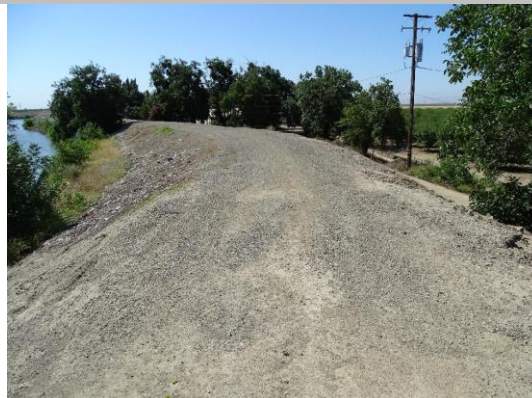
Photo 1 of 3 : UCIP_FA_2022_73989_89624.jpg

Top of Levee: view of crown.

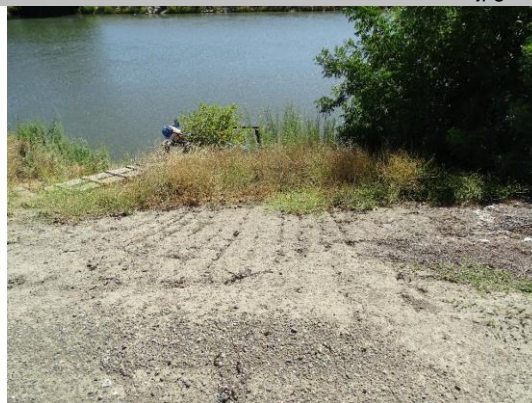
Photo 2 of 3 : UCIP_FA_2022_73989_89625.jpg

Water-Side: view of WS slope with no sign of crossing.

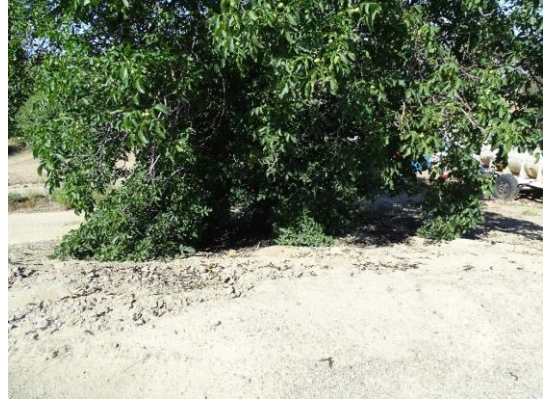
Photo 3 of 3 : UCIP_FA_2022_73989_89626.jpg

Land-Side: view of LS slope with no sign of crossing.
