**Flood Control Project Maintenance
Levee Inspections**

Maintenance Issue Types Only, Levee Inspection Report By Mile - Fall 2023

Reclamation District No. 0524 Middle Roberts Island

Waterway	Bank	Unit Miles	Inspection Start/End	Inspector
Unit No. 01 San Joaquin River	Left	6.20	10/06/2023 10/06/2023	Alberto De Leon

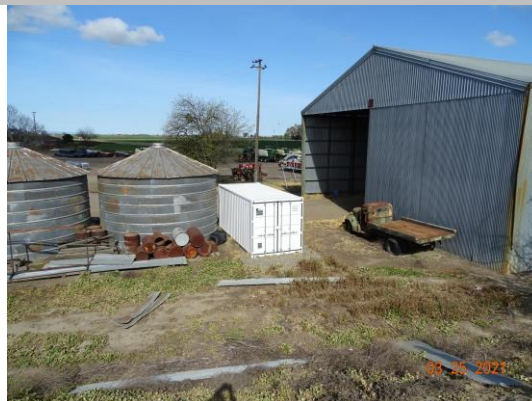
Photo 1 of 1 : FA_2023_RD0524_107_138_20230905_00022.jpg

LM Start	0.00	Rating **	A	Issue No.	138
LM End	0.00	Issue Type +	Ma	Location *	N/A
Category	Earthen Levee			GPS Latitude/Longitude	
				Start	End
Item	Emergency Supplies & Equipment			°	°
DWR ID	DWR_RD0524_01_s_2013_138				
Comment Code					
ES : Emergency Supplies & Equipment					
Inspector Comment					
The LMA has emergency supplies or equipment stored in a shipping container at LM 4.65, (37.890799, -121.32913).

View of container with Districts Flood Fight Materials. Spring 2021

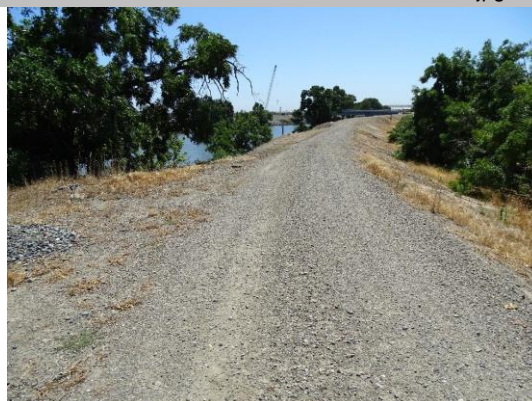
Photo 1 of 3 : UCIP_FA_2023_73982_89287.jpg

Comment Code					
Inspector Comment					
DS_ID:20598					
FS_ID:73982					
EP_NO: N/A					
Repair Type: Non-Urgent					
EVAL Issue:					
Crossing Status: Found					
UCIP Comments: 06/23/2020 Record updated from No Action Needed to Non-Urgent. System Feature. Crossing appears abandoned.					
(D.Sanoski - DWR UCIP)					
FIELD_STRUCT_DESC: *ABANDONED* 36-inch drainage pipe of an unknown material through the levee, 15 feet below the crown. Landside (LS) end is not visible. Concrete headwall at outlet on the waterside (WS) slope is visible. Pipe appears to be abandoned in place. Slide gate on the WS removed. [Additional Reference(s): DWR Levee Log, 2004 (HLM 0.99). USACE San Joaquin O&M Manual, Unit 7, April 1964, Revised 29 December 2016, (0.99), listed as 36-inch pipe].					
FS Date: 6/23/2020 2:32:00 PM

Top of Levee: view of crown.

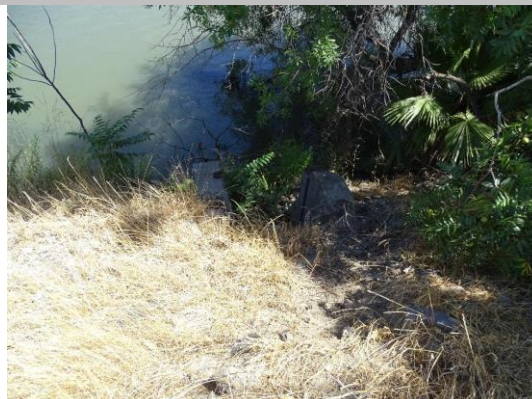
Photo 2 of 3 : UCIP_FA_2023_73982_89288.jpg

Water-Side: view of WS slope.

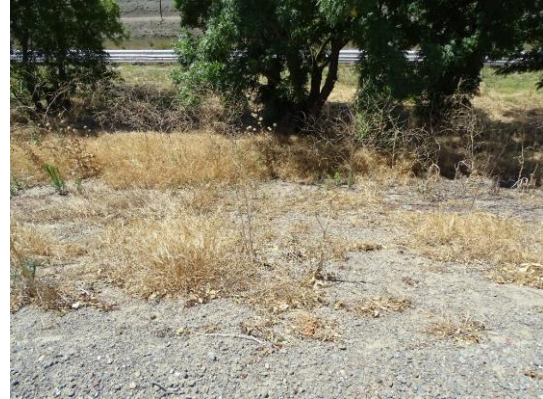
Photo 3 of 3 : UCIP_FA_2023_73982_89289.jpg

LM Start	0.98	Rating **	M	Issue No.	927 (cont)
LM End	0.98	Issue Type +	Ma	Location *	
Category	Supplemental			GPS Latitude/Longitude	
				Start	End
Item	DWR UCIP LMA Responsibility			37.935163°	37.935163°
				-121.331887°	-121.331887°
DWR ID	20598

Land-Side: view of LS slope.

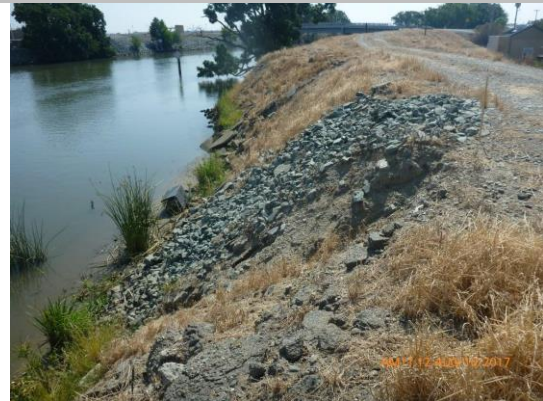
Photo 1 of 1 : LEVAL_FA_2023_536_4109.jpg

LM Start	1.00	Rating **	A/W	Issue No.	198
LM End	1.01	Issue Type +	Ma	Location *	WS
Category	Earthen Levee			GPS Latitude/Longitude	
				Start	End
Item	Erosion / Bank Caving			37.935100°	37.935100°
				-121.331500°	-121.331300°
DWR ID	LMA-442

Fall Inspection 2021: Revetment is present on the waterside toe and there is no active erosion. This was a 2017 Storm Damage Site. Slope protection repairs are needed along the waterside slope due to riprap displacement from high water. Based upon levee inspections, it was determined the waterside levee slope is eroding, deteriorating, and degrading.

There appears to be previous repair site adjacent to LMA-442.

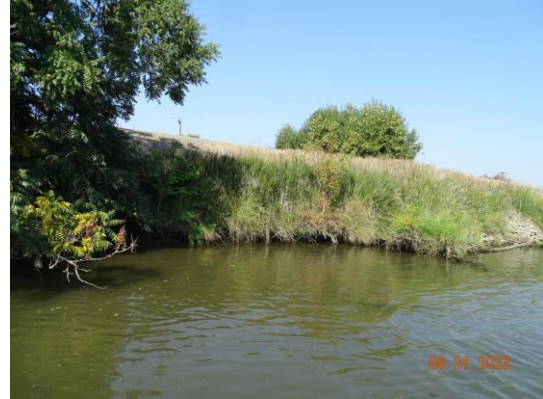
Photo 1 of 2 : SJR2023_RD524U01RM41.79_5.JPG

Comment Code					
Inspector Comment					
Site ID: RD0524U01RM41.79					
8/31/2023: From 2010 to present, no significant changes were observed during the annual survey. Minimal vegetation covers the upper levee slope. The lower slope is covered with medium dense vegetation. Riprap is visible in some areas.					
09/07/2010: Vegetation is visible at the water line. There is an exposed pipe discharge partially hanging at the mid-slope, possibly still used for discharging irrigation/runoff water. There is minimal rip rap protection along the bank, and what's left of it is no longer adequately protecting the bank.					
9/29/2009: Site consists of a 400-foot long eroding bank with minimal vegetation and protection; the existing rip rap has sloughed, rendering it useless; note that there is an exposed section of a pipe.					
10/18/2006: There is extensive loss of rip rap on some sections; sewage disposal pond is on the landside of the levee; there is an exposed pipe outlet "hanging" from the upper slope.

LM Start	1.15	Rating **	U	Issue No.	1 (cont)
LM End	1.23	Issue Type +	Ma	Location *	WS

8/31/2023: View of the erosion from the opposite bank.

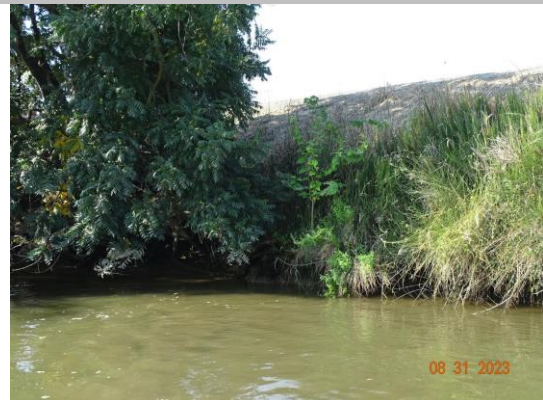
Photo 2 of 2 : SJR2023_RD524U01RM41.79_1.JPG

8/31/2023: Close-up view of the erosion.

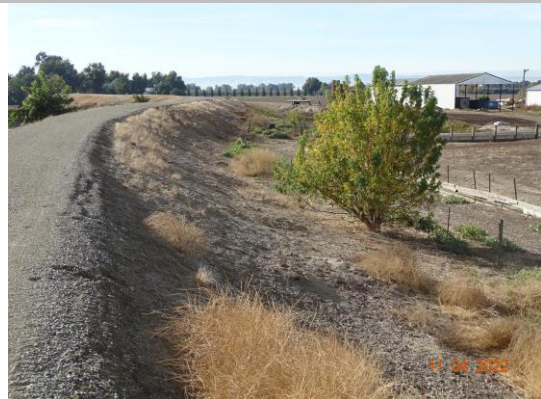
Photo 1 of 1 : FA_2023_RD0524_107_925_20230905_00040.jpg

LM Start	2.94	Rating **	M	Issue No.	925
LM End	3.28	Issue Type +	Ma	Location *	LS
Category	Earthen Levee			GPS Latitude/Longitude	
				Start	End
Item	Animal Control			37.913206°	37.908410°
				-121.324533°	-121.325438°
DWR ID	DWR_RD0524_01_s_2012_925				
Comment Code					
A1 : Exterminate rodents and backfill and compact or grout burrows.					
Inspector Comment					
There are several rodent holes on the levee slope.

View of landside slope with multiple animal burrows. Fall 2022

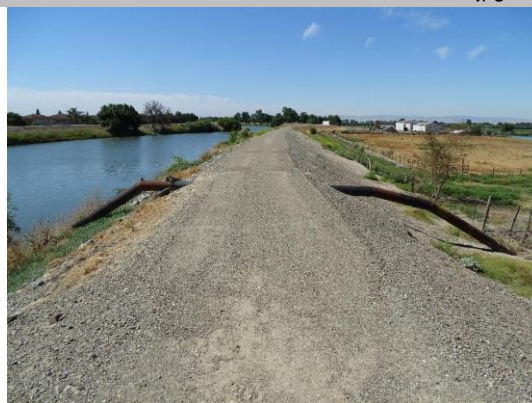
Photo 1 of 3 : UCIP_FA_2023_73984_89412.jpg

Comment Code					
Inspector Comment					
DS_ID:20617 FS_ID:73984 EP_NO: N/A Repair Type: No Action Needed EVAL Issue: Crossing Status: Indicator Found UCIP Comments: 06/24/2020 Record remains No Action Needed. No issues observed during inspection. System Feature. (D.Sanoski - DWR UCIP) 08/20/2013 Review crossing with inspector as records indicate that this should be an 8-inch pipe through levee 3.0 feet below crown, pump on landward side. Siphon breaker on the waterward slope. Originally included in the 1964 O&M manual. (W.Wylie - DWR UCIP) FIELD_STRUCT_DESC: 16-inch wrapped steel storm discharge pipe through the levee, 1.5 feet below the crown. Pump on steel pile structure at drainage canal off landside (LS) toe. [Additional Reference(s): DWR Levee Log, 2004 (HLM 2.99, listed as 8-inch pipe). USACE San Joaquin O&M Manual, Unit 7, April 1964, Revised 29 December 2016, (2.99), listed as 9-inch pipe]. FS Date: 6/24/2020 2:44:00 PM

Overview of Levee: view of crown with pipe through crown.

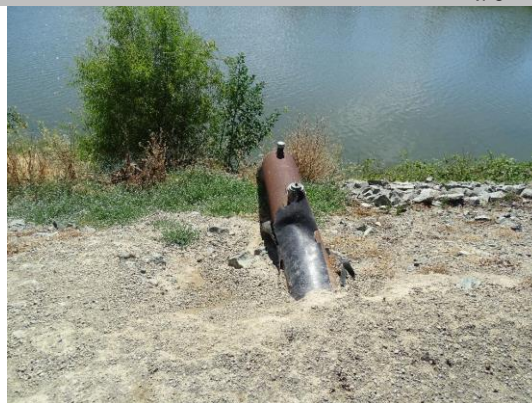
Photo 2 of 3 : UCIP_FA_2023_73984_89413.jpg

Water-Side: view of WS slope with pipe out of slope.

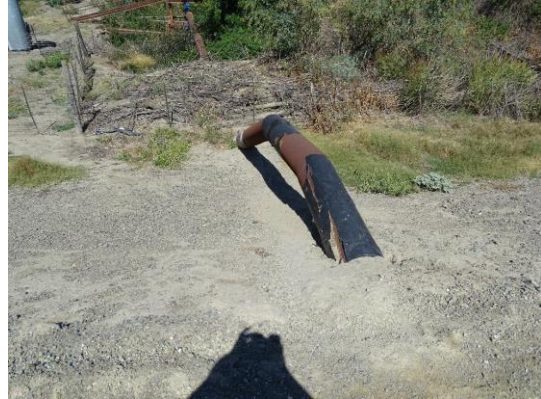
Photo 3 of 3 : UCIP_FA_2023_73984_89414.jpg

LM Start	2.95	Rating **	A/W	Issue No.	928 (cont)
LM End	2.95	Issue Type +	Ma	Location *	
Category	Supplemental			GPS Latitude/Longitude	
				Start	End
Item	DWR UCIP LMA Responsibility			37.913101°	37.913101°
				-121.324500°	-121.324500°
DWR ID	20617

Land-Side: view of LS slope and pipe out of slope.

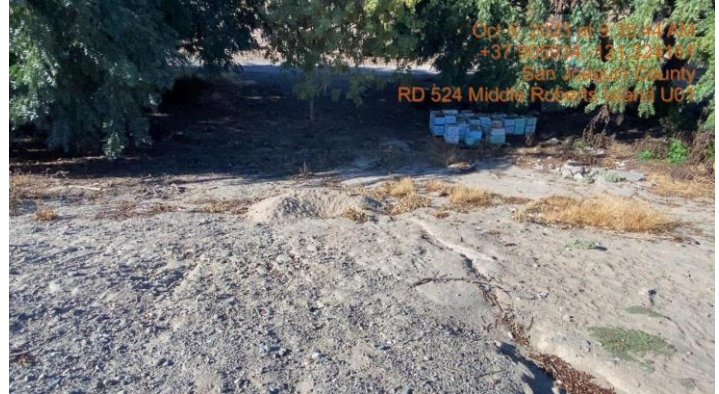
Photo 1 of 1 : FA_2023_RD0524_107_24_20231101_00071.jpg

LM Start	3.48	Rating **	U	Issue No.	24
LM End	3.48	Issue Type +	Ma	Location *	LS
Category	Earthen Levee			GPS Latitude/Longitude	
				Start	End
Item	Animal Control			37.905968°	37.905968°
				-121.324232°	-121.324232°
DWR ID	DWR_RD0524_01_f_2023_24				
Comment Code					
A3 : No rodents visible, but rodent burrows visible; need to backfill and compact or grout burrows.					
Inspector Comment

View of large animal burrow on the landside slope. Fall 2023

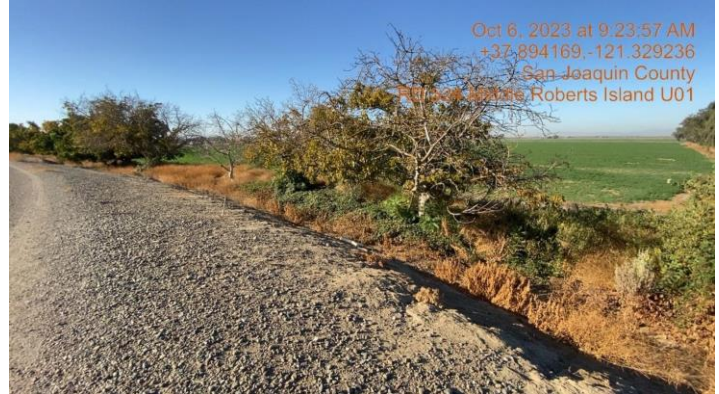
Photo 1 of 1 : FA_2023_RD0524_107_150_20231101_00070.jpg

LM Start	4.38	Rating **	U	Issue No.	150
LM End	4.38	Issue Type +	Ma	Location *	LS
Category	Earthen Levee			GPS Latitude/Longitude	
				Start	End
Item	Vegetation			37.894237°	37.894237°
				-121.329257°	-121.329257°
DWR ID	DWR_RD0524_01_f_2022_150				
Comment Code					
V2 : Remove the wild growth and woody vegetation other than native grasses from the levee slopes.					
Inspector Comment

View of wild vegetation growth along the landside slope and easement.
Fall 2023

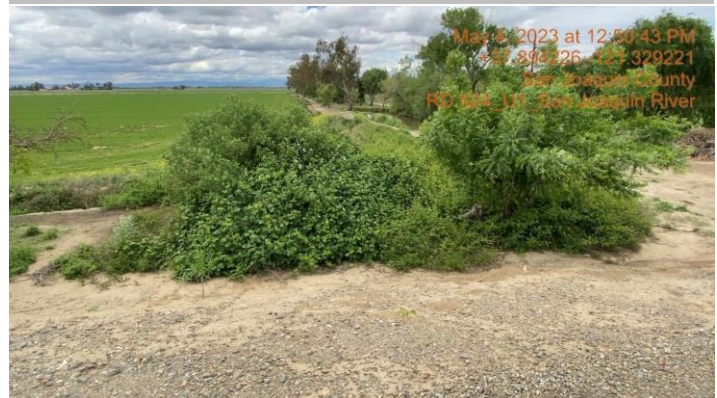
Photo 1 of 1 : FA_2023_RD0524_107_16_20230905_00014.jpg

LM Start	4.55	Rating **	M	Issue No.	16
LM End	4.55	Issue Type +	Ma	Location *	LS
Category	Earthen Levee			GPS Latitude/Longitude	
				Start	End
Item	Trim / Thin Trees			37.891967°	37.891967°
				-121.328256°	-121.328256°
DWR ID	DWR_RD0524_01_s_2023_16				
Comment Code					
T3 : Fallen tree with root ball.					
Inspector Comment

View of fallen tree along the landside slope and easement. Spring 2023

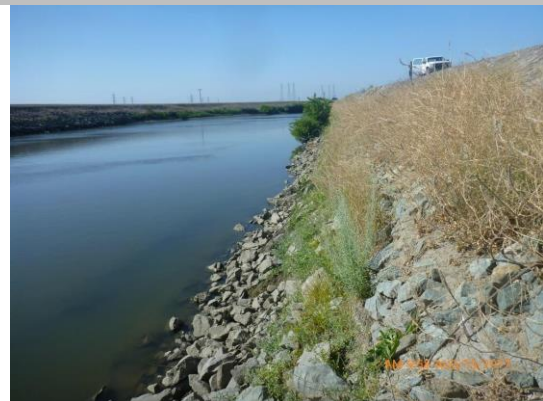
Photo 1 of 1 : LEVAL_FA_2023_523_4217.jpg

LM Start	4.76	Rating **	A/W	Issue No.	236
LM End	4.76	Issue Type +	Ma	Location *	WS
Category	Earthen Levee			GPS Latitude/Longitude	
				Start	End
Item	Erosion / Bank Caving			37.889300°	37.889300°
				-121.329800°	-121.329800°
DWR ID	DWR_RD0524_01_s_2020_236				
Comment Code					
E1 : Note and monitor erosion site.					
Inspector Comment					
This is a 2017 Strom Damage Site, ID No. 523, LMA-429.

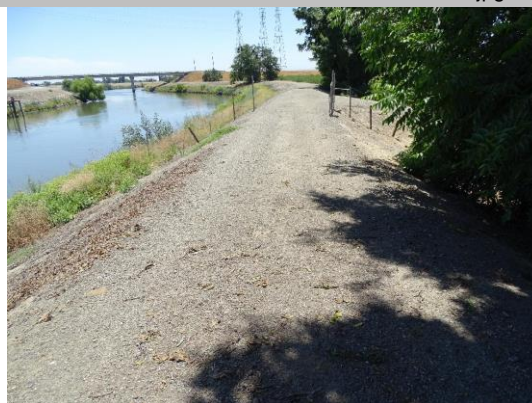
Photo 1 of 3 : UCIP_FA_2023_73986_89484.jpg

Comment Code					
Inspector Comment					
DS_ID:20659 FS_ID:73986 EP_NO: N/A Repair Type: Non-Urgent EVAL Issue: Crossing Status: Not Found UCIP Comments: 06/24/2020 Record updated from No Action Needed to Non-Urgent. Crossing appears to have been removed, but needs to be confirmed. Crossing not found. Limited inspection on LS due to overgrown vegetation. System Feature. (D.Sanoski - DWR UCIP) FIELD_STRUCT_DESC: 10-inch steel drainage pipe through the levee, 6 feet below the crown. Pump on the landside (LS). Flap gate on the waterside (WS) end. [Additional Reference(s): DWR Levee Log, 2004 (HLM 5.48). USACE San Joaquin O&M Manual, Unit 7, April 1964, Revised 29 December 2016, (5.48), listed as 10-inch pipe]. Drawing No. 07-04-1490, Sheet 1490/4, (Station 8+01.3)]. FS Date: 6/24/2020 2:24:00 PM

Top of Levee: view of crown.

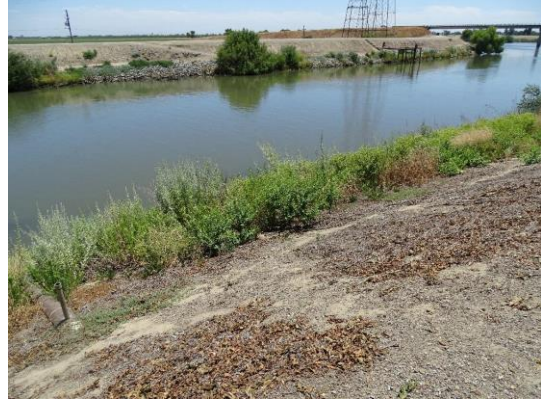
Photo 2 of 3 : UCIP_FA_2023_73986_89485.jpg

Water-Side: view of WS slope.

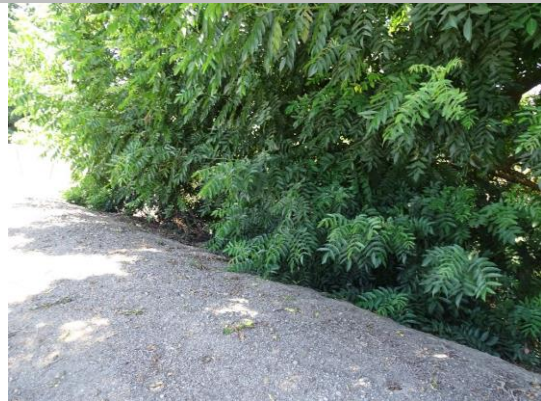
Photo 3 of 3 : UCIP_FA_2023_73986_89486.jpg

Land-Side: view of LS slope.

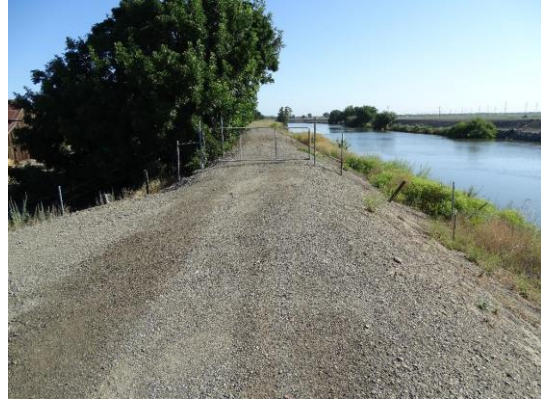
Photo 1 of 3 : UCIP_FA_2023_73987_89490.jpg

Comment Code					
Inspector Comment					
DS_ID:20631 FS_ID:73987 EP_NO: N/A Repair Type: Non-Urgent EVAL Issue: Crossing Status: Found UCIP Comments: 06/25/2020 Record remains Non-Urgent. Limited inspection on LS due to overgrown vegetation. System Feature. (D.Sanoski - DWR UCIP) 08/23/2013 Recent work being done on WS slope. Pipe may still be in use. (W.Wylie - DWR UCIP) FIELD_STRUCT_DESC: 10-inch steel drainage pipe through the levee, 6 feet below the crown. 8-inch pipe sleeved through this pipe. [Additional Reference(s): DWR Levee Log, 2004 (HLM 5.50). USACE San Joaquin O&M Manual, Unit 7, April 1964, Revised 29 December 2016, (5.50), listed as 10-inch pipe]. FS Date: 6/25/2020 2:53:00 PM

Top of Levee: view of crown.

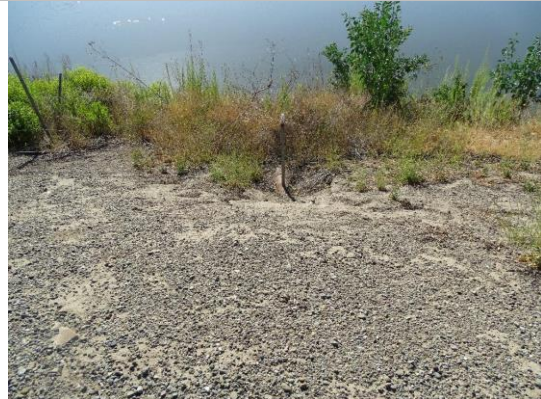
Photo 2 of 3 : UCIP_FA_2023_73987_89491.jpg

Water-Side: view of WS slope and pipe.

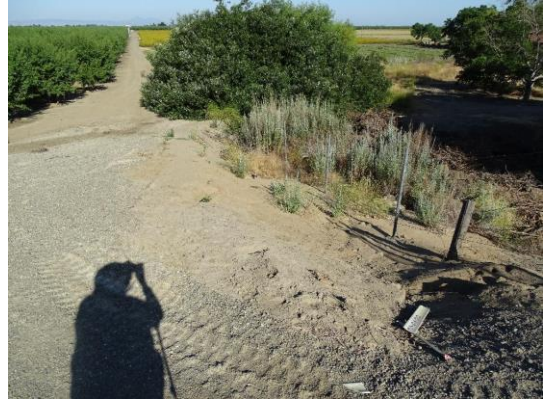
Photo 3 of 3 : UCIP_FA_2023_73987_89492.jpg

Land-Side: view of LS slope with no sign of inlet pipe due to overgrown vegetation limiting inspection.

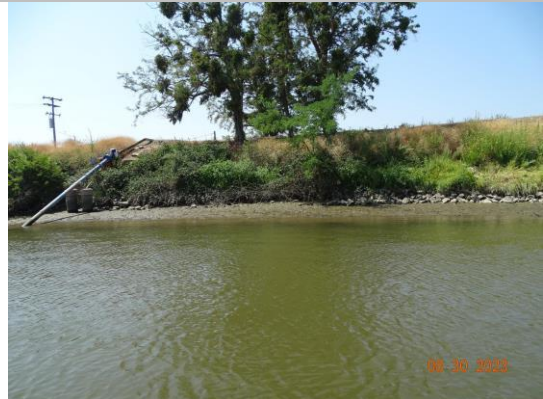
Photo 1 of 2 : SJR2023_RD524U01RM46.06_1.JPG

LM Start	5.53	Rating **	M	Issue No.	2
LM End	5.54	Issue Type +	Ma	Location *	WS
Category	Supplemental		GPS Latitude/Longitude		
			Start	End	
Item	DWR Erosion Survey		37.878798°	37.878798°	
			-121.333111°	-121.333111°	
DWR ID	RD0524U01RM46.06

8/31/2023: From 2021 to present, no significant changes were observed during the annual survey.

09/24/2020: From 2014 to present, no significant changes were observed during the annual survey. Vegetation is limiting the view but undercutting of the levee toe is still visible.

8/31/2023: View of the erosion immediately downstream of an irrigation pipe.

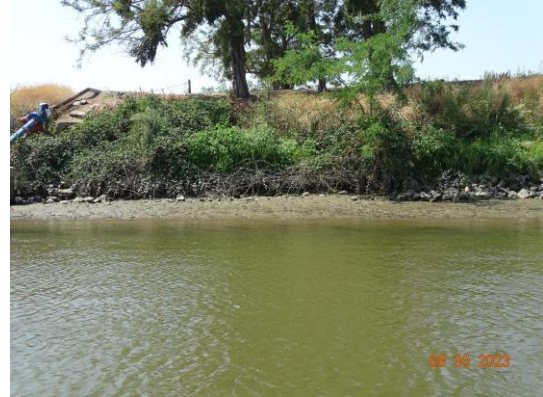
Photo 2 of 2 : SJR2023_RD524U01RM46.06_2.JPG

8/31/2023: Close-up view of the erosion.

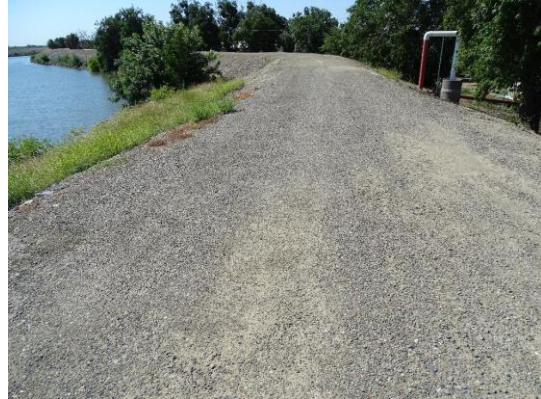
Photo 1 of 3 : UCIP_FA_2023_73988_89618.jpg

Comment Code						
Inspector Comment						
DS_ID:20637 FS_ID:73988 EP_NO: N/A Repair Type: Non-Urgent EVAL Issue: Crossing Status: Not Found UCIP Comments: 06/25/2020 Record updated from No Action Needed to Non-Urgent. Geophysical results did not confirm presence of pipe through levee. Record will remain in UCIP's inspection records until future Levee Improvement Project can confirm no crossing was found through the levee. System Feature. (D.Sanoski - DWR UCIP) FIELD_STRUCT_DESC: 12-inch drainage pipe of an unknown material through the levee, 8 feet below the crown. Concrete box structure on the waterside (WS) slope. [Additional Reference(s): DWR Levee Log, 2004 (HLM 5.91). USACE San Joaquin O&M Manual, Unit 7, April 1964, Revised 29 December 2016, (5.91), listed as 12-inch pipe, abandoned]. FS Date: 6/25/2020 2:57:00 PM

Top of Levee: view of crown.

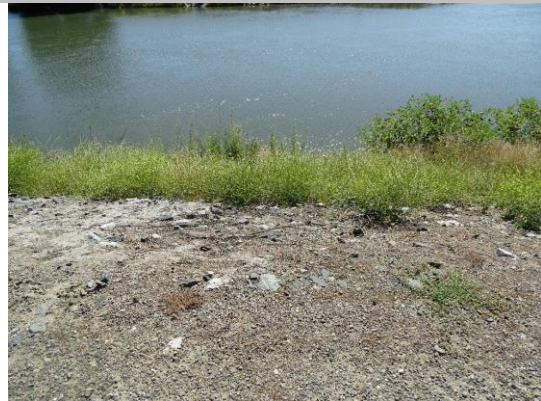
Photo 2 of 3 : UCIP_FA_2023_73988_89619.jpg

Water-Side: view of WS slope with no sign of pipe or concrete structure.

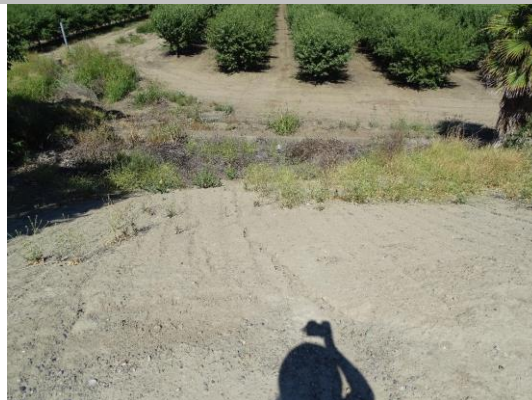
Photo 3 of 3 : UCIP_FA_2023_73988_89620.jpg

Land-Side: view of LS slope with no sign of pipe.

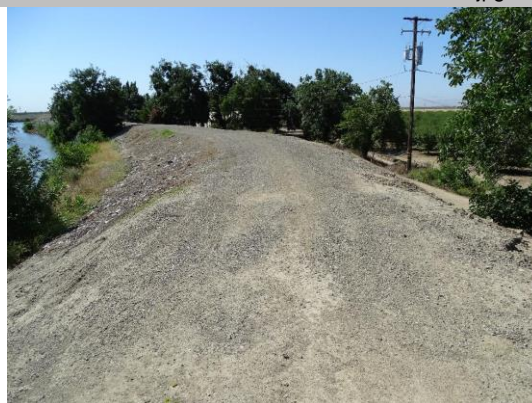
Photo 1 of 3 : UCIP_FA_2023_73989_89624.jpg

DS_ID:20639
FS_ID:73989
EP_NO: N/A
Repair Type: Non-Urgent
EVAL Issue:
Crossing Status: Not Found
UCIP Comments: 06/25/2020 Record updated from No Action Needed to Non-Urgent. Crossing not found. Geophysical results did not confirm presence of pipe through levee. Record will remain in UCIP's inspection records until future Levee Improvement Project can confirm no crossing was found through the levee. System Feature. (D.Sanoski - DWR UCIP)
FIELD_STRUCT_DESC: 21-inch by 21-inch reinforced concrete box drainage culvert through the levee, 20 feet below the crown. Brick distribution box at the toe of the waterside (WS) slope. Concrete distribution box at the toe of the landside (LS) slope. [Additional Reference(s): DWR Levee Log, 2004. USACE San Joaquin O&M Manual 7, April 1964, (HLM 5.94)].
FS Date: 6/25/2020 2:57:00 PM

Top of Levee: view of crown.

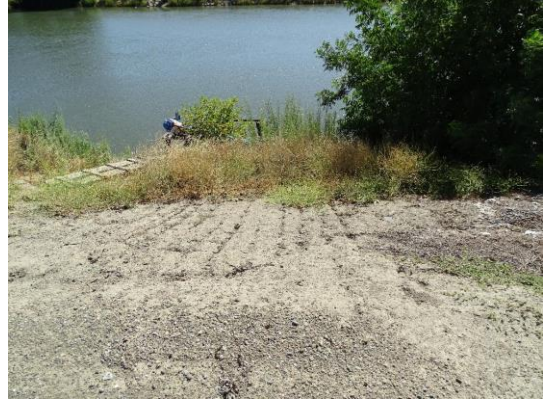
Photo 2 of 3 : UCIP_FA_2023_73989_89625.jpg

Water-Side: view of WS slope with no sign of crossing.

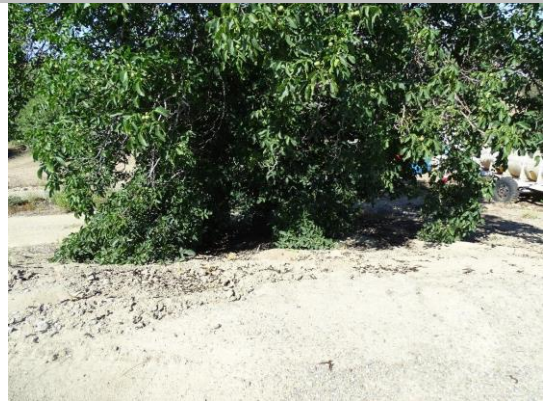
Photo 3 of 3 : UCIP_FA_2023_73989_89626.jpg

Land-Side: view of LS slope with no sign of crossing.

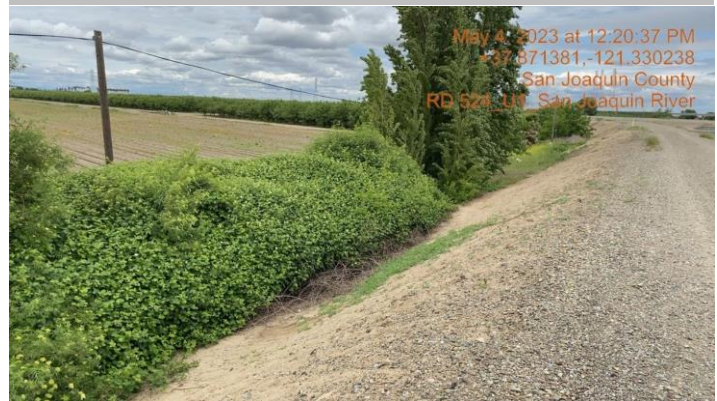
Photo 1 of 1 : FA_2023_RD0524_107_98_20230905_00016.jpg

View of berry bushes and ivy along the landside slope and easement.
Spring 2023

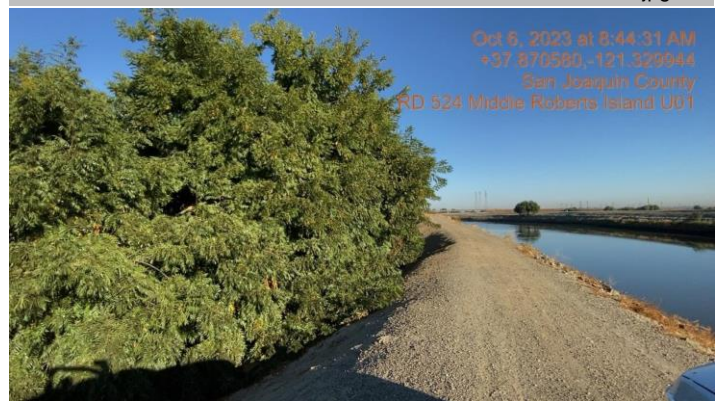
Photo 1 of 1 : FA_2023_RD0524_107_188_20231101_00068.jpg

LM Start	6.16	Rating **	U	Issue No.	188
LM End	6.18	Issue Type +	Ma	Location *	LS
Category	Earthen Levee			GPS Latitude/Longitude	
				Start	End
Item	Trim / Thin Trees			37.870930°	37.870675°
				-121.330048°	-121.329969°
DWR ID	DWR_RD0524_01_f_2021_188				
Comment Code					
T1 : Trim and thin trees to at least five feet above ground level to allow visibility of the ground and room to flood fight.					
Inspector Comment

View of untrimmed trees along the landside slope. Fall 2023
