**Flood Control Project Maintenance
Levee Inspections**

Maintenance Issue Types Only, Levee Inspection Report By Mile - Fall 2024

Reclamation District No. 0524 Middle Roberts Island

Waterway	Bank	Unit Miles	Inspection Start/End	Inspector
Unit No. 01 San Joaquin River	Left	6.20	10/29/2024 10/29/2024	Alberto De Leon

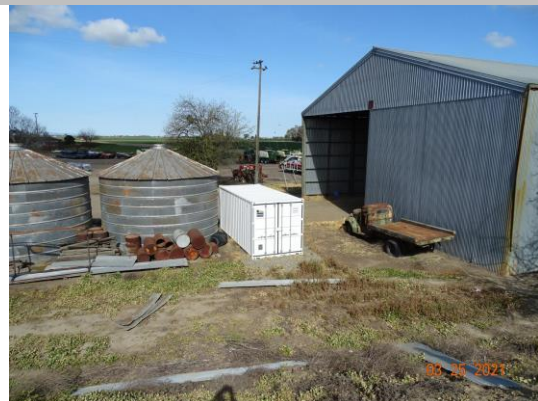
Photo 1 of 1 : FA_2024_RD0524_107_138_20240910_00022.jpg

LM Start	0.00	Rating **	A	Issue No.	138
LM End	0.00	Issue Type +	Ma	Location *	N/A
Category	Earthen Levee		GPS Latitude/Longitude		
			Start	End	
Item	Emergency Supplies & Equipment				
DWR ID	DWR_RD0524_01_s_2013_138				
Comment Code					
ES : Emergency Supplies & Equipment					
Inspector Comment					
The LMA has emergency supplies or equipment stored in a shipping container at LM 4.65, (37.890799, -121.32913).

View of container with Districts Flood Fight Materials. Spring 2021

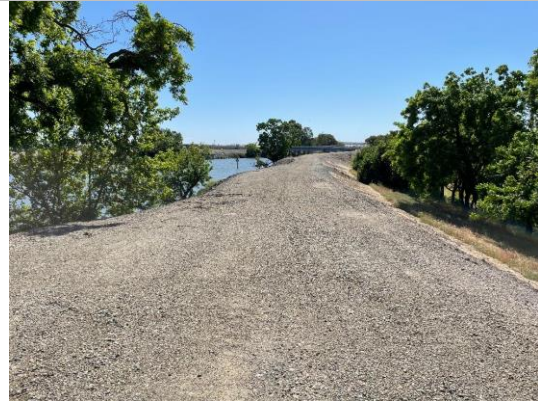
Photo 1 of 3 : UCIP_FA_2024_83469_122088.jpg

Overview of levee crown looking U/S.

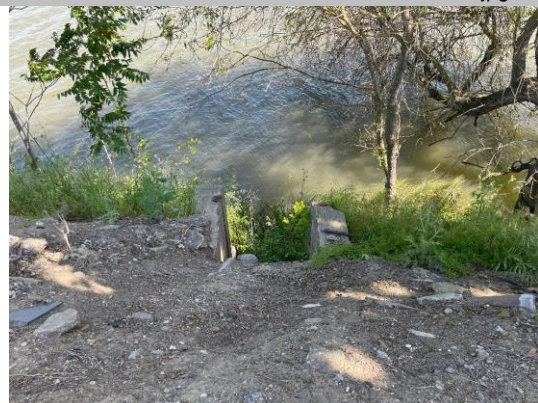
Photo 2 of 3 : UCIP_FA_2024_83469_122089.jpg

WS view: overview of WS slope with the concrete headwall in WS slope.

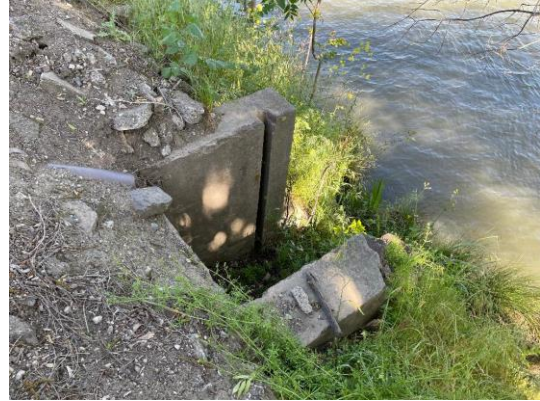
Photo 3 of 3 : UCIP_FA_2024_83469_122090.jpg

Comment Code					
Inspector Comment					
DS_ID:20598 FS_ID:83469 EP_NO: N/A Repair Type: Non-Urgent EVAL Issue: Crossing Status: Found UCIP Comments: 04/29/2024 Record remains Non-Urgent. Pipe is a good candidate for internal pipe inspection. (J. Taylor - DWR UCIP)06/23/2020 Record updated from No Action Needed to Non-Urgent. System Feature. Crossing appears abandoned. (D.Sanoski - DWR UCIP) FIELD_STRUCT_DESC: 36-inch drainage pipe of an unknown material through the levee, 15 feet below the crown. Landside (LS) end is not visible. Concrete headwall at outlet on the waterside (WS) slope is visible. Pipe appears to be abandoned in place. Slide gate on the WS removed. [Additional Reference(s): DWR Levee Log, 2004 (HLM 0.99). USACE San Joaquin O&M Manual, Unit 7, April 1964, Revised 29 December 2016, (0.99), listed as 36-inch pipe]. FS Date: 4/29/2024 12:26:34 PM

WS view: view of concrete headwall. Pipe not safely accessible.

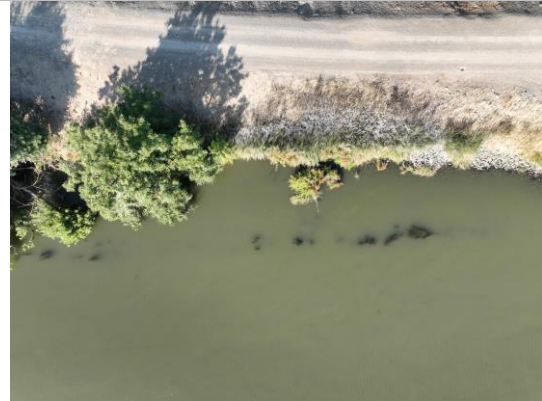
Photo 1 of 1 : SJR2024_RD0524U01RM41.79_1.JPG

Comment Code					
Inspector Comment					
Site ID: RD0524U01RM41.79					
8/9/2024: From 2010 to present, no significant changes were observed during the annual survey. Minimal vegetation covers the upper levee slope. The lower slope is covered with medium dense vegetation. Riprap is visible in some areas.					
09/07/2010: Vegetation is visible at the water line. There is an exposed pipe discharge partially hanging at the mid-slope, possibly still used for discharging irrigation/runoff water. There is minimal rip rap protection along the bank, and what's left of it is no longer adequately protecting the bank.					
9/29/2009: Site consists of a 400-foot long eroding bank with minimal vegetation and protection; the existing rip rap has sloughed, rendering it useless; note that there is an exposed section of a pipe.					
10/18/2006: There is extensive loss of rip rap on some sections; sewage disposal pond is on the landside of the levee; there is an exposed pipe outlet "hanging" from the upper slope.

8/9/2024: Aerial view of the erosion.

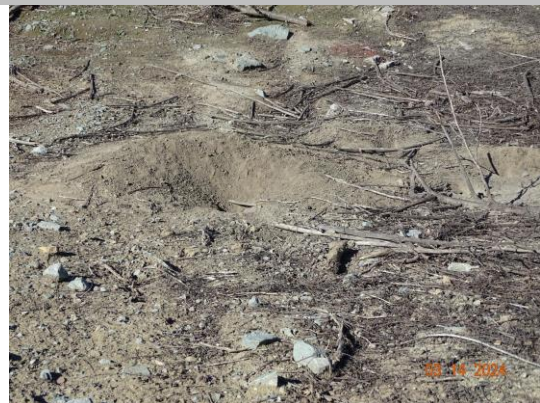
Photo 1 of 1 : FA_2024_RD0524_107_50_20240910_00017.jpg

LM Start	1.29	Rating **	U	Issue No.	50
LM End	1.29	Issue Type +	Ma	Location *	LS
Category	Earthen Levee			GPS Latitude/Longitude	
				Start	End
Item	Animal Control			37.932091°	37.932091°
				-121.328432°	-121.328432°
DWR ID	DWR_RD0524_01_s_2024_50				
Comment Code					
A3 : No rodents visible, but rodent burrows visible; need to backfill and compact or grout burrows.					
Inspector Comment

View of large animal burrow along the landside slope. Spring 2024

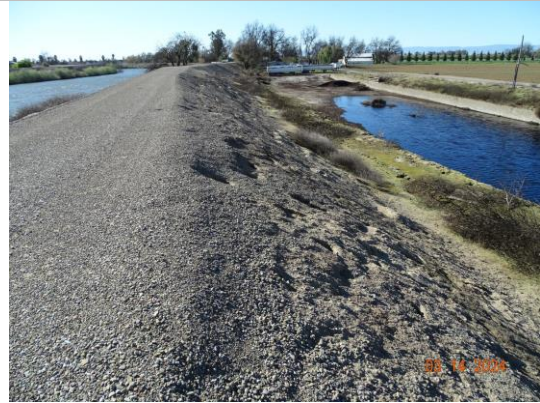
Photo 1 of 1 : FA_2024_RD0524_107_925_20240910_00035.jpg

LM Start	2.94	Rating **	U	Issue No.	925
LM End	3.28	Issue Type +	Ma	Location *	LS
Category	Earthen Levee			GPS Latitude/Longitude	
				Start	End
Item	Animal Control			37.913206°	37.908410°
				-121.324533°	-121.325438°
DWR ID	DWR_RD0524_01_s_2012_925				
Comment Code					
A1 : Exterminate rodents and backfill and compact or grout burrows.					
Inspector Comment					
There are several rodent holes on the levee slope.

View of multiple animal burrows along the landside slope. Spring 2024

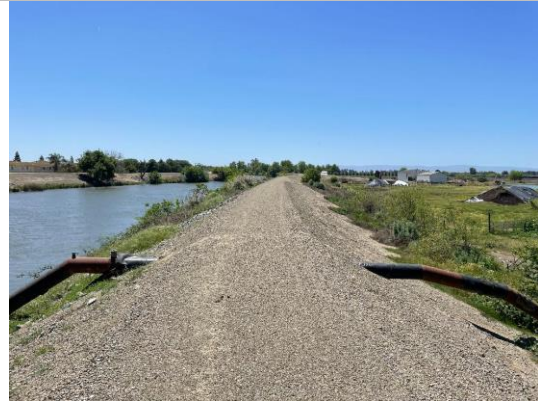
Photo 1 of 3 : UCIP_FA_2024_83695_122789.jpg

Overview of levee crown.

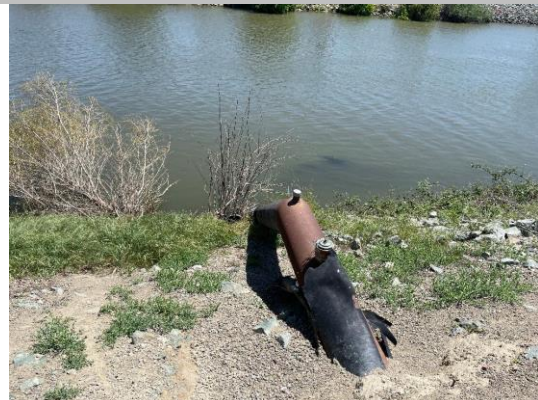
Photo 2 of 3 : UCIP_FA_2024_83695_122790.jpg

WS view: overview of WS slope and channel with pipe visible on slope and entering near WS shoulder.

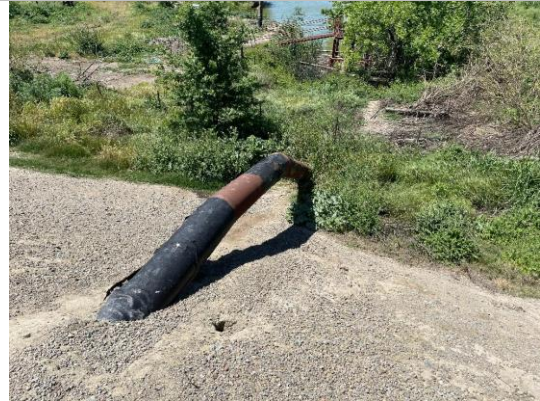
Photo 3 of 3 : UCIP_FA_2024_83695_122791.jpg

LS view: overview of LS slope and toe with pipe visible on slope and entering near LS shoulder.

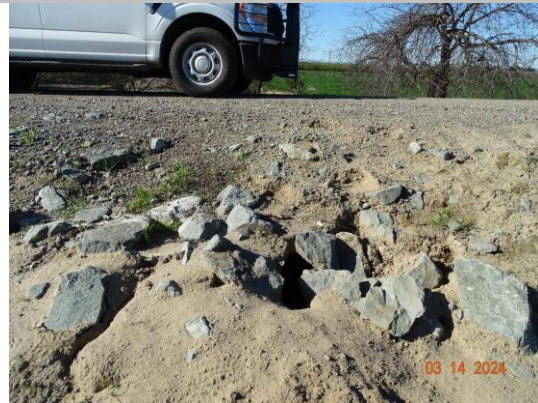
Photo 1 of 1 : FA_2024_RD0524_107_41_20240910_00014.jpg

LM Start	3.49	Rating **	U	Issue No.	41
LM End	3.49	Issue Type +	Ma	Location *	WS
Category	Earthen Levee			GPS Latitude/Longitude	
				Start	End
Item	Animal Control			37.905844°	37.905844°
				-121.324057°	-121.324057°
DWR ID	DWR_RD0524_01_s_2024_41				
Comment Code					
A3 : No rodents visible, but rodent burrows visible; need to backfill and compact or grout burrows.					
Inspector Comment

View of large animal burrow along the waterside slope. Spring 2024

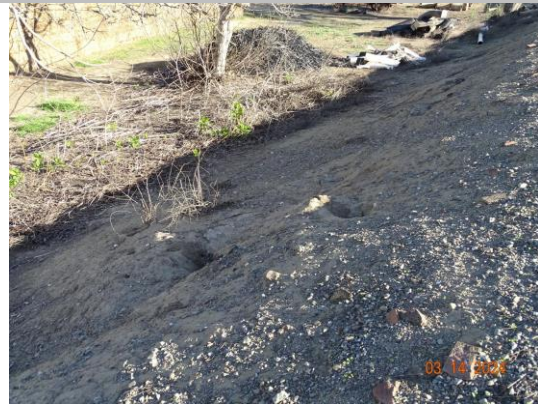
Photo 1 of 1 : FA_2024_RD0524_107_28_20240910_00009.jpg

LM Start	4.63	Rating **	U	Issue No.	28
LM End	4.63	Issue Type +	Ma	Location *	LS
Category	Earthen Levee			GPS Latitude/Longitude	
				Start	End
Item	Animal Control			37.891013°	37.891013°
				-121.328949°	-121.328949°
DWR ID	DWR_RD0524_01_s_2024_28				
Comment Code					
A3 : No rodents visible, but rodent burrows visible; need to backfill and compact or grout burrows.					
Inspector Comment

View of multiple burrow holes along the landside slope. Spring 2024

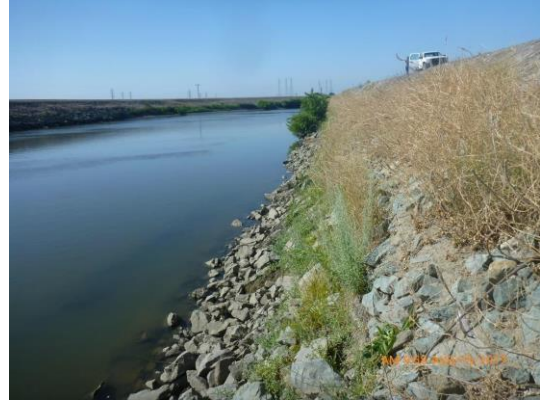
Photo 1 of 2 : LEVAL_FA_2024_523_4217.jpg

LM Start	4.76	Rating **	A/W	Issue No.	236
LM End	4.76	Issue Type +	Ma	Location *	WS
Category	Earthen Levee			GPS Latitude/Longitude	
				Start	End
Item	Erosion / Bank Caving			37.889300°	37.889300°
				-121.329800°	-121.329800°
DWR ID	DWR_RD0524_01_s_2020_236				
Comment Code					
E1 : Note and monitor erosion site.					
Inspector Comment					
This is a 2017 Strom Damage Site, ID No. 523, LMA-429.

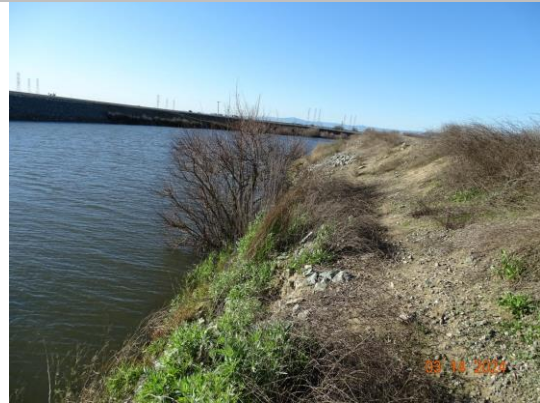
Photo 2 of 2 : FA_2024_RD0524_107_236_20240910_00030.jpg

View of bank erosion looking upstream. Spring 2024

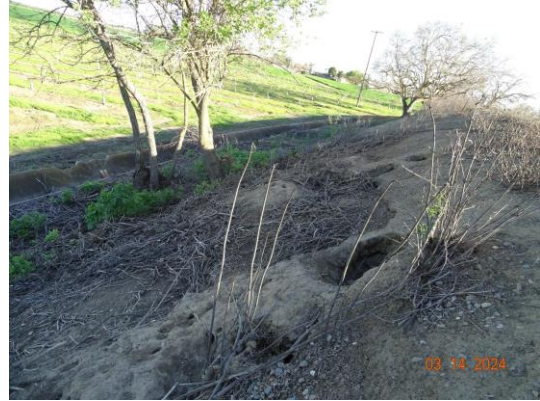
Photo 1 of 1 : FA_2024_RD0524_107_15_20240910_00007.jpg

LM Start	4.94	Rating **	U	Issue No.	15
LM End	4.96	Issue Type +	Ma	Location *	LS
Category	Earthen Levee			GPS Latitude/Longitude	
				Start	End
Item	Animal Control			37.887136°	37.886867°
				-121.331722°	-121.331893°
DWR ID	DWR_RD0524_01_s_2024_15				
Comment Code					
A3 : No rodents visible, but rodent burrows visible; need to backfill and compact or grout burrows.					
Inspector Comment

View of large animal burrow along the landside slope. Spring 2024

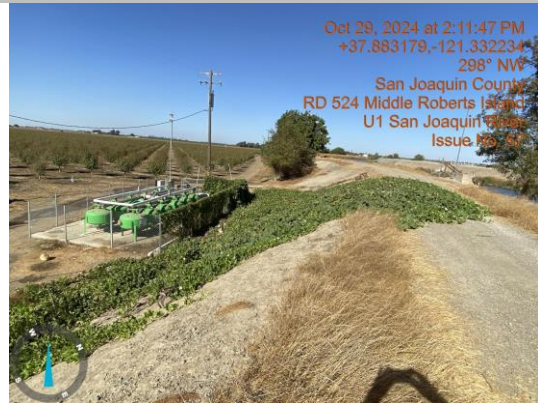
Photo 1 of 1 : FA_2024_RD0524_107_57_20241029_00089.jpg

View of vegetation on the landside slope and easement. Fall 2024

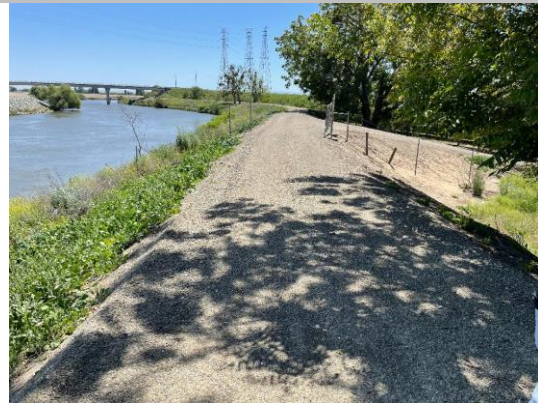
Photo 1 of 3 : UCIP_FA_2024_84030_122993.jpg

Overview of levee crown.

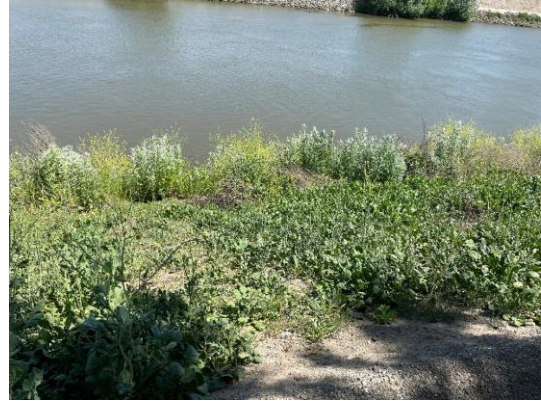
Photo 2 of 3 : UCIP_FA_2024_84030_122994.jpg

WS view: overview of WS slope and channel.

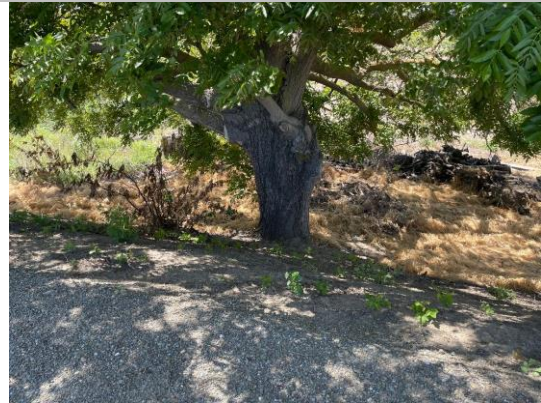
Photo 3 of 3 : UCIP_FA_2024_84030_122995.jpg

LS view: overview of LS slope and toe.

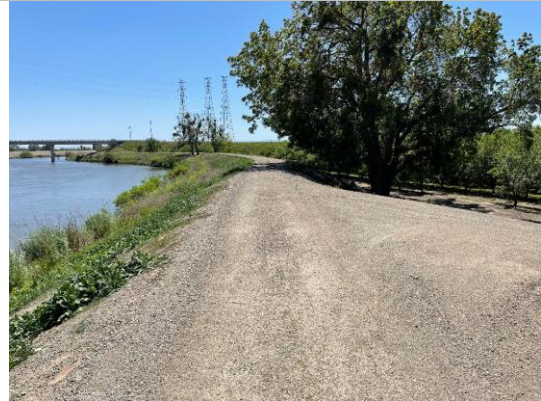
Photo 1 of 3 : UCIP_FA_2024_83784_122996.jpg

Overview of levee crown.

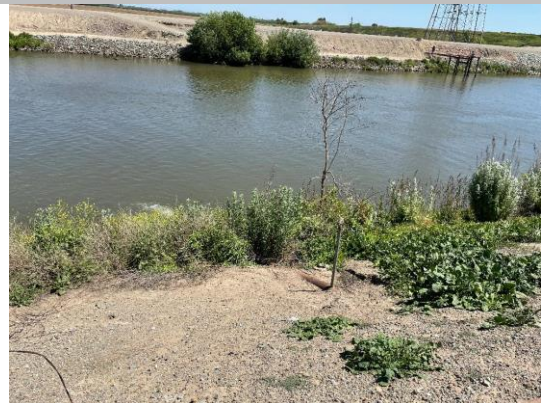
Photo 2 of 3 : UCIP_FA_2024_83784_122997.jpg

WS view: overview of WS slope and channel. Pipe visible on WS shoulder with siphon breaker. Pipe actively discharging into channel.

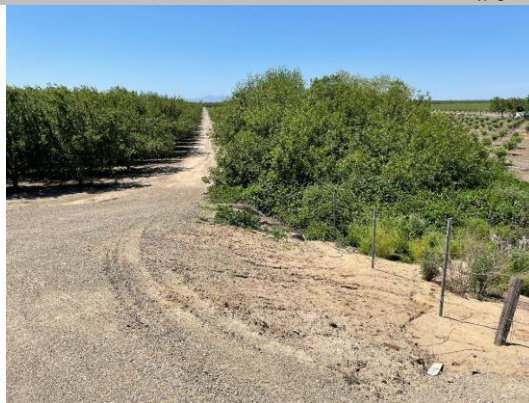
Photo 3 of 3 : UCIP_FA_2024_83784_122998.jpg

LS view: overview of LS slope and toe.

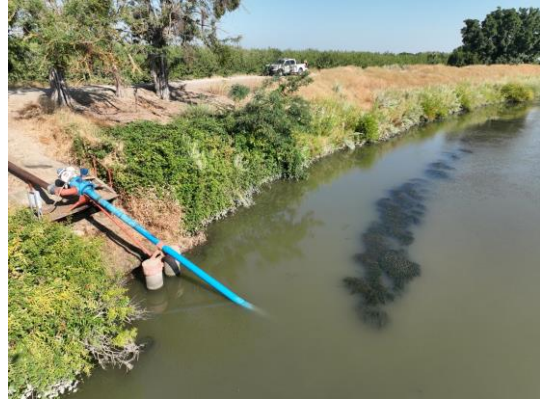
Photo 1 of 2 : SJR2024_RD0524U01RM46.06_4.JPG

8/9/2024: Aerial view of the erosion.

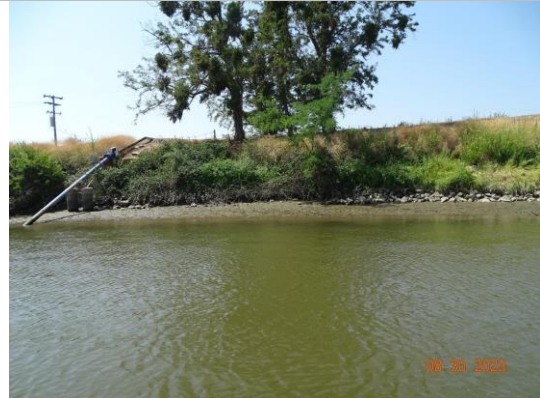
Photo 2 of 2 : SJR2024_RD0524U01RM46.06_7.JPG

8/31/2023: View of the erosion immediately downstream of an irrigation pipe.

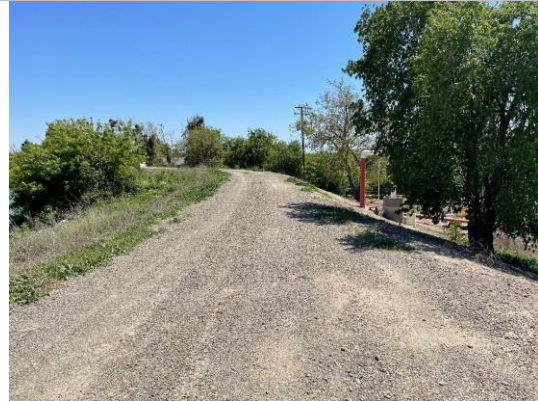
Photo 1 of 3 : UCIP_FA_2024_83813_123056.jpg

Overview of levee crown.

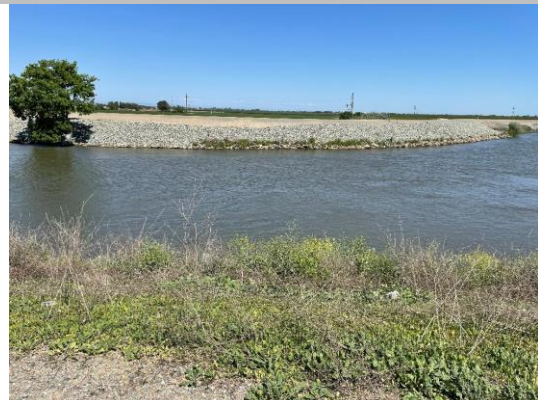
Photo 2 of 3 : UCIP_FA_2024_83813_123057.jpg

WS view: overview of WS slope and channel.

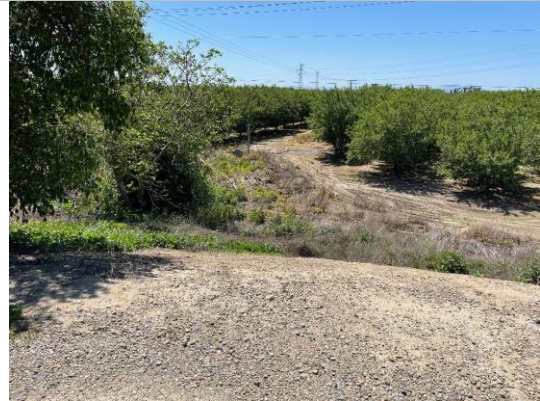
Photo 3 of 3 : UCIP_FA_2024_83813_123058.jpg

LS view: overview of LS slope and toe.

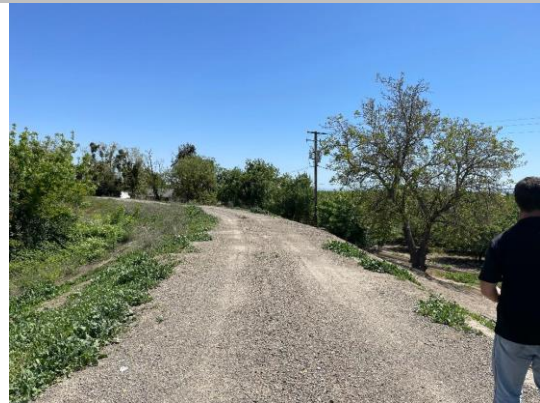
Photo 1 of 3 : UCIP_FA_2024_83816_123063.jpg

Overview of levee crown.

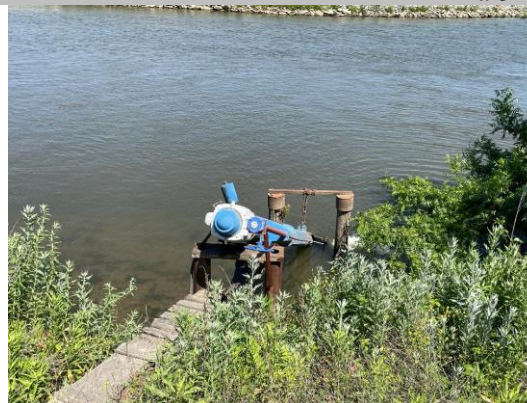
Photo 2 of 3 : UCIP_FA_2024_83816_123064.jpg

WS view: overview of WS slope and channel.

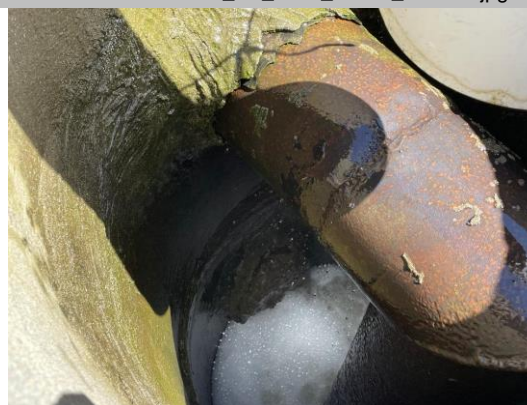
Photo 3 of 3 : UCIP_FA_2024_83816_123065.jpg

LS view: inside concrete riser on LS toe. Grouted pipe under visible pipe.

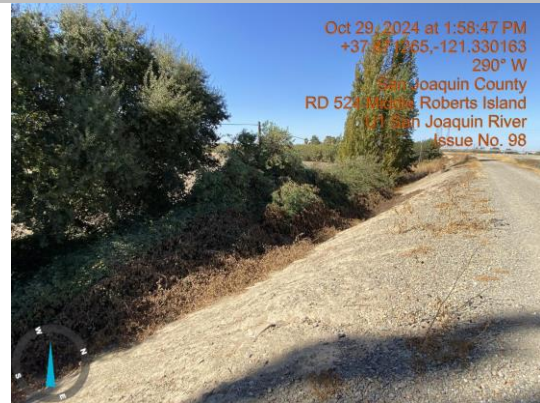
Photo 1 of 1 : FA_2024_RD0524_107_98_20241029_00088.jpg

View of berry bushes and ivy along the landside slope and easement.
Fall 2024

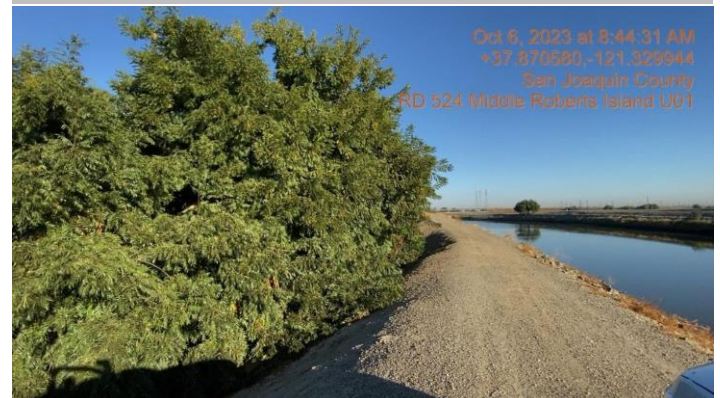
Photo 1 of 1 : FA_2024_RD0524_107_188_20240910_00025.jpg

LM Start	6.16	Rating **	U	Issue No.	188
LM End	6.18	Issue Type +	Ma	Location *	LS
Category	Earthen Levee			GPS Latitude/Longitude	
				Start	End
Item	Trim / Thin Trees			37.870930°	37.870675°
				-121.330048°	-121.329969°
DWR ID	DWR_RD0524_01_f_2021_188				
Comment Code					
T1 : Trim and thin trees to at least five feet above ground level to allow visibility of the ground and room to flood fight.					
Inspector Comment

View of untrimmed trees along the landside slope. Fall 2023
