**Flood Control Project Maintenance  
Levee Inspections**

## Maintenance Issue Types Only, Levee Inspection Report By Mile - Spring 2015

### Reclamation District No. 0524 Middle Roberts Island

Waterway		Bank	Unit Miles	Inspection Start/End	Inspector
Unit No. 01 San Joaquin River		Left	6.20	04/21/2015 04/21/2015	Richard Willoughby

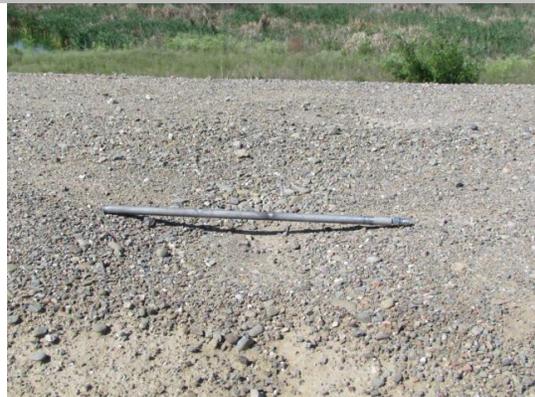
Photo 1 of 3 : SP\_2015\_RD0524\_107\_3\_20150309\_00006.jpg

LM Start	<b>0.21</b>	Rating **	M	Issue No.	<b>3</b>
LM End	<b>0.21</b>	Issue Type +	Ma	Location *	CR
Category	Earthen Levee			GPS Latitude/Longitude	
				Start	End
Item	Crown Surface / Depressions / Rutting			37.938890 °	37.938890 °
				-121.343657 °	-121.343657 °
DWR ID	DWR_RD0524_01_s_2012_3				
Action/Comments					
Repair depressions or ruts in the crown or slope. Inspector Comments: No change in status.

Looking west at 3" depression on levee crown. (Spring 2012)

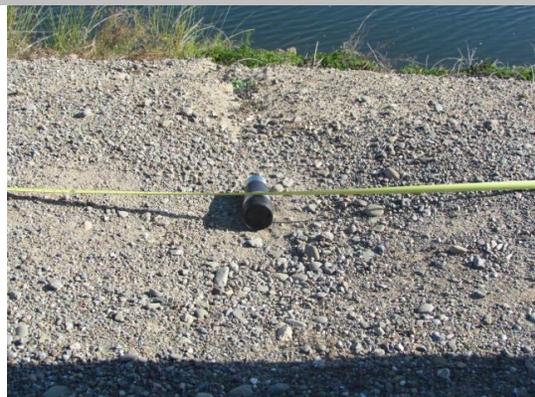
Photo 2 of 3 : SP\_2015\_RD0524\_107\_3\_20150309\_00007.jpg

Looking west at depression on levee crown near waterward shoulder.

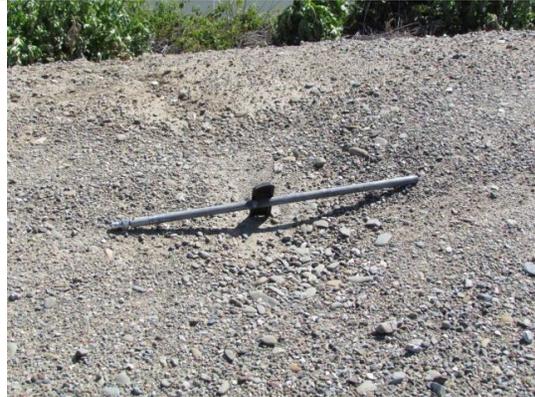
Photo 3 of 3 : SP\_2015\_RD0524\_107\_3\_20150309\_00008.jpg

Looking east at 3" depression on levee crown. (Spring 2012)

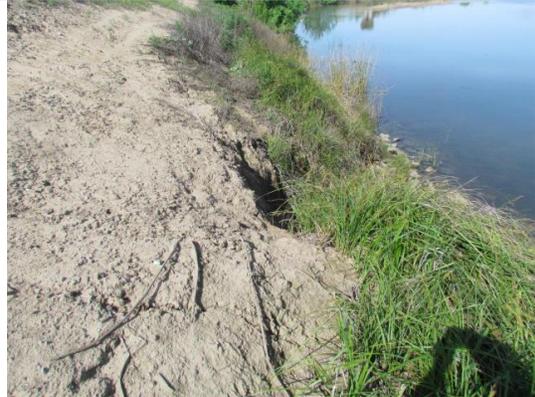
Photo 2 of 2 : SP\_2015\_RD0524\_107\_180\_20150309\_00148.jpg

LM Start	<b>0.34</b>	Rating **	M	Issue No.	<b>180 (cont)</b>
LM End	<b>0.34</b>	Issue Type +	Ma	Location *	WS
Category	Earthen Levee			GPS Latitude/Longitude	
				Start	End
Item	Erosion / Bank Caving			37.938461 °	37.938461 °
				-121.341626 °	-121.341626 °
DWR ID	DWR_RD0524_01_s_2014_180				
Action/Comments					
Schedule repair of erosion site prior to the next inspection. Inspector Comments: Erosion is located along the lower level of waterward slope.

Looking northeast at erosion on waterward toe.

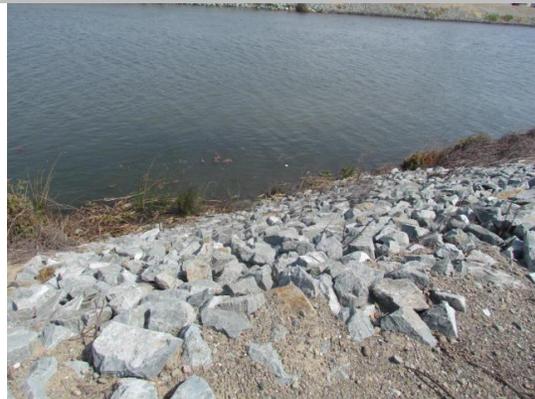
Photo 1 of 2 : SP\_2015\_RD0524\_107\_131\_20150424\_00206.jpg

LM Start	<b>0.40</b>	Rating **	U	Issue No.	<b>131</b>
LM End	<b>0.40</b>	Issue Type +	Ma	Location *	WS
Category	Supplemental			GPS Latitude/Longitude	
				Start	End
Item	DWR Erosion Survey			37.938870 °	37.938870 °
				-121.340460 °	-121.340460 °
DWR ID	DWR_RD0524_01_s_2015_131				
Action/Comments					
Inspector Comments: 6/19/2014: No significant change observed. 08/13/2013: No significant change at this site. 8/7/2012: The erosion is at the upper levee slope, and likely caused by slope slip. The lower levee slope is covered with dense vegetation. [2014 Site ID:RD0524U01RM40.99] 4/21/2015 Site repaired.

Looking east at repaired site.

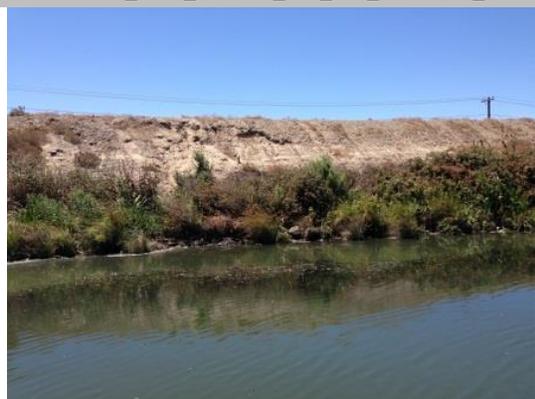
Photo 2 of 2 : SP\_2015\_RD0524\_107\_131\_20150309\_00130.jpg

Front view of the erosion site. Note the vegetation at the levee toe and lower slope.

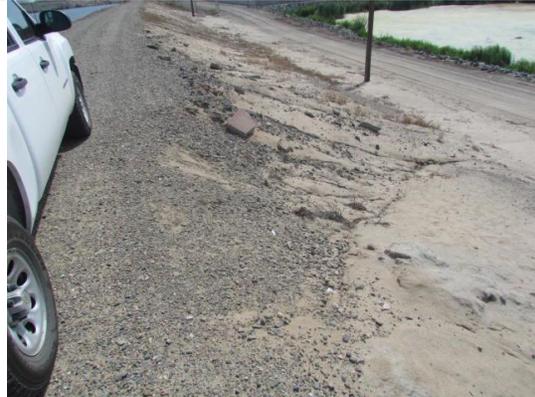
Photo 1 of 2 : SP\_2015\_RD0524\_107\_170\_20150424\_00207.jpg

LM Start	<b>0.41</b>	Rating **	M	Issue No.	<b>170</b>
LM End	<b>0.65</b>	Issue Type +	Ma	Location *	WS
Category	Earthen Levee			GPS Latitude/Longitude	
				Start	End
Item	Slope Stability			37.938628 °	37.938015 °
				-121.340385 °	-121.336165 °
DWR ID	DWR_RD0524_01_s_2015_170				
Action/Comments					
Repair slope instability. Inspector Comments: Several slope instabilities within this reach.

Looking south at slope damage on waterward shoulder.

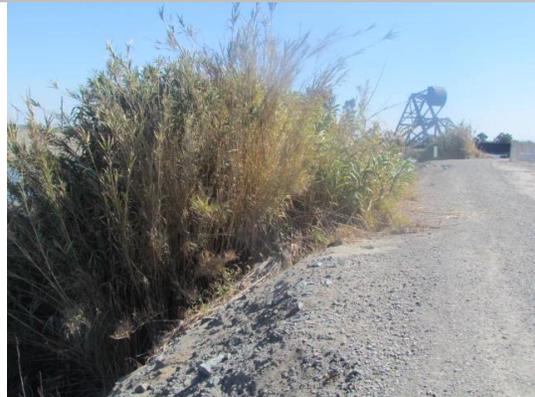
Photo 3 of 3 : SP\_2015\_RD0524\_107\_11\_20150309\_00015.jpg

Looking south at bamboo on waterside slope. (Fall Inspection 2012)

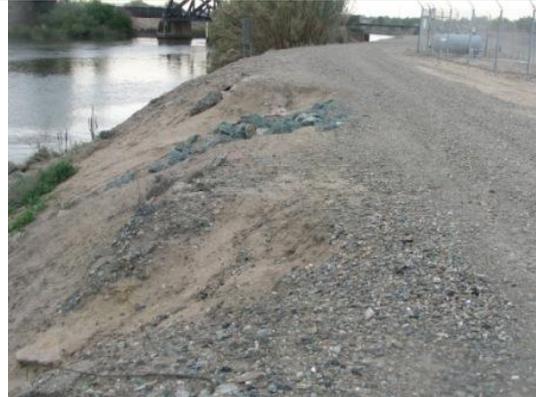
Photo 1 of 3 : SP\_2015\_RD0524\_107\_13\_20150309\_00017.jpg

LM Start	<b>0.64</b>	Rating **	M	Issue No.	<b>13</b>
LM End	<b>0.65</b>	Issue Type +	Ma	Location *	WS
Category	Earthen Levee		GPS Latitude/Longitude		
			Start	End	
Item	Slope Stability		37.938105 °	37.938023 °	
			-121.336288 °	-121.336173 °	
DWR ID	DWR_RD0524_01_s_2012_13				
Action/Comments					
Repair slope instability. Inspector Comments: Erosion extends from mid levee slope to shoulder.

View of the erosion.

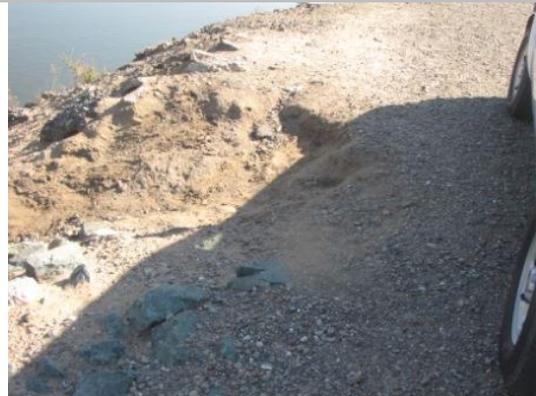
Photo 3 of 3 : SP\_2015\_RD0524\_107\_13\_20150309\_00019.jpg

Update view of the erosion site.

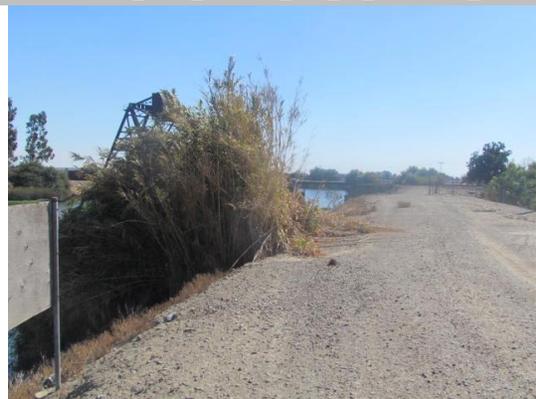
Photo 3 of 3 : SP\_2015\_RD0524\_107\_14\_20150309\_00022.jpg

Looking south at bamboo on waterside slope. (Fall 2012)

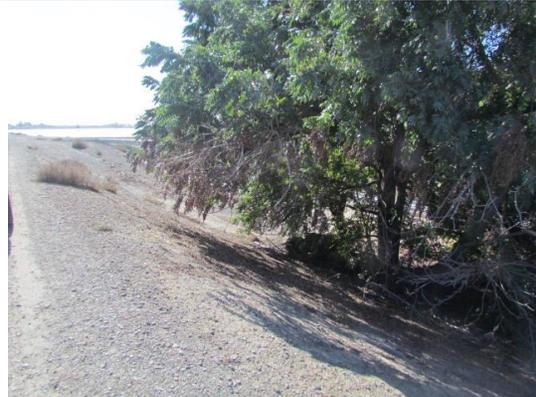
Photo 1 of 1 : SP\_2015\_RD0524\_107\_76\_20150309\_00088.jpg

Looking southwest at low hanging tree branches at landside toe.

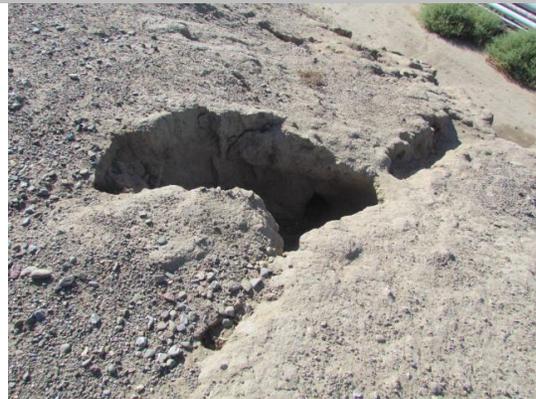
Photo 1 of 5 : SP\_2015\_RD0524\_107\_2\_20150309\_00001.jpg

LM Start	<b>0.81</b>	Rating **	U	Issue No.	<b>2</b>
LM End	<b>0.81</b>	Issue Type +	Ma	Location *	LS
Category	Earthen Levee			GPS Latitude/Longitude	
				Start	End
Item	Erosion / Bank Caving			37.936093 °	37.936004 °
				-121.334648 °	-121.334615 °
DWR ID	DWR_RD0524_01_f_2013_2				
Action/Comments					
Schedule repair of erosion site prior to the next inspection. Inspector Comments: Several holes and finger erosions on landward slope.

Looking southwest at hole on landward shoulder.

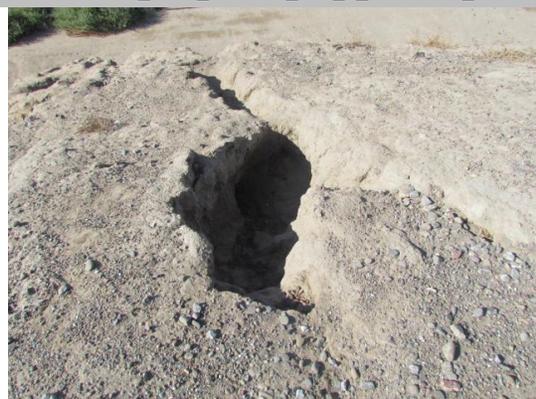
Photo 2 of 5 : SP\_2015\_RD0524\_107\_2\_20150309\_00002.jpg

Looking west at hole on landward shoulder.

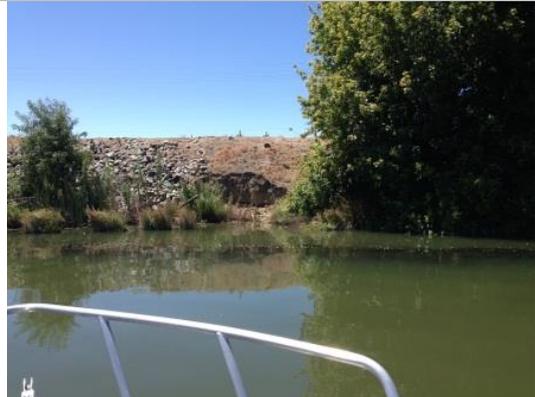
Photo 1 of 1 : SP\_2015\_RD0524\_107\_134\_20150309\_00133.jpg

LM Start	<b>0.91</b>	Rating **	U	Issue No.	<b>134</b>
LM End	<b>0.91</b>	Issue Type +	Ma	Location *	WS
Category	Supplemental			GPS Latitude/Longitude	
				Start	End
Item	DWR Erosion Survey			37.935576 °	37.935576 °
				-121.333202 °	-121.333202 °
DWR ID	DWR_RD0524_01_s_2015_134				
Action/Comments					
Inspector Comments: 6/19/2014: No significant change observed. 08/13/2013: No significant change at this site. 08/07/2012: The site has been visited by boat survey. No significant change observed. 08/23/2011: The erosion site is immediately downstream of the riprap protection. [2014 Site ID:RD0524U01RM41.5]

Front view of the erosion. Note the riprap protection near the site.

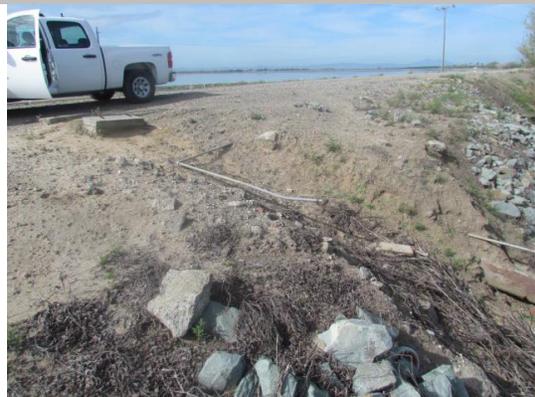
Photo 1 of 1 : SP\_2015\_RD0524\_107\_122\_20150309\_00124.jpg

Looking northwest at inch and half metal pipe on waterward slope.

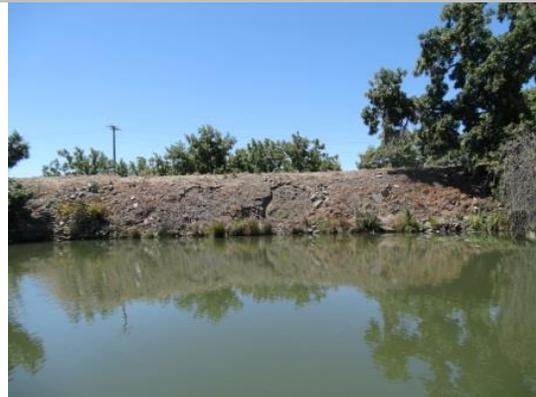
Photo 1 of 1 : SP\_2015\_RD0524\_107\_135\_20150309\_00134.jpg

LM Start	<b>1.00</b>	Rating **	U	Issue No.	<b>135</b>
LM End	<b>1.00</b>	Issue Type +	Ma	Location *	WS
Category	Supplemental			GPS Latitude/Longitude	
				Start	End
Item	DWR Erosion Survey			37.935410 °	37.935410 °
				-121.331560 °	-121.331560 °
DWR ID	DWR_RD0524_01_s_2015_135				
Action/Comments					
Inspector Comments: 6/19/2014: No significant change observed. 08/13/2013: No significant change at this site. 08/07/2012: The erosion was discovered during the boat survey. [2014 Site ID:RD0524U01RM41.58]

Close view of the erosion.

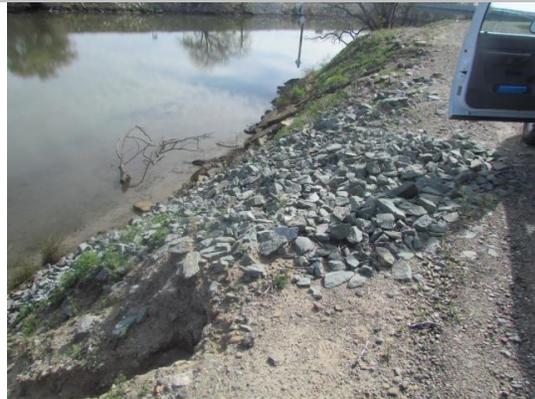
Photo 2 of 3 : SP\_2015\_RD0524\_107\_17\_20150309\_00024.jpg

Looking southeast at erosion next to repaired site on waterward slope (Spring 2013)

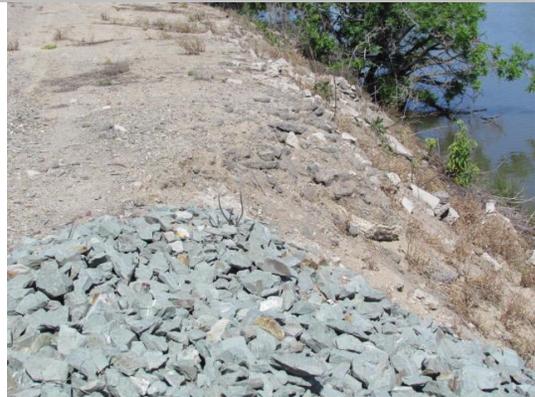
Photo 3 of 3 : SP\_2015\_RD0524\_107\_17\_20150309\_00025.jpg

Looking north at erosion site next to repaired site. (Spring 2012)

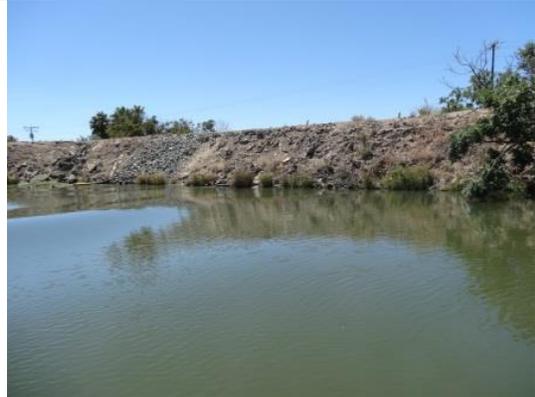
Photo 1 of 1 : SP\_2015\_RD0524\_107\_139\_20150309\_00136.jpg

LM Start	<b>1.00</b>	Rating **	U	Issue No.	<b>139</b>
LM End	<b>1.00</b>	Issue Type +	Ma	Location *	WS
Category	Supplemental			GPS Latitude/Longitude	
				Start	End
Item	DWR Erosion Survey			37.935326 °	37.935326 °
				-121.331537 °	-121.331537 °
DWR ID	DWR_RD0524_01_s_2015_139				
Action/Comments					
Inspector Comments: 6/19/2014: No significant change observed. 08/13/2013: No significant change at this site. 08/07/2012: The site has been visited by boat survey. Site has been repaired, but new erosion occurred at the levee slope and immediately upstream of the repaired site. 08/23/2011: The site is about 500 ft downstream of bridge. The levee

Front view of the site.

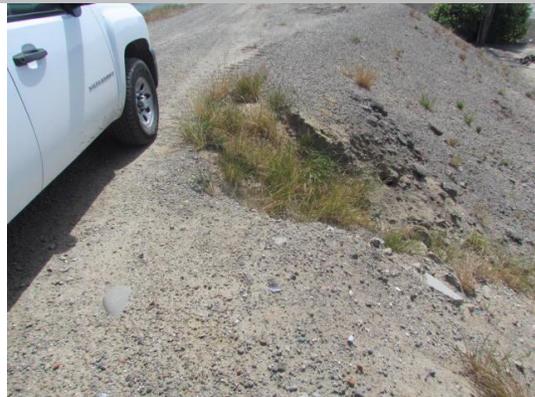
Photo 1 of 6 : SP\_2015\_RD0524\_107\_18\_20150424\_00209.jpg

LM Start	<b>1.08</b>	Rating **	M	Issue No.	<b>18</b>
LM End	<b>1.08</b>	Issue Type +	Ma	Location *	LS
Category	Earthen Levee			GPS Latitude/Longitude	
				Start	End
Item	Slope Stability			37.934645 °	37.934645 °
				-121.330310 °	-121.330310 °
DWR ID	DWR_RD0524_01_s_2012_18				
Action/Comments					
Repair slope instability. Inspector Comments: Slope damage extend from shoulder to middle of slope.

Looking south at caving on landward shoulder. (Spring 2015)

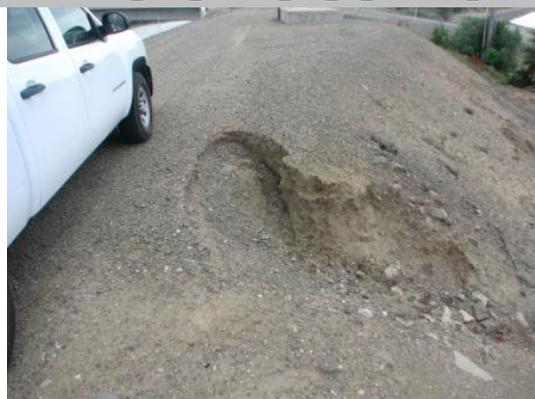
Photo 2 of 6 : SP\_2015\_RD0524\_107\_18\_20150309\_00026.jpg

Landward slope damage.

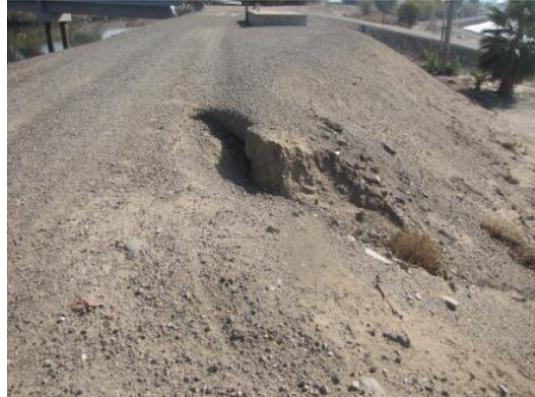
Photo 3 of 6 : SP\_2015\_RD0524\_107\_18\_20150309\_00027.jpg

LM Start	<b>1.08</b>	Rating **	M	Issue No.	<b>18 (cont)</b>
LM End	<b>1.08</b>	Issue Type +	Ma	Location *	LS
Category	Earthen Levee			GPS Latitude/Longitude	
				Start	End
Item	Slope Stability			37.934645 °	37.934645 °
				-121.330310 °	-121.330310 °
DWR ID	DWR_RD0524_01_s_2012_18				
Action/Comments					
Repair slope instability. Inspector Comments: Slope damage extend from shoulder to middle of slope.

Updated picture of the erosion site on the landside shoulder.

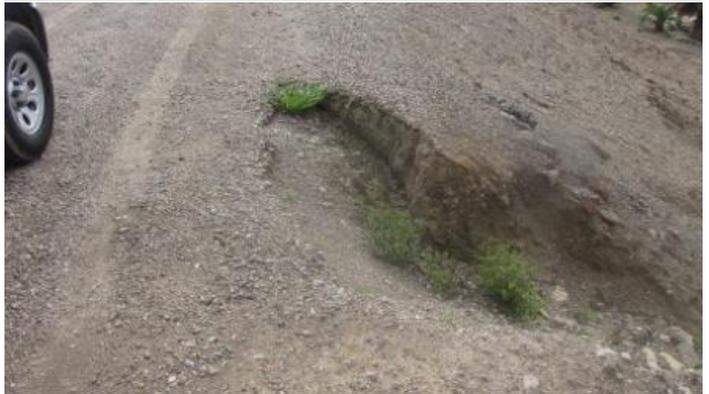
Photo 5 of 6 : SP\_2015\_RD0524\_107\_18\_20150309\_00029.jpg

Looking at updated slope stability as of 4/2010.

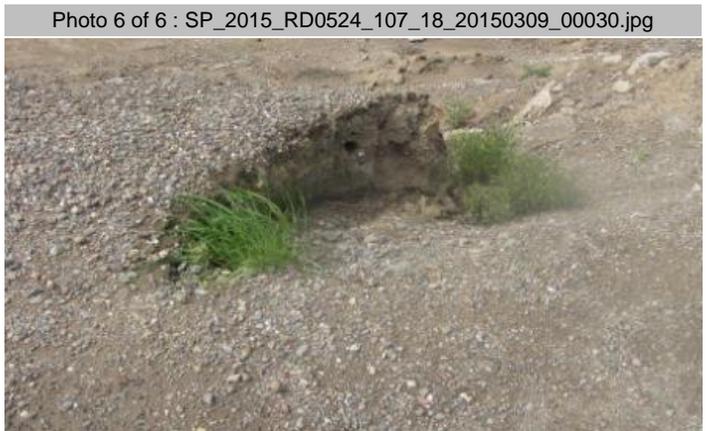
LM Start	<b>1.08</b>	Rating **	M	Issue No.	<b>18 (cont)</b>
LM End	<b>1.08</b>	Issue Type +	Ma	Location *	LS
Category	Earthen Levee			GPS Latitude/Longitude	
				Start	End
Item	Slope Stability			37.934645 °	37.934645 °
				-121.330310 °	-121.330310 °
DWR ID	DWR_RD0524_01_s_2012_18				
Action/Comments					
Repair slope instability. Inspector Comments: Slope damage extend from shoulder to middle of slope.

Updated view from above the slope stability.

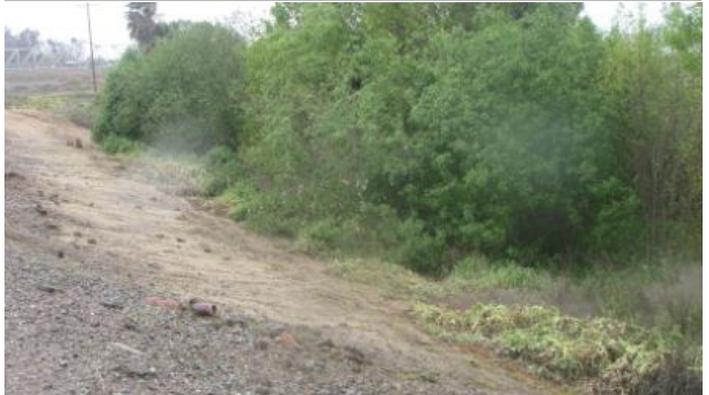
Photo 1 of 1 : SP\_2015\_RD0524\_107\_915\_20150309\_00164.jpg

Looking southwest at dense veg. on landside toe.

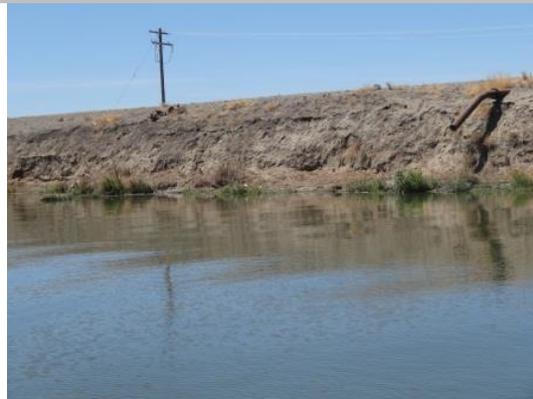
Photo 1 of 1 : SP\_2015\_RD0524\_107\_142\_20150309\_00138.jpg

Front view of the erosion. Note the drainage pipe on the site.

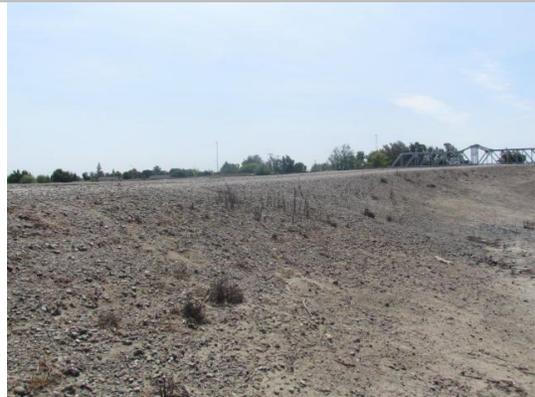
Photo 2 of 2 : SP\_2015\_RD0524\_107\_172\_20150424\_00212.jpg

Looking southeast at depression on levee crown.

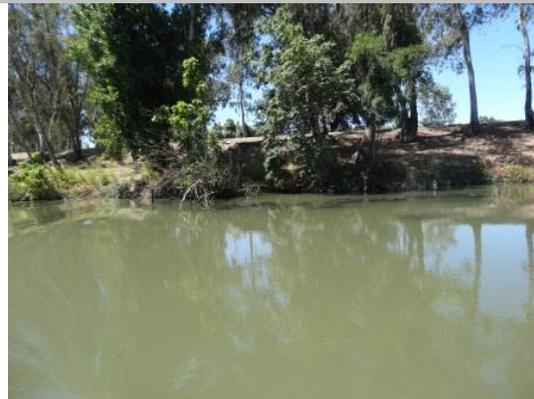
Photo 1 of 1 : SP\_2015\_RD0524\_107\_145\_20150309\_00141.jpg

Front view of the site where undermining has occurred.

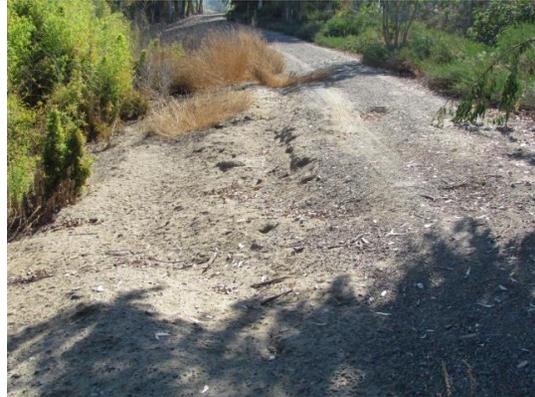
Photo 1 of 1 : SP\_2015\_RD0524\_107\_136\_20150309\_00135.jpg

Looking south at depression on levee crown near waterward shoulder.

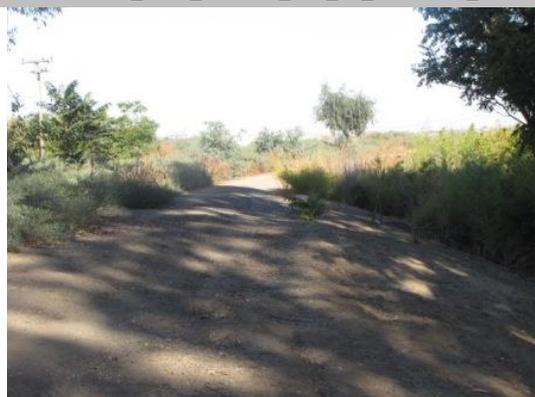
Photo 2 of 2 : SP\_2015\_RD0524\_107\_24\_20150309\_00040.jpg

Looking north at dense vegetation on the landside and waterside slopes.

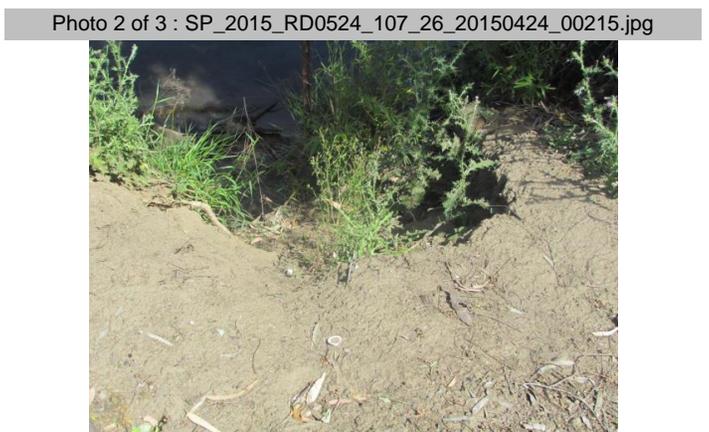
Looking east at waterward erosion.

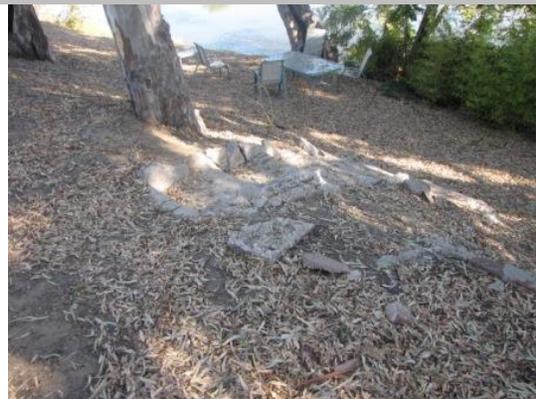
Photo 1 of 3 : SP\_2015\_RD0524\_107\_45\_20150309\_00062.jpg

Looking northeast at non-permitted concrete stairs on waterside slope.

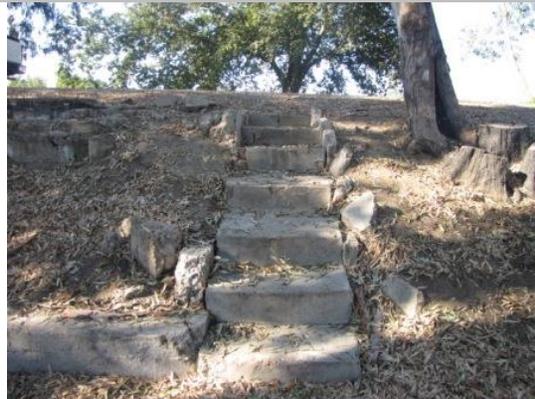
Photo 3 of 3 : SP\_2015\_RD0524\_107\_45\_20150309\_00064.jpg

Looking west at concrete stairs on waterside slope.

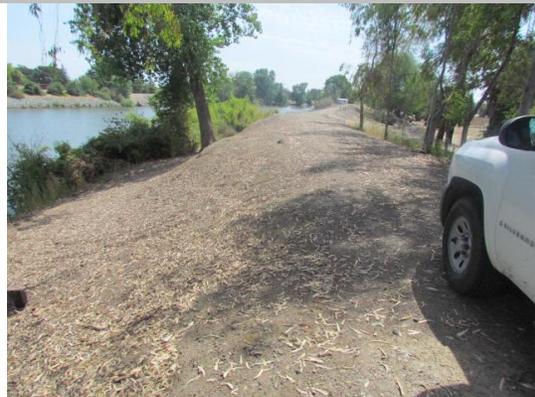
Photo 1 of 1 : SP\_2015\_RD0524\_107\_27\_20150424\_00217.jpg

Looking south at landward slope depression.

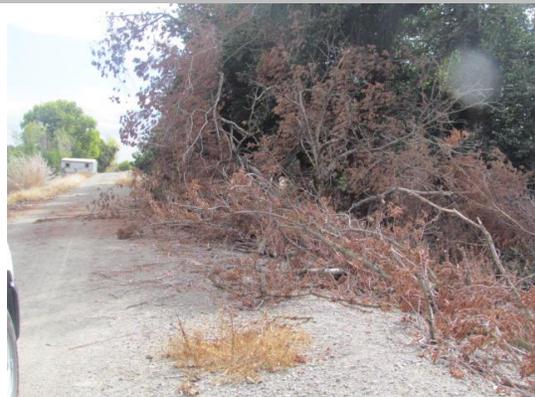
Photo 1 of 4 : SP\_2015\_RD0524\_107\_46\_20150309\_00065.jpg

Looking south at tree limbs on landward slope.

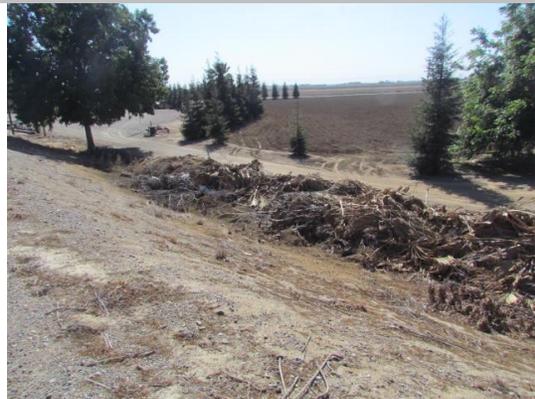
Photo 1 of 1 : SP\_2015\_RD0524\_107\_100\_20150309\_00103.jpg

Looking southwest at prunings on landside toe.

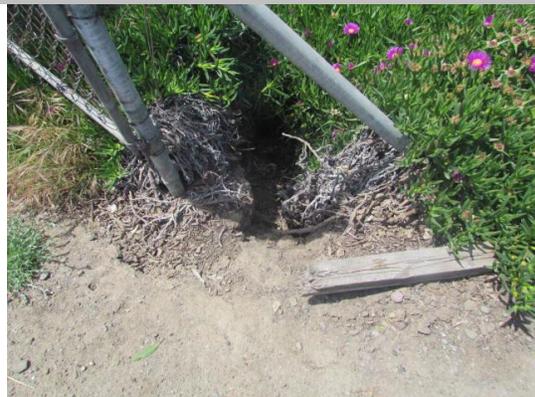
Photo 1 of 2 : SP\_2015\_RD0524\_107\_176\_20150424\_00218.jpg

Looking west at erosion within landscaping on landward shoulder and slope.

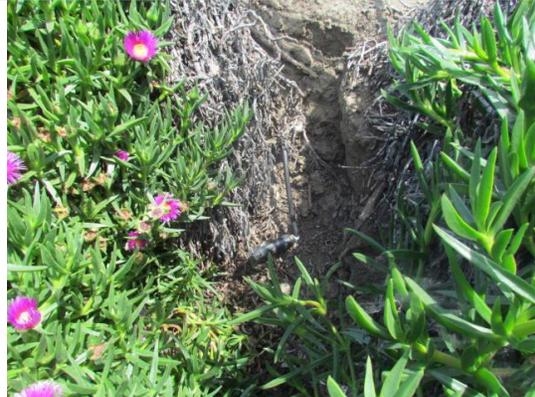
Photo 2 of 2 : SP\_2015\_RD0524\_107\_176\_20150424\_00219.jpg

Looking east at erosion within landscaping on landward slope and shoulder.

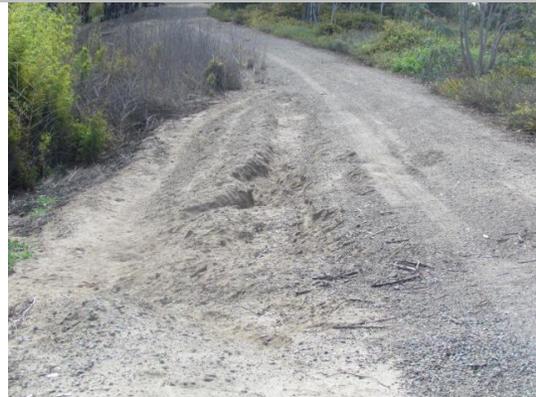
Photo 1 of 1 : SP\_2015\_RD0524\_107\_31\_20150309\_00044.jpg

Looking south slope damage on waterward shoulder and slope.

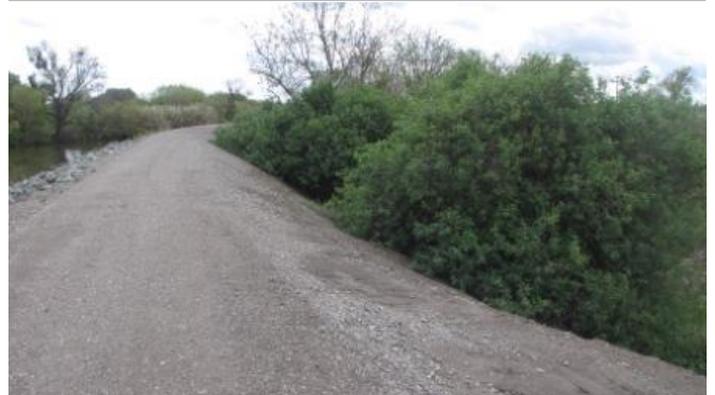
Photo 1 of 1 : SP\_2015\_RD0524\_107\_32\_20150309\_00045.jpg

Looking south at dense veg on landside slope and toe.

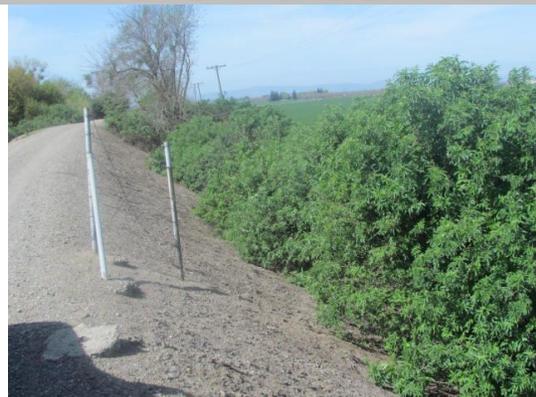
Photo 1 of 1 : SP\_2015\_RD0524\_107\_35\_20150309\_00049.jpg

Looking southwest at dense vegetation on landward toe.

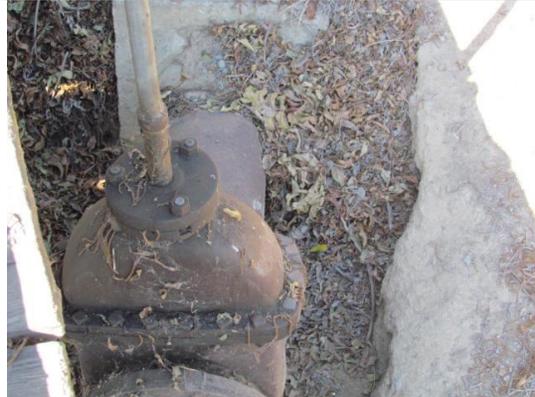
Photo 1 of 2 : SP\_2015\_RD0524\_107\_21\_20150309\_00032.jpg

Looking at erosion around irrigation pipe on waterward slope.

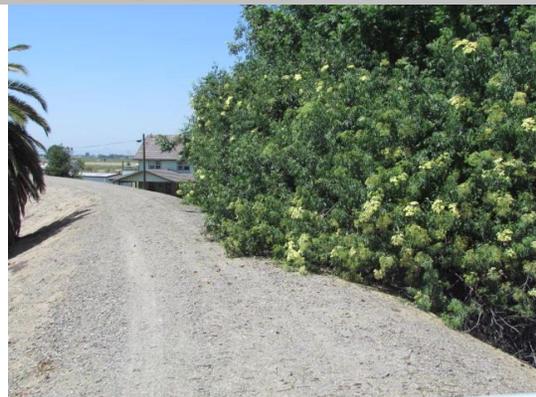
Photo 1 of 2 : SP\_2015\_RD0524\_107\_48\_20150309\_00069.jpg

Looking south at dense elderberry on landside slope.(Spring 2012)

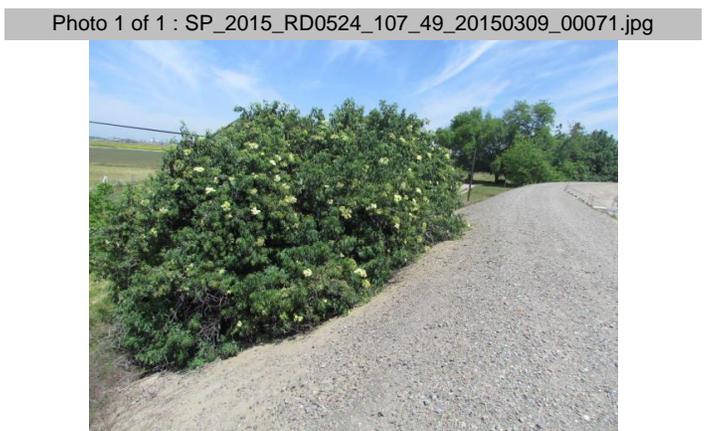
LM Start	<b>2.86</b>	Rating **	U	Issue No.	<b>49</b>
LM End	<b>2.86</b>	Issue Type +	Ma	Location *	LS
Category	Earthen Levee			GPS Latitude/Longitude	
				Start	End
Item	Vegetation			37.914427 °	37.914427 °
				-121.324198 °	-121.324198 °
DWR ID	DWR_RD0524_01_s_2012_49				
Action/Comments					
Elderberries are blocking visibility and flood fight capability.

Looking northwest at elderberry on landside slope.

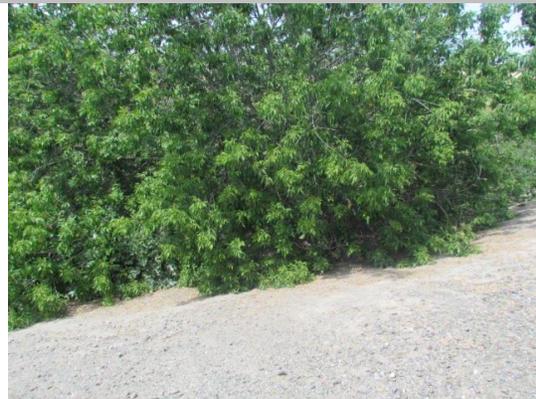
Photo 1 of 1 : SP\_2015\_RD0524\_107\_51\_20150424\_00220.jpg

Looking south at dense trees on landward slope.

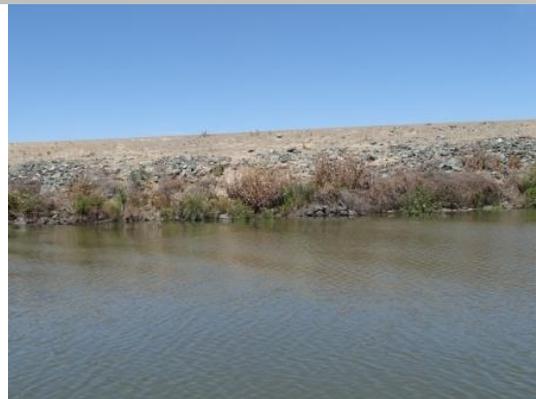
Photo 1 of 1 : SP\_2015\_RD0524\_107\_193\_20150309\_00154.jpg

Front view of the erosion.

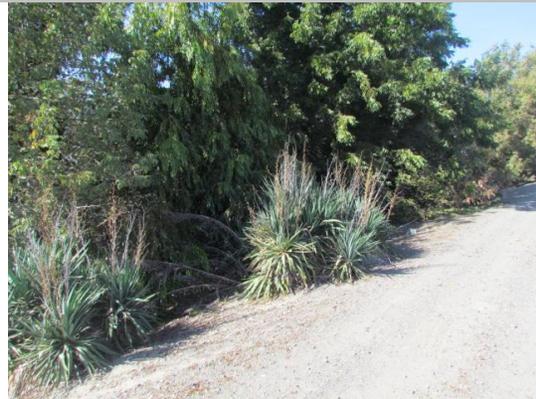
Photo 1 of 1 : SP\_2015\_RD0524\_107\_54\_20150309\_00073.jpg

Looking northwest at dense vegetation on landside slope.

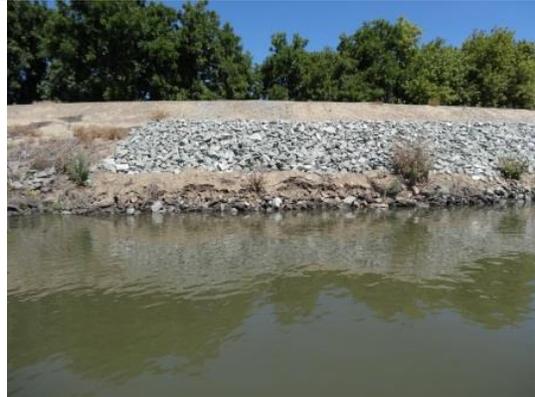
Photo 1 of 1 : SP\_2015\_RD0524\_107\_55\_20150309\_00074.jpg

View of the repaired site.

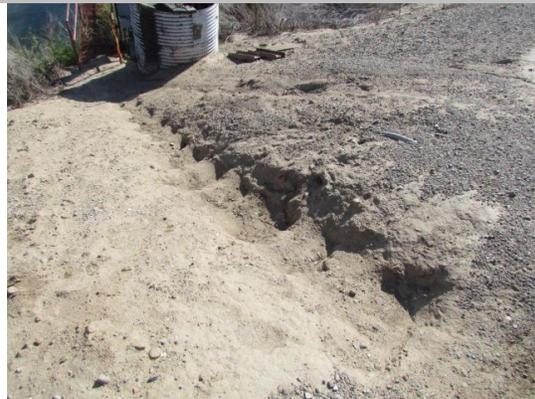
Photo 1 of 1 : SP\_2015\_RD0524\_107\_58\_20150309\_00077.jpg

Looking southeast steps cut into waterside slope.

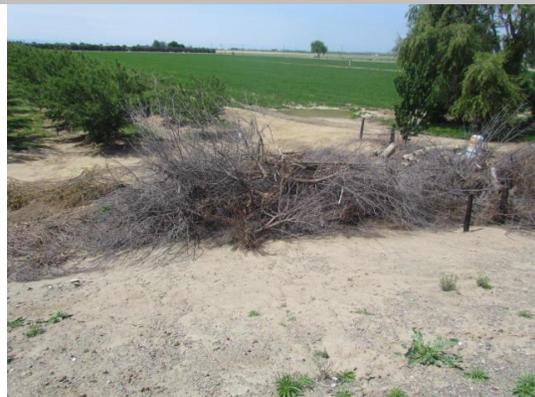
Photo 1 of 1 : SP\_2015\_RD0524\_107\_192\_20150424\_00222.jpg

Looking east at pruning pile at landward toe.

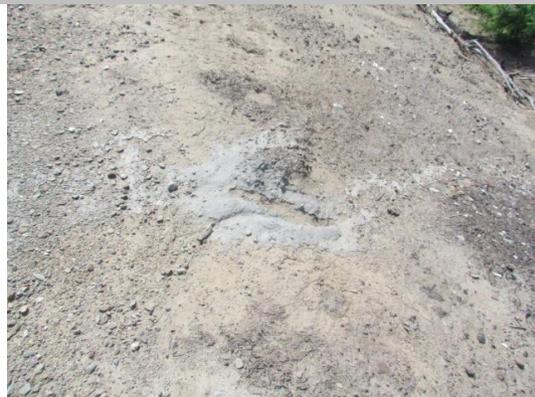
Photo 1 of 1 : SP\_2015\_RD0524\_107\_64\_20150424\_00229.jpg

Looking at typical view of grouted rodent holes on landward slope.

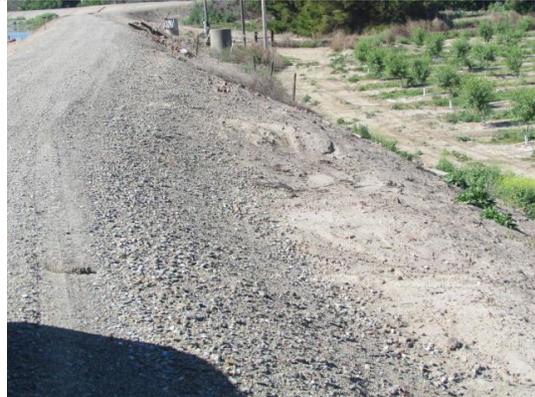
Photo 1 of 1 : SP\_2015\_RD0524\_107\_108\_20150309\_00109.jpg

Looking southwest at caving slope on landside of levee.

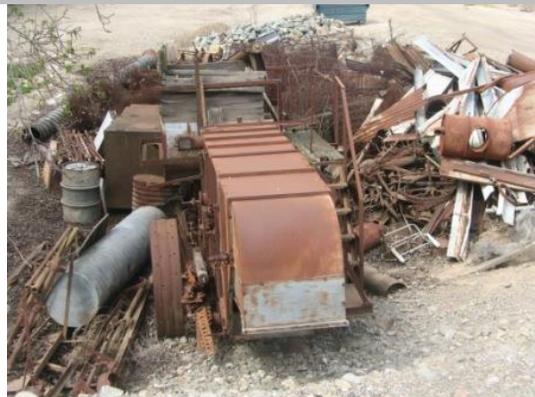
Photo 1 of 1 : SP\_2015\_RD0524\_107\_66\_20150309\_00081.jpg

Garbage at landward toe next to ramp at LM 4.64

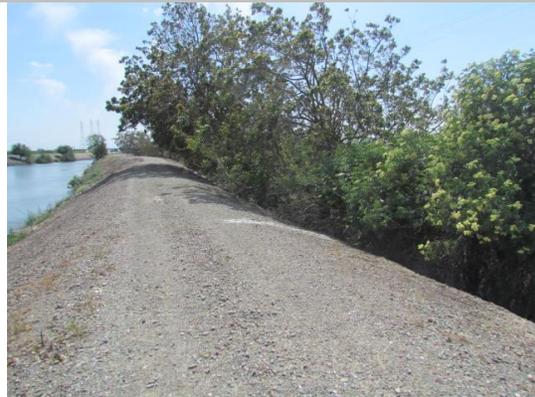
Photo 1 of 1 : SP\_2015\_RD0524\_107\_71\_20150424\_00232.jpg

Looking south at untrimmed trees on landward slope.

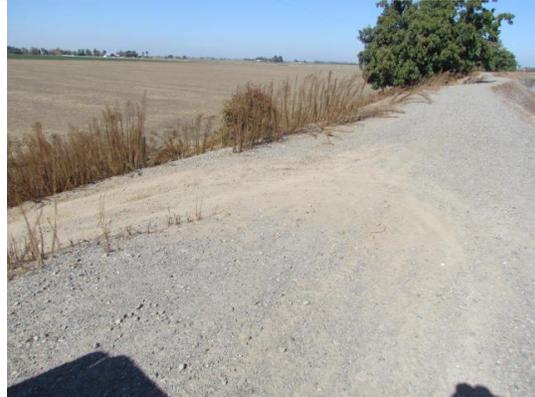
Photo 1 of 1 : SP\_2015\_RD0524\_107\_115\_20150309\_00118.jpg

Looking northwest at slope damage on landward slope.

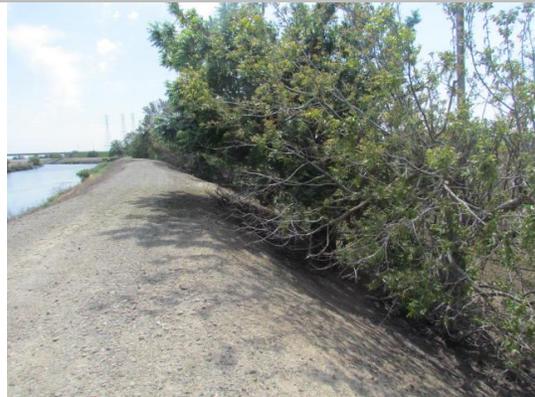
Photo 1 of 1 : SP\_2015\_RD0524\_107\_85\_20150424\_00233.jpg

Looking south at untrimmed trees on landward slope.

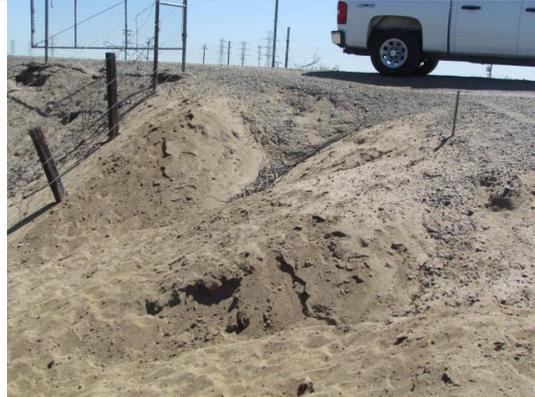
Photo 3 of 3 : SP\_2015\_RD0524\_107\_118\_20150309\_00121.jpg

Looking east at slope caving on landside slope.

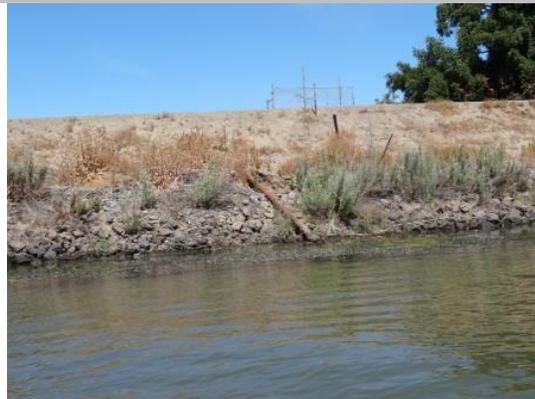
Photo 1 of 1 : SP\_2015\_RD0524\_107\_125\_20150309\_00126.jpg

Close view of the erosion and the pipe.

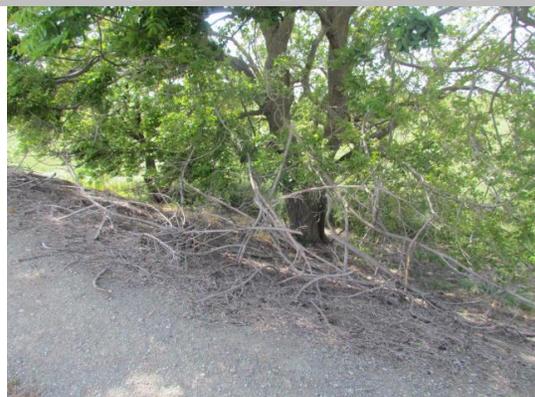
Photo 1 of 1 : SP\_2015\_RD0524\_107\_73\_20150424\_00235.jpg

Looking east at untrimmed trees on landward slope.

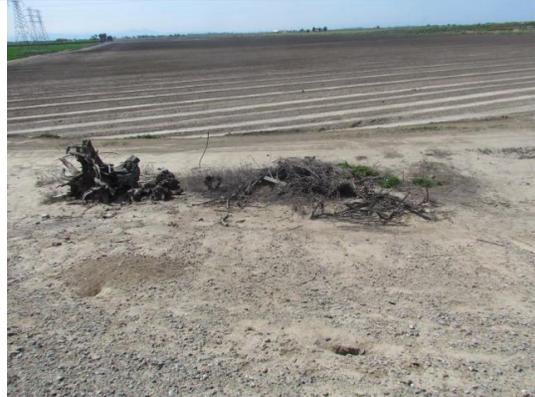
Photo 1 of 1 : SP\_2015\_RD0524\_107\_267\_20150424\_00236.jpg

Looking east at pruning piles at landward toe and berm.

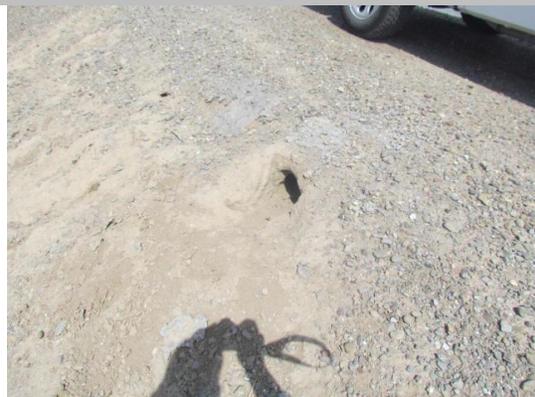
Photo 2 of 2 : SP\_2015\_RD0524\_107\_197\_20150424\_00238.jpg

Looking southwest at typical view of rodent hole at landward shoulder.

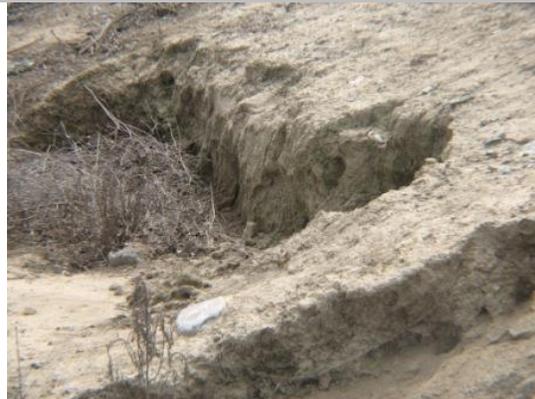
Photo 3 of 3 : SP\_2015\_RD0524\_107\_74\_20150309\_00085.jpg

Erosion at waterward toe and around irrigation pipe at LM 5.92

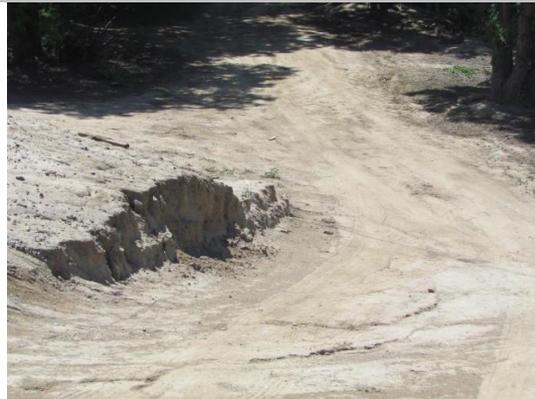
Photo 1 of 2 : SP\_2015\_RD0524\_107\_119\_20150309\_00122.jpg

Looking west at unauthorized ramp and landside slope damage.

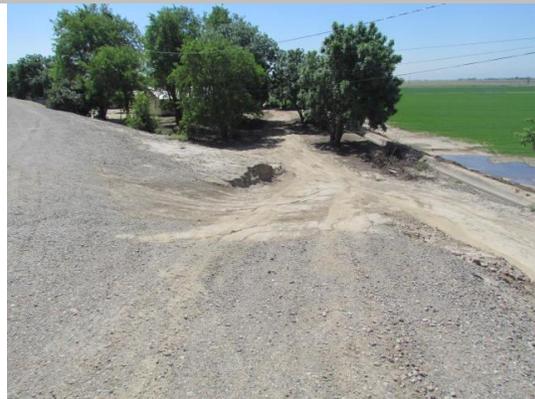
Photo 2 of 2 : SP\_2015\_RD0524\_107\_119\_20150309\_00123.jpg

Looking southwest at damaged slope and ramp on landside slope.
