**Flood Control Project Maintenance
Levee Inspections**

Fall 2010 Levee Maintenance Deficiency Summary Report

Reclamation District No. 0536 Egbert

Levee Inspection Report By Mile - Fall 2010

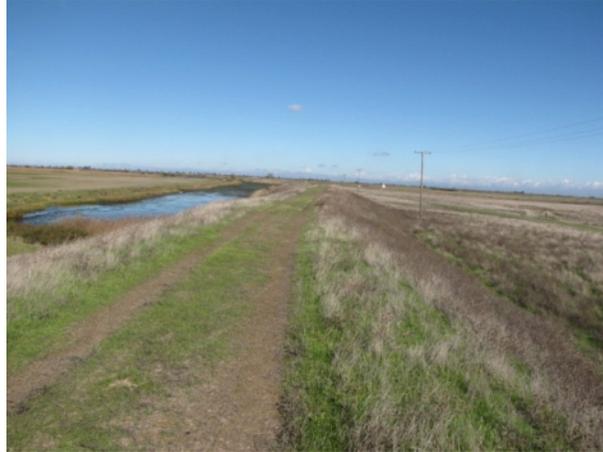
Levee Mile Report Line	2
Start Levee Mile	0.64
End Levee Mile	0.64
Location	Land Side
Category	Earthen Levee
Item	Vegetation
View of levee section Unit 1 RD 536 looking downstream, grasses cover the crown and both levee slopes land side and waterside levee mile 0.64. Photo taken 11-10-2010	
phillips_f_20101206_373.jpg

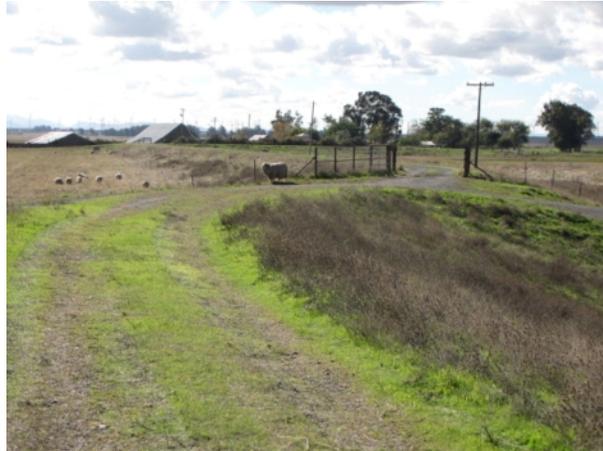
Levee Mile Report Line	2
Start Levee Mile	0.64
End Levee Mile	0.64
Location	Land Side
Category	Earthen Levee
Item	Vegetation
View of levee section RD 536 Unit 1 looking upstream from levee mile 0.64 waterside. Photo taken 11-20-2010	
phillips_f_20101206_374.jpg

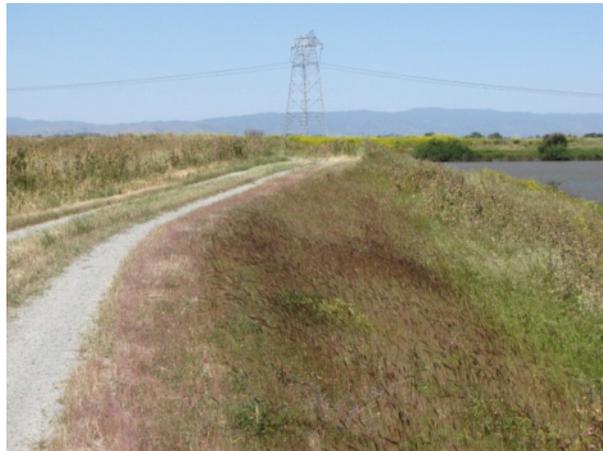
Levee Mile Report Line	3
Start Levee Mile	4.19
End Levee Mile	4.26
Location	Water Side
Category	Earthen Levee
Item	Vegetation
Looking upstream from levee mile 4.21.	
phillips_f_20100923_219.jpg

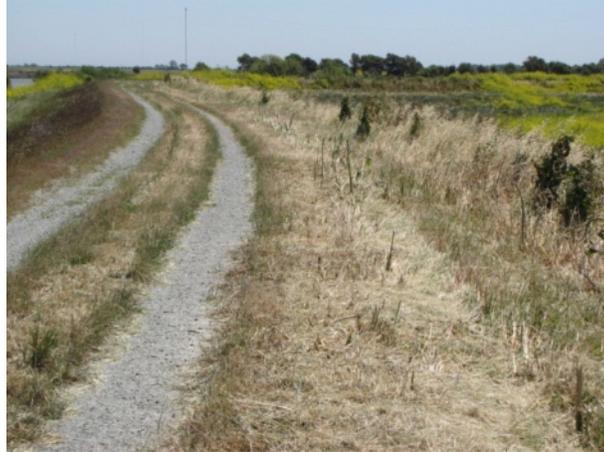
Levee Mile Report Line	3
Start Levee Mile	4.19
End Levee Mile	4.26
Location	Water Side
Category	Earthen Levee
Item	Vegetation
Looking downstream from levee mile 4.21	
phillips_f_20100923_220.jpg

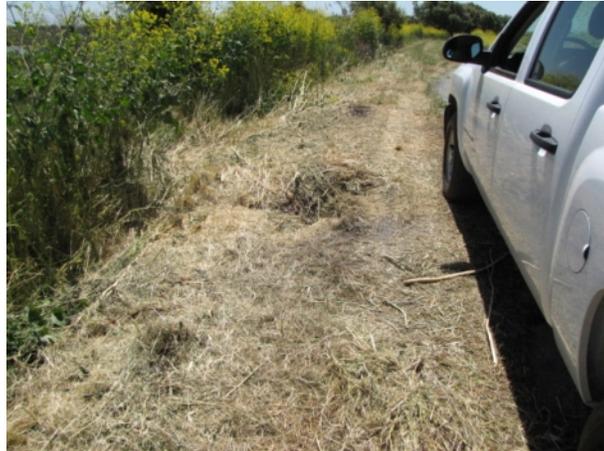
Levee Mile Report Line	9
Start Levee Mile	4.82
End Levee Mile	4.82
Location	Crown
Category	Earthen Levee
Item	Crown Surface / Depressions / Rutting
There is a big hole in the levee waterward. 38.248375 to -121.712188 the levee has wild growth on both slopes.	
phillips_f_20100923_218.jpg

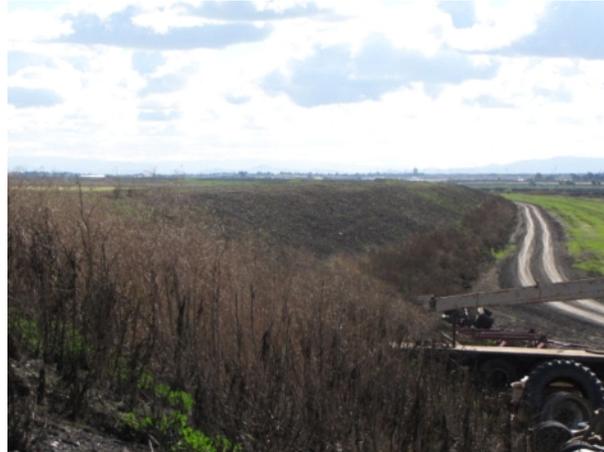
Levee Mile Report Line	1
Start Levee Mile	0.00
End Levee Mile	0.00
Location	Land Side
Category	Earthen Levee
Item	Vegetation
View of land side RD 536 Unit 2 looking downstream from levee miile 0.00 Photo taken 11-10-2010	
phillips_f_20101206_376.jpg

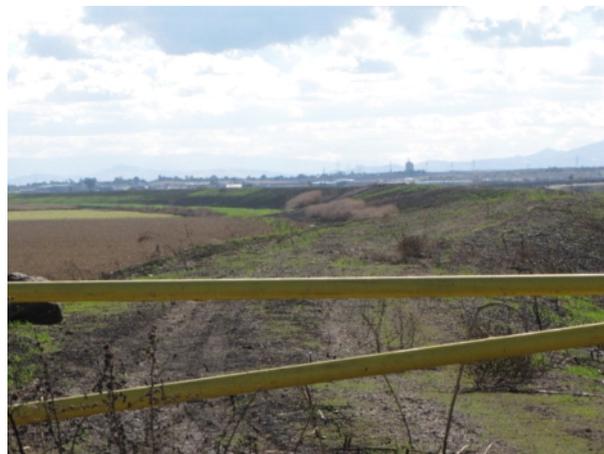
Levee Mile Report Line	1
Start Levee Mile	0.00
End Levee Mile	0.00
Location	Land Side
Category	Earthen Levee
Item	Vegetation
View of levee section looking downstream from levee mile 0.00 waterside RD 536 Photo taken 10-20-2010.	
phillips_f_20101206_377.jpg

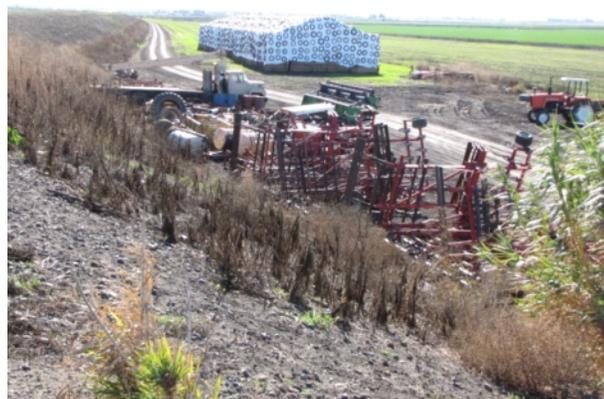
Levee Mile Report Line	2
Start Levee Mile	0.01
End Levee Mile	0.06
Location	Land Side
Category	Earthen Levee
Item	Encroachments
View of unauthorized encroachment levee miles 0.01-0.06 land side of RD 536 Unit 2. Farmer has stored equipment, materials and vehicle within 10-foot of landward toe. Photo taken 11-10-2010	
phillips_f_20101206_375.jpg
