**Flood Control Project Maintenance  
Levee Inspections**

**Fall 2014 Levee Maintenance Deficiency Summary Report**

**Sacramento River Basin**

**Reclamation District No. 0536 Egbert**

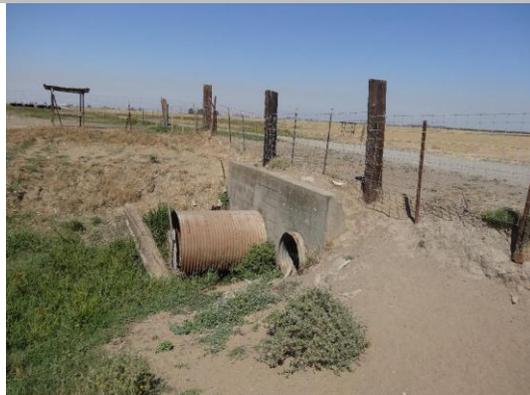
Photo 1 of 1 : UCIP\_2234.jpg

LM Start	<b>0.00</b>	Rating **	U	Issue No.	<b>3</b>
LM End	<b>0.00</b>	Issue Type +	En	Location *	WS
Category	Supplemental		GPS Latitude/Longitude		
			Start	End	
Item	DWR UCIP Field Study		38.244963 °	38.244963 °	
			-121.768960 °	-121.768960 °	
DWR ID	DWR_RD0536_01_f_2014_3				
Action/Comments					
Inspector Comments: FS_ID:20406 EP_NO: 10114 Repair Type: Urgent Crossing Status: Found UCIP Comments: - Holes in pipe outlet due to heavy corrosion. Needs detailed investigation of the pipe. Headwall cracked and tilted on WS. FIELD_STRUCT_DESC: 1 of 2: 60-inch corrugated metal pipe (of 60-inch and 36-inch CMP) through levee 10.0 feet below crown in drain ditch. (ABO 10114, 1974). Originally included in the 1953 O&M manual, Sac 106, May 1953. FS Date: 8/13/2013

LS view: two inlet CMPs with flap gates. Concrete headwall supports the pipes. A 36" CMP (right) and 60" CMP (left).

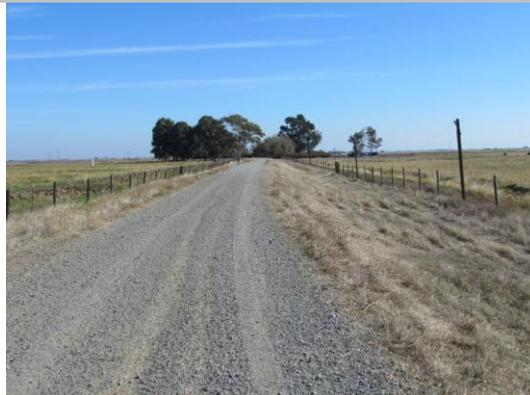
Photo 1 of 1 : FA\_2014\_RD0536\_208\_24\_20141107\_00016.jpg

LM Start	<b>0.03</b>	Rating **	A/W	Issue No.	<b>24</b>
LM End	<b>1.78</b>	Issue Type +	Ma	Location *	LS
Category	Earthen Levee		GPS Latitude/Longitude		
			Start	End	
Item	Vegetation		38.245012 °	38.259667 °	
			-121.768460 °	-121.749812 °	
DWR ID	DWR_RD0536_01_f_2014_24				
Action/Comments					
Control annual grass and weeds on the levee slopes and easements. Inspector Comments: At this location there is no problem with the vegetation.

Looking downstream from levee mile 0.02 landside slope.

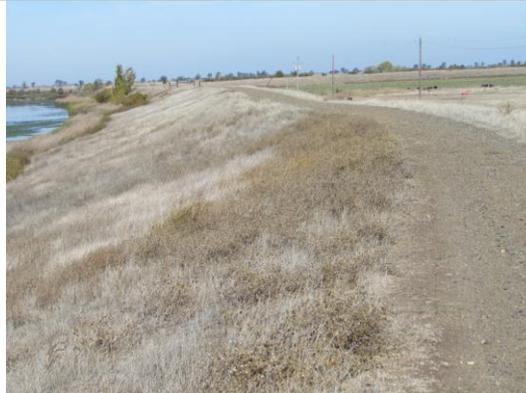
Photo 1 of 1 : FA\_2014\_RD0536\_208\_37\_20141107\_00017.jpg

LM Start	<b>0.92</b>	Rating **	<b>U</b>	Issue No.	<b>37</b>
LM End	<b>0.95</b>	Issue Type +	<b>Ma</b>	Location *	<b>WS</b>
Category	Earthen Levee		GPS Latitude/Longitude		
			Start	End	
Item	Vegetation		38.252822 °	38.253287 °	
			-121.758085 °	-121.757937 °	
DWR ID	DWR_RD0536_01_f_2014_37				
Action/Comments					
Remove the wild growth other than native grasses from the levee slopes. Inspector Comments: Unwanted weeds present on the waterward levee slope.

Looking downstream from levee mile 0.92 unsatisfactory growth of star thistle present on slope.

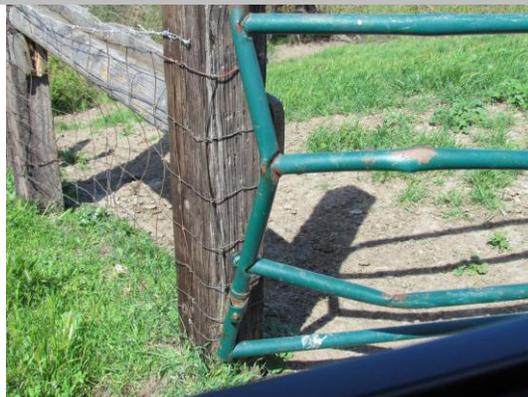
Photo 1 of 1 : FA\_2014\_RD0536\_208\_25\_20141030\_00002.jpg

LM Start	<b>1.10</b>	Rating **	U	Issue No.	<b>25</b>
LM End	<b>1.10</b>	Issue Type +	Ma	Location *	CR
Category	Earthen Levee		GPS Latitude/Longitude		
			Start	End	
Item	Repair Gates		38.255455 °	38.255455 °	
			-121.757587 °	-121.757587 °	
DWR ID	DWR_RD0536_01_s_2014_25				
Action/Comments					
Inspector Comments: This gate looks like its been run over, the bottom hinge is broken thus making the gate hard to open and close properly.

This gate needs to be replaced.

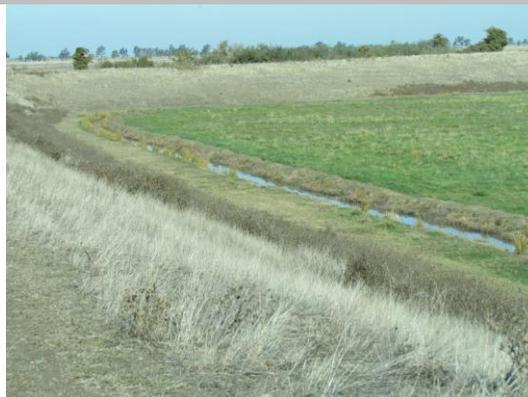
Photo 1 of 1 : FA\_2014\_RD0536\_208\_43\_20141107\_00018.jpg

LM Start	<b>1.19</b>	Rating **	U	Issue No.	<b>43</b>
LM End	<b>1.32</b>	Issue Type +	Ma	Location *	LS
Category	Earthen Levee		GPS Latitude/Longitude		
			Start	End	
Item	Vegetation		38.256722 °	38.258655 °	
			-121.757558 °	-121.757393 °	
DWR ID	DWR_RD0536_01_f_2014_43				
Action/Comments					
Remove the wild growth other than native grasses from the levee slopes. Inspector Comments: Remove the tall weeds from the landward levee slope.

Tall weeds on landside slope and toe of levee section.

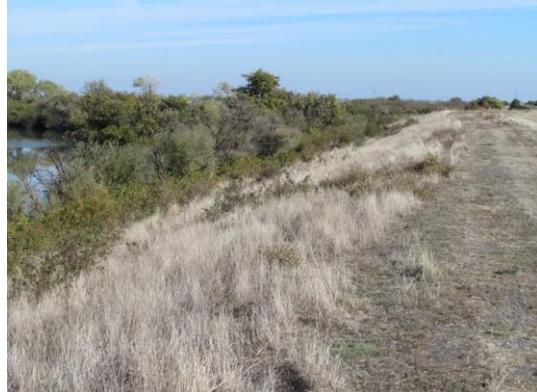
Photo 1 of 1 : FA\_2014\_RD0536\_208\_45\_20141107\_00019.jpg

LM Start	<b>1.34</b>	Rating **	U	Issue No.	<b>45</b>
LM End	<b>4.31</b>	Issue Type +	Ma	Location *	WS
Category	Earthen Levee		GPS Latitude/Longitude		
			Start	End	
Item	Vegetation		38.258860 °	38.248497 °	
			-121.757142 °	-121.717193 °	
DWR ID	DWR_RD0536_01_f_2014_45				
Action/Comments					
Remove the wild growth other than native grasses from the levee slopes. Inspector Comments: Unwanted wild growth of weeds and wild roses growing on the waterward levee slope.

Wild growth of wild roses present on waterside slope and toe.

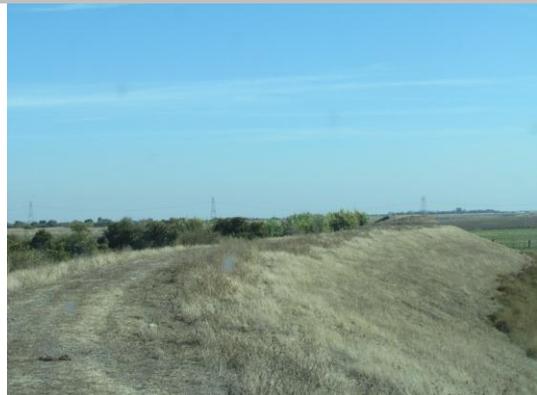
Photo 1 of 1 : FA\_2014\_RD0536\_208\_48\_20141107\_00020.jpg

LM Start	<b>1.42</b>	Rating **	U	Issue No.	<b>48</b>
LM End	<b>1.52</b>	Issue Type +	Ma	Location *	LS
Category	Earthen Levee		GPS Latitude/Longitude		
			Start	End	
Item	Vegetation		38.259203 °	38.258757 °	
			-121.755698 °	-121.753883 °	
DWR ID	DWR_RD0536_01_f_2014_48				
Action/Comments					
Remove the wild growth other than native grasses from the levee slopes. Inspector Comments: The landward levee slope is covered in wild weeds and star thistle.

Unwanted star thistle on shoulder landward downstream to levee mile 1.52

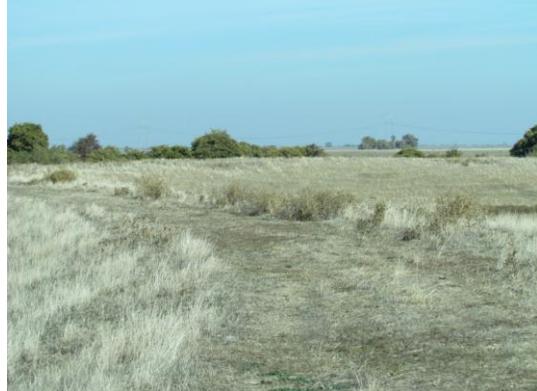
Photo 1 of 1 : FA\_2014\_RD0536\_208\_49\_20141107\_00021.jpg

LM Start	<b>1.59</b>	Rating **	U	Issue No.	<b>49</b>
LM End	<b>1.74</b>	Issue Type +	Ma	Location *	CR
Category	Earthen Levee		GPS Latitude/Longitude		
			Start	End	
Item	Vegetation		38.258792 °	38.259777 °	
			-121.752675 °	-121.750418 °	
DWR ID	DWR_RD0536_01_f_2014_49				
Action/Comments					
Keep the crown roadway free of vegetation. Inspector Comments: Crown roadway should be kept free of vegetation.

Unwanted grasses present on crown roadway.

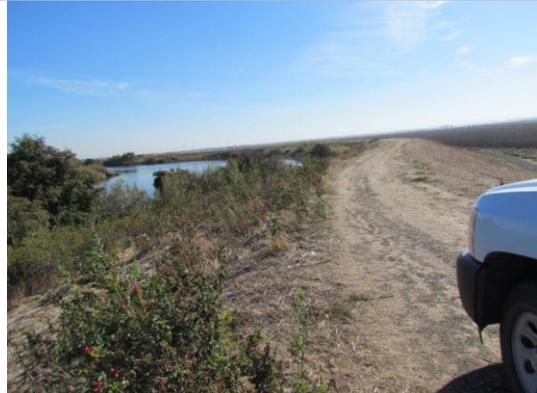
Photo 1 of 1 : FA\_2014\_RD0536\_208\_52\_20141107\_00022.jpg

LM Start	<b>1.85</b>	Rating **	U	Issue No.	<b>52</b>
LM End	<b>2.52</b>	Issue Type +	Ma	Location *	WS
Category	Earthen Levee		GPS Latitude/Longitude		
			Start	End	
Item	Vegetation		38.259965 °	38.257463 °	
			-121.748330 °	-121.738612 °	
DWR ID	DWR_RD0536_01_f_2014_52				
Action/Comments					
Remove the wild growth other than native grasses from the levee slopes. Inspector Comments: Remove wild growth from the waterward levee section.

Unwanted wild roses present on the waterside levee section.

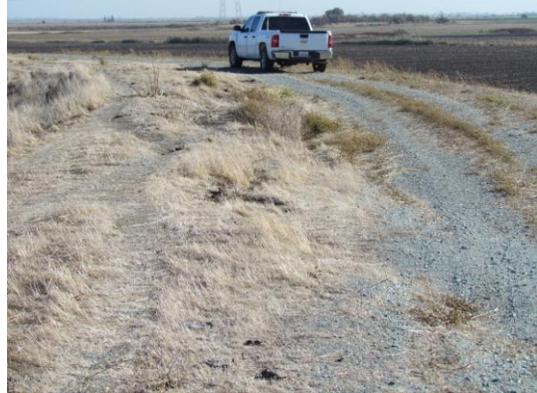
Photo 2 of 2 : FA\_2014\_RD0536\_208\_56\_20141107\_00024.jpg

LM Start	<b>2.69</b>	Rating **	U	Issue No.	<b>56 (cont)</b>
LM End	<b>2.71</b>	Issue Type +	Ma	Location *	CR
Category	Earthen Levee			GPS Latitude/Longitude	
				Start	End
Item	Crown Surface / Depressions / Rutting			38.255197 °	38.254973 °
				-121.737932 °	-121.737577 °
DWR ID	DWR_RD0536_01_f_2014_56				
Action/Comments					
Repair depressions or ruts in the crown or slope. Inspector Comments: District need to monitor the levee crown roadway at this location. There are some issues here.

Looking downstream at the crown roadway cracks and issues with stability.

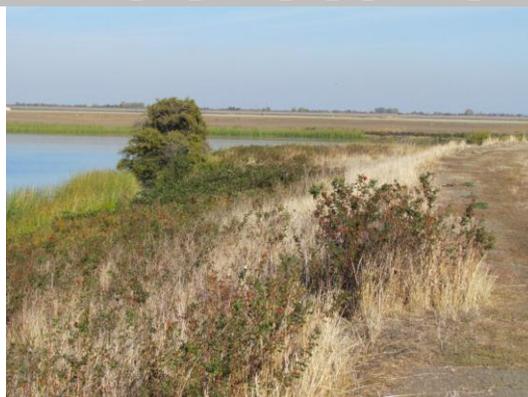
Photo 1 of 1 : FA\_2014\_RD0536\_208\_66\_20141107\_00025.jpg

LM Start	<b>3.27</b>	Rating **	U	Issue No.	<b>66</b>
LM End	<b>3.33</b>	Issue Type +	Ma	Location *	WS
Category	Earthen Levee		GPS Latitude/Longitude		
			Start	End	
Item	Vegetation		38.256562 °	38.256878 °	
			-121.728243 °	-121.727457 °	
DWR ID	DWR_RD0536_01_f_2014_66				
Action/Comments					
Remove the wild growth other than native grasses from the levee slopes. Inspector Comments: Remove the wild growth of wild roses on the waterside of the levee section.

Wild Roses on the waterward levee slope.

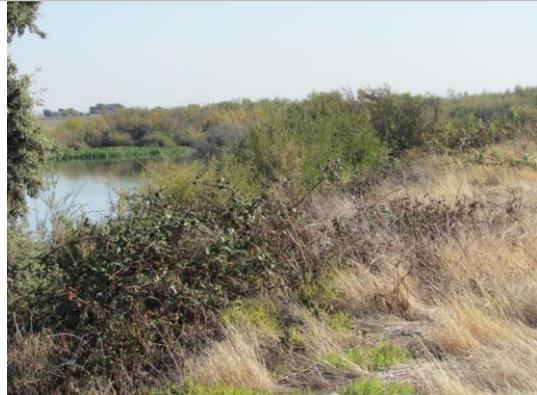
Photo 1 of 1 : FA\_2014\_RD0536\_208\_67\_20141107\_00026.jpg

LM Start	<b>3.41</b>	Rating **	U	Issue No.	<b>67</b>
LM End	<b>5.30</b>	Issue Type +	Ma	Location *	WS
Category	Earthen Levee		GPS Latitude/Longitude		
			Start	End	
Item	Vegetation		38.255950 °	38.245633 °	
			-121.726255 °	-121.702670 °	
DWR ID	DWR_RD0536_01_f_2014_67				
Action/Comments					
Remove the wild growth other than native grasses from the levee slopes. Inspector Comments: Remove the wild berries from the waterward levee slope.

Unwanted berryvines present on the waterward levee section.

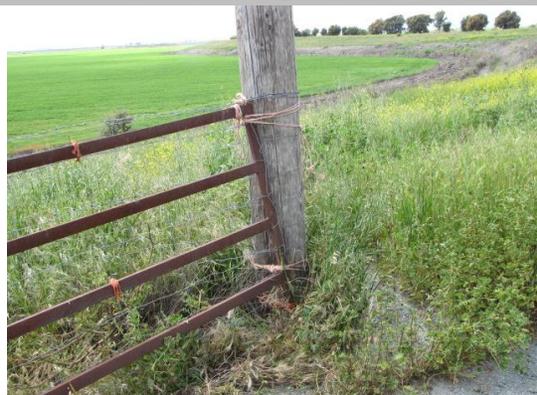
Photo 1 of 1 : FA\_2014\_RD0536\_208\_36\_20141030\_00004.jpg

LM Start	<b>3.68</b>	Rating **	U	Issue No.	<b>36</b>
LM End	<b>3.68</b>	Issue Type +	Ma	Location *	WS
Category	Earthen Levee		GPS Latitude/Longitude		
			Start	End	
Item	Repair Gates		38.252578 °	38.252578 °	
			-121.726439 °	-121.726439 °	
DWR ID	DWR_RD0536_01_s_2012_36				
Action/Comments					
Inspector Comments: This gate need to be repaired.

Repair this gate. Someone could get hurt trying to open and close this gate. No new picture was taken, no change to this gate. 09-04-2014.

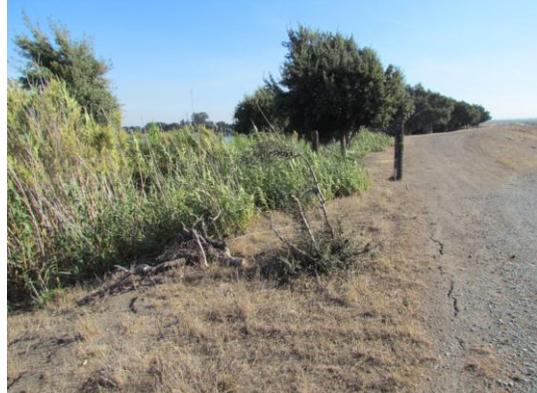
Photo 1 of 1 : FA\_2014\_RD0536\_208\_69\_20141107\_00027.jpg

Unsatisfactory growth of Arundo present on waterward levee section.

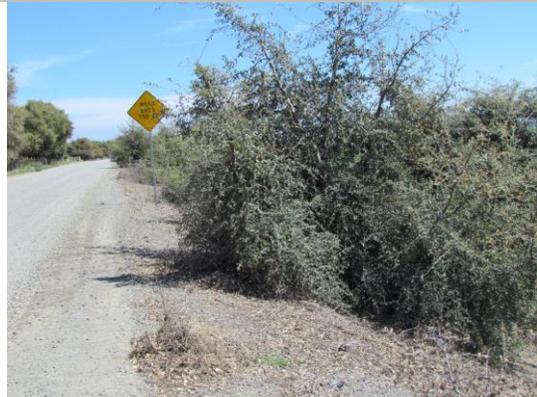
Photo 1 of 1 : FA\_2014\_RD0536\_208\_65\_20141030\_00007.jpg

Looking downstream from levee mile 5.17 to 5.31 at unsatisfactory woody tree growth on landside levee slope and shoulder.

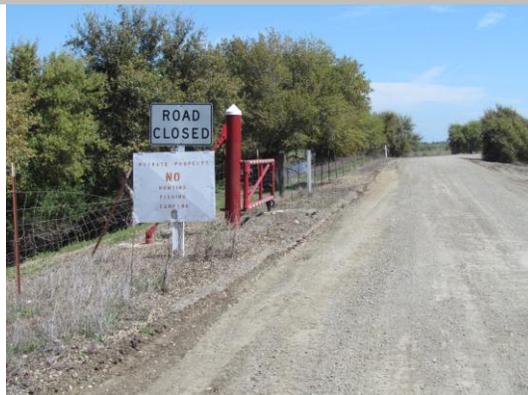
Photo 1 of 1 : FA\_2014\_RD0536\_208\_11\_20141030\_00001.jpg

This gate and barricade has no CVFPB permit on file.

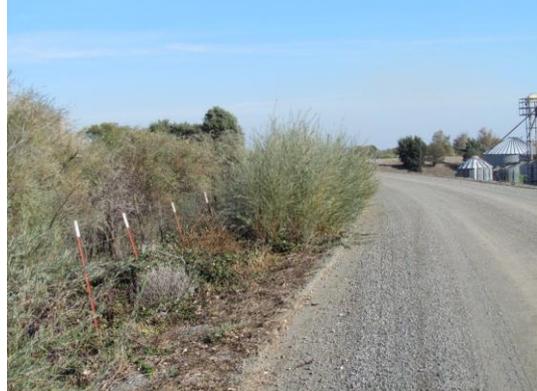
Photo 1 of 1 : FA\_2014\_RD0536\_208\_70\_20141107\_00028.jpg

Unsatisfactory growth of young trees present on waterside levee shoulder and slope.

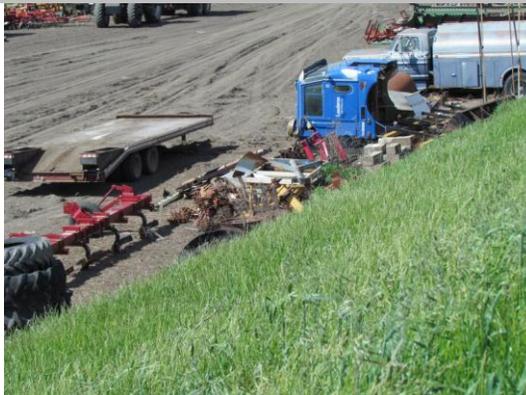
Photo 1 of 1 : FA\_2014\_RD0536\_209\_5\_20141008\_00001.jpg

Unauthorized encroachment on the landward side within 10-foot of the levee toe, looking back upstream. No new picture, no change with this issue.

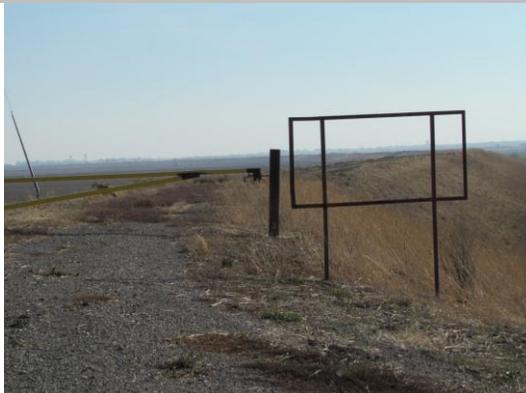
Photo 1 of 1 : FA\_2014\_RD0536\_209\_17\_20141112\_00009.jpg

LM Start	<b>0.02</b>	Rating **	U	Issue No.	<b>17</b>
LM End	<b>0.02</b>	Issue Type +	Ma	Location *	LS
Category	Earthen Levee		GPS Latitude/Longitude		
			Start	End	
Item	Vegetation		38.244225 °	38.244225 °	
			-121.696980 °	-121.696980 °	
DWR ID	DWR_RD0536_02_s_2014_17				
Action/Comments					
Remove the wild growth other than native grasses from the levee slopes. Inspector Comments: Remove the tall weeds present at the gate landside of levee.

Tall weeds present at gate on the landside slope.

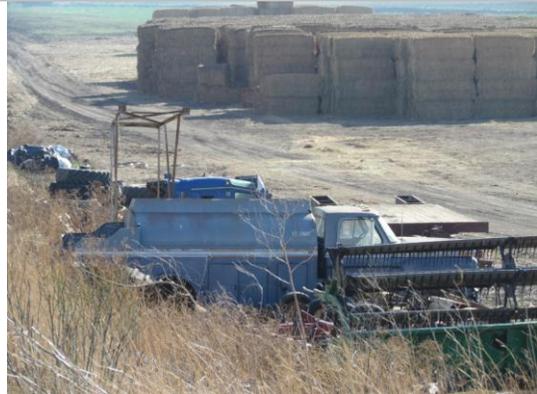
Photo 1 of 1 : FA\_2014\_RD0536\_209\_19\_20141112\_00010.jpg

Unauthorized Encroachment on the landward toe, farm equipment and fuel tanks within 10-foot of landside toe.

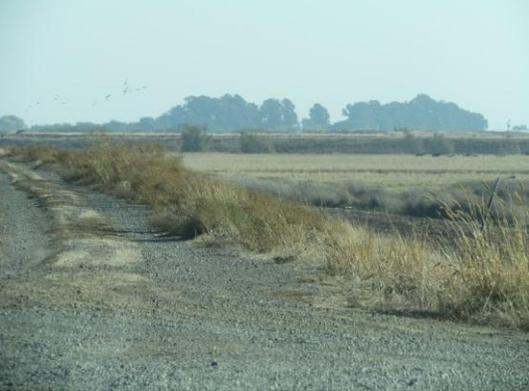
Photo 1 of 1 : FA\_2014\_RD0536\_209\_12\_20141112\_00013.jpg

Dead tall weeds present on the landward slope.

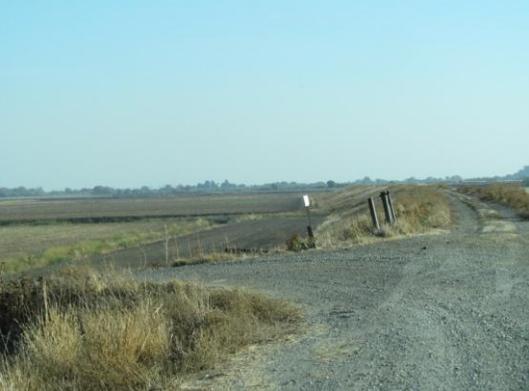
Photo 1 of 1 : FA\_2014\_RD0536\_209\_13\_20141112\_00012.jpg

LM Start	<b>2.53</b>	Rating **	U	Issue No.	<b>13</b>
LM End	<b>4.34</b>	Issue Type +	Ma	Location *	WS
Category	Earthen Levee		GPS Latitude/Longitude		
			Start	End	
Item	Vegetation		38.208848 °	38.196775 °	
			-121.691115 °	-121.699223 °	
DWR ID	DWR_RD0536_02_f_2014_13				
Action/Comments					
Control annual grass and weeds on the levee slopes and easements. Inspector Comments: Control the tall weeds from the levee section waterward.

Unwanted tall weeds present on the waterward levee slope.

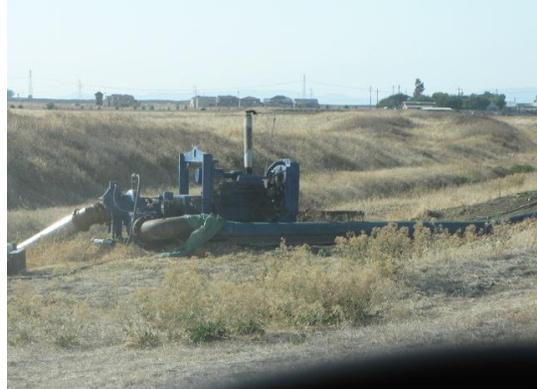
Photo 1 of 1 : FA\_2014\_RD0536\_209\_7\_20141008\_00002.jpg

Diesel motor and temporary pipe crossing levee. Photo taken 10-10-2013.
