**Flood Control Project Maintenance
Levee Inspections**

**Fall 2015 Levee Maintenance Deficiency Summary Report
Overall LMA & Unit Ratings, including USACE Erosion Survey**

Reclamation District No. 0536 Egbert

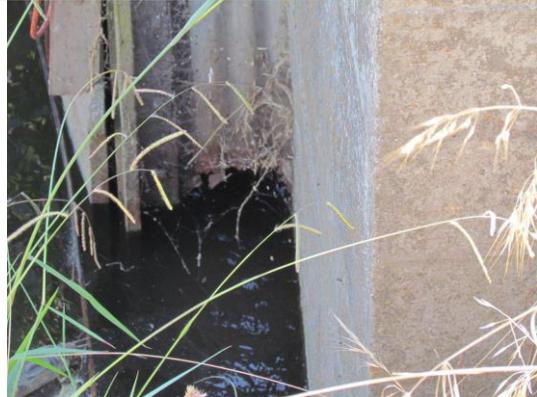
Photo 1 of 2 : FA_2015_RD0536_208_5_20151005_00025.jpg

LM Start	0.00	Rating **	U	Issue No.	5
LM End	0.00	Issue Type +	En	Location *	CR
Category	Earthen Levee		GPS Latitude/Longitude		
			Start	End	
Item	Encroachments		38.245009 °	38.245009 °	
			-121.768948 °	-121.768948 °	
DWR ID	DWR_RD0536_01_f_2015_5				
Action/Comments					
Pipe Inspector Comments: The pipe listed here 60' CMP has corrosion at the bottom of the pipe. DWR UCIP discovered this pipe in their report , they list it as Urgent.

LS view of the CMP 60", the corrosion is at the bottom portion of pipe. Close up view.

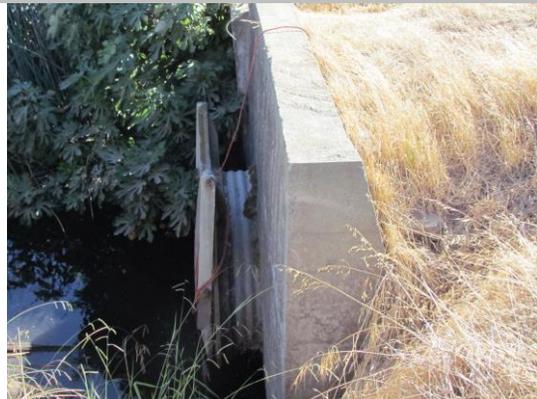
Photo 2 of 2 : FA_2015_RD0536_208_5_20151005_00026.jpg

Another view of the pipe from the LS.

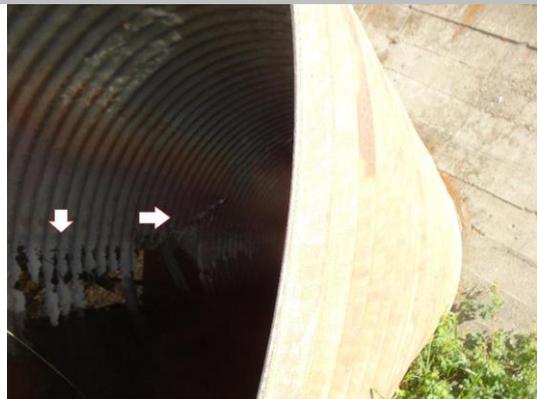
Photo 1 of 3 : UCIP_FA_2015_1745.jpg

LM Start	0.00	Rating **	U	Issue No.	71
LM End	0.00	Issue Type +	En	Location *	CR
Category	Supplemental		GPS Latitude/Longitude		
			Start	End	
Item	DWR UCIP Field Study		38.244963 °	38.244963 °	
			-121.768960 °	-121.768960 °	
DWR ID					
Action/Comments					
Inspector Comments: FS_ID:20406 DS_ID:22712 EP_NO: 10114 FS_HLM: 0 Repair Type: Urgent Crossing Status: Found

LS view: holes & cracks on CM pipe due to heavy corrosion. Needs detailed investigation of the pipe.

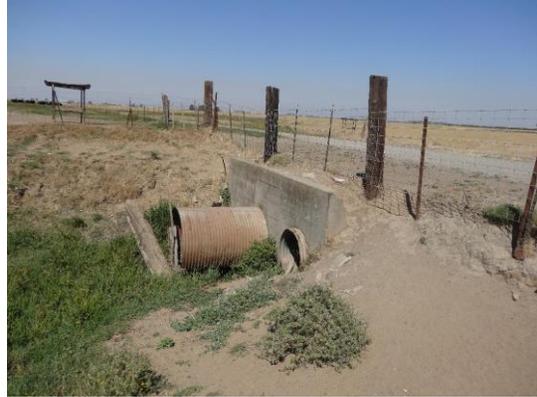
Photo 2 of 3 : UCIP_FA_2015_1746.jpg

LS view: two inlet CMPs with flap gates. Concrete headwall supports the pipes. A 36" CMP (right) and 60" CMP (left).

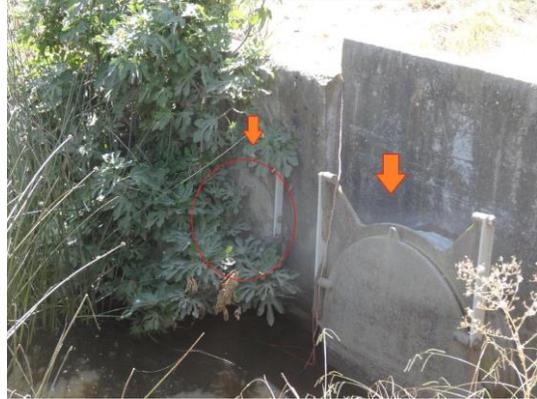
Photo 3 of 3 : UCIP_FA_2015_1747.jpg

WS view: two CMPs with flap gates. Concrete headwall supports the pipes. A 36" CMP (left) and 60" CMP (right).

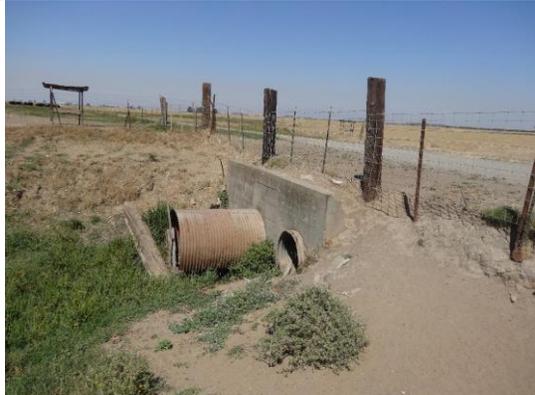
Photo 1 of 3 : UCIP_FA_2015_1708.jpg

LM Start	0.00	Rating **	M	Issue No.	72
LM End	0.00	Issue Type +	En	Location *	CR
Category	Supplemental			GPS Latitude/Longitude	
				Start	End
Item	DWR UCIP Field Study			38.244959 °	38.244959 °
				-121.768921 °	-121.768921 °
DWR ID					
Action/Comments					
Inspector Comments: FS_ID:20674 DS_ID:22726 EP_NO: 10114 FS_HLM: 0.002 Repair Type: Non-Urgent Crossing Status: Found

LS view: concrete headwall, 36" CMP (right) and 60" CMP (left)

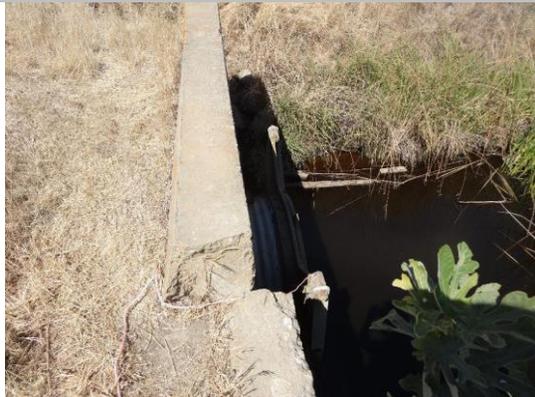
Photo 2 of 3 : UCIP_FA_2015_1712.jpg

WS view: cracked and tilted concrete headwall.

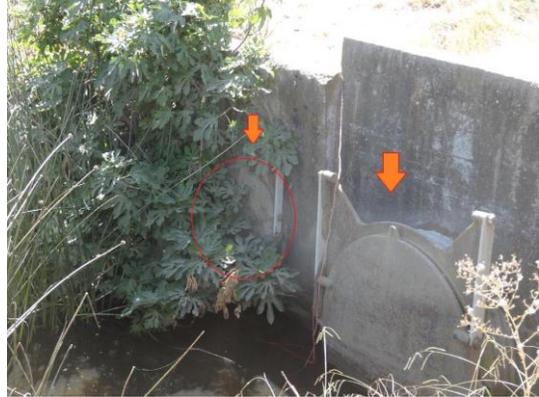
Photo 3 of 3 : UCIP_FA_2015_1713.jpg

WS view: concrete headwall, flap gates on 36" CMP (left) and 60" CMP (right)

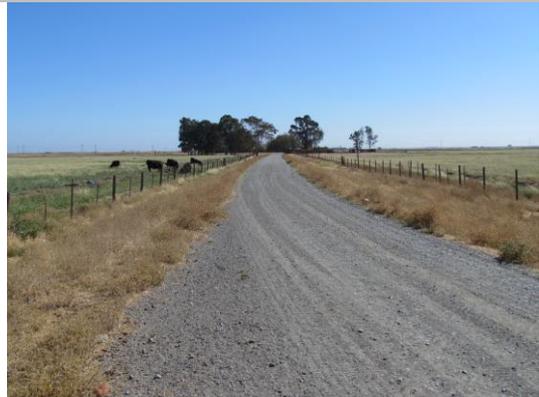
Photo 1 of 1 : FA_2015_RD0536_208_21_20151005_00027.jpg

LM Start	0.02	Rating **	M	Issue No.	57
LM End	0.02	Issue Type +	En	Location *	WS
Category	Earthen Levee			GPS Latitude/Longitude	
				Start	End
Item	Encroachments			38.244948 °	38.244948 °
				-121.768637 °	-121.768637 °
DWR ID	DWR_RD0536_01_f_ 2013_57				
Action/Comments					
Fence Inspector Comments: This is not a new fence.

Looking downstream of RD 536 landside, waterside and crown is in view.

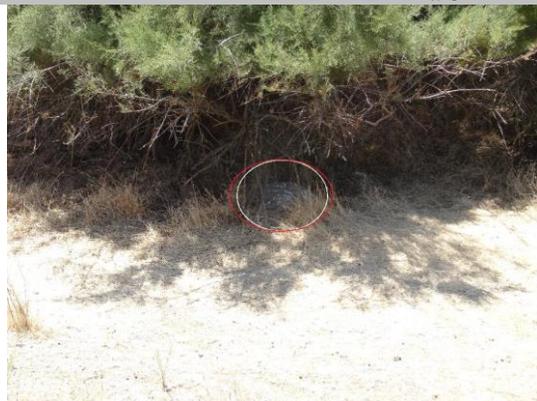
Photo 1 of 3 : UCIP_FA_2015_1714.jpg

LM Start	0.31	Rating **	M	Issue No.	73
LM End	0.31	Issue Type +	En	Location *	LS
Category	Supplemental		GPS Latitude/Longitude		
			Start	End	
Item	DWR UCIP Field Study		38.245605 °	38.245605 °	
			-121.763441 °	-121.763441 °	
DWR ID					
Action/Comments					
Inspector Comments: FS_ID:20675 DS_ID:22713 EP_NO: 10114 FS_HLM: 0.311 Repair Type: Non-Urgent Crossing Status: Found UCIP Comments: Outlet was blocked by concrete debris and dirt. Needs cleaning of debris. FIELD_STRUCT_DESC: 24-inch corrugated metal drain pipe through levee 10.5 feet below crown. Flap gate on waterward end. Originally included in the 1953 O&M manual, Sac 106, May 1953. FS Date: 08/13/2013

LS view: open CM pipe end on levee slope.

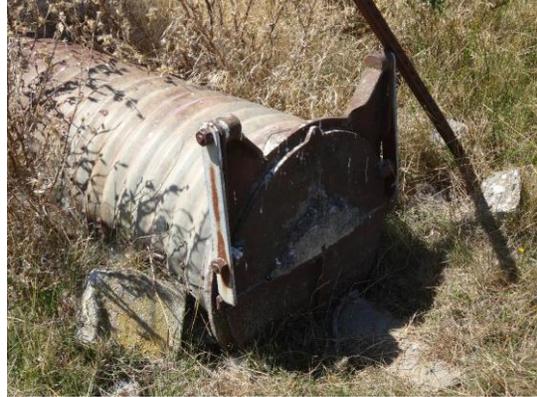
Photo 2 of 3 : UCIP_FA_2015_1715.jpg

WS view: CM pipe blocked by concrete debri on levee slope.

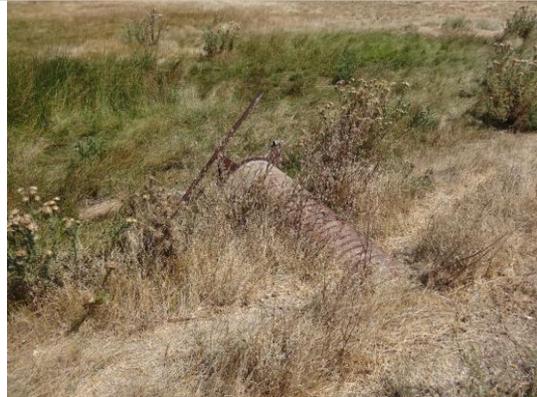
Photo 3 of 3 : UCIP_FA_2015_1716.jpg

WS view: overview of exposed CM pipe on levee slope.

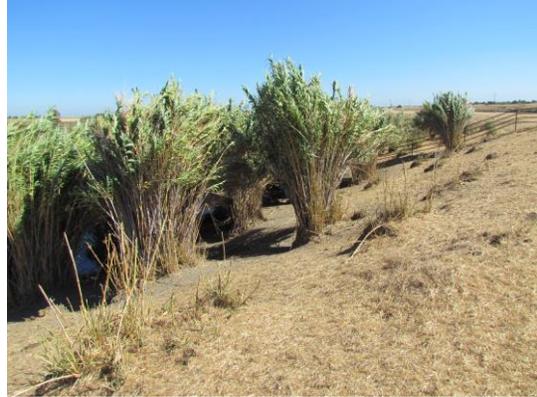
Photo 1 of 1 : FA_2015_RD0536_208_34_20151005_00028.jpg

Bambo and oother vegetation present on the waterside slope.

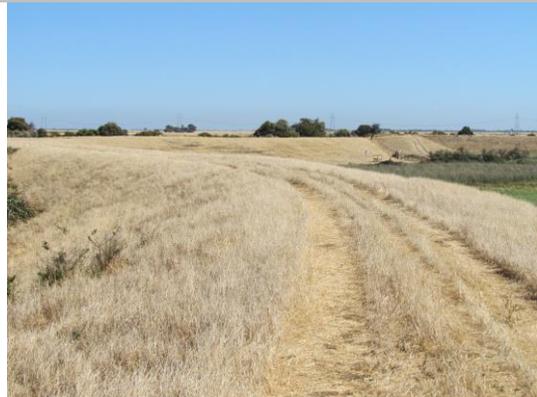
Photo 1 of 1 : FA_2015_RD0536_208_49_20151005_00029.jpg

LM Start	1.35	Rating **	M	Issue No.	47
LM End	1.55	Issue Type +	Ma	Location *	CR
Category	Earthen Levee		GPS Latitude/Longitude		
			Start	End	
Item	Crown Surface / Depressions / Rutting		38.258930 °	38.258637 °	
			-121.757085 °	-121.753397 °	
DWR ID	DWR_RD0536_01_f_2014_47				
Action/Comments					
Add appropriate material and re-grade the levee to bring the crown above the design elevation.

Unwanted grasses present on the crown roadway.

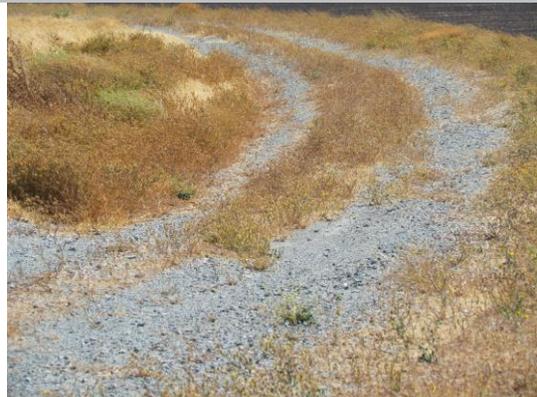
Photo 1 of 2 : FA_2015_RD0536_208_56_20151005_00030.jpg

LM Start	2.69	Rating **	U	Issue No.	56
LM End	2.71	Issue Type +	Ma	Location *	CR
Category	Earthen Levee			GPS Latitude/Longitude	
				Start	End
Item	Crown Surface / Depressions / Rutting			38.255197 °	38.254973 °
				-121.737932 °	-121.737577 °
DWR ID	DWR_RD0536_01_f_2014_56				
Action/Comments					
Repair depressions or ruts in the crown or slope. Inspector Comments: District need to monitor the levee crown roadway at this location. There are some issues here.

Close up view of the unsettling of the crown roadway.

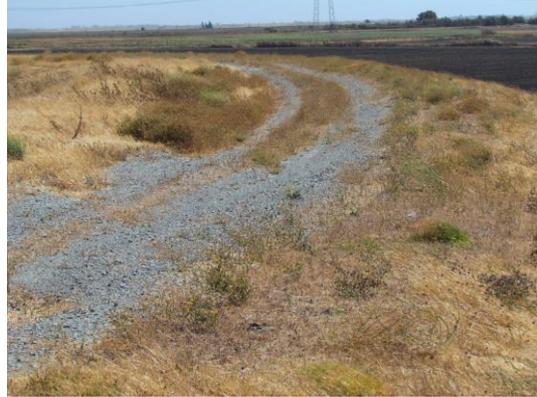
Photo 2 of 2 : FA_2015_RD0536_208_56_20151005_00031.jpg

Looking downstream at crown roadway there is still some settling going on here at this location.

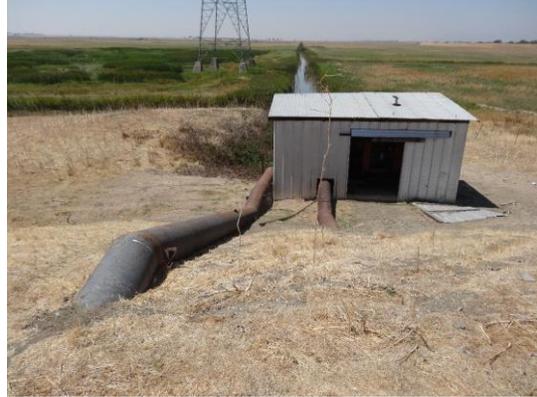
Photo 1 of 3 : UCIP_FA_2015_1717.jpg

LM Start	3.69	Rating **	M	Issue No.	74
LM End	3.69	Issue Type +	En	Location *	CR
Category	Supplemental			GPS Latitude/Longitude	
				Start	End
Item	DWR UCIP Field Study			38.252388 °	38.252388 °
				-121.726437 °	-121.726437 °
DWR ID					
Action/Comments					
Inspector Comments: FS_ID:41374 DS_ID:24023 EP_NO: N/A FS_HLM: 3.689 Repair Type: Non-Urgent Crossing Status: Found UCIP Comments: - Field discovered pipe.- Needs more information from the LMA/ DWR Inspector. - Dense vegetation on WS.- Pump feeds both pipes. FIELD_STRUCT_DESC: 1 of 2. A 18-inch steel pipe (of 16-inch & 18-inch pipe) approximately 4 ft. below crown and through the levee. Pump in pump house on landside. Pressure breaker on waterside levee slope. FS Date: 08/13/2013

WS view: exposed 18" steel pipe (left) and 16" steel pipe (right) on levee slope. Pump house on bank of drainage ditch.

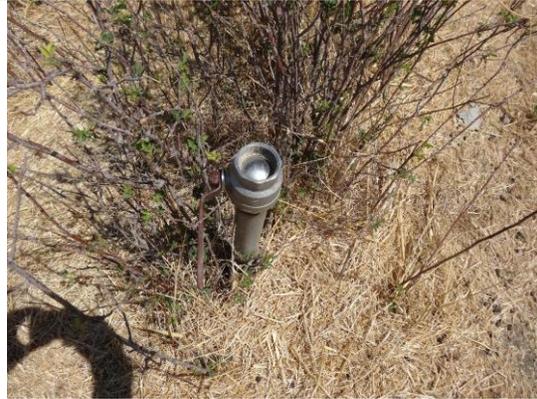
Photo 2 of 3 : UCIP_FA_2015_1718.jpg

WS view: pressure breaker/valve on levee slope.

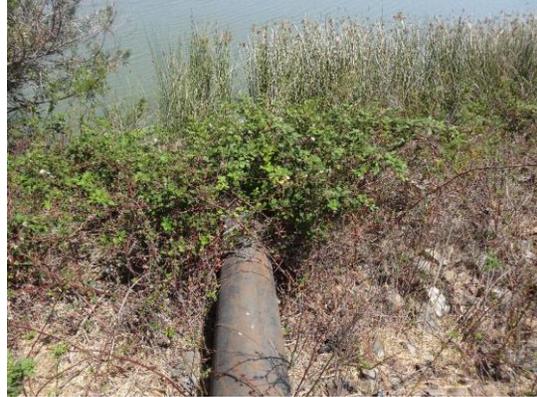
Photo 3 of 3 : UCIP_FA_2015_1719.jpg

WS view: exposed 18" steel pipe on levee slope.

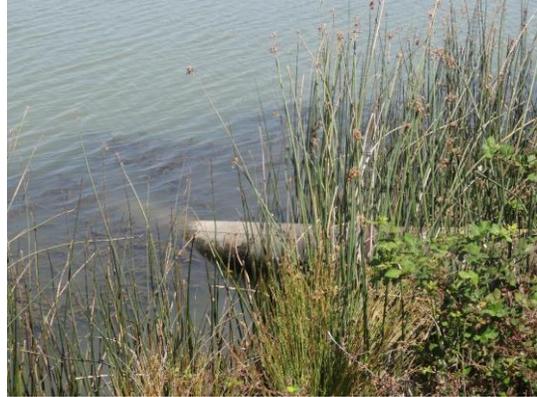
Photo 2 of 3 : UCIP_FA_2015_1492.jpg

WS view: steel pipe submerged into water in the stream.

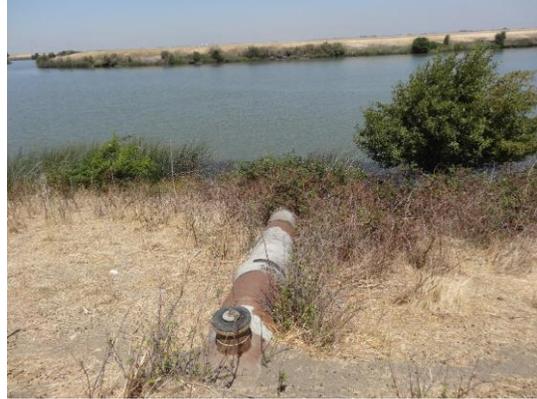
Photo 3 of 3 : UCIP_FA_2015_1493.jpg

WS view: exposed steel pipe with siphon breaker on levee slope.

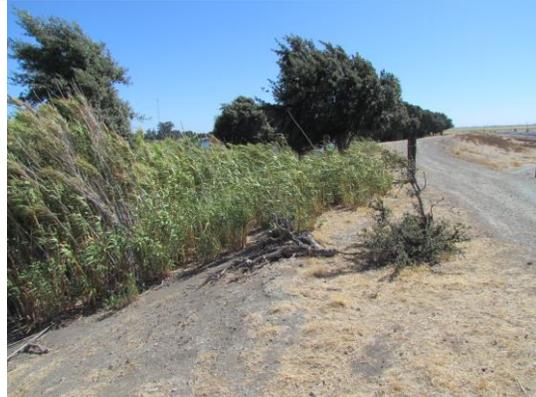
Photo 1 of 1 : FA_2015_RD0536_208_20_20151005_00033.jpg

This photo shows the unsafactory growth of wild arundo on the waterside slope.

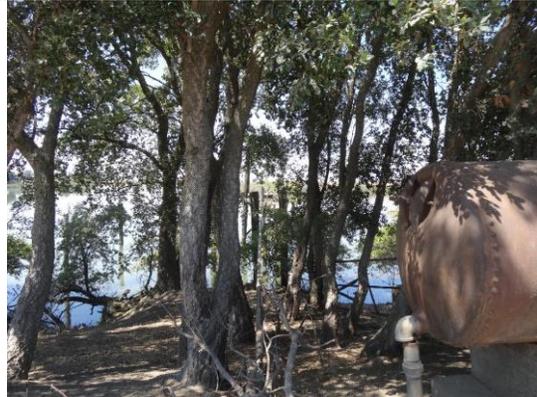
Photo 1 of 3 : UCIP_FA_2015_1494.jpg

Inspector Comments: FS_ID:20523
 DS_ID:22720
 EP_NO: 10116
 FS_HLM: 4.9653
 Repair Type: Non-Urgent
 Crossing Status: Found
 UCIP Comments: Pipe seems to be abandoned. Catwalk and pumphouse on riverside not found. It is not clear whether the pipe pass through the levee or not. Needs more info from LMA/DWR Inspector.
 FIELD_STRUCT_DESC: 3-inch B.I. galvanized pipe through levee 4.0 feet below crown. Concrete cradle and tank on waterward slope.
 FS Date: 08/13/2013

WS view: concrete cradle and abandoned steel tank on levee shoulder.

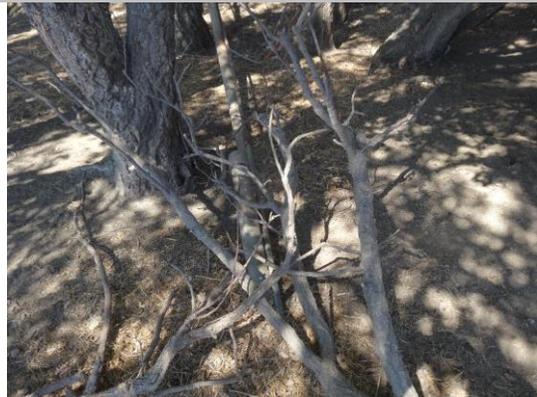
Photo 2 of 3 : UCIP_FA_2015_1495.jpg

WS view: exposed pipes on levee shoulder.

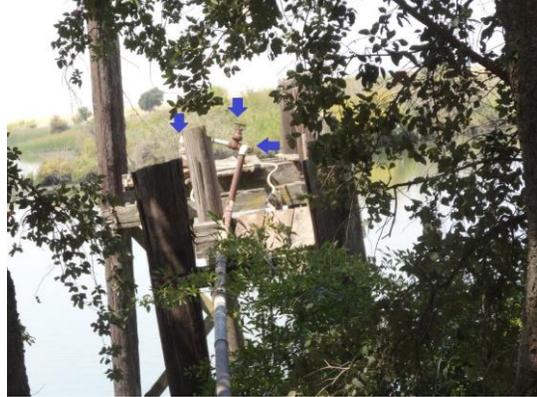
Photo 3 of 3 : UCIP_FA_2015_1496.jpg

WS view: pump, pipe, gate valve, and wooden piling structure in the stream.

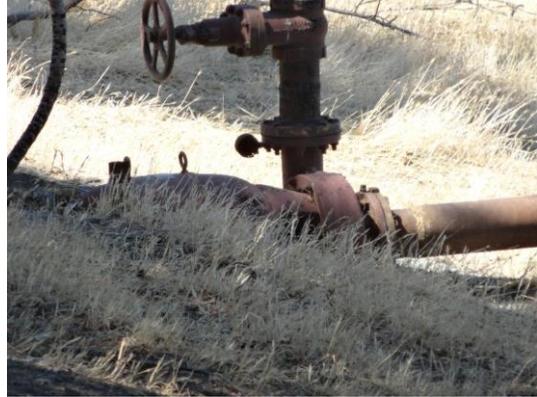
Photo 1 of 2 : UCIP_FA_2015_1497.jpg

LM Start	5.10	Rating **	M	Issue No.	77
LM End	5.10	Issue Type +	En	Location *	WS
Category	Supplemental			GPS Latitude/Longitude	
				Start	End
Item	DWR UCIP Field Study			38.245783 °	38.245783 °
DWR ID				-121.705999 °	-121.705999 °
Action/Comments					
Inspector Comments: FS_ID:20543 DS_ID:22721 EP_NO: 3873 FS_HLM: 5.1038 Repair Type: Non-Urgent Crossing Status: Found UCIP Comments: Pipe seems to be abandoned.Needs proper abandonment. FIELD_STRUCT_DESC: 6-inch pipe through levee 2.0 feet below crown. Pump on concrete base on waterward slope. Gate valve on waterward slope. (Permit No.3873, 1962). FS Date: 08/13/2013

WS view: closer view of abandoned pipe, pump, and gate valve on levee slope.

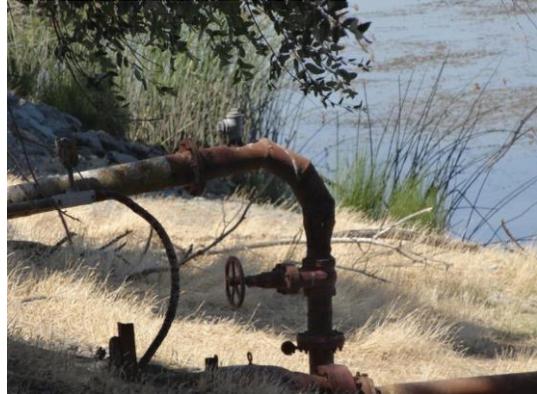
Photo 2 of 2 : UCIP_FA_2015_1498.jpg

WS view: abandoned pipe, pump, conduit, and gate valve on levee slope.

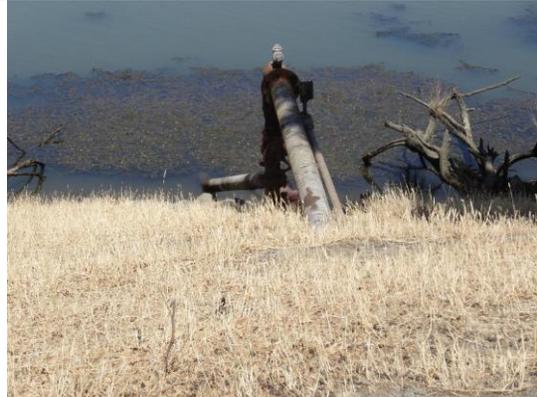
Photo 1 of 2 : UCIP_FA_2015_1781.jpg

LM Start	5.10	Rating **	M	Issue No.	78
LM End	5.10	Issue Type +	En	Location *	WS
Category	Supplemental			GPS Latitude/Longitude	
				Start	End
Item	DWR UCIP Field Study			38.245783 °	38.245783 °
				-121.705999 °	-121.705999 °
DWR ID					
Action/Comments					
Inspector Comments: FS_ID:20869 DS_ID:24664 EP_NO: N/A FS_HLM: 5.104 Repair Type: Non-Urgent Crossing Status: Found

WS view: closer view of pipe and pump on channel bank.

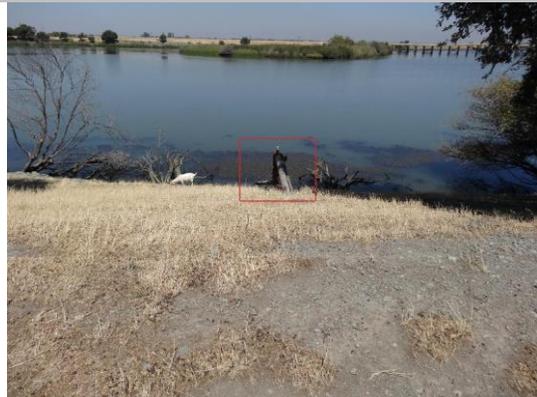
Photo 2 of 2 : UCIP_FA_2015_1782.jpg

WS view: pipe and pump on channel bank.

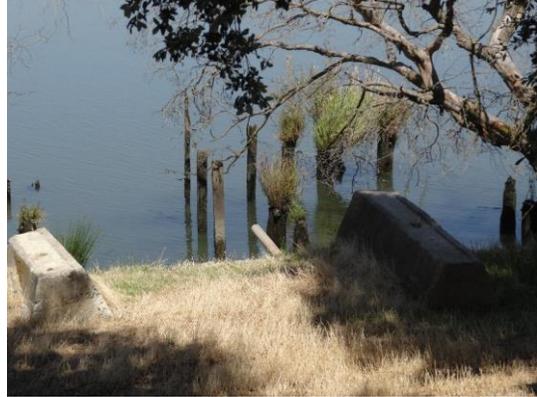
Photo 1 of 2 : UCIP_FA_2015_1499.jpg

LM Start	5.12	Rating **	M	Issue No.	79
LM End	5.12	Issue Type +	En	Location *	WS
Category	Supplemental			GPS Latitude/Longitude	
				Start	End
Item	DWR UCIP Field Study			38.245588 °	38.245588 °
				-121.705723 °	-121.705723 °
DWR ID					
Action/Comments					
Inspector Comments: FS_ID:20544 DS_ID:24024 EP_NO: N/A FS_HLM: 5.124 Repair Type: Non-Urgent Crossing Status: Found

WS view: abandoned steel pipe on concrete pad.

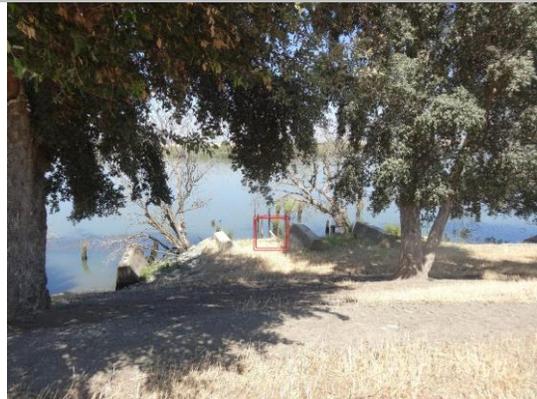
Photo 2 of 2 : UCIP_FA_2015_1500.jpg

WS view: overview of levee slope, concrete pad, and pipe.

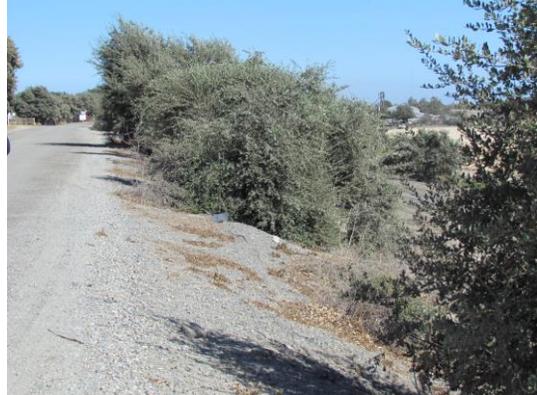
Photo 1 of 1 : FA_2015_RD0536_208_65_20151005_00034.jpg

Looking downstream from levee mile 5.17 to 5.39 at unsatisfactory woody tree growth on the landside levee slope.

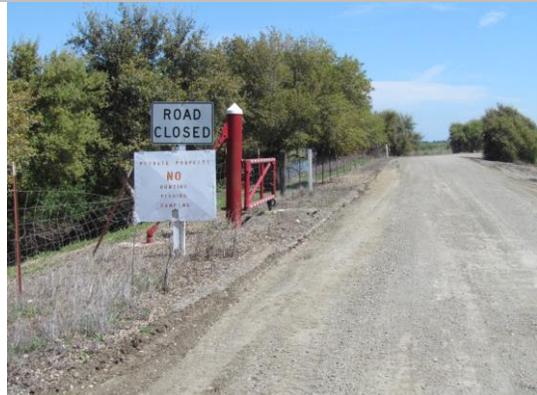
Photo 1 of 1 : FA_2015_RD0536_208_11_20150915_00001.jpg

This gate and barricade has no CVFPB permit on file.

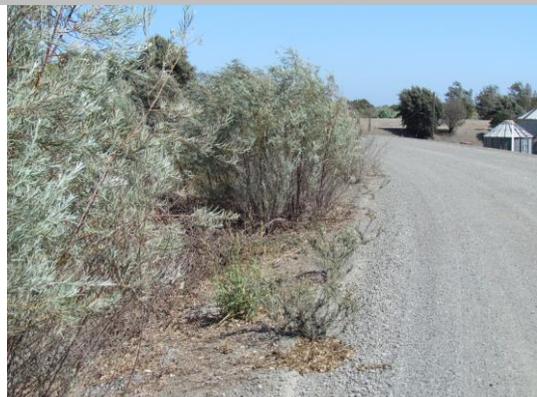
Photo 1 of 1 : FA_2015_RD0536_208_70_20151005_00035.jpg

Unsatisfactory growth of young tree growth present on the waterside levee slope.

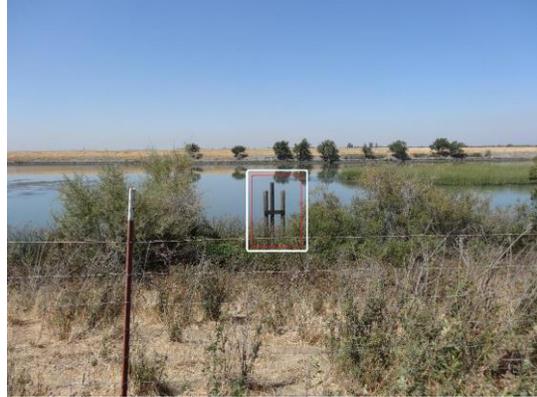
Photo 1 of 3 : UCIP_FA_2015_1171.jpg

WS view: wooden & steel piles on the slough. Probably the supports are for pipe and flap gate. Not accessible due to fence.

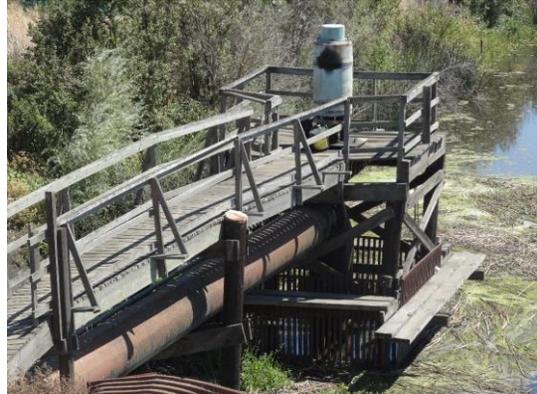
Photo 2 of 3 : UCIP_FA_2015_1551.jpg

LS view: pipe under the wooden walkway and pump on wooden platform in drain ditch.

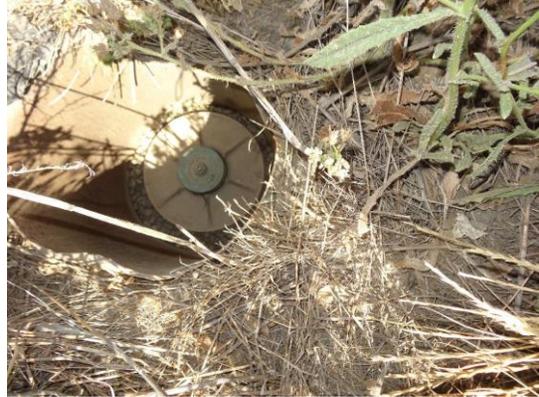
Photo 3 of 3 : UCIP_FA_2015_1552.jpg

WS view: uncovered siphon breaker on levee shoulder. It needs protection.

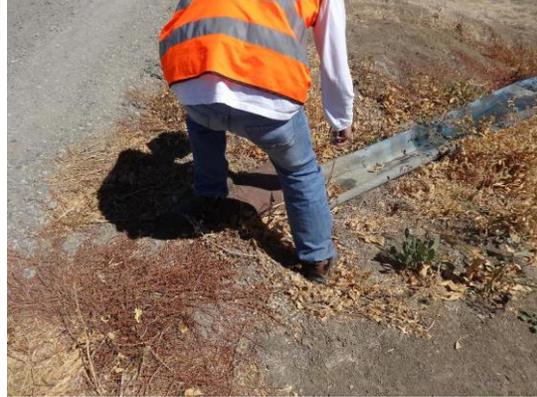
Photo 1 of 3 : UCIP_FA_2015_1705.jpg

WS view: steel pipe on levee shoulder at 2-inch below the crown.

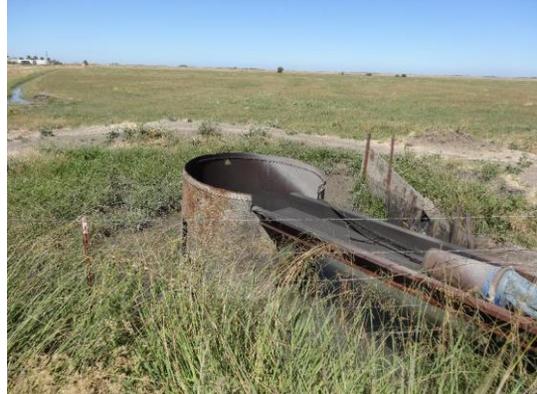
Photo 2 of 3 : UCIP_FA_2015_1706.jpg

LS view: steel standpipe on levee slope.

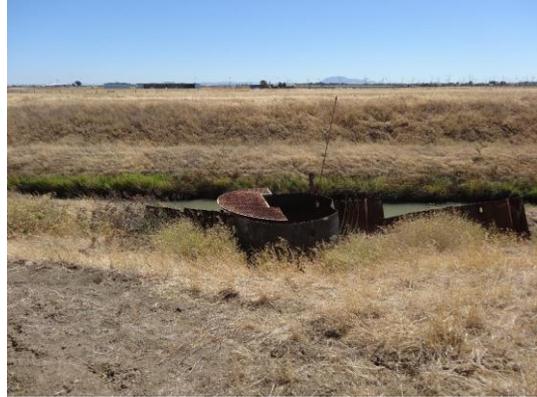
Photo 3 of 3 : UCIP_FA_2015_1707.jpg

WS view: steel standpipe on levee slope.

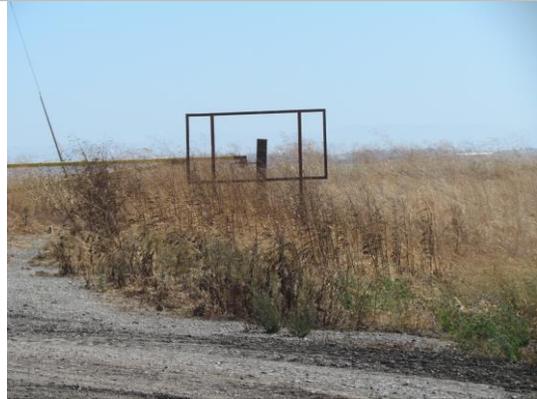
Photo 1 of 1 : FA_2015_RD0536_209_17_20151005_00010.jpg

Unsatisfactory growth on the landside slope.

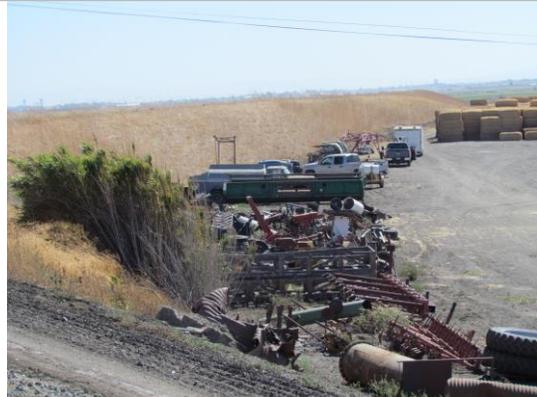
Photo 1 of 1 : FA_2015_RD0536_209_5_20151005_00009.jpg

Equipment placed within the easement on the landside levee slope.

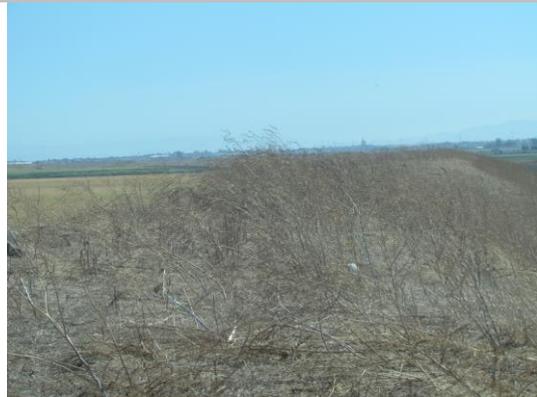
Photo 1 of 1 : FA_2015_RD0536_209_15_20151005_00011.jpg

Unsatisfactory growth of tall wild weeds growing on the crown roadway.

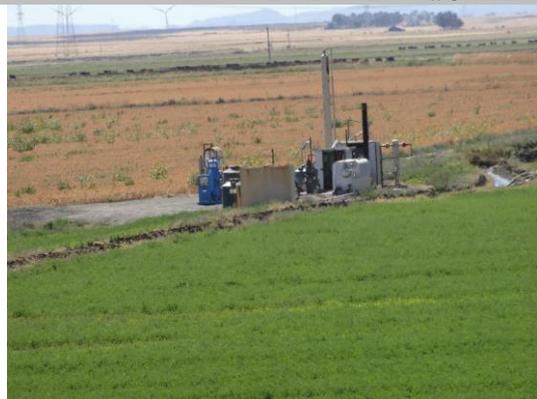
Photo 1 of 3 : UCIP_FA_2015_2065.jpg

WS view: natural gas extraction plant near levee on the field.

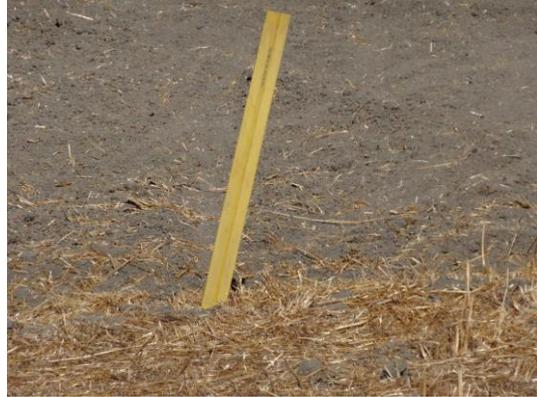
Photo 2 of 3 : UCIP_FA_2015_2066.jpg

WS view: closer look at gasline indicator. The indicator is different than standard indicators.

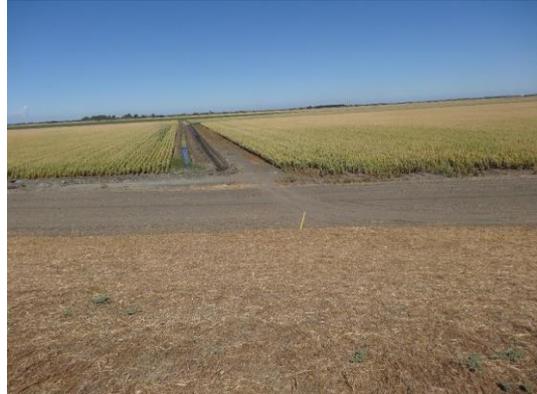
Photo 3 of 3 : UCIP_FA_2015_2067.jpg

WS view: overview of levee slope and gasline indicator. The indicator is different than standard indicators.

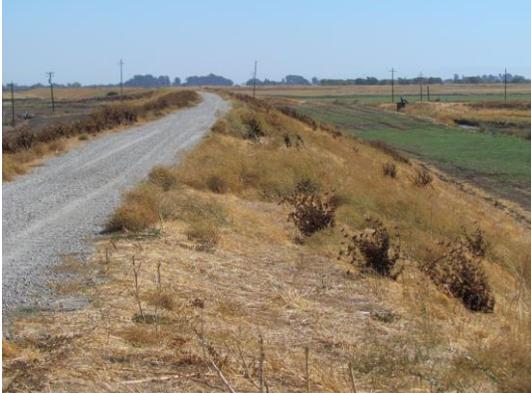
Photo 1 of 1 : FA_2015_RD0536_209_14_20151005_00013.jpg

Unsatisfactory tall weed growth on the landward levee section.

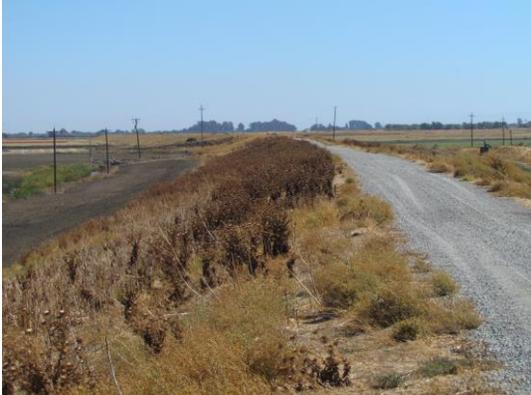
Photo 1 of 1 : FA_2015_RD0536_209_2_20151005_00012.jpg

Unsatisfactory wild growth of weeds on the waterside levee slope and shoulder.

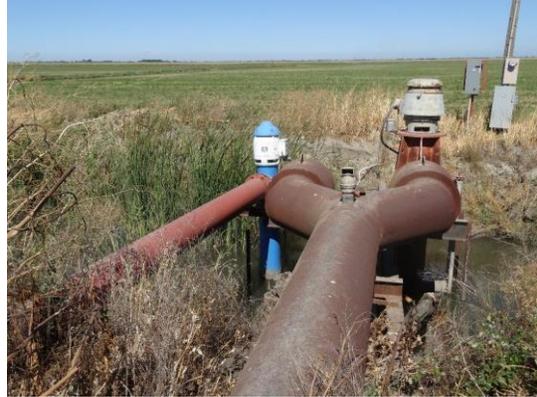
Photo 1 of 2 : UCIP_FA_2015_2063.jpg

WS view: closer view of pipe and pump (left). Big pump and appurtenances (right) for 24" steel pipe.

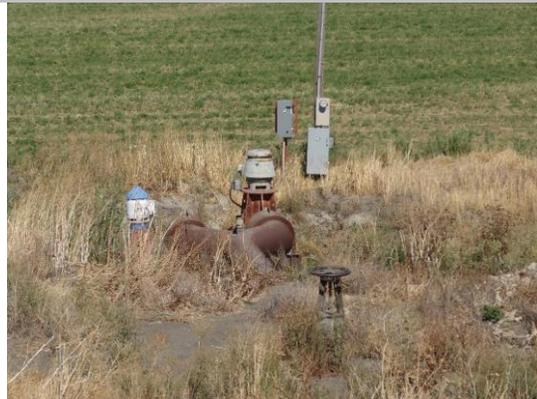
Photo 2 of 2 : UCIP_FA_2015_2064.jpg

WS view: overview of pipe and pump (left). Big pump and appurtenances (right) for 24" steel pipe.

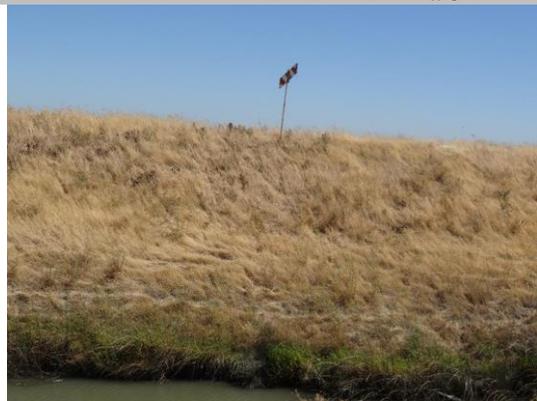
Photo 1 of 2 : UCIP_FA_2015_1704.jpg

WS view: gasline indicator across the channel.

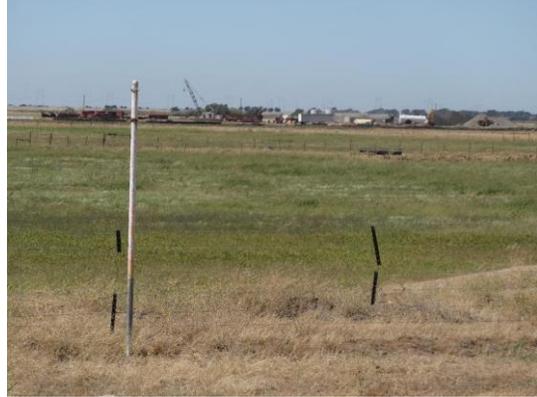
Photo 2 of 2 : UCIP_FA_2015_2068.jpg

LS view: gasline indicator on levee toe.
