**Flood Control Project Maintenance  
Levee Inspections**  
**LMA District Cover Sheet**  
**Spring 2015 Levee Inspection Results**

**Reclamation District No. 0536 Egbert**

**Spring 2015 Levee Inspection Results**

**Levee Inspection Report By Mile - Spring 2015**

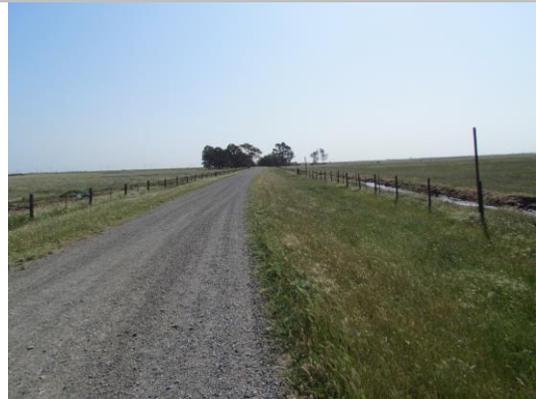
Photo 1 of 1 : SP\_2015\_RD0536\_208\_24\_20150601\_00026.jpg

LM Start	<b>0.03</b>	Rating **	A	Issue No.	<b>24</b>
LM End	<b>1.78</b>	Issue Type +	Ma	Location *	LS
Category	Earthen Levee		GPS Latitude/Longitude		
			Start	End	
Item	Vegetation		38.245012 °	38.259667 °	
			-121.768460 °	-121.749812 °	
DWR ID	DWR_RD0536_01_f_2014_24				
Action/Comments					
Control annual grass and weeds on the levee slopes and easements.

RD 536 Unit 1 landside.

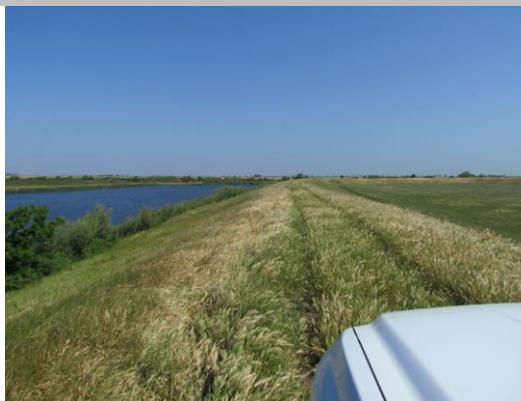
Photo 1 of 1 : SP\_2015\_RD0536\_208\_46\_20150601\_00028.jpg

LM Start	<b>0.72</b>	Rating **	U	Issue No.	<b>46</b>
LM End	<b>2.60</b>	Issue Type +	Ma	Location *	CR
Category	Earthen Levee			GPS Latitude/Longitude	
				Start	End
Item	Vegetation			38.250237 °	38.256348 °
				-121.759535 °	-121.738608 °
DWR ID	DWR_RD0536_01_s_2015_46				
Action/Comments					
Keep the crown roadway free of vegetation. Inspector Comments: Keep crown roadway free of vegetation.

Looking downstream crown roadway covered with unacceptable vegetation.

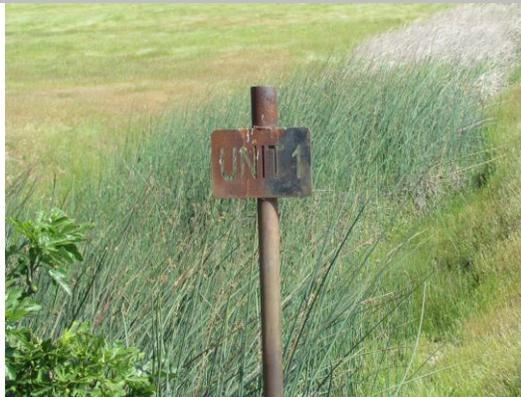
Photo 1 of 1 : SP\_2015\_RD0536\_208\_27\_20150601\_00027.jpg

LM Start	<b>0.93</b>	Rating **	M	Issue No.	<b>27</b>
LM End	<b>4.29</b>	Issue Type +	Ma	Location *	WS
Category	Earthen Levee		GPS Latitude/Longitude		
			Start	End	
Item	Vegetation		38.250750 °	38.248661 °	
			-121.749210 °	-121.717443 °	
DWR ID	DWR_RD0536_01_s_2012_27				
Action/Comments					
Remove the wild growth other than native grasses from the levee slopes. Inspector Comments: Control the wild growth of weeds on the levee shoulder and slope.

Looking downstream waterside slope.

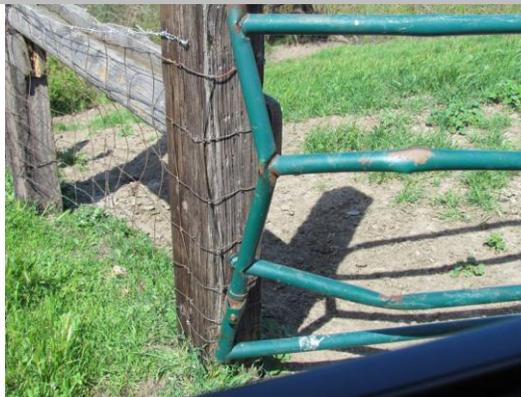
Photo 1 of 1 : SP\_2015\_RD0536\_208\_25\_20150312\_00003.jpg

LM Start	<b>1.10</b>	Rating **	M	Issue No.	<b>25</b>
LM End	<b>1.10</b>	Issue Type +	Ma	Location *	CR
Category	Earthen Levee		GPS Latitude/Longitude		
			Start	End	
Item	Repair Gates		38.255455 °	38.255455 °	
			-121.757587 °	-121.757587 °	
DWR ID	DWR_RD0536_01_s_2014_25				
Action/Comments					
Inspector Comments: This gate looks like its been run over, the bottom hinge is broken thus making the gate hard to open and close properly.

This gate needs to be replaced.

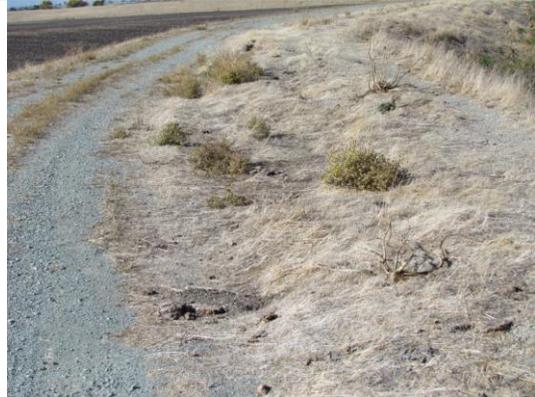
Photo 1 of 2 : SP\_2015\_RD0536\_208\_56\_20150312\_00012.jpg

LM Start	<b>2.69</b>	Rating **	U	Issue No.	<b>56</b>
LM End	<b>2.71</b>	Issue Type +	Ma	Location *	CR
Category	Earthen Levee			GPS Latitude/Longitude	
				Start	End
Item	Crown Surface / Depressions / Rutting			38.255197 °	38.254973 °
				-121.737932 °	-121.737577 °
DWR ID	DWR_RD0536_01_f_2014_56				
Action/Comments					
Repair depressions or ruts in the crown or slope. Inspector Comments: District need to monitor the levee crown roadway at this location. There are some issues here with settlement.

Looking back upstream waterward at the levee crown roadway stability issues.

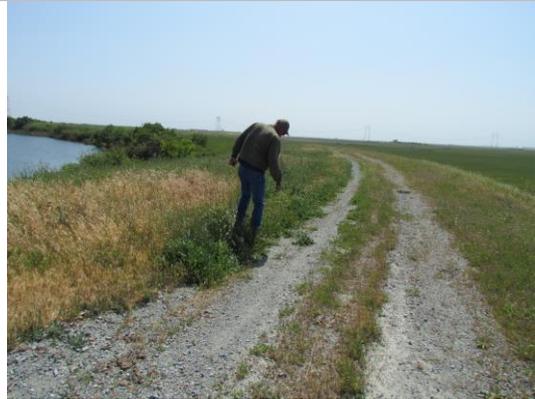
Photo 2 of 2 : SP\_2015\_RD0536\_208\_56\_20150601\_00029.jpg

Some settlement issues can't currently be seen due to the vegetation.

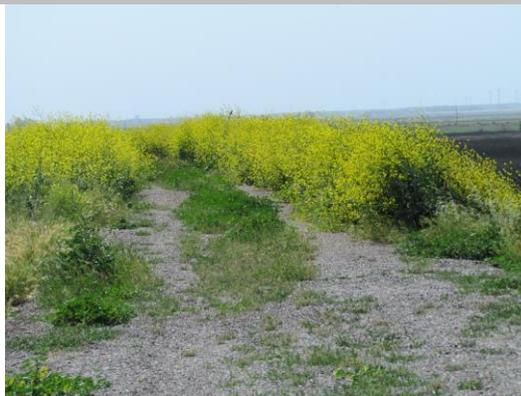
Photo 1 of 1 : SP\_2015\_RD0536\_208\_78\_20150601\_00030.jpg

LM Start	<b>3.36</b>	Rating **	U	Issue No.	<b>78</b>
LM End	<b>4.37</b>	Issue Type +	Ma	Location *	CR
Category	Earthen Levee			GPS Latitude/Longitude	
				Start	End
Item	Vegetation			38.256685 °	38.248572 °
				-121.726917 °	-121.716158 °
DWR ID	DWR_RD0536_01_s_2015_78				
Action/Comments					
Keep the crown roadway free of vegetation. Inspector Comments: Remove the unsatisfactory tall weeds from the levee section.

Unacceptable wild growth on the crown roadway and both slopes.

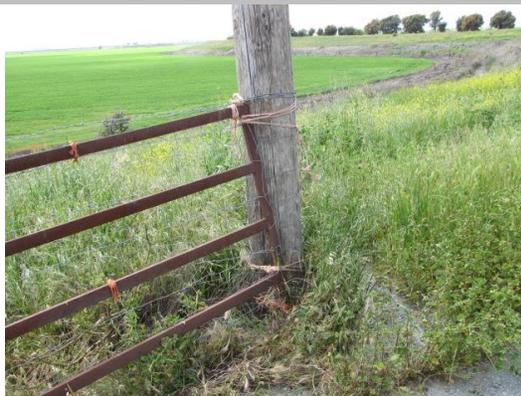
Photo 1 of 1 : SP\_2015\_RD0536\_208\_36\_20150312\_00004.jpg

LM Start	<b>3.67</b>	Rating **	M	Issue No.	<b>36</b>
LM End	<b>3.67</b>	Issue Type +	Ma	Location *	WS
Category	Earthen Levee			GPS Latitude/Longitude	
				Start	End
Item	Repair Gates			38.252578 °	38.252578 °
				-121.726439 °	-121.726439 °
DWR ID	DWR_RD0536_01_s_2012_36				
Action/Comments					
Inspector Comments: This gate need to be repaired.

Repair this gate. Someone could get hurt trying to open and close this gate.

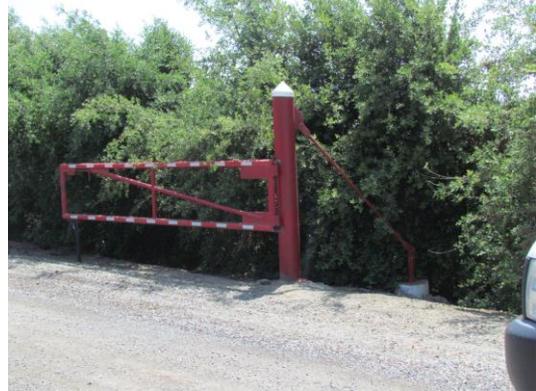
Photo 1 of 1 : SP\_2015\_RD0536\_208\_11\_20150601\_00032.jpg

LM Start	<b>5.34</b>	Rating **	U	Issue No.	<b>11</b>
LM End	<b>5.34</b>	Issue Type +	En	Location *	CR
Category	Earthen Levee		GPS Latitude/Longitude		
			Start	End	
Item	Encroachments		38.245644 °	38.245644 °	
			-121.701945 °	-121.701945 °	
DWR ID	DWR_RD0536_01_s_2013_11				
Action/Comments					
Fence Inspector Comments: The District said that the property owner had this gate and barricade installed by the County road Department.

This gate has no CVFPB permit on file.

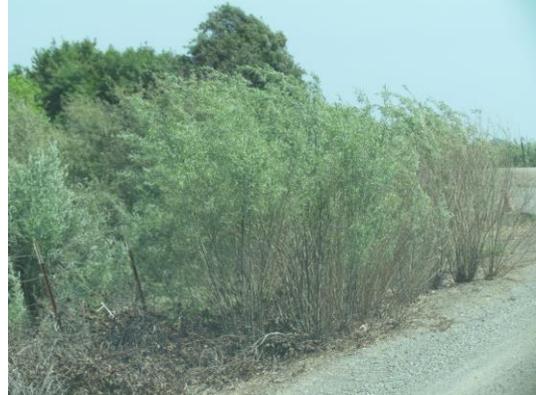
Photo 1 of 1 : SP\_2015\_RD0536\_208\_70\_20150601\_00031.jpg

LM Start	<b>5.46</b>	Rating **	U	Issue No.	<b>70</b>
LM End	<b>5.58</b>	Issue Type +	Ma	Location *	WS
Category	Earthen Levee		GPS Latitude/Longitude		
			Start	End	
Item	Vegetation		38.245608 °	38.245610 °	
			-121.699768 °	-121.697493 °	
DWR ID	DWR_RD0536_01_f_2014_70				
Action/Comments					
Remove the wild growth other than native grasses from the levee slopes. Inspector Comments: The district needs to remove the wild growth from the waterward levee slope and shoulder.

Unacceptable woody tree growth on the waterside levee slope.

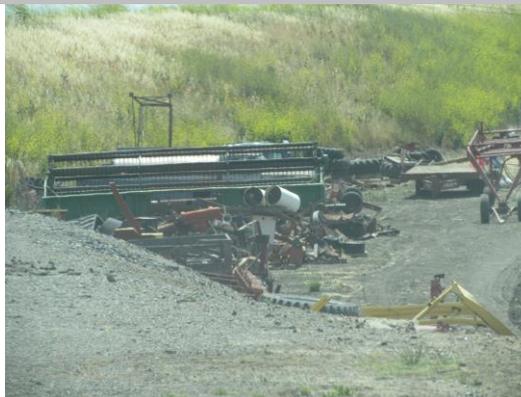
Photo 1 of 1 : SP\_2015\_RD0536\_209\_19\_20150601\_00013.jpg

LM Start	<b>0.17</b>	Rating **	U	Issue No.	<b>19</b>
LM End	<b>0.17</b>	Issue Type +	En	Location *	LS
Category	Earthen Levee		GPS Latitude/Longitude		
			Start	End	
Item	Encroachments		38.243168 °	38.243168 °	
			-121.697040 °	-121.697040 °	
DWR ID	DWR_RD0536_02_s_2014_19				
Action/Comments					
Equipment Inspector Comments: Remove the farm equipment along with other material stored at toe from the 10-foot easement of the landward toe.

Equipment stored within the 10-foot easement of the landside toe.
