**Flood Control Project Maintenance
Levee Inspections**
LMA District Cover Sheet
Spring 2016 Levee Inspection Results

Reclamation District No. 0536 Egbert

Levee Inspection Report By Mile - Spring 2016

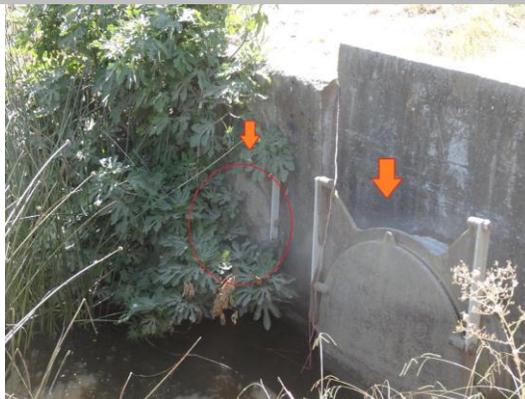
Photo 1 of 2 : UCIP_SP_2016_20406_34457.jpg

LM Start	0.00	Rating **	U	Issue No.	79
LM End	0.00	Issue Type +	En	Location *	WS
Category	Supplemental			GPS Latitude/Longitude	
				Start	End
Item	DWR UCIP Field Study			38.244963 °	38.244963 °
				-121.768960 °	-121.768960 °
DWR ID					
Comment Code					
Inspector Comment					
FS_ID:20406 DS_ID:22712 EP_NO: 10114 Repair Type: Urgent Crossing Status: Found UCIP Comments: - Holes in pipe outlet due to heavy corrosion.- Headwall cracked and tilted on WS. FIELD_STRUCT_DESC: 1 of 2: 60-inch corrugated metal pipe (of 60-inch and 36-inch CMP) through levee 10.0 feet below crown in drain ditch. (ABO 10114, 1974). Originally included in the 1953 O&M manual, Sac 106, May 1953. FS Date: 8/13/2013

WS view: two CMPs with flap gates. Concrete headwall supports the pipes. A 36" CMP (left) and 60" CMP (right).

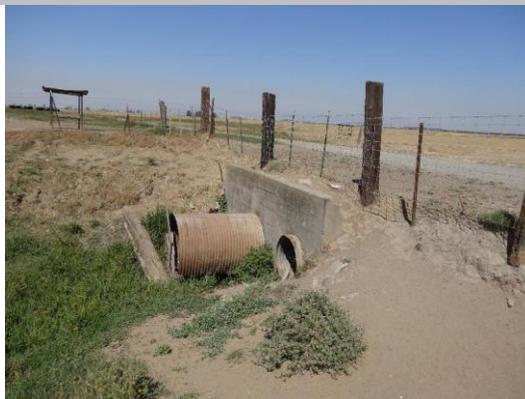
Photo 2 of 2 : UCIP_SP_2016_20406_34456.jpg

LM Start	0.00	Rating **	U	Issue No.	79 (cont)
LM End	0.00	Issue Type +	En	Location *	WS

LS view: two inlet CMPs with flap gates. Concrete headwall supports the pipes. A 36" CMP (right) and 60" CMP (left).

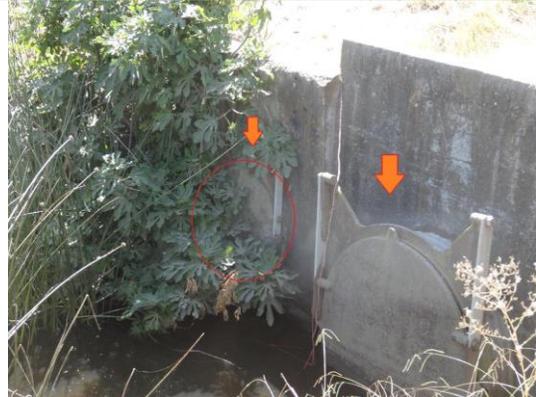
Photo 1 of 2 : UCIP_SP_2016_20674_34771.jpg

LM Start	0.00	Rating **	M	Issue No.	77
LM End	0.00	Issue Type +	En	Location *	WS
Category	Supplemental			GPS Latitude/Longitude	
				Start	End
Item	DWR UCIP Field Study			38.244959 °	38.244959 °
				-121.768921 °	-121.768921 °
DWR ID					
Comment Code					
Inspector Comment					
FS_ID:20674 DS_ID:22726 EP_NO: 10114 Repair Type: Non-Urgent Crossing Status: Found UCIP Comments: This pipe seems to be abandoned. Headwall cracked and tilted on WS. FIELD_STRUCT_DESC: 2 of 2: 36-inch corrugated metal pipe (of 60-inch and 36-inch CMP) through levee 10.0 feet below crown in drain ditch. (ABO 10114, 1974). Originally included in the 1953 O&M manual, Sac 106, May 1953. FS Date: 8/13/2013

WS view: concrete headwall, flap gates on 36" CMP (left) and 60" CMP (right)

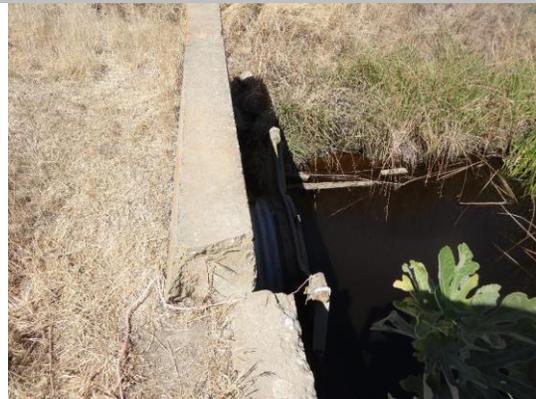
Photo 2 of 2 : UCIP_SP_2016_20674_34770.jpg

LM Start	0.00	Rating **	M	Issue No.	77 (cont)
LM End	0.00	Issue Type +	En	Location *	WS

WS view: cracked and tilted concrete headwall.

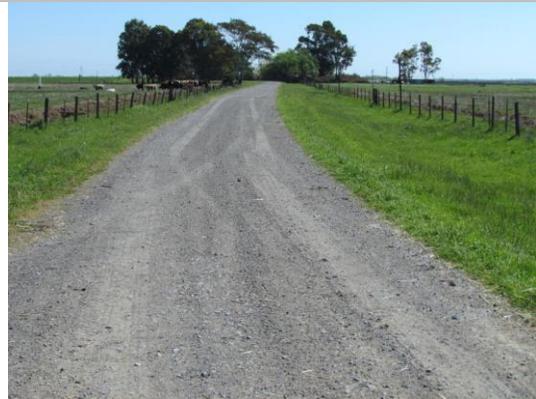
Photo 1 of 1 : SP_2016_RD0536_208_21_20160516_00040.jpg

RD 536 Unit 1 looking downstream from levee mile 0.02 to 0.22.

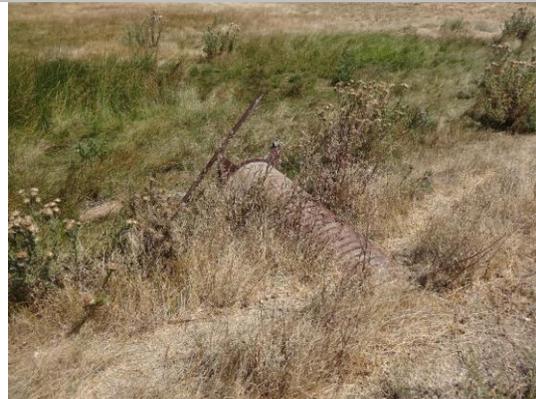
Photo 1 of 2 : UCIP_SP_2016_20675_34774.jpg

LM Start	0.31	Rating **	M	Issue No.	78
LM End	0.31	Issue Type +	En	Location *	LS
Category	Supplemental			GPS Latitude/Longitude	
				Start	End
Item	DWR UCIP Field Study			38.245605 °	38.245605 °
				-121.763441 °	-121.763441 °
DWR ID					
Comment Code					
Inspector Comment					
FS_ID:20675 DS_ID:22713 EP_NO: 10114 Repair Type: Non-Urgent Crossing Status: Found UCIP Comments: Outlet was blocked by concrete debri and dirt.Needs cleaning of debri. FIELD_STRUCT_DESC: 24-inch corrugated metal drain pipe through levee 10.5 feet below crown. Flap gate on waterward end. Originally included in the 1953 O&M manual, Sac 106, May 1953. FS Date: 8/13/2013

WS view: overview of exposed CM pipe on levee slope.

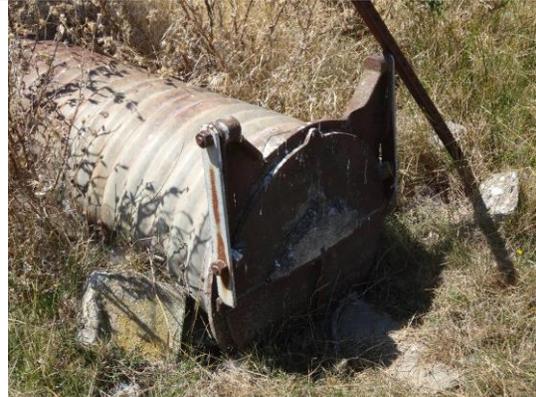
Photo 2 of 2 : UCIP_SP_2016_20675_34773.jpg

LM Start	0.31	Rating **	M	Issue No.	78 (cont)
LM End	0.31	Issue Type +	En	Location *	LS
Category	Supplemental			GPS Latitude/Longitude	
				Start	End
Item	DWR UCIP Field Study			38.245605 °	38.245605 °
				-121.763441 °	-121.763441 °
DWR ID					
Comment Code					
Inspector Comment					
FS_ID:20675 DS_ID:22713 EP_NO: 10114 Repair Type: Non-Urgent Crossing Status: Found UCIP Comments: Outlet was blocked by concrete debri and dirt.Needs cleaning of debri. FIELD_STRUCT_DESC: 24-inch corrugated metal drain pipe through levee 10.5 feet below crown. Flap gate on waterward end. Originally included in the 1953 O&M manual, Sac 106, May 1953. FS Date: 8/13/2013

WS view: CM pipe blocked by concrete debri on levee slope.

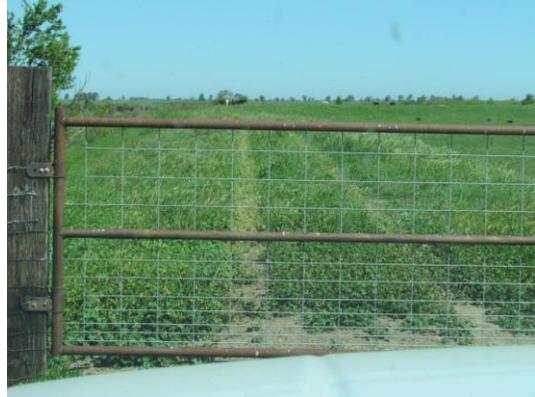
Photo 1 of 1 : SP_2016_RD0536_208_31_20160516_00046.jpg

RD 536 Unit 1 looking downstream from levee mile 1.10 - 2.60 tall weeds growing on the crown roadway.

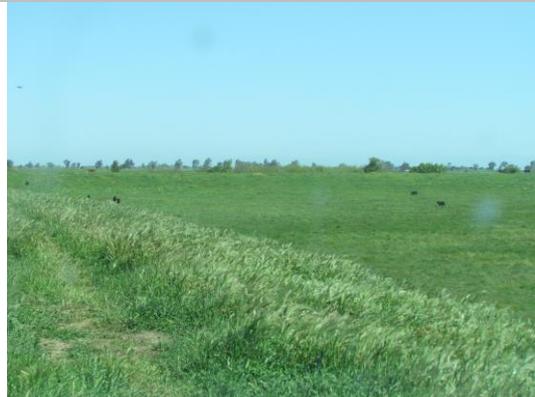
Photo 1 of 1 : SP_2016_RD0536_208_32_20160516_00043.jpg

LM Start	1.11	Rating **	U	Issue No.	32
LM End	5.57	Issue Type +	Ma	Location *	LS
Category	Earthen Levee		GPS Latitude/Longitude		
			Start	End	
Item	Vegetation		38.255533 °	38.245595 °	
			-121.757595 °	-121.697653 °	
DWR ID	DWR_RD0536_01_s_2016_32				
Comment Code					
V2 : Remove the wild growth other than native grasses from the levee slopes.					
Inspector Comment					
Remove the tall grasses from the landside levee slope.

RD 536 Unit 1 looking at the landside slope from levee mile 1.11- 5.57 the tall grasses completely covering the levee slope.

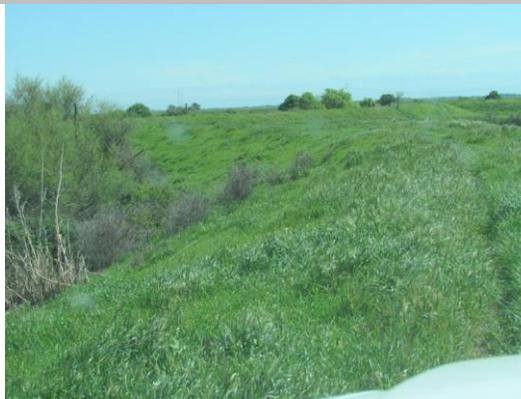
Photo 1 of 1 : SP_2016_RD0536_208_34_20160516_00044.jpg

RD 536 Unit 1 levee mile 1.15-4.25 tall grasses and other wild growth covering the waterside slope and toe.

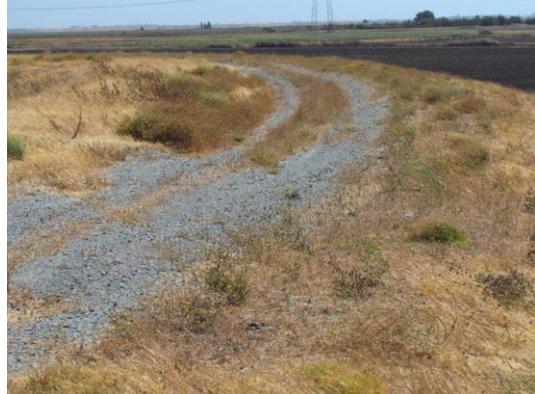
Photo 1 of 3 : SP_2016_RD0536_208_56_20160223_00009.jpg

Looking downstream at crown roadway there is still some settling going on here at this location.

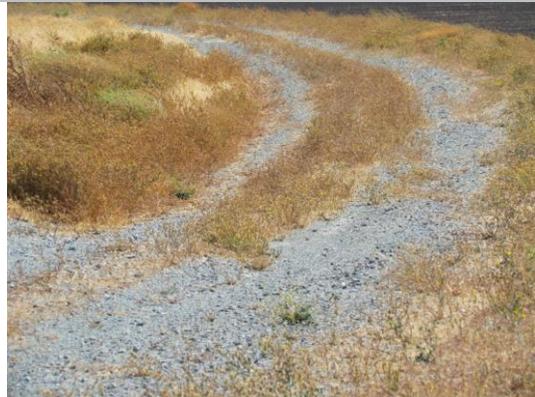
Photo 2 of 3 : SP_2016_RD0536_208_56_20160223_00010.jpg

LM Start	2.69	Rating **	U	Issue No.	56 (cont)
LM End	2.71	Issue Type +	Ma	Location *	CR

Close up view of the uneven settling of the crown roadway.

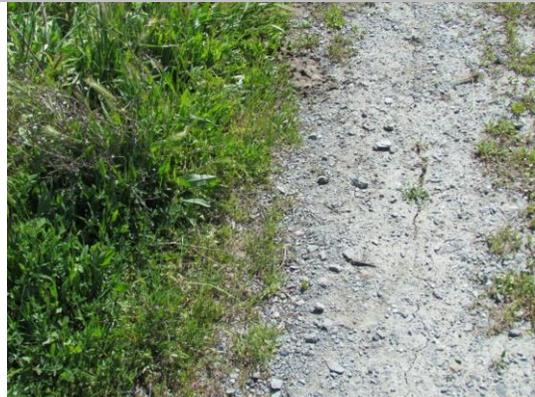
Photo 3 of 3 : SP_2016_RD0536_208_56_20160516_00041.jpg

LM Start	2.69	Rating **	U	Issue No.	56 (cont)
LM End	2.71	Issue Type +	Ma	Location *	CR

The crown roadway has some settling issues that can't be viewed due to the tall grasses allowed to grow on the crown.

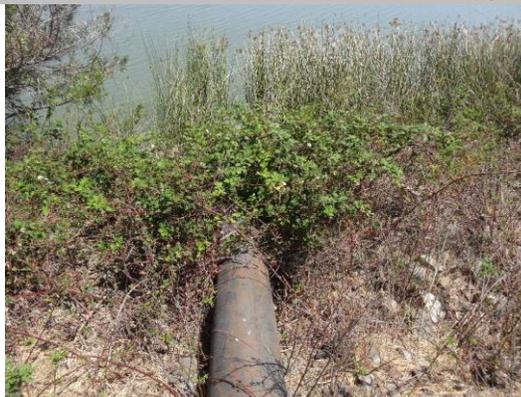
Photo 1 of 2 : UCIP_SP_2016_41374_34789.jpg

LM Start	3.69	Rating **	M	Issue No.	80
LM End	3.69	Issue Type +	En	Location *	WS
Category	Supplemental			GPS Latitude/Longitude	
				Start	End
Item	DWR UCIP Field Study			38.252388 °	38.252388 °
				-121.726437 °	-121.726437 °
DWR ID					
Comment Code					
Inspector Comment					
FS_ID:41374 DS_ID:24023 EP_NO: N/A Repair Type: Non-Urgent Crossing Status: Found UCIP Comments: - Field discovered pipe.- Needs more information from the LMA/ DWR Inspector. - Dense vegetation on WS.- Pump feeds both pipes. FIELD_STRUCT_DESC: 1 of 2. A 18-inch steel pipe (of 16-inch & 18-inch pipe) approximately 4 ft. below crown and through the levee. Pump in pump house on landside. Pressure breaker on waterside levee slope. FS Date: 8/13/2013

WS view: exposed 18" steel pipe on levee slope.

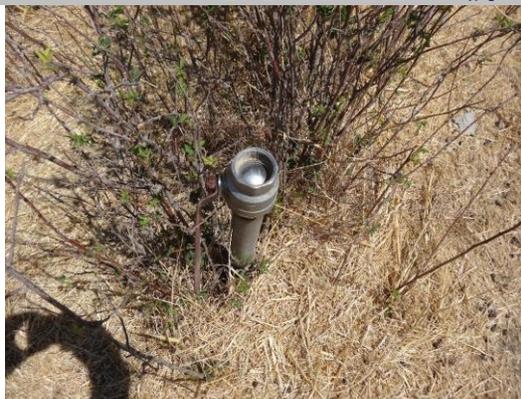
Photo 2 of 2 : UCIP_SP_2016_41374_34788.jpg

LM Start	3.69	Rating **	M	Issue No.	80 (cont)
LM End	3.69	Issue Type +	En	Location *	WS

WS view: pressure breaker/valve on levee slope.

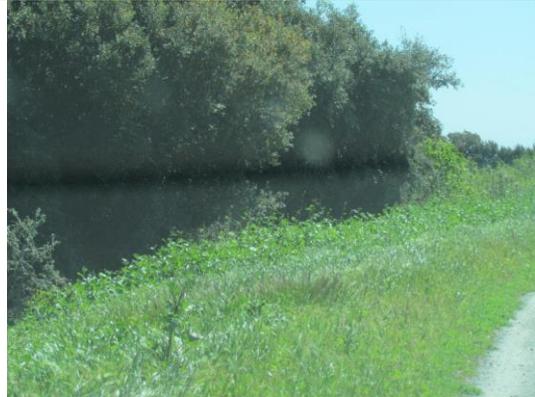
Photo 1 of 1 : SP_2016_RD0536_208_44_20160516_00045.jpg

RD 536 Unit 1 looking downstream from levee mile 4.55-4.96 unwanted tall weeds covering the waterward slope and toe.

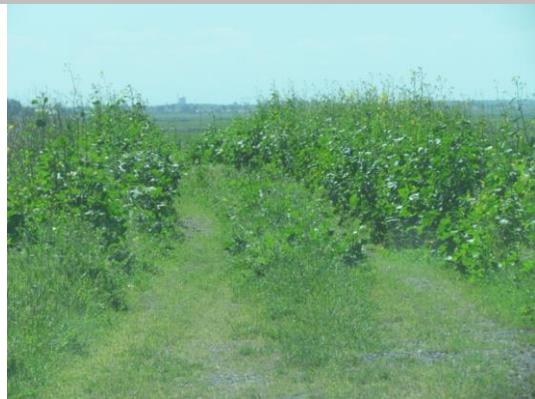
Photo 1 of 1 : SP_2016_RD0536_208_45_20160516_00047.jpg

LM Start	4.61	Rating **	U	Issue No.	45
LM End	4.96	Issue Type +	Ma	Location *	CR
Category	Earthen Levee		GPS Latitude/Longitude		
			Start	End	
Item	Vegetation		38.248548 °	38.245648 °	
			-121.712273 °	-121.708125 °	
DWR ID	DWR_RD0536_01_s_2016_45				
Comment Code					
V9 : Keep the crown roadway free of vegetation.					
Inspector Comment					
Remove the unwanted tall weeds from the crown roadway as the crown should be free from vegetation.

RD 536 Unit 1 looking downstream from levee miles 4.61 to 4.96 weeds taller than 5-foot growing on the crown roadway.

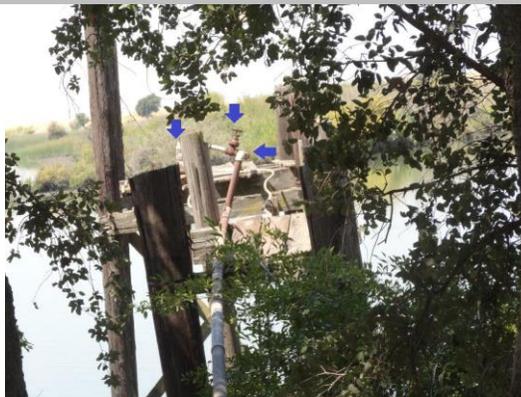
Photo 1 of 2 : UCIP_SP_2016_20523_34605.jpg

LM Start	4.96	Rating **	M	Issue No.	73
LM End	4.96	Issue Type +	En	Location *	WS
Category	Supplemental			GPS Latitude/Longitude	
				Start	End
Item	DWR UCIP Field Study			38.245643 °	38.245643 °
				-121.708162 °	-121.708162 °
DWR ID					
Comment Code					
Inspector Comment					
FS_ID:20523 DS_ID:22720 EP_NO: 10116 Repair Type: Non-Urgent Crossing Status: Found UCIP Comments: Pipe seems to be abandoned. Catwalk and pumphouse on riverside not found. It is not clear whether the pipe pass through the levee or not. Needs more info from LMA/DWR Inspector. FIELD_STRUCT_DESC: 3-inch B.I. galvanized pipe through levee 4.0 feet below crown. Concrete cradle and tank on waterward slope (ABO No.10116, 1975). Catwalk and pumphouse on riverside. Originally included in the 1953 O&M manual, Sac 106, May 1953. FS Date: 8/13/2013

WS view: pump, pipe, gate valve, and wooden piling structure in the stream.

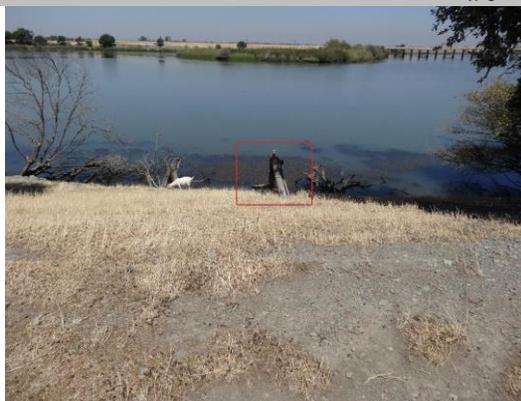
Photo 1 of 2 : UCIP_SP_2016_20869_35124.jpg

LM Start	5.10	Rating **	M	Issue No.	71
LM End	5.10	Issue Type +	En	Location *	WS
Category	Supplemental			GPS Latitude/Longitude	
				Start	End
Item	DWR UCIP Field Study			38.245783°	38.245783°
				-121.705999°	-121.705999°
DWR ID					
Comment Code					
Inspector Comment					
FS_ID:20869 DS_ID:24664 EP_NO: N/A Repair Type: Non-Urgent Crossing Status: Found UCIP Comments: Field discovered pipe crossing.Needs more information from LMA/DWR Inspector. Also needs more detailed inspection. FIELD_STRUCT_DESC: Approximately 6-inch steel pipe and an electric conduit through levee. A slant pump in steel support on channel bank. Gate valve on the pipe. No pipes and appurtenances on landside. Field discovered pipe crossing. FS Date: 8/13/2013

WS view: pipe and pump on channel bank.

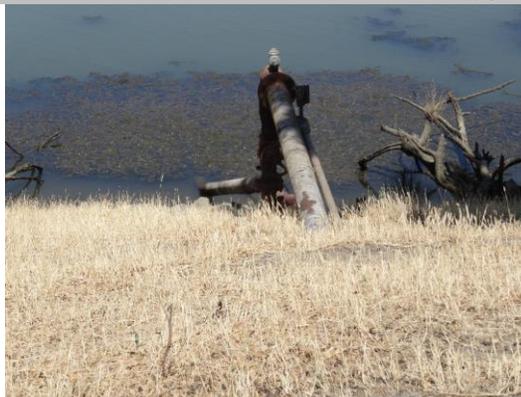
Photo 2 of 2 : UCIP_SP_2016_20869_35123.jpg

LM Start	5.10	Rating **	M	Issue No.	71 (cont)
LM End	5.10	Issue Type +	En	Location *	WS
Category	Supplemental			GPS Latitude/Longitude	
				Start	End
Item	DWR UCIP Field Study			38.245783 °	38.245783 °
				-121.705999 °	-121.705999 °
DWR ID					
Comment Code					
Inspector Comment					
FS_ID:20869 DS_ID:24664 EP_NO: N/A Repair Type: Non-Urgent Crossing Status: Found UCIP Comments: Field discovered pipe crossing. Needs more information from LMA/DWR Inspector. Also needs more detailed inspection. FIELD_STRUCT_DESC: Approximately 6-inch steel pipe and an electric conduit through levee. A slant pump in steel support on channel bank. Gate valve on the pipe. No pipes and appurtenances on landside. Field discovered pipe crossing. FS Date: 8/13/2013

WS view: closer view of pipe and pump on channel bank.

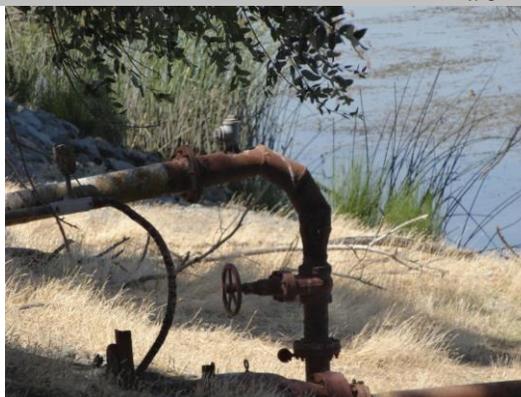
Photo 1 of 2 : UCIP_SP_2016_20543_34623.jpg

LM Start	5.10	Rating **	M	Issue No.	74
LM End	5.10	Issue Type +	En	Location *	WS
Category	Supplemental			GPS Latitude/Longitude	
				Start	End
Item	DWR UCIP Field Study			38.245783 °	38.245783 °
				-121.705999 °	-121.705999 °
DWR ID					
Comment Code					
Inspector Comment					
FS_ID:20543 DS_ID:22721 EP_NO: 3873 Repair Type: Non-Urgent Crossing Status: Found UCIP Comments: Pipe seems to be abandoned. Needs proper abandonment. FIELD_STRUCT_DESC: 6-inch pipe through levee 2. 0 feet below crown. Pump on concrete base on waterward slope. Gate valve on waterward slope. (Permit No.3873, 1962). FS Date: 8/13/2013

WS view: abandoned pipe, pump, conduit, and gate valve on levee slope.

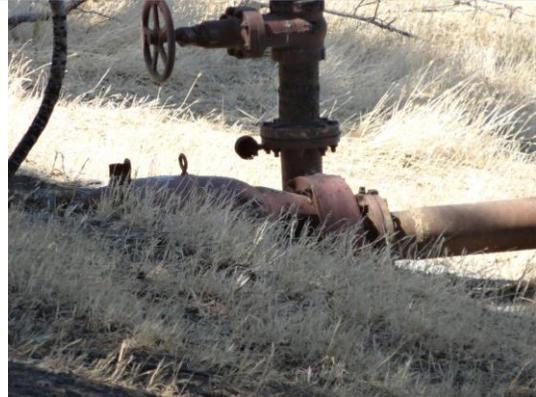
Photo 2 of 2 : UCIP_SP_2016_20543_34622.jpg

LM Start	5.10	Rating **	M	Issue No.	74 (cont)
LM End	5.10	Issue Type +	En	Location *	WS
Category	Supplemental			GPS Latitude/Longitude	
				Start	End
Item	DWR UCIP Field Study			38.245783 °	38.245783 °
				-121.705999 °	-121.705999 °
DWR ID					
Comment Code					
Inspector Comment					
FS_ID:20543 DS_ID:22721 EP_NO: 3873 Repair Type: Non-Urgent Crossing Status: Found UCIP Comments: Pipe seems to be abandoned.Needs proper abandonment. FIELD_STRUCT_DESC: 6-inch pipe through levee 2. 0 feet below crown. Pump on concrete base on waterward slope. Gate valve on waterward slope. (Permit No.3873, 1962). FS Date: 8/13/2013

WS view: closer view of abandoned pipe, pump, and gate valve on levee slope.

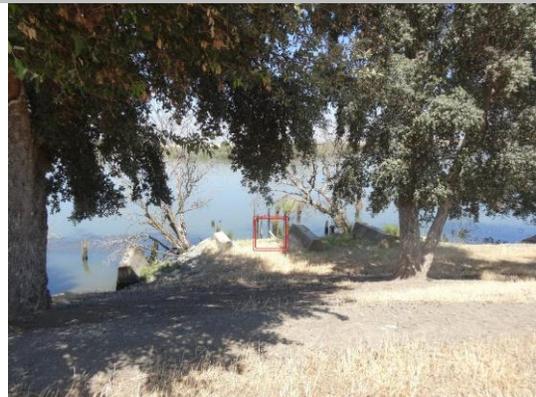
Photo 1 of 2 : UCIP_SP_2016_20544_34625.jpg

LM Start	5.12	Rating **	M	Issue No.	75
LM End	5.12	Issue Type +	En	Location *	WS
Category	Supplemental			GPS Latitude/Longitude	
				Start	End
Item	DWR UCIP Field Study			38.245588 °	38.245588 °
				-121.705723 °	-121.705723 °
DWR ID					
Comment Code					
Inspector Comment					
FS_ID:20544 DS_ID:24024 EP_NO: N/A Repair Type: Non-Urgent Crossing Status: Found UCIP Comments: - field discovered pipe.- seems abandoned pipe. Needs proper abandonment. FIELD_STRUCT_DESC: An abandoned 6-inch galvanized iron pipe on top of concrete pad and through levee. Details not available. FS Date: 8/13/2013

WS view: overview of levee slope, concrete pad, and pipe.

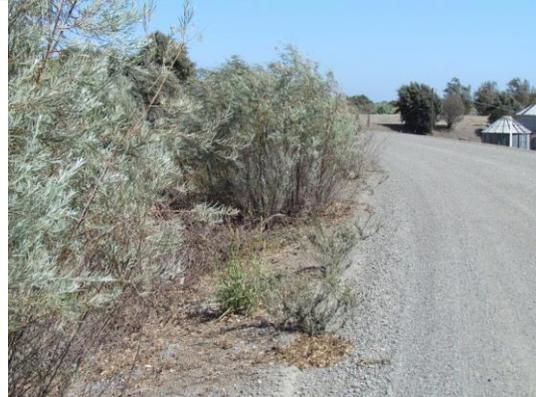
Photo 1 of 1 : SP_2016_RD0536_208_70_20160223_00012.jpg

Unsatisfactory growth of young tree growth present on the waterside levee slope.

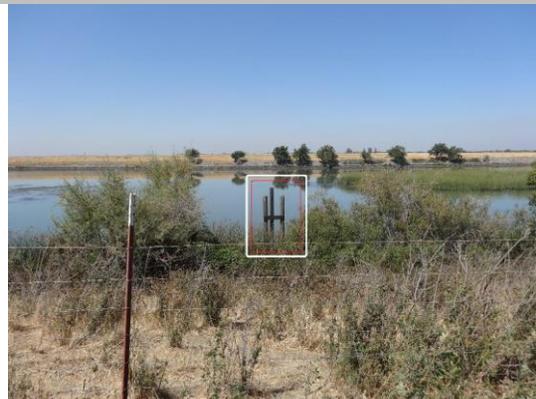
Photo 1 of 2 : UCIP_SP_2016_20563_34646.jpg

LM Start	5.49	Rating **	M	Issue No.	76
LM End	5.49	Issue Type +	En	Location *	WS
Category	Supplemental			GPS Latitude/Longitude	
				Start	End
Item	DWR UCIP Field Study			38.245512 °	38.245512 °
				-121.699119 °	-121.699119 °
DWR ID					
Comment Code					
Inspector Comment					
FS_ID:20563 DS_ID:22722 EP_NO: 7208 Repair Type: Non-Urgent Crossing Status: Found UCIP Comments: - siphon breaker needs cover/protection.- service pole on landside of the levee. FIELD_STRUCT_DESC: 30-inch steel drain pipe through levee 5.7 feet below crown. Pump in piling structure in drain ditch on landward side. Siphon breaker on waterward shoulder. (Permit No. 7208, 1971) FS Date: 8/13/2013

WS view: wooden & steel piles on the slough. Probably the supports are for pipe and flap gate. Not accessible due to fence.

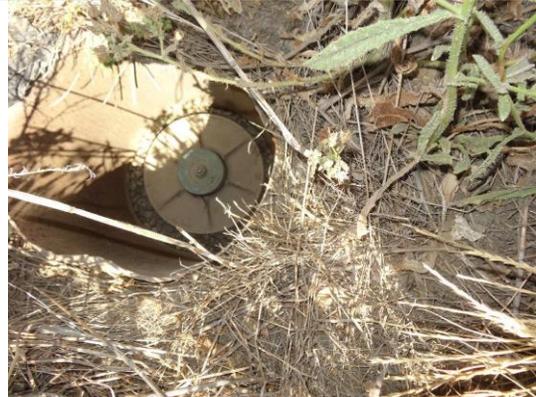
Photo 2 of 2 : UCIP_SP_2016_20563_34645.jpg

LM Start	5.49	Rating **	M	Issue No.	76 (cont)
LM End	5.49	Issue Type +	En	Location *	WS
Category	Supplemental			GPS Latitude/Longitude	
				Start	End
Item	DWR UCIP Field Study			38.245512 °	38.245512 °
				-121.699119 °	-121.699119 °
DWR ID					
Comment Code					
Inspector Comment					
FS_ID:20563 DS_ID:22722 EP_NO: 7208 Repair Type: Non-Urgent Crossing Status: Found UCIP Comments: - siphon breaker needs cover/protection.- service pole on landside of the levee. FIELD_STRUCT_DESC: 30-inch steel drain pipe through levee 5.7 feet below crown. Pump in piling structure in drain ditch on landward side. Siphon breaker on waterward shoulder. (Permit No. 7208, 1971) FS Date: 8/13/2013

WS view: uncovered siphon breaker on levee shoulder. It needs protection.

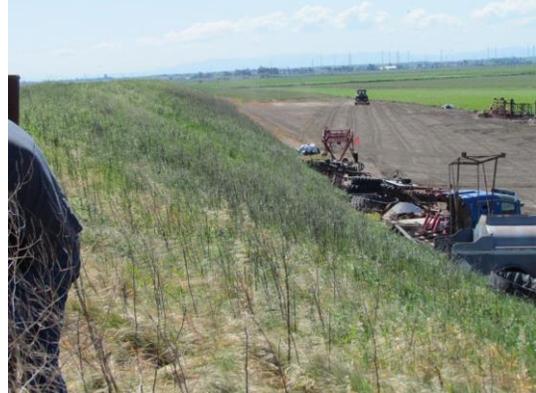
Photo 1 of 2 : SP_2016_RD0536_209_5_20160516_00018.jpg

RD 536 Unit 2 levee mile 0.09-0.13 landside toe, equipment placed within 10-foot easement.

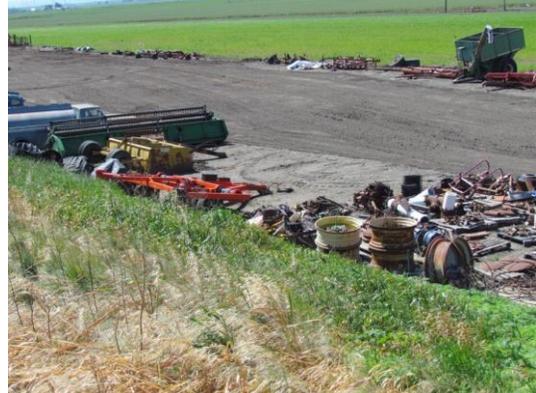
Photo 2 of 2 : SP_2016_RD0536_209_5_20160516_00019.jpg

LM Start	0.09	Rating **	U	Issue No.	5 (cont)
LM End	0.13	Issue Type +	En	Location *	LS

RD 536 Unit 2 levee mile 0.09- 0.13 another photo of the unauthorized encroachment placed within the 10-foot easement of the landside slope.

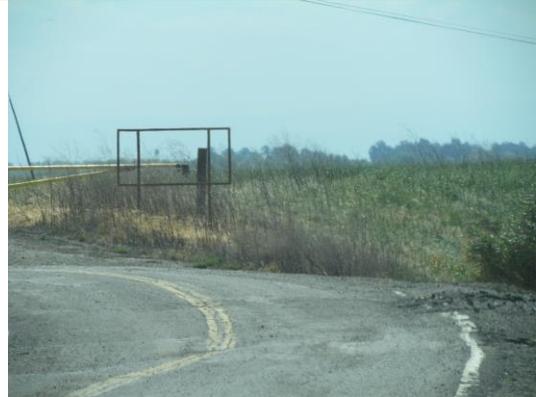
Photo 1 of 1 : SP_2016_RD0536_209_8_20160516_00017.jpg

RD 536 Unit 2 looking downstream from levee mile 0.11 to 4.48 tall weeds completely covering the landside levee slope.

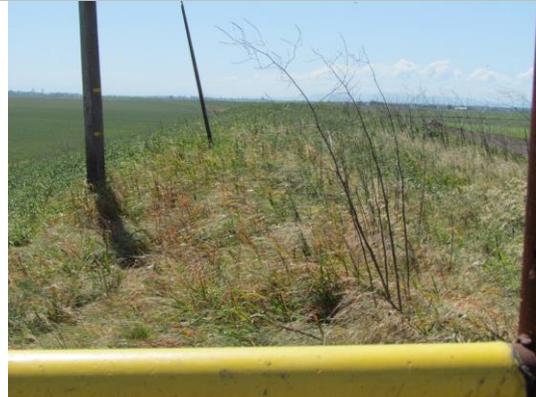
Photo 1 of 1 : SP_2016_RD0536_209_15_20160516_00020.jpg

RD 536 Unit 2 levee mile 0.11 - 0.86 crown roadway overgrown with tall weeds.

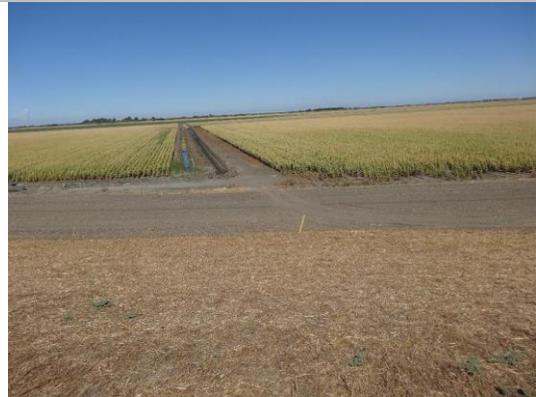
Photo 1 of 2 : UCIP_SP_2016_20664_34746.jpg

LM Start	1.47	Rating **	M	Issue No.	18
LM End	1.47	Issue Type +	En	Location *	CR
Category	Supplemental			GPS Latitude/Longitude	
				Start	End
Item	DWR UCIP Field Study			38.224423°	38.224423°
				-121.697049°	-121.697049°
DWR ID					
Comment Code					
Inspector Comment					
FS_ID:20664 DS_ID:22732 EP_NO: 17829 Repair Type: Non-Urgent Crossing Status: Indicator Found UCIP Comments: Indicator is found only on WS. The indicator is different than standard indicator. Needs more info from LMA/DWR Inspector. FIELD_STRUCT_DESC: 3.5-inch welded steel natural gas pipe through levee 44.0 feet below crown (Permit No. 17829, 2004). FS Date: 8/13/2013

WS view: overview of levee slope and gasoline indicator. The indicator is different than standard indicators.

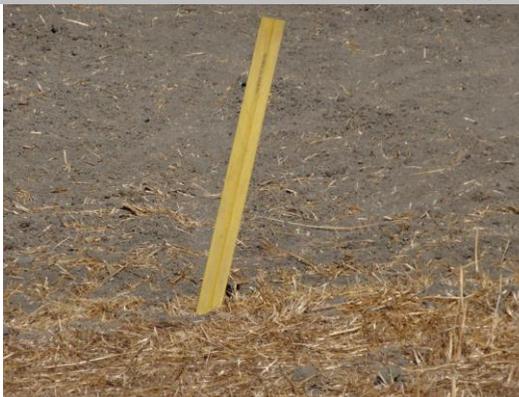
Photo 2 of 2 : UCIP_SP_2016_20664_34745.jpg

LM Start	1.47	Rating **	M	Issue No.	18 (cont)
LM End	1.47	Issue Type +	En	Location *	CR
Category	Supplemental			GPS Latitude/Longitude	
				Start	End
Item	DWR UCIP Field Study			38.224423 °	38.224423 °
				-121.697049 °	-121.697049 °
DWR ID					
Comment Code					
Inspector Comment					
FS_ID:20664 DS_ID:22732 EP_NO: 17829 Repair Type: Non-Urgent Crossing Status: Indicator Found UCIP Comments: Indicator is found only on WS. The indicator is different than standard indicator. Needs more info from LMA/DWR Inspector. FIELD_STRUCT_DESC: 3.5-inch welded steel natural gas pipe through levee 44.0 feet below crown (Permit No. 17829, 2004). FS Date: 8/13/2013

WS view: closer look at gasline indicator. The indicator is different than standard indicators.

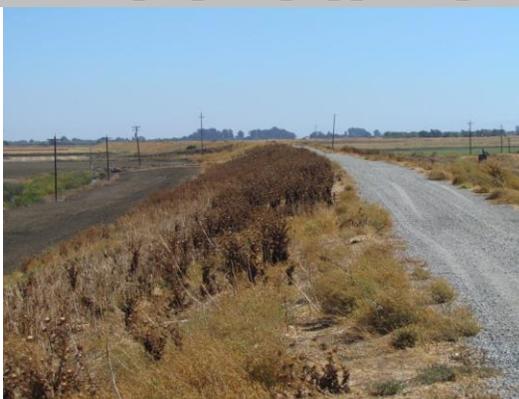
Photo 1 of 1 : SP_2016_RD0536_209_2_20160223_00001.jpg

Unsatisfactory wild growth of weeds on the waterside levee slope and shoulder.

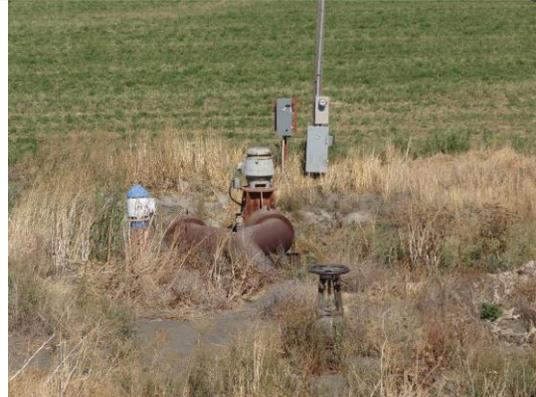
Photo 1 of 2 : UCIP_SP_2016_20647_34731.jpg

LM Start	2.50	Rating **	M	Issue No.	17
LM End	2.50	Issue Type +	En	Location *	WS
Category	Supplemental			GPS Latitude/Longitude	
				Start	End
Item	DWR UCIP Field Study			38.210063 °	38.210063 °
				-121.691768 °	-121.691768 °
DWR ID					
Comment Code					
Inspector Comment					
FS_ID:20647 DS_ID:24025 EP_NO: N/A Repair Type: Non-Urgent Crossing Status: Found UCIP Comments: Needs more info from LMA/DWR Inspector. Pump and pipe looks new. FIELD_STRUCT_DESC: A 12-inch steel pipe with vertical pump on drainage ditch. No other details available. FS Date: 8/13/2013

WS view: overview of pipe and pump (left). Big pump and appurtenances (right) for 24" steel pipe.

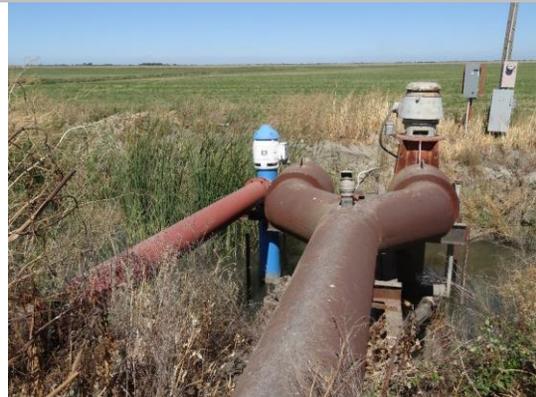
Photo 2 of 2 : UCIP_SP_2016_20647_34730.jpg

LM Start	2.50	Rating **	M	Issue No.	17 (cont)
LM End	2.50	Issue Type +	En	Location *	WS

WS view: closer view of pipe and pump (left). Big pump and appurtenances (right) for 24" steel pipe.

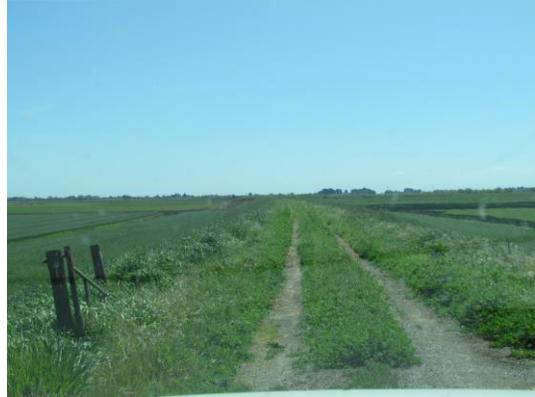
Photo 1 of 1 : SP_2016_RD0536_209_13_20160516_00021.jpg

RD 536 Unit 2 looking downstream from levee mile 2.61 - 3.60 crown roadway.

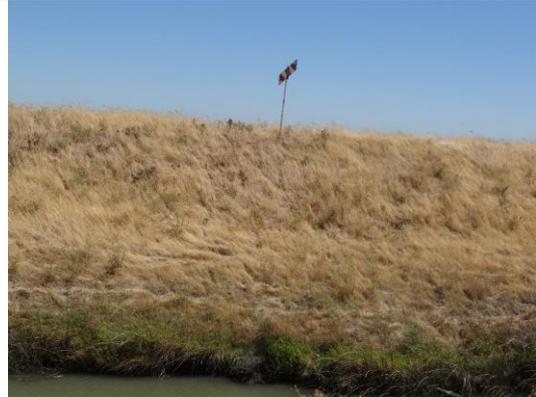
Photo 1 of 2 : UCIP_SP_2016_41845_34765.jpg

WS view: gasline indicator across the channel.

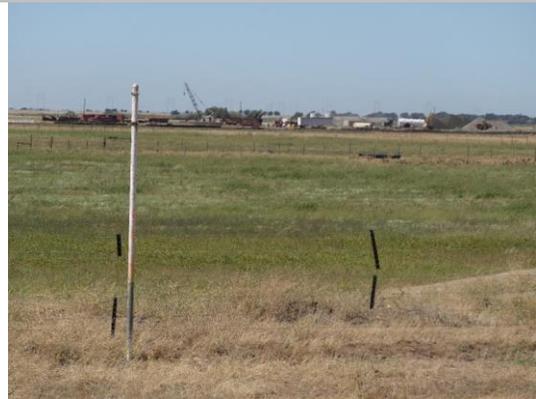
Photo 2 of 2 : UCIP_SP_2016_41845_34764.jpg

LS view: gasline indicator on levee toe.

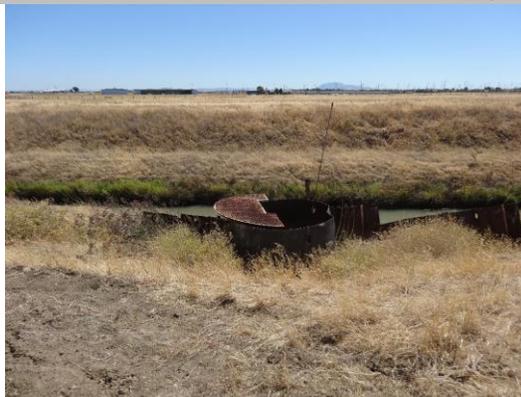
Photo 1 of 2 : UCIP_SP_2016_46813_34768.jpg

WS view: steel standpipe on levee slope.

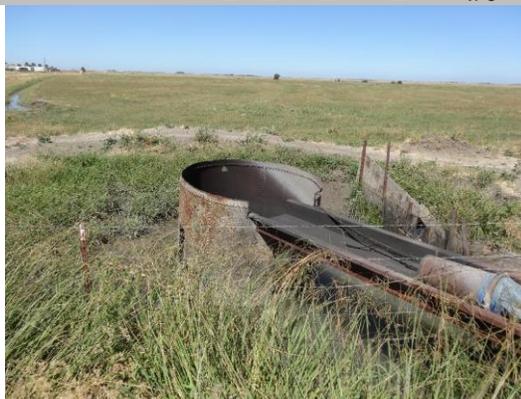
Photo 2 of 2 : UCIP_SP_2016_46813_34767.jpg

LS view: steel standpipe on levee slope.
