**Flood Control Project Maintenance
Levee Inspections**

Maintenance Issue Types Only, Levee Inspection Report By Mile - Spring 2015

Reclamation District No. 0536 Egbert

Waterway	Bank	Unit Miles	Inspection Start/End	Inspector
Unit No. 01 Lindsey Slough	Right	5.58	04/23/2015 04/23/2015	Herman Phillips

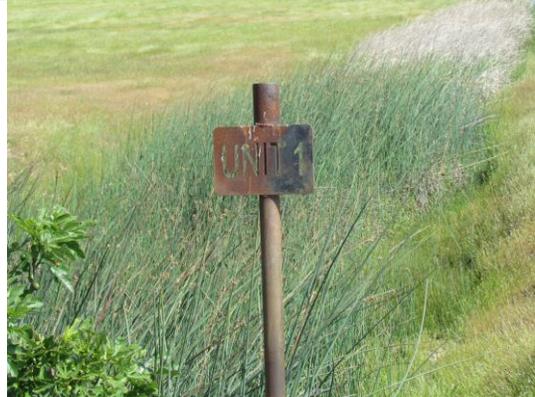
Photo 1 of 1 : SP_2015_RD0536_208_27_20150601_00027.jpg

LM Start	0.93	Rating **	M	Issue No.	27
LM End	4.29	Issue Type +	Ma	Location *	WS
Category	Earthen Levee		GPS Latitude/Longitude		
			Start	End	
Item	Vegetation		38.250750 °	38.248661 °	
			-121.749210 °	-121.717443 °	
DWR ID	DWR_RD0536_01_s_2012_27				
Action/Comments					
Remove the wild growth other than native grasses from the levee slopes. Inspector Comments: Control the wild growth of weeds on the levee shoulder and slope.

Looking downstream waterside slope.

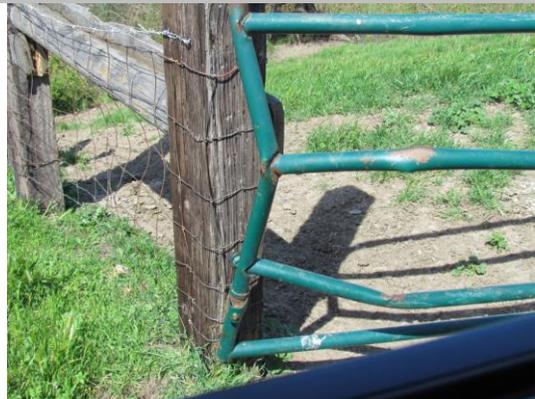
Photo 1 of 1 : SP_2015_RD0536_208_25_20150312_00003.jpg

LM Start	1.10	Rating **	M	Issue No.	25
LM End	1.10	Issue Type +	Ma	Location *	CR
Category	Earthen Levee		GPS Latitude/Longitude		
			Start	End	
Item	Repair Gates		38.255455 °	38.255455 °	
			-121.757587 °	-121.757587 °	
DWR ID	DWR_RD0536_01_s_2014_25				
Action/Comments					
Inspector Comments: This gate looks like its been run over, the bottom hinge is broken thus making the gate hard to open and close properly.

This gate needs to be replaced.

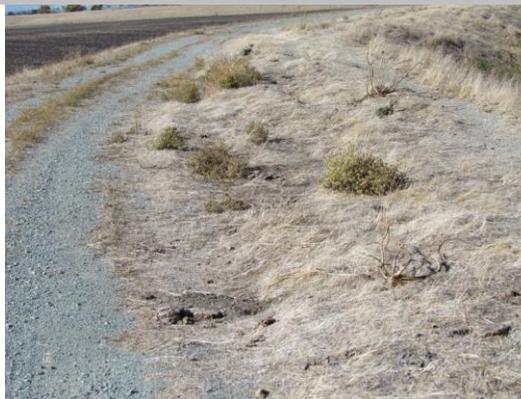
Photo 1 of 2 : SP_2015_RD0536_208_56_20150312_00012.jpg

LM Start	2.69	Rating **	U	Issue No.	56
LM End	2.71	Issue Type +	Ma	Location *	CR
Category	Earthen Levee		GPS Latitude/Longitude		
			Start	End	
Item	Crown Surface / Depressions / Rutting		38.255197 °	38.254973 °	
			-121.737932 °	-121.737577 °	
DWR ID	DWR_RD0536_01_f_2014_56				
Action/Comments					
Repair depressions or ruts in the crown or slope. Inspector Comments: District need to monitor the levee crown roadway at this location. There are some issues here with settlement.

Looking back upstream waterward at the levee crown roadway stability issues.

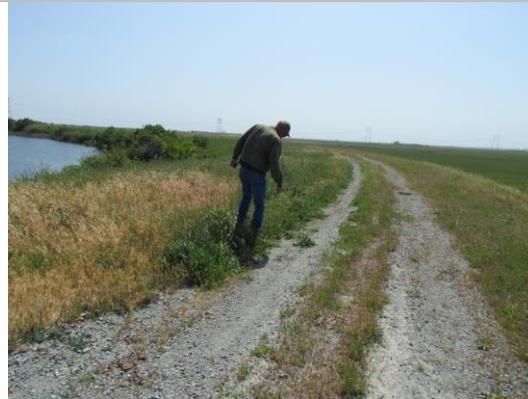
Photo 2 of 2 : SP_2015_RD0536_208_56_20150601_00029.jpg

LM Start	2.69	Rating **	U	Issue No.	56 (cont)
LM End	2.71	Issue Type +	Ma	Location *	CR
Category	Earthen Levee			GPS Latitude/Longitude	
				Start	End
Item	Crown Surface / Depressions / Rutting			38.255197 °	38.254973 °
				-121.737932 °	-121.737577 °
DWR ID	DWR_RD0536_01_f_2014_56				
Action/Comments					
Repair depressions or ruts in the crown or slope. Inspector Comments: District need to monitor the levee crown roadway at this location. There are some issues here with settlement.

Some settlement issues can't currently be seen due to the vegetation.

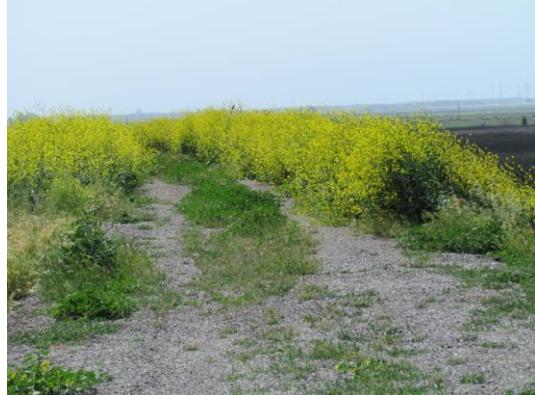
Photo 1 of 1 : SP_2015_RD0536_208_78_20150601_00030.jpg

LM Start	3.36	Rating **	U	Issue No.	78
LM End	4.37	Issue Type +	Ma	Location *	CR
Category	Earthen Levee		GPS Latitude/Longitude		
			Start	End	
Item	Vegetation		38.256685 °	38.248572 °	
			-121.726917 °	-121.716158 °	
DWR ID	DWR_RD0536_01_s_2015_78				
Action/Comments					
Keep the crown roadway free of vegetation. Inspector Comments: Remove the unsatisfactory tall weeds from the levee section.

Unacceptable wild growth on the crown roadway and both slopes.

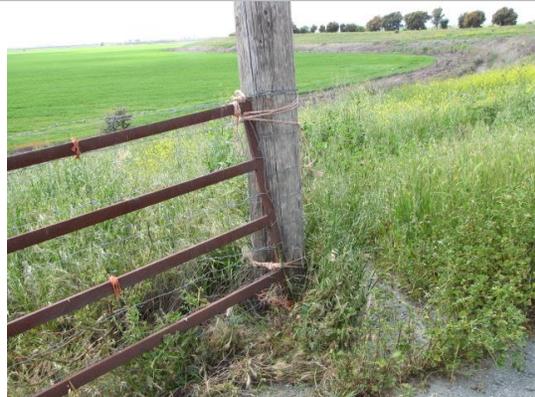
Photo 1 of 1 : SP_2015_RD0536_208_36_20150312_00004.jpg

LM Start	3.67	Rating **	M	Issue No.	36
LM End	3.67	Issue Type +	Ma	Location *	WS
Category	Earthen Levee		GPS Latitude/Longitude		
			Start	End	
Item	Repair Gates		38.252578 °	38.252578 °	
			-121.726439 °	-121.726439 °	
DWR ID	DWR_RD0536_01_s_2012_36				
Action/Comments					
Inspector Comments: This gate need to be repaired.

Repair this gate. Someone could get hurt trying to open and close this gate.

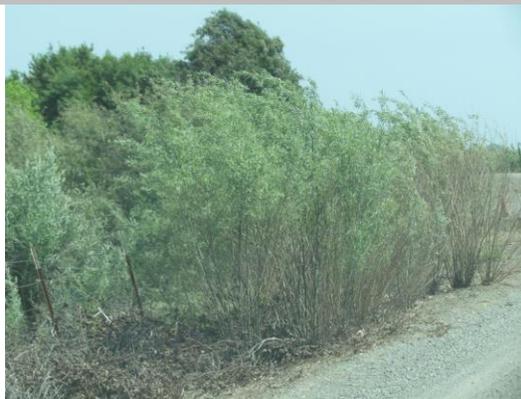
Photo 1 of 1 : SP_2015_RD0536_208_70_20150601_00031.jpg

LM Start	5.46	Rating **	U	Issue No.	70
LM End	5.58	Issue Type +	Ma	Location *	WS
Category	Earthen Levee		GPS Latitude/Longitude		
			Start	End	
Item	Vegetation		38.245608 °	38.245610 °	
			-121.699768 °	-121.697493 °	
DWR ID	DWR_RD0536_01_f_2014_70				
Action/Comments					
Remove the wild growth other than native grasses from the levee slopes. Inspector Comments: The district needs to remove the wild growth from the waterward levee slope and shoulder.

Unacceptable woody tree growth on the waterside levee slope.

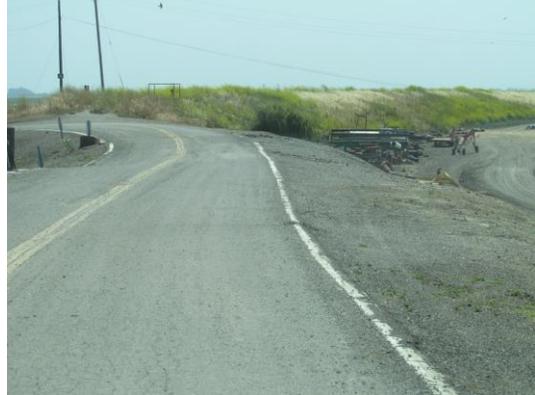
Photo 1 of 1 : SP_2015_RD0536_209_11_20150601_00010.jpg

LM Start	0.08	Rating **	U	Issue No.	11
LM End	1.47	Issue Type +	Ma	Location *	LS
Category	Earthen Levee		GPS Latitude/Longitude		
			Start	End	
Item	Vegetation		38.244368 °	38.224382 °	
			-121.697055 °	-121.697050 °	
DWR ID	DWR_RD0536_02_s_2015_11				
Action/Comments					
Control annual grass and weeds on the levee slopes and easements.

View looking downstream from landside shoulder.

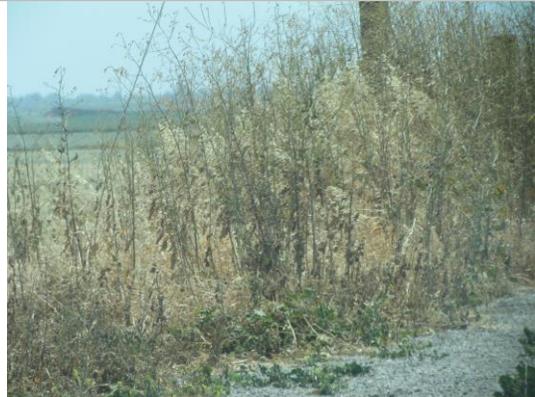
Photo 1 of 1 : SP_2015_RD0536_209_15_20150601_00011.jpg

LM Start	0.08	Rating **	U	Issue No.	15
LM End	1.47	Issue Type +	Ma	Location *	WS
Category	Earthen Levee		GPS Latitude/Longitude		
			Start	End	
Item	Vegetation		38.244368 °	38.224382 °	
			-121.697055 °	-121.697050 °	
DWR ID	DWR_RD0536_02_s_2015_15				
Action/Comments					
Remove the wild growth other than native grasses from the levee slopes. Inspector Comments: Remove the unacceptable tall weeds from the levee section waterside.

RD 536 Looking downstream from waterside shoulder.

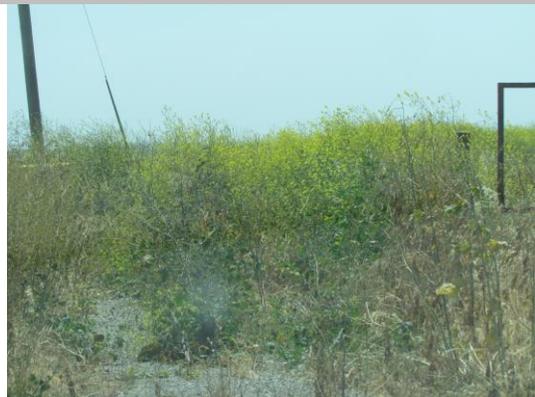
Photo 1 of 1 : SP_2015_RD0536_209_18_20150601_00012.jpg

LM Start	0.10	Rating **	U	Issue No.	18
LM End	0.99	Issue Type +	Ma	Location *	CR
Category	Earthen Levee		GPS Latitude/Longitude		
			Start	End	
Item	Vegetation		38.244158 °	°	
			-121.696970 °	°	
DWR ID	DWR_RD0536_02_s_2015_18				
Action/Comments					
Keep the crown roadway free of vegetation. Inspector Comments: The crown roadway completely blocked with unacceptable weeds.

Looking downstream at the crown roadway.
