**Flood Control Project Maintenance
Levee Inspections
LMA District Cover Sheet
Spring 2011 Levee Inspection Results**

Reclamation District No. 0536 Egbert

Spring 2011 Levee Inspection Results

Waterway	Bank	Unit Miles
Unit No. 01 Lindsey Slough	Right	5.66

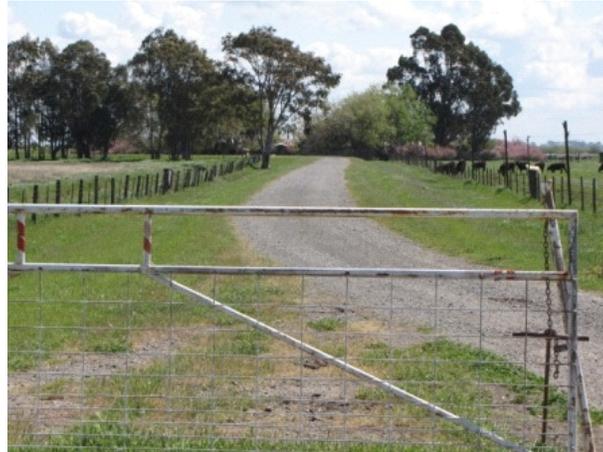
Levee Mile Report Line	1
Start Levee Mile	0.00
End Levee Mile	0.00
Location	Land Side
Category	Earthen Levee
Item	Vegetation
<p>Photo shows both levee slopes from levee 0.00 looking downstream RD 536. Photo taken 4-7-2011.</p>	
<p>phillips_s_20110411_245.jpg</p>

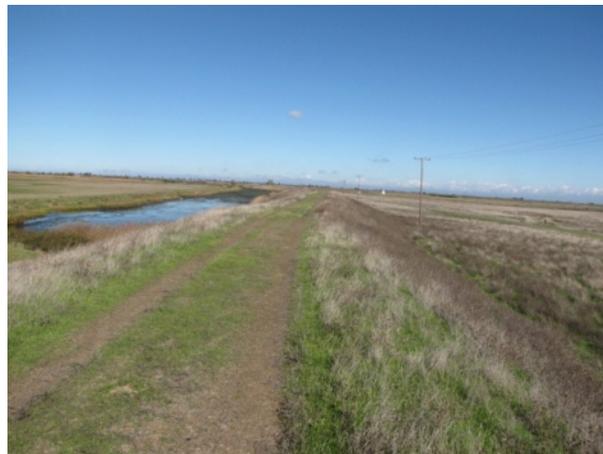
Levee Mile Report Line	2
Start Levee Mile	0.64
End Levee Mile	0.64
Location	Land Side
Category	Earthen Levee
Item	Vegetation
<p>View of levee section Unit 1 RD 536 looking downstream, grasses cover the crown and both levee slopes land side and waterside levee mile 0.64. Photo taken 11-10-2010</p>	
<p>phillips_s_20110228_084.jpg</p>

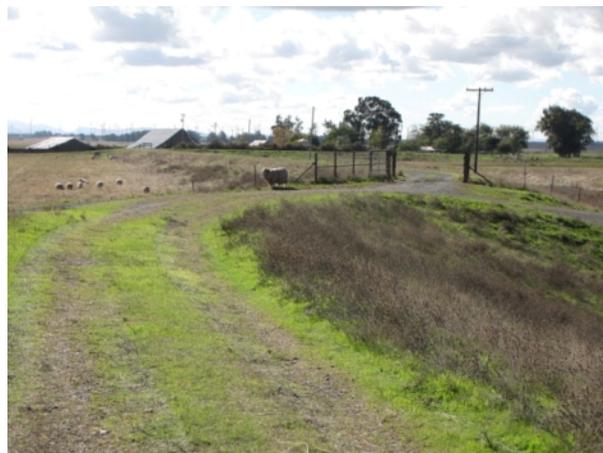
Levee Mile Report Line	2
Start Levee Mile	0.64
End Levee Mile	0.64
Location	Land Side
Category	Earthen Levee
Item	Vegetation
<p>View of levee section RD 536 Unit 1 looking upstream from levee mile 0.64 waterside. Photo taken 11-20-2010</p>	
<p>phillips_s_20110228_085.jpg</p>

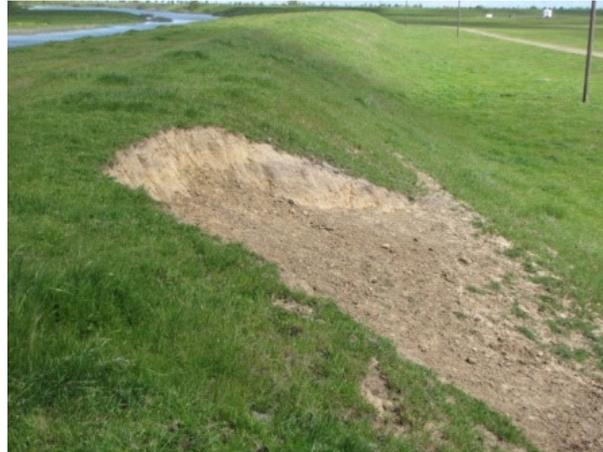
Levee Mile Report Line	3
Start Levee Mile	0.74
End Levee Mile	0.75
Location	Land Side
Category	Earthen Levee
Item	Erosion / Bank Caving
New erosion site located at levee mile 0.74 (38.25054 -121.759392 to 38.250543 - 121.759387. Photo taken 4-7-2011.	
phillips_s_20110411_243.jpg

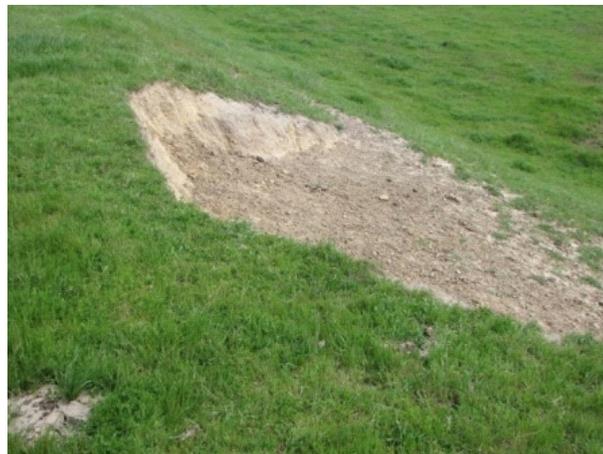
Levee Mile Report Line	3
Start Levee Mile	0.74
End Levee Mile	0.75
Location	Land Side
Category	Earthen Levee
Item	Erosion / Bank Caving
Another view of the erosion along the landside slope levee mile 0.74.	
phillips_s_20110411_244.jpg

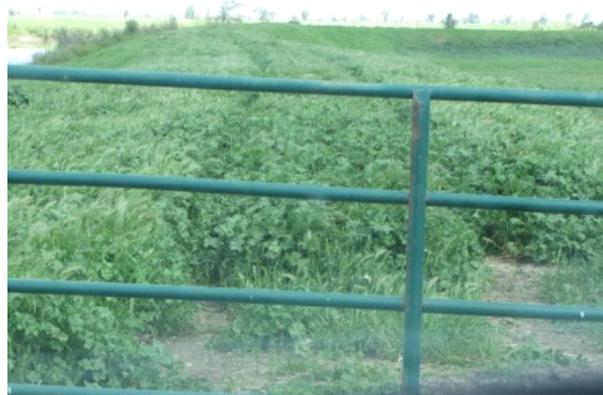
Levee Mile Report Line	4
Start Levee Mile	1.11
End Levee Mile	2.51
Location	Water Side
Category	Earthen Levee
Item	Vegetation
Unsatisfactory growth of weeds covering levee section levee mile 1.11 to levee mile 2.51. Photo taken 4-7-2011.	
phillips_s_20110411_246.jpg

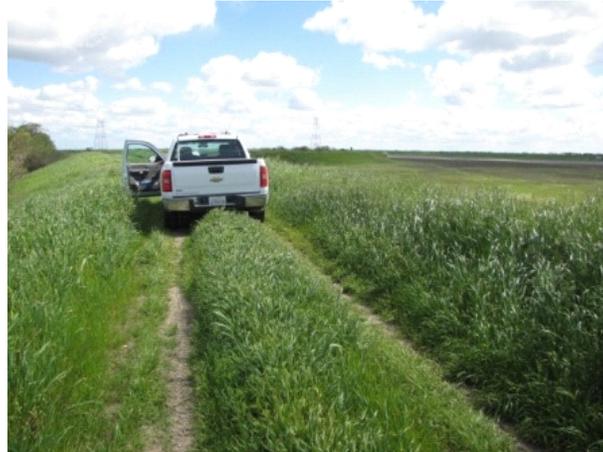
Levee Mile Report Line	5
Start Levee Mile	1.11
End Levee Mile	2.51
Location	Land Side
Category	Earthen Levee
Item	Vegetation
<p>This photo shows overgrown weed along the landward slope which goes from levee mile 1.11 through levee mile 2.51.</p>	
<p>phillips_s_20110411_248.jpg</p>

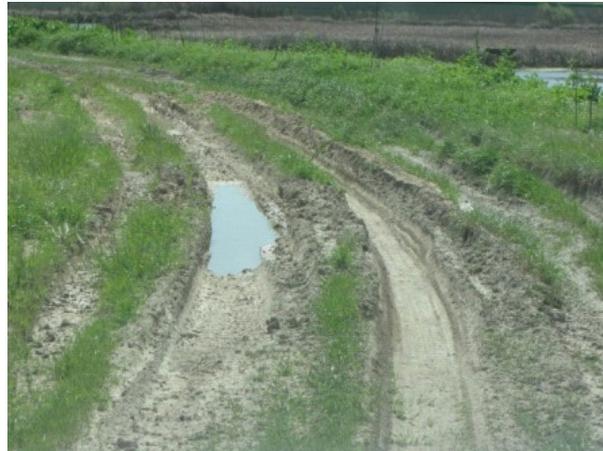
Levee Mile Report Line	7
Start Levee Mile	3.76
End Levee Mile	3.88
Location	Crown
Category	Earthen Levee
Item	Crown Surface / Depressions / Rutting
<p>Photo here shows deep ruts made into the crown roadway, unsatisfactory conditions. This section needs regrading for proper drainage. Photo taken 4-7-2011.</p>	
<p>phillips_s_20110411_247.jpg</p>

6	2.48	3.72	Earthen Levee	Vegetation	WS	M	Control annual grass and weeds on the levee slopes and easements.	38.257705 ° -121.739192 °	38.252544 ° -121.726465 °	9
7	3.76	3.88	Earthen Levee	Crown Surface / Depressions / Rutting	CR	M	Add appropriate gravel or road base. Grade and compact.	38.251905 ° -121.726274 °	38.250832 ° -121.724784 °	11 Y
8	4.19	4.26	Earthen Levee	Vegetation	WS	M	Remove the wild growth other than native grasses from the levee slopes. Inspector Comments: This levee section has problems with not only veg on crown road way but there are cattle that has caused some damage to the crown. 5-6-2010 DURING THIS INSPECTION, I see that the District has mowed a section of levee.	38.249522 ° -121.718727 °	38.248725 ° -121.717858 °	21 Y
9	4.46	4.46	Earthen Levee	Trim / Thin Trees	LS	M	Trim trees to at least five feet above ground level.	38.249122 ° -121.714686 °	38.249122 ° -121.714686 °	23

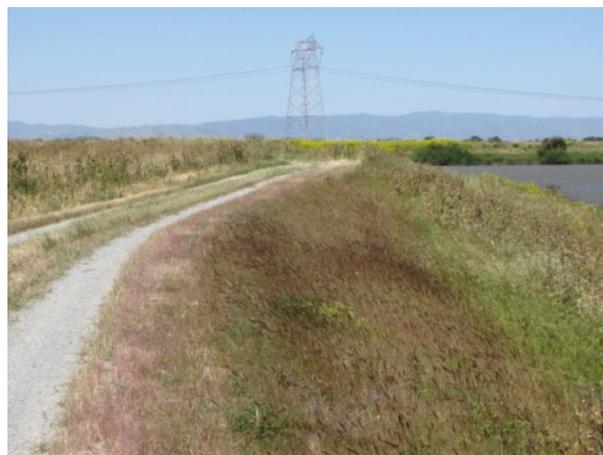
Levee Mile Report Line	8
Start Levee Mile	4.19
End Levee Mile	4.26
Location	Water Side
Category	Earthen Levee
Item	Vegetation
<p>Looking upstream from levee mile 4.21.</p>	
<p>phillips_s_20110228_087.jpg</p>

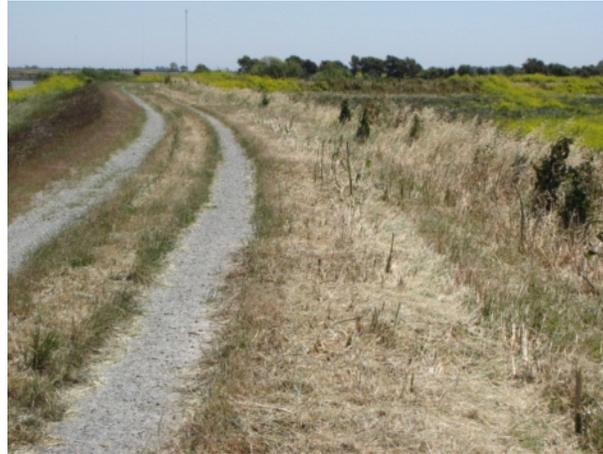
Levee Mile Report Line	8
Start Levee Mile	4.19
End Levee Mile	4.26
Location	Water Side
Category	Earthen Levee
Item	Vegetation
Looking downstream from levee mile 4.21	
phillips_s_20110228_088.jpg

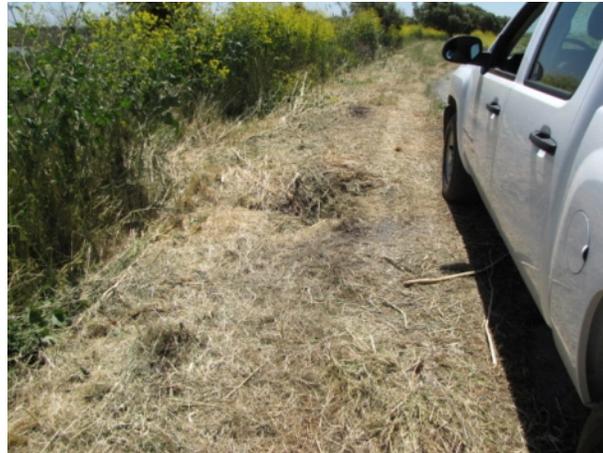
Levee Mile Report Line	14
Start Levee Mile	4.82
End Levee Mile	4.82
Location	Crown
Category	Earthen Levee
Item	Crown Surface / Depressions / Rutting
There is a big hole in the levee waterward. 38.248375 to -121.712188 the levee has wild growth on both slopes. Photo taken 2010.	
phillips_s_20110228_086.jpg

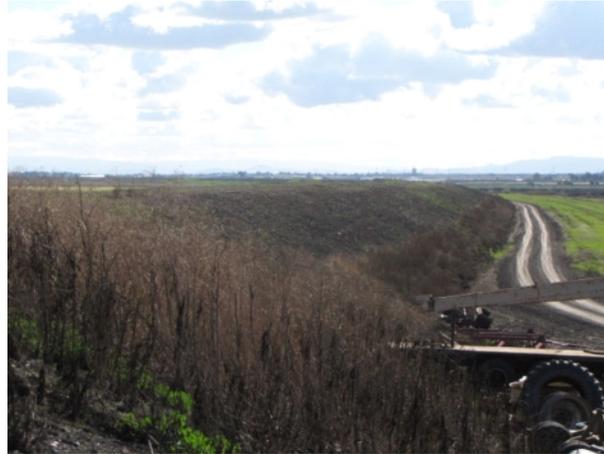
Levee Mile Report Line	1
Start Levee Mile	0.00
End Levee Mile	0.00
Location	Land Side
Category	Earthen Levee
Item	Vegetation
View of land side RD 536 Unit 2 looking downstream from levee mile 0.00 Photo taken 11-10-2010	
phillips_s_20110228_090.jpg

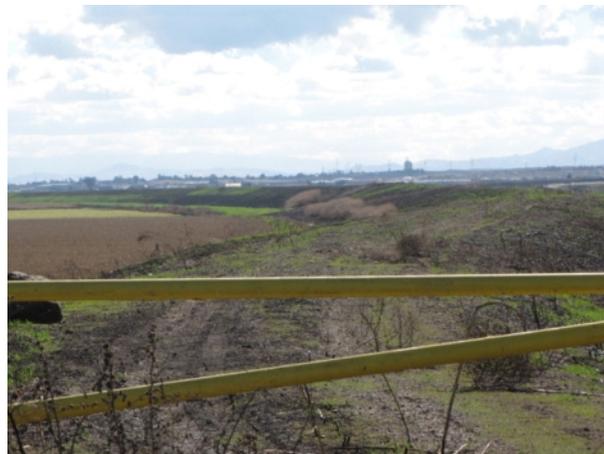
Levee Mile Report Line	1
Start Levee Mile	0.00
End Levee Mile	0.00
Location	Land Side
Category	Earthen Levee
Item	Vegetation
View of levee section looking downstream from levee mile 0.00 waterside RD 536 Photo taken 10-20-2010.	
phillips_s_20110228_091.jpg

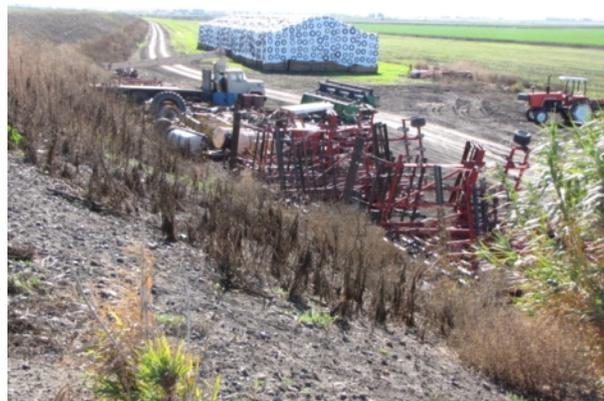
Levee Mile Report Line	2
Start Levee Mile	0.01
End Levee Mile	0.06
Location	Land Side
Category	Earthen Levee
Item	Encroachments
View of unauthorized encroachment levee miles 0.01-0.06 land side of RD 536 Unit 2. Farmer has stored equipment, materials and vehicle within 10-foot of landward toe. Photo taken 11-10-2010	
phillips_s_20110228_089.jpg

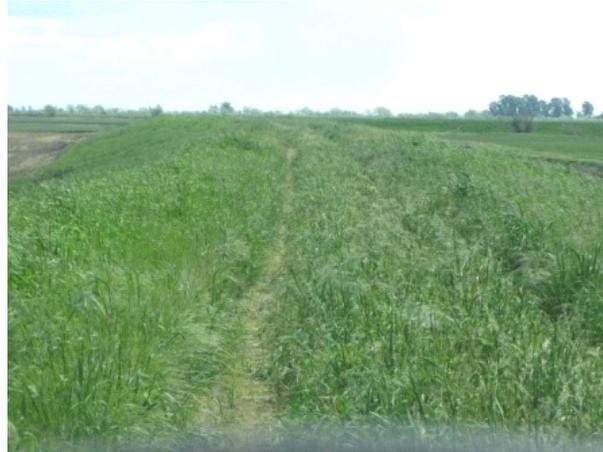
Levee Mile Report Line	4
Start Levee Mile	0.04
End Levee Mile	2.67
Location	Land Side
Category	Earthen Levee
Item	Vegetation
<p>Unsatisfactory growth of weeds covering slopes from levee mile 0.04 to 2.59. Photo taken 4-7-2011.</p>	
<p>phillips_s_20110411_250.jpg</p>

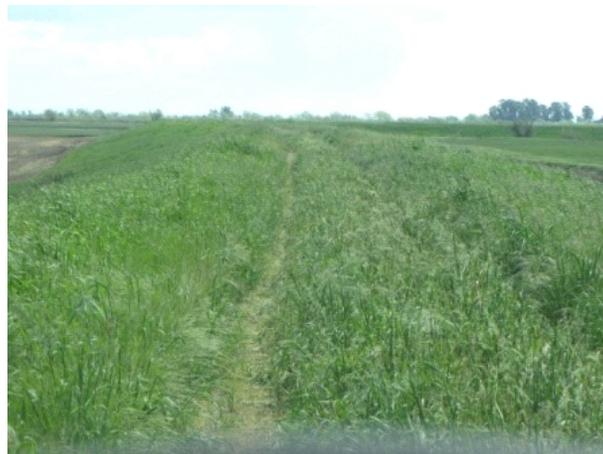
Levee Mile Report Line	5
Start Levee Mile	0.04
End Levee Mile	2.59
Location	Water Side
Category	Earthen Levee
Item	Vegetation
<p>Photo here shows growth covering water side slope. 0.04-2.59 Photo taken 4-7-2011.</p>	
<p>phillips_s_20110411_251.jpg</p>

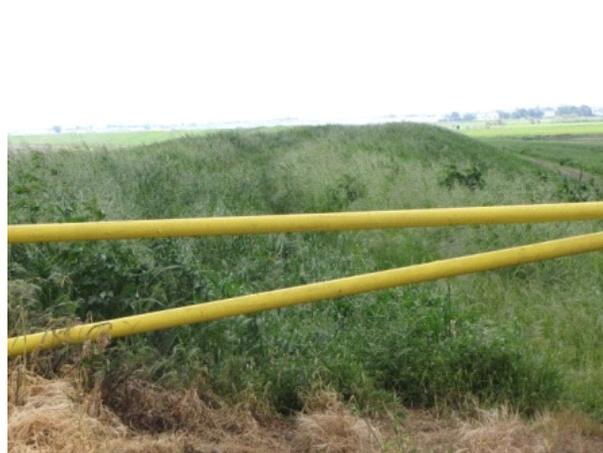
Levee Mile Report Line	6
Start Levee Mile	0.05
End Levee Mile	0.05
Location	Crown
Category	Earthen Levee
Item	Vegetation
<p>Photo here shows growth of weeds covering crown roadway and both slopes looking downstream from levee mile 0.05. Photo taken 4-7-2011.</p>	
<p>phillips_s_20110411_249.jpg</p>
