**Flood Control Project Maintenance
Levee Inspections**

Fall 2010 Levee Maintenance Deficiency Summary Report

Sacramento River Basin

Reclamation District No. 0537 Lovdal

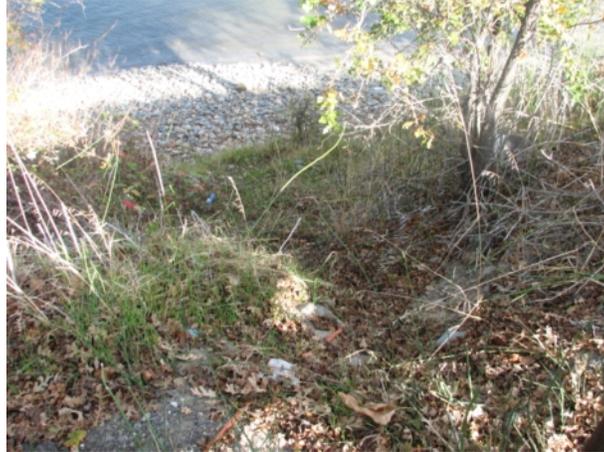
Levee Mile Report Line	10
Start Levee Mile	0.72
End Levee Mile	0.72
Location	Water Side
Category	Earthen Levee
Item	Erosion / Bank Caving
This is not a good photo of the eroision and the bank.	
johngw_f_20101118_366.jpg

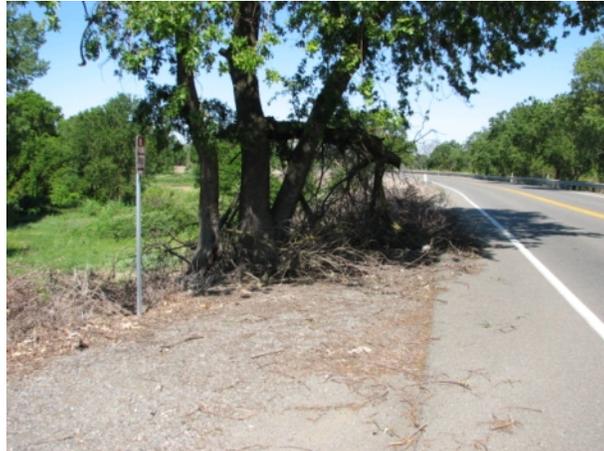
Levee Mile Report Line	11
Start Levee Mile	0.77
End Levee Mile	0.77
Location	Land Side
Category	Earthen Levee
Item	Encroachments
tree branches along shoulder	
johngw_f_20101012_111.jpg

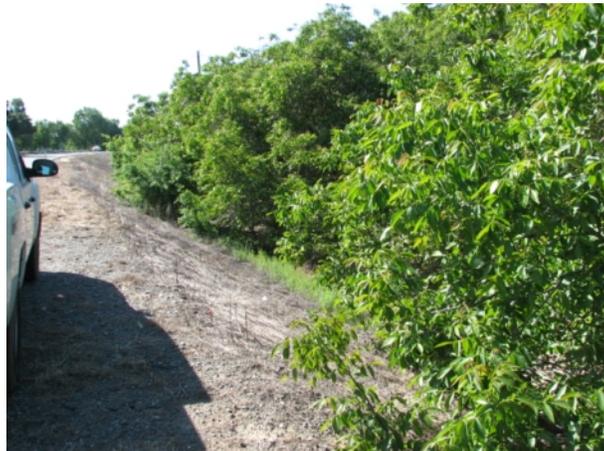
Levee Mile Report Line	12
Start Levee Mile	1.06
End Levee Mile	1.06
Location	Land Side
Category	Earthen Levee
Item	Trim / Thin Trees
trees needed to be raised	
johngw_f_20101012_112.jpg

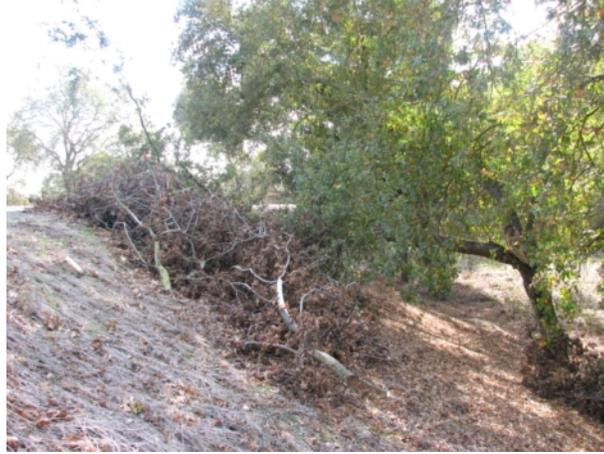
Levee Mile Report Line	13
Start Levee Mile	1.28
End Levee Mile	1.28
Location	Land Side
Category	Earthen Levee
Item	Trim / Thin Trees
The Oak tree has split in half and fell on the levee.	
johngw_f_20101118_367.jpg

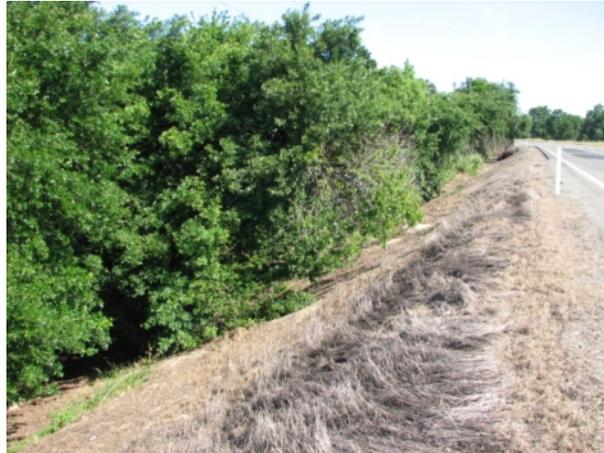
Levee Mile Report Line	14
Start Levee Mile	1.93
End Levee Mile	1.93
Location	Land Side
Category	Earthen Levee
Item	Trim / Thin Trees
trees need to be raised to 5'	
johngw_f_20101012_113.jpg

14	1.93	1.93	Earthen Levee	Trim / Thin Trees	LS	M	Trim trees to at least five feet above ground level.	38.633141 ° -121.564497 °	38.633141 ° -121.564497 °	5 Y
15	2.58	2.64	Earthen Levee	Encroachments	LS	PO	Landscaping	38.623988 ° -121.563663 °	38.623067 ° -121.563580 °	1 Y
16	2.94	2.96	Earthen Levee	Encroachments	LS	PO	Landscaping Inspector Comments: Arundo starting to creep up levee slope	38.618885 ° -121.563377 °	38.618490 ° -121.563382 °	3 Y
17	3.58	3.67	Earthen Levee	Vegetation	WS	M	Remove the wild growth other than native grasses from the levee slopes.	38.609995 ° -121.561103 °	38.608902 ° -121.560347 °	9 Y
18	3.67	3.67	Earthen Levee	Encroachments	WS	M	Prunings	38.608851 ° -121.560273 °	38.608851 ° -121.560273 °	14 Y

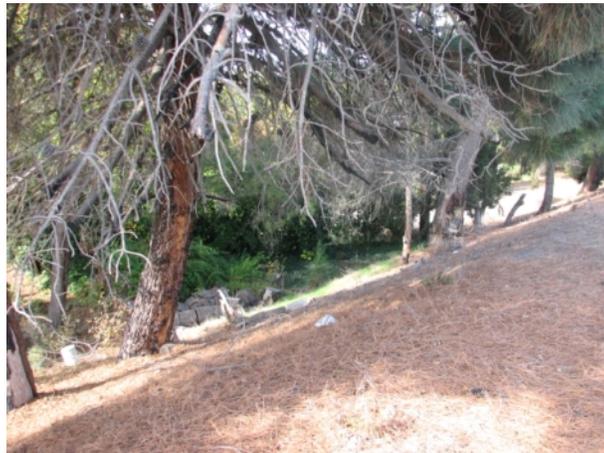
Levee Mile Report Line	15
Start Levee Mile	2.58
End Levee Mile	2.64
Location	Land Side
Category	Earthen Levee
Item	Encroachments
Landscape shrubs at the toe of the levee.	
johngw_f_20101118_368.jpg

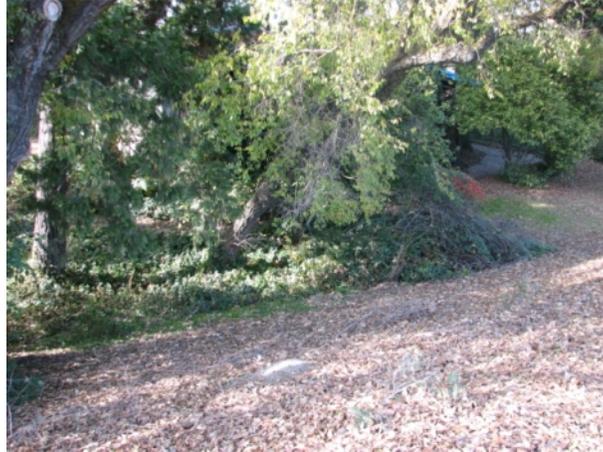
Levee Mile Report Line	16
Start Levee Mile	2.94
End Levee Mile	2.96
Location	Land Side
Category	Earthen Levee
Item	Encroachments
There is groundcover and landscape shrubs at the toe.	
johngw_f_20101118_369.jpg

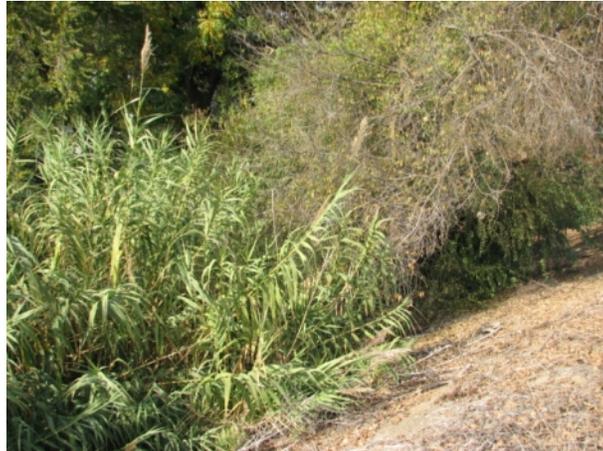
Levee Mile Report Line	16
Start Levee Mile	2.94
End Levee Mile	2.96
Location	Land Side
Category	Earthen Levee
Item	Encroachments
Arundo and vegetation with the landscape.	
johngw_f_20101118_370.jpg

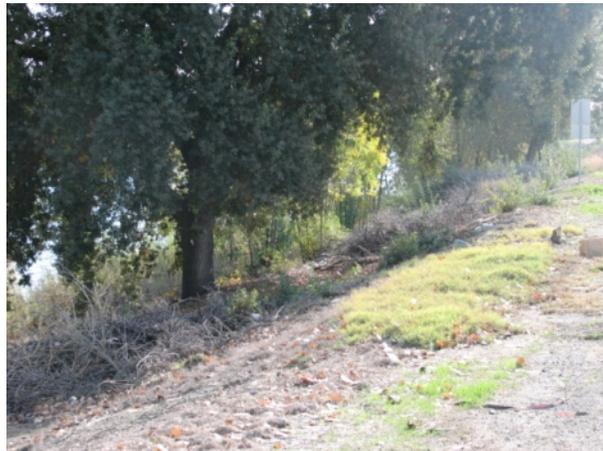
Levee Mile Report Line	17
Start Levee Mile	3.58
End Levee Mile	3.67
Location	Water Side
Category	Earthen Levee
Item	Vegetation
vegetation and pile of cut brush.	
johngw_f_20101118_364.jpg

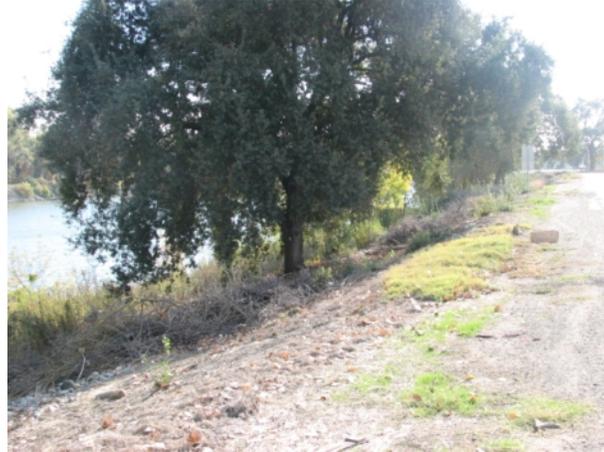
Levee Mile Report Line	17
Start Levee Mile	3.58
End Levee Mile	3.67
Location	Water Side
Category	Earthen Levee
Item	Vegetation
Vegetation on the waterside .	
johngw_f_20101118_365.jpg

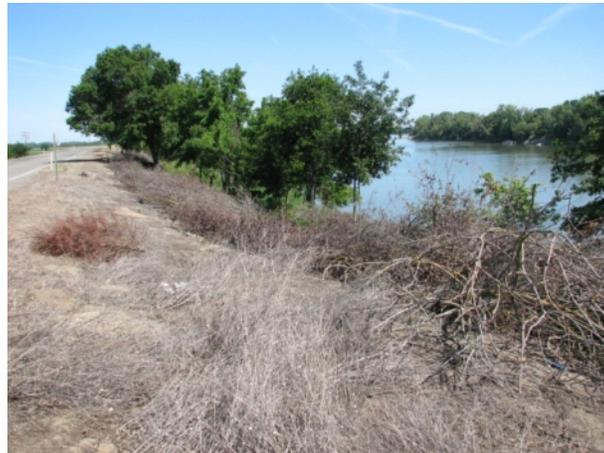
Levee Mile Report Line	18
Start Levee Mile	3.67
End Levee Mile	3.67
Location	Water Side
Category	Earthen Levee
Item	Encroachments
piles of prunnings	
johngw_f_20101012_119.jpg

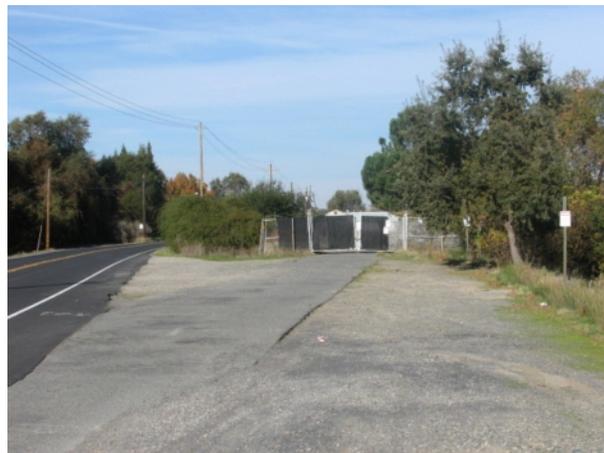
Levee Mile Report Line	19
Start Levee Mile	4.18
End Levee Mile	4.37
Location	Water Side
Category	Earthen Levee
Item	Encroachments
Old Sacramento Weir Yard building and fence compound on levee crown.	
johngw_f_20101118_363.jpg

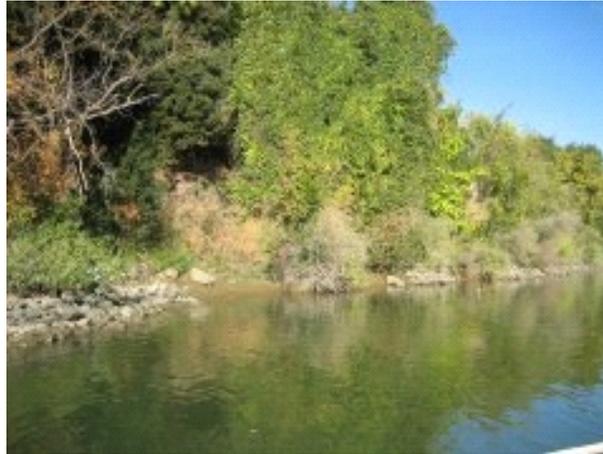
Levee Mile Report Line	20
Start Levee Mile	4.28
End Levee Mile	4.31
Location	Water Side
Category	Supplemental
Item	USACE Erosion Survey
2009: 15 ft berm, 1.5:1 slope, tree hazards and slumping, clays and silts, 2.87 ft/s [2009 SiteID:SAC_63-0_R]	
johngw_f_20101012_120.JPG

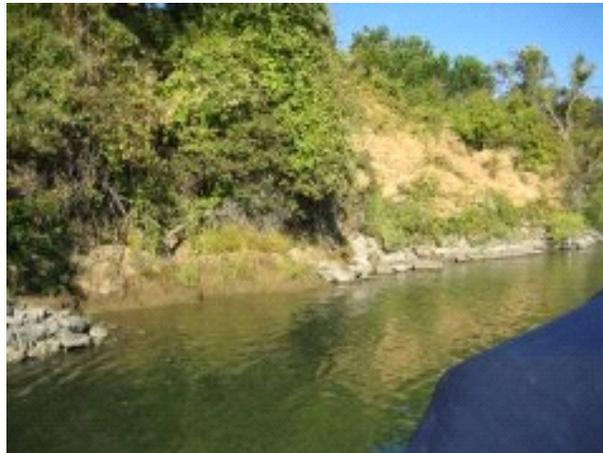
Levee Mile Report Line	21
Start Levee Mile	4.34
End Levee Mile	4.38
Location	Water Side
Category	Supplemental
Item	USACE Erosion Survey
2009: 10 ft berm, 1:1 slope, tree hazards and slumping, clays and silts, 3.08 ft/s [2009 SiteID:SAC_62-9_R]	
johngw_f_20101012_121.JPG

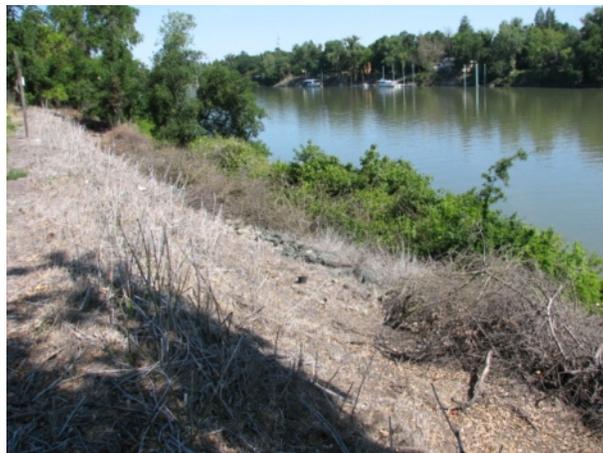
Levee Mile Report Line	23
Start Levee Mile	4.41
End Levee Mile	4.41
Location	Water Side
Category	Earthen Levee
Item	Encroachments
piles of prunnings	
johngw_f_20101012_118.jpg

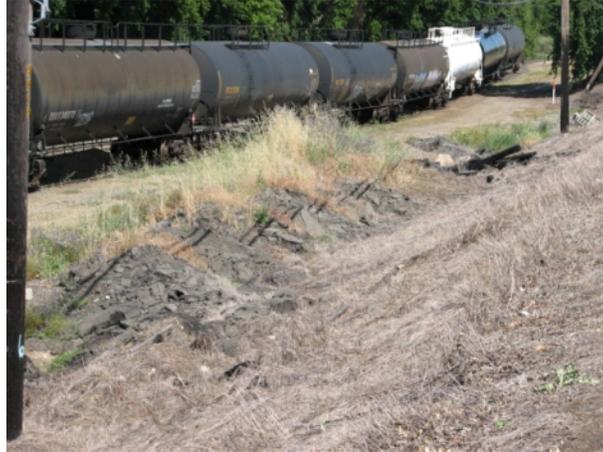
Levee Mile Report Line	24
Start Levee Mile	4.43
End Levee Mile	4.43
Location	Land Side
Category	Earthen Levee
Item	Encroachments
asphalt and railroad rails	
johngw_f_20101012_114.jpg

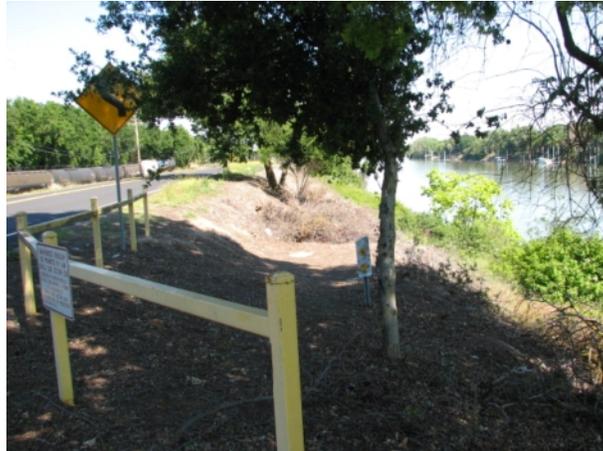
Levee Mile Report Line	25
Start Levee Mile	4.51
End Levee Mile	4.51
Location	Water Side
Category	Earthen Levee
Item	Encroachments
piles of prunnings	
johngw_f_20101012_117.jpg

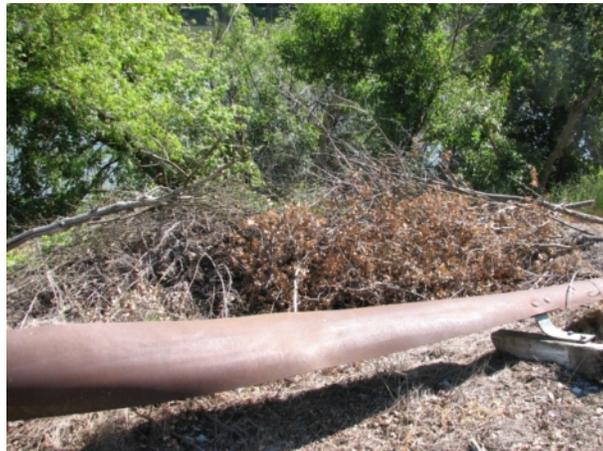
Levee Mile Report Line	26
Start Levee Mile	4.56
End Levee Mile	4.56
Location	Water Side
Category	Earthen Levee
Item	Encroachments
prunnings left in piles	
johngw_f_20101012_116.jpg

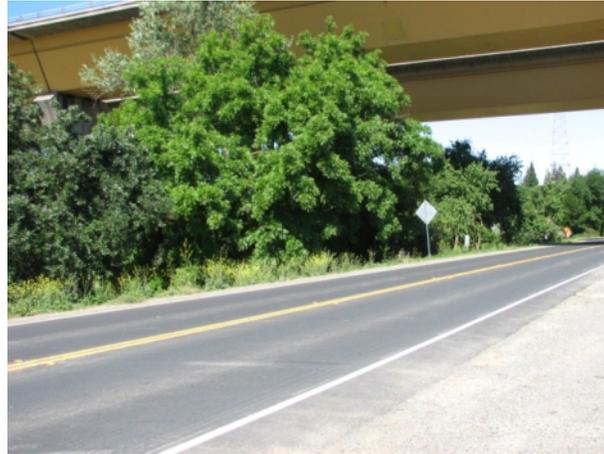
Levee Mile Report Line	27
Start Levee Mile	4.74
End Levee Mile	4.74
Location	Land Side
Category	Earthen Levee
Item	Trim / Thin Trees
trees need to be trimmed	
johngw_f_20101012_115.jpg

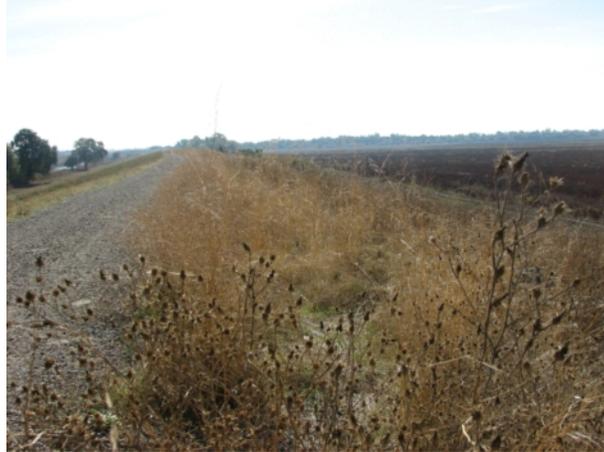
Levee Mile Report Line	1
Start Levee Mile	0.05
End Levee Mile	1.19
Location	Water Side
Category	Earthen Levee
Item	Vegetation
<p>Waterside slope has vegetation taller than 12" in height. Rip rap is place about 6'-10' down from the shoulder.</p>	
<p>johngw_f_20101108_306.jpg</p>

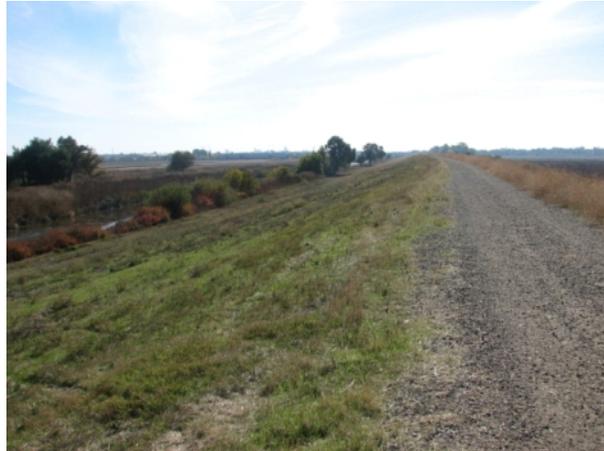
Levee Mile Report Line	2
Start Levee Mile	0.05
End Levee Mile	0.05
Location	Land Side
Category	Earthen Levee
Item	Vegetation
<p>This is the landside levee slope vegetation is less than 12" high.</p>	
<p>johngw_f_20101108_305.jpg</p>

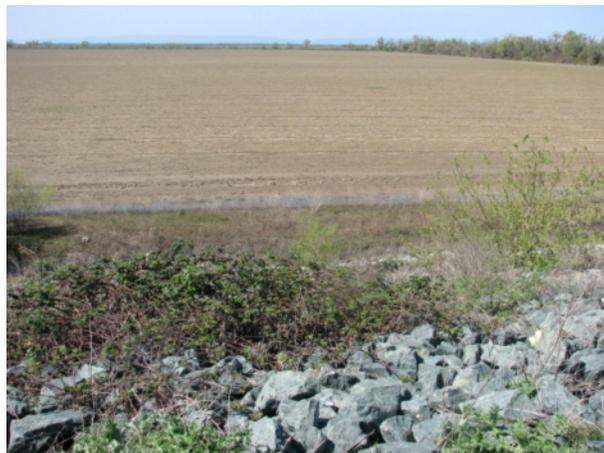
Levee Mile Report Line	3
Start Levee Mile	0.19
End Levee Mile	0.19
Location	Water Side
Category	Earthen Levee
Item	Vegetation
<p>Berries and small willow in rip-rap</p>	
<p>johngw_f_20101012_125.jpg</p>

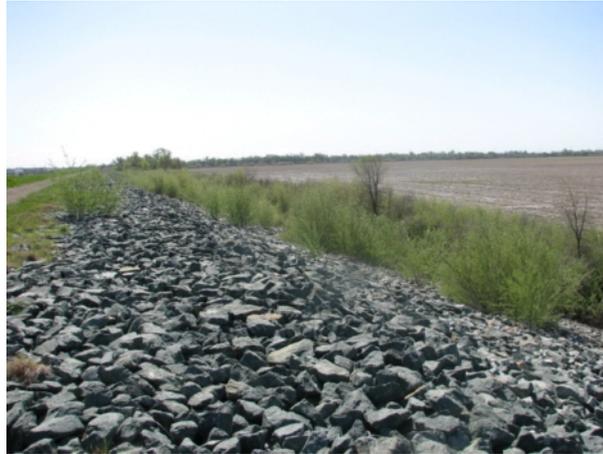
Levee Mile Report Line	4
Start Levee Mile	0.37
End Levee Mile	0.37
Location	Water Side
Category	Earthen Levee
Item	Trim / Thin Trees
willows need to be sprayed and removed	
johngw_f_20101012_123.jpg

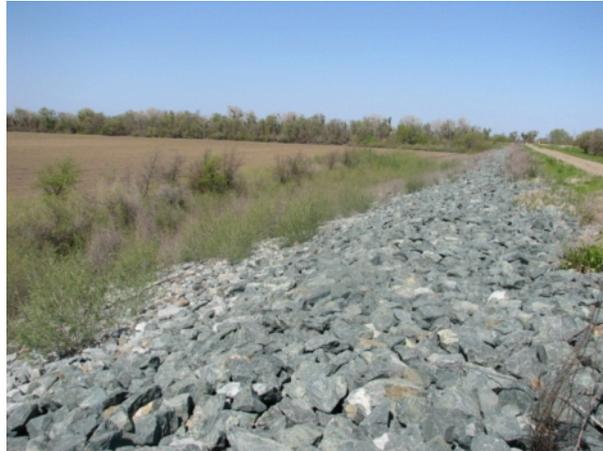
Levee Mile Report Line	4
Start Levee Mile	0.37
End Levee Mile	0.37
Location	Water Side
Category	Earthen Levee
Item	Trim / Thin Trees
willows looking up stream; need to remove willows	
johngw_f_20101012_124.jpg

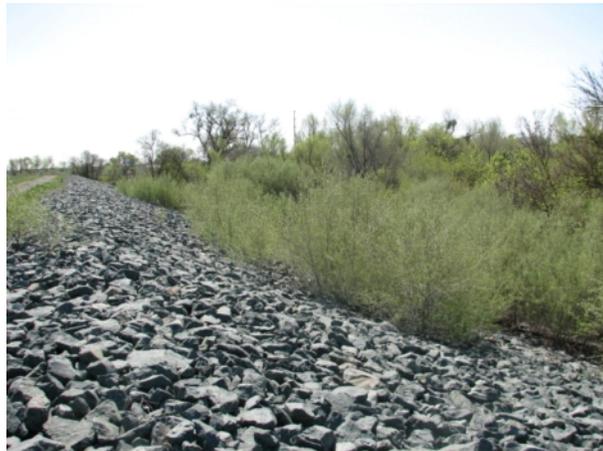
Levee Mile Report Line	5
Start Levee Mile	1.00
End Levee Mile	1.00
Location	Water Side
Category	Earthen Levee
Item	Trim / Thin Trees
willows need to be sprayed and removed	
johngw_f_20101012_122.jpg

5	1.00	1.00	Earthen Levee	Trim / Thin Trees	WS	M	Trim and thin trees to allow visibility of the ground and room to flood fight. Inspector Comments: cut and spray willows in rock area	38.584025 ° -121.569861 °	38.584025 ° -121.569861 °	1 Y
