**Flood Control Project Maintenance  
Levee Inspections  
LMA District Cover Sheet  
Spring 2011 Levee Inspection Results**

**Reclamation District No. 0537 Lovdal**

**Levee Inspection Report By Mile - Spring 2011**

Waterway		Bank	Unit Miles	Inspection Start/End	Inspector
Unit No. 01 Sacramento River		Right	4.76	03/09/2011 03/09/2011	John Williamson

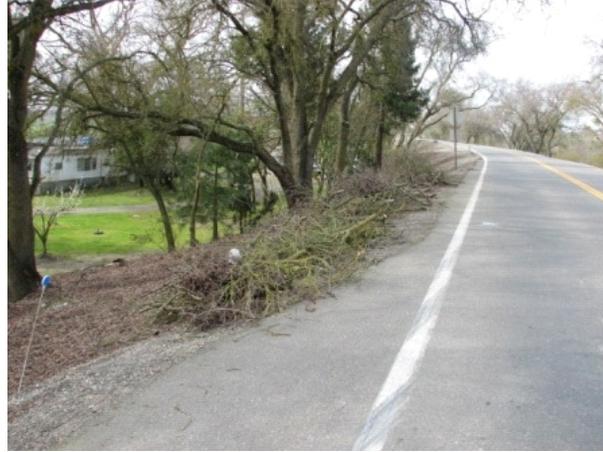
Levee Mile Report Line	2
Start Levee Mile	0.48
End Levee Mile	0.48
Location	Land Side
Category	Earthen Levee
Item	Encroachments
<p>The photo is of prunings along the roadside and need to be removed.</p>	
<p>johngw_s_20110310_363.jpg</p>

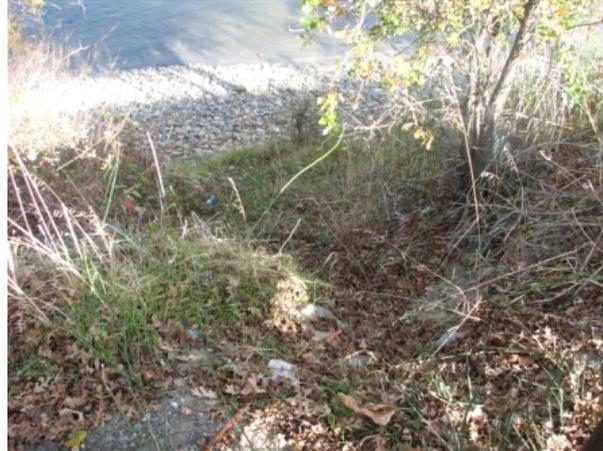
Levee Mile Report Line	3
Start Levee Mile	0.72
End Levee Mile	0.72
Location	Water Side
Category	Earthen Levee
Item	Erosion / Bank Caving
<p>This is a photo of the eroison and the bank.</p>	
<p>johngw_s_20110228_196.jpg</p>

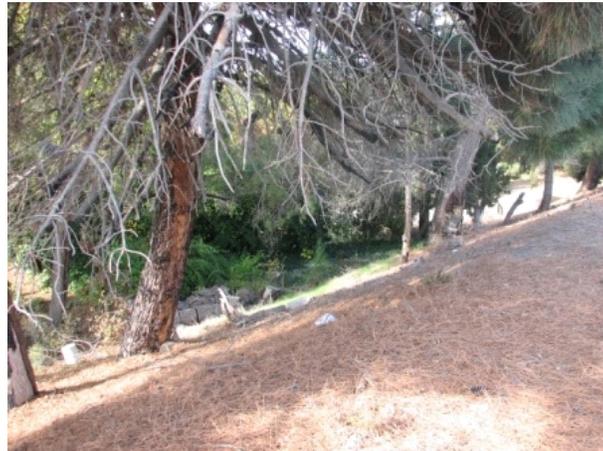
Levee Mile Report Line	8
Start Levee Mile	2.58
End Levee Mile	2.64
Location	Land Side
Category	Earthen Levee
Item	Encroachments
<p>Landscape shrubs at the toe of the levee.</p>	
<p>johngw_s_20110228_178.jpg</p>

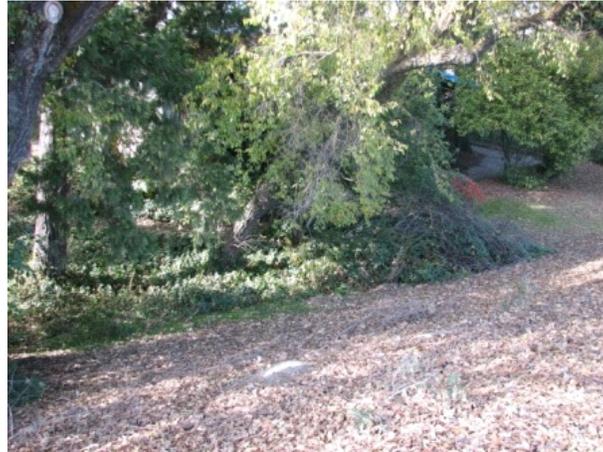
Levee Mile Report Line	9
Start Levee Mile	2.94
End Levee Mile	2.96
Location	Land Side
Category	Earthen Levee
Item	Encroachments
There is groundcover and landscape shrubs at the toe.	
johngw_s_20110228_180.jpg

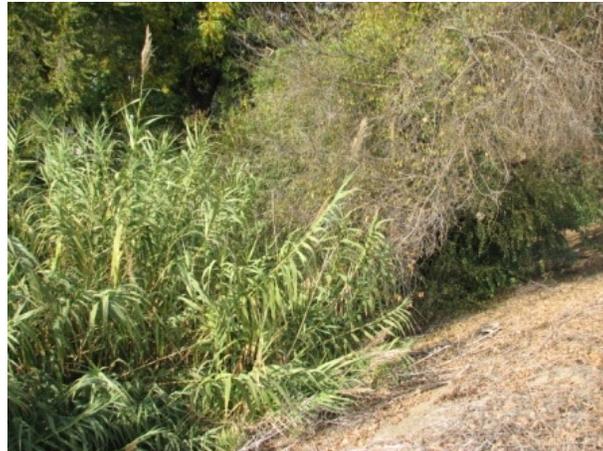
Levee Mile Report Line	9
Start Levee Mile	2.94
End Levee Mile	2.96
Location	Land Side
Category	Earthen Levee
Item	Encroachments
Arundo and vegetation with the landscape.	
johngw_s_20110228_181.jpg

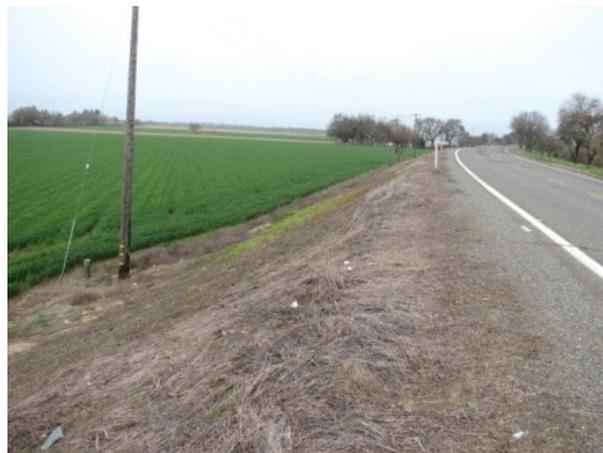
Levee Mile Report Line	10
Start Levee Mile	3.46
End Levee Mile	3.46
Location	Water Side
Category	Earthen Levee
Item	Vegetation
A view of the landside slope. The landside slope is difficult to mow and easier to spray.	
johngw_s_20110310_365.jpg

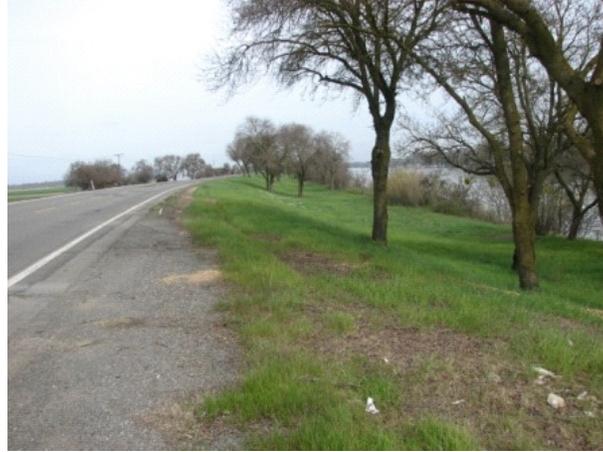
Levee Mile Report Line	11
Start Levee Mile	3.46
End Levee Mile	3.46
Location	Land Side
Category	Earthen Levee
Item	Vegetation
<p>Aviiew of the grasses on the waterside they do not exceed 12".</p>	
<p>johngw_s_20110310_364.jpg</p>

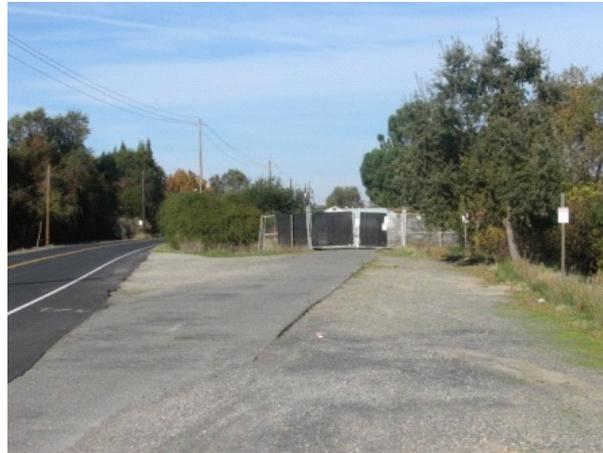
Levee Mile Report Line	14
Start Levee Mile	4.18
End Levee Mile	4.37
Location	Water Side
Category	Earthen Levee
Item	Encroachments
<p>Old Sacramento Weir Yard building and fence compound on levee crown.</p>	
<p>johngw_s_20110228_185.jpg</p>

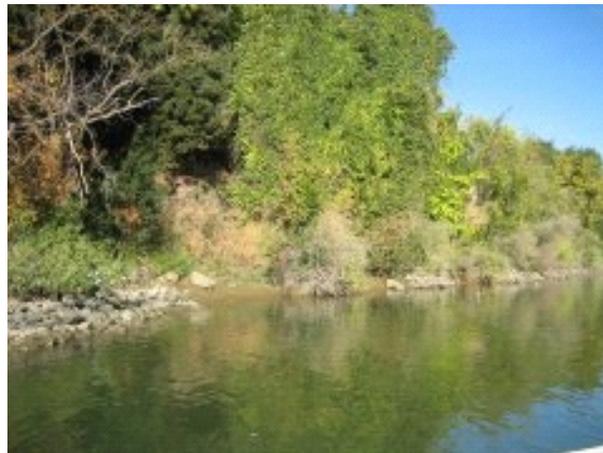
Levee Mile Report Line	15
Start Levee Mile	4.28
End Levee Mile	4.31
Location	Water Side
Category	Supplemental
Item	USACE Erosion Survey
<p>2009: 15 ft berm, 1.5:1 slope, tree hazards and slumping, clays and silts, 2.87 ft/s [2009 SiteID:SAC_63-0_R]</p>	
<p>johngw_s_20110228_194.JPG</p>

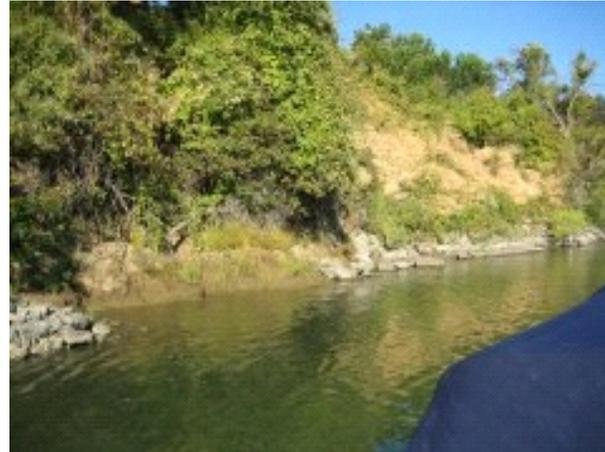
Levee Mile Report Line	16
Start Levee Mile	4.34
End Levee Mile	4.38
Location	Water Side
Category	Supplemental
Item	USACE Erosion Survey
2009: 10 ft berm, 1:1 slope, tree hazards and slumping, clays and silts, 3.08 ft/s [2009 SiteID:SAC_62-9_R]	
johngw_s_20110228_195.JPG

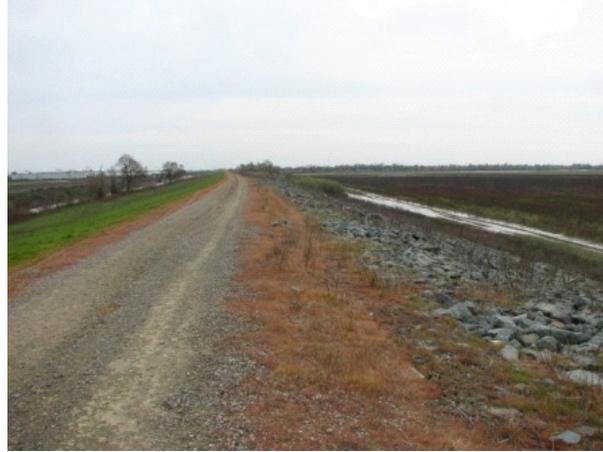
Levee Mile Report Line	1
Start Levee Mile	0.05
End Levee Mile	0.05
Location	Water Side
Category	Earthen Levee
Item	Vegetation
The view is looking into the sacramento Bypass and the waterside slope.	
johngw_s_20110310_366.jpg

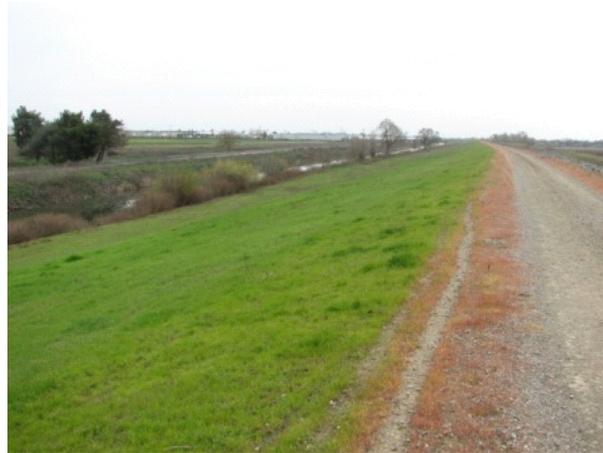
Levee Mile Report Line	2
Start Levee Mile	0.05
End Levee Mile	0.05
Location	Land Side
Category	Earthen Levee
Item	Vegetation
The view of the landside grasses that do not exceed 12".	
johngw_s_20110310_367.jpg
