**Flood Control Project Maintenance
Levee Inspections**
LMA District Cover Sheet
Spring 2014 Levee Inspection Results

Reclamation District No. 0537 Lovdal

Levee Inspection Report By Mile - Spring 2014

Waterway		Bank	Unit Miles	Inspection Start/End	Inspector
Unit No. 01 Sacramento River		Right	4.76	03/27/2014 03/27/2014	John Williamson

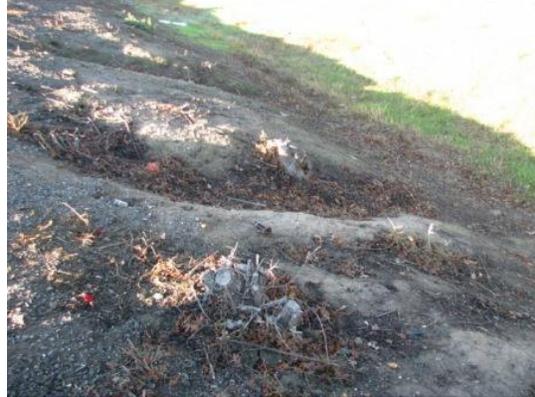
Photo 1 of 2 : johngw_s_20140306_907.jpg

LM Start	0.01	Rating **	N	Issue No.	963
LM End	0.21	Issue Type +	Ma	Location *	WS
Category	Earthen Levee		GPS Latitude/Longitude		
			Start	End	
Item	Trim / Thin Trees		38.643080 °	38.644849 °	
			-121.584260 °	-121.581221 °	
DWR ID	DWR_RD0537_01_s_2012_963				
Action/Comments					
Tree stumps. Inspector Comments: Trees stumps are visible on levee.

There are many stumps on the waterside levee. Fall 2012

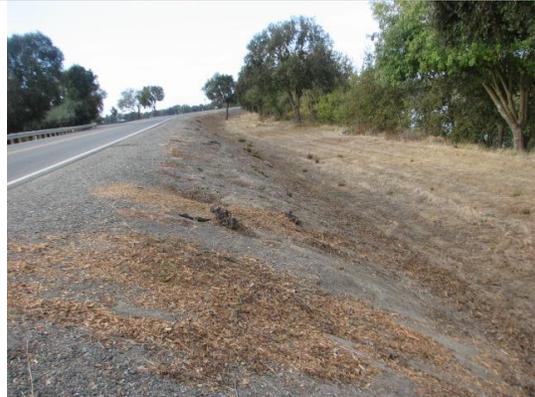
Photo 2 of 2 : johngw_s_20140306_908.jpg

The stumps are being controlled by the LMA. Fall 2013

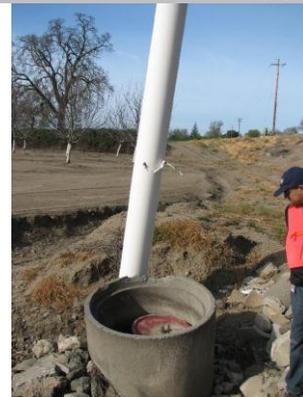
Photo 1 of 1 : UCIP_267.jpg

LM Start	0.05	Rating **	M	Issue No.	258
LM End	0.05	Issue Type +	En	Location *	WS
Category	Supplemental		GPS Latitude/Longitude		
			Start	End	
Item	DWR UCIP Field Study		38.643400 °	38.643400 °	
			-121.583380 °	-121.583380 °	
DWR ID	DWR_RD0537_01_s_2014_258				
Action/Comments					
Inspector Comments: FS_ID:10043

LS- standpipe and valve: this may not be the part of pipe crossing

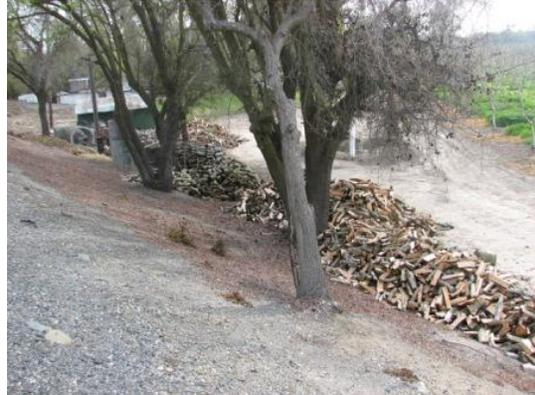
Photo 1 of 2 : johngw_s_20140306_898.jpg

LM Start	0.39	Rating **	M	Issue No.	47
LM End	0.39	Issue Type +	En	Location *	LS
Category	Earthen Levee			GPS Latitude/Longitude	
				Start	End
Item	Encroachments			38.646457 °	38.646457 °
				-121.578663 °	-121.578663 °
DWR ID	DWR_RD0537_01_s_2012_47				
Action/Comments					
Firewood

Firewood pile next to the landside levee slope, photo taken spring 2012.

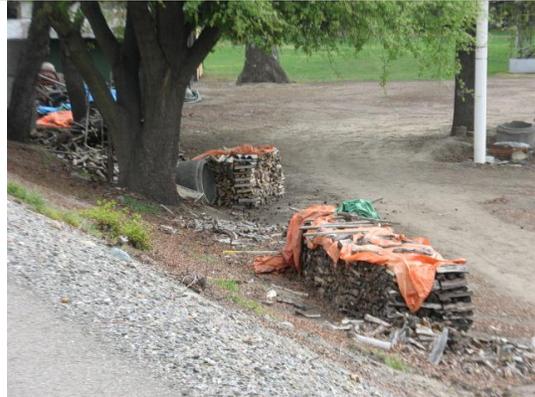
Photo 2 of 2 : johngw_s_20140401_716.jpg

Firewood is at the toe of the levee now stacked. Spring 2014

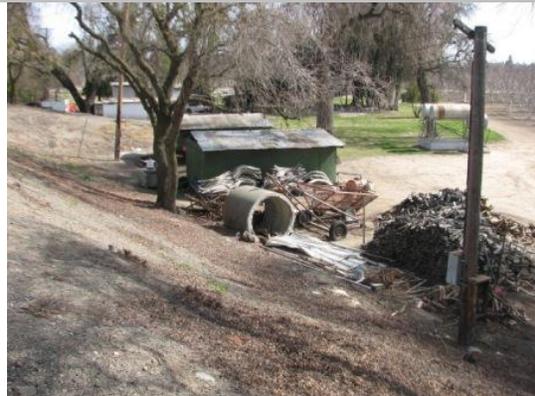
Photo 1 of 3 : johngw_s_20140306_887.jpg

LM Start	0.39	Rating **	M	Issue No.	6
LM End	0.39	Issue Type +	En	Location *	LS
Category	Earthen Levee			GPS Latitude/Longitude	
				Start	End
Item	Encroachments			38.646547 °	38.646547 °
				-121.578534 °	-121.578534 °
DWR ID	DWR_RD0537_01_s_2013_6				
Action/Comments					
Equipment

Irrigation pipe and equipment along the levee toe. Spring 2013

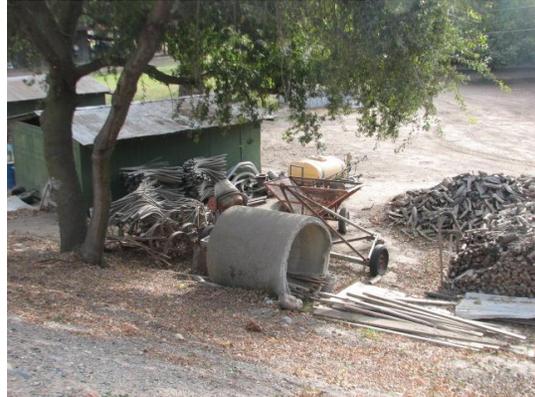
Photo 2 of 3 : johngw_s_20140306_888.jpg

LM Start	0.39	Rating **	M	Issue No.	6 (cont)
LM End	0.39	Issue Type +	En	Location *	LS
Category	Earthen Levee		GPS Latitude/Longitude		
			Start	End	
Item	Encroachments		38.646547 °	38.646547 °	
			-121.578534 °	-121.578534 °	
DWR ID	DWR_RD0537_01_s_2013_6				
Action/Comments					
Equipment Inspector Comments: Also building is in the easement.

The equipment is still within the easement. Fall 2013

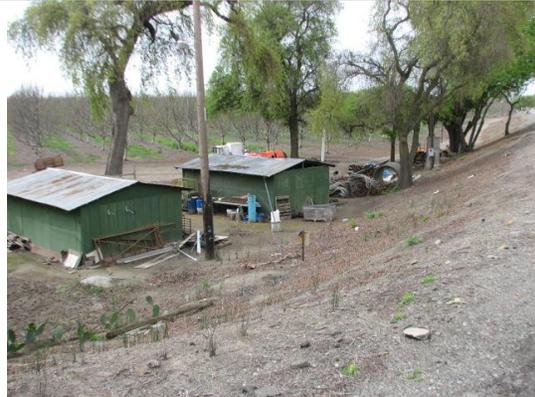
Photo 3 of 3 : johngw_s_20140401_718.jpg

The equipment and pipe at the levee toe. Spring 2014

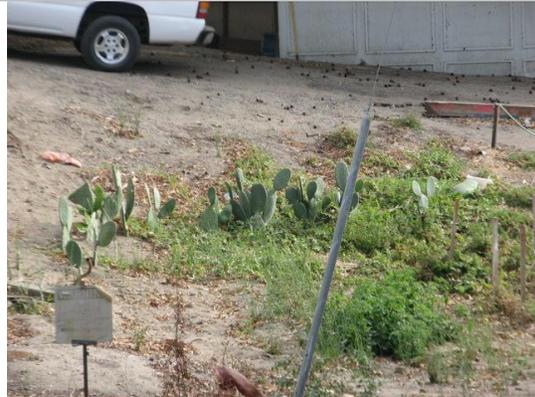
Photo 1 of 2 : johngw_s_20140306_892.jpg

LM Start	0.42	Rating **	M	Issue No.	18
LM End	0.42	Issue Type +	En	Location *	LS
Category	Earthen Levee		GPS Latitude/Longitude		
			Start	End	
Item	Vegetation		38.646803 °	38.646803 °	
			-121.578215 °	-121.578215 °	
DWR ID	DWR_RD0537_01_f_2013_18				
Action/Comments					
Landscaping

The landowner is planting cactus within the easement. Fall 2013

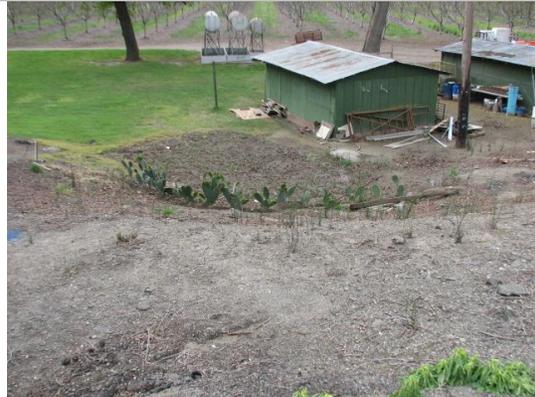
Photo 2 of 2 : johngw_s_20140401_717.jpg

The cactus is still growing along the levee slope. Spring 2014

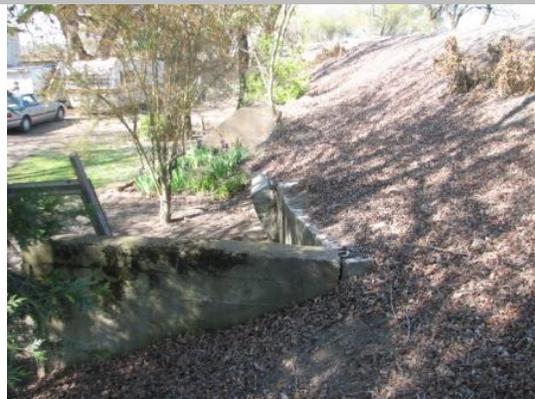
Photo 1 of 2 : johngw_s_20140306_901.jpg

Concrete retaining wall broken and leaning. Slope instability, photo taken spring 2012.

LM Start	0.45	Rating **	M	Issue No.	50
LM End	0.45	Issue Type +	Ma	Location *	LS
Category	Earthen Levee		GPS Latitude/Longitude		
			Start	End	
Item	Slope Stability		38.647005 °	38.647005 °	
			-121.577813 °	-121.577813 °	
DWR ID	DWR_RD0537_01_s_2012_50				
Action/Comments					
Repair slope instability.

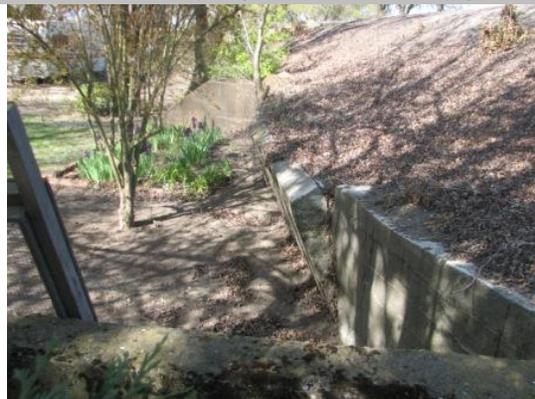
Photo 2 of 2 : johngw_s_20140306_902.jpg

A closer view of the retaining wall, spring 2012.

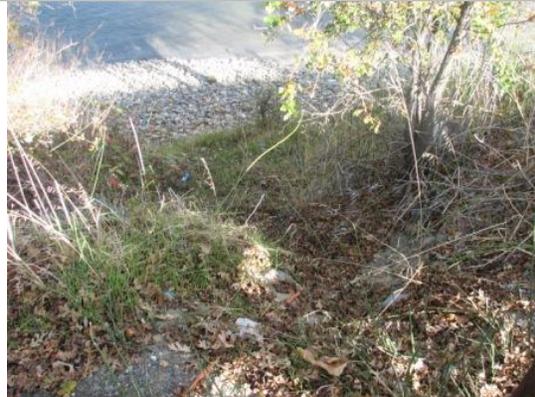
Photo 1 of 4 : johngw_s_20140306_903.jpg

This is a photo of the eroision at the bank.

LM Start	0.72	Rating **	M	Issue No.	954
LM End	0.72	Issue Type +	Ma	Location *	WS
Category	Earthen Levee		GPS Latitude/Longitude		
			Start	End	
Item	Erosion / Bank Caving		38.647903 °	38.647903 °	
			-121.573190 °	-121.573190 °	
DWR ID	DWR_RD0537_01_s_2012_954				
Action/Comments					
Note and monitor erosion site.

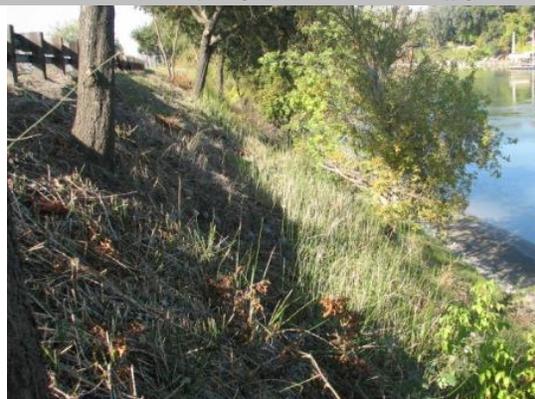
Photo 2 of 4 : johngw_s_20140306_904.jpg

The slope of an erosion site at Monument Bend. Fall 2011

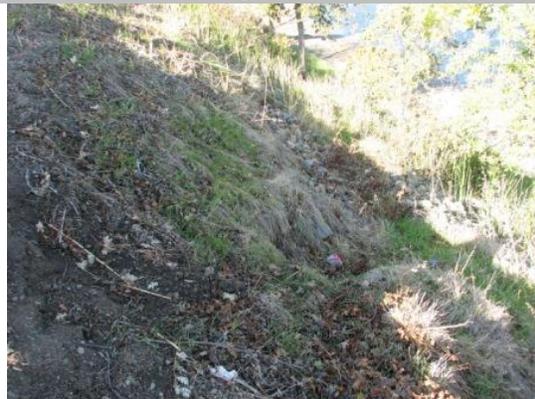
Photo 3 of 4 : johngw_s_20140306_905.jpg

Another view of some badly eroded areas. Fall 2011

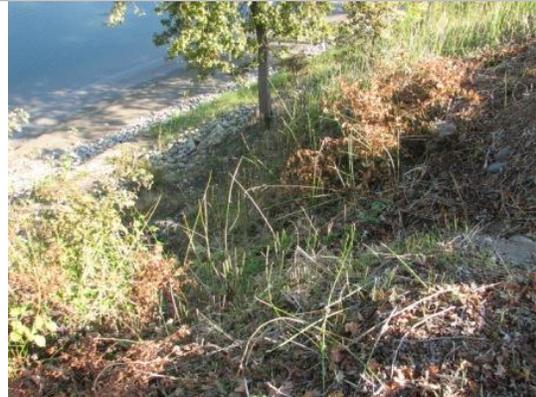
Photo 4 of 4 : johngw_s_20140306_906.jpg

Another view of the site. Fall 2011

LM Start	0.72	Rating **	M	Issue No.	954 (cont)
LM End	0.72	Issue Type +	Ma	Location *	WS
Category	Earthen Levee		GPS Latitude/Longitude		
			Start	End	
Item	Erosion / Bank Caving		38.647903 °	38.647903 °	
			-121.573190 °	-121.573190 °	
DWR ID	DWR_RD0537_01_s_2012_954				
Action/Comments					
Note and monitor erosion site.

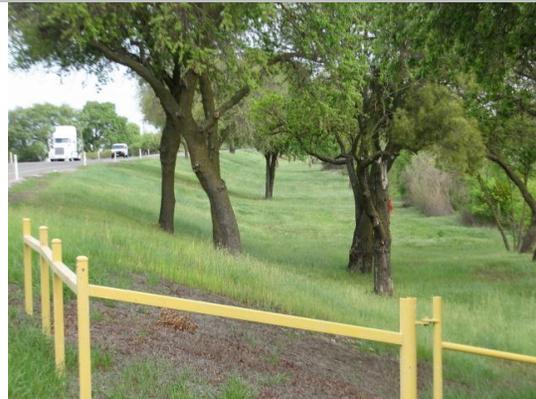
Photo 1 of 1 : johngw_s_20140401_713.jpg

LM Start	1.19	Rating **	M	Issue No.	261
LM End	3.56	Issue Type +	Ma	Location *	WS
Category	Earthen Levee		GPS Latitude/Longitude		
			Start	End	
Item	Vegetation		38.643481 °	38.610200 °	
			-121.566980 °	-121.561260 °	
DWR ID	DWR_RD0537_01_s_2014_261				
Action/Comments					
Control annual grass and weeds on the levee slopes and easements.

Tall grasses, weeds partially blocks visibility. Spring 2014

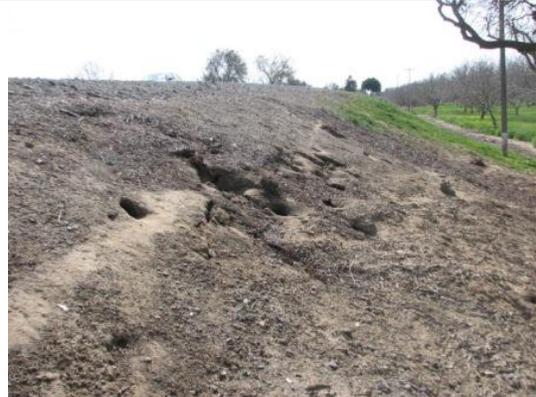
Photo 1 of 2 : johngw_s_20140306_895.jpg

LM Start	1.93	Rating **	U	Issue No.	40
LM End	1.93	Issue Type +	Ma	Location *	LS
Category	Earthen Levee		GPS Latitude/Longitude		
			Start	End	
Item	Animal Control		38.633148 °	38.633148 °	
			-121.564520 °	-121.564520 °	
DWR ID	DWR_RD0537_01_s_2012_40				
Action/Comments					
No rodents visible, but rodent burrows visible; need to backfill and

Rodent holes need to be backfilled but no rodents were present. Spring 2013

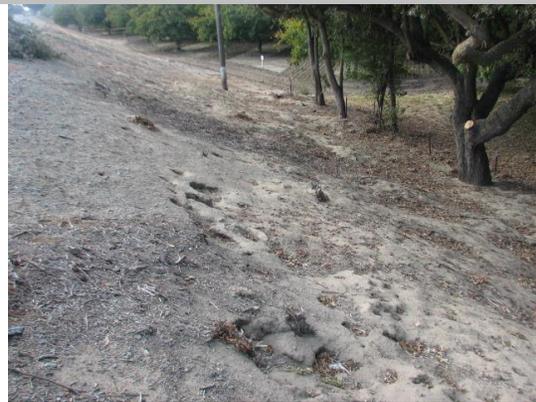
Photo 2 of 2 : johngw_s_20140306_896.jpg

There is no rodents visible and the old holes are starting to erode. Fall 2013

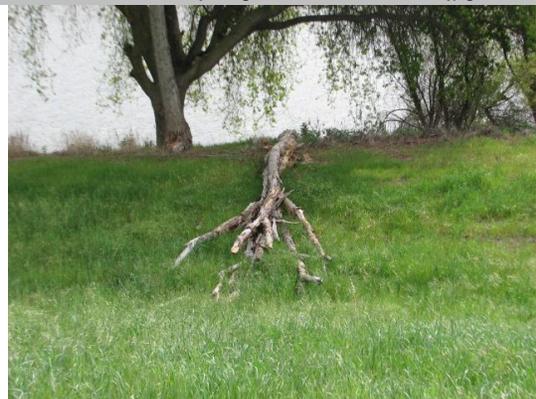
Photo 1 of 1 : johngw_s_20140401_714.jpg

LM Start	1.96	Rating **	M	Issue No.	262
LM End	1.96	Issue Type +	En	Location *	WS
Category	Earthen Levee		GPS Latitude/Longitude		
			Start	End	
Item	Encroachments		38.632795 °	38.632795 °	
			-121.564417 °	-121.564417 °	
DWR ID	DWR_RD0537_01_s_2014_262				
Action/Comments					
Tree or limb

Discarded tree laying on the waterside berm. Spring 2014

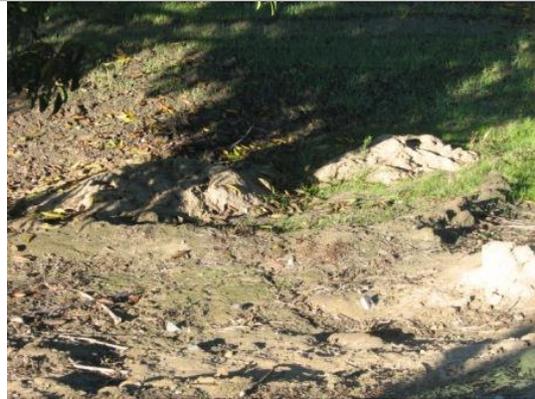
Photo 1 of 2 : johngw_s_20140306_899.jpg

LM Start	2.04	Rating **	A/W	Issue No.	49
LM End	2.04	Issue Type +	En	Location *	LS
Category	Earthen Levee			GPS Latitude/Longitude	
				Start	End
Item	Animal Control			38.631565 °	38.631565 °
				-121.564367 °	-121.564367 °
DWR ID	DWR_RD0537_01_s_2012_49				
Action/Comments					
No rodents visible, but rodent burrows visible; need to backfill and compact or grout burrows.

Large mounds of soil at the toe of the levee. Fall 2012

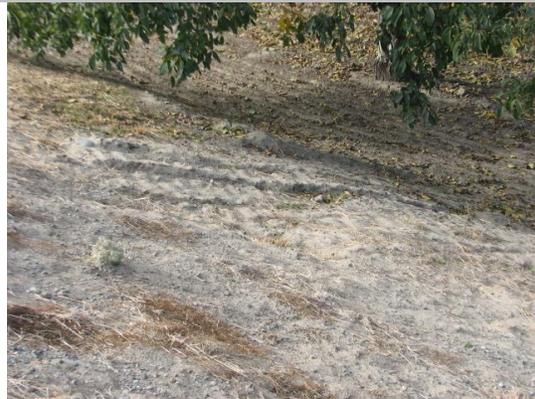
Photo 2 of 2 : johngw_s_20140306_900.jpg

The LMA has made an attempt to repair the rodent damage. No rodents are present. Fall 2013

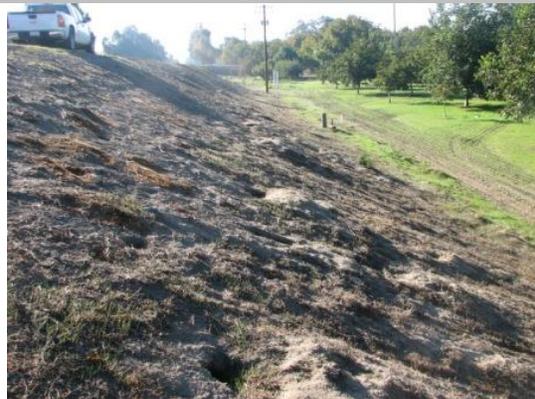
Photo 1 of 1 : johngw_s_20140306_897.jpg

LM Start	2.40	Rating **	A/W	Issue No.	42
LM End	2.40	Issue Type +	Ma	Location *	LS
Category	Earthen Levee			GPS Latitude/Longitude	
				Start	End
Item	Animal Control			38.626438 °	38.626438 °
				-121.563794 °	-121.563794 °
DWR ID	DWR_RD0537_01_s_2012_42				
Action/Comments					
No rodents visible, but rodent burrows visible; need to backfill and

A group of rodent hole on the levee slope. Fall 2012.

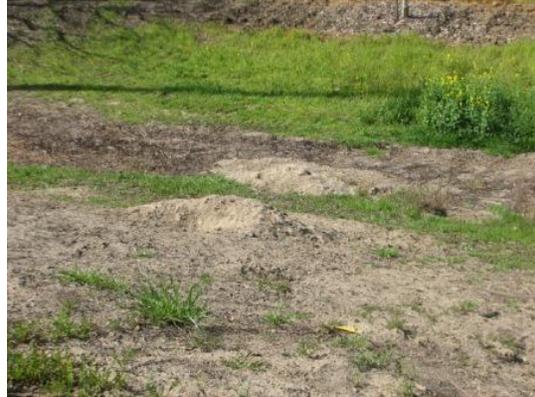
Photo 1 of 2 : johngw_s_20140306_889.jpg

Rodent holes need to be backfilled. No rodents present. Spring 2013

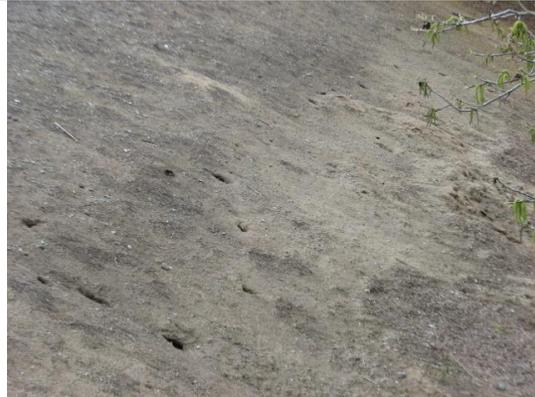
Photo 2 of 2 : johngw_s_20140401_719.jpg

Rodent holes need to be backfilled. Rodent program appears to be working. No rodent present. Spring 2014

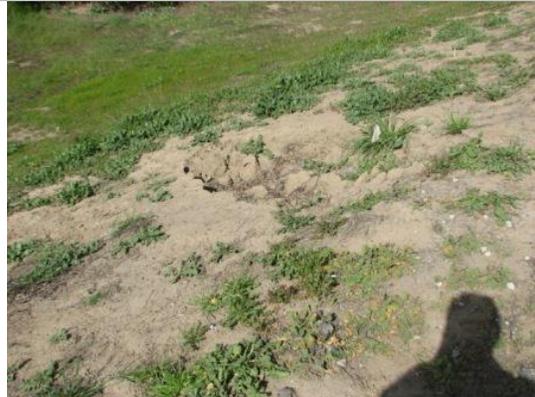
Photo 1 of 1 : johngw_s_20140306_891.jpg

LM Start	2.66	Rating **	A/W	Issue No.	10
LM End	2.66	Issue Type +	Ma	Location *	LS
Category	Earthen Levee		GPS Latitude/Longitude		
			Start	End	
Item	Animal Control		38.622883 °	38.622883 °	
			-121.563512 °	-121.563512 °	
DWR ID	DWR_RD0537_01_s_2013_10				
Action/Comments					
No rodents visible, but rodent burrows visible; need to backfill and

Rodent holes have collapsed and need to be backfilled before they start to erode. Spring 2013

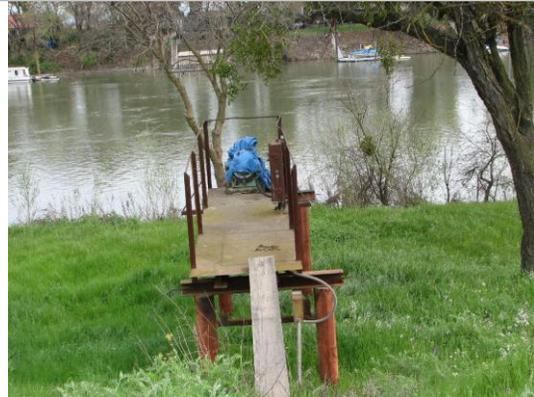
Photo 1 of 1 : UCIP_259.jpg

LM Start	2.76	Rating **	M	Issue No.	259
LM End	2.76	Issue Type +	En	Location *	LS
Category	Supplemental			GPS Latitude/Longitude	
				Start	End
Item	DWR UCIP Field Study			38.621437 °	38.621437 °
				-121.563373 °	-121.563373 °
DWR ID	DWR_RD0537_01_s_2014_259				
Action/Comments					
Inspector Comments: FS_ID:9937 EP_NO: N/A Repair Type: Crossing Status: UCIP Comments: Timber walkway missing. Wasted pipe and valve not visible due to vegetation. A 2" electrical conduit through the levee. FIELD_STRUCT_DESC: 12-inch pipe through the levee, 4.5 feet below the crown. Slant pump column on the waterward bank. Timber walkway mounted on pile structure across the berm. Siphon breaker in CM pipe riser on the landward slope. Concrete standpipe on the landward side. 6-inch wasted pipe down bank, gate valve on waste line. FS Date: 3/18/2013

WS- closer view of pump, pipe and steel structure.

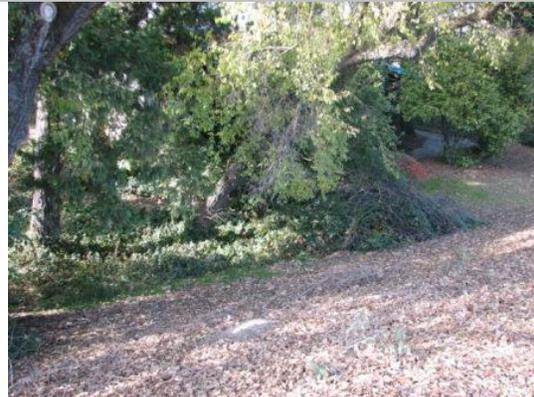
Photo 1 of 3 : johngw_s_20140306_880.jpg

LM Start	2.94	Rating **	M	Issue No.	3
LM End	2.96	Issue Type +	En	Location *	LS
Category	Earthen Levee			GPS Latitude/Longitude	
				Start	End
Item	Vegetation			38.618926 °	38.618490 °
				-121.563374 °	-121.563382 °
DWR ID	DWR_RD0537_01_s_2012_3				
Action/Comments					
Landscaping Inspector Comments: Arundo starting to creep up levee slope.

There is groundcover and landscape shrubs at the toe.

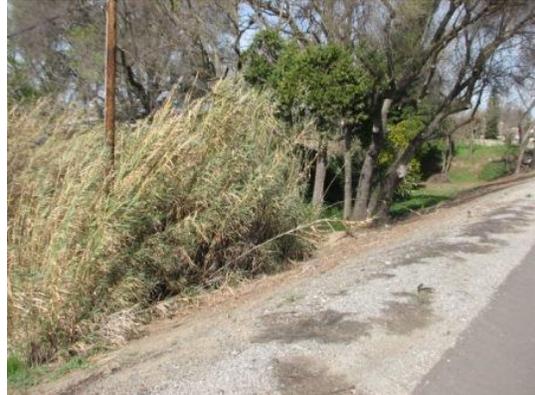
Photo 2 of 3 : johngw_s_20140306_881.jpg

The Arundo needs to be cut back to open the levee toe up. Spring 2013

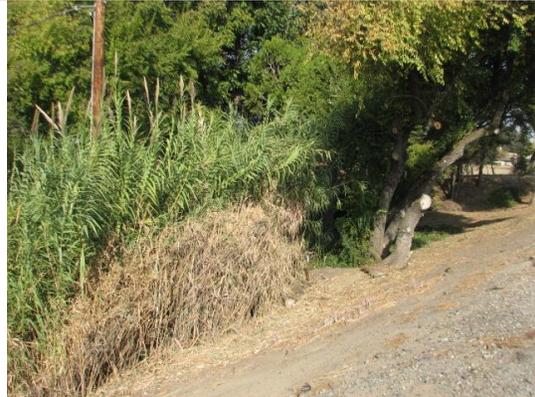
Photo 3 of 3 : johngw_s_20140306_882.jpg

The Arundo has been cut back close to the toe. It blocks visibility of the toe plus easement. Fall 2013

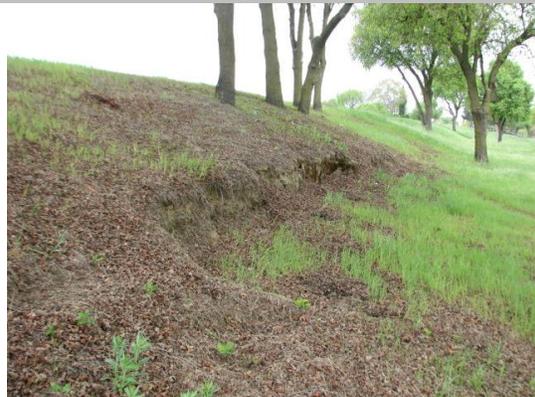
Photo 1 of 2 : johngw_s_20140401_720.jpg

Erosion cut in levee slope 2-3 feet deep. Spring 2014

LM Start	3.10	Rating **	U	Issue No.	264
LM End	3.10	Issue Type +	Ma	Location *	WS
Category	Earthen Levee		GPS Latitude/Longitude		
			Start	End	
Item	Erosion / Bank Caving		38.616504 °	38.616504 °	
			-121.563270 °	-121.563270 °	
DWR ID	DWR_RD0537_01_s_2014_264				
Action/Comments					
Schedule repair of erosion site prior to the next inspection.

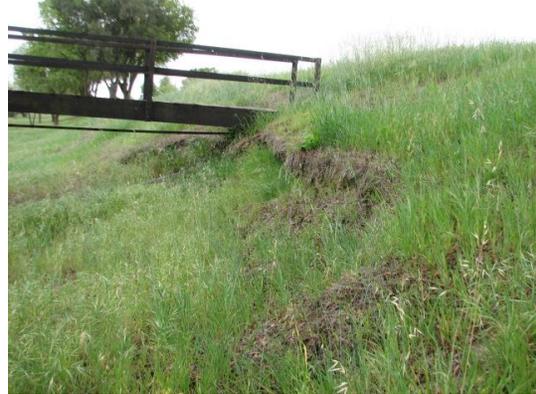
Photo 2 of 2 : johngw_s_20140401_721.jpg

Erosion cut 20 feet from the other one. Erosion 2-3 feet deep. Spring 2014

LM Start	3.10	Rating **	U	Issue No.	264 (cont)
LM End	3.10	Issue Type +	Ma	Location *	WS
Category	Earthen Levee		GPS Latitude/Longitude		
			Start	End	
Item	Erosion / Bank Caving		38.616504 °	38.616504 °	
			-121.563270 °	-121.563270 °	
DWR ID	DWR_RD0537_01_s_2014_264				
Action/Comments					
Schedule repair of erosion site prior to the next inspection.

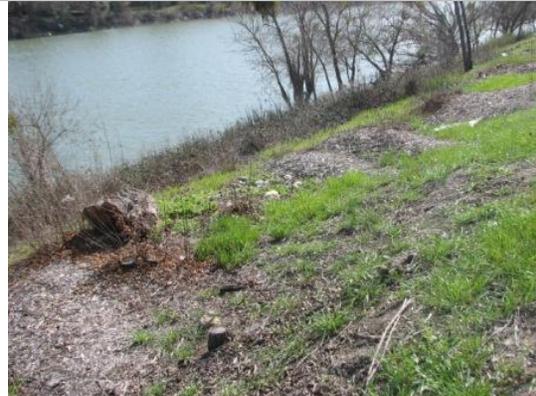
Photo 1 of 3 : johngw_s_20140306_885.jpg

LM Start	3.64	Rating **	N	Issue No.	5
LM End	3.64	Issue Type +	Ma	Location *	WS
Category	Earthen Levee		GPS Latitude/Longitude		
			Start	End	
Item	Trim / Thin Trees		38.609207 °	38.609207 °	
			-121.560539 °	-121.560539 °	
DWR ID	DWR_RD0537_01_f_2012_5				
Action/Comments					
Tree stumps.

Tree stumps on waterside levee slope. Spring 2013

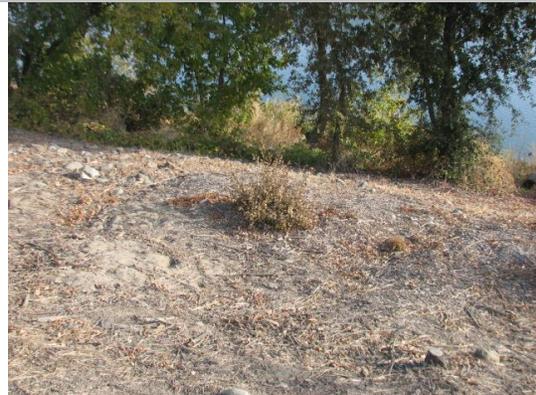
Photo 2 of 3 : johngw_s_20140306_886.jpg

The district has been spraying the stumps to keep from growing. Fall 2013

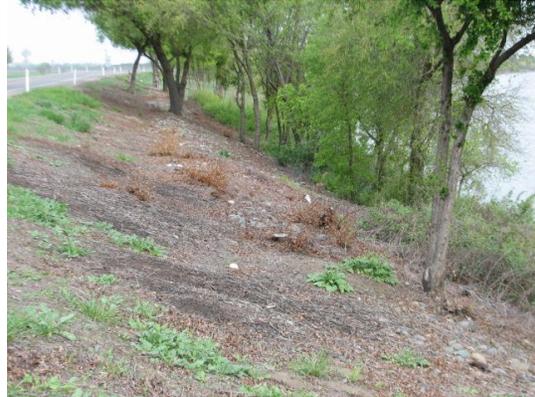
Photo 3 of 3 : johngw_s_20140401_712.jpg

Tree stumps on the waterside levee slope are being maintained. Spring 2014

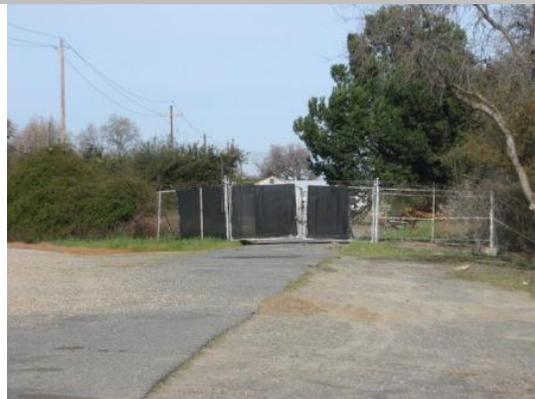
Photo 1 of 2 : johngw_s_20140306_890.jpg

Abandoned building and fence on the levee crown. Spring 2013

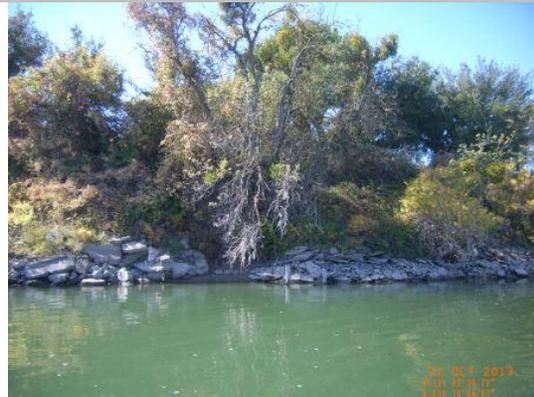
Photo 1 of 1 : USACE2013A_SAC_62-9_R_1.jpg

LM Start	4.31	Rating **	M	Issue No.	1
LM End	4.31	Issue Type +	Ma	Location *	WS
Category	Supplemental		GPS Latitude/Longitude		
			Start	End	
Item	USACE Erosion Survey		38.600907 °	38.601388 °	
			-121.552815 °	-121.553250 °	
DWR ID					
Action/Comments					
Inspector Comments: 1997 - This may have been a cobble rehabilitation site to the 1957 cobble that was place all the way to the I-80 Bridge. 2003 - Site is still very close to the levee and into the levee toe. 2011 - One new tree has fallen. 2013: No observed changes. [2013 Site ID: SAC_62-9_R]

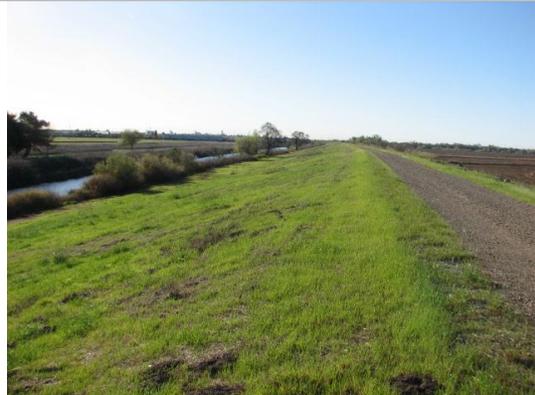
Photo 1 of 1 : johngw_s_20140317_639.jpg

The vegetation complies with standards. Spring 2014

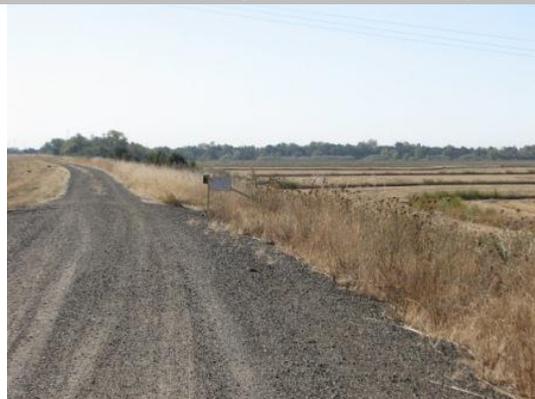
Photo 1 of 2 : johngw_s_20140306_942.jpg

The vegetation partially blocks visibility. Fall 2013

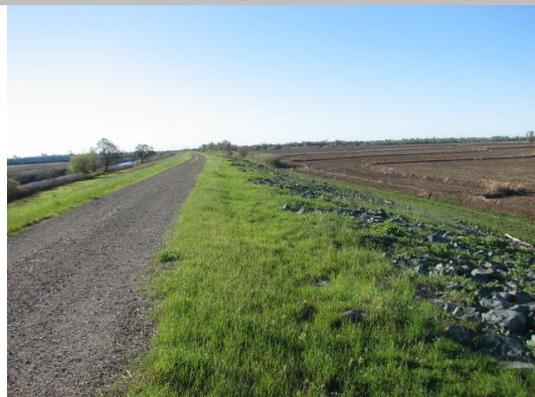
Photo 2 of 2 : johngw_s_20140317_640.jpg

The vegetation complies with standards could be sprayed. Spring 2014

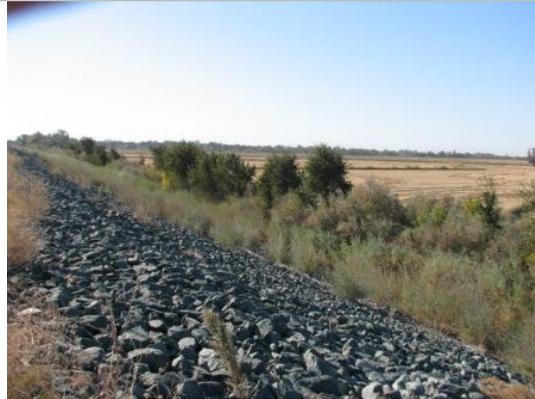
Photo 1 of 2 : johngw_s_20140306_943.jpg

Trees are at the toe of the waterside levee. Sandbar Willows are creeping up the slope. Fall 2013

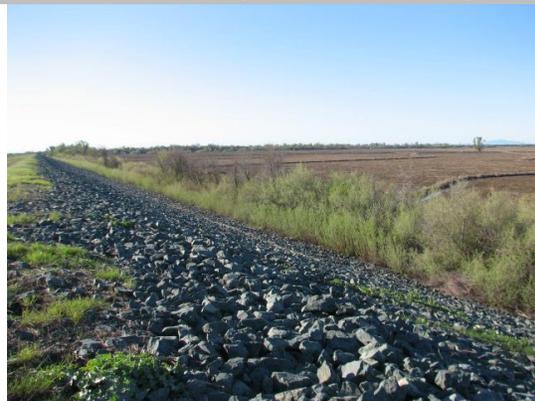
Photo 2 of 2 : johngw_s_20140317_641.jpg

Photo of the willows at the toe of the rip rap and levee. No other trees in the rip rap. Spring 2014

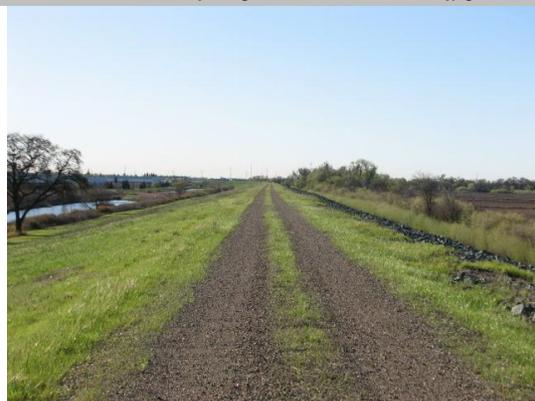
Photo 1 of 1 : johngw_s_20140317_642.jpg

Small vegetation on the crown but should be sprayed so not obstruct visibility. Spring 2014
