**Flood Control Project Maintenance
Levee Inspections**
LMA District Cover Sheet
Spring 2015 Levee Inspection Results

Reclamation District No. 0537 Lovdal

Levee Inspection Report By Mile - Spring 2015

Waterway	Bank	Unit Miles	Inspection Start/End	Inspector
Unit No. 01 Sacramento River	Right	4.74	04/14/2015 04/14/2015	Jai Lor

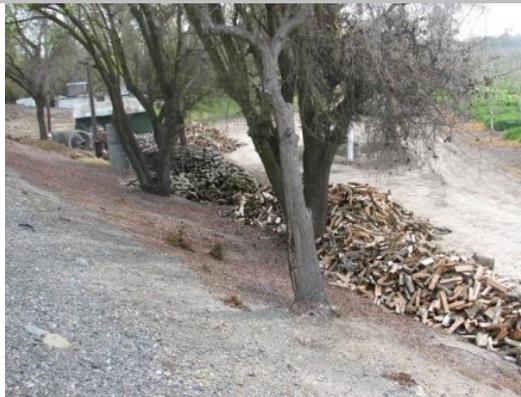
Photo 1 of 2 : SP_2015_RD0537_173_47_20150401_00018.jpg

LM Start	0.38	Rating **	M	Issue No.	47
LM End	0.38	Issue Type +	En	Location *	LS
Category	Earthen Levee			GPS Latitude/Longitude	
				Start	End
Item	Encroachments			38.646457 °	38.646457 °
				-121.578663 °	-121.578663 °
DWR ID	DWR_RD0537_01_s_2012_47				
Action/Comments					
Firewood

Firewood pile next to the landside levee slope, photo taken spring 2012.

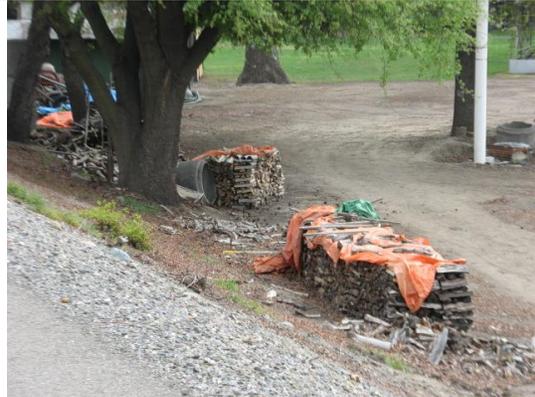
Photo 2 of 2 : SP_2015_RD0537_173_47_20150401_00019.jpg

Firewood is at the toe of the levee and is now stacked. Spring 2014

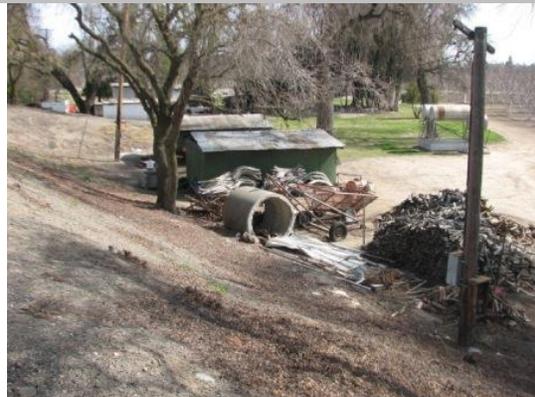
Photo 1 of 3 : SP_2015_RD0537_173_6_20150401_00006.jpg

LM Start	0.39	Rating **	M	Issue No.	6
LM End	0.39	Issue Type +	En	Location *	LS
Category	Earthen Levee			GPS Latitude/Longitude	
				Start	End
Item	Encroachments			38.646547 °	38.646547 °
				-121.578534 °	-121.578534 °
DWR ID	DWR_RD0537_01_s_2013_6				
Action/Comments					
Equipment Inspector Comments: Also building is in the easement.

Irrigation pipe and equipment along the levee toe. Spring 2013

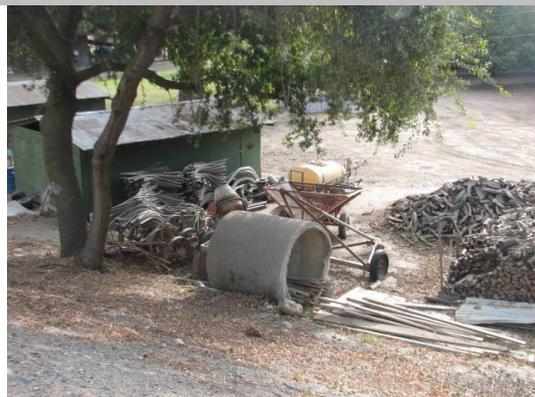
Photo 2 of 3 : SP_2015_RD0537_173_6_20150401_00007.jpg

The equipment is still within the easement. Fall 2013

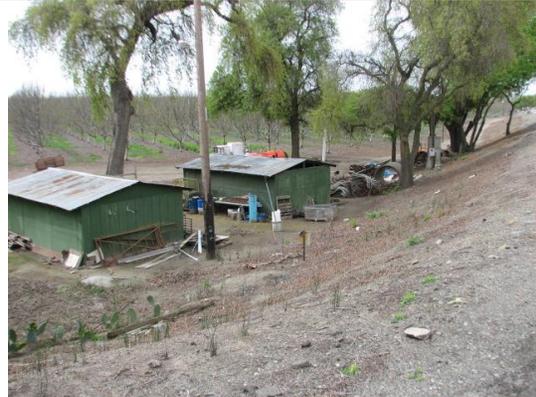
Photo 3 of 3 : SP_2015_RD0537_173_6_20150401_00008.jpg

The equipment and pipe at the levee toe. Spring 2014

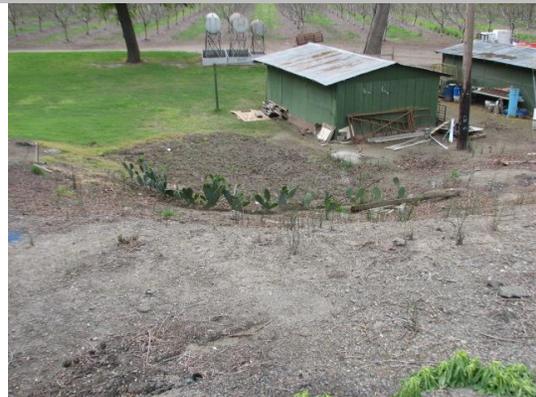
Photo 1 of 1 : SP_2015_RD0537_173_18_20150401_00015.jpg

LM Start	0.42	Rating **	M	Issue No.	18
LM End	0.42	Issue Type +	En	Location *	LS
Category	Earthen Levee			GPS Latitude/Longitude	
				Start	End
Item	Vegetation			38.646803 °	38.646803 °
				-121.578215 °	-121.578215 °
DWR ID	DWR_RD0537_01_f_2013_18				
Action/Comments					
Landscaping

The cactus is still growing along the levee slope. Spring 2014

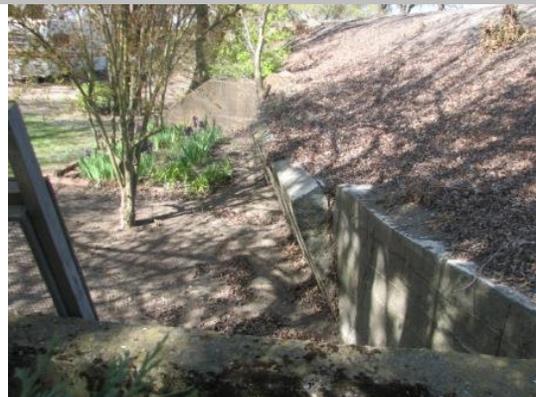
Photo 1 of 2 : SP_2015_RD0537_173_50_20150401_00022.jpg

A closer view of the retaining wall, spring 2012.

LM Start	0.44	Rating **	M	Issue No.	50
LM End	0.44	Issue Type +	Ma	Location *	LS
Category	Earthen Levee			GPS Latitude/Longitude	
				Start	End
Item	Slope Stability			38.647005 °	38.647005 °
				-121.577813 °	-121.577813 °
DWR ID	DWR_RD0537_01_s_2012_50				
Action/Comments					
Repair slope instability.

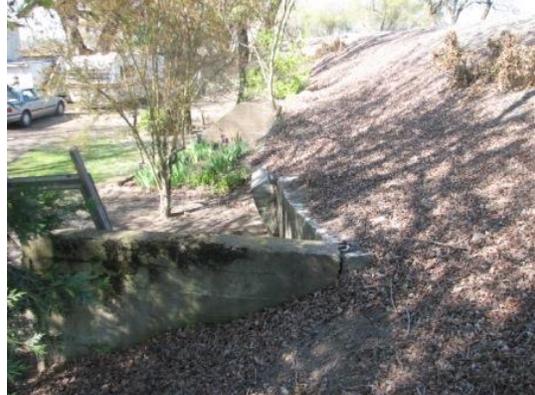
Photo 2 of 2 : SP_2015_RD0537_173_50_20150401_00023.jpg

Concrete retaining wall broken and leaning. Slope instability, photo taken spring 2012.

LM Start	0.44	Rating **	M	Issue No.	50 (cont)
LM End	0.44	Issue Type +	Ma	Location *	LS
Category	Earthen Levee			GPS Latitude/Longitude	
				Start	End
Item	Slope Stability			38.647005 °	38.647005 °
				-121.577813 °	-121.577813 °
DWR ID	DWR_RD0537_01_s_2012_50				
Action/Comments					
Repair slope instability.

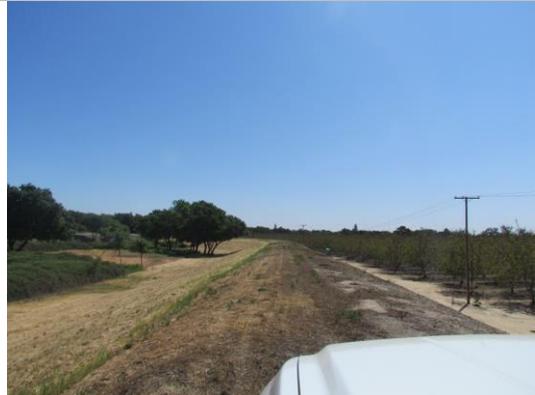
Photo 1 of 1 : SP_2015_RD0537_173_471_20150421_00065.jpg

View of the crown of the levee looking downstream. Spring 2015.

LM Start	0.59	Rating **	M	Issue No.	471
LM End	0.59	Issue Type +	Ma	Location *	CR
Category	Earthen Levee			GPS Latitude/Longitude	
				Start	End
Item	Crown Surface / Depressions / Rutting			38.647462 °	38.647462 °
				-121.575348 °	-121.575348 °
DWR ID	DWR_RD0537_01_s_2015_471				
Action/Comments					
Add appropriate gravel or road base. Grade and compact.

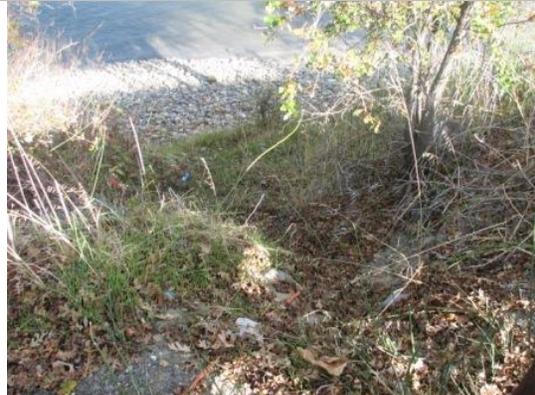
Photo 1 of 4 : SP_2015_RD0537_173_954_20150401_00028.jpg

LM Start	0.72	Rating **	A/W	Issue No.	954
LM End	0.72	Issue Type +	Ma	Location *	WS
Category	Earthen Levee			GPS Latitude/Longitude	
				Start	End
Item	Erosion / Bank Caving			38.647903 °	38.647903 °
				-121.573190 °	-121.573190 °
DWR ID	DWR_RD0537_01_s_2012_954				
Action/Comments					
Note and monitor erosion site. Inspector Comments: It's away from the project alignment.

This is a photo of the eroison at the bank.

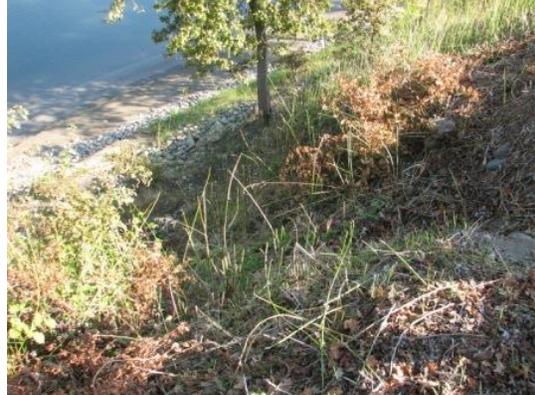
Photo 2 of 4 : SP_2015_RD0537_173_954_20150401_00029.jpg

Another view of the site. Fall 2011

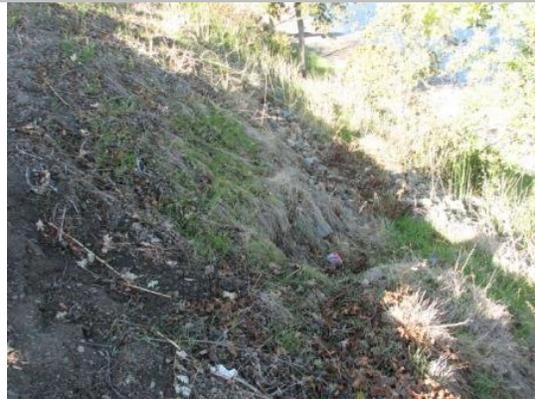
Photo 3 of 4 : SP_2015_RD0537_173_954_20150401_00030.jpg

Another view of some badly eroded areas. Fall 2011

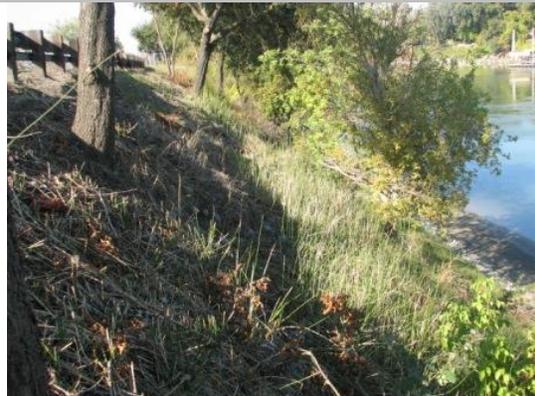
Photo 4 of 4 : SP_2015_RD0537_173_954_20150401_00031.jpg

The slope of an erosion site at Monument Bend. Fall 2011

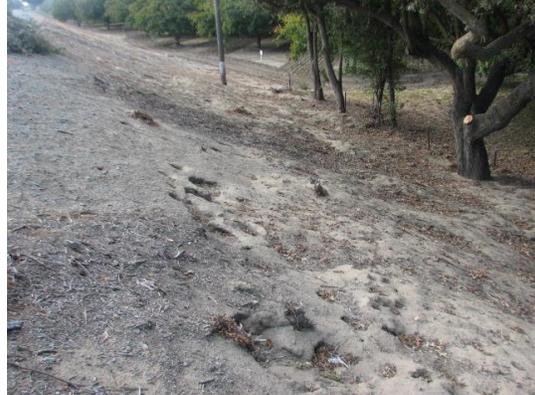
Photo 1 of 2 : SP_2015_RD0537_173_40_20150401_00016.jpg

There is no rodents visible and the old holes are starting to erode. Fall 2013

LM Start	1.91	Rating **	U	Issue No.	40
LM End	1.91	Issue Type +	Ma	Location *	LS
Category	Earthen Levee			GPS Latitude/Longitude	
				Start	End
Item	Animal Control			38.633148 °	38.633148 °
				-121.564520 °	-121.564520 °
DWR ID	DWR_RD0537_01_s_2012_40				
Action/Comments					
No rodents visible, but rodent burrows visible; need to backfill and compact or grout burrows.

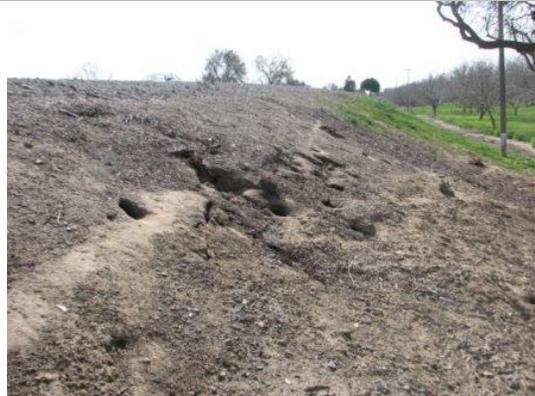
Photo 2 of 2 : SP_2015_RD0537_173_40_20150401_00017.jpg

Rodent holes need to be backfilled but no rodents were present. Spring 2013

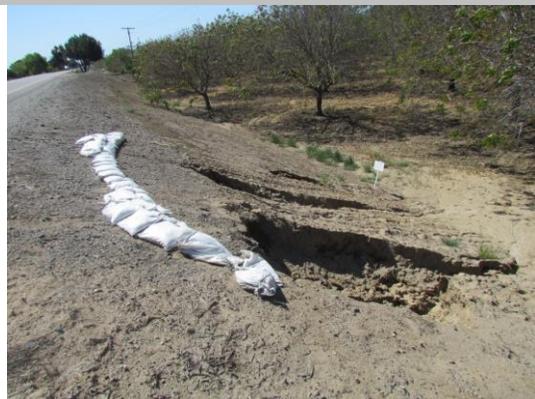
Photo 1 of 1 : SP_2015_RD0537_173_472_20150421_00066.jpg

View of the erosion on the landward side of the levee looking downstream. Spring 2015.

LM Start	1.99	Rating **	U	Issue No.	472
LM End	1.99	Issue Type +	Ma	Location *	LS
Category	Earthen Levee			GPS Latitude/Longitude	
				Start	End
Item	Erosion / Bank Caving			38.631957 °	38.631957 °
				-121.564435 °	-121.564435 °
DWR ID	DWR_RD0537_01_s_2015_472				
Action/Comments					
Schedule repair of erosion site prior to the next inspection.

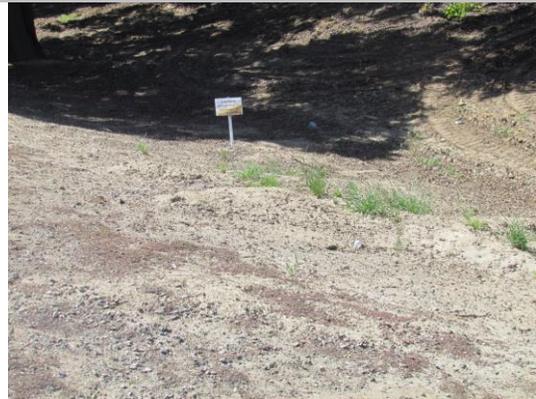
Photo 1 of 3 : SP_2015_RD0537_173_7_20150421_00067.jpg

View of the mounds of the rodent holes on the landward side of the levee looking downstream. Spring 2015.

LM Start	2.50	Rating **	M	Issue No.	7
LM End	2.50	Issue Type +	Ma	Location *	LS
Category	Earthen Levee			GPS Latitude/Longitude	
				Start	End
Item	Animal Control			38.624549 °	38.624549 °
				-121.563650 °	-121.563650 °
DWR ID	DWR_RD0537_01_s_2013_7				
Action/Comments					
No rodents visible, but rodent burrows visible; need to backfill and compact or grout burrows.

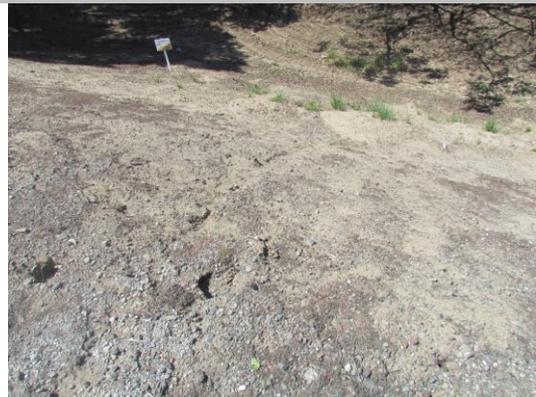
Photo 2 of 3 : SP_2015_RD0537_173_7_20150421_00068.jpg

Another view of the mounds of the rodent holes on the landward side of the levee. Spring 2015.

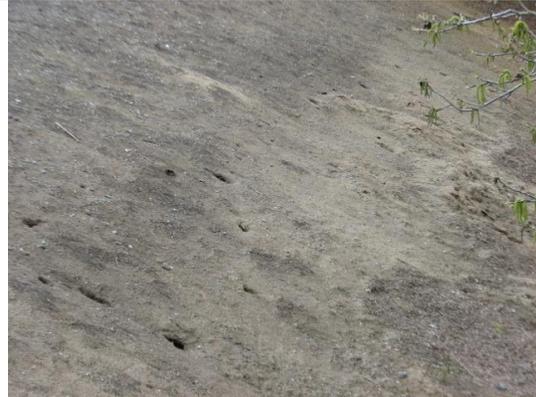
Photo 3 of 3 : SP_2015_RD0537_173_7_20150401_00010.jpg

Rodent holes need to be backfilled. Rodent program appears to be working. No rodent present. Spring 2014

LM Start	2.50	Rating **	M	Issue No.	7 (cont)
LM End	2.50	Issue Type +	Ma	Location *	LS
Category	Earthen Levee			GPS Latitude/Longitude	
				Start	End
Item	Animal Control			38.624549 °	38.624549 °
				-121.563650 °	-121.563650 °
DWR ID	DWR_RD0537_01_s_2013_7				
Action/Comments					
No rodents visible, but rodent burrows visible; need to backfill and compact or grout burrows.

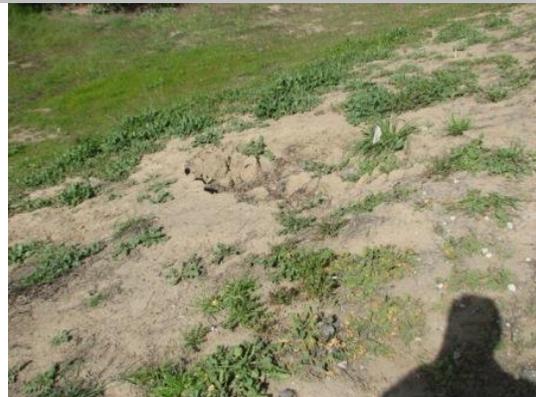
Photo 1 of 1 : SP_2015_RD0537_173_10_20150401_00013.jpg

Rodent holes have collapsed and need to be backfilled before they start to erode. Spring 2013

LM Start	2.62	Rating **	A/W	Issue No.	10
LM End	2.62	Issue Type +	Ma	Location *	LS
Category	Earthen Levee			GPS Latitude/Longitude	
				Start	End
Item	Animal Control			38.622883 °	38.622883 °
				-121.563512 °	-121.563512 °
DWR ID	DWR_RD0537_01_s_2013_10				
Action/Comments					
No rodents visible, but rodent burrows visible; need to backfill and compact or grout burrows.

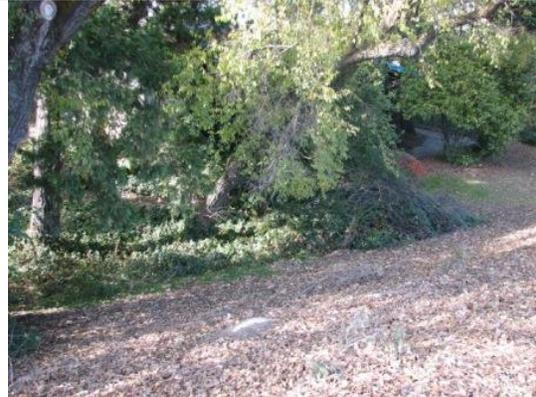
Photo 1 of 3 : SP_2015_RD0537_173_3_20150401_00003.jpg

There is groundcover and landscape shrubs at the toe.

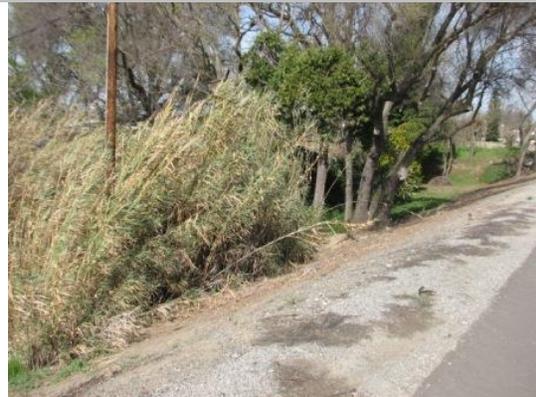
Photo 2 of 3 : SP_2015_RD0537_173_3_20150401_00004.jpg

The Arundo needs to be cut back to open the levee toe up. Spring 2013

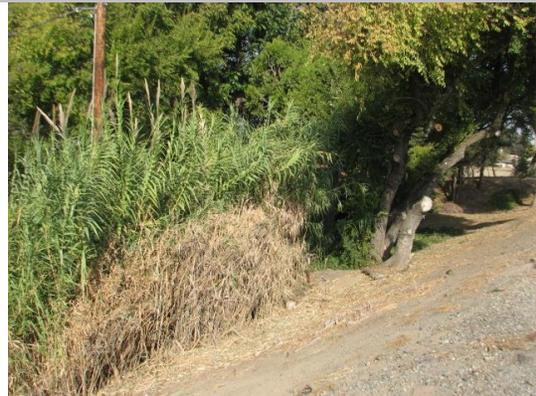
Photo 3 of 3 : SP_2015_RD0537_173_3_20150401_00005.jpg

The Arundo has been cut back close to the toe. It blocks visibility of the toe plus easement. Fall 2013

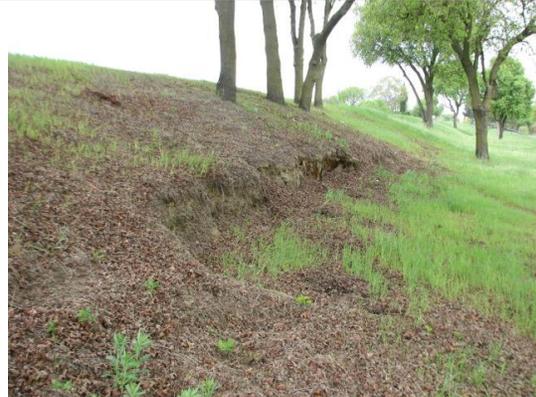
Photo 1 of 2 : SP_2015_RD0537_173_264_20150401_00026.jpg

Erosion cut in levee slope 2-3 feet deep. Spring 2014

LM Start	3.06	Rating **	U	Issue No.	264
LM End	3.06	Issue Type +	Ma	Location *	WS
Category	Earthen Levee			GPS Latitude/Longitude	
				Start	End
Item	Erosion / Bank Caving			38.616504 °	38.616504 °
				-121.563270 °	-121.563270 °
DWR ID	DWR_RD0537_01_s_2014_264				
Action/Comments					
Schedule repair of erosion site prior to the next inspection.

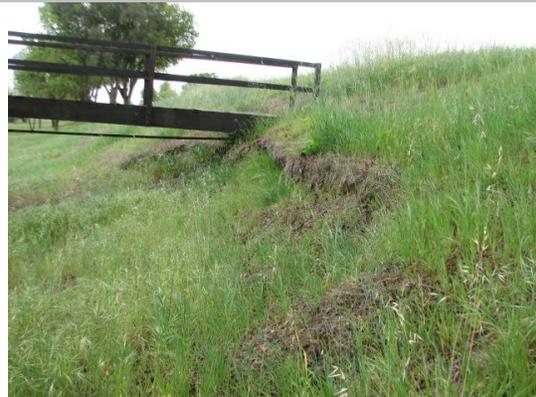
Photo 2 of 2 : SP_2015_RD0537_173_264_20150401_00027.jpg

Erosion cut 20 feet from the other one. Erosion 2-3 feet deep. Spring 2014

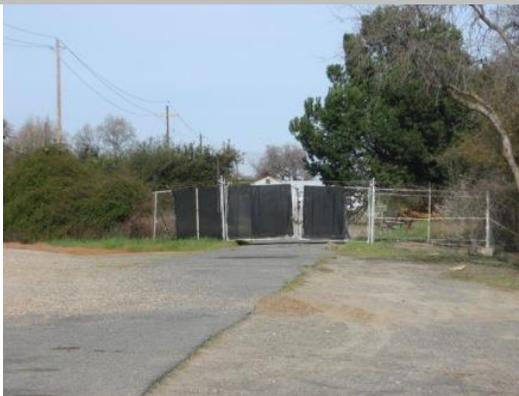
Photo 1 of 2 : SP_2015_RD0537_173_8_20150401_00011.jpg

Abandoned building and fence on the levee crown. Spring 2013

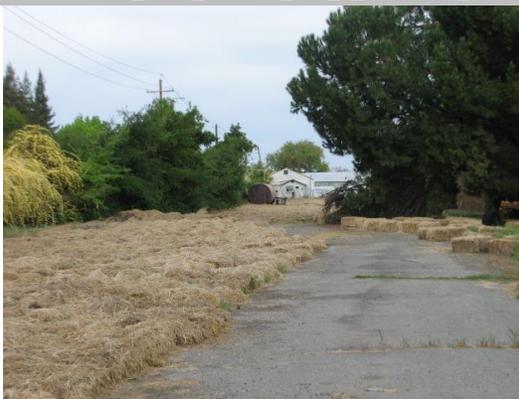
Photo 2 of 2 : SP_2015_RD0537_173_8_20150401_00012.jpg

Building and old equipment within the fenced compound. Spring 2014

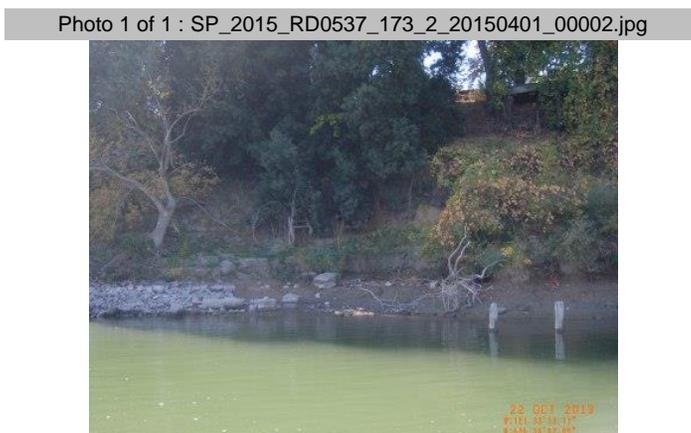
LM Start	4.25	Rating **	M	Issue No.	2
LM End	4.27	Issue Type +	Ma	Location *	WS
Category	Supplemental			GPS Latitude/Longitude	
				Start	End
Item	USACE Erosion Survey			38.602101 °	38.601708 °
				-121.553909 °	-121.553603 °
DWR ID	DWR_RD0537_01_f_2014_2				
Action/Comments					
Inspector Comments: 1997 - Erosion near the downstream corner of the Sacramento Weir. 2000 - Local damage induced by human use. 2013: No observed changes. [2013 Site ID: SAC_63-0_R]

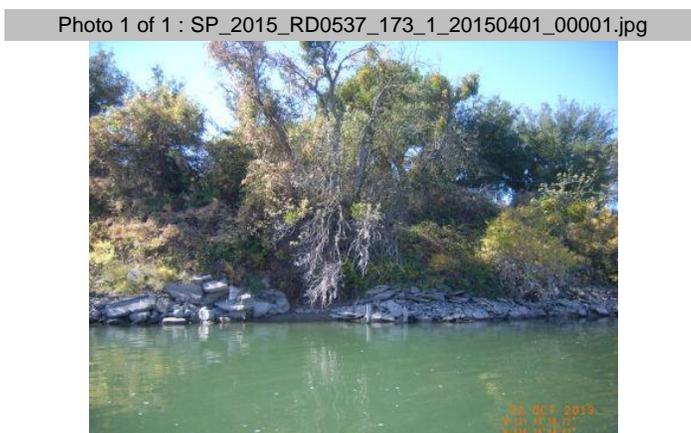
LM Start	4.31	Rating **	M	Issue No.	1
LM End	4.31	Issue Type +	Ma	Location *	WS
Category	Supplemental			GPS Latitude/Longitude	
				Start	End
Item	USACE Erosion Survey			38.600907 °	38.601388 °
				-121.552815 °	-121.553250 °
DWR ID	DWR_RD0537_01_f_2014_1				
Action/Comments					
Inspector Comments: 1997 - This may have been a cobble rehabilitation site to the 1957 cobble that was place all the way to the I-80 Bridge. 2003 - Site is still very close to the levee and into the levee toe. 2011 - One new tree has fallen. 2013: No observed changes. [2013 Site ID: SAC_62-9_R]

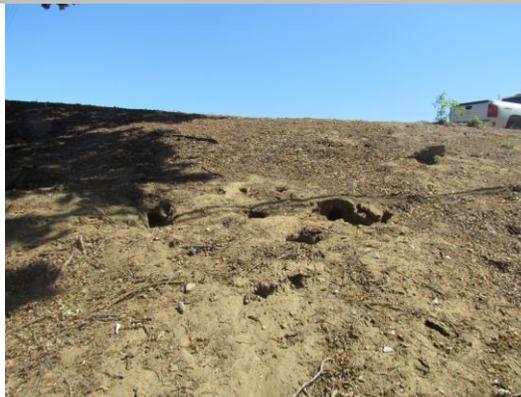
Photo 1 of 2 : SP_2015_RD0537_173_475_20150421_00069.jpg

View of the animal burrows on the landward side of the levee. Spring 2015.

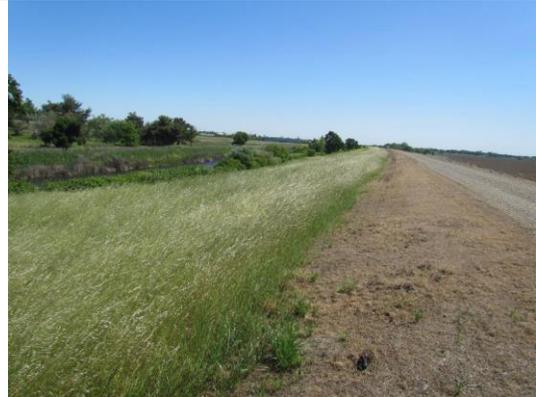
Photo 1 of 1 : SP_2015_RD0537_174_1_20150421_00006.jpg

View of the vegetation on the landward side of the levee looking downstream. Spring 2015.

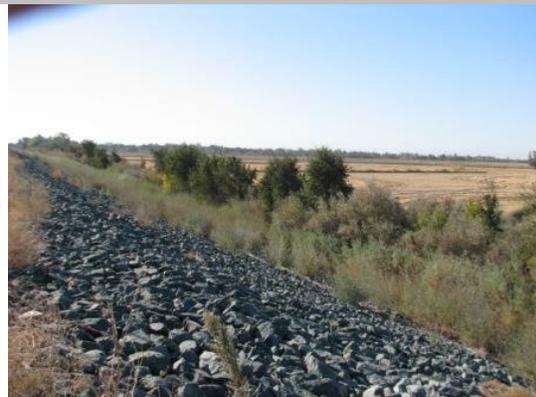
Photo 1 of 3 : SP_2015_RD0537_174_4_20150401_00003.jpg

Trees are at the toe of the waterside levee. Sandbar Willows are creeping up the slope. Fall 2013

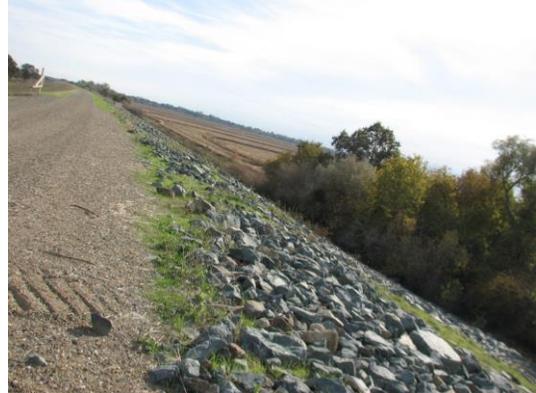
Photo 2 of 3 : SP_2015_RD0537_174_4_20150401_00004.jpg

Levee mile 0.00, vegetation at the toe of the levee. Fall 2014.

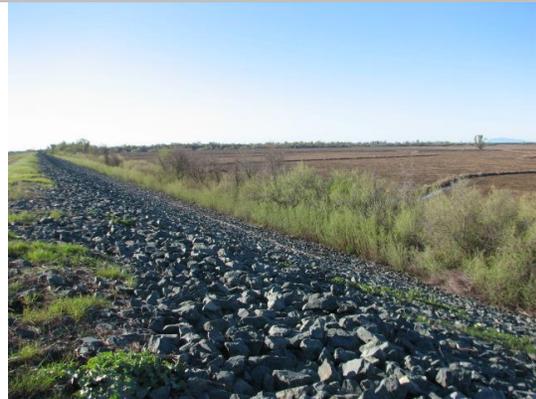
Photo 3 of 3 : SP_2015_RD0537_174_4_20150401_00005.jpg

Photo of the willows at the toe of the rip rap and levee. No other trees in the rip rap. Spring 2014
