**Flood Control Project Maintenance
Levee Inspections**

Fall 2008 Levee Maintenance Deficiency Summary Report

San Joaquin River Basin

Reclamation District No. 0544

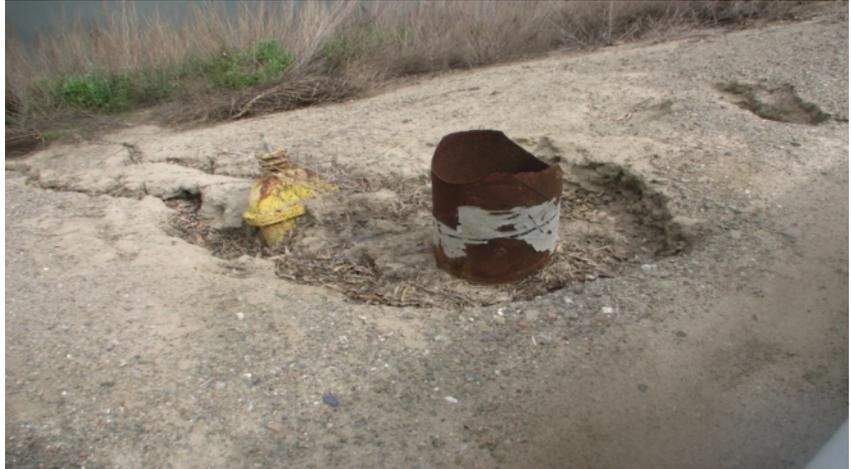
Levee Mile Report Line	8
Start Levee Mile	0.57
End Levee Mile	0.57
Location	
Category	Earthen Levee
Item	Slope Stability
Erosion around siphon pipe at LM 0.57

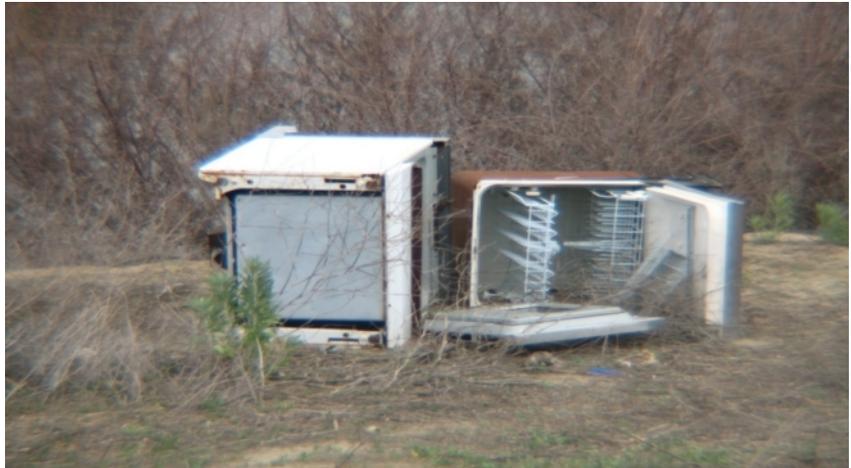
Levee Mile Report Line	26
Start Levee Mile	3.56
End Levee Mile	3.56
Location	
Category	Earthen Levee
Item	Encroachments
Garbage at waterward berm at LM 3.56

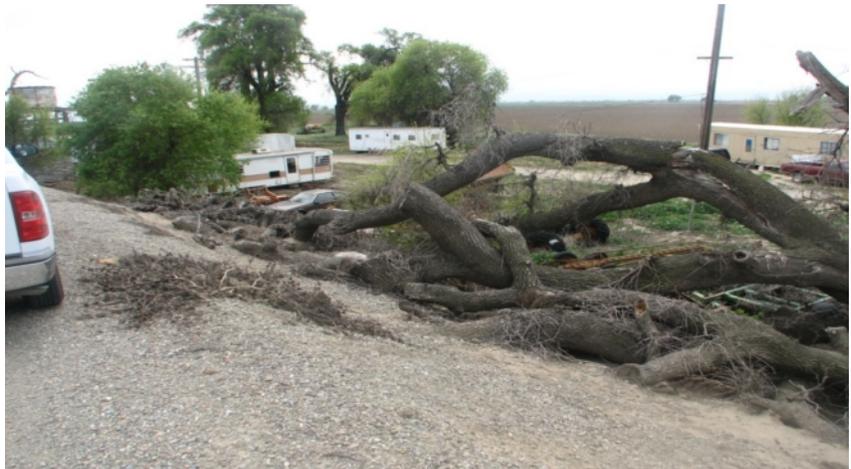
Levee Mile Report Line	36
Start Levee Mile	4.86
End Levee Mile	4.86
Location	
Category	Earthen Levee
Item	Encroachments
Tree limbs on landward slope and toe at LM 4.86

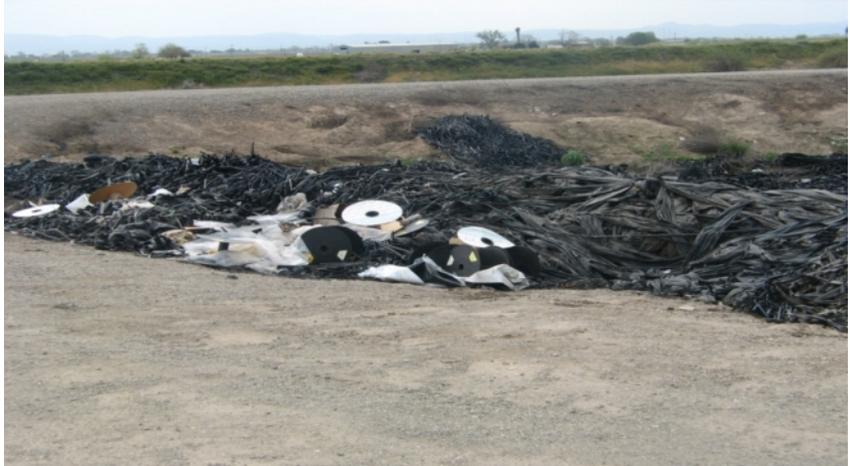
Levee Mile Report Line	15
Start Levee Mile	1.90
End Levee Mile	1.97
Location	
Category	Earthen Levee
Item	Encroachments
Garbage on landward slope from LM 1.90 to 1.97

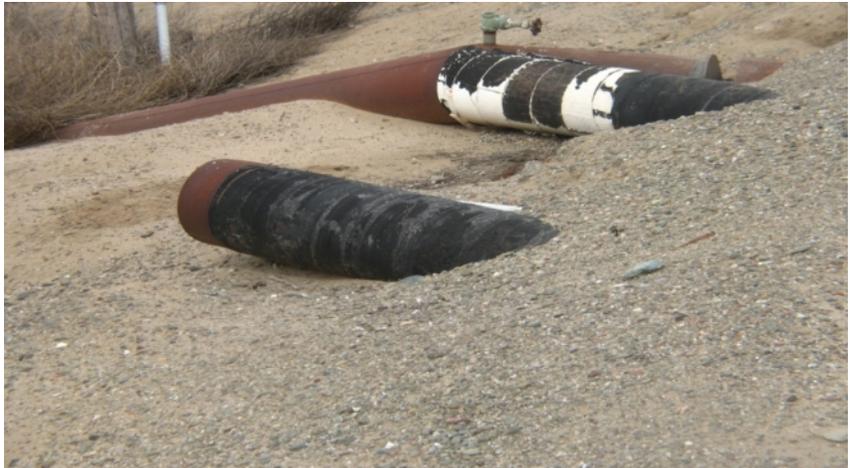
Levee Mile Report Line	25
Start Levee Mile	2.65
End Levee Mile	2.65
Location	
Category	Earthen Levee
Item	Encroachments
Abandoned pipe at LM 2.65 landside view

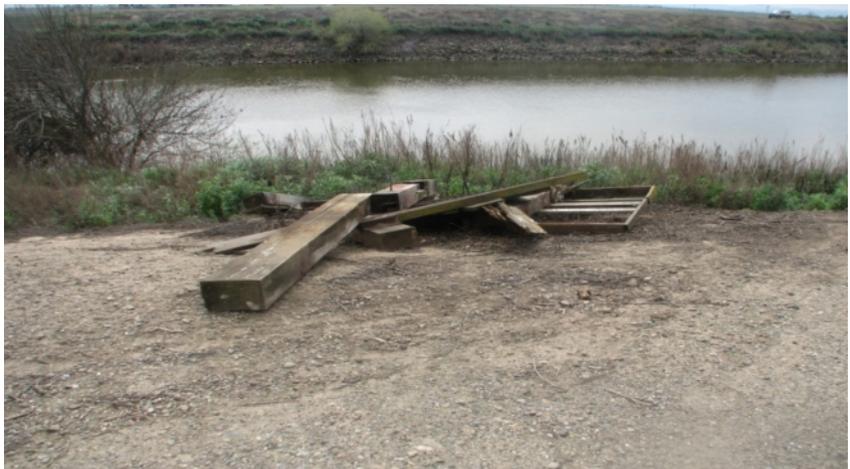
Levee Mile Report Line	28
Start Levee Mile	3.29
End Levee Mile	3.29
Location	
Category	Earthen Levee
Item	Encroachments
Garbage on waterwade shoulder at LM 3.29

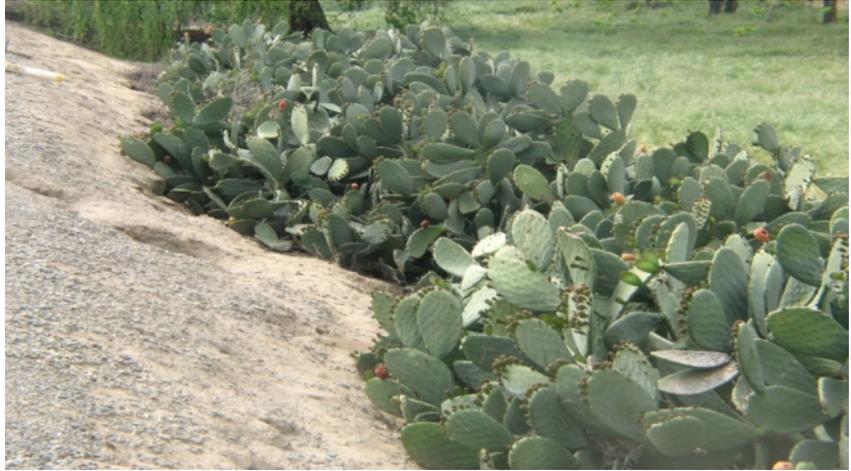
Levee Mile Report Line	31
Start Levee Mile	3.54
End Levee Mile	3.56
Location	
Category	Earthen Levee
Item	Vegetation
Cactus at landward toe from LM 3.54 to 3.56
