**Flood Control Project Maintenance
Levee Inspections**

Fall 2009 Levee Maintenance Deficiency Summary Report

San Joaquin River Basin

Reclamation District No. 0544 Upper Roberts Island

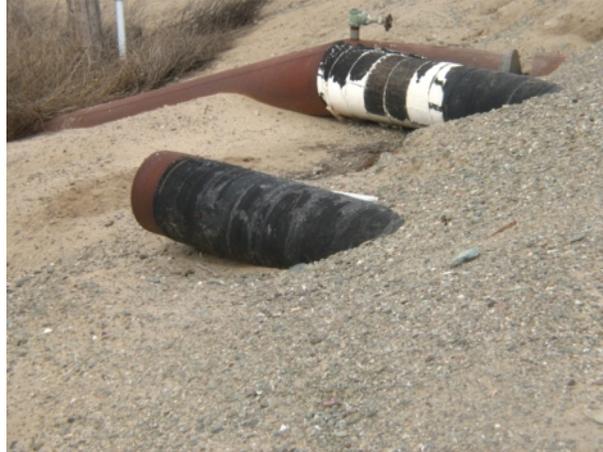
Levee Mile Report Line	20
Start Levee Mile	2.65
End Levee Mile	2.65
Location	Crown
Category	Earthen Levee
Item	Encroachments
Abandoned pipe at LM 2.65 landside view	
richard_20091125_121.jpg

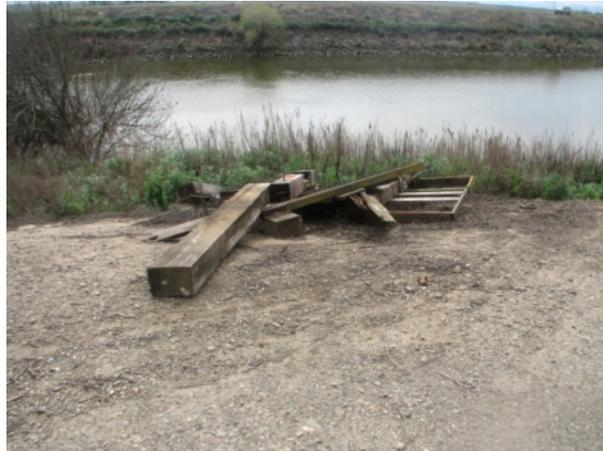
23	3.29	3.29	Earthen Levee	Encroachments	WS	M	Garbage	37.819188 ° -121.359932 °	37.819188 ° -121.359932 °	18 Y
24	3.53	3.56	Earthen Levee	Encroachments	LS	PO	Landscaping Inspector Comments: Cactus on landside slope.	37.819576 ° -121.364056 °	37.819530 ° -121.364653 °	36
25	3.53	3.84	Earthen Levee	Trim / Thin Trees	LS	M	Trim trees to at least five feet above ground level.	37.819533 ° -121.364058 °	37.821123 ° -121.368640 °	19
26	3.54	3.60	Earthen Levee	Animal Control	LS	A	No rodents visible, but rodent burrows visible; need to backfill and compact or grout borrows.	37.819512 ° -121.364217 °	37.819443 ° -121.365297 °	21
27	3.74	3.77	Earthen Levee	Trim / Thin Trees	LS	M	Trim trees to at least five feet above ground level.	37.819958 ° -121.367518 °	37.820267 ° -121.367812 °	45
28	3.83	3.86	Earthen Levee	Trim / Thin Trees	LS	M	Trim trees to at least five feet above ground level.	37.821003 ° -121.368507 °	37.821345 ° -121.368935 °	46

Levee Mile Report Line	23
Start Levee Mile	3.29
End Levee Mile	3.29
Location	Water Side
Category	Earthen Levee
Item	Encroachments
Garbage on waterside shoulder at LM 3.29	
richard_20091125_122.jpg
