**Flood Control Project Maintenance
Levee Inspections
LMA District Cover Sheet
Spring 2010 Levee Inspection Results**

Reclamation District No. 0544 Upper Roberts Island

Spring 2010 Levee Inspection Results

Levee Inspection Report By Mile - Spring 2010

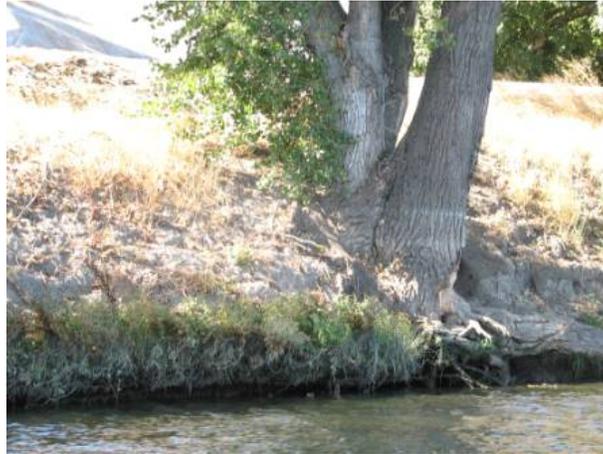
Levee Mile Report Line	5
Start Levee Mile	0.41
End Levee Mile	0.45
Location	Water Side
Category	Supplemental
Item	DWR Erosion Survey
<p>2009: No major change observed; despite dense vegetation, the bank is eroding and sloughing; the levee toe is being undermined; note the tree on site; the site was previously rated "U" [2009 SiteID:RD0544U1RM47.12]</p>	
<p>SJR2009_S2.5 LM0.43 102108a.jpg</p>

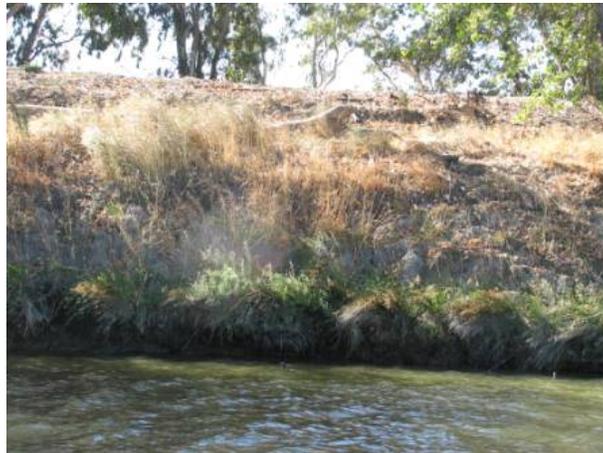
Levee Mile Report Line	5
Start Levee Mile	0.41
End Levee Mile	0.45
Location	Water Side
Category	Supplemental
Item	DWR Erosion Survey
<p>2009: No major change observed; despite dense vegetation, the bank is eroding and sloughing; the levee toe is being undermined; note the tree on site; the site was previously rated "U" [2009 SiteID:RD0544U1RM47.12]</p>	
<p>SJR2009_S2.5 LM0.43 102108c.jpg</p>

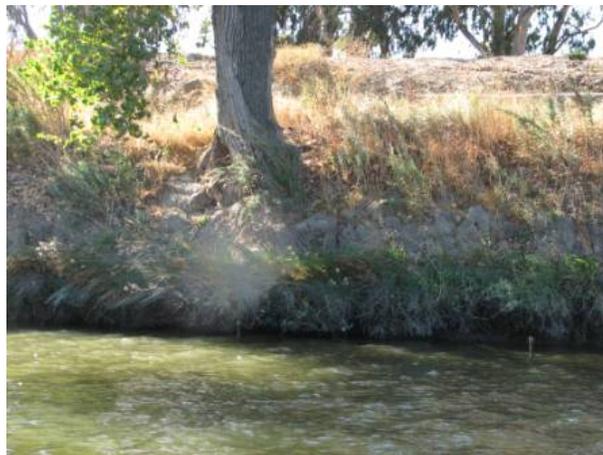
Levee Mile Report Line	5
Start Levee Mile	0.41
End Levee Mile	0.45
Location	Water Side
Category	Supplemental
Item	DWR Erosion Survey
<p>2009: No major change observed; despite dense vegetation, the bank is eroding and sloughing; the levee toe is being undermined; note the tree on site; the site was previously rated "U" [2009 SiteID:RD0544U1RM47.12]</p>	
<p>SJR2009_S2.5 LM0.43 102108d.jpg</p>

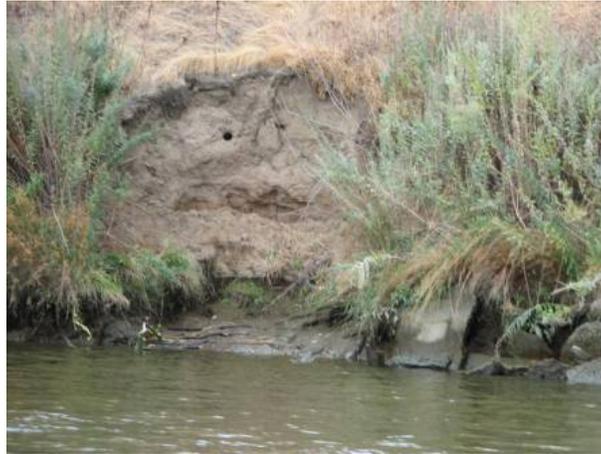
SJR2009_RM47.12U1 092909D.JPG

Levee Mile Report Line	5
Start Levee Mile	0.41
End Levee Mile	0.45
Location	Water Side
Category	Supplemental
Item	DWR Erosion Survey

2009: No major change observed; despite dense vegetation, the bank is eroding and sloughing; the levee toe is being undermined; note the tree on site; the site was previously rated "U" [2009 SiteID:RD0544U1RM47.12]

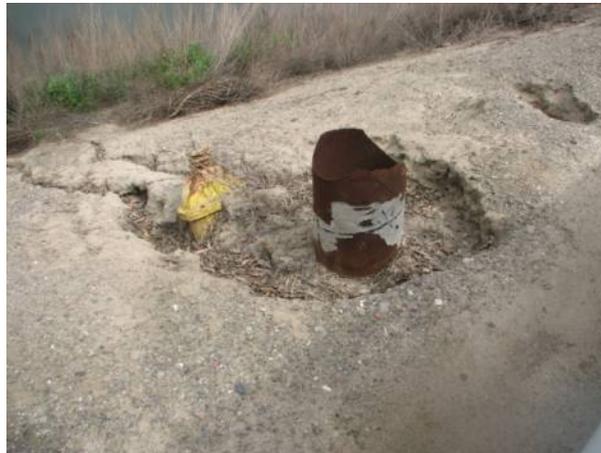
richard_s_20100316_071.jpg

Levee Mile Report Line	8
Start Levee Mile	0.57
End Levee Mile	0.57
Location	Water Side
Category	Earthen Levee
Item	Slope Stability

Erosion around siphon pipe at LM 0.57

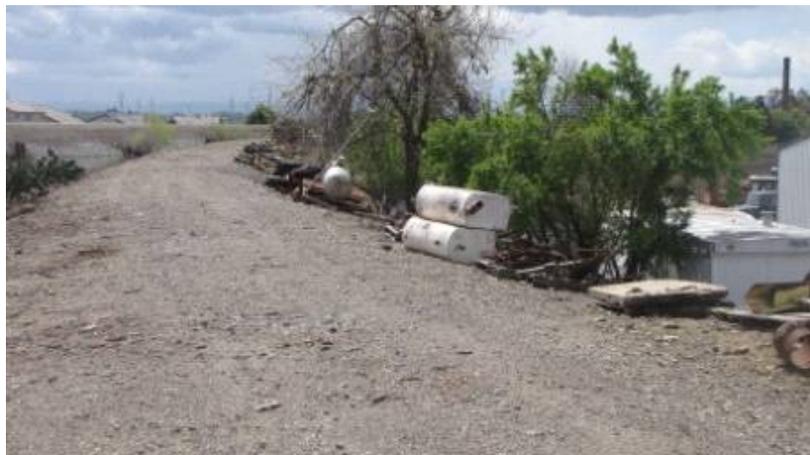
richard_s_20100408_225.jpg

Levee Mile Report Line	19
Start Levee Mile	3.55
End Levee Mile	3.55
Location	Water Side
Category	Earthen Levee
Item	Encroachments

Looking south at equipment stored on landside shoulder.

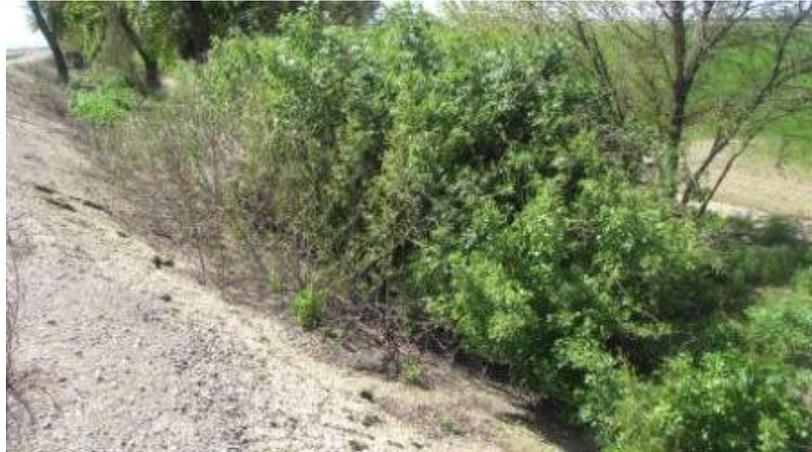
Levee Mile Report Line	24
Start Levee Mile	4.53
End Levee Mile	4.53
Location	Land Side
Category	Earthen Levee
Item	Vegetation
Looking south at elderberries on landside slope and toe.	
richard_s_20100408_226.jpg

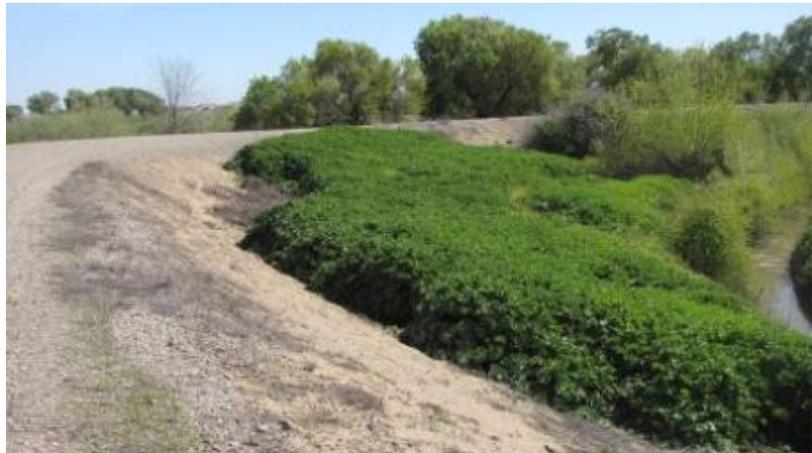
Levee Mile Report Line	35
Start Levee Mile	5.00
End Levee Mile	5.30
Location	Land Side
Category	Earthen Levee
Item	Vegetation
Looking southeast at dense veg. on landside slope and toe.	
richard_s_20100408_227.jpg

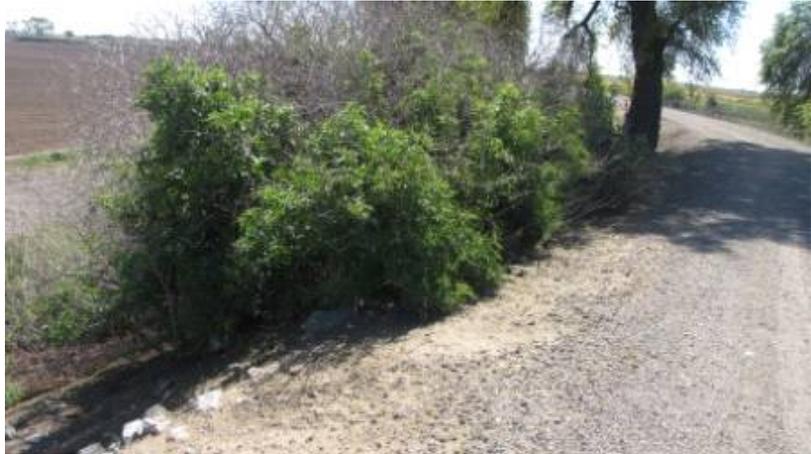
Levee Mile Report Line	5
Start Levee Mile	0.41
End Levee Mile	0.41
Location	Land Side
Category	Earthen Levee
Item	Vegetation
Looking northwest at elderberries on landside slope and toe.	
richard_s_20100408_228.jpg

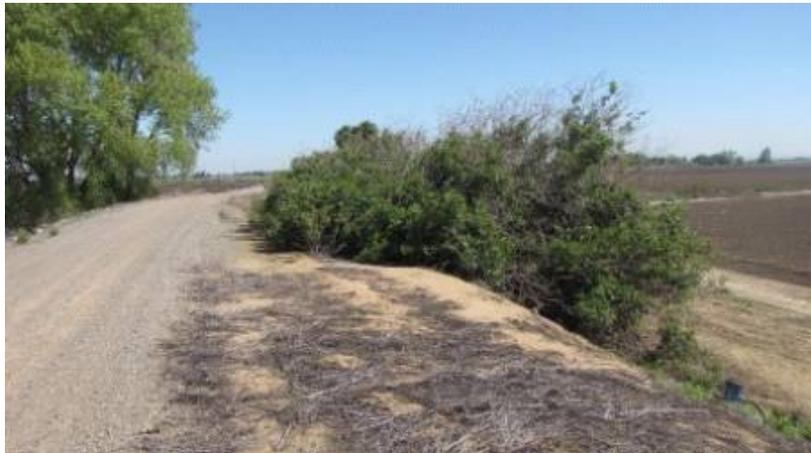
Levee Mile Report Line	9
Start Levee Mile	0.74
End Levee Mile	0.74
Location	Land Side
Category	Earthen Levee
Item	Vegetation
Looking south at elderberries on landside slope and toe.	
richard_s_20100408_229.jpg

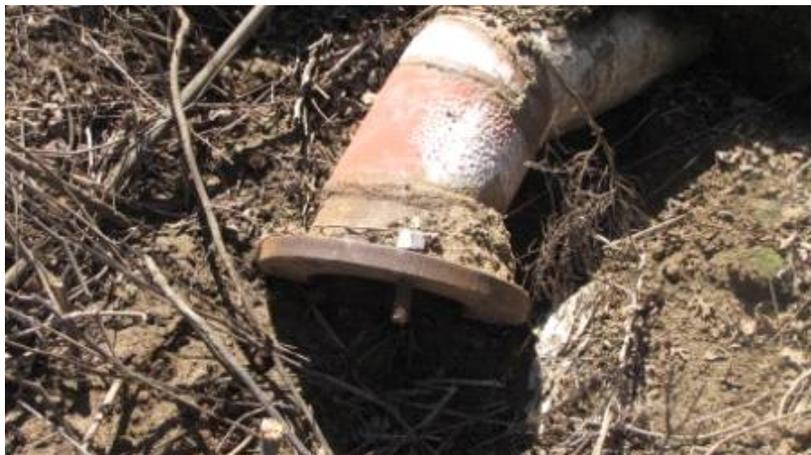
Levee Mile Report Line	17
Start Levee Mile	1.40
End Levee Mile	1.40
Location	Land Side
Category	Earthen Levee
Item	Encroachments
Looking east at pipe on landside slope.	
richard_s_20100408_230.jpg

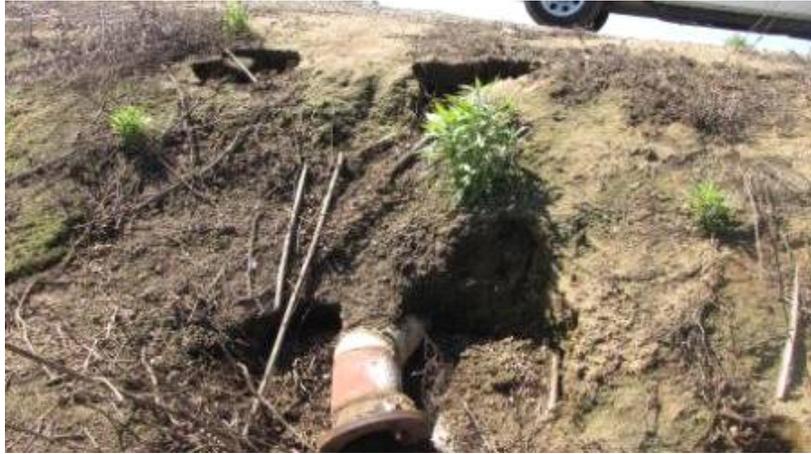
Levee Mile Report Line	17
Start Levee Mile	1.40
End Levee Mile	1.40
Location	Land Side
Category	Earthen Levee
Item	Encroachments
Looking east at pipe and erosion just above pipe on landside slope and shoulder.	
richard_s_20100408_231.jpg

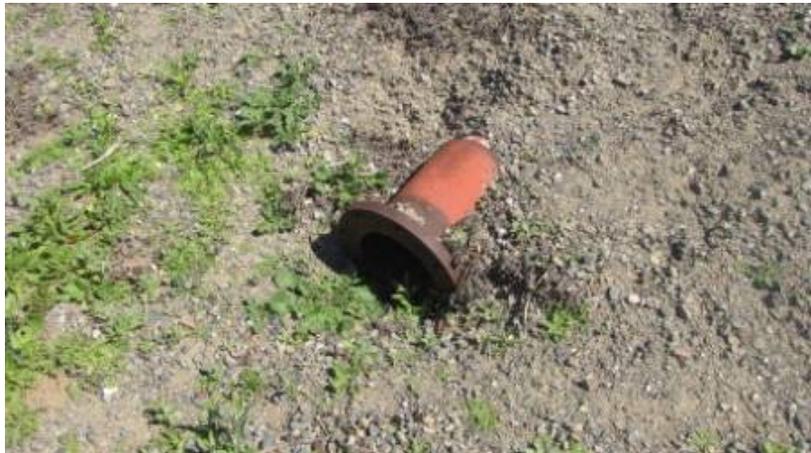
Levee Mile Report Line	17
Start Levee Mile	1.40
End Levee Mile	1.40
Location	Land Side
Category	Earthen Levee
Item	Encroachments
Looking west at east end of pipe on waterside slope.	
richard_s_20100408_232.jpg

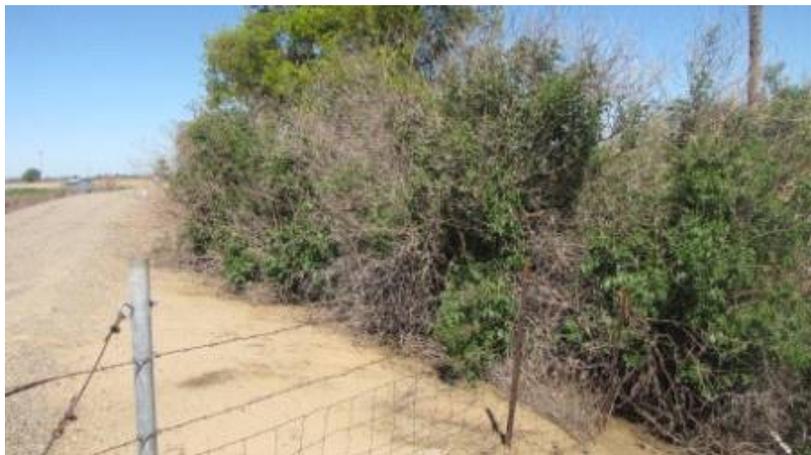
Levee Mile Report Line	18
Start Levee Mile	1.41
End Levee Mile	1.41
Location	Land Side
Category	Earthen Levee
Item	Vegetation
Looking south at elderberries on landside slope and toe.	
richard_s_20100408_233.jpg

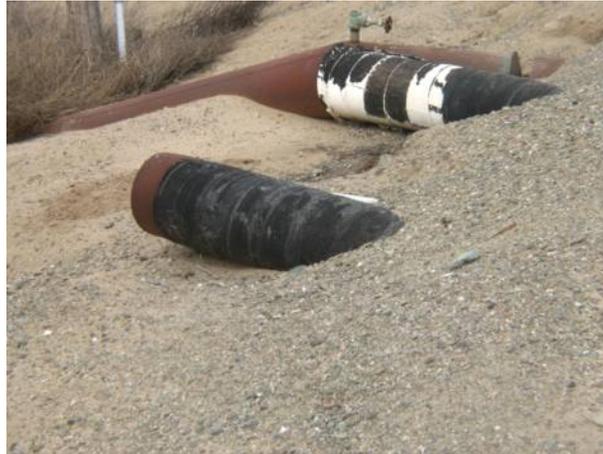
Levee Mile Report Line	29
Start Levee Mile	2.65
End Levee Mile	2.65
Location	Crown
Category	Earthen Levee
Item	Encroachments
Abandoned pipe at LM 2.65 landside view	
richard_s_20100316_072.jpg

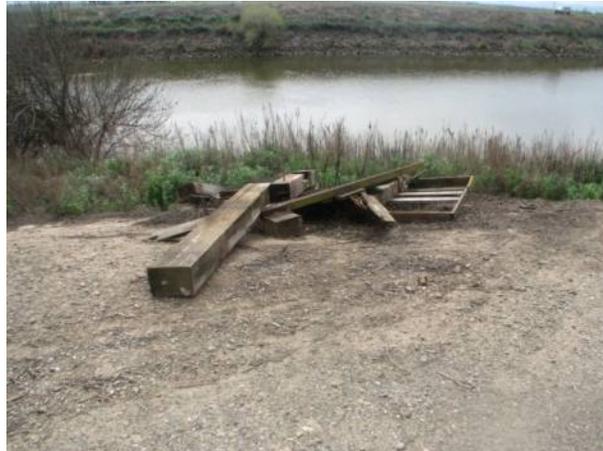
Levee Mile Report Line	33
Start Levee Mile	3.29
End Levee Mile	3.29
Location	Water Side
Category	Earthen Levee
Item	Encroachments
Garbage on waterside shoulder at LM 3.29	
richard_s_20100316_073.jpg

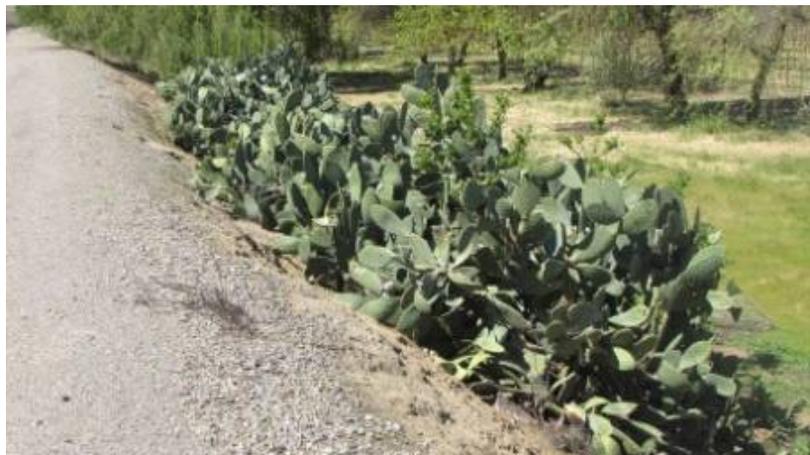
Levee Mile Report Line	34
Start Levee Mile	3.53
End Levee Mile	3.56
Location	Land Side
Category	Earthen Levee
Item	Vegetation
Looking southwest at overgrown cactus on landside slope.	
richard_s_20100408_234.jpg

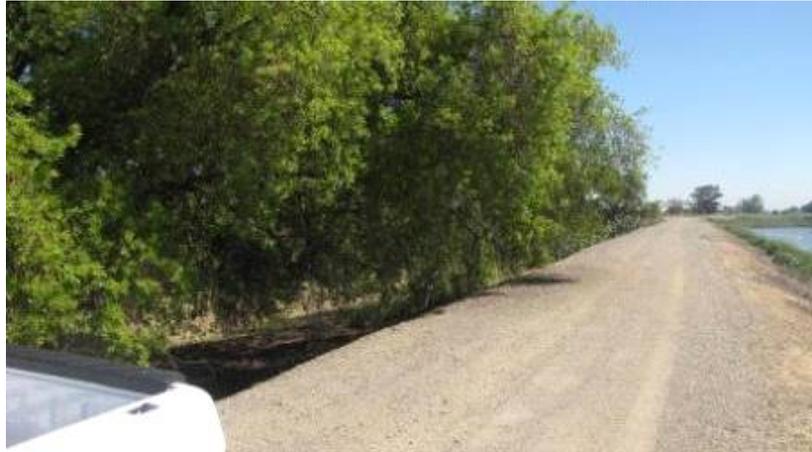
richard_s_20100408_236.jpg

Levee Mile Report Line	36
Start Levee Mile	3.59
End Levee Mile	3.59
Location	Land Side
Category	Earthen Levee
Item	Trim / Thin Trees

Looking northwest at dense trees on landside slope and toe.
