**Flood Control Project Maintenance
Levee Inspections**

Maintenance Issue Types Only, Levee Inspection Report By Mile - Fall 2014

Reclamation District No. 0544 Upper Roberts Island

Waterway	Bank	Unit Miles	Inspection Start/End	Inspector
Unit No. 01 San Joaquin River	Left	6.05	10/21/2014 10/21/2014	Richard Willoughby

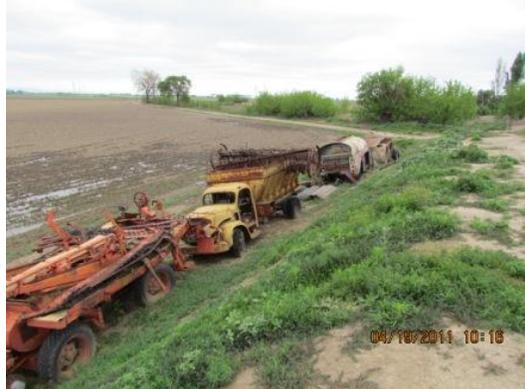
Photo 1 of 2 : FA_2014_RD0544_108_4_20141020_00003.jpg

Looking north at equipment along landside toe.

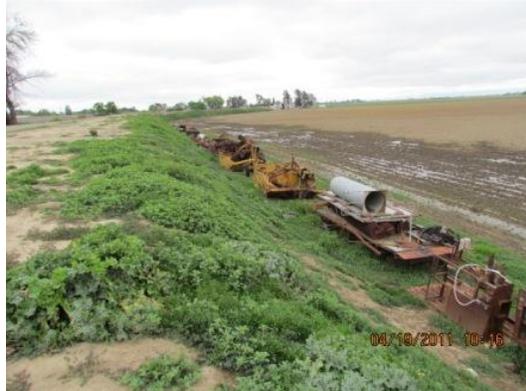
Photo 2 of 2 : FA_2014_RD0544_108_4_20141020_00004.jpg

Looking south at equipment along landside toe.

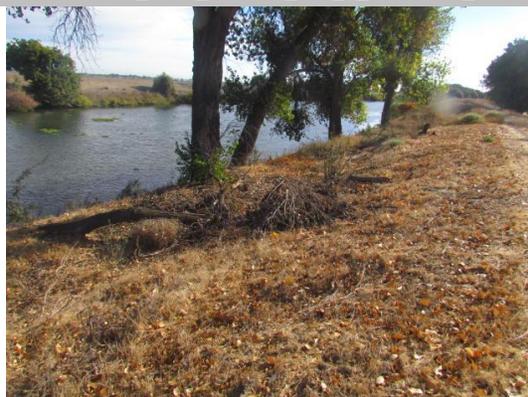
Photo 1 of 1 : FA_2014_RD0544_108_6_20141023_00055.jpg

LM Start	0.45	Rating **	M	Issue No.	6
LM End	0.45	Issue Type +	Ma	Location *	WS
Category	Earthen Levee		GPS Latitude/Longitude		
			Start	End	
Item	Encroachments		37.864713 °	37.864713 °	
			-121.326708 °	-121.326708 °	
DWR ID	DWR_RD0544_01_f_2013_6				
Action/Comments					
Prunings Inspector Comments: Broken tree limbs on waterward slope and berm.

Looking southeast at tree branch on waterward slope.

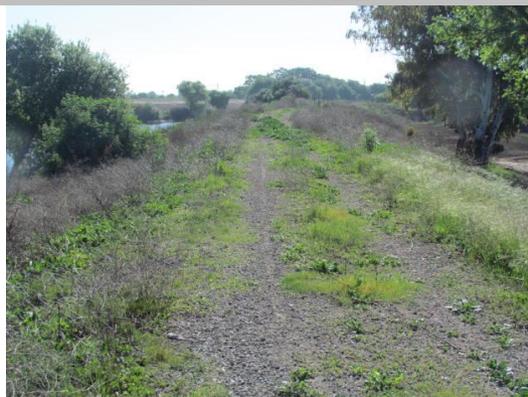
Photo 1 of 2 : FA_2014_RD0544_108_3_20141020_00001.jpg

LM Start	0.48	Rating **	M	Issue No.	3
LM End	0.68	Issue Type +	Ma	Location *	WS
Category	Earthen Levee		GPS Latitude/Longitude		
			Start	End	
Item	Vegetation		37.864578 °	37.863753 °	
			-121.326210 °	-121.322835 °	
DWR ID	DWR_RD0544_01_s_2012_3				
Action/Comments					
Remove the wild growth other than native grasses from the levee slopes.

Looking south at typical view of levee. (Spring 2014)

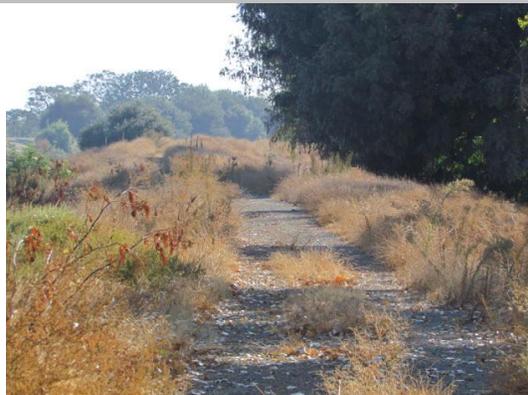
Photo 2 of 2 : FA_2014_RD0544_108_3_20141020_00002.jpg

Looking south at overgrown on landward and waterward slopes.

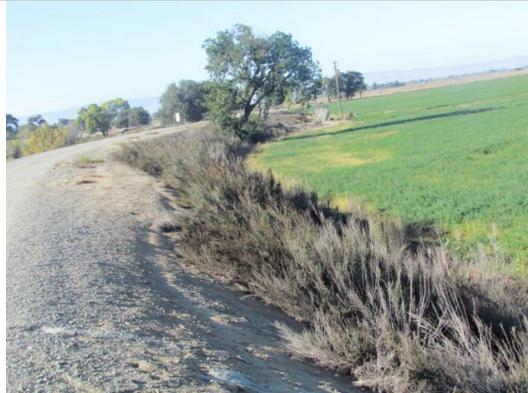
Photo 1 of 1 : FA_2014_RD0544_108_15_20141023_00056.jpg

Looking southeast at dense vegetation on landward toe.

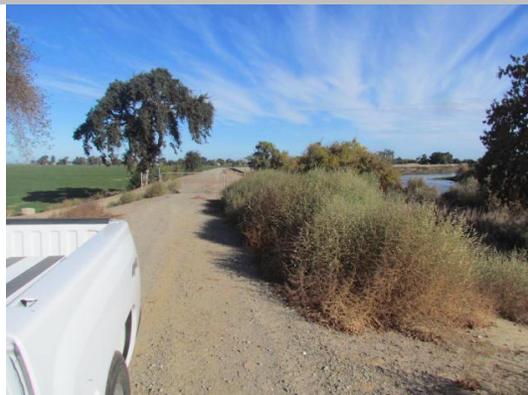
Photo 1 of 1 : FA_2014_RD0544_108_94_20141023_00057.jpg

Looking north at vegetation on waterward shoulder and slope.

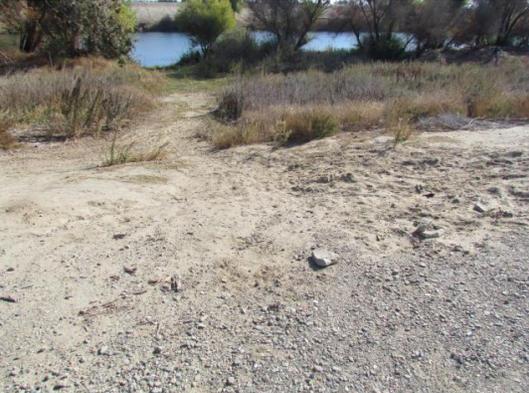
Photo 1 of 2 : FA_2014_RD0544_108_64_20141020_00032.jpg

LM Start	1.56	Rating **	M	Issue No.	64
LM End	1.56	Issue Type +	Ma	Location *	WS
Category	Earthen Levee		GPS Latitude/Longitude		
			Start	End	
Item	Slope Stability		37.854081 °	37.854081 °	
			-121.321268 °	-121.321268 °	
DWR ID	DWR_RD0544_01_f_2013_64				
Action/Comments					
Repair the levee slope damaged by vehicle traffic and prevent access where possible. Inspector Comments: Damaged levee slope due to fishermen using slope as a ramp.

Looking east at damaged waterward slope.

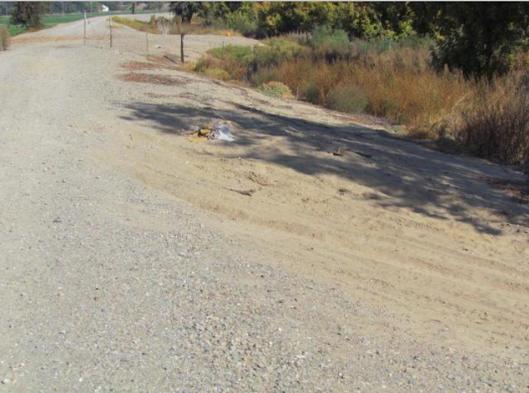
Photo 2 of 2 : FA_2014_RD0544_108_64_20141020_00033.jpg

Looking northeast at waterward slope.

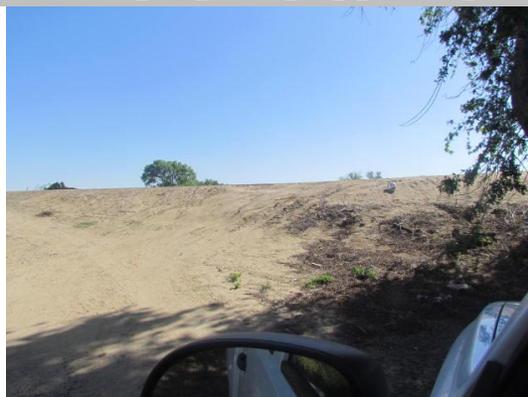
Photo 1 of 1 : FA_2014_RD0544_108_5_20141020_00005.jpg

LM Start	1.83	Rating **	M	Issue No.	5
LM End	1.83	Issue Type +	Ma	Location *	LS
Category	Earthen Levee		GPS Latitude/Longitude		
			Start	End	
Item	Slope Stability		37.853188 °	37.853188 °	
			-121.324145 °	-121.324145 °	
DWR ID	DWR_RD0544_01_s_2013_5				
Action/Comments					
Repair the levee slope damaged by vehicle traffic and prevent access where possible. Inspector Comments: Slope damaged by vehicle traffic.

Looking east at landward slope damaged by vehicle traffic.

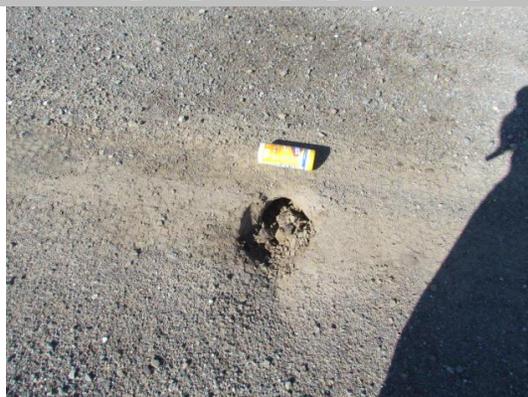
Photo 1 of 2 : FA_2014_RD0544_108_90_20141020_00042.jpg

Looking at rodent hole on levee crown.

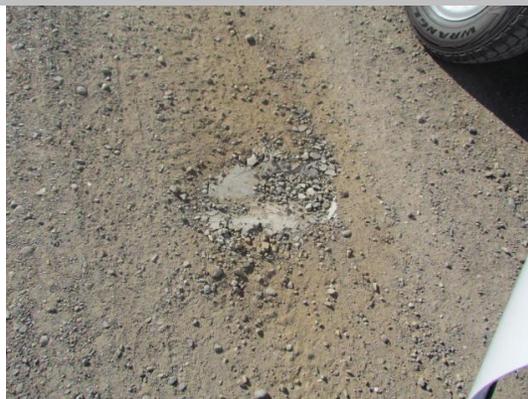
Photo 2 of 2 : FA_2014_RD0544_108_90_20141023_00058.jpg

Looking at grouted rodent hole on levee crown.

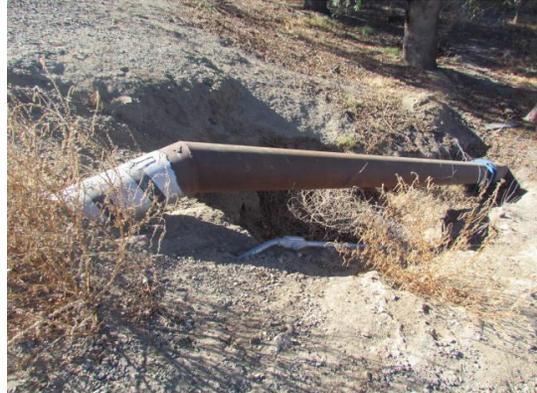
Photo 1 of 3 : FA_2014_RD0544_108_23_20141023_00059.jpg

LM Start	2.28	Rating **	U	Issue No.	23
LM End	2.28	Issue Type +	Ma	Location *	LS
Category	Earthen Levee		GPS Latitude/Longitude		
			Start	End	
Item	Erosion / Bank Caving		37.847985 °	37.847985 °	
			-121.324837 °	-121.324837 °	
DWR ID	DWR_RD0544_01_s_2012_23				
Action/Comments					
Schedule repair of erosion site prior to the next inspection. Inspector Comments: Caving/erosion around irrigation pipe on landside slope.

Looking south at erosion around irrigation pipe on landside slope. (Fall 2014)

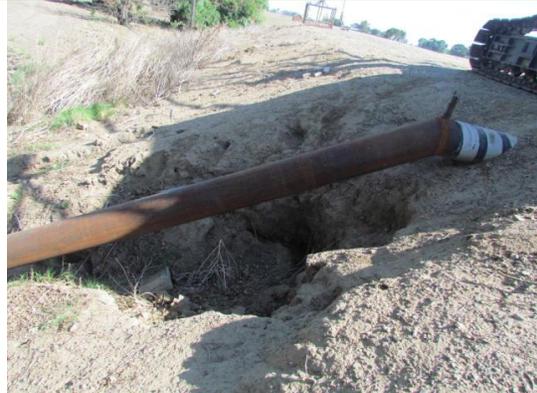
Photo 2 of 3 : FA_2014_RD0544_108_23_20141020_00019.jpg

Looking north at erosion under irrigation pipe on landside slope.

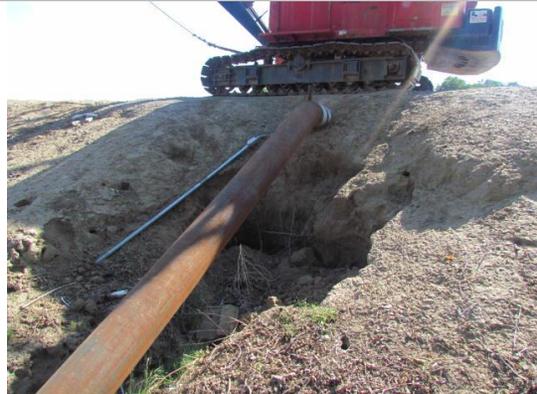
Photo 3 of 3 : FA_2014_RD0544_108_23_20141020_00018.jpg

Looking east at erosion under irrigation pipe on landside slope.

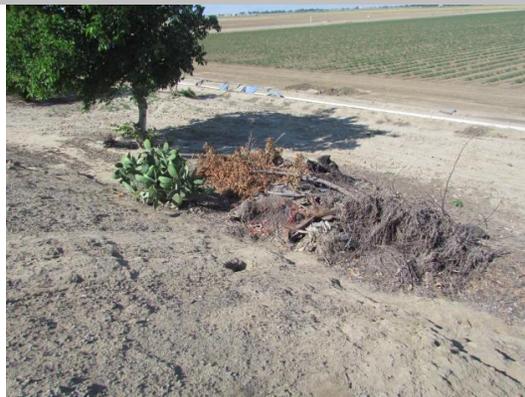
Photo 1 of 1 : FA_2014_RD0544_108_7_20141020_00006.jpg

Looking southwest at garbage at landside toe.

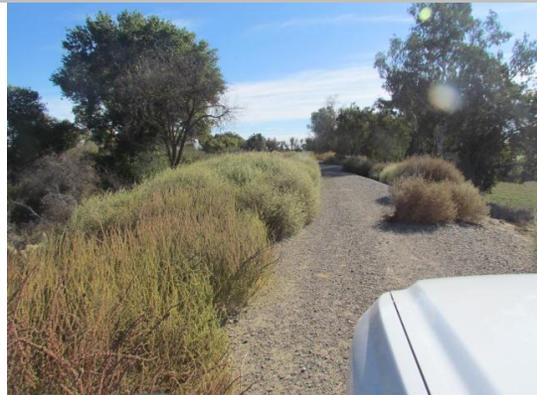
Photo 1 of 1 : FA_2014_RD0544_108_99_20141023_00061.jpg

Looking south at dense vegetation on waterward shoulder and slope.

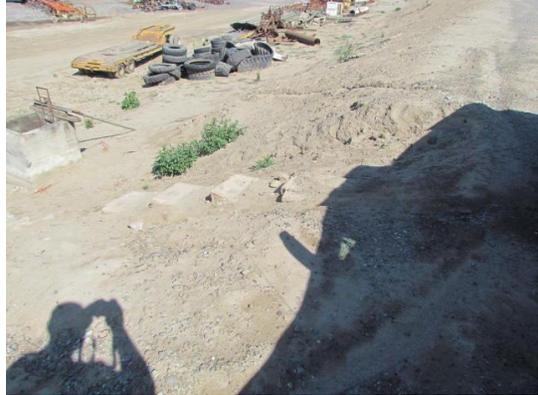
Photo 1 of 2 : FA_2014_RD0544_108_60_20141020_00028.jpg

LM Start	2.58	Rating **	M	Issue No.	60
LM End	2.58	Issue Type +	Ma	Location *	LS
Category	Earthen Levee		GPS Latitude/Longitude		
			Start	End	
Item	Slope Stability		37.844337 °	37.844337 °	
			-121.321853 °	-121.321853 °	
DWR ID	DWR_RD0544_01_s_2012_60				
Action/Comments					
Repair the levee slope damaged by foot traffic and prevent access where possible.

Looking north at slope damage on landside slope.

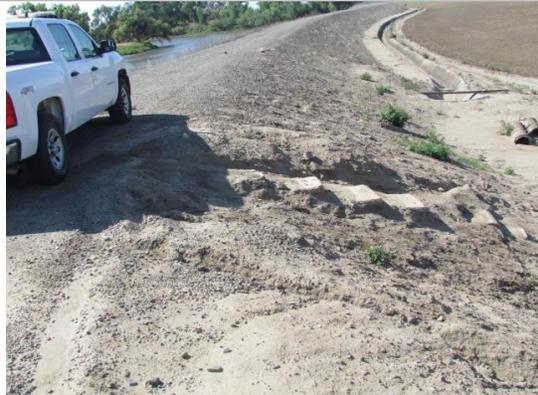
Photo 2 of 2 : FA_2014_RD0544_108_60_20141020_00029.jpg

Looking south at slope damage on landside slope.

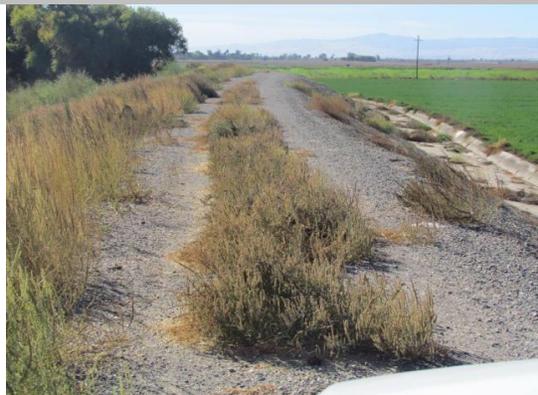
Photo 1 of 1 : FA_2014_RD0544_108_100_20141023_00063.jpg

Looking south at vegetation on levee crown.

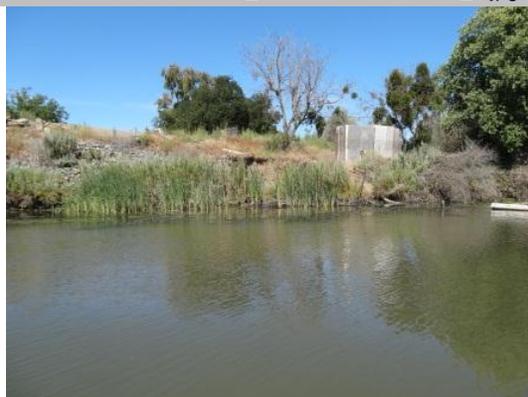
Photo 1 of 1 : SJR2014_RD0544U01RM49.67_1.jpg

LM Start	2.94	Rating **	U	Issue No.	78
LM End	2.94	Issue Type +	Ma	Location *	WS
Category	Supplemental		GPS Latitude/Longitude		
			Start	End	
Item	DWR Erosion Survey		37.840697 °	37.840697 °	
			-121.318252 °	-121.318252 °	
DWR ID					
Action/Comments					
Inspector Comments: 6/19/2014: No significant change observed. 08/13/2013: Pump has been removed. A larger pocket erosion has been found at the erosion site. 08/07/2012: The erosion is immediately upstream of a river bend. Dense vegetation is visible at the erosion site. [2014 Site ID:RD0544U01RM49.67]

Upstream view of the site.

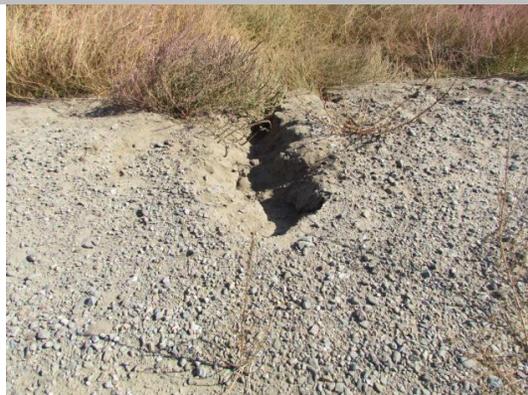
Photo 1 of 1 : FA_2014_RD0544_108_76_20141020_00038.jpg

LM Start	3.15	Rating **	M	Issue No.	76
LM End	3.15	Issue Type +	Ma	Location *	WS
Category	Earthen Levee		GPS Latitude/Longitude		
			Start	End	
Item	Slope Stability		37.837929 °	37.837929 °	
			-121.317663 °	-121.317663 °	
DWR ID	DWR_RD0544_01_f_2013_76				
Action/Comments					
Repair slope instability. Inspector Comments: Slope damaged extends from levee slope to shoulder.

Looking east at slope damage on waterward slope.

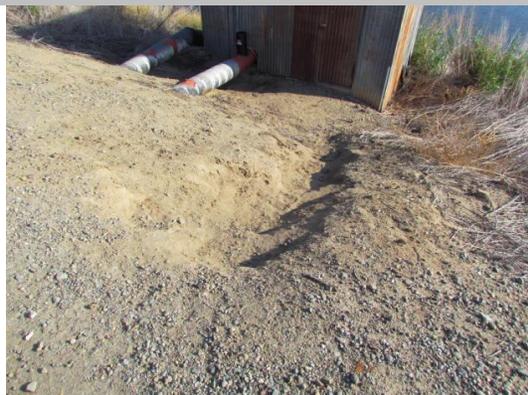
Photo 1 of 1 : FA_2014_RD0544_108_62_20141020_00030.jpg

LM Start	3.19	Rating **	M	Issue No.	62
LM End	3.19	Issue Type +	Ma	Location *	WS
Category	Earthen Levee		GPS Latitude/Longitude		
			Start	End	
Item	Slope Stability		37.837530 °	37.837530 °	
			-121.317510 °	-121.317510 °	
DWR ID	DWR_RD0544_01_s_2012_62				
Action/Comments					
Repair the levee slope damaged by foot traffic and prevent access where possible. Inspector Comments: Slope damage due to foot traffic.

Looking east at slope damaged by foot traffic near pump house on waterside of levee.

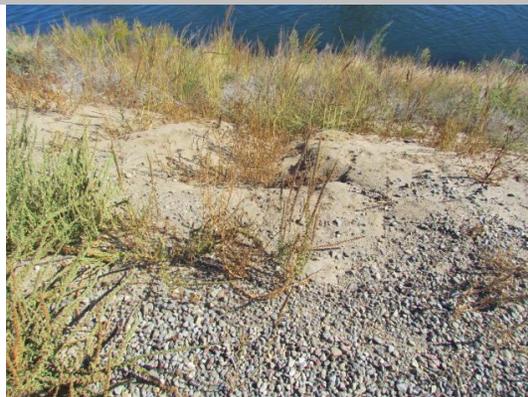
Photo 1 of 1 : FA_2014_RD0544_108_50_20141023_00071.jpg

LM Start	3.32	Rating **	M	Issue No.	50
LM End	3.32	Issue Type +	Ma	Location *	WS
Category	Earthen Levee		GPS Latitude/Longitude		
			Start	End	
Item	Erosion / Bank Caving		37.835815 °	37.835815 °	
			-121.316997 °	-121.316997 °	
DWR ID	DWR_RD0544_01_s_2012_50				
Action/Comments					
Note and monitor erosion site. Inspector Comments: Erosion located on waterside shoulder. Erosion caused by rain runoff.

Looking east at erosion on waterward slope.

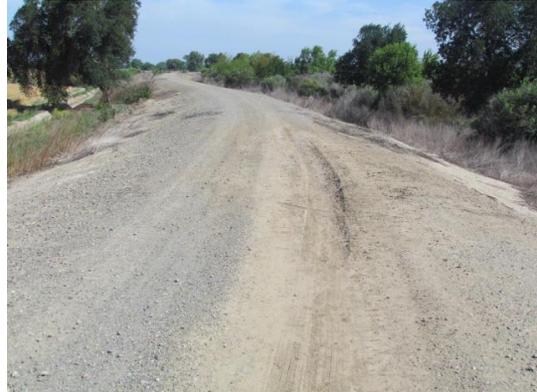
Photo 1 of 1 : FA_2014_RD0544_108_63_20141020_00031.jpg

Looking south at one of several sites needing gravel or road base on levee crown.

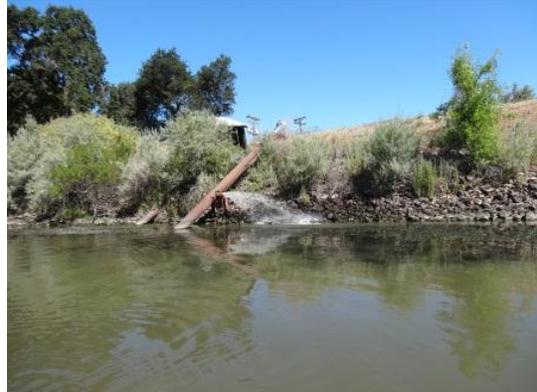
Photo 1 of 1 : SJR2014_RD0544U01RM51.04_1.jpg

View from upstream of the site.

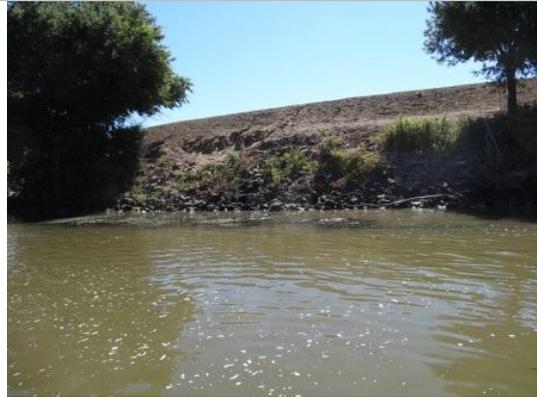
Photo 1 of 1 : SJR2014_RD0544U01RM51.09_1.jpg

View from downstream.

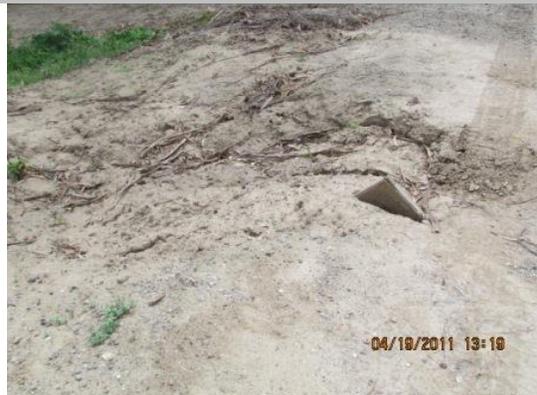
Photo 1 of 2 : FA_2014_RD0544_108_58_20141020_00026.jpg

Looking southeast at depression on waterside shoulder.

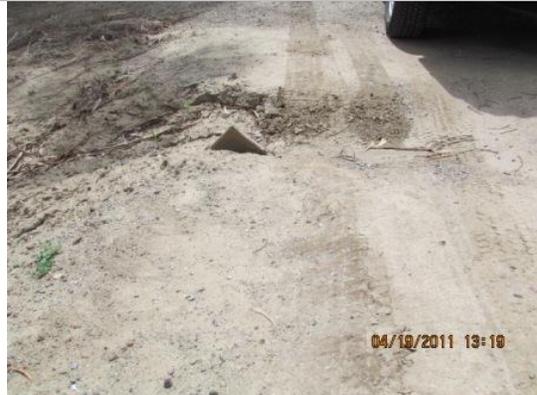
Photo 2 of 2 : FA_2014_RD0544_108_58_20141020_00027.jpg

Looking south at depression greater than 6" on waterside shoulder.

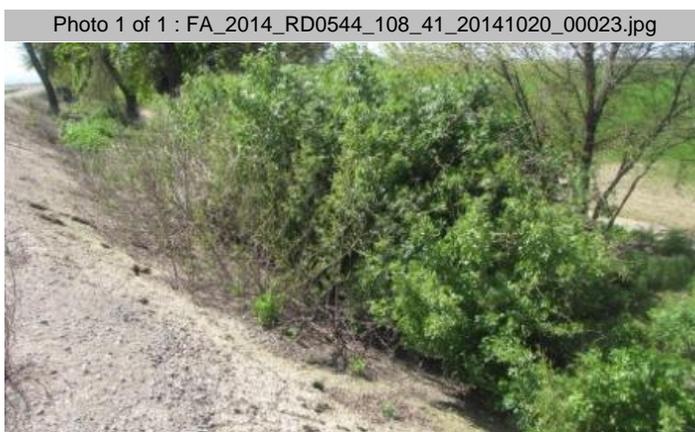
LM Start	4.53	Rating **	U	Issue No.	41
LM End	4.53	Issue Type +	Ma	Location *	LS
Category	Earthen Levee		GPS Latitude/Longitude		
			Start	End	
Item	Vegetation		37.822934 °	37.822934 °	
			-121.316870 °	-121.316870 °	
DWR ID	DWR_RD0544_01_s_2012_41				
Action/Comments					
Elderberries are blocking visibility and flood fight capability.

Looking south at elderberries on landside slope and toe.

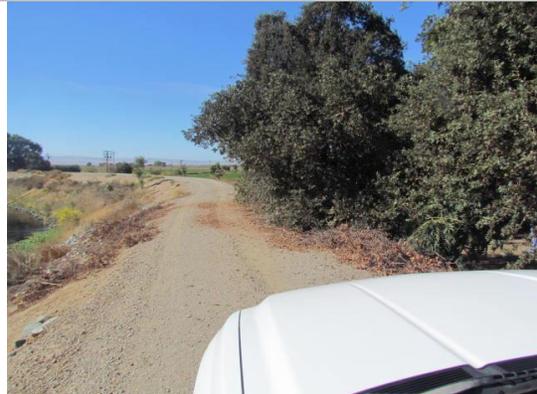
Photo 1 of 1 : FA_2014_RD0544_108_105_20141023_00072.jpg

Looking south at overgrown tree on landward shoulder.

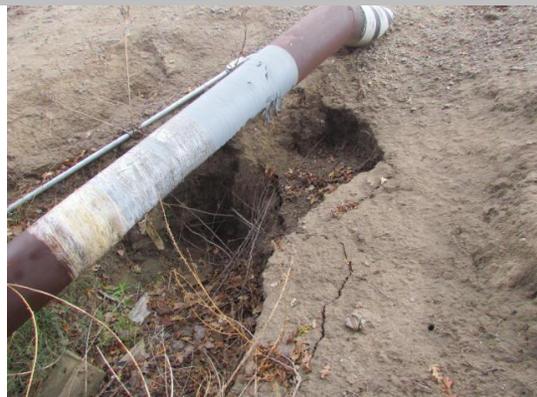
Photo 1 of 2 : FA_2014_RD0544_108_28_20141020_00020.jpg

Looking northeast at erosion around irrigation pipe on landside slope.

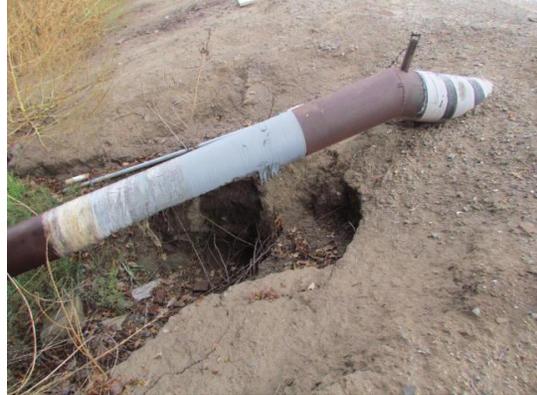
Photo 2 of 2 : FA_2014_RD0544_108_28_20141020_00021.jpg

Looking north at erosion around irrigation pipe on landside

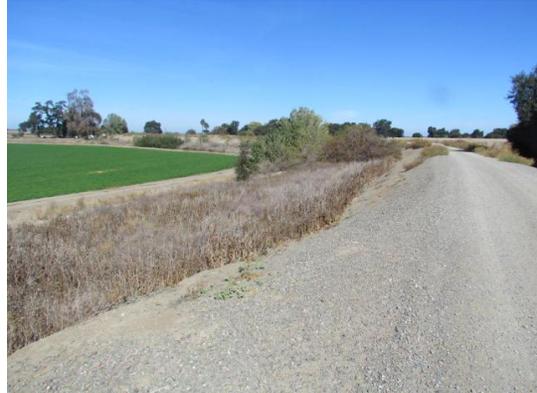
Photo 1 of 3 : FA_2014_RD0544_108_33_20141023_00073.jpg

Looking north at dead vegetation still blocking landward toe.

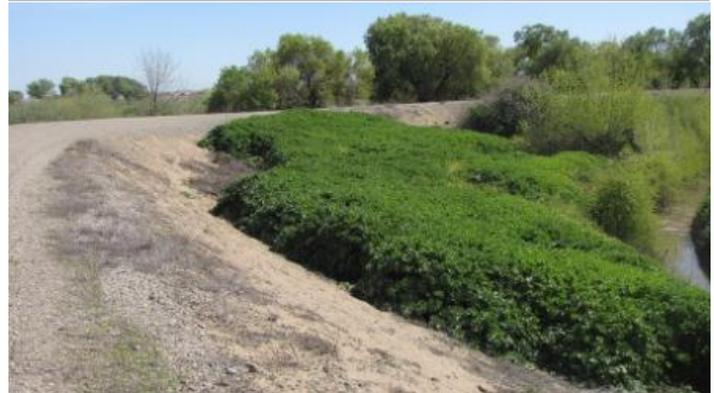
Photo 2 of 3 : FA_2014_RD0544_108_33_20141020_00022.jpg

Looking southeast at dense veg. on landside slope and toe.

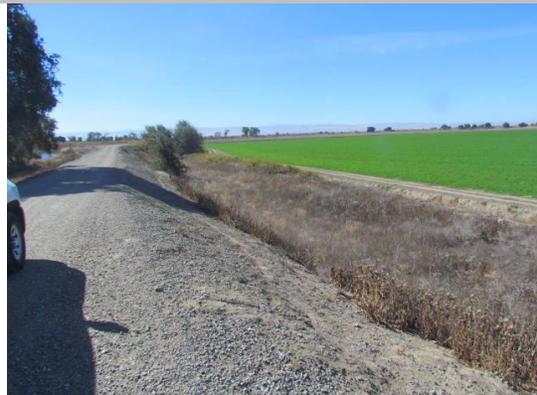
Photo 3 of 3 : FA_2014_RD0544_108_33_20141023_00074.jpg

Looking south at dead vegetation still blocking landward toe.

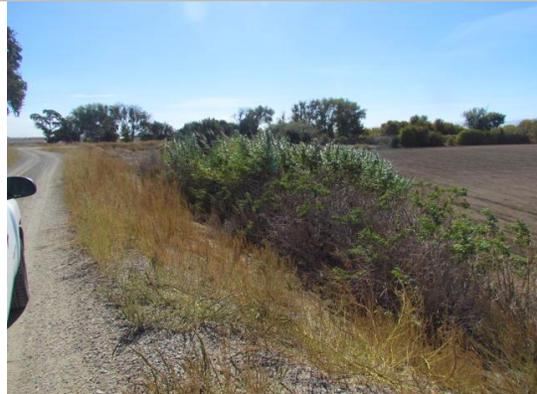
Photo 1 of 1 : FA_2014_RD0544_108_35_20141023_00075.jpg

Looking south at bamboo on landward slope and toe.

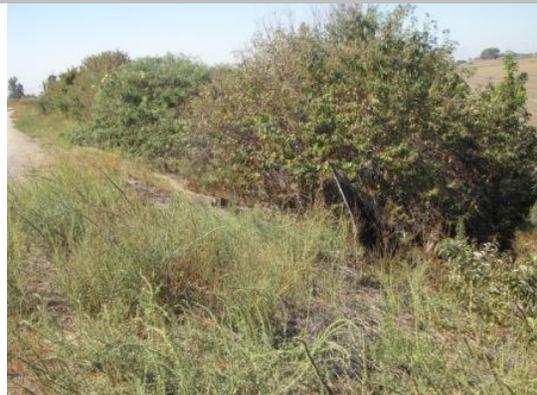
Photo 1 of 2 : FA_2014_RD0544_108_18_20141020_00016.jpg

Looking south at elderberries on landside slope and toe.

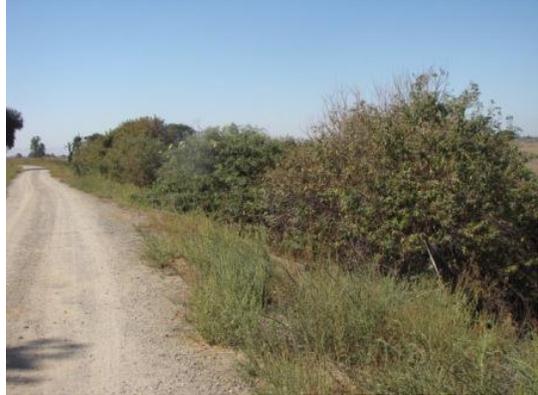
Photo 2 of 2 : FA_2014_RD0544_108_18_20141020_00017.jpg

Looking southwest on elderberries on landside slope and toe.

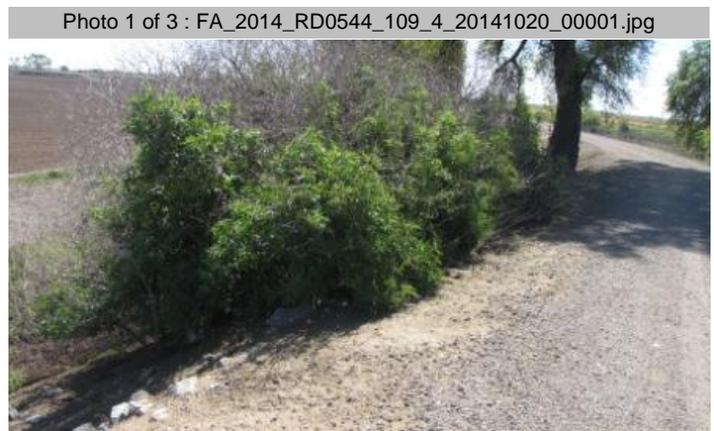
LM Start	0.41	Rating **	U	Issue No.	4
LM End	0.41	Issue Type +	Ma	Location *	LS
Category	Earthen Levee		GPS Latitude/Longitude		
			Start	End	
Item	Vegetation		37.809788 °	37.809788 °	
			-121.334727 °	-121.334727 °	
DWR ID	DWR_RD0544_02_s_2012_4				
Action/Comments					
Elderberries are blocking visibility and flood fight capability.

Looking northwest at elderberries on landside slope and toe.

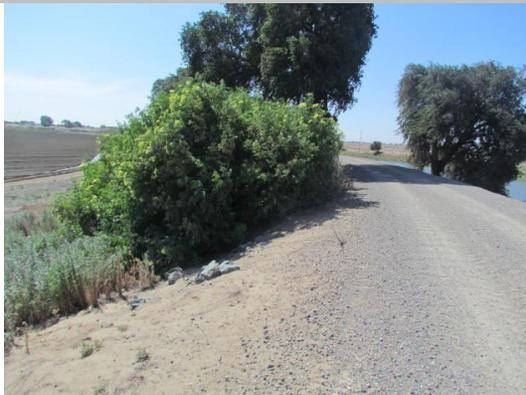
Photo 2 of 3 : FA_2014_RD0544_109_4_20141020_00002.jpg

Looking northwest at elderberry on landside slope. (Spring 2012)

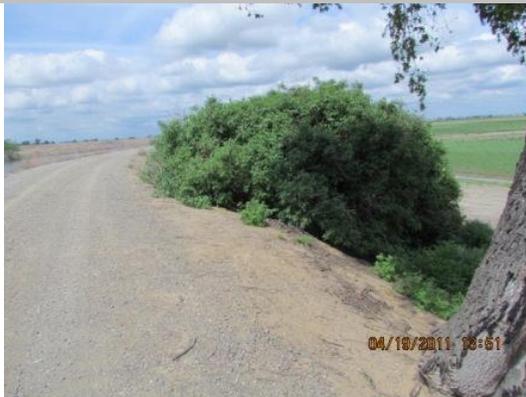
Photo 3 of 3 : FA_2014_RD0544_109_4_20141020_00003.jpg

Looking south at elderberries on landside slope.

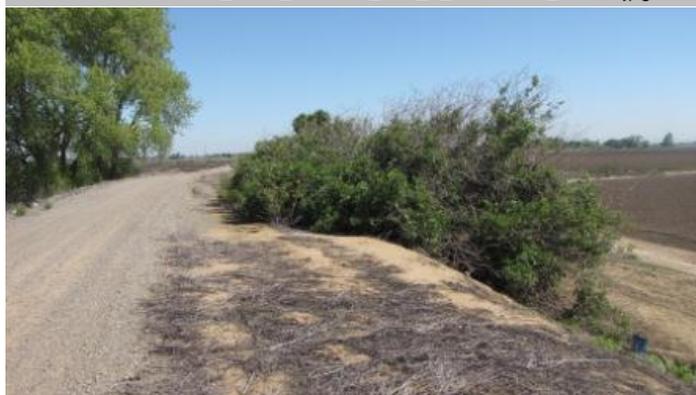
Photo 1 of 1 : FA_2014_RD0544_109_5_20141020_00004.jpg

Looking south at elderberries on landside slope and toe.

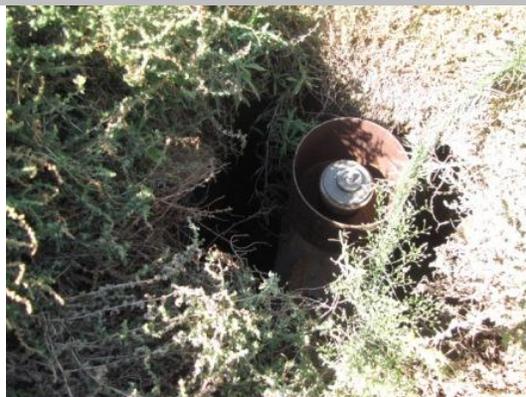
Photo 1 of 8 : FA_2014_RD0544_109_8_20141020_00006.jpg

Looking at top of siphon on waterside shoulder with 3' of caving around pipe.

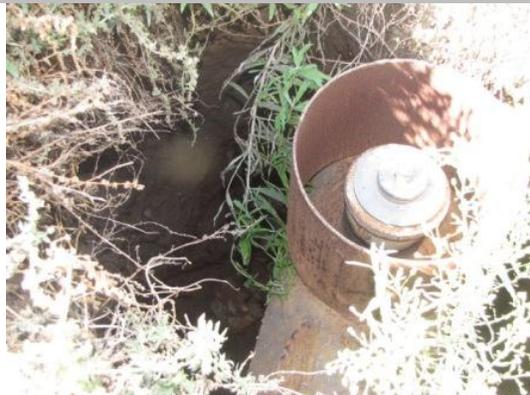
Photo 2 of 8 : FA_2014_RD0544_109_8_20141020_00007.jpg

Looking at caving around 10" siphon pipe on waterside shoulder.

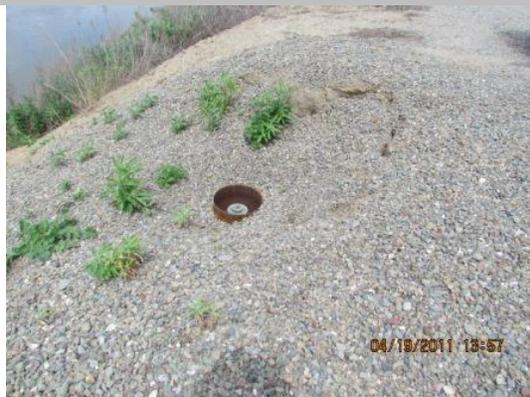
Photo 3 of 8 : FA_2014_RD0544_109_8_20141020_00008.jpg

Looking south at depression greater than 6" on waterside shoulder.

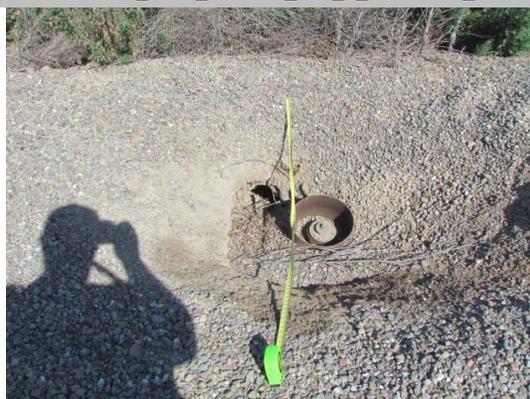
Photo 4 of 8 : FA_2014_RD0544_109_8_20141020_00009.jpg

Looking east at caving around siphon on waterside shoulder. (Spring 2012)

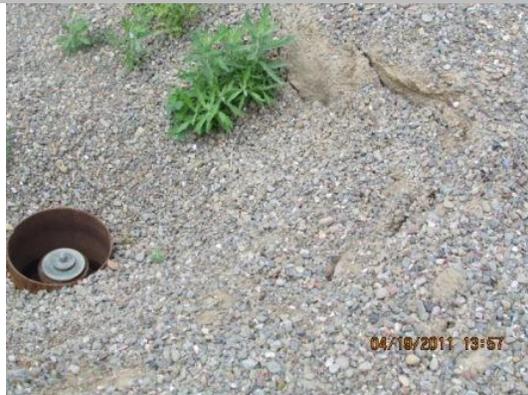
Photo 5 of 8 : FA_2014_RD0544_109_8_20141020_00010.jpg

Looking at top of siphon with a depression greater than 6" on waterside shoulder.

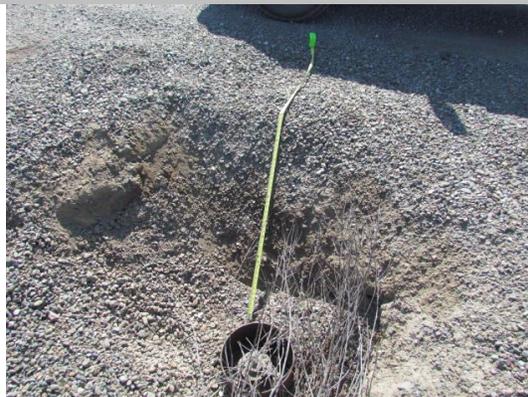
Photo 6 of 8 : FA_2014_RD0544_109_8_20141020_00011.jpg

Looking west at caving around siphon on waterside shoulder. (Spring 2012)

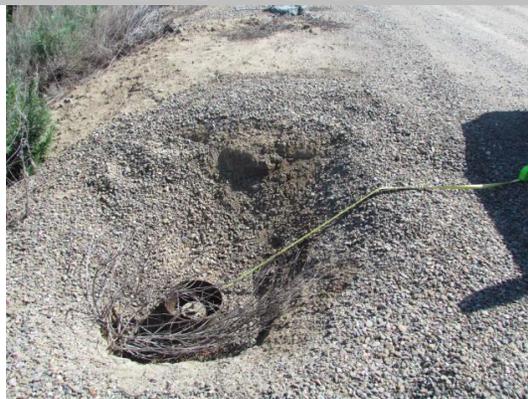
Photo 7 of 8 : FA_2014_RD0544_109_8_20141020_00012.jpg

Looking south at caving around siphon on waterside shoulder. (Spring 2012)

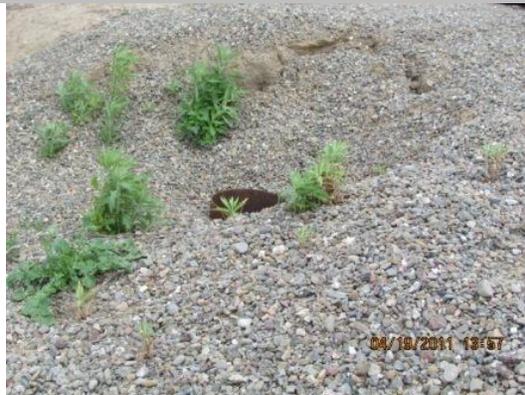
Photo 8 of 8 : FA_2014_RD0544_109_8_20141020_00013.jpg

Looking south at depression greater than 6" around siphon on waterside shoulder.

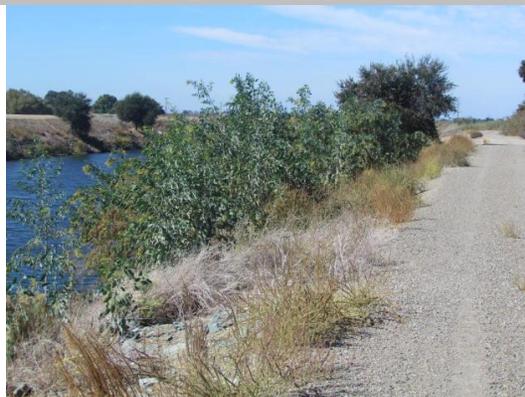
Photo 1 of 1 : FA_2014_RD0544_109_49_20141023_00050.jpg

Looking south at several tobacco plants on waterward slope.

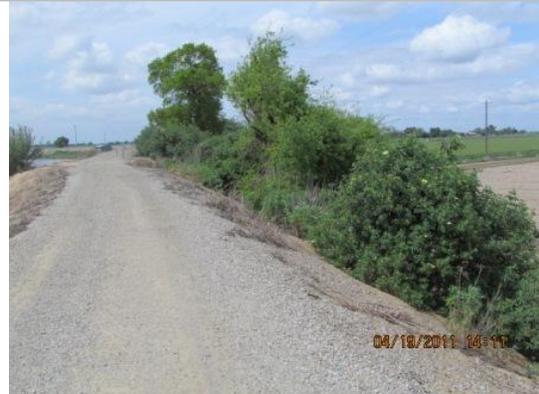
Photo 1 of 2 : FA_2014_RD0544_109_10_20141020_00015.jpg

Looking southwest at elderberries on landside slope.

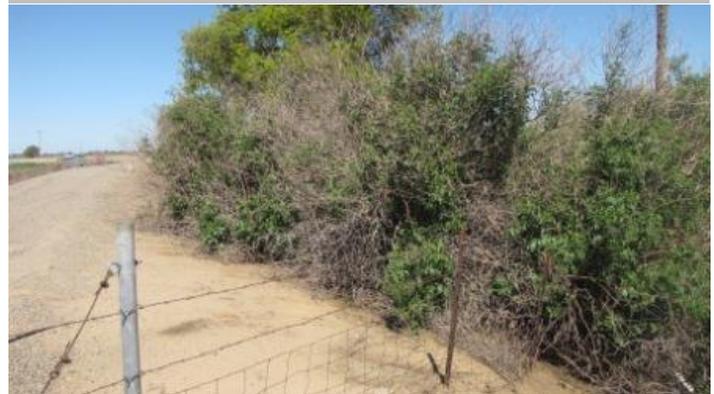
Photo 2 of 2 : FA_2014_RD0544_109_10_20141020_00016.jpg

Looking south at elderberries on landside slope and toe.

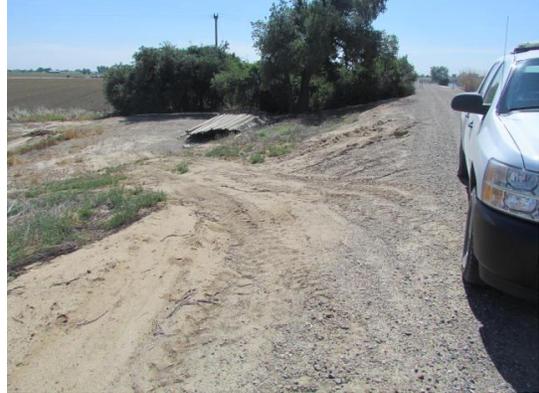
Photo 1 of 2 : FA_2014_RD0544_109_22_20141020_00030.jpg

Looking northwest at slope damage caused by vehicle traffic.

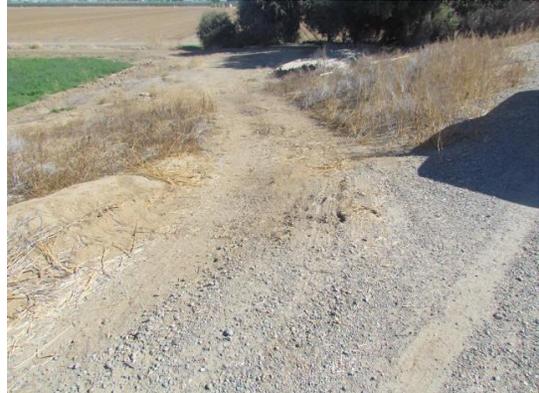
Photo 2 of 2 : FA_2014_RD0544_109_22_20141023_00051.jpg

Looking northwest at slope damage caused by vehicle traffic (Fall 2014).

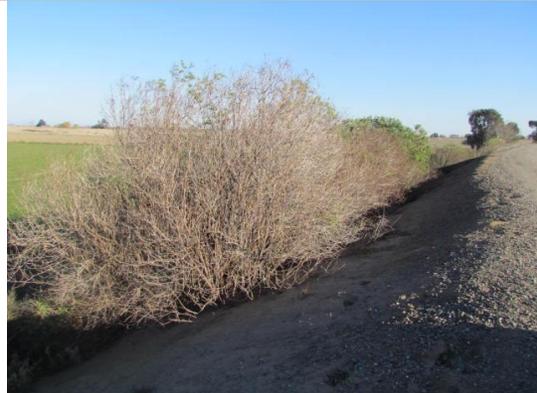
Photo 1 of 1 : FA_2014_RD0544_109_13_20141020_00018.jpg

Looking northwest at elderberries on landside slope and toe.

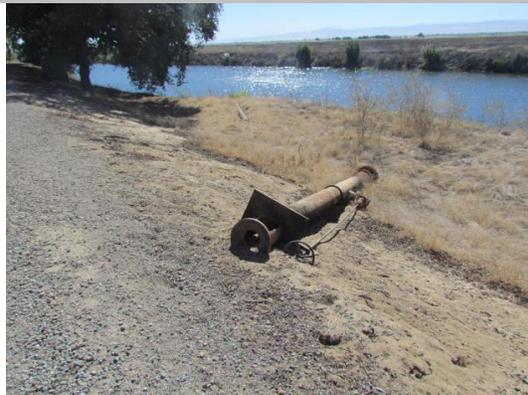
Photo 1 of 1 : FA_2014_RD0544_109_50_20141023_00052.jpg

Looking northwest at pipe on waterward slope.

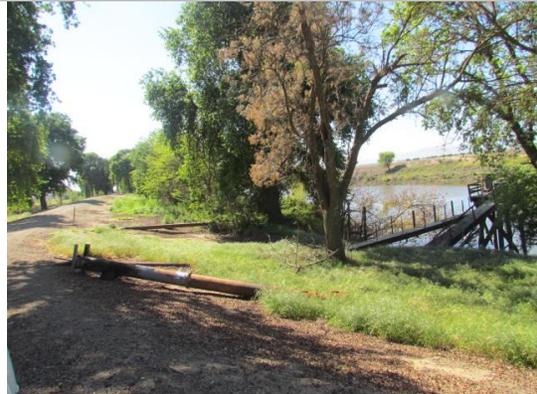
Photo 1 of 1 : FA_2014_RD0544_109_51_20141020_00038.jpg

Looking north at old pump shaft and pipe on waterward slope.

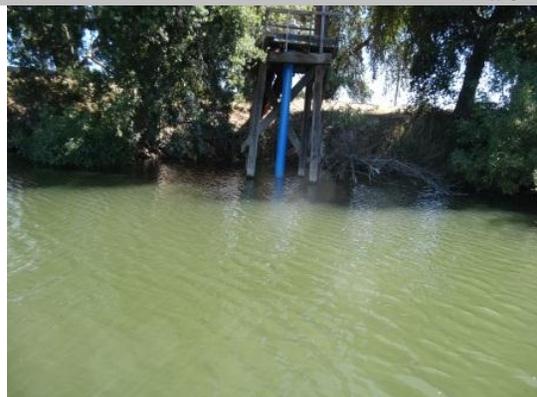
Photo 1 of 1 : SJR2014_RD0544U02RM33.21_1.jpg

Front view of the erosion site. View is partially blocked by the pump structure and vegetation.

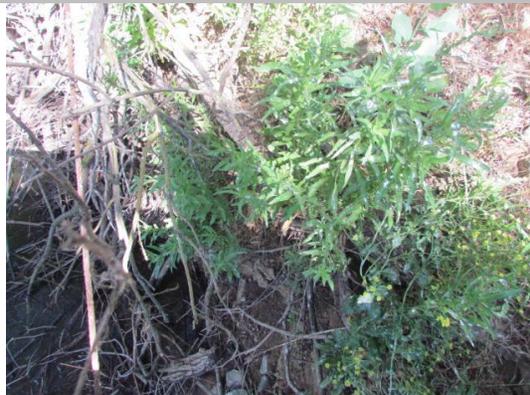
Photo 1 of 3 : FA_2014_RD0544_109_24_20141020_00032.jpg

Looking south at breaver hole at waterside toe.

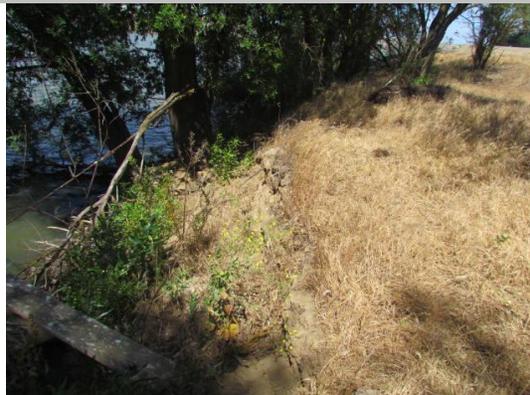
Photo 2 of 3 : FA_2014_RD0544_109_24_20141020_00033.jpg

Looking south at river erosion at waterside toe near pumping station.

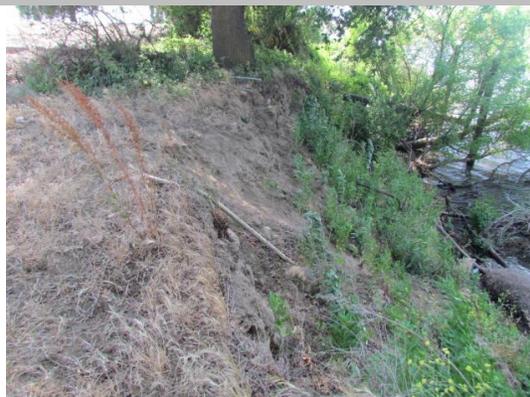
Photo 3 of 3 : FA_2014_RD0544_109_24_20141020_00034.jpg

Looking north at erosion on waterside slope.

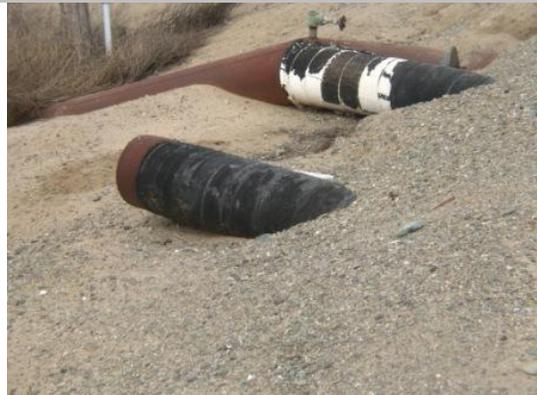
Photo 1 of 1 : FA_2014_RD0544_109_15_20141020_00019.jpg

Abandoned pipe at LM 2.65, landside view.

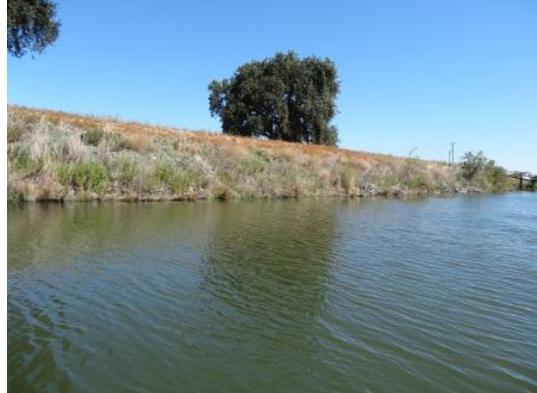
Photo 1 of 1 : SJR2014_RD0544U02RM32.91_1.jpg

Front view of pocket erosion. Note the vegetation and riprap at the site.

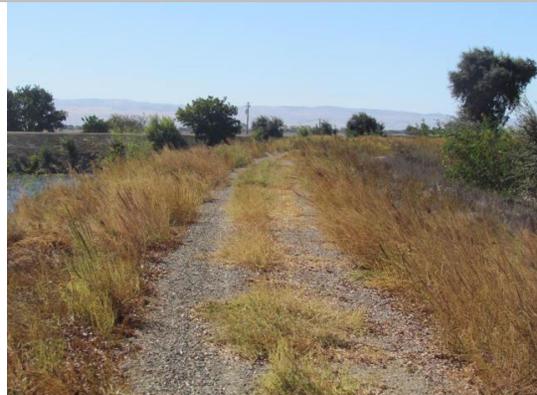
Photo 1 of 1 : FA_2014_RD0544_109_52_20141023_00053.jpg

Looking south at vegetation on levee crown.

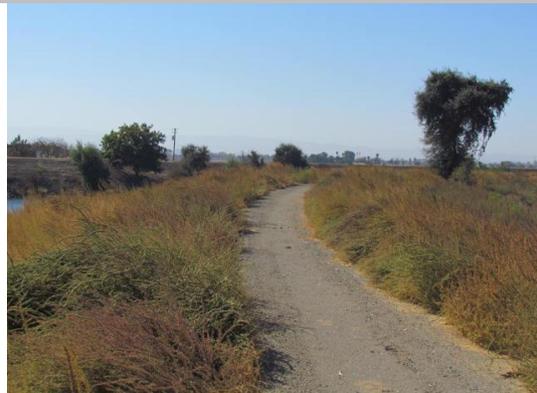
Photo 1 of 1 : FA_2014_RD0544_109_43_20141020_00037.jpg

Looking south a dense vegetation on landward and waterward slope.

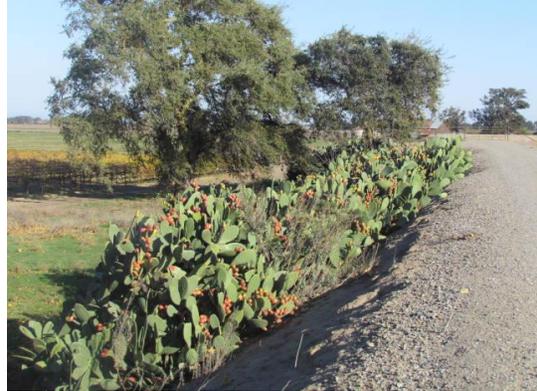
Photo 1 of 2 : FA_2014_RD0544_109_36_20141020_00035.jpg

Looking north at cactus on landside slope and toe.

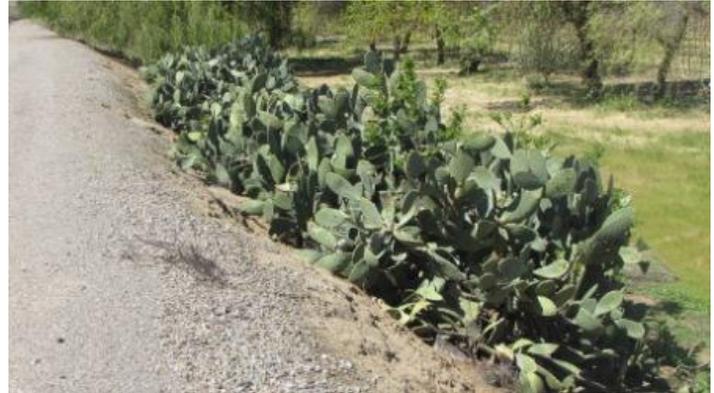
Photo 2 of 2 : FA_2014_RD0544_109_36_20141020_00036.jpg

Looking southwest at overgrown cactus on landside slope.
