**Flood Control Project Maintenance  
Levee Inspections**

## Maintenance Issue Types Only, Levee Inspection Report By Mile - Spring 2015

### Reclamation District No. 0544 Upper Roberts Island

Waterway	Bank	Unit Miles	Inspection Start/End	Inspector
Unit No. 01 San Joaquin River	Left	6.05	04/28/2015 04/28/2015	Richard Willoughby

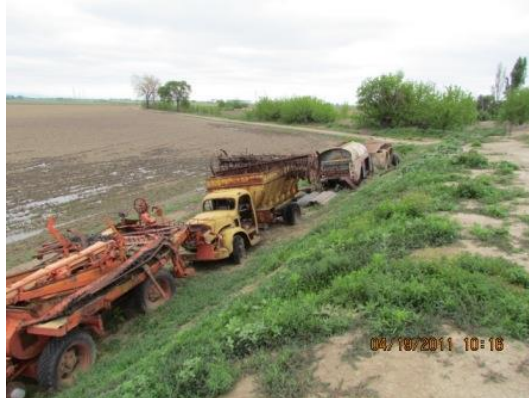
Photo 2 of 3 : SP\_2015\_RD0544\_108\_4\_20150309\_00003.jpg

Looking north at equipment along landside toe.

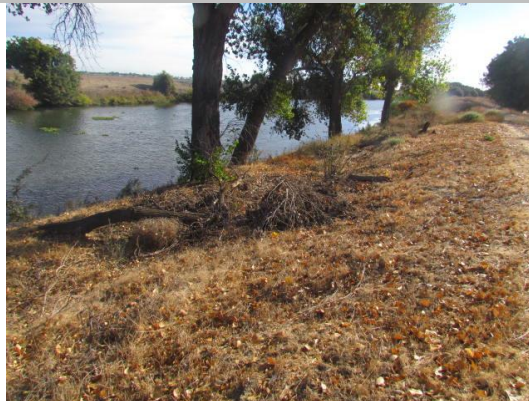
Photo 1 of 1 : SP\_2015\_RD0544\_108\_6\_20150309\_00006.jpg

LM Start	0.45	Rating **	M	Issue No.	6
LM End	0.45	Issue Type +	Ma	Location *	WS
Category	Earthen Levee			GPS Latitude/Longitude	
				Start	End
Item	Encroachments			37.864713 °	37.864713 °
				-121.326708 °	-121.326708 °
DWR ID	DWR_RD0544_01_f_2013_6				
Action/Comments					
Prunings					
Inspector Comments: Broken tree limbs on waterward slope and berm.

Looking southeast at tree branch on waterward slope.

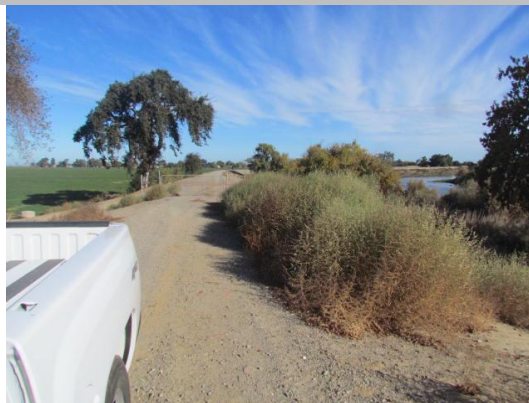
Photo 1 of 1 : SP\_2015\_RD0544\_108\_94\_20150309\_00054.jpg

Looking north at vegetation on waterward shoulder and slope.

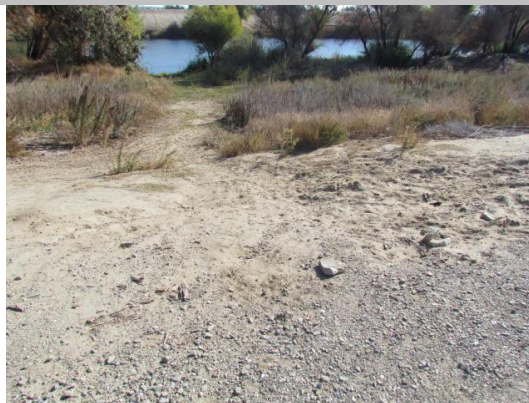
Photo 1 of 2 : SP\_2015\_RD0544\_108\_64\_20150309\_00043.jpg

LM Start	1.56	Rating **	M	Issue No.	64
LM End	1.56	Issue Type +	Ma	Location *	WS
Category	Earthen Levee			GPS Latitude/Longitude	
				Start	End
Item	Slope Stability			37.854081 °	37.854081 °
				-121.321268 °	-121.321268 °
DWR ID	DWR_RD0544_01_f_2013_64				
Action/Comments					
Repair the levee slope damaged by vehicle traffic and prevent access where possible.					
Inspector Comments: Damaged levee slope due to fishermen using slope as a ramp.

Looking east at damaged waterward slope.

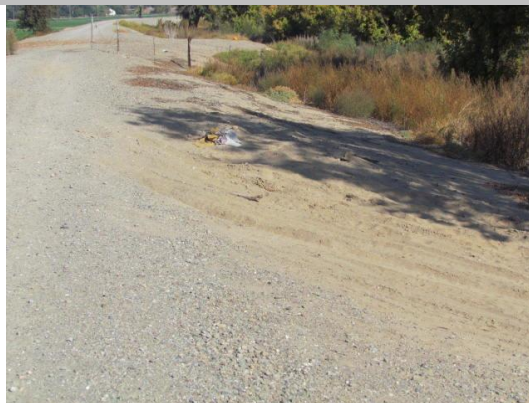
Photo 2 of 2 : SP\_2015\_RD0544\_108\_64\_20150309\_00044.jpg

Looking northeast at waterward slope.

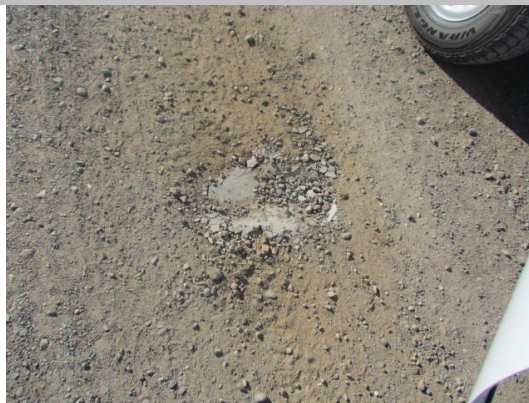
Photo 2 of 2 : SP\_2015\_RD0544\_108\_90\_20150309\_00051.jpg

Looking at grouted rodent hole on levee crown.

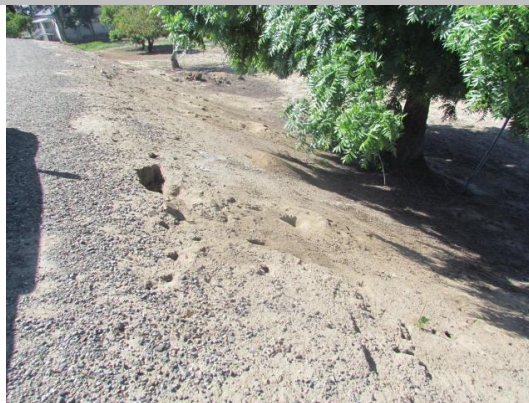
Photo 1 of 2 : SP\_2015\_RD0544\_108\_34\_20150430\_00076.jpg

Looking south at several rodent holes on landward shoulder and slope.

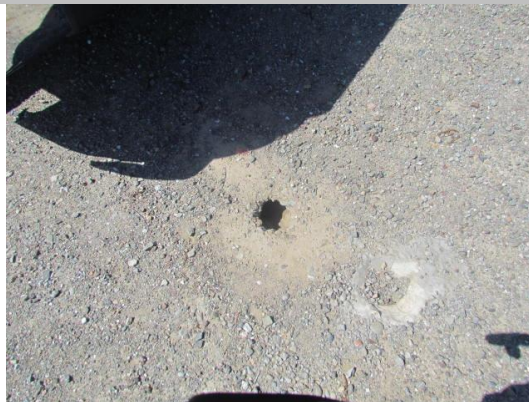
Photo 2 of 2 : SP\_2015\_RD0544\_108\_34\_20150430\_00077.jpg

Looking at rodent hole on levee crown.

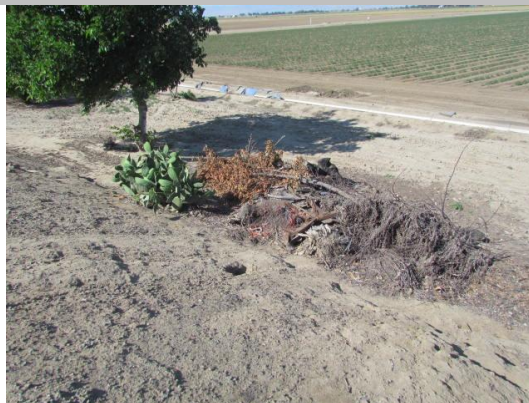
Photo 1 of 1 : SP\_2015\_RD0544\_108\_7\_20150309\_00007.jpg

Looking southwest at garbage at landside toe.

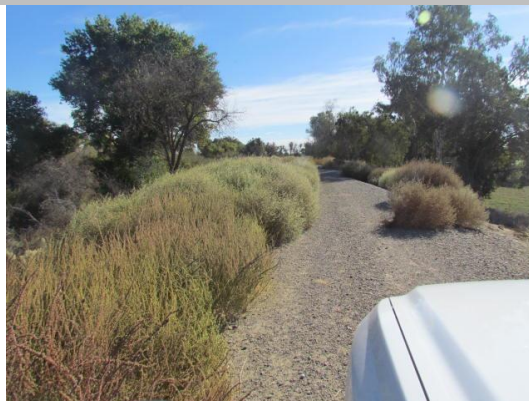
Photo 1 of 1 : SP\_2015\_RD0544\_108\_99\_20150309\_00055.jpg

Looking south at dense vegetation on waterward shoulder and slope.

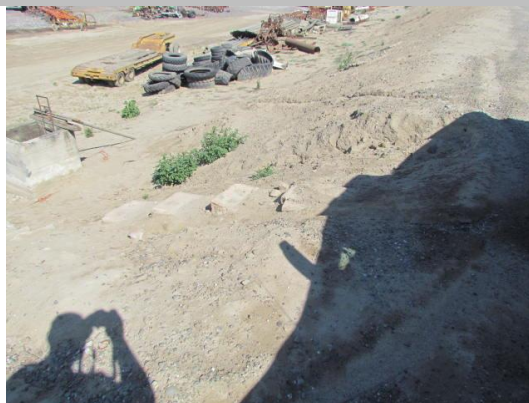
Photo 1 of 2 : SP\_2015\_RD0544\_108\_60\_20150309\_00039.jpg

LM Start	2.57	Rating **	M	Issue No.	60
LM End	2.57	Issue Type +	Ma	Location *	LS
Category	Earthen Levee			GPS Latitude/Longitude	
				Start	End
Item	Slope Stability			37.844337 °	37.844337 °
				-121.321853 °	-121.321853 °
DWR ID	DWR_RD0544_01_s_2012_60				
Action/Comments					
Repair the levee slope damaged by foot traffic and prevent access where possible.

Looking north at slope damage on landside slope.

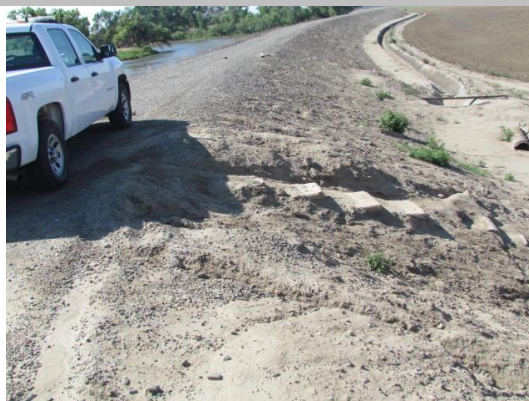
Photo 2 of 2 : SP\_2015\_RD0544\_108\_60\_20150309\_00040.jpg

Looking south at slope damage on landside slope.

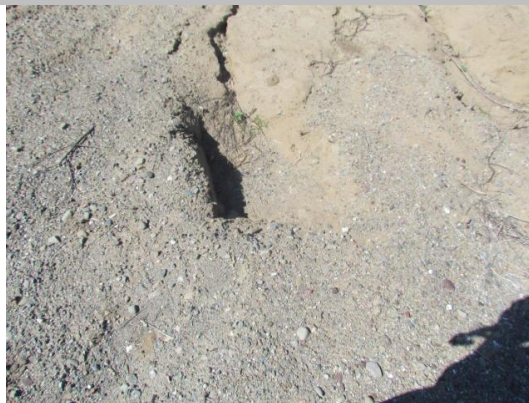
Photo 1 of 2 : SP\_2015\_RD0544\_108\_107\_20150430\_00078.jpg

Looking south at depression on landward slope.

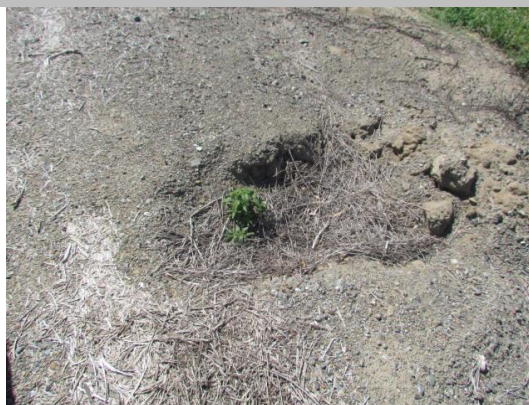
Photo 2 of 2 : SP\_2015\_RD0544\_108\_107\_20150430\_00079.jpg

Looking west at depression on landward shoulder.

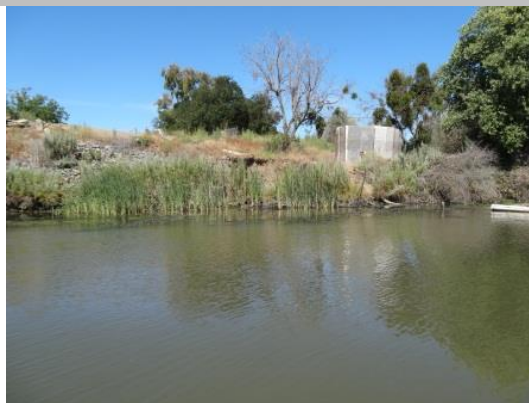
Photo 1 of 1 : SP\_2015\_RD0544\_108\_78\_20150309\_00048.jpg

LM Start	2.95	Rating **	U	Issue No.	78
LM End	2.95	Issue Type +	Ma	Location *	WS
Category	Supplemental			GPS Latitude/Longitude	
				Start	End
Item	DWR Erosion Survey			37.840697 °	37.840697 °
				-121.318252 °	-121.318252 °
DWR ID	DWR_RD0544_01_s _ 2015_78				
Action/Comments					
Inspector Comments: 6/19/2014: No significant change observed. 08/13/2013: Pump has been removed. A larger pocket erosion has been found at the erosion site. 08/07/2012: The erosion is immediately upstream of a river bend. Dense vegetation is visible at the erosion site. [2014 Site ID:RD0544U01RM49.67]

Upstream view of the site.

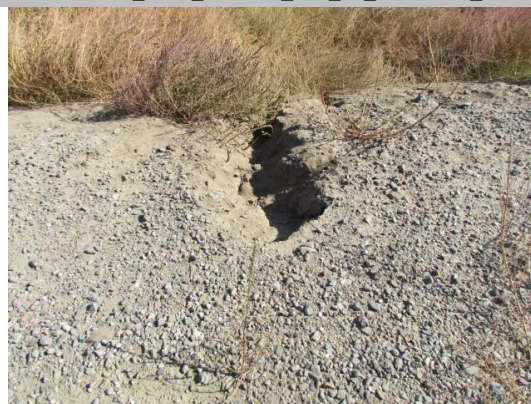
Photo 1 of 1 : SP\_2015\_RD0544\_108\_76\_20150309\_00047.jpg

LM Start	3.14	Rating **	M	Issue No.	76
LM End	3.14	Issue Type +	Ma	Location *	WS
Category	Earthen Levee			GPS Latitude/Longitude	
				Start	End
Item	Slope Stability			37.837929 °	37.837929 °
				-121.317663 °	-121.317663 °
DWR ID	DWR_RD0544_01_f_2013_76				
Action/Comments					
Repair slope instability. Inspector Comments: Slope damaged extends from levee slope to shoulder.

Looking east at slope damage on waterward slope.

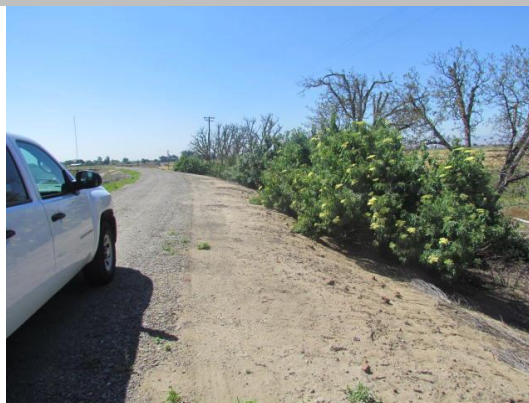
Photo 1 of 1 : SP\_2015\_RD0544\_108\_49\_20150430\_00080.jpg

Looking southwest at untrimmed trees at landward toe.

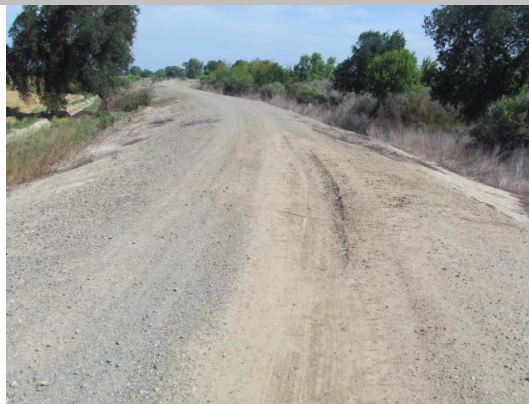
Photo 1 of 1 : SP\_2015\_RD0544\_108\_63\_20150309\_00042.jpg

Looking south at one of several sites needing gravel or road base on levee crown.

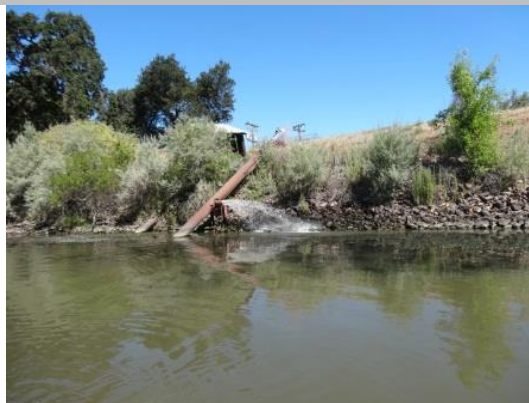
Photo 1 of 1 : SP\_2015\_RD0544\_108\_79\_20150309\_00049.jpg

LM Start	4.23	Rating **	M	Issue No.	79
LM End	4.23	Issue Type +	Ma	Location *	WS
Category	Supplemental			GPS Latitude/Longitude	
				Start	End
Item	DWR Erosion Survey			37.825248 °	37.825248 °
				-121.313856 °	-121.313856 °
DWR ID	DWR_RD0544_01_s _ 2015_79				
Action/Comments					
Inspector Comments: 06/19/2014: No significant change observed. 08/13/2013: The erosion has been caused by irrigation pipe. [2014 Site ID:RD0544U01RM51.04]

View from upstream of the site.

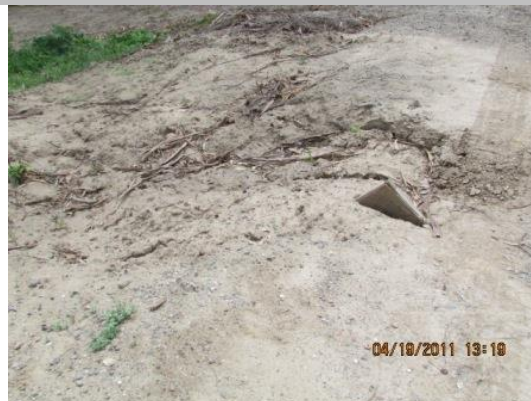
Photo 1 of 2 : SP\_2015\_RD0544\_108\_58\_20150309\_00037.jpg

Looking southeast at depression on waterside shoulder.

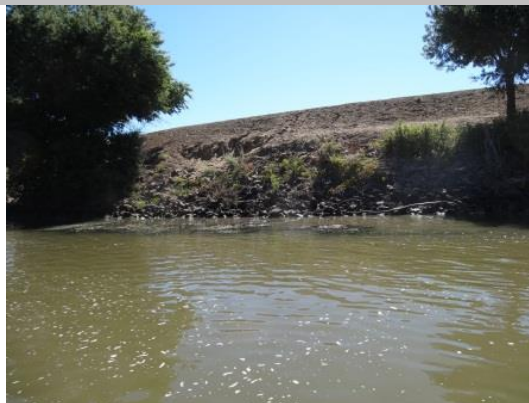
Photo 1 of 1 : SP\_2015\_RD0544\_108\_101\_20150309\_00057.jpg

View from downstream.

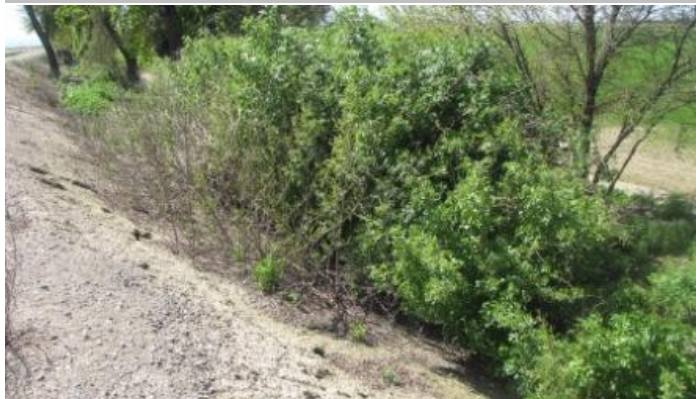
Photo 1 of 1 : SP\_2015\_RD0544\_108\_41\_20150309\_00034.jpg

Looking south at elderberries on landside slope and toe.

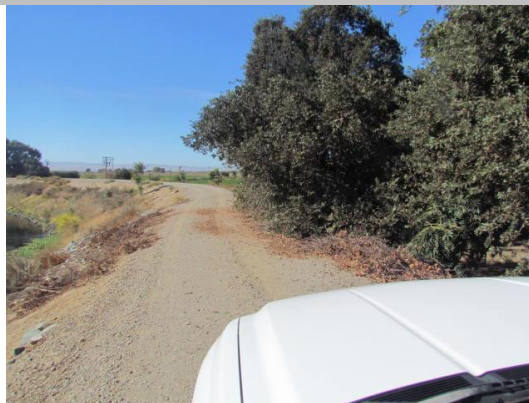
Photo 1 of 1 : SP\_2015\_RD0544\_108\_105\_20150309\_00058.jpg

Looking south at overgrown tree on landward shoulder.

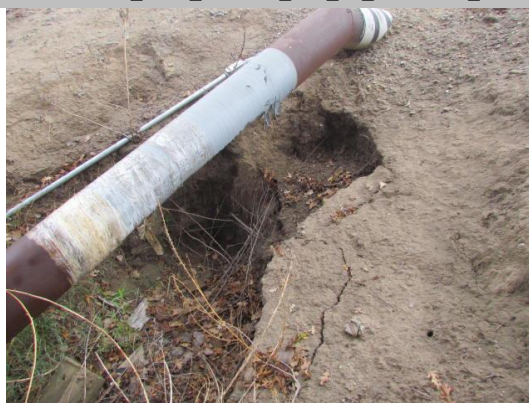
Photo 1 of 2 : SP\_2015\_RD0544\_108\_28\_20150309\_00027.jpg

Looking northeast at erosion around irrigation pipe on landside slope.

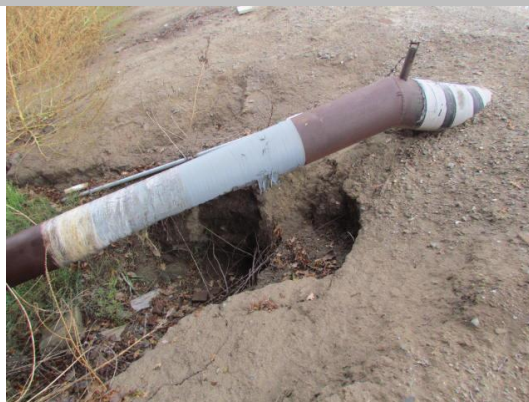
Photo 2 of 2 : SP\_2015\_RD0544\_108\_28\_20150309\_00028.jpg

Looking north at erosion around irrigation pipe on landside

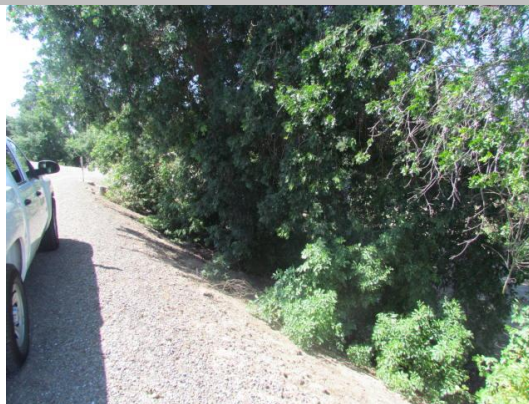
Photo 1 of 1 : SP\_2015\_RD0544\_108\_112\_20150430\_00082.jpg

Looking southwest at dense trees on landward slope and toe.

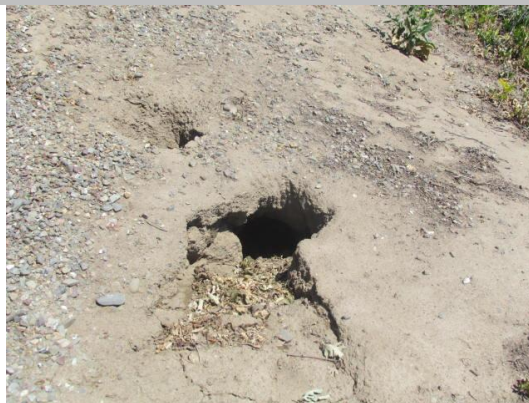
Photo 1 of 1 : SP\_2015\_RD0544\_108\_113\_20150430\_00083.jpg

Looking north at large hole on waterward slope.

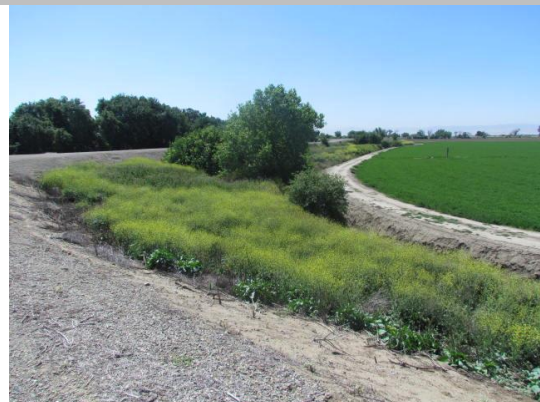
Photo 1 of 5 : SP\_2015\_RD0544\_108\_33\_20150430\_00084.jpg

Looking southwest at dense vegetation at landward slope and toe.(Spring 2015)

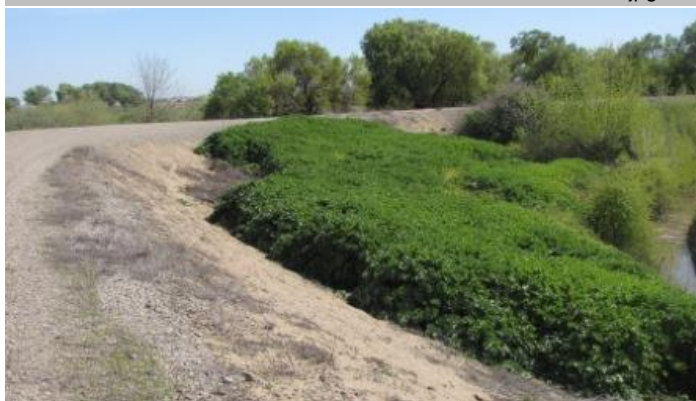
Photo 4 of 5 : SP\_2015\_RD0544\_108\_33\_20150309\_00030.jpg

Looking southeast at dense veg. on landside slope and toe.

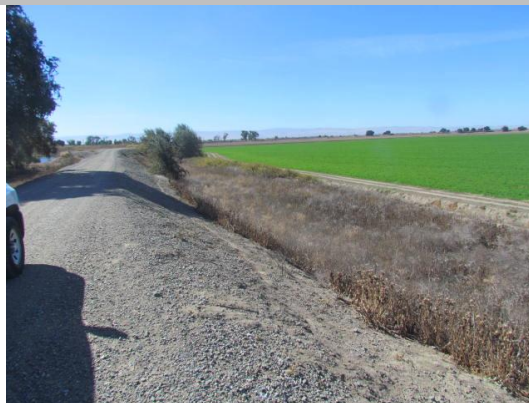
Photo 5 of 5 : SP\_2015\_RD0544\_108\_33\_20150309\_00031.jpg

Looking south at dead vegetation still blocking landward toe.

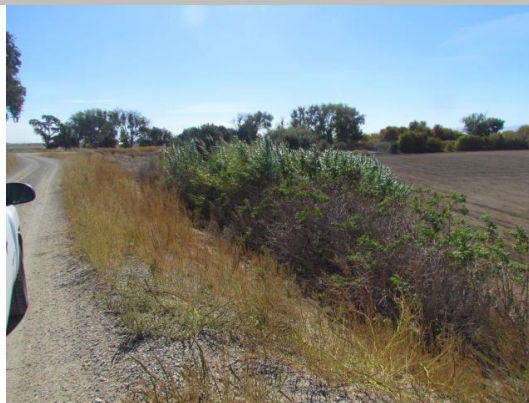
Photo 1 of 1 : SP\_2015\_RD0544\_108\_35\_20150309\_00032.jpg

Looking south at bamboo on landward slope and toe.

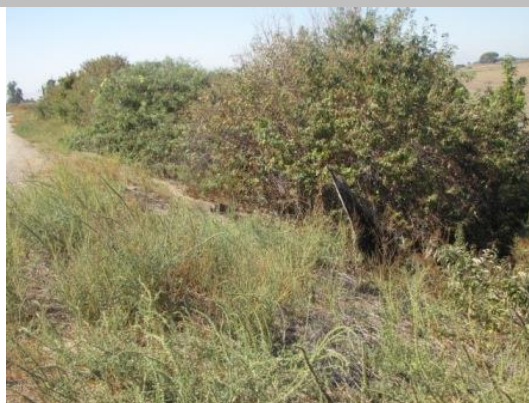
Photo 2 of 3 : SP\_2015\_RD0544\_108\_18\_20150309\_00022.jpg

Looking south at elderberries on landside slope and toe.

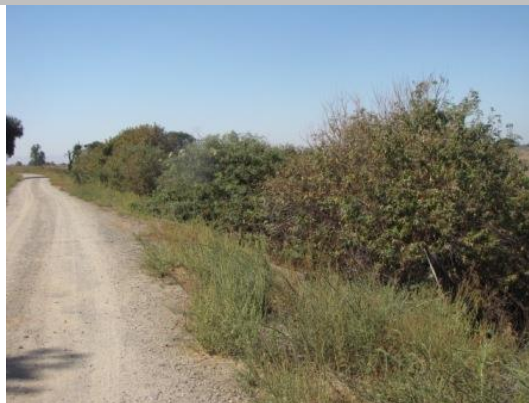
Photo 3 of 3 : SP\_2015\_RD0544\_108\_18\_20150309\_00023.jpg

Looking southwest on elderberries on landside slope and toe.

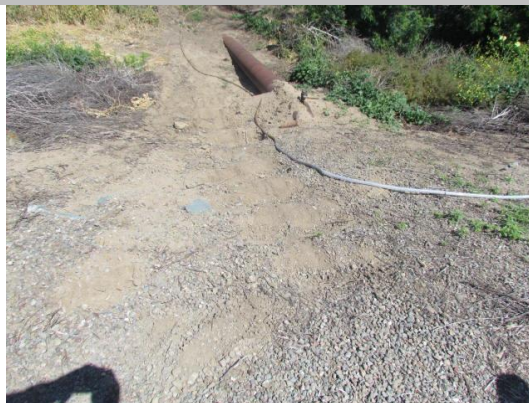
Photo 1 of 3 : SP\_2015\_RD0544\_108\_115\_20150430\_00087.jpg

Looking west at slope damage on landward slope.

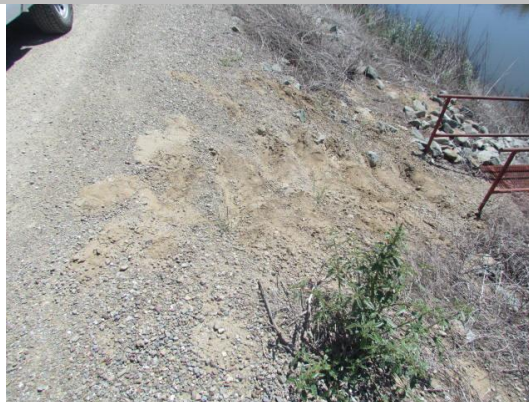
Photo 2 of 3 : SP\_2015\_RD0544\_108\_115\_20150430\_00088.jpg

Looking east at slope damage on waterward slope.

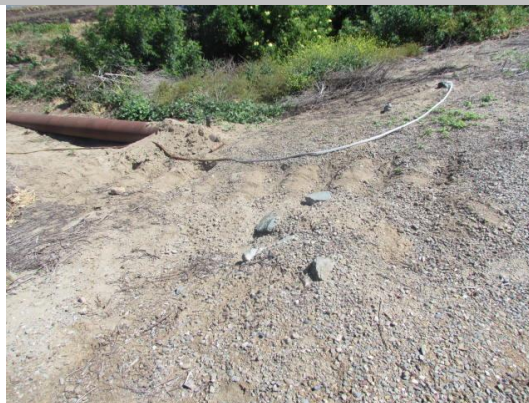
Photo 3 of 3 : SP\_2015\_RD0544\_108\_115\_20150430\_00089.jpg

Looking northwest at slope damage on landward toe.

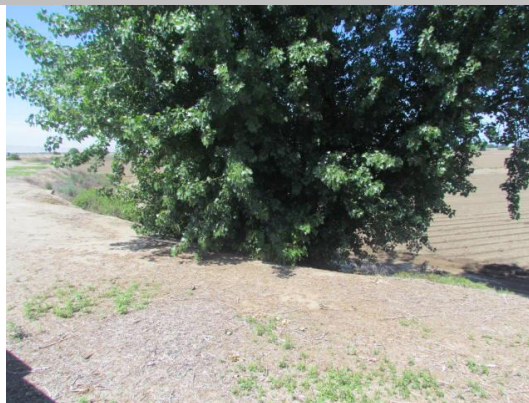
Photo 1 of 1 : SP\_2015\_RD0544\_108\_117\_20150430\_00090.jpg

Looking west at untrimmed tree on landward slope.

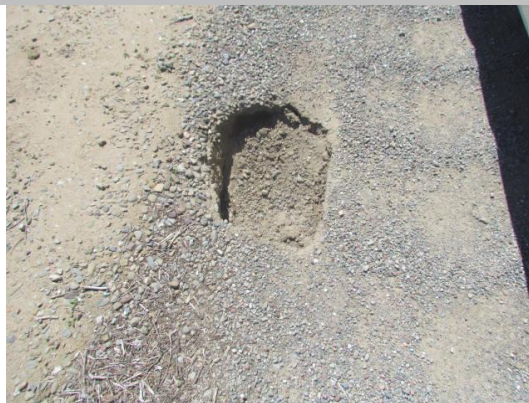
Photo 1 of 1 : SP\_2015\_RD0544\_109\_46\_20150430\_00055.jpg

Looking at depression on landward shoulder.

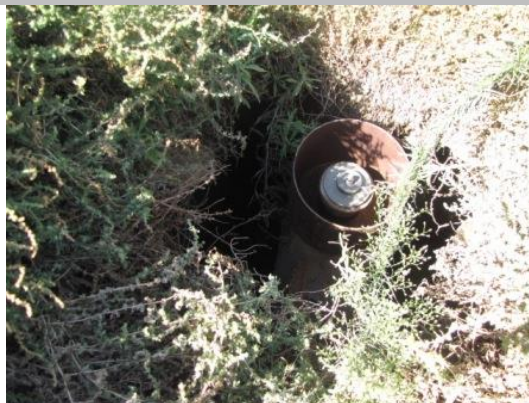
Photo 1 of 8 : SP\_2015\_RD0544\_109\_8\_20150309\_00006.jpg

Looking at top of siphon on waterside shoulder with 3' of caving around pipe.

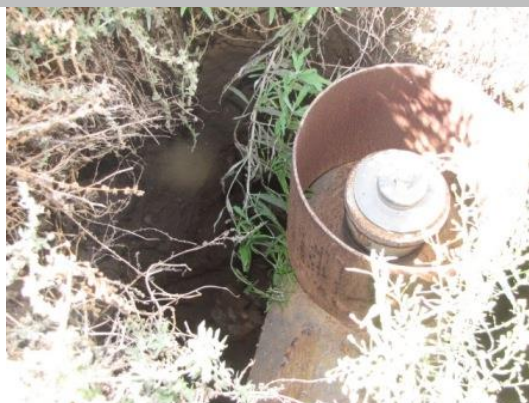
Photo 2 of 8 : SP\_2015\_RD0544\_109\_8\_20150309\_00007.jpg

Looking at caving around 10" siphon pipe on waterside shoulder.

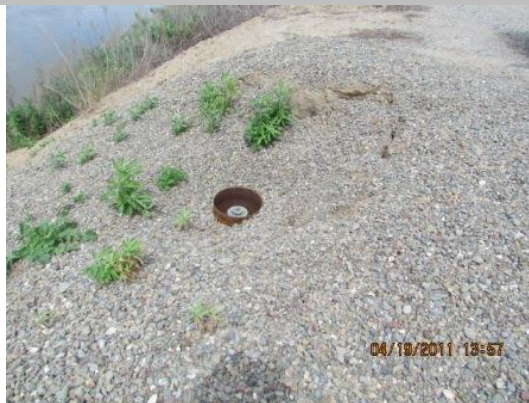
Photo 3 of 8 : SP\_2015\_RD0544\_109\_8\_20150309\_00008.jpg

Looking south at depression greater than 6" on waterside shoulder.

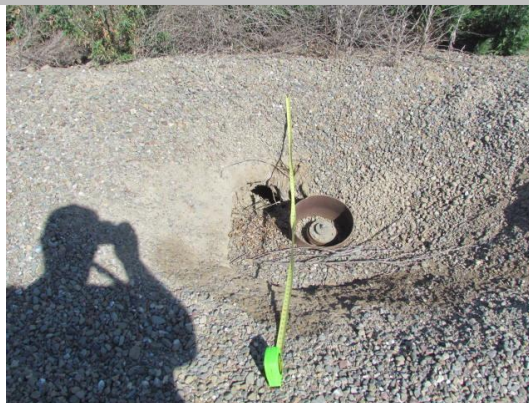
Photo 4 of 8 : SP\_2015\_RD0544\_109\_8\_20150309\_00009.jpg

Looking east at caving around siphon on waterside shoulder. (Spring 2012)

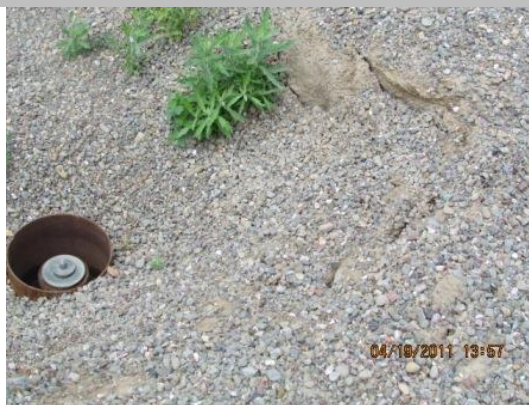
Photo 5 of 8 : SP\_2015\_RD0544\_109\_8\_20150309\_00010.jpg

Looking at top of siphon with a depression greater than 6" on waterside shoulder.

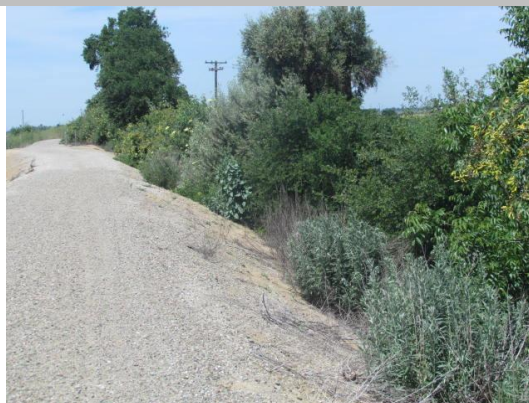
Photo 1 of 2 : SP\_2015\_RD0544\_109\_49\_20150430\_00056.jpg

Looking southwest at dense vegetation on landward slope and toe.

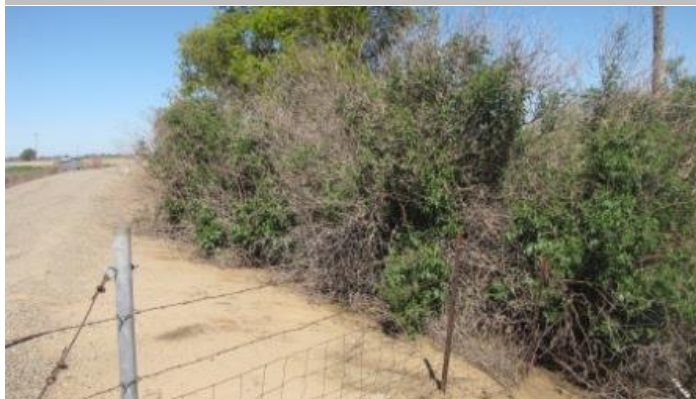
Photo 2 of 2 : SP\_2015\_RD0544\_109\_10\_20150309\_00016.jpg

Looking south at elderberries on landside slope and toe.

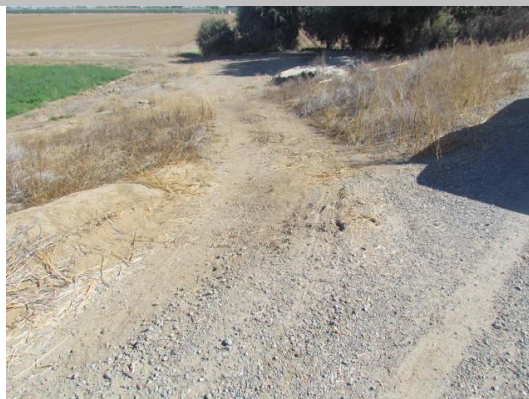
Photo 1 of 2 : SP\_2015\_RD0544\_109\_22\_20150309\_00031.jpg

Looking northwest at slope damage caused by vehicle traffic (Fall 2014).

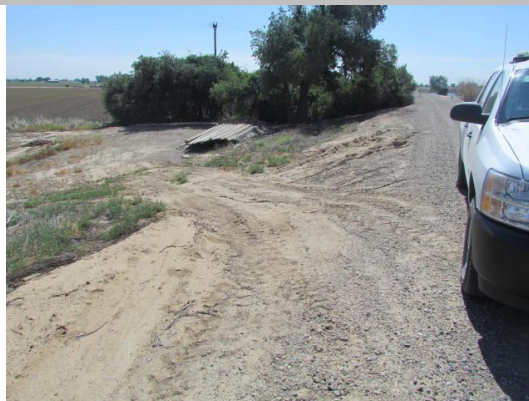
Photo 2 of 2 : SP\_2015\_RD0544\_109\_22\_20150309\_00032.jpg

Looking northwest at slope damage caused by vehicle traffic.

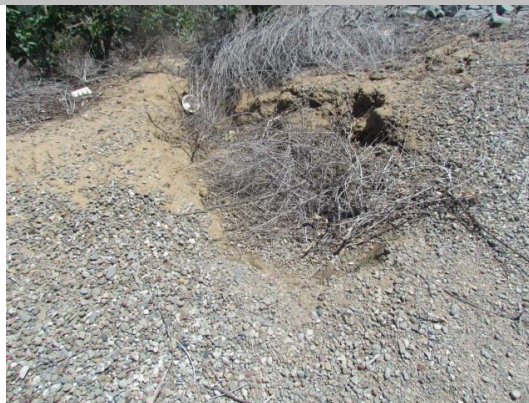
Photo 1 of 2 : SP\_2015\_RD0544\_109\_38\_20150430\_00057.jpg

Looking southeast at erosion/caving on waterward slope.

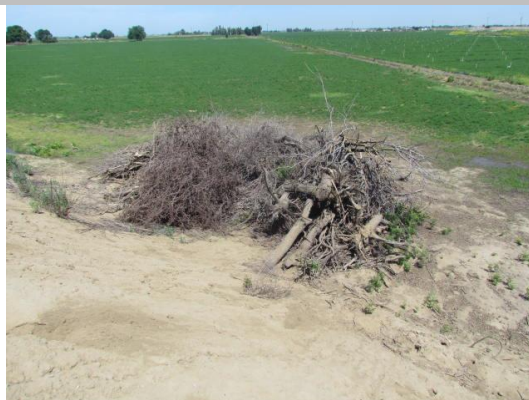
Photo 1 of 1 : SP\_2015\_RD0544\_109\_57\_20150430\_00059.jpg

Looking west at pruning pile at landward toe.(Spring 2015)

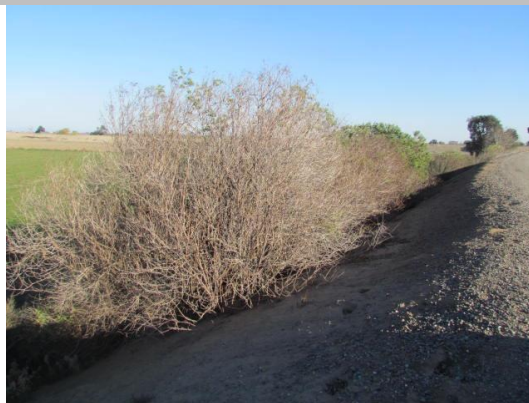
Photo 1 of 1 : SP\_2015\_RD0544\_109\_13\_20150309\_00018.jpg

Looking northwest at elderberries on landside slope and toe.

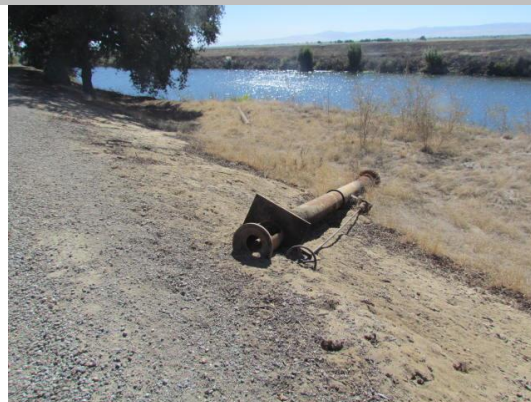
Photo 1 of 1 : SP\_2015\_RD0544\_109\_50\_20150309\_00041.jpg

Looking northwest at pipe on waterward slope.

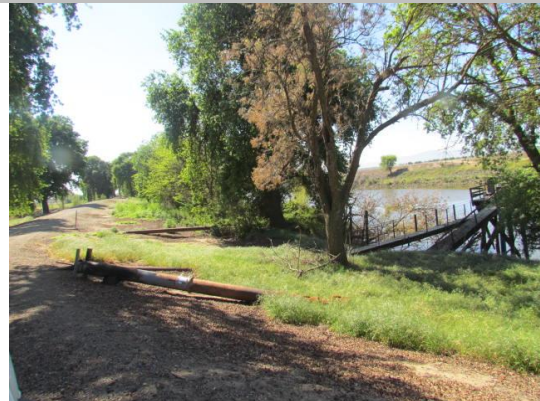
Photo 1 of 1 : SP\_2015\_RD0544\_109\_51\_20150309\_00042.jpg

Looking north at old pump shaft and pipe on waterward slope.

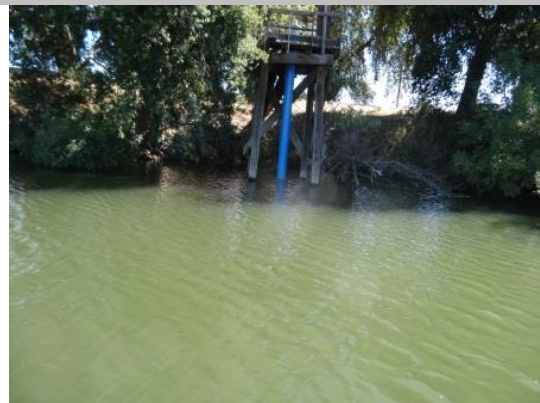
Photo 1 of 1 : SP\_2015\_RD0544\_109\_12\_20150309\_00017.jpg

Front view of the erosion site. View is partially blocked by the pump structure and vegetation.

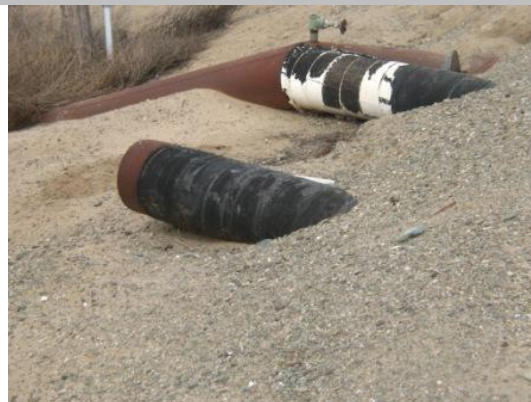
Photo 1 of 1 : SP\_2015\_RD0544\_109\_15\_20150309\_00019.jpg

Abandoned pipe at LM 2.65, landside view.

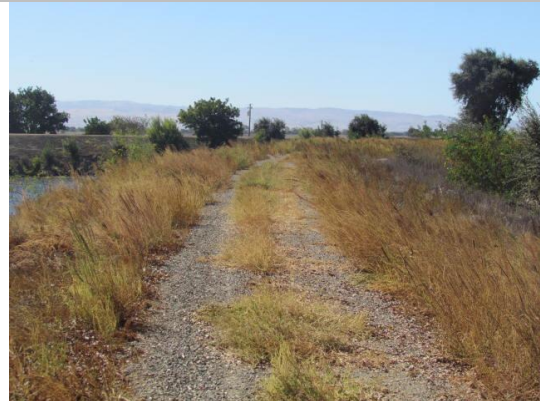
Photo 1 of 1 : SP\_2015\_RD0544\_109\_52\_20150309\_00043.jpg

Looking south at vegetation on levee crown.

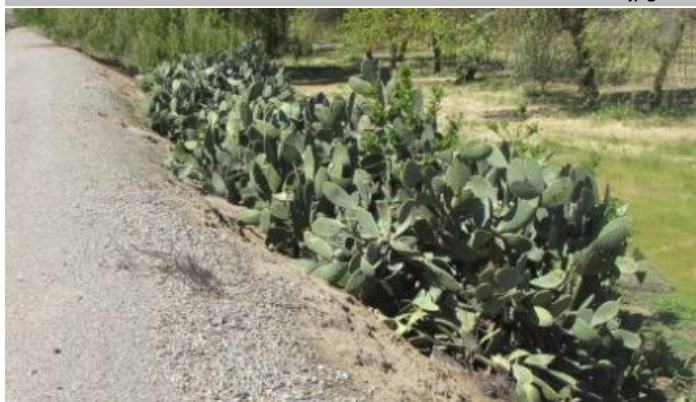
Photo 2 of 2 : SP\_2015\_RD0544\_109\_36\_20150309\_00038.jpg

Looking southwest at overgrown cactus on landside slope.

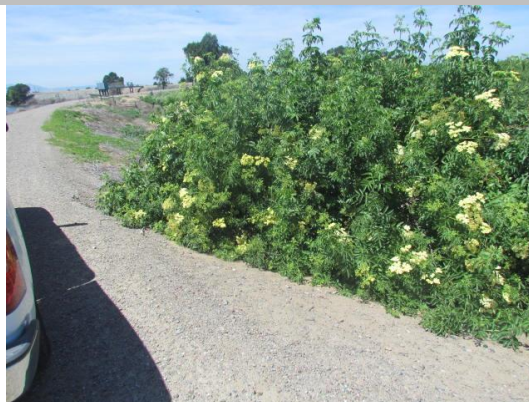
Photo 1 of 1 : SP\_2015\_RD0544\_109\_64\_20150430\_00061.jpg

Looking southwest at dense elderberry bush on landward slope and toe.  
(Spring 2015)
