**Flood Control Project Maintenance
Levee Inspections**

Maintenance Issue Types Only, Levee Inspection Report By Mile - Spring 2016

Reclamation District No. 0544 Upper Roberts Island

Waterway	Bank	Unit Miles	Inspection Start/End	Inspector
Unit No. 01 San Joaquin River	Left	6.05	04/19/2016 04/19/2016	Richard Willoughby

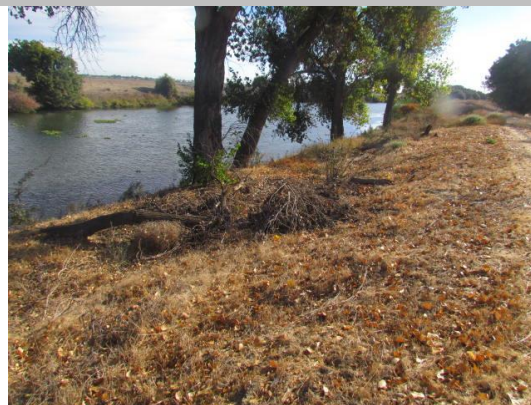
Photo 1 of 1 : SP_2016_RD0544_108_6_20160404_00010.jpg

LM Start	0.45	Rating **	M	Issue No.	6
LM End	0.45	Issue Type +	Ma	Location *	WS
Category	Earthen Levee			GPS Latitude/Longitude	
				Start	End
Item	Encroachments			37.864713 °	37.864713 °
				-121.326708 °	-121.326708 °
DWR ID	DWR_RD0544_01_f_2013_6				
Comment Code					
PR : Prunings					
Inspector Comment					
Broken tree limbs on waterward slope and berm.

Looking southeast at tree branch on waterward slope.

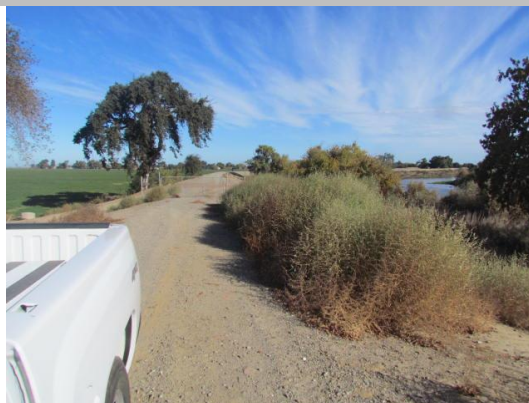
Photo 1 of 1 : SP_2016_RD0544_108_94_20160404_00058.jpg

Looking north at vegetation on waterward shoulder and slope.

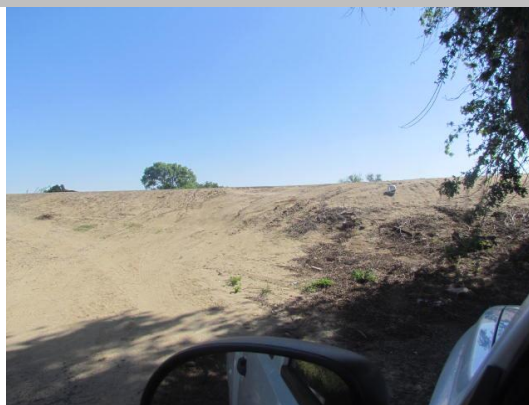
Photo 1 of 1 : SP_2016_RD0544_108_5_20160404_00009.jpg

LM Start	1.82	Rating **	M	Issue No.	5
LM End	1.82	Issue Type +	Ma	Location *	LS
Category	Earthen Levee			GPS Latitude/Longitude	
				Start	End
Item	Slope Stability			37.853188 °	37.853188 °
				-121.324145 °	-121.324145 °
DWR ID	DWR_RD0544_01_s _ 2013_5				
Comment Code					
S3 : Repair the levee slope damaged by vehicle traffic and prevent access where possible.					
Inspector Comment					
Slope damaged by vehicle traffic.

Looking east at landward slope damaged by vehicle traffic.

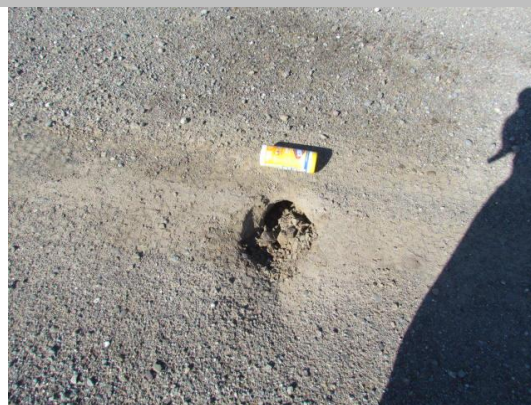
Photo 1 of 2 : SP_2016_RD0544_108_90_20160404_00052.jpg

Looking at rodent hole on levee crown.

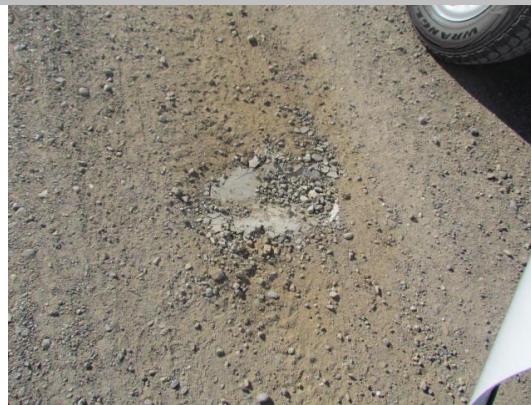
Photo 2 of 2 : SP_2016_RD0544_108_90_20160404_00053.jpg

Looking at grouted rodent hole on levee crown.

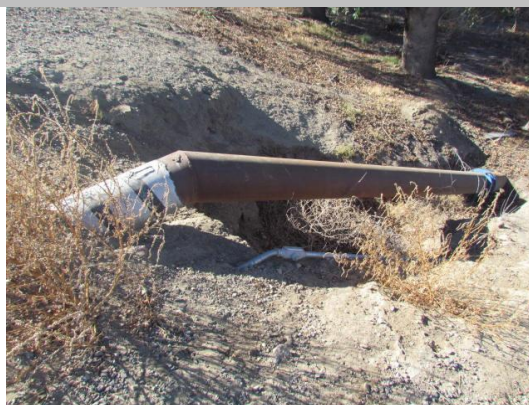
Photo 1 of 3 : SP_2016_RD0544_108_23_20160404_00017.jpg

LM Start	2.26	Rating **	U	Issue No.	23
LM End	2.26	Issue Type +	Ma	Location *	LS
Category	Earthen Levee			GPS Latitude/Longitude	
				Start	End
Item	Erosion / Bank Caving			37.848155 °	37.848155 °
				-121.324897 °	-121.324897 °
DWR ID	DWR_RD0544_01_s_2012_23				
Comment Code					
E2 : Schedule repair of erosion site prior to the next inspection.					
Inspector Comment					
Caving/erosion around irrigation pipe on landside slope.

Looking south at erosion around irrigation pipe on landside slope. (Fall 2014)

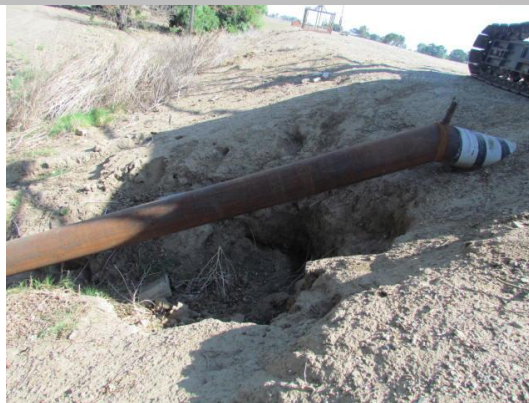
Photo 2 of 3 : SP_2016_RD0544_108_23_20160404_00018.jpg

Looking north at erosion under irrigation pipe on landside slope.

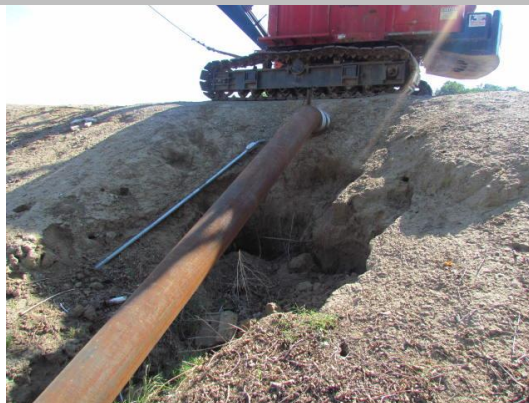
Photo 3 of 3 : SP_2016_RD0544_108_23_20160404_00019.jpg

LM Start	2.26	Rating **	U	Issue No.	23 (cont)	
LM End	2.26	Issue Type +	Ma	Location *	LS	
Category	Earthen Levee			GPS Latitude/Longitude		
				Start		End
Item	Erosion / Bank Caving			37.848155 °		37.848155 °
				-121.324897 °		-121.324897 °
DWR ID	DWR_RD0544_01_s_2012_23					
Comment Code						
E2 : Schedule repair of erosion site prior to the next inspection.						
Inspector Comment						
Caving/erosion around irrigation pipe on landside slope.

Looking east at erosion under irrigation pipe on landside slope.

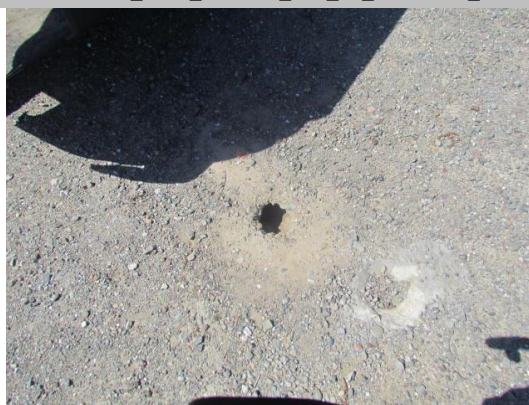
Photo 2 of 2 : SP_2016_RD0544_108_34_20160404_00026.jpg

Looking at rodent hole on levee crown.

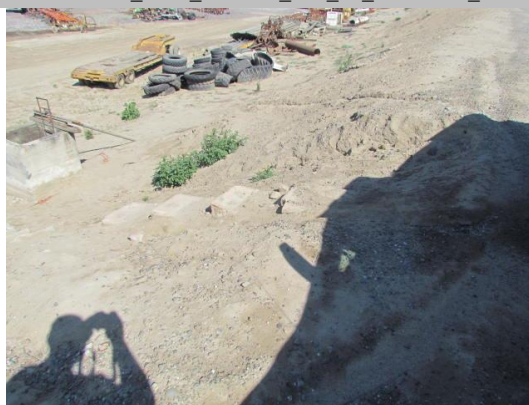
Photo 1 of 2 : SP_2016_RD0544_108_60_20160404_00041.jpg

LM Start	2.57	Rating **	M	Issue No.	60
LM End	2.57	Issue Type +	Ma	Location *	LS
Category	Earthen Levee			GPS Latitude/Longitude	
				Start	End
Item	Slope Stability			37.844337 °	37.844337 °
				-121.321853 °	-121.321853 °
DWR ID	DWR_RD0544_01_s_2012_60				
Comment Code					
S2 : Repair the levee slope damaged by foot traffic and prevent access where possible.					
Inspector Comment					
Finger erosion on landward slope.

Looking north at slope damage on landside slope.

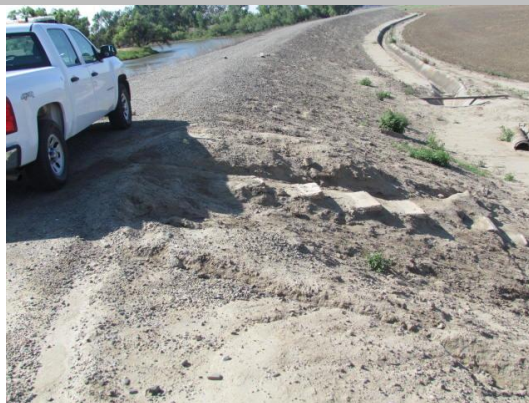
Photo 2 of 2 : SP_2016_RD0544_108_60_20160404_00042.jpg

LM Start	2.57	Rating **	M	Issue No.	60 (cont)	
LM End	2.57	Issue Type +	Ma	Location *	LS	
Category	Earthen Levee			GPS Latitude/Longitude		
				Start		End
Item	Slope Stability			37.844337 °		37.844337 °
				-121.321853 °		-121.321853 °
DWR ID	DWR_RD0544_01_s_2012_60					
Comment Code						
S2 : Repair the levee slope damaged by foot traffic and prevent access where possible.						
Inspector Comment						
Finger erosion on landward slope.

Looking south at slope damage on landside slope.

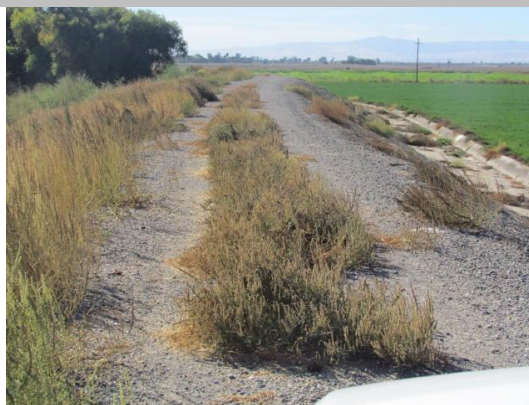
Photo 1 of 1 : SP_2016_RD0544_108_100_20160404_00061.jpg

Looking south at vegetation on levee crown.

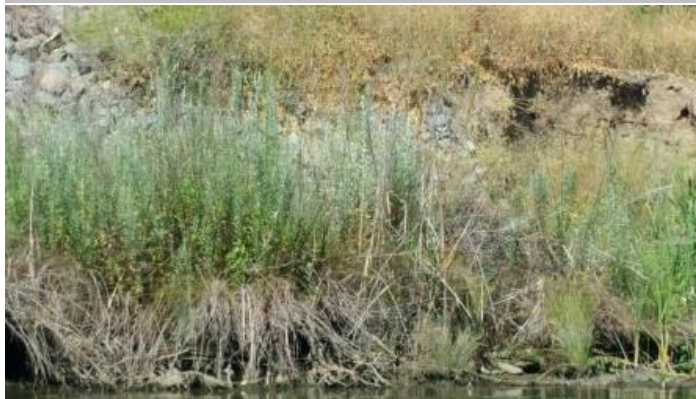
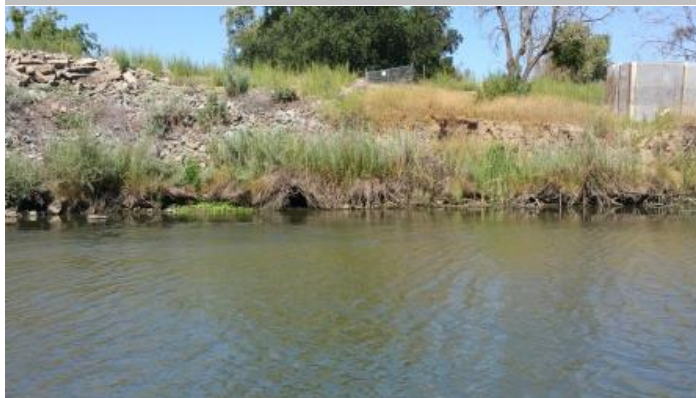
LM Start	2.95	Rating **	U	Issue No.	38
LM End	2.95	Issue Type +	Ma	Location *	WS
Category	Supplemental			GPS Latitude/Longitude	
				Start	End
Item	DWR Erosion Survey			37.840697 °	37.840697 °
				-121.318252 °	-121.318252 °
DWR ID	DWR_RD0544_01_s _ 2016_38				
Comment Code					
Inspector Comment					
06/24/2015: No significant change observed.					
6/19/2014: No significant change observed.					
08/13/2013: Pump has been removed. A larger pocket erosion has been found at the erosion site.					
08/07/2012: The erosion is immediately upstream of a river bend.					
Dense vegetation is visible at the erosion site. [2015 Site ID:RD0544U01RM49.67]

Close view of the site.

Front view of the erosion.

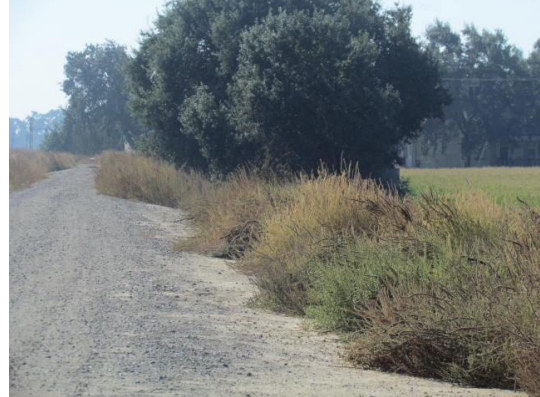
Photo 1 of 1 : SP_2016_RD0544_108_47_20160404_00037.jpg

Looking south at dense veg on landward slope fall 2015.

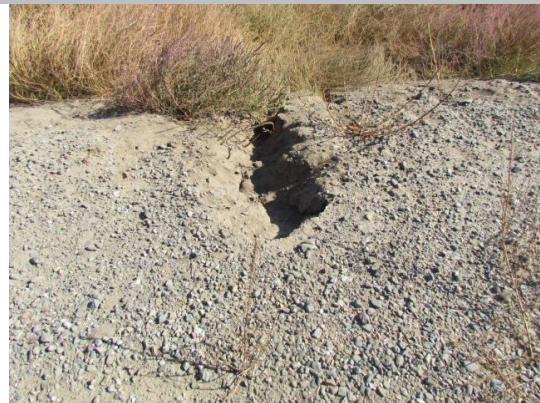
Photo 1 of 1 : SP_2016_RD0544_108_76_20160404_00048.jpg

LM Start	3.14	Rating **	M	Issue No.	76
LM End	3.14	Issue Type +	Ma	Location *	WS
Category	Earthen Levee			GPS Latitude/Longitude	
				Start	End
Item	Slope Stability			37.837929 °	37.837929 °
				-121.317663 °	-121.317663 °
DWR ID	DWR_RD0544_01_f_2013_76				
Comment Code					
S1 : Repair slope instability.					
Inspector Comment					
Slope damaged extends from levee slope to shoulder.

Looking east at slope damage on waterward slope.

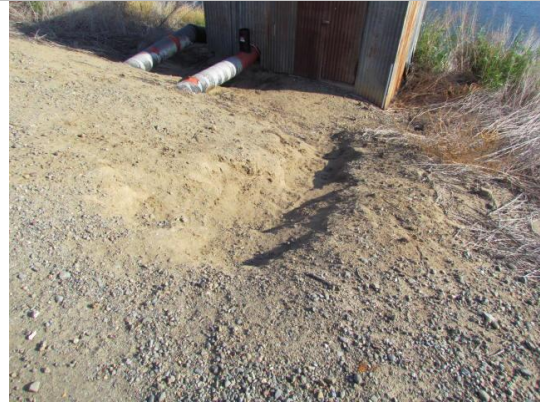
Photo 1 of 1 : SP_2016_RD0544_108_62_20160404_00043.jpg

LM Start	3.17	Rating **	M	Issue No.	62
LM End	3.17	Issue Type +	Ma	Location *	WS
Category	Earthen Levee			GPS Latitude/Longitude	
				Start	End
Item	Slope Stability			37.837530 °	37.837530 °
				-121.317510 °	-121.317510 °
DWR ID	DWR_RD0544_01_s_2012_62				
Comment Code					
S2 : Repair the levee slope damaged by foot traffic and prevent access where possible.					
Inspector Comment					
Slope damage due to foot traffic.

Looking east at slope damaged by foot traffic near pump house on waterside of levee.

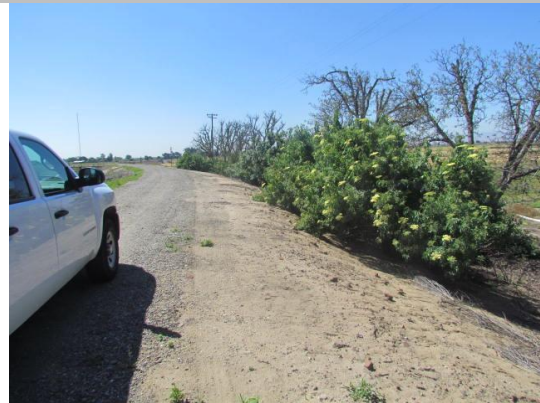
Photo 1 of 1 : SP_2016_RD0544_108_49_20160404_00038.jpg

Looking southwest at untrimmed trees at landward toe.

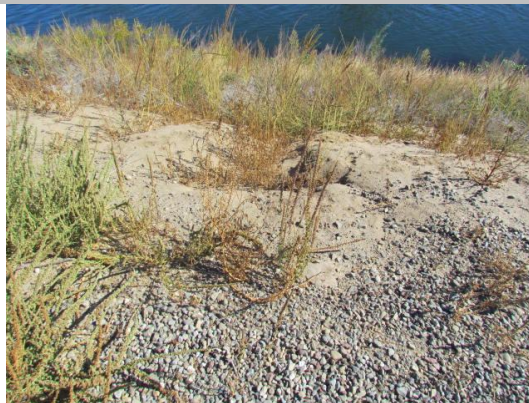
Photo 1 of 1 : SP_2016_RD0544_108_50_20160404_00039.jpg

LM Start	3.29	Rating **	M	Issue No.	50
LM End	3.29	Issue Type +	Ma	Location *	WS
Category	Earthen Levee			GPS Latitude/Longitude	
				Start	End
Item	Erosion / Bank Caving			37.835815 °	37.835815 °
				-121.316997 °	-121.316997 °
DWR ID	DWR_RD0544_01_s _ 2012_50				
Comment Code					
E1 : Note and monitor erosion site.					
Inspector Comment					
Erosion located on waterside shoulder. Erosion caused by rain runoff.

Looking east at erosion on waterward slope.

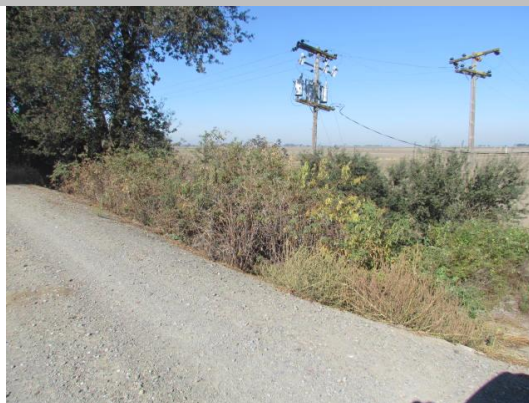
Photo 1 of 1 : SP_2016_RD0544_108_57_20160404_00040.jpg

Looking southwest at dense elderberries on landward slope fall 2015.

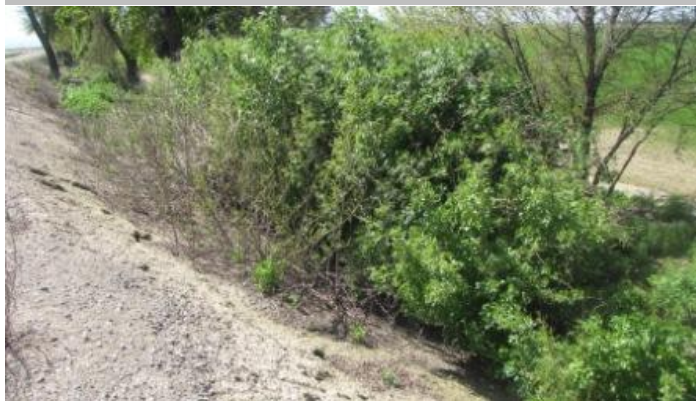
Photo 1 of 1 : SP_2016_RD0544_108_41_20160404_00033.jpg

Looking south at elderberries on landside slope and toe.

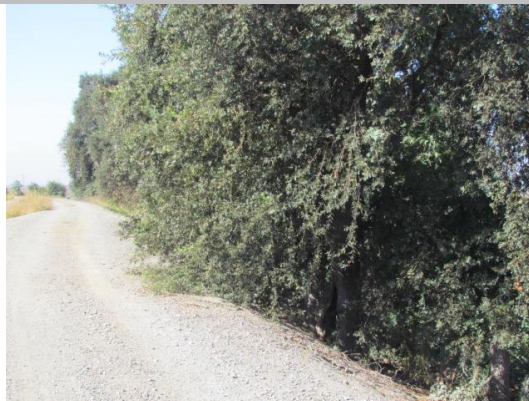
Photo 1 of 1 : SP_2016_RD0544_108_104_20160404_00062.jpg

Looking southwest at dense untrimmed trees on landward slope fall 2015.

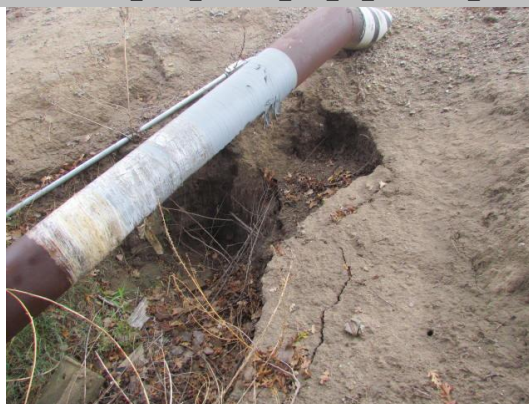
Photo 1 of 2 : SP_2016_RD0544_108_28_20160404_00021.jpg

Looking northeast at erosion around irrigation pipe on landside slope.

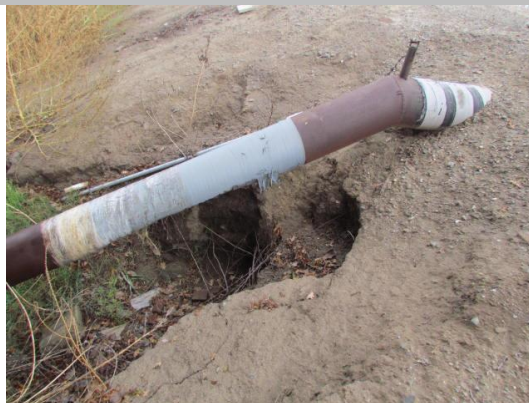
Photo 2 of 2 : SP_2016_RD0544_108_28_20160404_00022.jpg

Looking north at erosion around irrigation pipe on landside

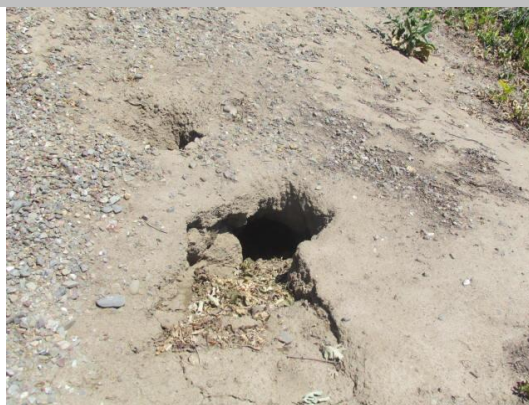
Photo 1 of 1 : SP_2016_RD0544_108_113_20160404_00068.jpg

Looking north at large hole on waterward slope.

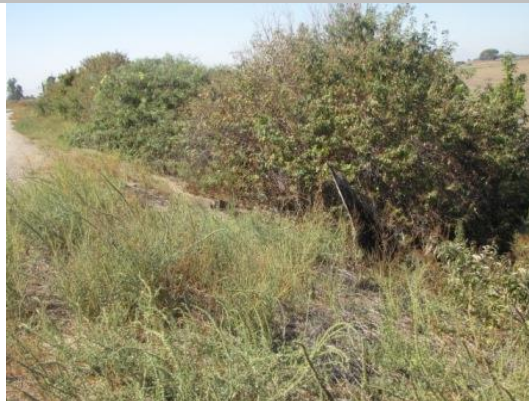
Photo 2 of 2 : SP_2016_RD0544_108_18_20160404_00016.jpg

Looking south at elderberries on landside slope and toe.

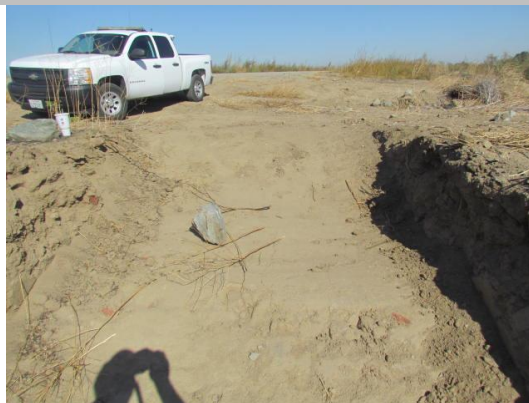
Photo 1 of 4 : SP_2016_RD0544_108_121_20160404_00076.jpg

Looking west at excavation on waterward berm.

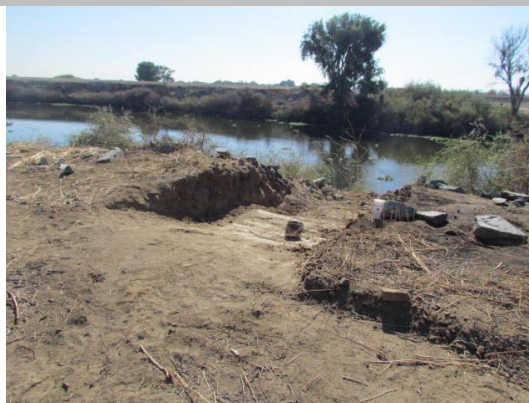
Photo 3 of 4 : SP_2016_RD0544_108_121_20160404_00078.jpg

Looking northeast at excavation on waterward berm

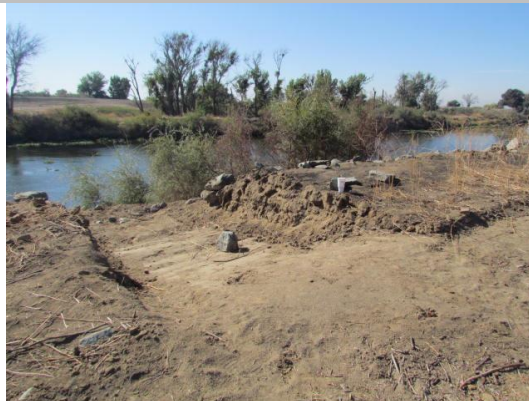
Photo 4 of 4 : SP_2016_RD0544_108_121_20160404_00079.jpg

Looking southeast at excavation on waterward berm.

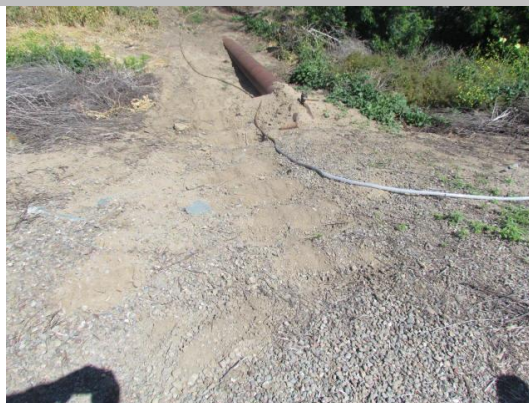
Photo 1 of 3 : SP_2016_RD0544_108_115_20160404_00069.jpg

Looking west at slope damage on landward slope.

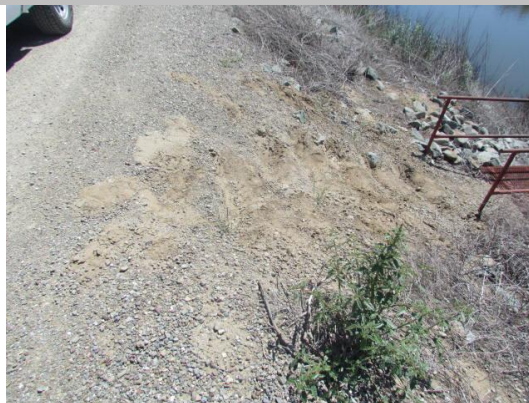
Photo 2 of 3 : SP_2016_RD0544_108_115_20160404_00070.jpg

Looking east at slope damage on waterward slope.

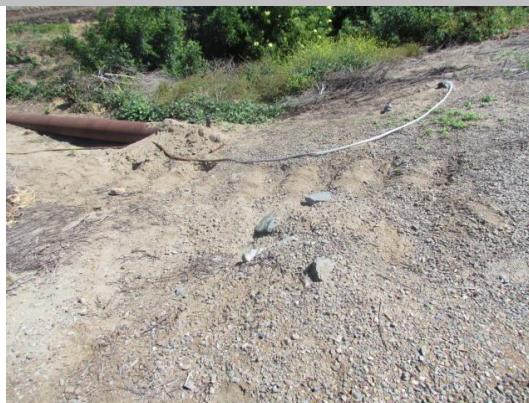
Photo 3 of 3 : SP_2016_RD0544_108_115_20160404_00071.jpg

Looking northwest at slope damage on landward toe.

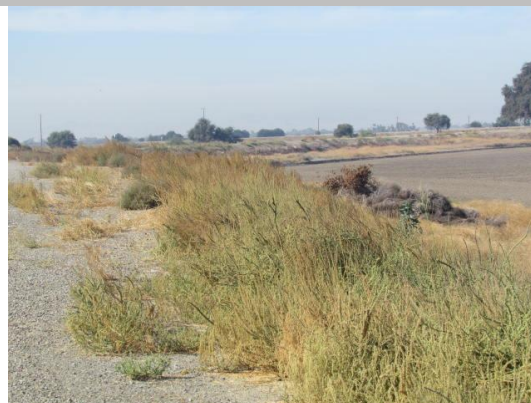
Photo 1 of 2 : SP_2016_RD0544_109_3_20160404_00002.jpg

Looking south at dense veg on landward slope and toe fall 2015.

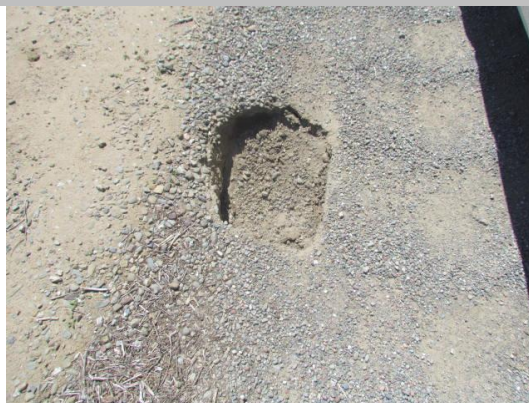
Photo 1 of 1 : SP_2016_RD0544_109_46_20160404_00040.jpg

Looking at depression on landward shoulder.

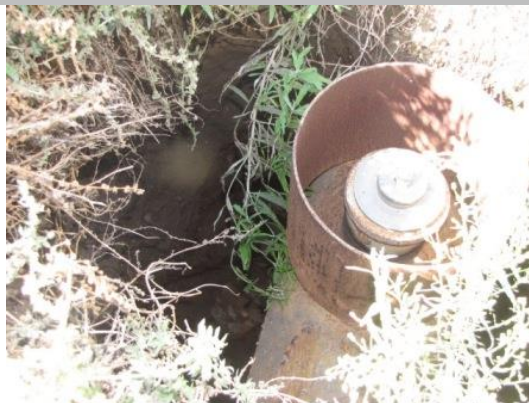
Photo 2 of 8 : SP_2016_RD0544_109_8_20160404_00008.jpg

Looking at caving around 10" siphon pipe on waterside shoulder.

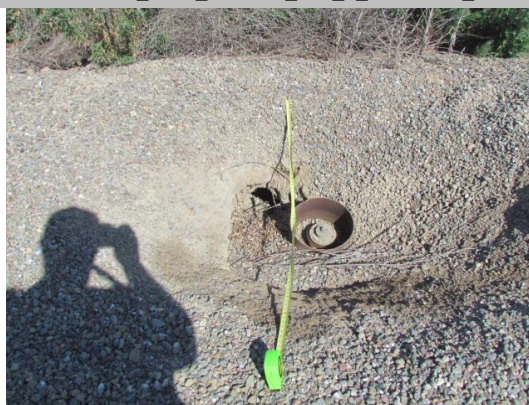
Photo 4 of 8 : SP_2016_RD0544_109_8_20160404_00010.jpg

Looking east at caving around siphon on waterside shoulder. (Spring 2012)

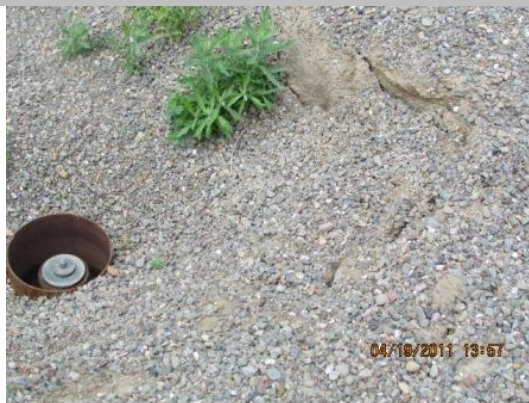
Photo 5 of 8 : SP_2016_RD0544_109_8_20160404_00011.jpg

Looking at top of siphon with a depression greater than 6" on waterside shoulder.

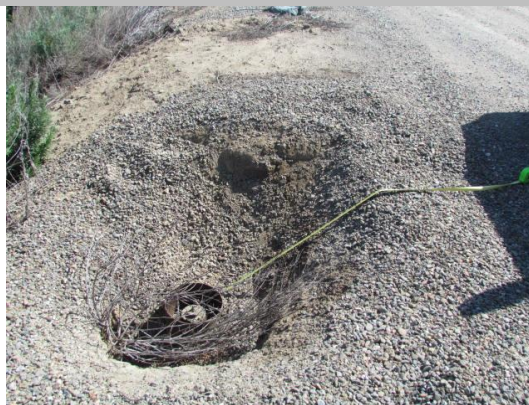
Photo 7 of 8 : SP_2016_RD0544_109_8_20160404_00013.jpg

Looking south at caving around siphon on waterside shoulder. (Spring 2012)

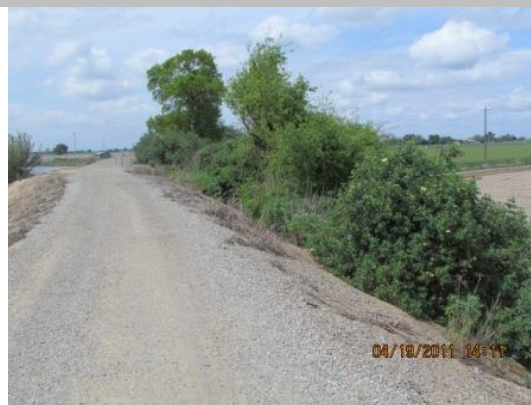
Photo 1 of 2 : SP_2016_RD0544_109_10_20160404_00018.jpg

Looking southwest at elderberries on landside slope.

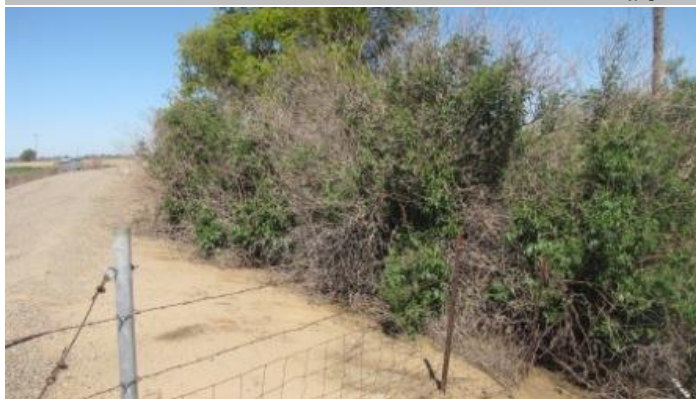
Photo 2 of 2 : SP_2016_RD0544_109_10_20160404_00019.jpg

Looking south at elderberries on landside slope and toe.

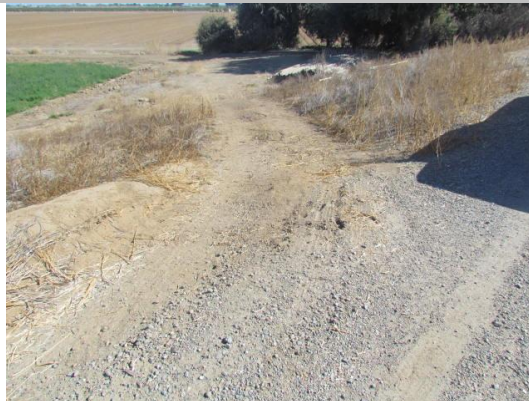
Photo 1 of 2 : SP_2016_RD0544_109_22_20160404_00031.jpg

Looking northwest at slope damage caused by vehicle traffic (Fall 2014).

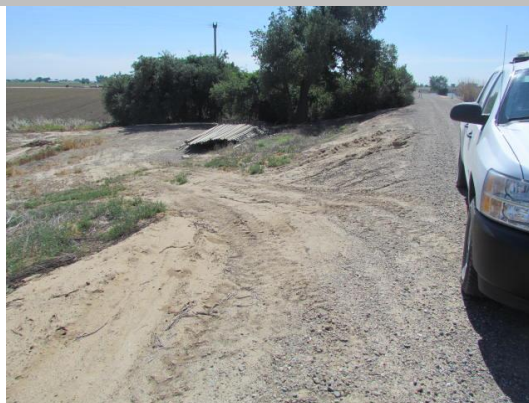
Photo 2 of 2 : SP_2016_RD0544_109_22_20160404_00032.jpg

Looking northwest at slope damage caused by vehicle traffic.

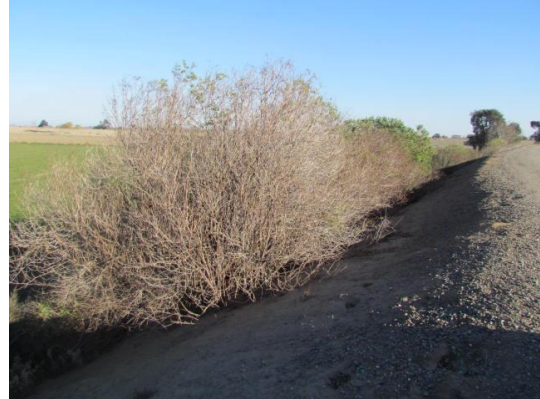
Photo 1 of 1 : SP_2016_RD0544_109_13_20160404_00022.jpg

Looking northwest at elderberries on landside slope and toe.

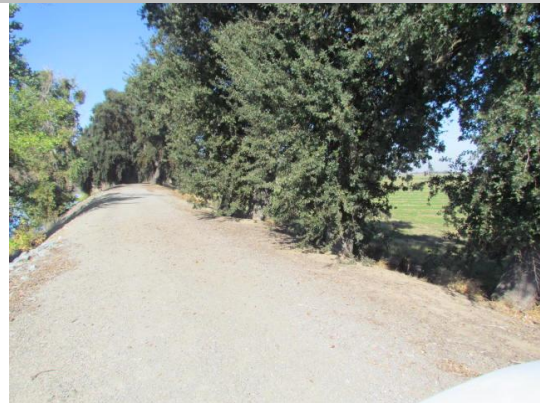
Photo 1 of 1 : SP_2016_RD0544_109_59_20160404_00050.jpg

Looking southwest at untrimmed trees on landward slope and toe fall 2015.

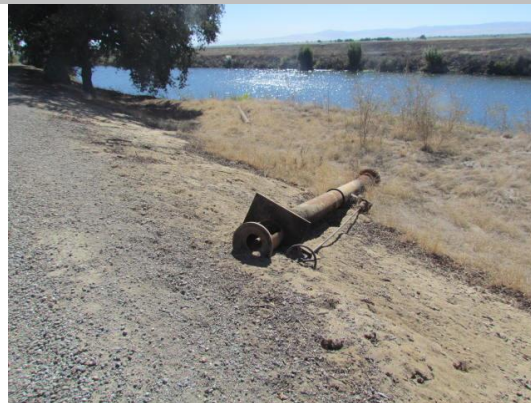
Photo 1 of 1 : SP_2016_RD0544_109_50_20160404_00043.jpg

Looking northwest at pipe on waterward slope.

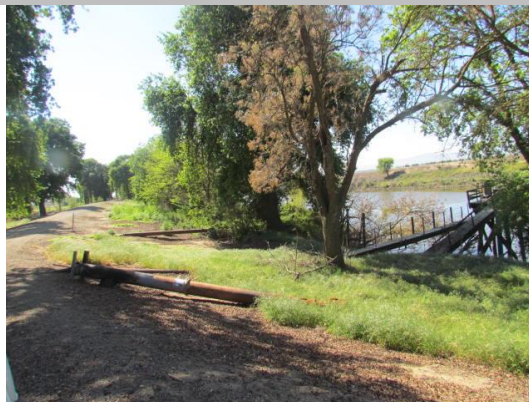
Photo 1 of 1 : SP_2016_RD0544_109_51_20160404_00044.jpg

Looking north at old pump shaft and pipe on waterward slope.

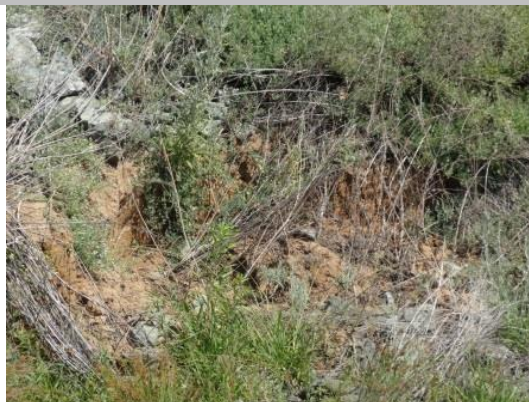
Photo 2 of 2 : SP_2016_RD0544_109_7_20160404_00006.jpg

Close view of pocket erosion.

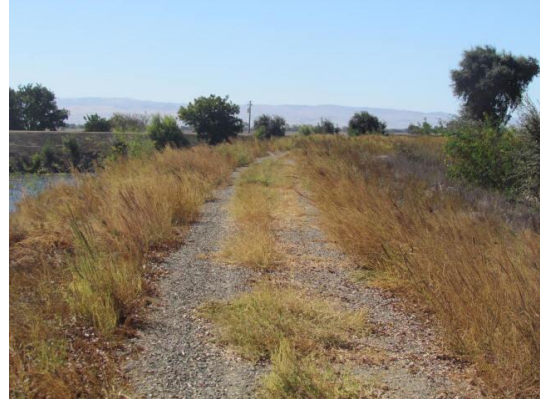
Photo 1 of 1 : SP_2016_RD0544_109_52_20160404_00045.jpg

Looking south at vegetation on levee crown.

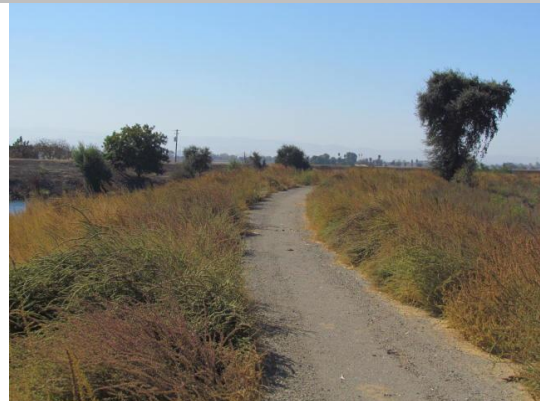
Photo 1 of 1 : SP_2016_RD0544_109_43_20160404_00039.jpg

Looking south a dense vegetation on landward and waterward slope.

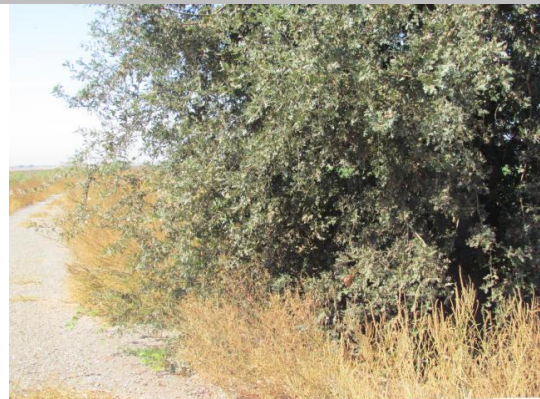
Photo 1 of 1 : SP_2016_RD0544_109_53_20160404_00046.jpg

Looking southwest at untrimmed tree on landward slope fall 2015.

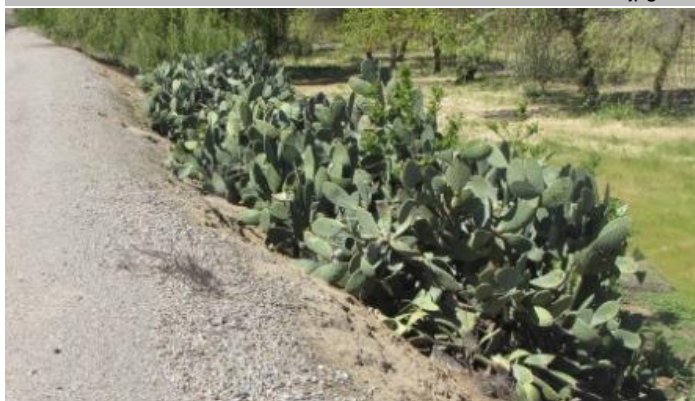
Photo 3 of 3 : SP_2016_RD0544_109_36_20160404_00036.jpg

Looking southwest at overgrown cactus on landside slope spring 2015.

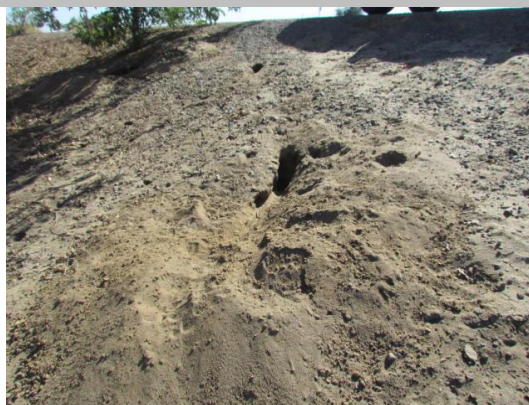
Photo 2 of 2 : SP_2016_RD0544_109_67_20160404_00055.jpg

Looking north at typical view of rodent holes on landward slope.

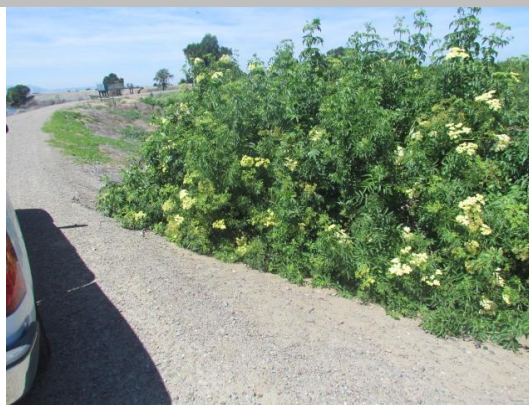
Photo 1 of 1 : SP_2016_RD0544_109_64_20160404_00052.jpg

Looking southwest at dense elderberry bush on landward slope and toe.
(Spring 2015)
