**Flood Control Project Maintenance
Levee Inspections**

Maintenance Issue Types Only, Levee Inspection Report By Mile - Spring 2017

Reclamation District No. 0544 Upper Roberts Island

Waterway	Bank	Unit Miles	Inspection Start/End	Inspector
Unit No. 01 San Joaquin River	Left	6.05	04/05/2017 04/05/2017	Richard Willoughby

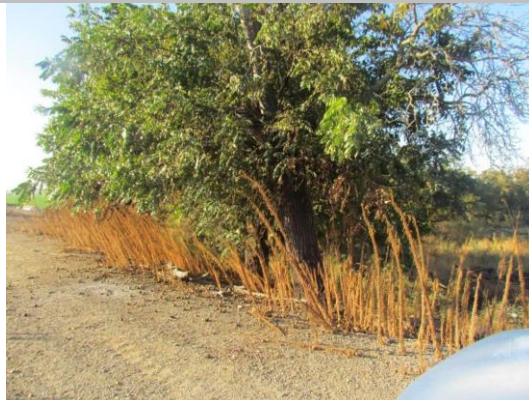
Photo 1 of 1 : SP_2017_RD0544_108_92_20170316_00058.jpg

LM Start	0.01	Rating **	U	Issue No.	92
LM End	0.01	Issue Type +	Ma	Location *	LS
Category	Earthen Levee			GPS Latitude/Longitude	
				Start	End
Item	Trim / Thin Trees			37.870285 °	37.870285 °
				-121.329822 °	-121.329822 °
DWR ID	DWR_RD0544_01_f_2014_92				
Comment Code					
T1 : Trim trees to at least five feet above ground level.					
Inspector Comment					
Untrimmed tree on landward slope.

Looking southwest at untrimmed tree on landward slope.

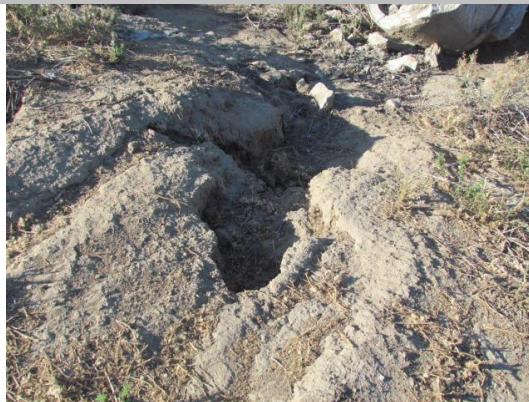
Photo 1 of 1 : SP_2017_RD0544_108_118_20170316_00075.jpg

LM Start	0.06	Rating **	U	Issue No.	118
LM End	0.06	Issue Type +	Ma	Location *	LS
Category	Earthen Levee			GPS Latitude/Longitude	
				Start	End
Item	Erosion / Bank Caving			37.869570 °	37.869570 °
				-121.329556 °	-121.329556 °
DWR ID	DWR_RD0544_01_f_2015_118				
Comment Code					
E2 : Schedule repair of erosion site prior to the next inspection.					
Inspector Comment					
Finger erosion noted on landward slope.

Looking west at landside erosion for shoulder to middle of levee slope.

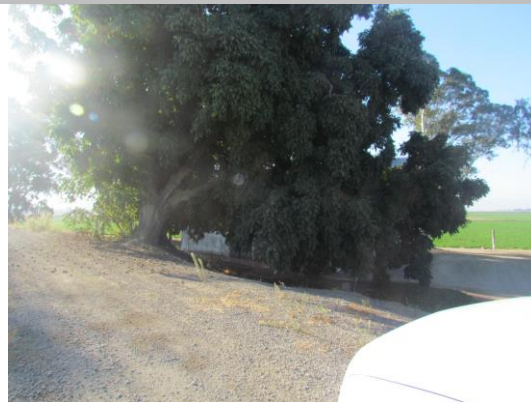
Photo 1 of 1 : SP_2017_RD0544_108_2_20170316_00002.jpg

Looking southwest at untrimmed tree on landward slope.

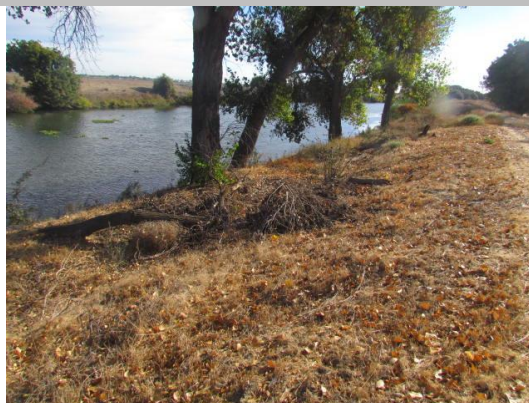
Photo 1 of 1 : SP_2017_RD0544_108_6_20170316_00009.jpg

LM Start	0.45	Rating **	M	Issue No.	6
LM End	0.45	Issue Type +	Ma	Location *	WS
Category	Earthen Levee			GPS Latitude/Longitude	
				Start	End
Item	Encroachments			37.864713 °	37.864713 °
				-121.326708 °	-121.326708 °
DWR ID	DWR_RD0544_01_f_2013_6				
Comment Code					
PR : Prunings					
Inspector Comment					
Broken tree limbs on waterward slope and berm.

Looking southeast at tree branch on waterward slope.

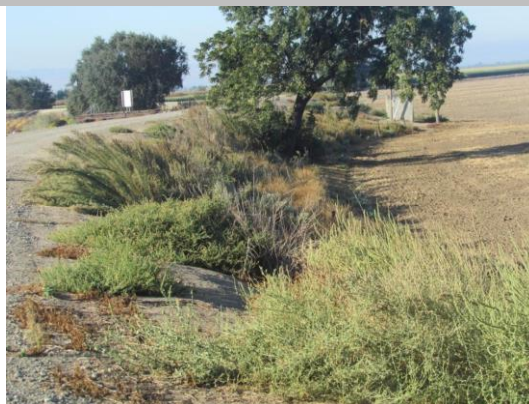
Photo 1 of 1 : SP_2017_RD0544_108_89_20170316_00057.jpg

Looking southwest at dense veg on landward slope and toe.

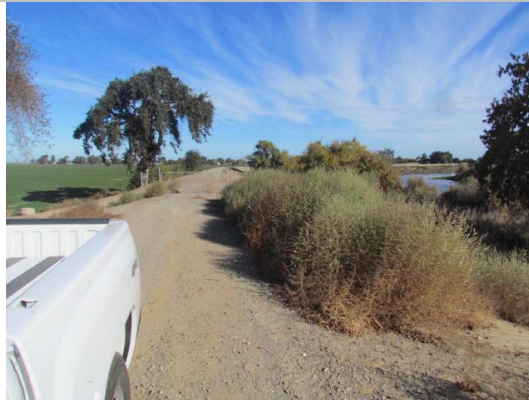
Photo 1 of 1 : SP_2017_RD0544_108_94_20170316_00060.jpg

Looking north at vegetation on waterward shoulder and slope.

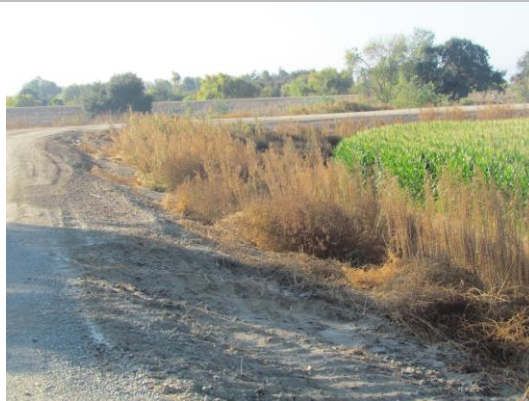
Photo 1 of 1 : SP_2017_RD0544_108_42_20170316_00032.jpg

Looking at dense veg. on landward slope and toe.

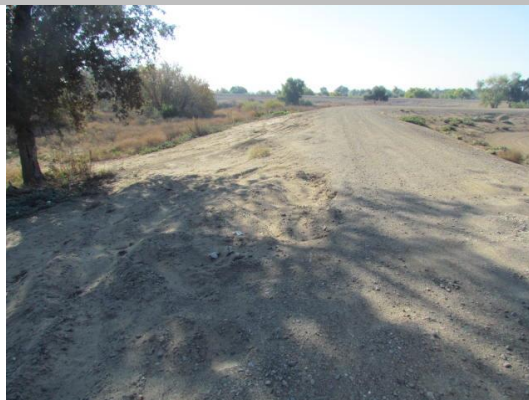
Photo 1 of 3 : SP_2017_RD0544_108_119_20170316_00076.jpg

LM Start	1.50	Rating **	U	Issue No.	119
LM End	1.51	Issue Type +	Ma	Location *	WS
Category	Earthen Levee			GPS Latitude/Longitude	
				Start	End
Item	Slope Stability			37.854844 °	37.854564 °
				-121.321090 °	-121.321031 °
DWR ID	DWR_RD0544_01_f_2015_119				
Comment Code					
S3 : Repair the levee slope damaged by vehicle traffic and prevent access where possible.					
Inspector Comment					
Damaged levee slope due to fishermen using slope as a ramp.

Looking southeast at damaged waterward slope fall 2015.

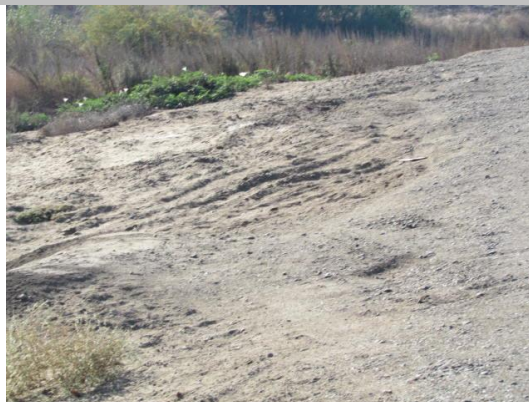
Photo 2 of 3 : SP_2017_RD0544_108_119_20170316_00077.jpg

Looking east at damaged waterward slope fall 2015.

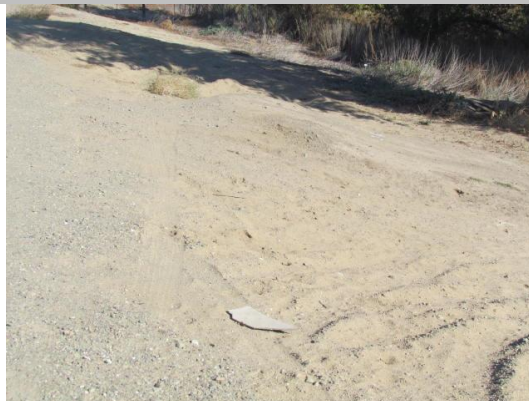
Photo 3 of 3 : SP_2017_RD0544_108_119_20170316_00078.jpg

LM Start	1.50	Rating **	U	Issue No.	119 (cont)	
LM End	1.51	Issue Type +	Ma	Location *	WS	
Category	Earthen Levee			GPS Latitude/Longitude		
				Start		End
Item	Slope Stability			37.854844 °		37.854564 °
				-121.321090 °		-121.321031 °
DWR ID	DWR_RD0544_01_f_2015_119					
Comment Code						
S3 : Repair the levee slope damaged by vehicle traffic and prevent access where possible.						
Inspector Comment						
Damaged levee slope due to fishermen using slope as a ramp.

Looking southeast at damaged waterward slope fall 2015

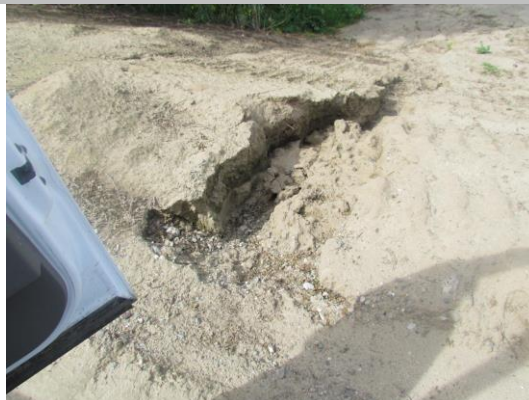
Photo 1 of 2 : SP_2017_RD0544_108_80_20170407_00129.jpg

LM Start	1.82	Rating **	U	Issue No.	80
LM End	1.82	Issue Type +	Ma	Location *	LS
Category	Earthen Levee		GPS Latitude/Longitude		
			Start	End	
Item	Erosion / Bank Caving		37.853173 °	37.853173 °	
			-121.324145 °	-121.324145 °	
DWR ID	DWR_RD0544_01_s_2017_80				
Comment Code					
E2 : Schedule repair of erosion site prior to the next inspection.					
Inspector Comment					
Repair slope damage due to water runoff.

Looking west at slope damage due to rain runoff on waterward slope.

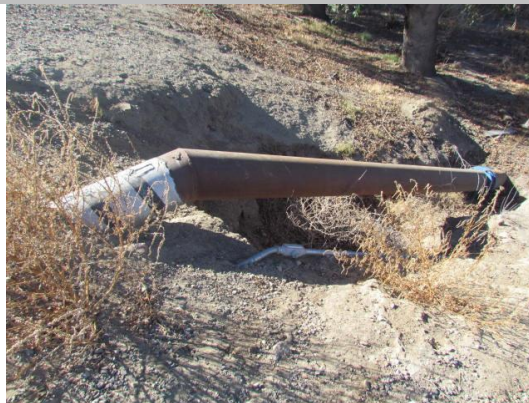
Photo 1 of 3 : SP_2017_RD0544_108_23_20170316_00018.jpg

LM Start	2.26	Rating **	U	Issue No.	23
LM End	2.26	Issue Type +	Ma	Location *	LS
Category	Earthen Levee			GPS Latitude/Longitude	
				Start	End
Item	Erosion / Bank Caving			37.848155 °	37.848155 °
				-121.324897 °	-121.324897 °
DWR ID	DWR_RD0544_01_s_2012_23				
Comment Code					
E2 : Schedule repair of erosion site prior to the next inspection.					
Inspector Comment					
Caving/erosion around irrigation pipe on landside slope.

Looking south at erosion around irrigation pipe on landside slope. (Fall 2014)

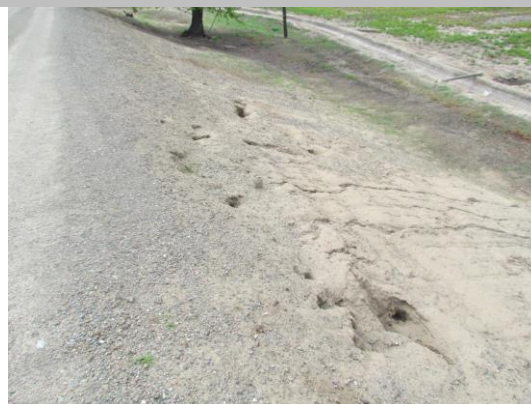
Photo 1 of 1 : SP_2017_RD0544_108_8_20170407_00132.jpg

Looking southwest at several rodent holes on landward shoulder and slope.

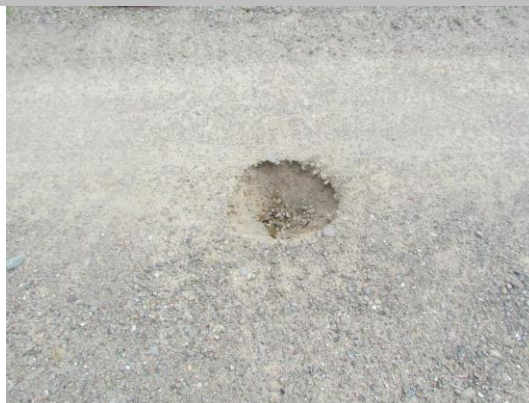
Photo 1 of 1 : SP_2017_RD0544_108_90_20170410_00133.jpg

LM Start	2.30	Rating **	U	Issue No.	90
LM End	2.30	Issue Type +	Ma	Location *	CR
Category	Earthen Levee			GPS Latitude/Longitude	
				Start	End
Item	Crown Surface / Depressions / Rutting			37.847542 °	37.847542 °
				-121.324732 °	-121.324732 °
DWR ID	DWR_RD0544_01_s_2017_90				
Comment Code					
C2 : Repair depressions or ruts in the crown or slope.					
Inspector Comment					
Sinkhole forming in crown.

Looking at sinkhole on levee crown.

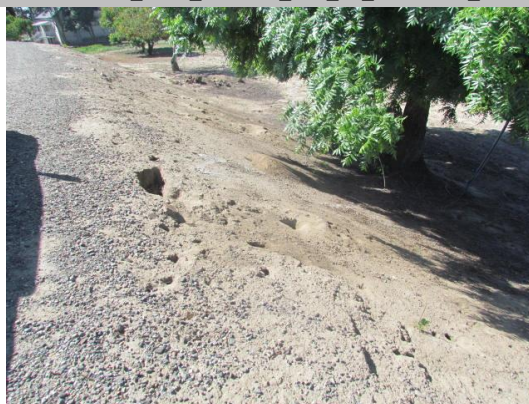
Photo 2 of 3 : SP_2017_RD0544_108_34_20170316_00026.jpg

Looking south at several rodent holes on landward shoulder and slope.

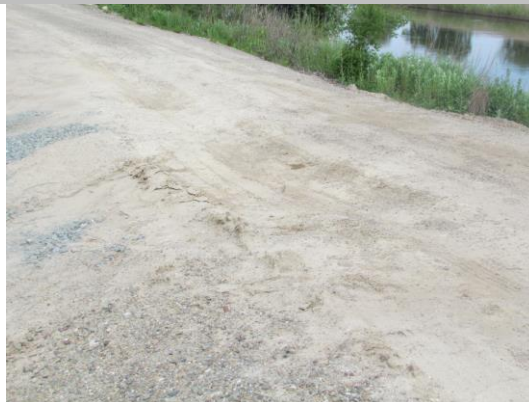
Photo 1 of 1 : SP_2017_RD0544_108_91_20170410_00135.jpg

LM Start	2.43	Rating **	U	Issue No.	91
LM End	2.43	Issue Type +	Ma	Location *	LS
Category	Earthen Levee			GPS Latitude/Longitude	
				Start	End
Item	Slope Stability			37.845973 °	37.845973 °
				-121.323373 °	-121.323373 °
DWR ID	DWR_RD0544_01_s_2017_91				
Comment Code					
S3 : Repair the levee slope damaged by vehicle traffic and prevent access where possible.					
Inspector Comment					
Slope stability with depression in crown due to vehicle traffic.

Looking south at depression on levee crown and landward slope.

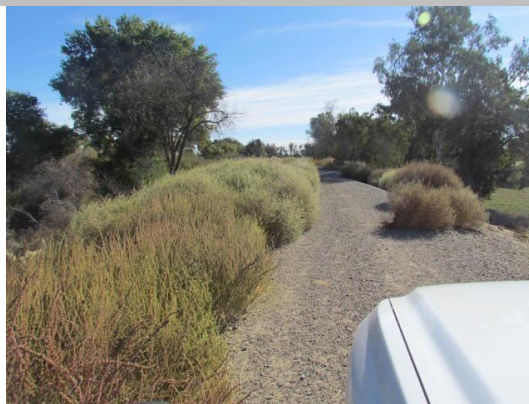
Photo 1 of 1 : SP_2017_RD0544_108_99_20170316_00064.jpg

Looking south at dense vegetation on waterward shoulder and slope.

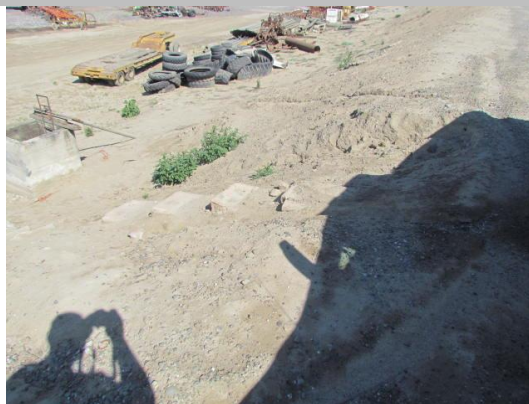
Photo 1 of 2 : SP_2017_RD0544_108_60_20170316_00043.jpg

LM Start	2.54	Rating **	M	Issue No.	60
LM End	2.58	Issue Type +	Ma	Location *	LS
Category	Earthen Levee			GPS Latitude/Longitude	
				Start	End
Item	Slope Stability			37.844765 °	37.844253 °
				-121.322143 °	-121.321850 °
DWR ID	DWR_RD0544_01_s_2012_60				
Comment Code					
S2 : Repair the levee slope damaged by foot traffic and prevent access where possible.					
Inspector Comment					
Finger erosion on landward slope.

Looking north at slope damage on landside slope.

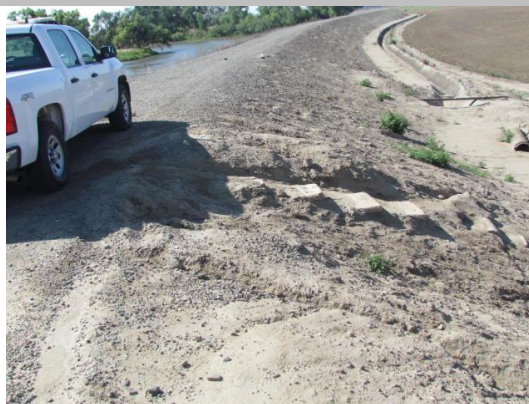
Photo 2 of 2 : SP_2017_RD0544_108_60_20170316_00044.jpg

Looking south at slope damage on landside slope.

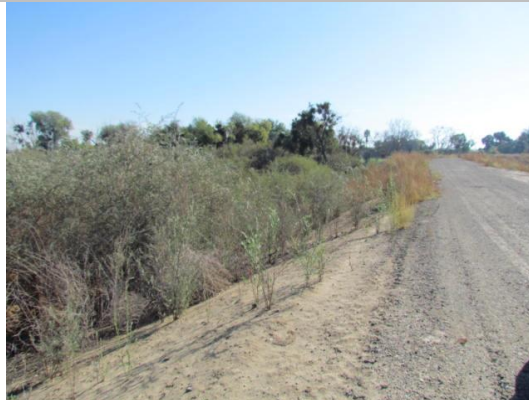
Photo 1 of 1 : SP_2017_RD0544_108_106_20170316_00067.jpg

Looking southeast at dense willows (veg) on waterward slope and toe fall 2015.

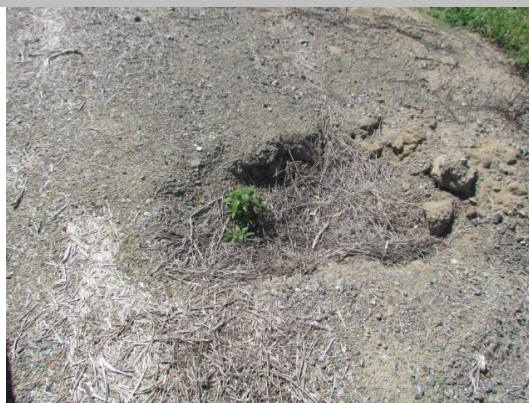
Photo 2 of 2 : SP_2017_RD0544_108_107_20170316_00069.jpg

Looking west at depression on landward shoulder.

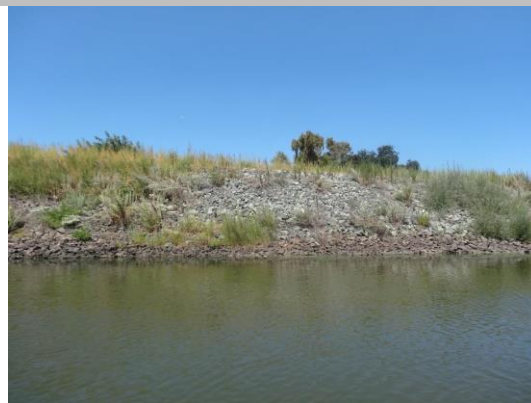
Photo 1 of 2 : SP_2017_RD0544_108_46_20170316_00035.jpg

LM Start	2.95	Rating **	U	Issue No.	46
LM End	2.95	Issue Type +	Ma	Location *	WS
Category	Supplemental			GPS Latitude/Longitude	
				Start	End
Item	DWR Erosion Survey			37.840697 °	37.840697 °
				-121.318252 °	-121.318252 °
DWR ID	DWR_RD0544_01_s_2017_46				
Comment Code					
Inspector Comment					
07/25/2016: No significant change observed.					
06/24/2015: No significant change observed.					
06/19/2014: No significant change observed.					
08/13/2013: Pump has been removed. A larger pocket erosion has been found at the erosion site.					
08/07/2012: The erosion is immediately upstream of a river bend.					
Dense vegetation is visible at the erosion site. [2016 Site ID:RD0544U01RM49.67]

Front view of the erosion.

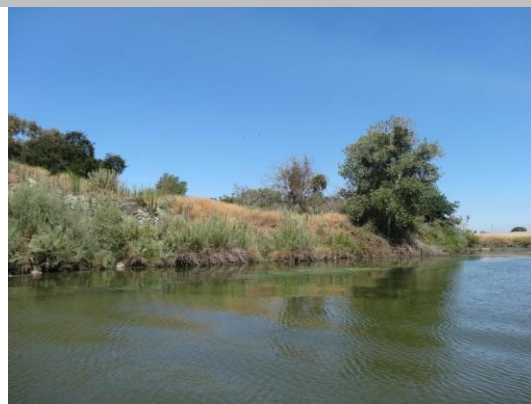
Photo 2 of 2 : SP_2017_RD0544_108_46_20170316_00036.jpg

Close view of the site.

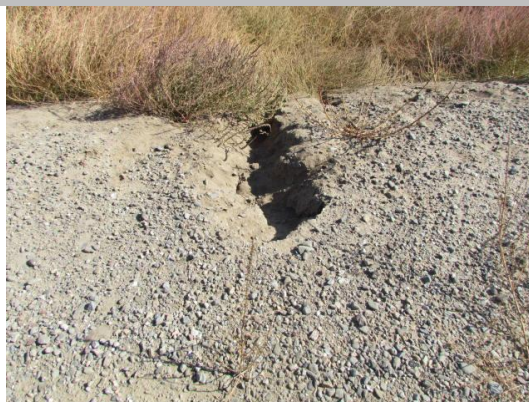
Photo 1 of 1 : SP_2017_RD0544_108_76_20170316_00050.jpg

LM Start	3.14	Rating **	M	Issue No.	76
LM End	3.14	Issue Type +	Ma	Location *	WS
Category	Earthen Levee			GPS Latitude/Longitude	
				Start	End
Item	Erosion / Bank Caving			37.837929 °	37.837929 °
				-121.317663 °	-121.317663 °
DWR ID	DWR_RD0544_01_f_2013_76				
Comment Code					
E2 : Schedule repair of erosion site prior to the next inspection.					
Inspector Comment					
Slope damaged extends from levee slope to shoulder.

Looking east at slope damage on waterward slope.

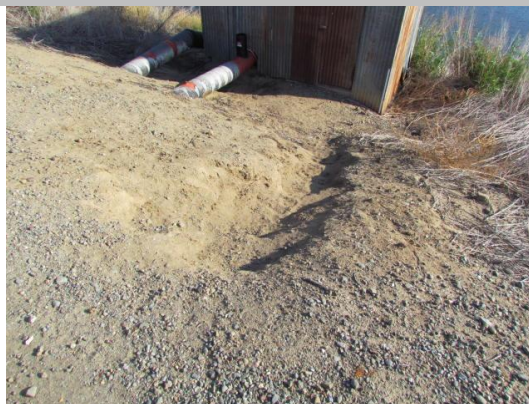
Photo 1 of 1 : SP_2017_RD0544_108_62_20170316_00045.jpg

LM Start	3.17	Rating **	M	Issue No.	62
LM End	3.17	Issue Type +	Ma	Location *	WS
Category	Earthen Levee			GPS Latitude/Longitude	
				Start	End
Item	Slope Stability			37.837530 °	37.837530 °
				-121.317510 °	-121.317510 °
DWR ID	DWR_RD0544_01_s_2012_62				
Comment Code					
S2 : Repair the levee slope damaged by foot traffic and prevent access where possible.					
Inspector Comment					
Slope damage due to foot traffic.

Looking east at slope damaged by foot traffic near pump house on waterside of levee.

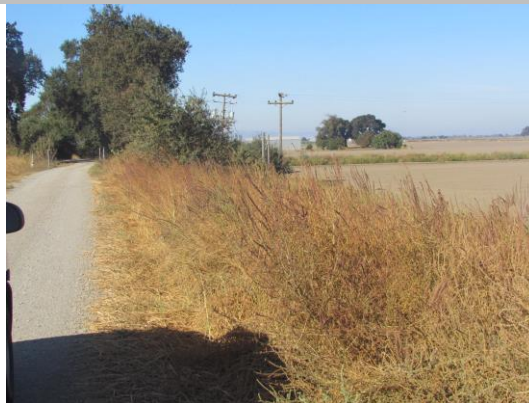
Photo 1 of 1 : SP_2017_RD0544_108_48_20170316_00038.jpg

Looking south at typical view of dense veg on landward slope.

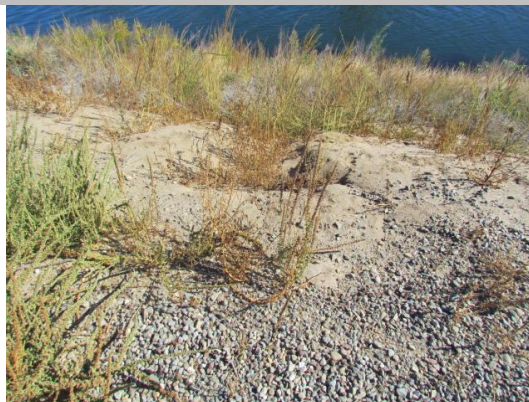
Photo 1 of 1 : SP_2017_RD0544_108_50_20170316_00040.jpg

LM Start	3.29	Rating **	M	Issue No.	50
LM End	3.29	Issue Type +	Ma	Location *	WS
Category	Earthen Levee			GPS Latitude/Longitude	
				Start	End
Item	Erosion / Bank Caving			37.835815 °	37.835815 °
				-121.316997 °	-121.316997 °
DWR ID	DWR_RD0544_01_s_2012_50				
Comment Code					
E1 : Note and monitor erosion site.					
Inspector Comment					
Erosion located on waterside shoulder. Erosion caused by rain runoff.

Looking east at erosion on waterward slope.

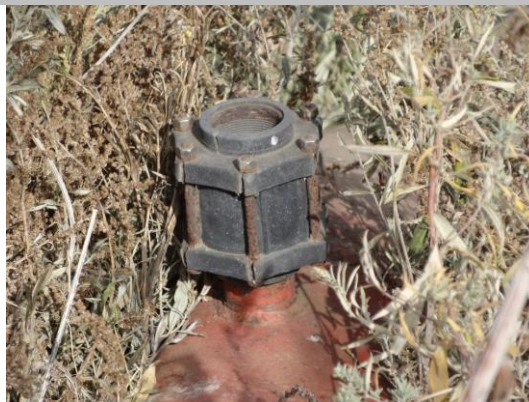
Photo 2 of 3 : UCIP_SP_2017_24892_44852.jpg

WS view: exposed steel pipe and air vent on the pipe.

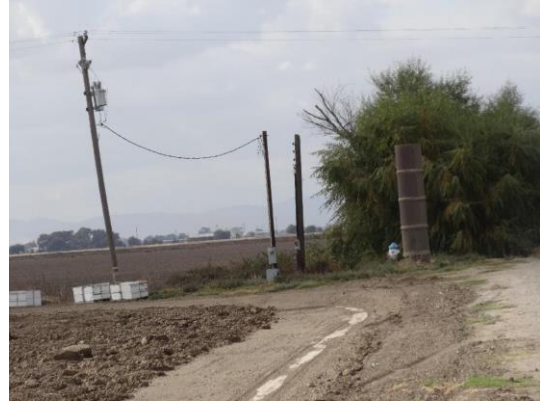
Photo 3 of 3 : UCIP_SP_2017_24892_44851.jpg

LS view: service pole, pump, and a concrete standpipe on bank of drainage ditch about 500 ft from the levee.

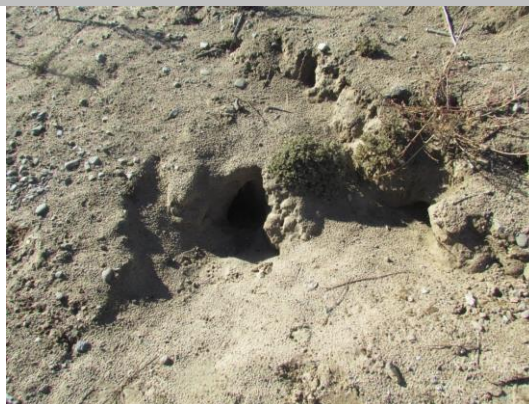
Photo 1 of 1 : SP_2017_RD0544_108_11_20170316_00013.jpg

Looking at large rodent holes on waterward slope.

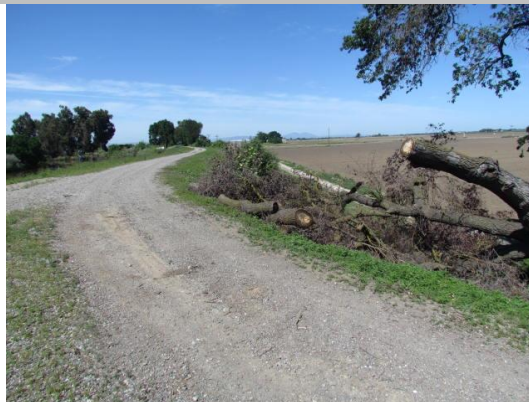
Photo 1 of 2 : SP_2017_RD0544_108_123_20170316_00085.jpg

Looking southwest at tree limbs on landward slope,

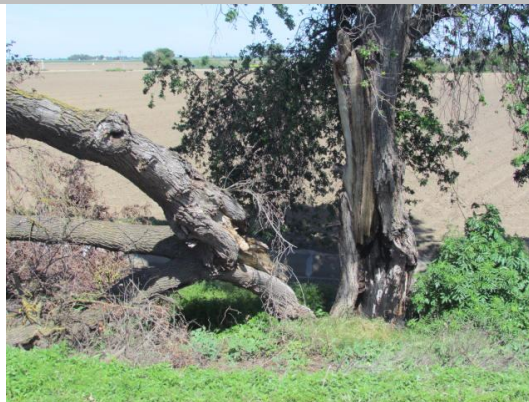
Photo 2 of 2 : SP_2017_RD0544_108_123_20170316_00086.jpg

Looking west at split tree on landward slope.

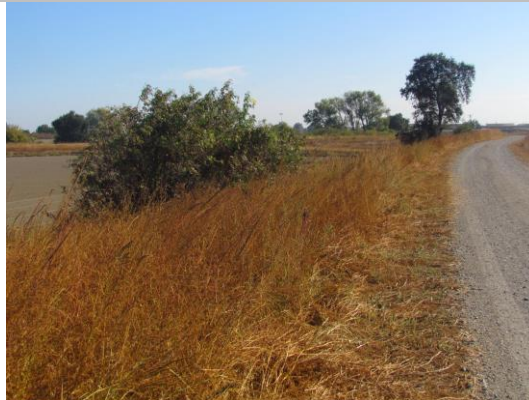
Photo 1 of 1 : SP_2017_RD0544_108_52_20170316_00041.jpg

Looking south at dense veg on landward slope.

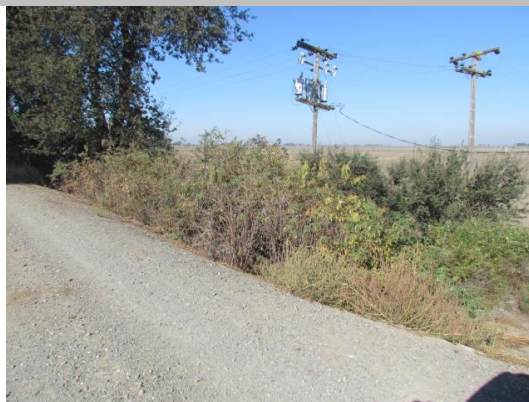
Photo 1 of 1 : SP_2017_RD0544_108_57_20170316_00042.jpg

Looking southwest at dense elderberries on landward slope fall 2015.

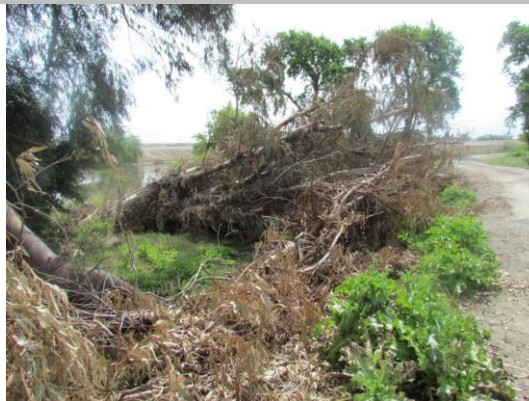
Photo 1 of 1 : SP_2017_RD0544_108_100_20170410_00137.jpg

Looking south at broken tree limb and branches on waterward slope.

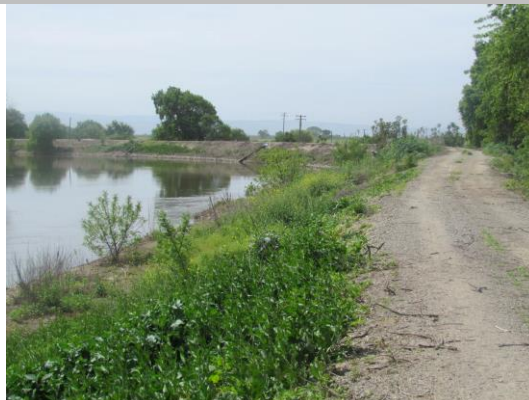
Photo 1 of 1 : SP_2017_RD0544_108_117_20170410_00139.jpg

Looking south at dense veg on waterward slope.

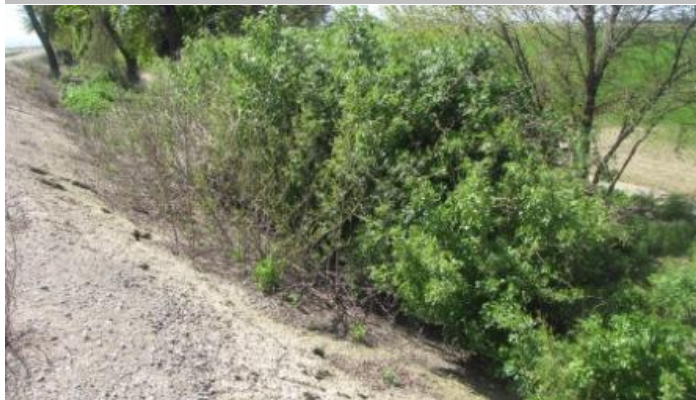
Photo 1 of 1 : SP_2017_RD0544_108_41_20170316_00031.jpg

Looking south at elderberries on landside slope and toe.

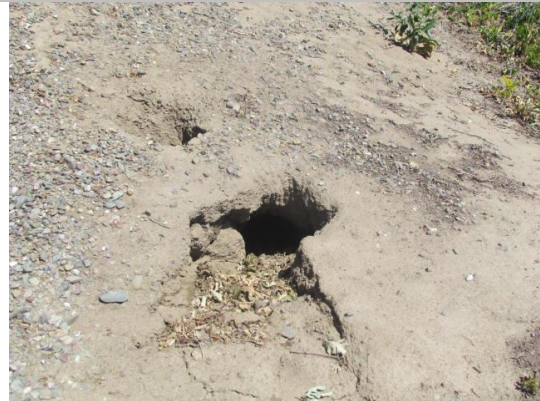
Photo 1 of 1 : SP_2017_RD0544_108_113_20170316_00071.jpg

Looking north at large hole on waterward slope.

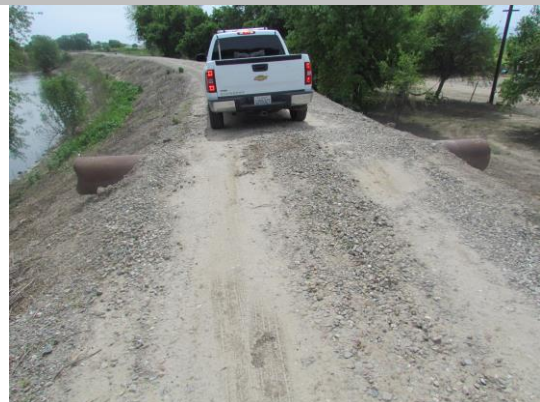
Photo 1 of 1 : SP_2017_RD0544_108_28_20170410_00140.jpg

Looking south at pipe across levee crown.

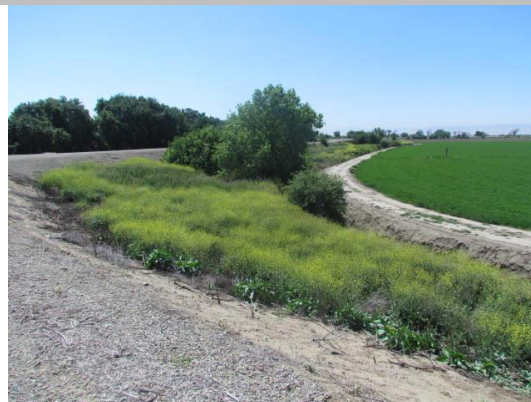
Photo 2 of 2 : SP_2017_RD0544_108_33_20170316_00025.jpg

Looking southwest at dense vegetation at landward slope and toe.(Spring 2015)

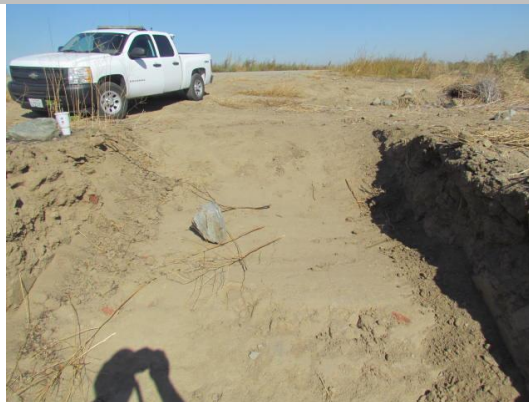
Photo 1 of 4 : SP_2017_RD0544_108_121_20170316_00080.jpg

Looking west at excavation on waterward berm.

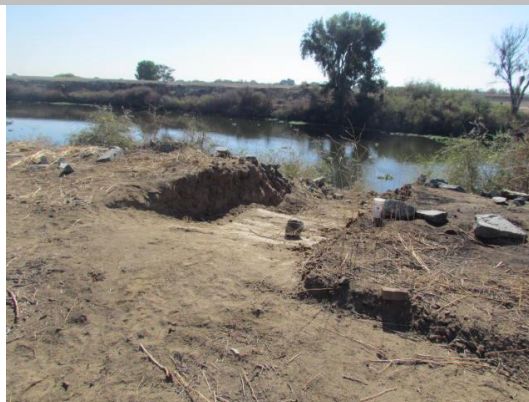
Photo 3 of 4 : SP_2017_RD0544_108_121_20170316_00082.jpg

Looking northeast at excavation on waterward berm

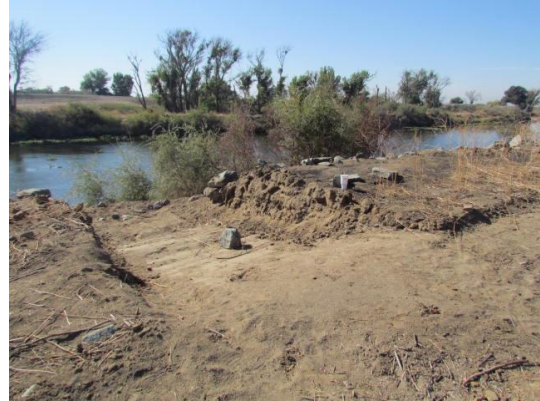
Photo 4 of 4 : SP_2017_RD0544_108_121_20170316_00083.jpg

Looking southeast at excavation on waterward berm.

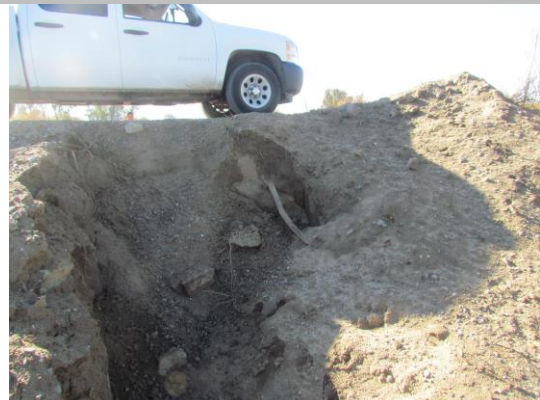
Photo 1 of 3 : SP_2017_RD0544_108_115_20170316_00072.jpg

Looking west at large excavation on landward slope.

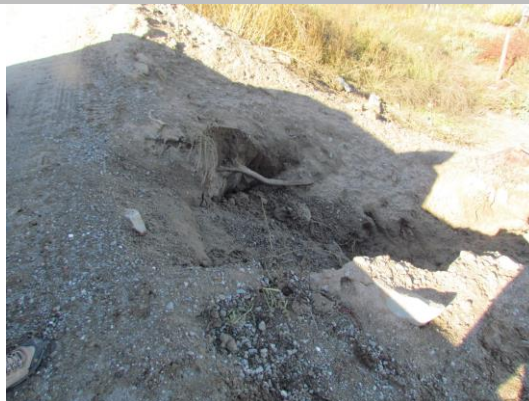
Photo 2 of 3 : SP_2017_RD0544_108_115_20170316_00073.jpg

Looking south at large excavation on landward slope.

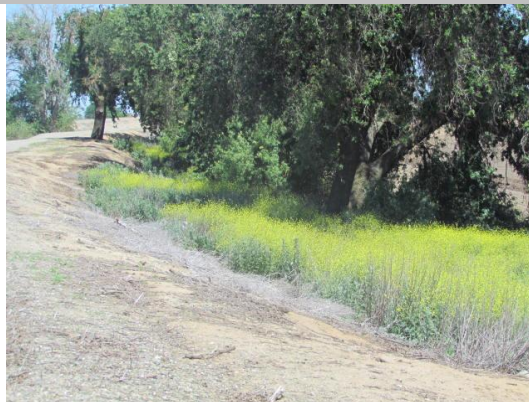
Photo 1 of 1 : SP_2017_RD0544_109_1_20170316_00001.jpg

Looking southwest at dense vegetation at landward toe.

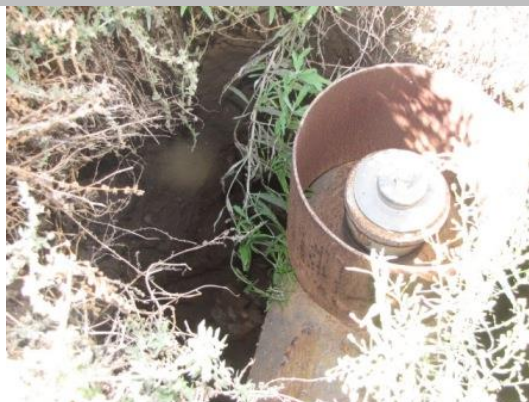
Photo 2 of 6 : SP_2017_RD0544_109_8_20170316_00008.jpg

Looking at caving around 10" siphon pipe on waterside shoulder.

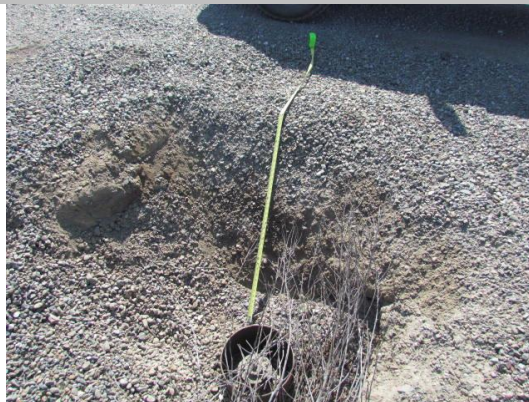
Photo 5 of 6 : SP_2017_RD0544_109_8_20170316_00011.jpg

Looking west at caving around siphon on waterside shoulder. (Spring 2012)

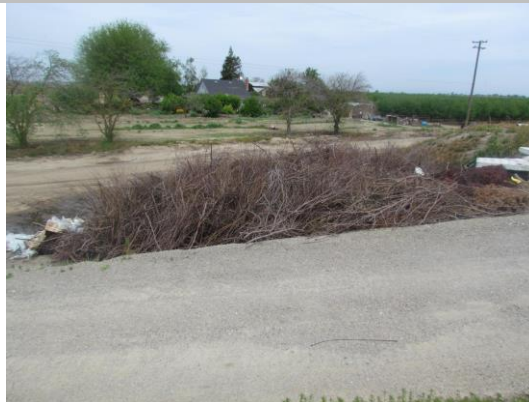
Photo 1 of 1 : SP_2017_RD0544_109_72_20170410_00091.jpg

Looking west at large pruning pile at landward toe.

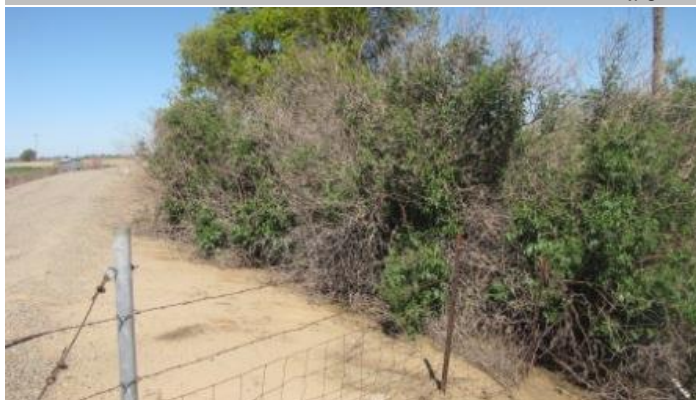
Photo 2 of 2 : SP_2017_RD0544_109_10_20170316_00016.jpg

Looking south at elderberries on landside slope and toe.

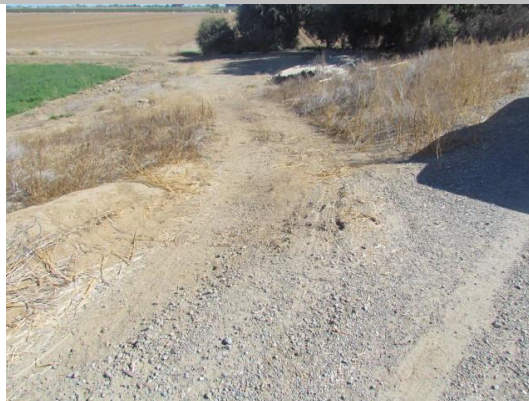
Photo 1 of 2 : SP_2017_RD0544_109_22_20170316_00028.jpg

Looking northwest at slope damage caused by vehicle traffic (Fall 2014).

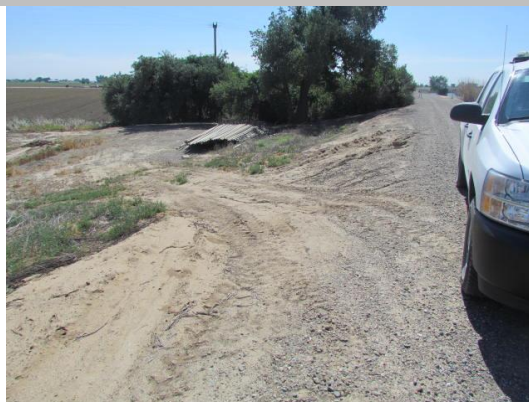
Photo 2 of 2 : SP_2017_RD0544_109_22_20170316_00029.jpg

Looking northwest at slope damage caused by vehicle traffic.

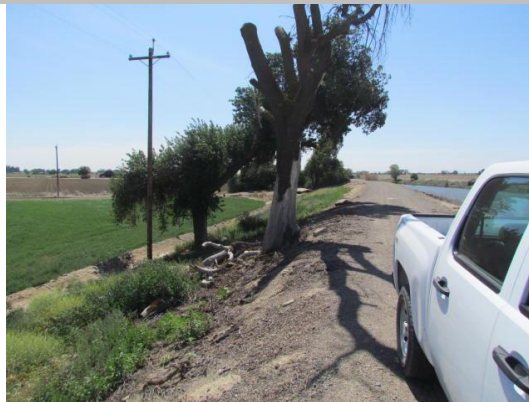
Photo 1 of 1 : SP_2017_RD0544_109_23_20170316_00030.jpg

Looking north at dead tree and tree limbs on landside shoulder and slope.

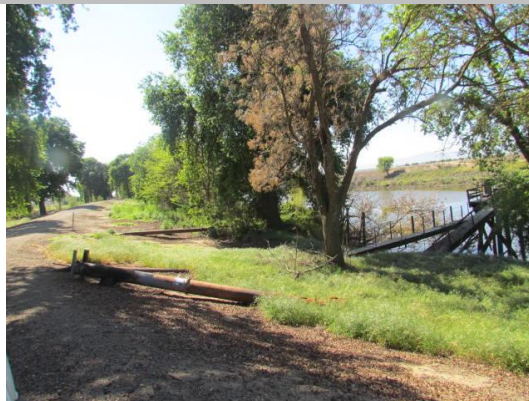
Photo 1 of 1 : SP_2017_RD0544_109_51_20170316_00041.jpg

Looking north at old pump shaft and pipe on waterward slope.

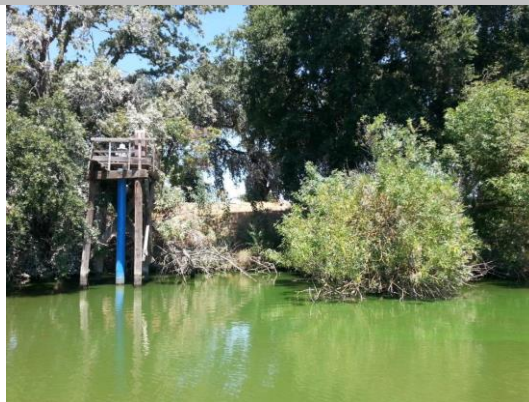
Photo 1 of 2 : SP_2017_RD0544_109_12_20170316_00017.jpg

Front view of the erosion site. View is partially blocked by the pump structure and vegetation at the site.

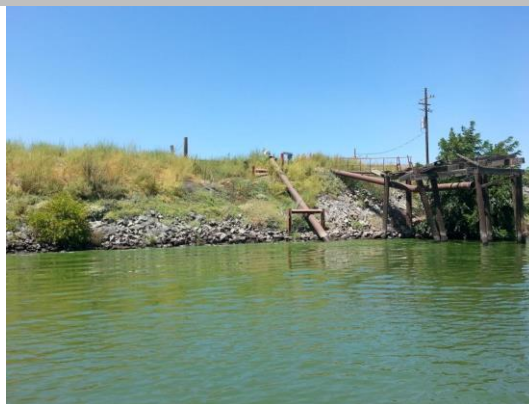
Photo 1 of 2 : SP_2017_RD0544_109_9_20170316_00013.jpg

Front view of the erosion site.

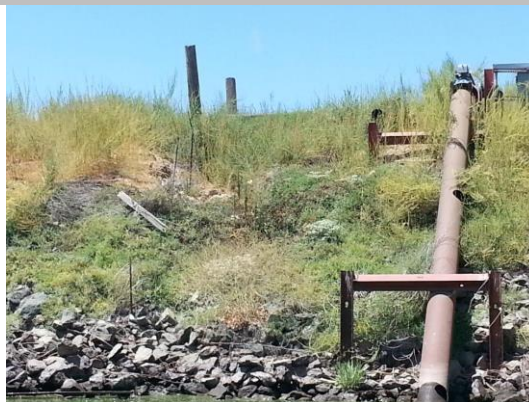
Photo 2 of 2 : SP_2017_RD0544_109_9_20170316_00014.jpg

Close view of the erosion. Vegetation around the site is visible.

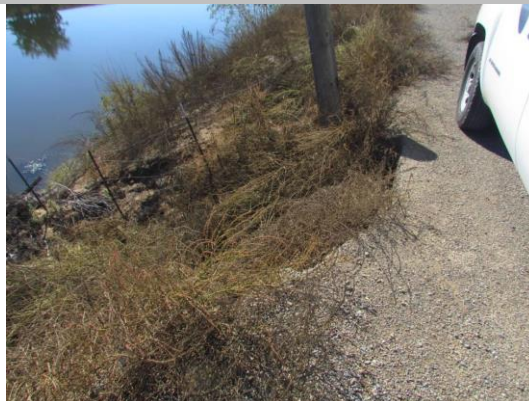
Photo 1 of 3 : SP_2017_RD0544_109_69_20170316_00055.jpg

Looking south at erosion on waterward shoulder and slope.

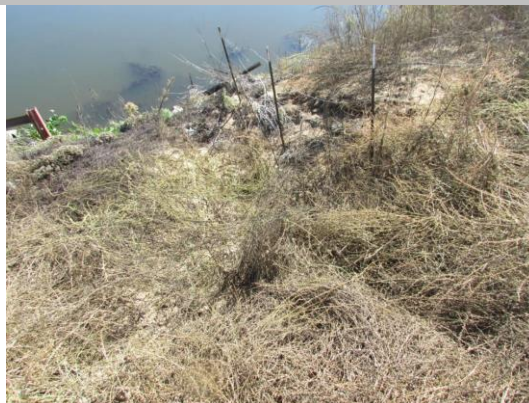
Photo 3 of 3 : SP_2017_RD0544_109_69_20170316_00057.jpg

Looking south at waterward erosion.

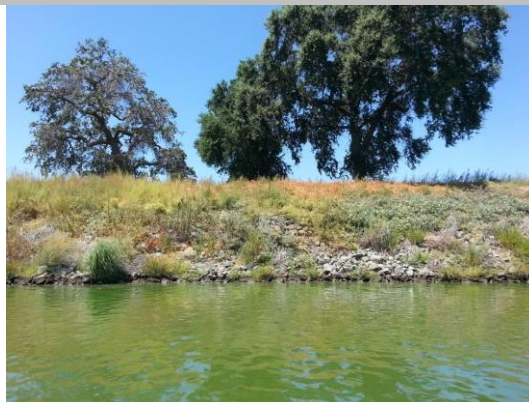
Photo 1 of 2 : SP_2017_RD0544_109_7_20170316_00005.jpg

Front view of the pocket erosion. Note the vegetation and riprap at the site.

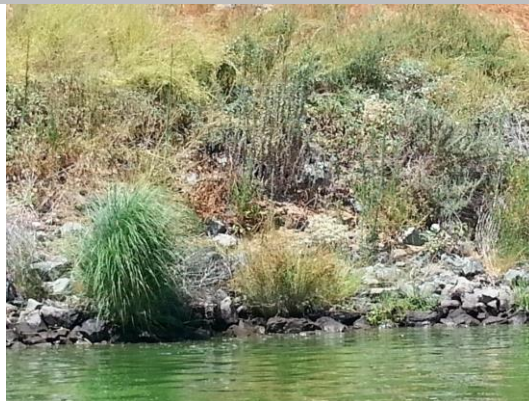
Photo 2 of 2 : SP_2017_RD0544_109_7_20170316_00006.jpg

Close view of the erosion.

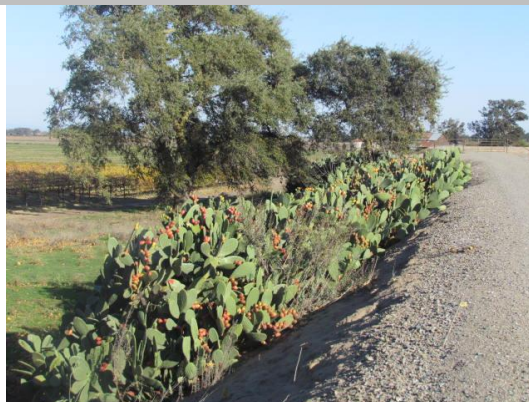
Photo 2 of 3 : SP_2017_RD0544_109_36_20170316_00032.jpg

Looking north at cactus on landside slope and toe spring 2015

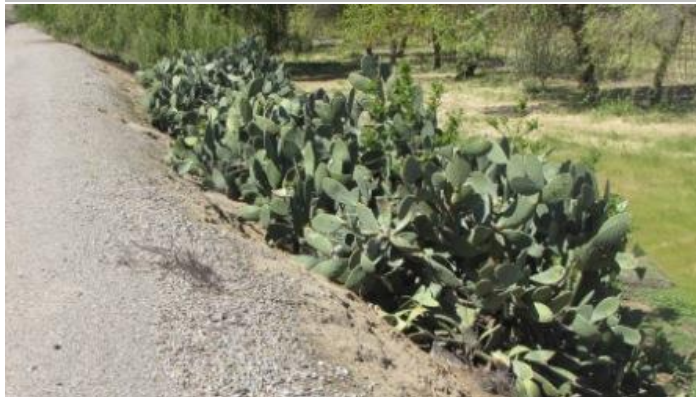
Photo 3 of 3 : SP_2017_RD0544_109_36_20170316_00033.jpg

Looking southwest at overgrown cactus on landside slope spring 2015.

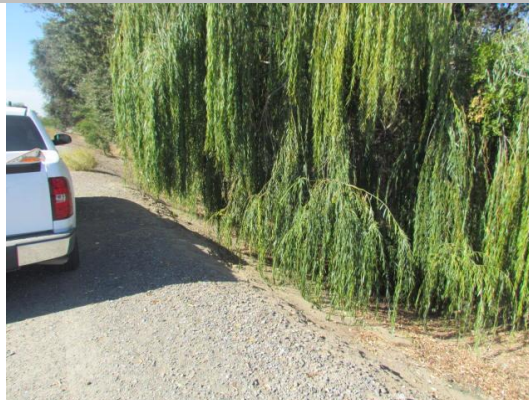
Photo 1 of 1 : SP_2017_RD0544_109_55_20170316_00044.jpg

Looking southwest at untrimmed trees on landward slope and toe fall 2015.

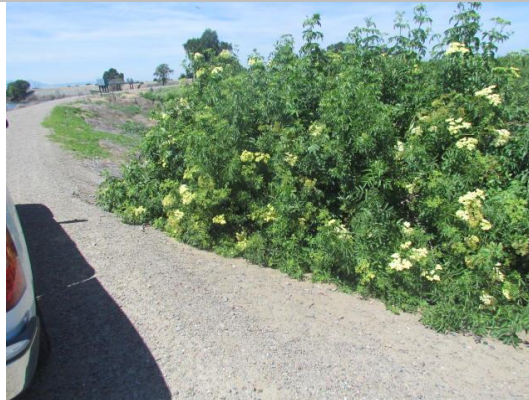
Photo 1 of 1 : SP_2017_RD0544_109_64_20170316_00049.jpg

Looking southwest at dense elderberry bush on landward slope and toe.
(Spring 2015)

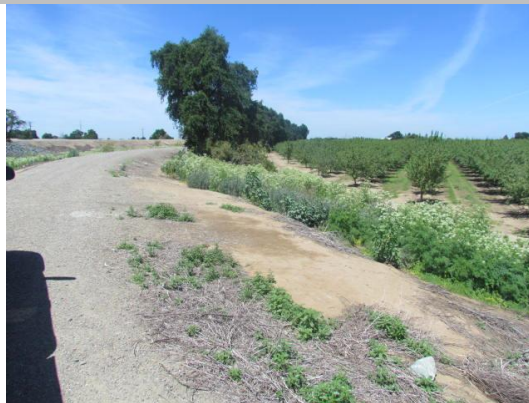
Photo 1 of 1 : SP_2017_RD0544_109_65_20170316_00050.jpg

Looking southwest at dense vegetation on landward slope and toe.
(Spring 2015)
