**Flood Control Project Maintenance
Levee Inspections**

Maintenance Issue Types Only, Levee Inspection Report By Mile - Spring 2018

Reclamation District No. 0544 Upper Roberts Island

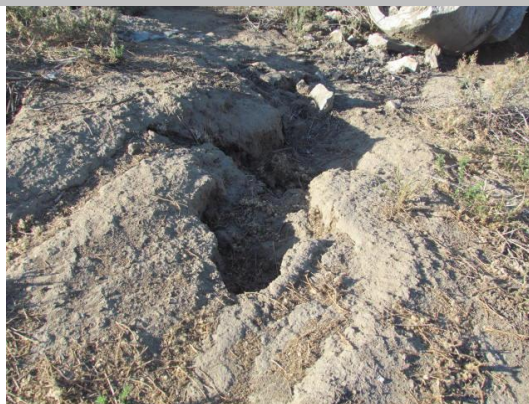
Photo 1 of 1 : SP_2018_RD0544_108_118_20180323_00088.jpg

| Finger erosion noted on landside slope. | | | | | |

Looking west at landside erosion for shoulder to middle of levee slope.

| E2 : Schedule repair of erosion site prior to the next inspection. | | | | | |

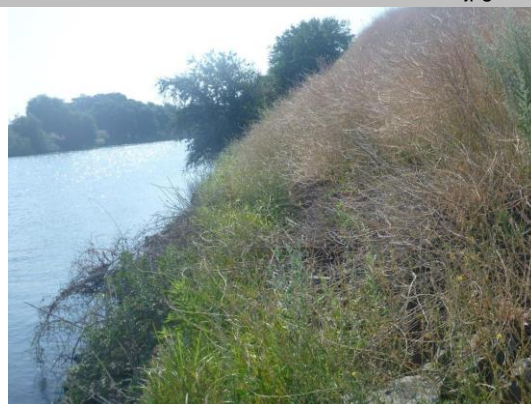
Photo 2 of 3 : LEVAL_SP_2018_571_4480.jpg

| Description:Slope protection repairs are needed along the waterside slope due to erosion and riprap displacement from high water. Based upon levee inspections, it was determined the waterside levee slope is eroding, deteriorating, and degrading. The eroded levee sections need to be restored back to design standards to prevent further deterioration and damage. | | | | | |

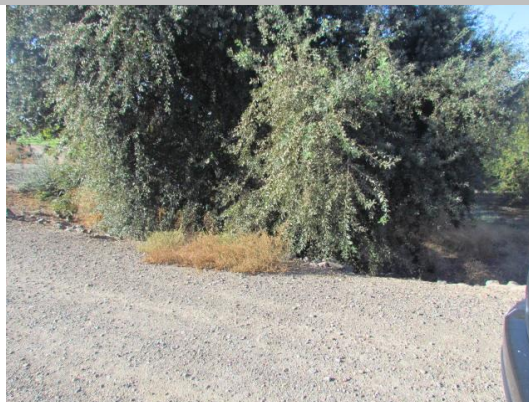
Photo 1 of 1 : SP_2018_RD0544_108_93_20180323_00069.jpg

Looking west at untrimmed trees on landward slope and toe fall 2015.

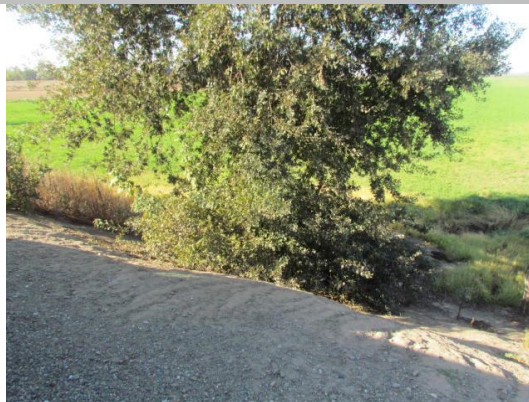
Photo 1 of 1 : SP_2018_RD0544_108_87_20180323_00064.jpg

Looking west at untrimmed tree at landward toe fall 2015.

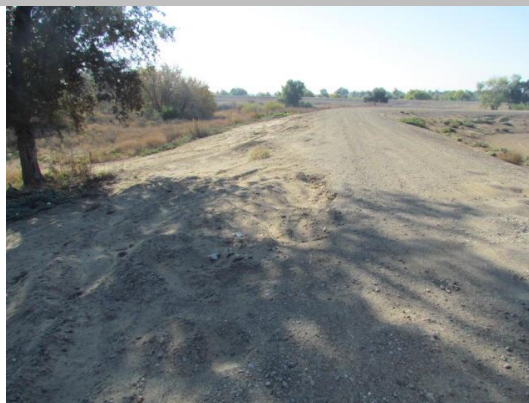
Photo 1 of 3 : SP_2018_RD0544_108_119_20180323_00089.jpg

| Damaged levee slope due to fishermen using slope as a ramp. | | | | | |

Looking southeast at damaged waterward slope fall 2015.

| S2 : Repair the levee slope damaged by foot traffic and prevent access where possible. | | | | | |

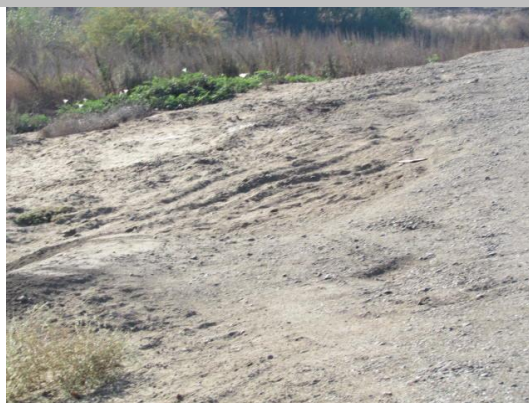
Photo 2 of 3 : SP_2018_RD0544_108_119_20180323_00090.jpg

Looking east at damaged waterward slope fall 2015.

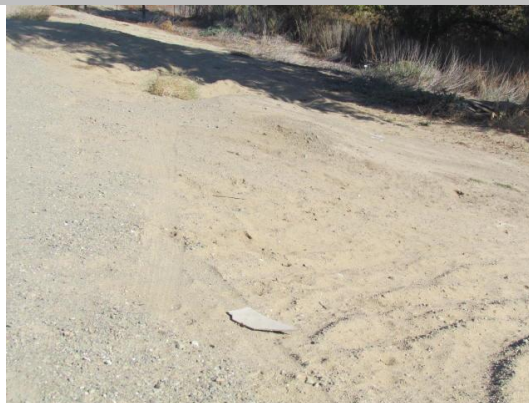
Photo 3 of 3 : SP_2018_RD0544_108_119_20180323_00091.jpg

Looking southeast at damaged waterward slope fall 2015

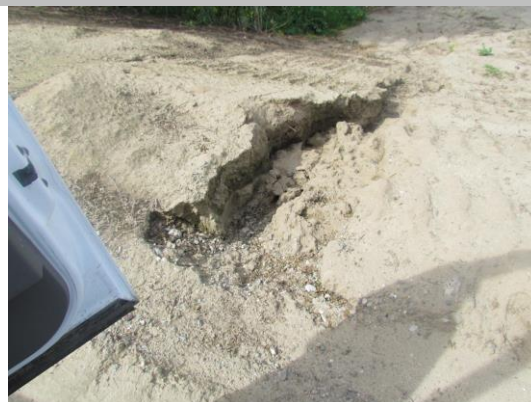
Photo 1 of 2 : SP_2018_RD0544_108_80_20180323_00058.jpg

Looking west at slope damage due to rain runoff on waterward slope.

| E2 : Schedule repair of erosion site prior to the next inspection. | | | | | |
| Repair slope damage due to water runoff. | | | | | |

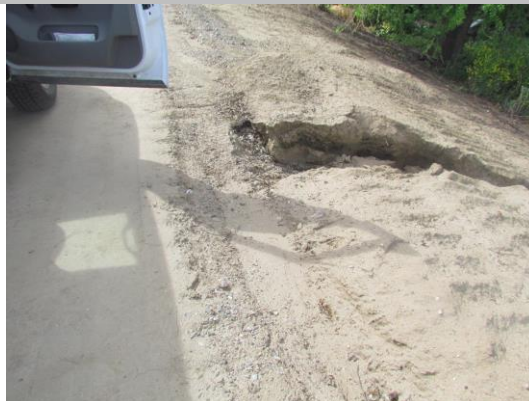
Photo 2 of 2 : SP_2018_RD0544_108_80_20180323_00059.jpg

Looking south at slope damage due to rain runoff on waterward slope.

| E2 : Schedule repair of erosion site prior to the next inspection. | | | | | | |
| Repair slope damage due to water runoff. | | | | | | |

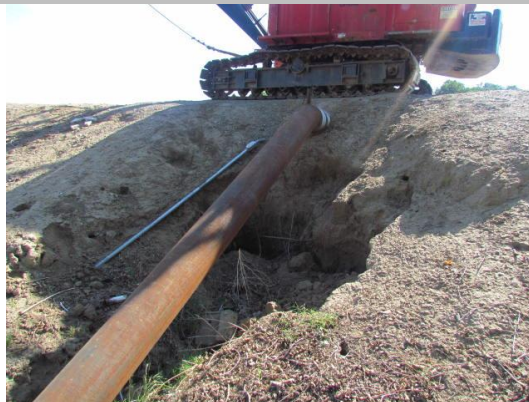
Photo 3 of 3 : SP_2018_RD0544_108_23_20180323_00026.jpg

Looking east at erosion under irrigation pipe on landside slope.

| E2 : Schedule repair of erosion site prior to the next inspection. | | | | | |

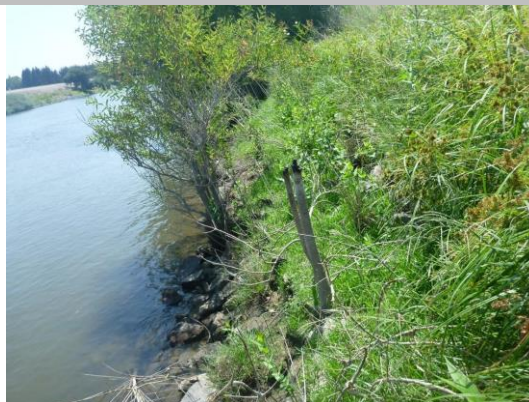
Photo 2 of 3 : LEVAL_SP_2018_568_4545.jpg

| Description:Slope protection repairs are needed along the waterside slope due to erosion and riprap displacement from high water. Based upon levee inspections, it was determined the waterside levee slope is eroding, deteriorating, and degrading. The eroded levee sections need to be restored back to design standards to prevent further deterioration and damage. | | | | | |

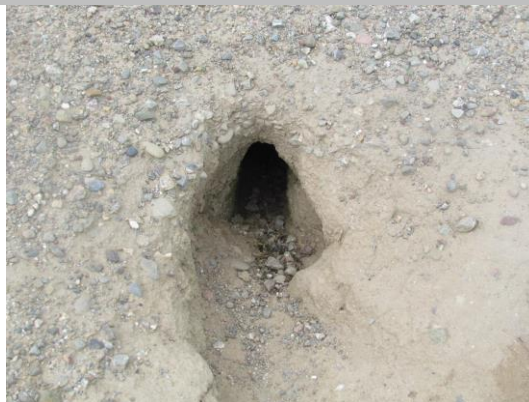
Photo 1 of 3 : SP_2018_RD0544_108_34_20180323_00029.jpg

Looking east at large rodent hole on landward slope.

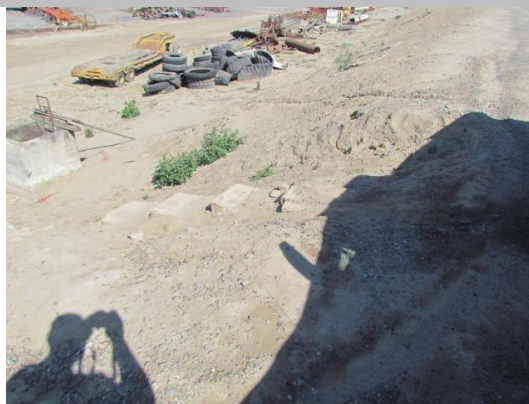
Photo 1 of 2 : SP_2018_RD0544_108_60_20180323_00043.jpg

Looking north at slope damage on landside slope.

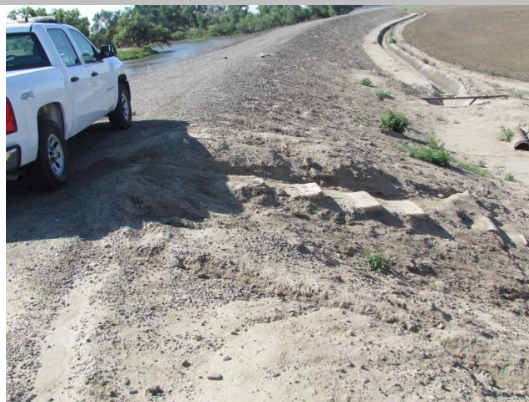
Photo 2 of 2 : SP_2018_RD0544_108_60_20180323_00044.jpg

Looking south at slope damage on landside slope.

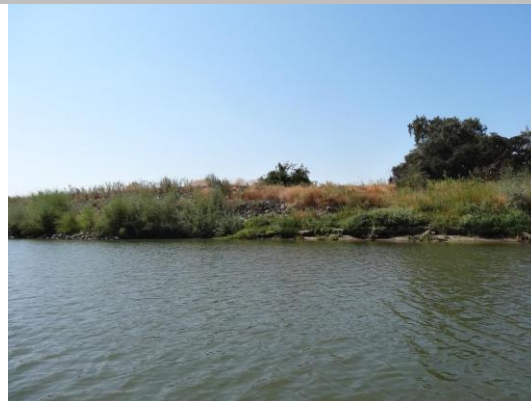
Photo 1 of 3 : SP_2018_RD0544_108_5_20180323_00010.jpg

Front view of the erosion.

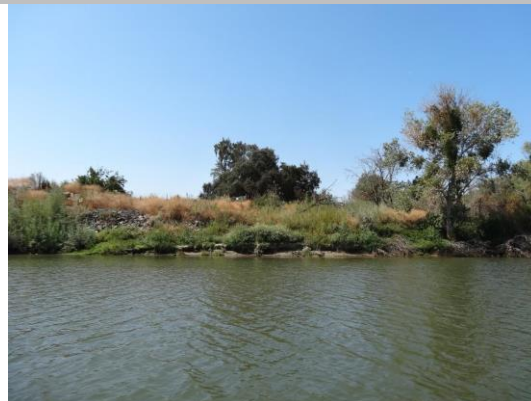
Photo 2 of 3 : SP_2018_RD0544_108_5_20180323_00011.jpg

Front view of the erosion.

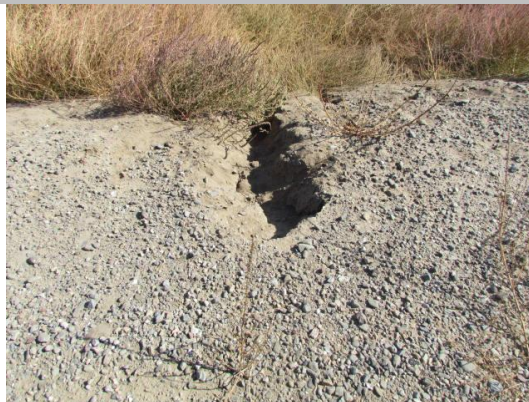
Photo 1 of 1 : SP_2018_RD0544_108_76_20180323_00053.jpg

Looking east at slope damage on waterward slope.

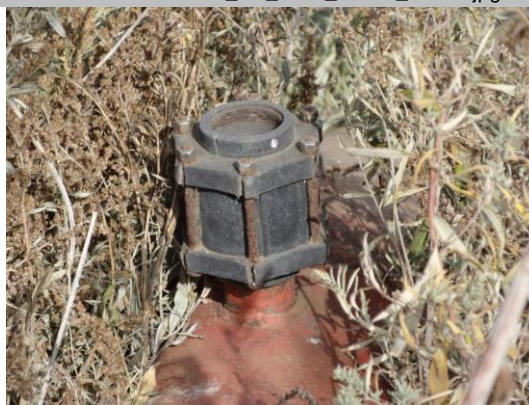
Photo 2 of 3 : UCIP_SP_2018_24892_44852.jpg

WS view: exposed steel pipe and air vent on the pipe.

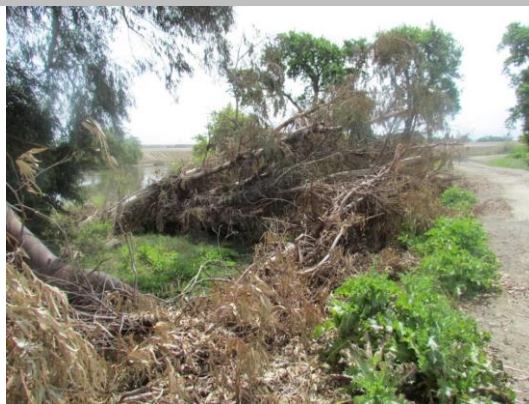
Photo 1 of 1 : SP_2018_RD0544_108_100_20180323_00074.jpg

Looking south at broken tree limb and branches on waterward slope.

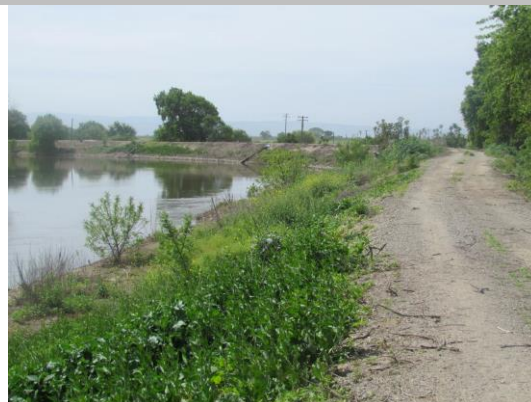
Photo 2 of 2 : SP_2018_RD0544_108_117_20180323_00087.jpg

Looking south at dense veg on waterward slope.

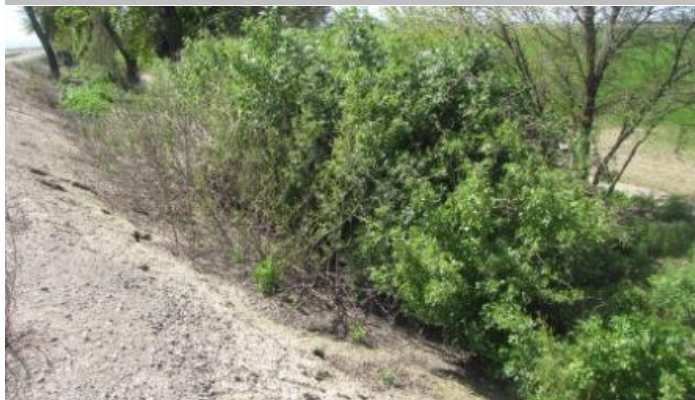
Photo 1 of 1 : SP_2018_RD0544_108_41_20180323_00035.jpg

Looking south at elderberries on landside slope and toe.

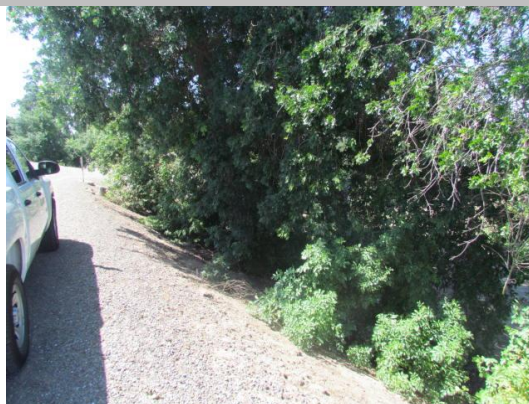
Photo 1 of 1 : SP_2018_RD0544_108_112_20180323_00081.jpg

Looking southwest at dense trees on landward slope and toe.

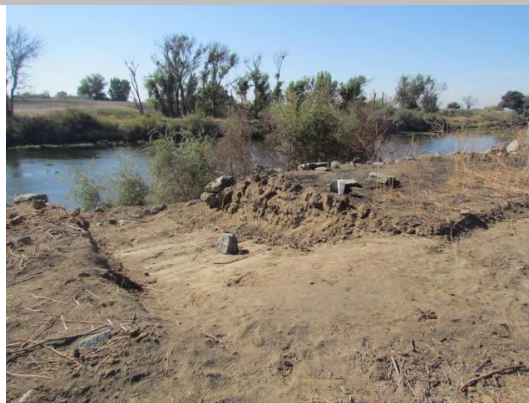
Photo 4 of 4 : SP_2018_RD0544_108_121_20180323_00096.jpg

Looking southeast at excavation on waterward berm.

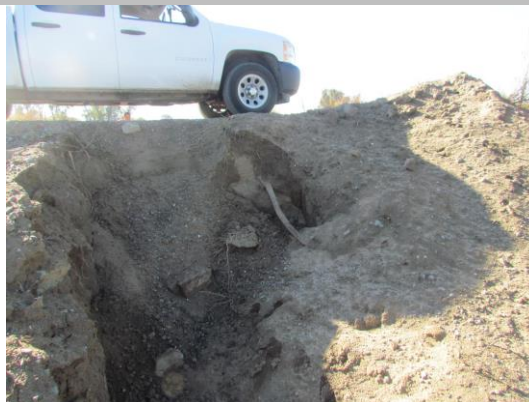
Photo 1 of 3 : SP_2018_RD0544_108_115_20180323_00083.jpg

Looking west at large excavation on landward slope.

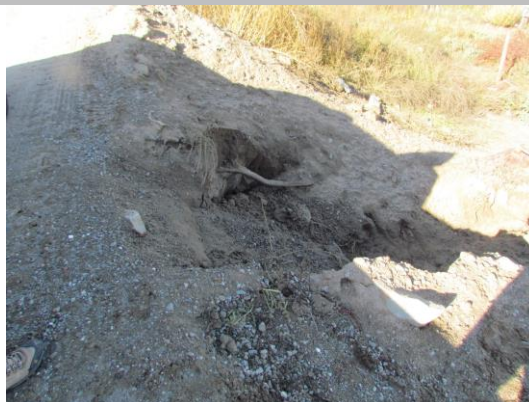
Photo 2 of 3 : SP_2018_RD0544_108_115_20180323_00084.jpg

Looking south at large excavation on landward slope.

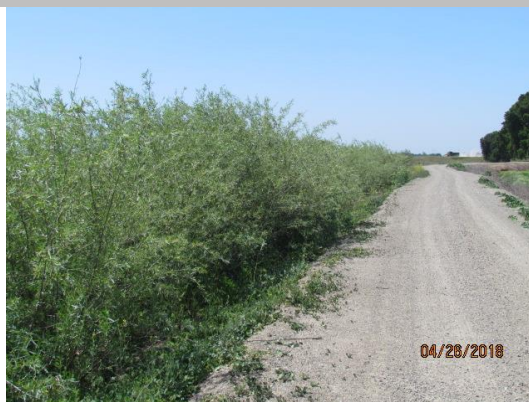
Photo 1 of 1 : SP_2018_RD0544_109_2_20180427_00130.jpg

Looking southeast at dense veg on waterward slope. (Spring 2018)

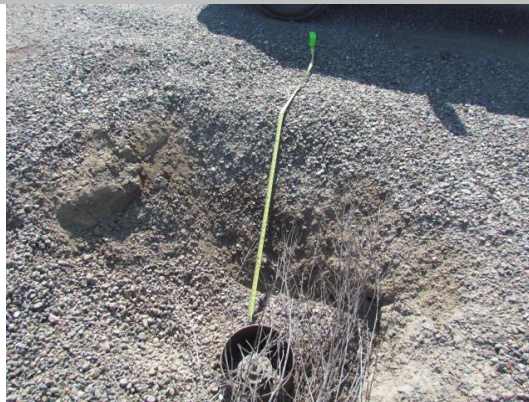
Photo 3 of 4 : SP_2018_RD0544_109_8_20180323_00012.jpg

Looking west at caving around siphon on waterside shoulder. (Spring 2012)

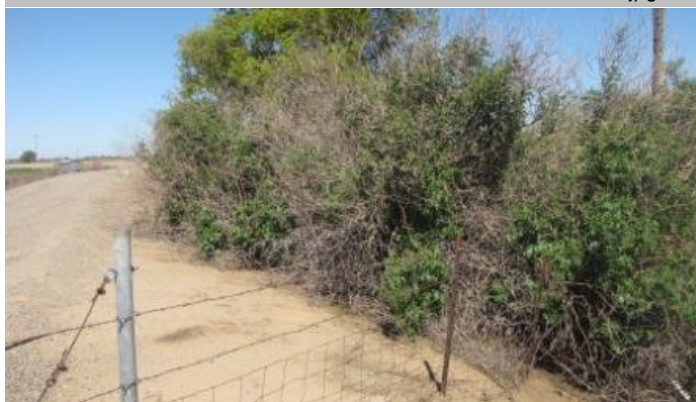
Photo 2 of 2 : SP_2018_RD0544_109_10_20180323_00015.jpg

Looking south at elderberries on landside slope and toe.

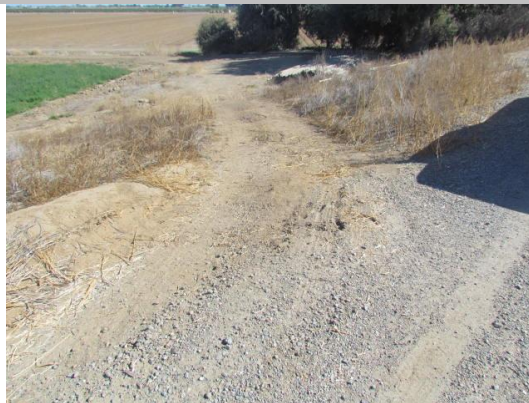
Photo 1 of 2 : SP_2018_RD0544_109_22_20180323_00025.jpg

Looking northwest at slope damage caused by vehicle traffic (Fall 2014).

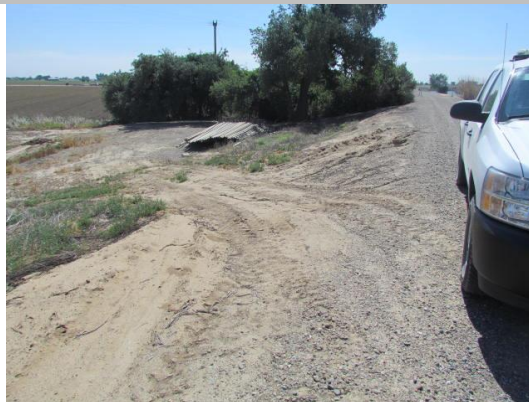
Photo 2 of 2 : SP_2018_RD0544_109_22_20180323_00026.jpg

Looking northwest at slope damage caused by vehicle traffic.

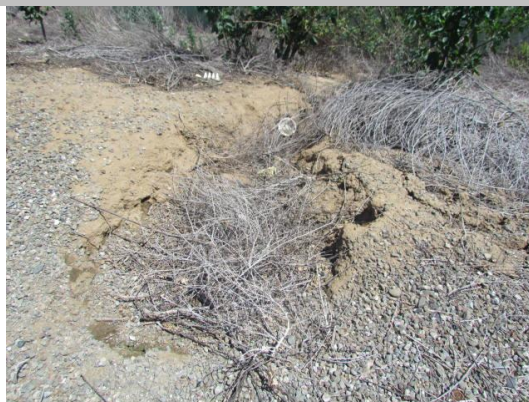
Photo 2 of 2 : SP_2018_RD0544_109_38_20180323_00037.jpg

Looking east at erosion/caving on waterward slope.

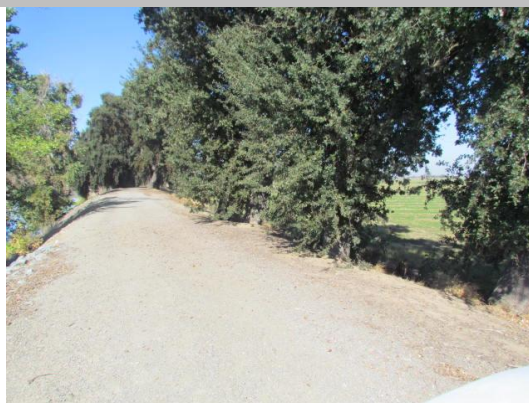
Photo 2 of 2 : SP_2018_RD0544_109_59_20180323_00048.jpg

Looking southwest at untrimmed trees on landward slope and toe fall 2015.

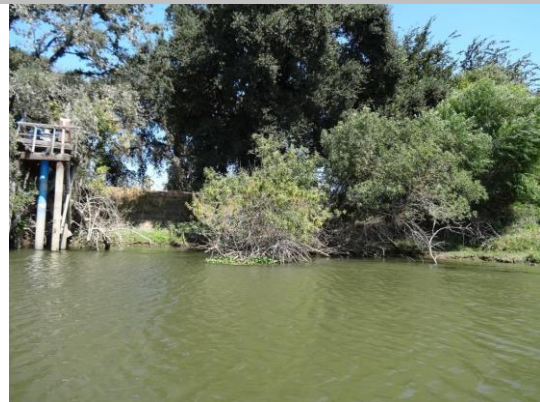
Photo 1 of 3 : SP_2018_RD0544_109_11_20180323_00016.jpg

Front view of the erosion site. View is partially blocked by the pump structure and vegetation at the site.

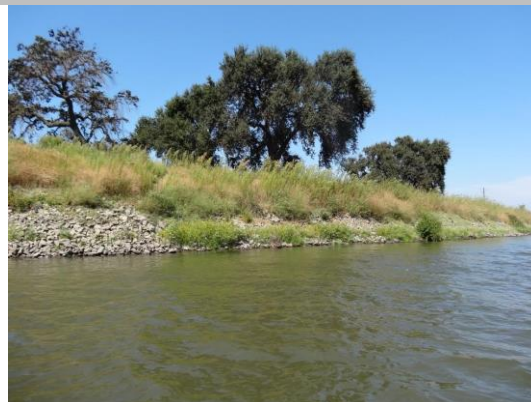
Photo 1 of 2 : SP_2018_RD0544_109_7_20180323_00006.jpg

Front view of the pocket erosion. Note vegetation and riprap at the site.

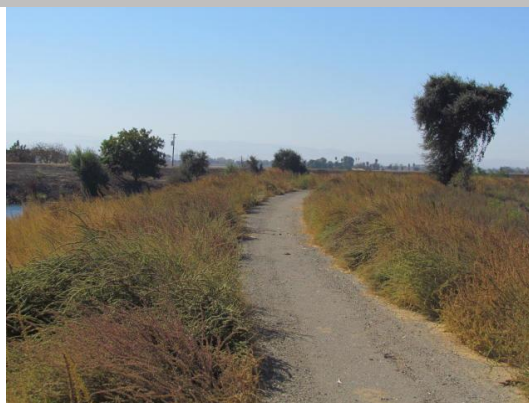
Photo 2 of 2 : SP_2018_RD0544_109_43_20180323_00040.jpg

Looking at dense vegetation on landward and waterward slope.

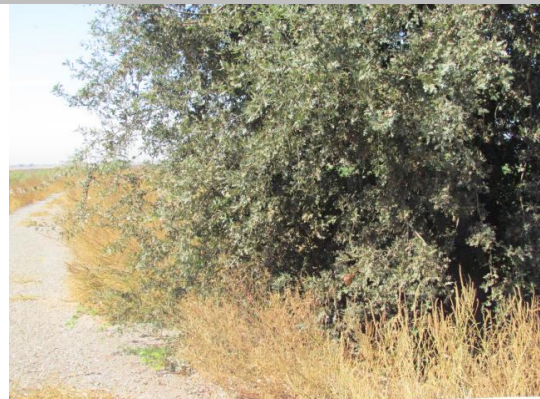
Photo 1 of 1 : SP_2018_RD0544_109_53_20180323_00044.jpg

Looking southwest at untrimmed tree on landward slope fall 2015.

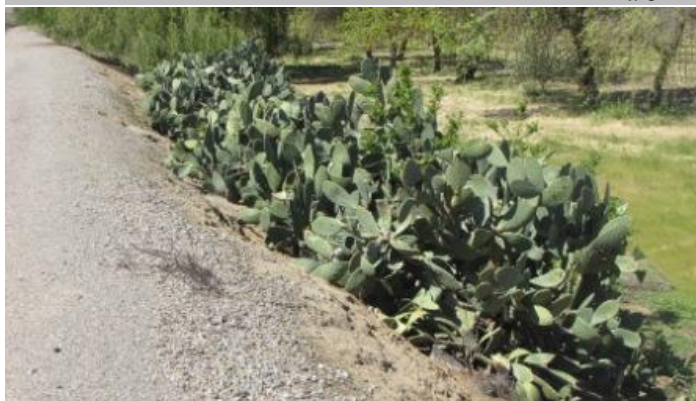
Photo 3 of 3 : SP_2018_RD0544_109_36_20180323_00032.jpg

Looking southwest at overgrown cactus on landside slope spring 2015.
