**Flood Control Project Maintenance
Levee Inspections**

Maintenance Issue Types Only, Levee Inspection Report By Mile - Spring 2019

Reclamation District No. 0544 Upper Roberts Island

Waterway	Bank	Unit Miles	Inspection Start/End	Inspector
Unit No. 01 San Joaquin River	Left	6.05	05/09/2019 05/09/2019	Alberto De Leon

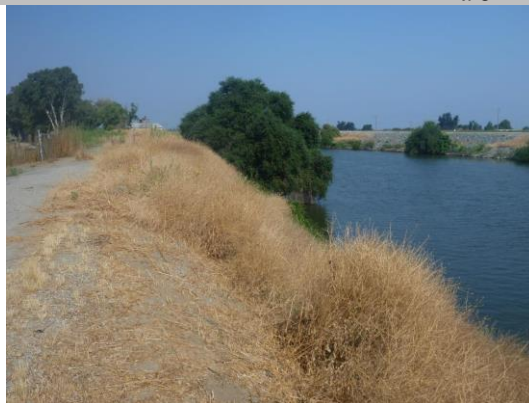
Photo 3 of 3 : LEVAL_SP_2019_571_4487.jpg

LM Start	0.64	Rating **	A/W	Issue No.	75 (cont)
LM End	0.64	Issue Type +	Ma	Location *	
Category	Supplemental			GPS Latitude/Longitude	
				Start	End
Item	2017 Storm Damage			37.863900 °	37.863900 °
				-121.323500 °	-121.323400 °
DWR ID	DWR_RD0544_01_f _ 2017_75				
Comment Code					
Inspector Comment					
Levee Evaluation Comments					
Description:Slope protection repairs are needed along the waterside slope due to erosion and riprap displacement from high water. Based upon levee inspections, it was determined the waterside levee slope is eroding, deteriorating, and degrading. The eroded levee sections need to be restored back to design standards to prevent further deterioration and damage.					
Site ID No:571					
Site Designation:LMA-477					
Repair Type: Erosion					
Rating:Area of Concern					
Field Date:8/10/2017					
Notes:

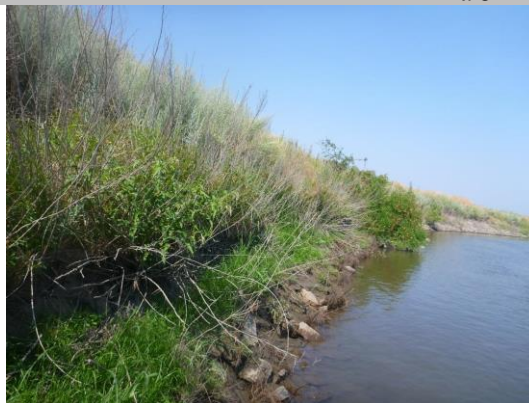
Photo 3 of 3 : LEVAL_SP_2019_570_4602.jpg

LM Start	0.99	Rating **	A/W	Issue No.	77 (cont)
LM End	1.02	Issue Type +	Ma	Location *	
Category	Supplemental			GPS Latitude/Longitude	
				Start	End
Item	2017 Storm Damage			37.860400 °	37.860200 °
				-121.320300 °	-121.319700 °
DWR ID	DWR_RD0544_01_f_2017_77				
Comment Code					
Inspector Comment					
Levee Evaluation Comments					
Description:Slope protection repairs are needed along the waterside slope due to erosion and riprap displacement from high water. Based upon levee inspections, it was determined the waterside levee slope is eroding, deteriorating, and degrading. The eroded levee sections need to be restored back to design standards to prevent further deterioration and damage.					
Site ID No:570					
Site Designation:LMA-476					
Repair Type: Erosion					
Rating:Area of Concern					
Field Date:8/10/2017					
Notes:

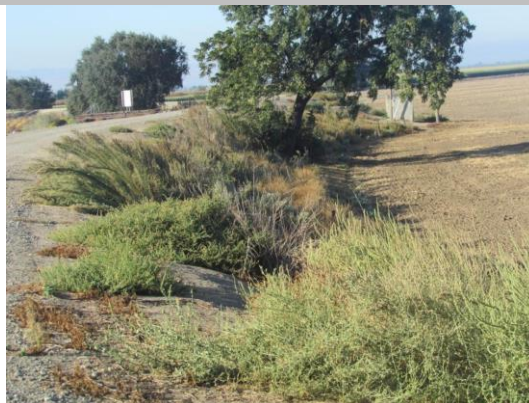
Photo 1 of 1 : SP_2019_RD0544_108_89_20190313_00057.jpg

Looking southwest at dense veg on landward slope and toe.

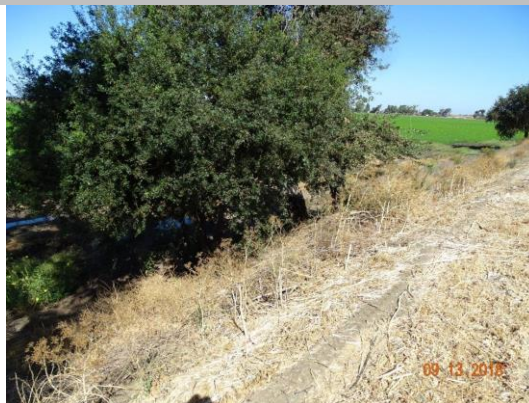
Photo 1 of 1 : SP_2019_RD0544_108_42_20190313_00029.jpg

Looking at untrimmed tree at landward toe. (Fall 2018)

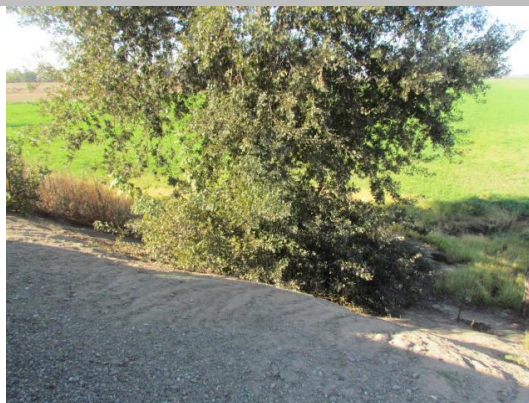
Photo 1 of 1 : SP_2019_RD0544_108_87_20190313_00056.jpg

Looking west at untrimmed tree at landward toe, Fall 2015.

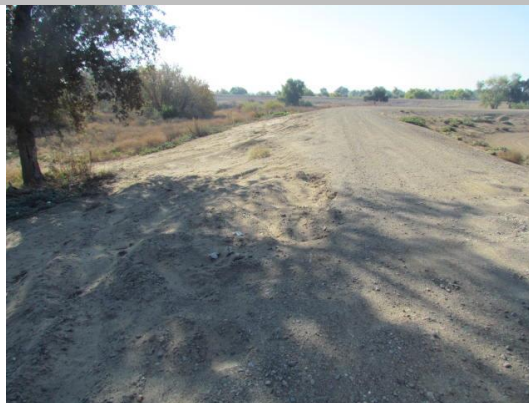
Photo 1 of 3 : SP_2019_RD0544_108_119_20190313_00074.jpg

LM Start	1.50	Rating **	M	Issue No.	119
LM End	1.51	Issue Type +	Ma	Location *	WS
Category	Earthen Levee			GPS Latitude/Longitude	
				Start	End
Item	Slope Stability			37.854844 °	37.854564 °
				-121.321090 °	-121.321031 °
DWR ID	DWR_RD0544_01_f_2015_119				
Comment Code					
S2 : Repair the levee slope damaged by foot traffic and prevent access where possible.					
Inspector Comment					
The slope is damaged due to fishermen using the slope as a ramp.

Looking southeast at damaged waterward slope, Fall 2015.

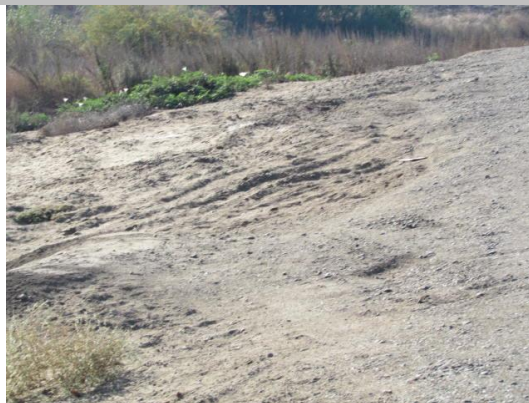
Photo 2 of 3 : SP_2019_RD0544_108_119_20190313_00075.jpg

LM Start	1.50	Rating **	M	Issue No.	119 (cont)	
LM End	1.51	Issue Type +	Ma	Location *	WS	
Category	Earthen Levee			GPS Latitude/Longitude		
				Start		End
Item	Slope Stability			37.854844 °		37.854564 °
				-121.321090 °		-121.321031 °
DWR ID	DWR_RD0544_01_f_2015_119					
Comment Code						
S2 : Repair the levee slope damaged by foot traffic and prevent access where possible.						
Inspector Comment						
The slope is damaged due to fishermen using the slope as a ramp.

Looking east at damaged waterward slope, Fall 2015.

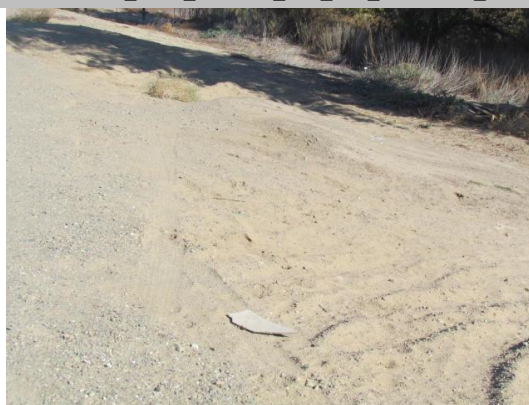
Photo 3 of 3 : SP_2019_RD0544_108_119_20190313_00076.jpg

Looking southeast at damaged waterward slope, Fall 2015

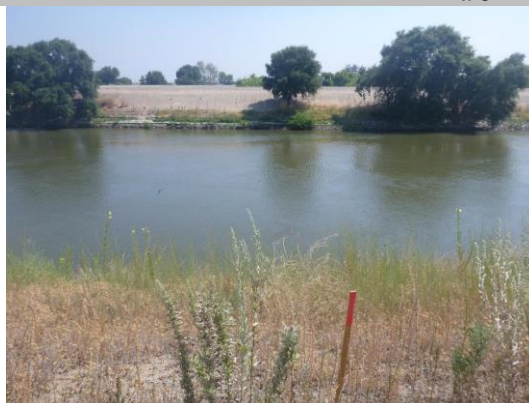
Photo 1 of 3 : LEVAL_SP_2019_569_4614.jpg

LM Start	1.89	Rating **	A/W	Issue No.	127
LM End	1.91	Issue Type +	Ma	Location *	
Category	Supplemental		GPS Latitude/Longitude		
			Start	End	
Item	2017 Storm Damage		37.852300 °	37.852000 °	
			-121.323700 °	-121.323600 °	
DWR ID	DWR_RD0544_01_f_2017_127				
Comment Code					
Inspector Comment					
Levee Evaluation Comments Description:Slope protection repairs are needed along the waterside slope due to erosion and riprap displacement from high water. Based upon levee inspections, it was determined the waterside levee slope is eroding, deteriorating, and degrading. The eroded levee sections need to be restored back to design standards to prevent further deterioration and damage. Site ID No:569 Site Designation:LMA-475 Repair Type: Erosion Rating:Area of Concern Field Date:8/10/2017 Notes:

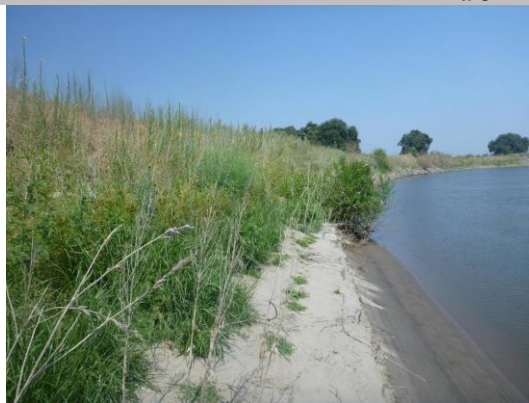
Photo 2 of 3 : LEVAL_SP_2019_569_4615.jpg

LM Start	1.89	Rating **	A/W	Issue No.	127 (cont)
LM End	1.91	Issue Type +	Ma	Location *	
Category	Supplemental			GPS Latitude/Longitude	
				Start	End
Item	2017 Storm Damage			37.852300 °	37.852000 °
				-121.323700 °	-121.323600 °
DWR ID	DWR_RD0544_01_f_2017_127				
Comment Code					
Inspector Comment					
Levee Evaluation Comments					
Description:Slope protection repairs are needed along the waterside slope due to erosion and riprap displacement from high water. Based upon levee inspections, it was determined the waterside levee slope is eroding, deteriorating, and degrading. The eroded levee sections need to be restored back to design standards to prevent further deterioration and damage.					
Site ID No:569					
Site Designation:LMA-475					
Repair Type: Erosion					
Rating:Area of Concern					
Field Date:8/10/2017					
Notes:

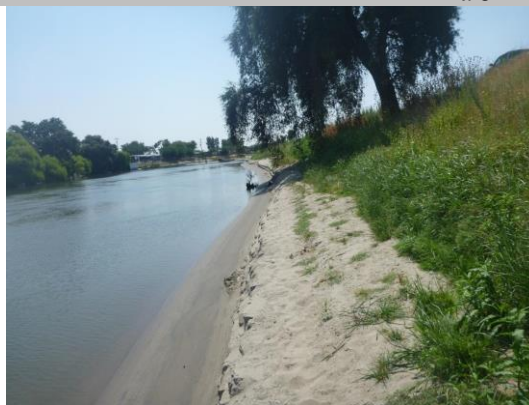
Photo 3 of 3 : LEVAL_SP_2019_569_4616.jpg

LM Start	1.89	Rating **	A/W	Issue No.	127 (cont)
LM End	1.91	Issue Type +	Ma	Location *

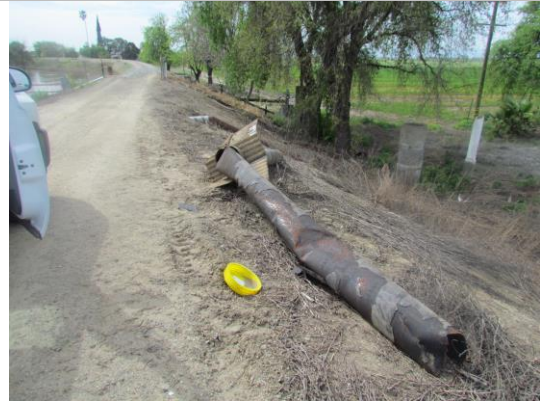
Photo 1 of 1 : SP_2019_RD0544_108_82_20190313_00053.jpg

Looking southwest at old irrigation pipe on landward shoulder.

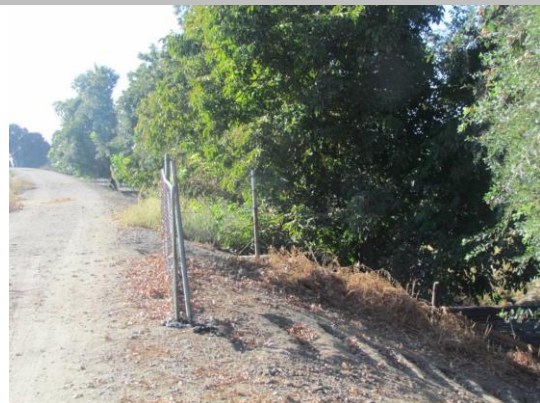
Photo 1 of 1 : SP_2019_RD0544_108_98_20190313_00063.jpg

Looking south at untrimmed trees on landward slope.

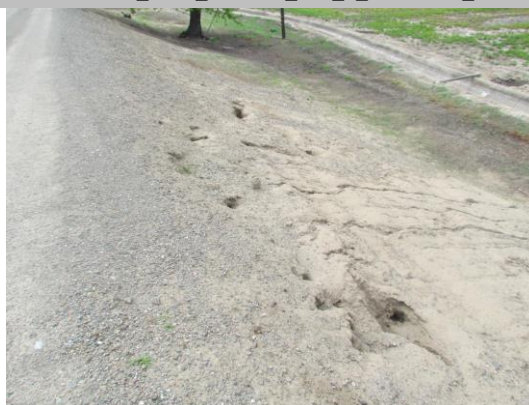
Photo 1 of 1 : SP_2019_RD0544_108_8_20190313_00013.jpg

Looking southwest at several rodent holes on landward shoulder and slope.

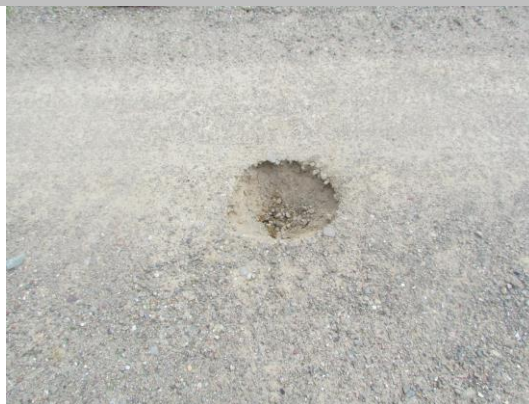
Photo 1 of 1 : SP_2019_RD0544_108_90_20190313_00058.jpg

LM Start	2.30	Rating **	M	Issue No.	90
LM End	2.30	Issue Type +	Ma	Location *	CR
Category	Earthen Levee			GPS Latitude/Longitude	
				Start	End
Item	Crown Surface / Depressions / Rutting			37.847542 °	37.847542 °
				-121.324732 °	-121.324732 °
DWR ID	DWR_RD0544_01_s_2019_90				
Comment Code					
C2 : Repair depressions or ruts in the crown or slope.					
Inspector Comment

Looking at sinkhole on levee crown.

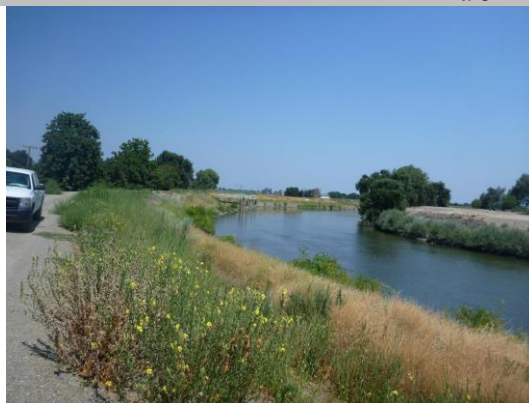
Photo 1 of 3 : LEVAL_SP_2019_568_4540.jpg

LM Start	2.31	Rating **	A/W	Issue No.	128
LM End	2.35	Issue Type +	Ma	Location *	
Category	Supplemental			GPS Latitude/Longitude	
				Start	End
Item	2017 Storm Damage			37.847300 °	37.846800 °
				-121.324700 °	-121.324400 °
DWR ID	DWR_RD0544_01_f_2017_128				
Comment Code					
Inspector Comment					
Levee Evaluation Comments					
Description:Slope protection repairs are needed along the waterside slope due to erosion and riprap displacement from high water. Based upon levee inspections, it was determined the waterside levee slope is eroding, deteriorating, and degrading. The eroded levee sections need to be restored back to design standards to prevent further deterioration and damage.					
Site ID No:568					
Site Designation:LMA-474					
Repair Type: Erosion					
Rating:Area of Concern					
Field Date:8/10/2017					
Notes:

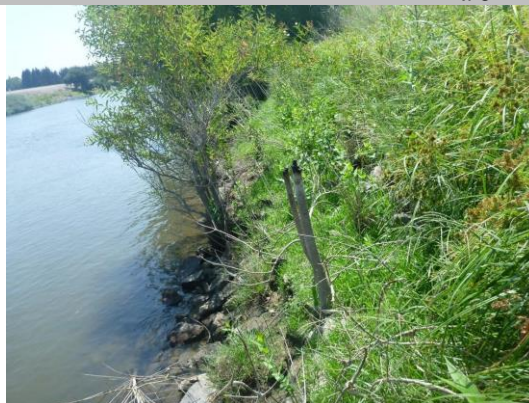
Photo 2 of 3 : LEVAL_SP_2019_568_4545.jpg

LM Start	2.31	Rating **	A/W	Issue No.	128 (cont)
LM End	2.35	Issue Type +	Ma	Location *	
Category	Supplemental			GPS Latitude/Longitude	
				Start	End
Item	2017 Storm Damage			37.847300 °	37.846800 °
				-121.324700 °	-121.324400 °
DWR ID	DWR_RD0544_01_f_2017_128				
Comment Code					
Inspector Comment					
Levee Evaluation Comments					
Description:Slope protection repairs are needed along the waterside slope due to erosion and riprap displacement from high water. Based upon levee inspections, it was determined the waterside levee slope is eroding, deteriorating, and degrading. The eroded levee sections need to be restored back to design standards to prevent further deterioration and damage.					
Site ID No:568					
Site Designation:LMA-474					
Repair Type: Erosion					
Rating:Area of Concern					
Field Date:8/10/2017					
Notes:

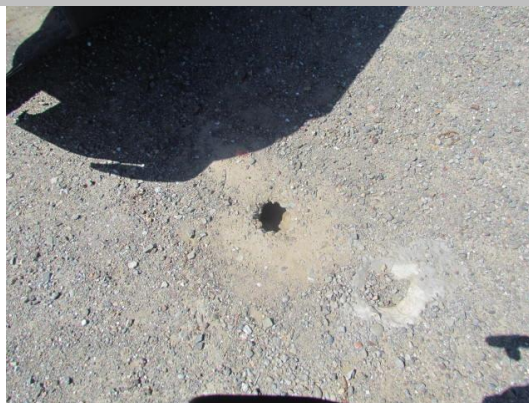
Photo 3 of 3 : SP_2019_RD0544_108_34_20190313_00025.jpg

Looking at rodent hole on levee crown.

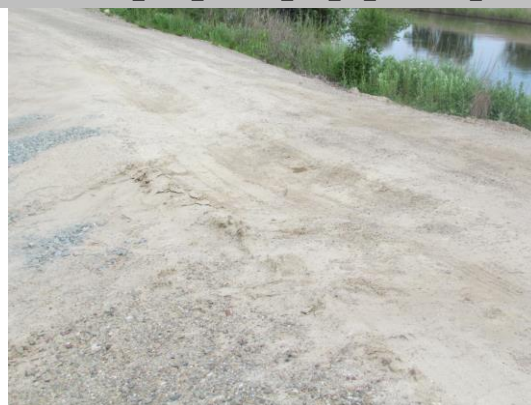
Photo 1 of 1 : SP_2019_RD0544_108_91_20190313_00059.jpg

LM Start	2.43	Rating **	U	Issue No.	91
LM End	2.43	Issue Type +	Ma	Location *	LS
Category	Earthen Levee			GPS Latitude/Longitude	
				Start	End
Item	Slope Stability			37.845973 °	37.845973 °
				-121.323373 °	-121.323373 °
DWR ID	DWR_RD0544_01_s_2017_91				
Comment Code					
S3 : Repair the levee slope damaged by vehicle traffic and prevent access where possible.					
Inspector Comment					
There is slope stability with a depression in the crown due to vehicle traffic.

Looking south at depression on levee crown and landward slope.

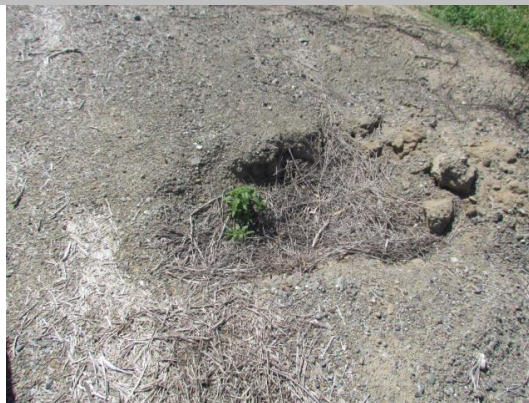
Looking west at depression on landward shoulder.

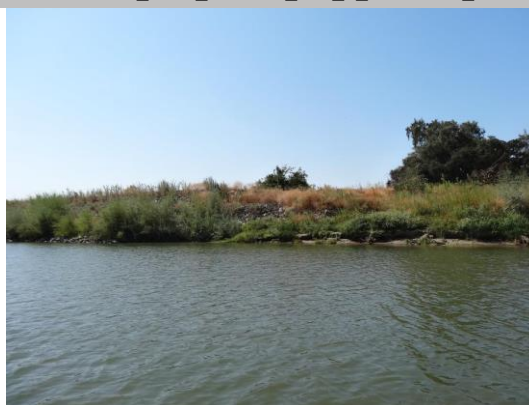
Front view of the erosion.

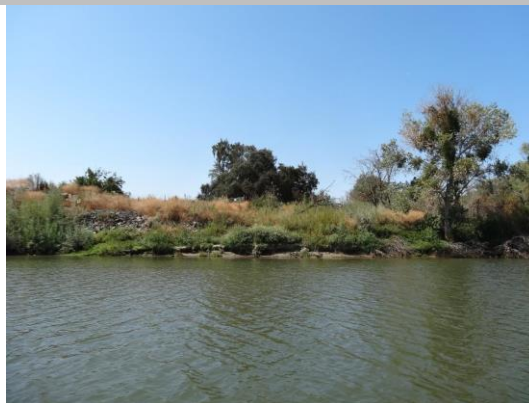
Front view of the erosion.

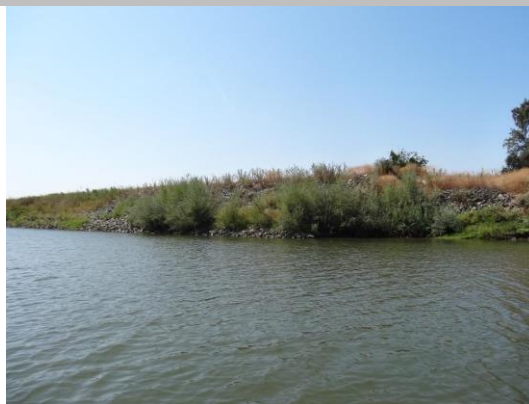
Downstream view of the site.

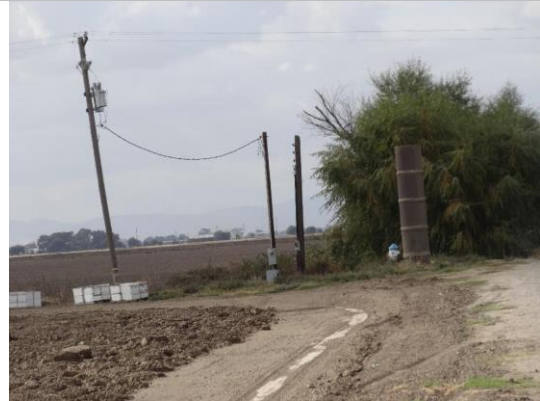
LS view: service pole, pump, and a concrete standpipe on bank of drainage ditch about 500 ft from the levee.

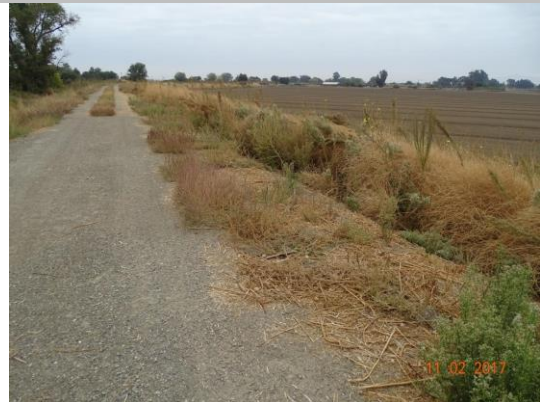
Looking southeast at the landside slope.

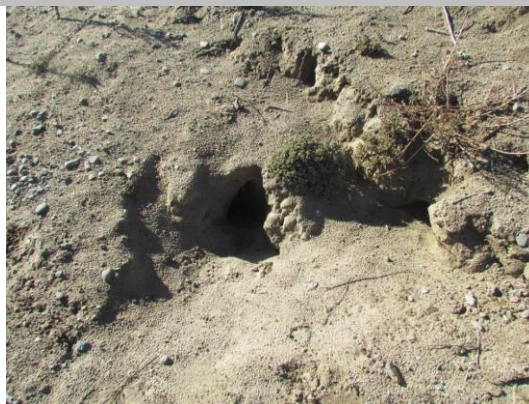
LM Start	3.92	Rating **	M	Issue No.	11
LM End	4.05	Issue Type +	Ma	Location *	WS
Category	Earthen Levee			GPS Latitude/Longitude	
				Start	End
Item	Animal Control			37.828078 °	37.826315 °
				-121.311483 °	-121.311024 °
DWR ID	DWR_RD0544_01_s_2012_11				
Comment Code					
A1 : Exterminate rodents and backfill and compact or grout burrows.					
Inspector Comment					
There are large rodent holes on the waterside slope.

Looking at large rodent holes on waterward slope.

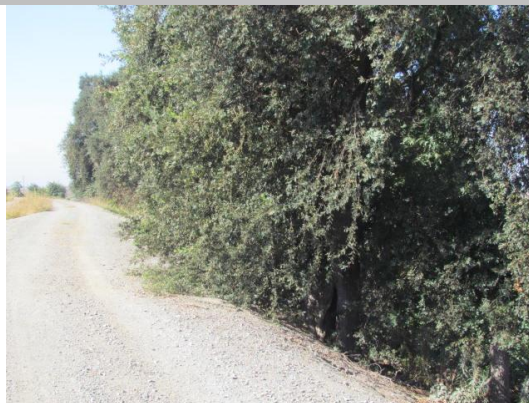
Looking southwest at dense untrimmed trees on landward slope fall 2015.

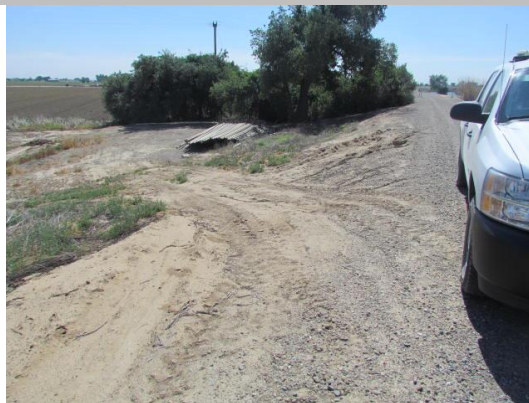
Looking northwest at slope damage caused by vehicle traffic.

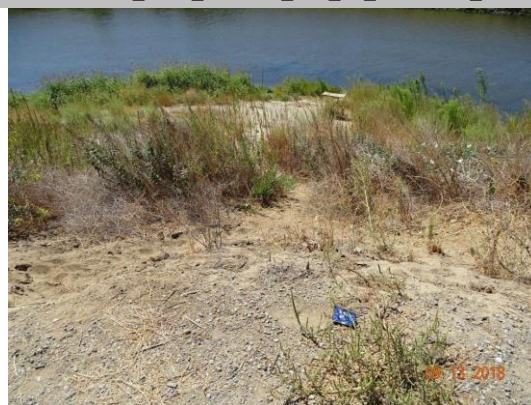
Looking east at foot erosion on waterward slope. (Fall 2018)

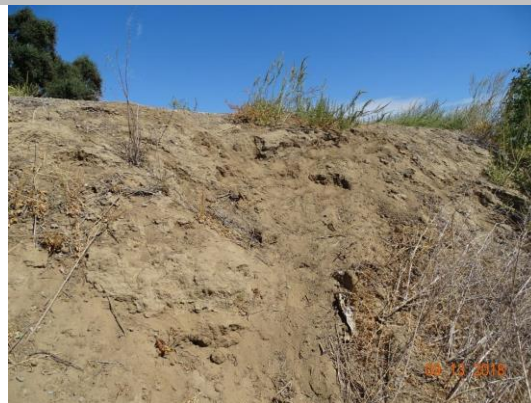
Looking west at erosion on waterward slope. (Fall 2018)

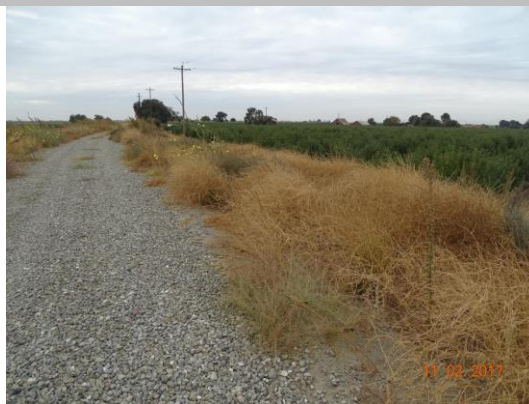
Looking southwest at the landside slope.

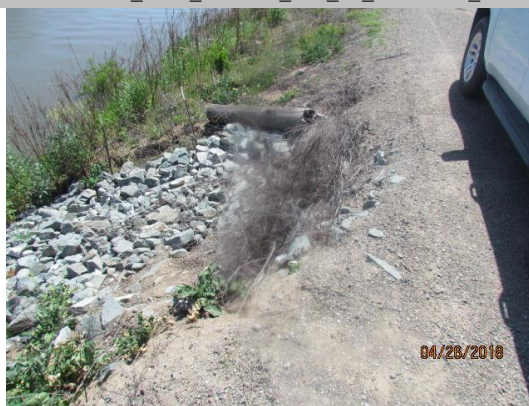
Looking south at erosion on shoulder. (Spring 2018)

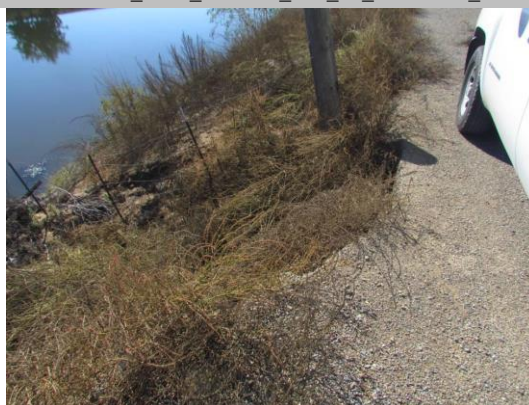
Looking south at erosion on waterward shoulder and slope.

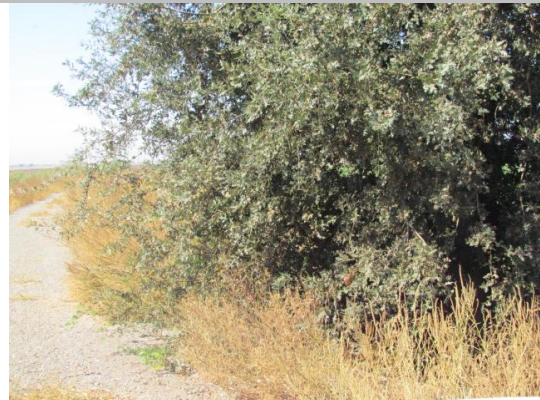
LM Start	2.80	Rating **	M	Issue No.	53
LM End	2.80	Issue Type +	Ma	Location *	LS
Category	Earthen Levee			GPS Latitude/Longitude	
				Start	End
Item	Trim / Thin Trees			37.817187 °	37.817187 °
				-121.352964 °	-121.352964 °
DWR ID	DWR_RD0544_02_f _ 2014_53				
Comment Code					
T2 : Thin trees to allow visibility of the ground and room to flood fight.					
Inspector Comment

Looking southwest at untrimmed tree on landward slope fall 2015.
