**Flood Control Project Maintenance
Levee Inspections**

Maintenance Issue Types Only, Levee Inspection Report By Mile - Spring 2020

Reclamation District No. 0544 Upper Roberts Island

Waterway	Bank	Unit Miles	Inspection Start/End	Inspector
Unit No. 01 San Joaquin River	Left	6.05	04/29/2020 04/29/2020	Alberto De Leon

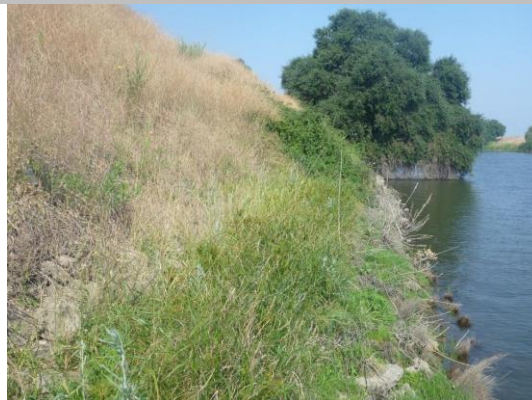
Photo 1 of 1 : LEVAL_SP_2020_571_4478.jpg

LM Start	0.64	Rating **	A/W	Issue No.	75
LM End	0.64	Issue Type +	Ma	Location *	WS
Category	Earthen Levee			GPS Latitude/Longitude	
				Start	End
Item	Erosion / Bank Caving			37.863900 °	37.863900 °
				-121.323500 °	-121.323400 °
DWR ID	LMA-477				
Comment Code					
E1 : Note and monitor erosion site.					
Inspector Comment					
2017 Storm Damage Site. Slope protection repairs are needed along the waterside slope due to erosion and riprap displacement from high water.					
Site ID No:571					
Site Designation:LMA-477

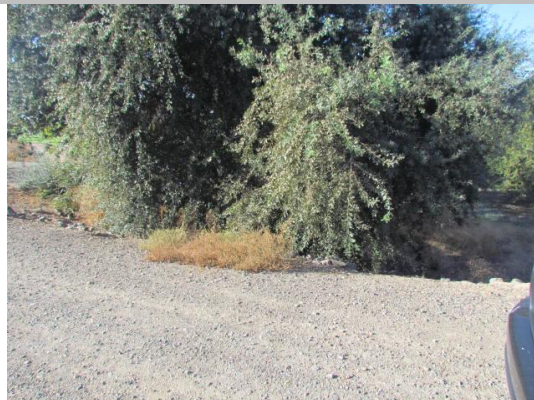
Photo 1 of 1 : SP_2020_RD0544_108_93_20200228_00046.jpg

Looking west at untrimmed trees on landward slope and toe, Fall 2015.

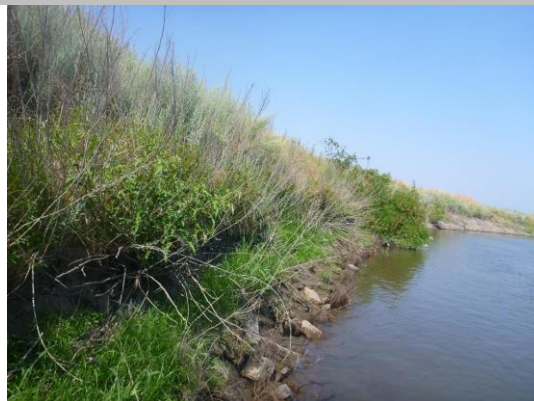
Photo 1 of 1 : LEVAL_SP_2020_570_4602.jpg

LM Start	0.99	Rating **	A/W	Issue No.	77
LM End	1.02	Issue Type +	Ma	Location *	WS
Category	Earthen Levee			GPS Latitude/Longitude	
				Start	End
Item	Erosion / Bank Caving			37.860400 °	37.860200 °
				-121.320300 °	-121.319700 °
DWR ID	LMA-476				
Comment Code					
E1 : Note and monitor erosion site.					
Inspector Comment					
2017 Storm Damage Site, Slope protection repairs are needed along the waterside slope due to erosion and riprap displacement from high water.					
Site ID No:570					
Site Designation:LMA-476

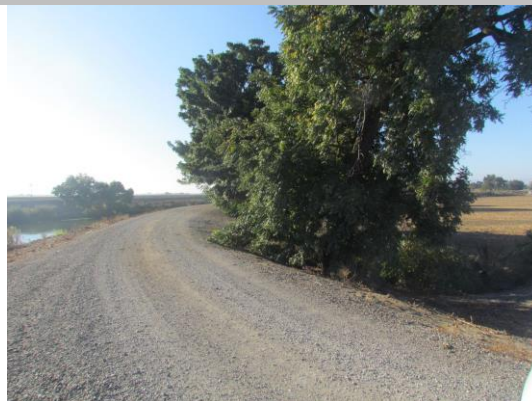
Photo 1 of 1 : SP_2020_RD0544_108_39_20200228_00016.jpg

Looking southwest at untrimmed tree on landward slope.

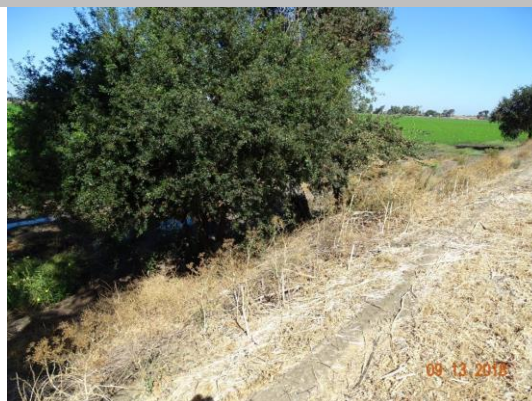
Photo 1 of 1 : SP_2020_RD0544_108_42_20200228_00017.jpg

Looking at untrimmed tree at landward toe. (Fall 2018)

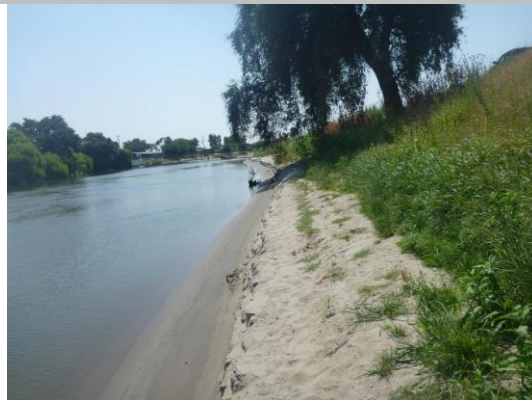
Photo 1 of 1 : LEVAL_SP_2020_569_4616.jpg

LM Start	1.89	Rating **	A/W	Issue No.	127
LM End	1.91	Issue Type +	Ma	Location *	WS
Category	Earthen Levee			GPS Latitude/Longitude	
				Start	End
Item	Erosion / Bank Caving			37.852300 °	37.852000 °
				-121.323700 °	-121.323600 °
DWR ID	LMA-475				
Comment Code					
E1 : Note and monitor erosion site.					
Inspector Comment					
2017 Storm Damage Site,Slope protection repairs are needed along the waterside slope due to erosion and riprap displacement from high water. Site ID No:569. Site Designation:LMA-475

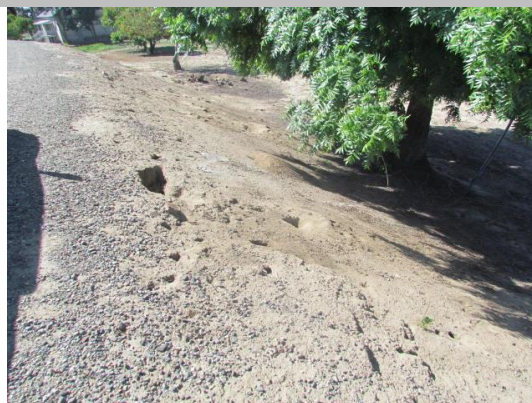
Photo 1 of 1 : SP_2020_RD0544_108_34_20200228_00013.jpg

LM Start	2.19	Rating **	U	Issue No.	34
LM End	2.36	Issue Type +	Ma	Location *	LS
Category	Earthen Levee			GPS Latitude/Longitude	
				Start	End
Item	Animal Control			37.849042 °	37.846743 °
				-121.324826 °	-121.324336 °
DWR ID	DWR_RD0544_01_s_2012_34				
Comment Code					
A3 : No rodents visible, but rodent burrows visible; need to backfill and compact or grout burrows.					
Inspector Comment					
There are several rodent holes within this landside reach.

Looking south at several rodent holes on landward shoulder and slope.

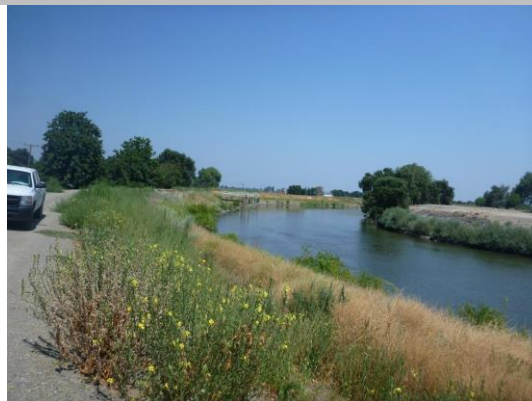
Photo 1 of 1 : LEVAL_SP_2020_568_4540.jpg

LM Start	2.31	Rating **	A/W	Issue No.	128
LM End	2.35	Issue Type +	Ma	Location *	WS
Category	Earthen Levee		GPS Latitude/Longitude		
			Start	End	
Item	Erosion / Bank Caving		37.847300 °	37.846800 °	
			-121.324700 °	-121.324400 °	
DWR ID	LMA-474				
Comment Code					
E1 : Note and monitor erosion site.					
Inspector Comment					
2017 Storm Damage Site, Slope protection repairs are needed along the waterside slope due to erosion and riprap displacement from high water. Site ID No:568 Site Designation:LMA-474

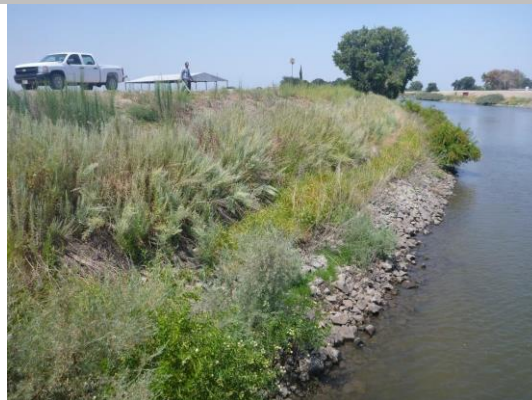
Photo 1 of 1 : LEVAL_SP_2020_567_4554.jpg

LM Start	2.53	Rating **	A/W	Issue No.	129
LM End	2.56	Issue Type +	Ma	Location *	WS
Category	Earthen Levee			GPS Latitude/Longitude	
				Start	End
Item	Erosion / Bank Caving			37.844900 °	37.844500 °
				-121.322300 °	-121.321900 °
DWR ID	LMA-473				
Comment Code					
E1 : Note and monitor erosion site.					
Inspector Comment					
2017 Storm Damage Site, Slope protection repairs are needed along the waterside slope due to erosion and riprap displacement from high water.					
Site ID No:567					
Site Designation:LMA-473

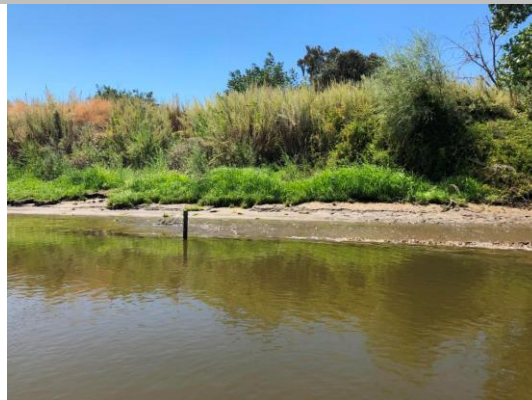
Photo 1 of 3 : SP_2020_RD0544_108_5_20200228_00003.jpg

Site ID: RD0544U01RM49.67
 08/13/2019: No significant change observed.
 09/13/2017: No significant change observed.
 07/25/2016: No significant change observed.
 06/24/2015: No significant change observed.
 06/19/2014: No significant change observed.
 08/13/2013: Pump has been removed. A larger pocket erosion has been found at the erosion site.
 08/07/2012: The erosion is immediately upstream of a river bend.
 Dense vegetation is visible at the erosion site.

Front view of the erosion.

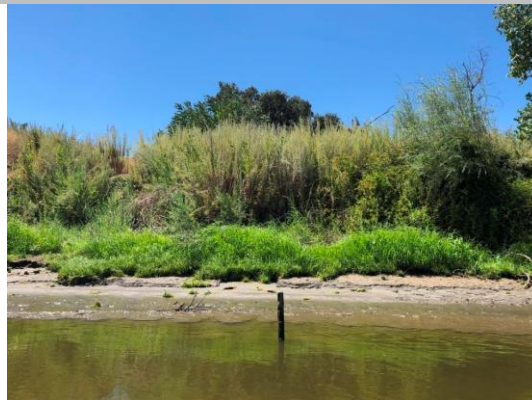
Photo 2 of 3 : SP_2020_RD0544_108_5_20200228_00004.jpg

Front view of the erosion.

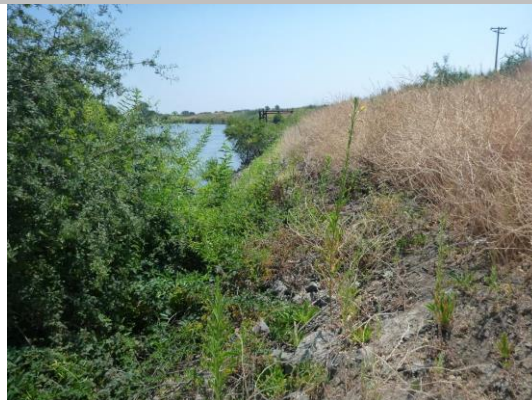
Photo 1 of 1 : LEVAL_SP_2020_566_4714.jpg

LM Start	3.21	Rating **	A/W	Issue No.	131
LM End	3.22	Issue Type +	Ma	Location *	WS
Category	Earthen Levee			GPS Latitude/Longitude	
				Start	End
Item	Erosion / Bank Caving			37.836900 °	37.836700 °
				-121.317300 °	-121.317300 °
DWR ID	LMA-472				
Comment Code					
E1 : Note and monitor erosion site.					
Inspector Comment					
2017 storm damage site, ID 566, LMA-472. Slope protection repairs are needed along the waterside slope due to erosion and riprap displacement from high water.

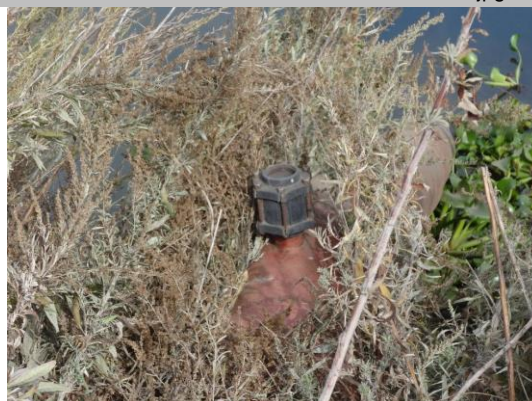
Photo 1 of 3 : UCIP_SP_2020_24892_44853.jpg

Comment Code						
Inspector Comment						
DS_ID:22658 FS_ID:24892 EP_NO: N/A Repair Type: No Action Needed Crossing Status: Found UCIP Comments: - pipe on channel bank looks comparatively new.- pump approximately 500 ft. from the levee center on landside in drainage ditch.- a tall concrete standpipe and service pole near the pump. FIELD_STRUCT_DESC: 12-inch steel drainage discharge pipe through the levee, 3 feet below the crown. Pump and concrete standpipe in a drainage ditch on the landside (LS). Air vent on the waterside (WS). [Additional Reference(s): DWR Levee Log, 2005. USACE San Joaquin O&M Manual 7, April 1964, (HLM 3.53)]. FS Date: 10/29/2013

WS view: exposed steel pipe on bank of the channel.

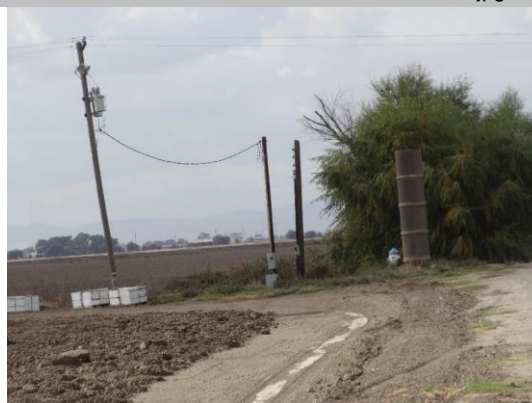
Photo 3 of 3 : UCIP_SP_2020_24892_44851.jpg

LS view: service pole, pump, and a concrete standpipe on bank of drainage ditch about 500 ft from the levee.

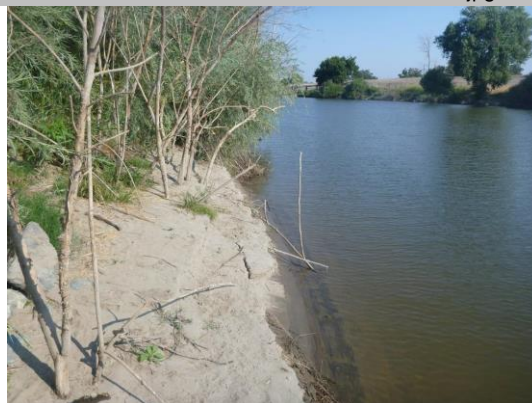
Photo 1 of 1 : LEVAL_SP_2020_565_4745.jpg

LM Start	3.65	Rating **	A/W	Issue No.	132
LM End	3.67	Issue Type +	Ma	Location *	WS
Category	Earthen Levee			GPS Latitude/Longitude	
				Start	End
Item	Erosion / Bank Caving			37.831800 °	37.831600 °
				-121.312700 °	-121.312600 °
DWR ID	LMA-471				
Comment Code					
E1 : Note and monitor erosion site.					
Inspector Comment					
2017 Storm Damage Site, Slope protection repairs are needed along the waterside slope due to erosion and riprap displacement from high water.					
Site ID No:565					
Site Designation:LMA-471

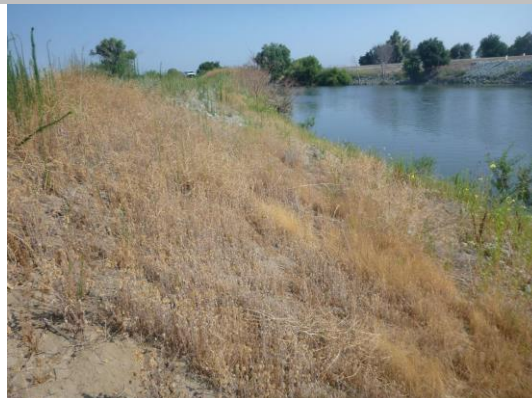
Photo 1 of 1 : LEVAL_SP_2020_564_4748.jpg

LM Start	3.69	Rating **	A/W	Issue No.	133
LM End	3.73	Issue Type +	Ma	Location *	WS
Category	Earthen Levee			GPS Latitude/Longitude	
				Start	End
Item	Erosion / Bank Caving			37.831300 °	37.830700 °
				-121.312600 °	-121.312300 °
DWR ID	LMA-470				
Comment Code					
E1 : Note and monitor erosion site.					
Inspector Comment					
2017 Storm Damage Site, Slope protection repairs are needed along the waterside slope due to erosion and riprap displacement from high water.					
Site ID No:564					
Site Designation:LMA-470

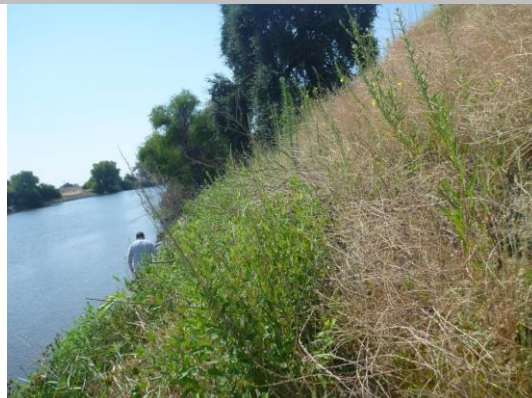
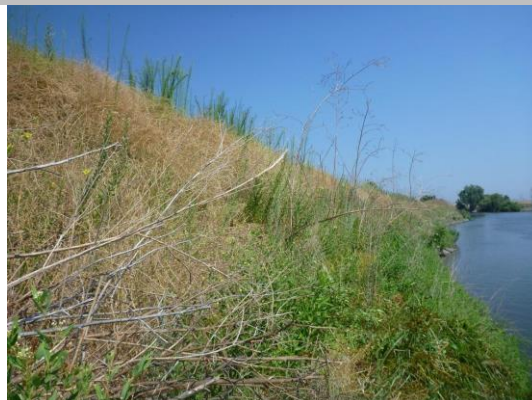
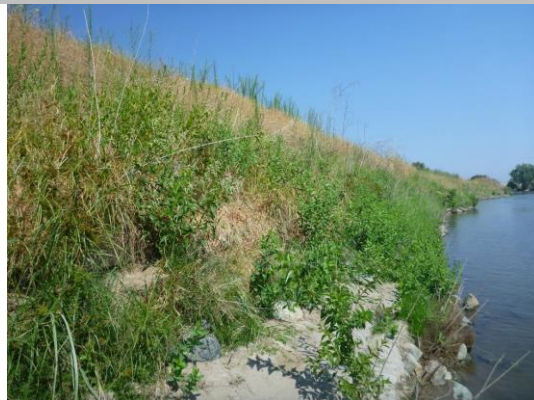
LM Start	3.79	Rating **	A/W	Issue No.	135
LM End	3.82	Issue Type +	Ma	Location *	WS
Category	Supplemental			GPS Latitude/Longitude	
				Start	End
Item	2017 Storm Damage			37.829800 °	37.829400 °
				-121.312100 °	-121.312000 °
DWR ID	LMA 468-469				
Comment Code					
Inspector Comment					
Planned For Repair.					
Levee Evaluation Comments					
Description:Slope protection repairs are needed along the waterside slope due to erosion and riprap displacement from high water. Based upon levee inspections, it was determined the waterside levee slope is eroding, deteriorating, and degrading. The eroded levee sections need to be restored back to design standards to prevent further deterioration and damage.					
Site ID No:562					
Site Designation:LMA 468-469					
Repair Type: Erosion					
Rating:Serious					
Field Date:8/11/2017					
Notes: Site combined with LMA-469:

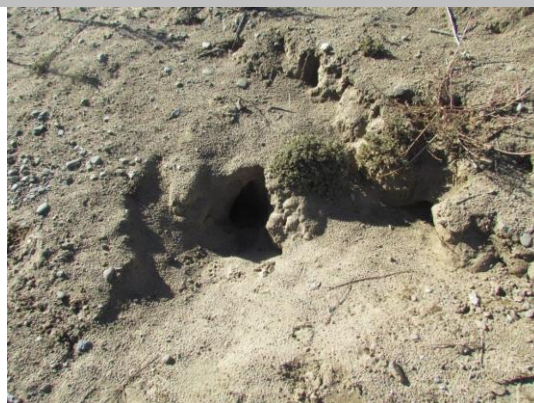
Photo 1 of 1 : SP_2020_RD0544_108_11_20200228_00009.jpg

LM Start	3.92	Rating **	M	Issue No.	11
LM End	4.05	Issue Type +	Ma	Location *	WS
Category	Earthen Levee			GPS Latitude/Longitude	
				Start	End
Item	Animal Control			37.828078 °	37.826315 °
				-121.311483 °	-121.311024 °
DWR ID	DWR_RD0544_01_s_2012_11				
Comment Code					
A1 : Exterminate rodents and backfill and compact or grout burrows.					
Inspector Comment					
There are large rodent holes on the waterside slope.

Looking at large rodent holes on waterward slope.

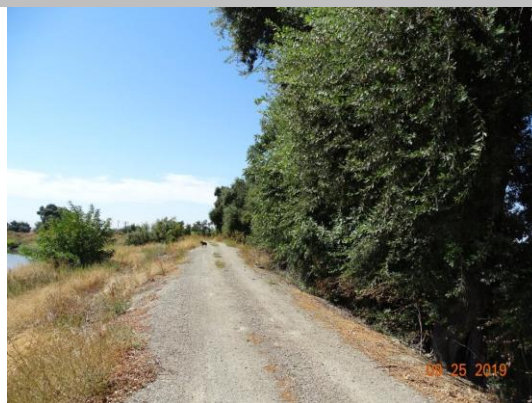
Photo 1 of 1 : SP_2020_RD0544_108_104_20200228_00050.jpg

View of untrimmed trees on landside slope. Fall 2019

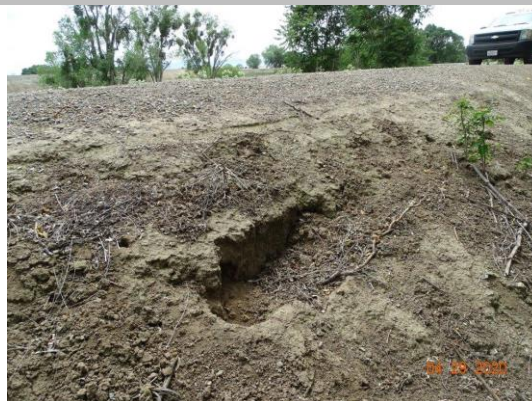
Photo 1 of 1 : SP_2020_RD0544_108_51_20200504_00132.jpg

View of animal burrow on landside slope. Spring 2020

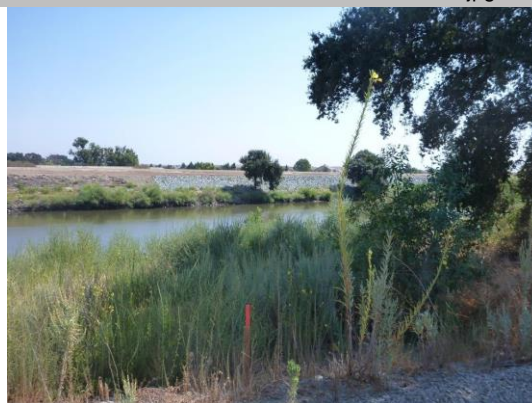
Photo 1 of 1 : LEVAL_SP_2020_557_4510.jpg

LM Start	5.36	Rating **	A/W	Issue No.	141
LM End	5.37	Issue Type +	Ma	Location *	WS
Category	Earthen Levee			GPS Latitude/Longitude	
				Start	End
Item	Erosion / Bank Caving			37.813400 °	37.813300 °
				-121.319300 °	-121.319200 °
DWR ID	LMA-463

Comment Code					
E1 : Note and monitor erosion site.					
Inspector Comment					
2017 Storm Damage Site, ID No:557, LMA-463. Slope protection repairs are needed along the waterside slope due to erosion and riprap displacement from high water.

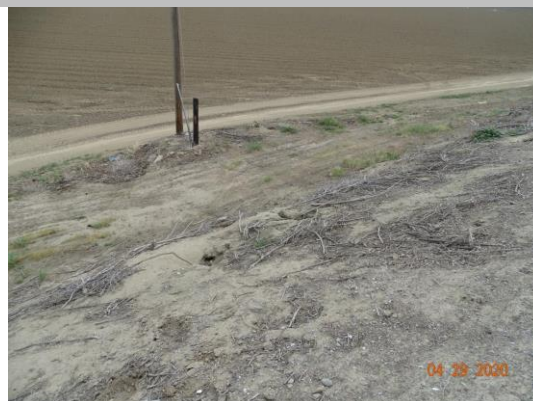
Photo 1 of 1 : SP_2020_RD0544_109_65_20200504_00107.jpg

View of multiple large animal burrows on landside slope. Spring 2020

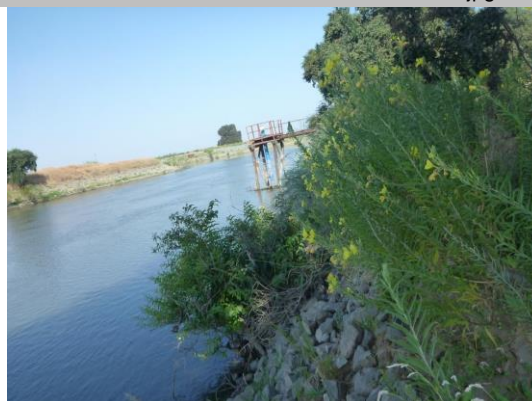
Photo 1 of 1 : LEVAL_SP_2020_550_4570.jpg

LM Start	2.18	Rating **	A/W	Issue No.	88
LM End	2.19	Issue Type +	Ma	Location *	WS
Category	Earthen Levee			GPS Latitude/Longitude	
				Start	End
Item	Erosion / Bank Caving			37.820400 °	37.820500 °
				-121.345800 °	-121.345900 °
DWR ID	LMA-456

Comment Code					
E1 : Note and monitor erosion site.					
Inspector Comment					
2017 storm damage site, ID 550, site LMA-456. Monitor waterside slope for erosion and riprap displacement during high water.

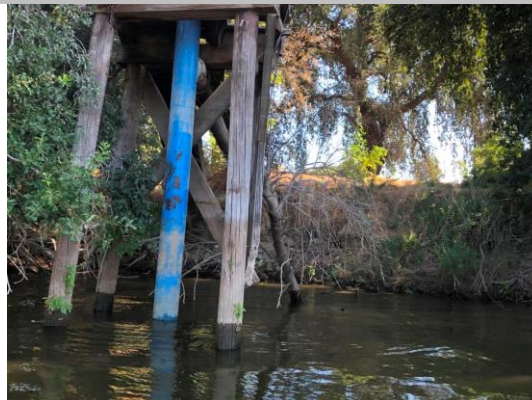
Photo 1 of 3 : SP_2020_RD0544_109_7_20200228_00005.jpg

Front view of the erosion site. View is partially blocked by the pump structure and vegetation at the site.

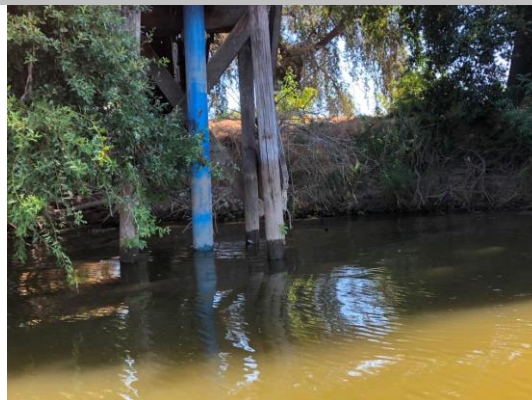
Photo 2 of 3 : SP_2020_RD0544_109_7_20200228_00006.jpg

Front view of the site.

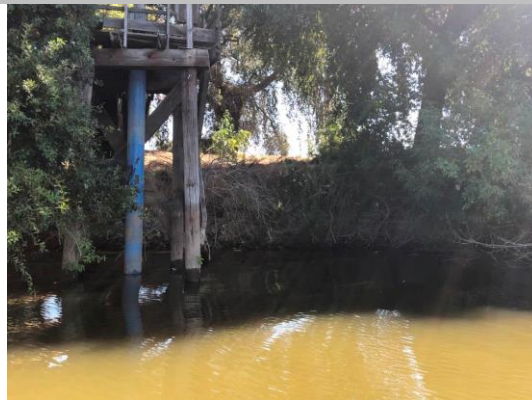
Photo 3 of 3 : SP_2020_RD0544_109_7_20200228_00007.jpg

Close-up view of the site.

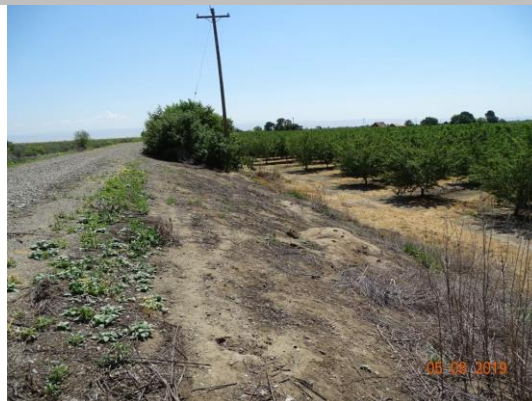
Photo 1 of 1 : SP_2020_RD0544_109_36_20200228_00019.jpg

View of landside slope with multiple animal burrows. (Spring 2019)

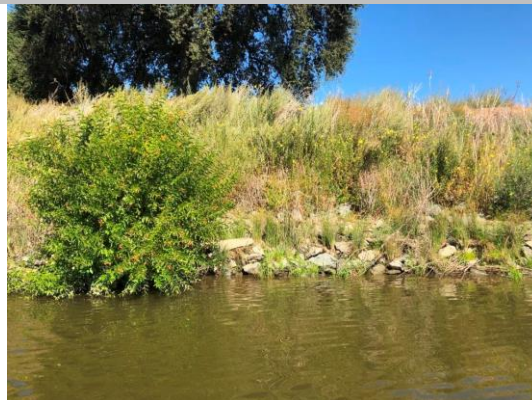
Photo 1 of 2 : SP_2020_RD0544_109_1_20200228_00001.jpg

Front view of the pocket erosion. Note vegetation and riprap at the site.

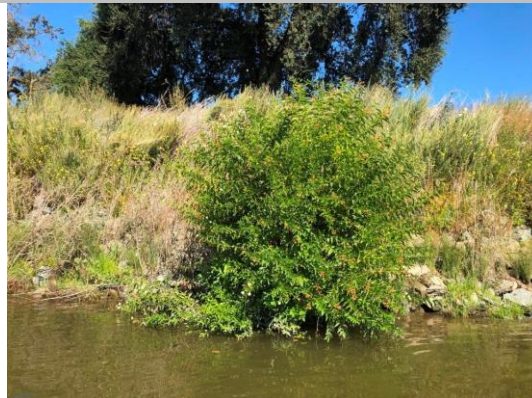
Photo 2 of 2 : SP_2020_RD0544_109_1_20200228_00002.jpg

Front view of the pocket erosion.

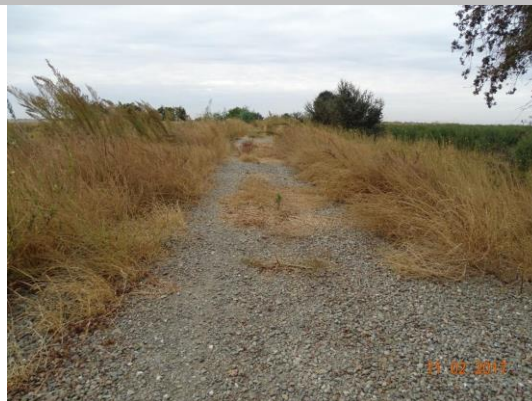
Photo 1 of 2 : SP_2020_RD0544_109_43_20200228_00023.jpg

LM Start	2.71	Rating **	M	Issue No.	43
LM End	3.45	Issue Type +	Ma	Location *	LS
Category	Earthen Levee			GPS Latitude/Longitude	
				Start	End
Item	Vegetation			37.817747 °	37.819583 °
				-121.351578 °	-121.363559 °
DWR ID	DWR_RD0544_02_s_2012_43				
Comment Code					
V2 : Remove the wild growth other than native grasses from the levee slopes.					
Inspector Comment

Looking southwest at levee.

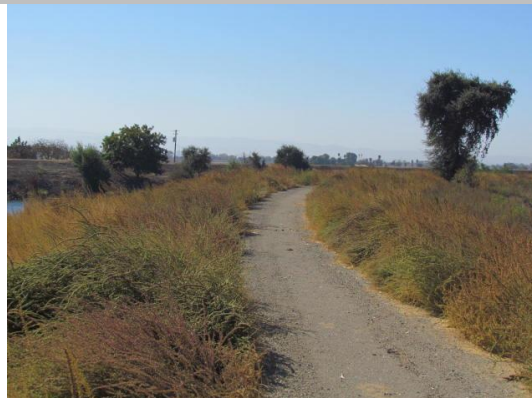
Photo 2 of 2 : SP_2020_RD0544_109_43_20200228_00024.jpg

Looking at dense vegetation on landward and waterward slope.

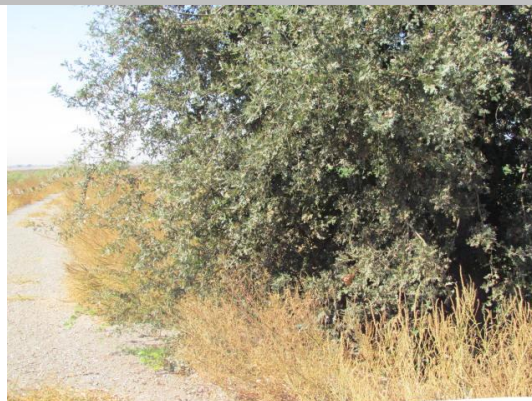
Photo 1 of 1 : SP_2020_RD0544_109_53_20200228_00025.jpg

Looking southwest at untrimmed tree on landward slope fall 2015.

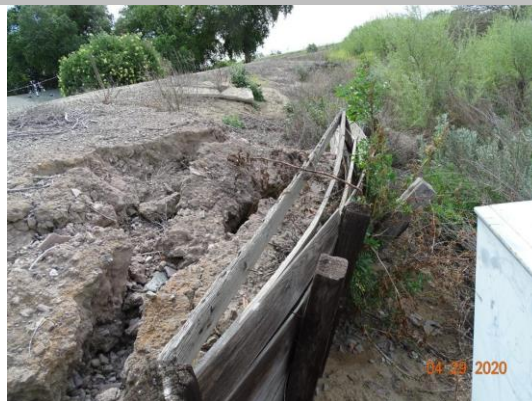
Photo 1 of 2 : SP_2020_RD0544_109_78_20200504_00105.jpg

View of soil separation and damaged retaining wall on waterside slope.
Spring 2020

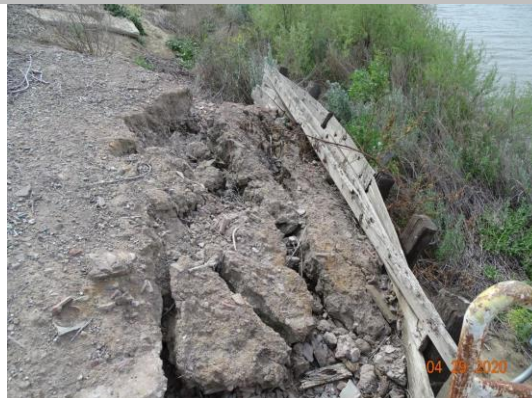
Photo 2 of 2 : SP_2020_RD0544_109_78_20200504_00104.jpg

View of soil separation and damaged retaining wall on waterside slope.
Spring 2020

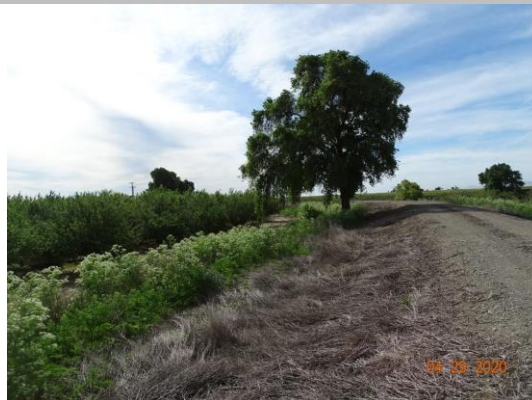
Photo 1 of 1 : SP_2020_RD0544_109_22_20200504_00100.jpg

View of overgrown vegetation on landside slope. Spring 2020

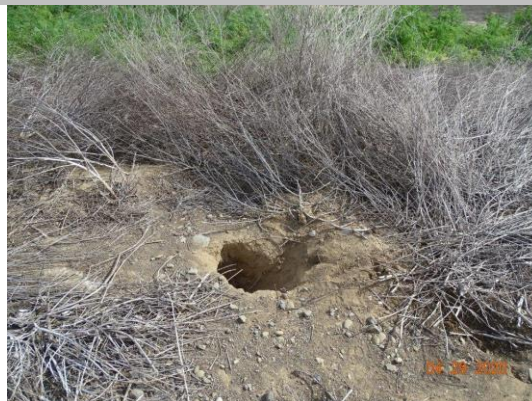
Photo 1 of 1 : SP_2020_RD0544_109_23_20200504_00101.jpg

View of animal burrow on landside slope. Spring 2020
