**Flood Control Project Maintenance
Levee Inspections**

Maintenance Issue Types Only, Levee Inspection Report By Mile - Spring 2021

Reclamation District No. 0544 Upper Roberts Island

Waterway	Bank	Unit Miles	Inspection Start/End	Inspector
Unit No. 01 San Joaquin River	Left	6.05	03/30/2021 03/30/2021	Alberto De Leon

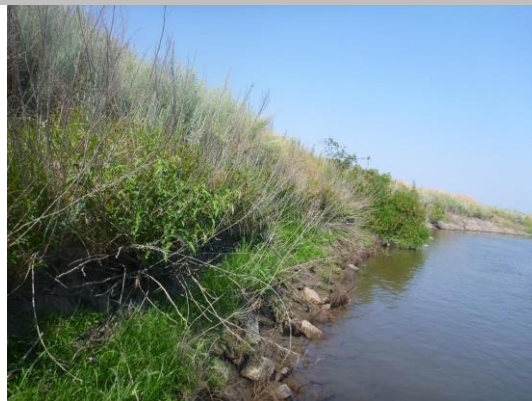
Photo 1 of 1 : LEVAL_SP_2021_570_4602.jpg

LM Start	0.99	Rating **	M	Issue No.	77
LM End	1.02	Issue Type +	Ma	Location *	WS
Category	Earthen Levee			GPS Latitude/Longitude	
				Start	End
Item	Erosion / Bank Caving			37.860400 °	37.860200 °
				-121.320300 °	-121.319700 °
DWR ID	LMA-476				
Comment Code					
E2 : Schedule repair of erosion site prior to the next inspection.					
Inspector Comment					
2017 Storm Damage Site, Slope protection repairs are needed along the waterside slope due to erosion and riprap displacement from high water.					
Site ID No:570					
Site Designation:LMA-476

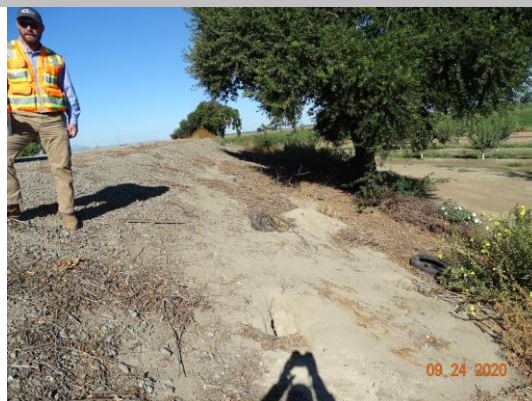
Photo 1 of 1 : SP_2021_RD0544_108_46_20210210_00012.jpg

View of landside slope with multiple large rodent holes. Fall 2020

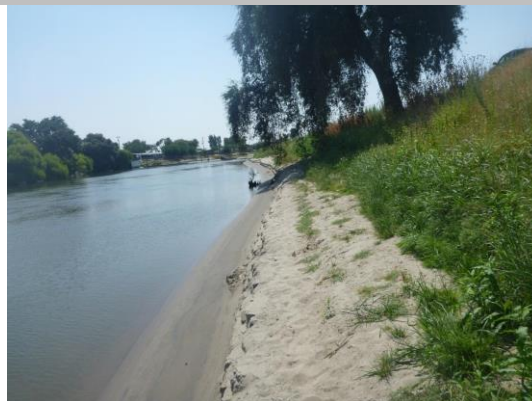
Photo 1 of 1 : LEVAL_SP_2021_569_4616.jpg

LM Start	1.89	Rating **	M	Issue No.	127
LM End	1.91	Issue Type +	Ma	Location *	WS
Category	Earthen Levee			GPS Latitude/Longitude	
				Start	End
Item	Erosion / Bank Caving			37.852300 °	37.852000 °
				-121.323700 °	-121.323600 °
DWR ID	LMA-475				
Comment Code					
E2 : Schedule repair of erosion site prior to the next inspection.					
Inspector Comment					
2017 Storm Damage Site,Slope protection repairs are needed along the waterside slope due to erosion and riprap displacement from high water. Site ID No:569. Site Designation:LMA-475

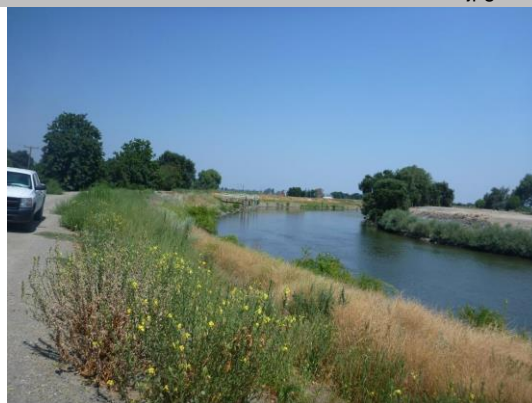
Photo 1 of 1 : LEVAL_SP_2021_568_4540.jpg

LM Start	2.31	Rating **	M	Issue No.	128
LM End	2.35	Issue Type +	Ma	Location *	WS
Category	Earthen Levee		GPS Latitude/Longitude		
			Start	End	
Item	Erosion / Bank Caving		37.847300 °	37.846800 °	
			-121.324700 °	-121.324400 °	
DWR ID	LMA-474				
Comment Code					
E2 : Schedule repair of erosion site prior to the next inspection.					
Inspector Comment					
2017 Storm Damage Site, Slope protection repairs are needed along the waterside slope due to erosion and riprap displacement from high water. Site ID No:568 Site Designation:LMA-474

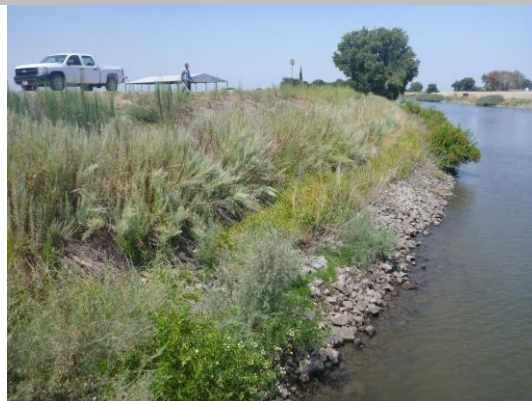
Photo 1 of 1 : LEVAL_SP_2021_567_4554.jpg

LM Start	2.53	Rating **	M	Issue No.	129
LM End	2.56	Issue Type +	Ma	Location *	WS
Category	Earthen Levee			GPS Latitude/Longitude	
				Start	End
Item	Erosion / Bank Caving			37.844900 °	37.844500 °
				-121.322300 °	-121.321900 °
DWR ID	LMA-473				
Comment Code					
E2 : Schedule repair of erosion site prior to the next inspection.					
Inspector Comment					
2017 Storm Damage Site, Slope protection repairs are needed along the waterside slope due to erosion and riprap displacement from high water.					
Site ID No:567					
Site Designation:LMA-473

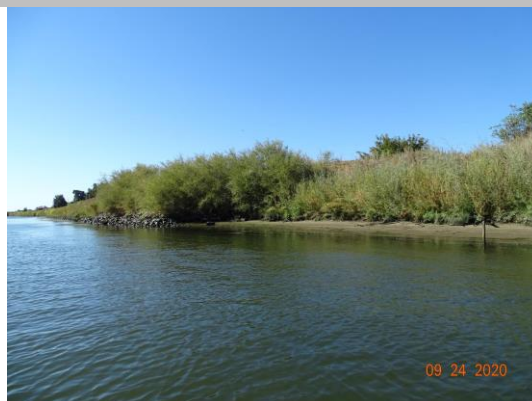
Photo 1 of 2 : SP_2021_RD0544_108_1_20210210_00001.jpg

09/24/2020: From 2014 to present, no significant changes were observed during the annual survey. The site is immediately downstream of a levee slope section protected with riprap.

9/24/2020: View of the erosion looking upstream with riprap visible beyond the upstream end.

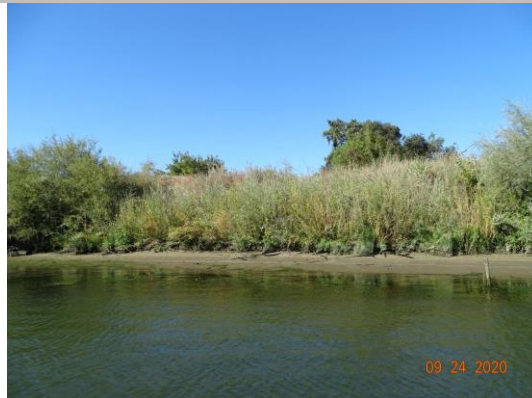
Photo 2 of 2 : SP_2021_RD0544_108_1_20210210_00002.jpg

9/24/2020: Close-up view of the erosion.

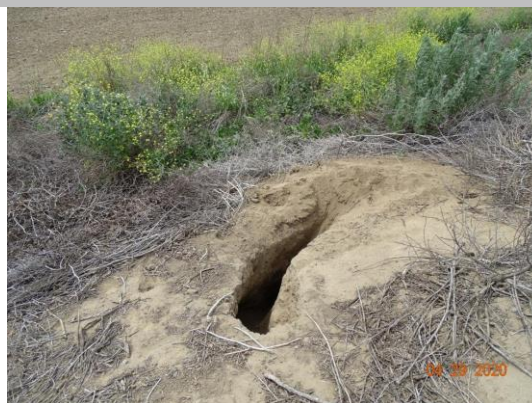
Photo 1 of 1 : SP_2021_RD0544_108_92_20210210_00023.jpg

View of large animal burrow on landside slope. Spring 2020

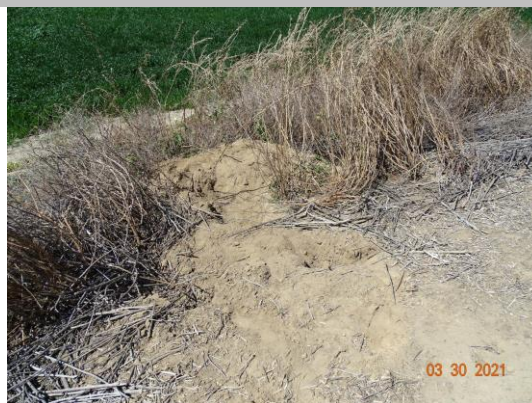
Photo 1 of 1 : SP_2021_RD0544_108_107_20210412_00090.jpg

View of large animal burrow along the landside slope. Spring 2021

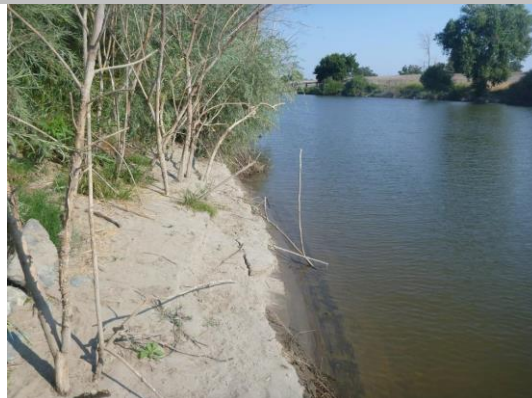
Photo 1 of 1 : LEVAL_SP_2021_565_4745.jpg

LM Start	3.65	Rating **	M	Issue No.	132
LM End	3.67	Issue Type +	Ma	Location *	WS
Category	Earthen Levee			GPS Latitude/Longitude	
				Start	End
Item	Erosion / Bank Caving			37.831800 °	37.831600 °
				-121.312700 °	-121.312600 °
DWR ID	LMA-471				
Comment Code					
E2 : Schedule repair of erosion site prior to the next inspection.					
Inspector Comment					
2017 Storm Damage Site, Slope protection repairs are needed along the waterside slope due to erosion and riprap displacement from high water.					
Site ID No:565					
Site Designation:LMA-471

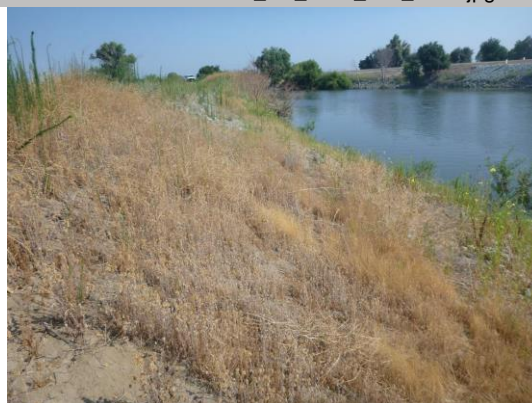
Photo 1 of 1 : LEVAL_SP_2021_564_4748.jpg

LM Start	3.69	Rating **	M	Issue No.	133
LM End	3.73	Issue Type +	Ma	Location *	WS
Category	Earthen Levee			GPS Latitude/Longitude	
				Start	End
Item	Erosion / Bank Caving			37.831300 °	37.830700 °
				-121.312600 °	-121.312300 °
DWR ID	LMA-470				
Comment Code					
E2 : Schedule repair of erosion site prior to the next inspection.					
Inspector Comment					
2017 Storm Damage Site, Slope protection repairs are needed along the waterside slope due to erosion and riprap displacement from high water.					
Site ID No:564					
Site Designation:LMA-470

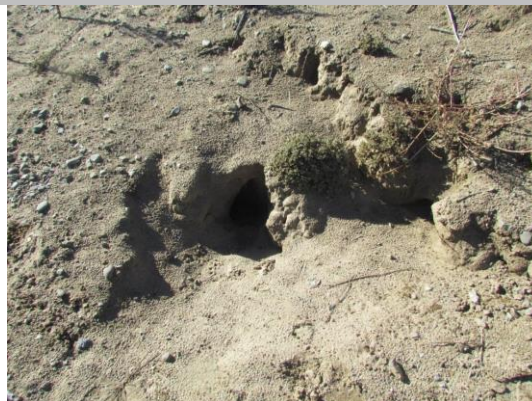
Photo 1 of 1 : SP_2021_RD0544_108_11_20210210_00006.jpg

Looking at large rodent holes on waterward slope.

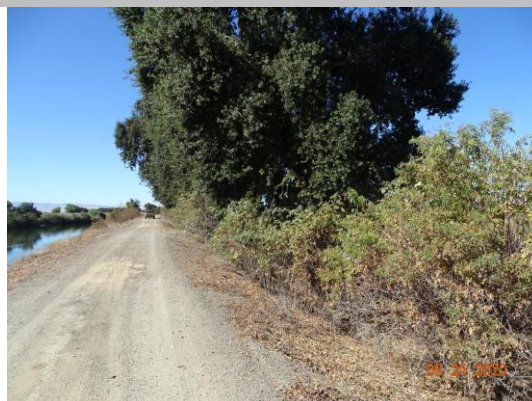
Photo 1 of 1 : SP_2021_RD0544_108_100_20210210_00026.jpg

View vegetation and wild growth on landside slope. Fall 2020

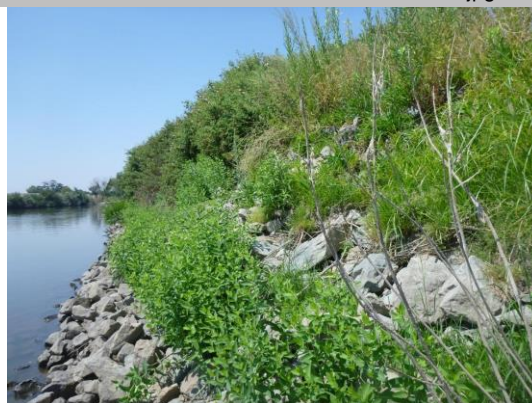
Photo 1 of 1 : LEVAL_SP_2021_561_4862.jpg

LM Start	4.46	Rating **	M	Issue No.	136
LM End	4.48	Issue Type +	Ma	Location *	WS
Category	Earthen Levee			GPS Latitude/Longitude	
				Start	End
Item	Erosion / Bank Caving			37.823200 °	37.823000 °
				-121.316400 °	-121.316800 °
DWR ID	LMA-467				
Comment Code					
E2 : Schedule repair of erosion site prior to the next inspection.					
Inspector Comment					
2017 storm damage site, ID 561, LMA-467. Slope protection repairs are needed along the waterside slope due to erosion and riprap displacement from high water. Site combined with LMA-466 in field; length and coordinates redefined in field.

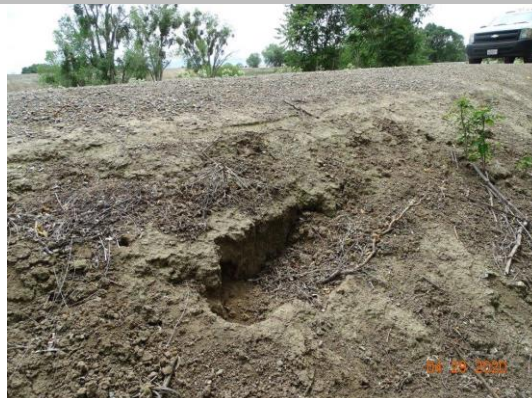
Photo 1 of 1 : SP_2021_RD0544_108_51_20210210_00014.jpg

View of animal burrow on landside slope. Spring 2020

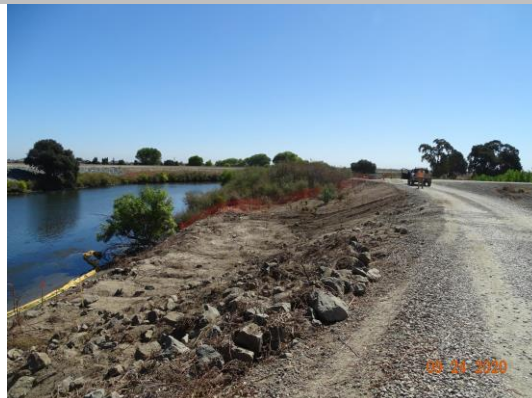
Photo 1 of 4 : SP_2021_RD0544_108_140_20210210_00041.jpg

View of waterside erosion repair in progress. Fall 2020

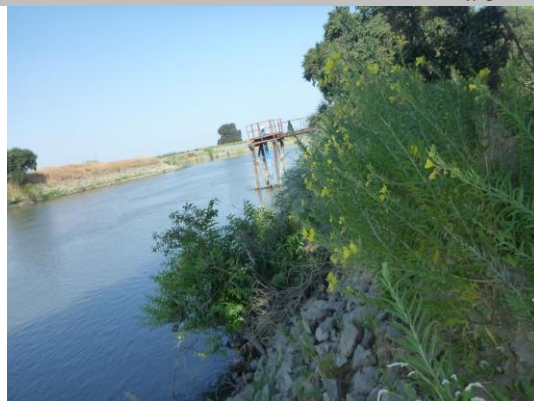
Photo 1 of 1 : LEVAL_SP_2021_550_4570.jpg

LM Start	2.18	Rating **	A/W	Issue No.	88
LM End	2.19	Issue Type +	Ma	Location *	WS
Category	Earthen Levee			GPS Latitude/Longitude	
				Start	End
Item	Erosion / Bank Caving			37.820400 °	37.820500 °
				-121.345800 °	-121.345900 °
DWR ID	LMA-456

Comment Code					
E1 : Note and monitor erosion site.					
Inspector Comment					
2017 storm damage site, ID 550, site LMA-456. Monitor waterside slope for erosion and riprap displacement during high water.

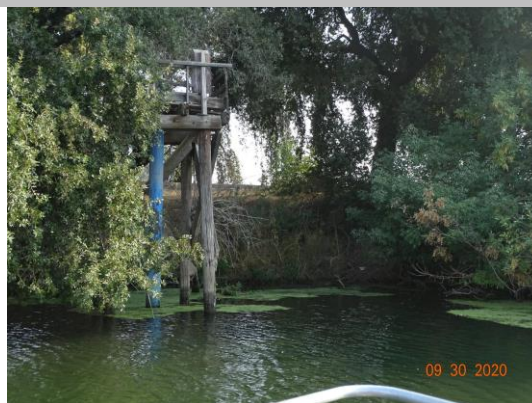
Photo 1 of 2 : SP_2021_RD0544_109_1_20210210_00001.jpg

9/30/2020: View of the erosion with the irrigation pipe and pump station.

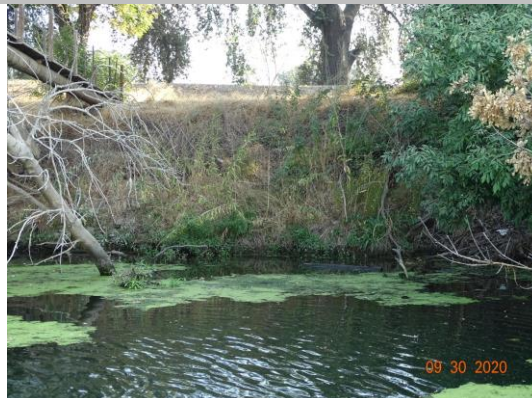
Photo 2 of 2 : SP_2021_RD0544_109_1_20210210_00002.jpg

9/30/2020: Close-up view of the erosion.

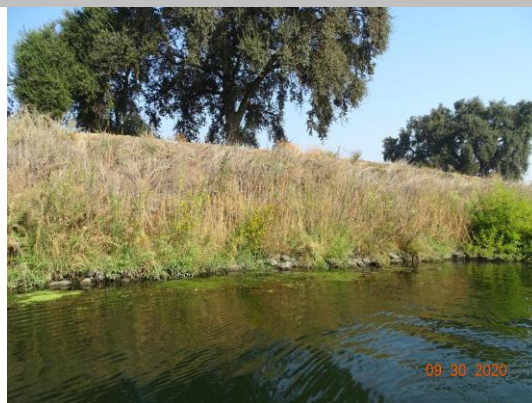
Photo 1 of 2 : SP_2021_RD0544_109_2_20210210_00003.jpg

9/30/2020: View of an erosion pocket.

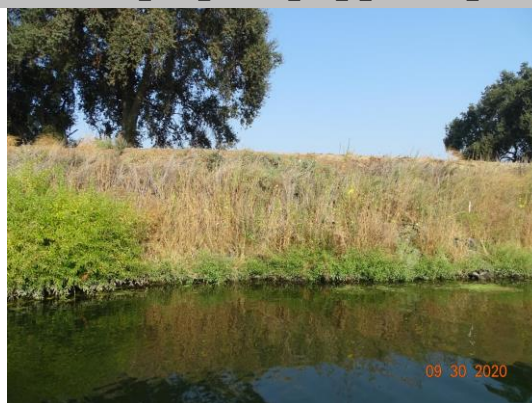
Photo 2 of 2 : SP_2021_RD0544_109_2_20210210_00004.jpg

9/30/2020: Another erosion pocket.

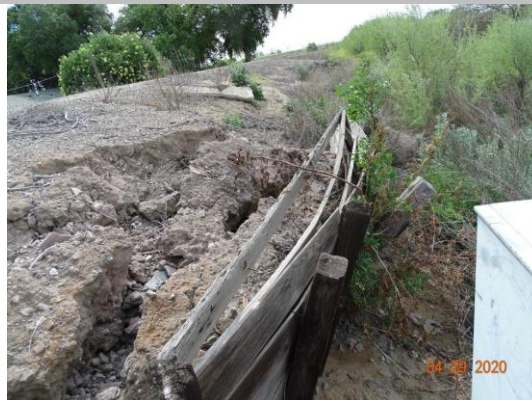
Photo 1 of 2 : SP_2021_RD0544_109_78_20210210_00017.jpg

View of soil separation and damaged retaining wall on waterside slope.
Spring 2020

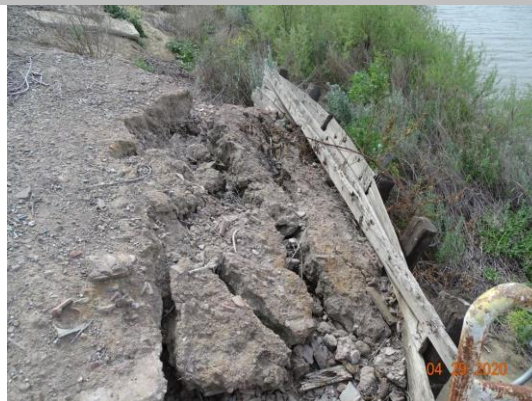
Photo 2 of 2 : SP_2021_RD0544_109_78_20210210_00018.jpg

View of soil separation and damaged retaining wall on waterside slope.
Spring 2020

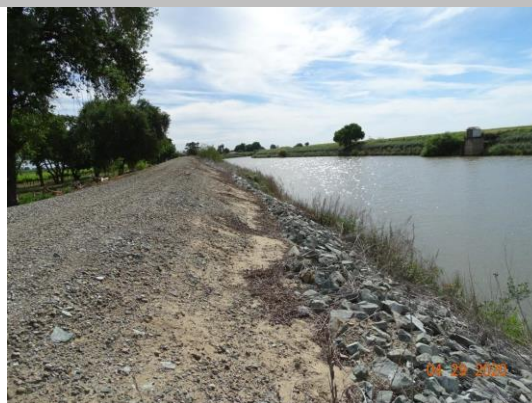
Photo 1 of 1 : SP_2021_RD0544_109_95_20210210_00030.jpg

View of revetment at the erosion site on waterside slope. Spring 2020

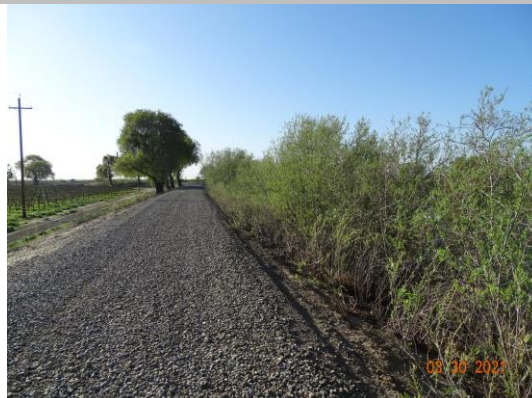
Photo 1 of 1 : SP_2021_RD0544_109_69_20210412_00061.jpg

View vegetation and wild growth on waterside slope. Spring 2021
