**Flood Control Project Maintenance
Levee Inspections**

Maintenance Issue Types Only, Levee Inspection Report By Mile - Spring 2022

Reclamation District No. 0544 Upper Roberts Island

Waterway	Bank	Unit Miles	Inspection Start/End	Inspector
Unit No. 01 San Joaquin River	Left	6.05	04/19/2022 04/19/2022	Alberto De Leon

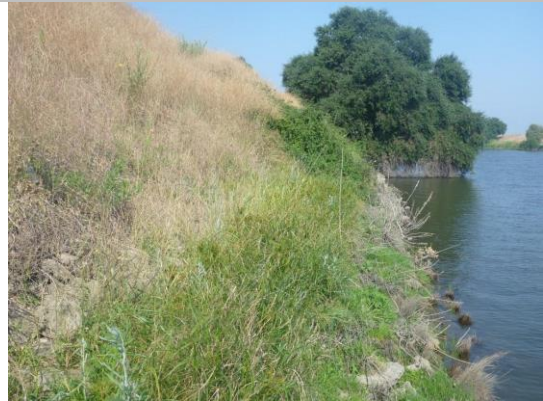
Photo 1 of 1 : LEVAL_SP_2022_571_4478.jpg

LM Start	0.64	Rating **	A/W	Issue No.	75
LM End	0.64	Issue Type +	Ma	Location *	WS
Category	Earthen Levee			GPS Latitude/Longitude	
				Start	End
Item	Erosion / Bank Caving			37.863900 °	37.863900 °
				-121.323500 °	-121.323400 °
DWR ID	LMA-477				
Comment Code					
E1 : Note and monitor erosion site.					
Inspector Comment					
2017 Storm Damage Site. Slope protection repairs are needed along the waterside slope due to erosion and riprap displacement from high water.					
Site ID No:571					
Site Designation:LMA-477

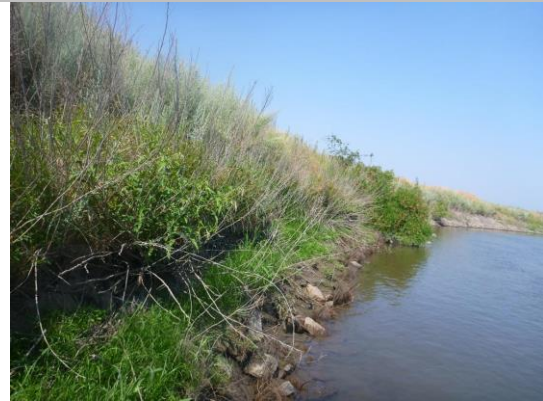
Photo 1 of 1 : LEVAL_SP_2022_570_4602.jpg

LM Start	0.99	Rating **	A/W	Issue No.	77
LM End	1.02	Issue Type +	Ma	Location *	WS
Category	Earthen Levee			GPS Latitude/Longitude	
				Start	End
Item	Erosion / Bank Caving			37.860400 °	37.860200 °
				-121.320300 °	-121.319700 °
DWR ID	LMA-476				
Comment Code					
E1 : Note and monitor erosion site.					
Inspector Comment					
2017 Storm Damage Site, Slope protection repairs are needed along the waterside slope due to erosion and riprap displacement from high water.					
Site ID No:570					
Site Designation:LMA-476

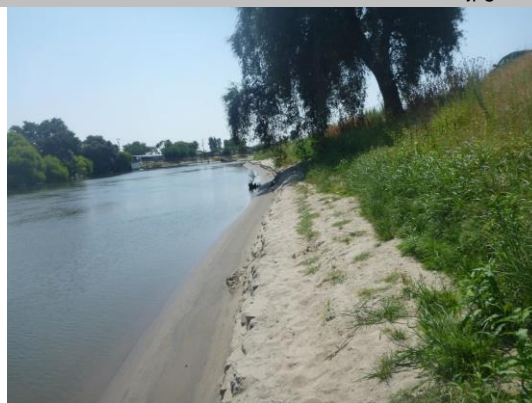
Photo 1 of 1 : LEVAL_SP_2022_569_4616.jpg

LM Start	1.89	Rating **	M	Issue No.	127
LM End	1.91	Issue Type +	Ma	Location *	WS
Category	Earthen Levee			GPS Latitude/Longitude	
				Start	End
Item	Erosion / Bank Caving			37.852300 °	37.852000 °
				-121.323700 °	-121.323600 °
DWR ID	LMA-475				
Comment Code					
E2 : Schedule repair of erosion site prior to the next inspection.					
Inspector Comment					
2017 Storm Damage Site. Slope protection repairs are needed along the waterside slope due to erosion and riprap displacement from high water. Site ID No:569. Site Designation:LMA-475

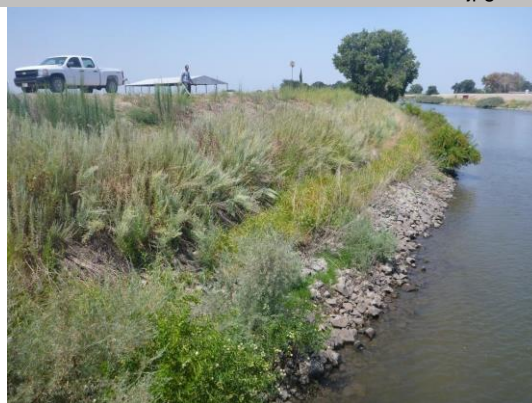
Photo 1 of 1 : LEVAL_SP_2022_567_4554.jpg

LM Start	2.53	Rating **	M	Issue No.	129
LM End	2.56	Issue Type +	Ma	Location *	WS
Category	Earthen Levee			GPS Latitude/Longitude	
				Start	End
Item	Erosion / Bank Caving			37.844900 °	37.844500 °
				-121.322300 °	-121.321900 °
DWR ID	LMA-473				
Comment Code					
E2 : Schedule repair of erosion site prior to the next inspection.					
Inspector Comment					
2017 Storm Damage Site, Slope protection repairs are needed along the waterside slope due to erosion and riprap displacement from high water.					
Site ID No:567					
Site Designation:LMA-473

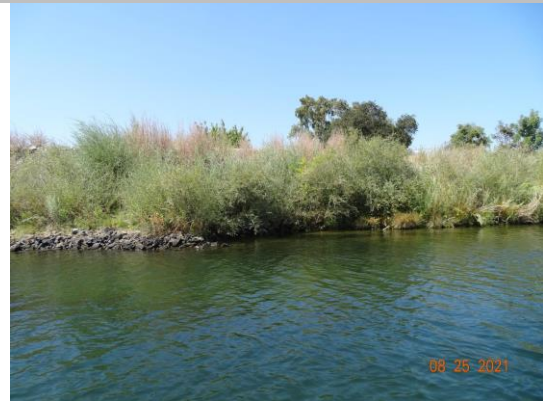
Photo 1 of 2 : SP_2022_RD0544_108_1_20220406_00001.jpg

LM Start	2.94	Rating **	M	Issue No.	1
LM End	2.95	Issue Type +	Ma	Location *	WS
Category	Supplemental			GPS Latitude/Longitude	
				Start	End
Item	DWR Erosion Survey			37.840541 °	37.840541 °
				-121.318430 °	-121.318430 °
DWR ID	RD0544U01RM49.67				
Comment Code					
Inspector Comment					
Site ID: RD0544U01RM49.67					
08/25/2021: No significant changes were observed since the previous inspection.					
09/24/2020: From 2014 to present, no significant changes were observed during the annual survey. The site is immediately downstream of a levee slope section protected with riprap.					
08/13/2013: Pump has been removed. A larger pocket erosion has been found at the erosion site.					
08/07/2012: The erosion is immediately upstream of a river bend.					
Dense vegetation is visible at the erosion site.

08/25/2021: View of the erosion looking upstream.

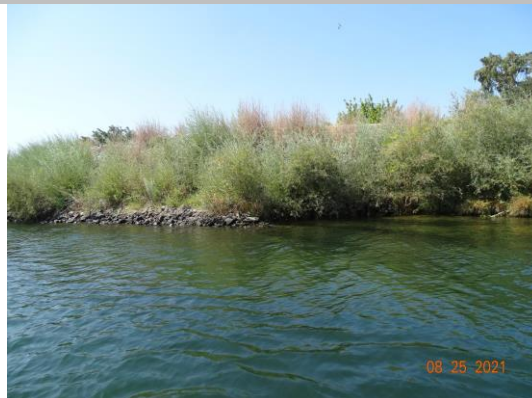
Photo 2 of 2 : SP_2022_RD0544_108_1_20220406_00002.jpg

08/25/2021: Close-up view of the erosion.

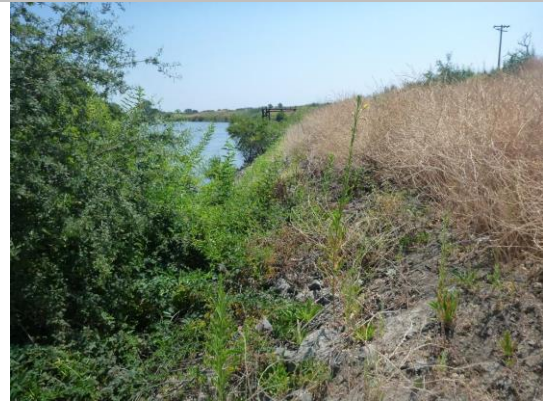
Photo 1 of 1 : LEVAL_SP_2022_566_4714.jpg

LM Start	3.21	Rating **	A/W	Issue No.	131
LM End	3.22	Issue Type +	Ma	Location *	WS
Category	Earthen Levee			GPS Latitude/Longitude	
				Start	End
Item	Erosion / Bank Caving			37.836900 °	37.836700 °
				-121.317300 °	-121.317300 °
DWR ID	LMA-472				
Comment Code					
E1 : Note and monitor erosion site.					
Inspector Comment					
2017 storm damage site, ID 566, LMA-472. Slope protection repairs are needed along the waterside slope due to erosion and riprap displacement from high water.

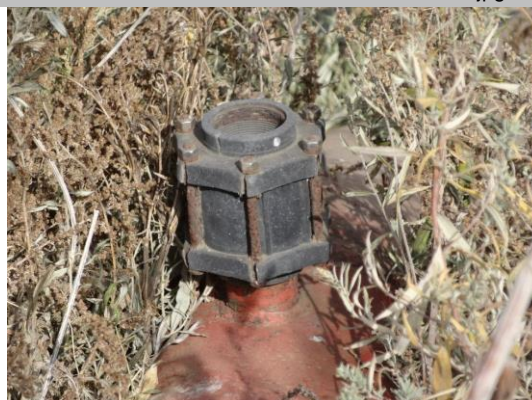
Photo 2 of 3 : UCIP_SP_2022_24892_44852.jpg

WS view: exposed steel pipe and air vent on the pipe.

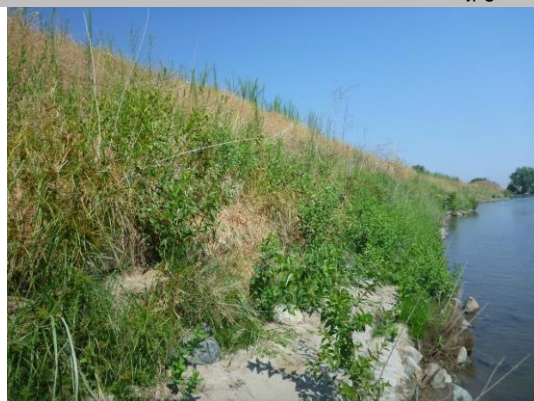
LM Start	3.79	Rating **	A/W	Issue No.	135
LM End	3.82	Issue Type +	Ma	Location *	WS
Category	Supplemental			GPS Latitude/Longitude	
				Start	End
Item	2017 Storm Damage			37.829800 °	37.829400 °
				-121.312100 °	-121.312000 °
DWR ID	LMA 468-469				
Comment Code					
Inspector Comment					
Planned For Repair.					
Levee Evaluation Comments					
Description:Slope protection repairs are needed along the waterside slope due to erosion and riprap displacement from high water. Based upon levee inspections, it was determined the waterside levee slope is eroding, deteriorating, and degrading. The eroded levee sections need to be restored back to design standards to prevent further deterioration and damage.					
Site ID No:562					
Site Designation:LMA 468-469					
Repair Type: Erosion					
Rating:Serious					
Field Date:8/11/2017					
Notes: Site combined with LMA-469;

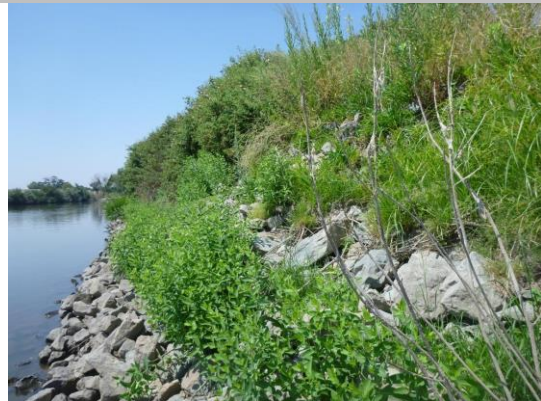
Photo 1 of 1 : LEVAL_SP_2022_561_4862.jpg

LM Start	4.46	Rating **	A/W	Issue No.	136
LM End	4.48	Issue Type +	Ma	Location *	WS
Category	Earthen Levee			GPS Latitude/Longitude	
				Start	End
Item	Erosion / Bank Caving			37.823200 °	37.823000 °
				-121.316400 °	-121.316800 °
DWR ID	LMA-467				
Comment Code					
E1 : Note and monitor erosion site.					
Inspector Comment					
2017 storm damage site, ID 561, LMA-467. Slope protection repairs are needed along the waterside slope due to erosion and riprap displacement from high water. Site combined with LMA-466 in field; length and coordinates redefined in field.

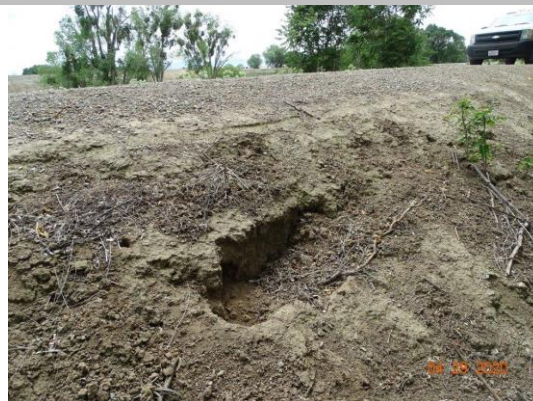
Photo 1 of 1 : SP_2022_RD0544_108_51_20220406_00009.jpg

View of animal burrow on landside slope. Spring 2020

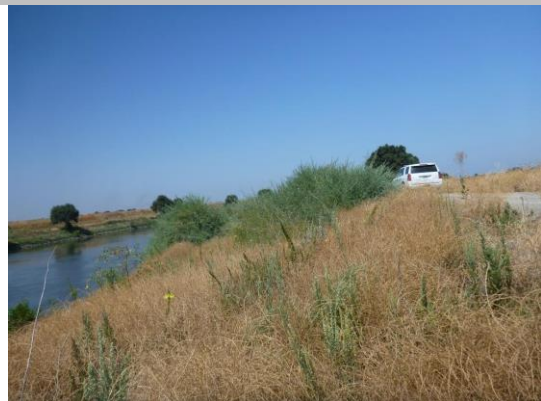
Photo 1 of 1 : LEVAL_SP_2022_556_4520.jpg

LM Start	0.21	Rating **	A/W	Issue No.	37
LM End	0.23	Issue Type +	Ma	Location *	WS
Category	Earthen Levee			GPS Latitude/Longitude	
				Start	End
Item	Erosion / Bank Caving			37.808300 °	37.808400 °
				-121.332000 °	-121.332200 °
DWR ID	LMA-462				
Comment Code					
E1 : Note and monitor erosion site.					
Inspector Comment					
2017 Storm Damage Site, ID No:556, LMA-462. Waterside slope should be monitored for erosion and riprap displacement during high water.

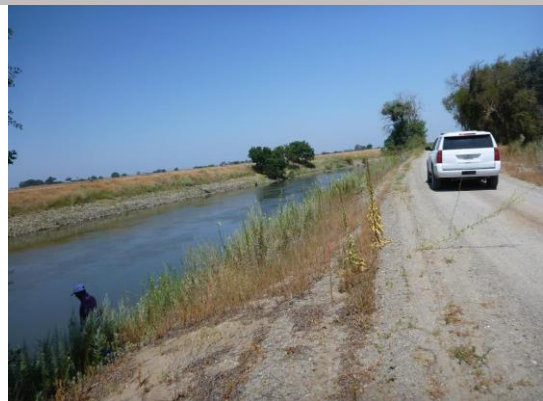
Photo 1 of 1 : LEVAL_SP_2022_554_4630.jpg

LM Start	0.57	Rating **	A/W	Issue No.	80
LM End	0.58	Issue Type +	Ma	Location *	WS
Category	Earthen Levee			GPS Latitude/Longitude	
				Start	End
Item	Erosion / Bank Caving			37.812300 °	37.812400 °
				-121.335100 °	-121.335100 °
DWR ID	LMA-460				
Comment Code					
E1 : Note and monitor erosion site.					
Inspector Comment					
2017 StormDamage Site, ID No:554, LMA-460. Monitor waterside slope for possible erosion and rip rap displacement during high water events.

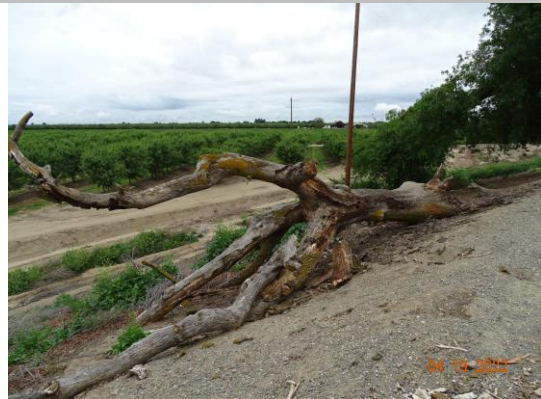
Photo 1 of 1 : SP_2022_RD0544_109_67_20220422_00057.jpg

View of fallen tree branch along the landside slope. Spring 2022

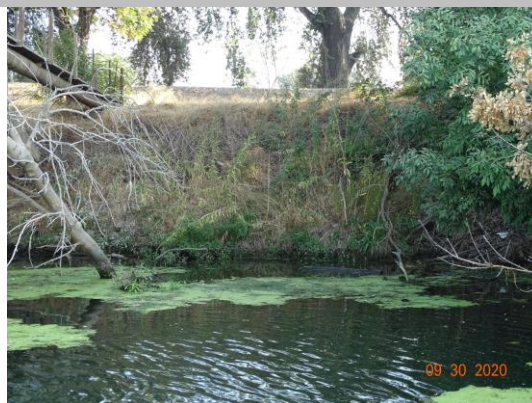
Photo 1 of 1 : SP_2022_RD0544_109_1_20220406_00001.jpg

9/30/2020: Close-up view of the slope instability.

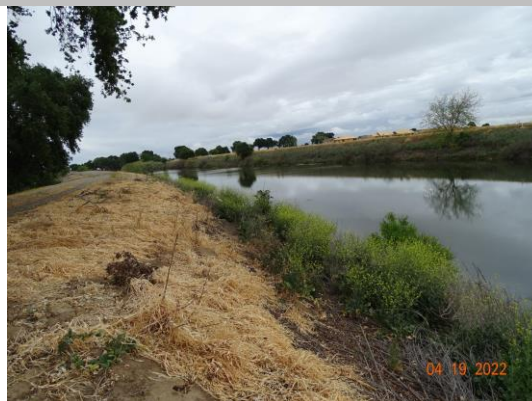
Photo 2 of 2 : SP_2022_RD0544_109_90_20220422_00056.jpg

View of waterside slope. Spring 2022

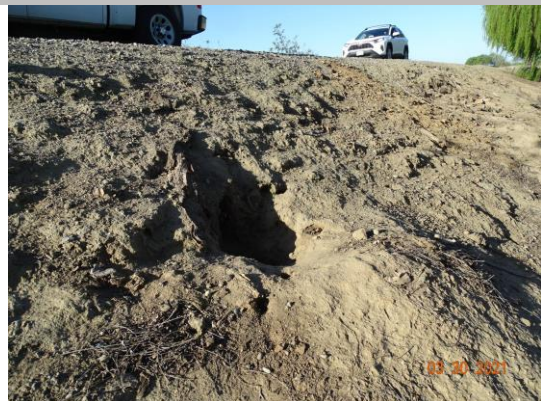
Photo 1 of 1 : SP_2022_RD0544_109_65_20220406_00010.jpg

View of large animal burrow along the landside slope. Spring 2021

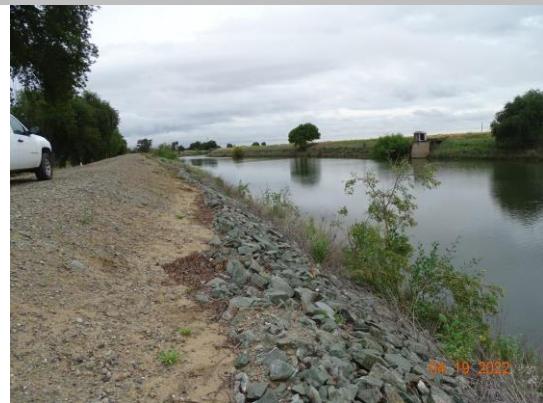
Photo 1 of 1 : SP_2022_RD0544_109_95_20220422_00054.jpg

View of revetment at the erosion site on waterside slope. Spring 2022

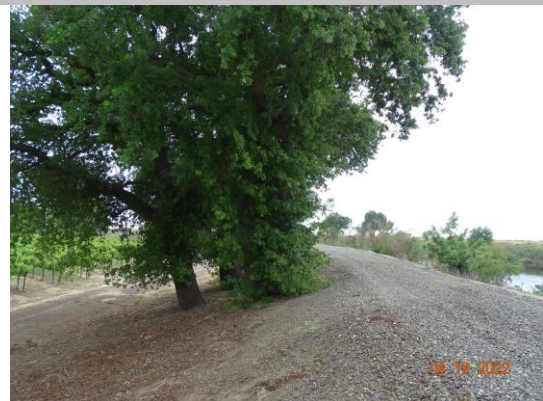
Photo 1 of 1 : SP_2022_RD0544_109_29_20220422_00052.jpg

LM Start	3.69	Rating **	M	Issue No.	29
LM End	3.69	Issue Type +	Ma	Location *	LS
Category	Earthen Levee			GPS Latitude/Longitude	
				Start	End
Item	Trim / Thin Trees			37.820066 °	37.820066 °
				-121.367692 °	-121.367692 °
DWR ID	DWR_RD0544_02_s_2022_29				
Comment Code					
T1 : Trim and thin trees to at least five feet above ground level to allow visibility of the ground and room to flood fight.					
Inspector Comment

View of untrimmed trees along the landside slope. Spring 2022
