**Flood Control Project Maintenance
Levee Inspections**

Maintenance Issue Types Only, Levee Inspection Report By Mile - Spring 2023

Reclamation District No. 0544 Upper Roberts Island

Waterway	Bank	Unit Miles	Inspection Start/End	Inspector
Unit No. 01 San Joaquin River	Left	6.05	05/04/2023 05/04/2023	Alberto De Leon

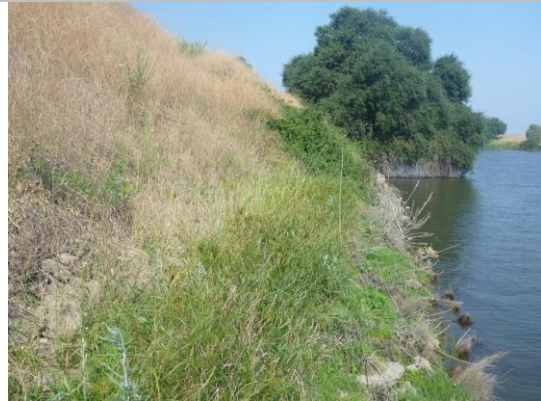
Photo 1 of 1 : LEVAL_SP_2023_571_4478.jpg

LM Start	0.64	Rating **	A/W	Issue No.	75
LM End	0.64	Issue Type +	Ma	Location *	WS
Category	Earthen Levee			GPS Latitude/Longitude	
				Start	End
Item	Erosion / Bank Caving			37.863900°	37.863900°
				-121.323500°	-121.323400°
DWR ID	LMA-477				
Comment Code					
E1 : Note and monitor erosion site.					
Inspector Comment					
2017 Storm Damage Site.					
Site ID No:571					
Site Designation:LMA-477

View of erosion within the waterside bank looking downstream.

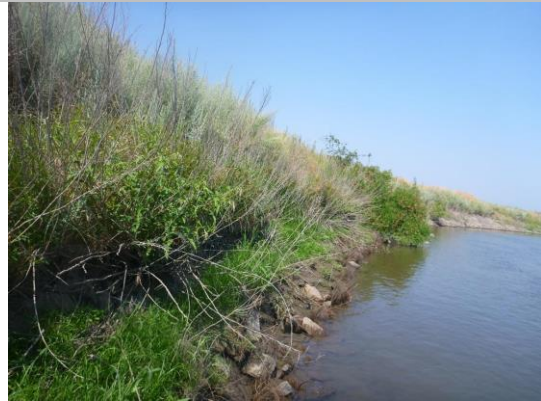
Photo 1 of 1 : LEVAL_SP_2023_570_4602.jpg

LM Start	0.99	Rating **	A/W	Issue No.	77
LM End	1.02	Issue Type +	Ma	Location *	WS
Category	Earthen Levee			GPS Latitude/Longitude	
				Start	End
Item	Erosion / Bank Caving			37.860400°	37.860200°
				-121.320300°	-121.319700°
DWR ID	LMA-476				
Comment Code					
E1 : Note and monitor erosion site.					
Inspector Comment					
2017 Storm Damage Site, Site ID No:570 Site Designation:LMA-476

View of erosion within the waterside bank looking downstream.

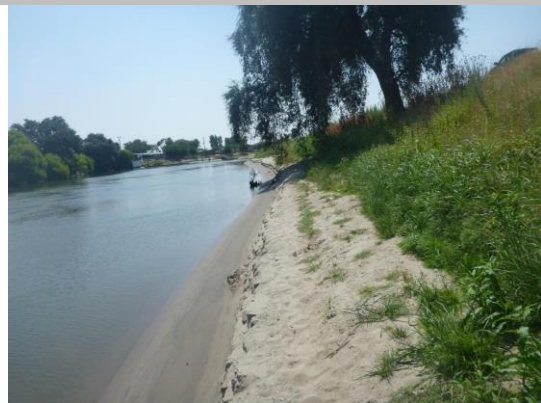
Photo 1 of 1 : LEVAL_SP_2023_569_4616.jpg

LM Start	1.89	Rating **	M	Issue No.	127
LM End	1.91	Issue Type +	Ma	Location *	LS
Category	Earthen Levee			GPS Latitude/Longitude	
				Start	End
Item	Erosion / Bank Caving			37.852300°	37.852000°
				-121.323700°	-121.323600°
DWR ID	LMA-475				
Comment Code					
E2 : Schedule repair of erosion site prior to the next inspection.					
Inspector Comment					
This is a 2017 Storm Damage Site. Slope protection repairs are needed along the waterside slope due to erosion and riprap displacement from high water. Site ID No:569. Site Designation:LMA-475

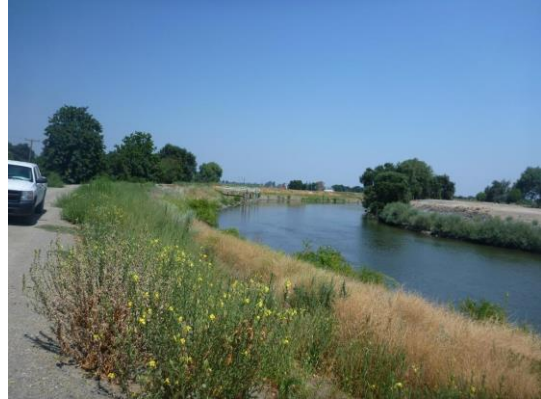
Photo 1 of 1 : LEVAL_SP_2023_568_4540.jpg

LM Start	2.31	Rating **	A/W	Issue No.	128
LM End	2.35	Issue Type +	Ma	Location *	WS
Category	Earthen Levee			GPS Latitude/Longitude	
				Start	End
Item	Erosion / Bank Caving			37.847300°	37.846800°
				-121.324700°	-121.324400°
DWR ID	LMA-474				
Comment Code					
E1 : Note and monitor erosion site.					
Inspector Comment					
2017 Storm Damage Site, Site ID No:568 Site Designation:LMA-474

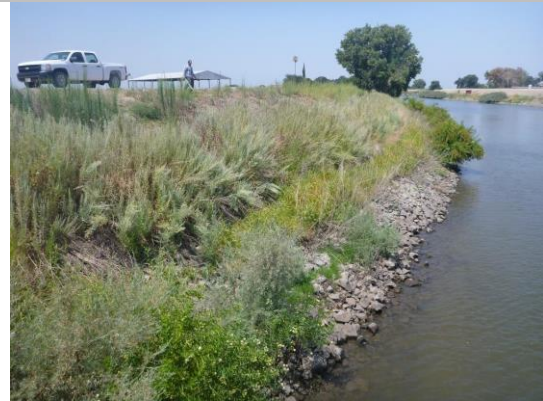
Photo 1 of 1 : LEVAL_SP_2023_567_4554.jpg

LM Start	2.53	Rating **	M	Issue No.	129
LM End	2.56	Issue Type +	Ma	Location *	LS
Category	Earthen Levee			GPS Latitude/Longitude	
				Start	End
Item	Erosion / Bank Caving			37.844900°	37.844500°
				-121.322300°	-121.321900°
DWR ID	LMA-473				
Comment Code					
E2 : Schedule repair of erosion site prior to the next inspection.					
Inspector Comment					
This is a 2017 Storm Damage Site. Slope protection repairs are needed along the waterside slope due to erosion and riprap displacement from high water.					
Site ID No:567					
Site Designation:LMA-473

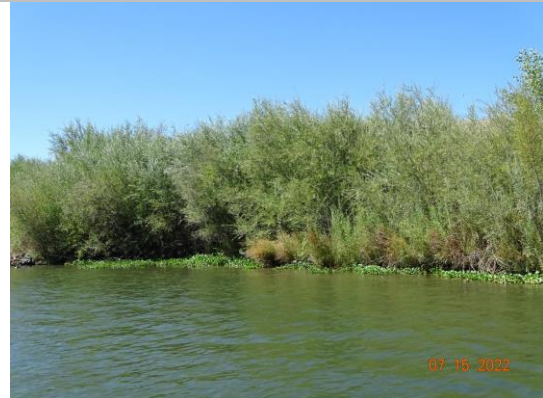
Photo 1 of 2 : SP_2023_RD0544_108_1_20230306_00001.jpg

07/15/2022: From 2014 to present, no significant changes were observed during the annual survey. The site is immediately downstream of a levee slope section protected with riprap.

08/13/2013: Pump has been removed. A larger pocket erosion has been found at the erosion site.

7/15/2022: Front view of the erosion.

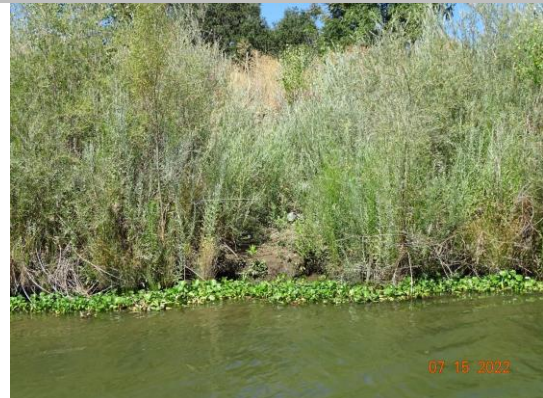
Photo 2 of 2 : SP_2023_RD0544_108_1_20230306_00002.jpg

7/15/2022: Close-up view of the erosion.

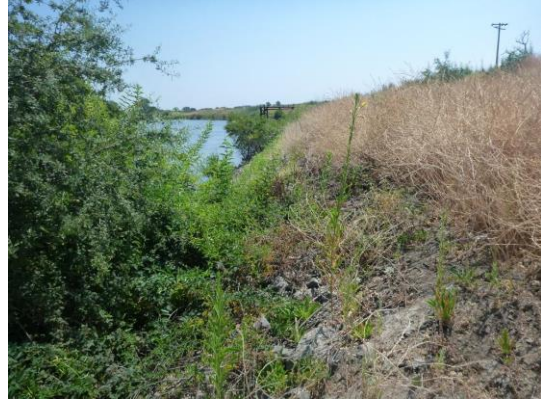
Photo 1 of 1 : LEVAL_SP_2023_566_4714.jpg

LM Start	3.21	Rating **	A/W	Issue No.	131
LM End	3.22	Issue Type +	Ma	Location *	WS
Category	Earthen Levee			GPS Latitude/Longitude	
				Start	End
Item	Erosion / Bank Caving			37.836900°	37.836700°
				-121.317300°	-121.317300°
DWR ID	LMA-472				
Comment Code					
E1 : Note and monitor erosion site.					
Inspector Comment					
This was a 2017 storm damage site, ID 566, LMA-472.

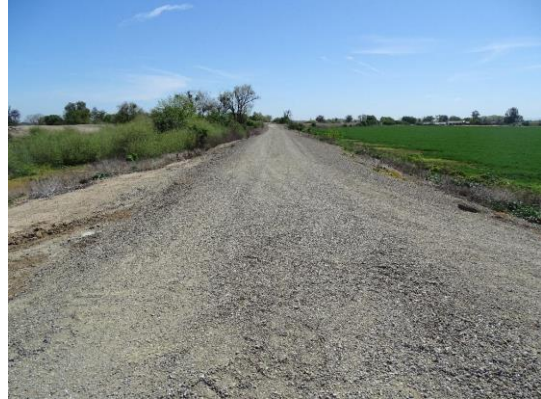
Photo 1 of 3 : UCIP_SP_2023_73212_109530.jpg

Comment Code					
Inspector Comment					
DS_ID:22658 FS_ID:73212 EP_NO: N/A Repair Type: Non-Urgent EVAL Issue: 6, Levee Damage or Threat for Levee Damage Crossing Status: Found UCIP Comments: 03/24/2022 Record updated from No Action Needed to Non-Urgent. Threat for levee damage with sink hole on LS slope along pipe alignment. No permit has been identified authorizing pipe. (D.Sanoski - DWR UCIP) 10/29/2013 Pipe on channel bank looks comparatively new, pump approximately 500 ft. from the levee center on landside in drainage ditch, and a tall concrete standpipe and service pole near the pump. (P. Khoi - DWR UCIP) FIELD_STRUCT_DESC: 12-inch steel drainage discharge pipe through the levee, 3 feet below the crown. Pump and concrete standpipe in a drainage ditch on the landside (LS). Air vent on the waterside (WS). [Additional Reference(s): DWR Levee Log, 2005. USACE San Joaquin O&M Manual 7, April 1964, (HLM 3.53)]. FS Date: 3/24/2022 1:59:23 PM

View of crown.

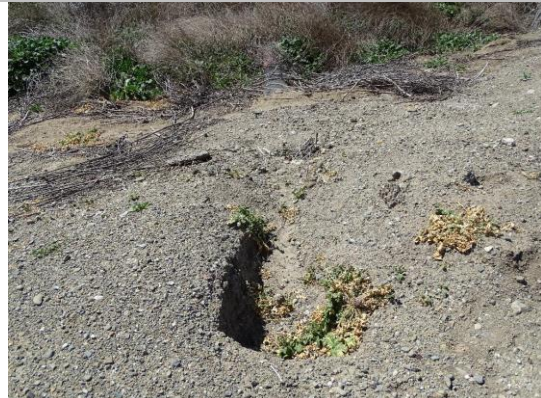
Photo 2 of 3 : UCIP_SP_2023_73212_109525.jpg

View of sinkhole on LS slope along pipe alignment with exposed pipe near toe.

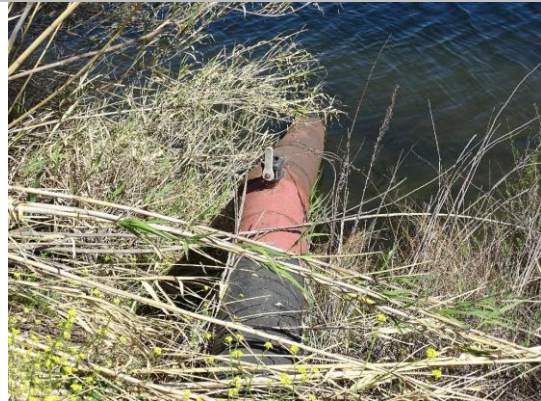
Photo 3 of 3 : UCIP_SP_2023_73212_109526.jpg

View of pipe at WS toe with air vent.

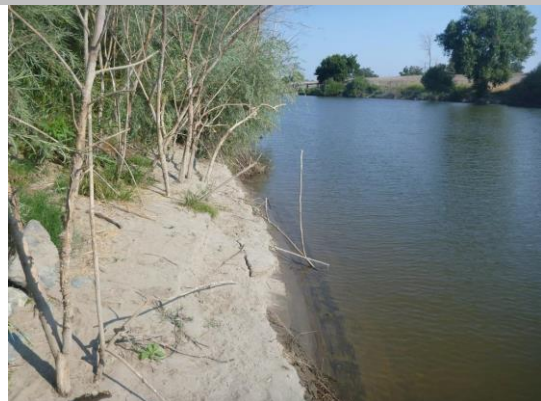
Photo 1 of 1 : LEVAL_SP_2023_565_4745.jpg

LM Start	3.65	Rating **	A/W	Issue No.	132
LM End	3.67	Issue Type +	Ma	Location *	WS
Category	Earthen Levee			GPS Latitude/Longitude	
				Start	End
Item	Erosion / Bank Caving			37.831800°	37.831600°
				-121.312700°	-121.312600°
DWR ID	LMA-471				
Comment Code					
E1 : Note and monitor erosion site.					
Inspector Comment					
2017 Storm Damage Site, Site ID No:565 Site Designation:LMA-471

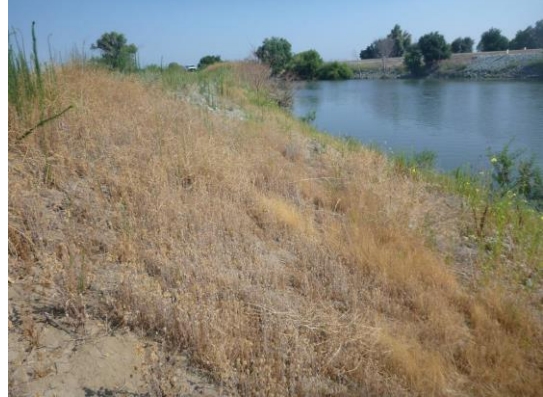
Photo 1 of 1 : LEVAL_SP_2023_564_4748.jpg

LM Start	3.69	Rating **	A/W	Issue No.	133
LM End	3.73	Issue Type +	Ma	Location *	WS
Category	Earthen Levee			GPS Latitude/Longitude	
				Start	End
Item	Erosion / Bank Caving			37.831300°	37.830700°
				-121.312600°	-121.312300°
DWR ID	LMA-470				
Comment Code					
E1 : Note and monitor erosion site.					
Inspector Comment					
2017 Storm Damage Site, Site ID No:564 Site Designation:LMA-470

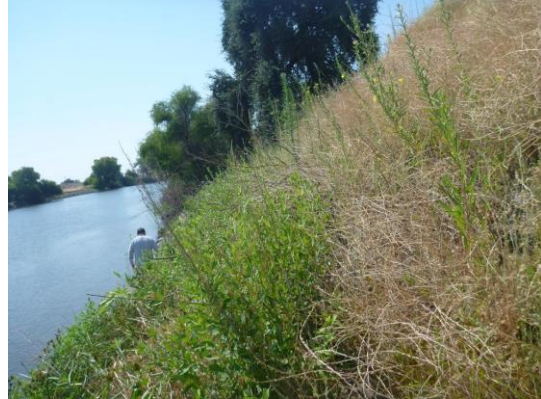
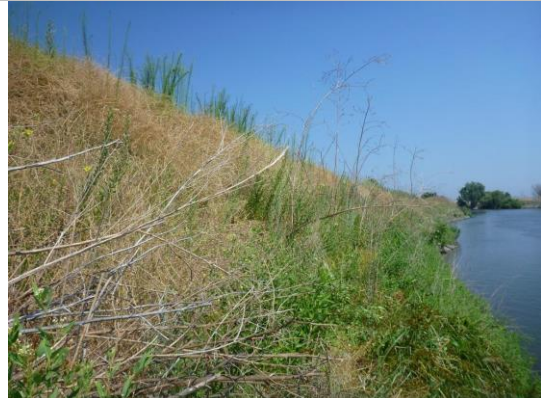
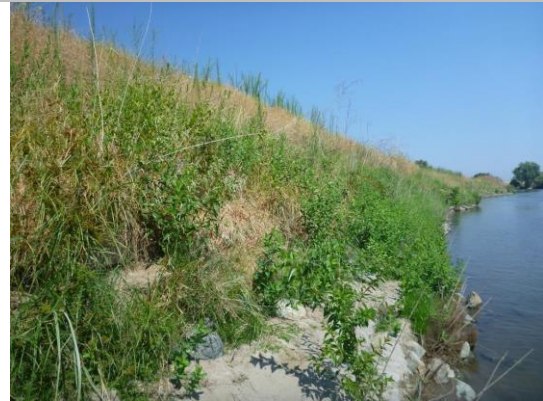
LM Start	3.79	Rating **	A/W	Issue No.	135
LM End	3.82	Issue Type +	Ma	Location *	WS
Category	Earthen Levee			GPS Latitude/Longitude	
				Start	End
Item	Erosion / Bank Caving			37.829800°	37.829400°
				-121.312100°	-121.312000°
DWR ID	DWR_RD0544_01_s_2023_135				
Comment Code					
E1 : Note and monitor erosion site.					
Inspector Comment					
This is 2017 Storm Damage site. Slope protection repairs are needed along the waterside slope due to erosion and riprap displacement from high water. Based upon levee inspections, it was determined the waterside levee slope is eroding, deteriorating, and degrading. The eroded levee sections need to be restored back to design standards to prevent further deterioration and damage.					
Site ID No:562					
Site Designation:LMA 468-469

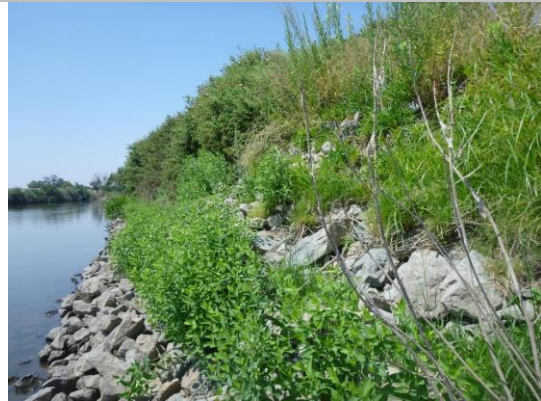
Photo 1 of 1 : LEVAL_SP_2023_561_4862.jpg

LM Start	4.46	Rating **	A/W	Issue No.	136
LM End	4.48	Issue Type +	Ma	Location *	WS
Category	Earthen Levee			GPS Latitude/Longitude	
				Start	End
Item	Erosion / Bank Caving			37.823200°	37.823000°
				-121.316400°	-121.316800°
DWR ID	LMA-467				
Comment Code					
E1 : Note and monitor erosion site.					
Inspector Comment					
This is a 2017 storm damage site, ID 561, LMA-467. Site combined with LMA-466 in field.

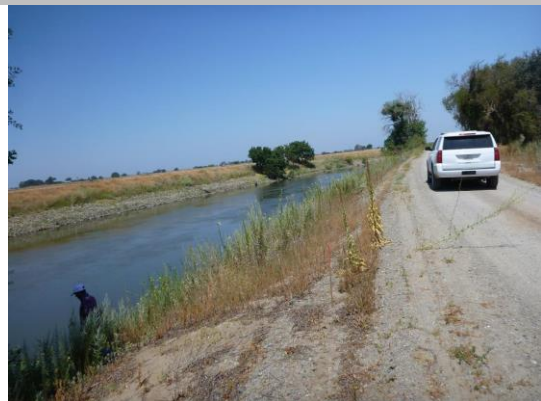
Photo 1 of 1 : LEVAL_SP_2023_554_4630.jpg

LM Start	0.57	Rating **	A/W	Issue No.	80
LM End	0.58	Issue Type +	Ma	Location *	WS
Category	Earthen Levee			GPS Latitude/Longitude	
				Start	End
Item	Erosion / Bank Caving			37.812300°	37.812400°
				-121.335100°	-121.335100°
DWR ID	LMA-460				
Comment Code					
E1 : Note and monitor erosion site.					
Inspector Comment					
This is a 2017 Storm Damage Site, ID No:554, LMA-460. Monitor waterside slope for possible erosion and rip rap displacement during high water events.

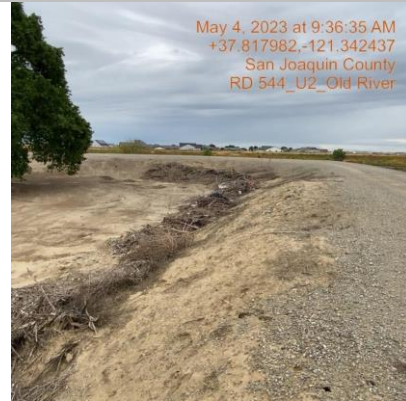
Photo 1 of 1 : SP_2023_RD0544_109_17_20230511_00044.jpg

View of prunings along the landside easement. Spring 2023

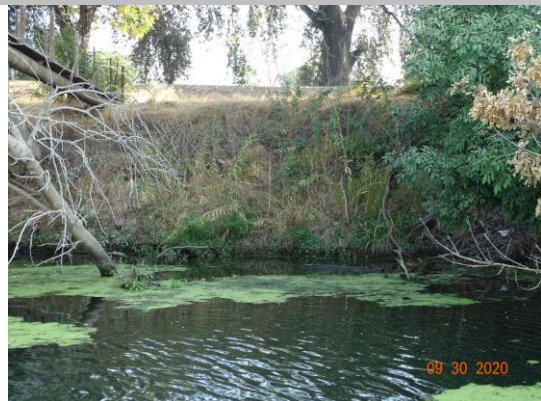
Photo 1 of 1 : SP_2023_RD0544_109_1_20230306_00001.jpg

Close-up view of the bank erosion. Fall 2020

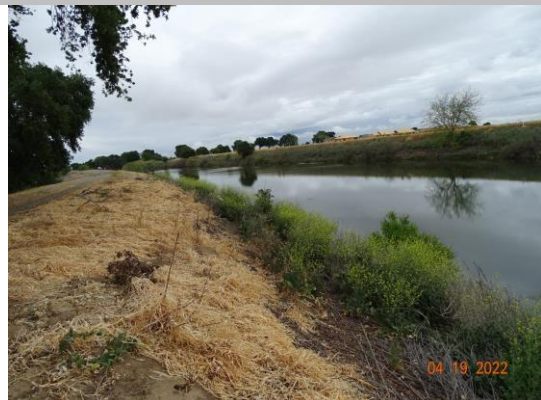
Photo 2 of 2 : SP_2023_RD0544_109_90_20230306_00019.jpg

View of waterside slope. Spring 2022

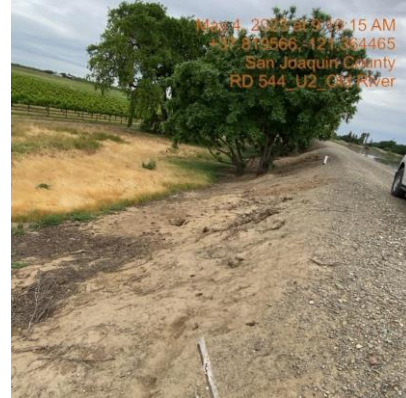
Photo 1 of 1 : SP_2023_RD0544_109_15_20230511_00043.jpg

View of multiple burrow holes along the landside slope. Spring 2023

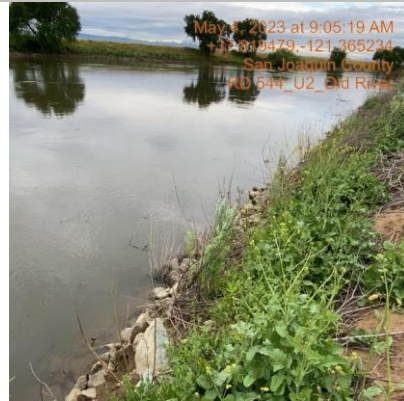
Photo 1 of 1 : SP_2023_RD0544_109_94_20230511_00042.jpg

View of rip rap along the waterside bank.

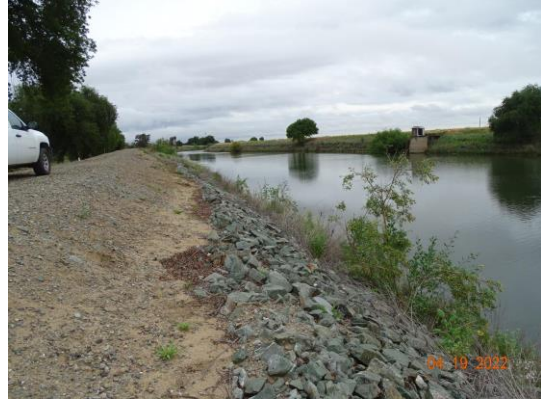
Photo 1 of 1 : SP_2023_RD0544_109_95_20230306_00024.jpg

View of revetment at the erosion site on waterside slope. Spring 2022

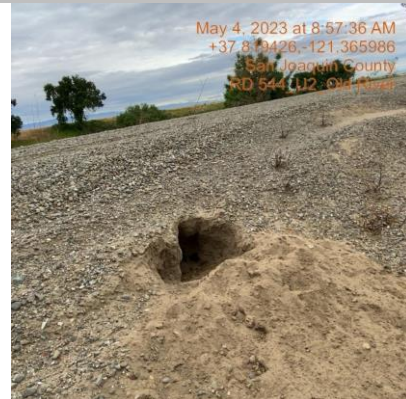
Photo 1 of 1 : SP_2023_RD0544_109_12_20230511_00040.jpg

LM Start	3.59	Rating **	U	Issue No.	12
LM End	3.59	Issue Type +	Ma	Location *	LS
Category	Earthen Levee			GPS Latitude/Longitude	
				Start	End
Item	Animal Control			37.819393°	37.819393°
				-121.366063°	-121.366063°
DWR ID	DWR_RD0544_02_s_2023_12				
Comment Code					
A3 : No rodents visible, but rodent burrows visible; need to backfill and compact or grout burrows.					
Inspector Comment

View of animal burrow along the landside slope. Spring 2023

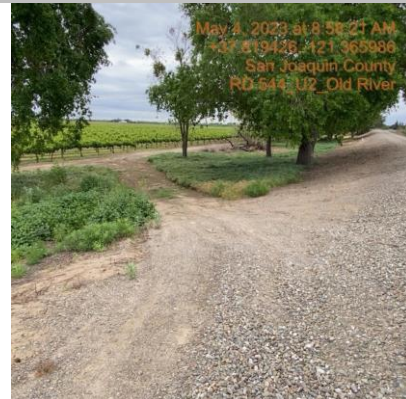
Photo 1 of 1 : SP_2023_RD0544_109_14_20230511_00041.jpg

LM Start	3.59	Rating **	M	Issue No.	14
LM End	3.59	Issue Type +	Ma	Location *	LS
Category	Earthen Levee			GPS Latitude/Longitude	
				Start	End
Item	Erosion / Vehicle Traffic			37.819404°	37.819404°
				-121.366075°	-121.366075°
DWR ID	DWR_RD0544_02_s_2023_14				
Comment Code					
E6 : Repair the levee slope damaged by vehicle traffic and prevent access where possible.					
Inspector Comment					
The landside slope is being used to access the levee crown.

View of access path along the landside slope and easement. Spring 2023
