**Flood Control Project Maintenance
Levee Inspections**

Maintenance Issue Types Only, Levee Inspection Report By Mile - Spring 2024

Reclamation District No. 0544 Upper Roberts Island

Waterway	Bank	Unit Miles	Inspection Start/End	Inspector
Unit No. 01 San Joaquin River	Left	6.05	03/13/2024 03/13/2024	Alberto De Leon

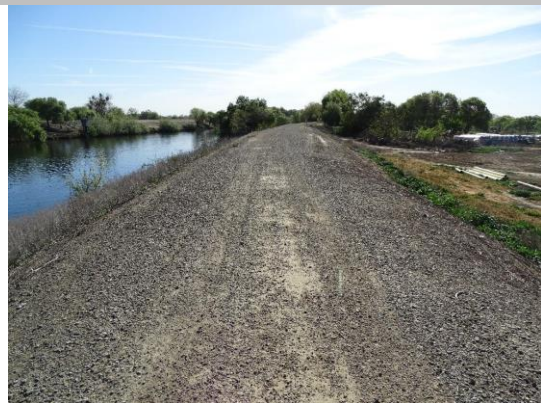
Photo 1 of 3 : UCIP_SP_2024_73194_109430.jpg

Comment Code					
Inspector Comment					
DS_ID:22644 FS_ID:73194 EP_NO: N/A Repair Type: Non-Urgent EVAL Issue: Crossing Status: Not Found UCIP Comments: 03/24/2022 Record remains Non-Urgent. Crossing not found. No permit has been identified authorizing pipe. (D.Sanoski - DWR UCIP) FIELD_STRUCT_DESC: 10-inch steel drainage pipe through the levee, 3.5 feet below the crown. Flap gate on the waterside (WS) end. Installed by USACE in 1962. Unable to locate in February 1984. [Additional Reference(s): DWR Levee Log, 2005 (HLM 0.56).USACE San Joaquin O&M Manual, Unit 7, April 1964, Revised 29 December 2016, (HLM 0.56), listed as 10-inch pipe.] FS Date: 3/24/2022 12:23:54 PM

View of crown.

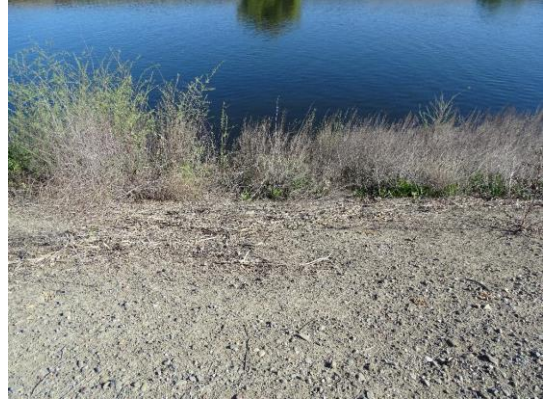
Photo 2 of 3 : UCIP_SP_2024_73194_109431.jpg

View of WS slope.

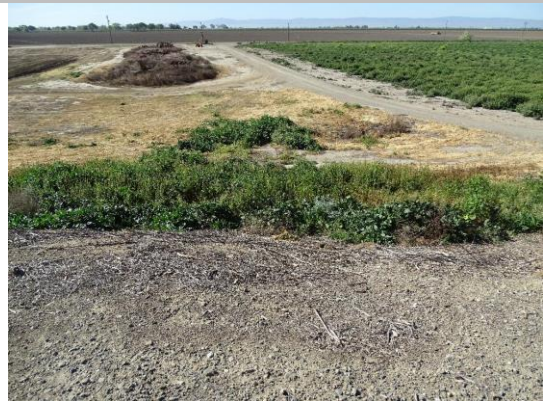
Photo 3 of 3 : UCIP_SP_2024_73194_109432.jpg

View of LS slope.

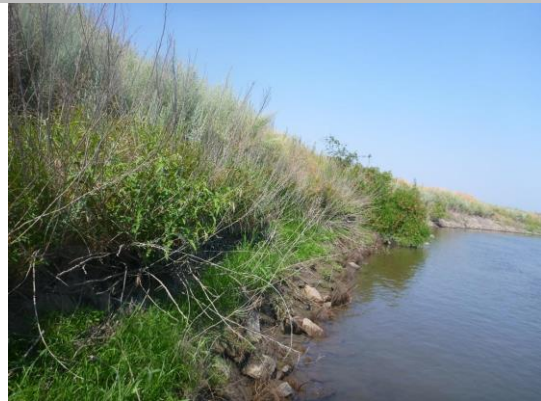
Photo 1 of 1 : LEVAL_SP_2024_570_4602.jpg

LM Start	0.99	Rating **	A/W	Issue No.	77
LM End	1.02	Issue Type +	Ma	Location *	WS
Category	Earthen Levee			GPS Latitude/Longitude	
				Start	End
Item	Erosion / Bank Caving			37.860400°	37.860200°
				-121.320300°	-121.319700°
DWR ID	LMA-476				
Comment Code					
E1 : Note and monitor erosion site.					
Inspector Comment					
2017 Storm Damage Site, Site ID No:570 Site Designation:LMA-476

View of erosion within the waterside bank looking downstream.

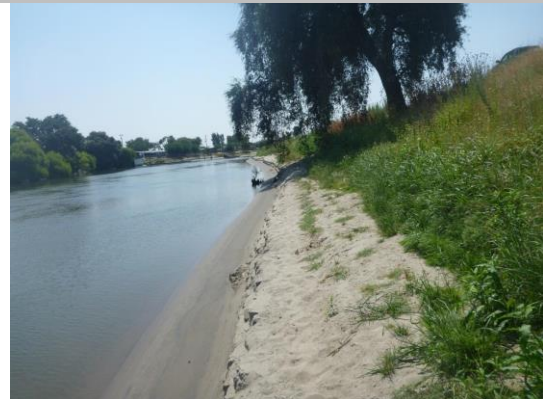
Photo 1 of 1 : LEVAL_SP_2024_569_4616.jpg

LM Start	1.89	Rating **	M	Issue No.	127
LM End	1.91	Issue Type +	Ma	Location *	LS
Category	Earthen Levee			GPS Latitude/Longitude	
				Start	End
Item	Erosion / Bank Caving			37.852300°	37.852000°
				-121.323700°	-121.323600°
DWR ID	LMA-475				
Comment Code					
E2 : Schedule repair of erosion site prior to the next inspection.					
Inspector Comment					
This is a 2017 Storm Damage Site. Slope protection repairs are needed along the waterside slope due to erosion and riprap displacement from high water. Site ID No:569. Site Designation:LMA-475

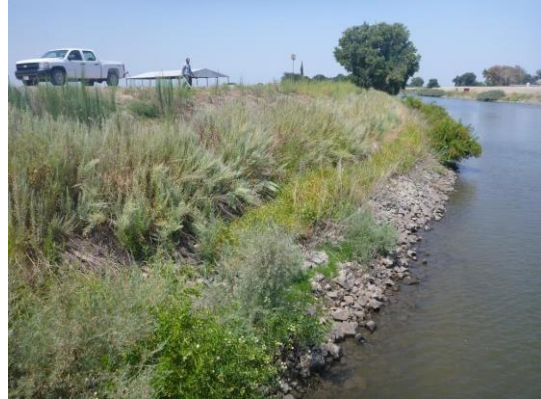
Photo 1 of 1 : LEVAL_SP_2024_567_4554.jpg

LM Start	2.53	Rating **	M	Issue No.	129
LM End	2.56	Issue Type +	Ma	Location *	LS
Category	Earthen Levee			GPS Latitude/Longitude	
				Start	End
Item	Erosion / Bank Caving			37.844900°	37.844500°
				-121.322300°	-121.321900°
DWR ID	LMA-473				
Comment Code					
E2 : Schedule repair of erosion site prior to the next inspection.					
Inspector Comment					
This is a 2017 Storm Damage Site. Slope protection repairs are needed along the waterside slope due to erosion and riprap displacement from high water.					
Site ID No:567					
Site Designation:LMA-473

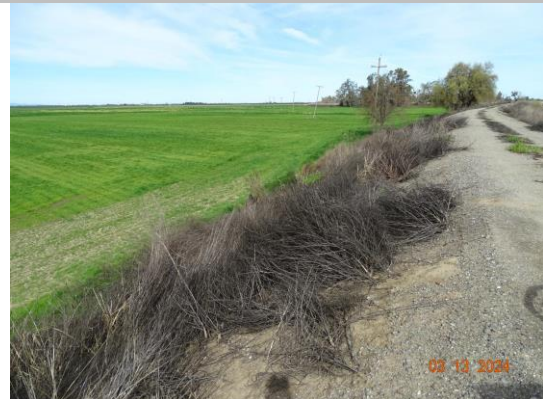
Photo 1 of 1 : SP_2024_RD0544_108_40_20240313_00055.jpg

Typical view of wild vegetation growth along the landside slope and easement. Spring 2024

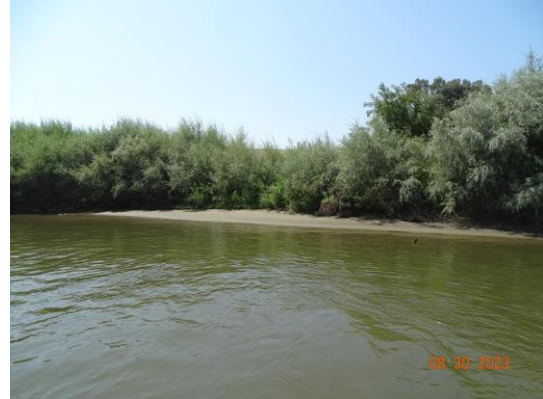
Photo 1 of 2 : SP_2024_RD0544_108_1_20240214_00001.jpg

LM Start	2.94	Rating **	M	Issue No.	1
LM End	2.95	Issue Type +	Ma	Location *	WS
Category	Supplemental			GPS Latitude/Longitude	
				Start	End
Item	DWR Erosion Survey			37.840541°	37.840541°
				-121.318430°	-121.318430°
DWR ID	RD0544U01RM49.67				
Comment Code					
Inspector Comment					
Site ID: RD0544U01RM49.67 8/30/2023: From 2013 to present, no significant changes were observed during the annual survey. The site is immediately downstream of a levee slope section protected with riprap. 08/13/2013: Pump has been removed. A larger pocket erosion has been found at the erosion site. 08/07/2012: The erosion is immediately upstream of a river bend. Dense vegetation is visible at the erosion site.

8/30/2023: Front view of the erosion.

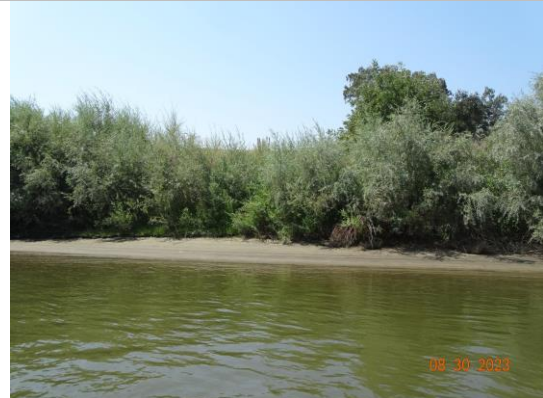
Photo 2 of 2 : SP_2024_RD0544_108_1_20240214_00002.jpg

8/30/2023: Close-up view of the erosion.

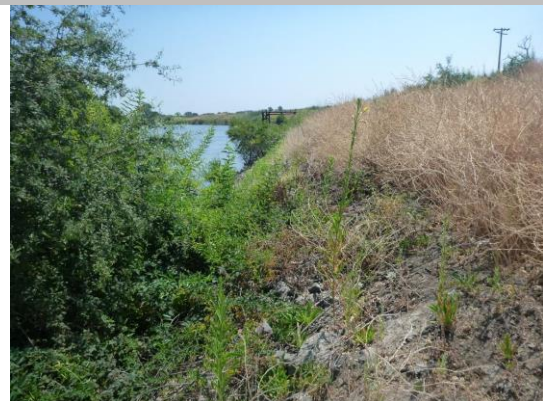
Photo 1 of 1 : LEVAL_SP_2024_566_4714.jpg

LM Start	3.21	Rating **	A/W	Issue No.	131
LM End	3.22	Issue Type +	Ma	Location *	WS
Category	Earthen Levee			GPS Latitude/Longitude	
				Start	End
Item	Erosion / Bank Caving			37.836900°	37.836700°
				-121.317300°	-121.317300°
DWR ID	LMA-472				
Comment Code					
E1 : Note and monitor erosion site.					
Inspector Comment					
This was a 2017 storm damage site, ID 566, LMA-472.

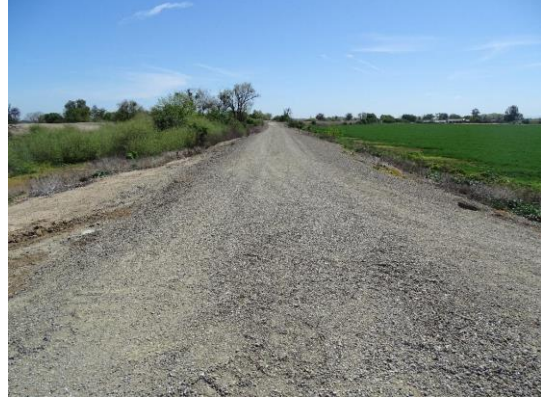
Photo 1 of 3 : UCIP_SP_2024_73212_109530.jpg

Comment Code						
Inspector Comment						
DS_ID:22658						
FS_ID:73212						
EP_NO: N/A						
Repair Type: Non-Urgent						
EVAL Issue: 6, Levee Damage or Threat for Levee Damage						
Crossing Status: Found						
UCIP Comments: 03/24/2022 Record updated from No Action Needed to Non-Urgent. Threat for levee damage with sink hole on LS slope along pipe alignment. No permit has been identified authorizing pipe. (D.Sanoski - DWR UCIP)						
10/29/2013 Pipe on channel bank looks comparatively new, pump approximately 500 ft. from the levee center on landside in drainage ditch, and a tall concrete standpipe and service pole near the pump. (P. Khoi - DWR UCIP)						
FIELD_STRUCT_DESC: 12-inch steel drainage discharge pipe through the levee, 3 feet below the crown. Pump and concrete standpipe in a drainage ditch on the landside (LS). Air vent on the waterside (WS). [Additional Reference(s): DWR Levee Log, 2005 (HLM 3.51). USACE San Joaquin O&M Manual, Unit 7, April 1964, Revised 29 December 2016, (HLM 3.53), listed as 12-inch pipe.]

View of crown.

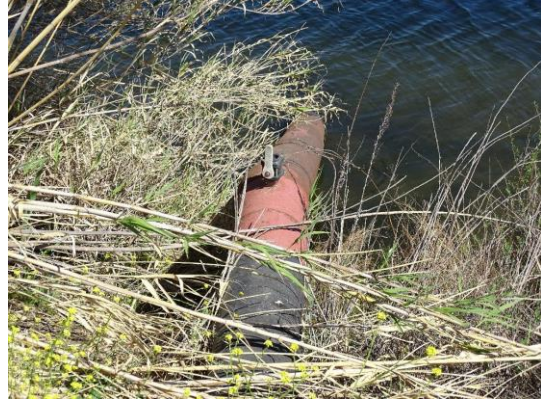
Photo 3 of 3 : UCIP_SP_2024_73212_109526.jpg

View of pipe at WS toe with air vent.

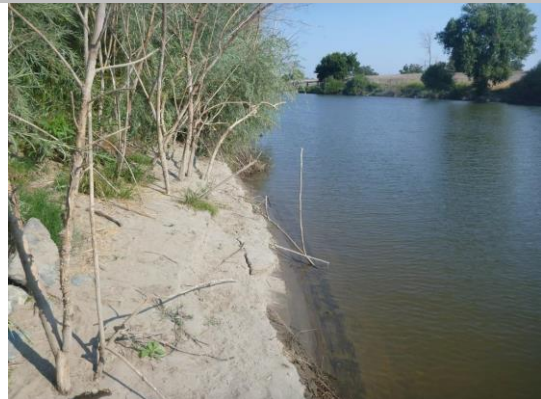
Photo 1 of 1 : LEVAL_SP_2024_565_4745.jpg

LM Start	3.65	Rating **	A/W	Issue No.	132
LM End	3.67	Issue Type +	Ma	Location *	WS
Category	Earthen Levee			GPS Latitude/Longitude	
				Start	End
Item	Erosion / Bank Caving			37.831800°	37.831600°
				-121.312700°	-121.312600°
DWR ID	LMA-471				
Comment Code					
E1 : Note and monitor erosion site.					
Inspector Comment					
2017 Storm Damage Site, Site ID No:565 Site Designation:LMA-471

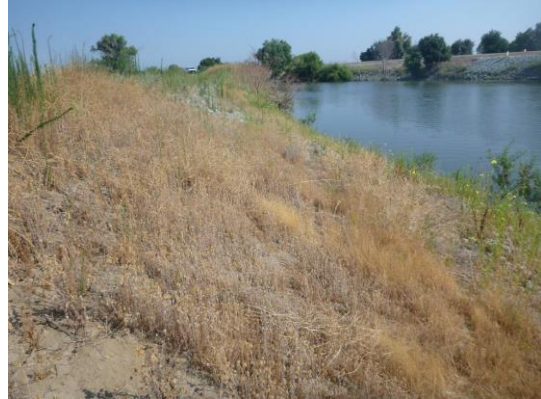
Photo 1 of 1 : LEVAL_SP_2024_564_4748.jpg

LM Start	3.69	Rating **	A/W	Issue No.	133
LM End	3.73	Issue Type +	Ma	Location *	WS
Category	Earthen Levee			GPS Latitude/Longitude	
				Start	End
Item	Erosion / Bank Caving			37.831300°	37.830700°
				-121.312600°	-121.312300°
DWR ID	LMA-470				
Comment Code					
E1 : Note and monitor erosion site.					
Inspector Comment					
2017 Storm Damage Site, Site ID No:564 Site Designation:LMA-470

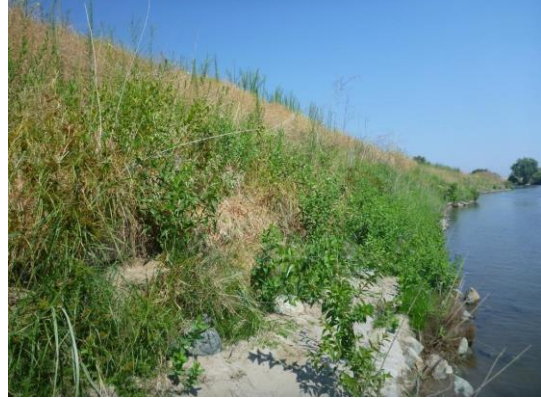
LM Start	3.79	Rating **	A/W	Issue No.	135
LM End	3.82	Issue Type +	Ma	Location *	WS
Category	Earthen Levee			GPS Latitude/Longitude	
				Start	End
Item	Erosion / Bank Caving			37.829800°	37.829400°
				-121.312100°	-121.312000°
DWR ID	DWR_RD0544_01_s_2023_135				
Comment Code					
E1 : Note and monitor erosion site.					
Inspector Comment					
This is 2017 Storm Damage site. Slope protection repairs are needed along the waterside slope due to erosion and riprap displacement from high water. Based upon levee inspections, it was determined the waterside levee slope is eroding, deteriorating, and degrading. The eroded levee sections need to be restored back to design standards to prevent further deterioration and damage.					
Site ID No:562					
Site Designation:LMA 468-469

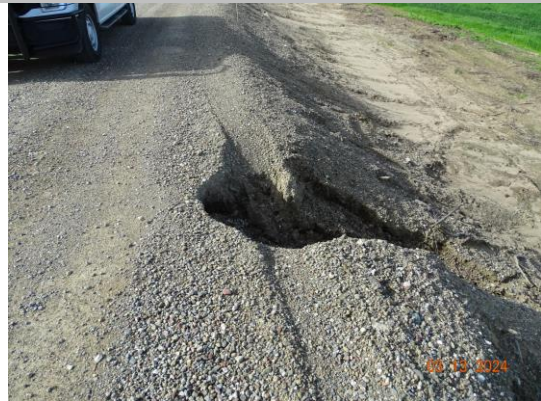
Photo 1 of 2 : SP_2024_RD0544_108_16_20240313_00052.jpg

View of erosion looking upstream. Spring 2024

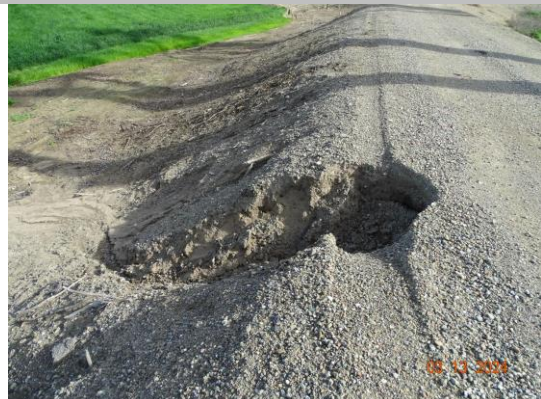
Photo 2 of 2 : SP_2024_RD0544_108_16_20240313_00054.jpg

View of erosion looking downstream. Spring 2024

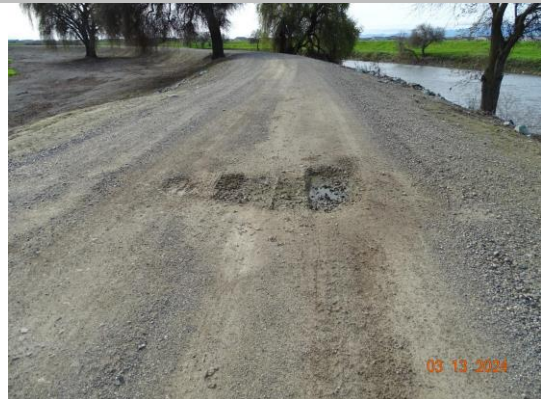
Photo 1 of 1 : SP_2024_RD0544_109_29_20240313_00047.jpg

View of ruts on crown surface. Spring 2024

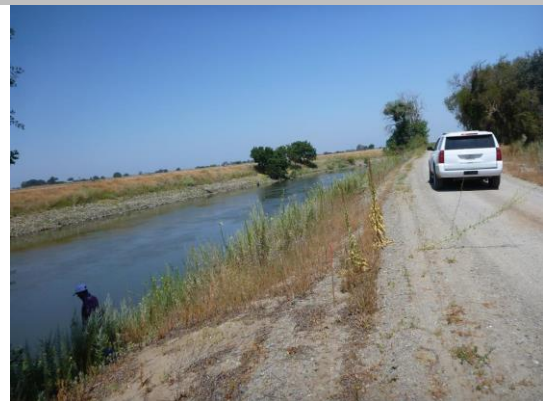
Photo 1 of 1 : LEVAL_SP_2024_554_4630.jpg

LM Start	0.57	Rating **	A/W	Issue No.	80
LM End	0.58	Issue Type +	Ma	Location *	WS
Category	Earthen Levee			GPS Latitude/Longitude	
				Start	End
Item	Erosion / Bank Caving			37.812300°	37.812400°
				-121.335100°	-121.335100°
DWR ID	LMA-460				
Comment Code					
E1 : Note and monitor erosion site.					
Inspector Comment					
This is a 2017 Storm Damage Site, ID No:554, LMA-460. Monitor waterside slope for possible erosion and rip rap displacement during high water events.

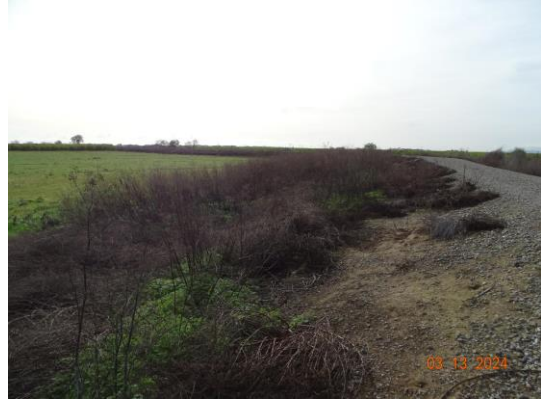
Photo 1 of 1 : SP_2024_RD0544_109_21_20240313_00045.jpg

Typical view of wild growth vegetation along the landside slope. Spring 2024

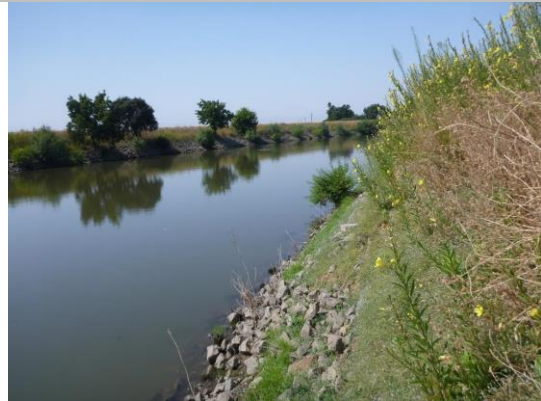
Photo 1 of 2 : LEVAL_SP_2024_548_4666.jpg

LM Start	2.65	Rating **	A/W	Issue No.	90
LM End	2.71	Issue Type +	Ma	Location *	WS
Category	Earthen Levee			GPS Latitude/Longitude	
				Start	End
Item	Erosion / Bank Caving			37.818382°	37.817800°
				-121.350804°	-121.351500°
DWR ID	LMA-454				
Comment Code					
E1 : Note and monitor erosion site.					
Inspector Comment					
This is a 2017 Storm Damage Site, ID No:548, LMA-454. Monitor waterside slope for possible erosion issues and rip rap displacement during high water events.

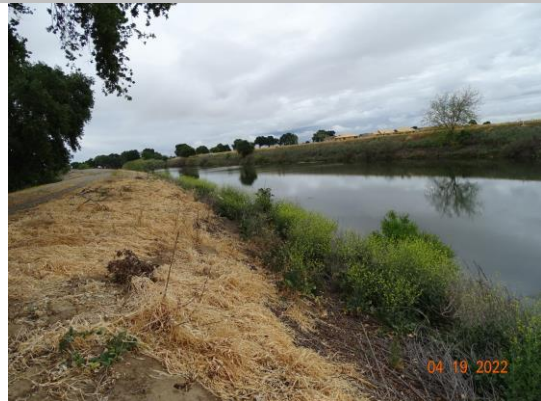
Photo 2 of 2 : SP_2024_RD0544_109_90_20240214_00016.jpg

View of waterside slope. Spring 2022

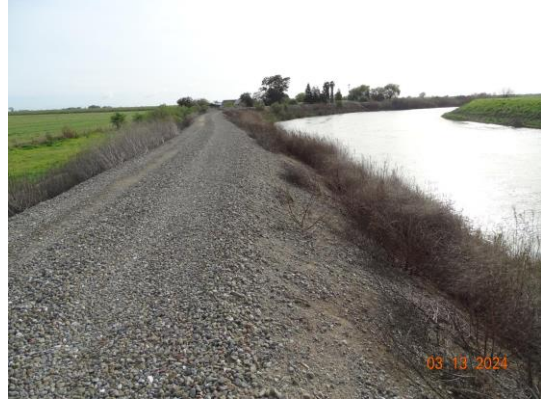
Photo 1 of 1 : SP_2024_RD0544_109_19_20240313_00044.jpg

Typical view of wild growth vegetation along the waterside slope. Spring 2024

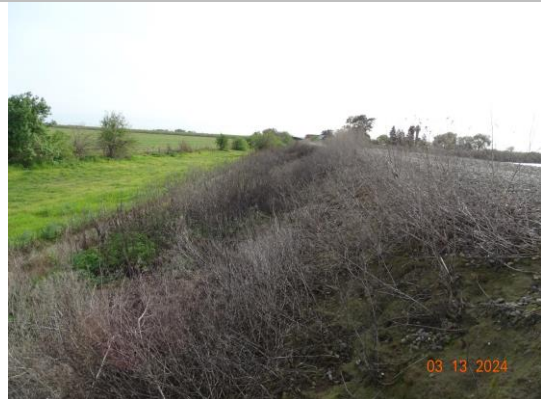
Photo 1 of 1 : SP_2024_RD0544_109_11_20240313_00043.jpg

LM Start	3.31	Rating **	U	Issue No.	11
LM End	3.44	Issue Type +	Ma	Location *	LS
Category	Earthen Levee			GPS Latitude/Longitude	
				Start	End
Item	Vegetation			37.819794°	37.819639°
				-121.361051°	-121.363387°
DWR ID	DWR_RD0544_02_f_2023_11				
Comment Code					
V2 : Remove the wild growth and woody vegetation other than native grasses from the levee slopes.					
Inspector Comment

Typical view of wild growth vegetation along the landside slope and easement. Spring 2024

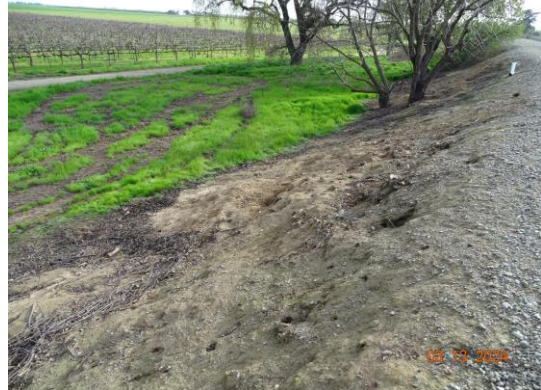
Photo 1 of 1 : SP_2024_RD0544_109_15_20240313_00041.jpg

View of multiple burrow holes along the landside slope. Spring 2024

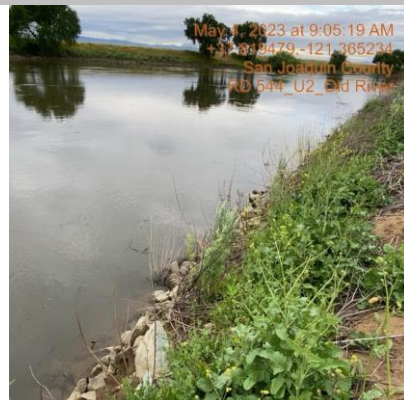
Photo 1 of 1 : SP_2024_RD0544_109_94_20240214_00020.jpg

View of rip rap along the waterside bank.

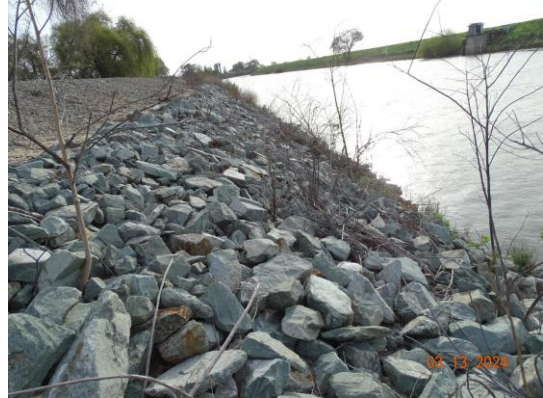
Photo 1 of 2 : SP_2024_RD0544_109_95_20240313_00039.jpg

View of revetment at the erosion site on waterside slope. Spring 2024

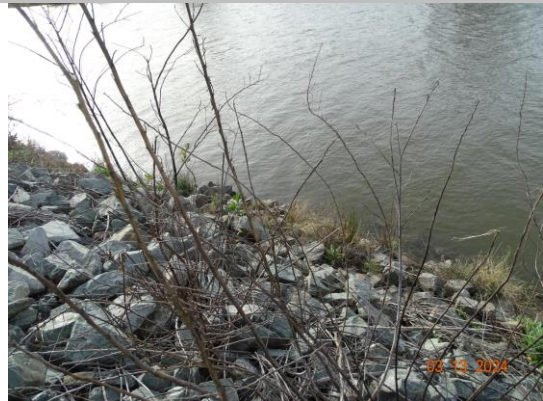
Photo 2 of 2 : SP_2024_RD0544_109_95_20240313_00040.jpg

View of revetment at the erosion site on waterside slope. Spring 2024

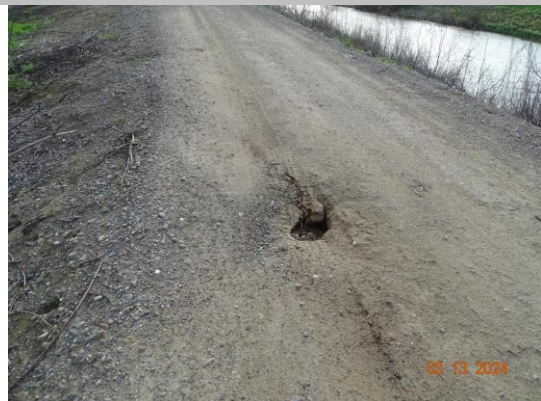
Photo 1 of 1 : SP_2024_RD0544_109_26_20240313_00037.jpg

View of hole on crown surface road. Spring 2024
