**Flood Control Project Maintenance
Levee Inspections**
LMA District Cover Sheet
Spring 2008 Levee Inspection Results

Reclamation District No. 0544

**Flood Control Project Maintenance
Levee Inspections
Unit Cover Sheet
Spring 2008 Levee Inspection Results
Reclamation District No. 0544**

Levee Inspection Report By Mile - Spring 2008

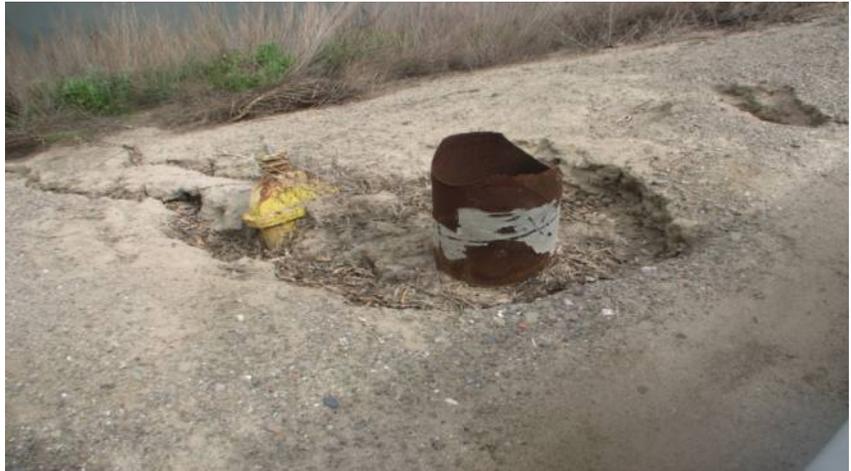
Levee Mile Report Line	7
Start Levee Mile	0.57
End Levee Mile	0.57
Location	
Category	Earthen Levee
Item	Slope Stability
Erosion around siphon pipe at LM 0.57

6	0.52	0.54	Earthen Levee	Trim / Thin Trees	LS	M	Trim trees to at least five feet above ground level.	37.864498 ° -121.325692 °	37.864448 ° -121.325400 °		6
7	0.57	0.57	Earthen Levee	Slope Stability	WS	M	Repair slope instability.	37.864357 ° -121.324860 °	37.864357 ° -121.324860 °	Y	7
8	1.66	1.66	Earthen Levee	Encroachments	LS	M	Prunings	37.854775 ° -121.322668 °	37.854775 ° -121.322668 °		8
9	2.45	2.45	Earthen Levee	Encroachments	LS	M	Material Inspector Comments: Material at toe	37.846150 ° -121.323583 °	37.846150 ° -121.323583 °		9
10	3.56	3.56	Earthen Levee	Encroachments	WS	M	Garbage	37.833153 ° -121.314433 °	37.833153 ° -121.314433 °	Y	10
11	4.05	4.16	Earthen Levee	Animal Control	LS	M	Exterminate rodents and backfill and compact or grout burrows.	37.826815 ° -121.310815 °	37.825790 ° -121.312027 °		11
12	4.50	4.69	Earthen Levee	Encroachments	WS	M	Prunings	37.823118 ° -121.316393 °	37.821958 ° -121.319592 °		12

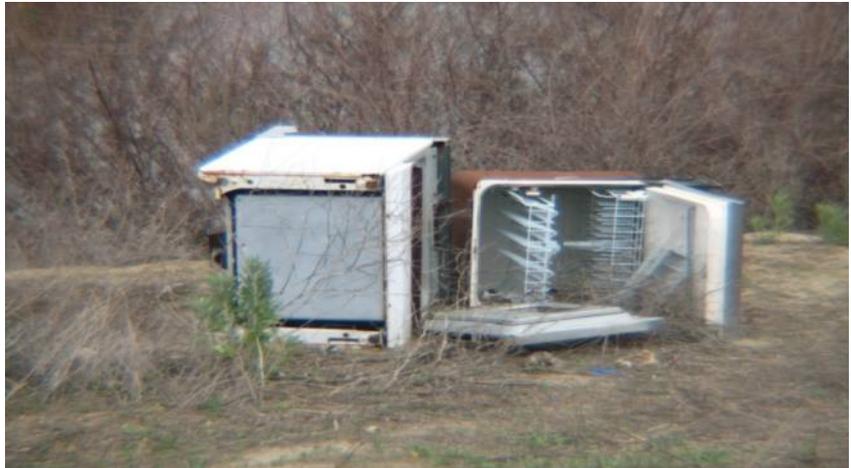
Levee Mile Report Line	10
Start Levee Mile	3.56
End Levee Mile	3.56
Location	
Category	Earthen Levee
Item	Encroachments
Garbage at waterward berm at LM 3.56

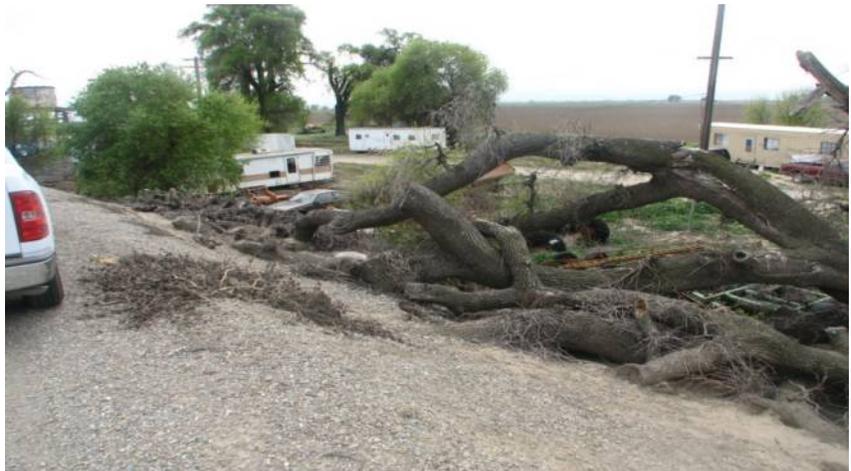
Levee Mile Report Line	14
Start Levee Mile	4.86
End Levee Mile	4.86
Location	
Category	Earthen Levee
Item	Encroachments
Tree limbs on landward slope and toe at LM 4.86

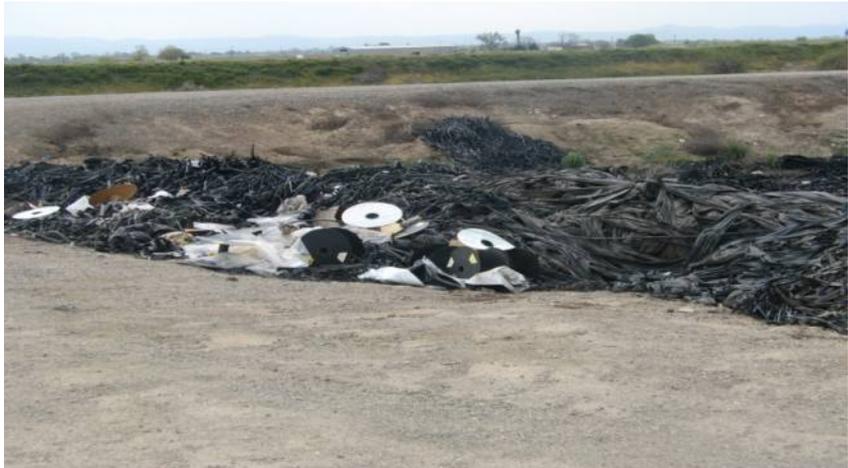
Levee Mile Report Line	12
Start Levee Mile	1.90
End Levee Mile	1.97
Location	
Category	Earthen Levee
Item	Encroachments
Garbage on landward slope from LM 1.90 to 1.97

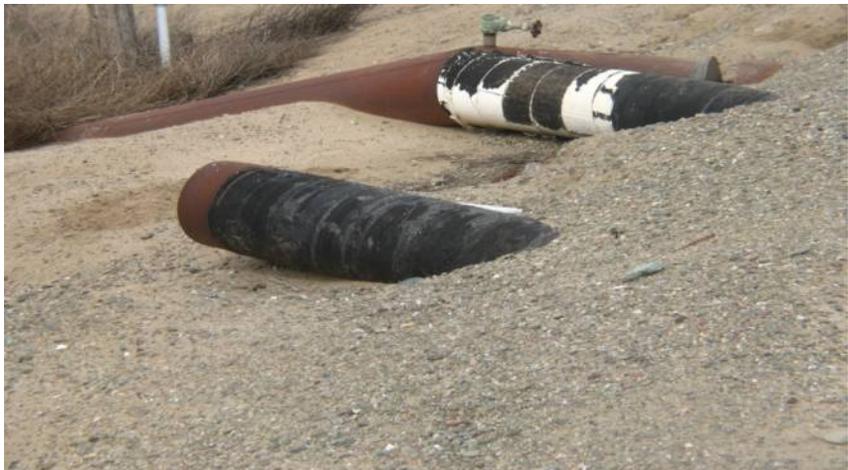
Levee Mile Report Line	15
Start Levee Mile	2.65
End Levee Mile	2.65
Location	
Category	Earthen Levee
Item	Encroachments
Abandoned pipe at LM 2.65 landside view

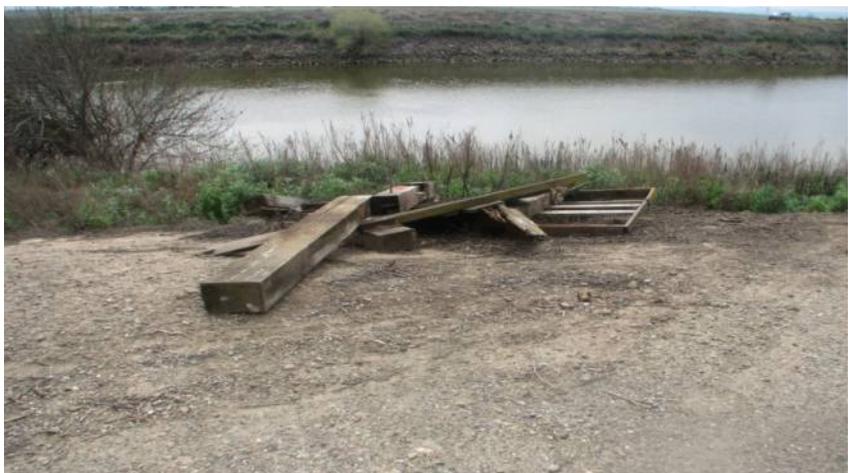
Levee Mile Report Line	18
Start Levee Mile	3.29
End Levee Mile	3.29
Location	
Category	Earthen Levee
Item	Encroachments
Garbage on waterwade shoulder at LM 3.29

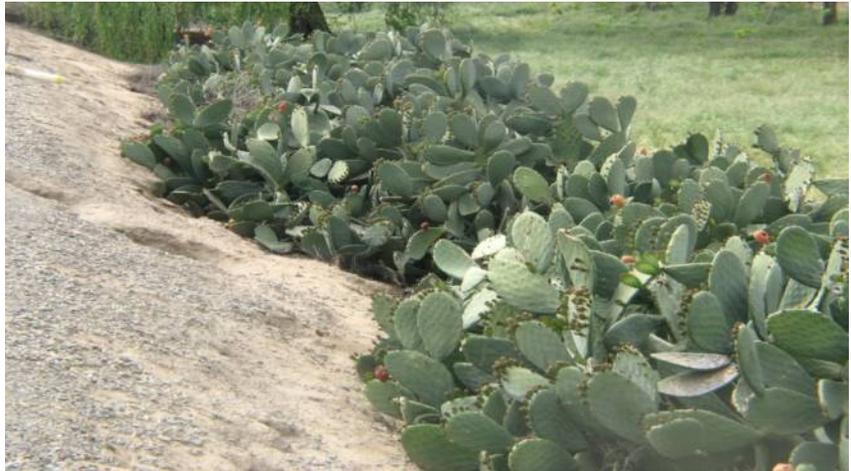
Levee Mile Report Line	20
Start Levee Mile	3.54
End Levee Mile	3.56
Location	
Category	Earthen Levee
Item	Vegetation
Cactus at landward toe from LM 3.54 to 3.56
